ICON
ARCHITECTURAL GROUP

FACILITY ASSESSMENT FOR GRAND FORKS PUBLIC SCHOOLS

Grand Forks, ND

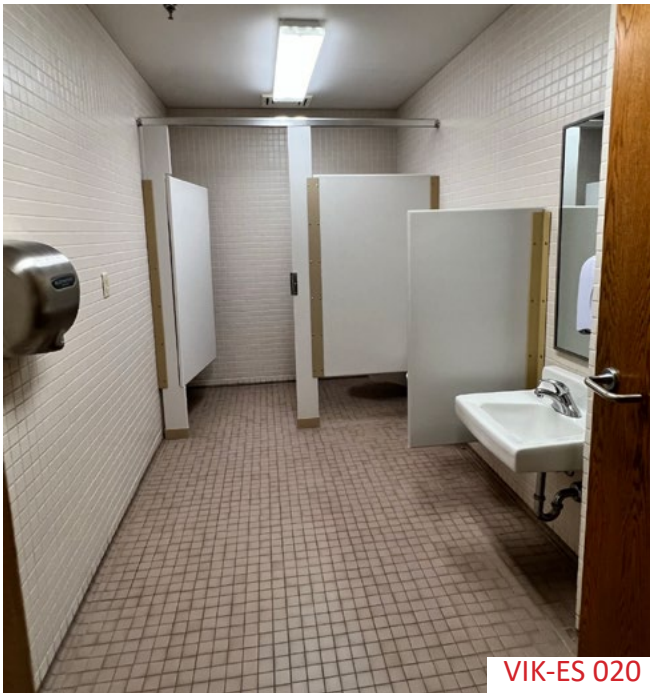
VIK-ES 020

All boys' and girls' restrooms are not accessible.

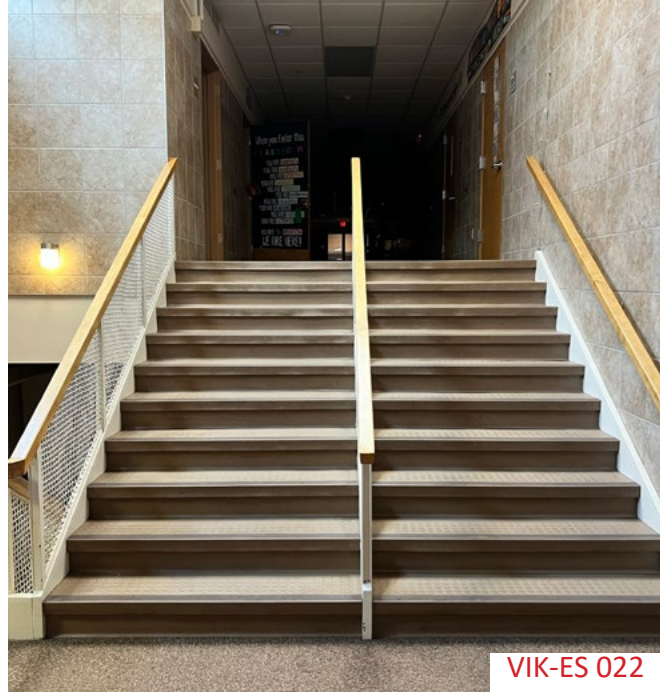
VIK-ES 022

Guard rails for all stairwells do not meet height requirements.

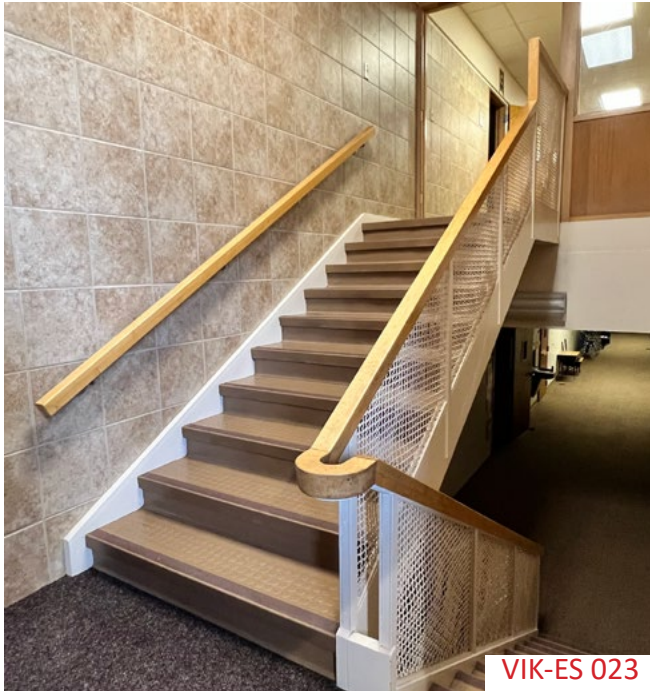
Handrail cross sections exceed size limitations per code.

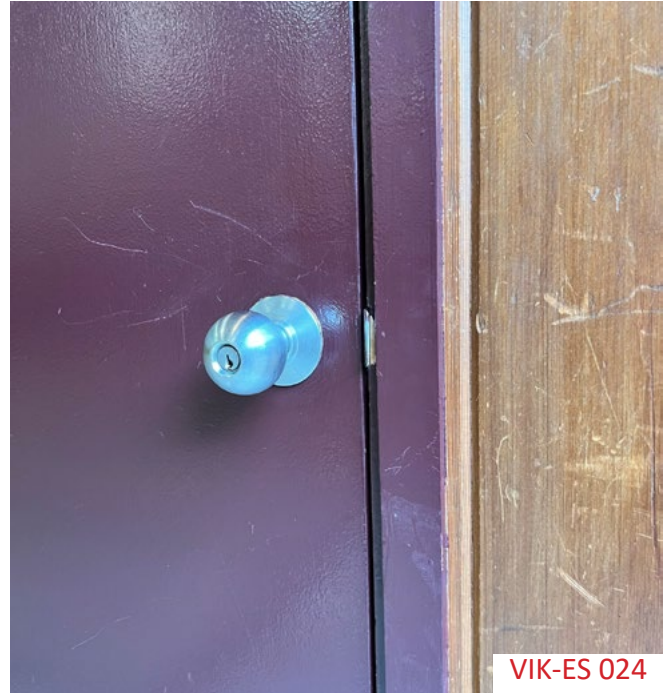
Doors in STAR rooms and storage rooms in the gym do not have accessible door hardware.

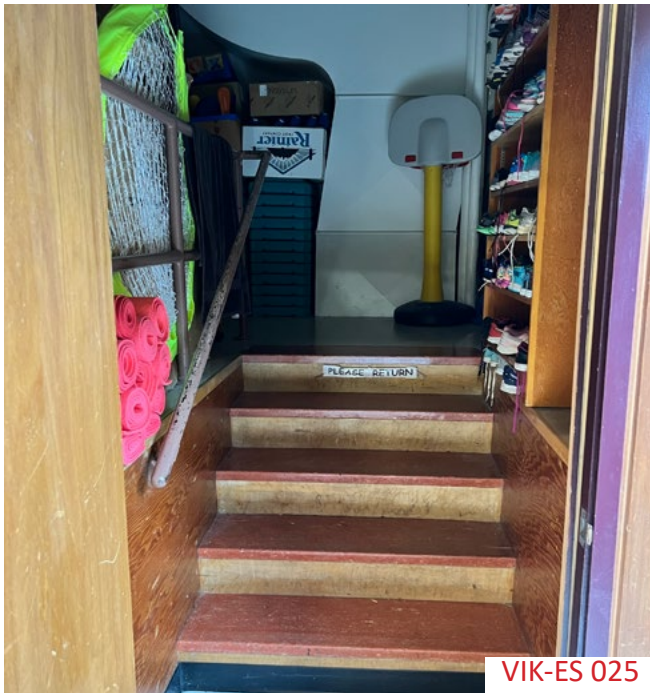
Stairwells leading up to the stage do not have handrails on both sides.

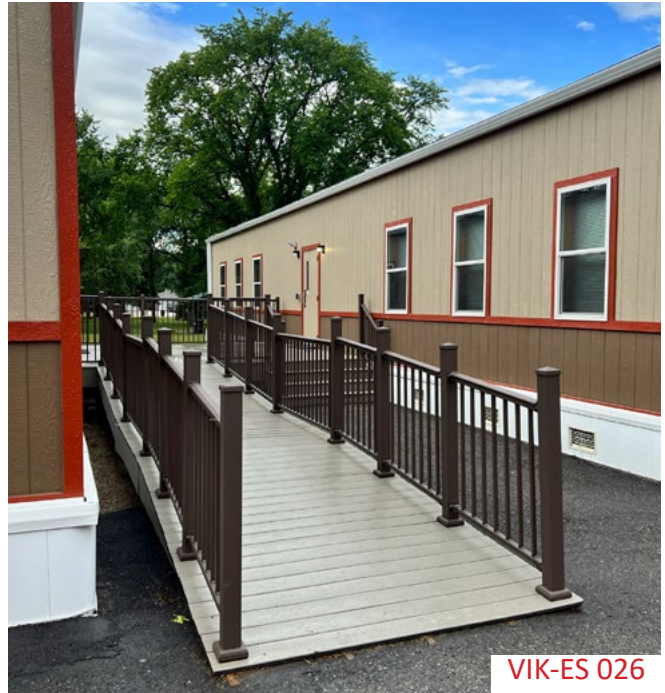
Handrails are not present in stairwells on ramps leading to portable classrooms.

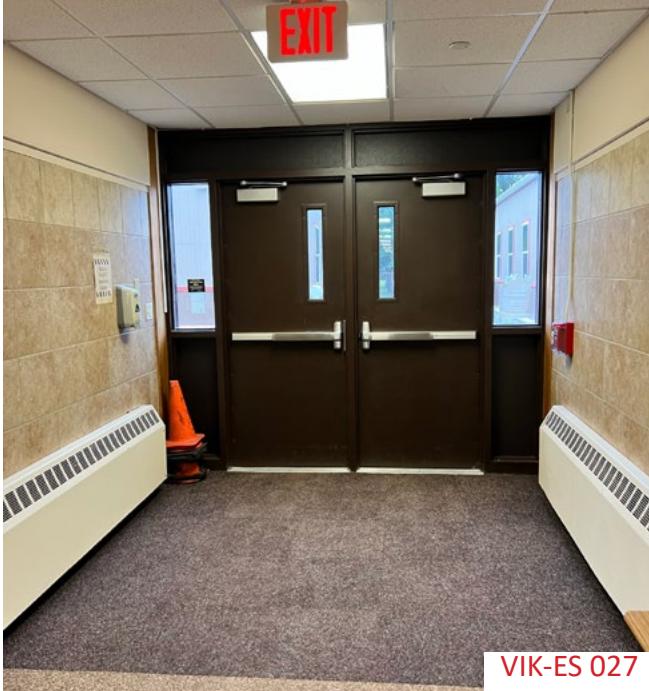
All public entrances should be protected with an enclosed vestibule, as required by energy code.

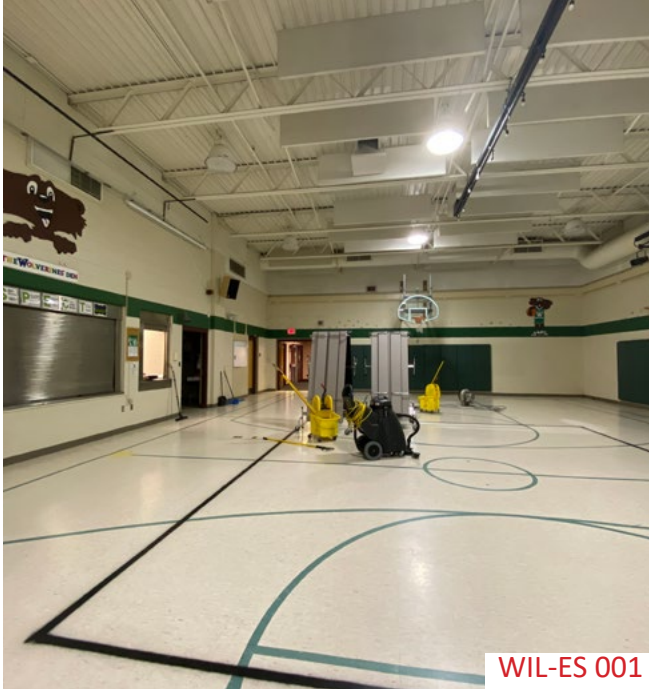
WIL-ES 001

The school lacks in space as larger classrooms were split into two, the gym is also used as the cafeteria, and the nurse's office is too small.

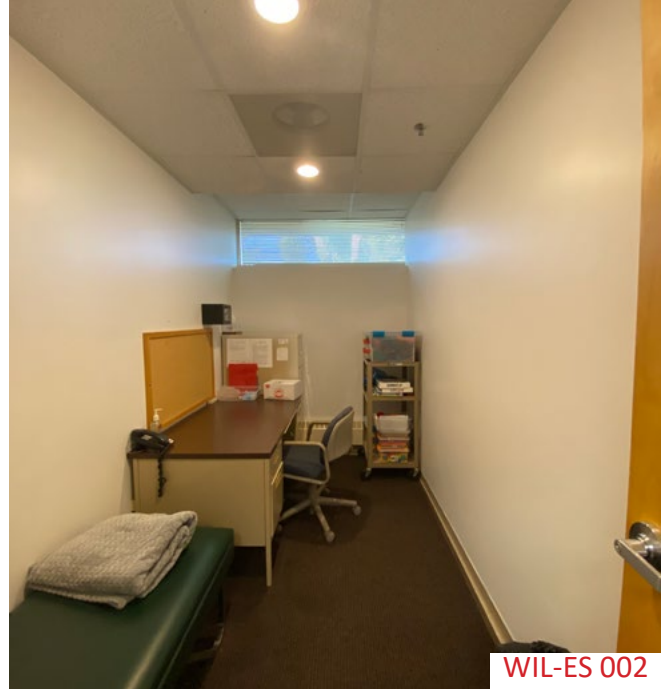
WIL-ES 002

The school lacks in space as larger classrooms were split into two, the gym is also used as the cafeteria, and the nurse's office is too small.

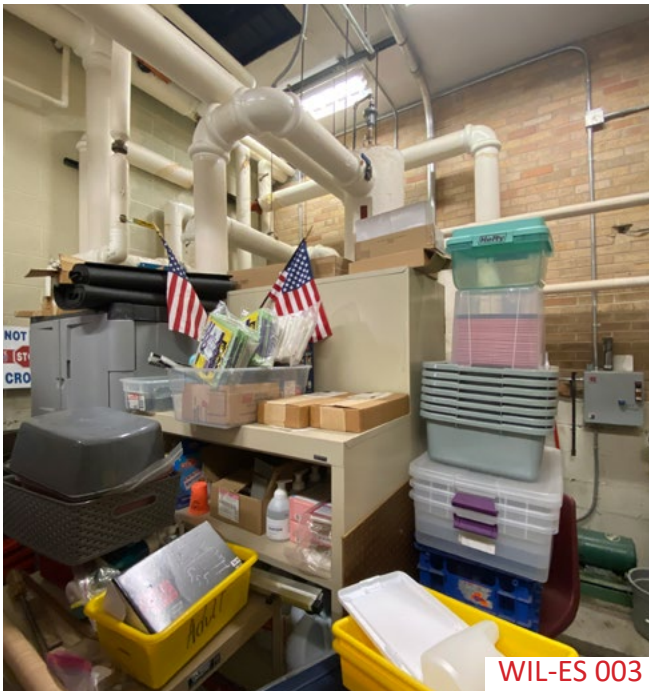
WIL-ES 003

There is also a lack of storage with the mechanical room acting as a storage room.

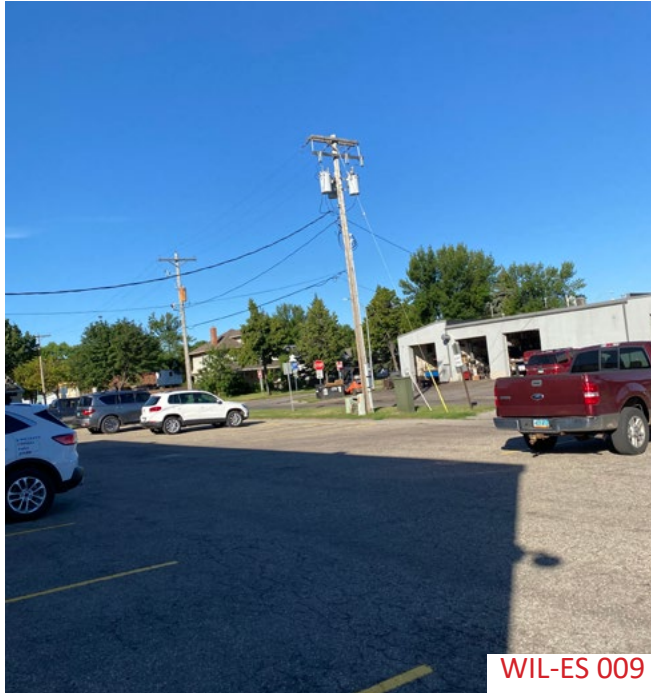
WIL-ES 009

The school's parking lot is small with current drop-off/pick-up not optimal.

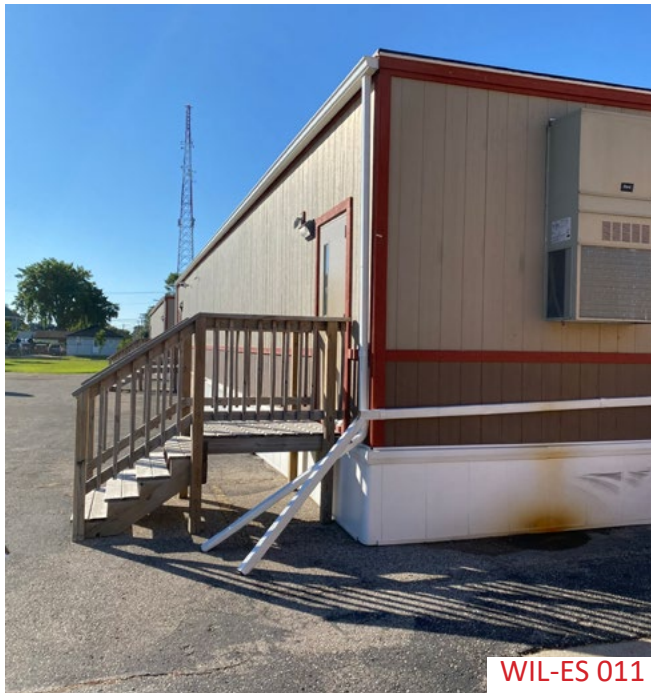
WIL-ES 011

Two portable classrooms are found on the east side of the building.

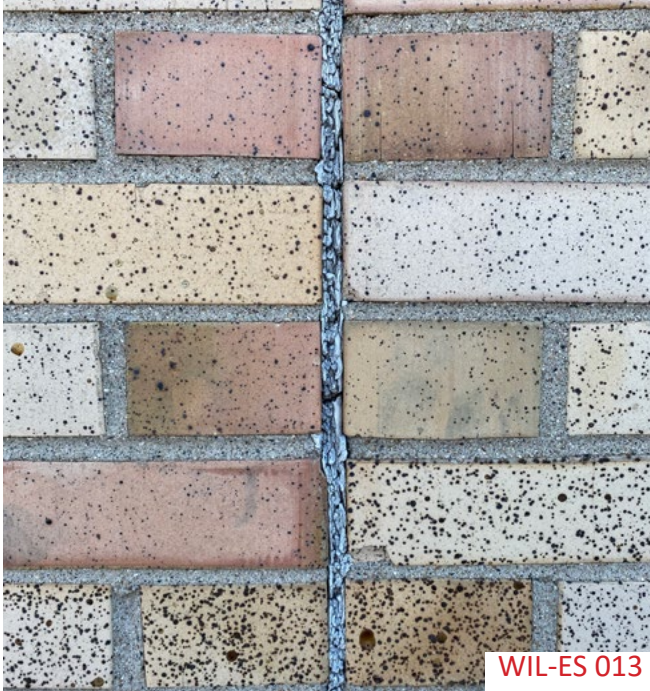
WIL-ES 013

Caulking is in bad condition and should be redone.

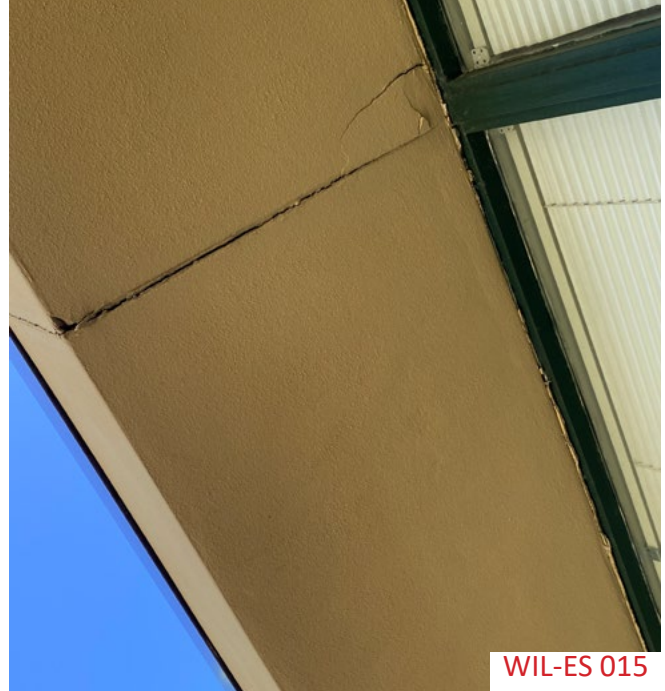
WIL-ES 015

Cracking was seen along the span of the EFIS along with the caulking needing to be redone.

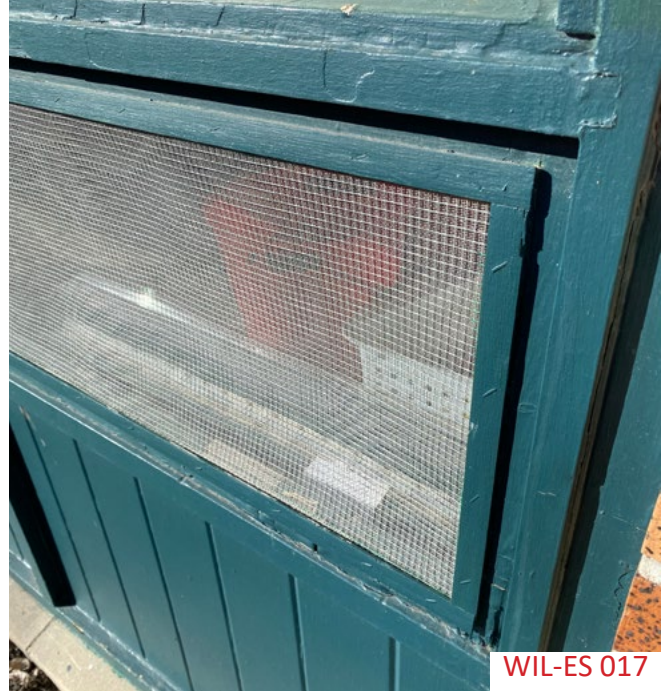
WIL-ES 017

Wire mesh windows outside are painted shut.

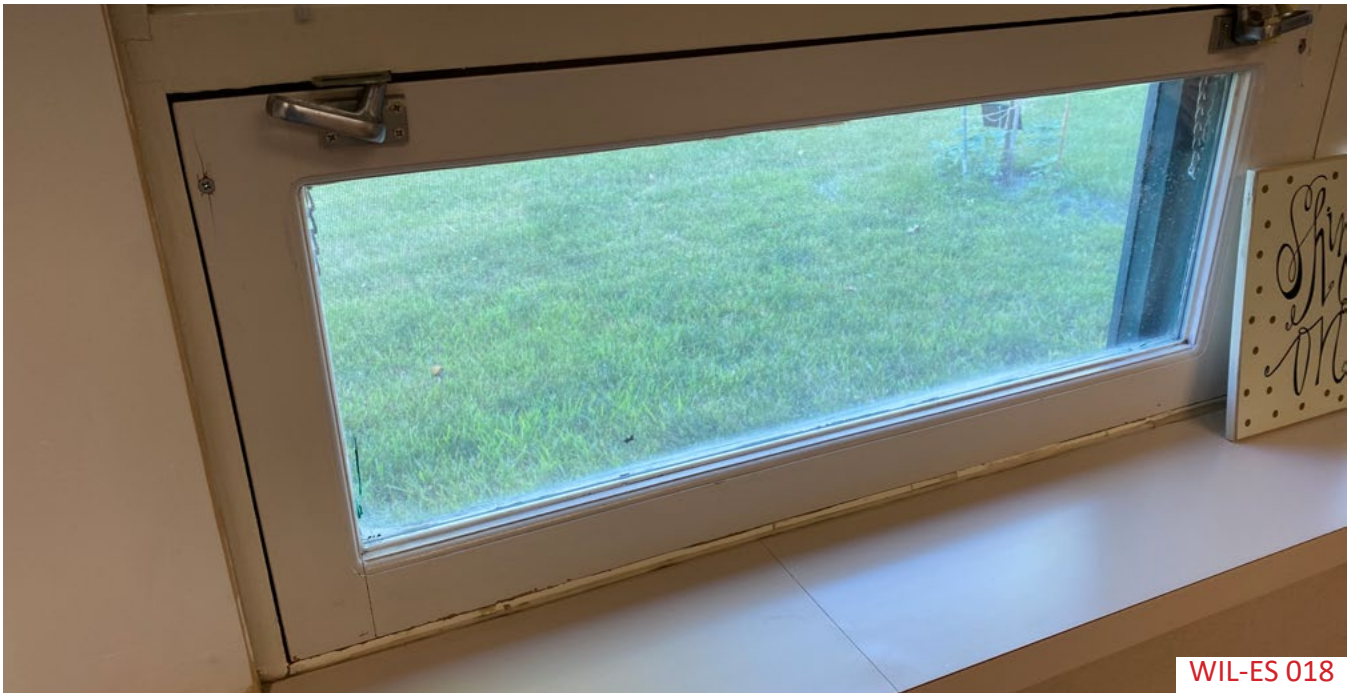
WIL-ES 018

Due to the age of the windows, the sealant has shrunk and no longer runs the entire width of the glass panels.

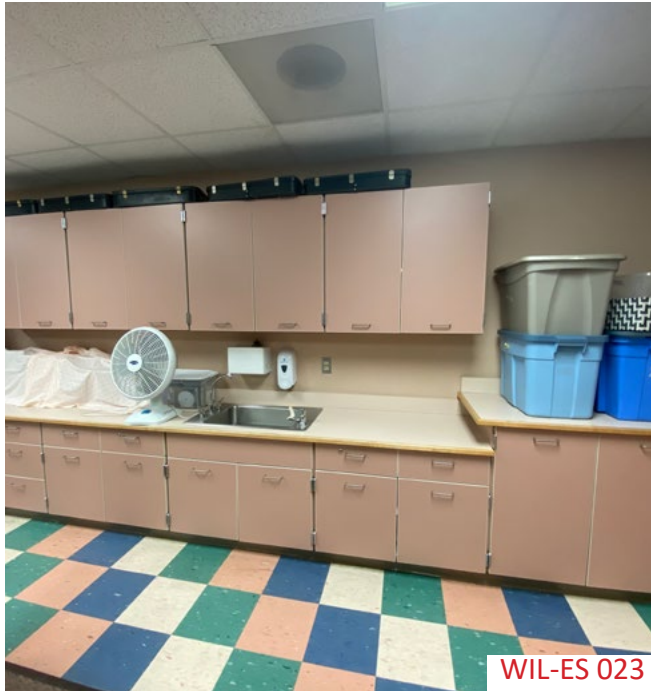
WIL-ES 023

Some classrooms have dated tile in front of cabinetry.

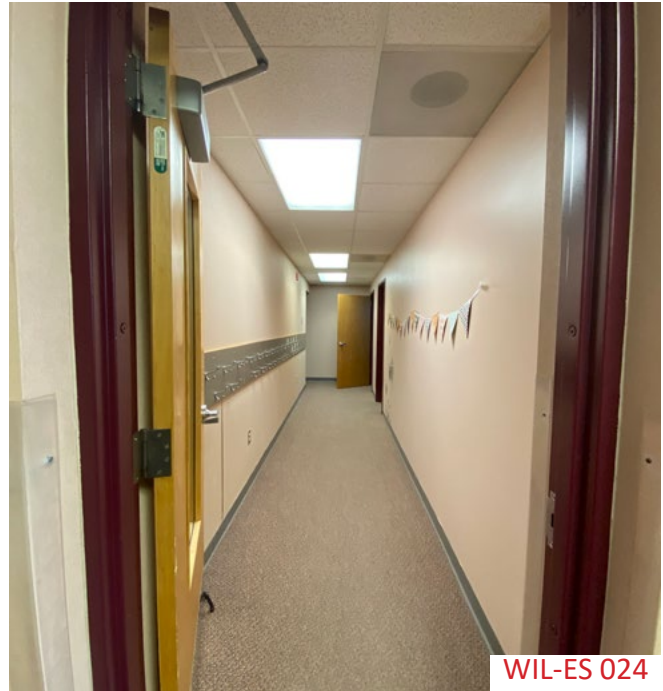
WIL-ES 024

Entry hallway door needs to swing out per occupancy loads, and panic hardware is needed as well.

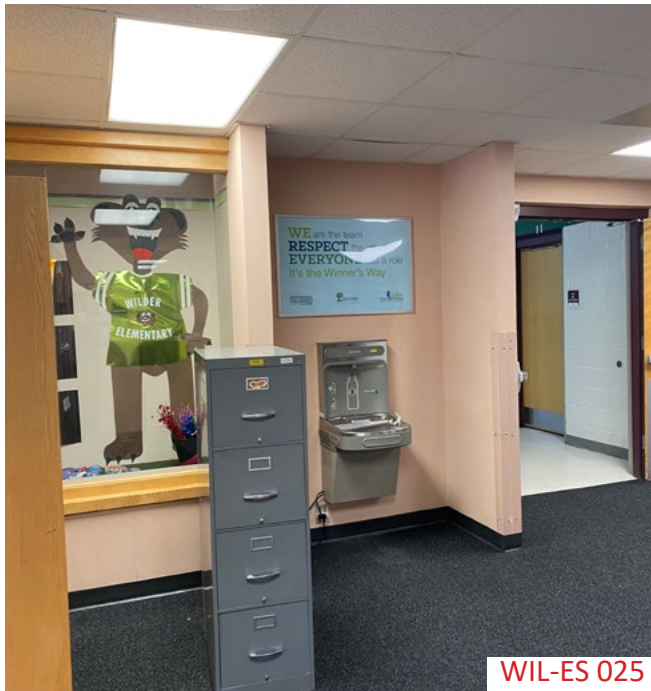
WIL-ES 025

Drinking fountains throughout the building do not meet the required ratio of wheelchair accessible fountains to standing person accessible fountains.

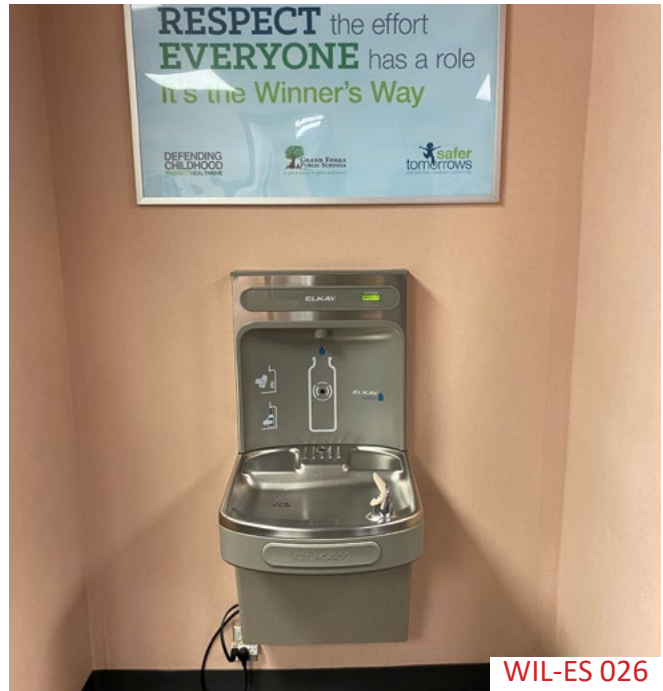
WIL-ES 026

Drinking fountains throughout the building do not meet the required ratio of wheelchair accessible fountains to standing person accessible fountains.

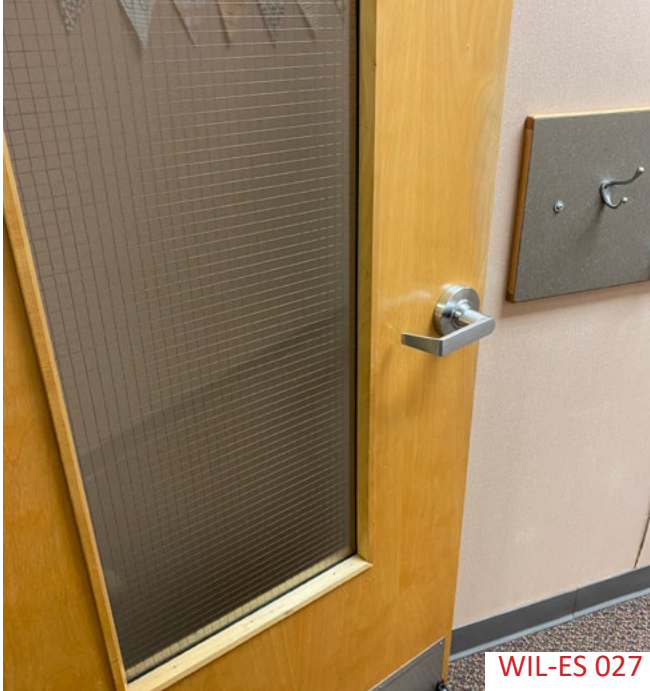
WIL-ES 027

Traditional wire glass throughout building is no longer to code as an acceptable type of safety glass.

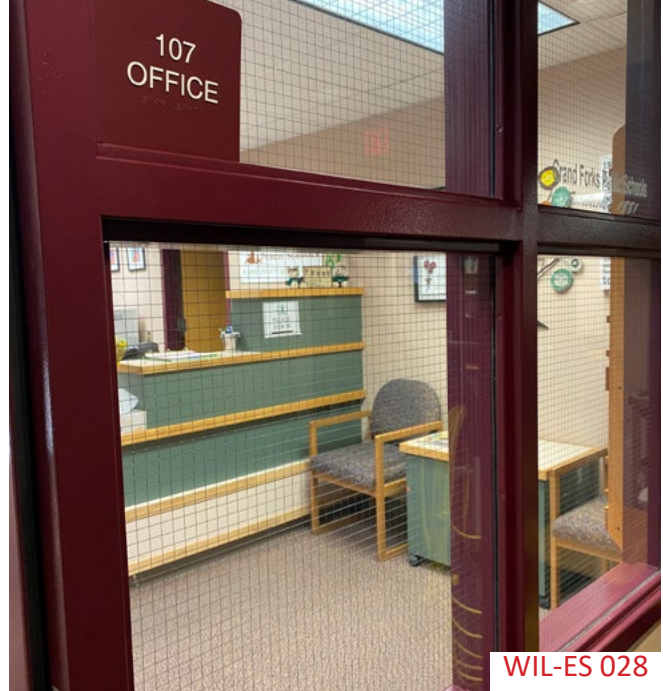
WIL-ES 028

Traditional wire glass throughout building is no longer to code as an acceptable type of safety glass.

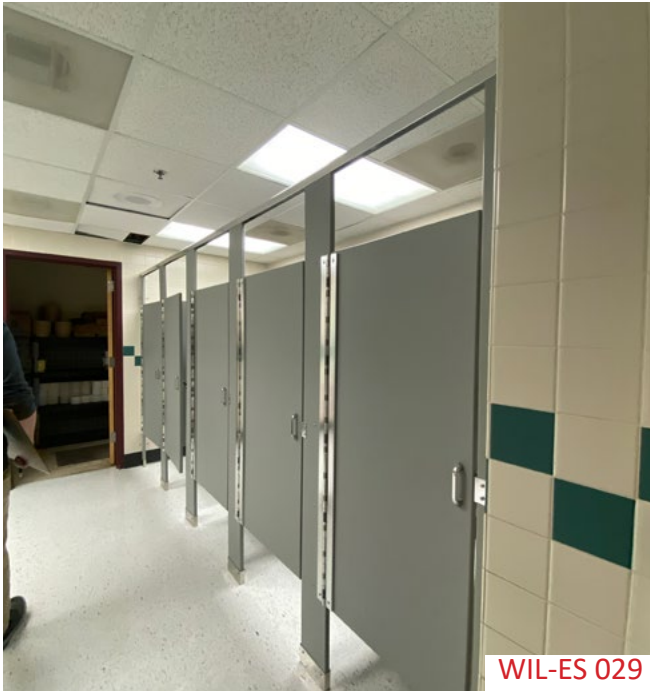
WIL-ES 029

Both girl's and boy's restrooms are not accessible.

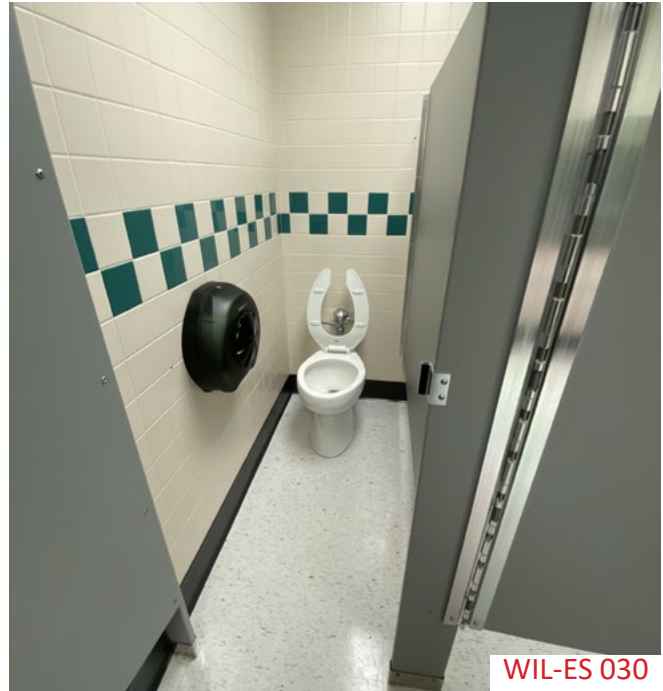
WIL-ES 030

Both girl's and boy's restrooms are not accessible.

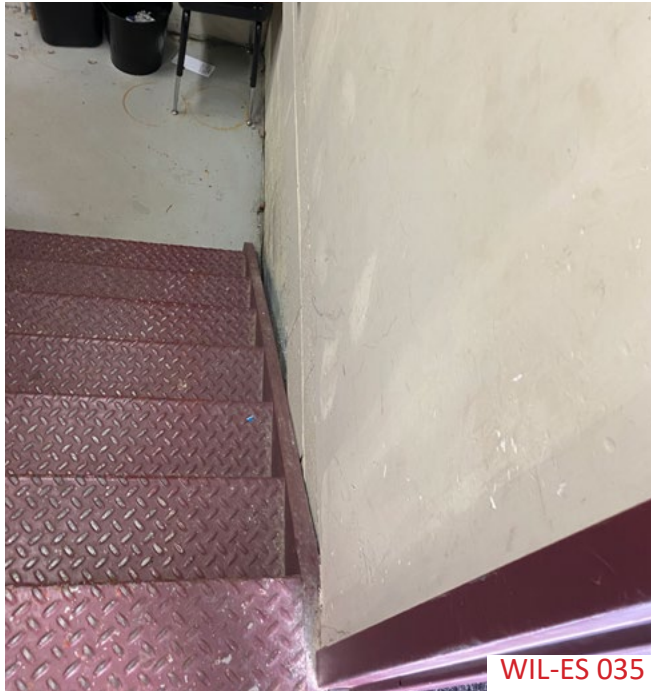
WIL-ES 035

All stairs in mechanical rooms do not have handrails on both sides, as required by code.

Add grab bars in the kindergarten restrooms that are missing grab bars	7	2 Ea	\$478.09 /Ea	\$956					\$956
Add handrails to the stairs in mechanical area	8	120 LF	\$131.89 /LF	\$15,826					\$15,826
Add interior vestibule to doors 1 and 2	9	2 Ea	\$18,446.81 /Ea	\$36,894					\$36,894
Create an ADA accessible entrance to the playground	10	1 LS	\$12,602.87 /LS	\$12,603					\$12,603
Replace the sheetrock (tape and paint) on the exterior walls where moisture was trapped in side	11	4,800 SF	\$14.80 /SF	\$71,046					\$71,046
Total Code Compliance		22,333 SF	\$16.09 / SF	\$359,273	\$0	\$0	\$0		\$359,273
Security									
Secure entrance, administration office and special education relocation remodel	12	2,720 SF	\$266.94 /SF				\$726,077		\$726,077
Total Security		2,720 SF	\$266.94 / SF	\$0	\$0	\$0	\$726,077		\$726,077
Addition/Remodel (Educational Adequacy)									
Administration	13	117 SF	\$339.20 /SF				\$39,686		\$39,686

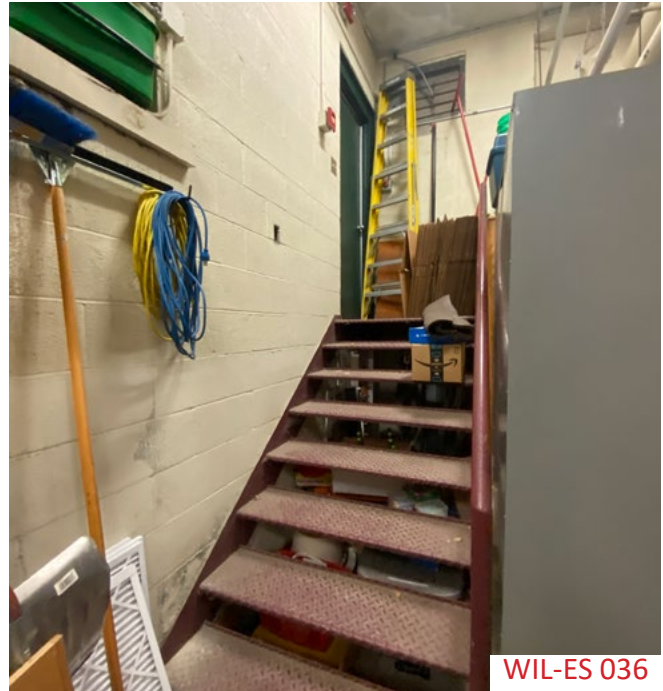
WIL-ES 036

All stairs in mechanical rooms do not have handrails on both sides, as required by code.

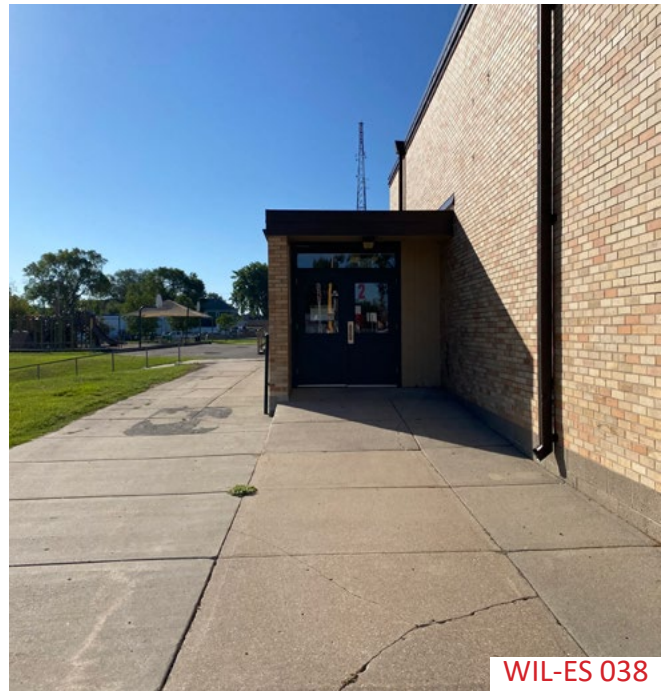
WIL-ES 038

Doors 1 and 2 are not protected with enclosed vestibules, as required by energy code.

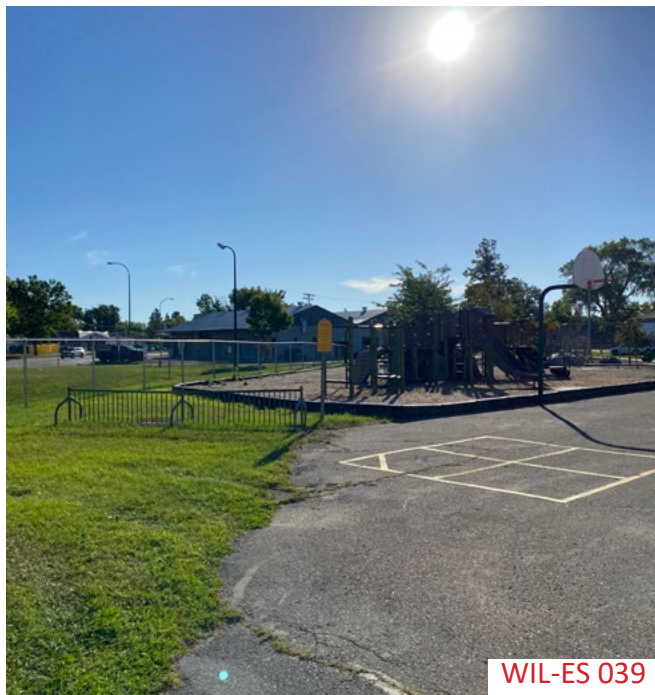
The playground is not accessible on all sides.

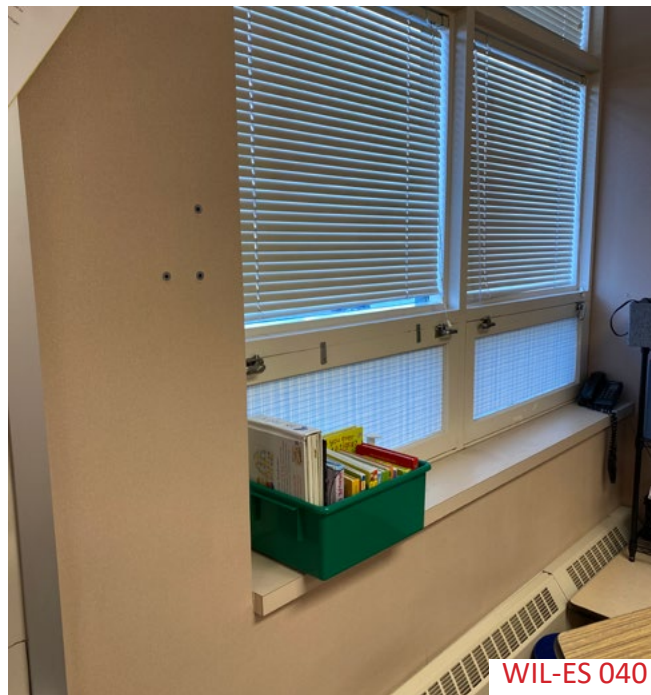
Portions of exterior walls are covered with vinyl wall covering on the interior side, which is not to code.

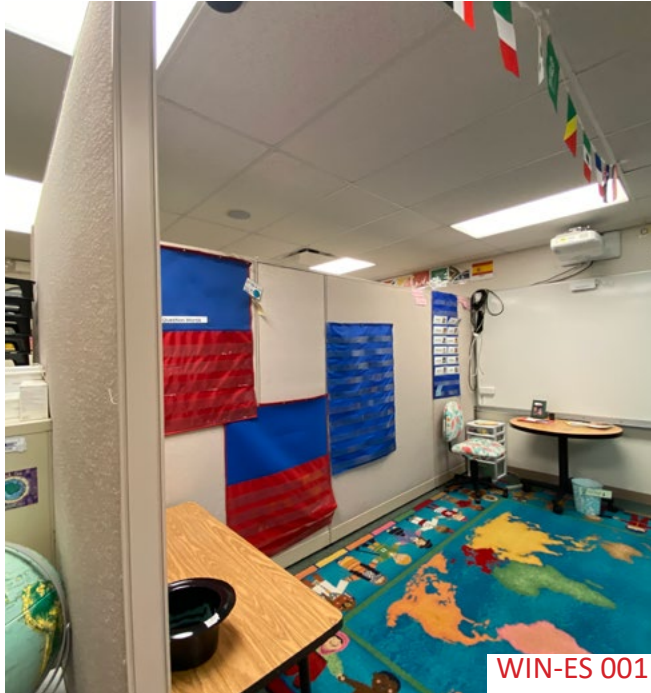
WIN-ES 001

Many of the classrooms are split by shelves and partial walls to simulate smaller areas for individualized learning which is not ideal.

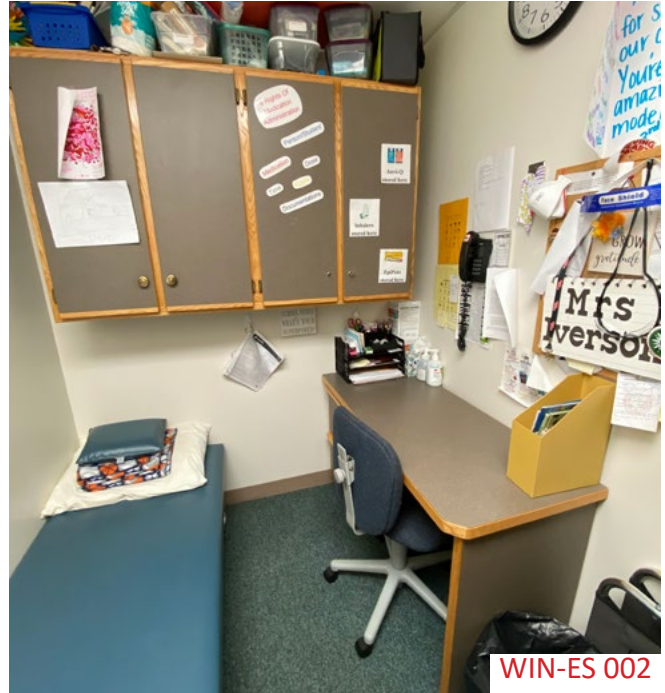
WIN-ES 002

The nurse's office has little space, and a bigger room would allow for more than one student to be in there at a time.

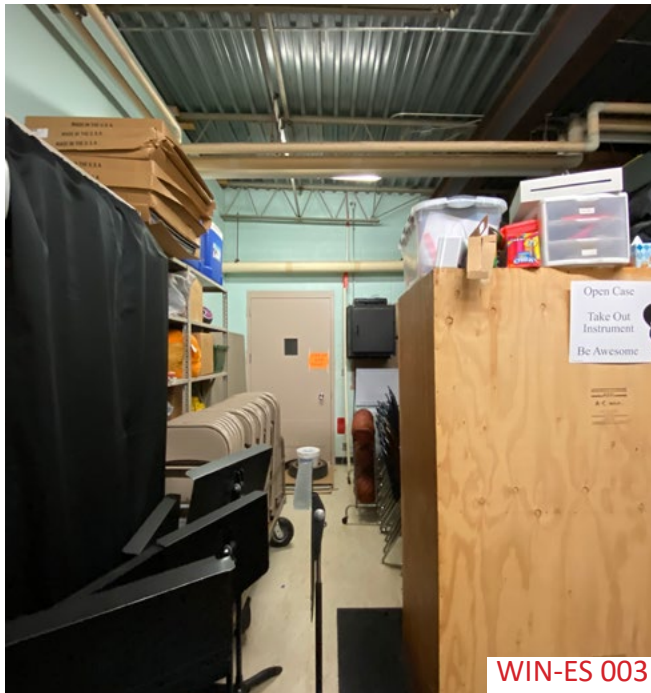
WIN-ES 003

More storage space within the building is needed at the mechanical room is filled with objects.

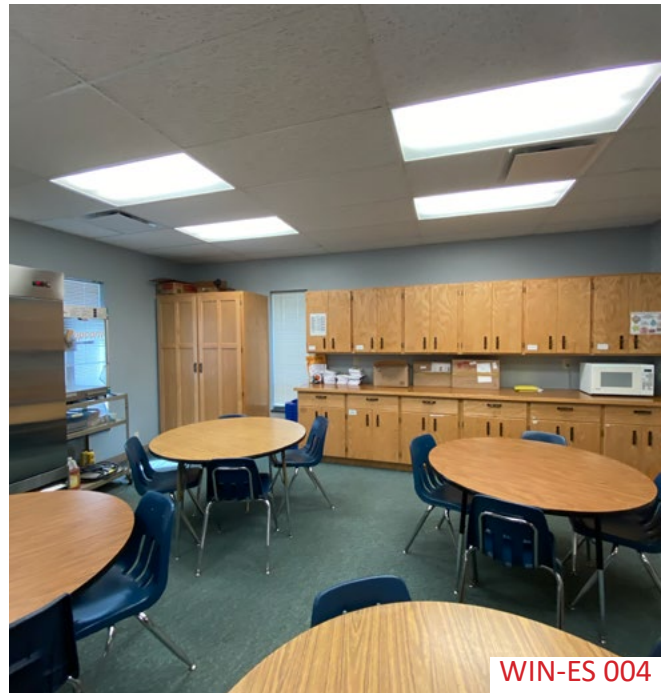
WIN-ES 004

The casework in the building is dated but is functionally sound.

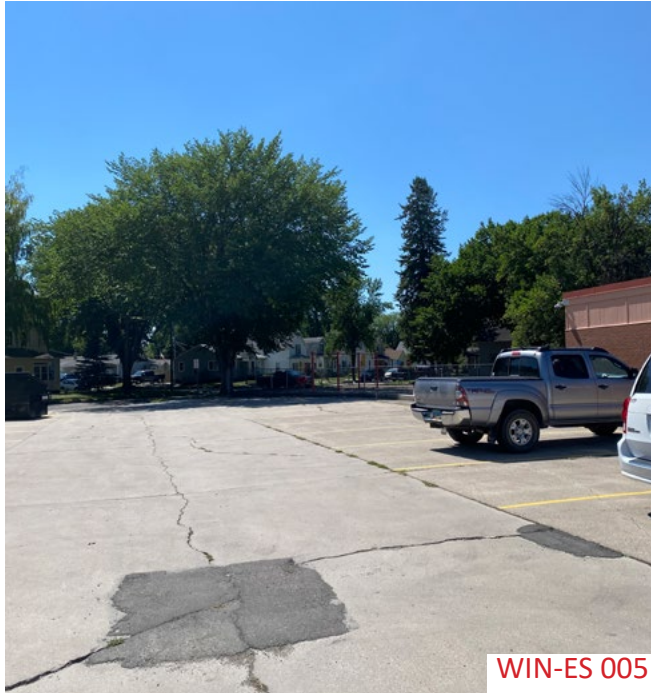
The asphalt on the site had lots of cracking and was uneven near the entrances which creates issues for accessibility.

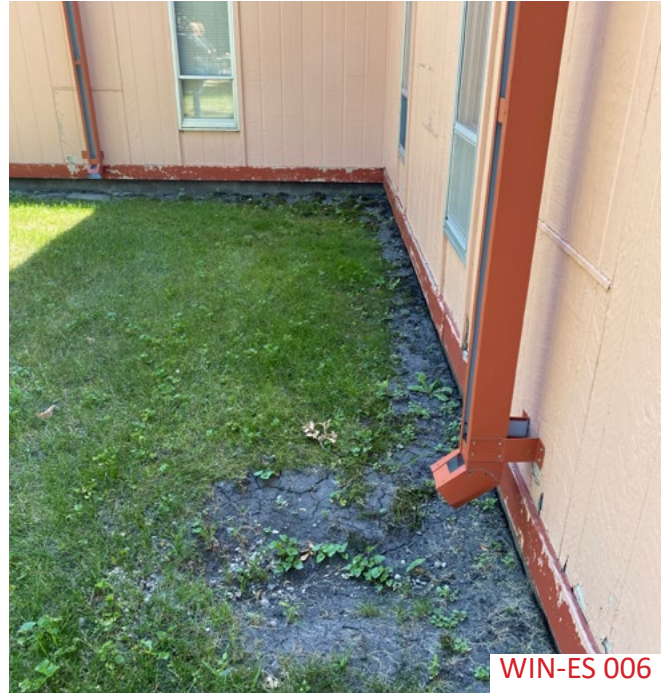
Numerous downspouts did not have concrete splash blocks underneath them to reduce water damage to the site.

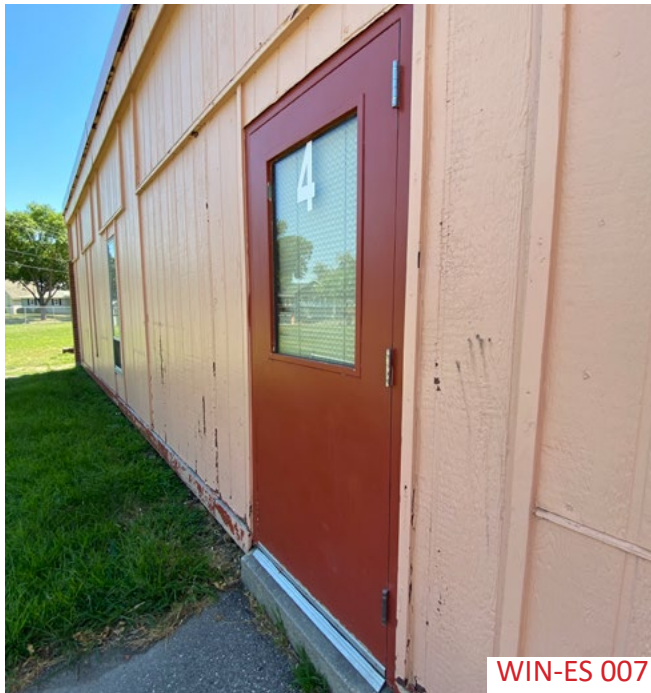
Door 4 needs a concrete stoop on the exterior.

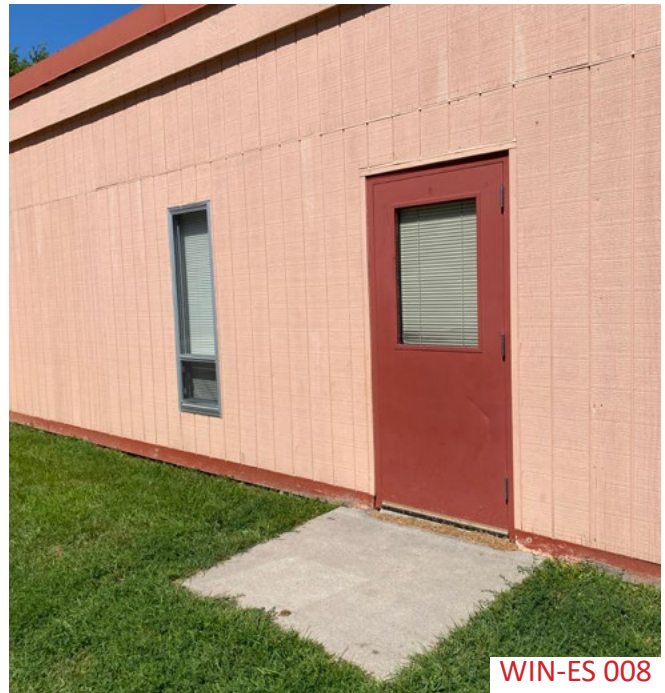
Several emergency exit doors had concrete stoops that need to be connected to public ways.

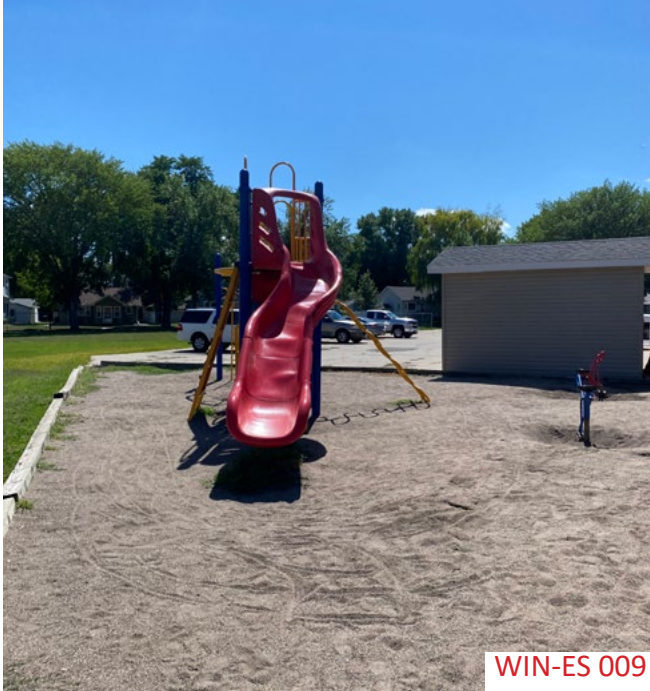
WIN-ES 009

Both of the playgrounds are not accessible and have sand bases which should be swapped with a safer alternative.

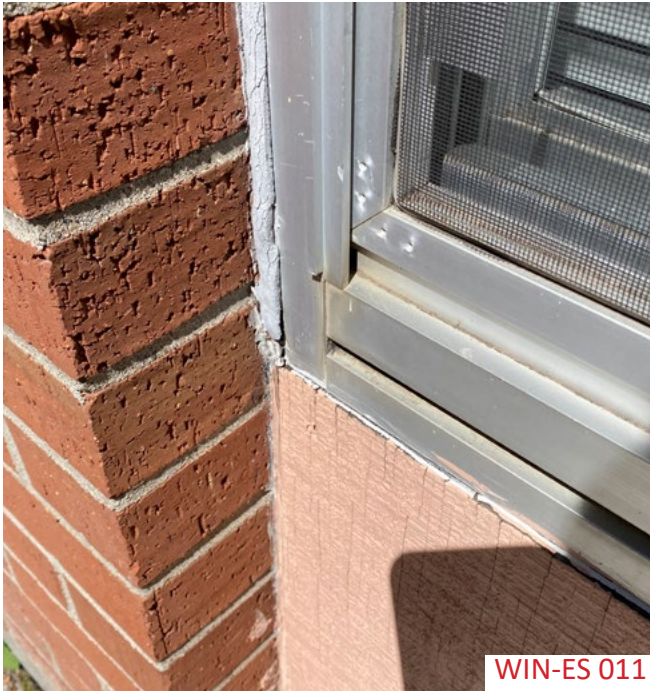
WIN-ES 011

The exterior brick is overall in good condition. There is some cracking seen near the exterior doors of the mechanical room (010). Caulking around the windows could use some attention (011).

Caulking around the windows could use touching up.

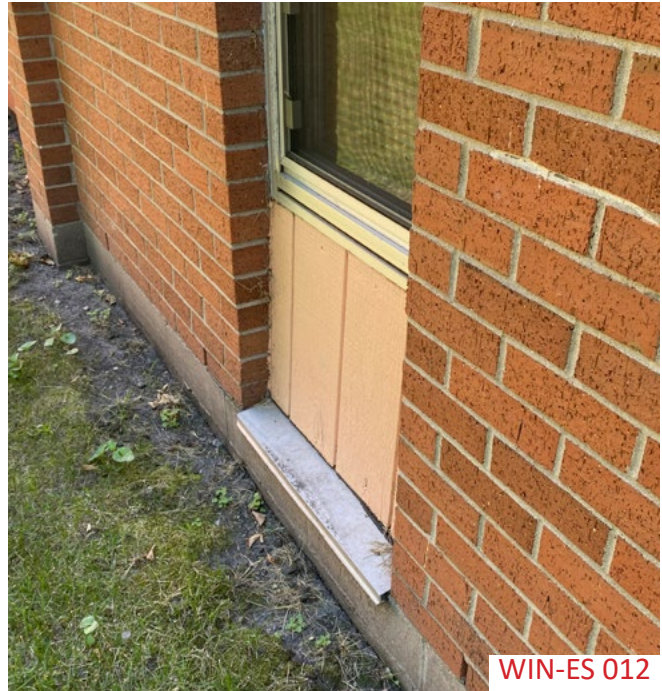
WIN-ES 012

The wooden baseboard does not have the appropriate flashing for water protection.

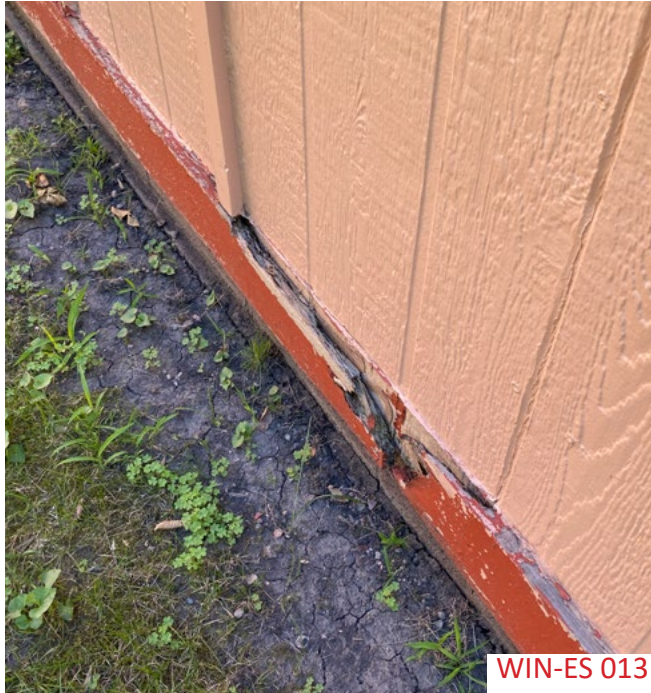
WIN-ES 013

The wooden baseboard does not have the appropriate flashing for water protection, therefore the wood is rotting and falling off in a number of areas.

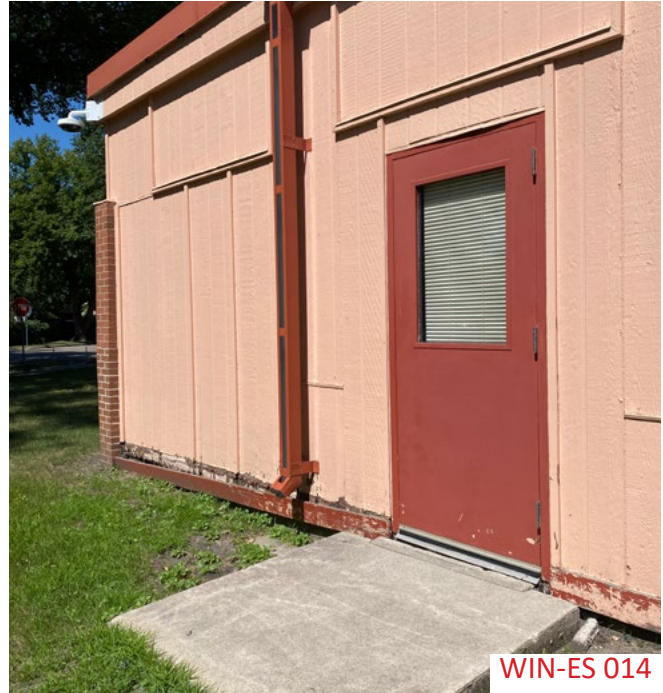
WIN-ES 014

The wooden baseboard does not have the appropriate flashing for water protection, therefore the wood is rotting and falling off in a number of areas.

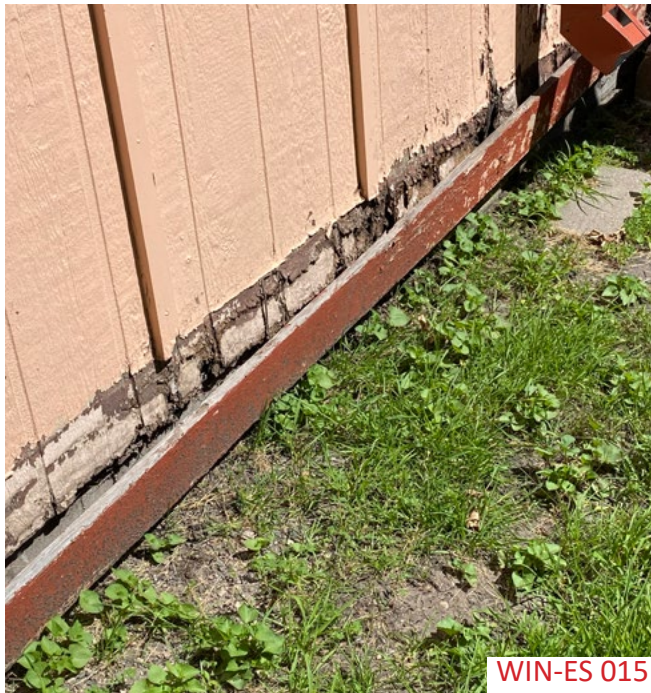
WIN-ES 015

The wooden baseboard does not have the appropriate flashing for water protection, therefore the wood is rotting and falling off in a number of areas.

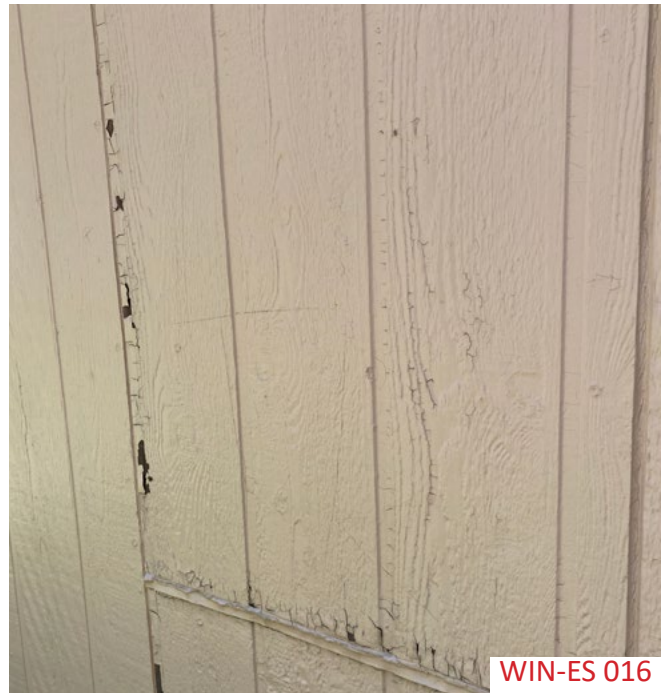
WIN-ES 016

The paint is peeling off as well, further reducing the water protection of the exterior.

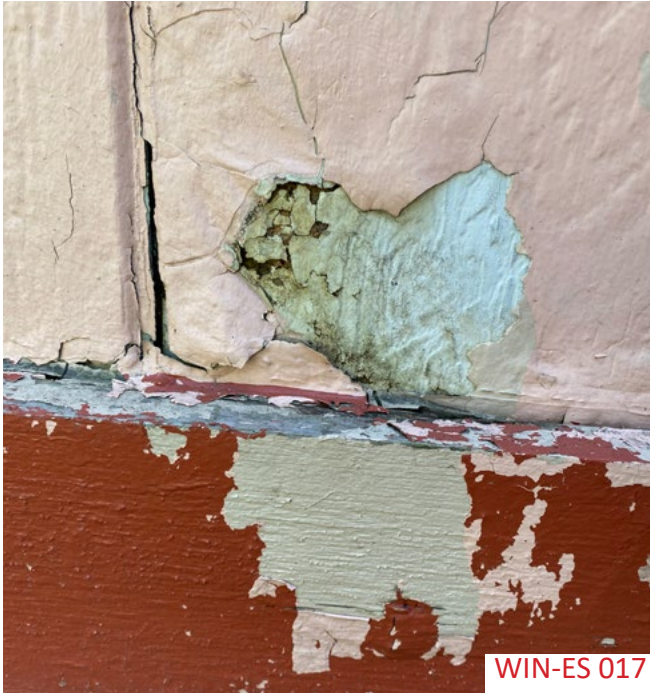
The paint is peeling off as well, further reducing the water protection of the exterior.

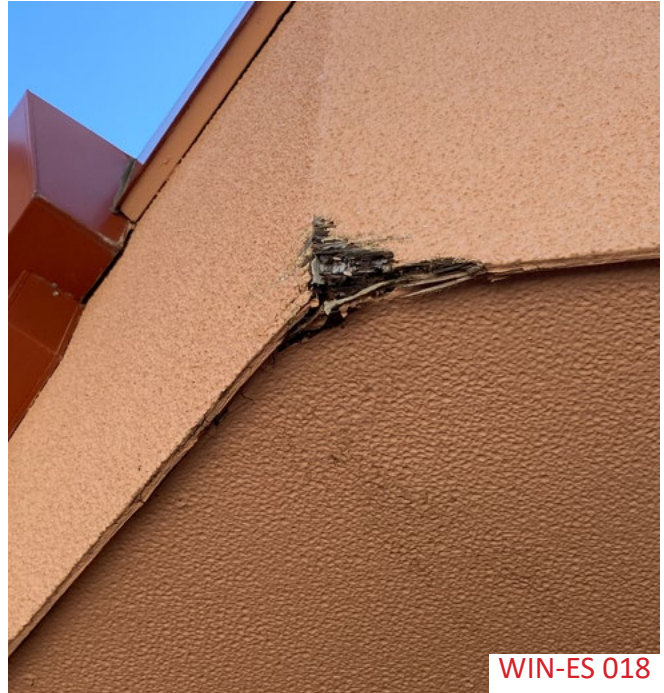
The plastered wood over the entrance is showing signs of age and is deteriorating.
