ICON
ARCHITECTURAL GROUP

FACILITY ASSESSMENT FOR GRAND FORKS PUBLIC SCHOOLS

Grand Forks, ND

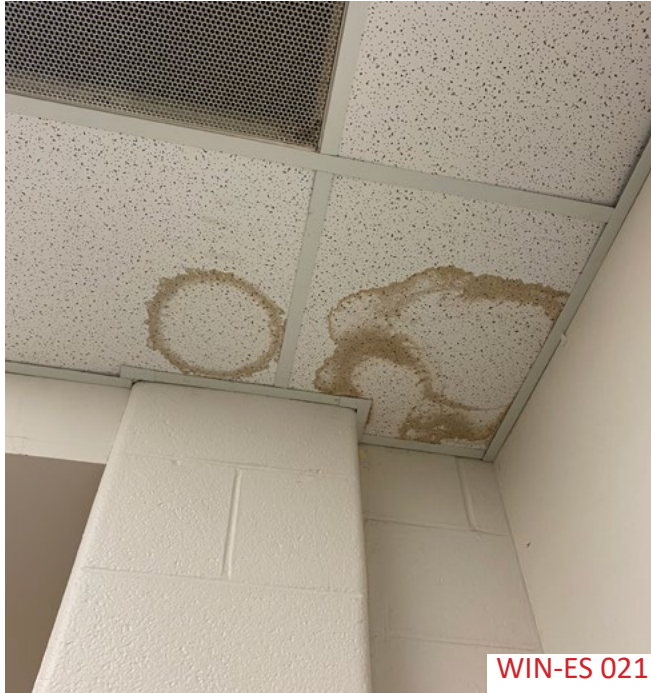
There were only a few water spots seen in the resource room.

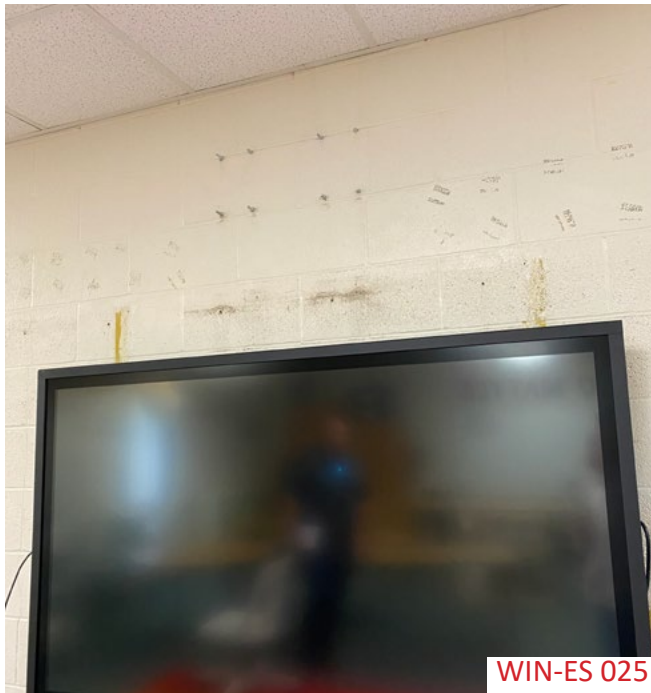
In Room 147C, the CMU paint has patches and could use some retouching.

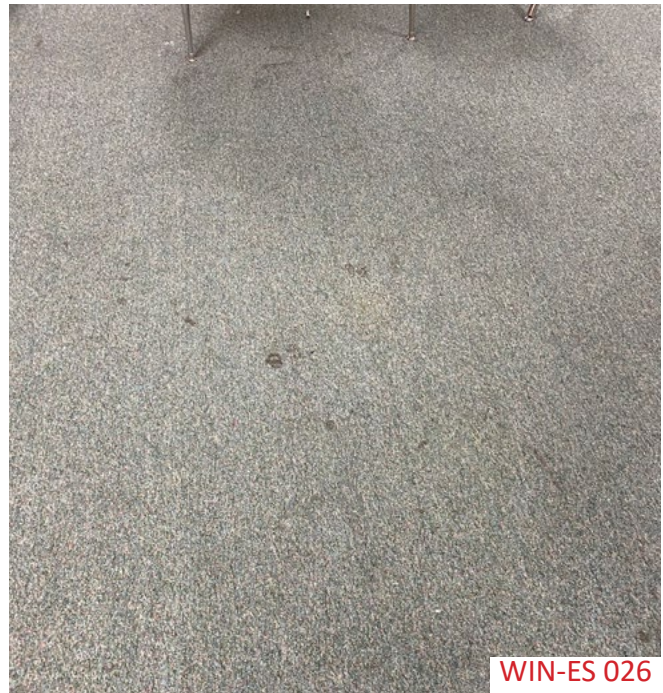
The carpeting in the hallway was recently replaced, but the classrooms still have old carpet.

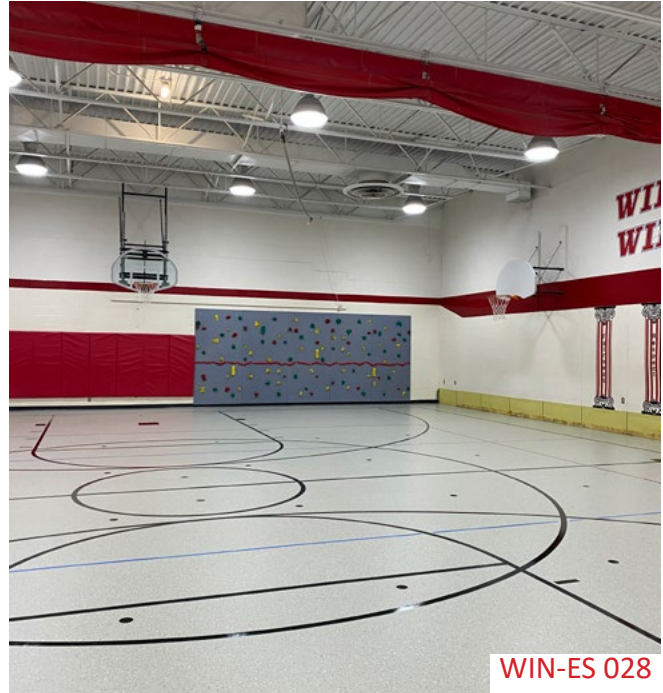
WIN-ES 028

The gym floor was recently redone and is in great shape.

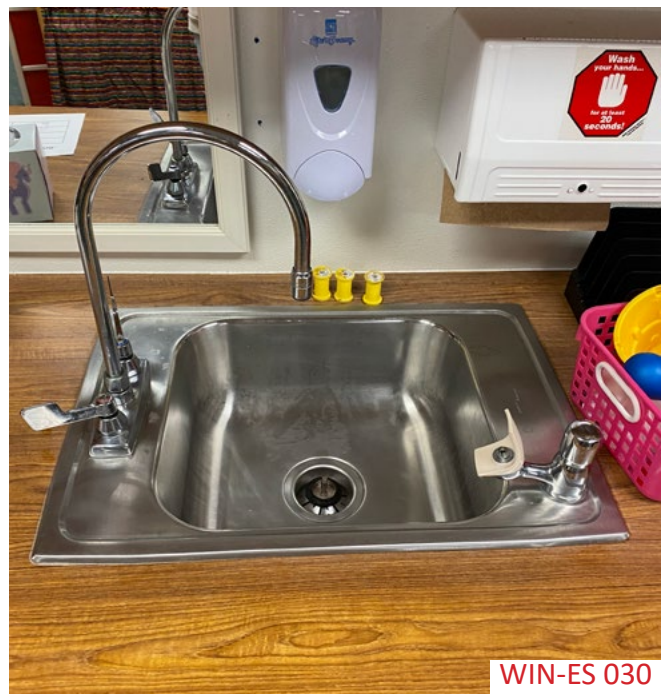
WIN-ES 030

Water fountains within sinks are no longer to code.

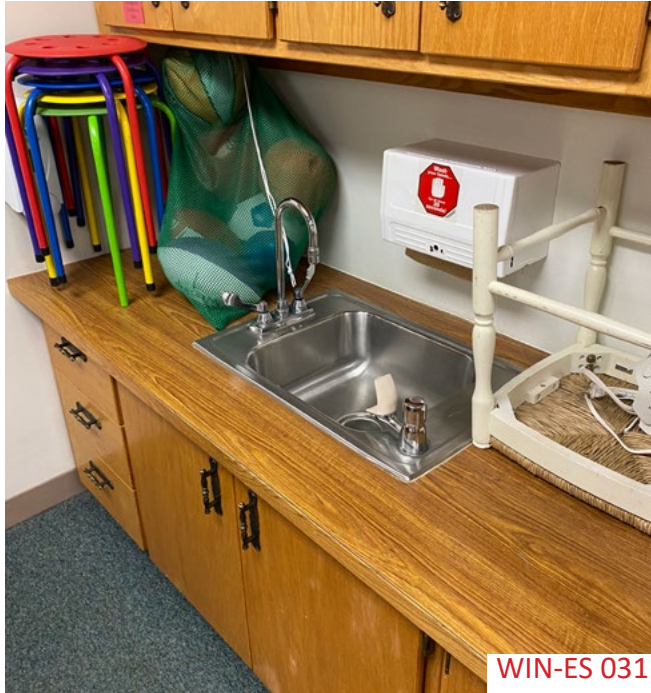
WIN-ES 031

Sinks in classrooms and offices are not accessible.

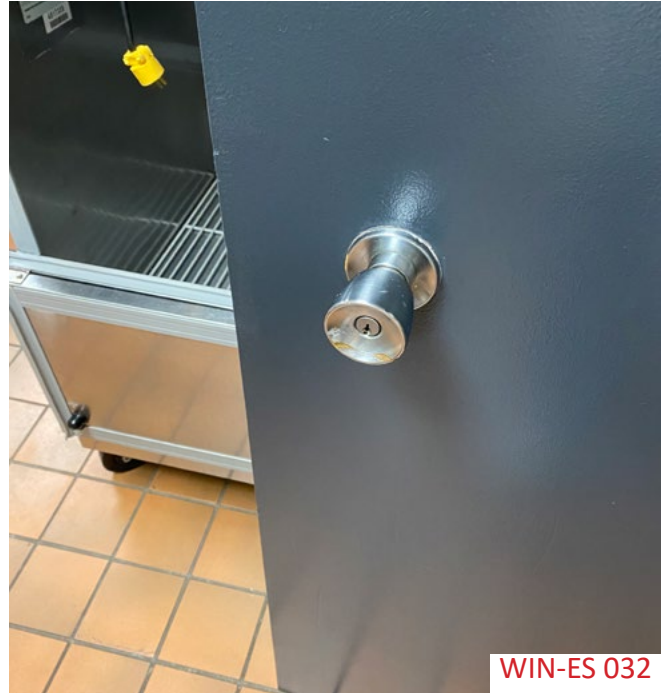
WIN-ES 032

Many doors throughout the building have hardware that is not accessible.

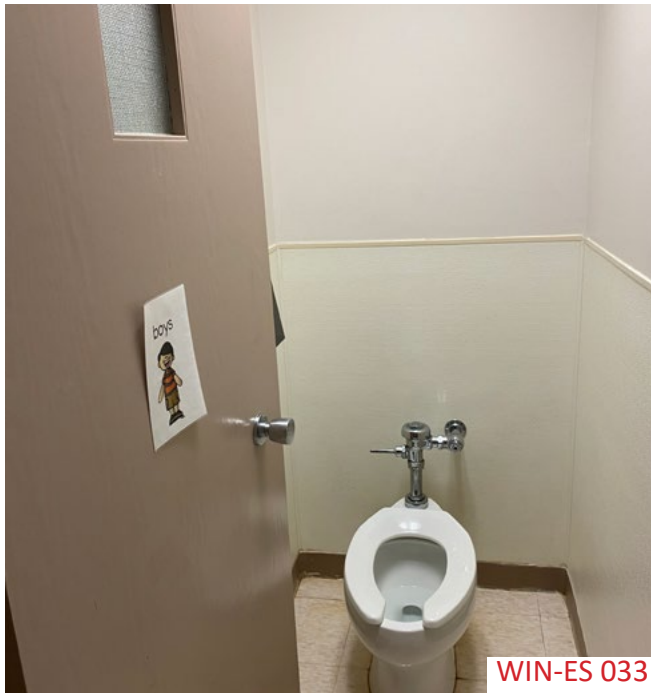
WIN-ES 033

The bathrooms accessed through Room 102D are not accessible.

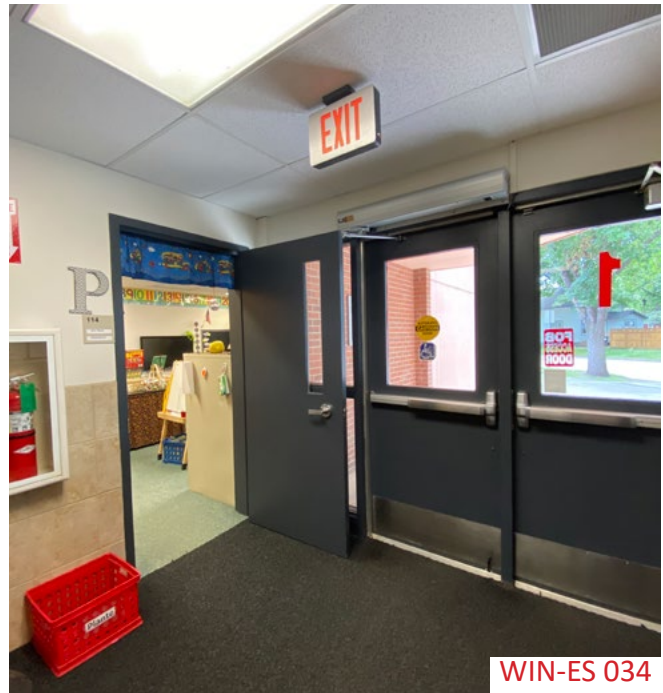
WIN-ES 034

Door 1, 3 and 7 are not protected with an enclosed vestibule, as required by energy code.

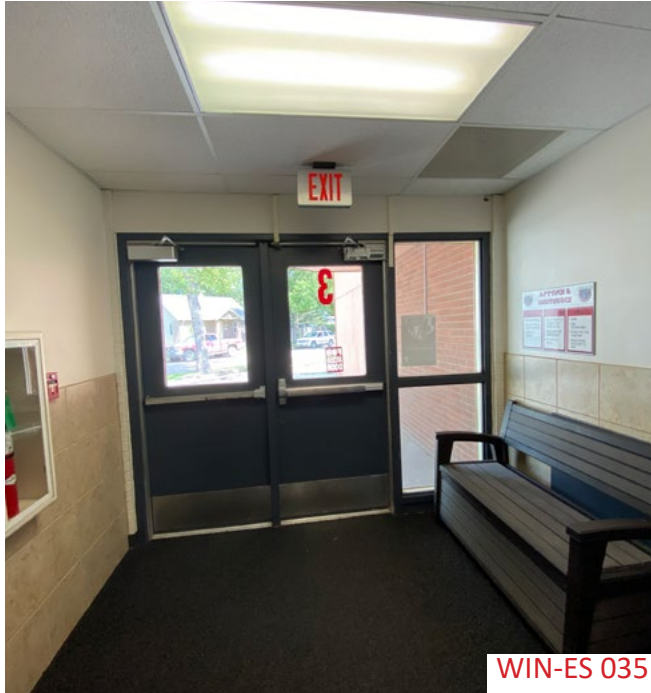
WIN-ES 035

Door 1, 3 and 7 are not protected with an enclosed vestibule, as required by energy code.

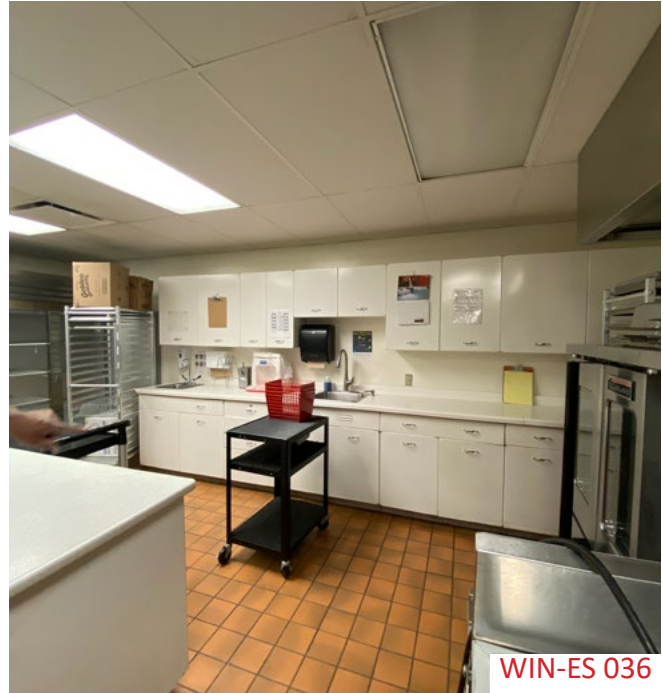
WIN-ES 036

Prep surfaces in the kitchen need to be stainless steel for food safety.

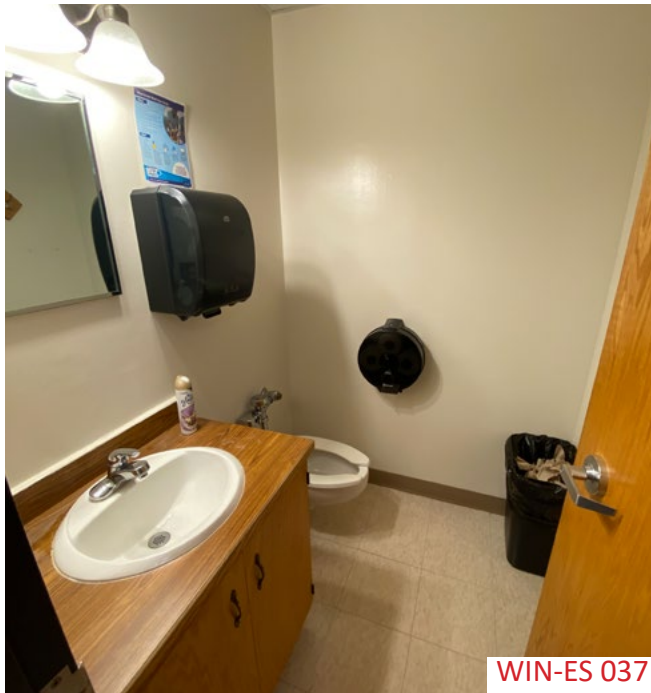
WIN-ES 037

Staff restroom is not accessible.

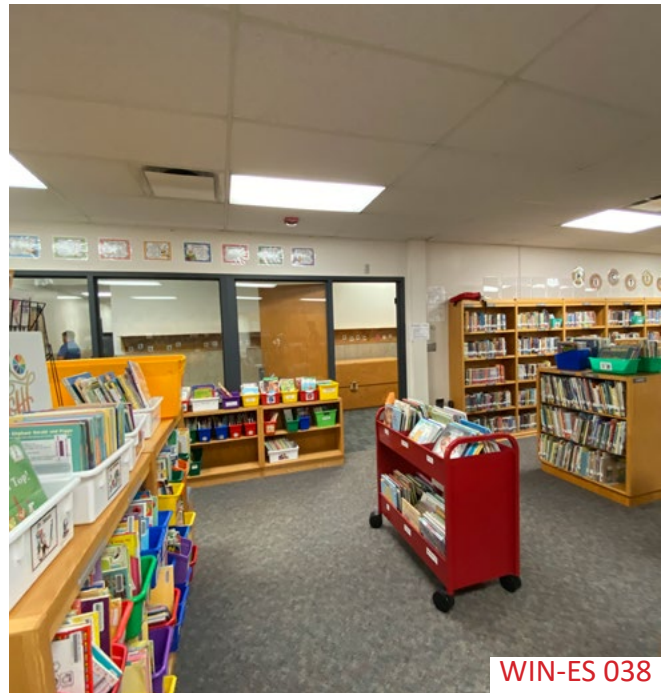
WIN-ES 038

Interior windows in the library and main office do not have safety glass as required by code.

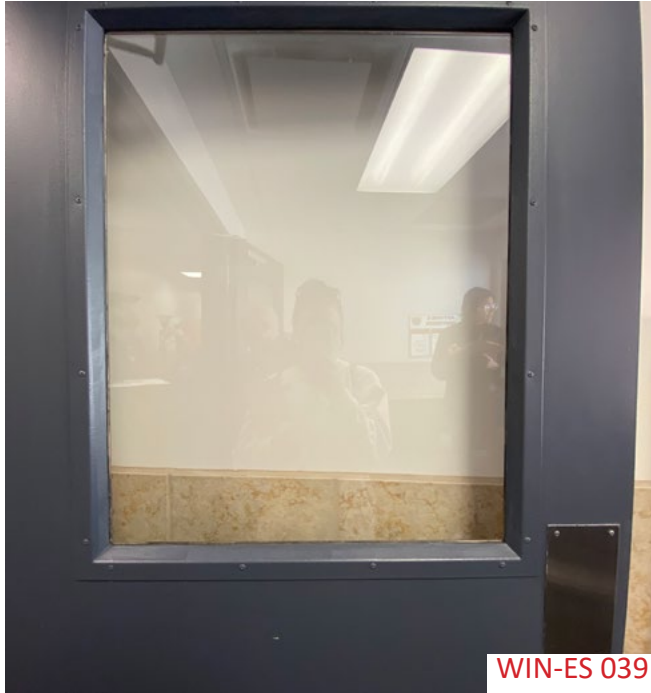
WIN-ES 039

Numerous doors have glass windows that are not safety glass as required by code.

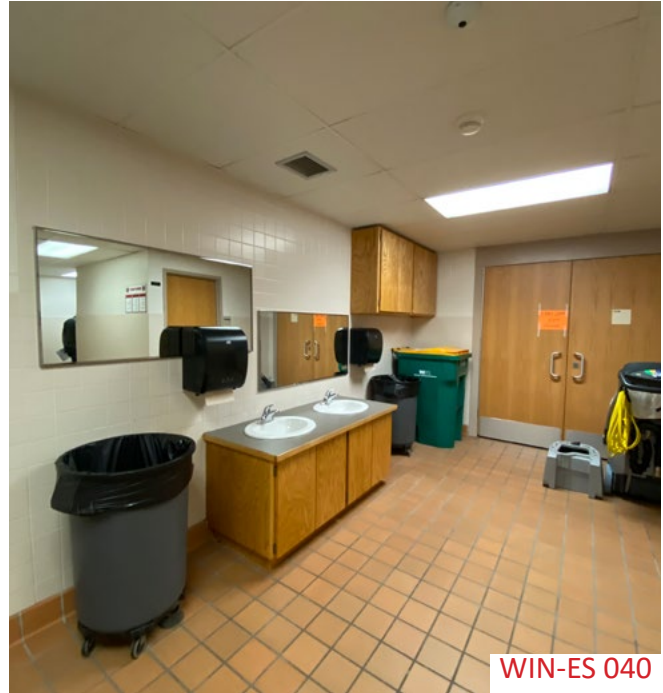
WIN-ES 040

Sinks outside of the student restrooms are not accessible.

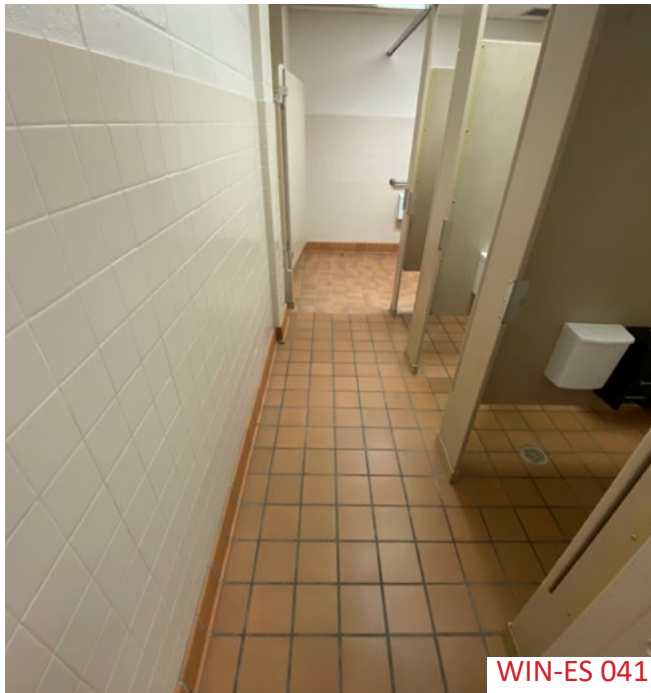
WIN-ES 041

The pathway to the accessible stalls in the restrooms does not meet maneuverability requirements.
