**VERONA AREA SCHOOL DISTRICT  
FACILITIES STUDY**

Updated April 2023  
EUA Project: 322693

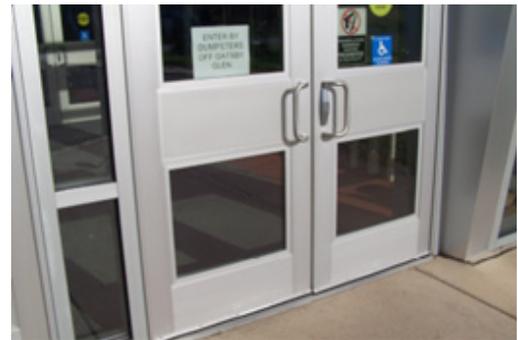
ALUMINUM ENTRY DOORS

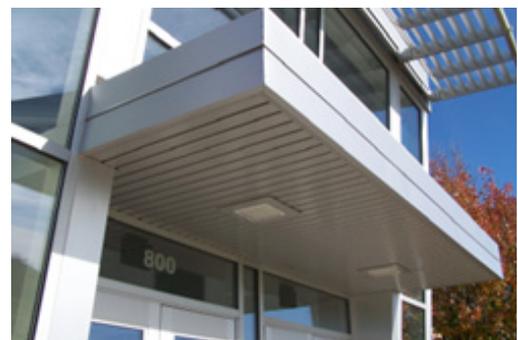
CANOPY

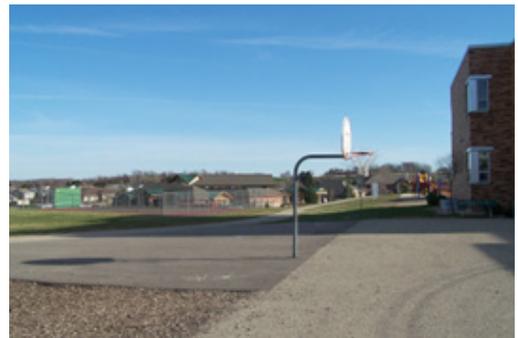
PAVING AT REAR AND PLAY AREAS IN GOOD CONDITION

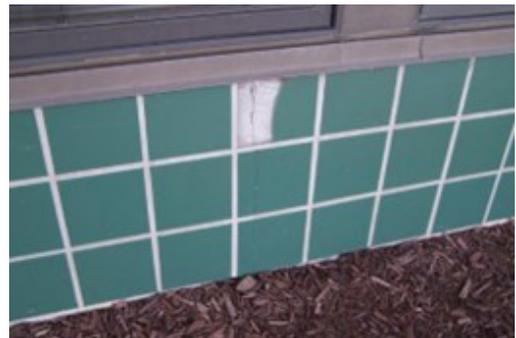
CRACKS AT TILE AREAS, SUMMER 23 PROJECT

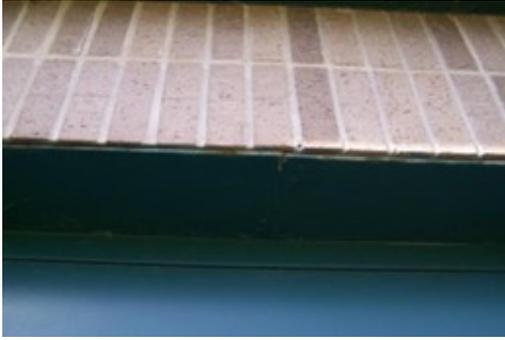
SOME RUST ON LINTELS

- Asphalt parking lots may need to be replaced in the future. Scheduled as part of work to be performed in 2023.
- Additions to the existing buildings will be problematic due to lack of open space.
- Clean and paint rusting lintels.

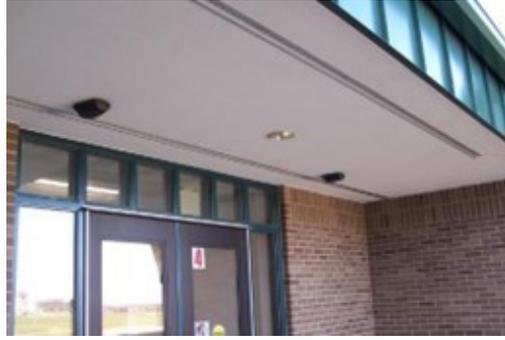
VENTED SOFFIT AT NEW ADDITION

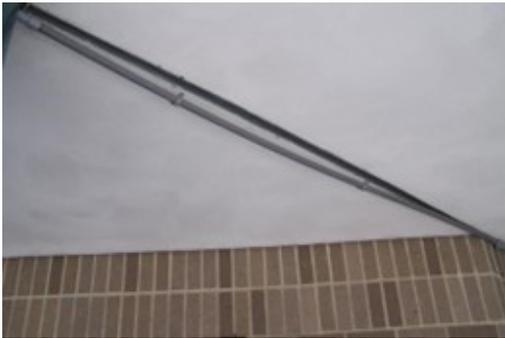
LOOSE CONDUIT AT MAIN ENTRY

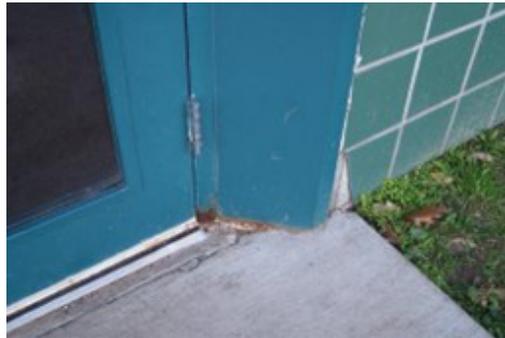
RUSTED STEEL DOORS AND FRAMES

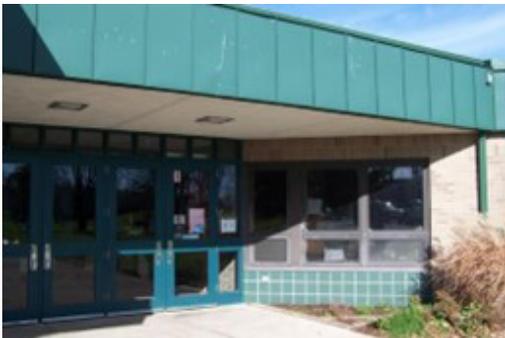
SCRATCHES ON METAL FASCIA

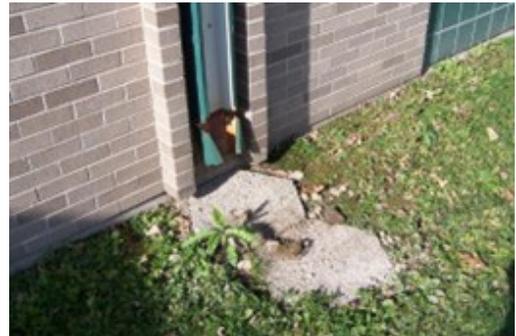
DOWNSPOUT AND SPLASH BLOCK  
CONDITION

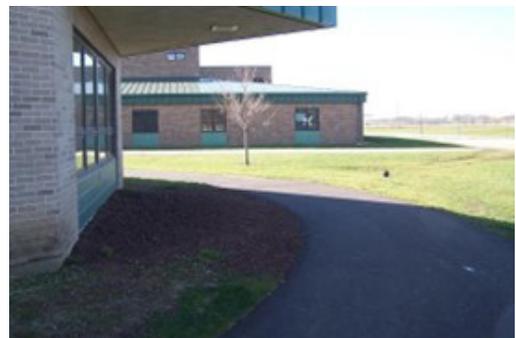
ASPHALT CONDITION GOOD

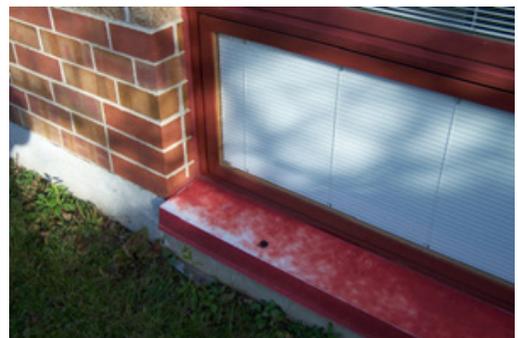
FADING WINDOW SILL FINISH

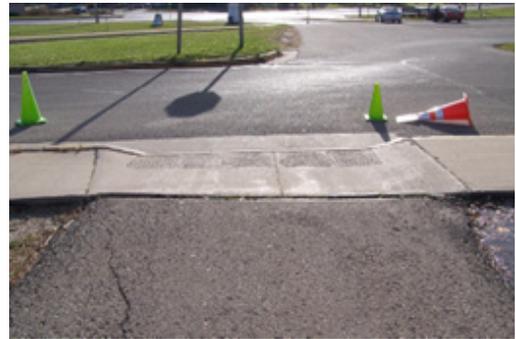
- Expected Life Span: 20 years.
- Current Condition: Good (Fair at the north and west entry locations)
- Main concrete walk areas in good overall condition. Some sections have settled and should be maintained or repaired to avoid tripping hazards.
- Some concrete stoops/pads have settled and created a tripping hazard.
- Asphalt areas and drives generally in fair condition and have been maintained. Some Alligator cracking along the edges of paths and by the main play area. The alligator cracking suggests poor subsurface conditions or overloading.
- Asphalt play area in fair condition.

CONCRETE TO LANDSCAPE HEIGHT DIFFERENCE

- Continue VASD’s Slips and Falls program to identify and correct areas of uneven concrete and asphalt.
- Grind areas of concrete that exceed 1/2” height differential from adjacent slabs.
- Monitor concrete pads at entries.
- Plan for future replacement/repair of asphalt areas next to the play area.
- Fill in the landscape next to sidewalks where there is a difference of 1/2”. This will prevent the erosion of support material under the paved surfaces.

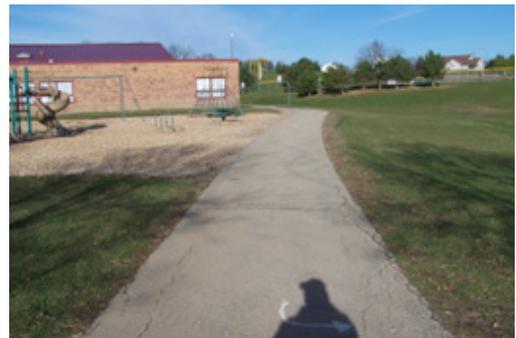
ASPHALT PATH CONDITION

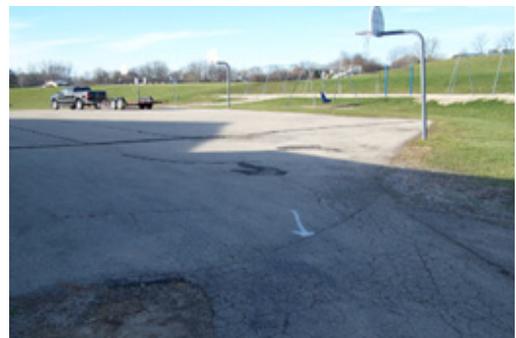
ASPHALT CONDITION AT PLAY AREA POOR CONDITION

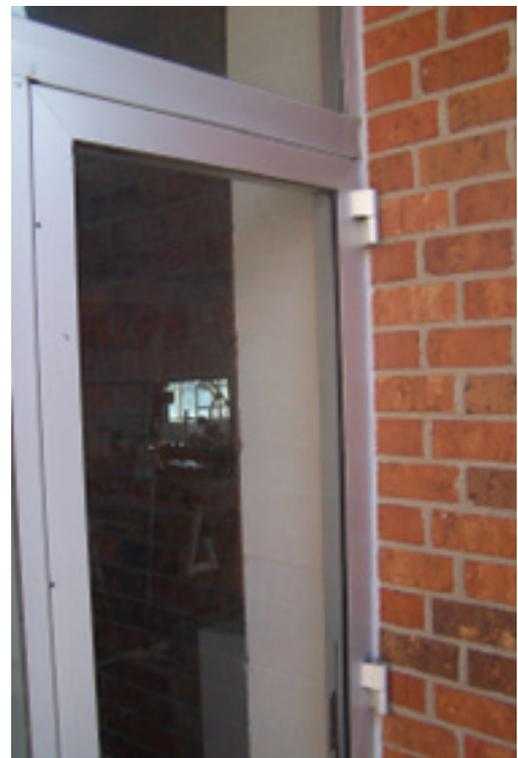
SINGLE PANE GLASS

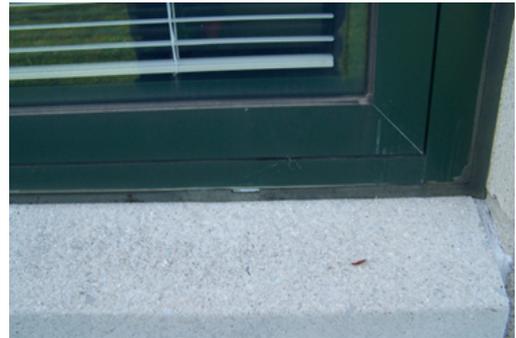
CUT STONE FACE DETERIORATION

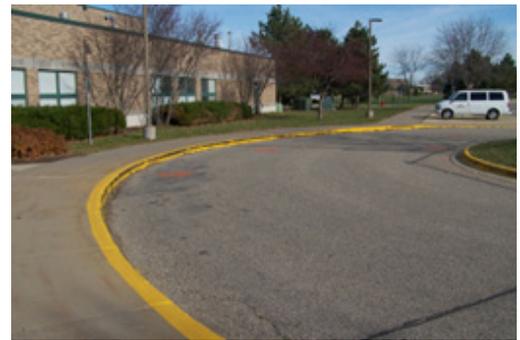
ASPHALT AND CONCRETE AT ENTRY

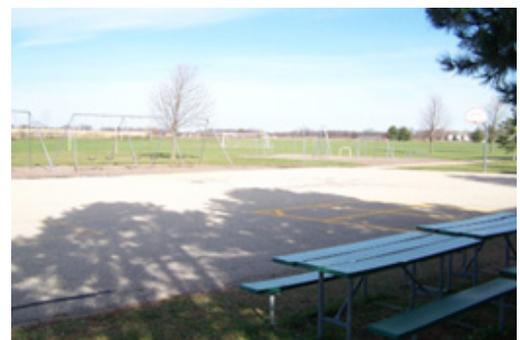
ASPHALT AT PLAY AREA

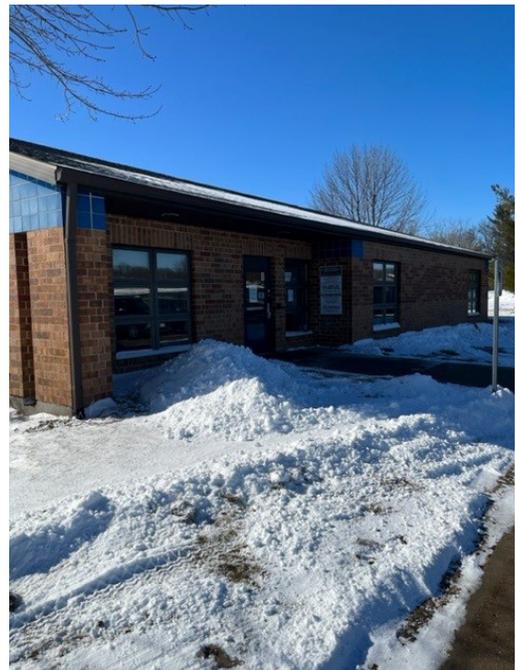
- Expected Life Span: 20 years for fiberglass shingle roof.
- Roof has ridge and continuous soffit vents.
- Gutters and downspouts provided over aluminum fascia.
- R-38 Roof insulation.
- Current Condition: Good

- None at this time. Monitor for general maintenance. Budget for a roof replacement in the 10-year Facility Plan.
