# 2021 DISTRICT WIDE BUILDING ENVELOPE ASSESSMENT

## Tamalpais Union High School District

BEAM Professionals  
2600 Tenth Street, Suite 700  
Berkeley, CA 94710  
Ph: (510) 460-1999  
[www.BEAMProf.com](http://www.BEAMProf.com)

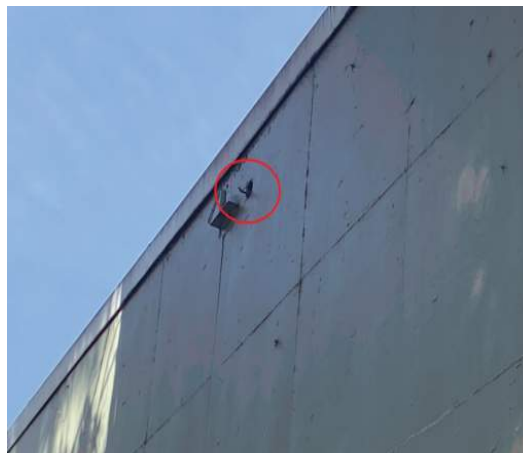
| 7 | Electric J box has no cover and wires are exposed. |

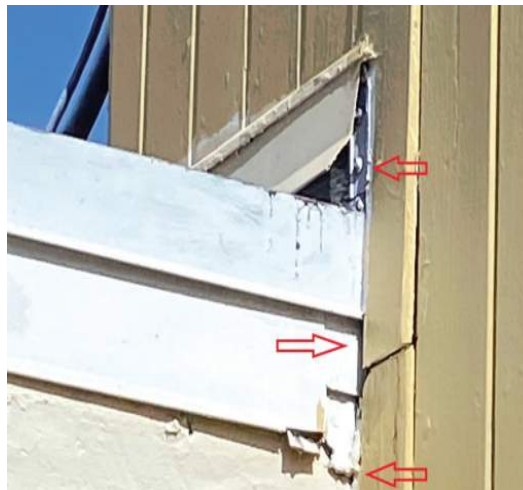
| 8 | Transition between roof fascia/ base flashing and wall system not properly sealed. |

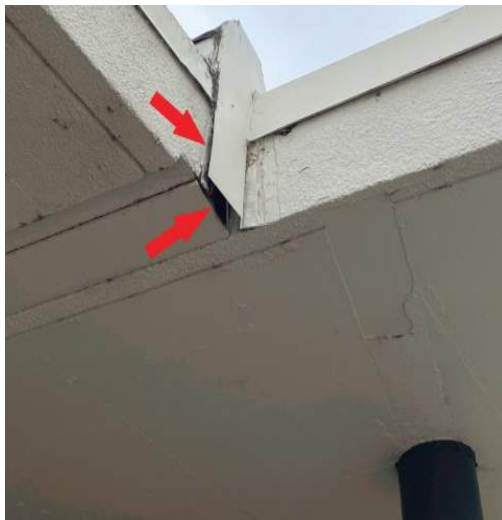
2 EJ cover unsealed

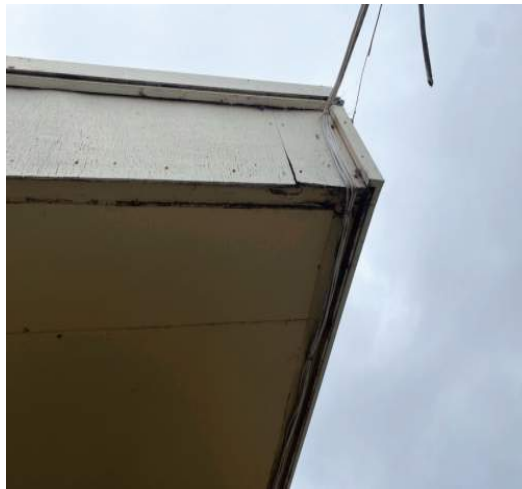
7 E1 rotten fascia wood

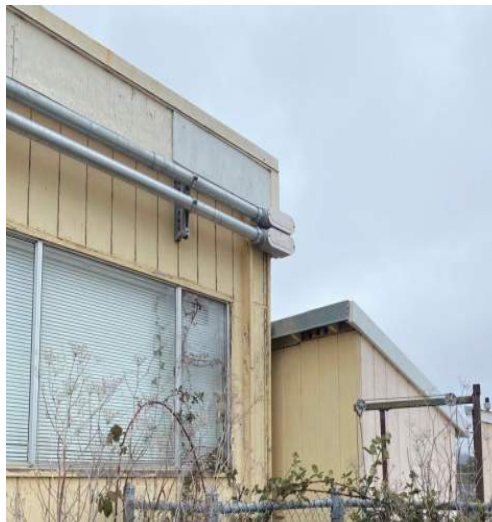
8 D1 derteriorated wood

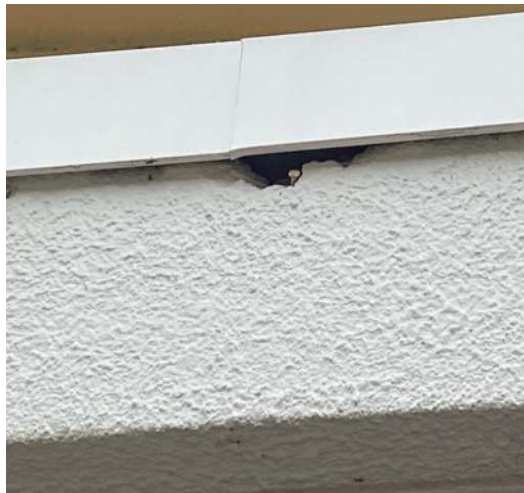
9 Holes in stucco behind coping

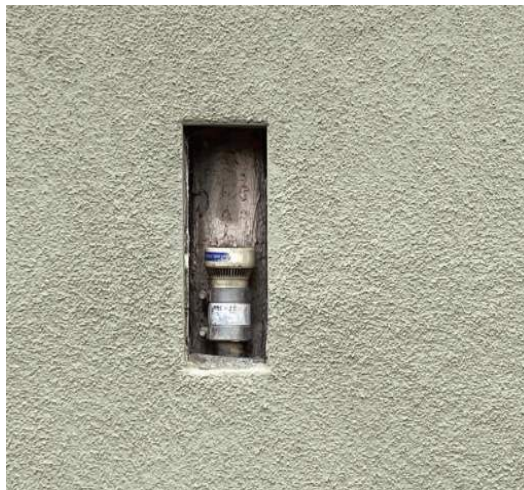
10 Open utility hole in stucco

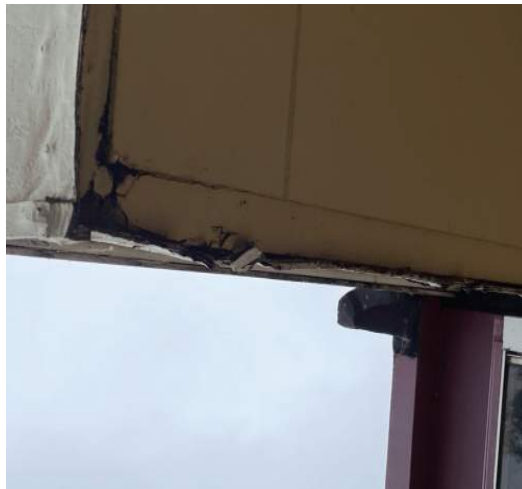
11 Parapet soffit wood rotten

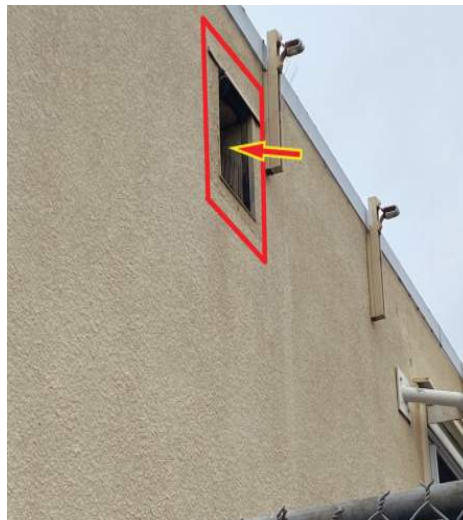
12 Unused ventilation

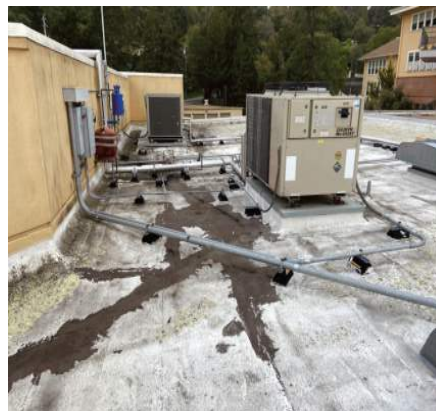
| 2 | Multiple field repairs throughout mod bit system starting to separate and crack possible water intrusion |

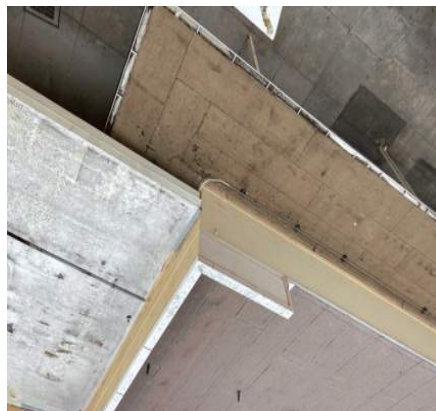
| 4 | Multiple lap seams starting to separate on mod bit system |

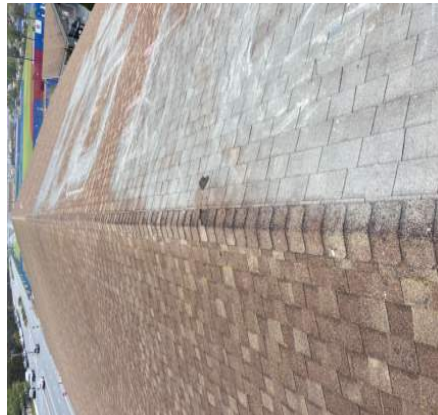
| 5 | Moderate granule loss on the Architecttural shingle roof system |

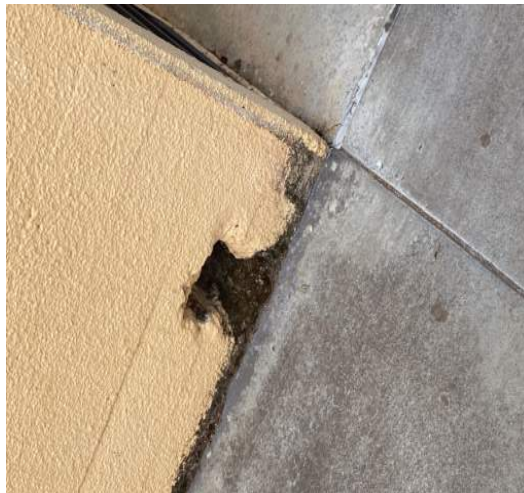
9 Hole in wall

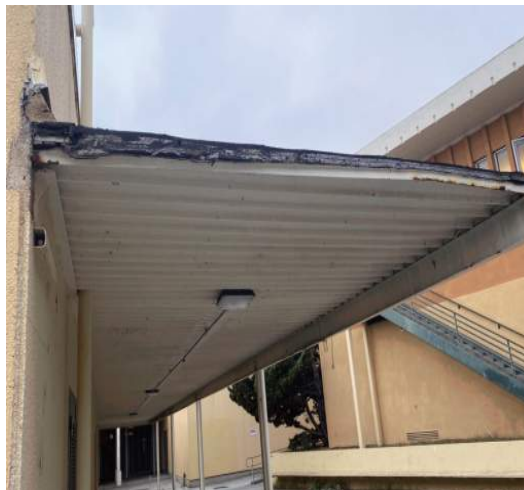
10 Rotten overhang

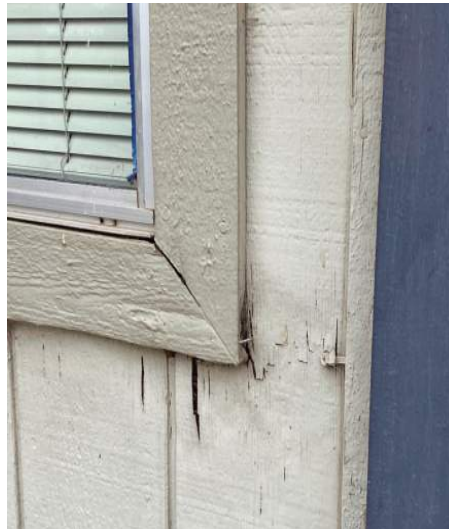
2 Framing around seal rotting

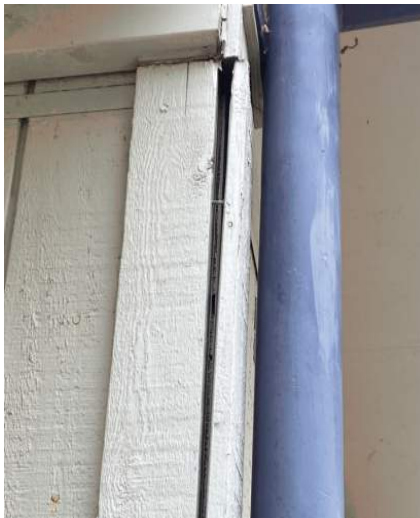
3 Siding warped point of ingress

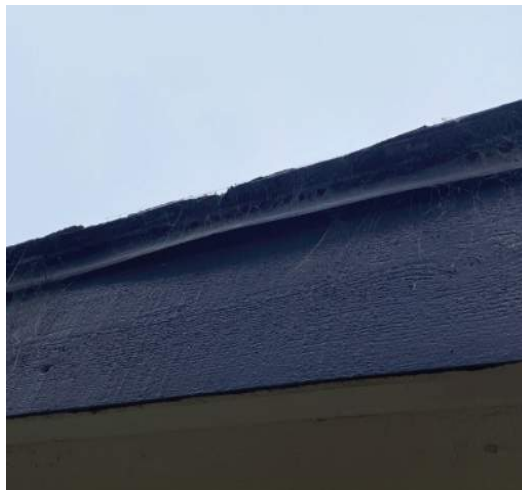
5 Fishmouth above coping

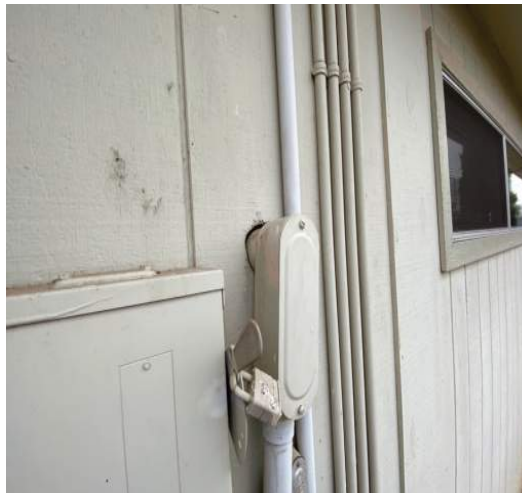
| Drawing Number | Comments |
|---|---|
| 6 | Unsealed Electrical penetration |

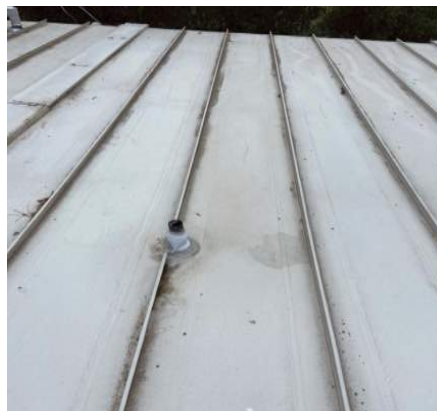
| 4 | All pipe penetrations, soil pipes, and conduits have multiple repairs made to them. All repairs are short term |

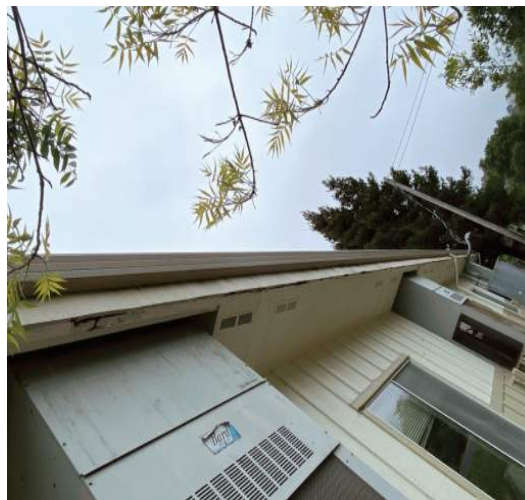
| 1 | C1 backside wood fascia rotten |

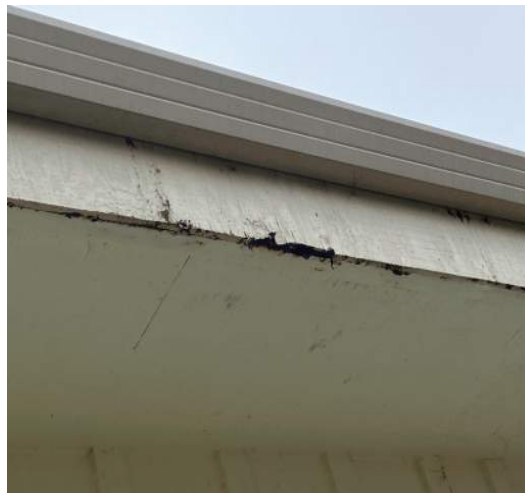
| 2 | Fascia rotting |

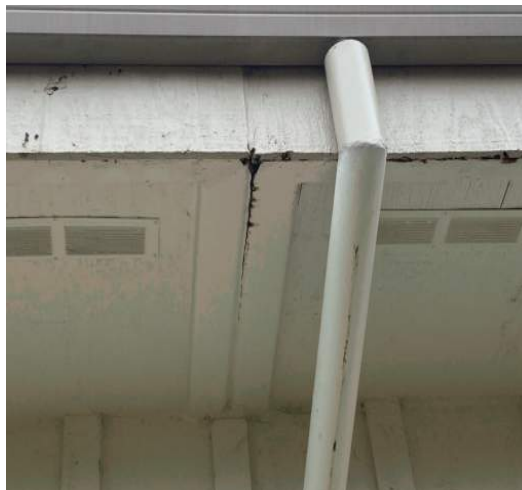
4 Soffit splitting

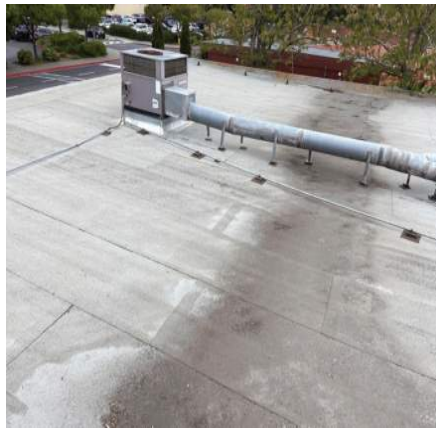
2      Loss of granules from standing water on roof

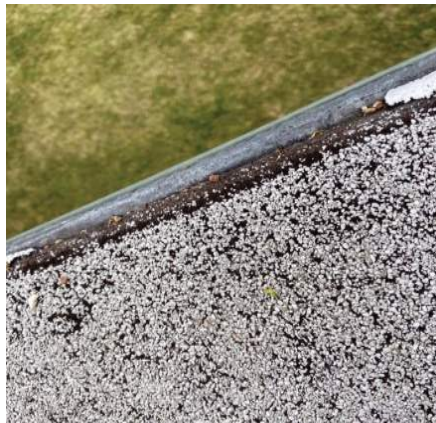
3      Multiple perimeter edge laps curling up and separating possible water intrusion

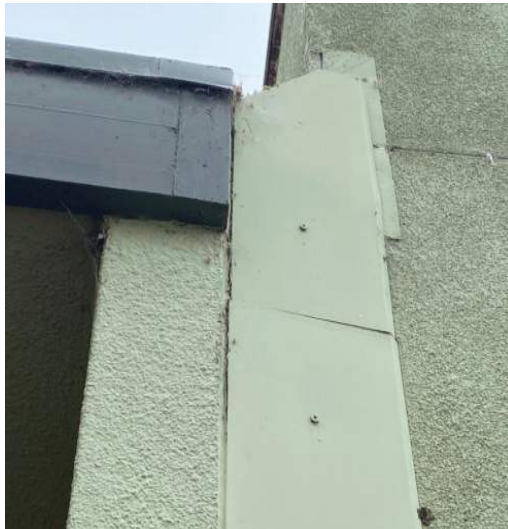
1 Ej sealant and fasteners

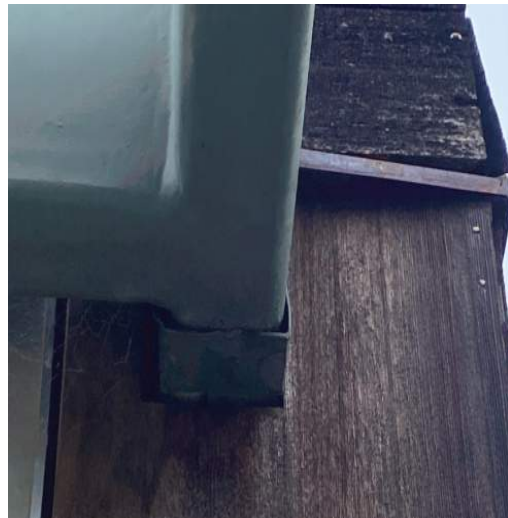
2 Points of water ingress

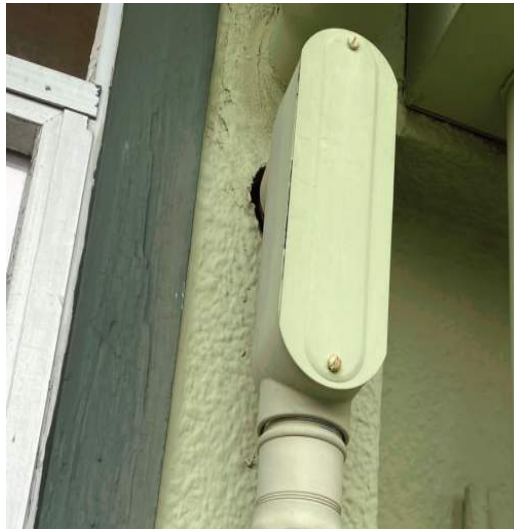
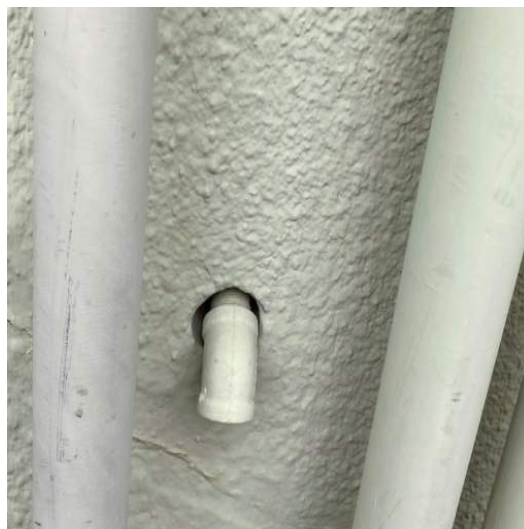
4 Penetration unsealed

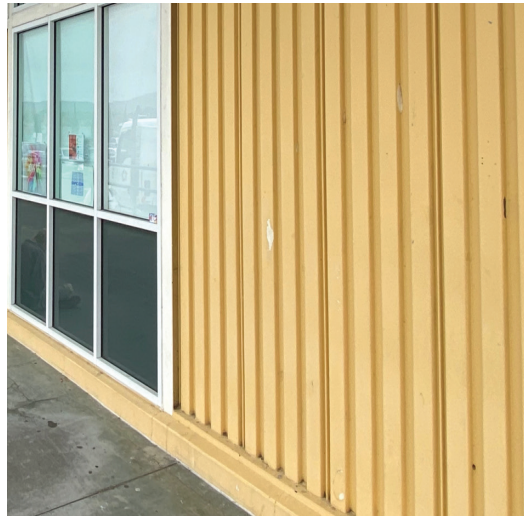
- 1 Standing Seam walls are in good shape

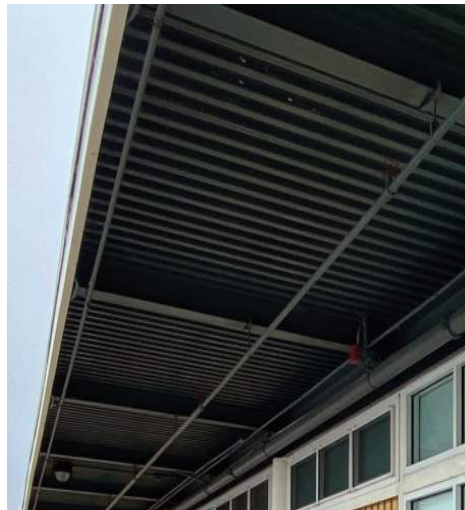
- 2 Facia Board requires painting

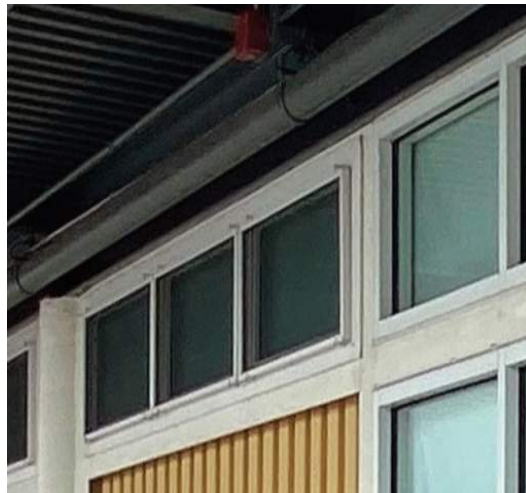
| Drawing Number | Comments |
|---|---|
| 3 | Window frames are in good standing order |

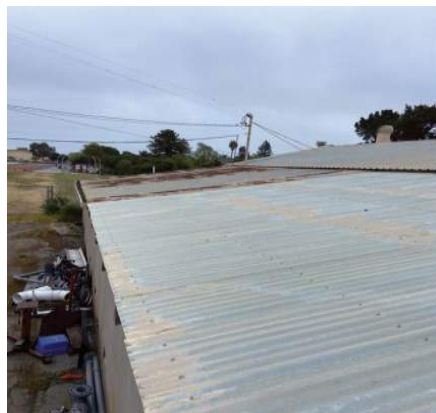
- 3 Multiple areas have rust visible

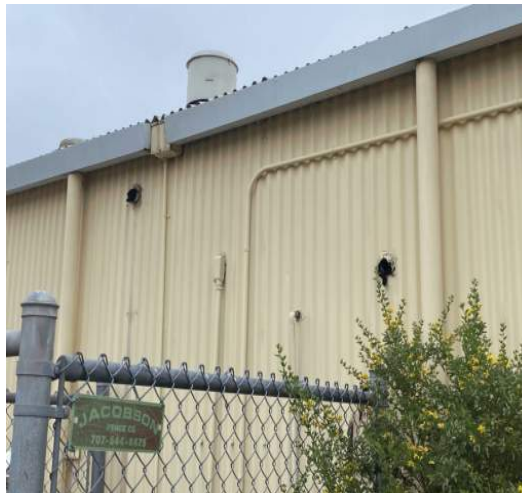
| Drawing Number | Comments |
|---|---|
| 3 | Unused penetrations in wall |
