FACILITY CONDITION ASSESSMENT

LUCHA Elementary School
1711 East San Antonio Street
San Jose, California 95116

159228.22R000-002.354

December 5, 2022

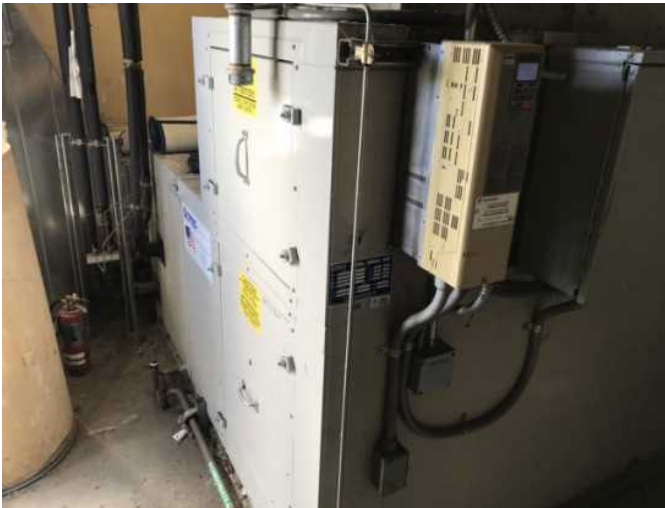
7 - AIR HANDLER

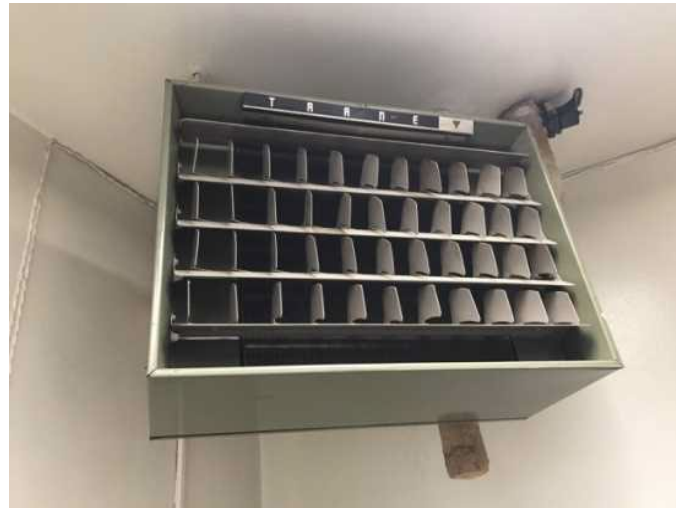
8 - UNIT HEATER

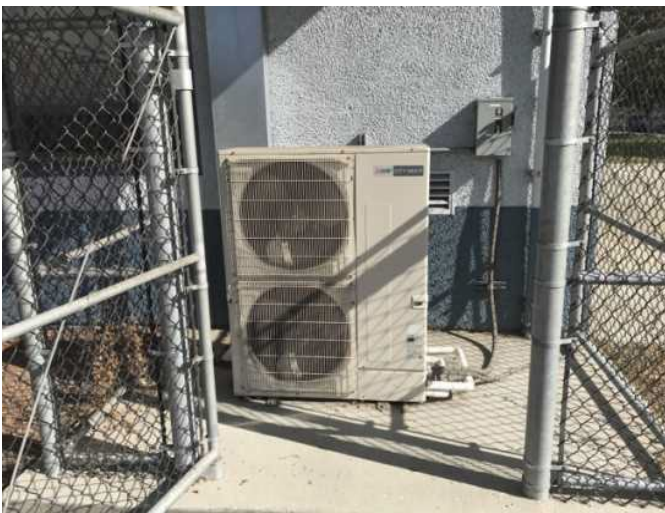
9 - SPLIT SYSTEM DUCTLESS CONDENSER

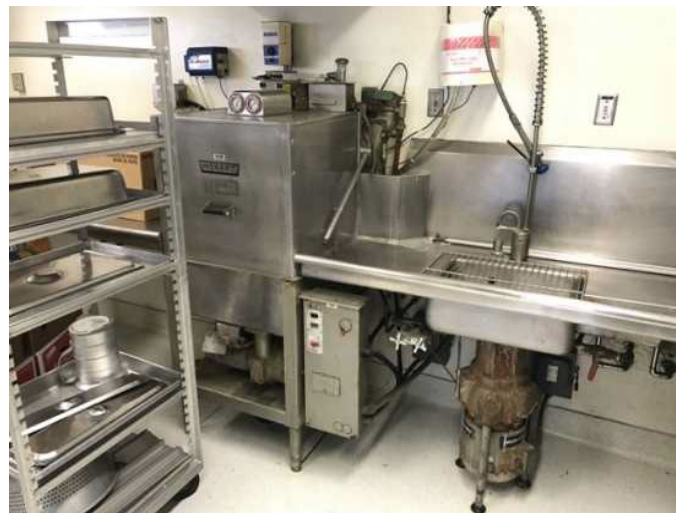
10 - DISH WASHER

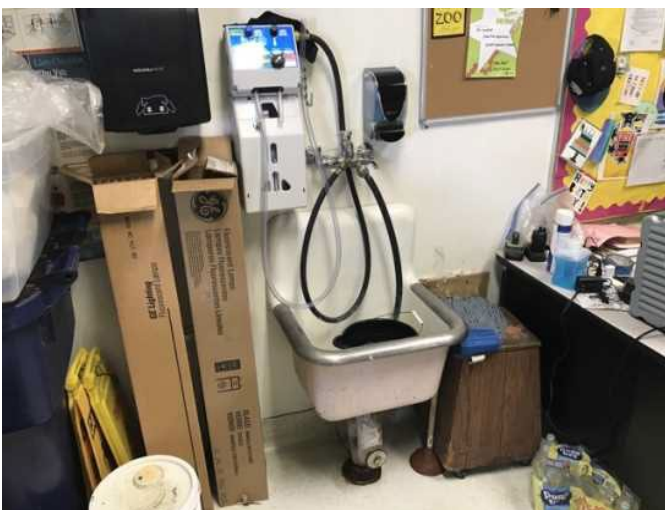
11 - SERVICE SINK

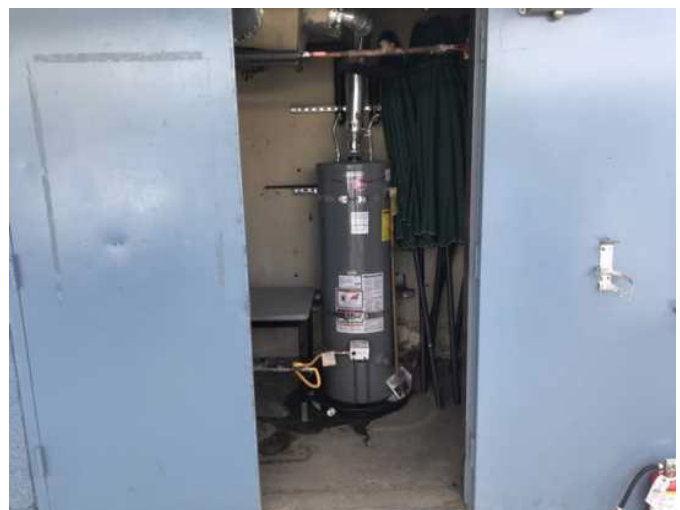
12 - GAS WATER HEATER

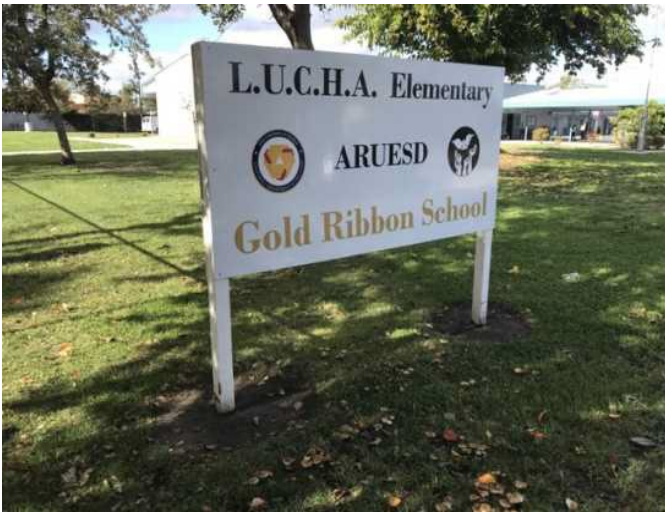
1 - SIGNAGE

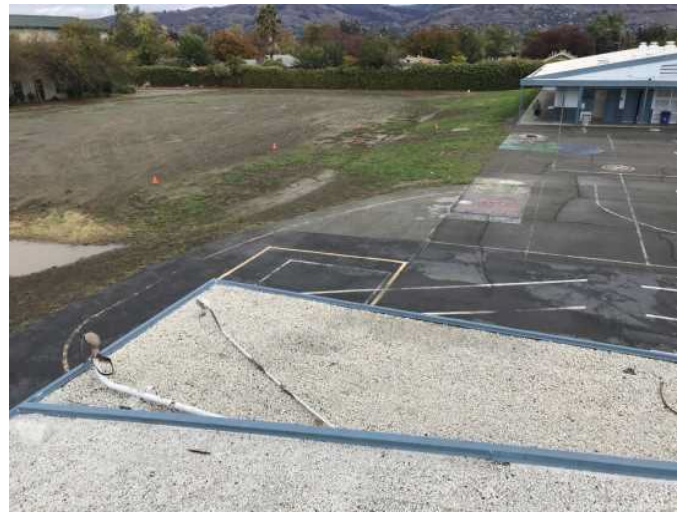
2 - SITE OVERVIEW

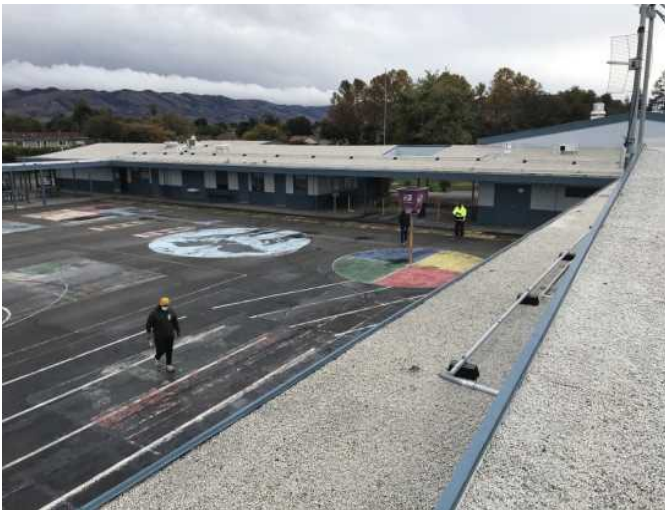
3 - SITE OVERVIEW

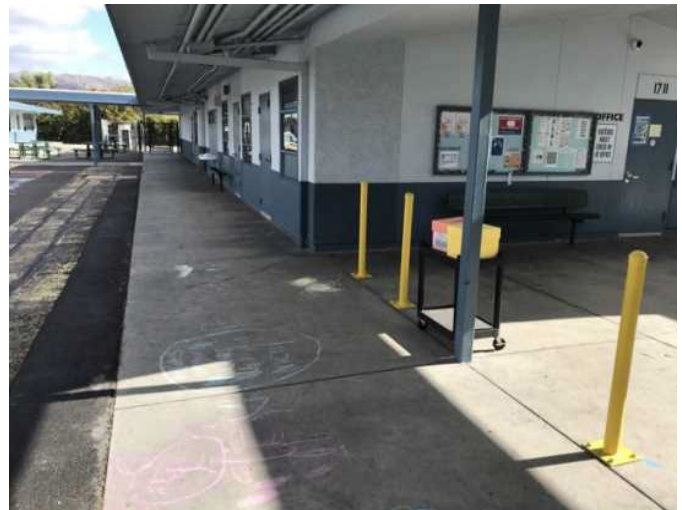
4 - CONCRETE SIDEWALK

Accessibility	Presently it does not appear an accessibility study is needed for this building. See Appendix D.	
Additional Studies	No additional studies are recommended for the general site at this time.	
Key Issues and Findings	Replace broken asphalt playground pavement. Playground asphalt pavement needs seal and stipe. Missing grass fields. Replace broken or displaced concrete sidewalk throughout campus.

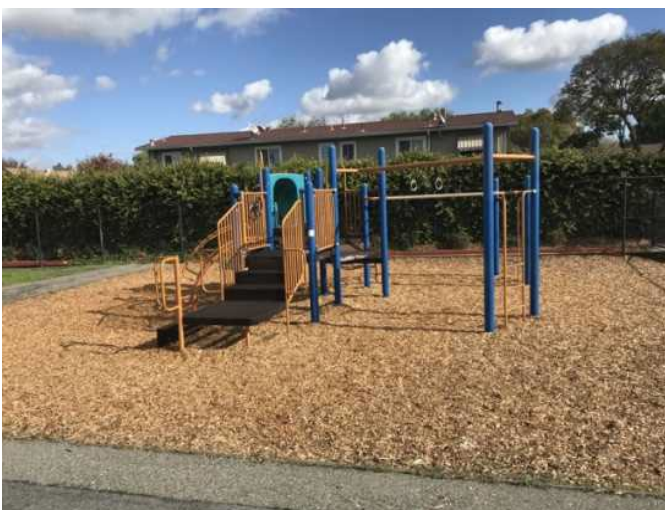
5 - PLAY STRUCTURE

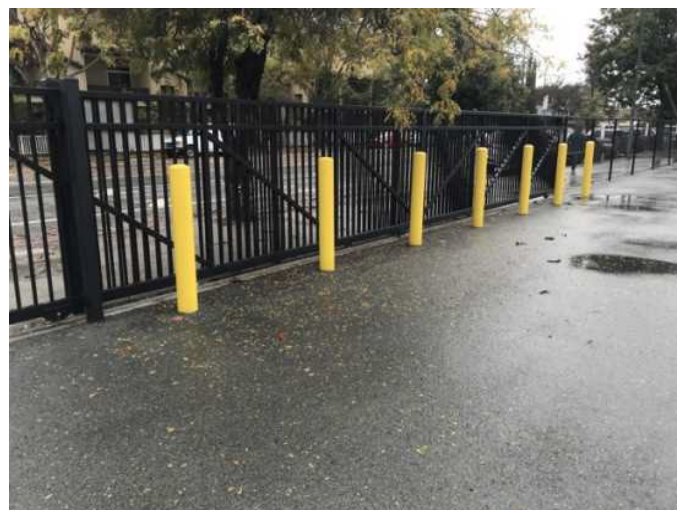
6 - BOLLARDS

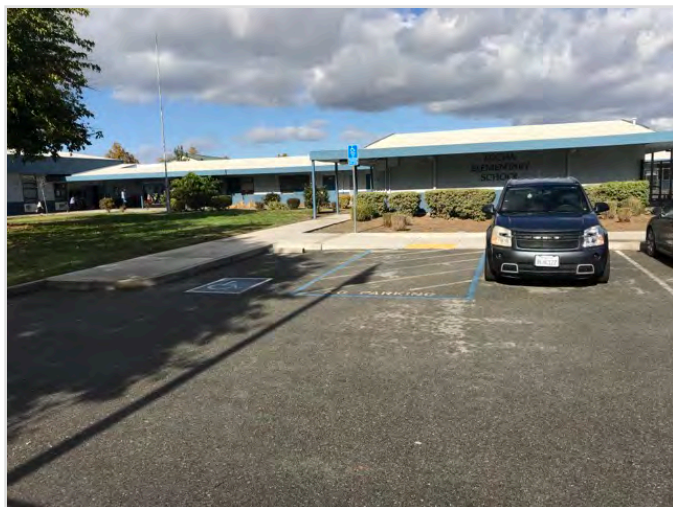
OVERVIEW OF ACCESSIBLE PARKING AREA

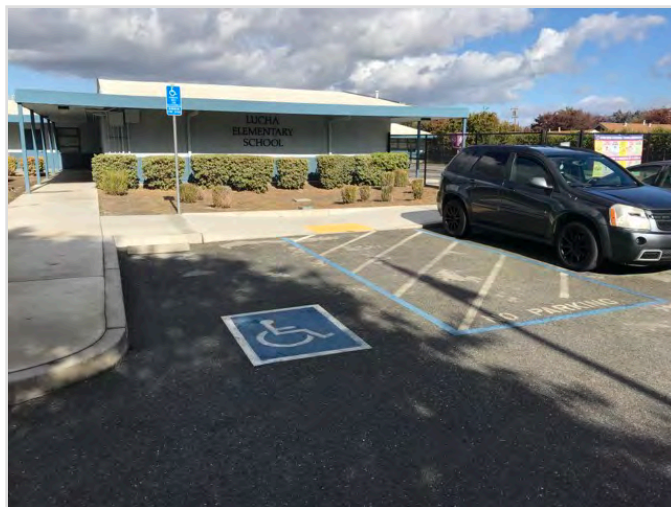
CLOSE-UP OF STALL

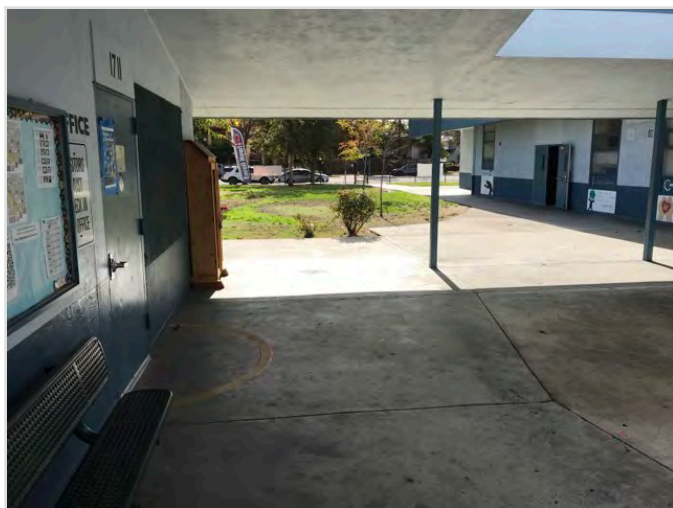
ACCESSIBLE PATH

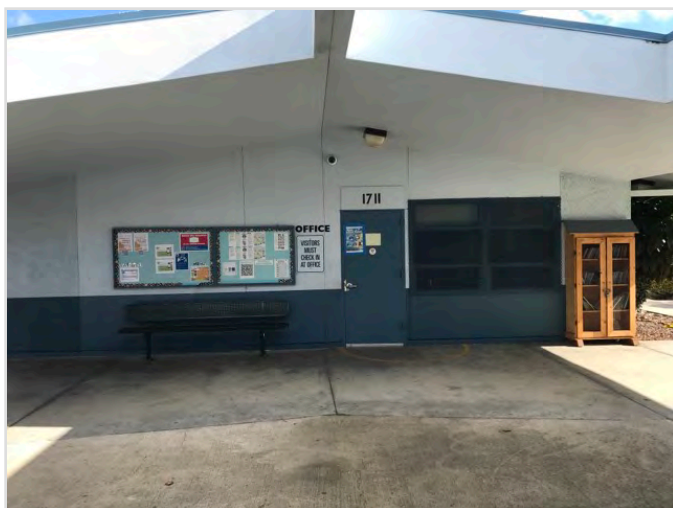
ACCESSIBLE ENTRANCE

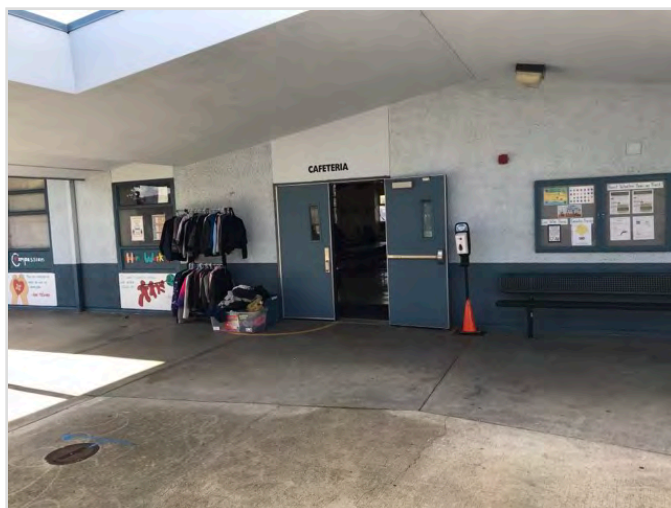
ACCESSIBLE ENTRANCE

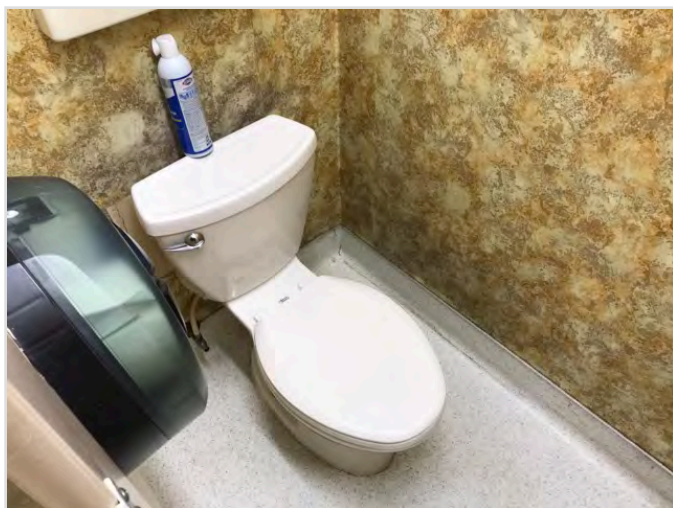
TOILET STALL OVERVIEW

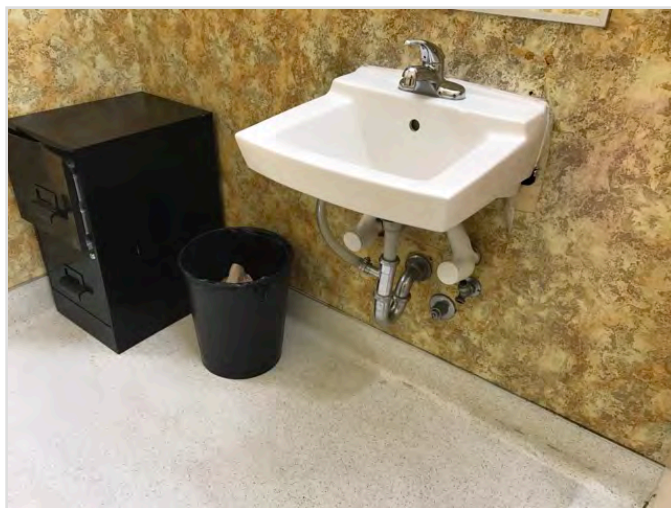
SINK, FAUCET HANDLES AND ACCESSORIES

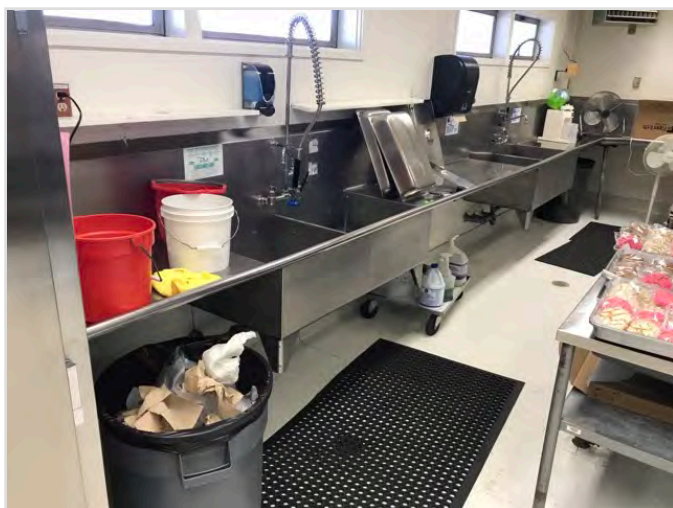
SINK CLEARANCE

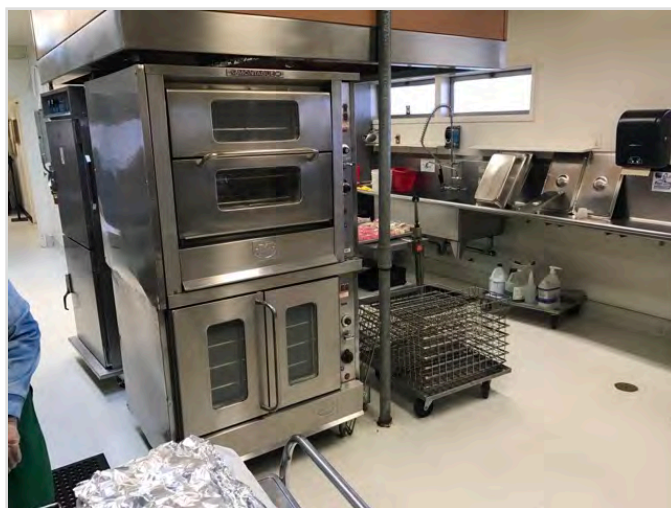
OVEN WITH CONTROLS

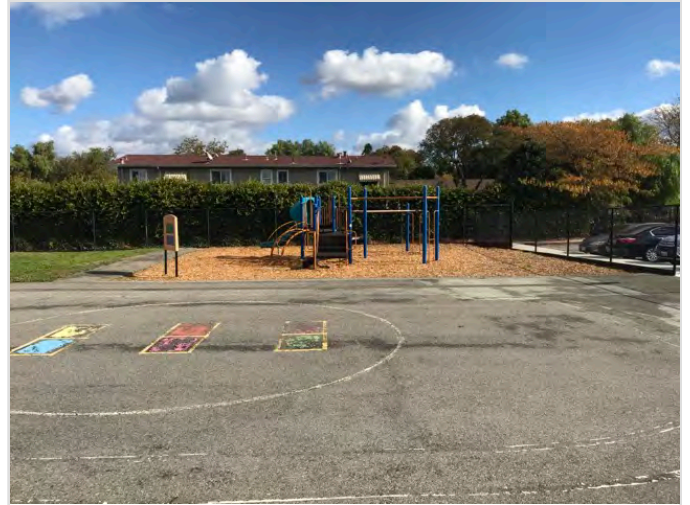
OVERVIEW OF PLAYGROUND
