FACILITY CONDITION ASSESSMENT

Alum Rock Unified School District 2930 Gay Avenue San Jose, California 95127 Kolvira Chheng

Chavez Elementary 2000 Kammerer Avenue San Jose, California 95116

DATE OF REPORT:

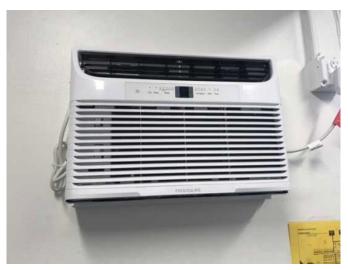
9 - AIR CONDITIONER

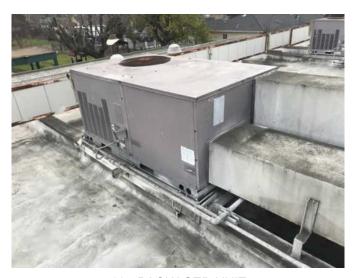
10 - PACKAGED UNIT

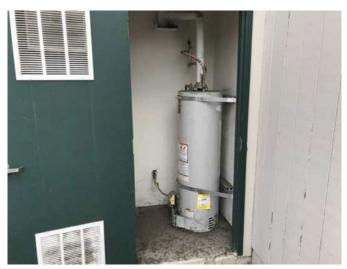
11 - WATER HEATER

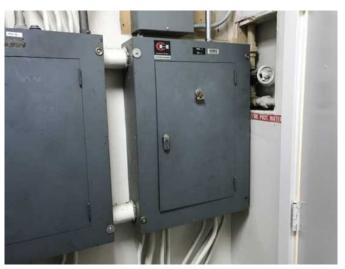
12 - DISTRIBUTION PANEL

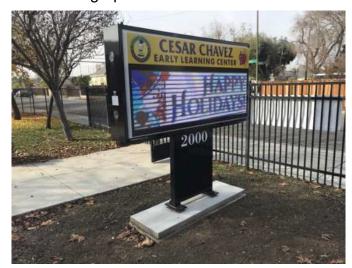
1 - SIGNAGE

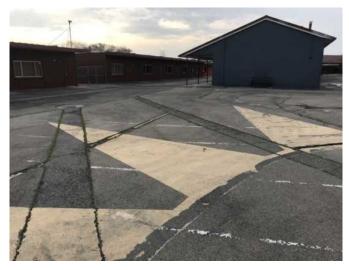
Key Issues and Findings	Asphalt playgrounds have many large cracks.

2 - PLAYGROUND

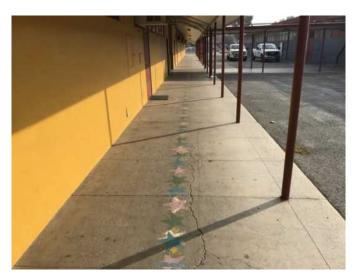
3 - SIDEWALK

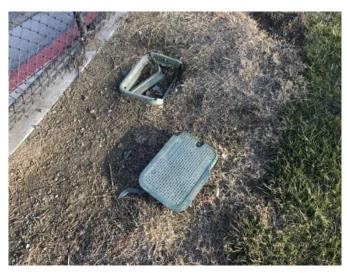
4 - IRRIGATION SYSTEM CONTROLS

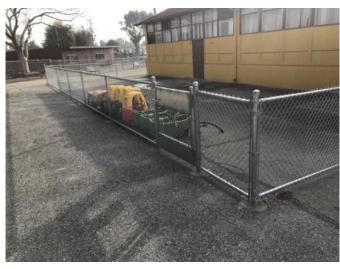
5 - FENCES

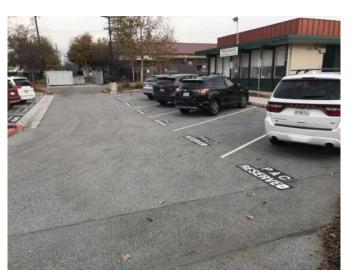
6 - PARKING LOT

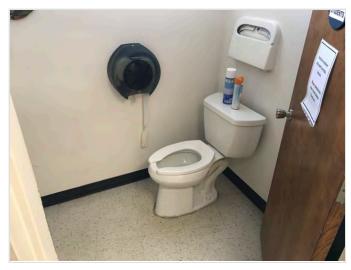
RESTROOM NOT ACCESSIBLE

Detailed follow-up accessibility studies are included as recommendations because potential moderate to major issues were observed at the buildings identified above. Reference the appendix for specific data, photos, and tables or checklists associated with this limited accessibility survey.
