FACILITY CONDITION ASSESSMENT

Alum Rock Unified School District 2930 Gay Avenue San Jose, California 95127 Kolvira Chheng

Cureton Elementary 3720 East Hills Drive San Jose, California 95127

DATE OF REPORT: January 3, 2023

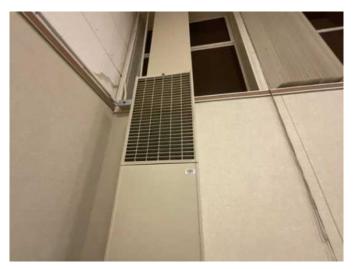
3 - DAMAGED CEILING
