FACILITY CONDITION ASSESSMENT

McCollam Elementary 3311 Lucian Avenue San Jose, California 95127

Bureau Veritas 10461 Mill Run Circle, Suite 1100 Owings Mills, Maryland 21117 800.733.0660 www.us.bureauveritas.com

DATE OF REPORT: January 25, 2023

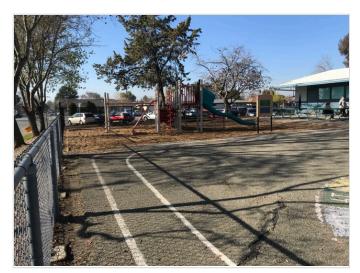
OVERVIEW OF PLAYGROUND
