FACILITY CONDITION ASSESSMENT

Renaissance at Fischer Middle School 1720 Hopkins Drive San Jose, California 95122

Bureau Veritas 10461 Mill Run Circle, Suite 1100 Owings Mills, Maryland 21117 800.733.0660 www.us.bureauveritas.com

October 26, 2022

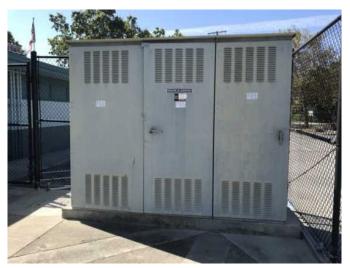
10 - PACKAGED UNIT - DAMAGED BY VANDALISM

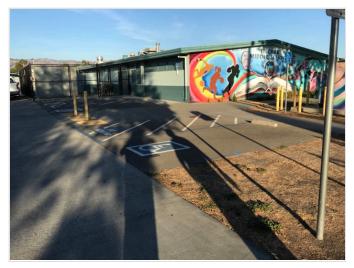
OVERVIEW OF ACCESSIBLE PARKING AREA

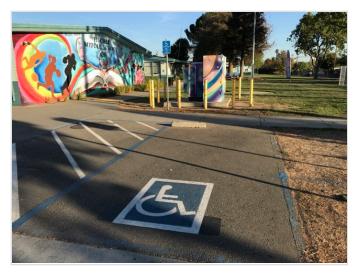
CLOSE-UP OF STALL

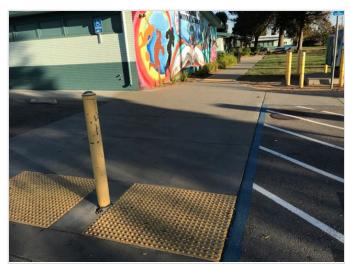
CURB CUT

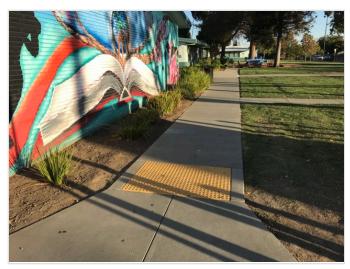
ACCESSIBLE PATH

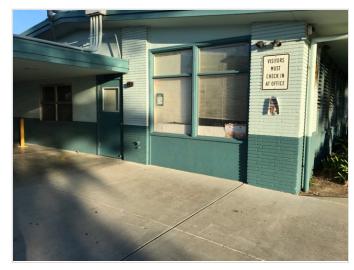
ACCESSIBLE ENTRANCE

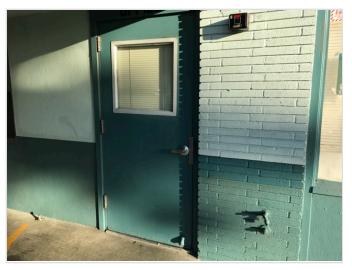
DOOR HARDWARE

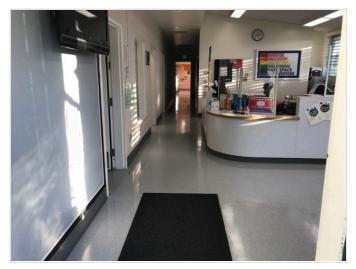
ACCESSIBLE INTERIOR PATH

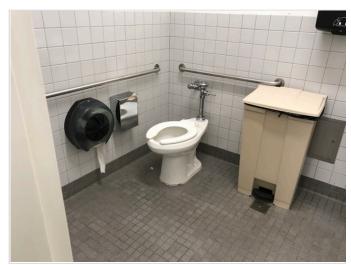
TOILET STALL OVERVIEW
