Addendum 1

Project: **BRFP NUMBER 2324-03 – TROY SCHOOL DISTRICT 2024 SITE IMPROVEMENTS PAVING PROJECTS**

Report on Geotechnical
Pavement Investigation

**Baker Middle School
1359 Torpey Road
Troy, Michigan 48083**

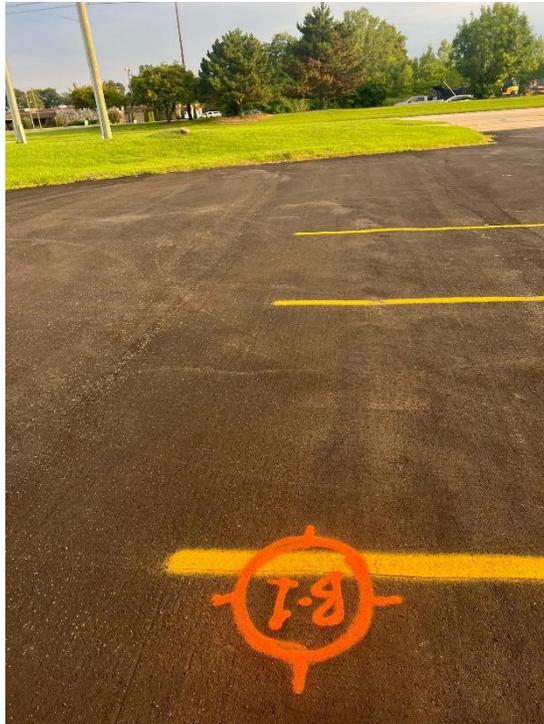
The south Portland cement concrete is in poor condition with extensive cracking throughout (Photograph Nos. 10 and 17 through 20). The west lot appears to have been slurry coated (Photograph Nos. 1 through 7) which is covering the fatigue and block cracking visible in historical aerial photographs. The interface of the three pavement surfaces is shown in Photograph No. 8.

Photograph No. 2: Looking north across west lot.

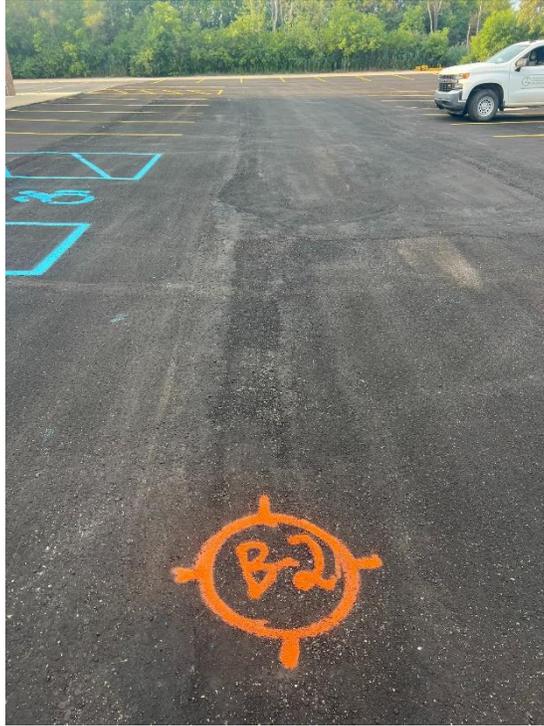
Photograph No. 3: Looking south.

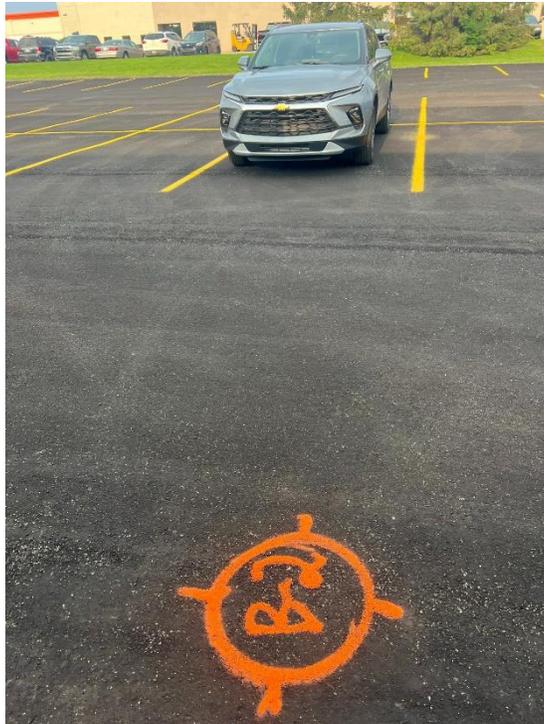
Photograph No. 4: Looking west.

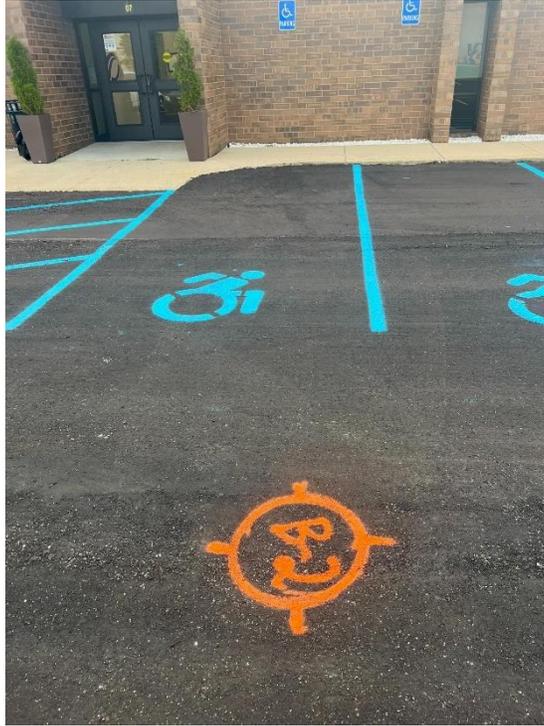
Photograph No. 5: Looking east, pavement flush with sidewalk about building.

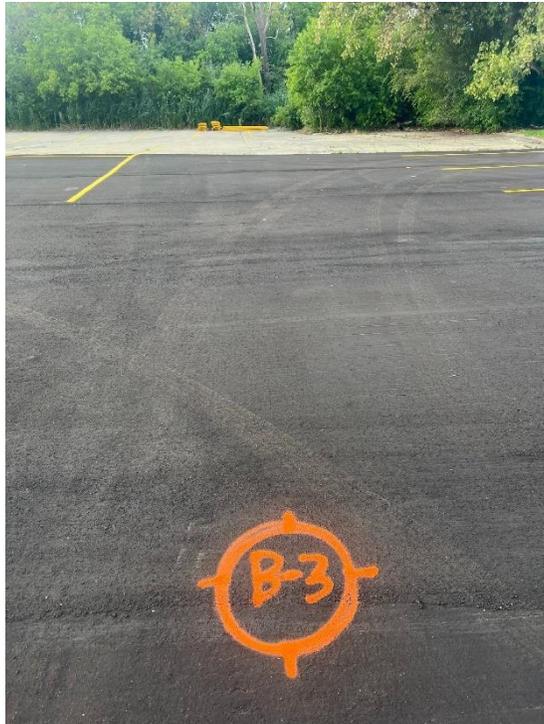
Photograph No. 6: Looking south toward concrete pavement at south end of the lot.

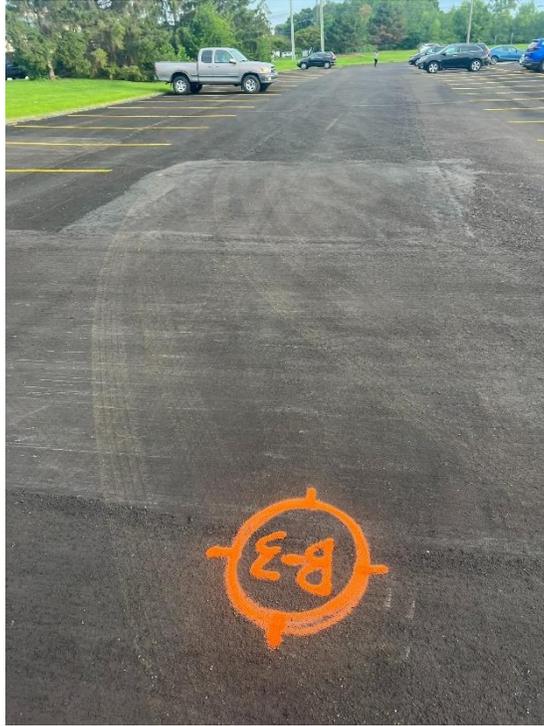
Photograph No. 7: Looking north across west lot.

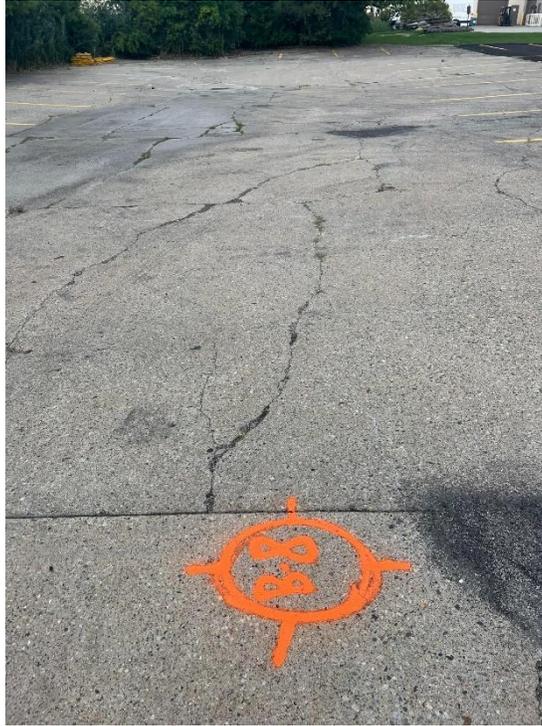
Photograph No. 17: Moderate to high severity longitudinal and transverse cracking, looking west along concrete lot.
