TOWN OF SUFFIELD

CONDITIONS ASSESSMENT & MASTER PLAN

Draft as submitted August 1, 2022 for review

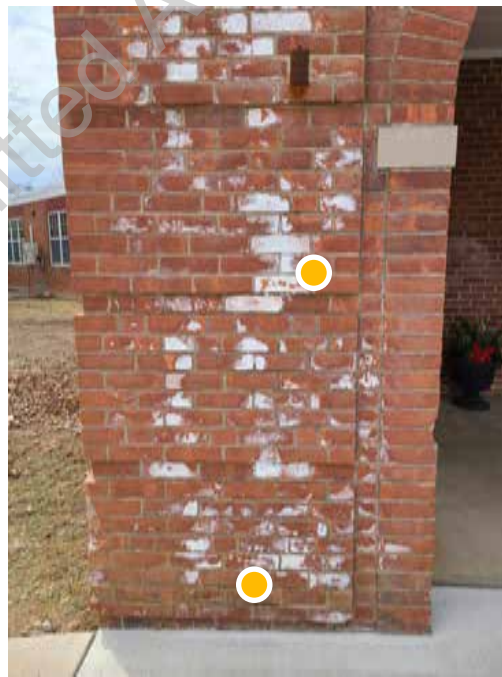
● D1. 4: Detail view of masonry arch with efflorescence and related deterioration at base of wall.

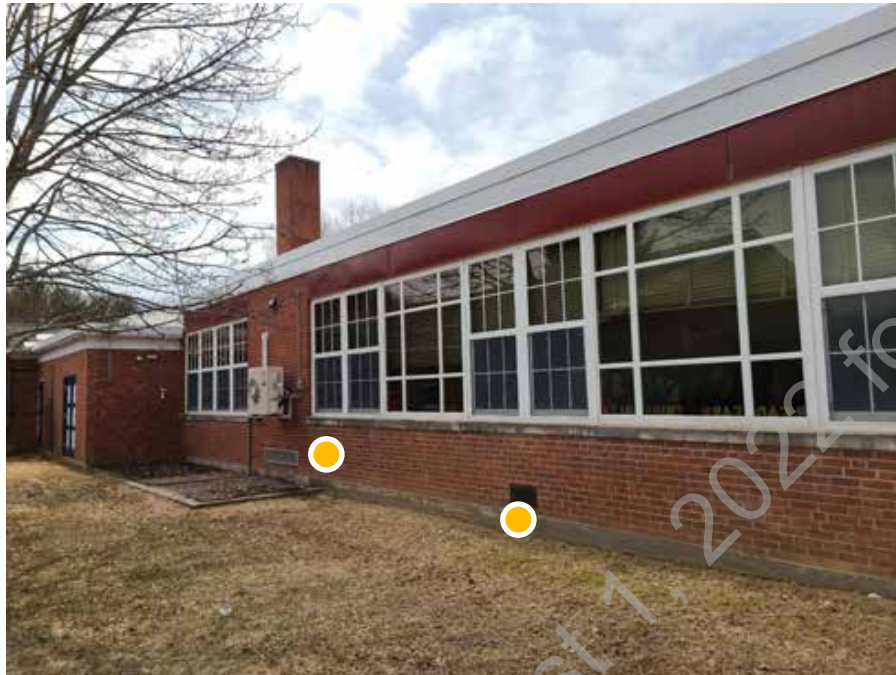
● D1. 5: View of original classroom wing (1954). Note deterioration of masonry joints and foundation wall at grade.

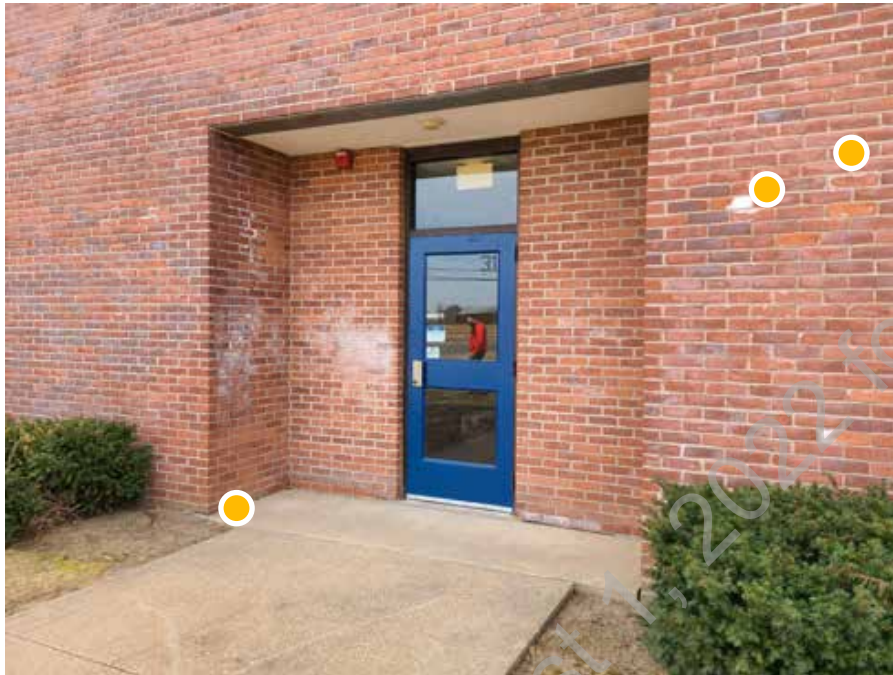
D1. 9: Detail view of entrance into 1988 classroom addition. Note masonry spalling and efflorescence due to moisture infiltration into composite wall construction.

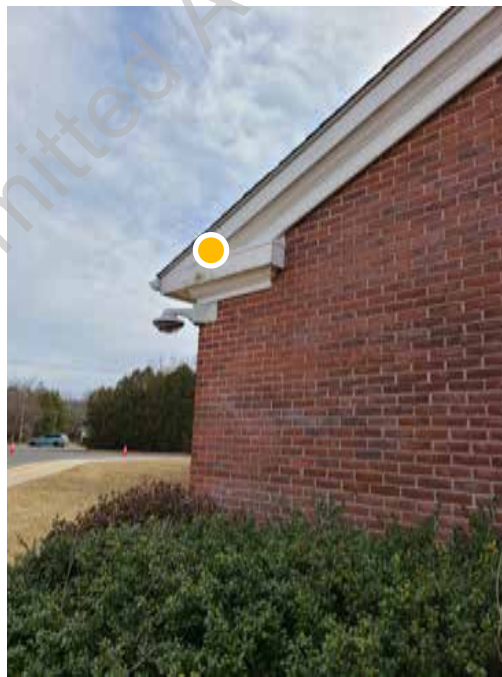
D1. 10: Detail view of trim detailing at 1988 addition along with spalling and deteriorated masonry composite wall.

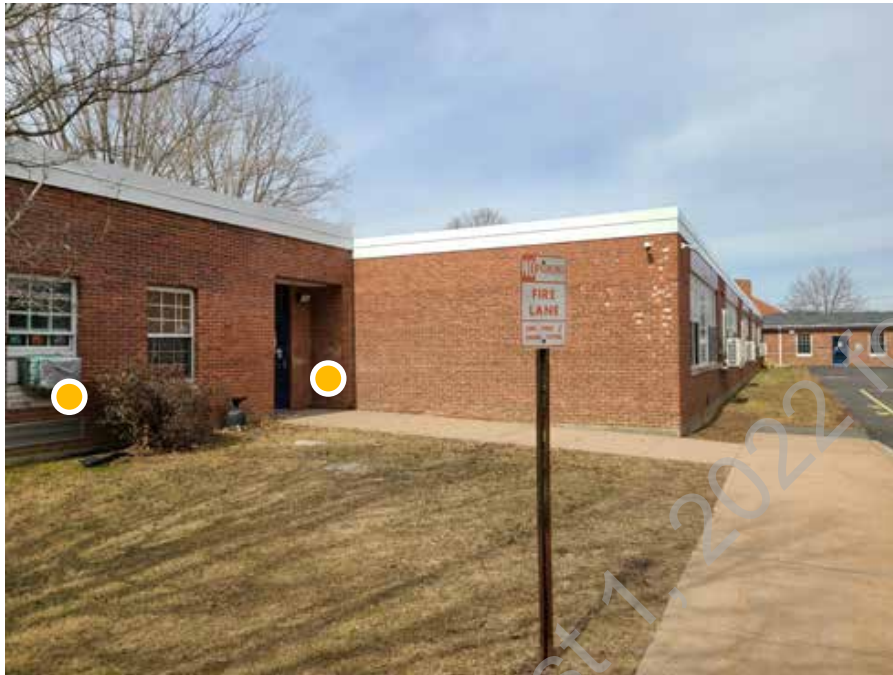
● D1. 13: View of entry into PK classroom addition (1988), note window mounted air conditioning unit.

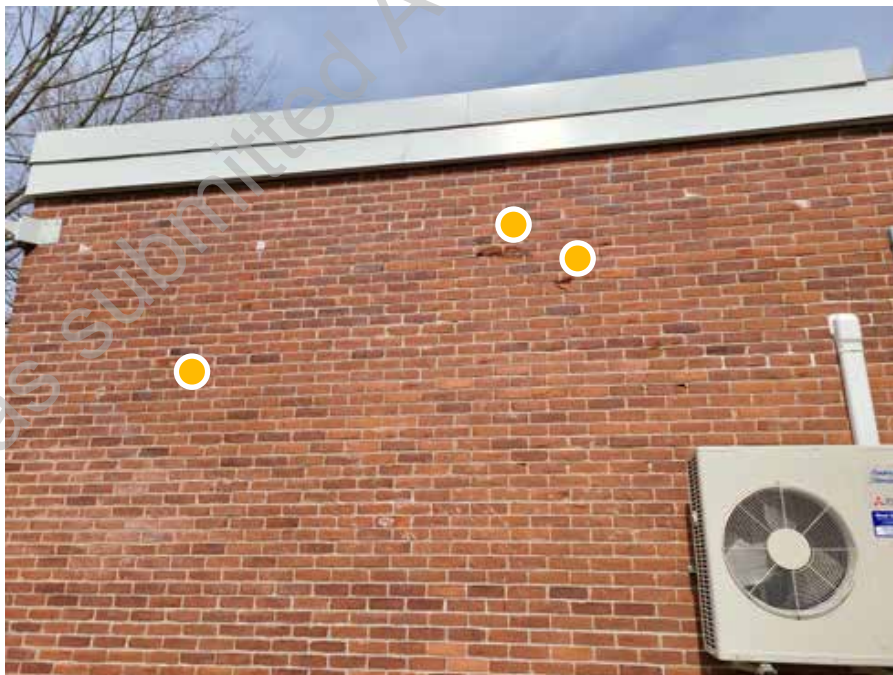
● D1. 14: Detail view of 1988 classroom addition with brick spalling and deterioration of masonry joints.

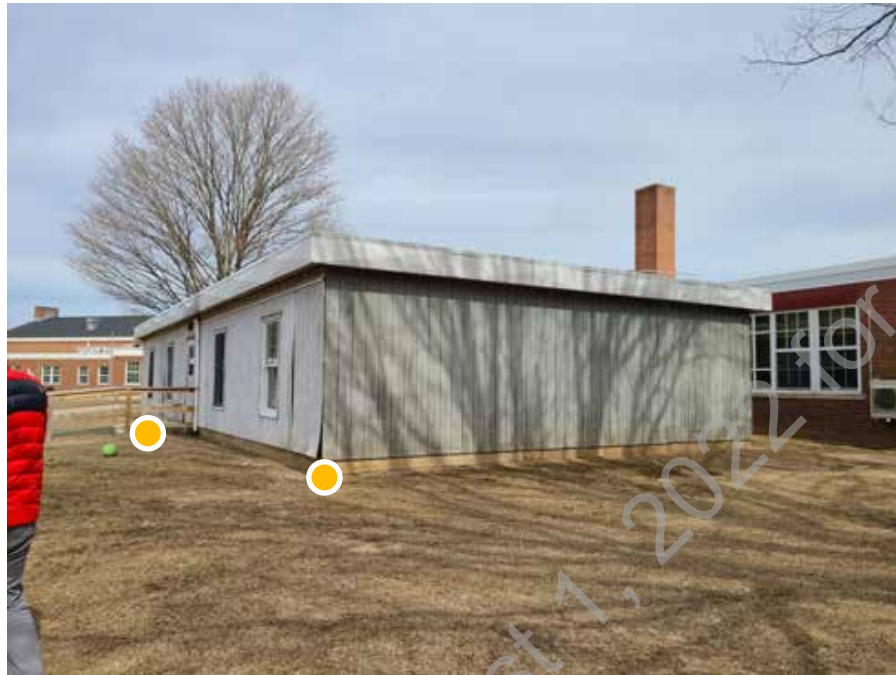
● D1. 15: Corner view of the modular classroom building with modified ramp entry shown (left). Note deterioration of T-111 siding.

MODULARS: The modular construction classroom wing is past its useful life and should be replaced with a permanent solution.

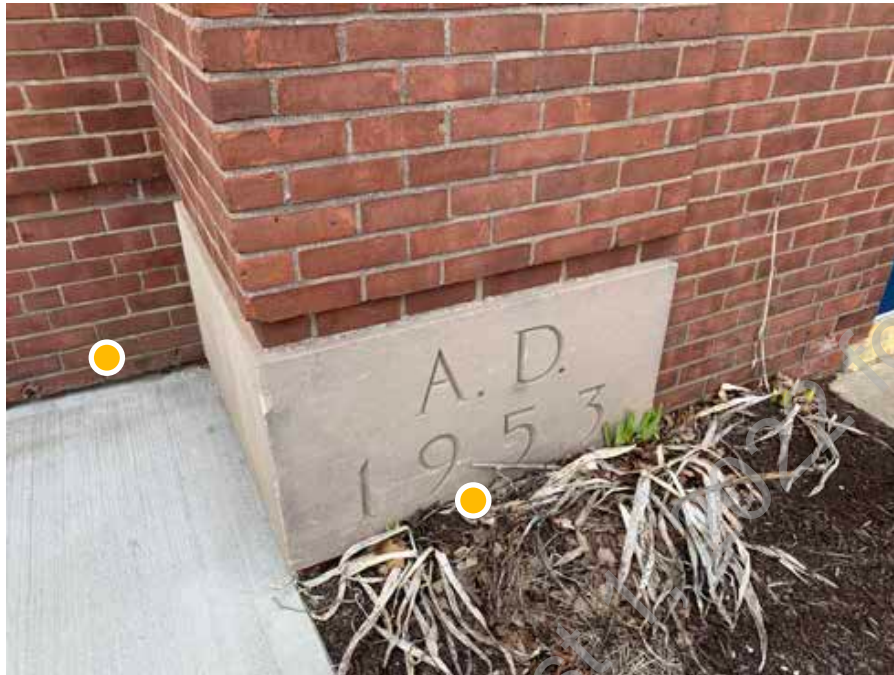
D1. 17: Monument stone at original building. Note deterioration at base of masonry wall.

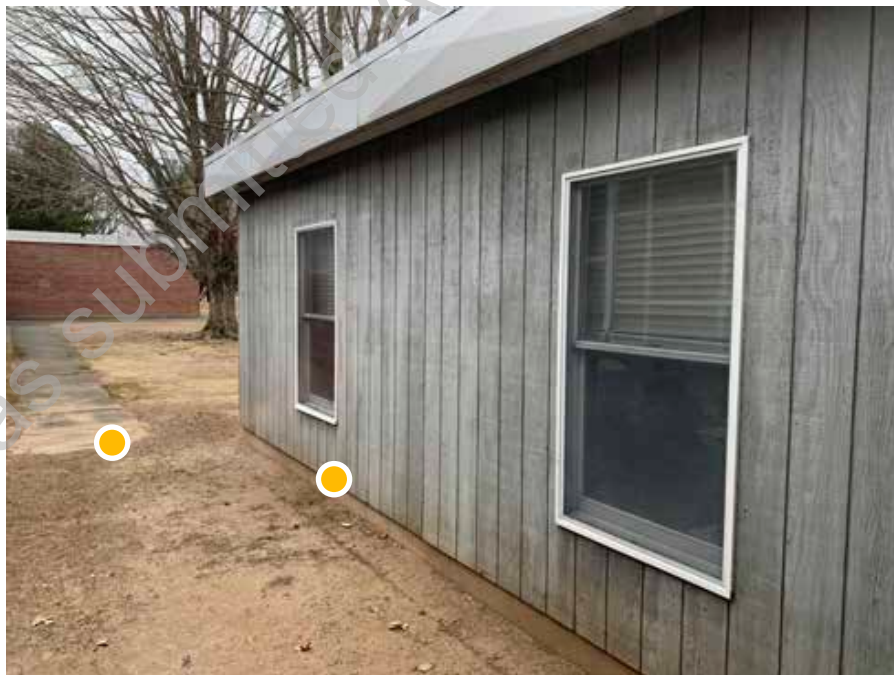
D1. 18: Detail view of the modular classroom building, note deterioration of siding and asphalt sidewalk in poor condition.

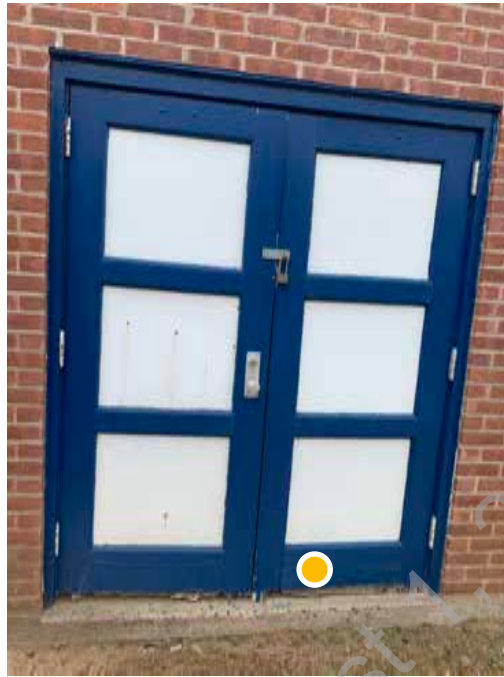
● D1. 21: View of exterior doors to mechanical space, note the poor condition at base.

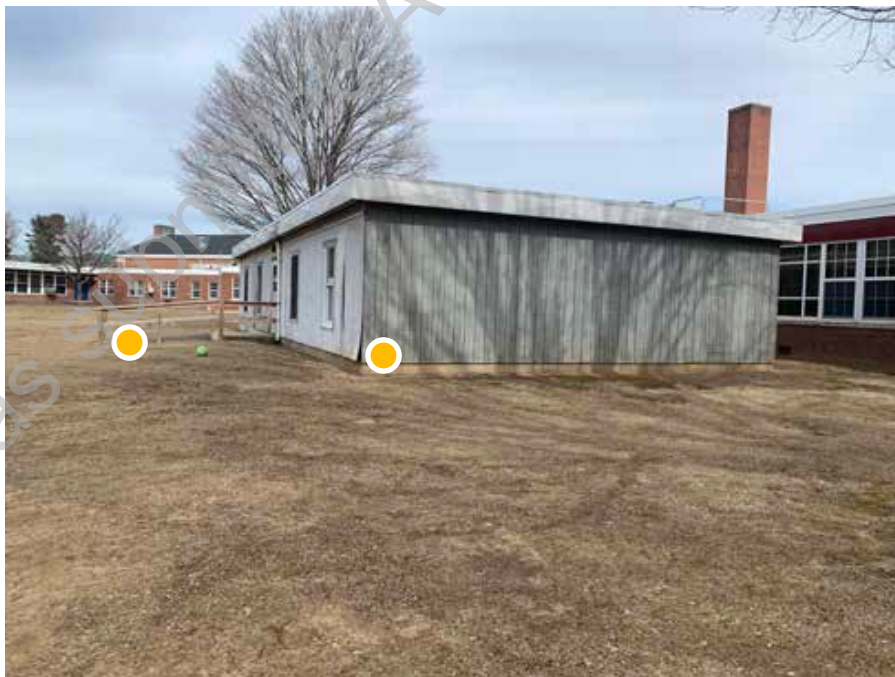
● D1. 26: View of 1985 modular classroom building. Note deterioration of the T-111 siding and non compliant ADA access ramp.

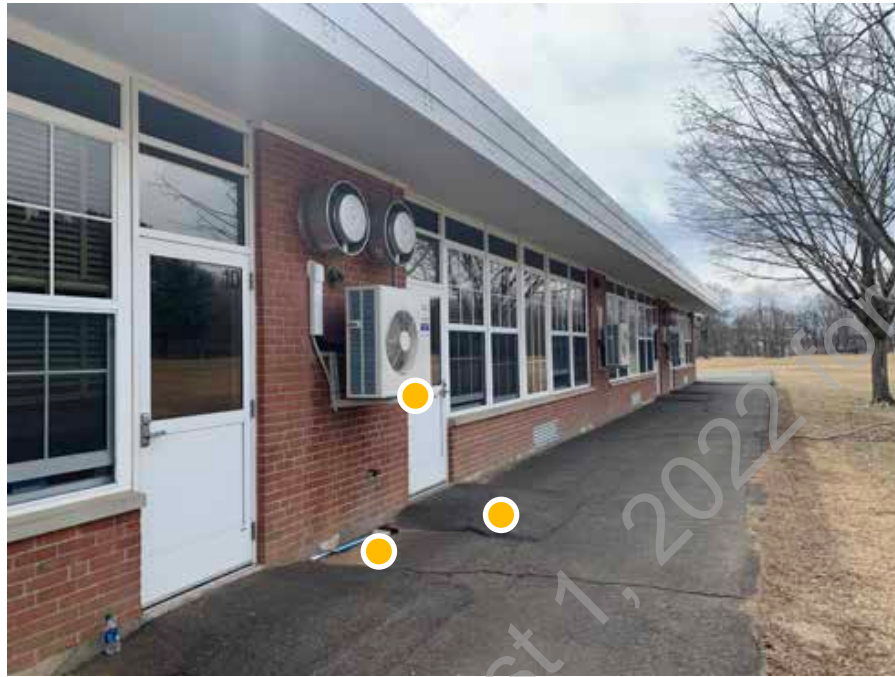
- D1. 27: View of typical classroom (1961 Addition) with direct access to exterior. Note the condition of the asphalt pavement and the wall mounted condenser unit conflicting with the walk path.

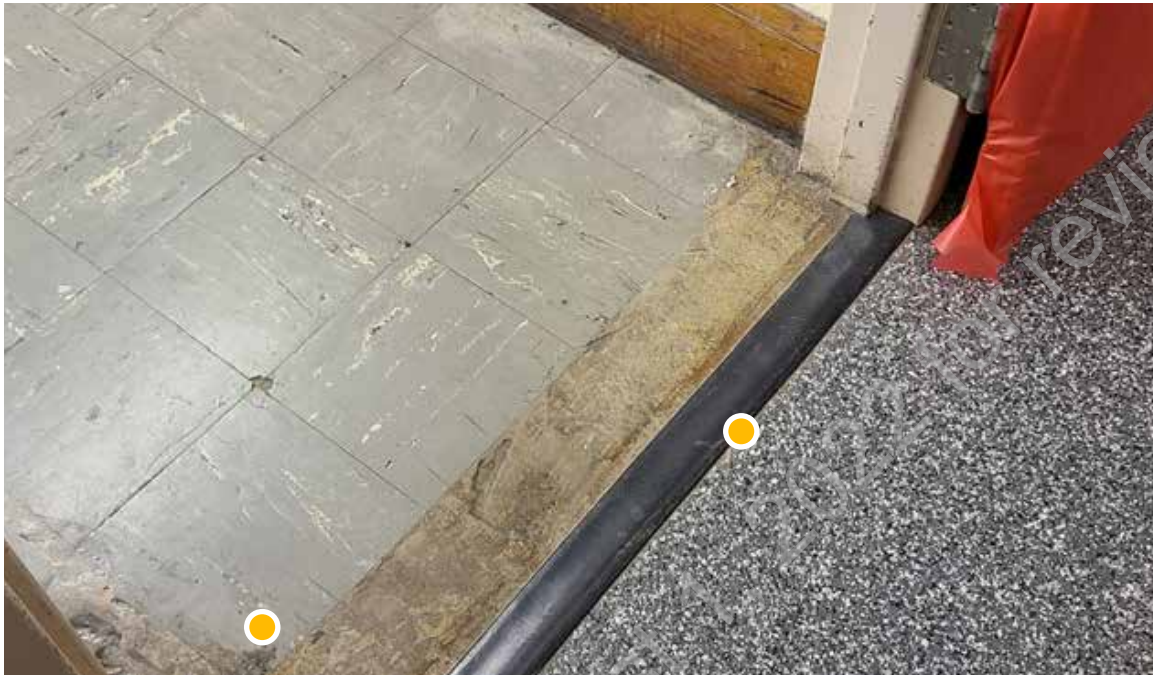
● D1. 35: Typical flooring transition between Kindergarten classrooms and corridor.
Note: Possible VAT (vinyl asbestos tile).

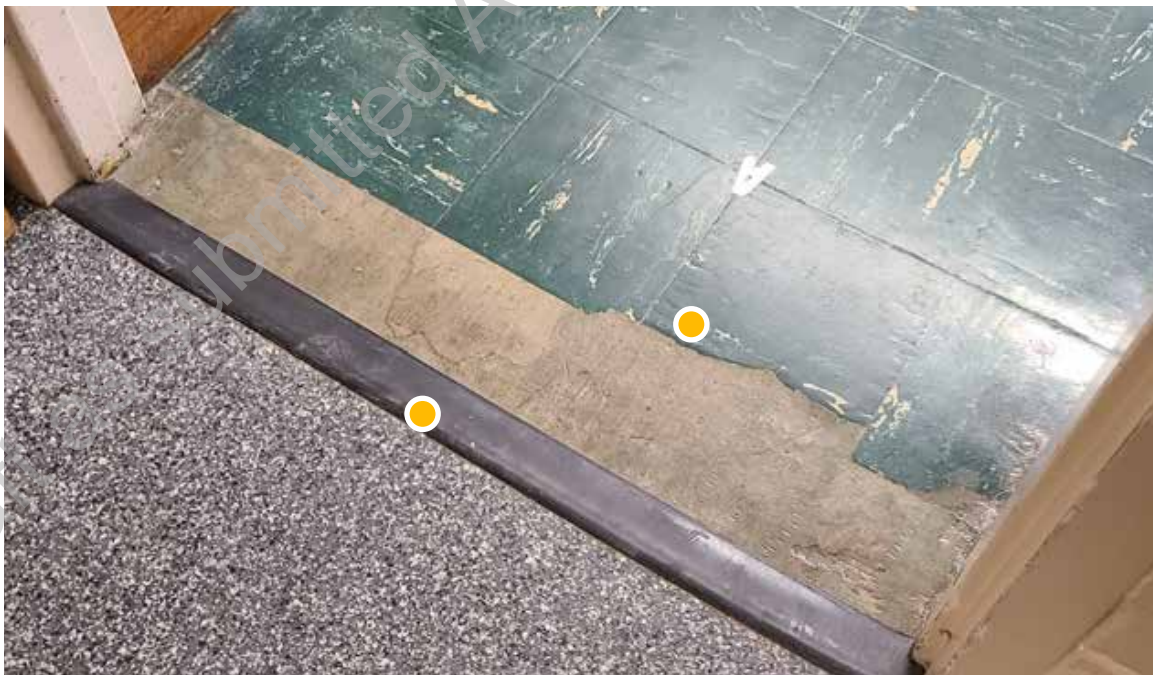
● D1. 36: Typical flooring transition between Kindergarten classrooms and corridor.
Note: Possible VAT (vinyl asbestos tile).

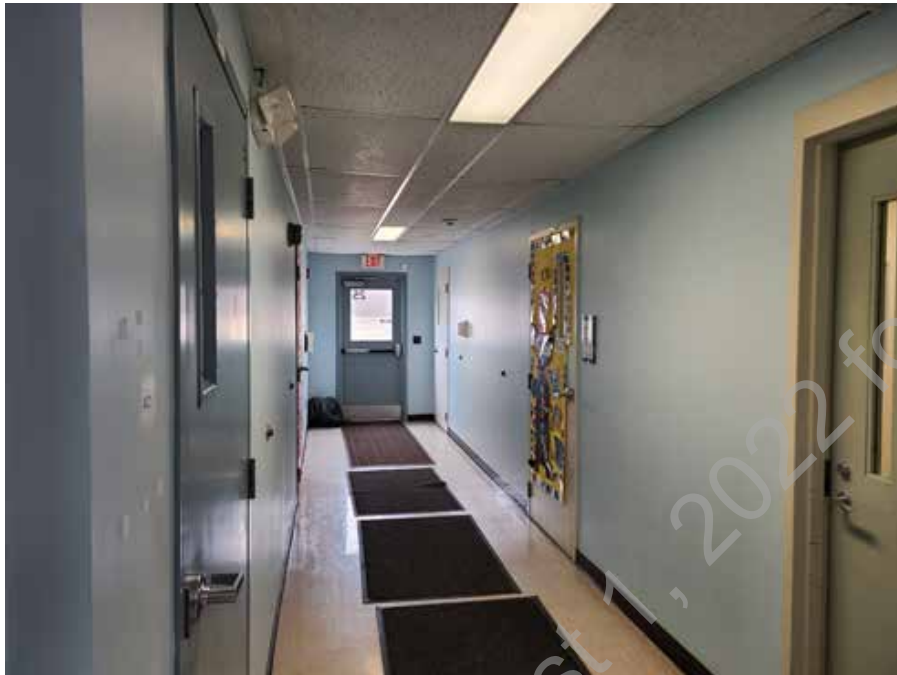
● D1. 37: View of connecting corridor through and into the modular classroom building (1985)

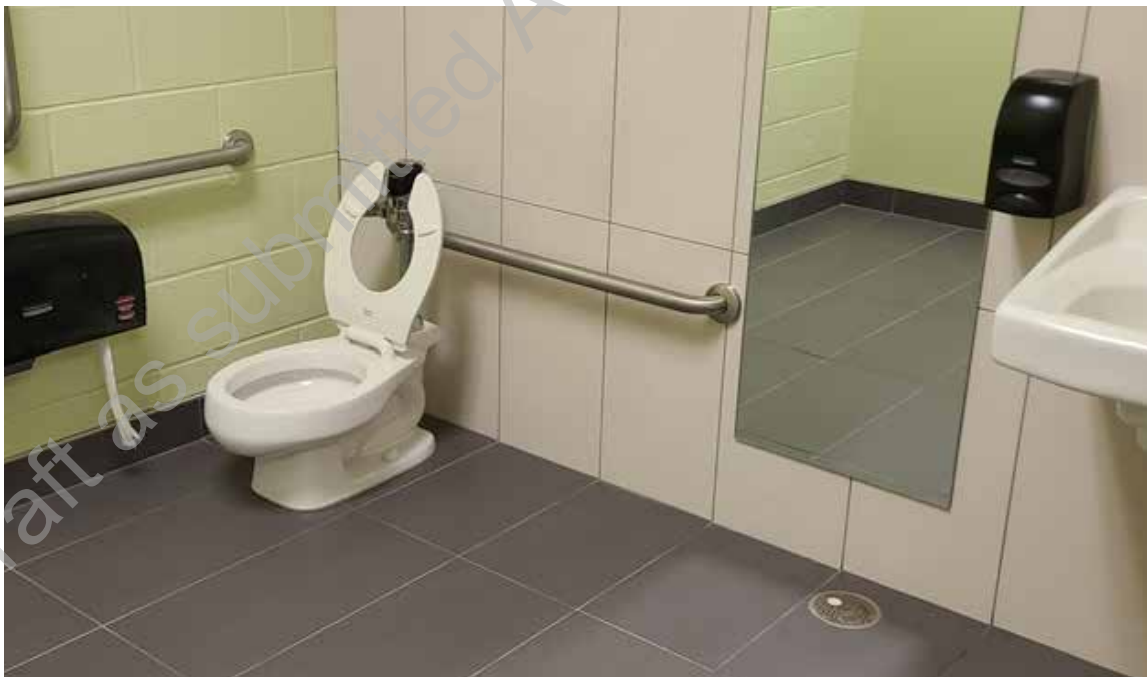
● D1. 38: Renovated toilet rooms in the PK wing (1988 Addition)

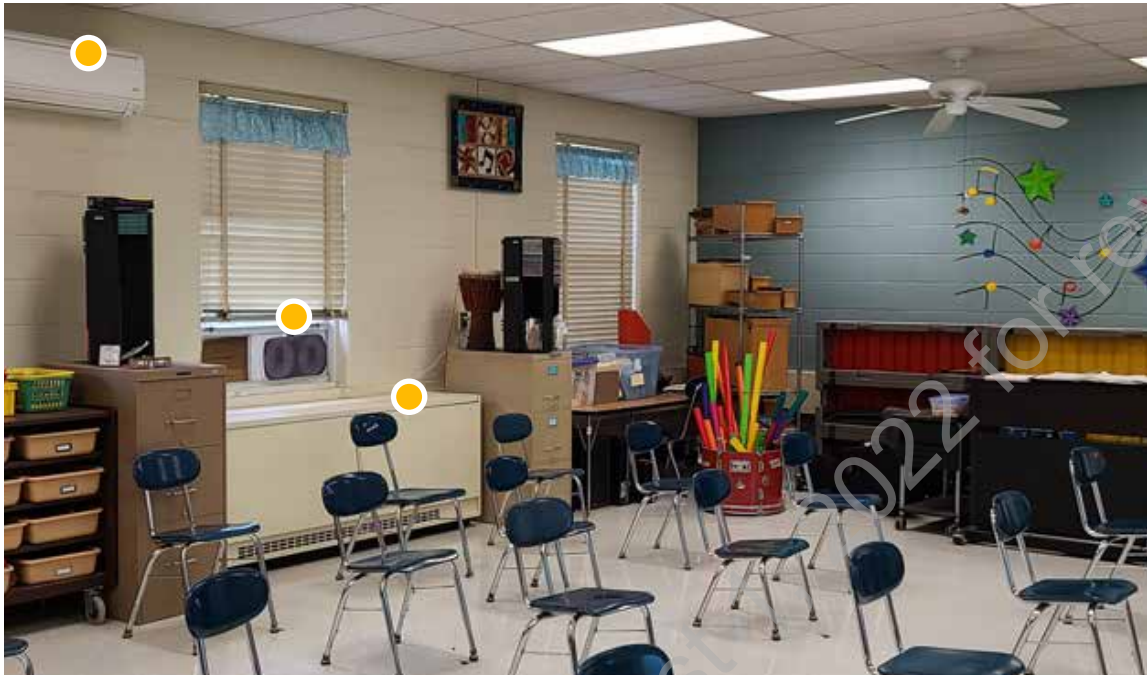
● D1. 41: View of music room with unit ventilator (center/left), window mounted fan for fresh air, and mini split unit (top left).

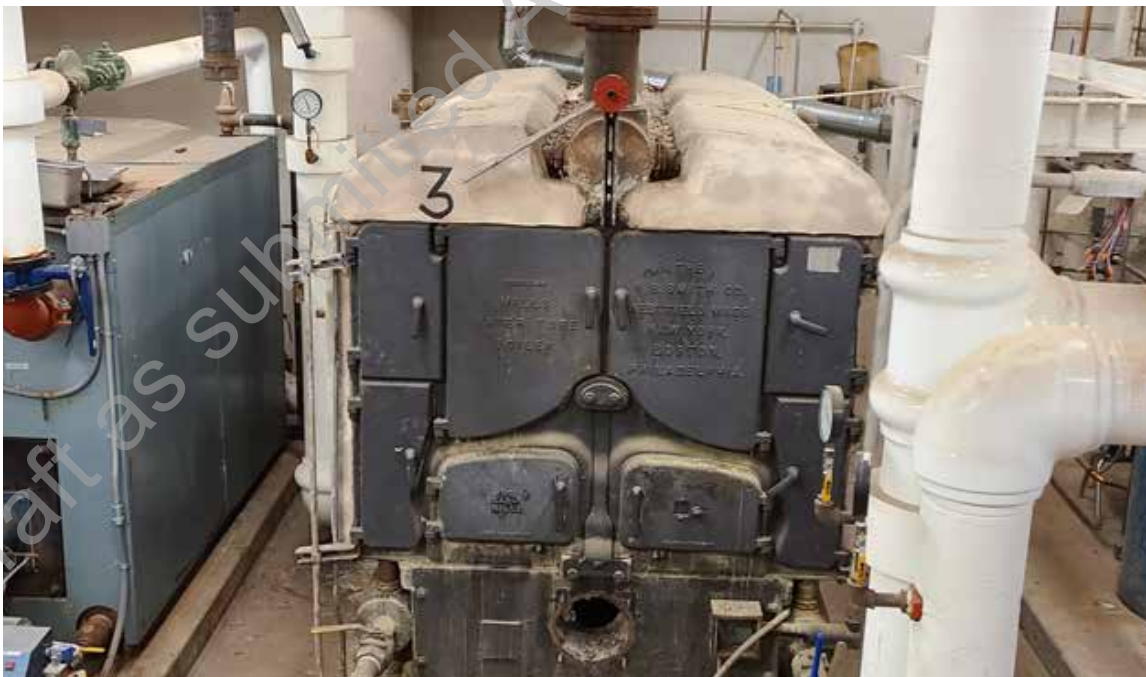
D1. 46: Abandoned Old Cast Iron Boiler in Mechanical Room.

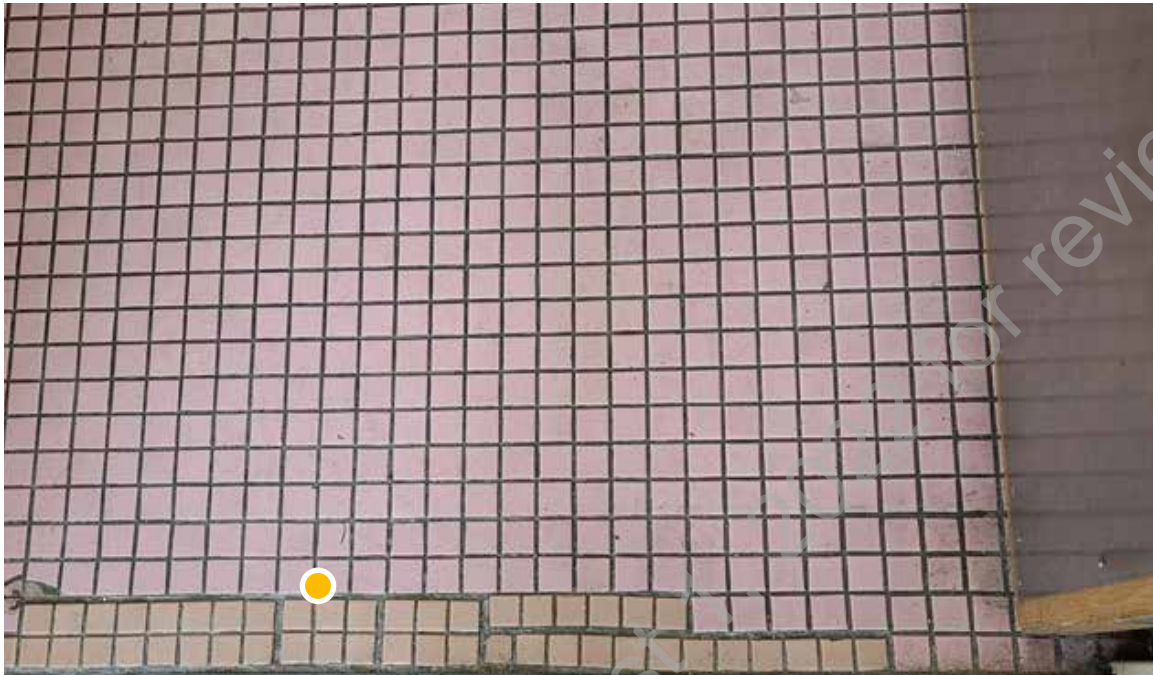
● D1. 55: Typical original bathroom floor tile with patched area.

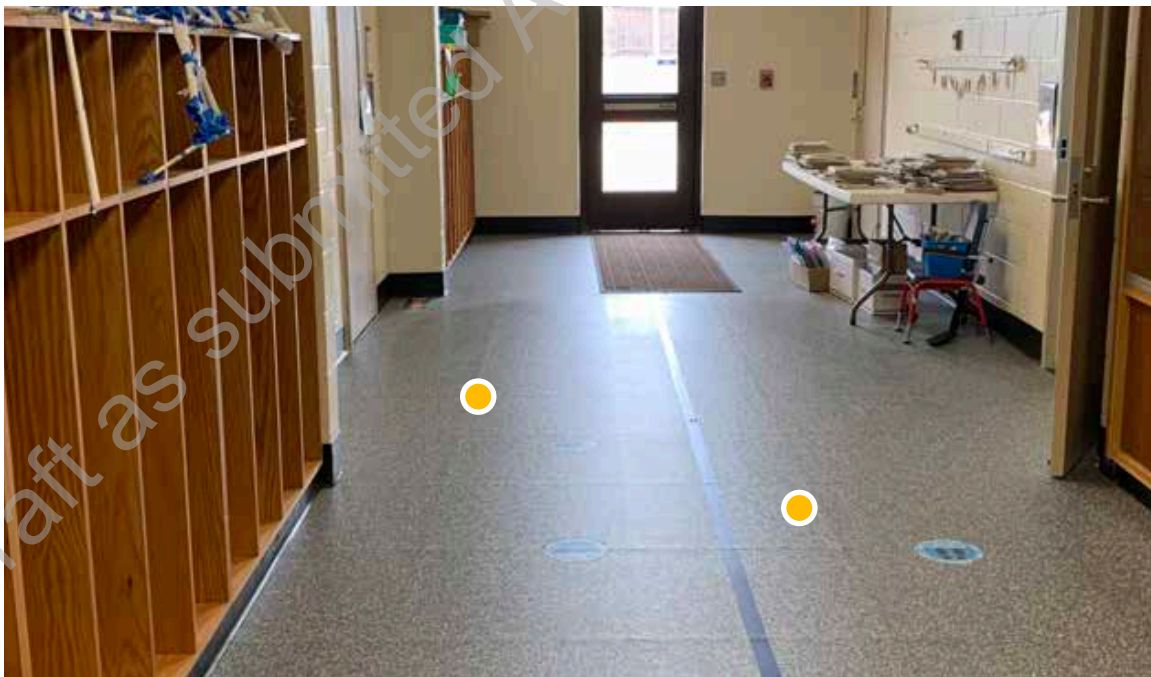
● D1. 62: View of flooring retrofit over existing possible VAT (vinyl asbestos tile). Note seaming telegraphing through surface.

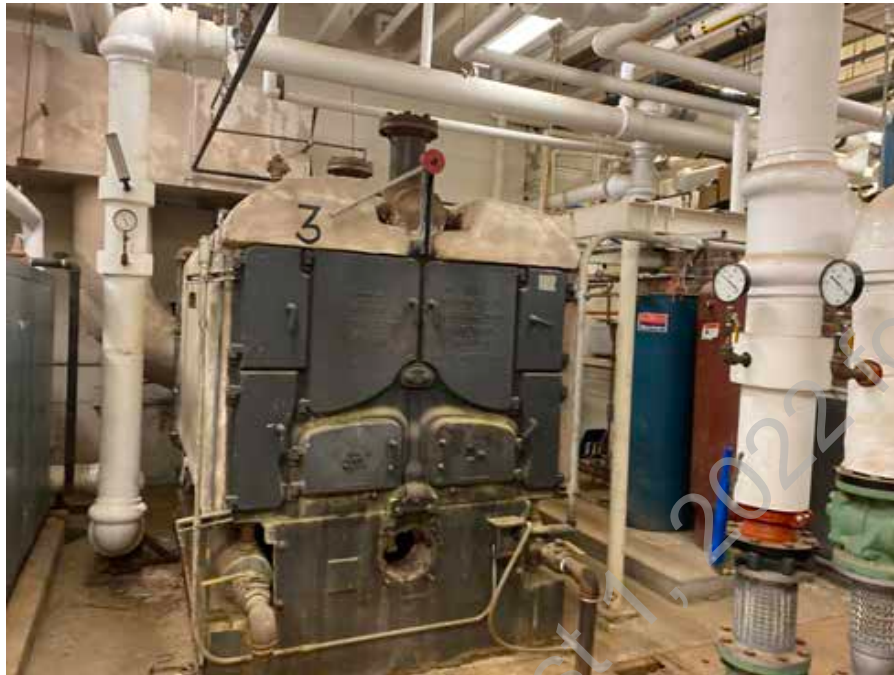
● D2. 1: Abandoned Old Cast Iron Boiler in Mechanical Room.

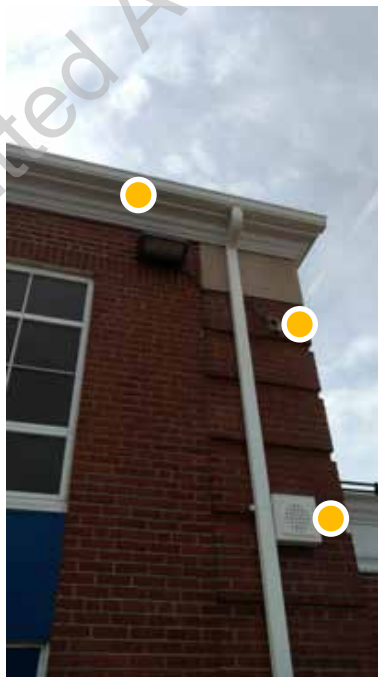
● D2. 14: View at exterior corner of gymnasium depicting roof leader, PA system and security camera retrofits.

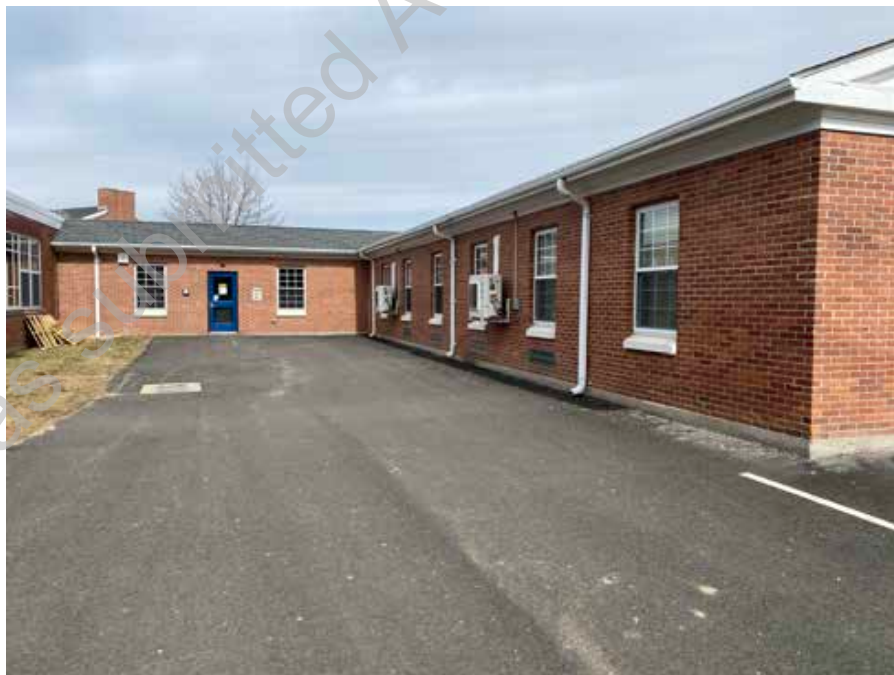
● D2. 18: View of paved parking area adjacent to classroom space (media center and connecting corridor beyond).

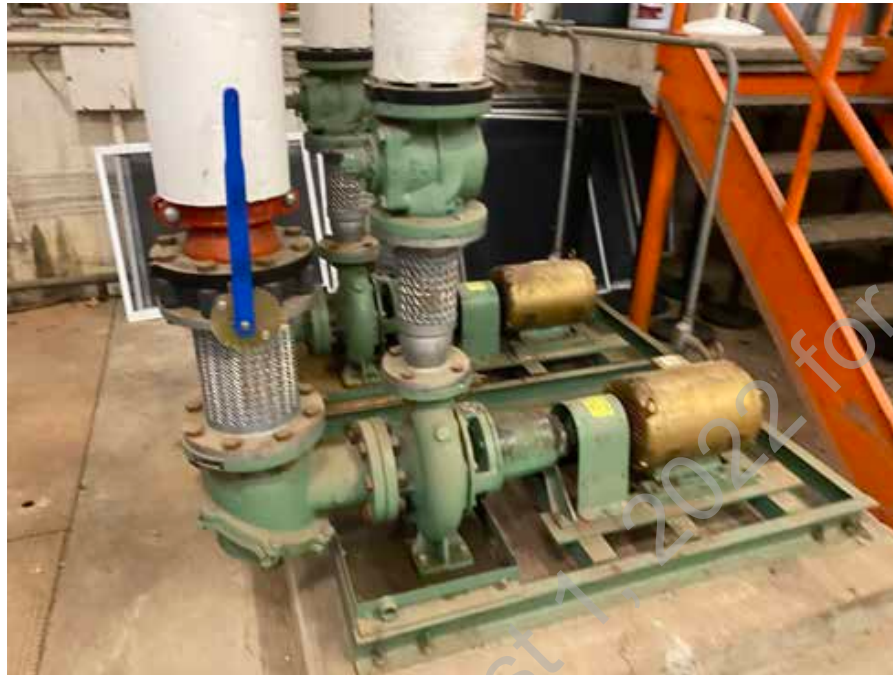
● D2. 19: Hot Water Pumps in poor condition.

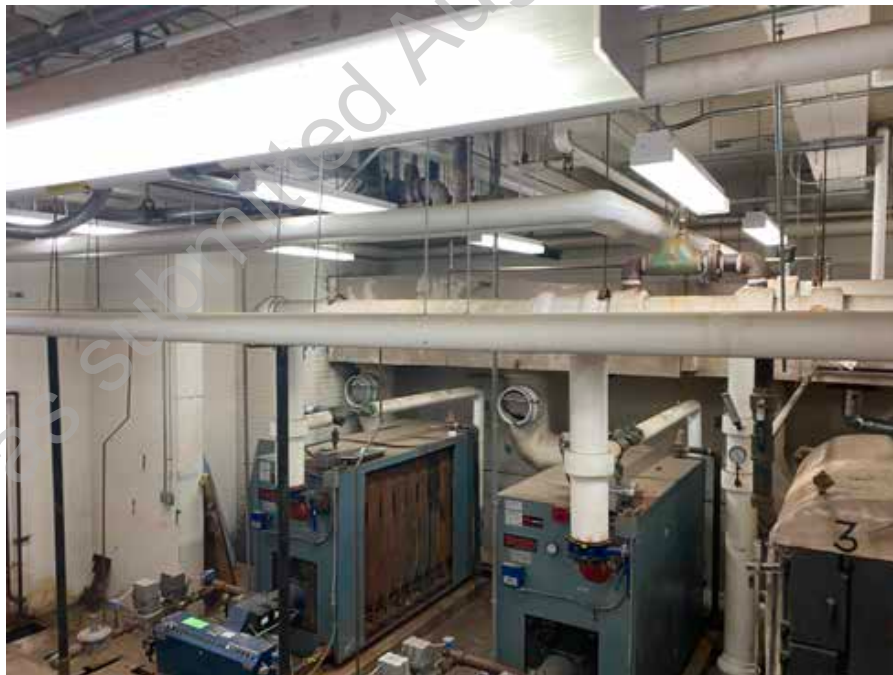
● D2. 22: Mechanical and Plumbing Piping in poor condition.

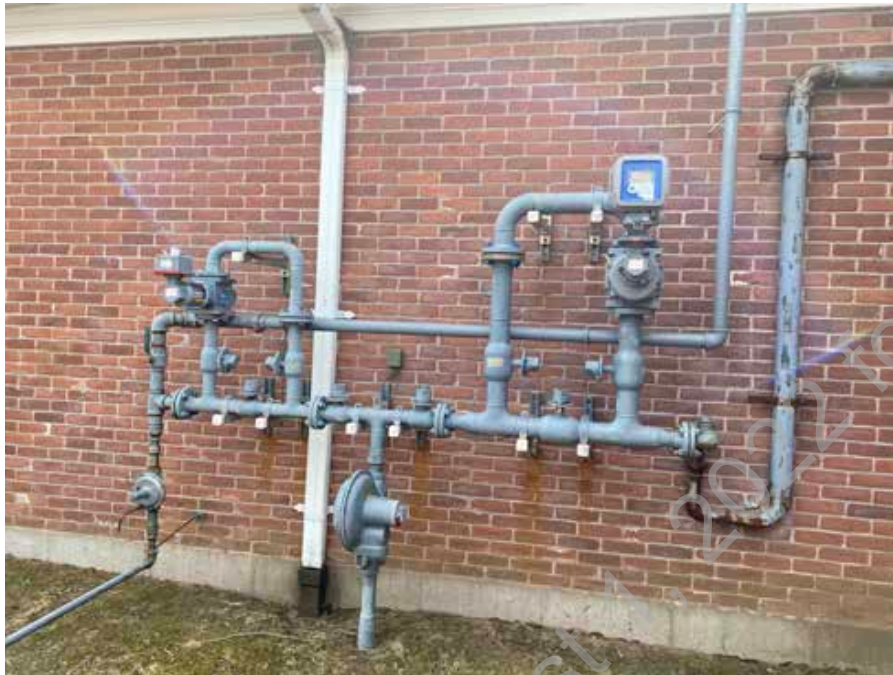
● D2. 25: Natural Gas Service in Good Condition.

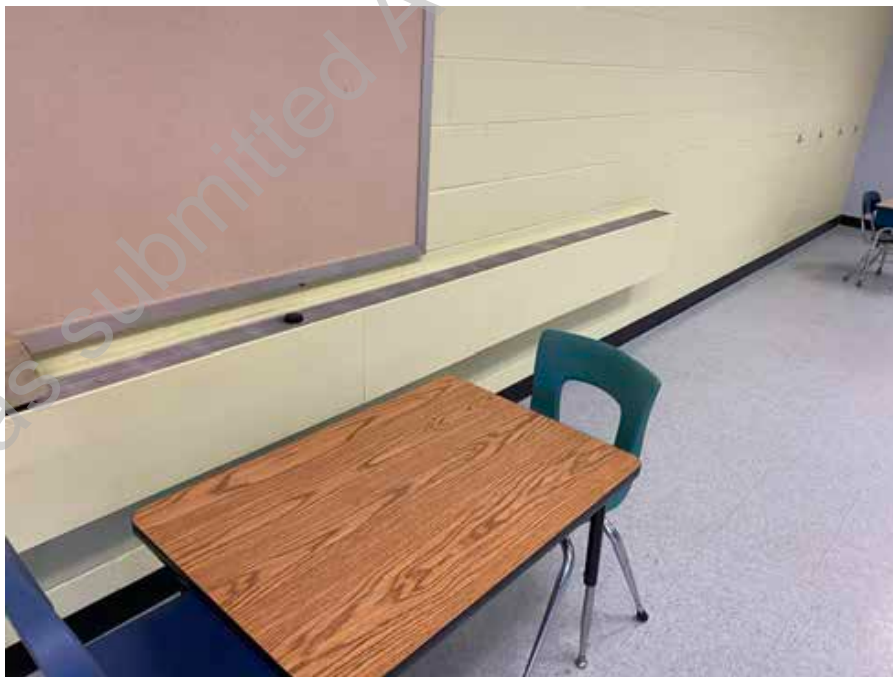
● D2. 26: View of elevated perimeter radiation (heating) in poor condition adjacent to student

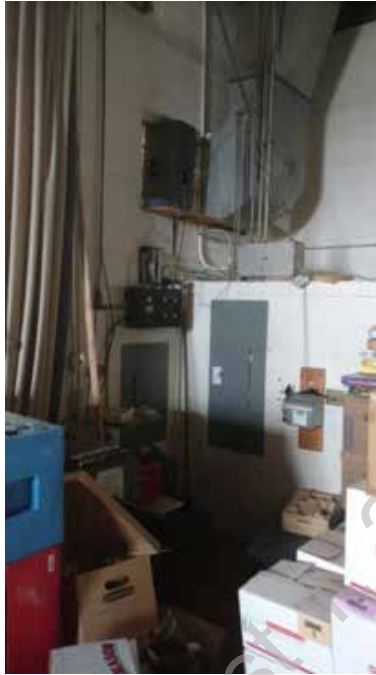
● D2. 27: Old Stage Power Panels.

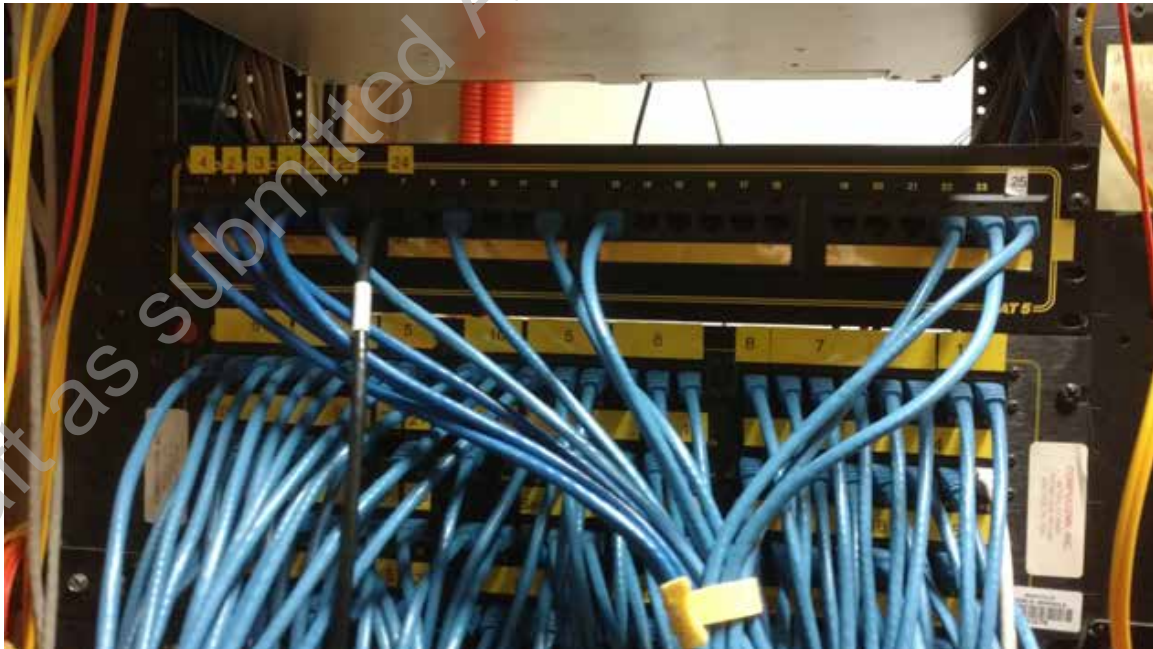
● D2. 28: Older Cat 5 Network Infrastructure.

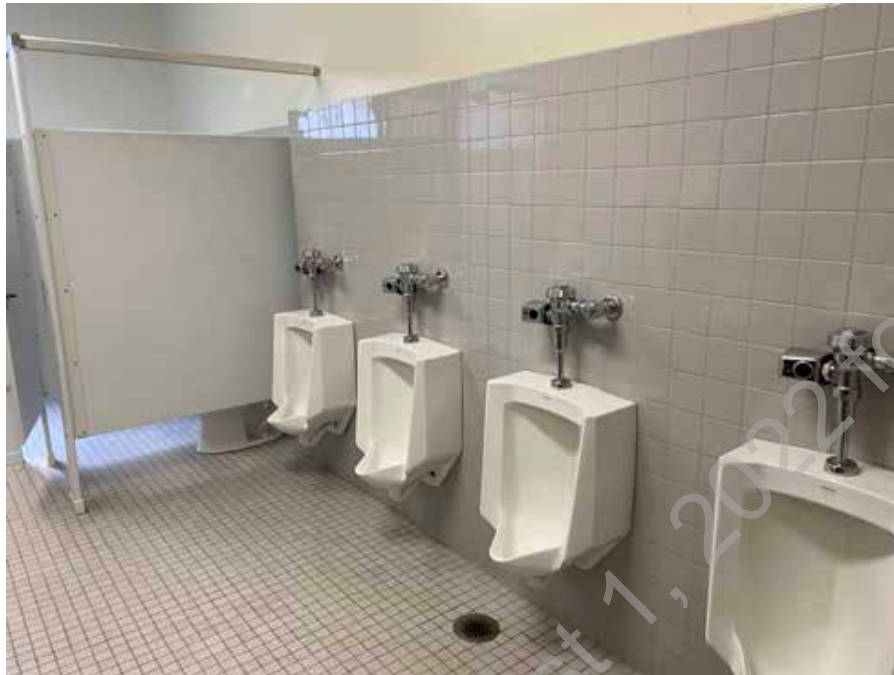
● D2. 29: Plumbing Fixtures in Fair Working Condition.

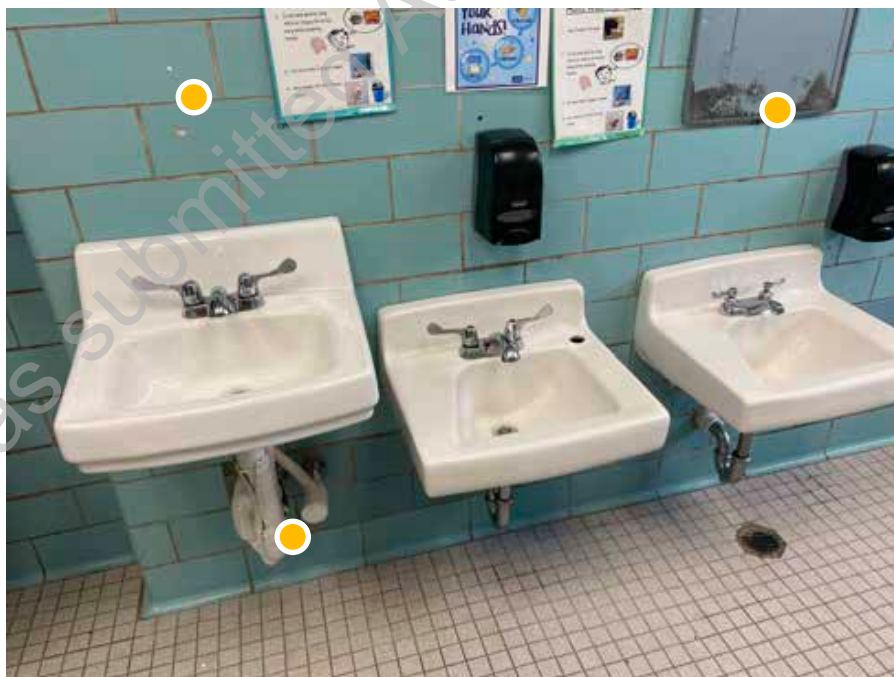
● D2. 30: View of typical toilet room with original wall and floor tile. ADA adjustments made to one site for floor clearance. Wrap protection in poor condition. No accessible mirror or soap dispenser.

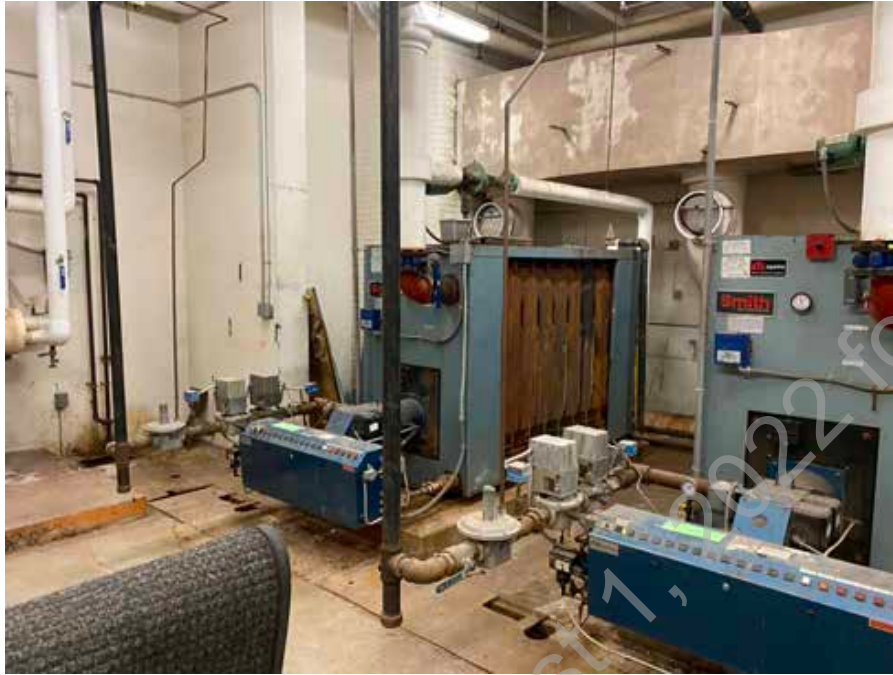
● D2. 33: Smith Natural Gas Cast Iron Hot Water Boilers in poor condition.

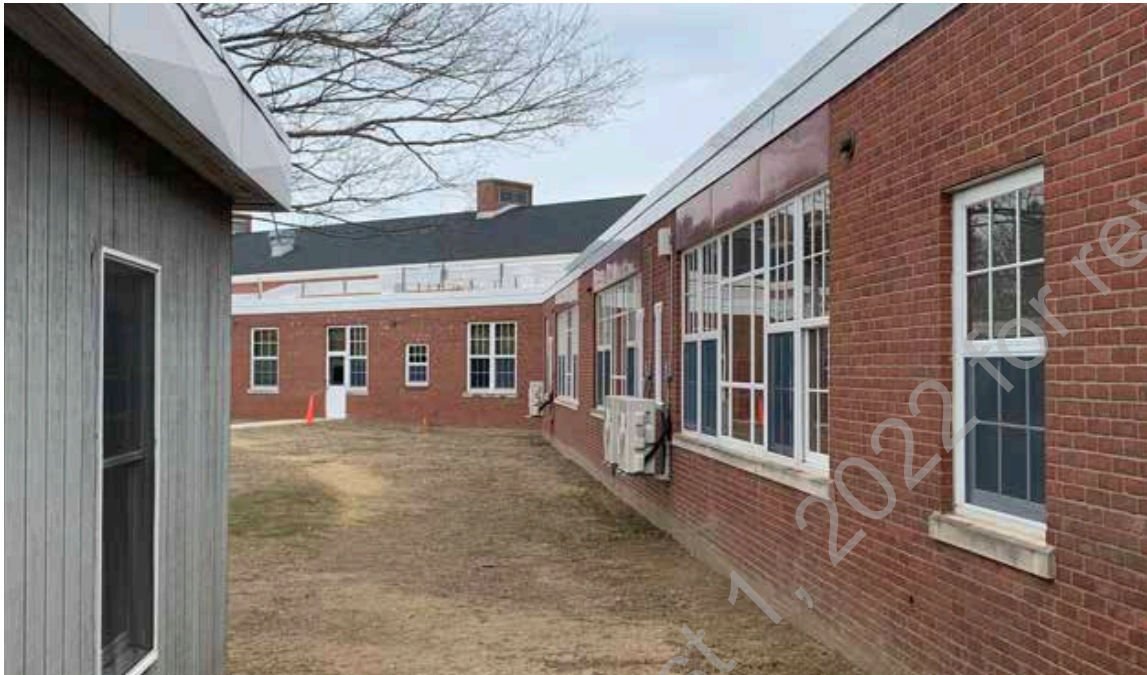
● D3. 7: View of modular classroom building (left) and typical condition of exterior of classroom wing.

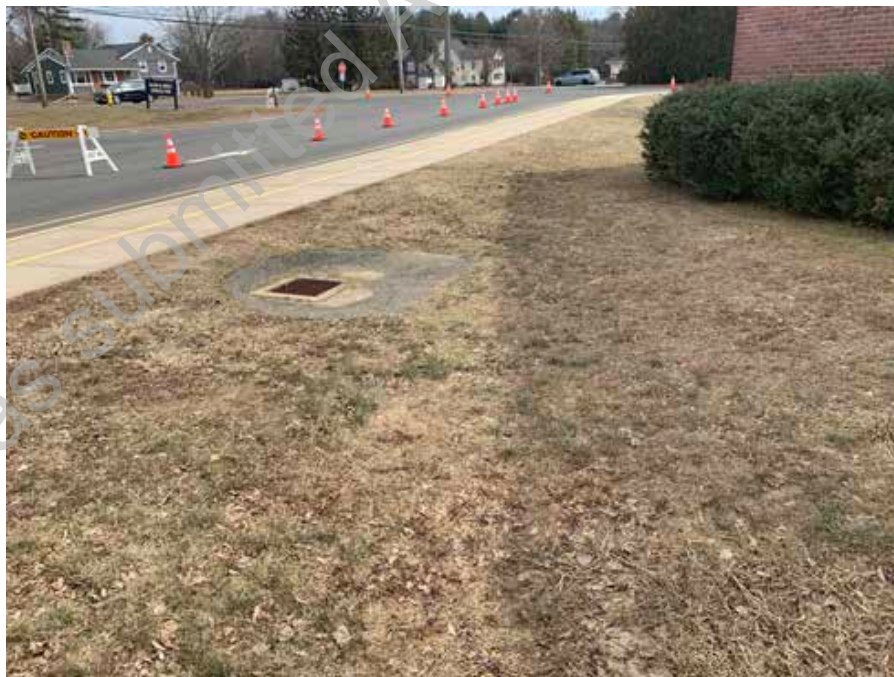
● D3. 8: Typical condition of grass areas throughout site. Unconventional location and construction of yard drain.

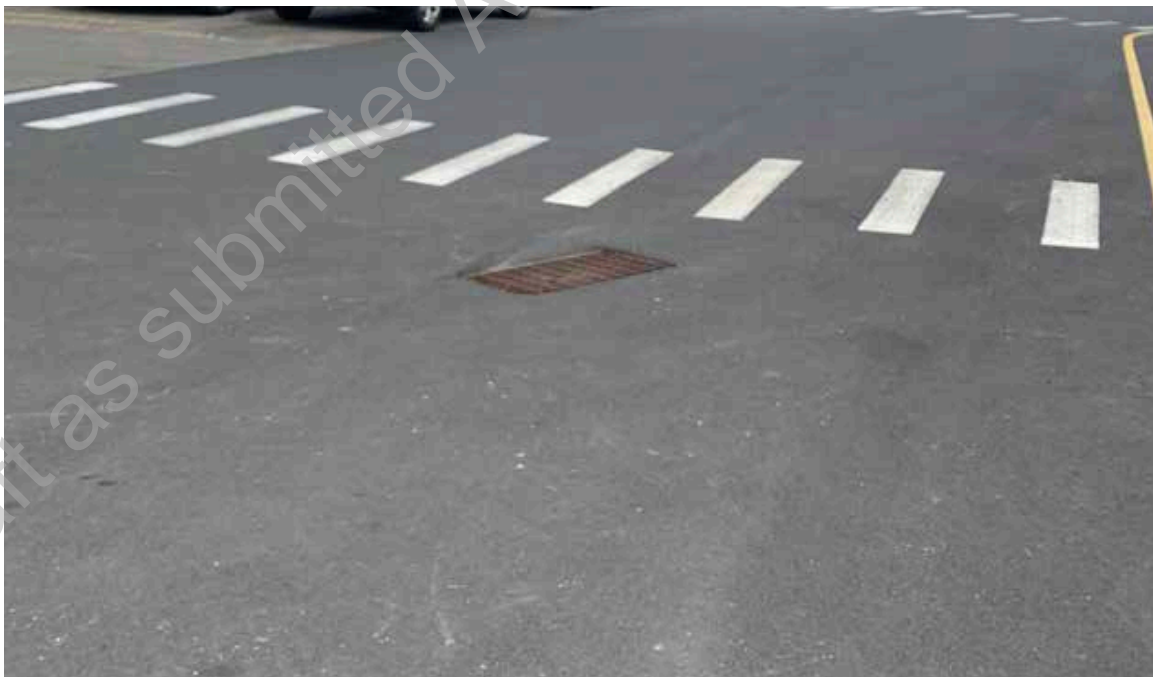
● D3. 14: View of repaired/paving replacement at main entrance drive. Storm water collection system as originally installed.

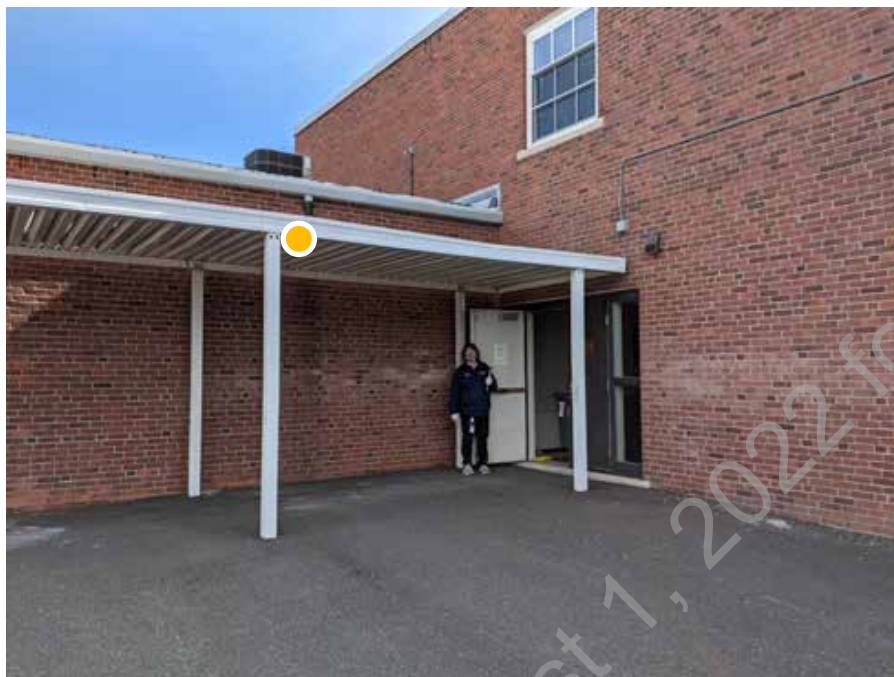
● D1. 1: View of temporary roof that was once connected to the modular building (1994).
