TOWN OF SUFFIELD

CONDITIONS ASSESSMENT & MASTER PLAN

Draft as submitted August 1, 2022 for review

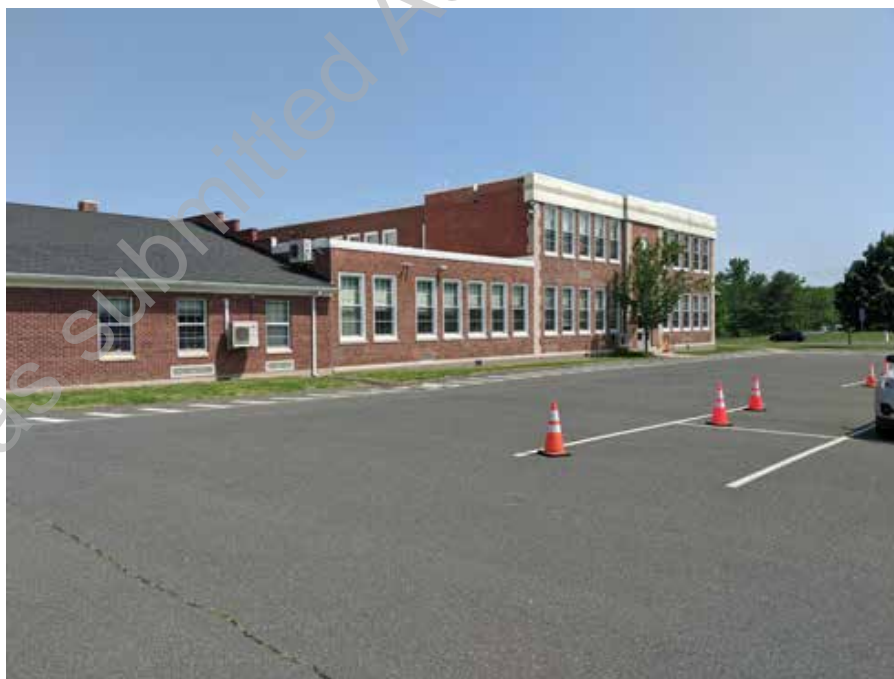
● D1. 2: View to the south with 1987 addition to left and original 1939 building on right.

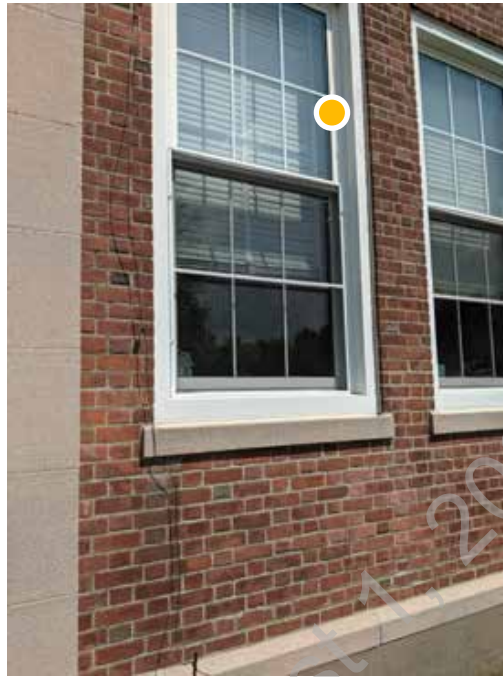
● D1. 3: Detailed view of window and masonry at original 1939 building.

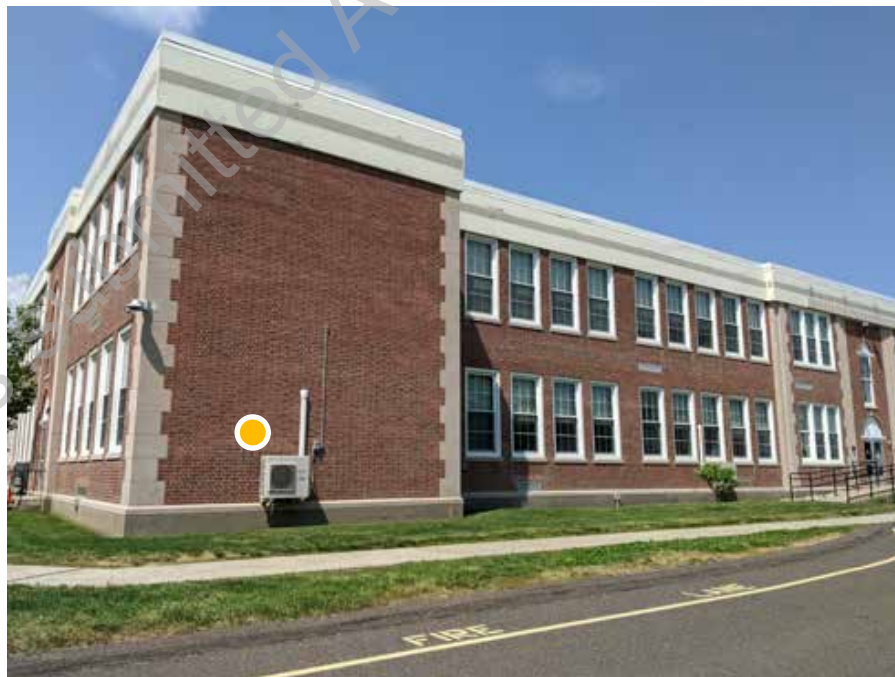
● D1. 4: View of south façade of original 1939 building, note modifications for wall mounted air conditioning unit.

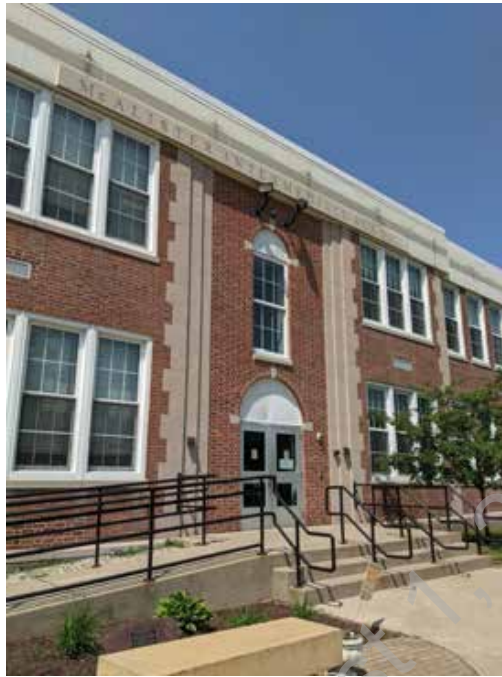
● D1. 5: Detail view of main entry and site modifications to the original 1939 building.

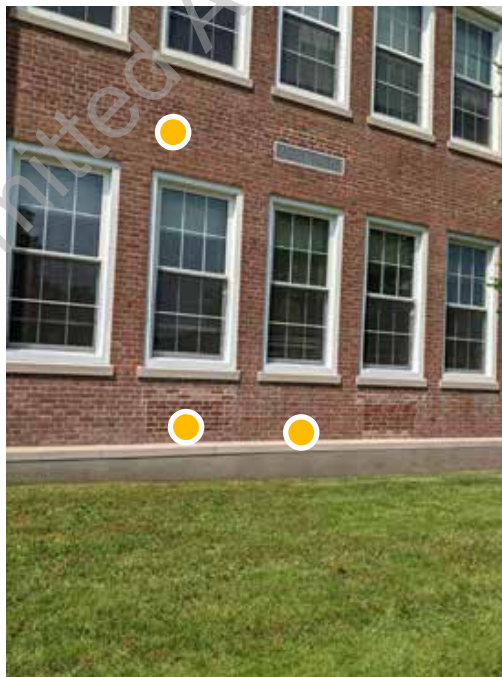
● D1. 6: Detail view of the south façade of original 1939 building depicting masonry repairs and infill over the years.

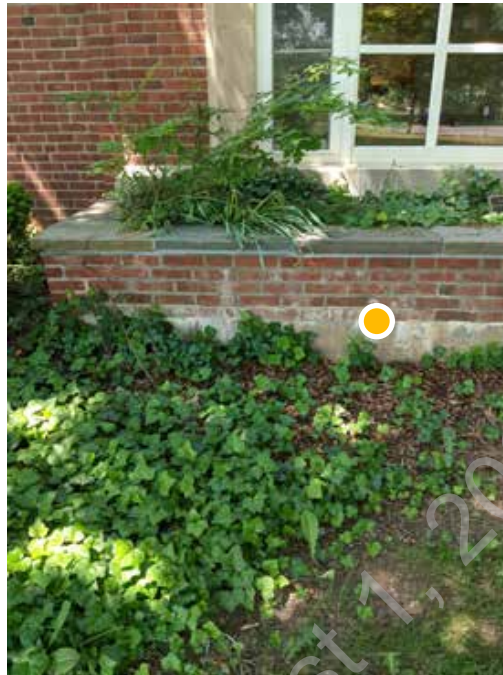
- D1. 7: Detail view of the south façade of 1956 addition, note the efflorescence on the masonry due to moisture infiltration into the composite wall construction.

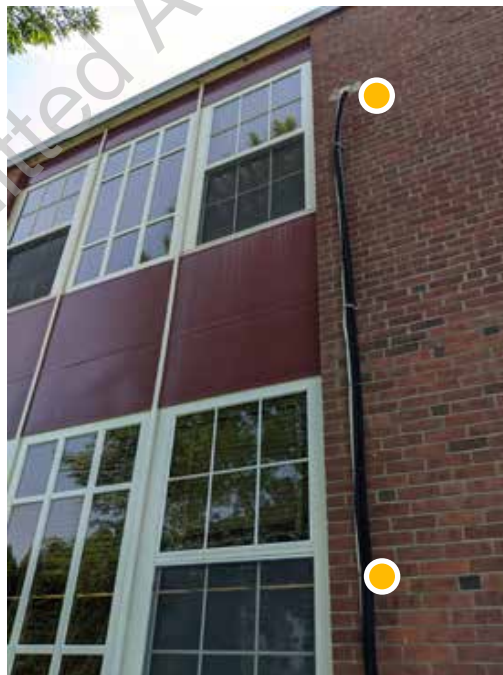
- D1. 8: Detail view of the east façade of the 1956 addition, note modifications for mechanical equipment piping.

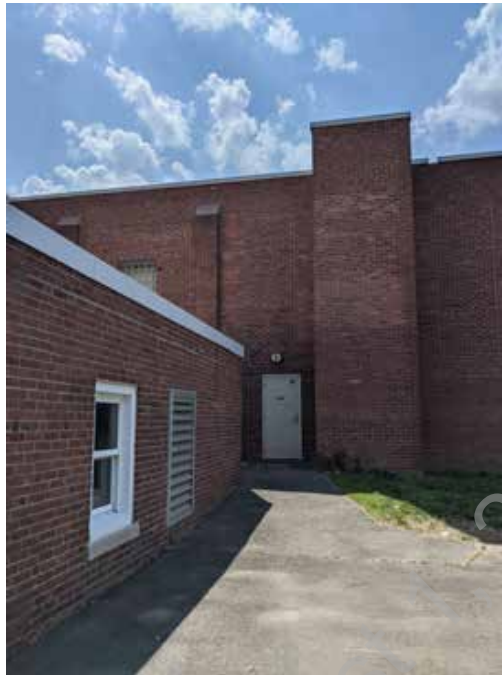
- D1. 9: Detail view of mechanical and storage space adjacent to gymnasium, part of the original 1939 building. Note poor condition of asphalt access ways and overall masonry wall.

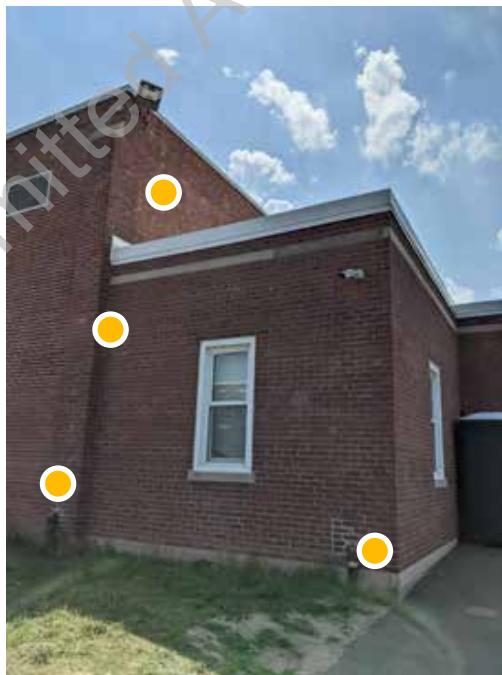
- D1. 10: Detail view of north side of original 1939 building, note masonry repairs and overall deterioration of masonry façade and jointing.

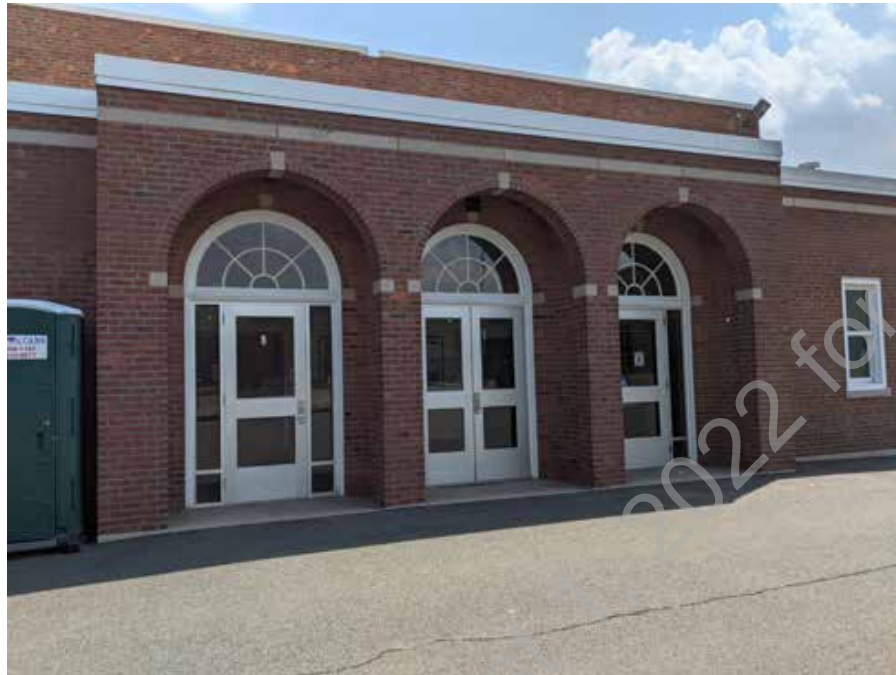
● D1. 11: View of north entrance to the gymnasium area.

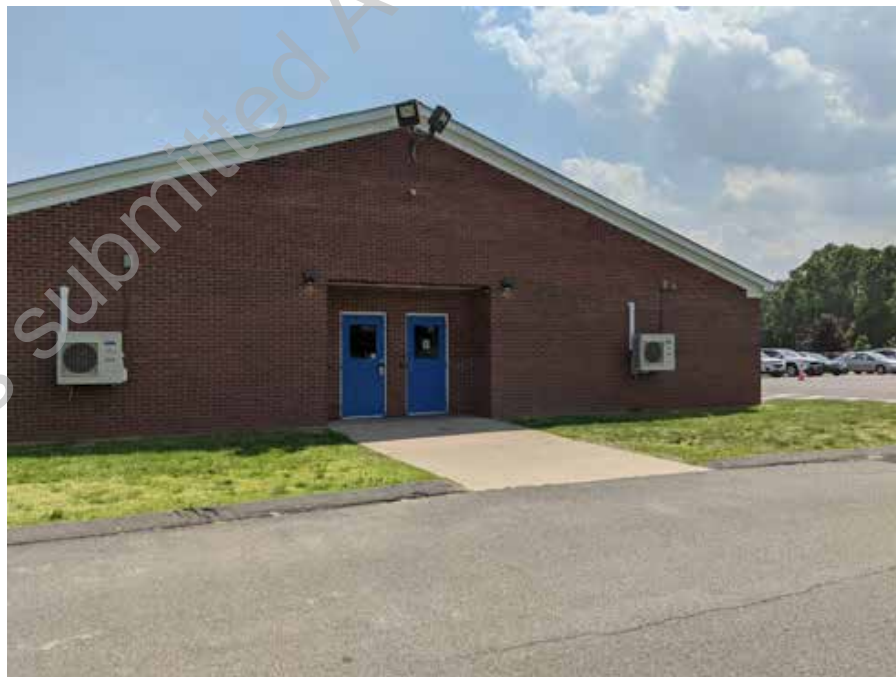
● D1. 12: View to entry/egress doors into the 1987 addition, north façade. Note wall mounted air conditioning and parking lot lighting modifications.

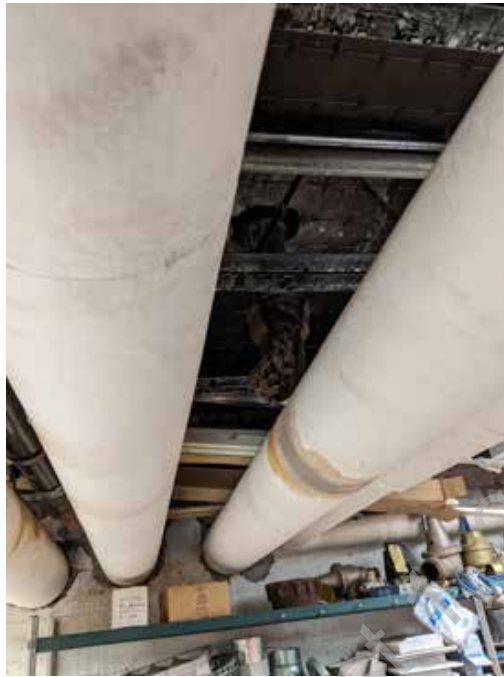
DOMESTIC WATER PIPING: Domestic water piping was observed to be a combination of copper and steel piping. The piping is original to the 1939 construction and 1956 and 1987 additions with some enhancements during renovations along the way. Overall the majority of the piping appears to be approximately 50 years old and at the end of its useful life.

● D1. 13: Existing Piping.

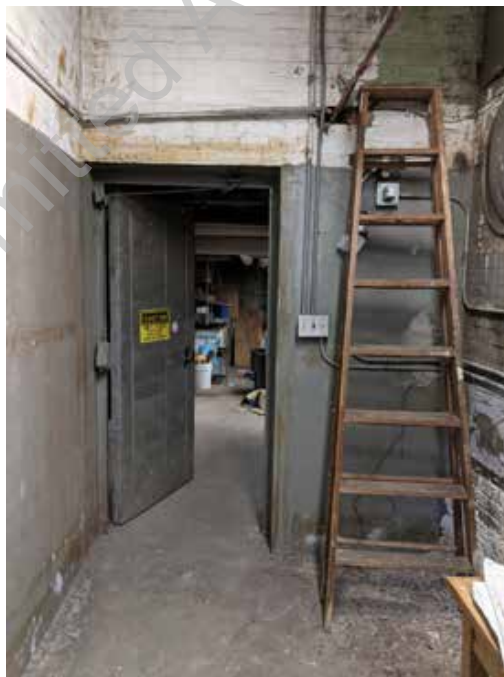
● D1. 14: Basement Electric Room.

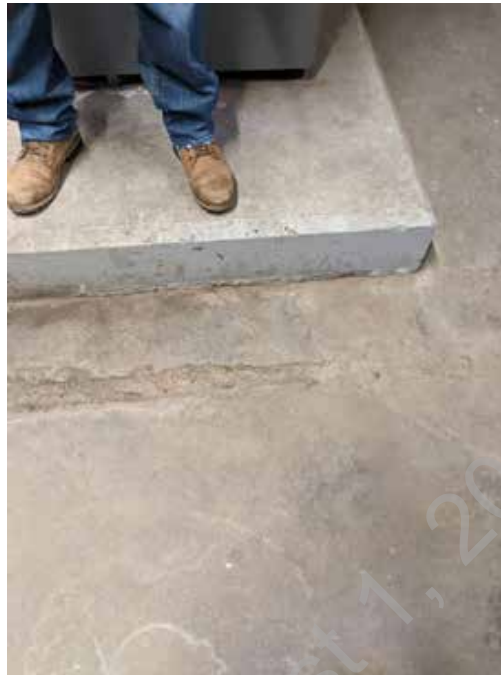
- D1. 15: Detail view of the concrete equipment curbs in the lower level mechanical space.

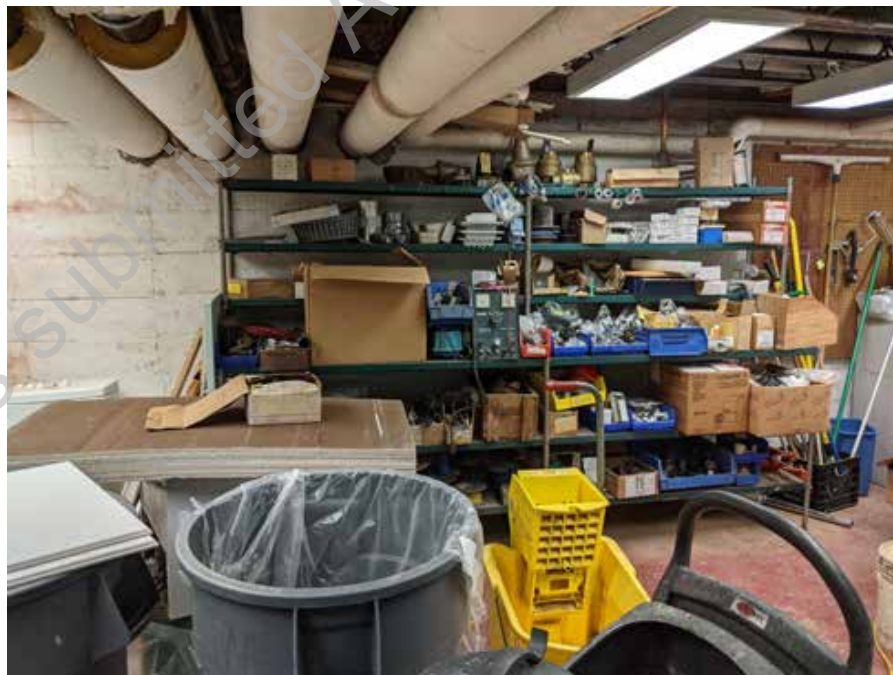
- D1. 16: View of materials storage in the lower level mechanical space of the original 1939 building.

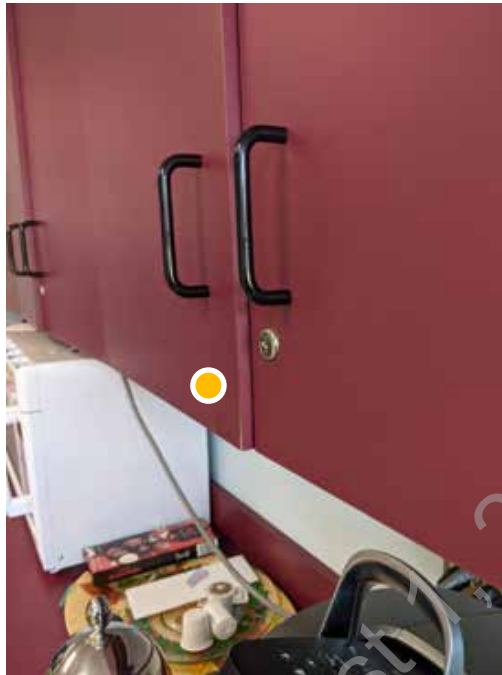
● D1. 17: Detail view of recent millwork / cabinetry upgrades to the media center. Note poor construction and failing hinges.

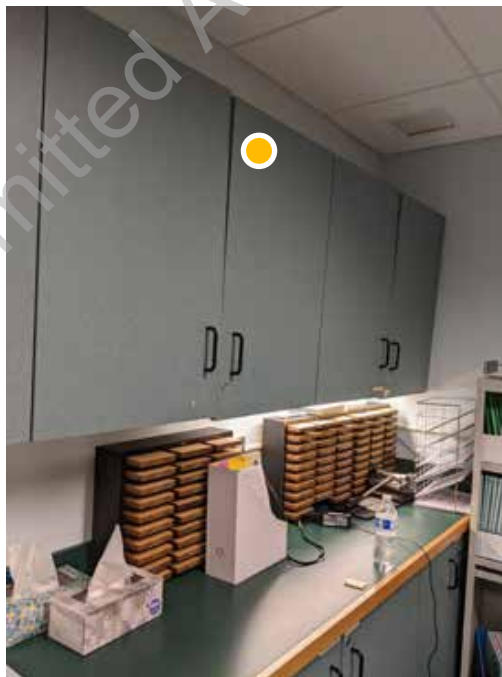
● D1. 18: Detail view of recent millwork / cabinetry upgrades to the media center. Note poor construction and failing hinges.

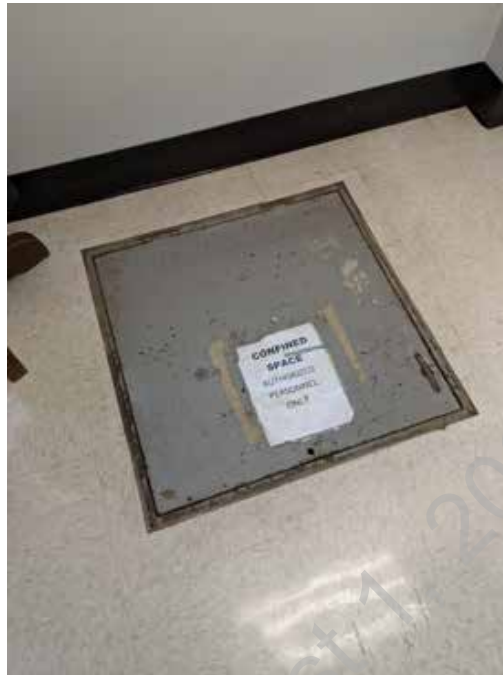
- D1. 19: Detail view of floor access panel to utility tunnels in the 1956 addition. Confined space with original piping.

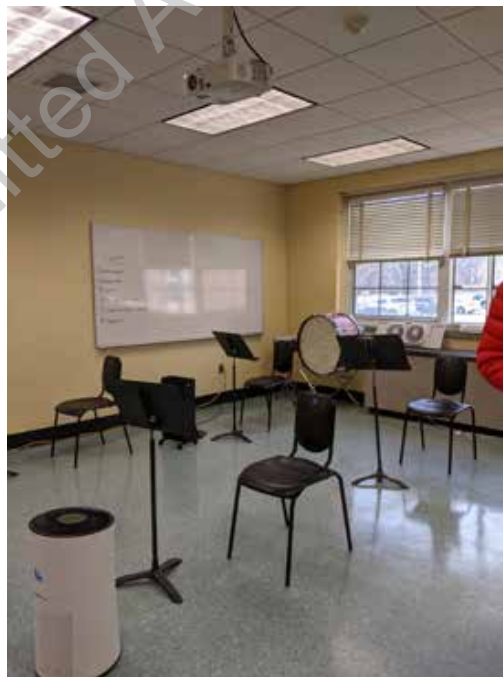
- D1. 20: View of recent upgrades to the music room in the 1956 addition.

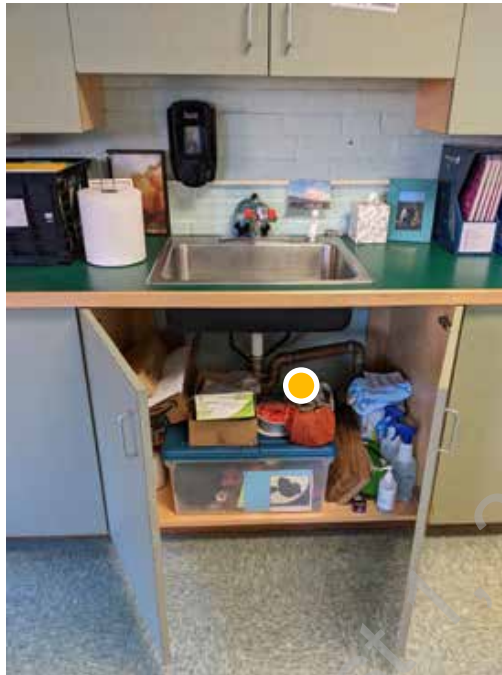
D1. 21: Detail view of inaccessible sink unit in the art room

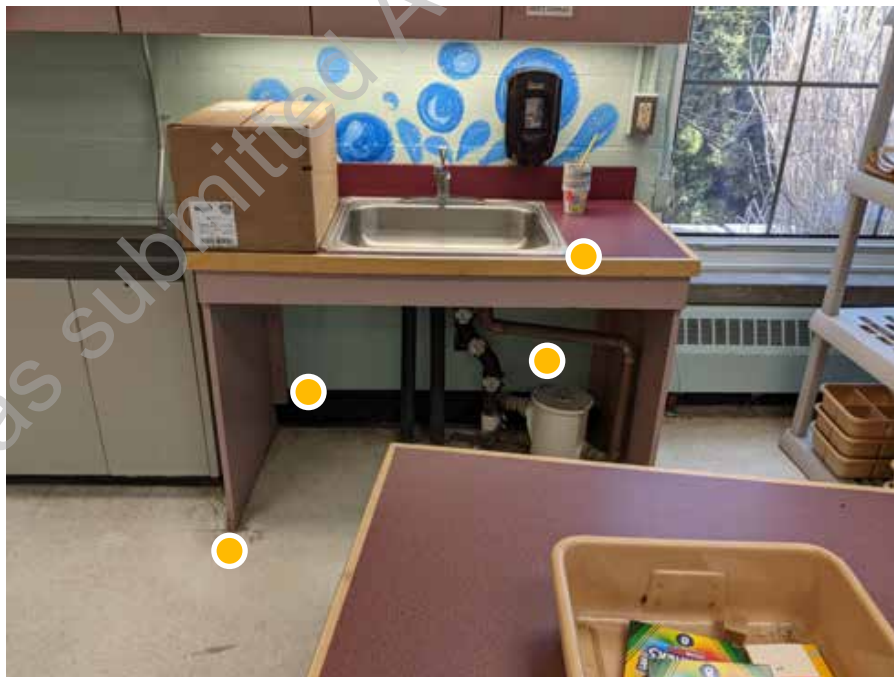
D1. 22: Detail view of inaccessible art room sink. Note the age and poor condition of the millwork and adjacent flooring.

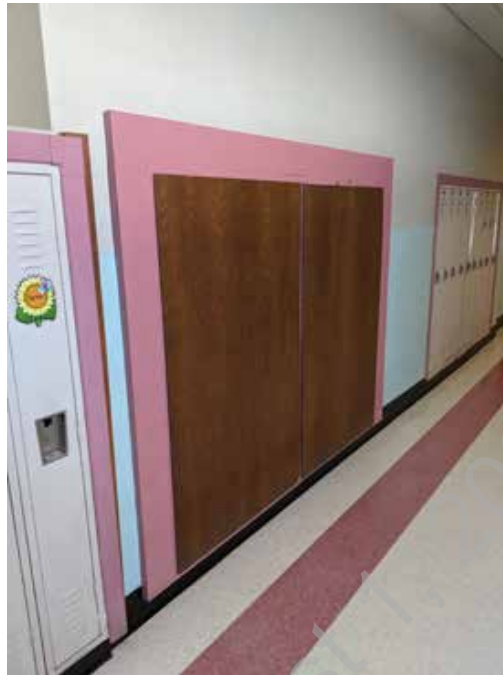
- D1. 23: View of wood infill panels at upper level of the original 1939 building. This area has been modified several times over the years, rendering portions of the space unusable.

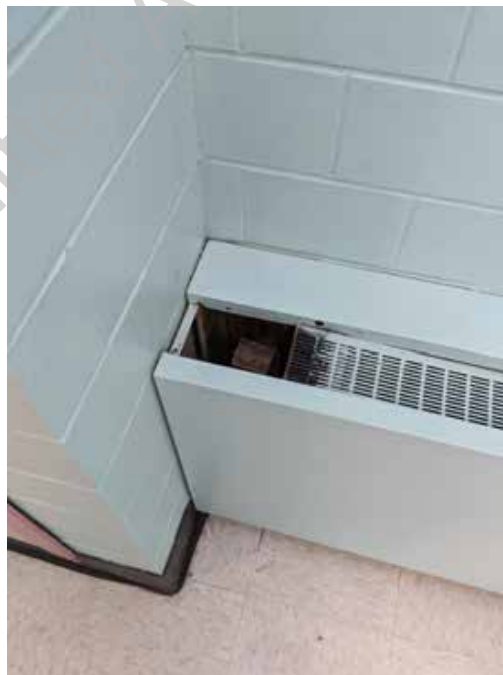
- D1. 24: Existing Baseboard Missing Part of the Cover.

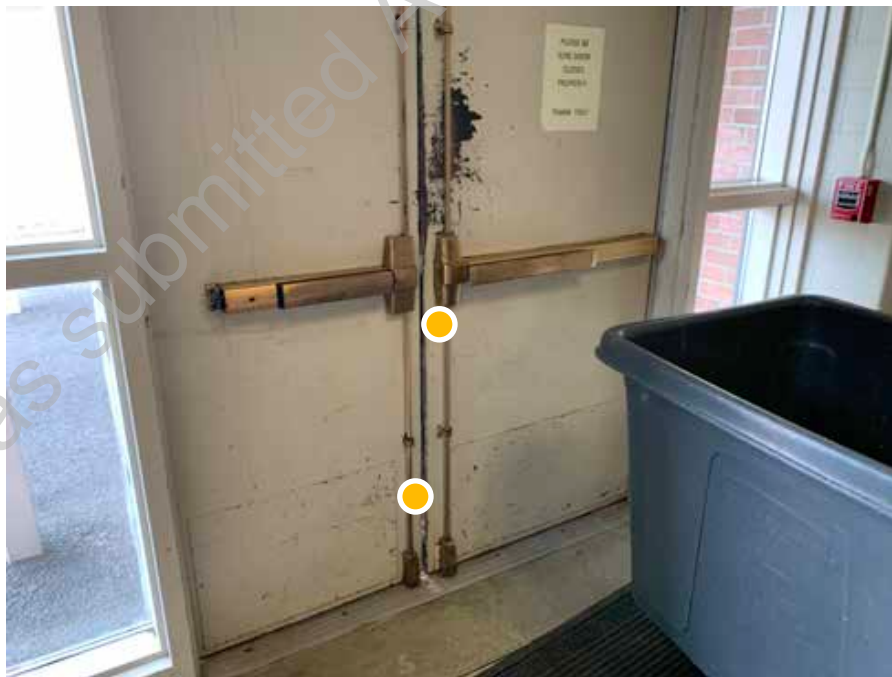
D1. 26: Detail view of typical exterior double door assembly. Note the overall poor condition and gaps in the perimeter.

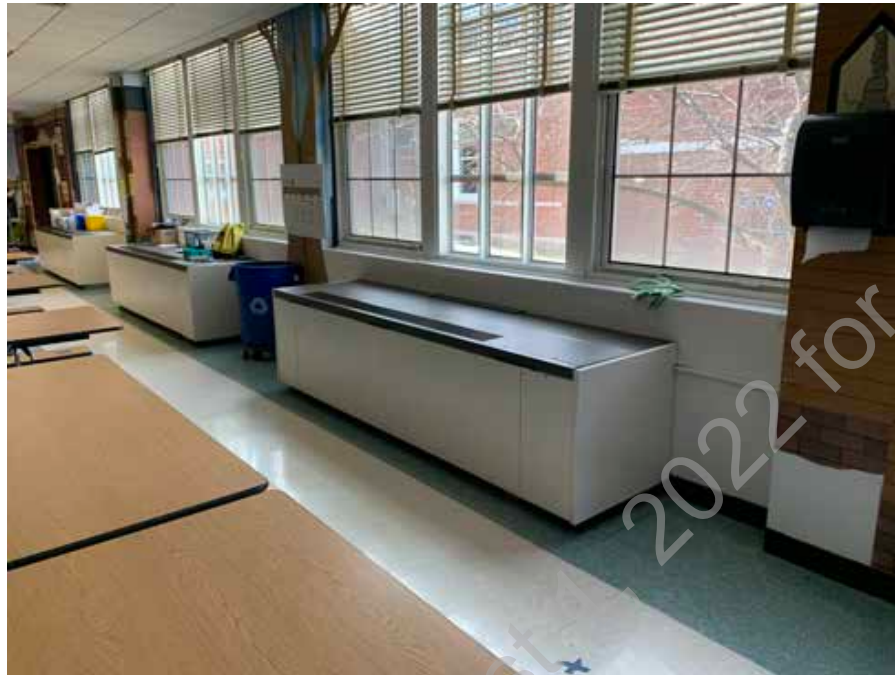
VENTILATION SYSTEMS: The unit ventilators throughout the building provide ventilation air to the spaces they serve. The unit ventilators are not working efficiently and are not ventilating properly, they are at the end of their useful lives and will need to be replaced. There are five existing heating and ventilating units throughout the building. One serves the Boys Locker Room, one serves the Girls Locker Room, one serves the Kitchen, and two serve the Gymnasium. The heating and ventilating unit that serves the Kitchen was installed during the 1992 renovation. This unit provides heating and the make-up ventilation air to the Kitchen if the exhaust hood is running. It is approximately 30 years old and at the end of its useful life. The four other heating and ventilating units were renovated from steam coils to hot water heating coils during the 1992 renovations. These four units provide heating and ventilation to the rooms they serve, but are approximately 40 to 50 years old and past the end of their useful lives. There is a vertical direct expansion cooling and hot water heating air handling unit located in a closet indoors. The unit has its own condensing unit located outside and provides heating and cooling to the space it serves. The unit appears to be 15 to 20 years old and is in fair working condition. A majority of the rooms throughout the building contain an exhaust fan that takes all of the exhaust air out of the building. The exhaust fans vary in age but a majority were worked on during the 1992 renovation. The exhaust fans are approximately 30 to 50 years old and at the end of their useful lives.

● D1. 27: Existing Unit Ventilator.

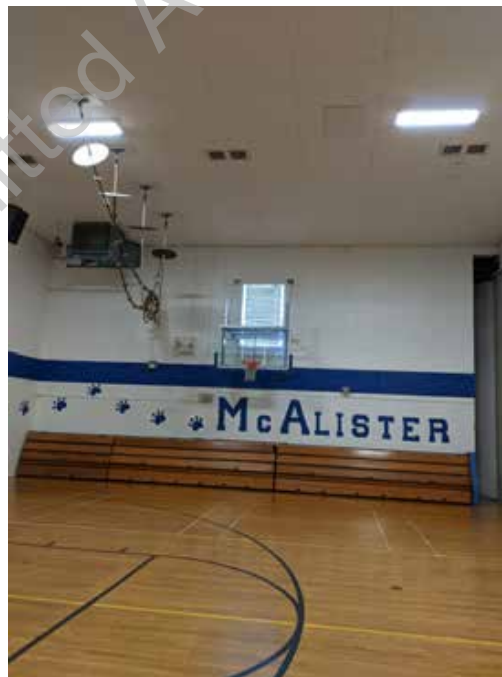
GYMNASIUM: The gymnasium has original wood plank floors that have been refinished multiple times over their life. They are in fair to poor condition and should be repaired or replaced. The moveable partition that can be used to separate the gym into two sides is in fair condition. During walkthroughs this partition was still functioning and showed no signs of heavy use. The existing wooden bleachers, appearing to be original to the structure, are in poor condition and should be replaced. The ceiling in the gymnasium looks to be a possibly asbestos containing acoustic tile. Some tiles are missing are missing and/or damaged causing potential concern. The wall material within the Gymnasium is painted masonry, which is spalling, indicating moisture infiltration through the wall. Wood doors and frames leading to adjacent storage rooms are in poor condition, particularly at the base. These storage rooms have extremely low plaster ceilings that are cracking and spalling due to moisture infiltration. The stage within the gymnasium space has a lift which was not functioning at the time of the walkthrough. This area has a plaster ceiling in poor condition with spalling and delamination. In addition, there are also large openings in the ceiling plane due to plumbing and electrical modifications. The vestibule which leads outside from the gymnasium is in fair condition. Some ceiling tiles are bending and stained which indicates possible moisture presence at some point.

● D1. 28: Overall view of gymnasium in original 1939 building, space has seen limited improvements over the years, note ceiling mounted heating unit and original ACM ceiling tiles.

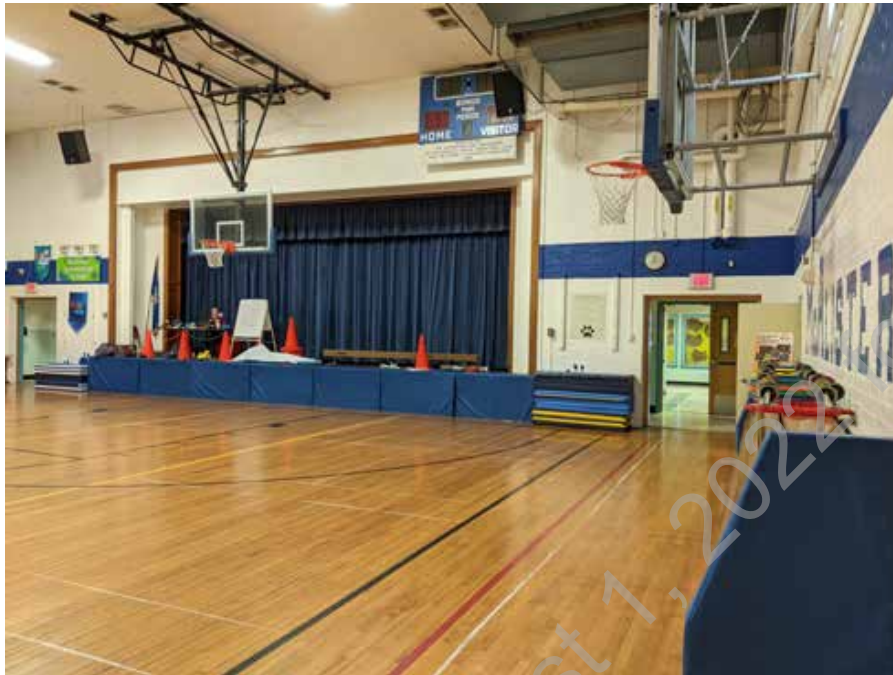
● D1. 29: View towards stage in gymnasium/auditorium.

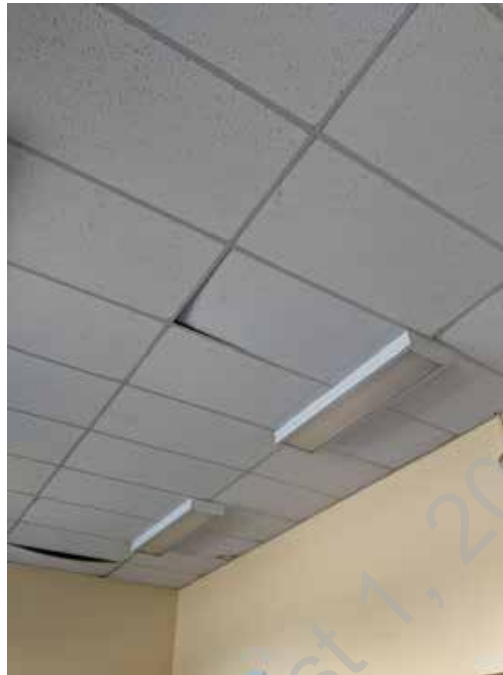
- D1. 31: Detail view of typical space in original 1939 building, ceiling depicts bowing tiles indicating moisture/humidity control challenges within the space.

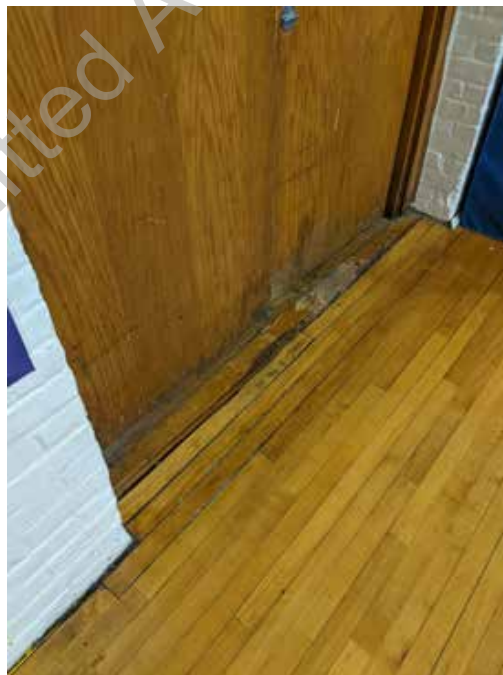
- D1. 32: Detail view of deteriorated wood flooring transition.

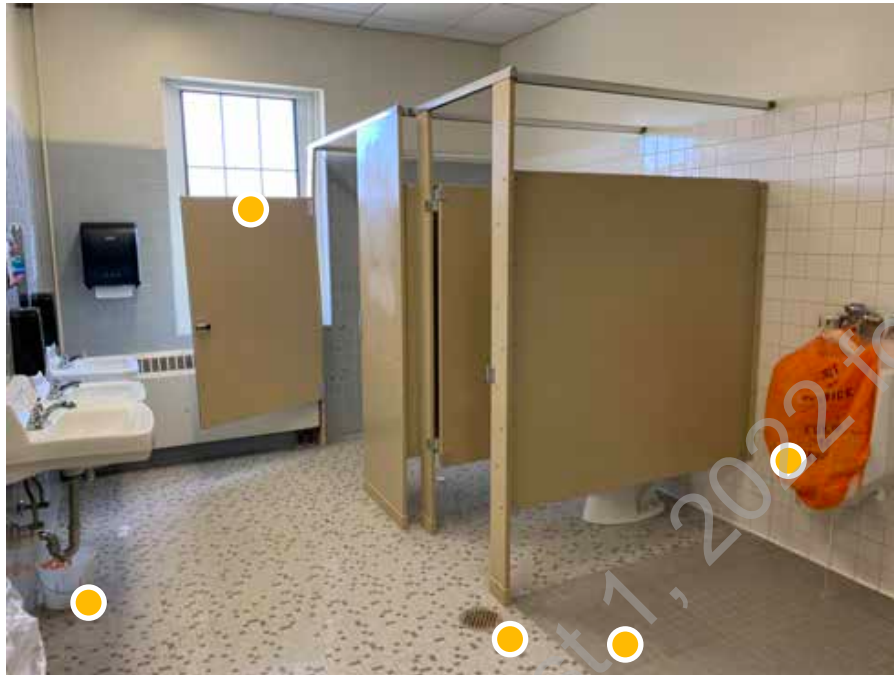
PLUMBING FIXTURES: The plumbing fixtures in the building vary in age from different renovations to various additions. The majority of plumbing fixtures are approximately 40 to 50 years old with the newest being around 20 years old. Many of the plumbing fixtures are failing and non-compliant with code, they are at the end of their useful lives and will need to be replaced.

● D1. 33: View of typical bathroom space, note non functioning fixtures, broken and/or deteriorated toilet partitions, and buckets to prevent sink leaks. Also note indication of previous modifications to space via the different floor tiles.

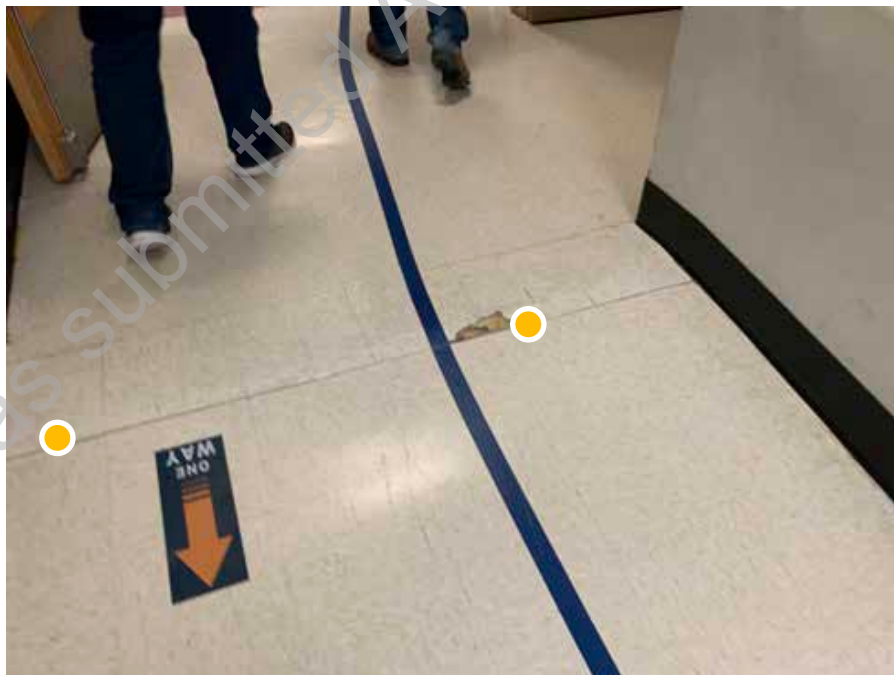
CORRIDORS: In general, corridors throughout the building are in fair condition with damaged vinyl floor tiles that have been patched with mis-matched tiles and damaged/patched masonry intermittently. These tiles should be removed and replaced with tiles that match adjacent floor material.

● D1. 34: Typical VCT flooring in corridors, note the deterioration, missing and/or broken tile at the expansion joints between building additions.

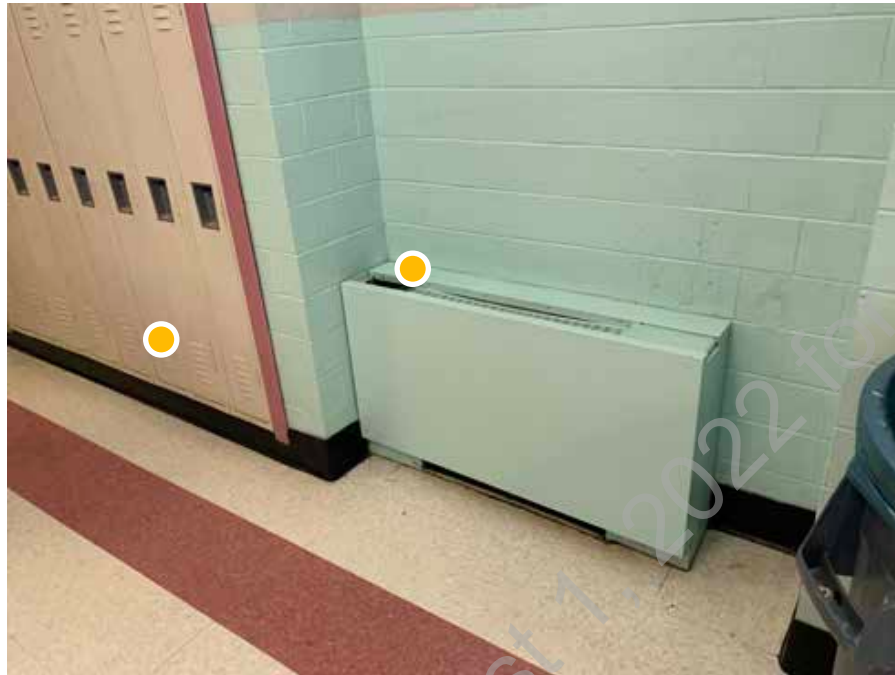
● D1. 35: Typical classroom corridor with metal lockers and unit cabinet heater (poor condition overall)

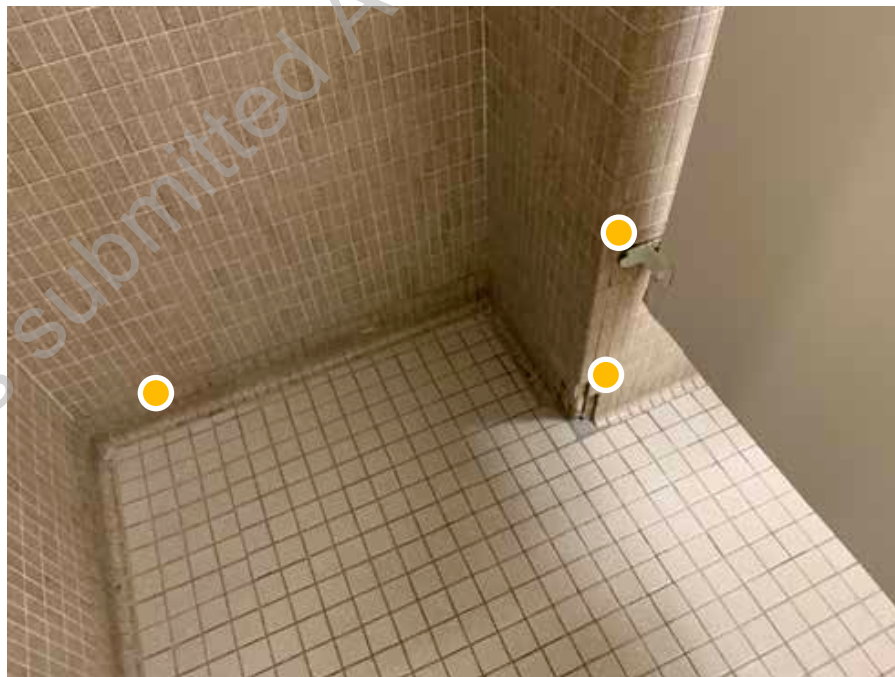
● D1. 36: Detail view of typical bathroom depicting missing and/or broken floor and wall tiles along with retrofit or painted toilet partitions.

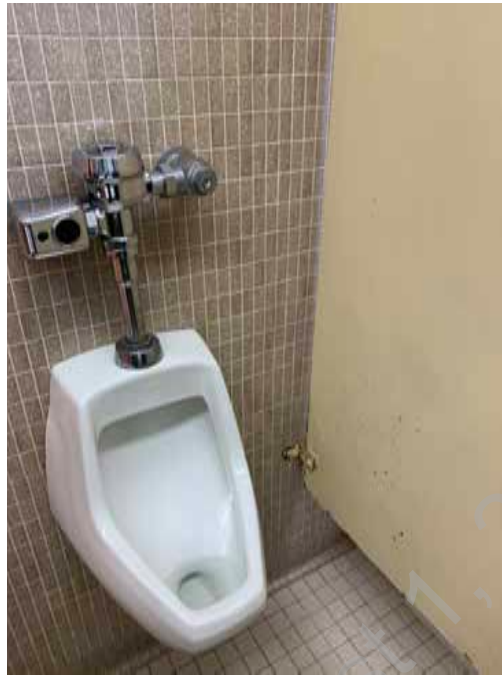
● D1. 37: Detail view of replacement fixture in bathroom.

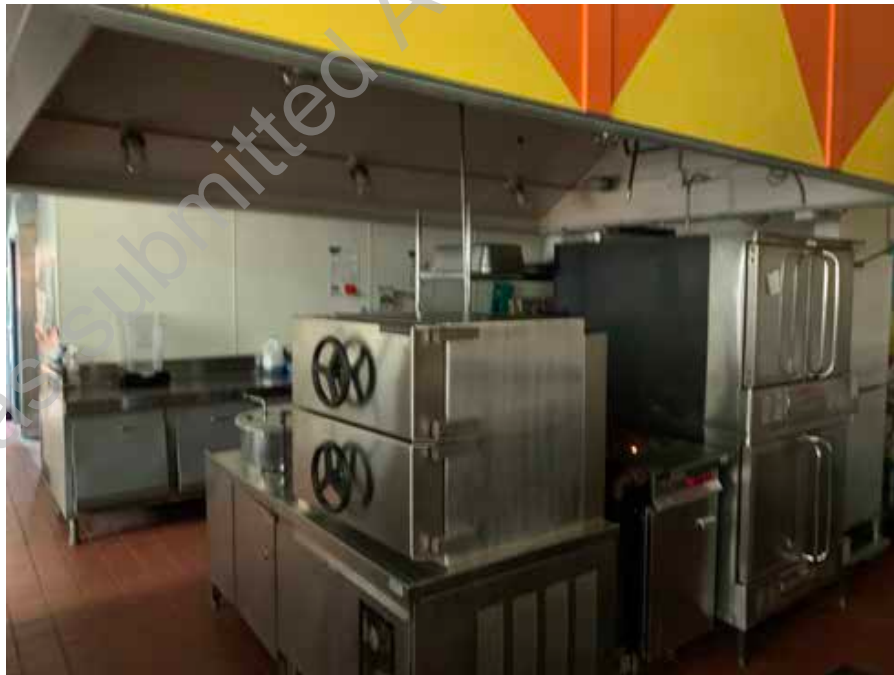
● D1. 38: Existing Kitchen Hood

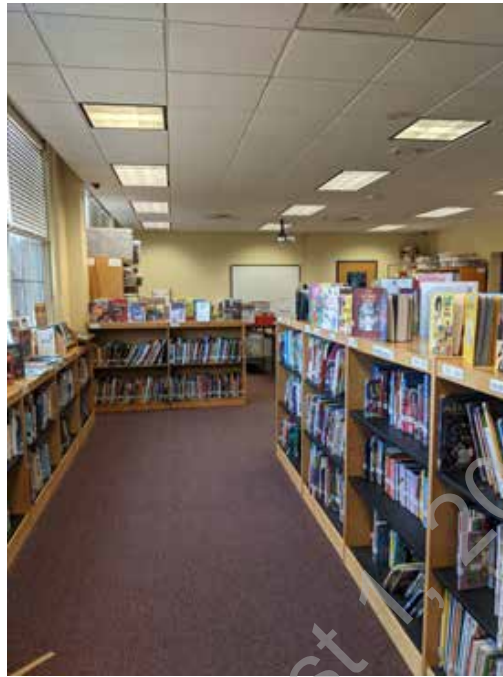
● D1. 39: View of media center.

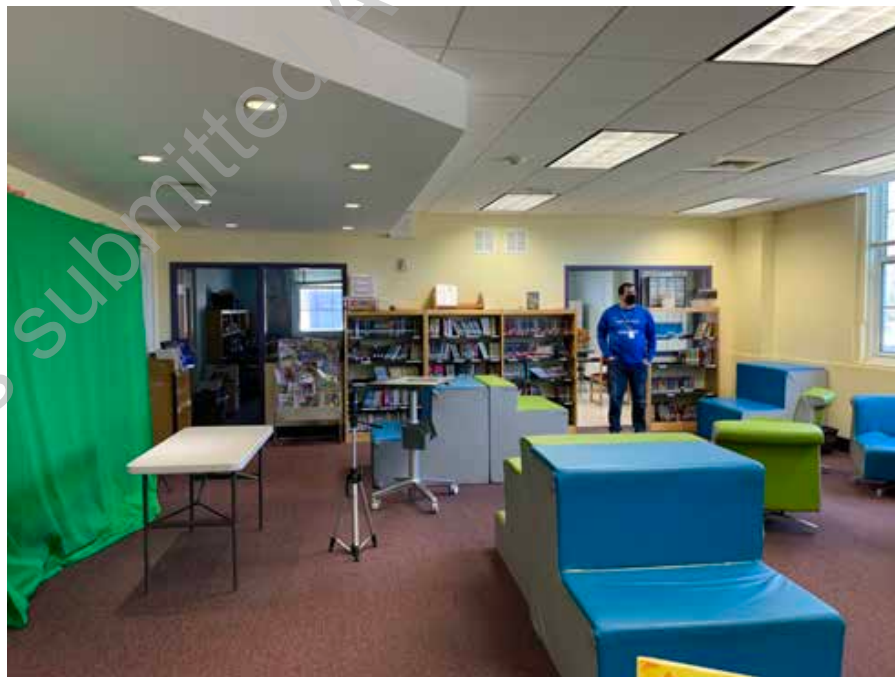
● D1. 40: View of media center with recent FF&E (furniture, fixtures, and equipment) upgrades.

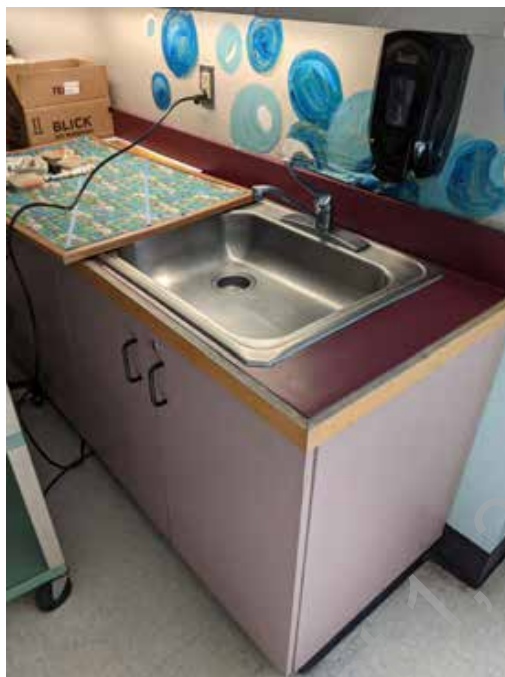
● D1. 41: Detail view of art room sink.

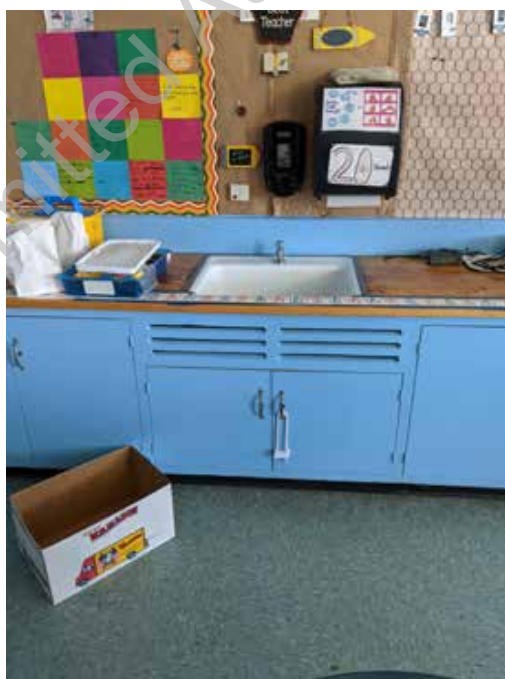
● D1. 42: View of original millwork and sink in typical classrooms, 1956 addition.

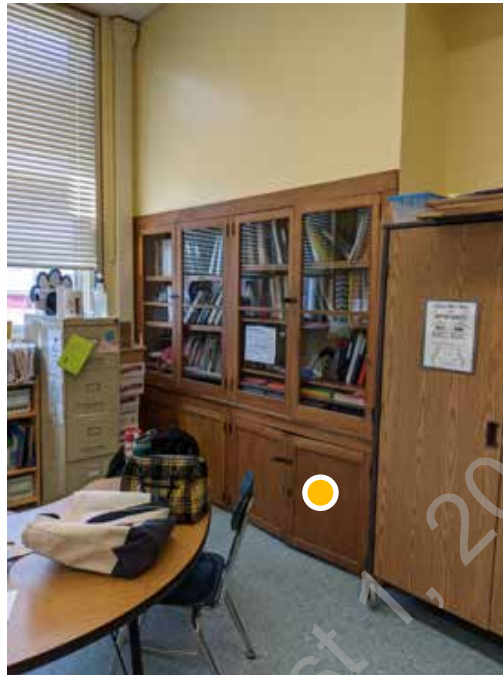
● D1. 43: View of typical built in cabinetry in the original 1939 building.

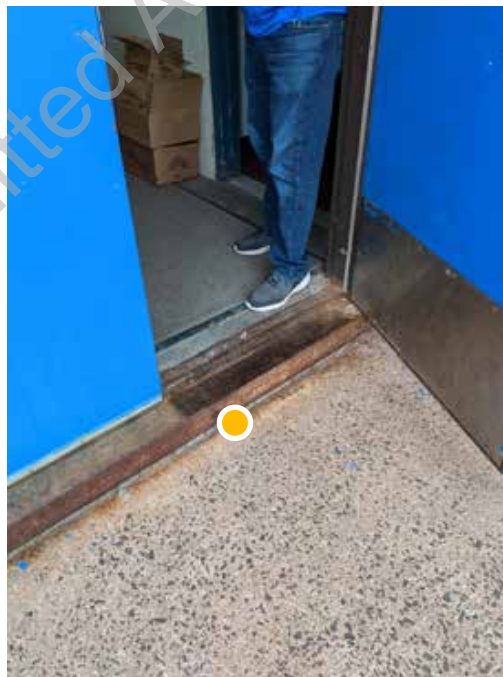
● D1. 44: Loading/receiving door access, note step up into building making delivery and access difficult.

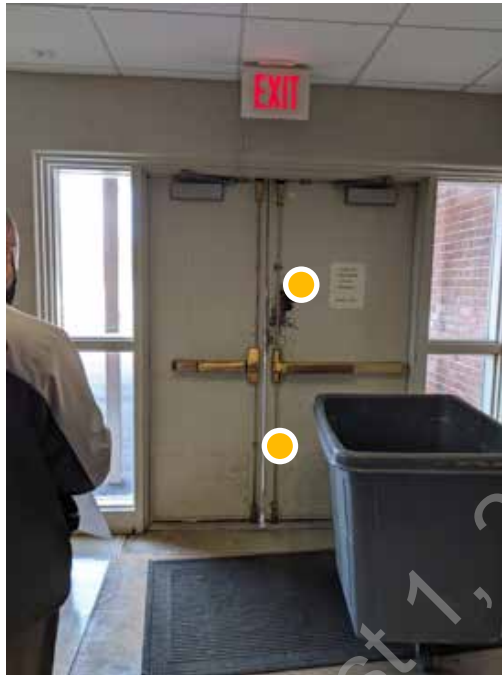
- D1. 45: Typical exterior double door assembly, note the gap between the door slabs and the overall poor condition of the assembly.

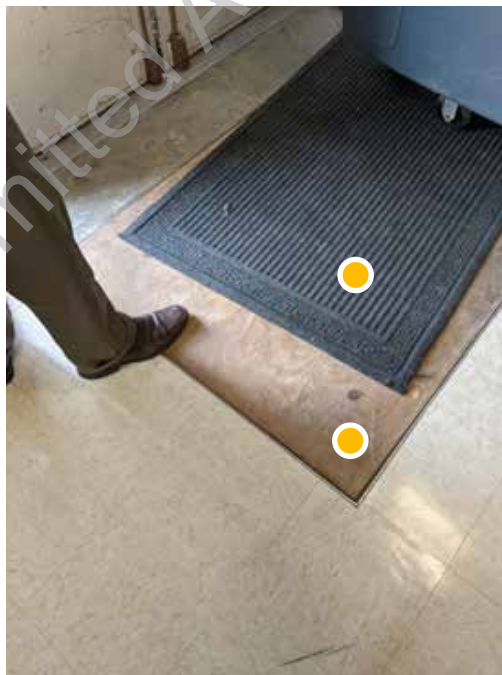
- D1. 46: Plywood infill panel retrofit with partial walk off mat, in front of egress door in 1956 addition.

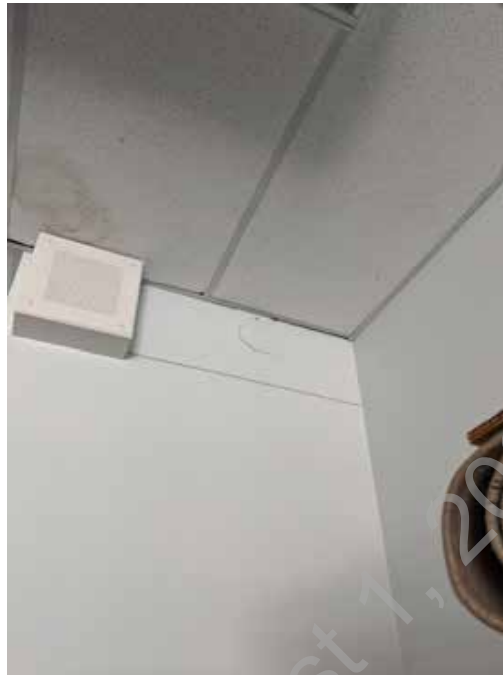
● D1. 47: Existing Surface Mounted Speaker for Public Address System.

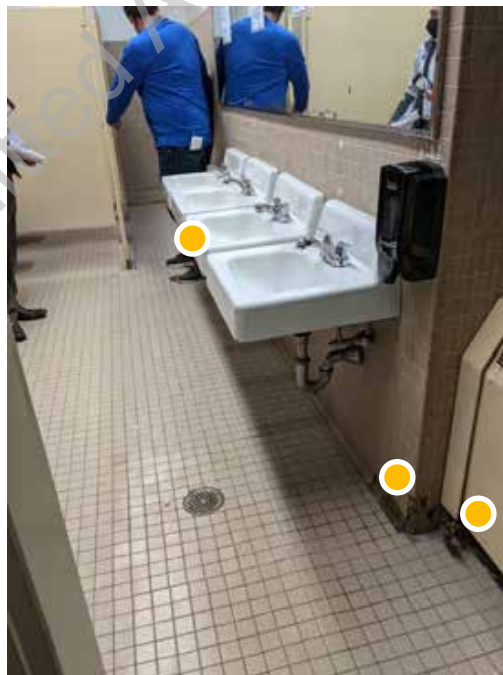
● D1. 48: View of typical bathroom, note condition of floor and wall tile, non accessible sink units, inaccessible toilet partition compartments and the exposed unit cabinet heater.

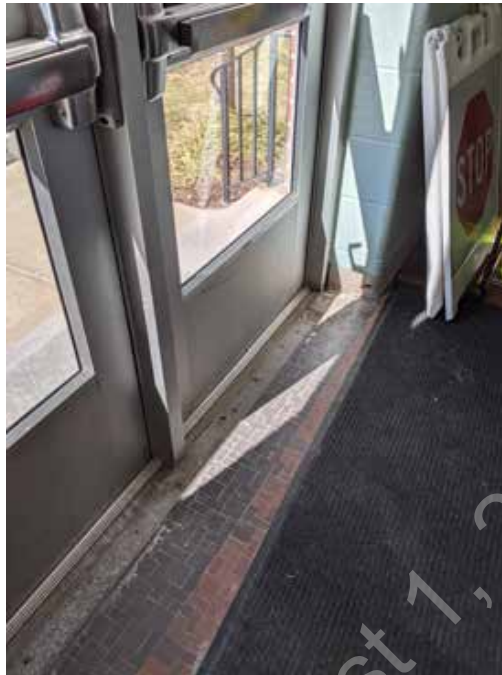
● D1. 49: Detail view of typical sill at exterior door.

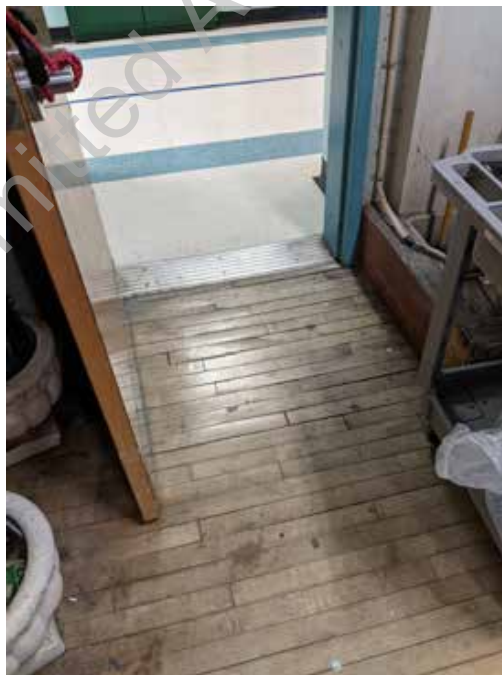
● D1. 50: Janitorial/Custodian support space in original 1939 building.

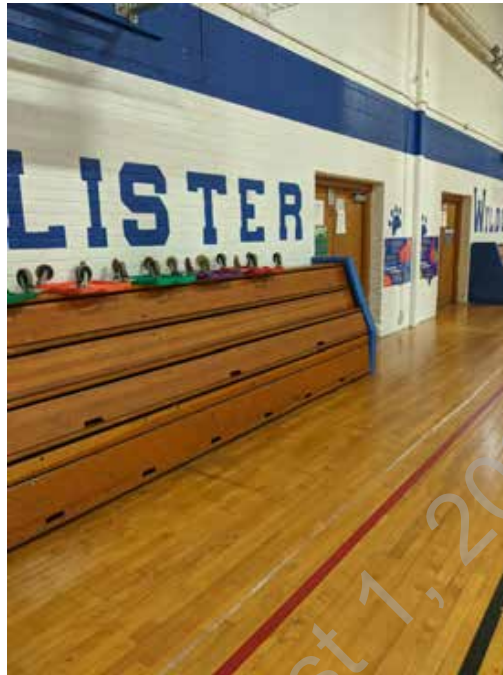
● D1. 51: Detail view of existing wood bleachers.
