TOWN OF SUFFIELD

CONDITIONS ASSESSMENT & MASTER PLAN

Draft as submitted August 1, 2022 for review

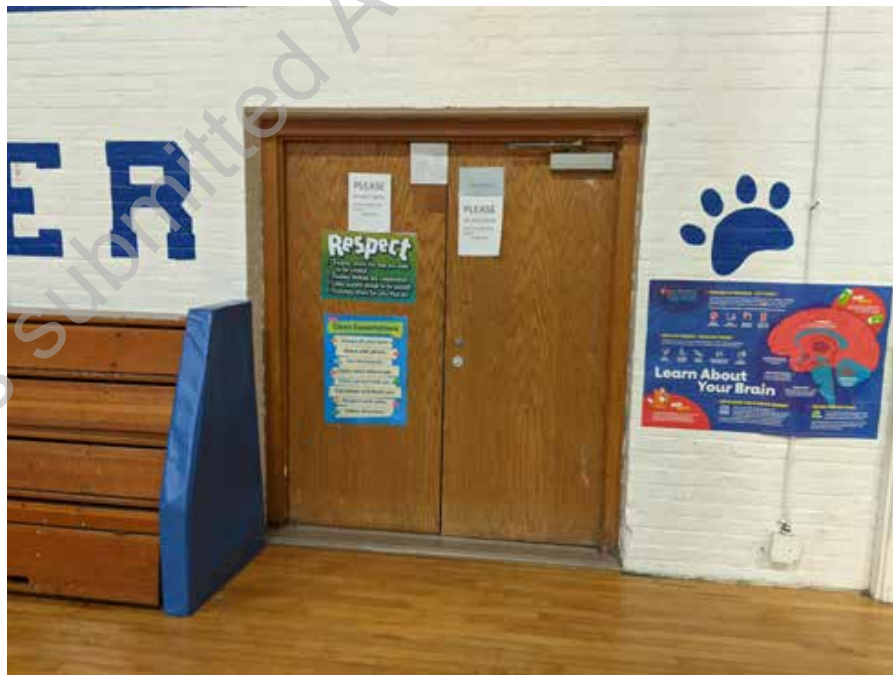
● D1. 52: Typical storage room doors adjacent to existing gymnasium/Auditorium in original 1939 building.

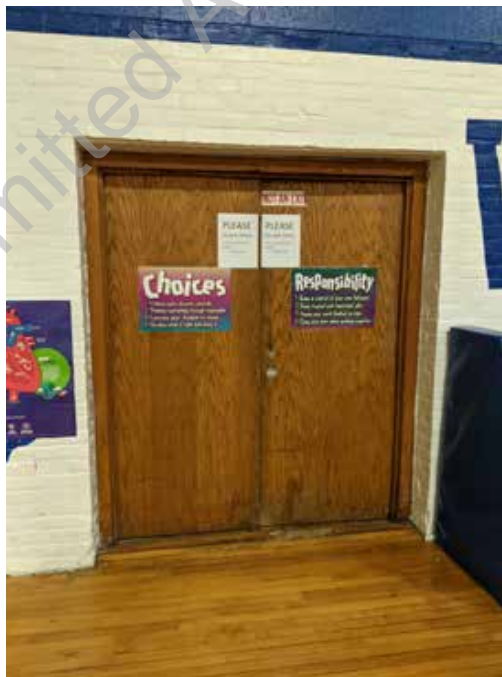
- D1. 54: View of typical storage room doors from gymnasium, note the poor overall condition.

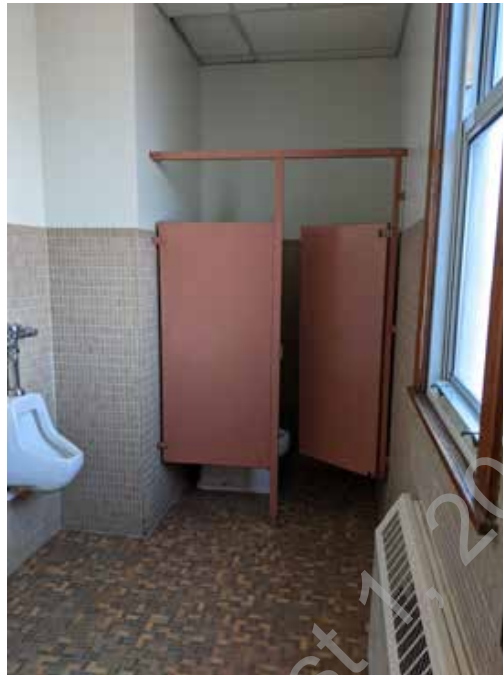
- D1. 55: Toilet reconfiguration in original 1939 building does not allow for proper access and/or compliance with accessibility codes.

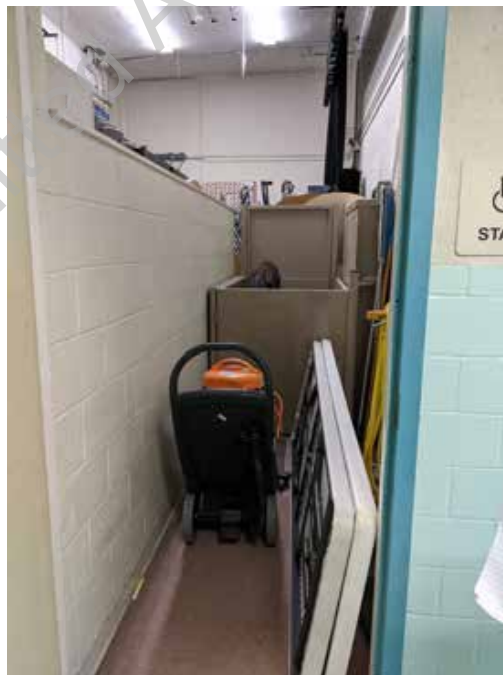
- D1. 56: Detail view of inoperable accessibility lift to stage.

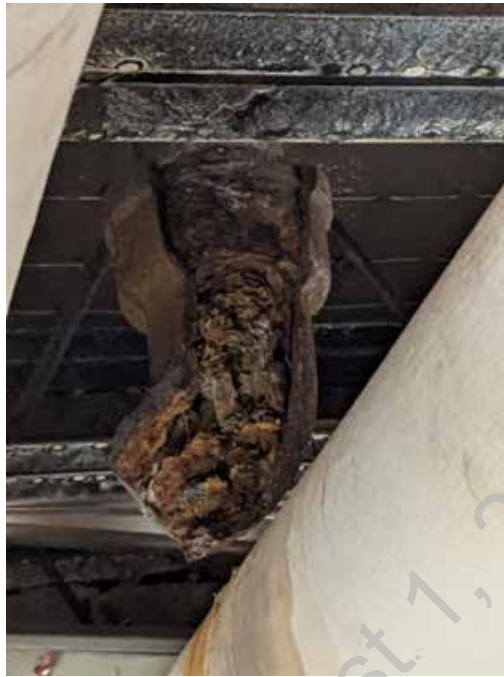
● D1. 57: Abandoned Floor Drain.

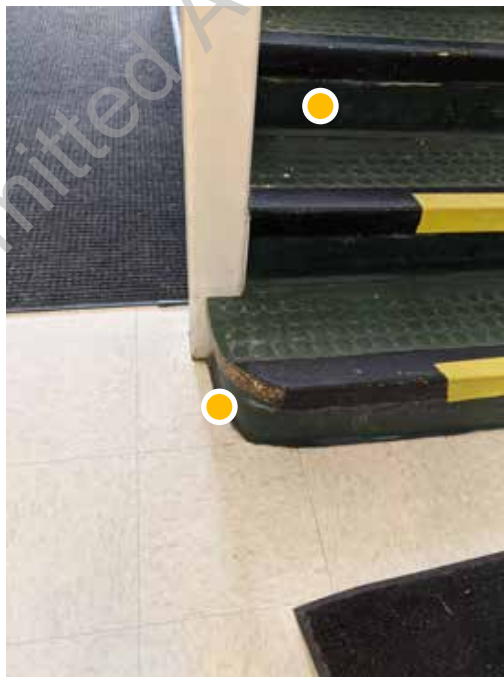
● D1. 58: Detail view of typical poor condition of the rubber treads and risers at the stairs.

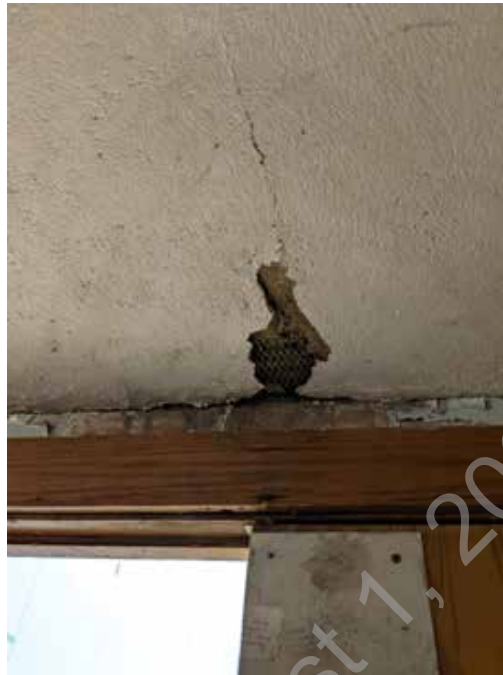
- D1. 59: Detail view of the poor condition of the original ceilings in portion of the support spaces in the original 1939 building.

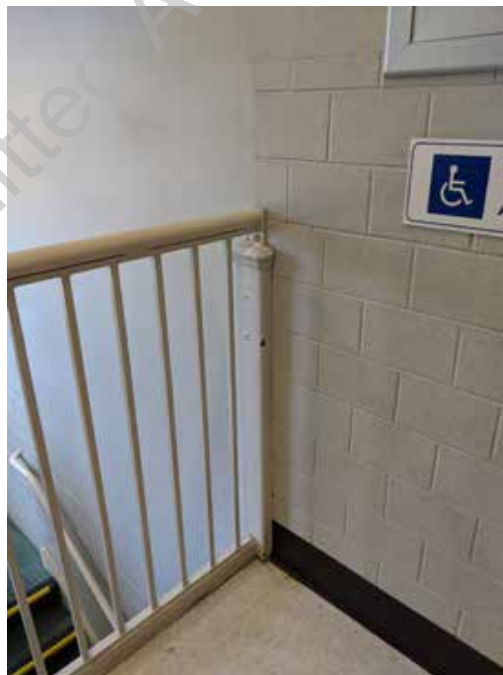
- D1. 60: View of the area of refuge at the upper level of the original 1939 building.

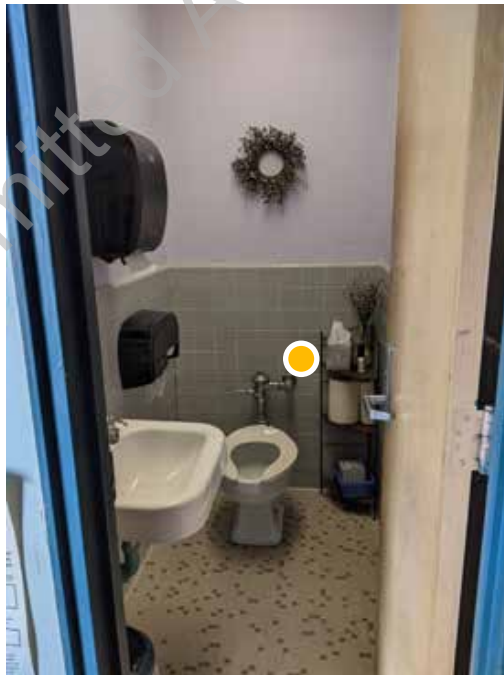
D1. 62: View of single use toilet room, does not comply with current accessibility codes(no grab bars, floor clearances, sink/reach, etc.).

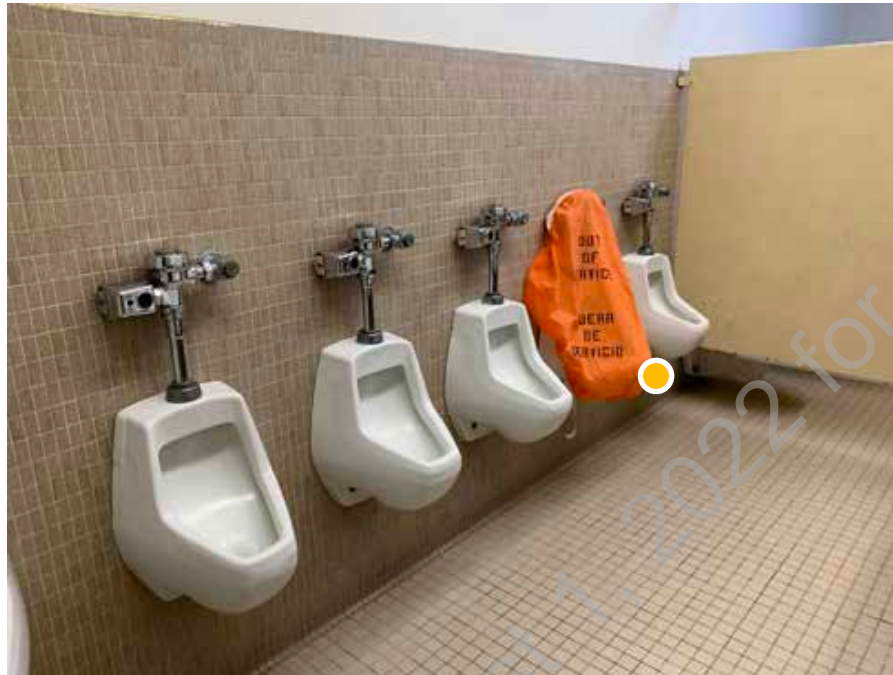
● D1. 63: View of typical bathroom assembly with some non functioning fixtures.

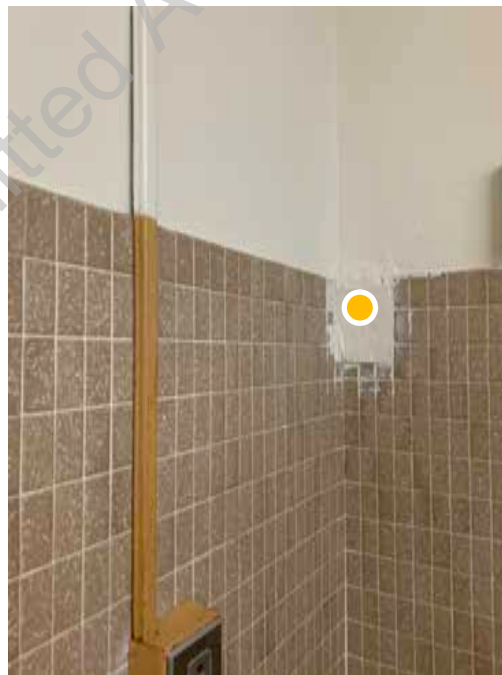
● D1. 64: Detail view of the wall tile repairs, various conditions throughout the bathroom spaces.

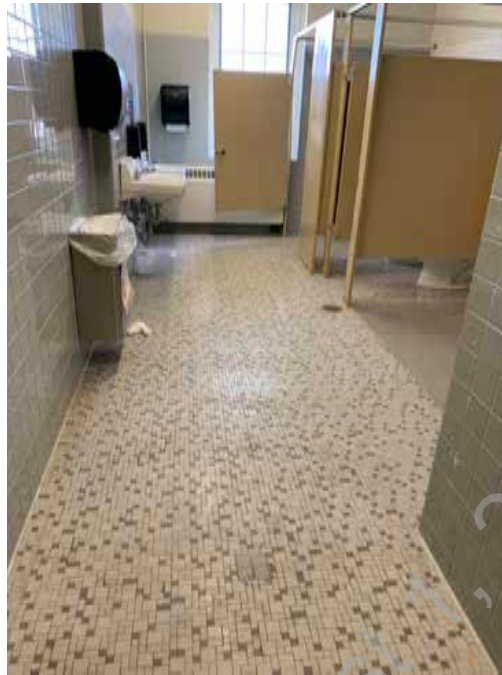
- D1. 65: View of typical bathroom depicting various tile repairs/replacement, does not comply with current accessibility codes.

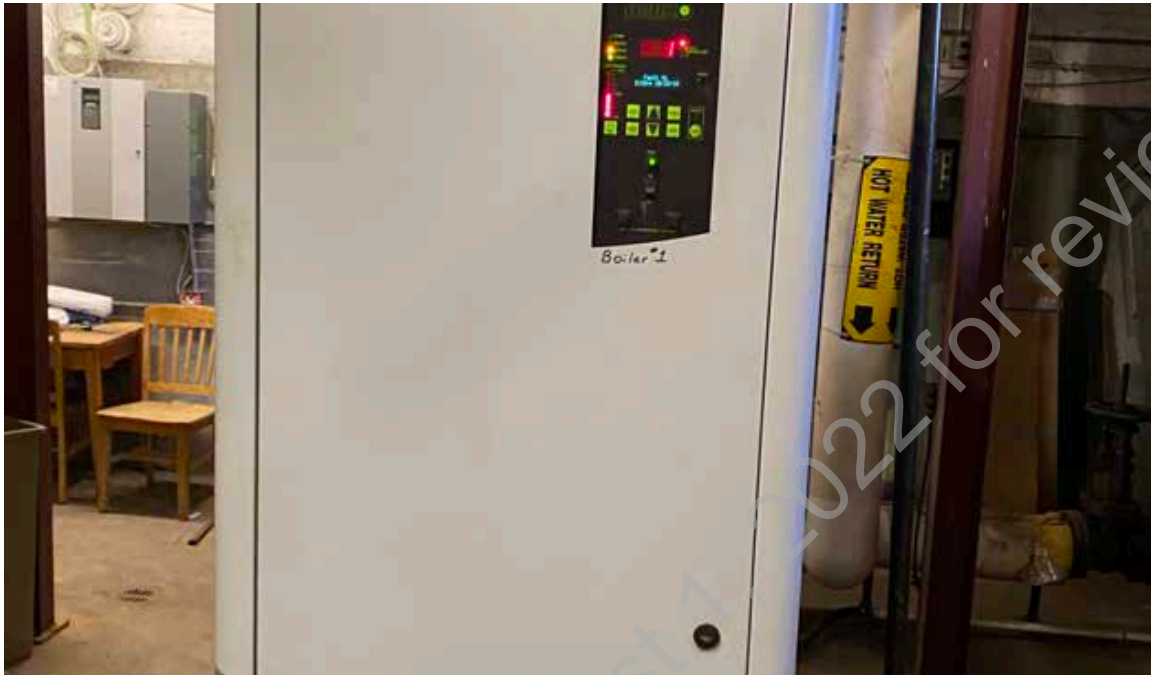
● D2. 1: Aerco Natural Gas Condensing Boiler in good condition.

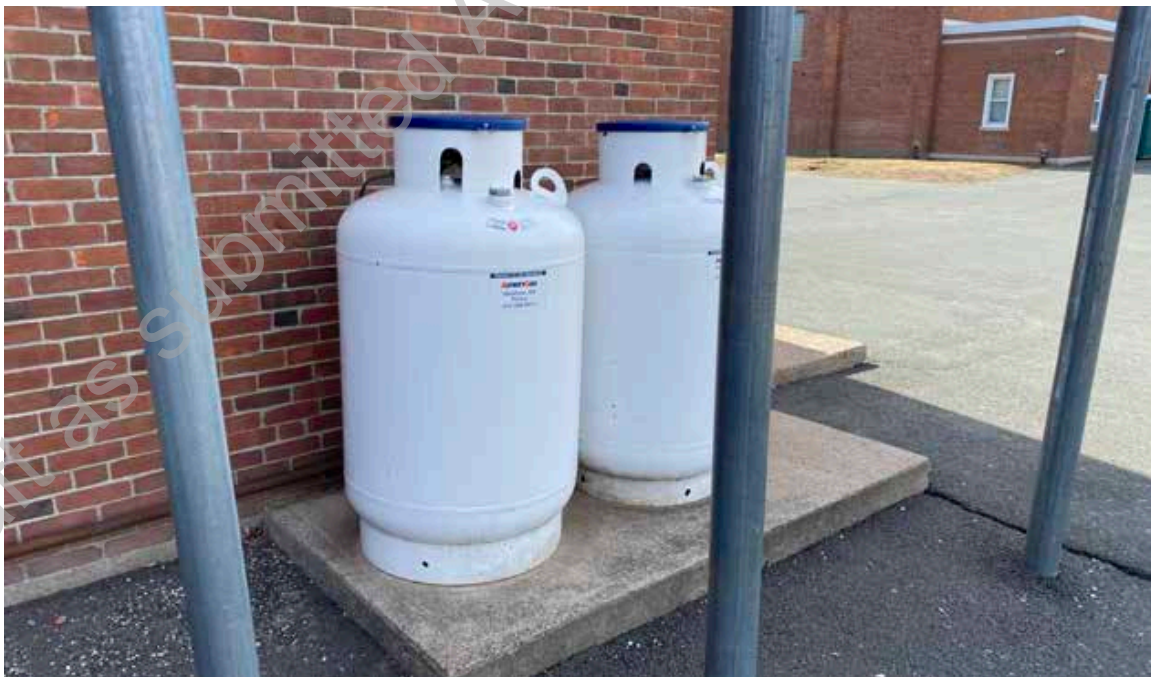
● D2. 2: AmeriGas Propane Tanks Serving Kitchen Equipment.

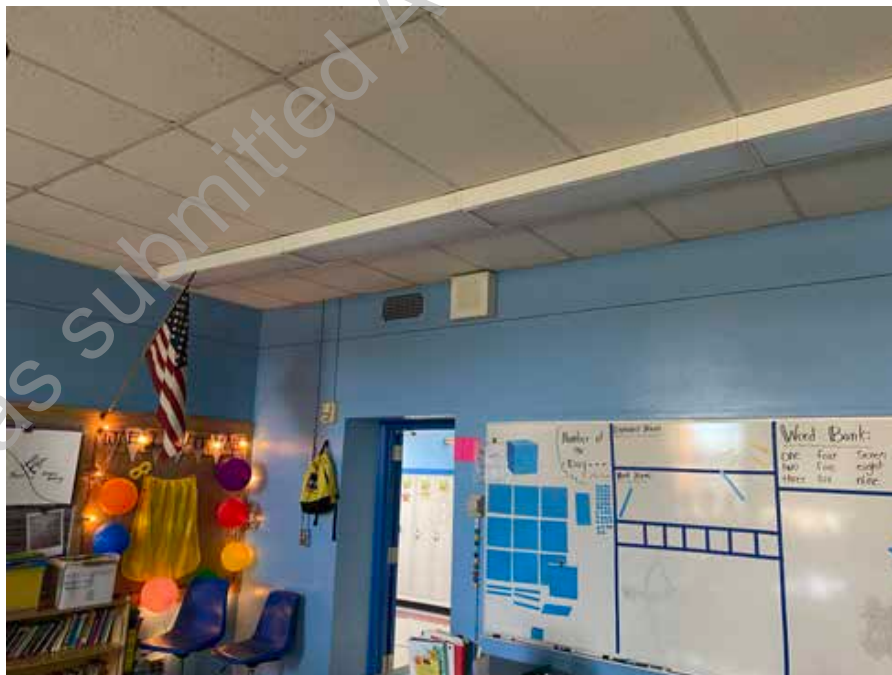
● D2. 4: View of typical classroom with antiquated and inefficient fluorescent lighting surface mounted to ceiling.

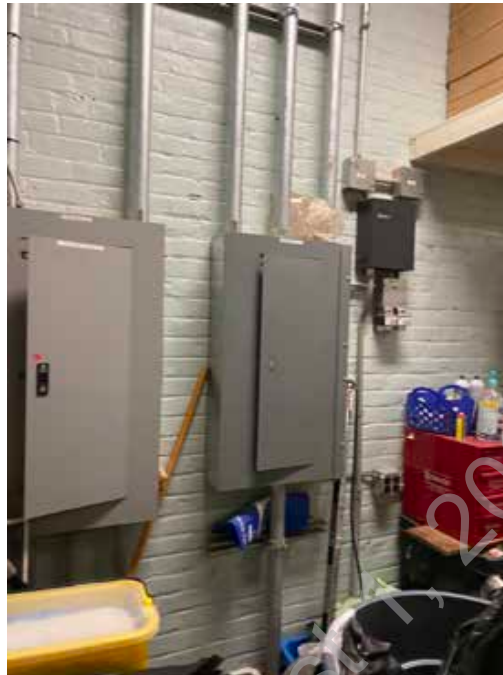
● D2. 5: Electrical Branch Circuit Panels.

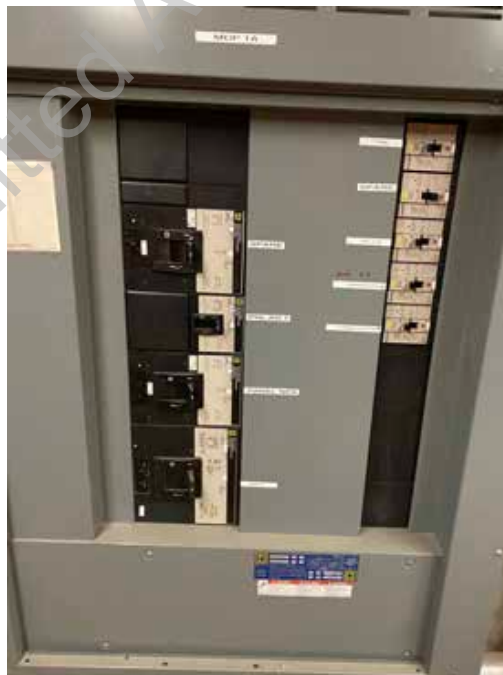
● D2. 6: Electrical Main Distribution Panel #1.

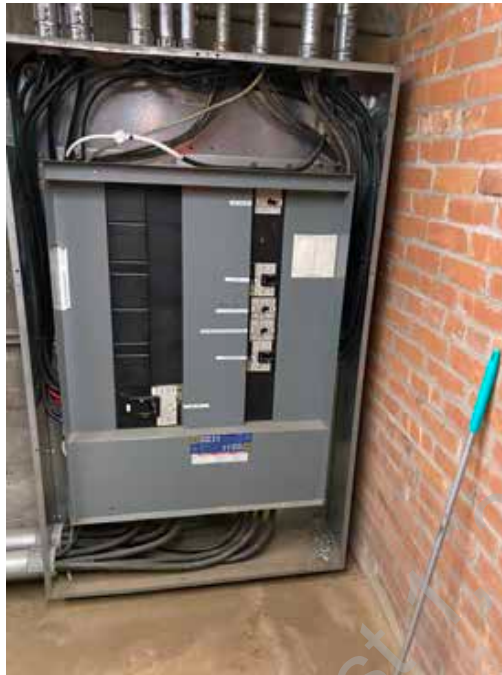
● D2. 7: Electrical Main Distribution Panel #2.

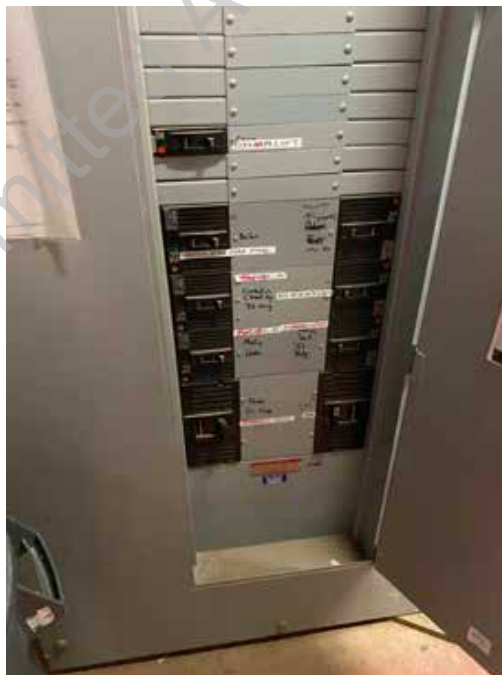
● D2. 8: Electrical Main Distribution Panel #3.

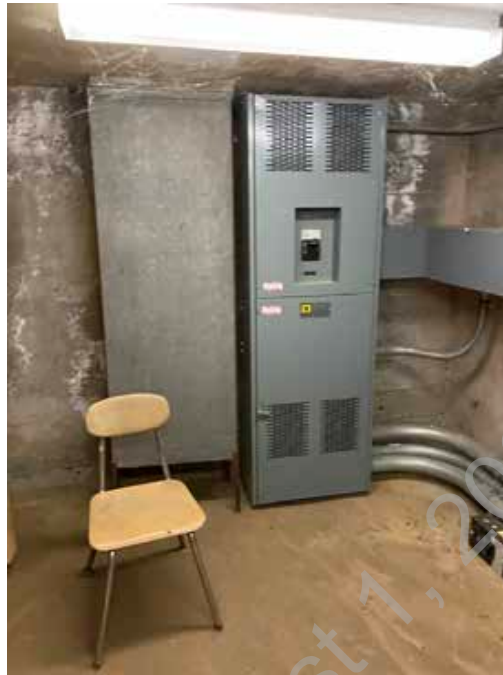
● D2. 9: Electrical Main Service Switch.

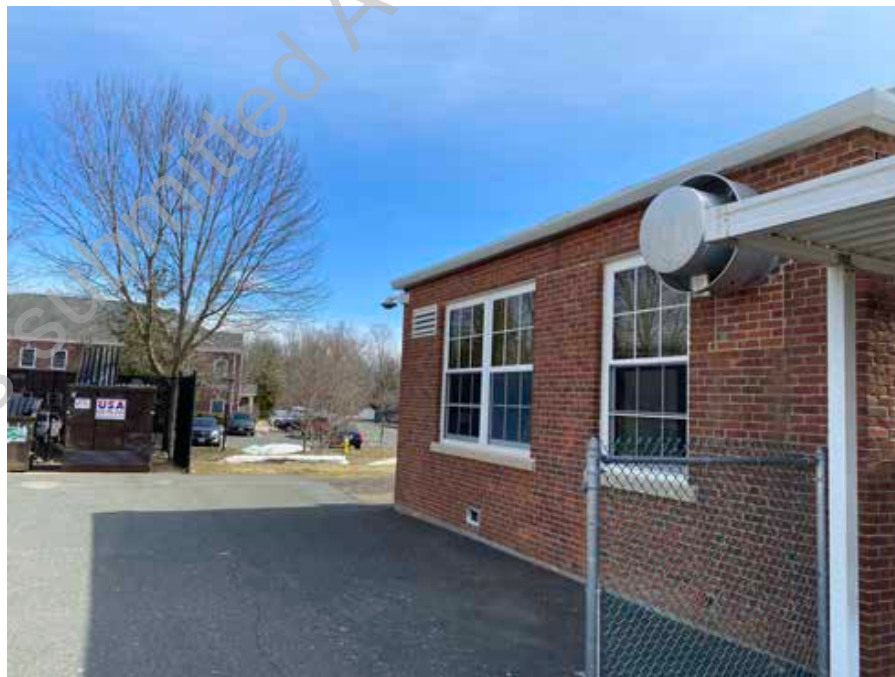
● D2. 10: Detail view of dumpster area (left) and wall mounted exhaust hood (right) in 1956 addition.

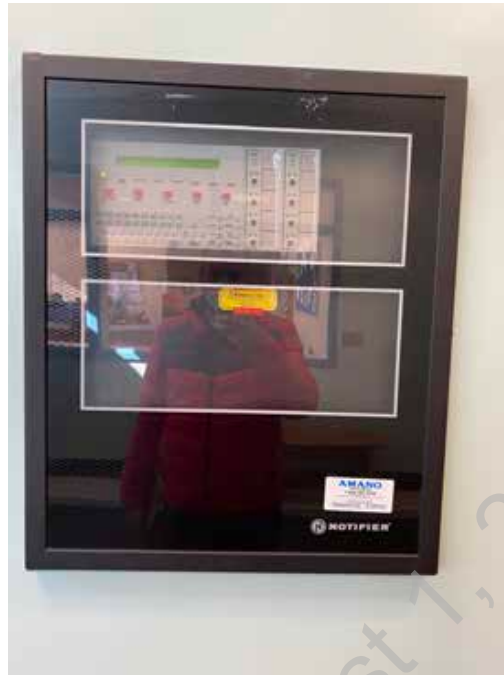
● D2. 11: Fire Alarm Control Panel.

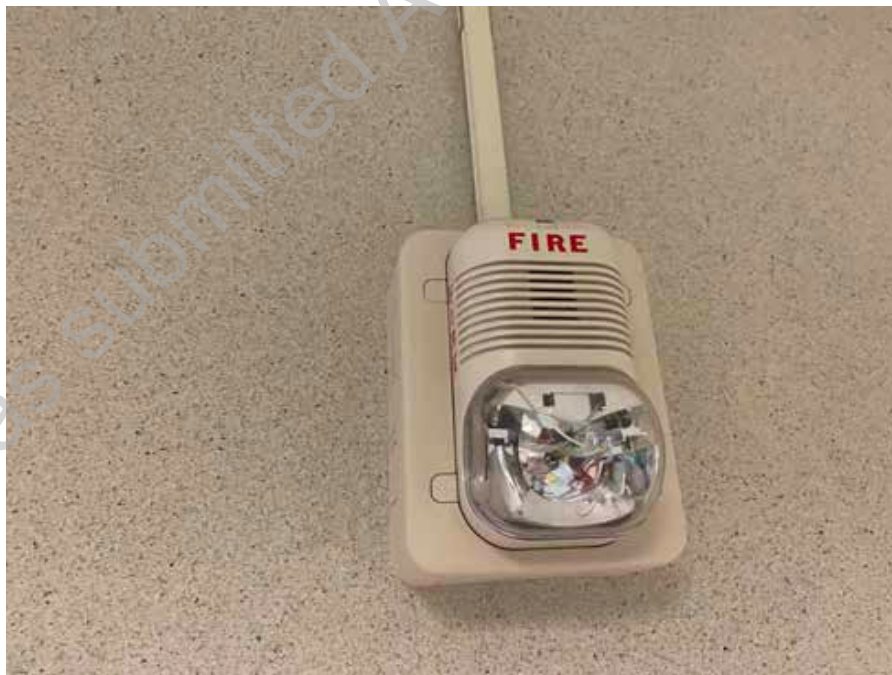
● D2. 12: Fire Alarm HornStrobe.

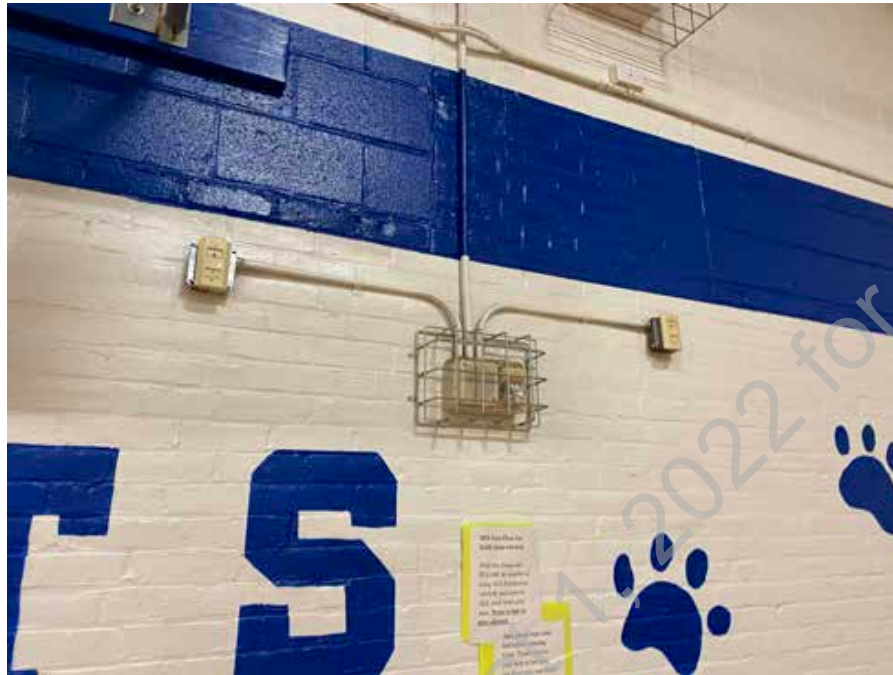
● D2. 13: Fire Alarm Speaker Strobe with RTU Test Switches.

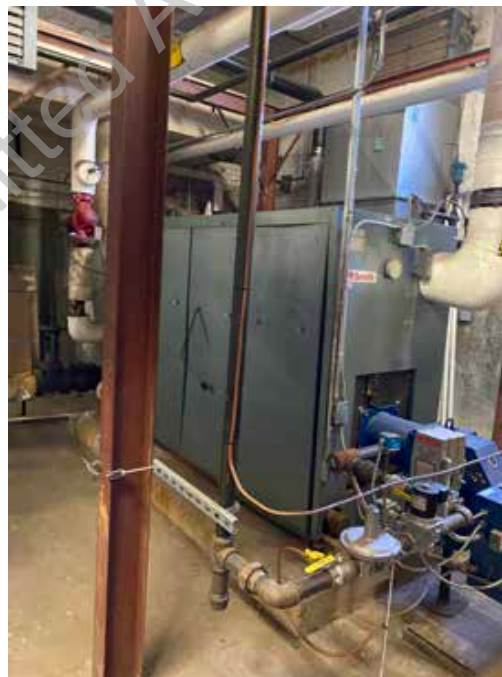
● D2. 14: H.B. Smith Natural Gas Boiler in Poor Working Condition.

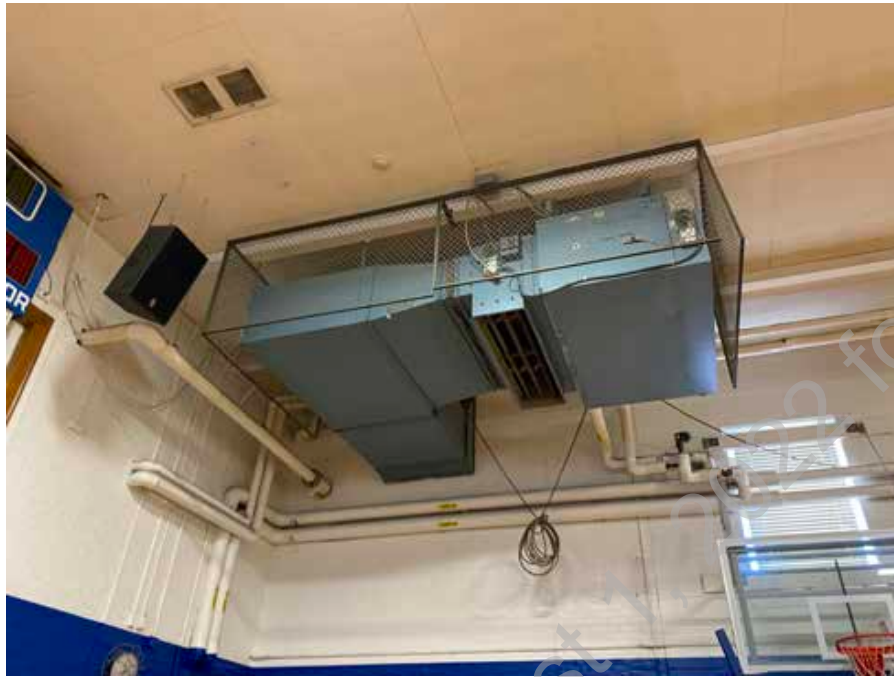
● D2. 15: Heating and Ventilating Unit Serving Gymnasium.

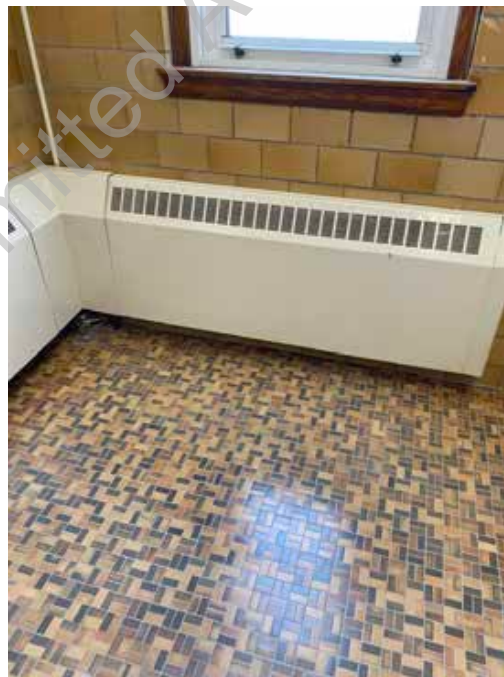
● D2. 16: Hot Water Fin Tube Radiation in poor working condition.

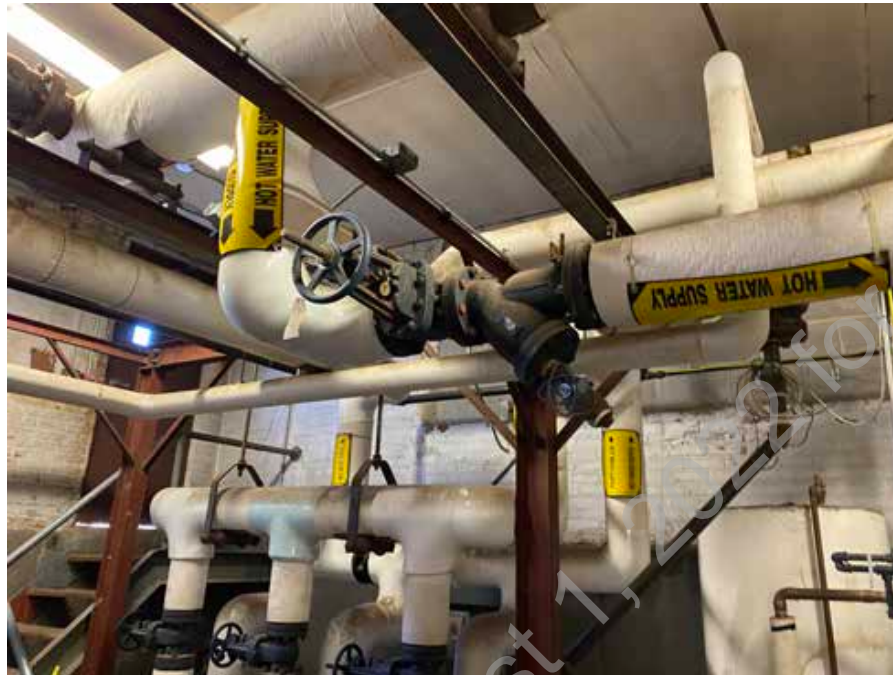
● D2. 17: Hot Water Piping in poor condition.

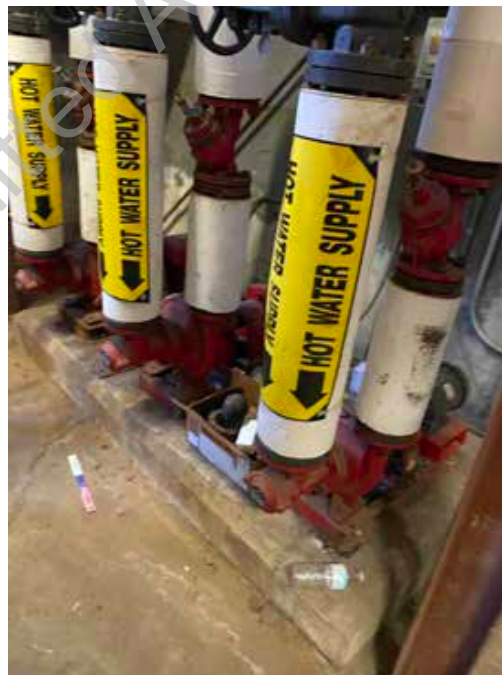
● D2. 18: Hot Water Supply Pumps in poor condition.

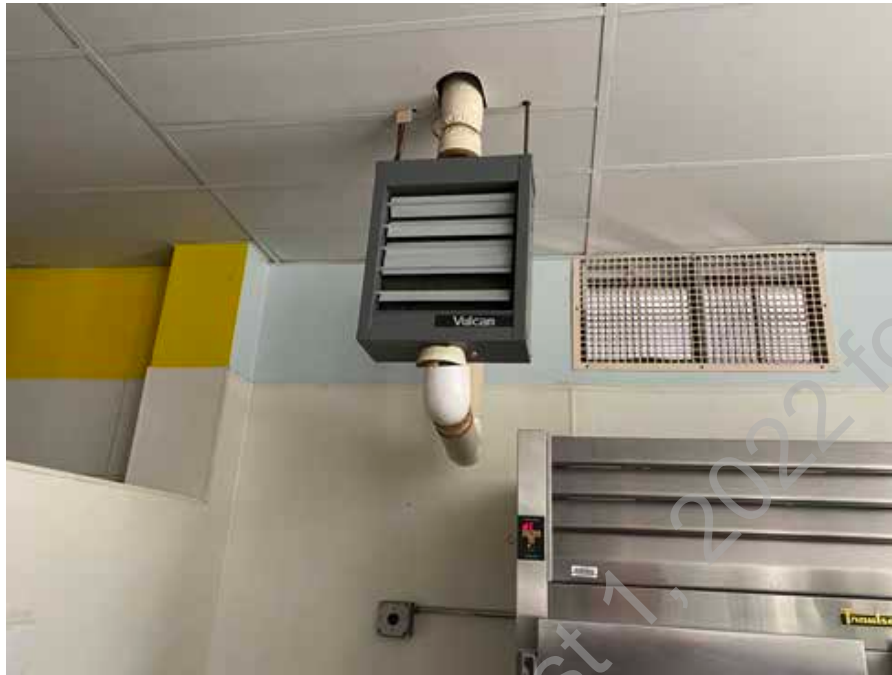
● D2. 19: Hot Water Unit Heater Serving Kitchen.

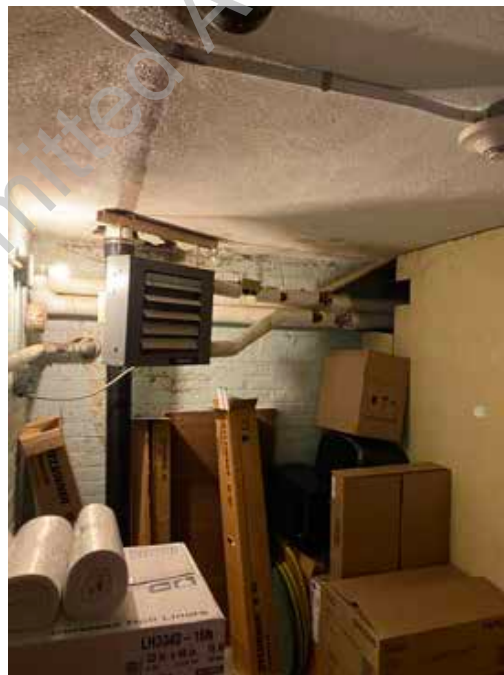
● D2. 20: Hot Water Unit Heater in Poor Condition.

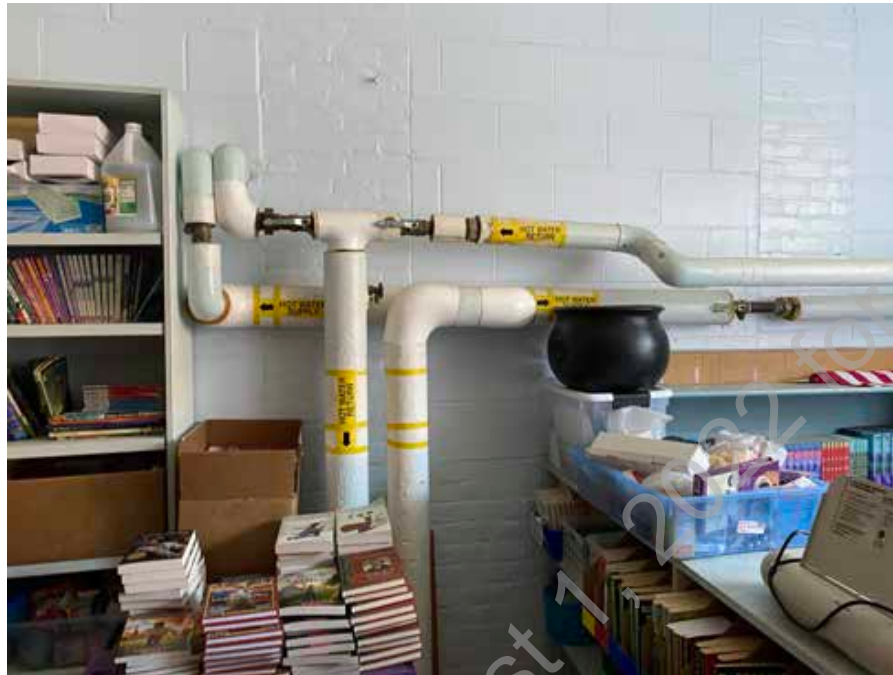
● D2. 21: Detail view of exposed piping retrofits within an existing educational space.

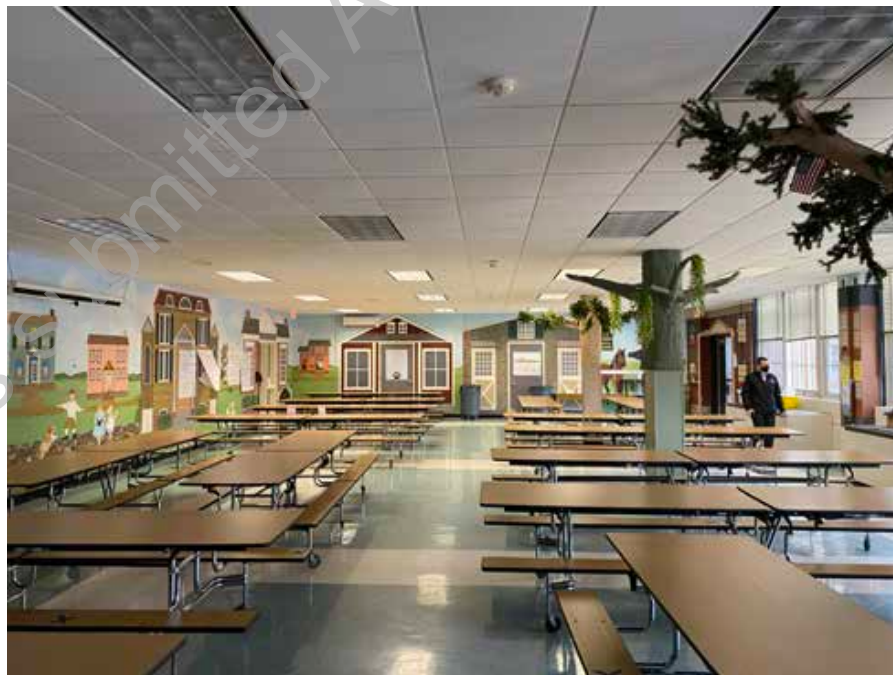
● D2. 22: View of cafeteria.

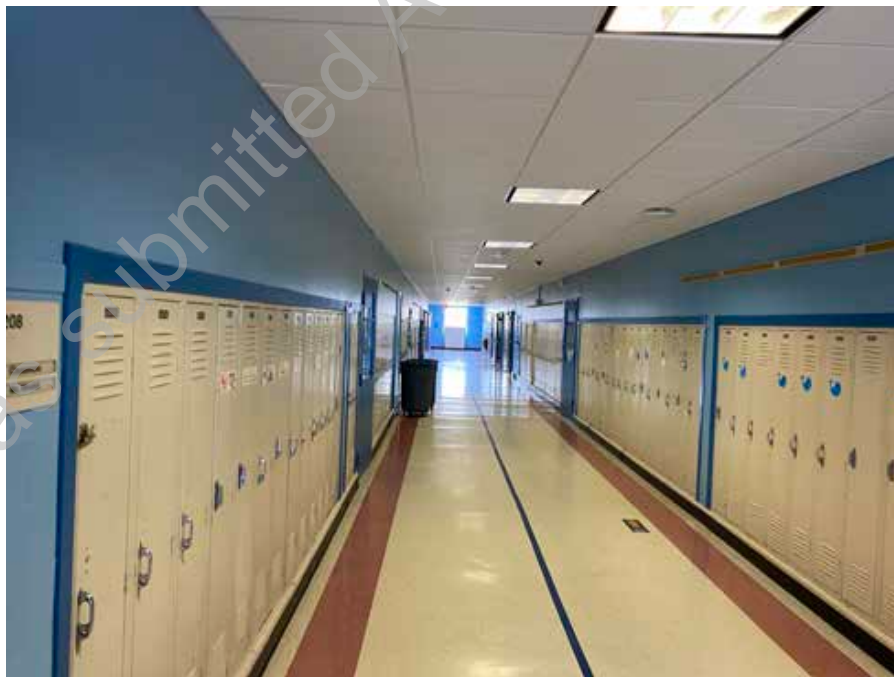
- D2. 24: View of second floor of 1956 addition depicting locker retrofit surrounds and modified/upgraded ceiling.

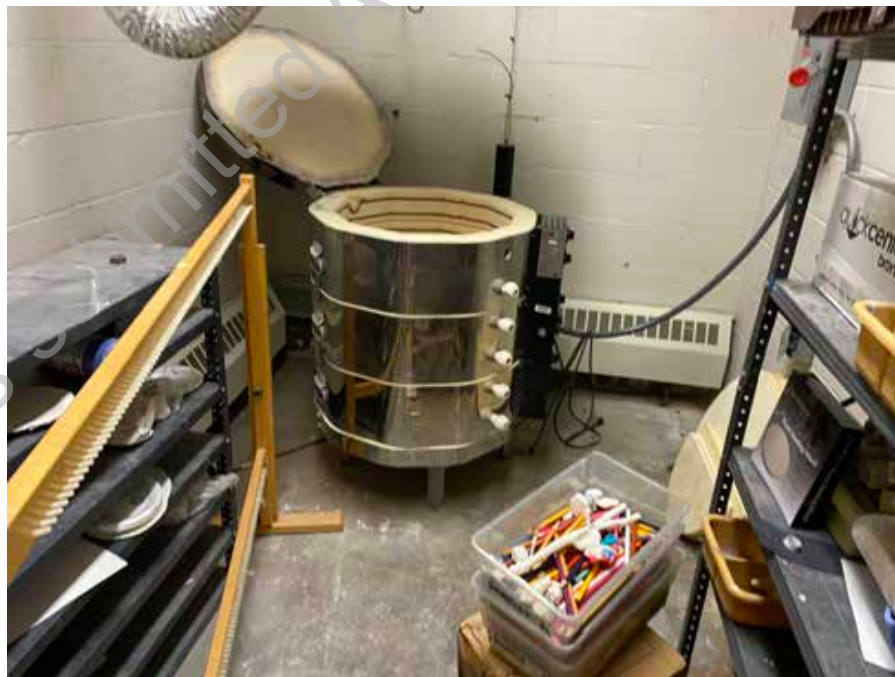
● D2. 26: Detail view of the kiln room.

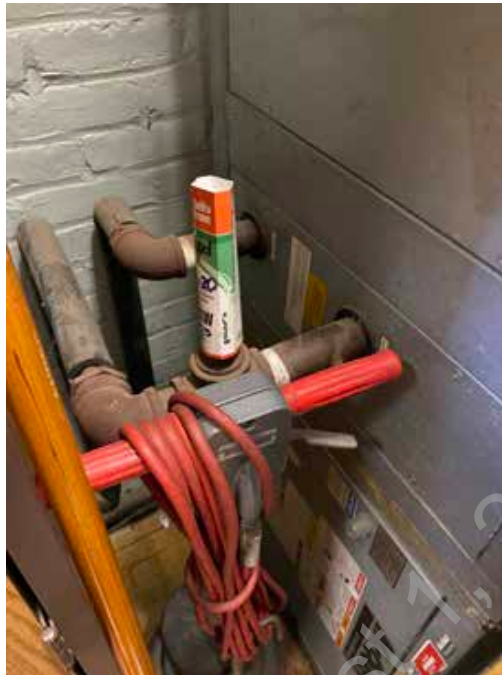
● D2. 27: McQuay Heating and Ventilating Unit.

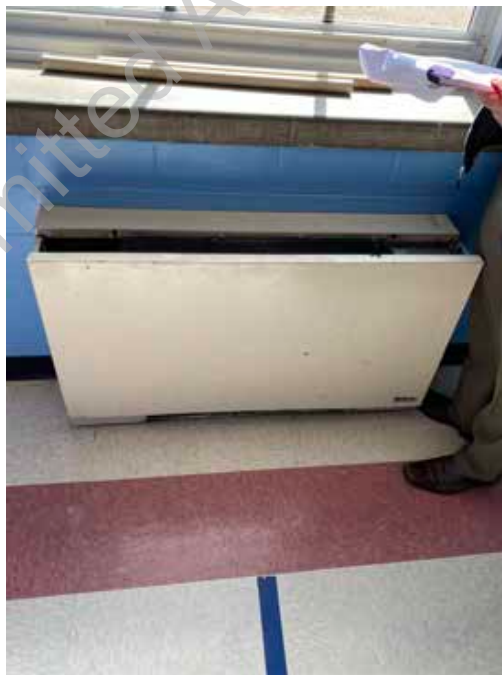
● D2. 28: Detail view of poor condition of typical cabinet heaters throughout the building. McQuay Hot Water Convectors Needs Replacement.

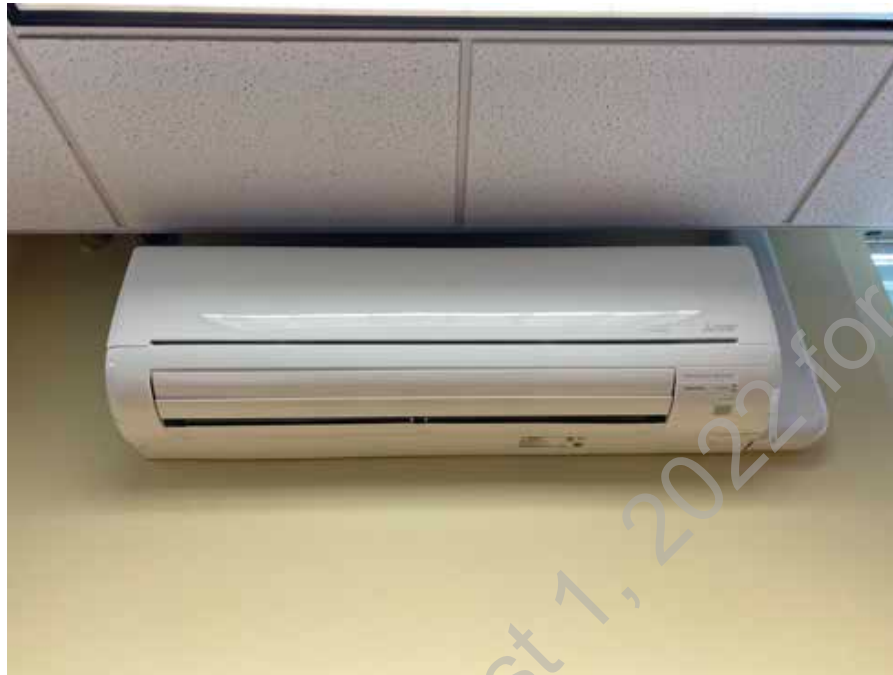
● D2. 29: Mitsubishi Split Unit in Classroom.

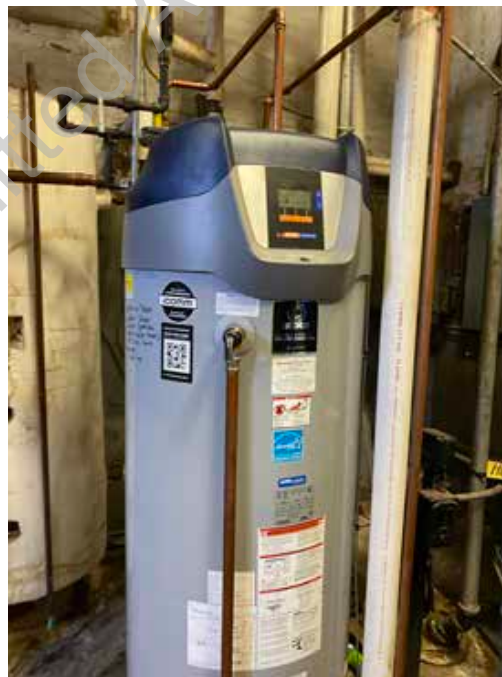
● D2. 30: Natural Gas Domestic Hot Water Heater.

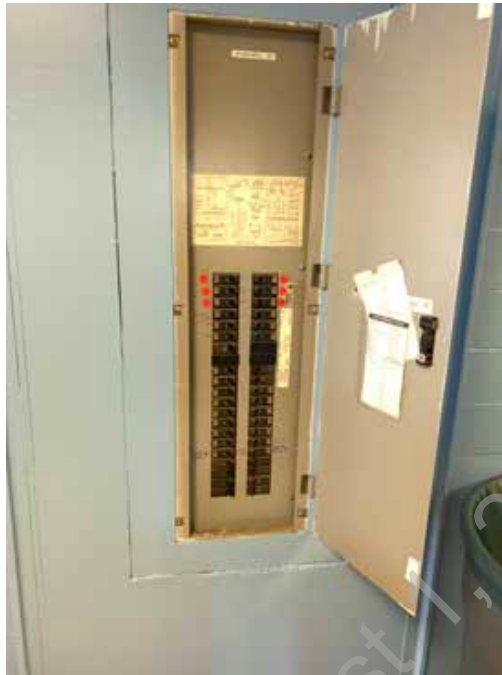
● D2. 31: Old Electrical Distribution.

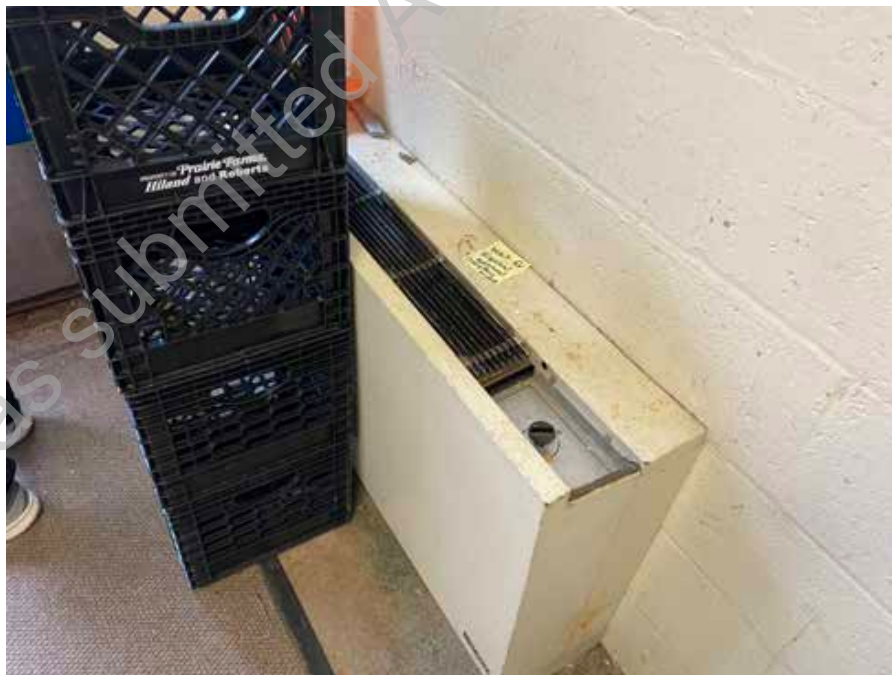
● D2. 32: Old Hot Water Convactor needs replacement.

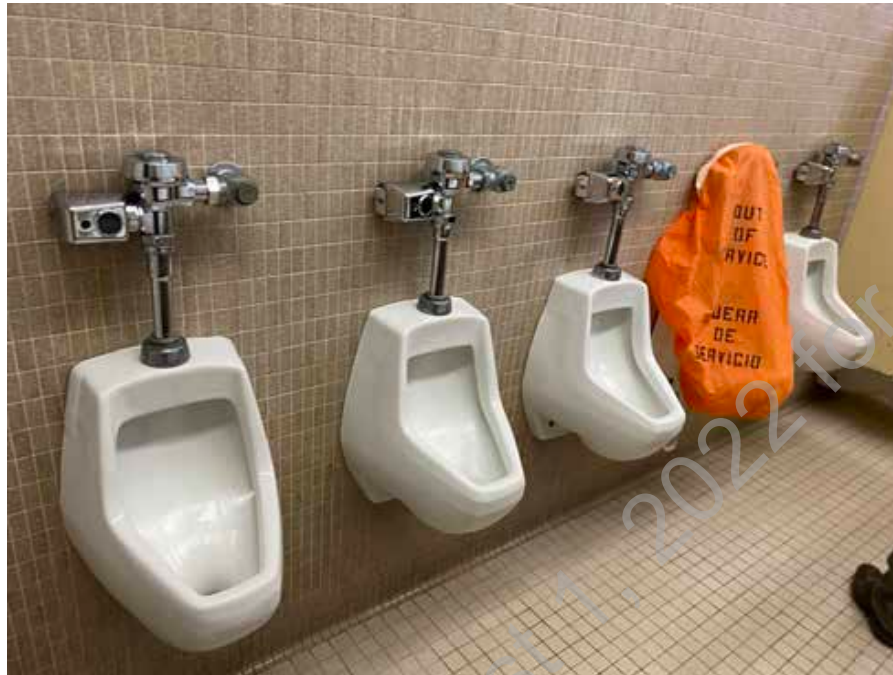
- D2. 33: Detail view of retrofit plumbing fixtures, does not comply with current accessibility codes

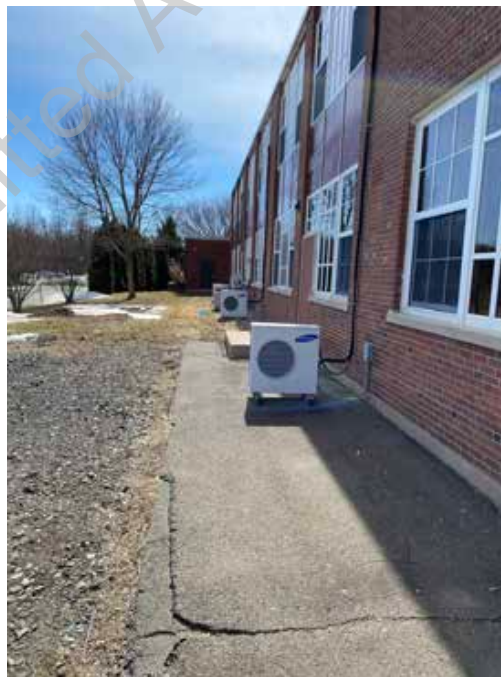
- D2. 34: View of the east façade of the 1956 addition depicting the ground mounted condenser units and poor condition of asphalt pads.

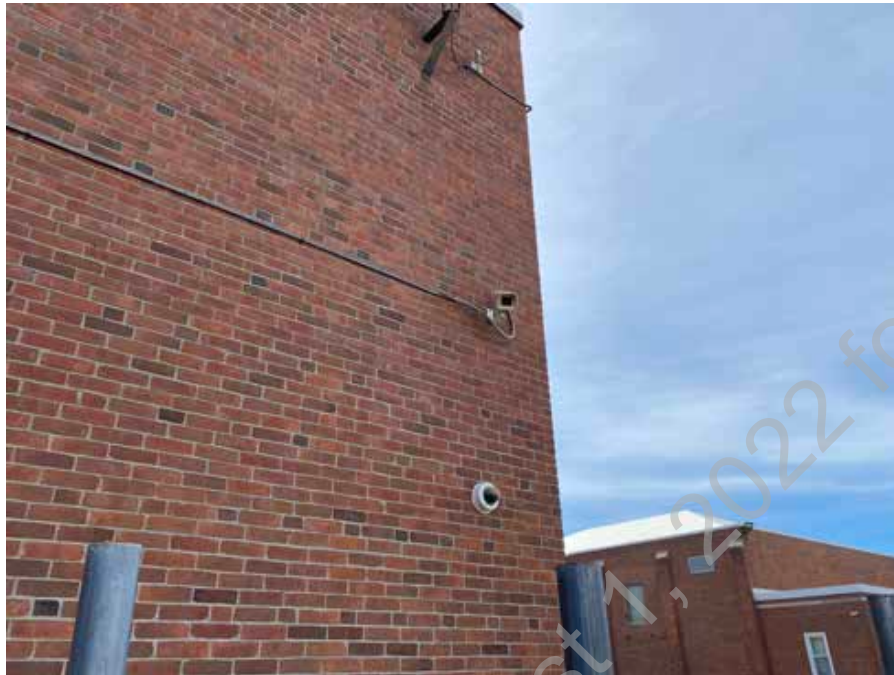
● D2. 35: Detail view of retrofit security cameras.

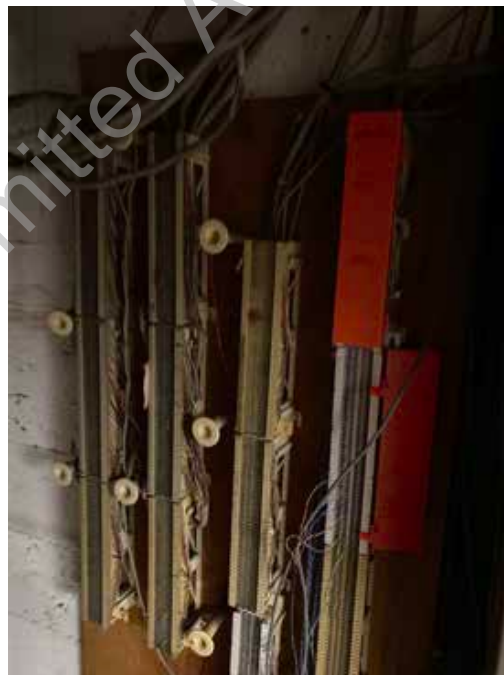
● D2. 36: Telephone Distribution.

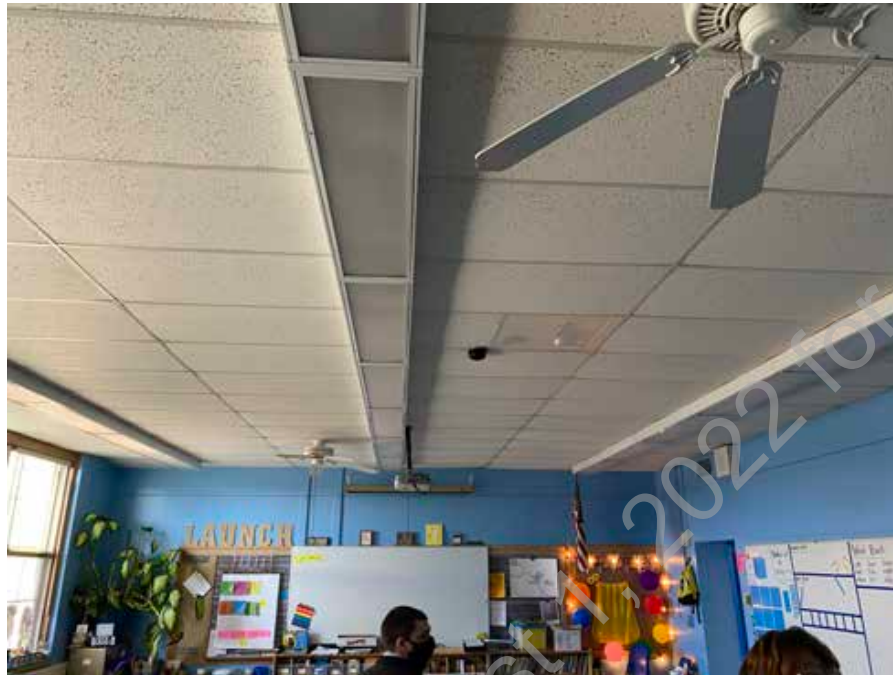
● D2. 37: View of typical classroom ceiling with inefficient fluorescent lighting surface mounted to ceiling.

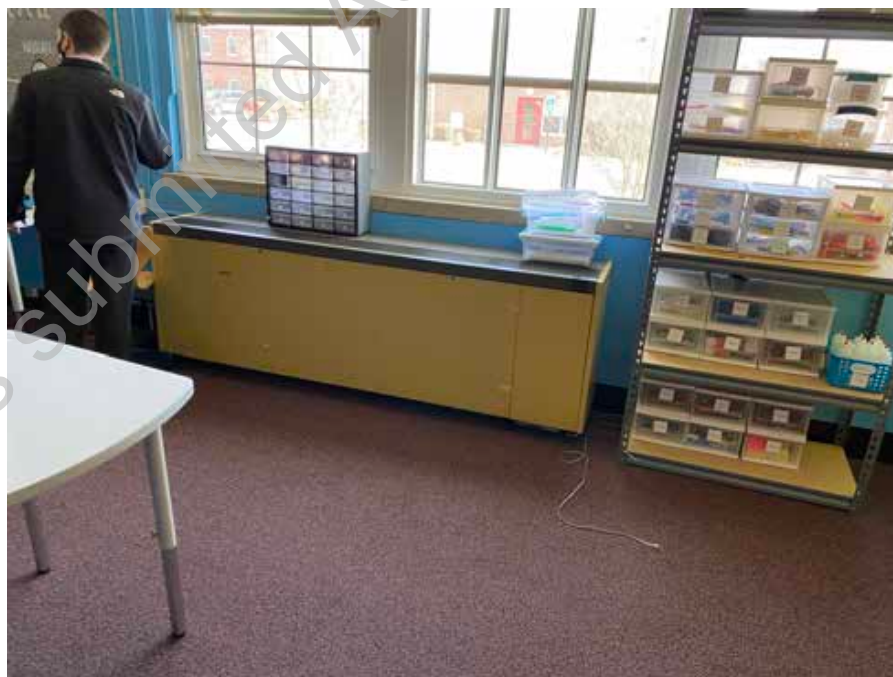
● D2. 38: Detail view of typical unit ventilator in educational spaces.
