TOWN OF SUFFIELD

CONDITIONS ASSESSMENT & MASTER PLAN

Draft as submitted August 1, 2022 for review

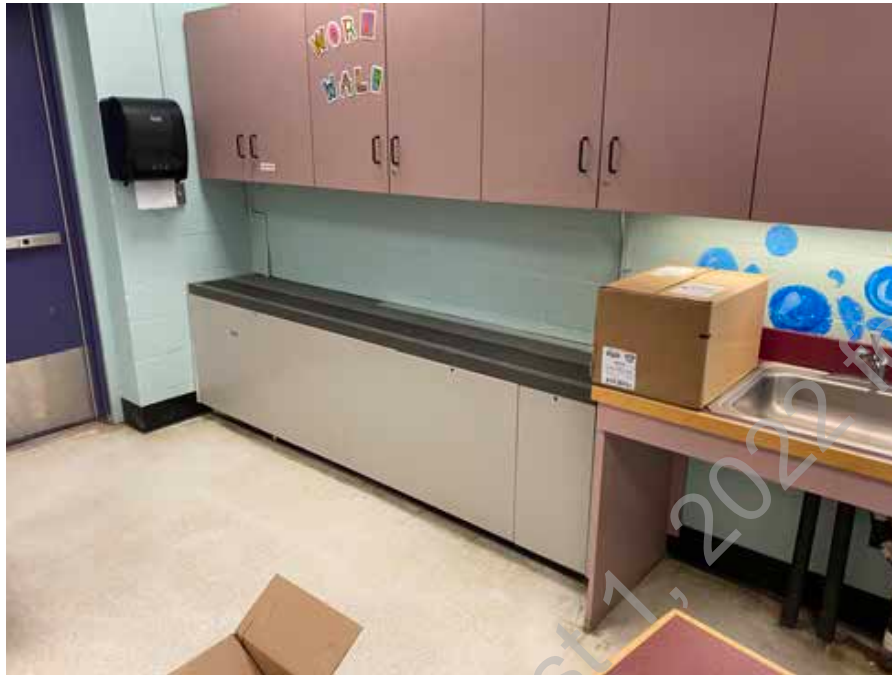
● D2. 39: Detail view of typical unit ventilator in educational spaces.

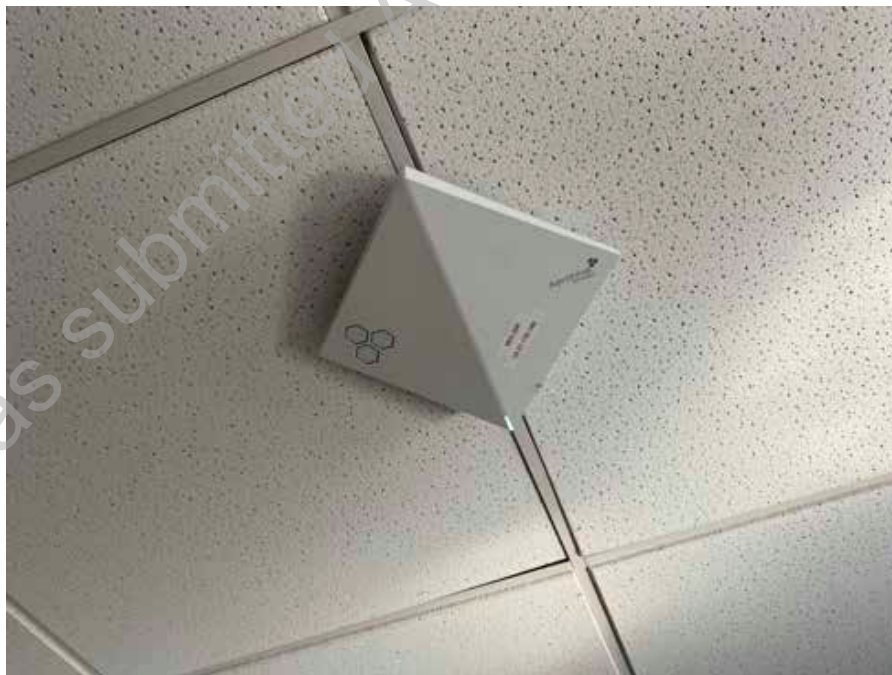
● D2. 40: Wireless Access Point.

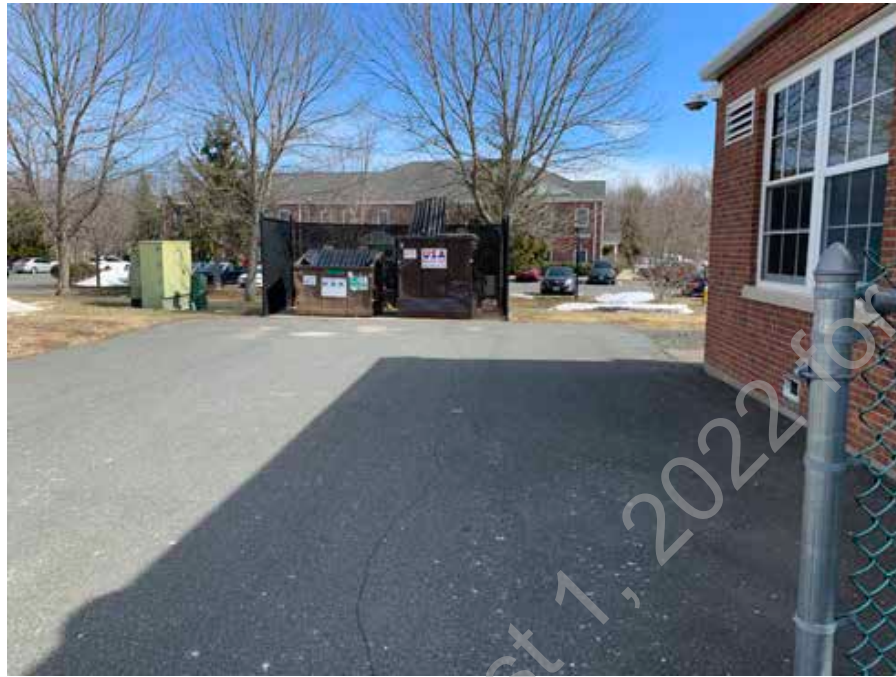
● D3. 1: View of dumpster enclosure, east side of the site.

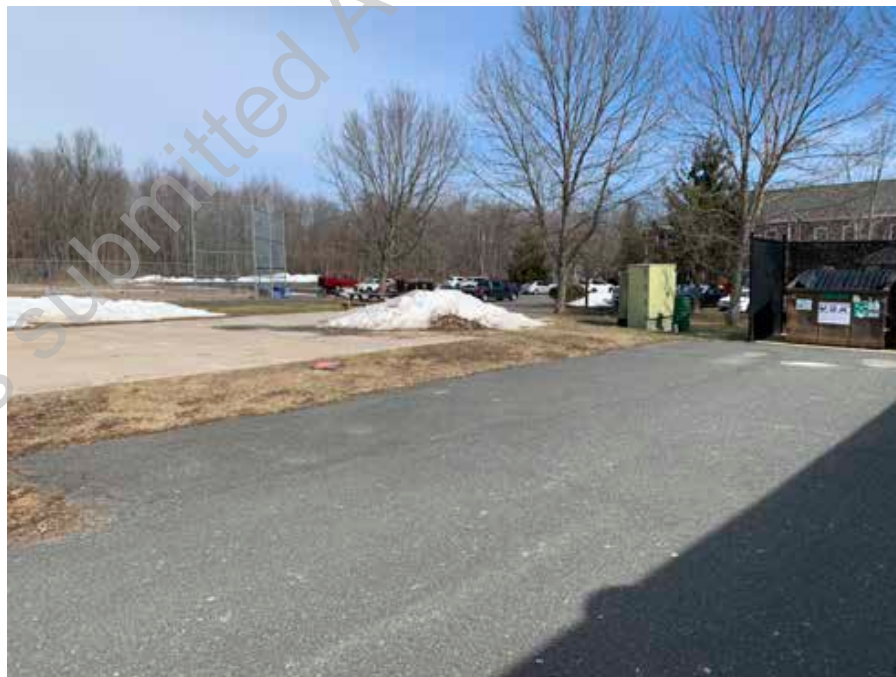
● D3. 2: View of concrete pad, location of former modular building.

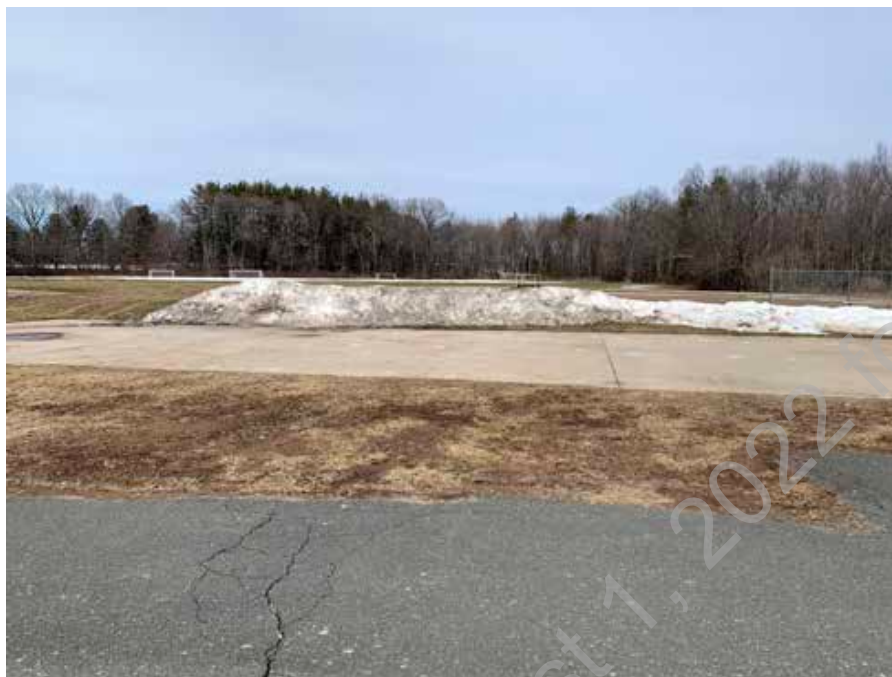
- D3. 3: Detail view of the overall poor condition of the asphalt paving at the south side of the site.

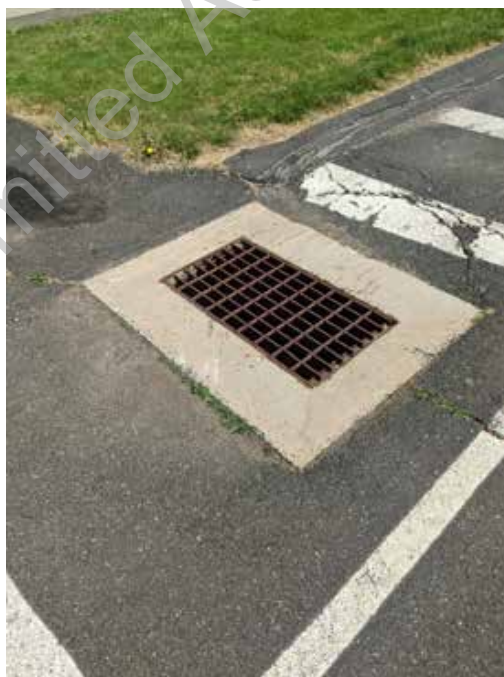
- D3. 4: Detail view of the overall poor condition of the asphalt paving and its relationship to the storm drain/collection system.

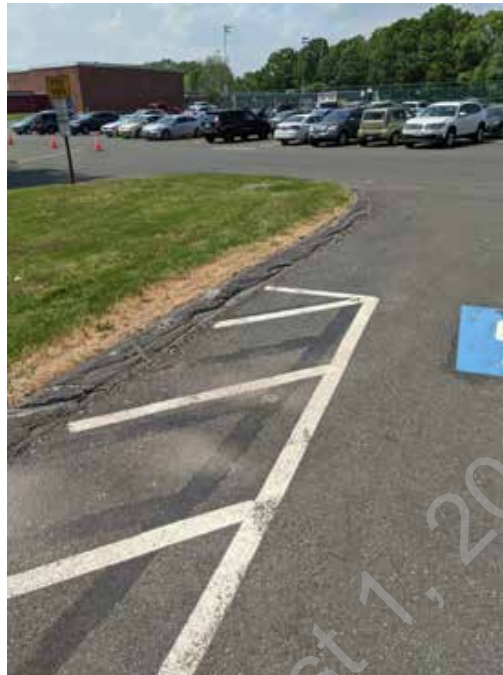
- D3. 5: Detail view of the overall poor condition of the asphalt curbing at the west side of the site.

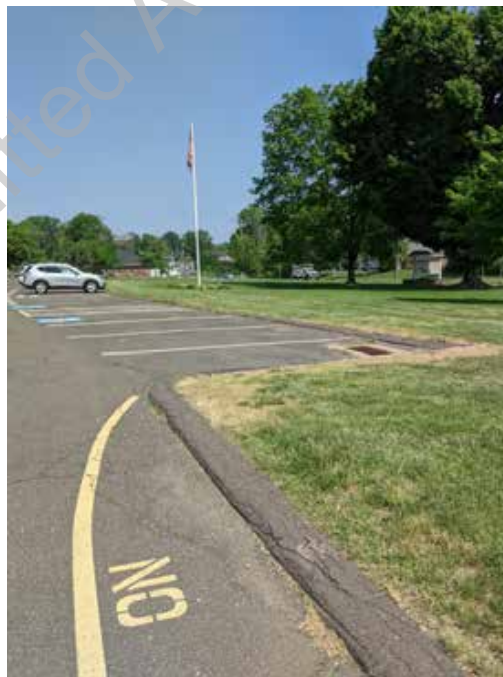
- D3. 6: Detail view of the visitor parking area on the south side of the site.

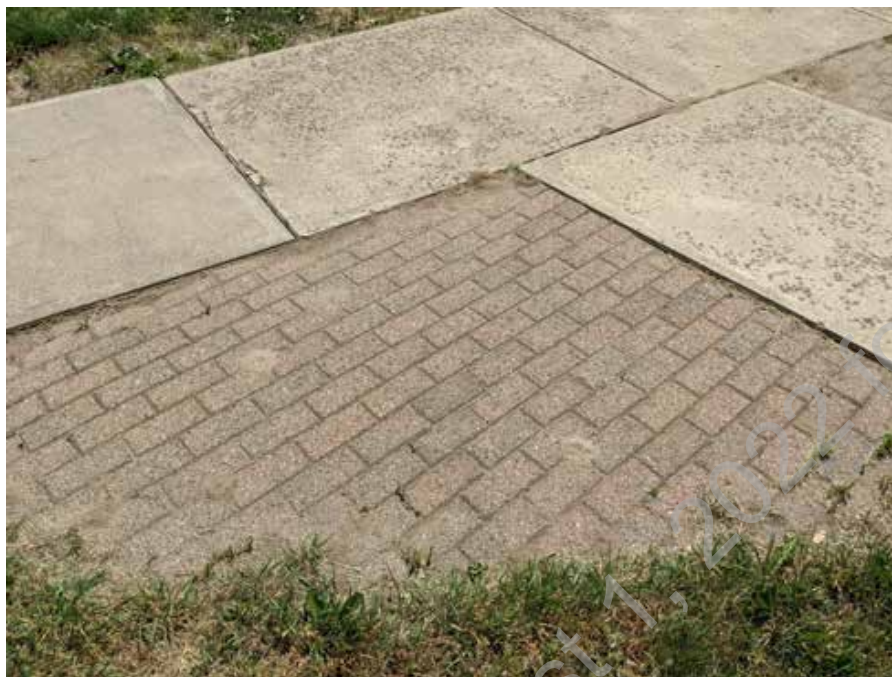
- D3. 7: Detail view of the concrete pavers in poor condition overall and requiring replacement.

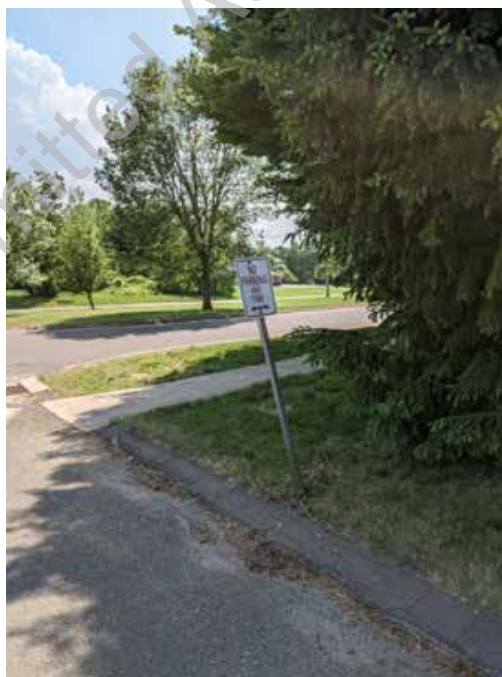
- D3. 8: Detail view of the overall poor condition of the asphalt paving, curbing and signage.

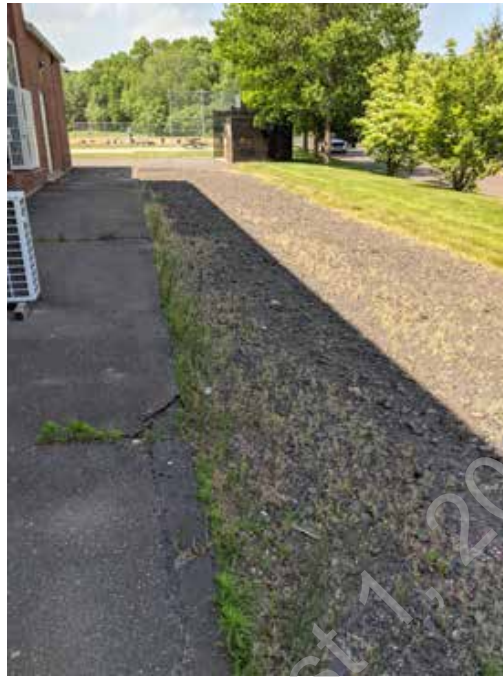
- D3. 9: Detail view of the overall poor condition of the asphalt sidewalk and gravel area on the east side of the site.

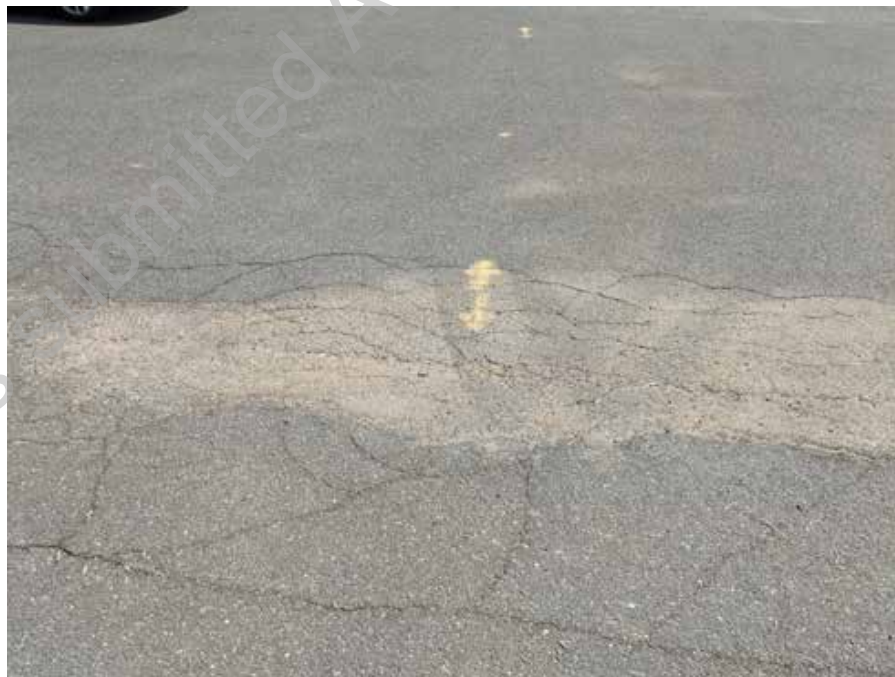
- D3. 10: Typical condition of asphalt paving overall due to age/condition and possibly poor drainage.

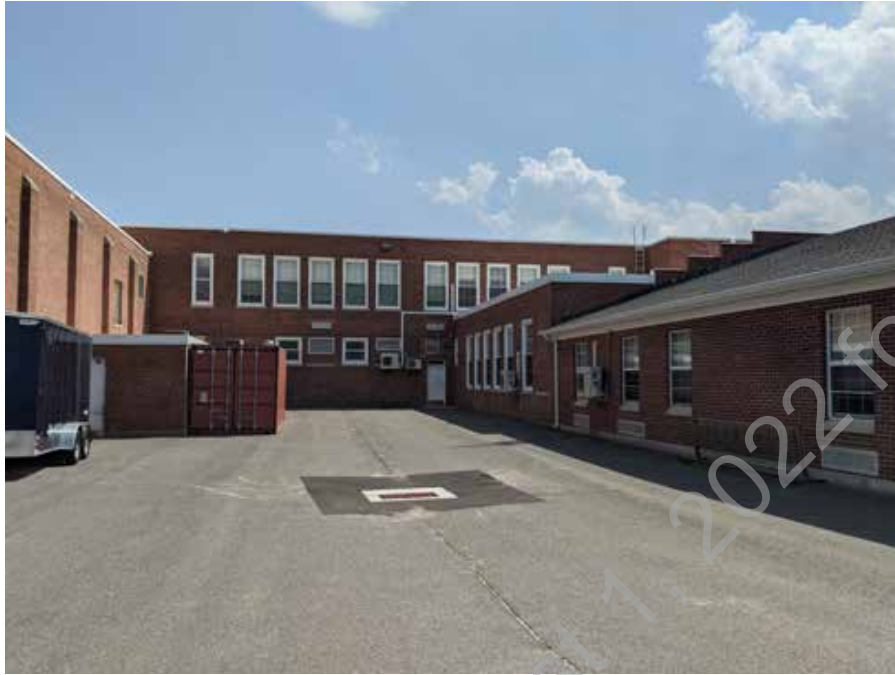
- D3. 11: Detail view of the loading receiving area and patch/repairs to the existing storm basin.

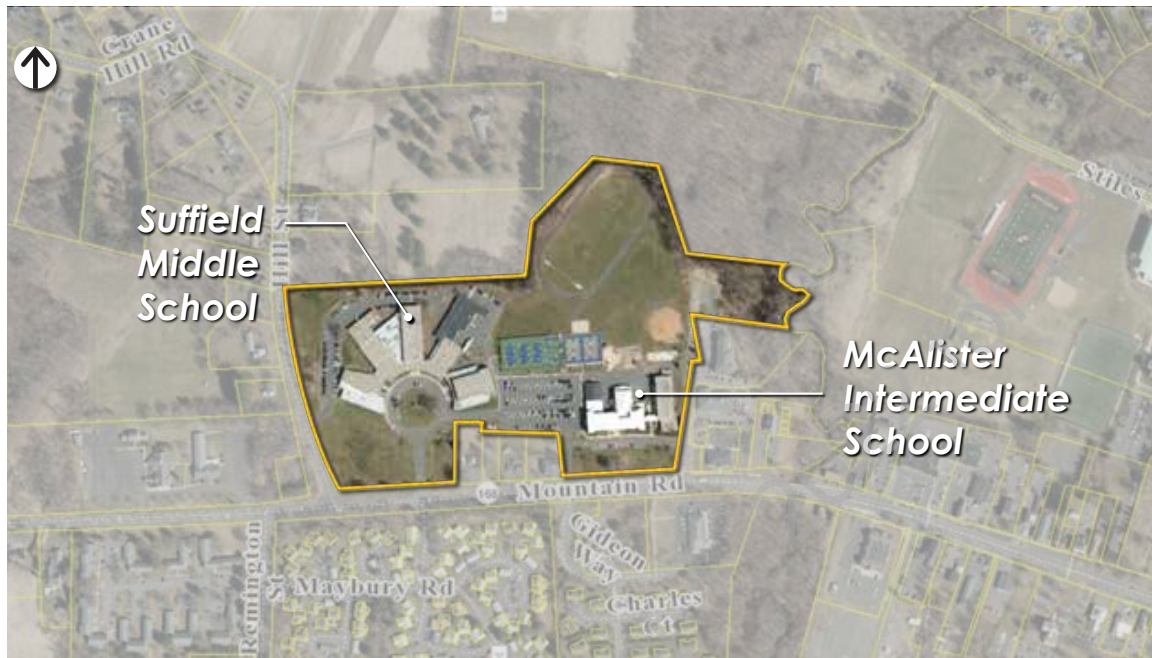
A1. 1: Aerial View of Existing School and Property

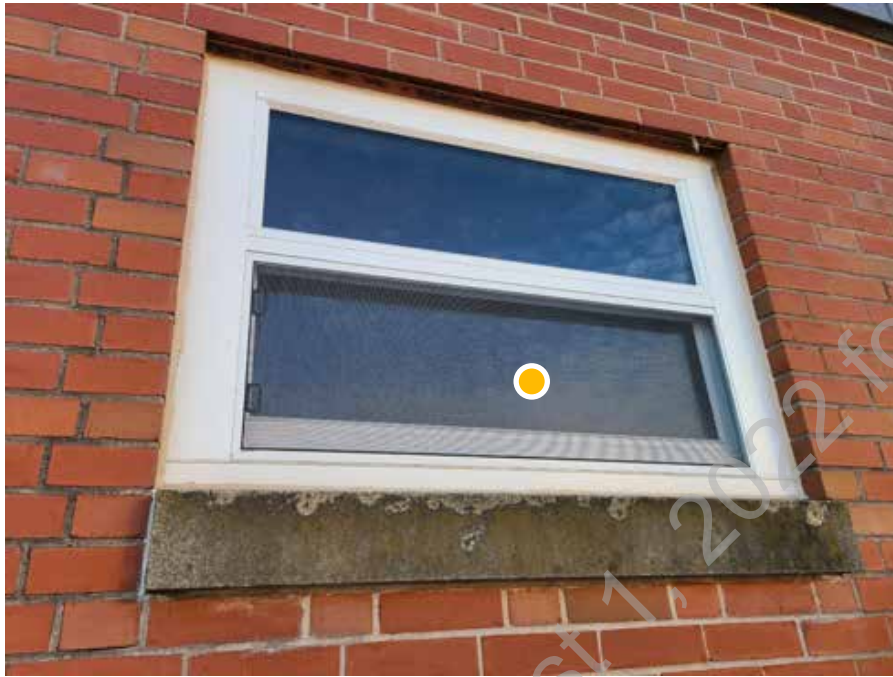
● D1. 1: Detail view of window opening in original 1964 building.

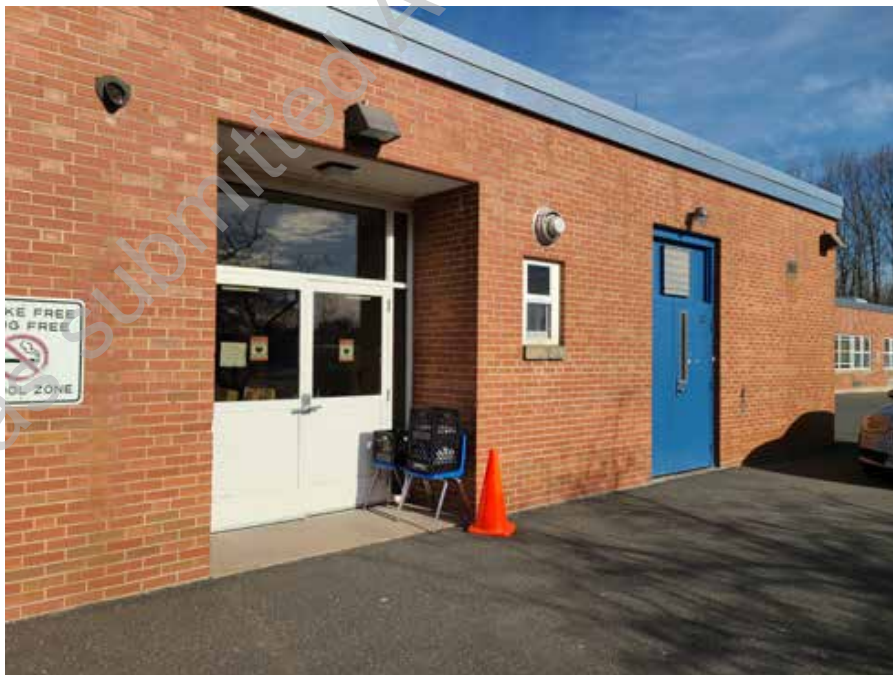
● D1. 2: Detail view of loading/receiving area at cafeteria.

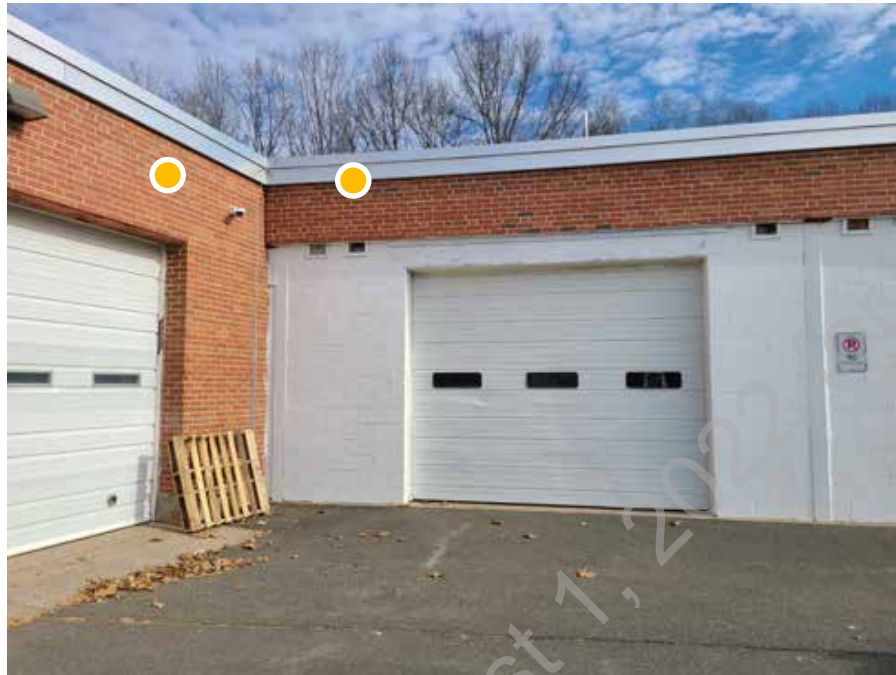
● D1. 3: View of garage doors into 1965 Vo-ag addition (left) and 1972 addition (right). Currently used for facilities.

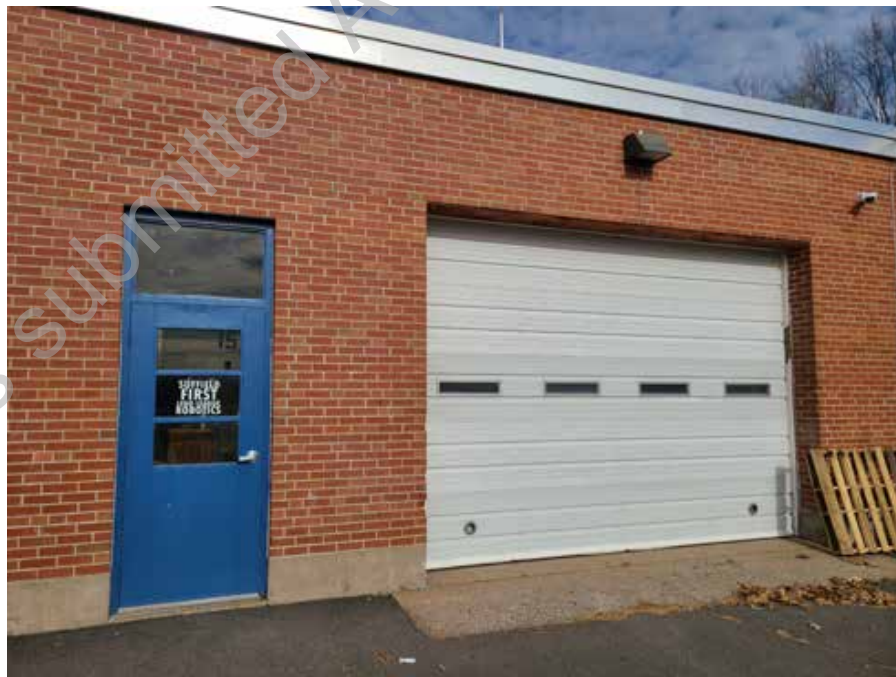
● D1. 4: View toward original Vo-ag 1965 addition, now renovated tech room.

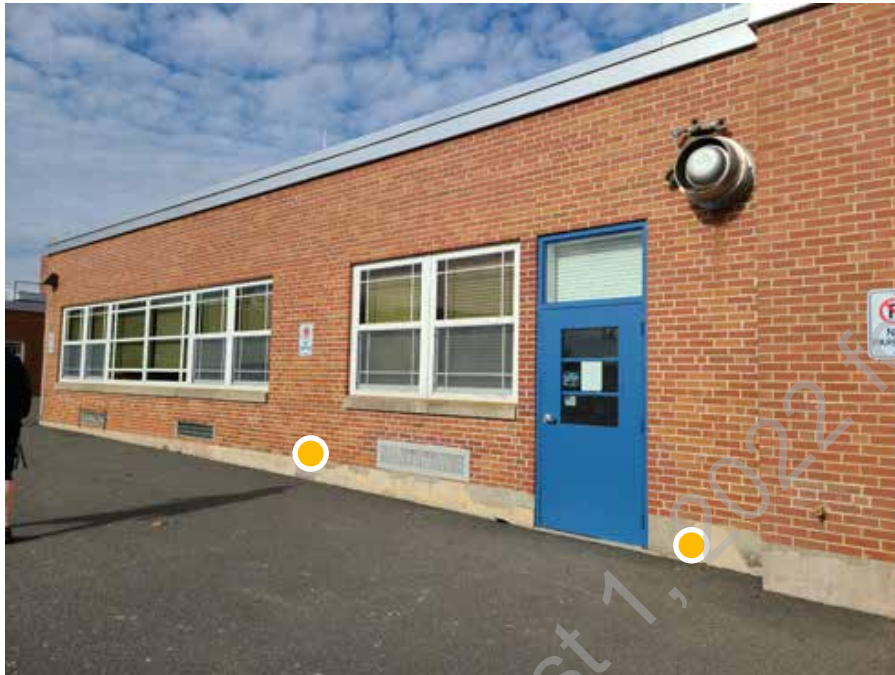
WALLS: Exterior walls are in fair condition overall. Masonry is in fair condition, requiring repointing and repair mostly at corners and roofs due to moisture infiltration. A former greenhouse, now just a raised exterior planter, sits at the North side of the building. When demolished, roof flashing was left and is still engaged in the exterior wall. This has potential to allow for moisture infiltration and should be removed. Brick staining and efflorescence was observed around the entire exterior envelope. Building joints are in fair to poor condition with a mix of mortar, caulk, and some areas with nothing at all. Exposed foundation walls are spalling and require repair.

D1. 5: View of typical exterior wall in 1965 Vo-ag addition. Note spalling concrete foundation wall

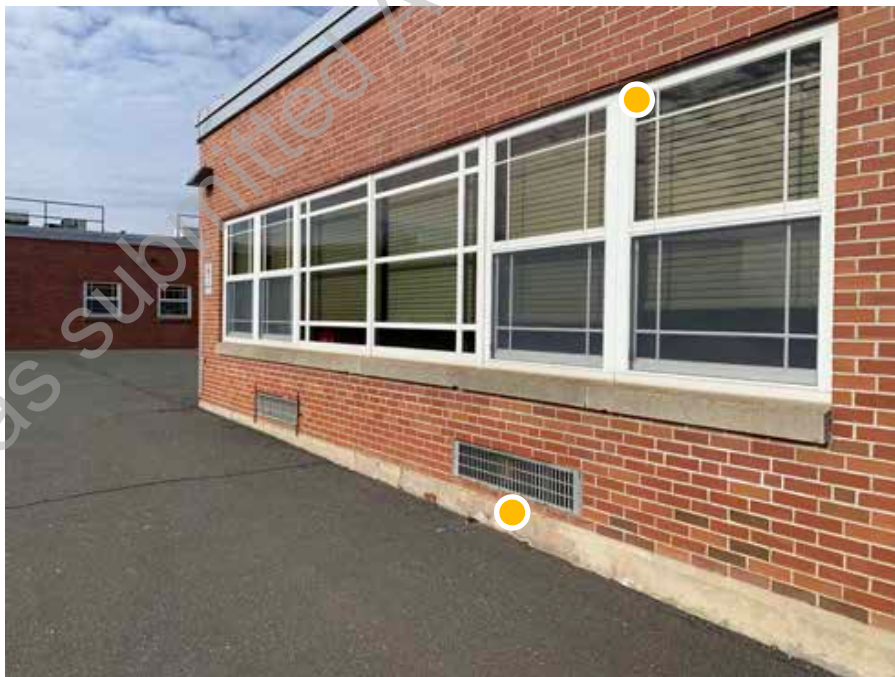
D1. 6: Detail view of 1965 Vo-ag addition, note deteriorating steel lintels above windows and spalling concrete foundation wall below.

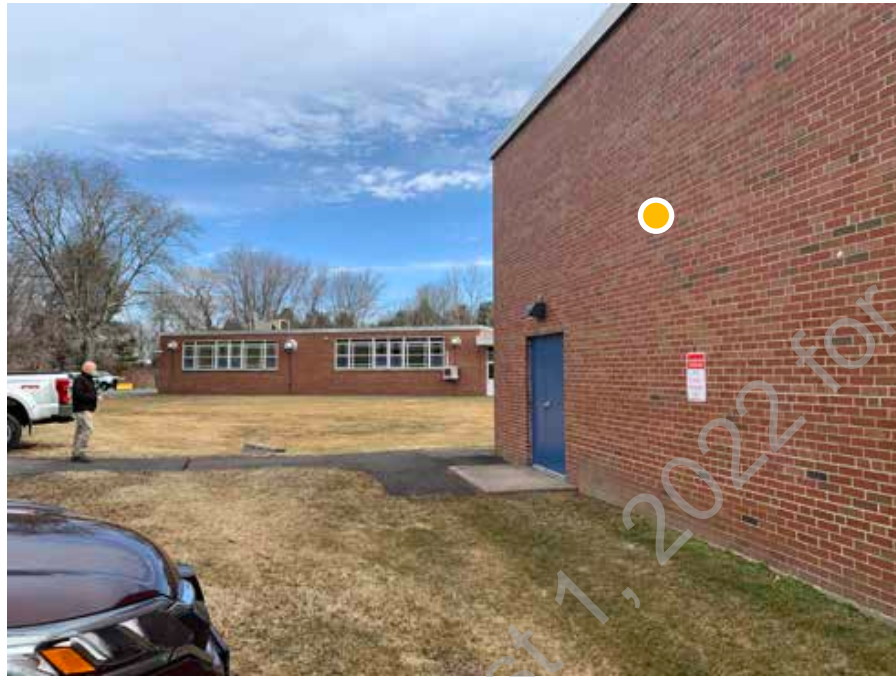
● D1. 7: View of 1972 stage storage addition

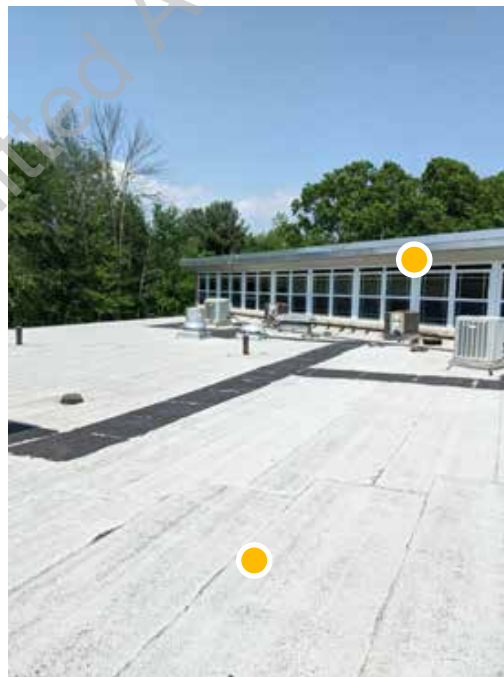
● D1. 8: View of 1972 addition roof in foreground with original 1964 two story classroom wing beyond.

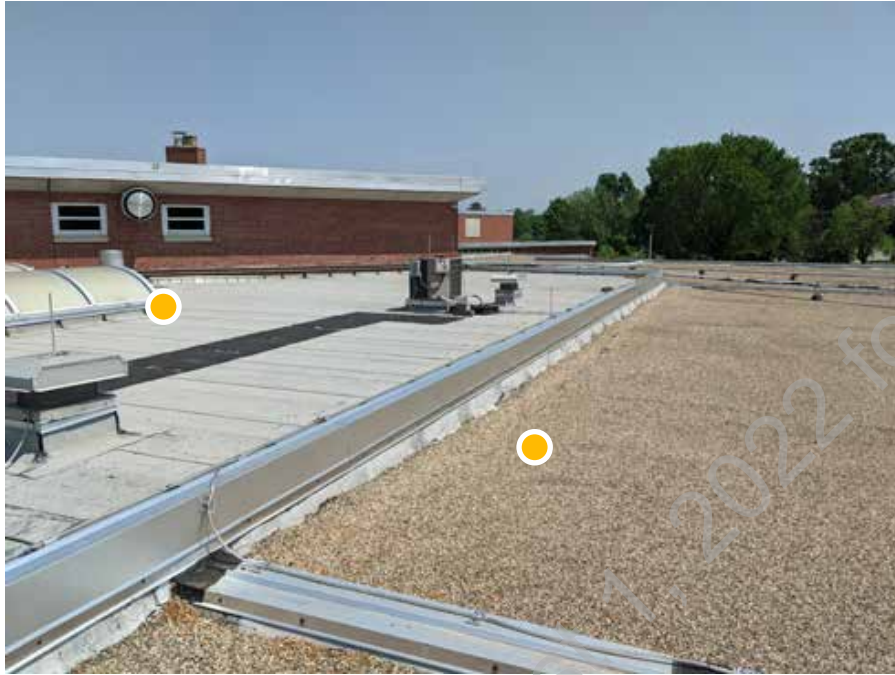
D1. 9: View of 1972 addition roof (left) with original 1964 two story classroom wing beyond.

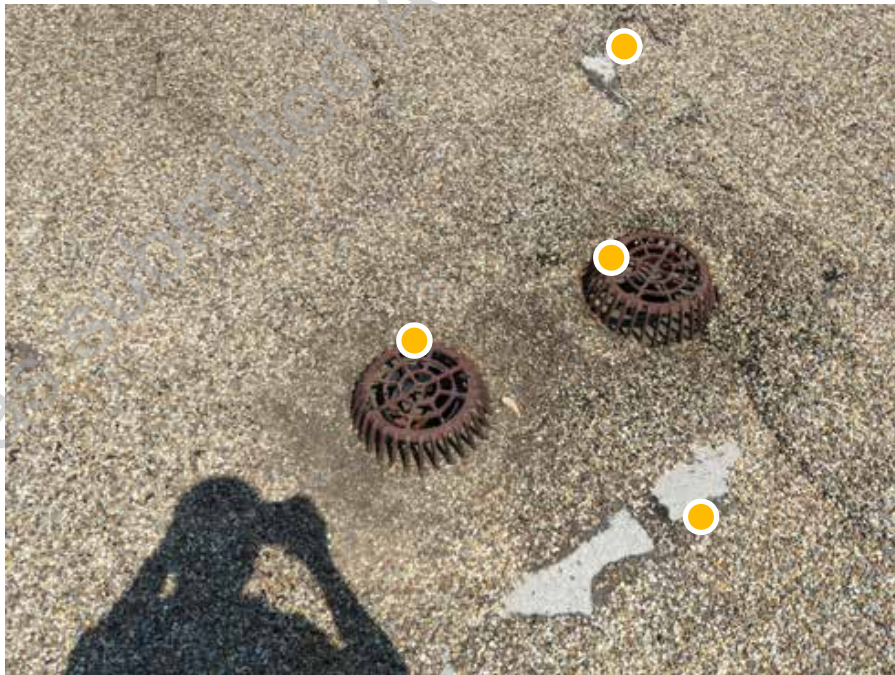
D1. 10: View of built up roofing with double roof drain, note portions of the roof have exposed built up with limited gravel protection.

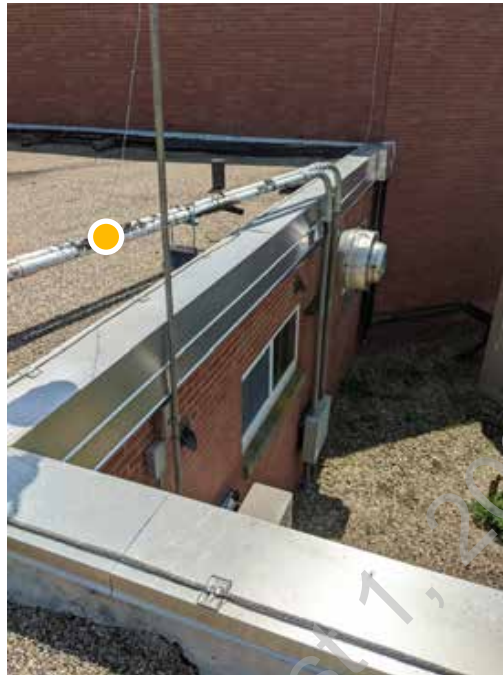
● D1. 11: View of original 1964 construction with surface mounted electrical conduits, roof mounted, into original electrical room.

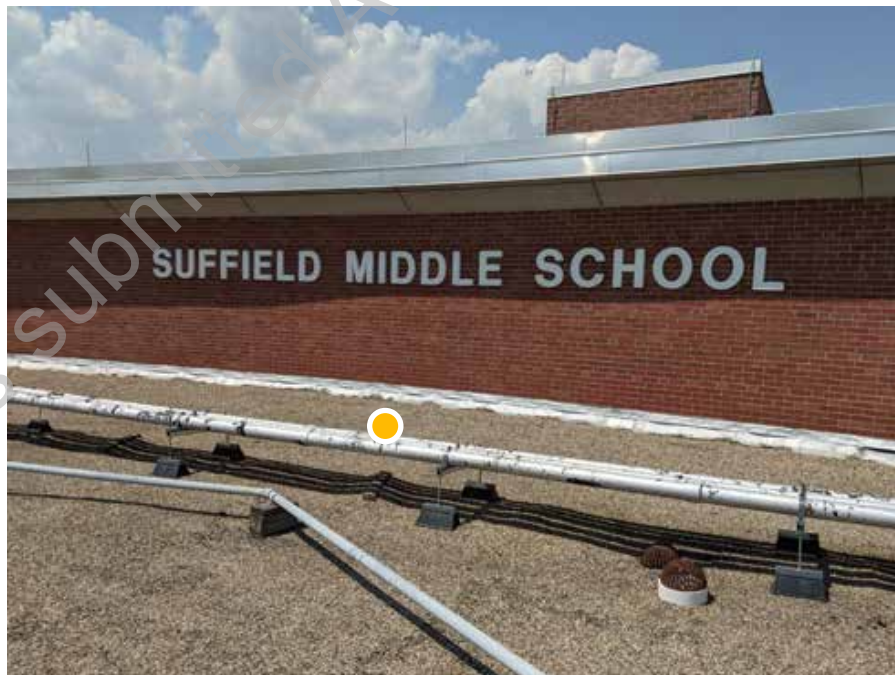
● D1. 12: Detail view of original 1964 construction, two story portion, with surface mounted electrical conduits, roof mounted, into original electrical room.

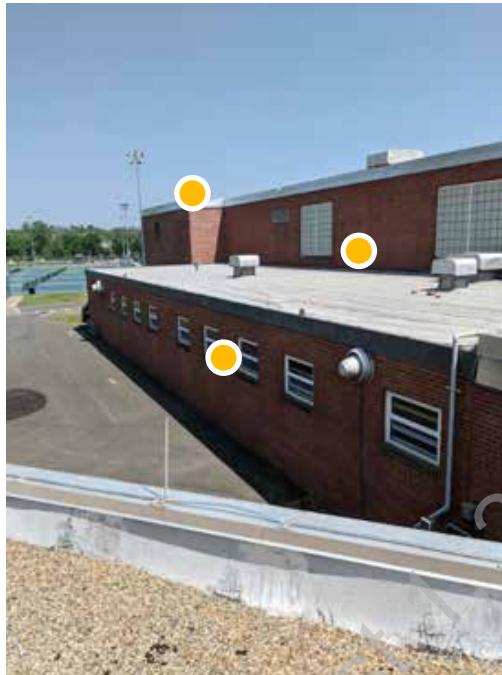
- D1. 13: View of original 1964 gymnasium foreground with 1972 auxiliary gym addition in background.

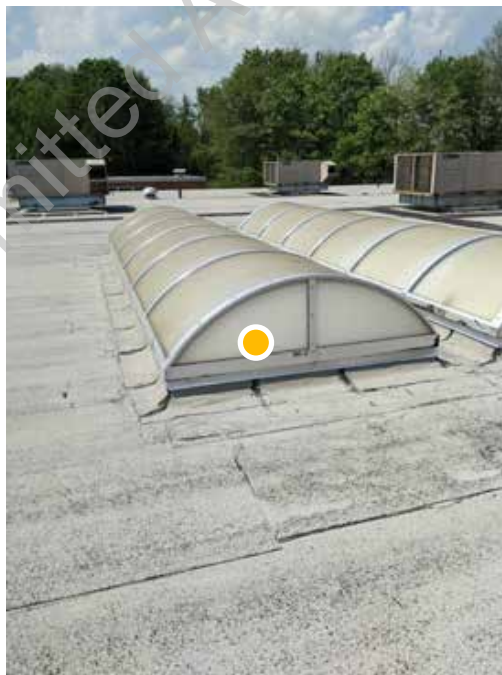
- D1. 14: Roof mounted barrel vault skylights into media center, part of the 1972 additions and modifications.

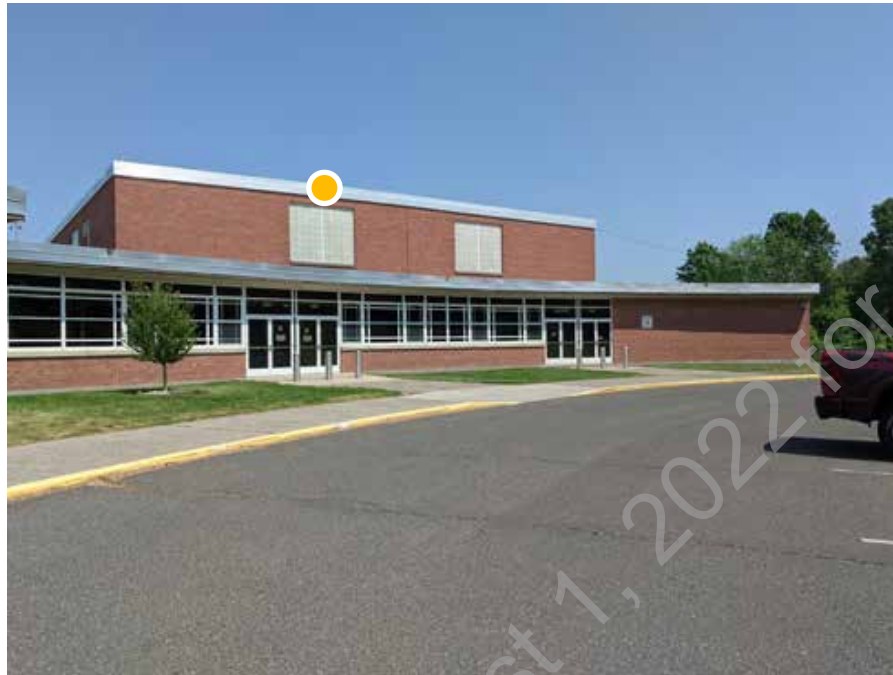
● D1. 15: View of entry to gymnasium portion of the building, original 1964 with window modifications in 2002.

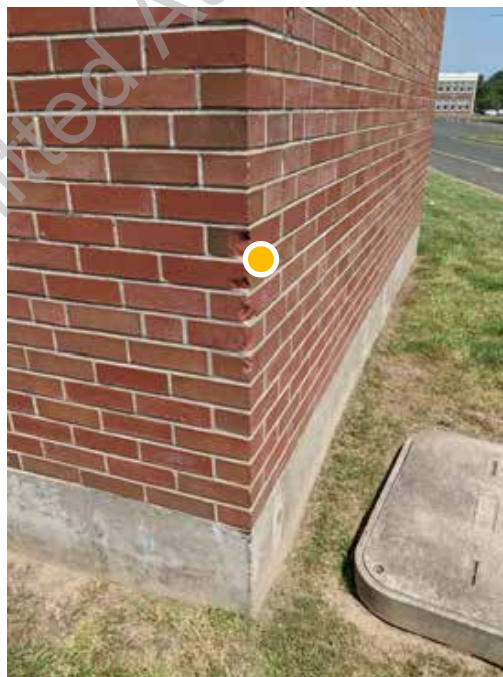
● D1. 16: Detail view of the overall condition of the composite masonry wall, part of the original 1964 building.

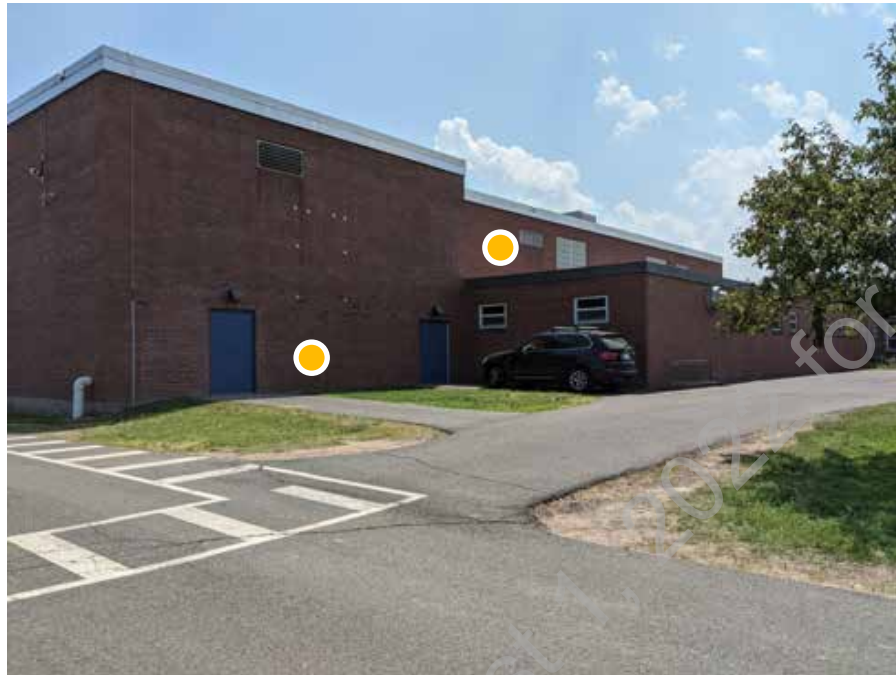
● D1. 19: View of 1972 auxiliary gym (left) and original 1964 construction (right).

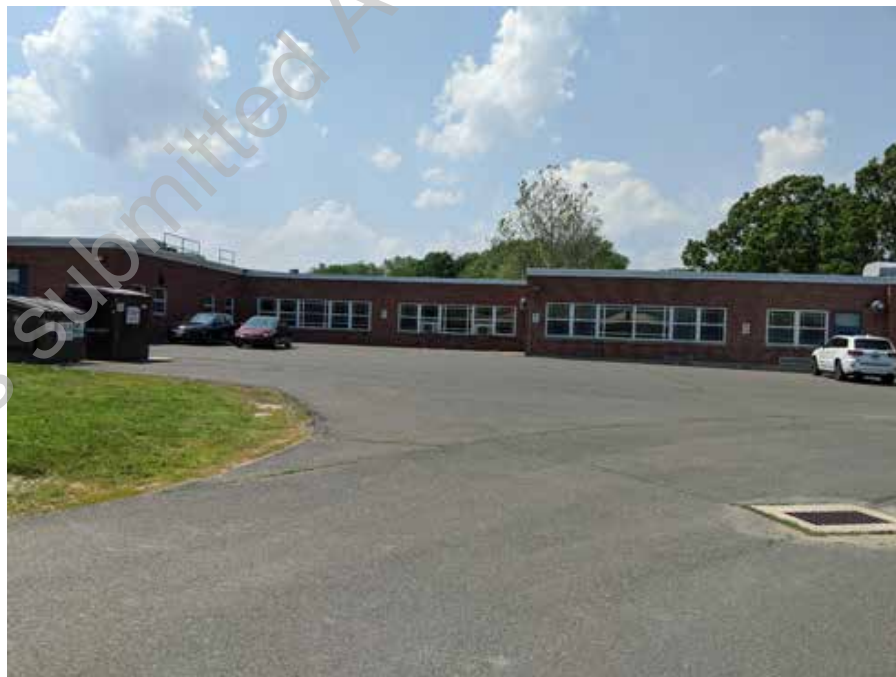
● D1. 20: Overall view of the original cafeteria in the 1964 building (left) and the Vo-ag addition (right) in 1965.

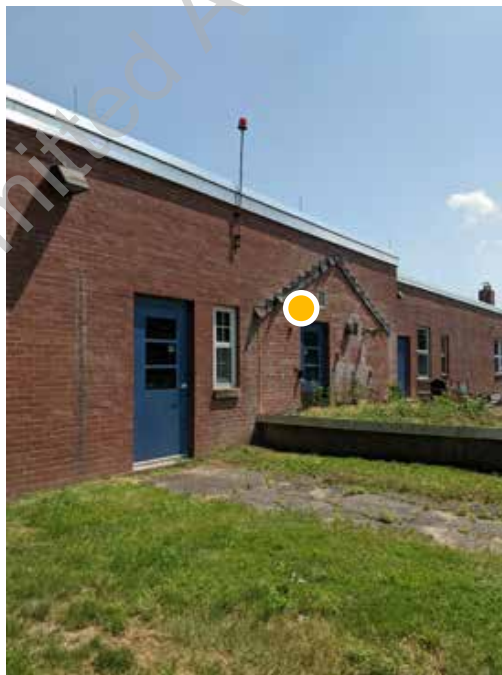
- D1. 22: View of the former greenhouse area of the 1965 Vo-ag addition, overall area in poor condition.

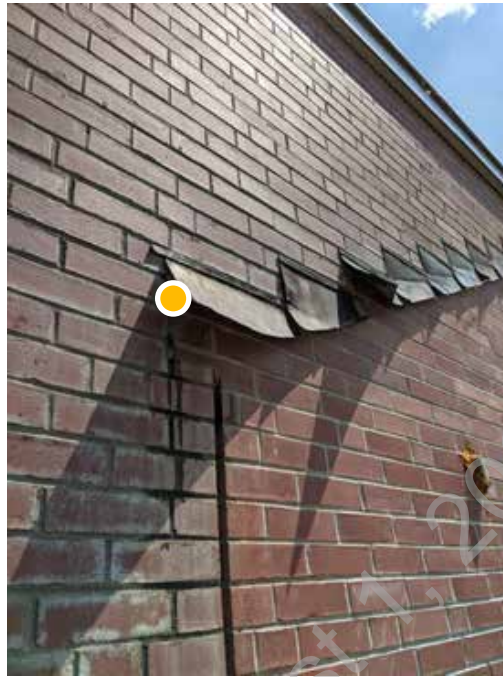
- D1. 23: Detail view of the step flashing that remains from the former greenhouse, part of the 1965 Vo-ag addition.

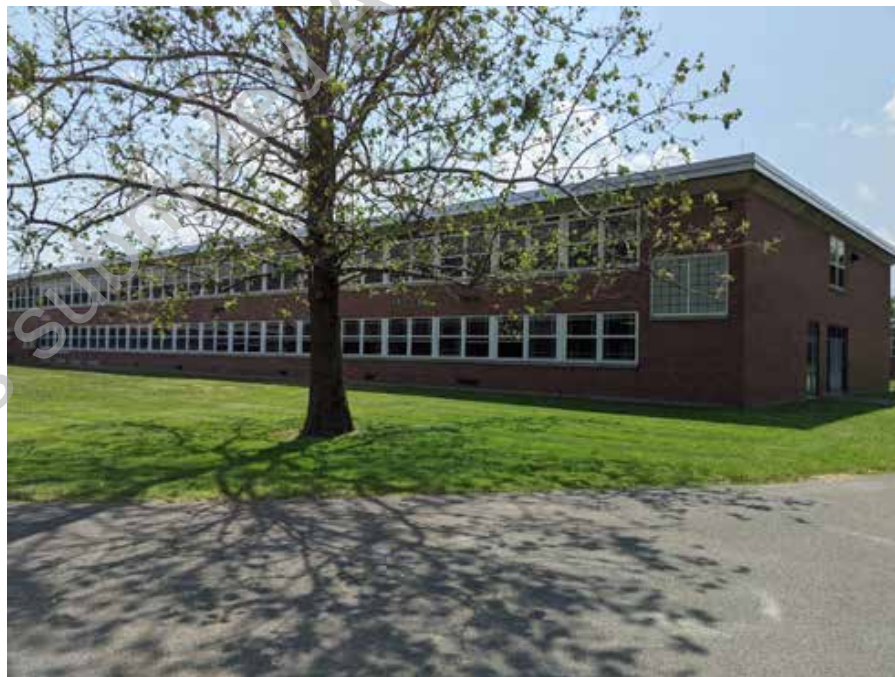
- D1. 24: Overall view of the two story classroom portion of the middle school, original construction 1964.

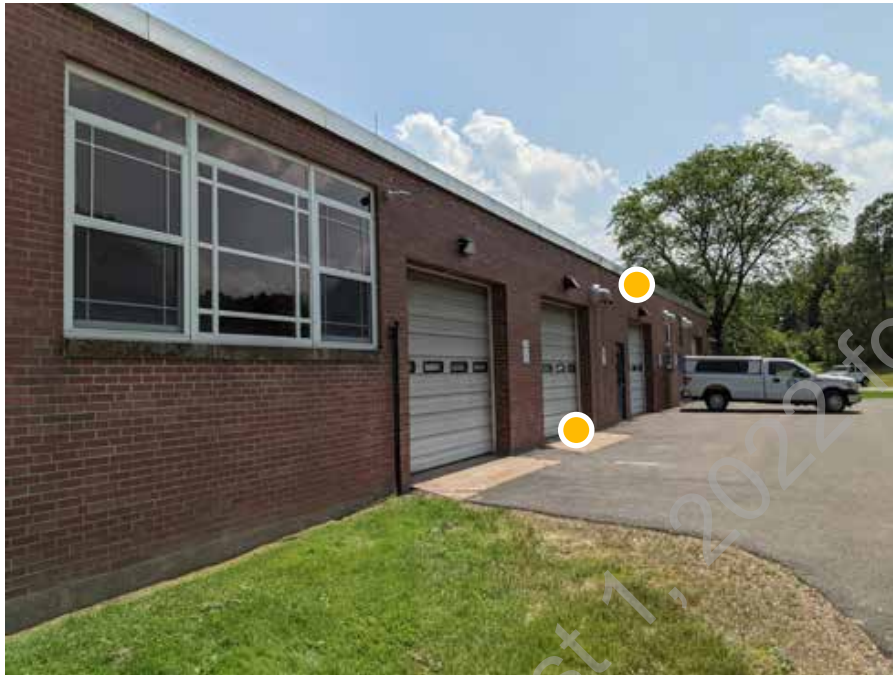
- D1. 25: View of 1972 addition (left) and original construction from 1964 (right). Interior program contains maintenance shop and specialized education.

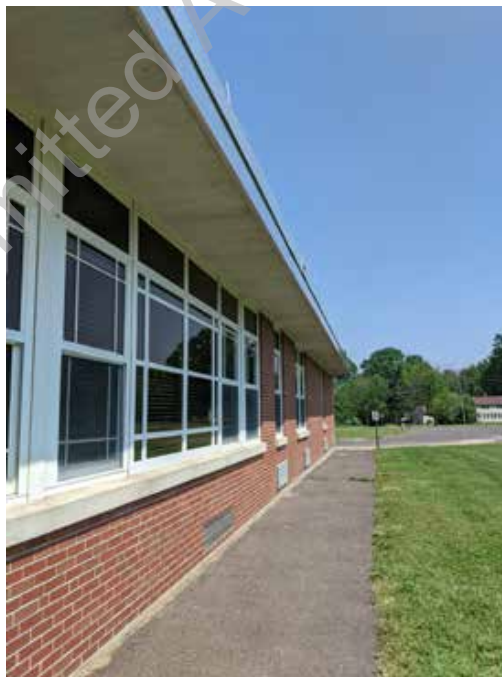
- D1. 26: View of single story classroom wing, original construction 1964.

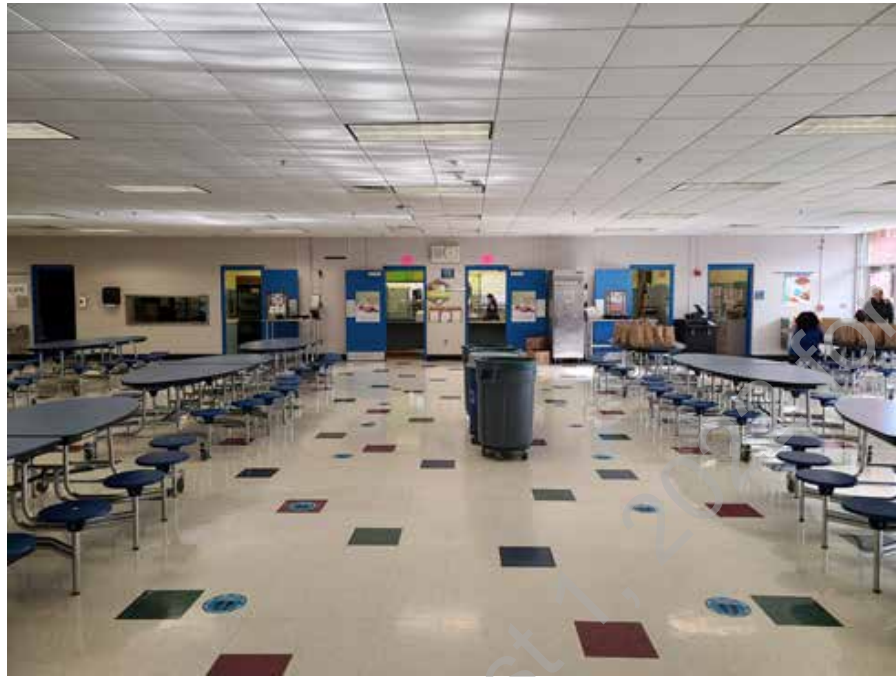
● D1. 27: View of existing cafeteria.

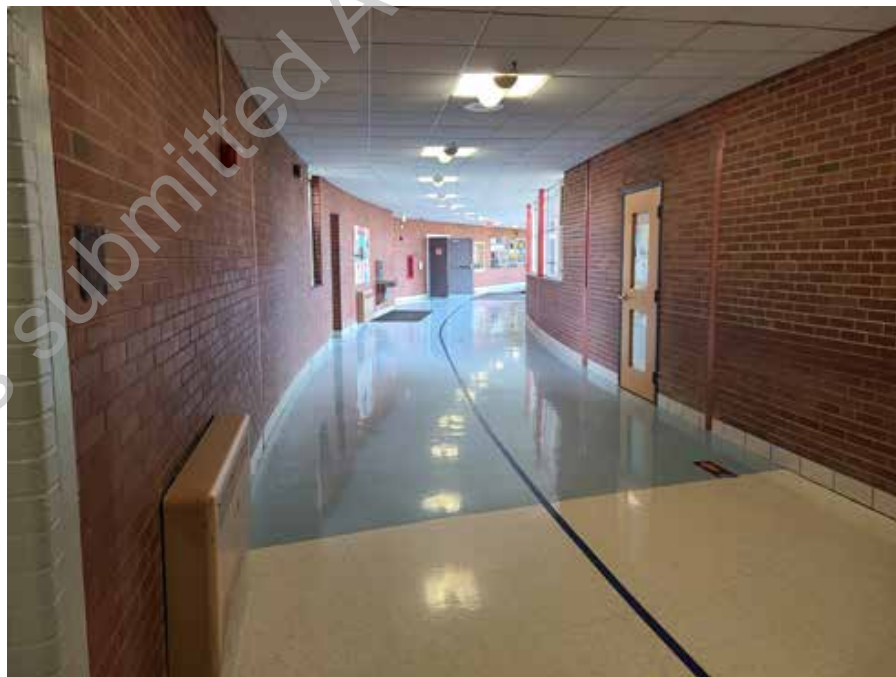
● D1. 28: View of curved main connector hallway.

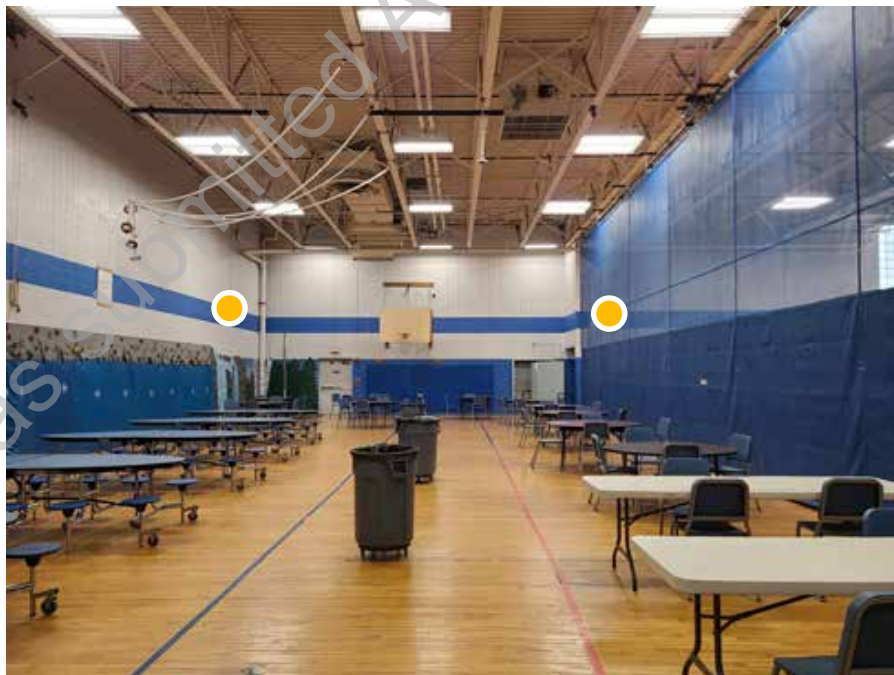
● D1. 30: View of auxiliary gymnasium.

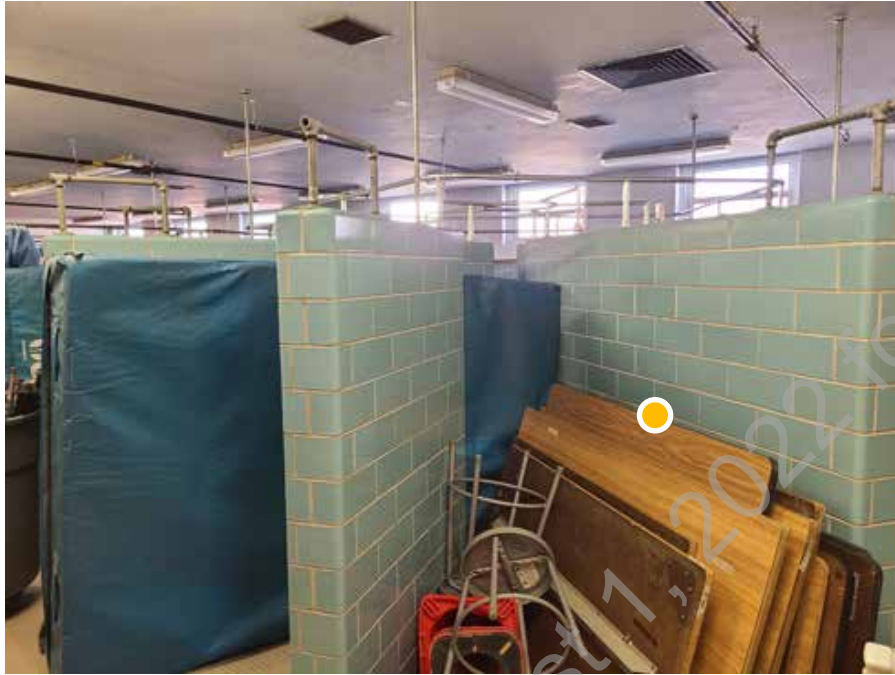
D1. 33: View of former girls locker and shower area located in original 1964 construction.

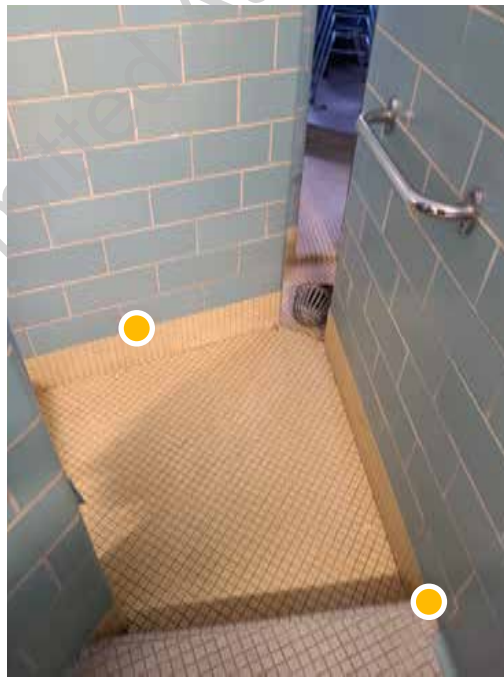
D1. 34: View of girls shower stall in original building, no longer utilized and does not meet current accessibility codes.
