TOWN OF SUFFIELD

CONDITIONS ASSESSMENT & MASTER PLAN

Draft as submitted August 1, 2022 for review

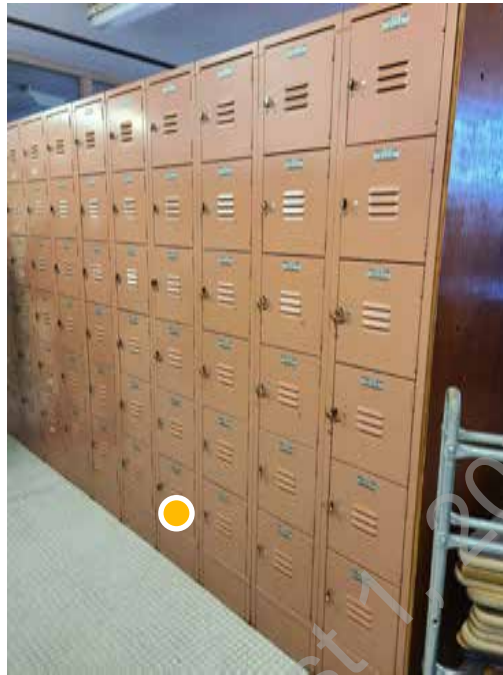
● D1. 35: View of lockers in girls locker room.

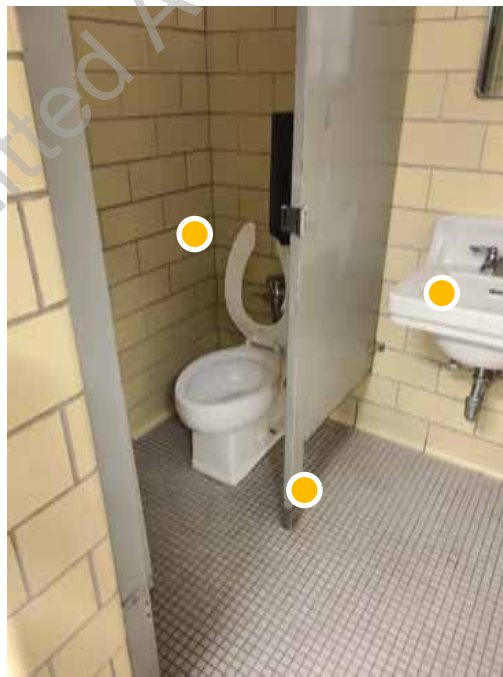
● D1. 36: Detail view of toilet configuration adjacent to girls locker room, does not meet current accessibility codes.

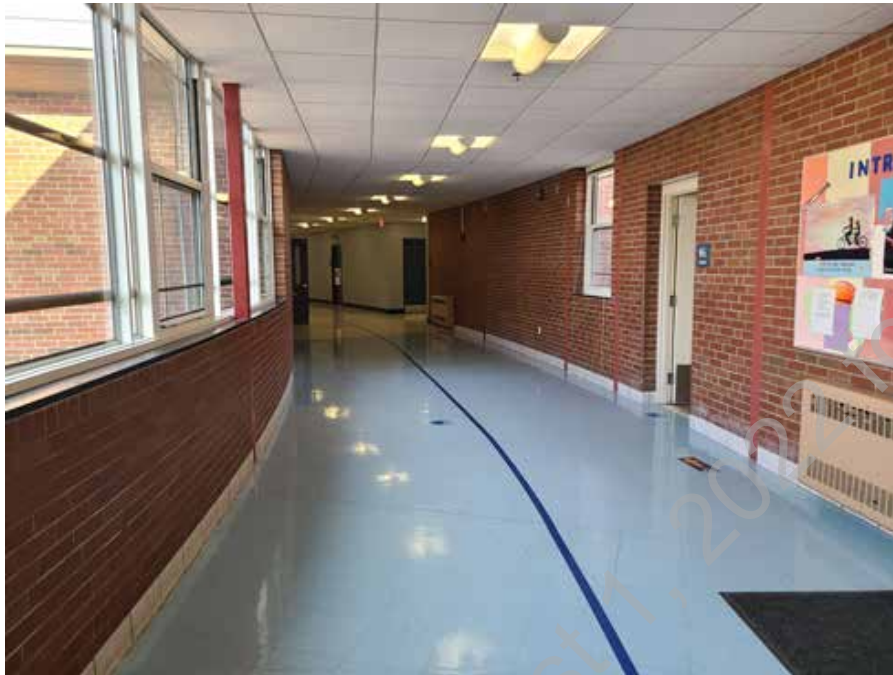
- D1. 37: View of connecting corridor adjacent to main gymnasium in the original building.

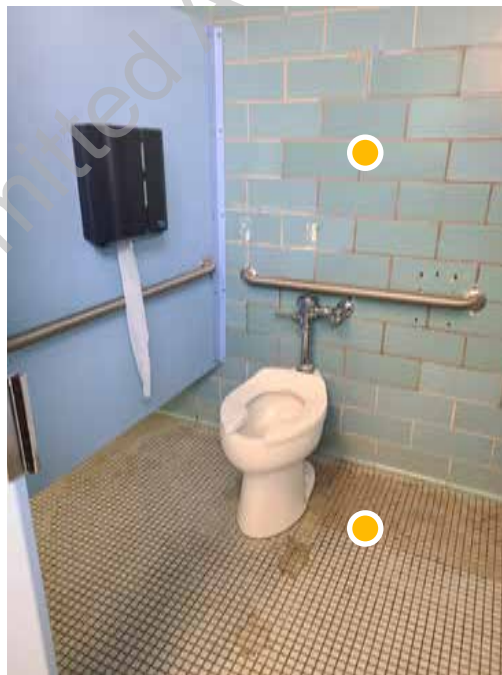
TOILET FACILITIES (GENERAL): Toilet rooms in the original construction are in poor condition and have received minimal updates. This is especially evident for the toilets by the gymnasium. Floor tile is damaged throughout. Where repairs or plumbing fixture replacement has occurred, the tile does not match adjacent material. Areas of glazed block walls are showing sign of deterioration and isolated settlement cracking. Exposed piping has severe damage to insulation due to its exposure in an unsupervised area. Temporary wood chase enclosures should be replaced with a permanent solution. Toilet room ceilings are generally in poor condition with many damaged, missing, or stained tiles. The women's toilet facility near the gymnasium is in similar condition to the men's but has received some modest upgrades to toilet partitions.

- D1. 38: Detail view of existing toilet reconfiguration in toilet rooms adjacent to gymnasium, note condition and repairs/patches on floors and walls.

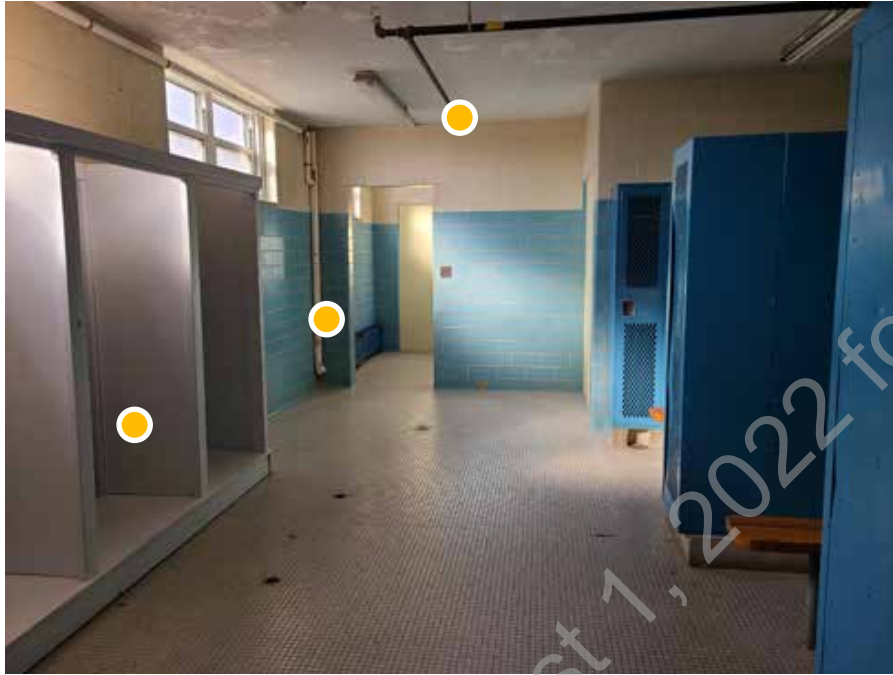
- D1. 41: Detail view of changing area retrofit in boys locker room, note poor condition of walls, ceilings, and exposed equipment and piping (original to the building).

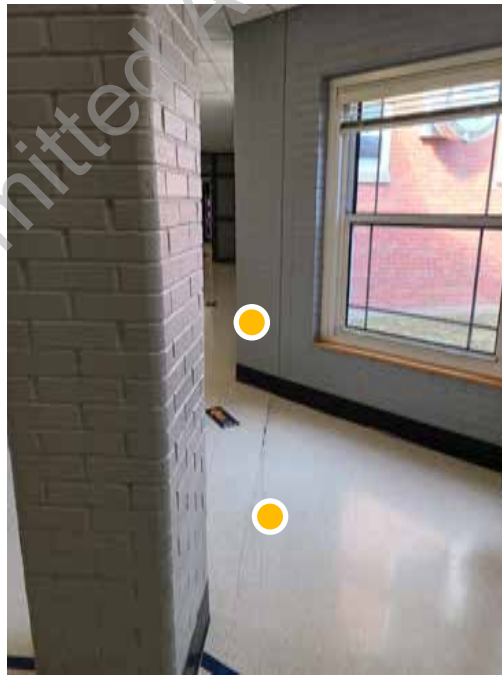
- D1. 42: 1972 corridor addition to original 1964 construction.

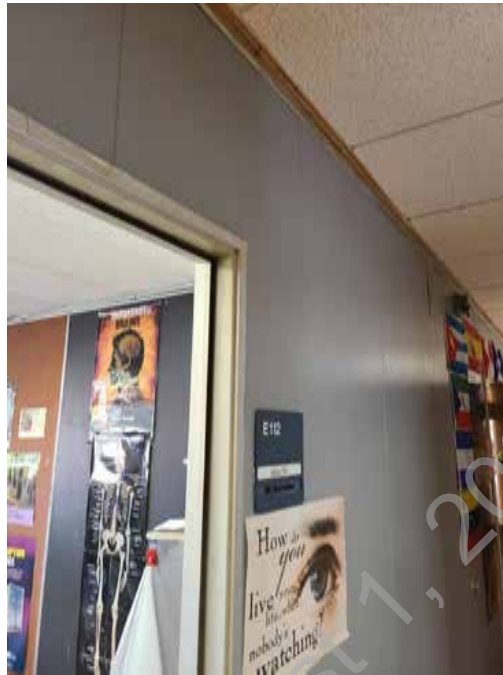
● D1. 43: Detail view of modular wall construction in the 1972 addition

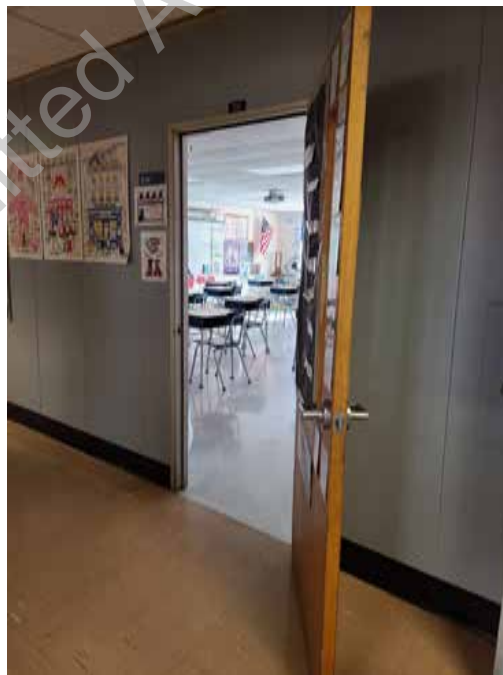
● D1. 44: View of typical door into classroom as a part of the modular wall construction (1972 addition).

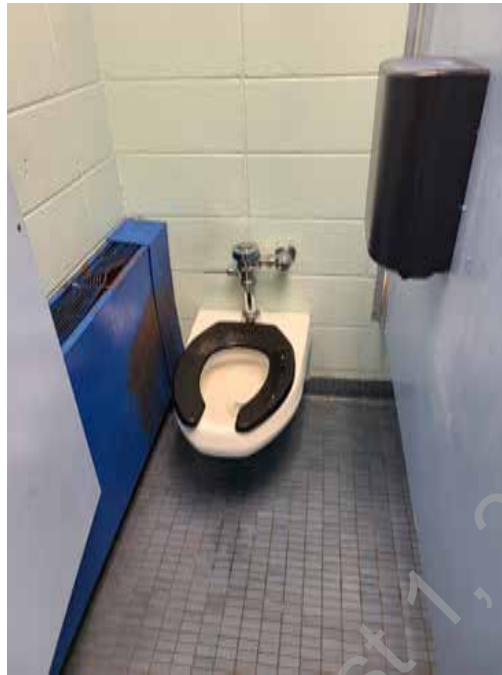
- D1. 45: Detail view of unit cabinet heater adjacent to plumbing fixture retrofit, does not meet current accessibility codes.

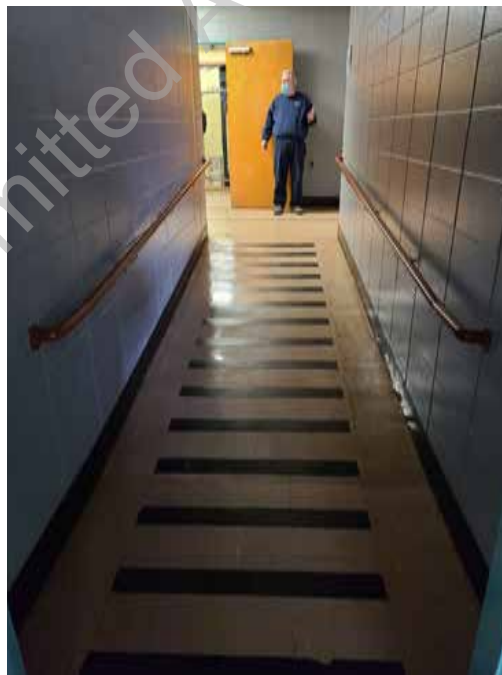
- D1. 46: Detail view of ramp into former teachers lounge area, does not meet current accessibility codes.

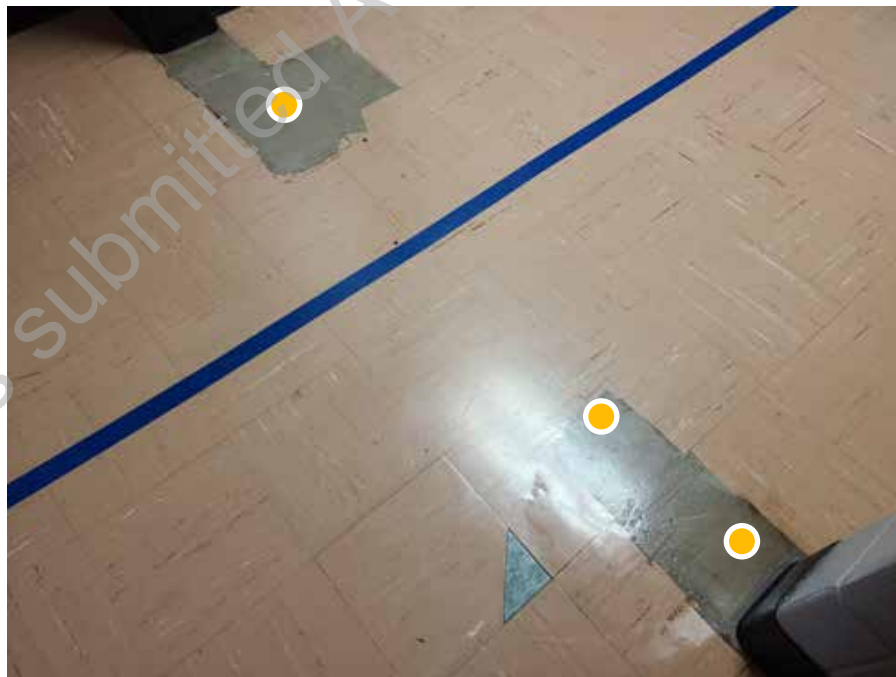
● D1. 48: Detail view of flooring patch/retrofit, possible vinyl asbestos tile original to building.

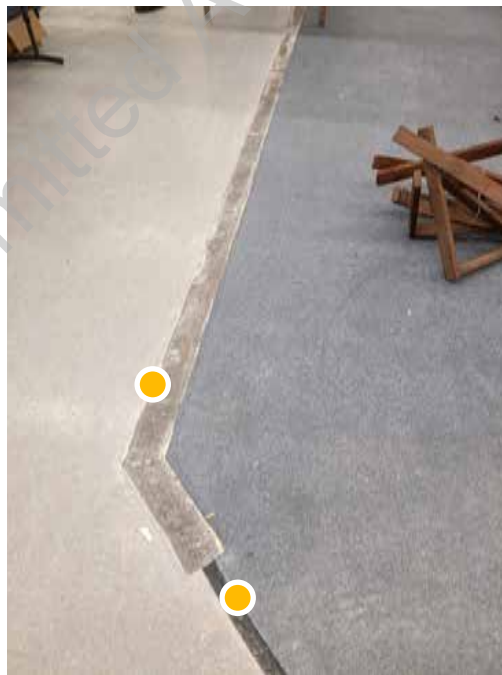
- D1. 50: Flooring transition retrofit and/or removal of transition altogether.

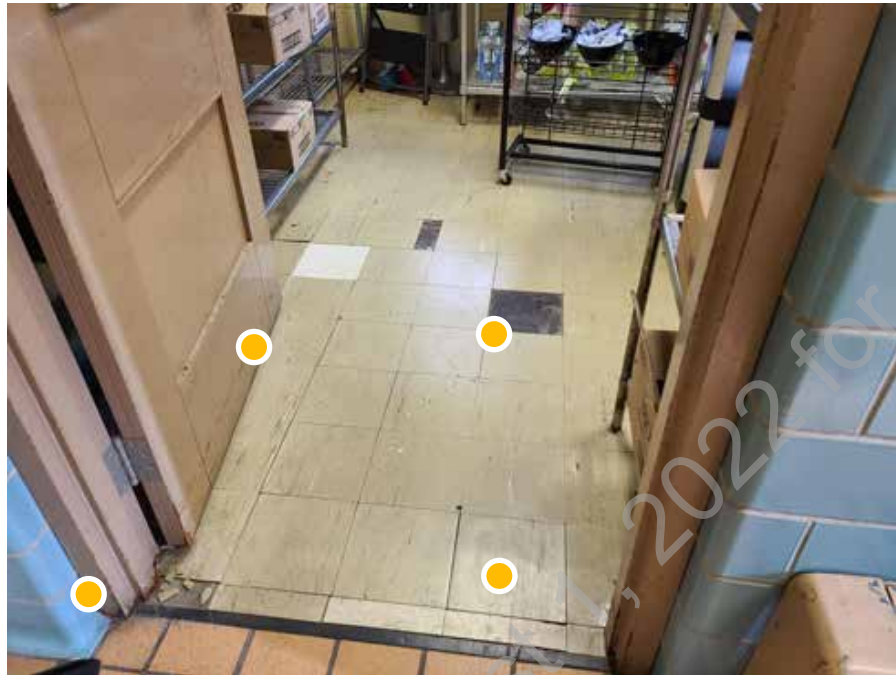
● D1. 51: Detail view of dry storage support space for the cafeteria, note the poor condition of the door, door frame and flooring.

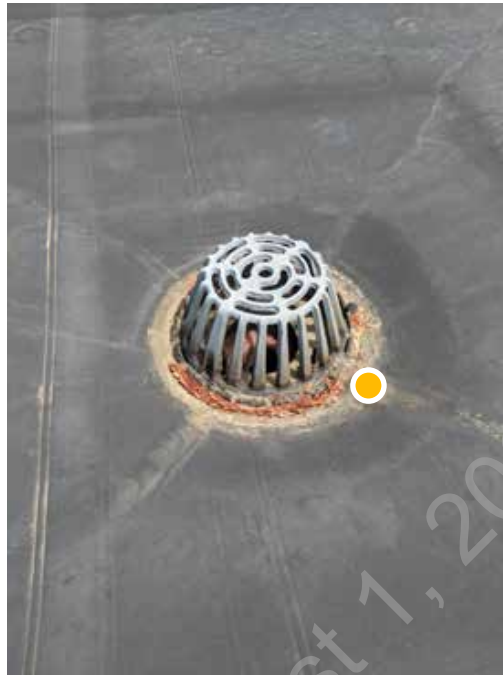
● D1. 3: Detail view of typical roof drain

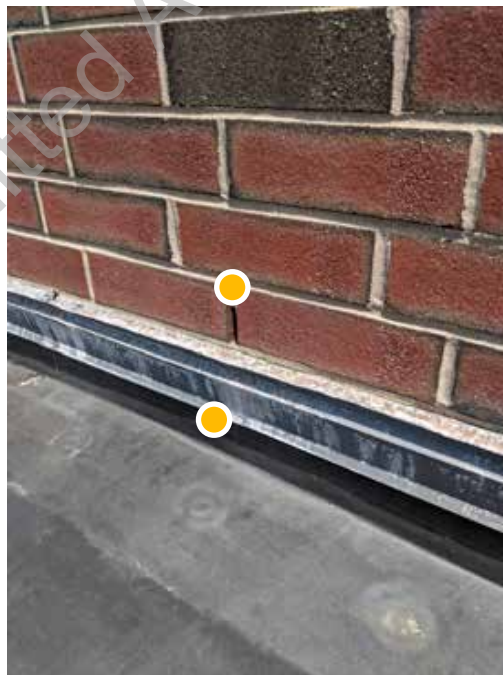
● D1. 4: Detail view of masonry wall weep holes and roof to wall counter flashing, in good condition overall

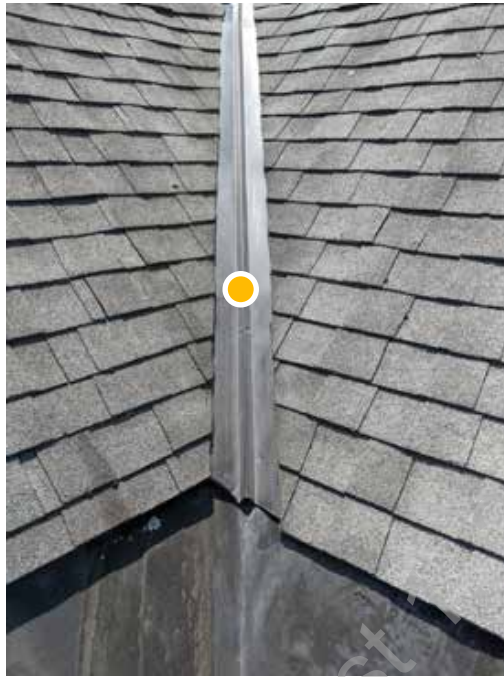
● D1. 5: Typical valley flashing at asphalt shingle roof in fair to good condition overall

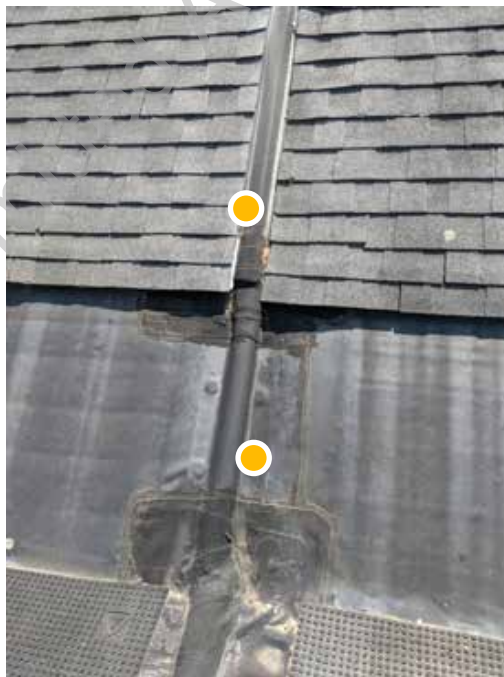
● D1. 6: Typical roof expansion joint at membrane roofing and asphalt shed roof

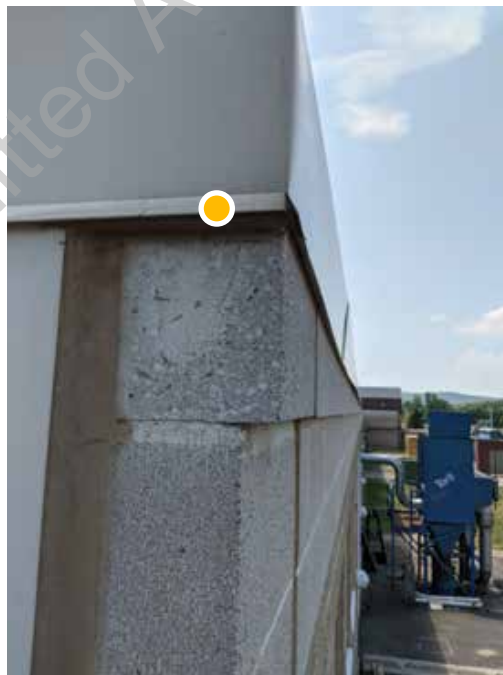
● D1. 8: Detail view of metal roof fascia at block wall, note the gap between face of wall and flashing, allows for pests and weather to penetrate the exterior envelope

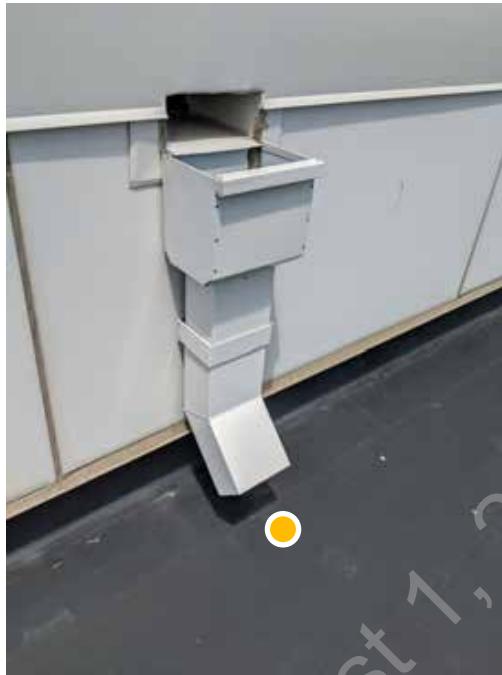
- D1. 9: Detail at roof scupper detail, note no splash block to prevent deterioration at membrane roof

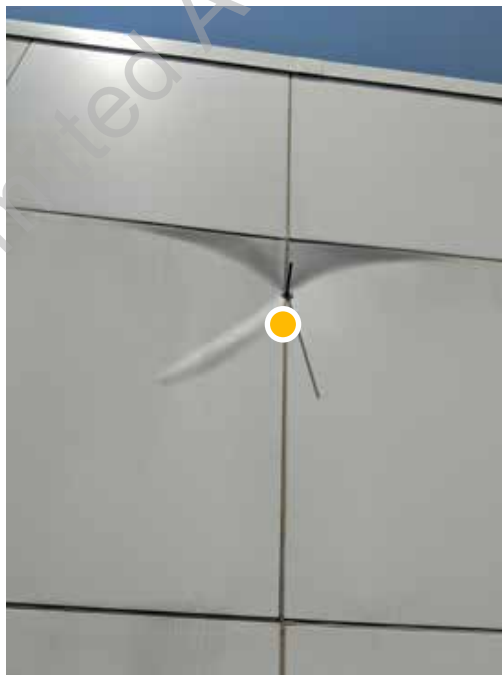
- D1. 10: Detail view of metal paneling, note caulk joint deterioration throughout paneling

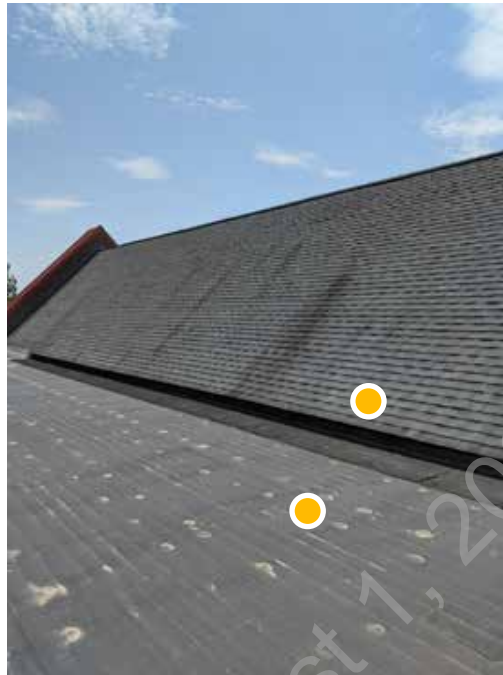
- D1. 11: Overall membrane roof in foreground with asphalt shed roof beyond, note substrate telegraphing through membrane, indication of nearing its end of useful life

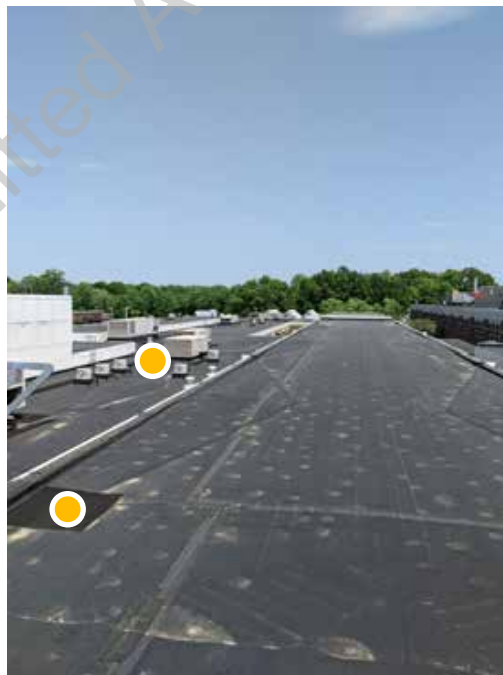
- D1. 12: Overall view of membrane roof with misc. roof top equipment

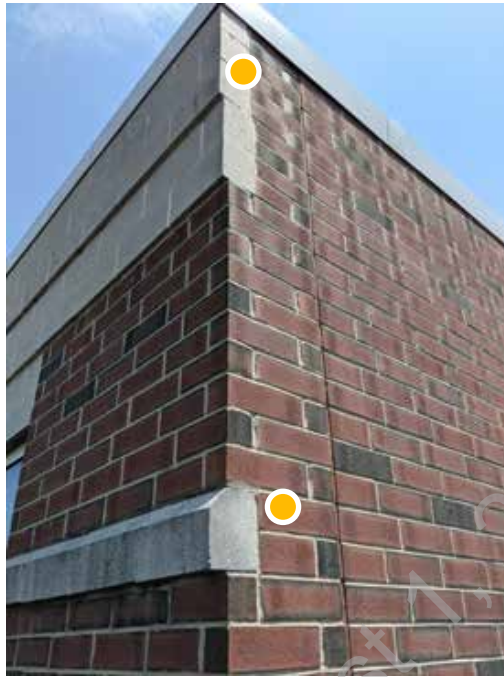
- D1. 13: Detail view of exterior masonry wall construction with concrete block articulation, note control joint

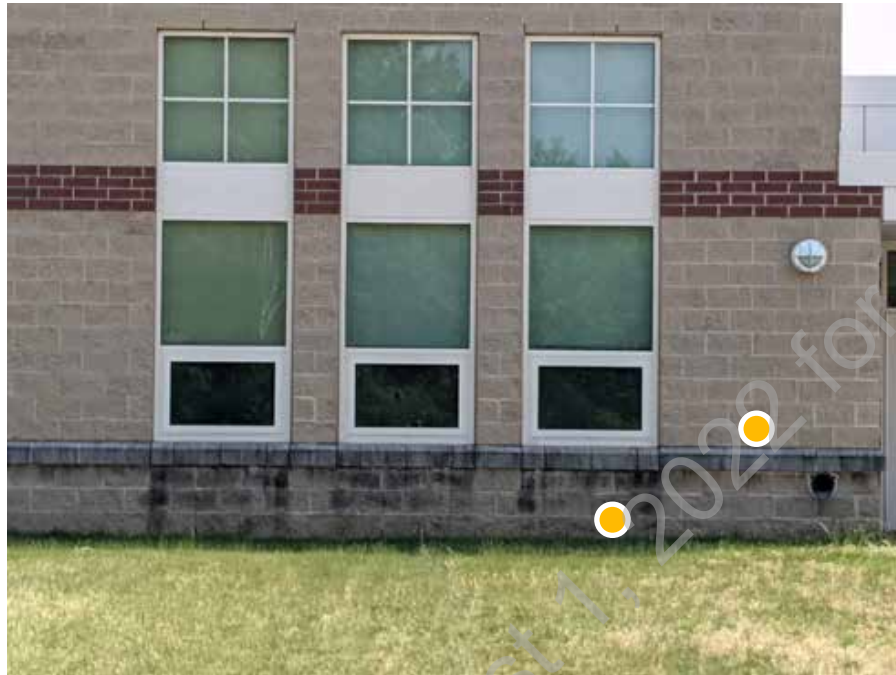
● D1. 15: North façade of existing school depicting signs of moisture infiltration and concrete block deterioration

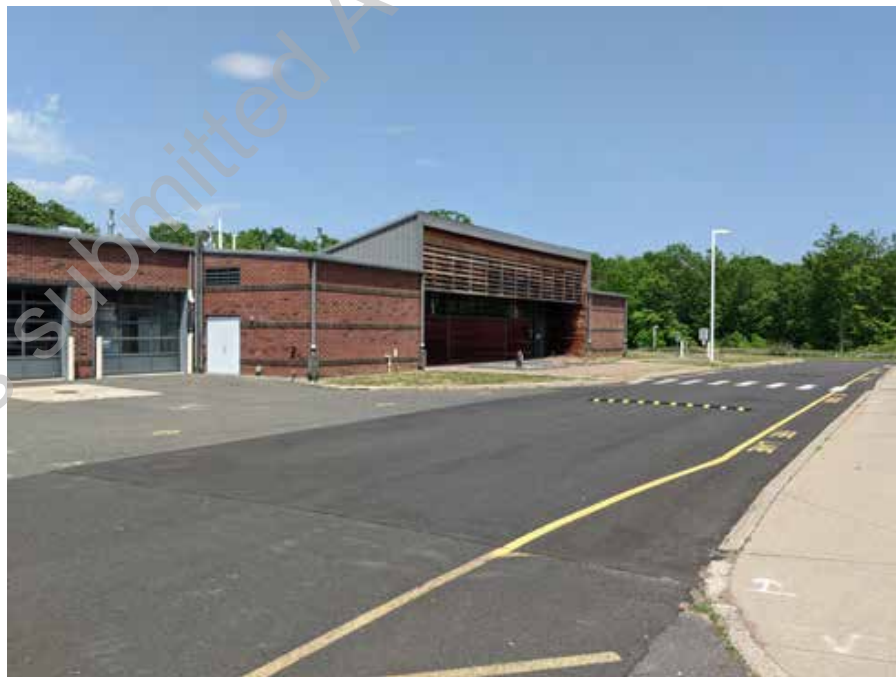
● D1. 16: View to agriscience building

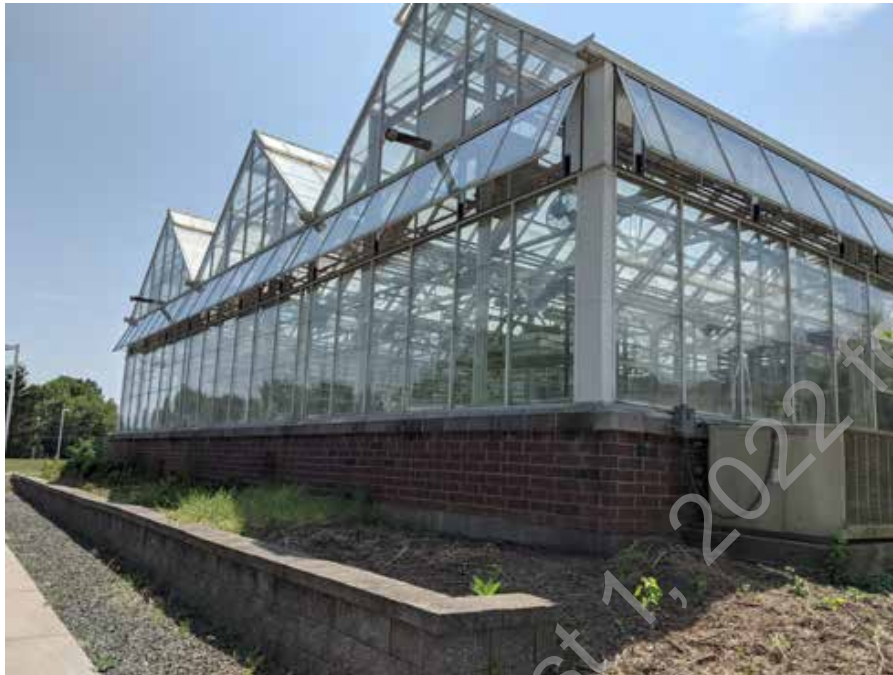
● D1. 17: View of greenhouse in fair to poor condition overall

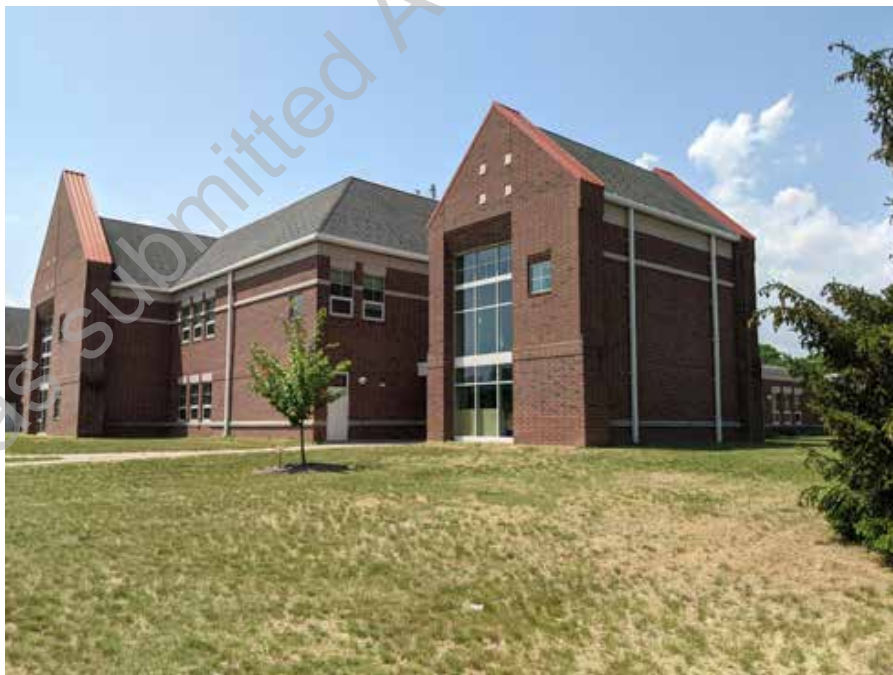
● D1. 18: View of egress stairwell (right) and two story typical classroom wing (left).

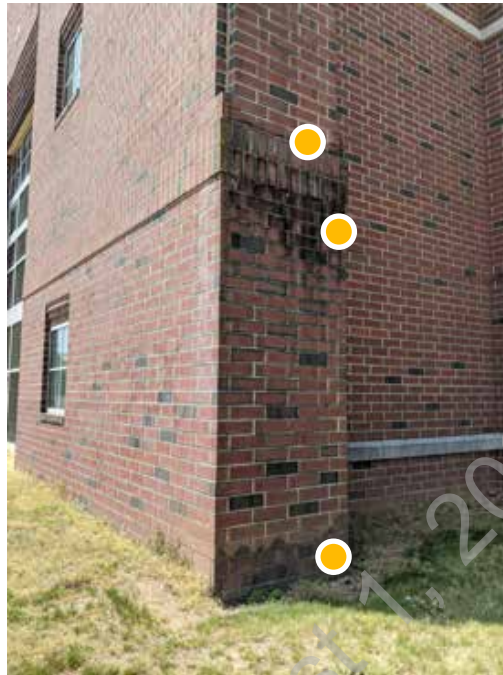
- D1. 19: Detail view of two story masonry façade depicting masonry deterioration, spalling, and signs of moisture infiltration

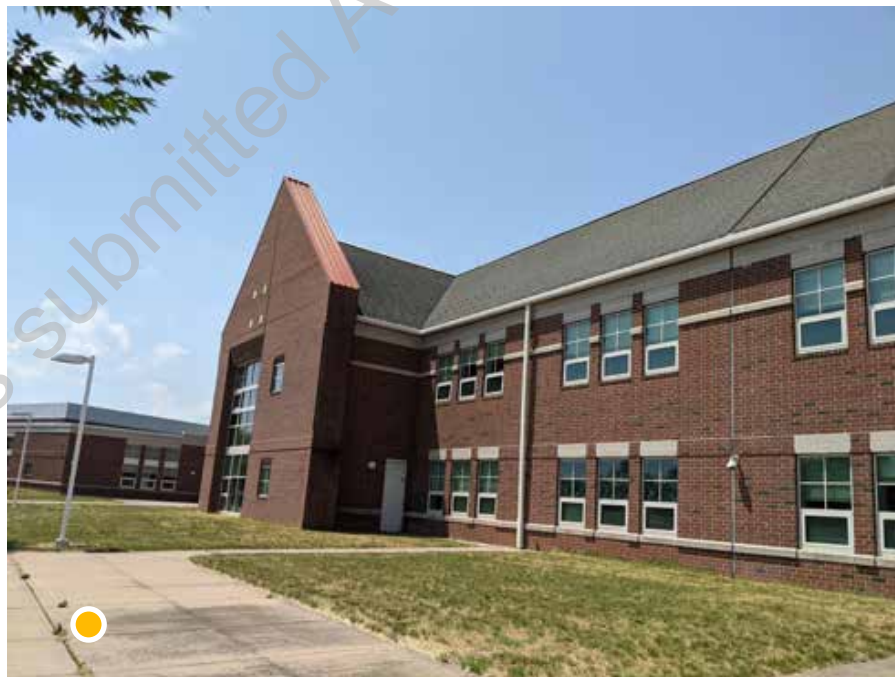
WALKWAYS/SITE STAIRS: Concrete sidewalks around the site are generally in fair condition. Some signs of deterioration, such as cracking and spalling, are beginning to appear in several locations and should be repaired to extend the life of the sidewalks. This is most notable at the main entry, which experiences the heaviest foot traffic. Organic growth was noted at control joints throughout entire concrete sidewalk system.

- D1. 20: Overall view of two story classroom wing, with existing concrete sidewalk in foreground, in fair condition overall

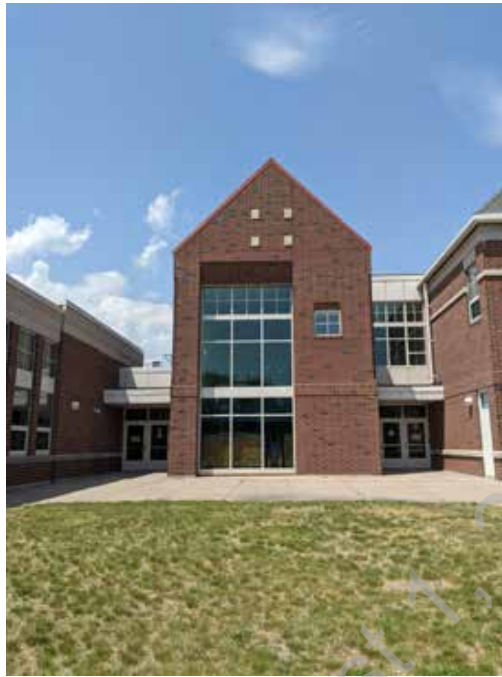
● D1. 21: View of egress stairwell (center) and flanking egress doors (left/right)

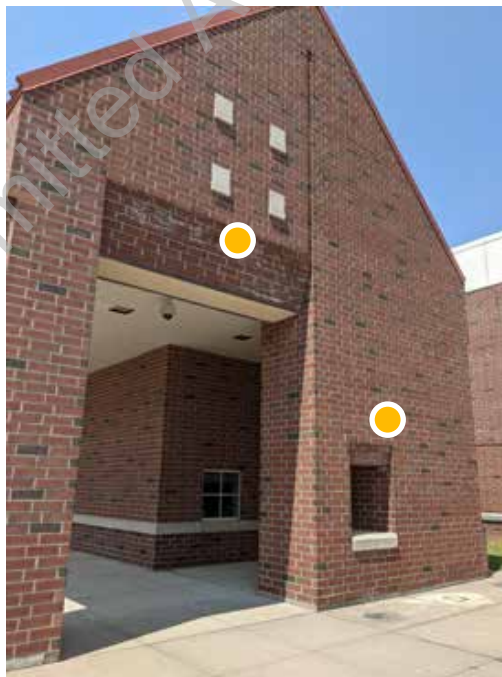
● D1. 22: Signs of efflorescence at entry canopy possible due to moisture infiltration into the masonry cavity.

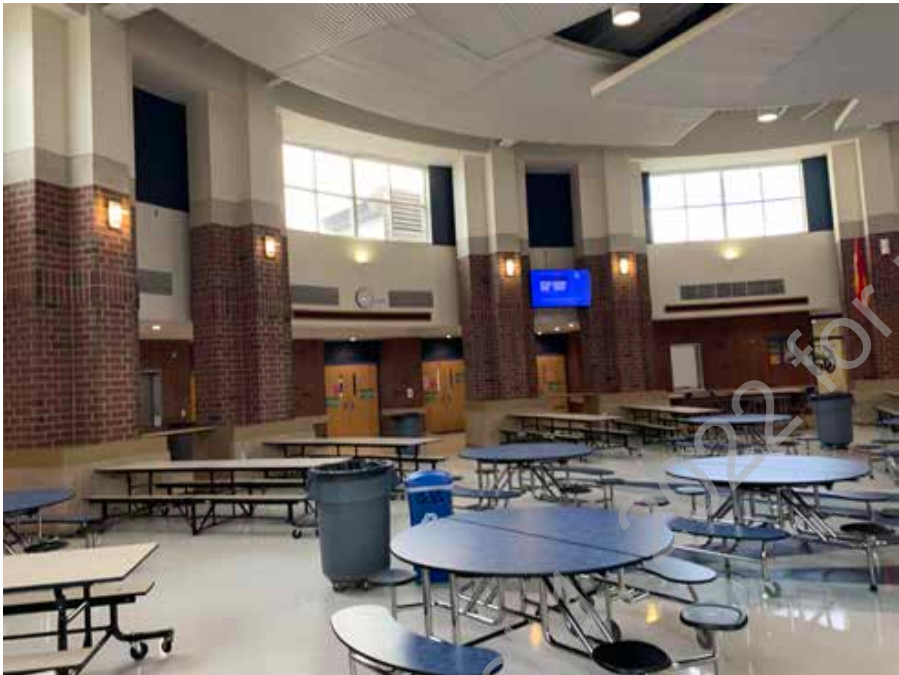
D1. 23: View of existing cafeteria

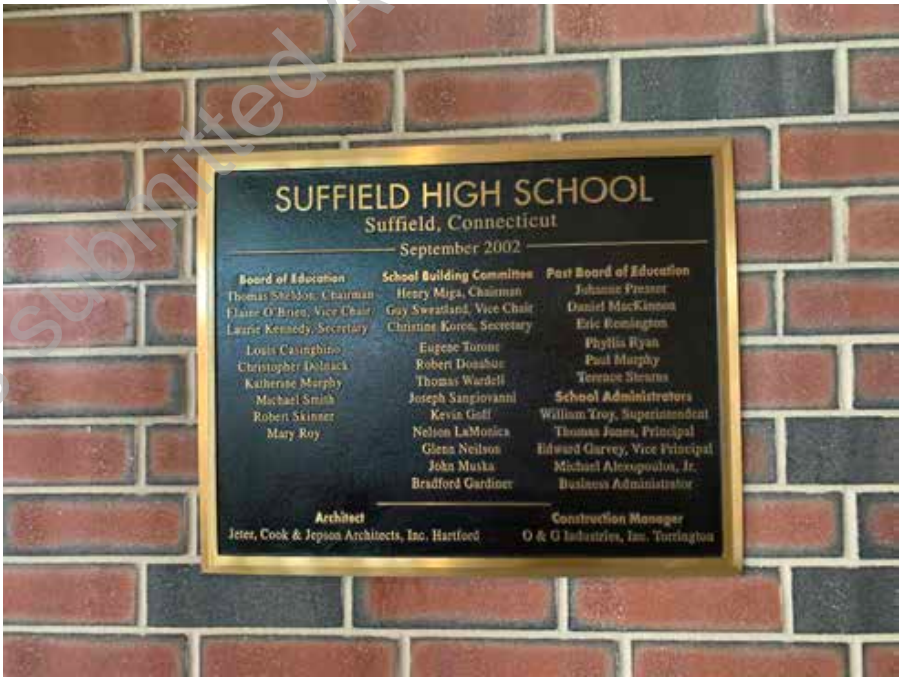
D1. 24: View of building plaque

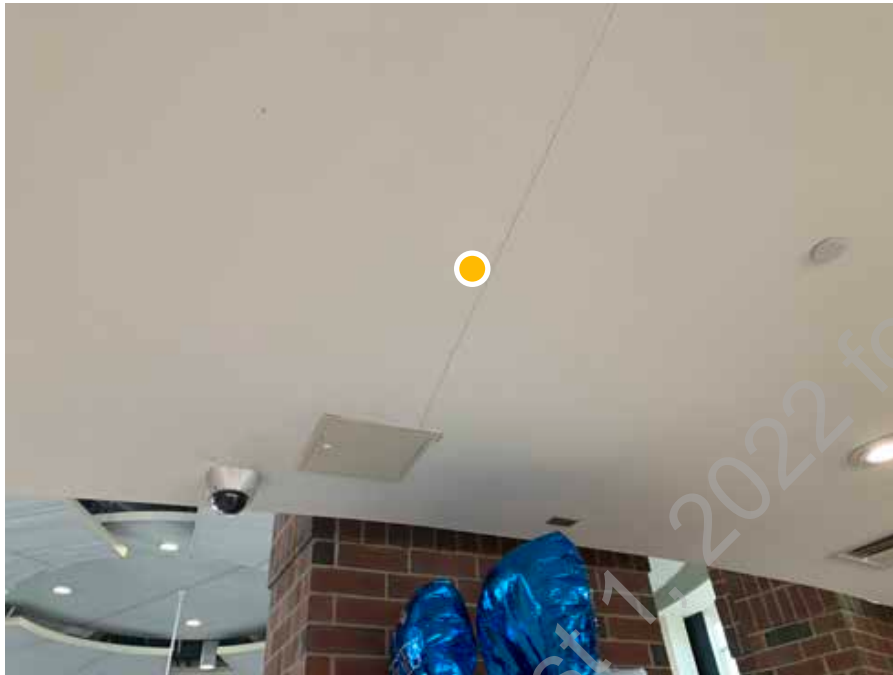
D1. 25: View of gypsum board ceiling around perimeter of cafeteria, note shrinkage cracking throughout ceiling.

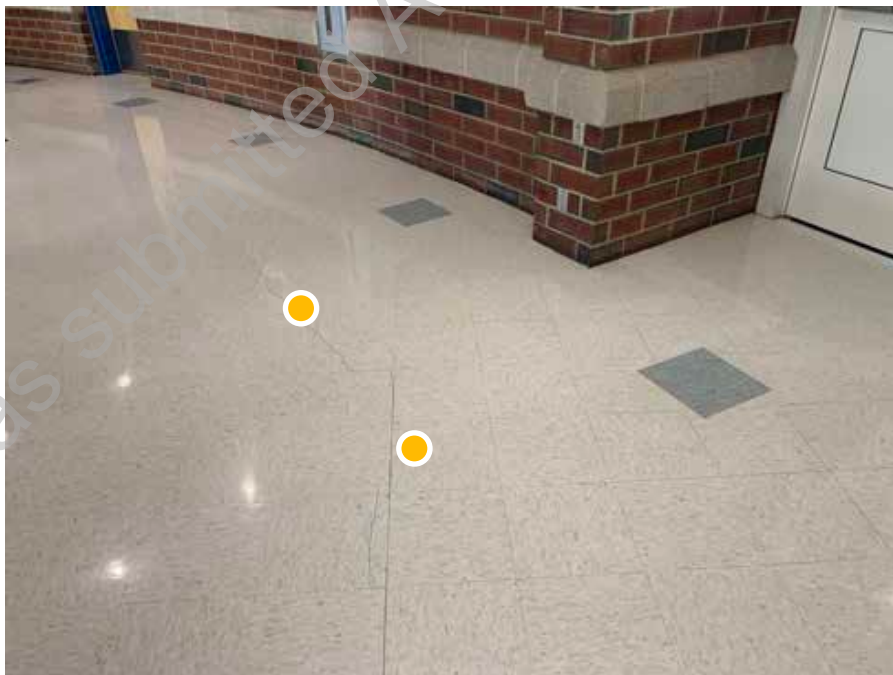
D1. 26: View of VCT flooring at main entry/cafeateria, note the stress cracks along the walkway

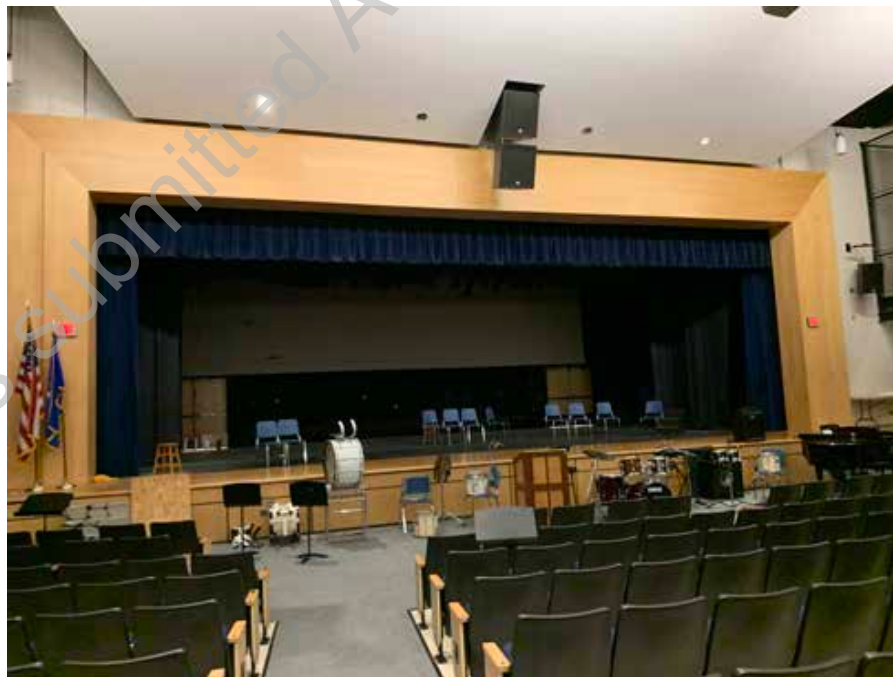
● D1. 28: View of Auditorium

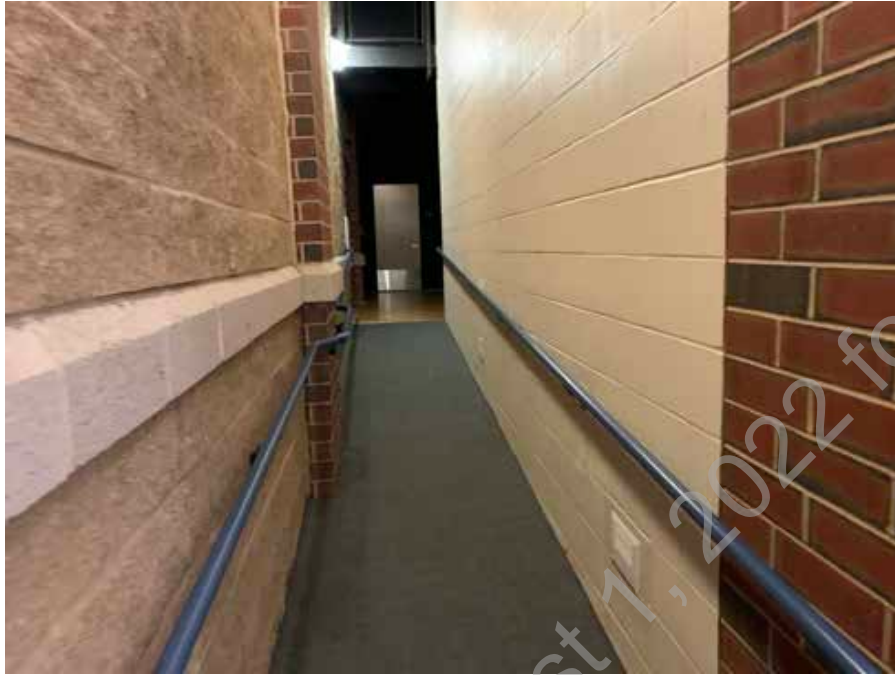
● D1. 29: View of accessible ramp to stage from Auditorium seating.

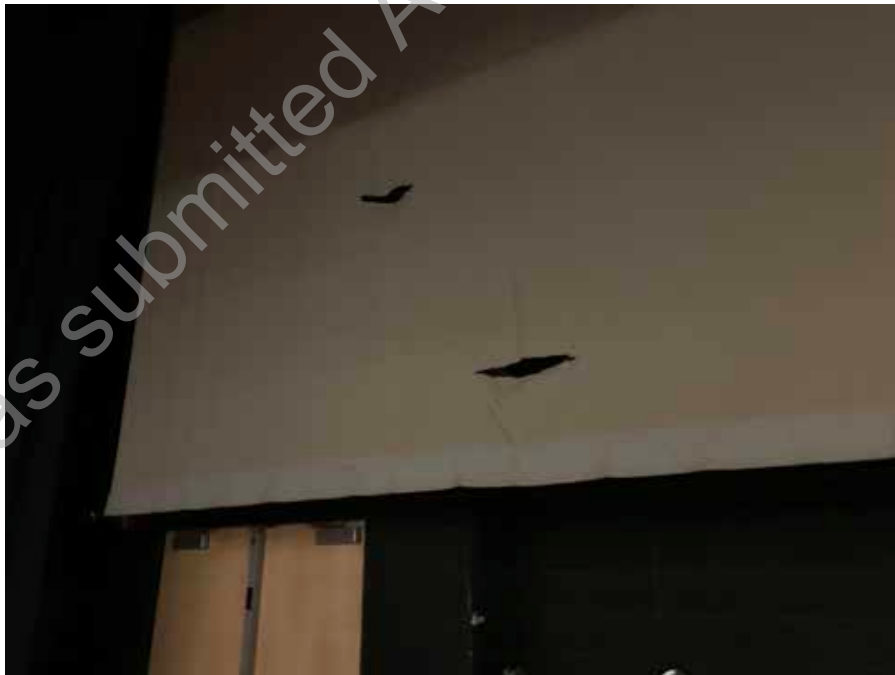
● D1. 30: Detail view of ceiling mounted projection screen at stage, note multiple tears in screen.

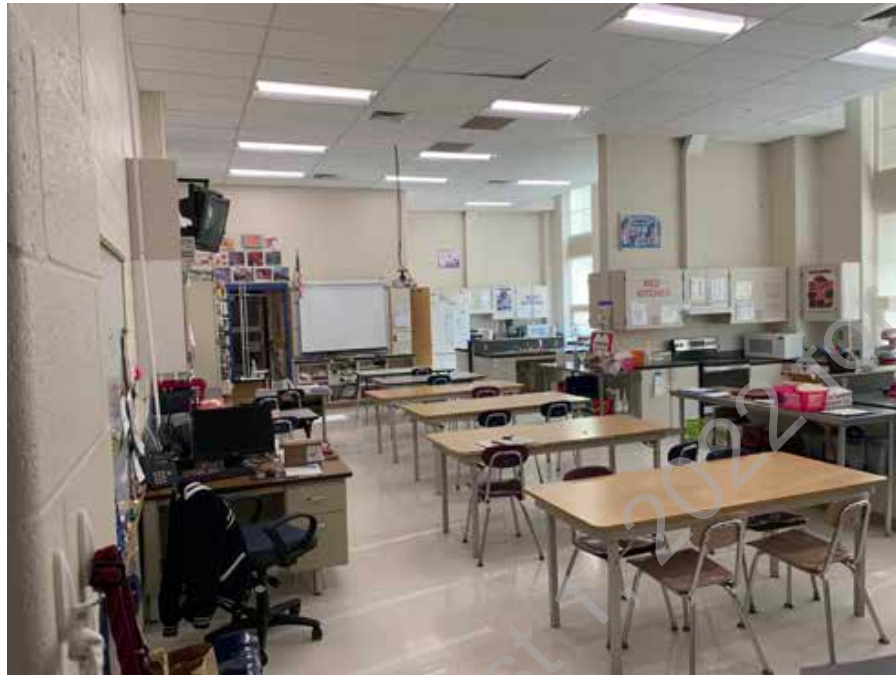
● D1. 31: View of home economics/life skills classroom, note limited to no accessible teaching stations.

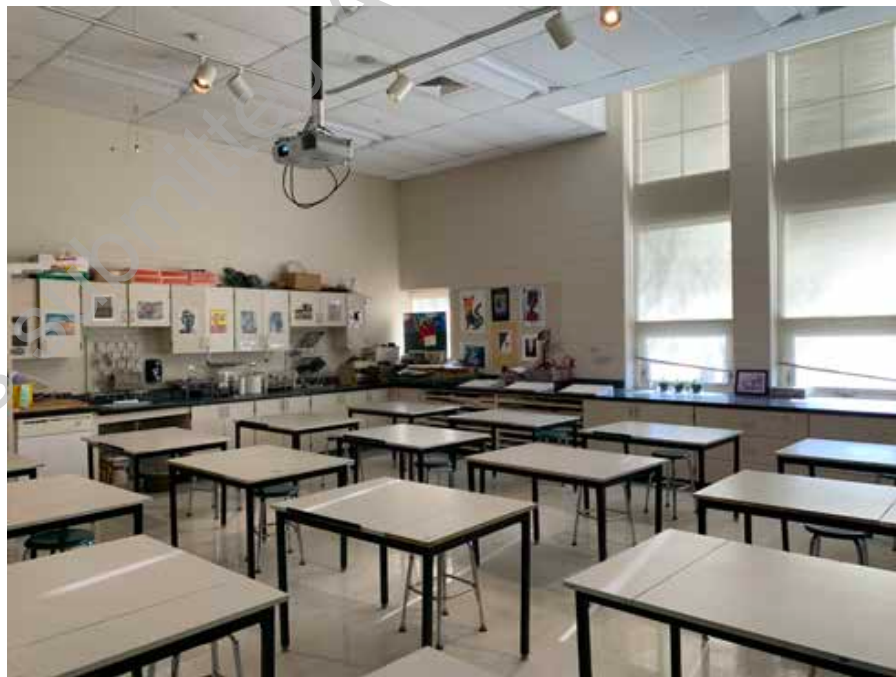
● D1. 32: View of art room

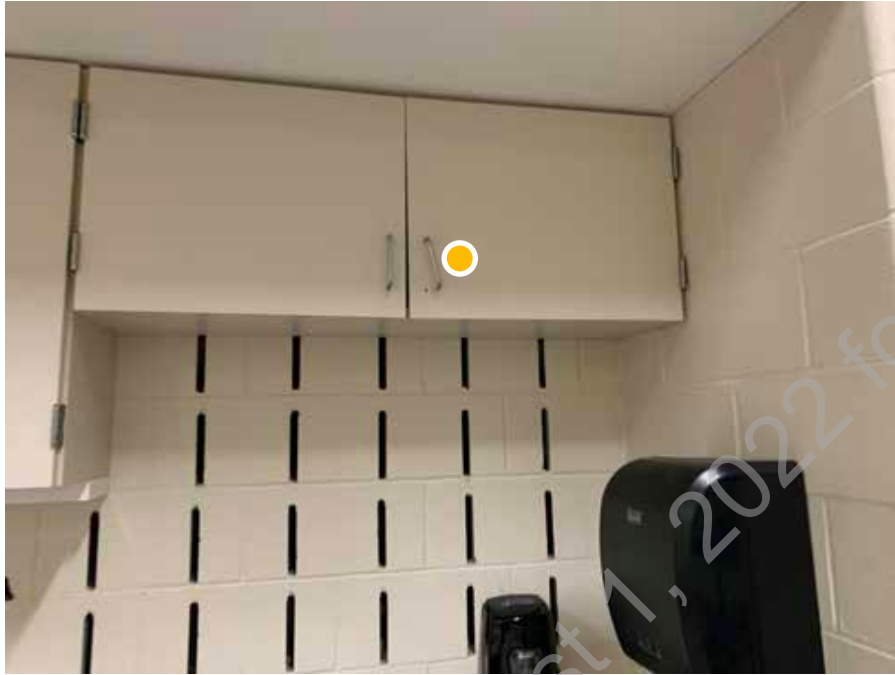
D1. 33: Detail view of storage room with damaged cabinetry

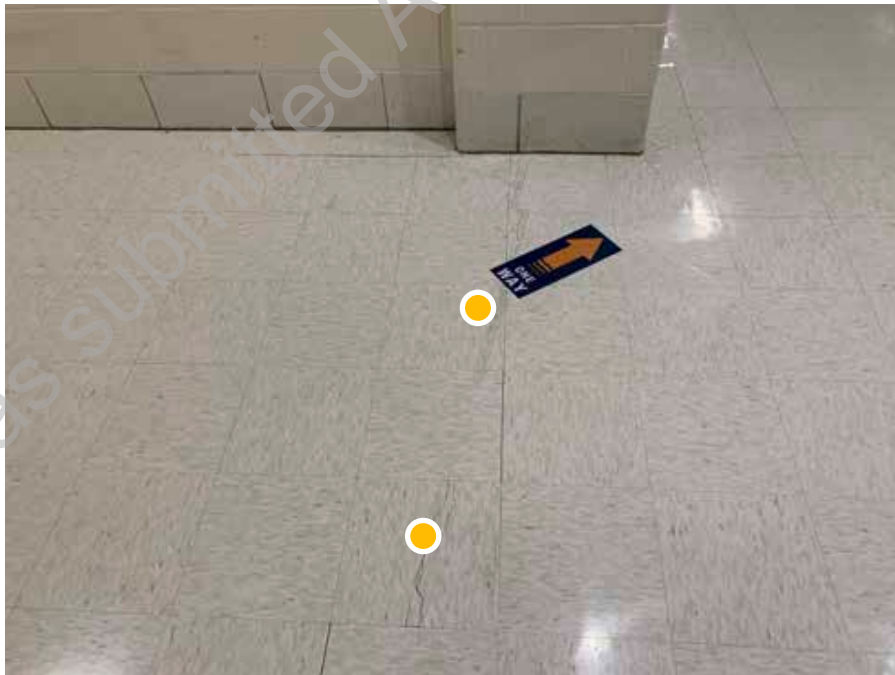
D1. 34: Detail view of the VCT flooring with stress cracks and indications of settlement in multiple locations.

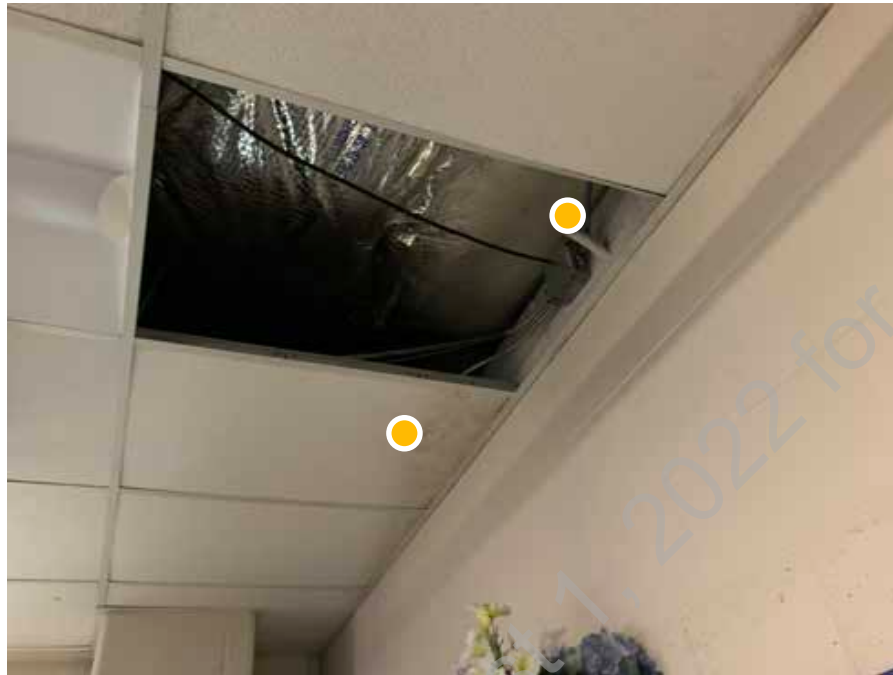
● D1. 35: Above ceiling moisture concerns were identified in a few storage areas and classrooms, note indication of containments on ceiling tiles

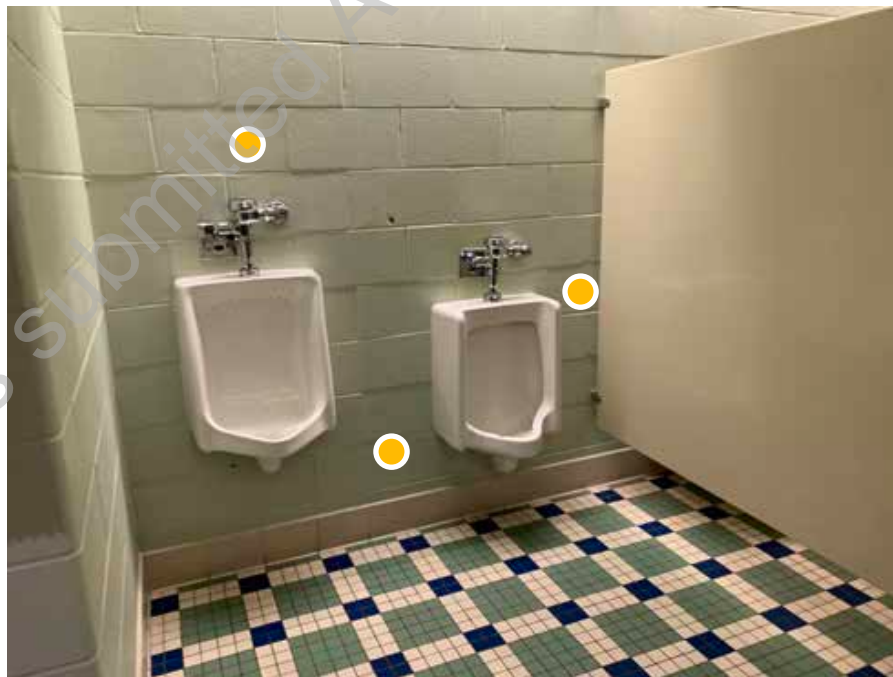
● D1. 36: View of typical boys/mens toilet room, note overall poor quality of construction and condition of CMU wet wall

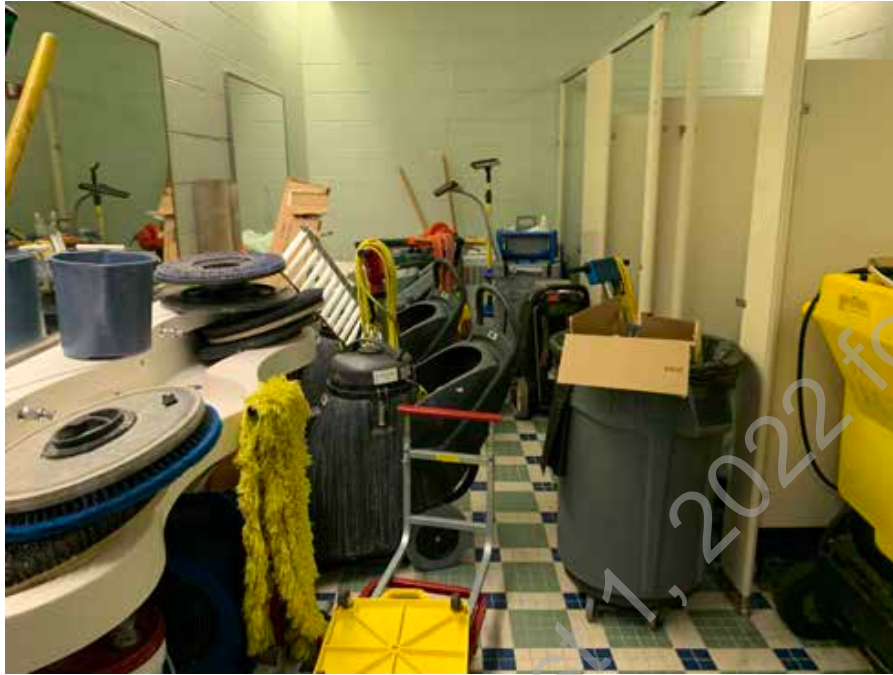
- D1. 37: Secondary bathroom adjacent to auditorium currently utilized as storage room.
