TOWN OF SUFFIELD

CONDITIONS ASSESSMENT & MASTER PLAN

Draft as submitted August 1, 2022 for review

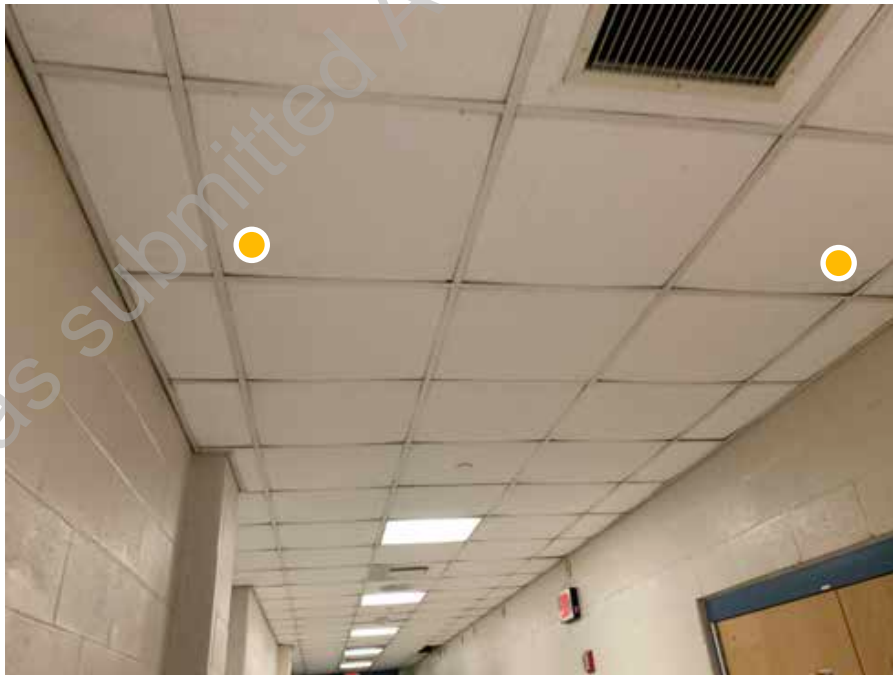
- D1. 38: Typical corridor ceiling indicate possible presence of humidity and/or moisture control concerns within overall building, due to the cupped edges of the ceiling tiles

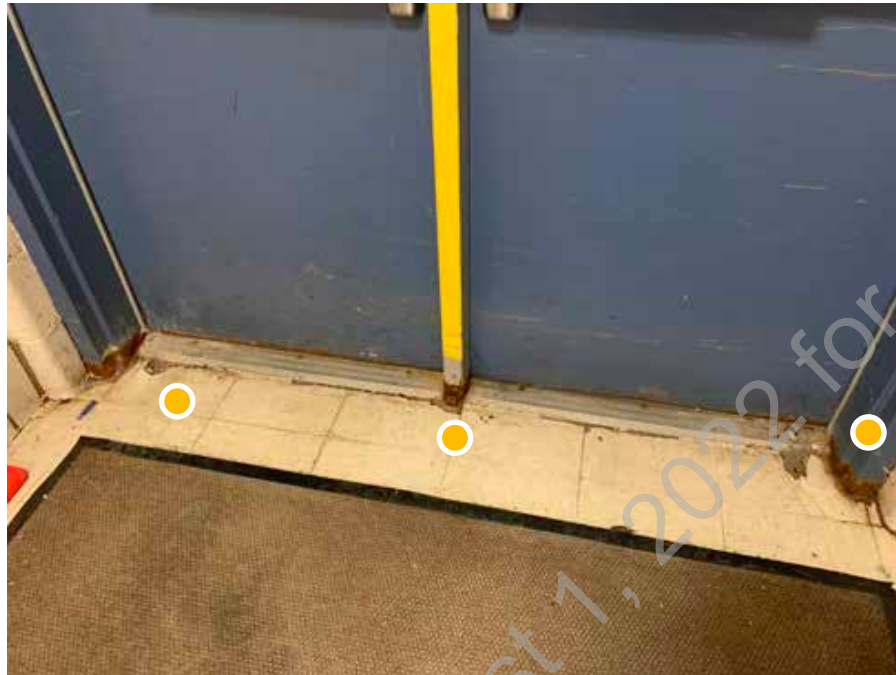
D1. 39: Detail view of exterior door, frame, and sill - all in fairly poor condition overall, signs of deterioration possibly due to moisture

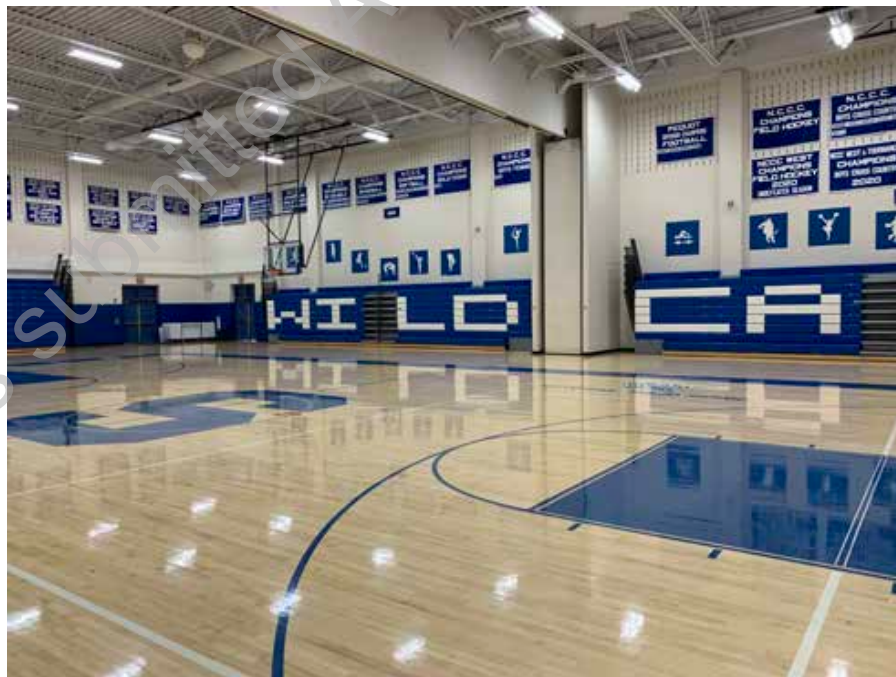
D1. 40: Overall view of existing gymnasium.

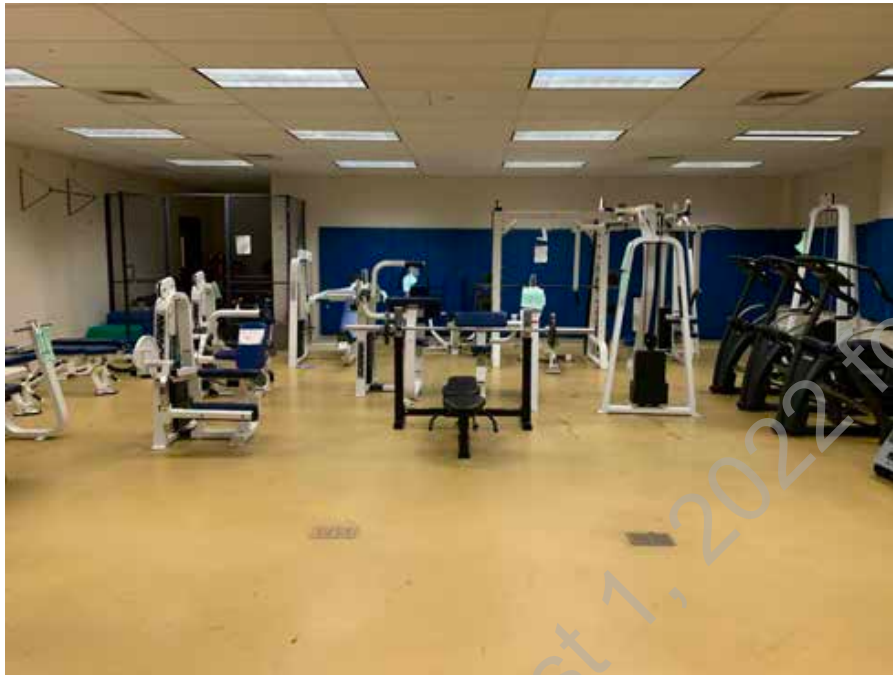
D1. 41: Overall view of weight/fitness room

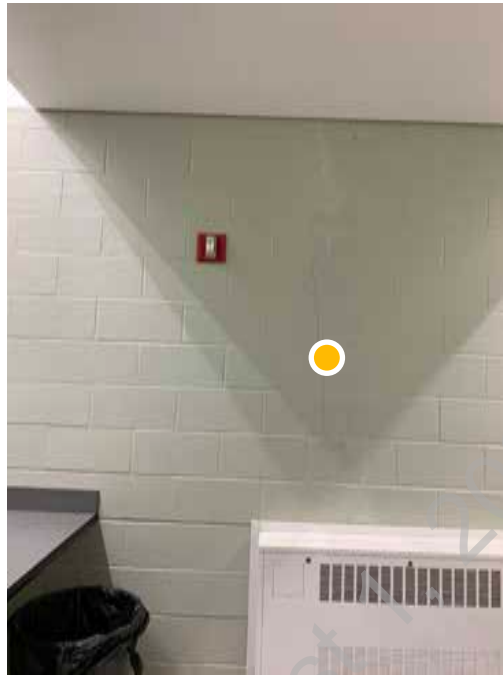
● D1. 43: Detail view of hairline stress fracture in CMU block wall construction, likely due to settlement.

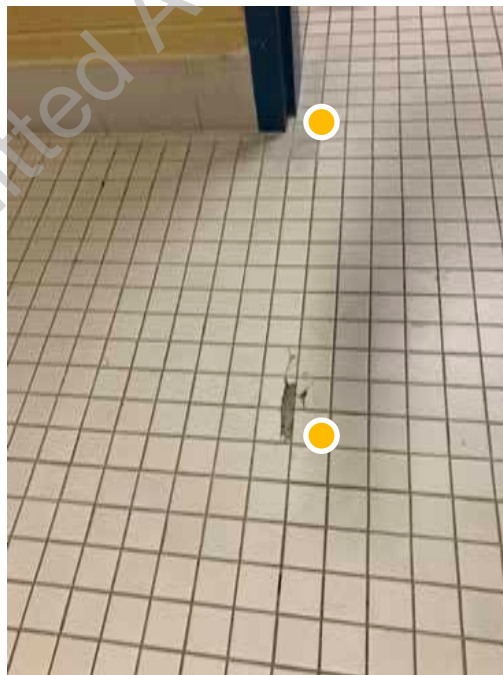
● D1. 44: Detail view of tile repairs and/or damage at toilet room

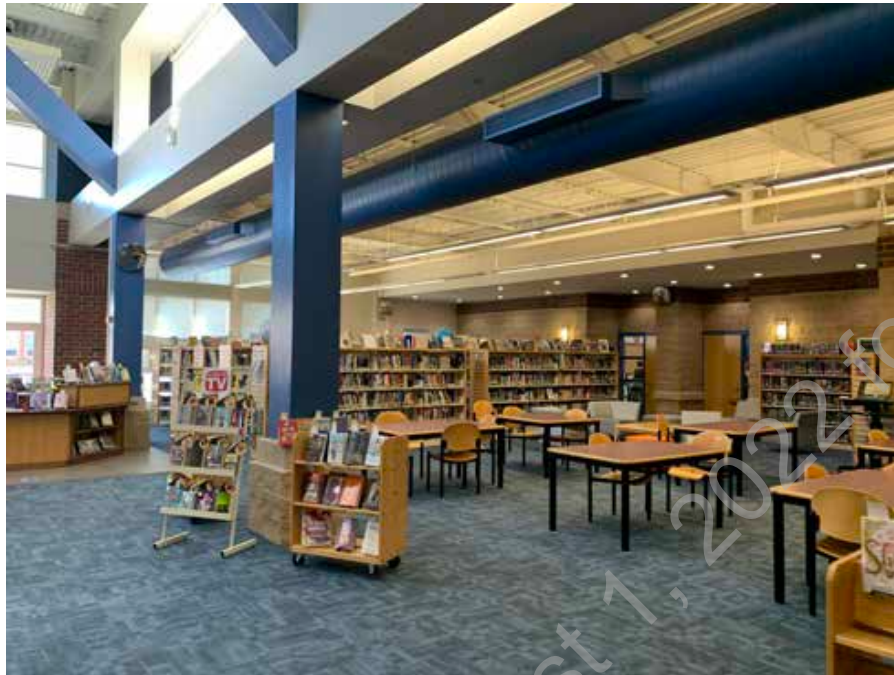
D1.45: View of media center

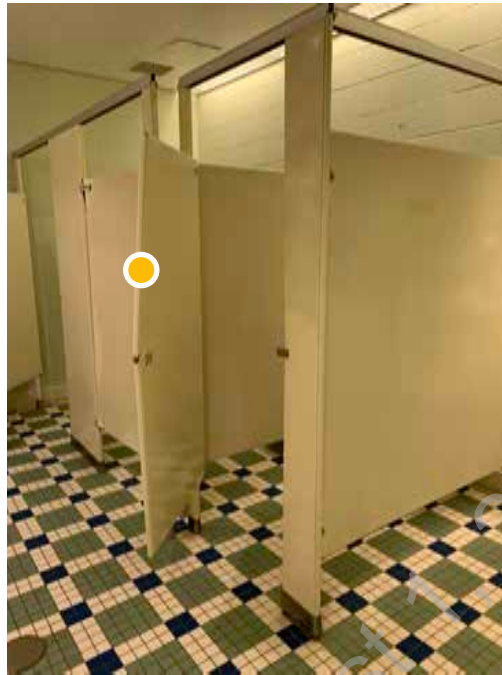
● D1. 49: Detail view of typical toilet room, note damaged metal toilet partition.

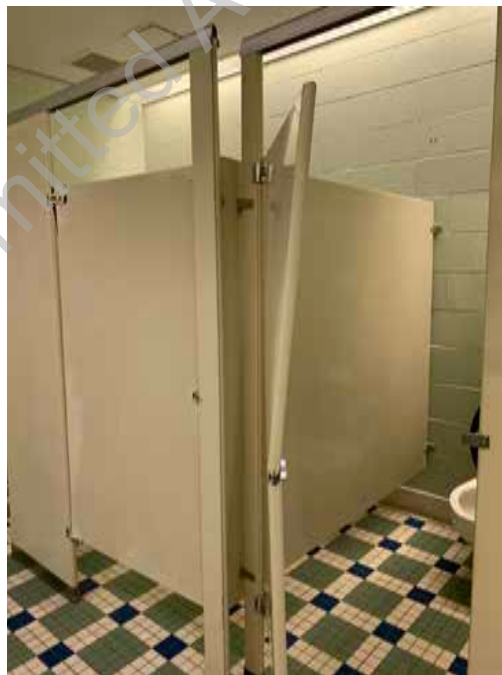
● D1. 50: Detail view of typical toilet room, note damaged metal toilet partition.

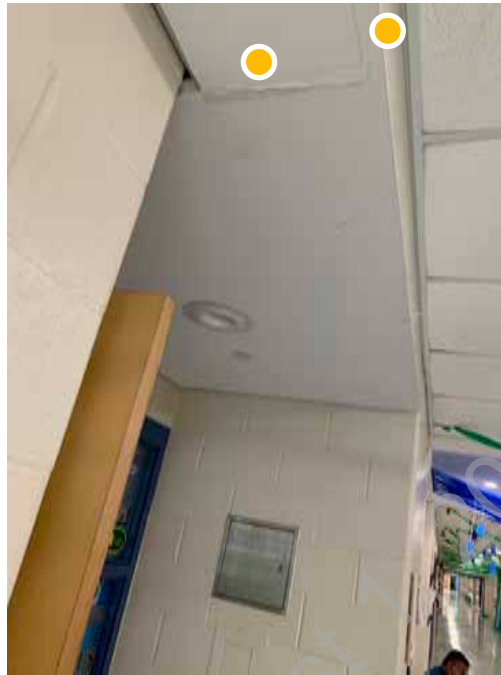
- D1. 51: Detail view of typical classroom corridor and entry alcove, note condition of gypsum soffit, damage due to expansion/contraction and possible moisture.

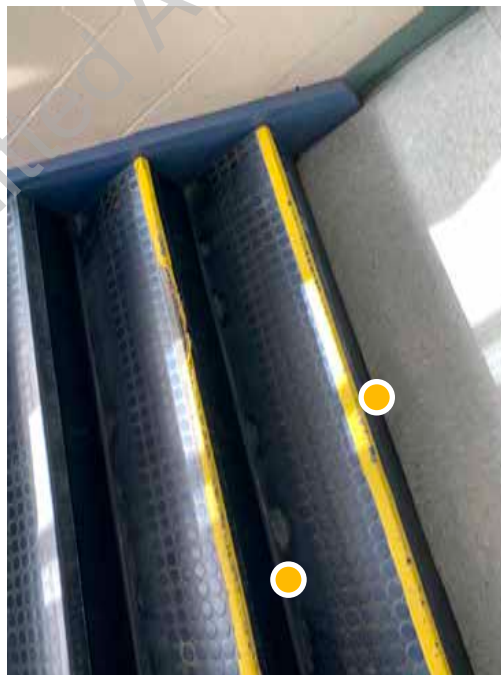
- D1. 52: Detail view of the rubber treads and risers at egress stairwell, note poor age/condition due to continual use.

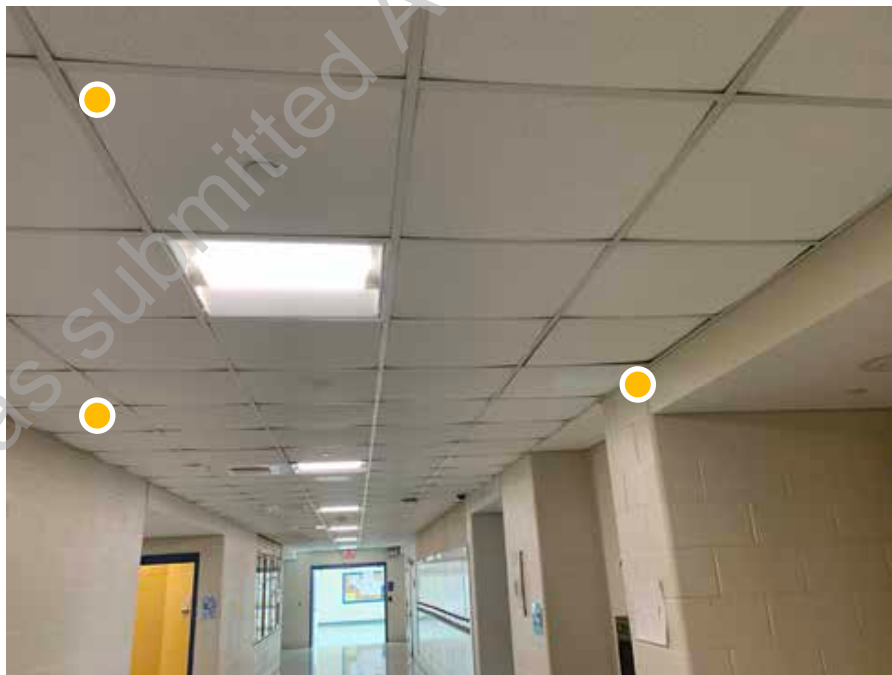
- D1. 54: Typical corridor ceiling indicate possible presence of humidity and/or moisture control concerns within overall building, due to the cupped edges of the ceiling tiles

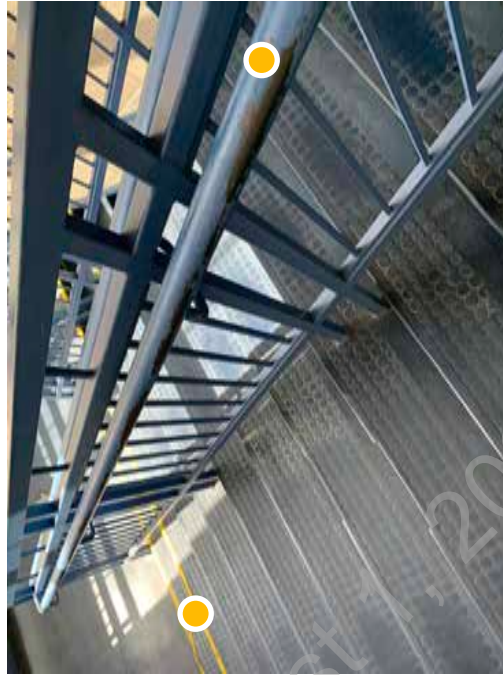
● D1. 55: Detail view of the rubber treads/risers and painted steel handrail/guard at egress stairwell, note poor age/condition due to continual use.

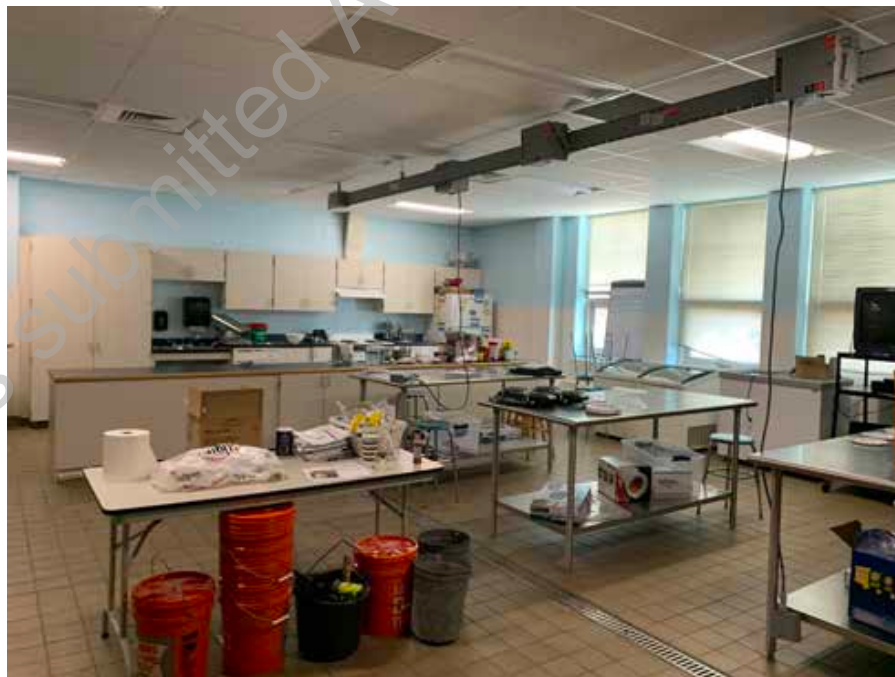
● D1. 56: View of Food Tech lab room

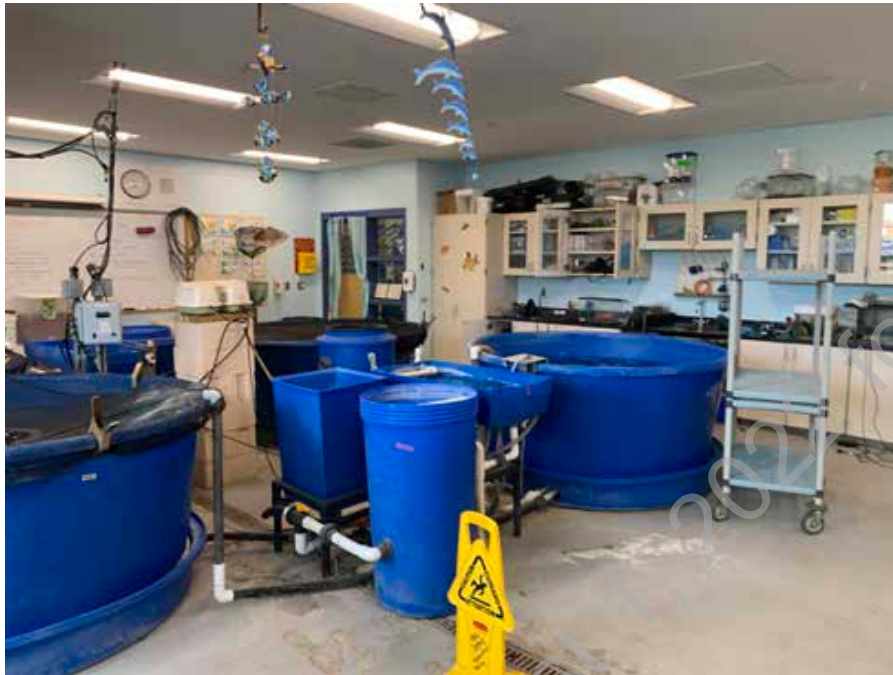
D1. 57: View of Aqua Culture lab room, note overall poor condition of floor

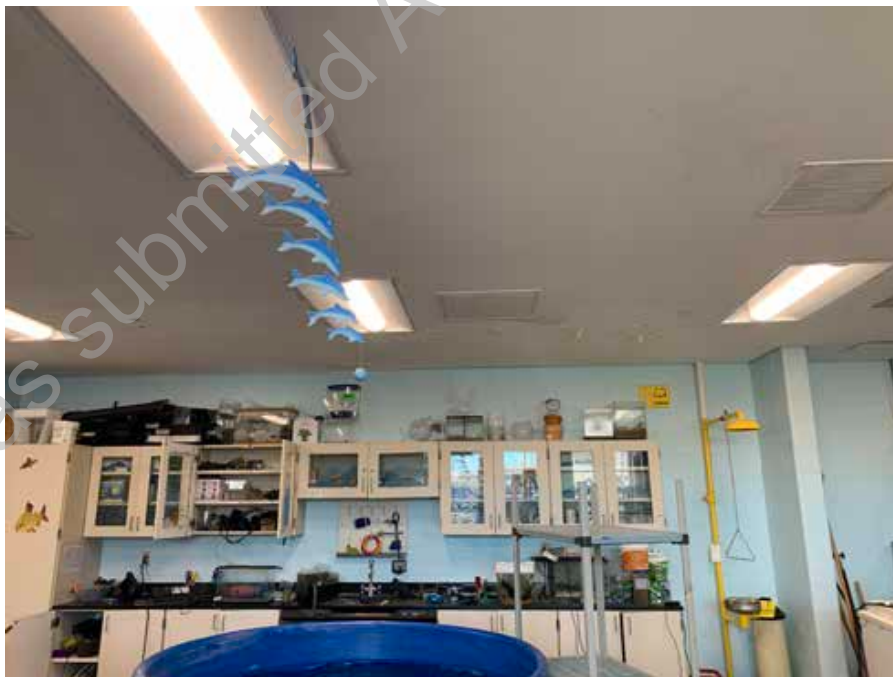
D1. 58: View of Aqua Culture lab room

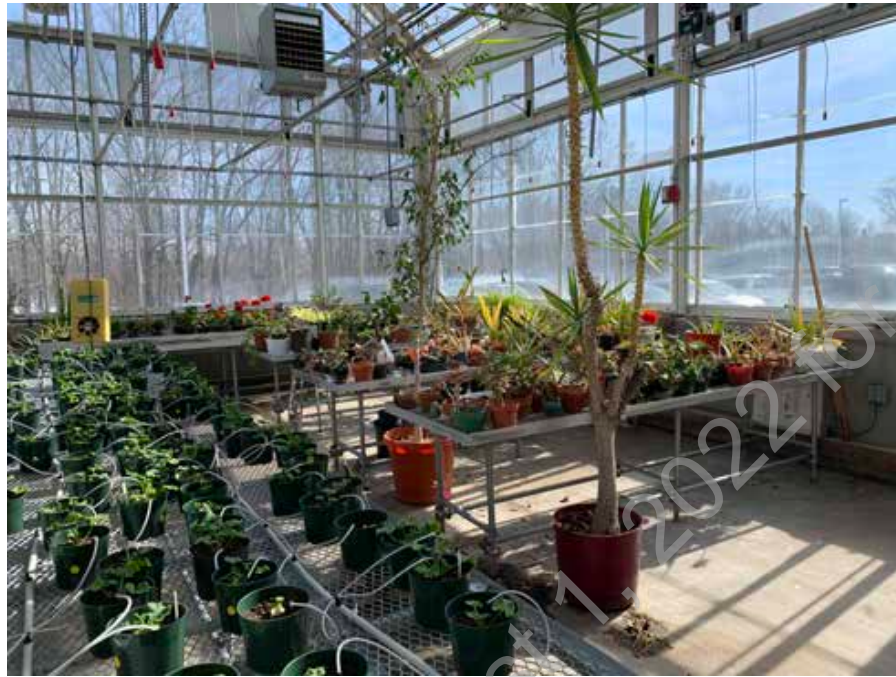
● D1. 59: View of greenhouse

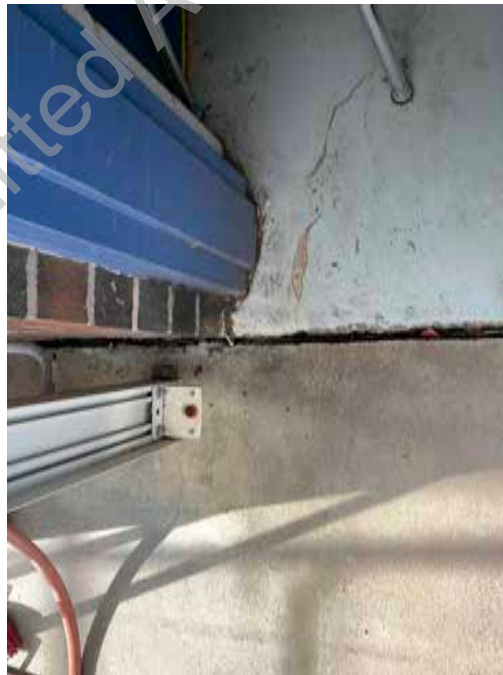
● D1. 60: Detail view of greenhouse/building intersection, note gap in expansion joint and condition of greenhouse frame system

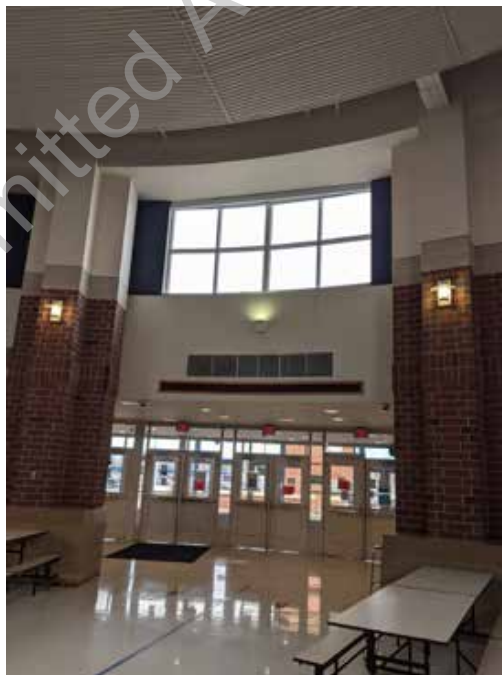
- D1. 62: View of main entry into the building.

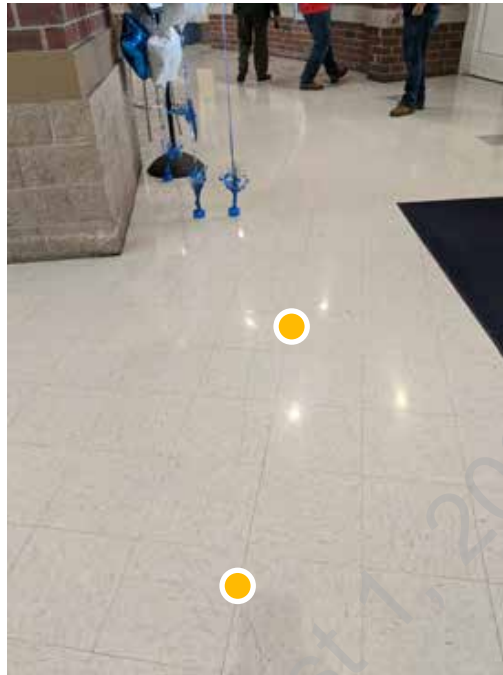
- D1. 63: View of VCT flooring at main entry/cafeteria, note the stress cracks along the walkway, lack of proper slab expansion/contraction joints likely cause

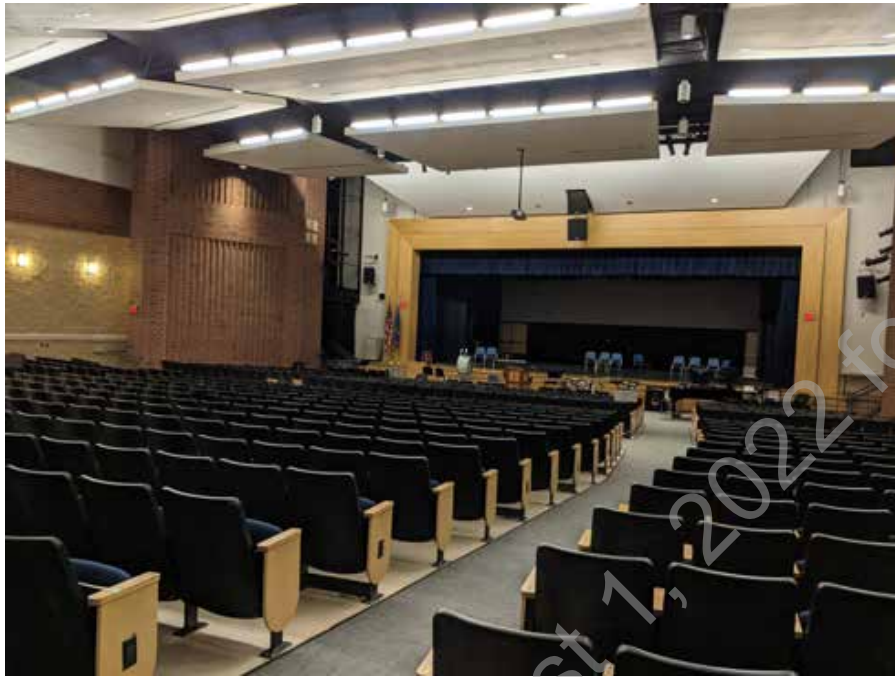
● D1. 65: Overall view of existing Auditorium

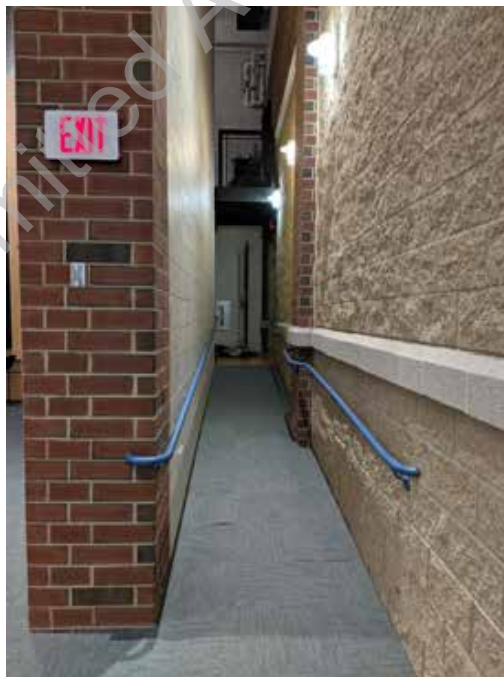
● D1. 66: Detail view of accessible ramp to stage area

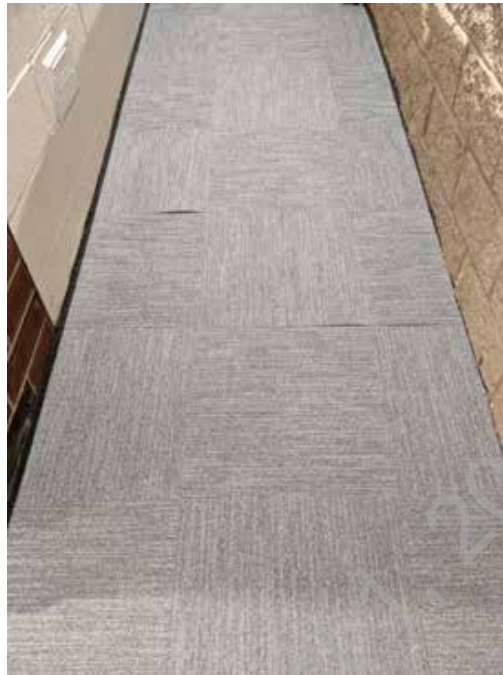
- D1. 67: Detail view of new carpet installation at access way to ramp, note seaming of joints not fully adhered to existing slab.

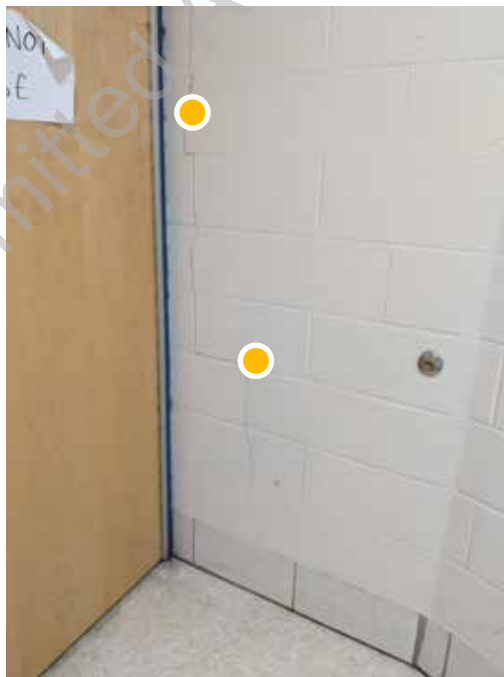
● D1. 70: Detail view of stress fractures in the CMU block wall likely due to building settlement.

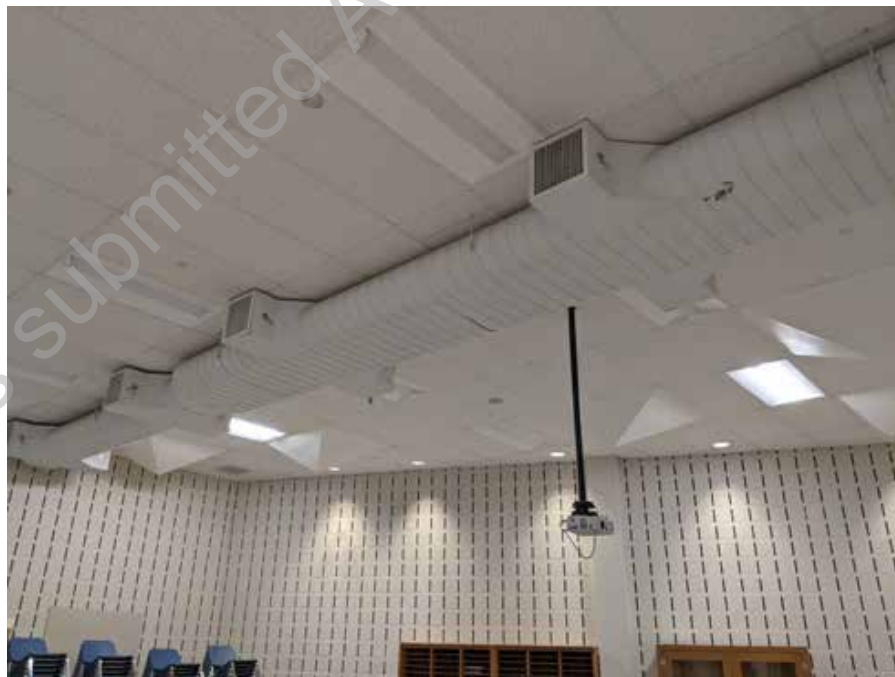
● D1. 72: Overall view of band/chorus room area.

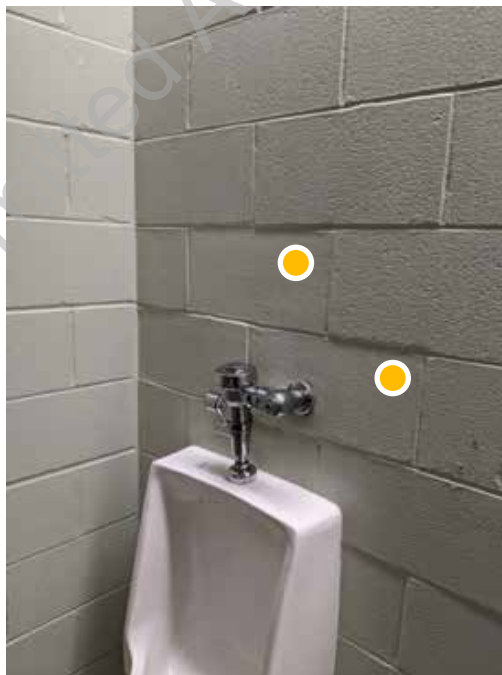
● D1. 74: Detail view of poorly constructed CMU wall, part of original construction.

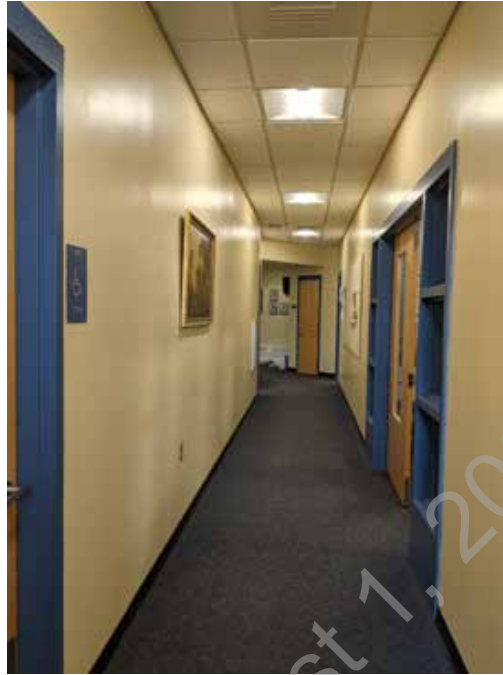
● D1. 75: Detail view of administrative area corridor and offices.

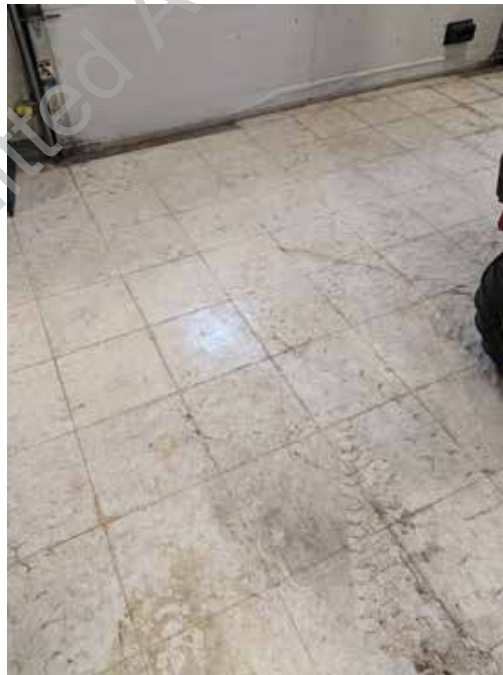
● D1. 76: Detail view of VCT flooring in maintenance / custodial area.

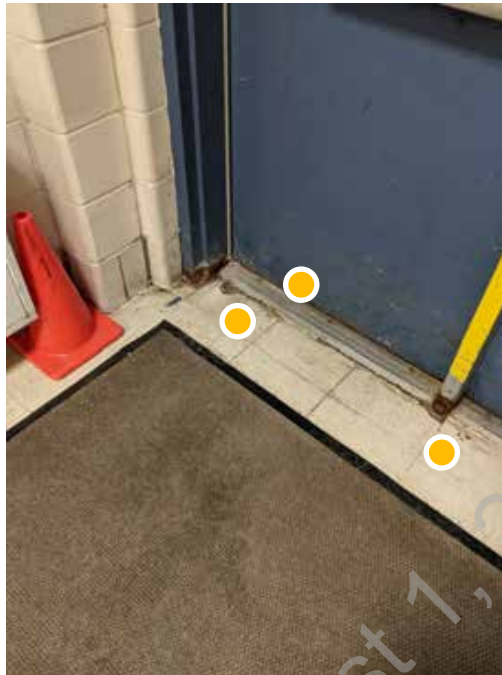
- D1. 77: Detail view of typical exterior metal door and frame, note poor condition at based of frame and door likely due to moisture.

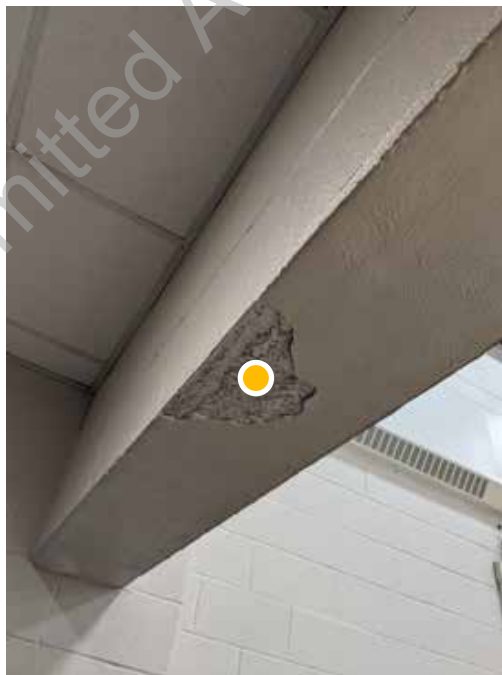
- D1. 78: Soffit plaster deterioration, likely due to deflection of steel carrying beam

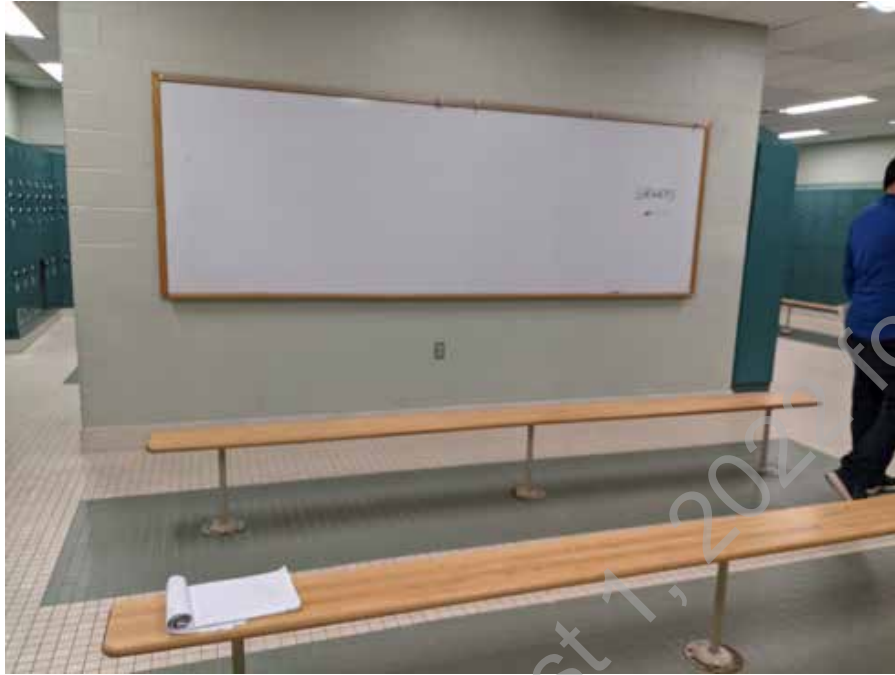
● D1. 81: View of benches in locker room

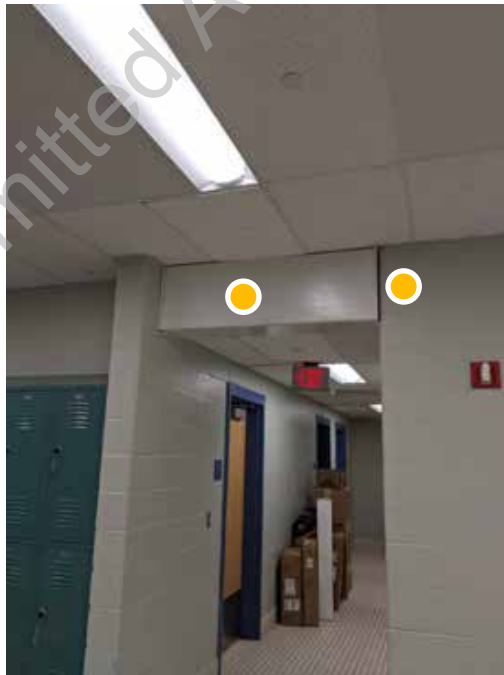
● D1. 82: Detail view of soffit repair in locker room areas, damaged due to use.

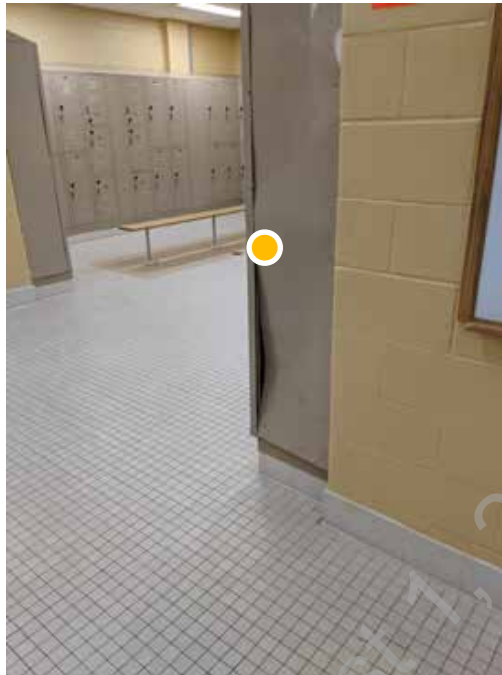
● D1. 85: Detail view of damaged locker unit

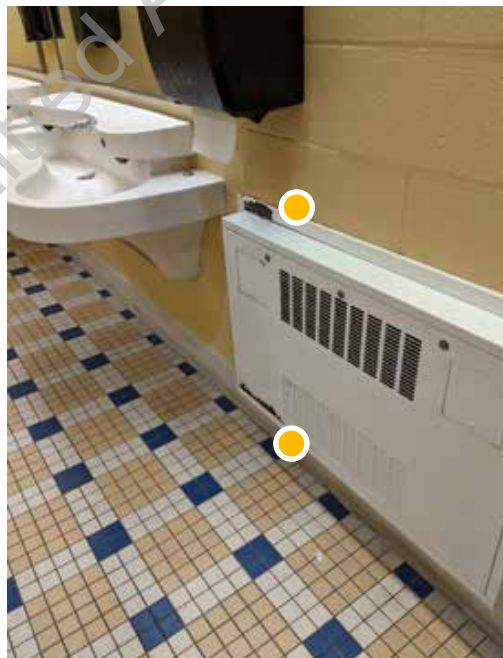
- D1. 88: Detail view of deteriorated wall cabinet heater

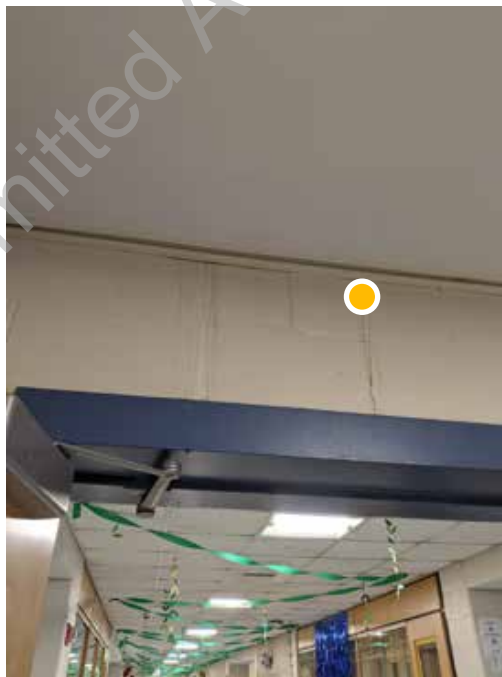
● D1. 90: Detail view of head condition at corridor doors, note visual signs of moisture/leaking.

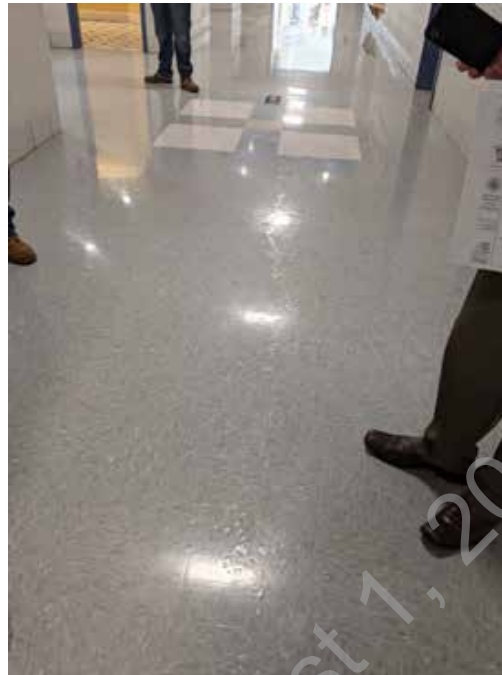
- D1. 91: Detail view of VCT floor replacement, note evidence "bubbling" in portions of the tile. The likely cause of this occurrence is moisture migration through the slab breaking down the water based adhesive utilized during the tile install. A moisture vapor reduction system should be applied prior to any flooring replacement program

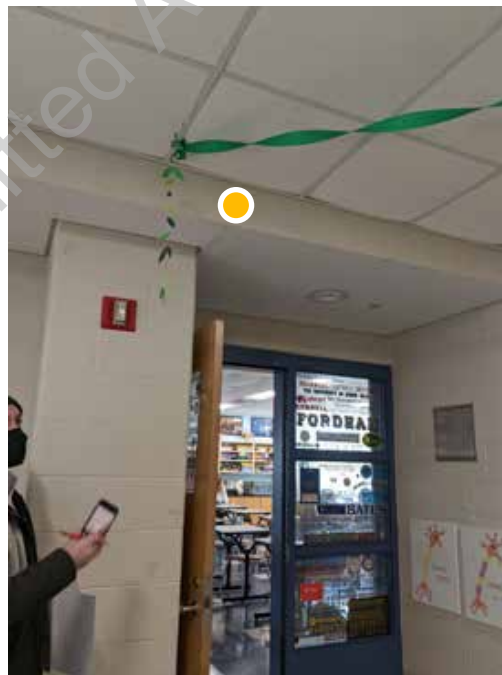
- D1. 92: Typical classroom entrance alcove, note shrinkage cracking at gypsum soffit.

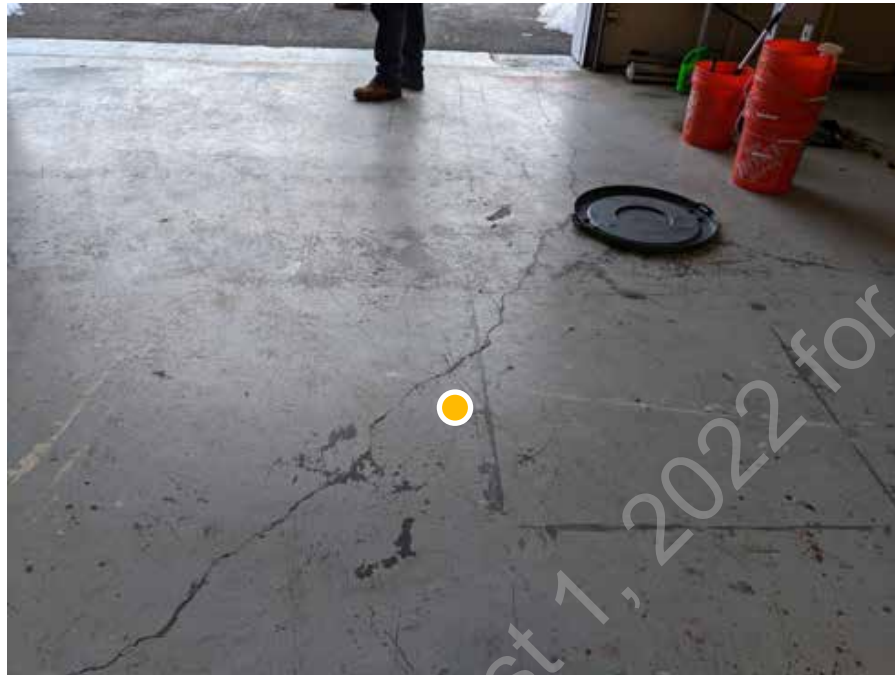
● D1. 99: Detail view of concrete slab cracking/deterioration likely caused by settlement and/or shrinkage.

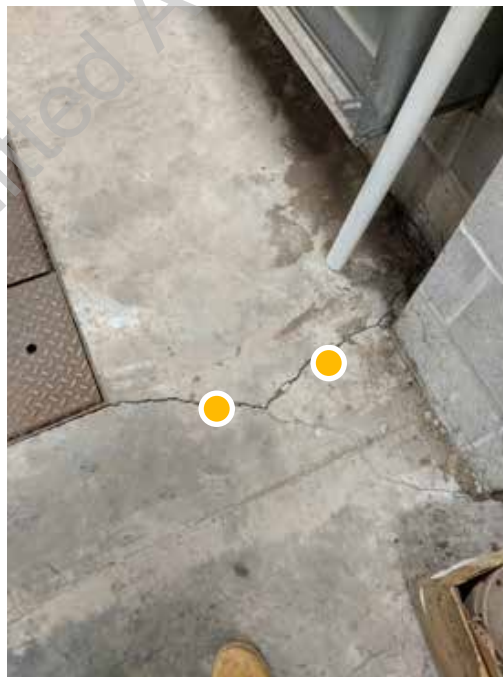
- D1. 104: Detail view of floor trenching in mechanical / boiler room, note concrete slab cracking likely due to expansion/contraction

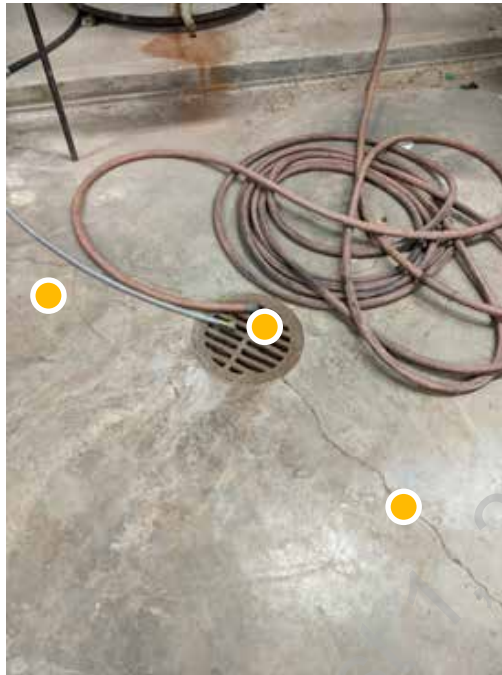
- D1. 105: Detail view of floor drain in mechanical / boiler room, note concrete slab cracking likely due to expansion/contraction

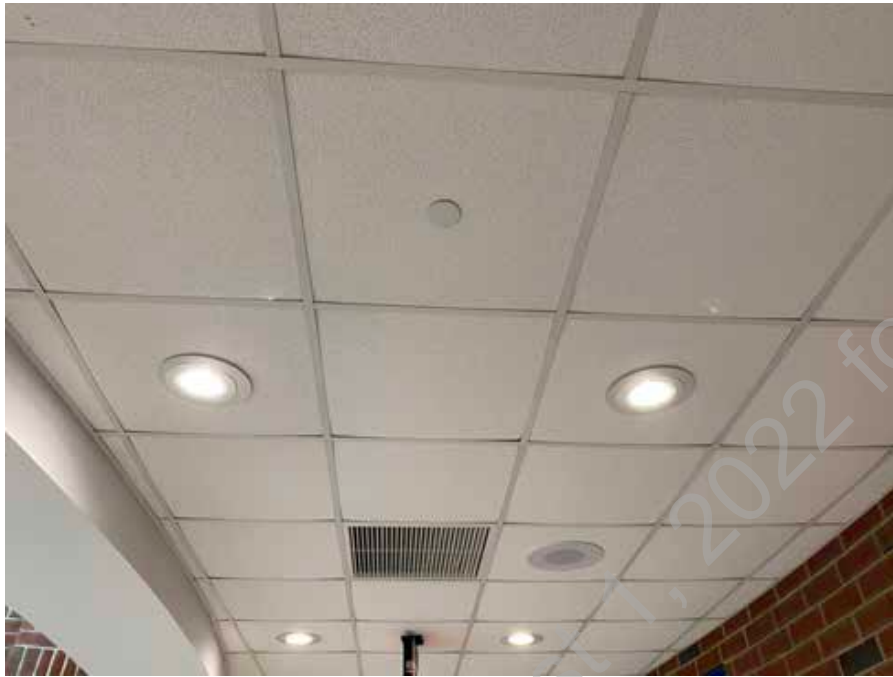
● D2. 9: Electrical Recessed Downlighting

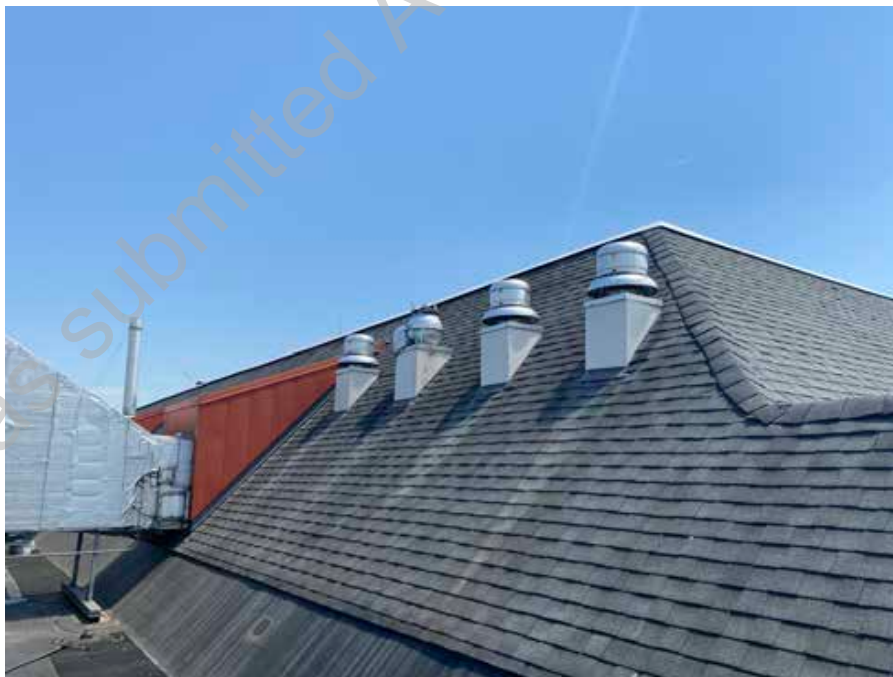
● D2. 10: Exhaust Fans on Roof in Good Condition

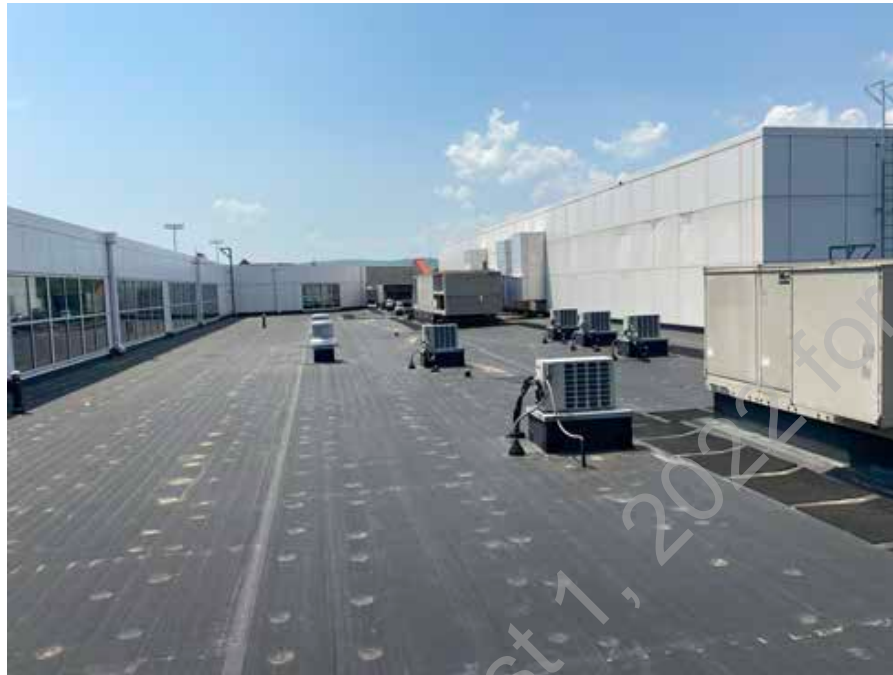
● D2. 11: Exhaust Fans, Rooftop Units, and Condensing Units on Roof

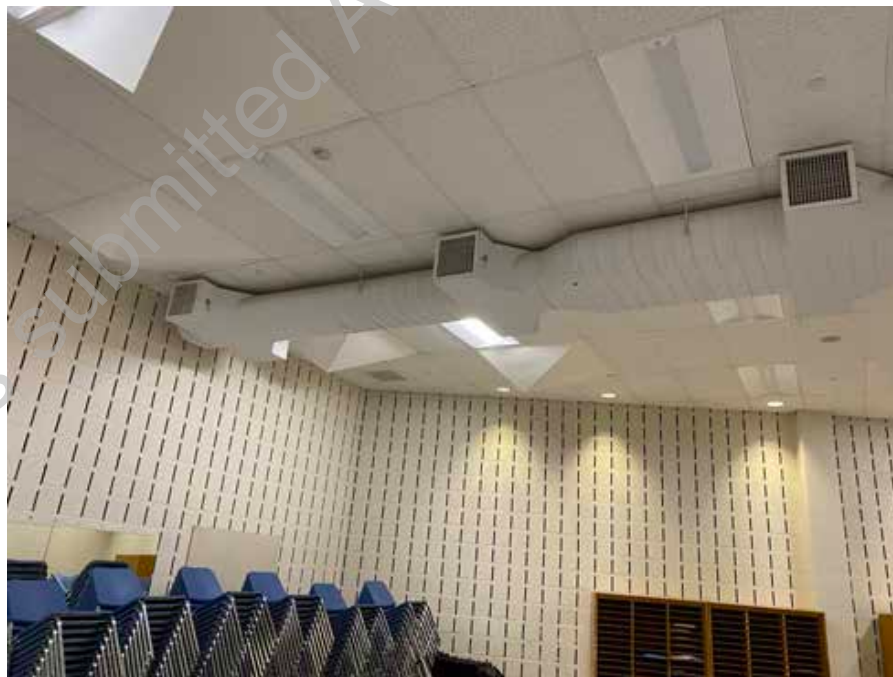
● D2. 12: Exposed Ductwork in Good Condition

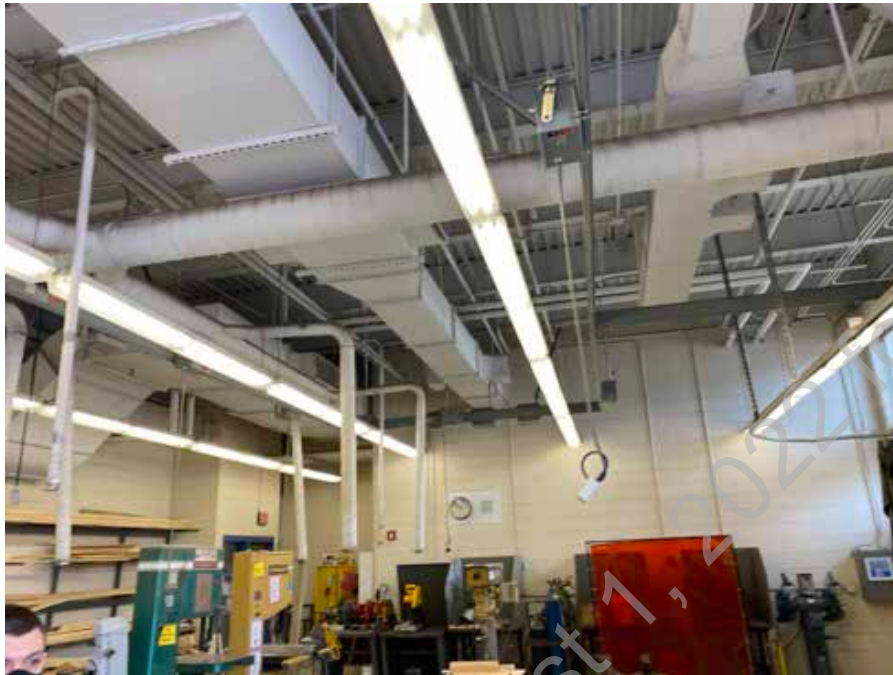
● D2. 13: Exposed Ductwork in Shop in Good Condition

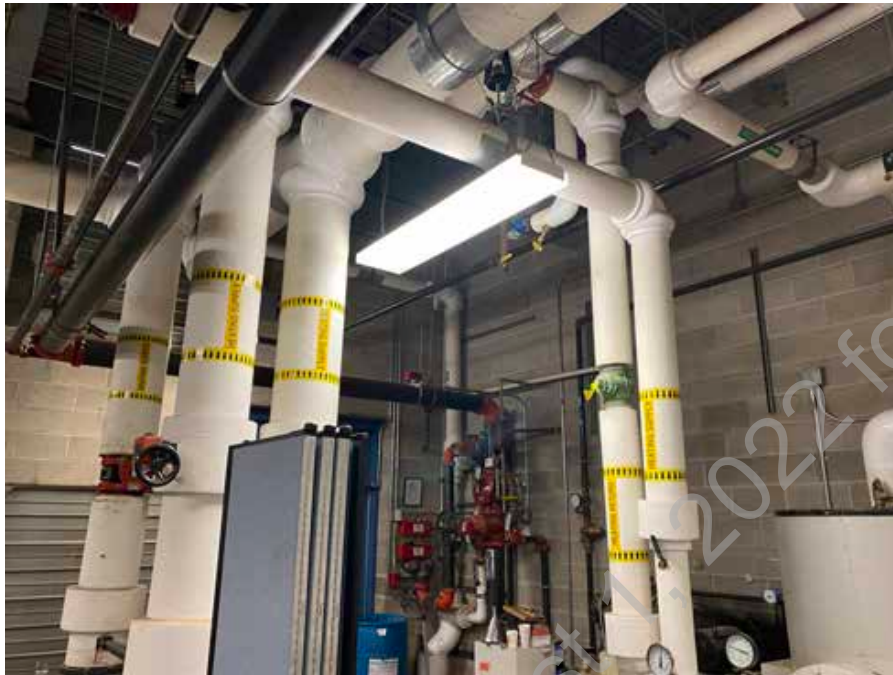
● D2. 25: Hot Water Piping in Good Condition

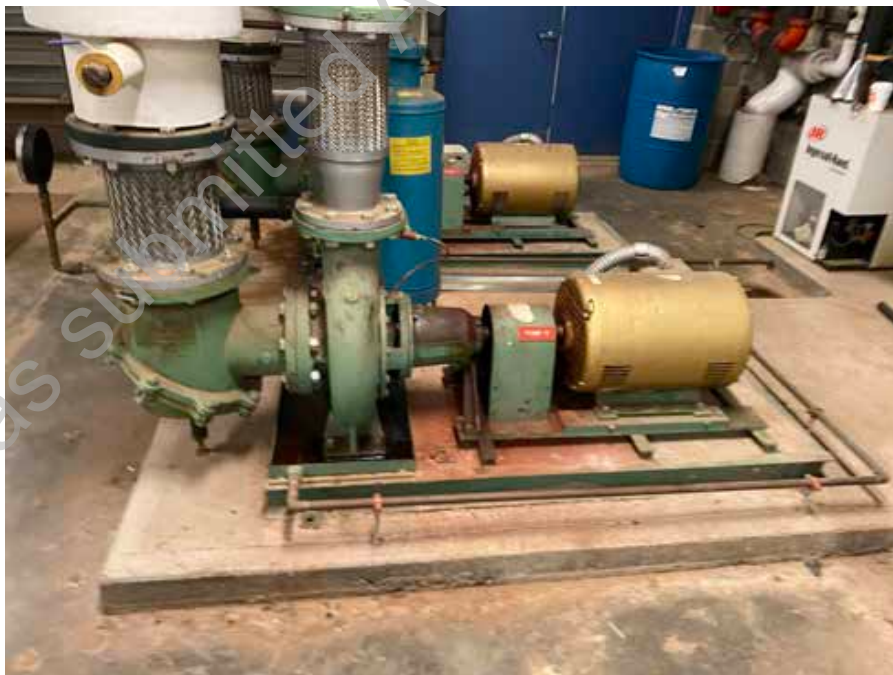
● D2. 26: Hot Water Pumps in Poor Condition

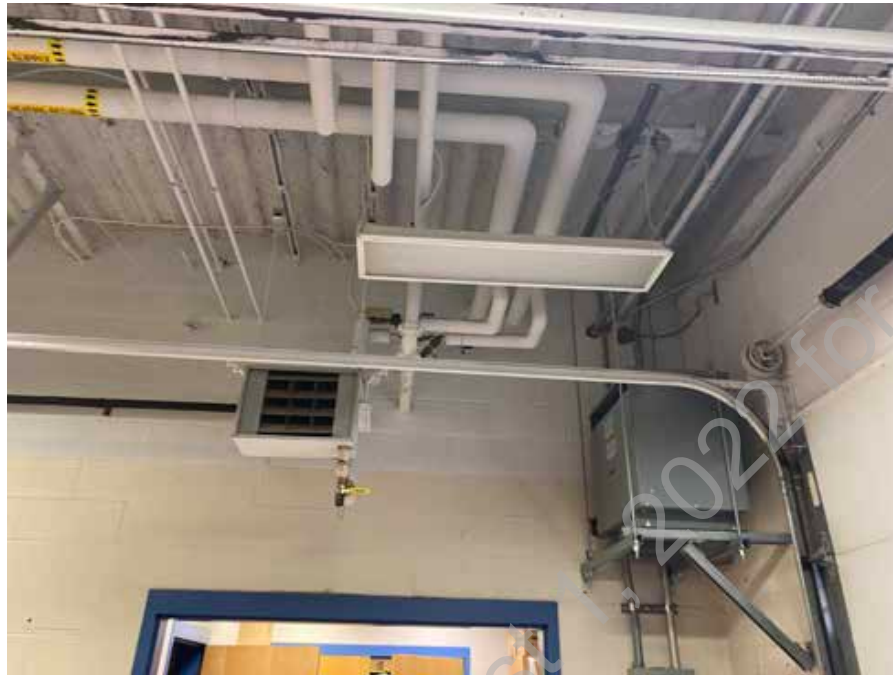
● D2. 27: Hot Water Unit Heater in Poor Condition
