TOWN OF SUFFIELD

CONDITIONS ASSESSMENT & MASTER PLAN

Draft as submitted August 1, 2022 for review

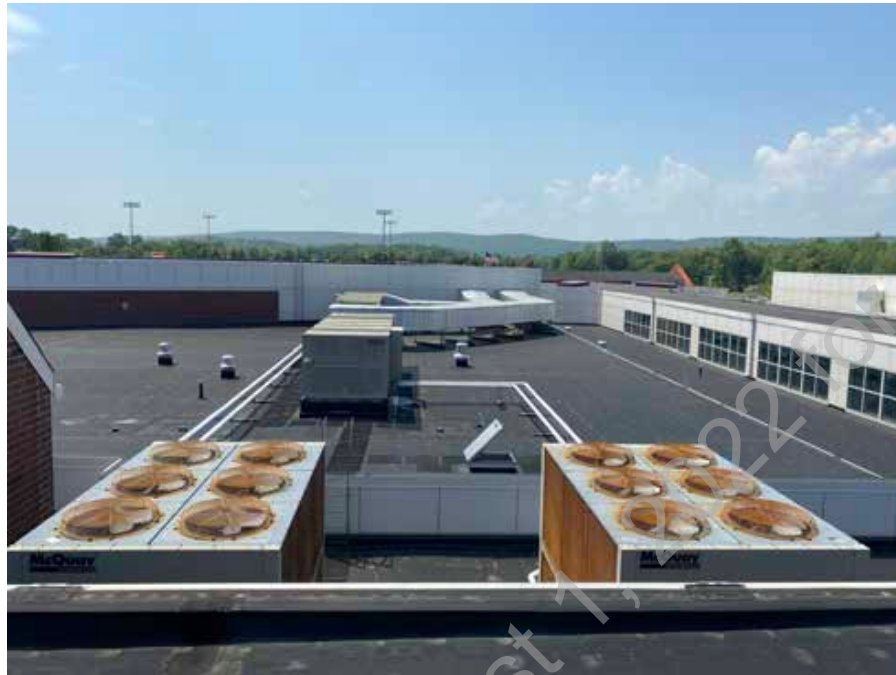
● D2. 39: McQuay Rooftop Units and Exposed Ductwork in Fair Condition

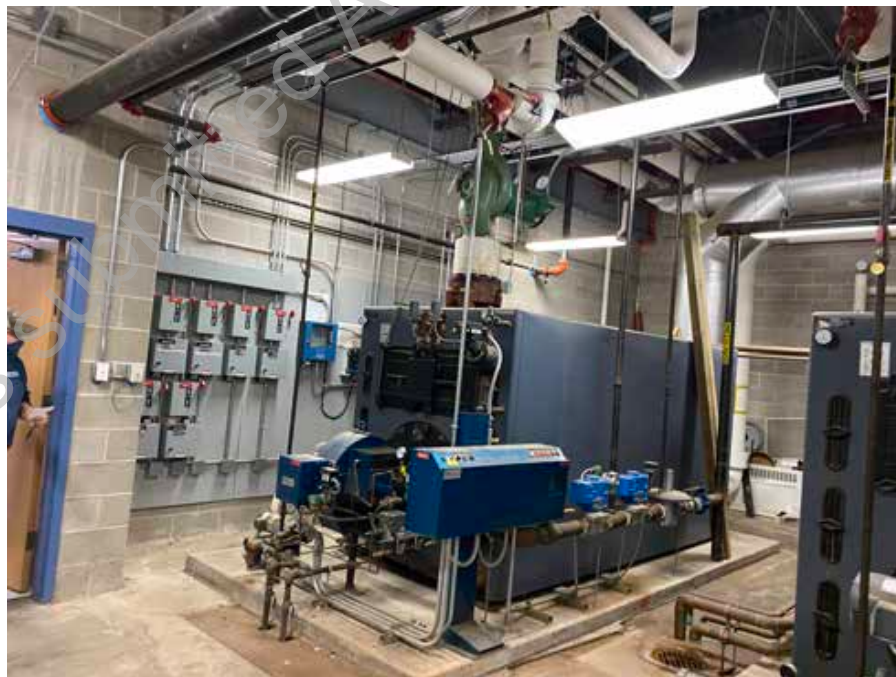
● D2. 40: Oil Fueled Cast Iron Boiler in Mechanical Room in Fair Condition

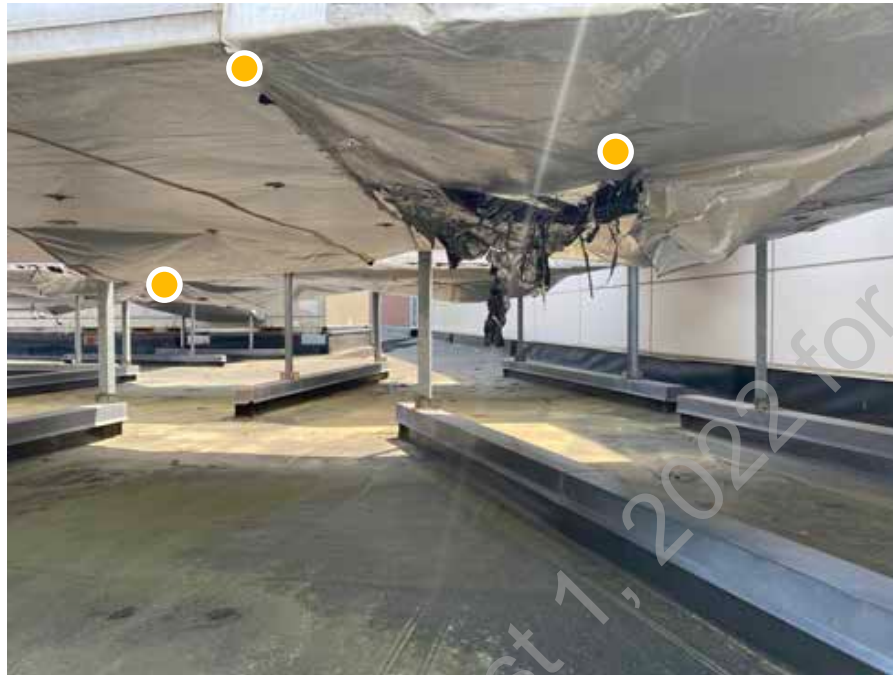
● D2. 43: View of the underside of the roof mounted ductwork, insulation wrap is in poor condition overall.

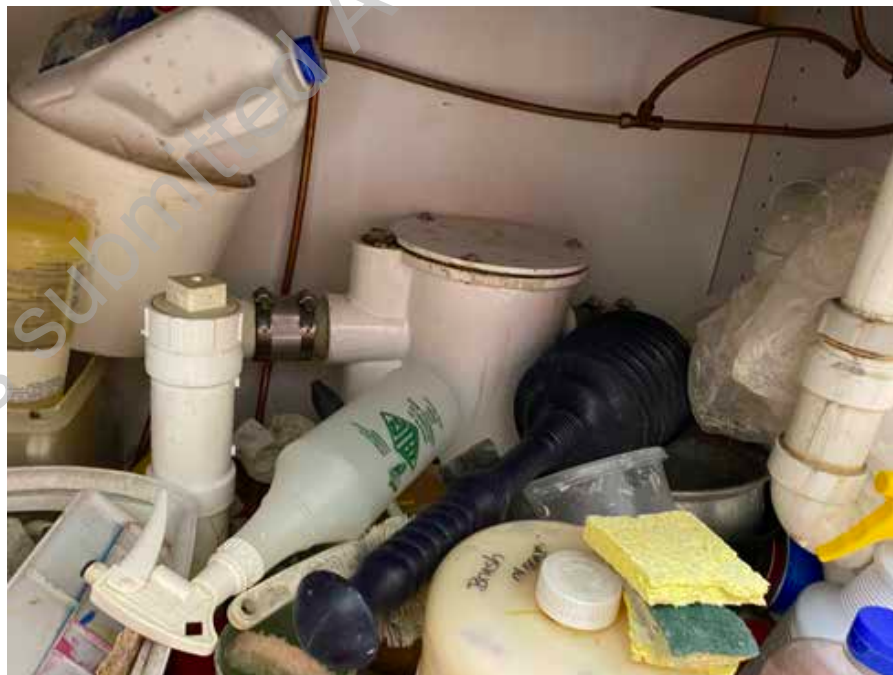
● D2. 44: Detail view of clay trap and PVC plumbing in fair to poor condition with indication of previous leaks via the staining

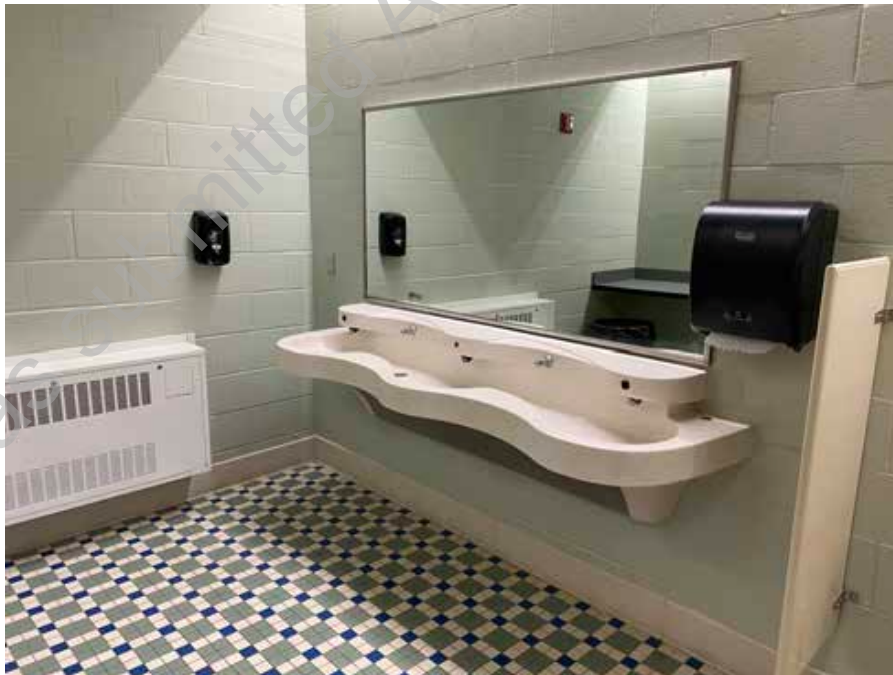
● D2. 50: Toilet Room Sink in Good Condition

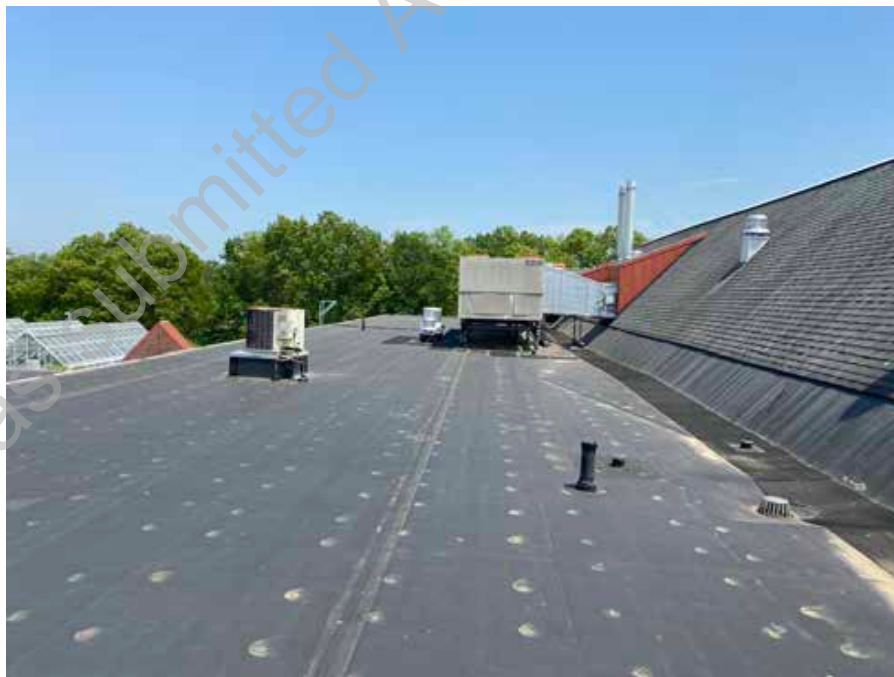
● D2. 54: Various Mechanical Equipment on Roof in Fair Condition

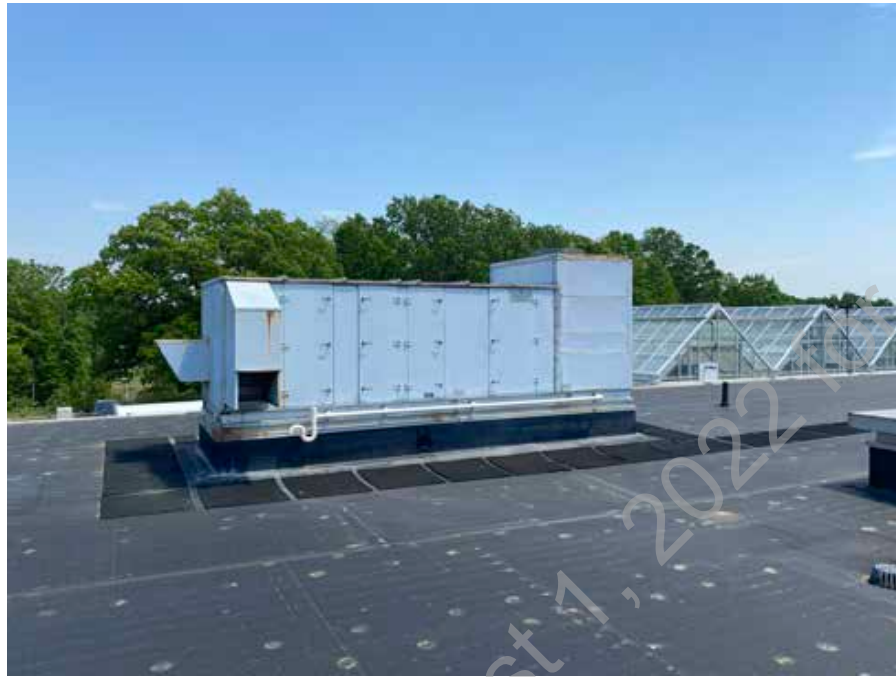
● D2. 55: Venmar Rooftop Unit in Fair Condition

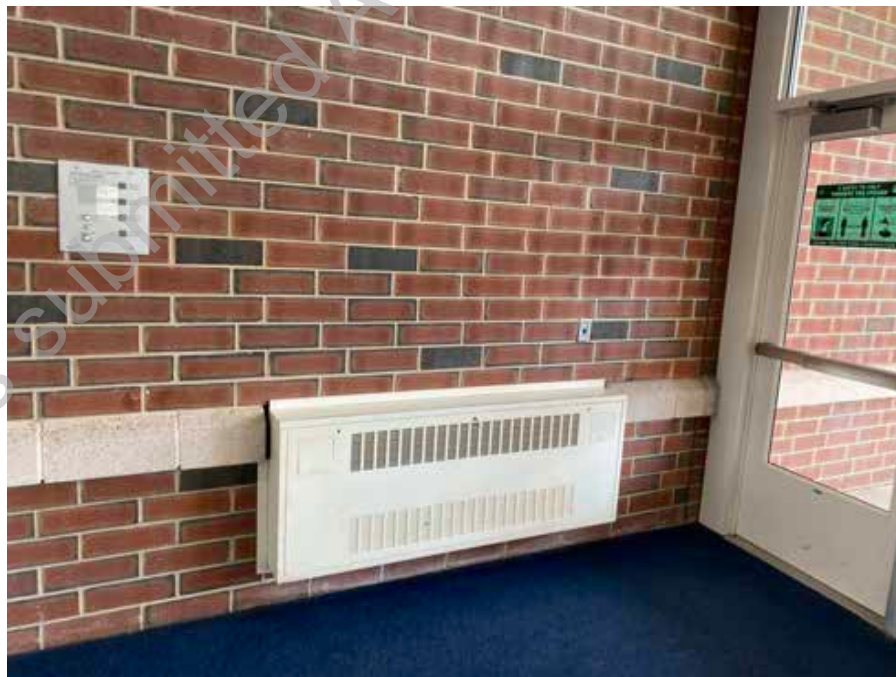
● D2. 56: Vestibule Hot Water Cabinet Unit Heater in Fair Condition

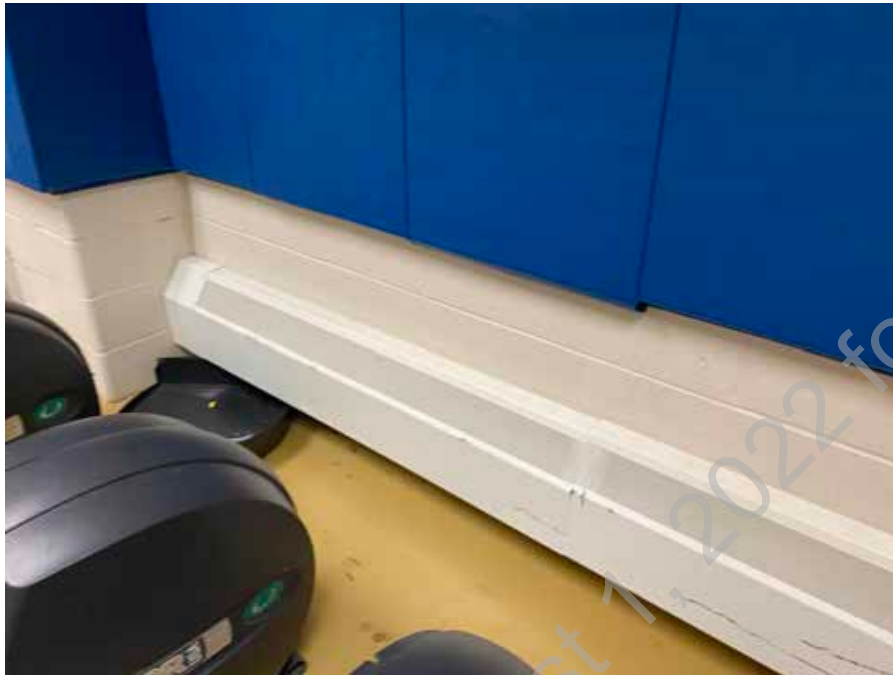
● D2. 57: Workout Room Fin Tube in Poor Condition

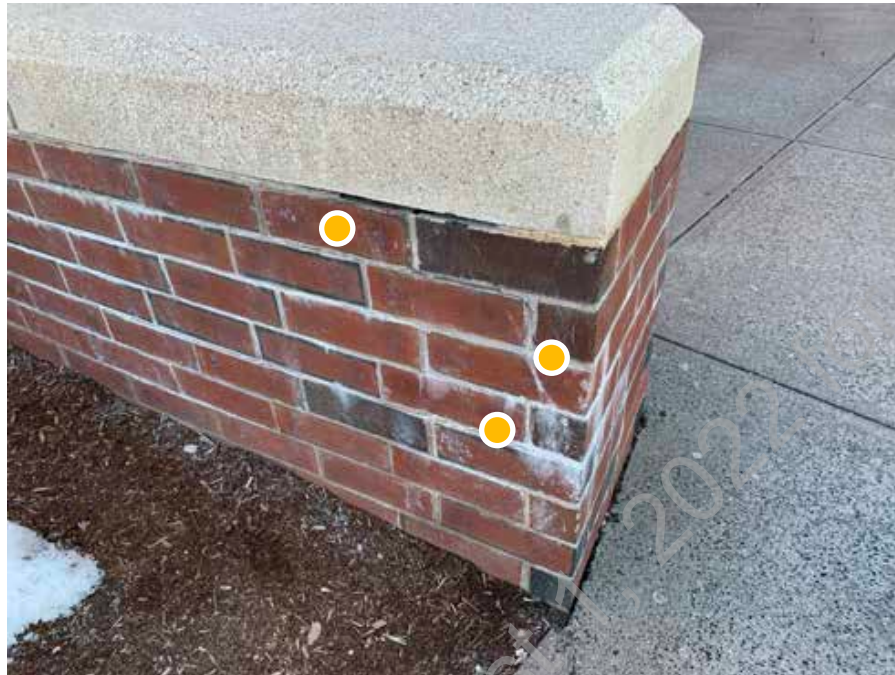
- D3. 1: Detail view of exterior masonry screen wall, note efflorescence likely caused by moisture infiltration into the cavity. Also note deterioration of the masonry joints.

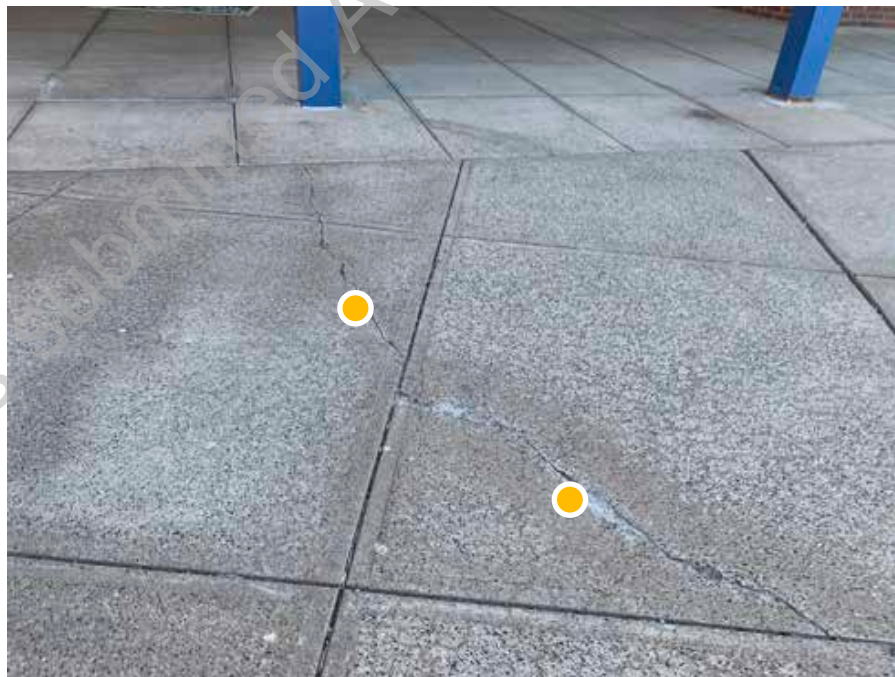
- D3. 2: Typical condition of concrete sidewalks adjacent to main entry of building, note severe cracking likely caused by settlement.

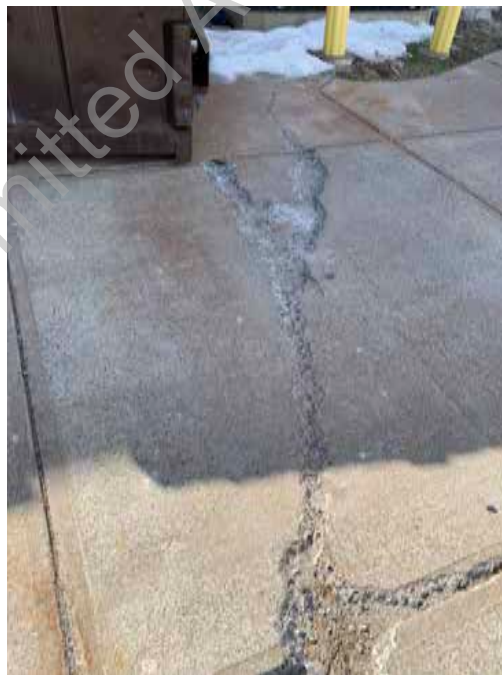
- D3. 4: Typical condition of concrete sidewalks adjacent to service area, note severe cracking likely caused by settlement and moisture infiltration.

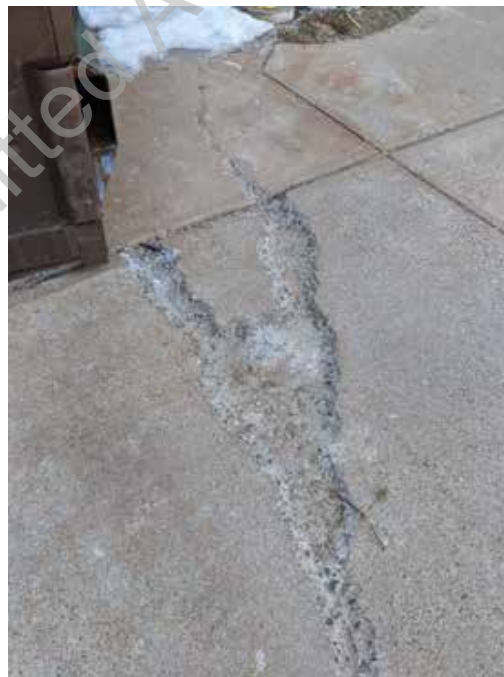
● D3. 6: Typical condition of concrete sidewalks adjacent to service area, note severe cracking likely caused by settlement and moisture infiltration.

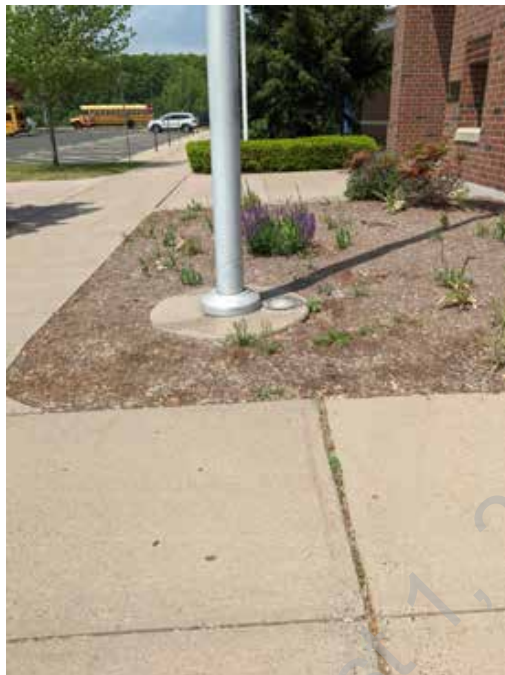
- D3. 7: Detail view of typical concrete sidewalk expansion joints, note poor condition and expansion filler requires replacement.

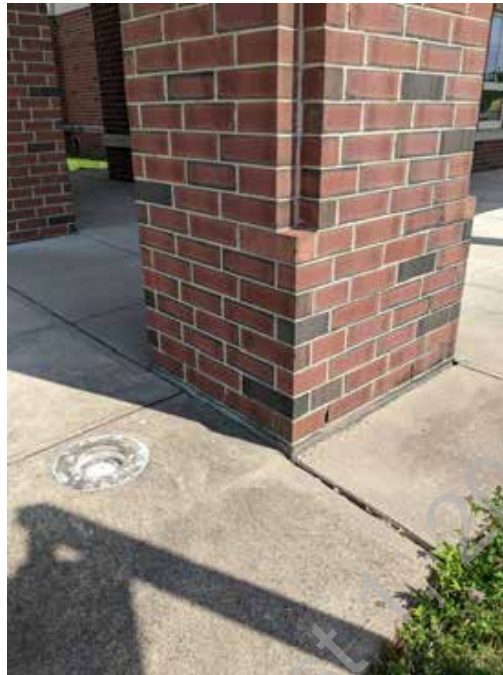
- D3. 13: View of masonry pier at entry area, note ground mounted lighting no longer functioning due to electrical wiring. Also note, sever settlement at concrete sidewalk expansion joint.

Bollard/Ground lighting	6	EA	\$3,500	\$ 21,000	\$ 2,100	\$ 315	\$ 1,575	\$ 1,050	\$ 26,400	\$ 3,255	\$ 29,295	\$ 5,859	\$ 35,154	Replaces existing bollard and recessed sidewalk lighting						
Playground Equipment	0	EA	\$65,000	\$ -	\$ -	\$ -	\$ -	\$ -	\$ -	\$ -	\$ -	\$ -	\$ -							
Fencing (4 ft vinyl coated chain link)	0	LF	\$65	\$ -	\$ -	\$ -	\$ -	\$ -	\$ -	\$ -	\$ -	\$ -	\$ -							
Turf Field Replacement	9,969	SY	\$0	\$ -	\$ -	\$ -	\$ -	\$ -	\$ -	\$ -	\$ -	\$ -	\$ -	Recently installed. No replacement necessary at this time						
Grass Field Replacement	29,578	SY	\$0	\$ -	\$ -	\$ -	\$ -	\$ -	\$ -	\$ -	\$ -	\$ -	\$ -	Recently installed. No replacement necessary at this time						
Tennis Courts	4,678	SY	\$0	\$ -	\$ -	\$ -	\$ -	\$ -	\$ -	\$ -	\$ -	\$ -	\$ -	Recently installed. No replacement necessary at this time						
Basketball Courts	1,233	SY	\$0	\$ -	\$ -	\$ -	\$ -	\$ -	\$ -	\$ -	\$ -	\$ -	\$ -	Recently installed. No replacement necessary at this time

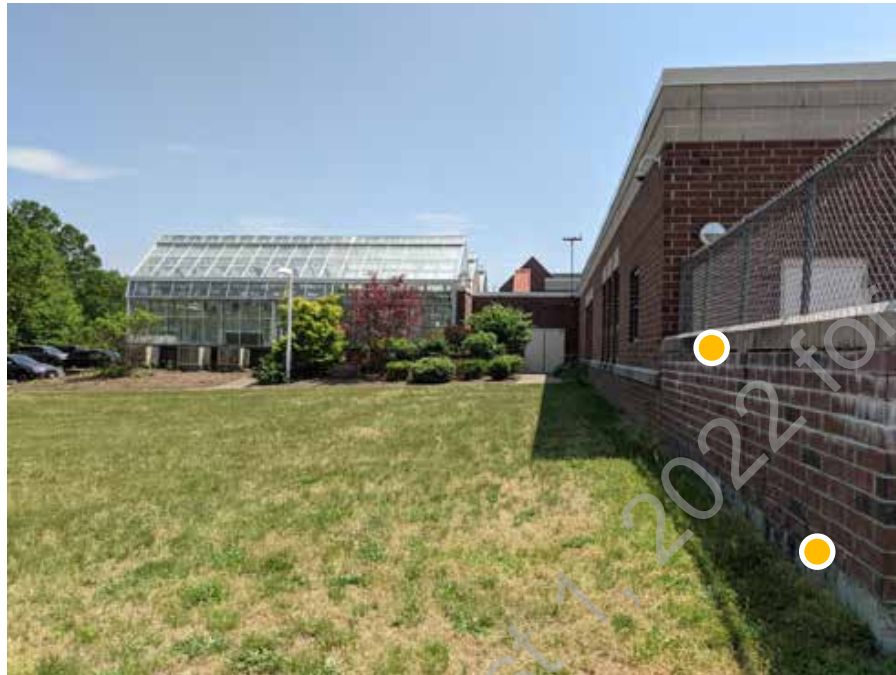
● D3. 17: View of east side of building with greenhouse structure in background. Masonry screen wall to right, note deterioration of masonry joints and efflorescence

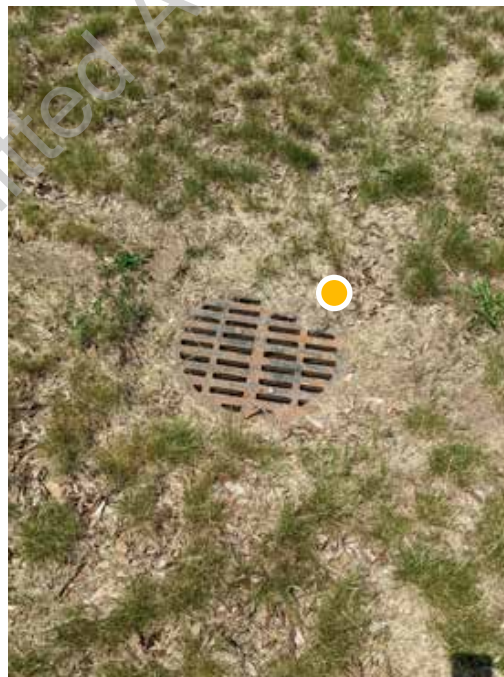
● D3. 18: Detail view of partially obstructed yard drain.

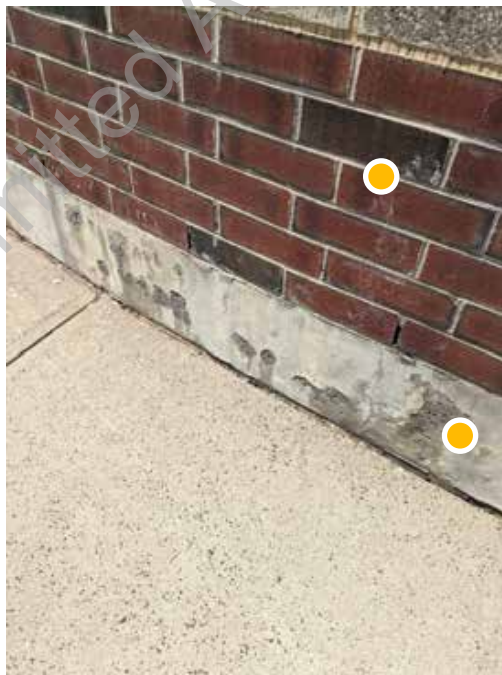
D3. 20: Detail view of typical screen wall, note deterioration of masonry jointing, efflorescence, and spalling at concrete foundation wall.

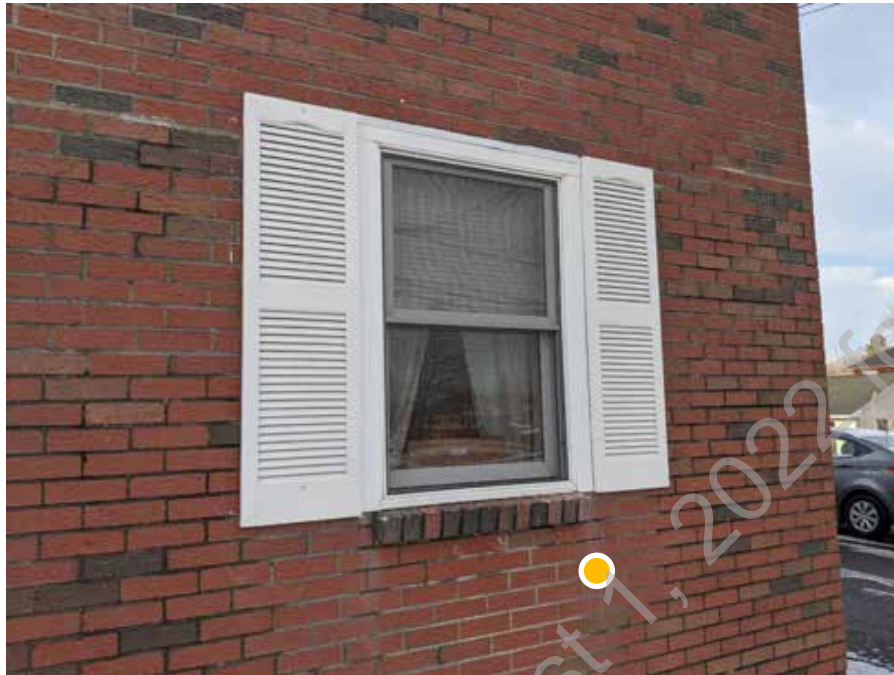
● D1. 5: Aluminum windows with brick sill; Brick staining

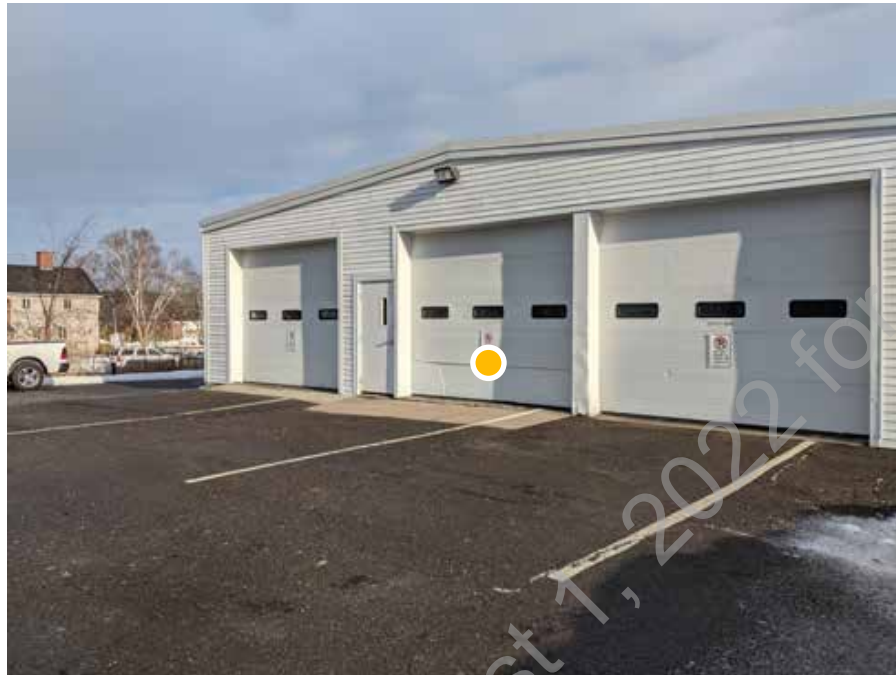
● D1. 7: Garage doors are dented

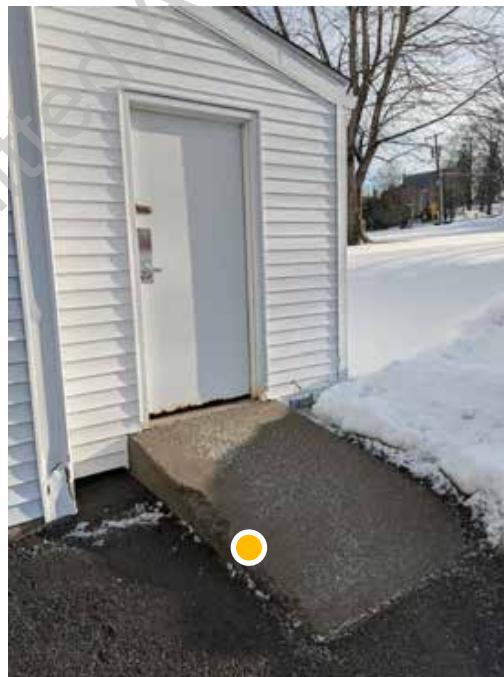
WALKWAYS/SITE STAIRS: Two small ramps are the only concrete sidewalks on the site. One leads up to the main entrance and the other exits from a small storage room door on the South façade. Both ramps are beginning to chip and require minor repairs.

● D1. 8: Spalling concrete at rear storage ramp

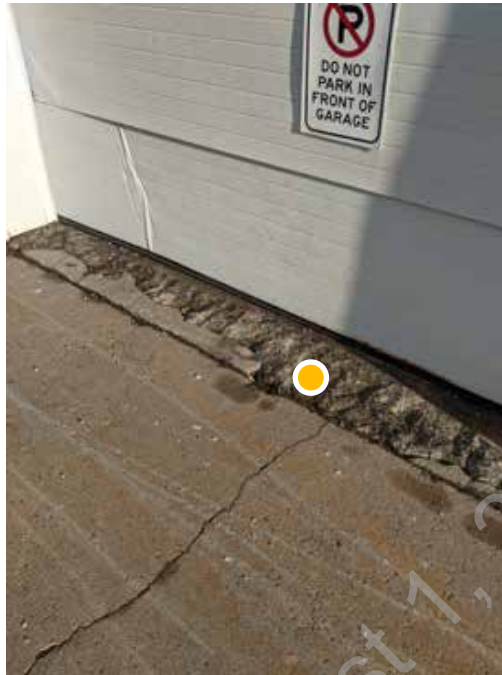
● D1. 9: Concrete spalling at garage door thresholds

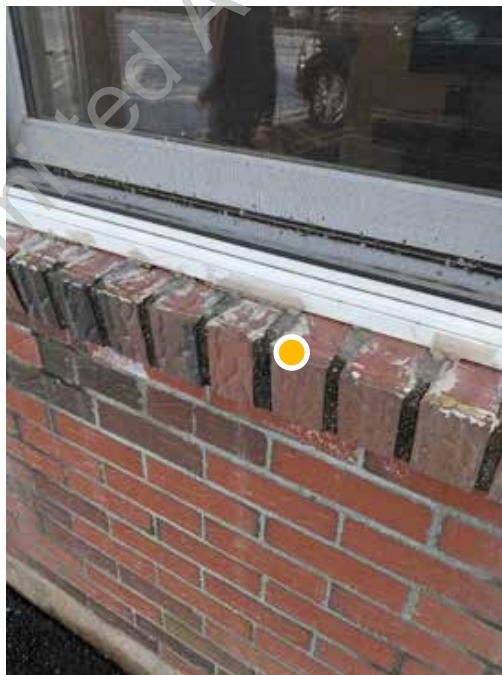
● D1. 10: Staining and poorly installed caulk at brick window sills

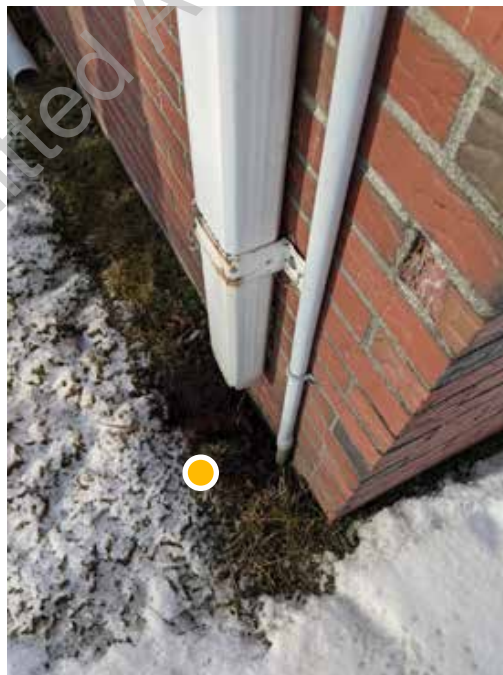
● D1. 12: Missing splashblock causing soil erosion

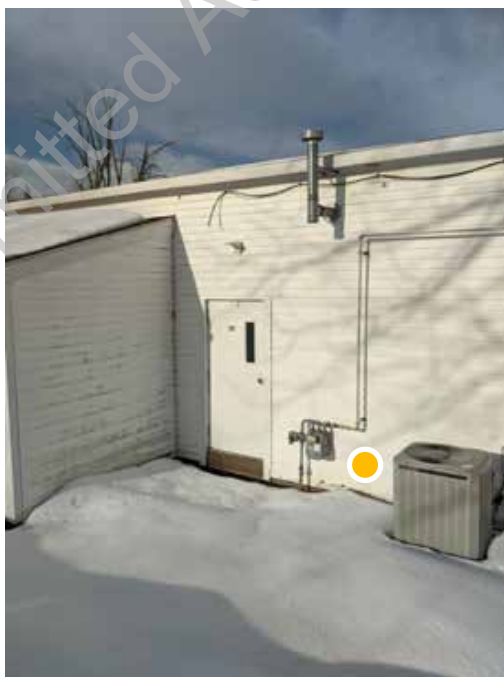
● D1. 14: Vinyl siding damaged at base

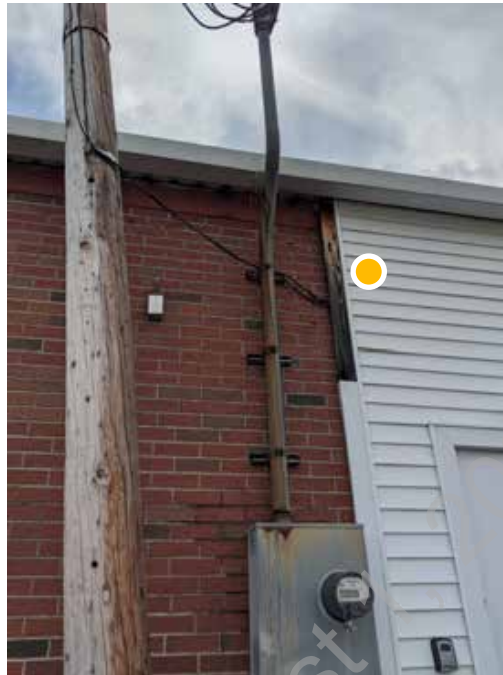
● D1. 15: Missing trim at vinyl siding along West Façade

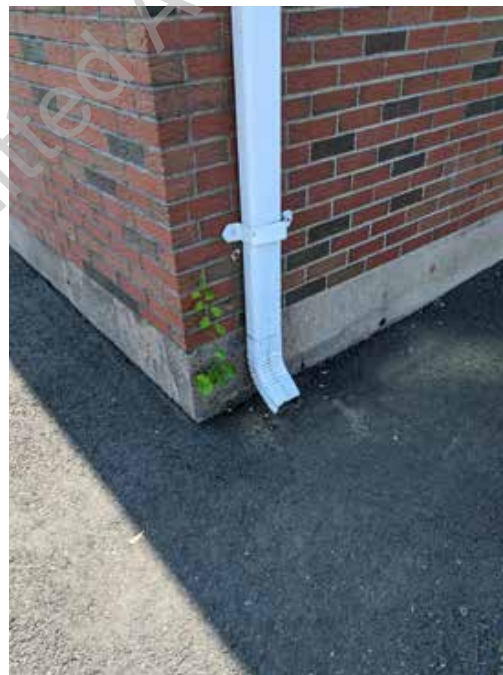
● D1. 16: Downspout dented along pavement

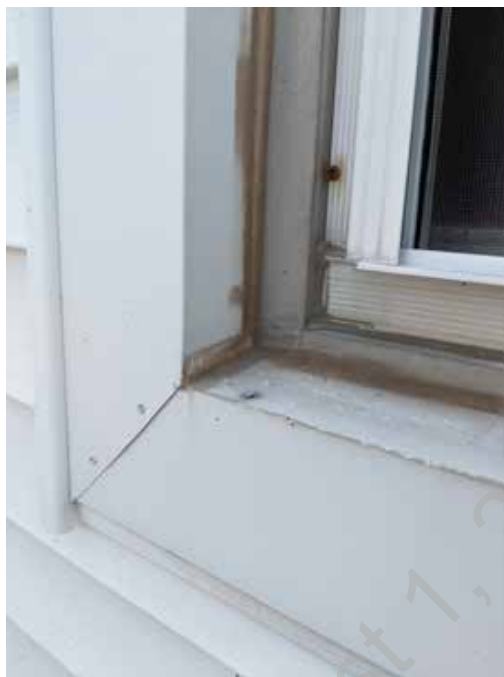
● D1. 17: Windows poorly caulked

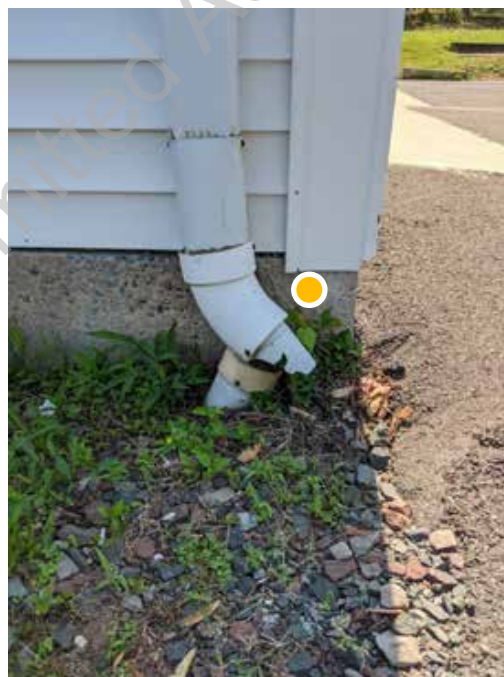
● D1. 18: Damaged downspout at connection to sub-surface drainage system

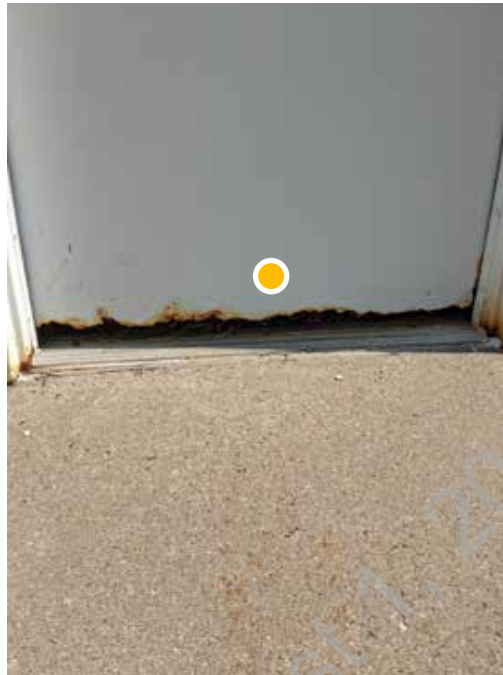
● D1. 19: Corrosion at base of storage room exterior door

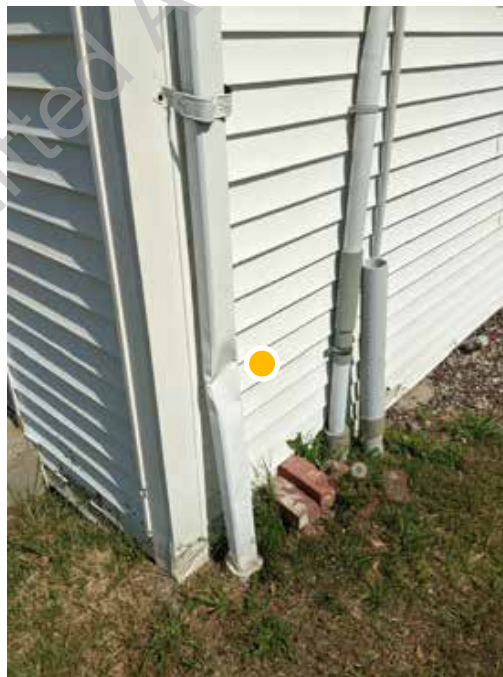
● D1. 20: Downspout damaged

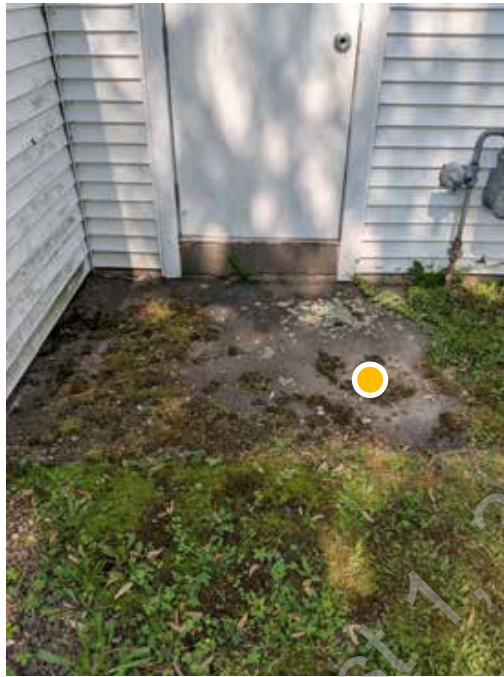
● D1. 21: Organic growth at concrete pad; Vinyl siding damaged at base

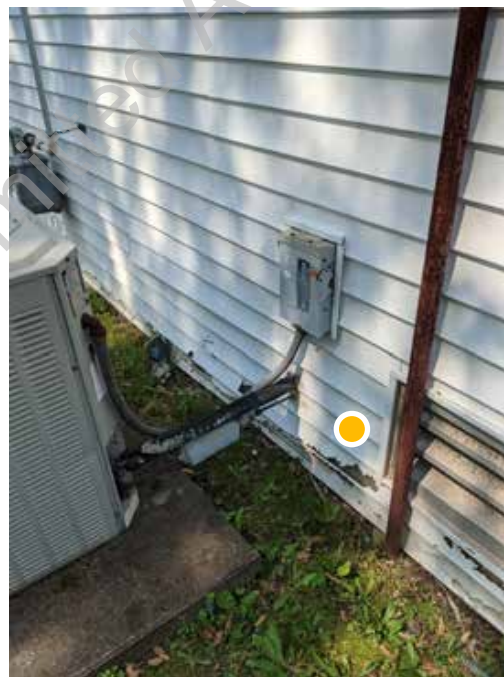
● D1. 22: Vinyl siding damaged at base

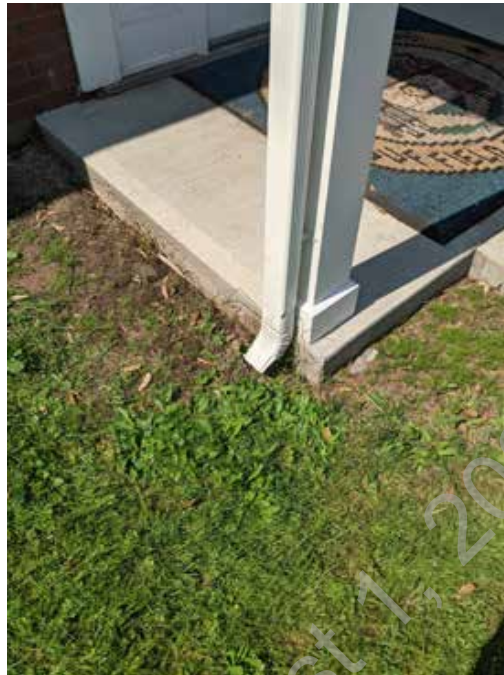
- D1. 23: Missing splashblock causing soil erosion at edge of concrete

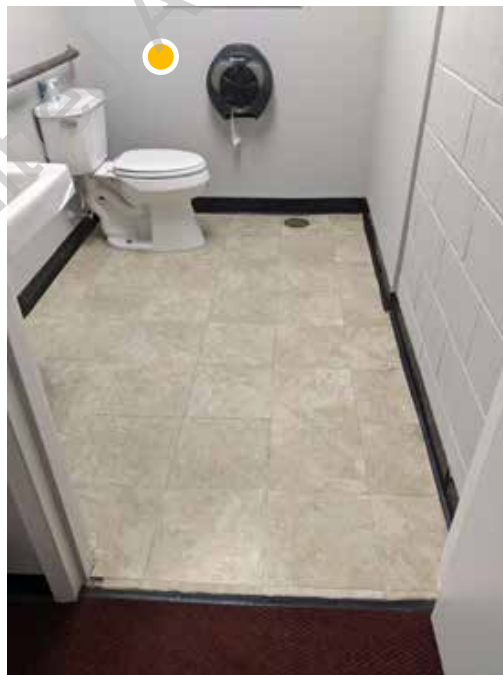
ADA: Toilet facilities are missing required grab bars to be considered ADA-compliant. A raised sill separates the office area from the garage and is not considered wheelchair accessible.

● D1. 28: Missing ADA grab bar at toilet rooms

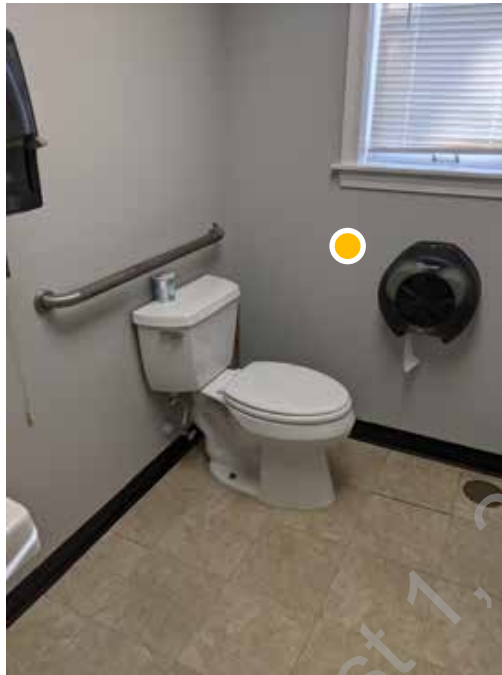
● D1. 29: Missing ADA grab bar at toilet rooms

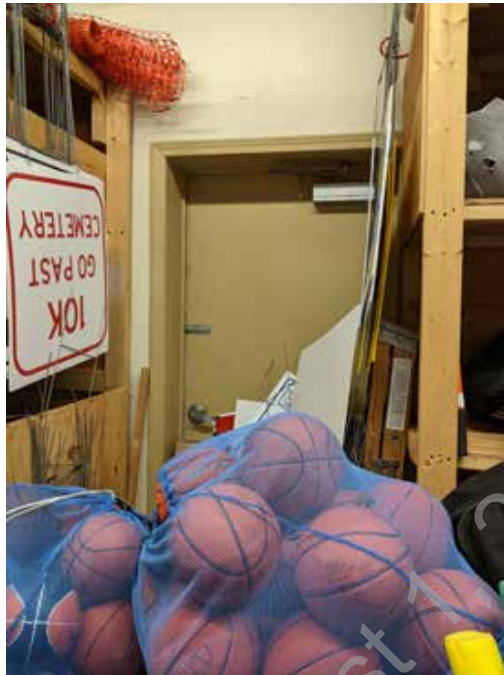
● D1. 33: Equipment in storage area prohibiting access to other spaces

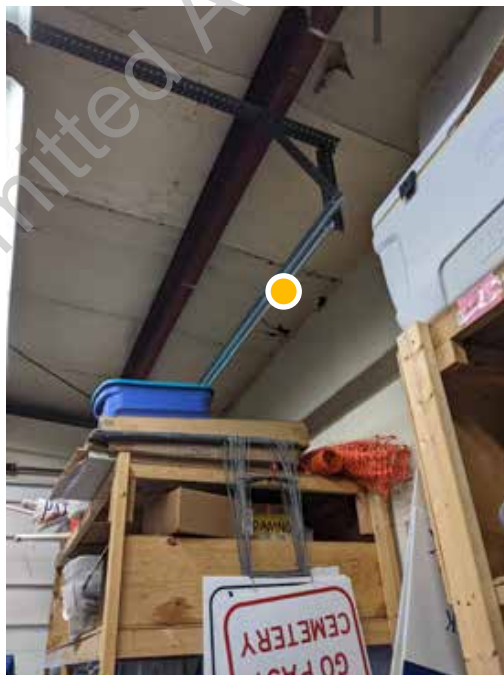
● D1. 34: Damaged roof insulation throughout storage garage

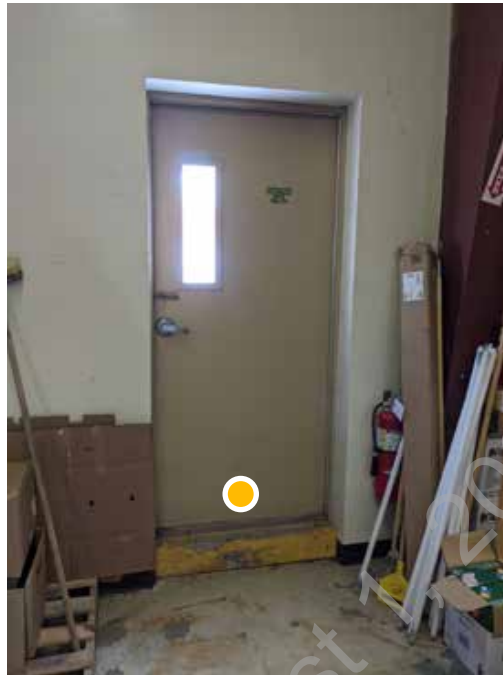
● D1. 35: Spalling concrete sill at exterior door in storage garage

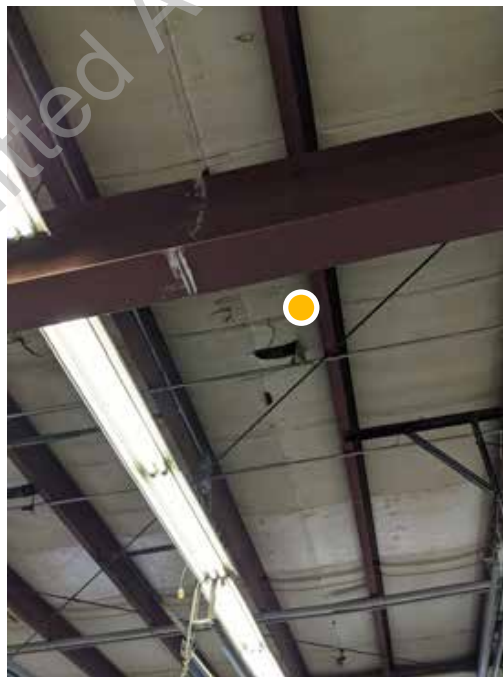
● D1. 36: Damaged roof insulation throughout storage garage

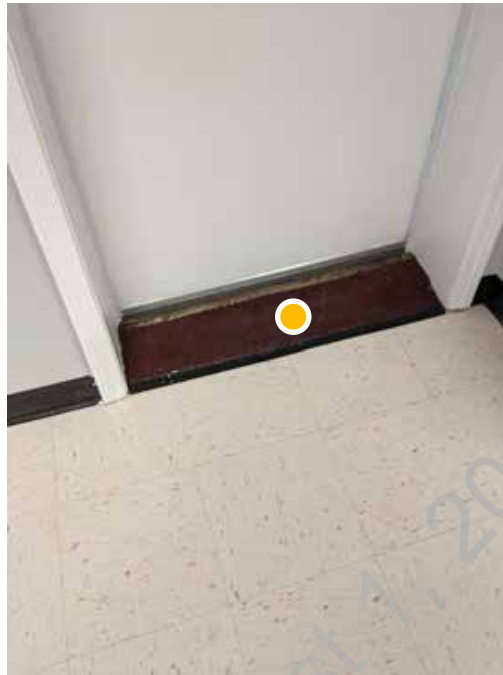
● D1. 39: Mismatched flooring at door threshold in break area

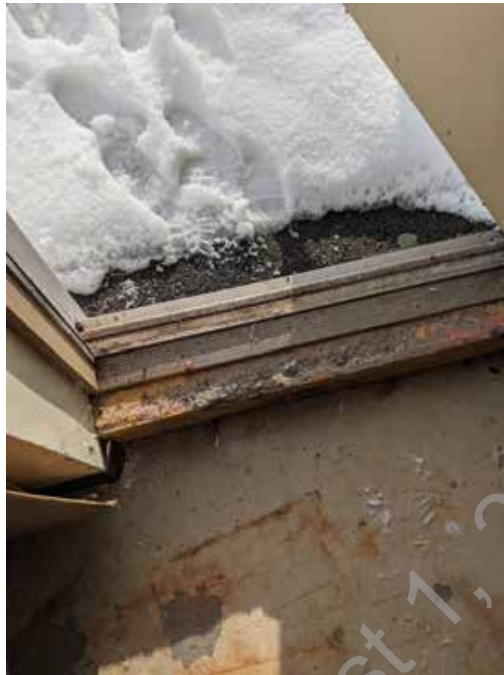
● D1. 41: Spalling concrete sill at exterior door in storage garage

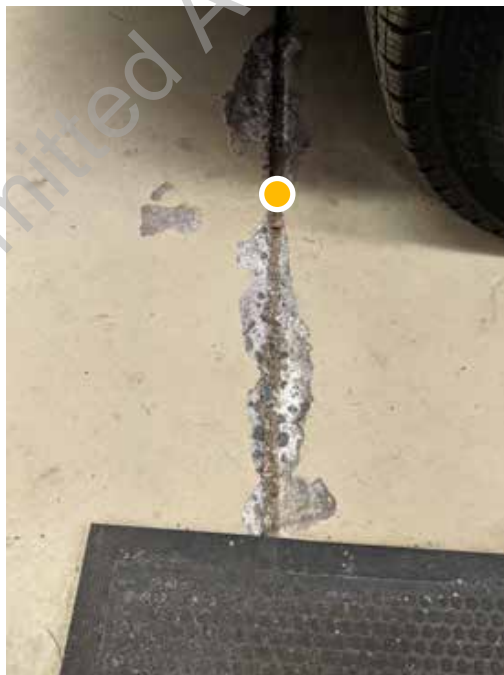
● D1. 42: Spalling concrete control joints in storage area

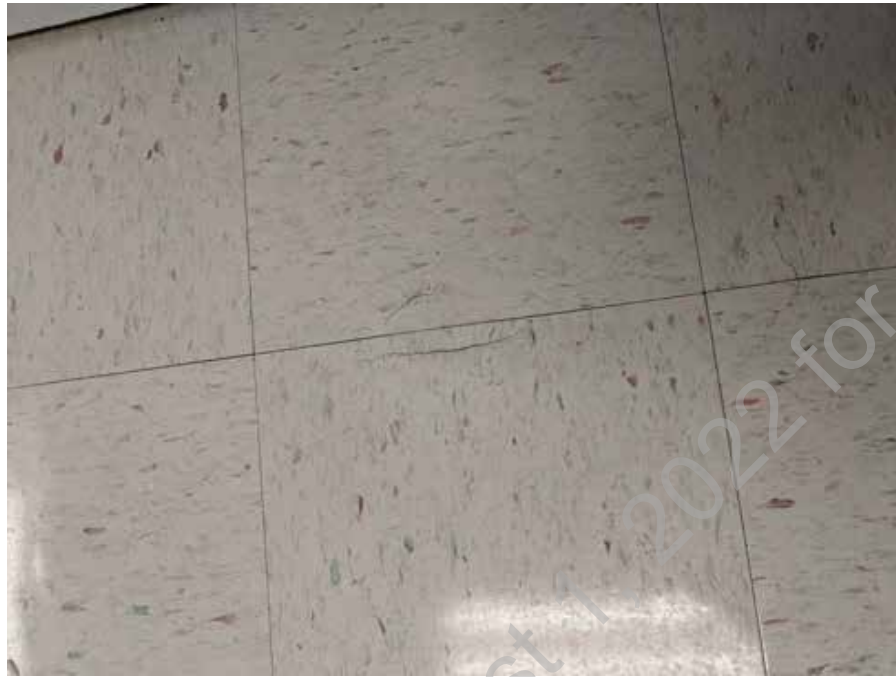
● D1. 43: Damaged vinyl tile flooring at break area

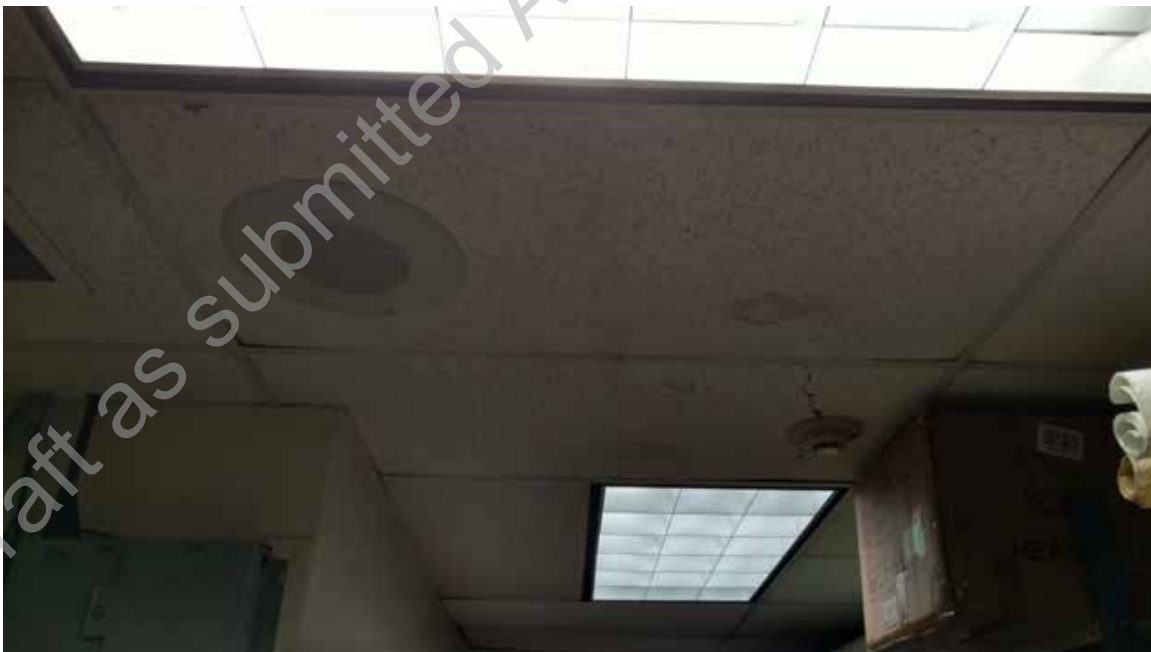
Ceiling speakers were observed throughout the space but it was not clear what could have been sourcing audio to these speakers. The system featured wall mounted volume controls in various locations.

● D2. 2: Ceiling Speaker

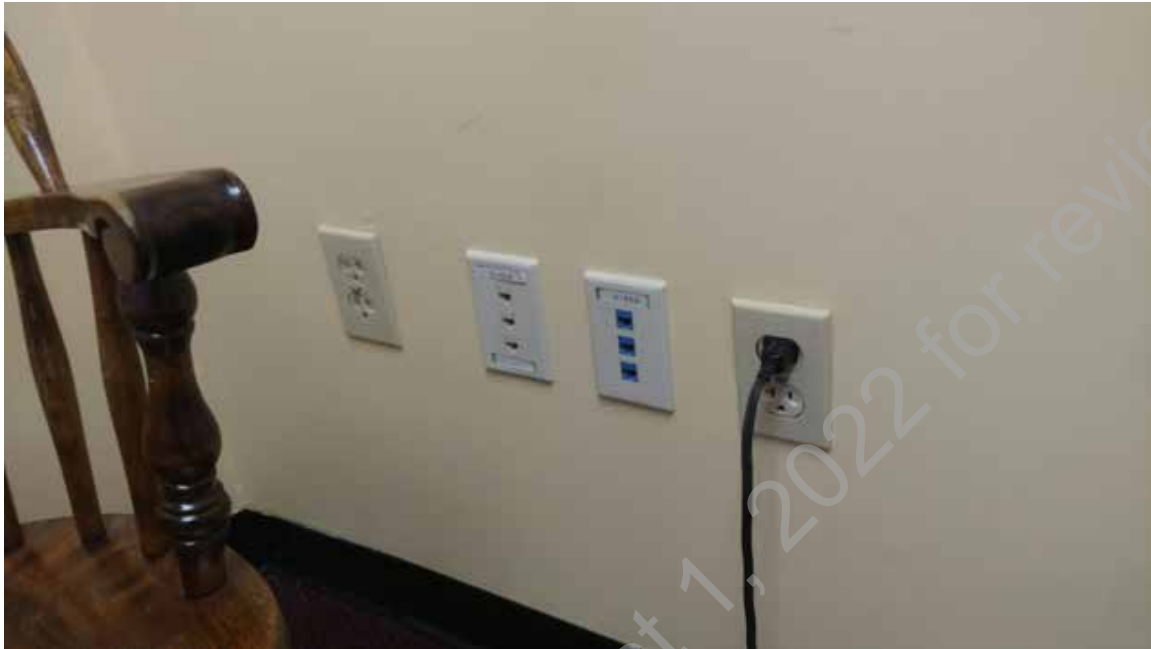
● D2. 3: Data Work Area Outlets

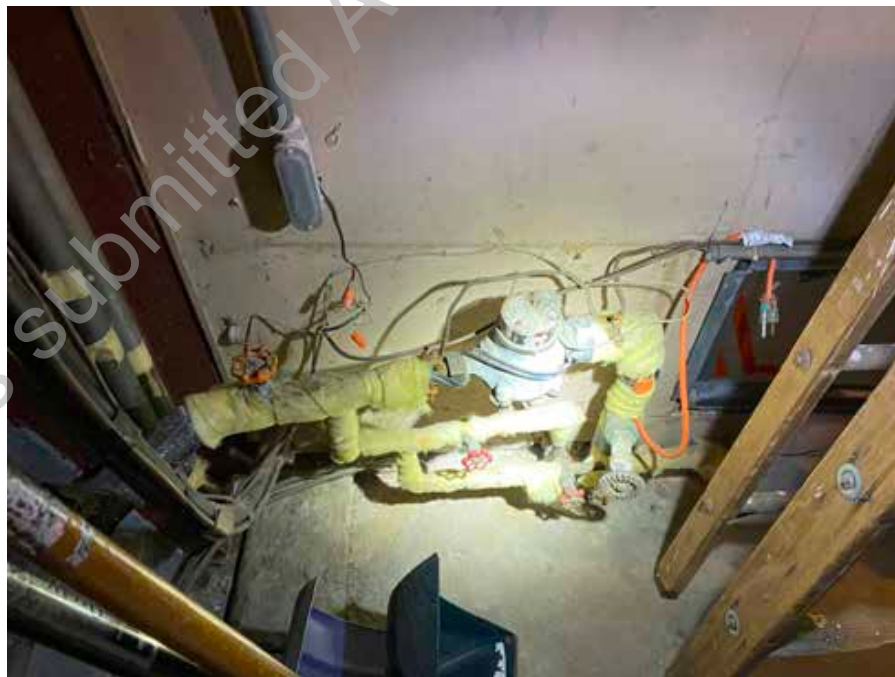
● D2. 4: Domestic Water Service in Poor Condition

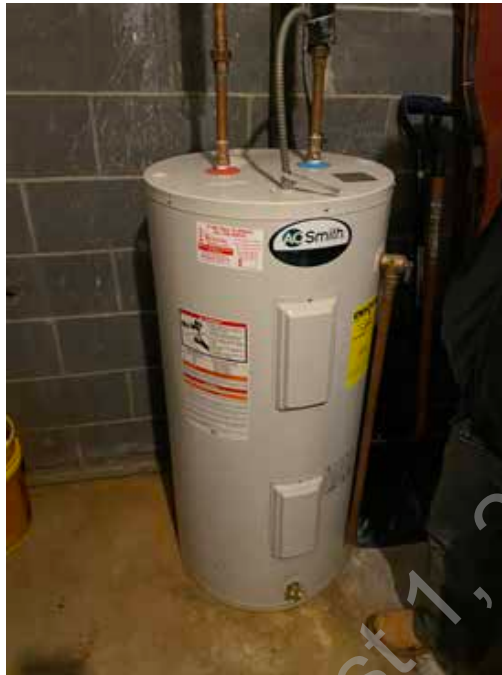
● D2. 5: Electric Domestic Hot Water Heater Located in Mechanical Room

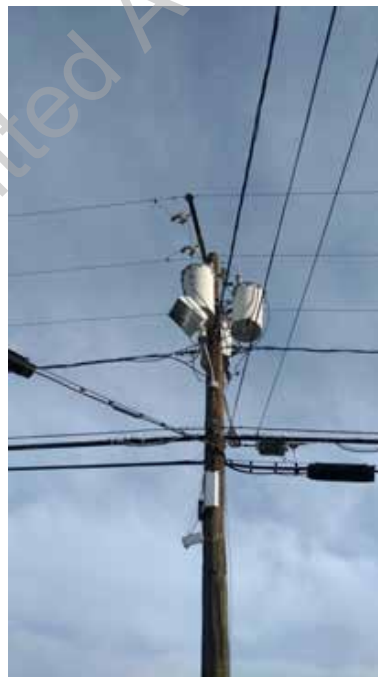
● D2. 6: Electric Service Utility Pole
