TOWN OF SUFFIELD

CONDITIONS ASSESSMENT & MASTER PLAN

Draft as submitted August 1, 2022 for review

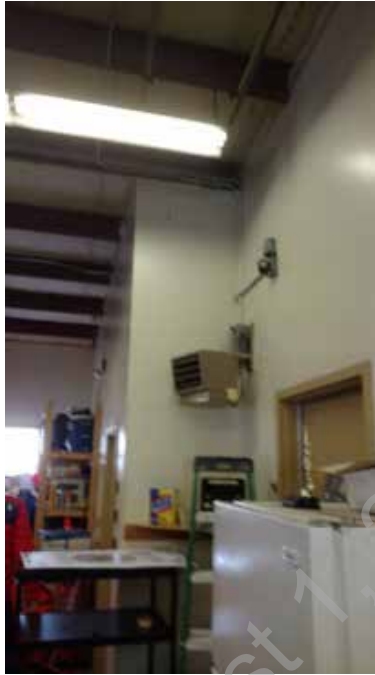
● D2. 7: Electric Unit Heater Serving Garage - Currently Inoperable

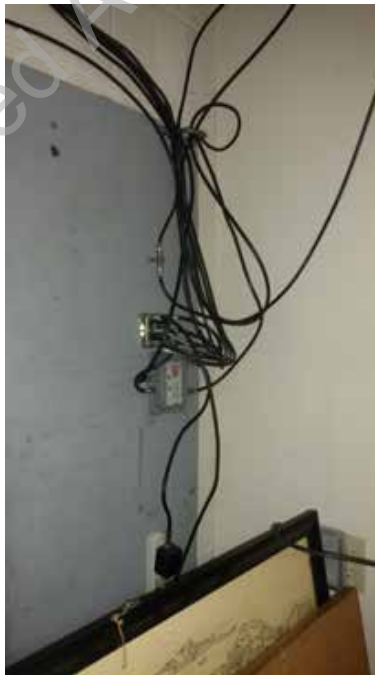
● D2. 8: Electrical Cable TV Distribution

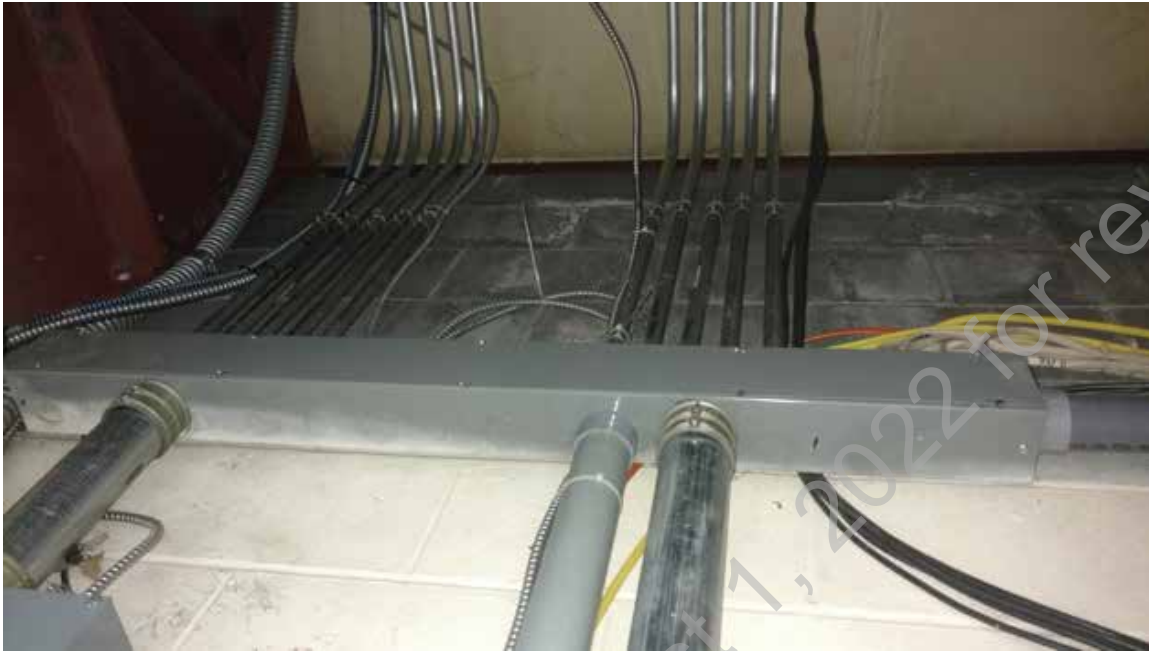
● D2. 9: Electrical Conduit Distribution

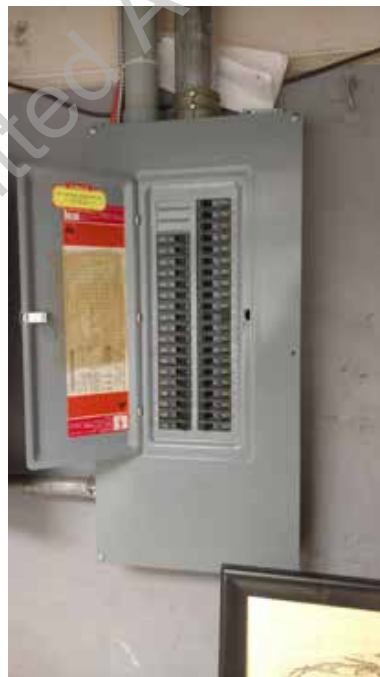
● D2. 10: Electrical Distribution

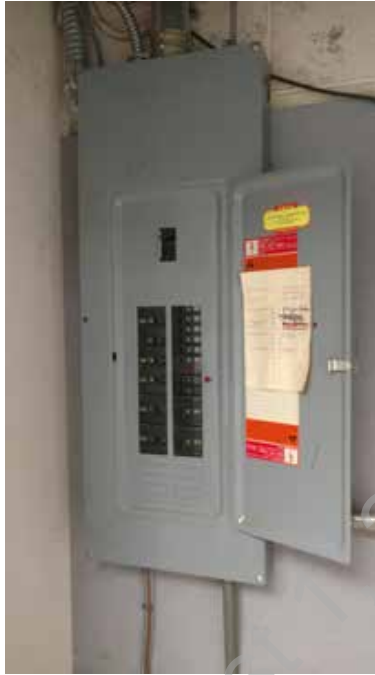
● D2. 11: Electrical Main Service Panel

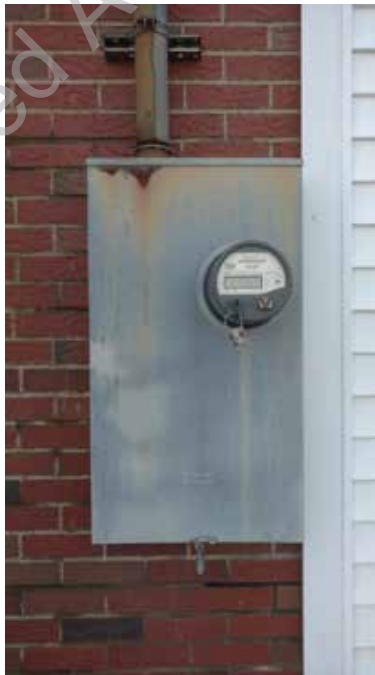
● D2. 12: Electrical Meter

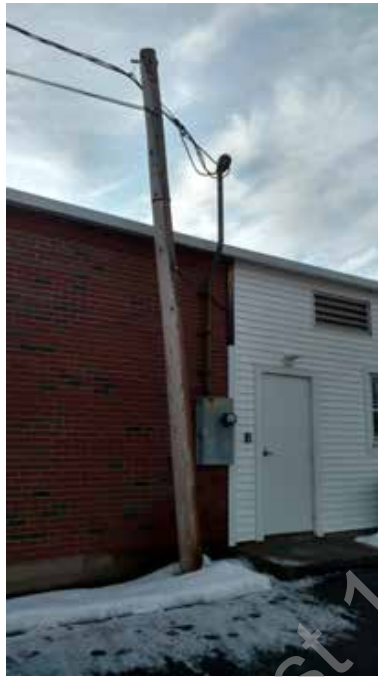
● D2. 13: Electrical Service Drop at Meter

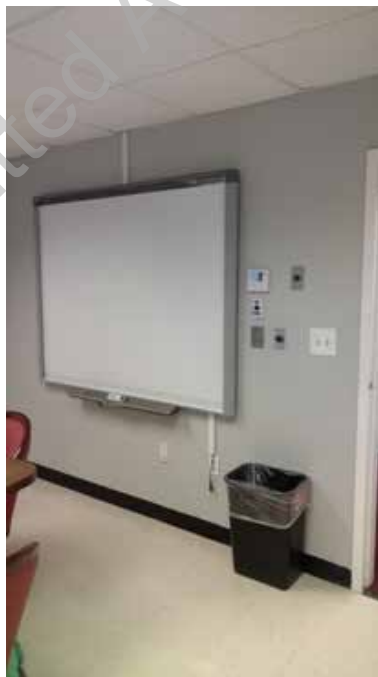
● D2. 14: Electrical Technology in Conference Room

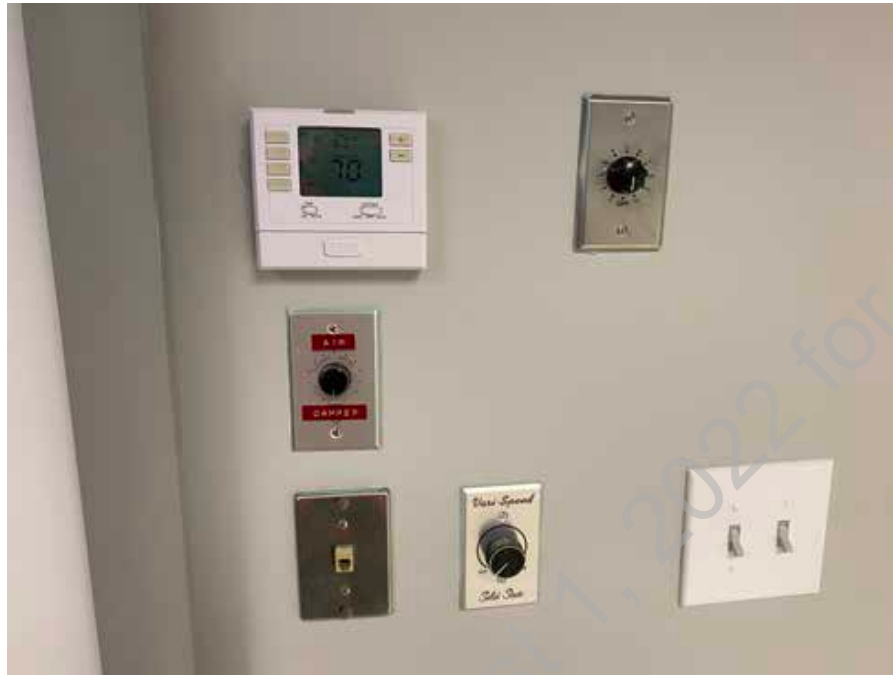
● D2. 15: Electrical Wall Controls

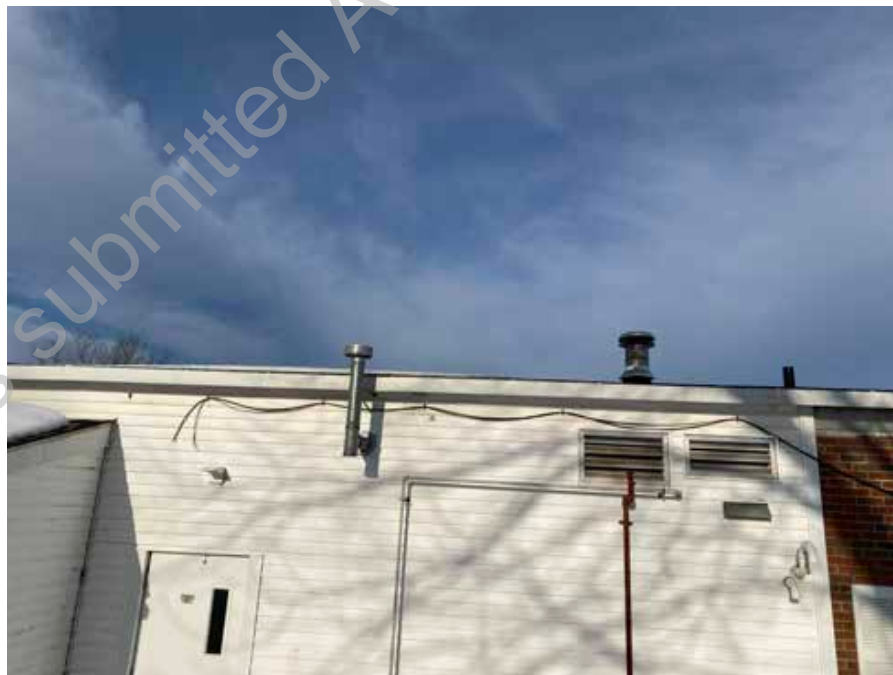
● D2. 16: Exhaust Fan and Vent on Roof

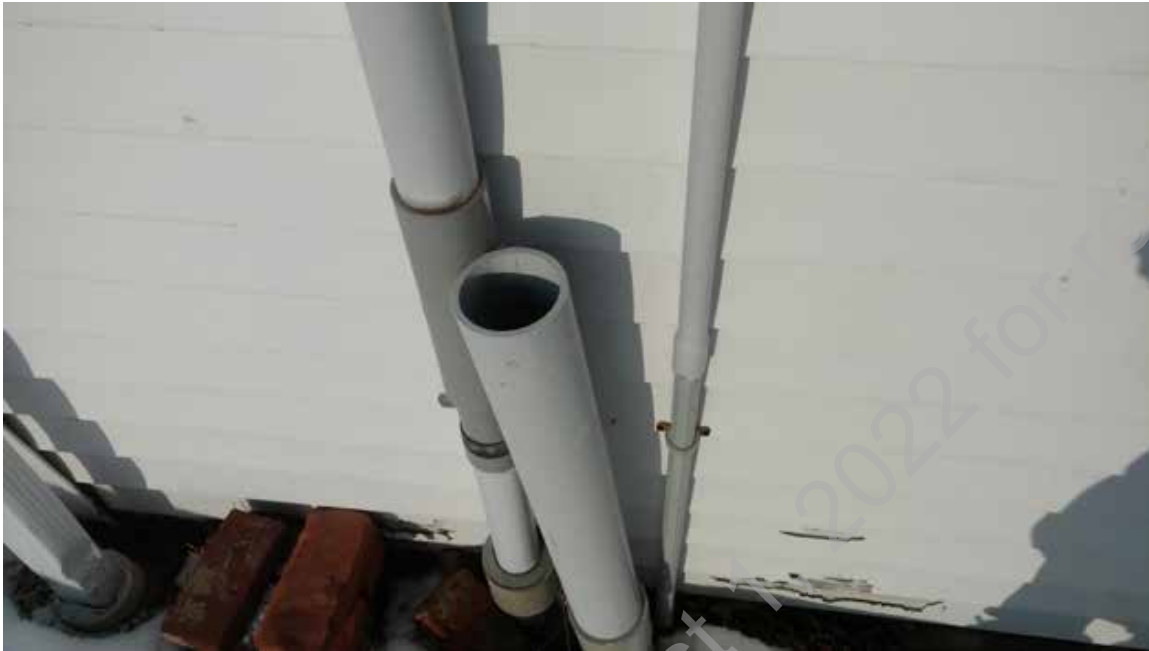
● D2. 17: Exterior Communication Conduit

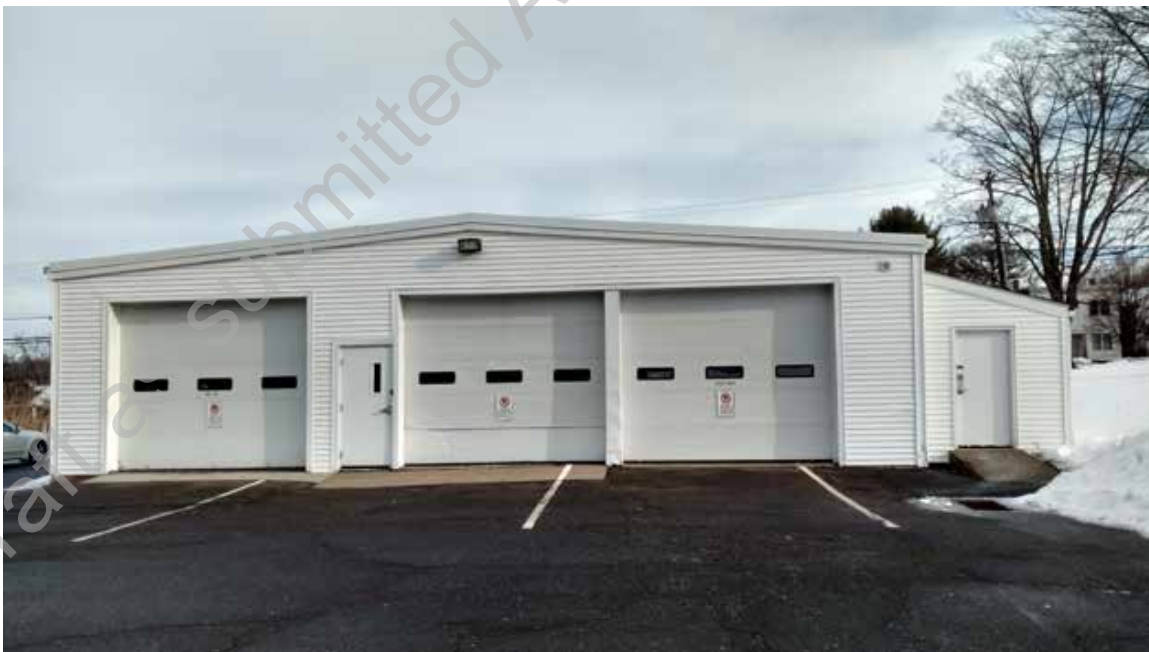
● D2. 18: Exterior HID Wall Pack Lighting Fixture

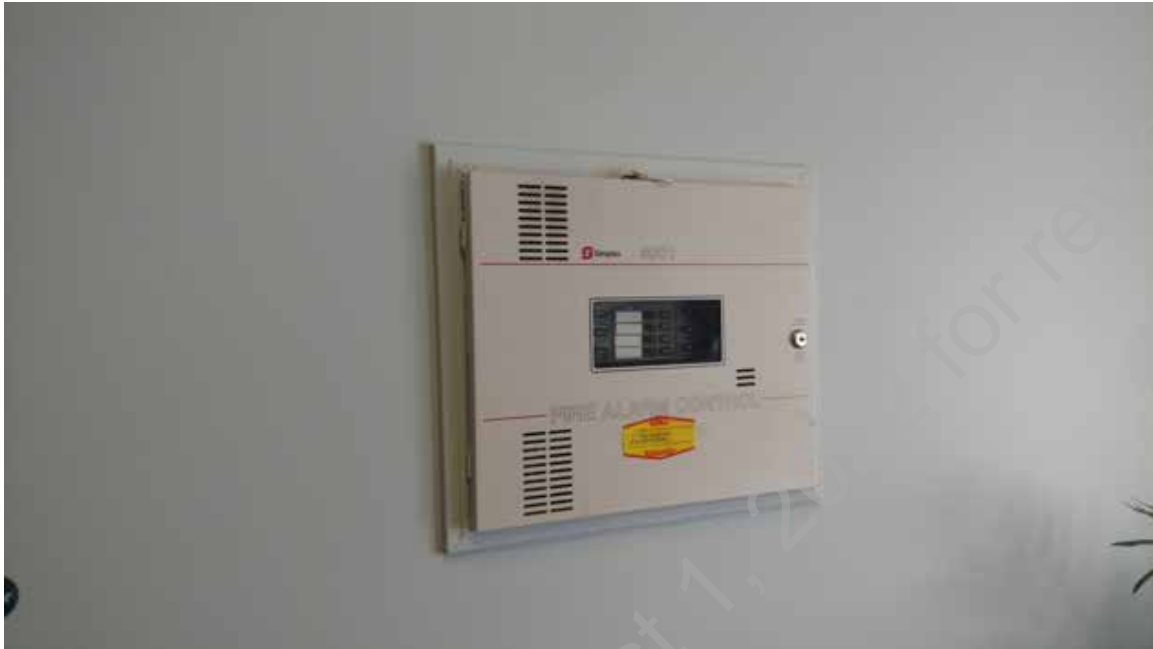
● D2. 19: Fire Alarm Control Panel

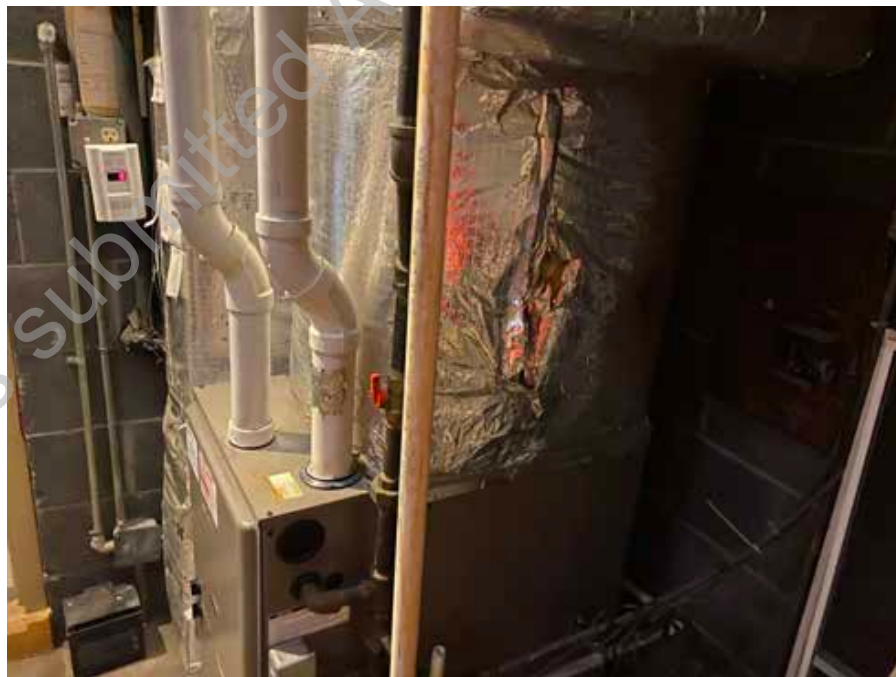
● D2. 20: Furnace Ductwork and Refrigerant Piping in Fair Condition

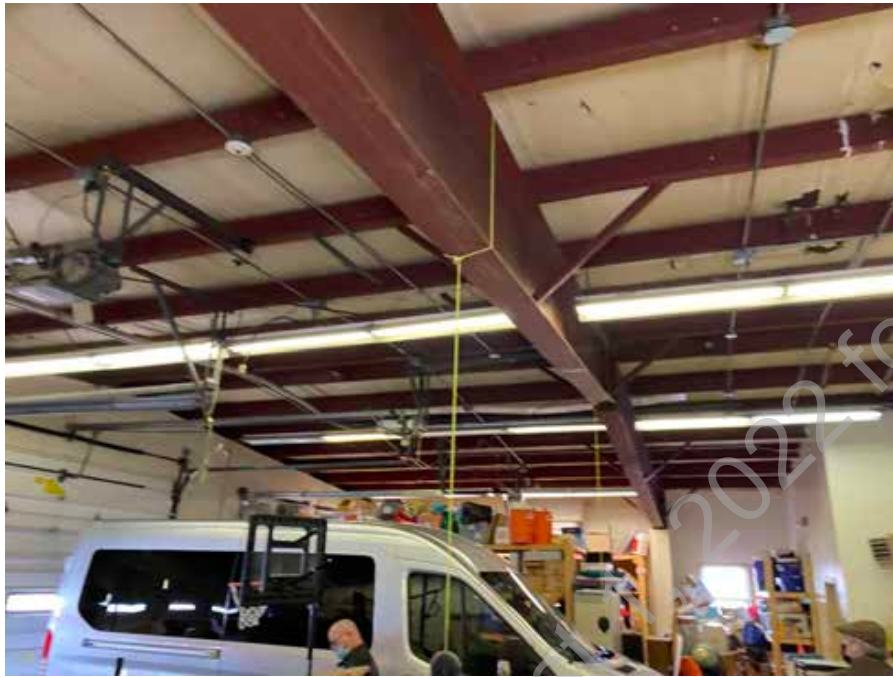
● D2. 21: Garage Lighting Fixtures

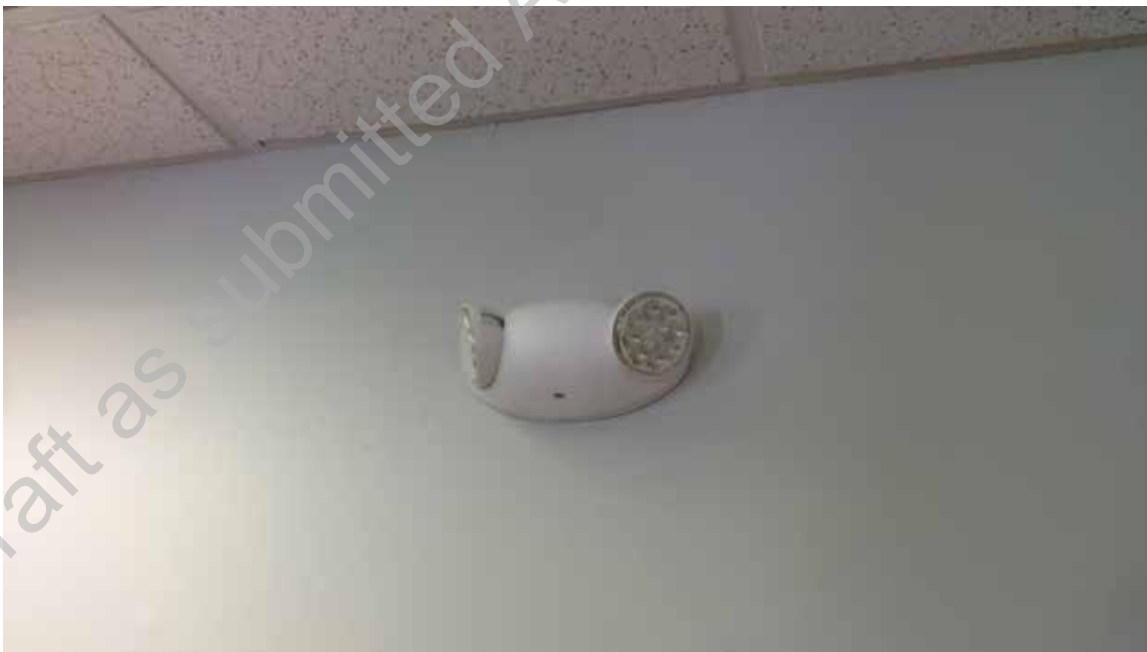
● D2. 22: Interior Egress Lighting Fixture

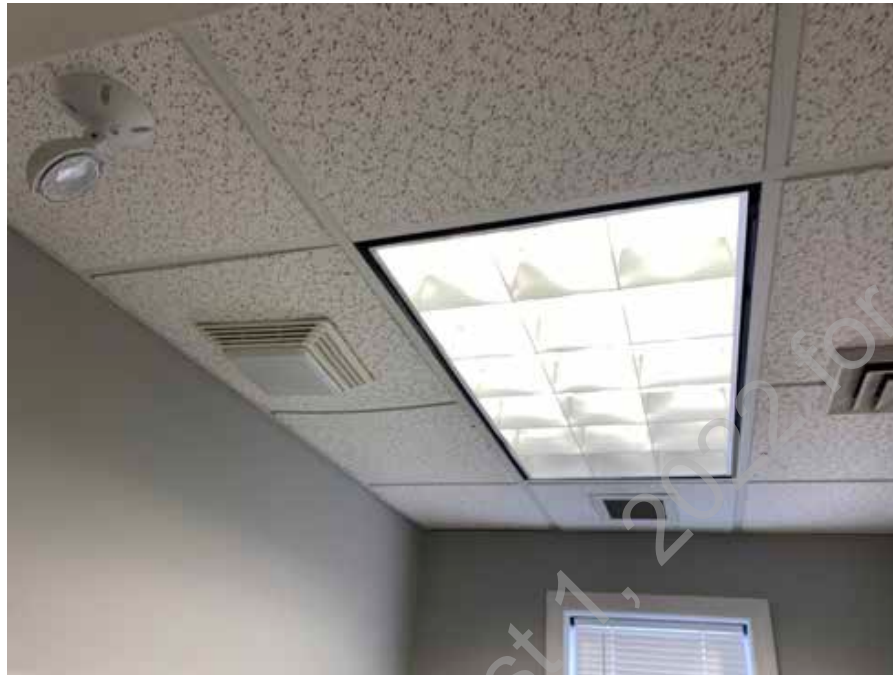
● D2. 23: Interior Lighting Fixture

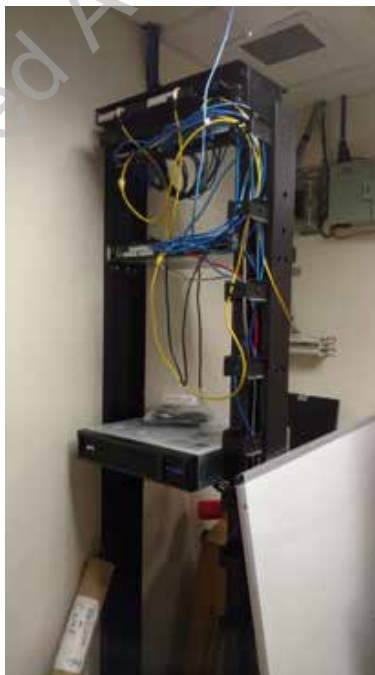
● D2. 24: MDF Data Network Rack

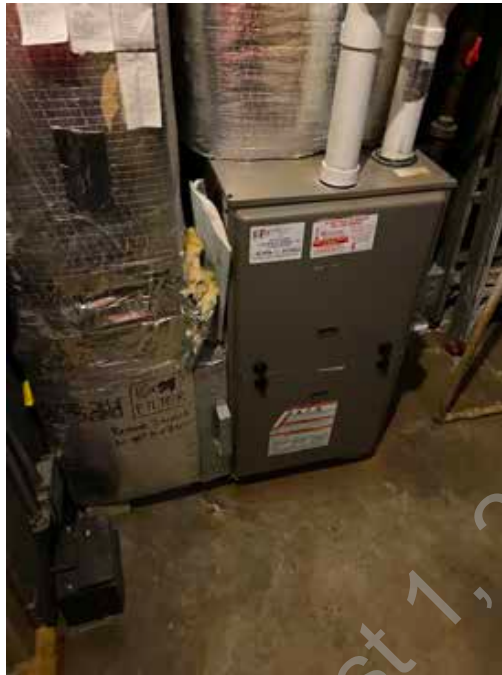
● D2. 25: Natural Gas Fired Furnace Located in Mechanical Room

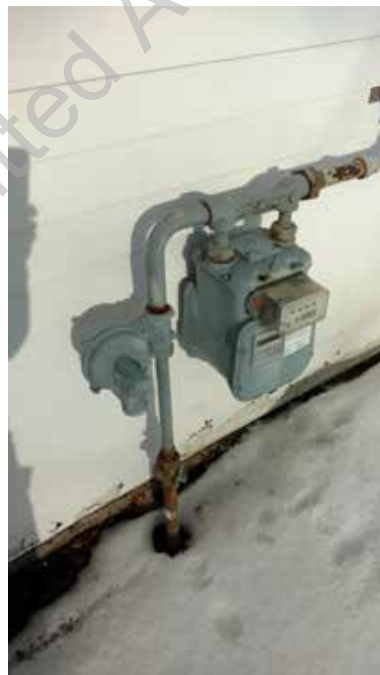
● D2. 26: Natural Gas Service Located Outside

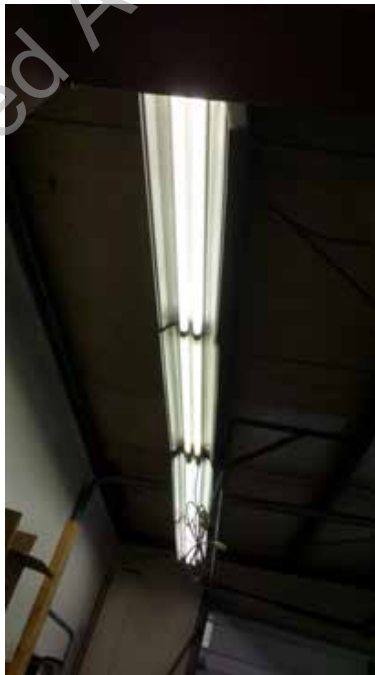
● D2. 28: Outdated T10 Fluorescent Lighting in Garage Bays

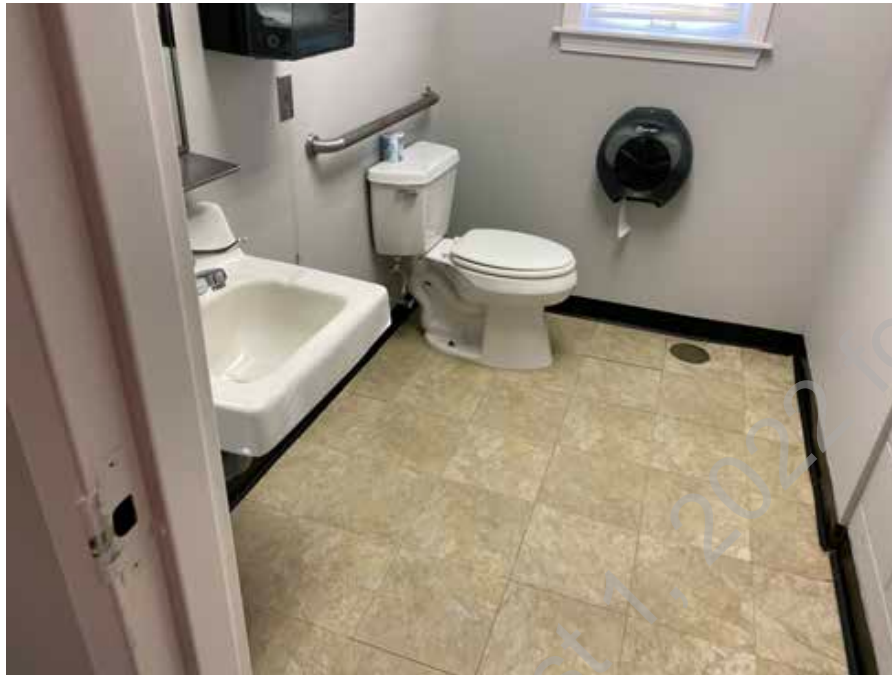
● D2. 29: Plumbing Fixtures in Good Working Condition

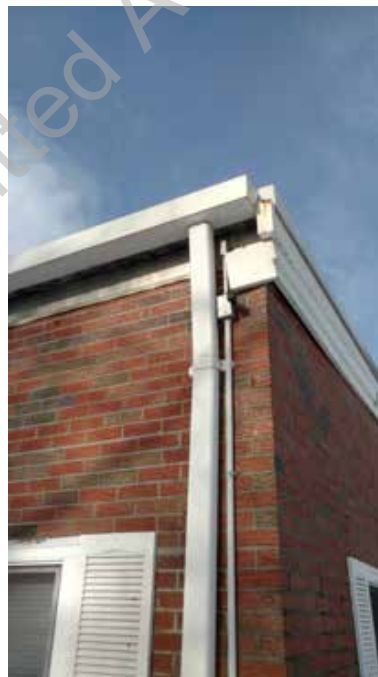
● D2. 30: Rood Drain Gutter System

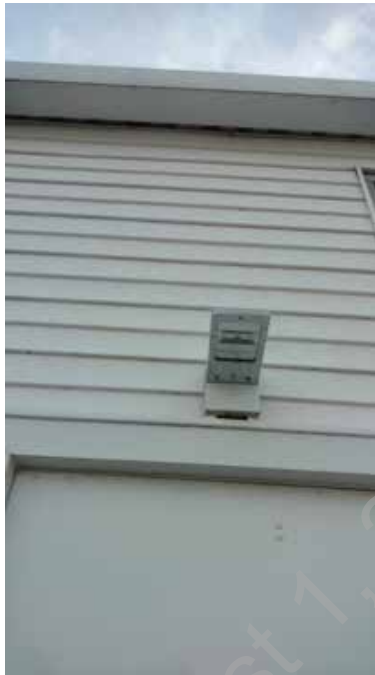
● D2. 31: Side Door Exterior Lighting Fixture

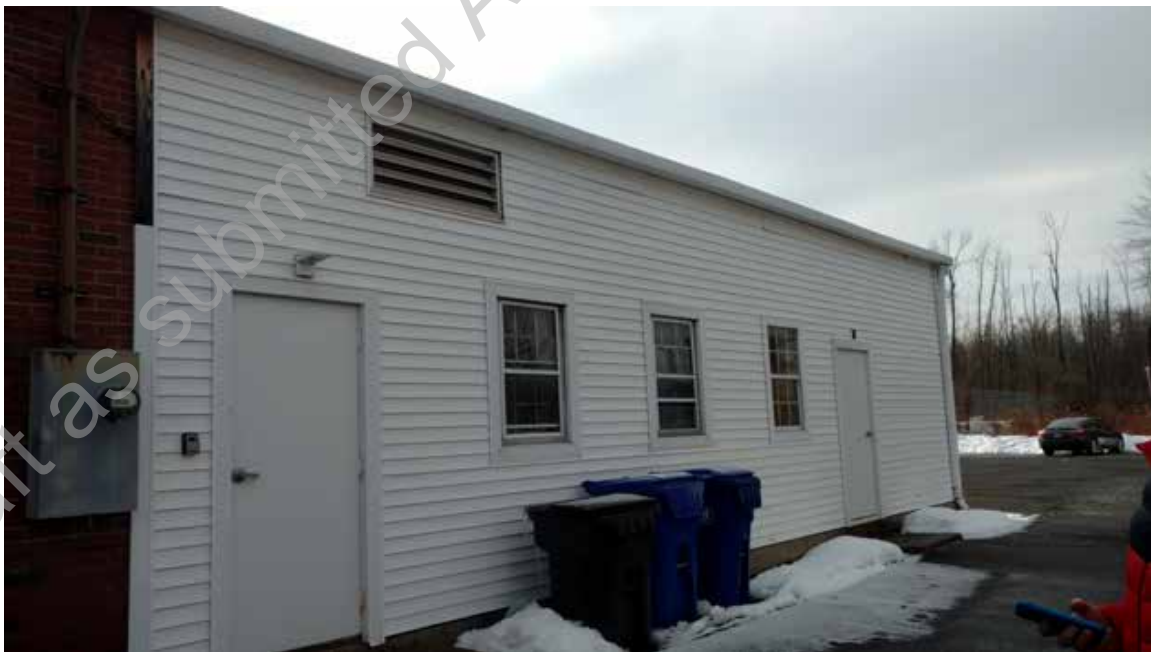
● D2. 32: Sidewall Exhaust Louver Serving Furnace

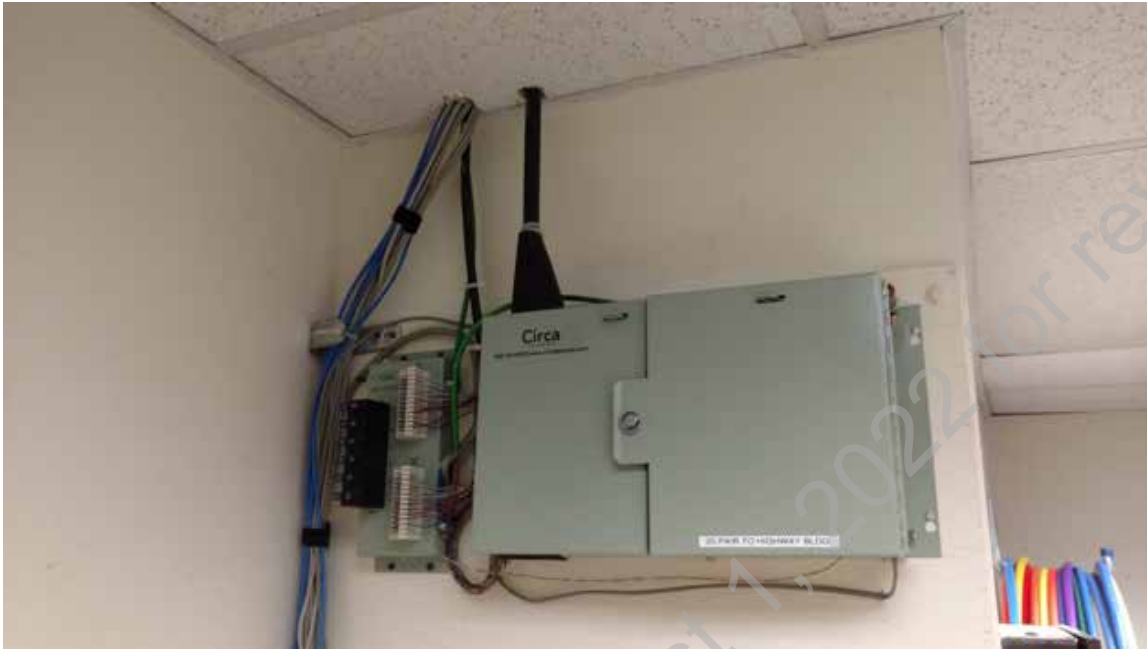
● D2. 33: Telecommunications Hub

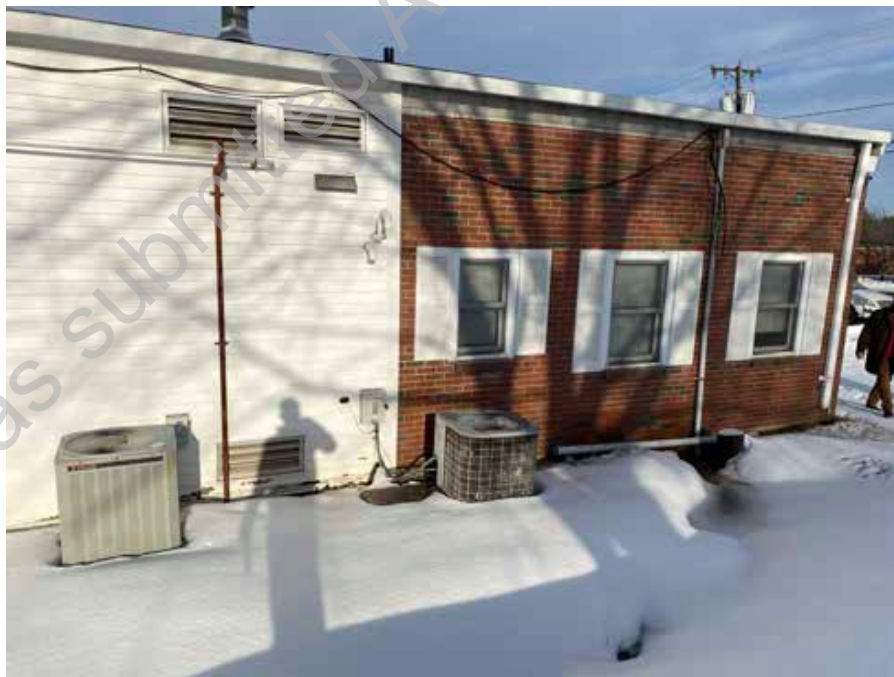
● D2. 34: Trane Condensing Unit Serving the Furnace and Old Abandoned Condensing Unit

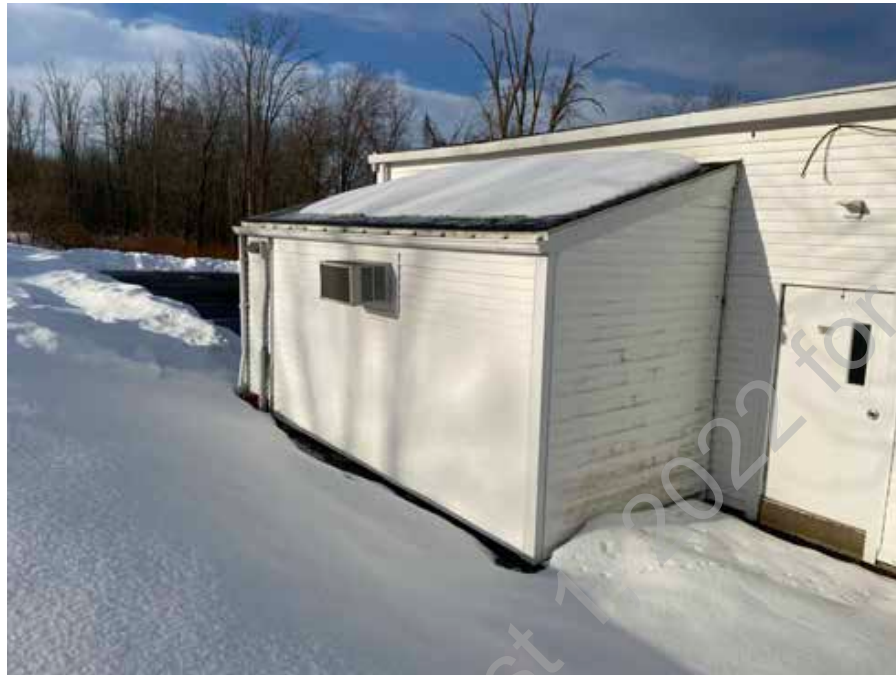
● D2. 35: Window Mounted AC Unit

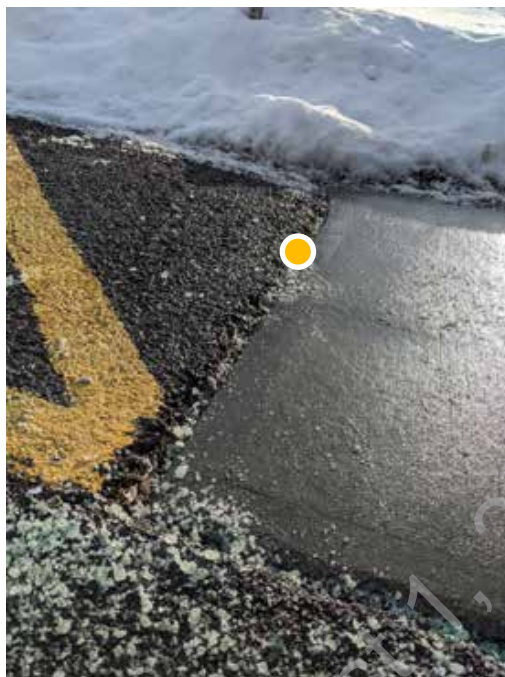
● D3. 1: Corrosion of pavement at base of entrance ramp

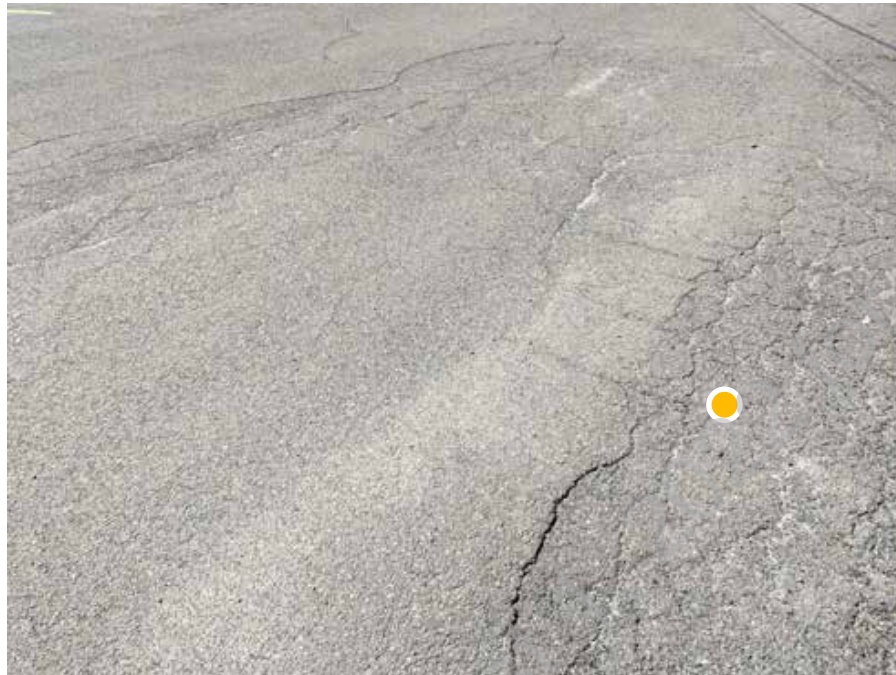
● D3. 3: Cracking pavement throughout parking areas and drive aisles

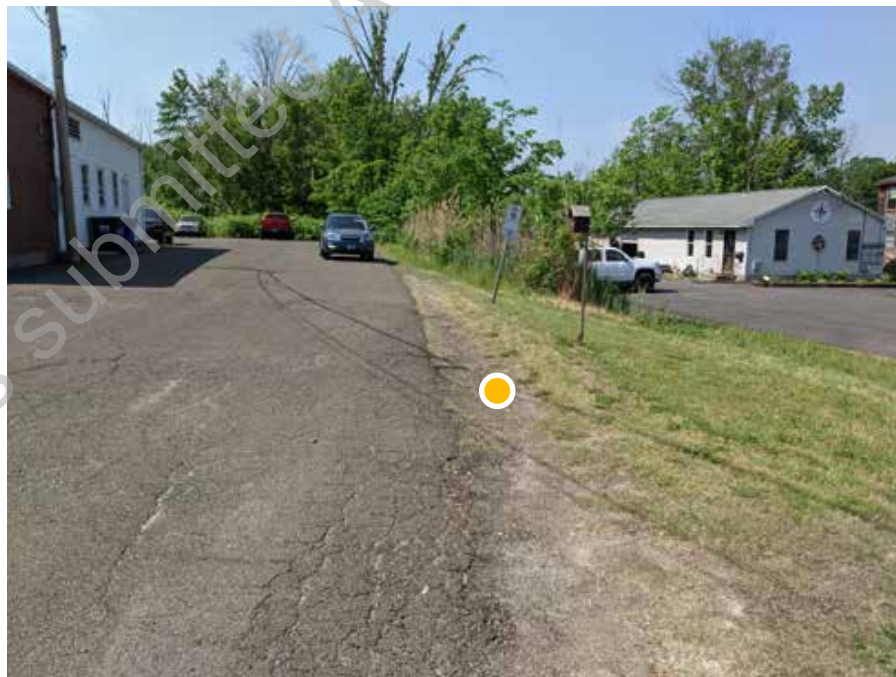
● D3. 4: Uneven and spotty lawn along West drive aisle

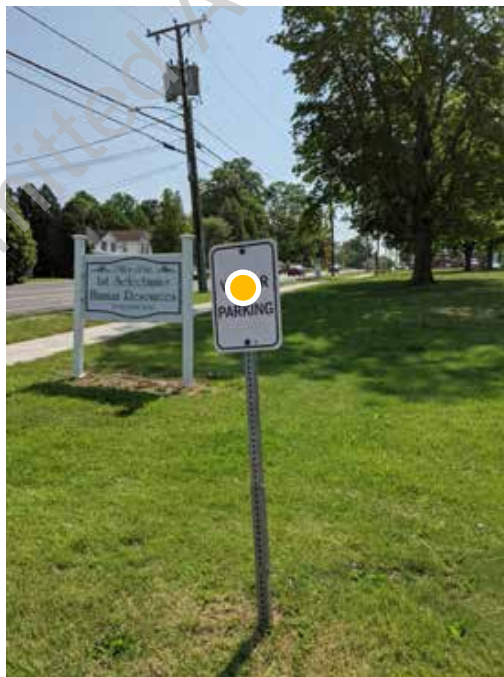
● D3. 6: Warped parking signage at main entry

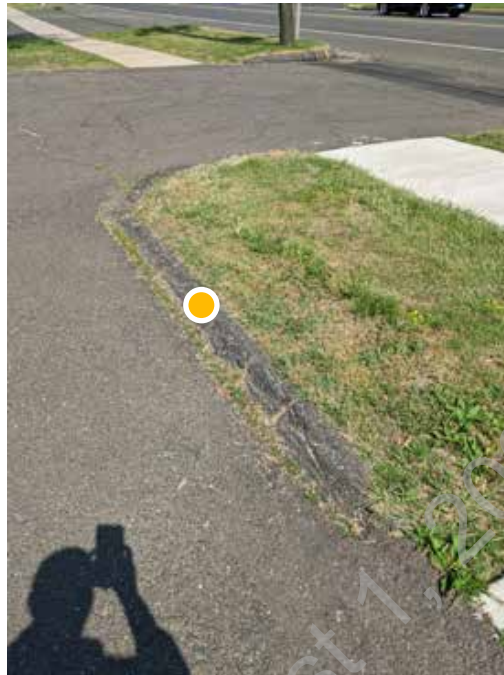
● D3. 7: Damaged bituminous curbs along parking and drive aisles

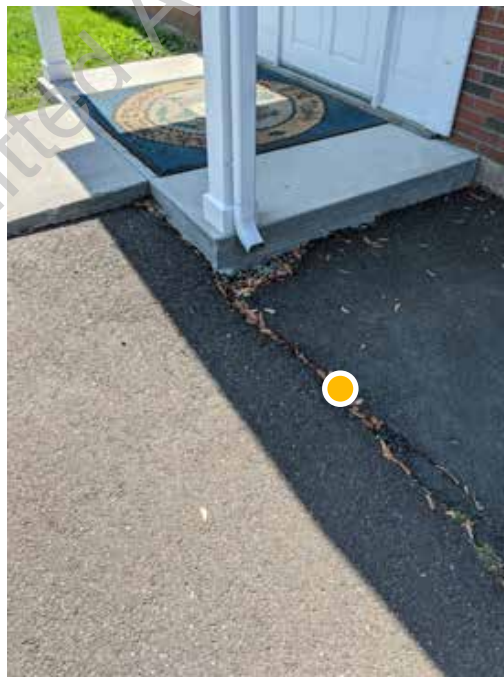
● D3. 8: Bituminous pavement cracking at main entry

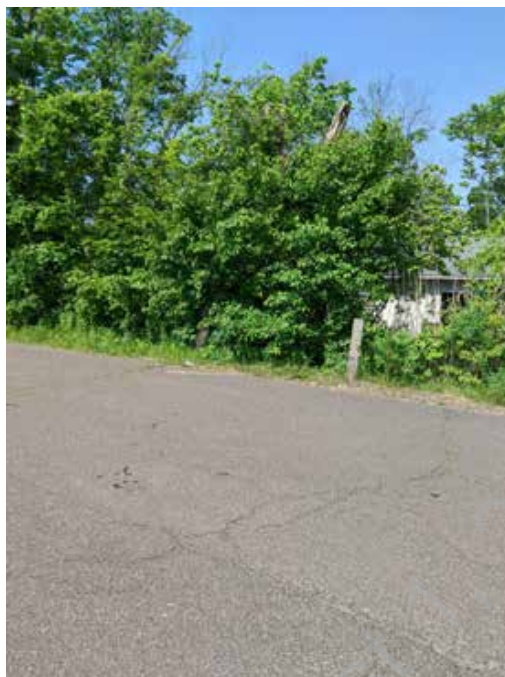
● D3. 9: Cracking pavement throughout parking areas and drive aisles

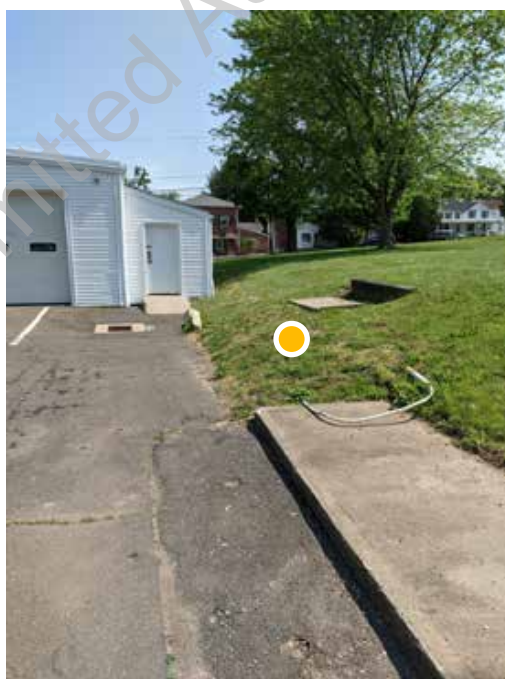
● D3. 10: Uneven and spotty lawn at rear parking area

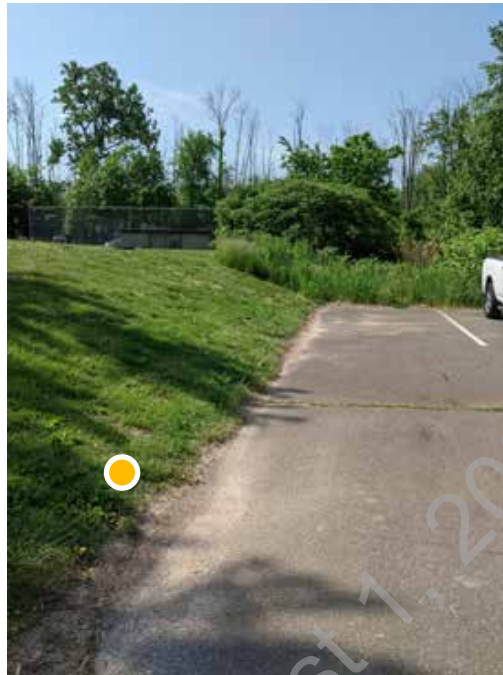
● D3. 11: Uneven and spotty lawn at rear parking area

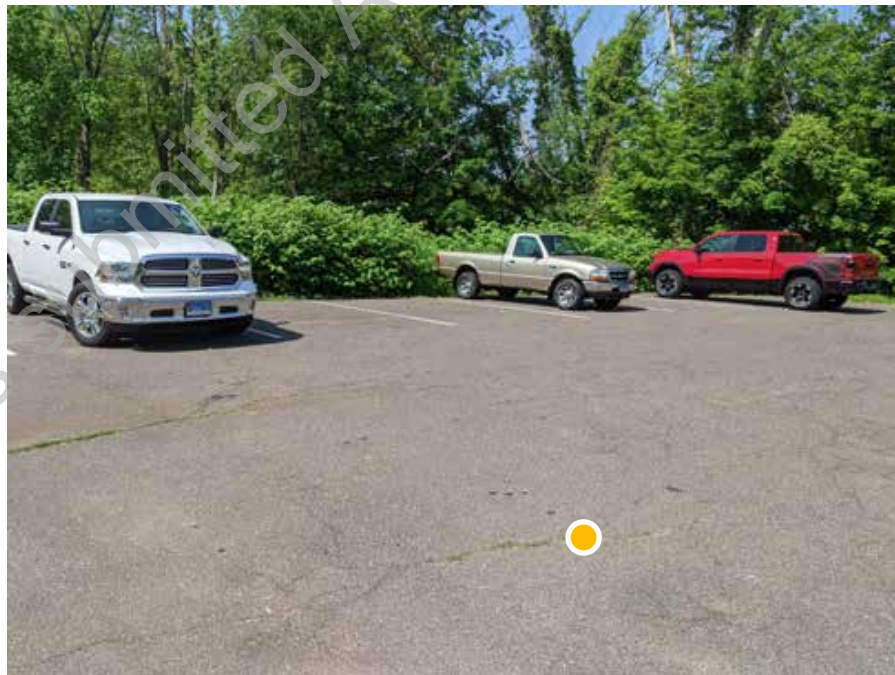
● D3. 12: Cracking pavement throughout parking areas and drive aisles

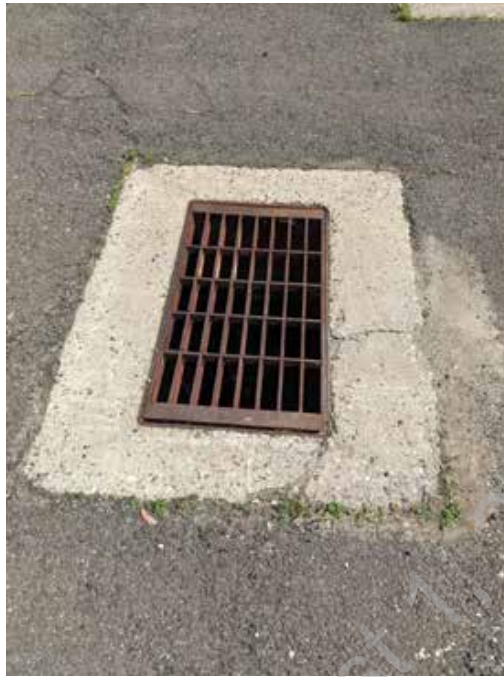
- D3. 13: Damaged concrete catch basin top at rear parking area; Metal grate is beginning to rust

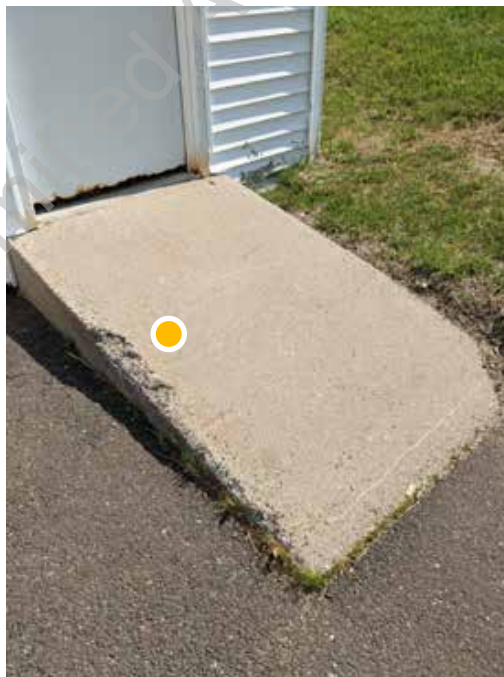
- D3. 14: Damaged concrete ramp at rear storage door

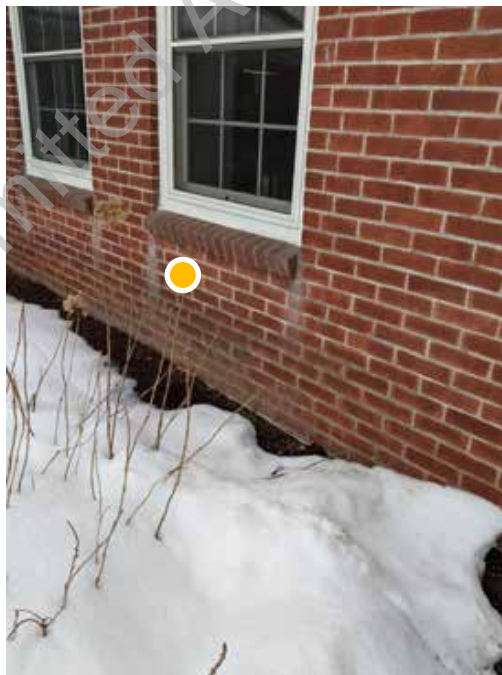
● D1. 10: Staining at brick below windows

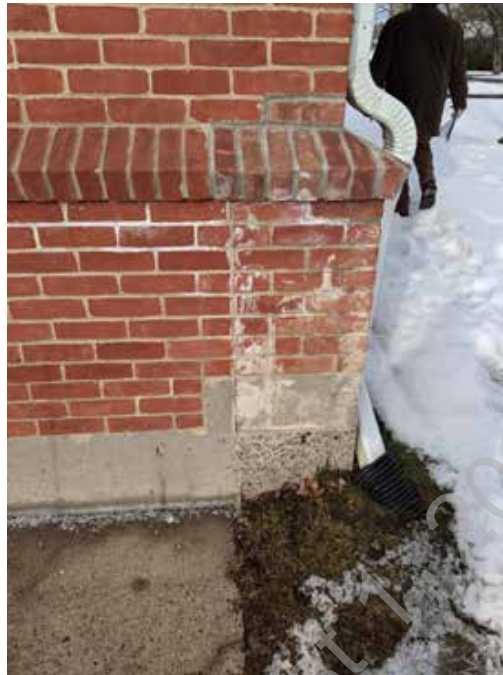
● D1. 11: Detail view of masonry; appears to be poorly patched

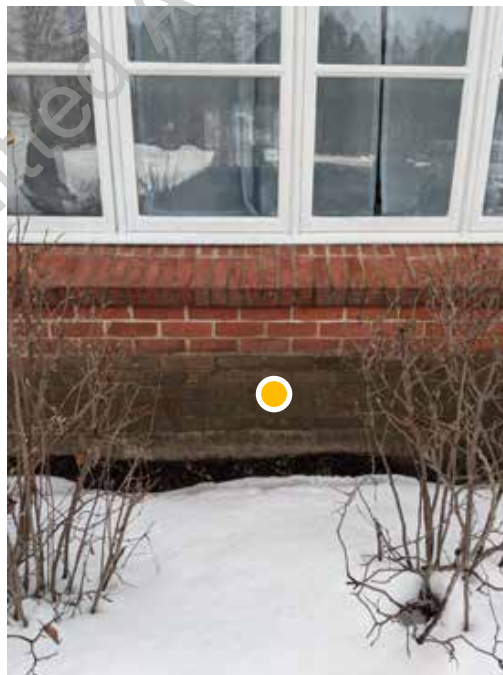
● D1. 12: Lack of gutter system above is causing soil erosion below and splashback onto brick façade

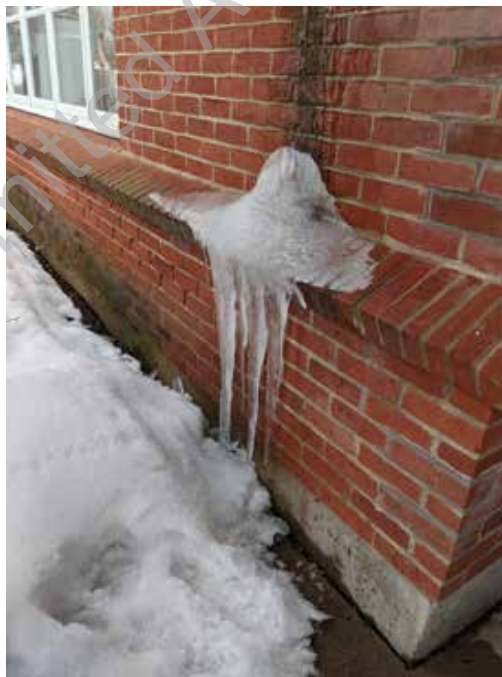
● D1. 14: Lack of proper gutter flashing above is causing ice build up and staining on brick shelf below

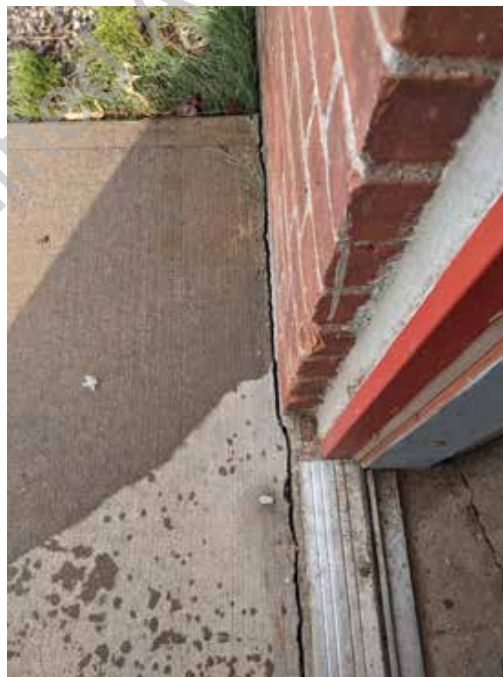
● D1. 16: Cracking at rear mechanical room sidewalk

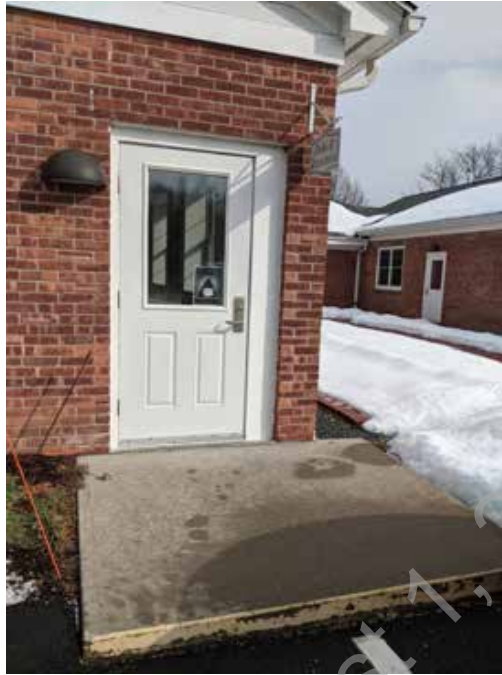
- D1. 17: Concrete step at entrance to Parks and Recreation; This entrance is not accessible

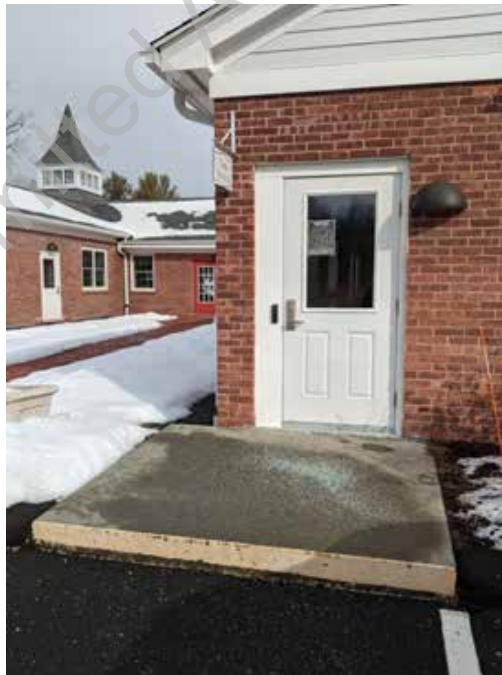
- D1. 18: Concrete step at entrance to Youth Services; This entrance is not accessible

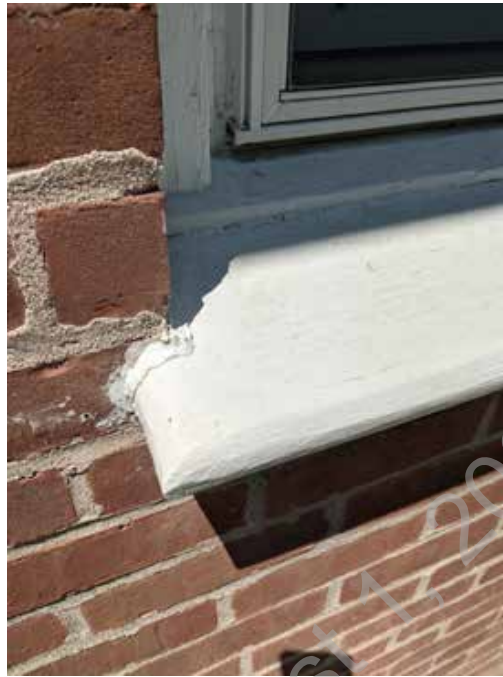
● D1. 19: Wood windows are poorly caulked

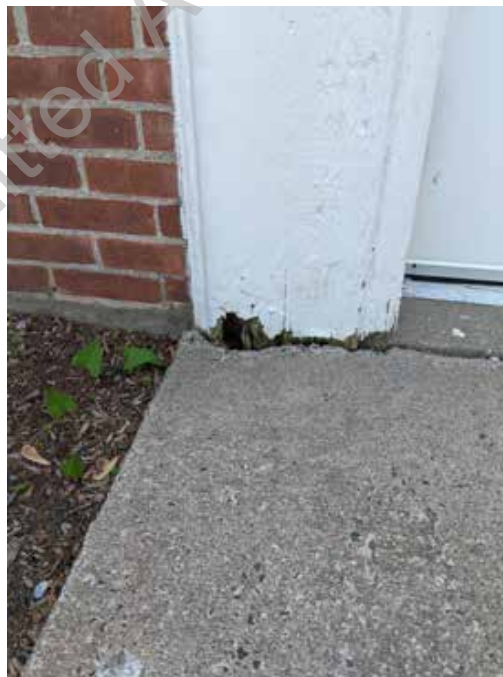
● D1. 20: Damaged wood trim at entry door

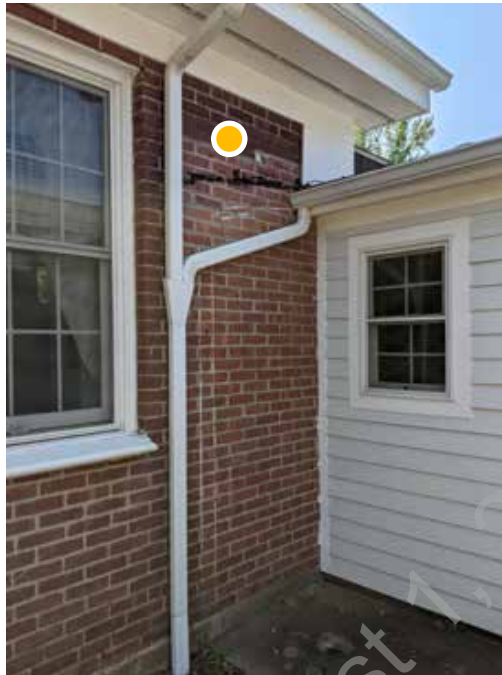
● D1. 21: Adhesive left from former roof to wall flashing location

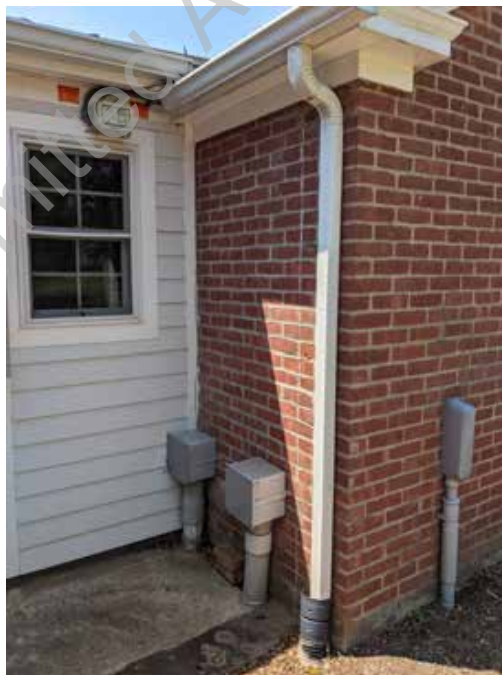
● D1. 22: Detail view of interior corner; a gap is present at the joint between brick and vinyl siding

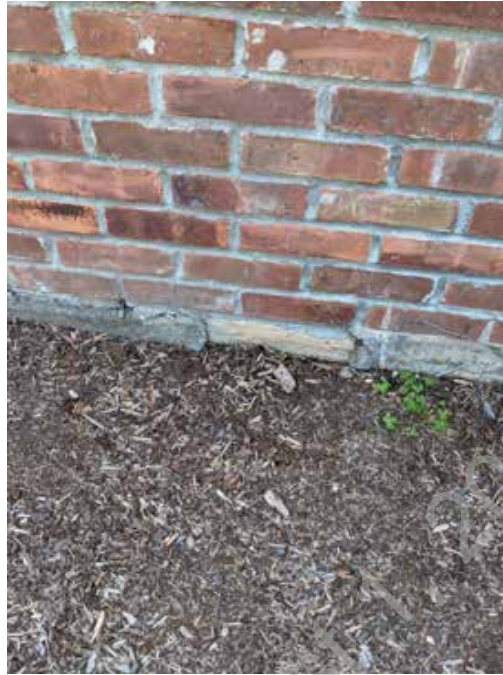
● D1. 23: Spalling concrete foundation at perimeter
