TOWN OF SUFFIELD

CONDITIONS ASSESSMENT & MASTER PLAN

Draft as submitted August 1, 2022 for review

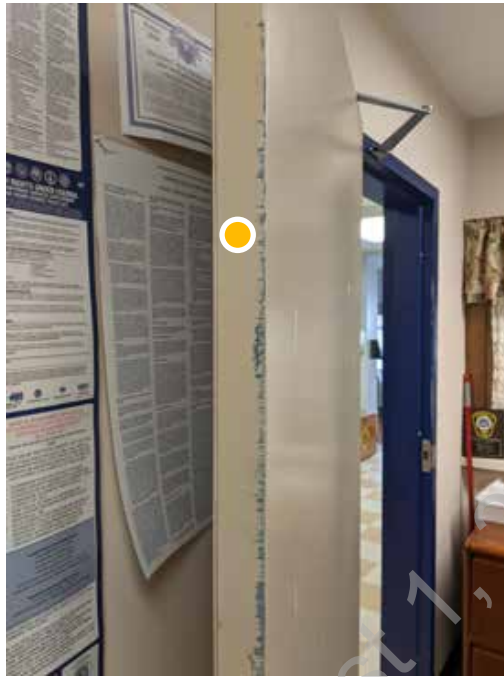
OFFICES: Offices around the main entry are carpeted and in good condition. Office doors in this area require adjustment to avoid rubbing on the frame. Re-painting of doors is required at these locations.

● D1. 29: Office doors need adjustment to prevent rubbing on frames

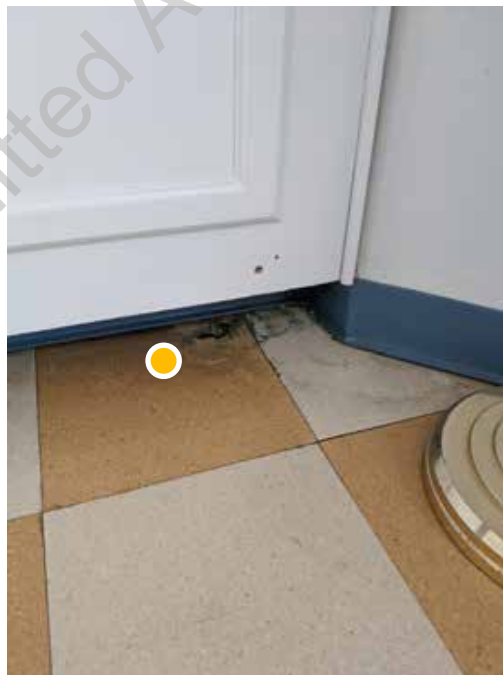
● D1. 32: Radiator leak has caused damage to vinyl tile floors

Interior Improvements				\$ -					\$ -	\$ -	\$ -											
Replace damaged VCT tiles	50	SF	\$8	\$ 385	\$ 39	\$ 6	\$ 29	\$ 19	\$ 477	\$ 60	\$ 537	\$ 107	\$ 644									
Repair/paint cracks in GWB walls, add control joints	30	SF	\$11	\$ 330	\$ 33	\$ 5	\$ 25	\$ 17	\$ 409	\$ 51	\$ 460	\$ 92	\$ 552									
Division 21 - Fire Protection				\$ -					\$ -	\$ -	\$ -											
Division 22 - Plumbing				\$ -					\$ -	\$ -	\$ -											
Water Distribution and Drainage Systems	11,702	SF	\$10	\$ 115,850	\$ 11,585	\$ 1,738	\$ 8,689	\$ 5,792	\$ 143,654	\$ 17,957	\$ 161,610	\$ 32,322	\$ 193,933	3-5yrs useful life. All original piping from the 1950 construction is past its useful life, all piping from the 2009 renovation is approaching the end of its useful life in 10+ years.								
Plumbing Fixtures / Equipment	11,702	SF	\$4	\$ 51,489	\$ 5,149	\$ 772	\$ 3,862	\$ 2,574	\$ 63,846	\$ 7,981	\$ 71,827	\$ 14,365	\$ 86,192	5-10yrs useful life. Replacement of all plumbing fixtures throughout the building.

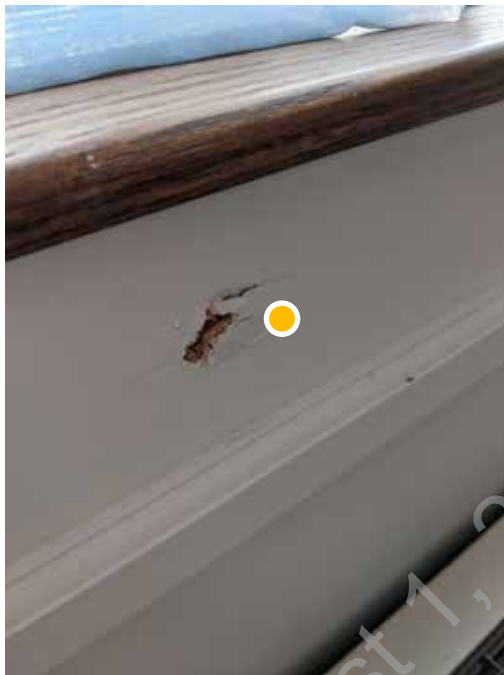
● D1. 33: Damaged wood trim below Dance Hall window

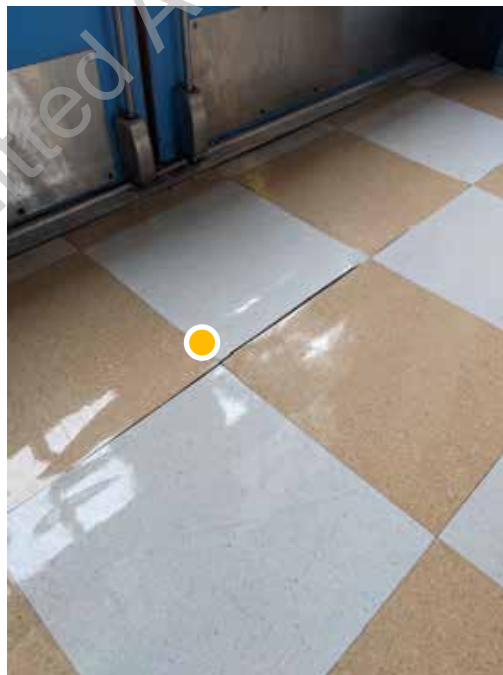
● D1. 36: Damaged vinyl tile flooring at entry doors into Dining

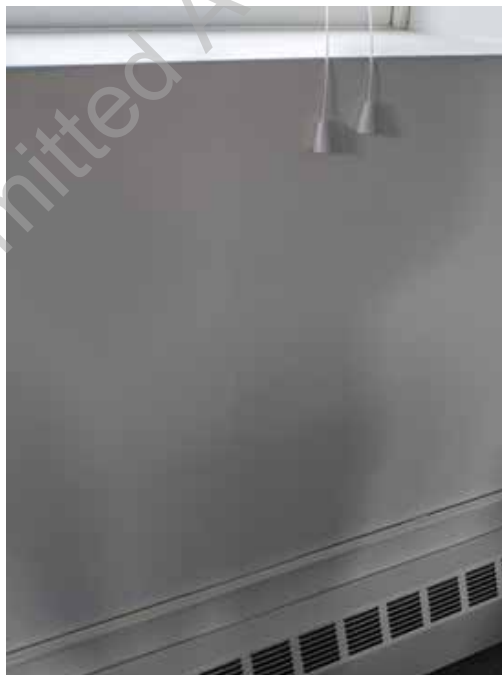
● D1. 38: Gypsum board cracking below windows

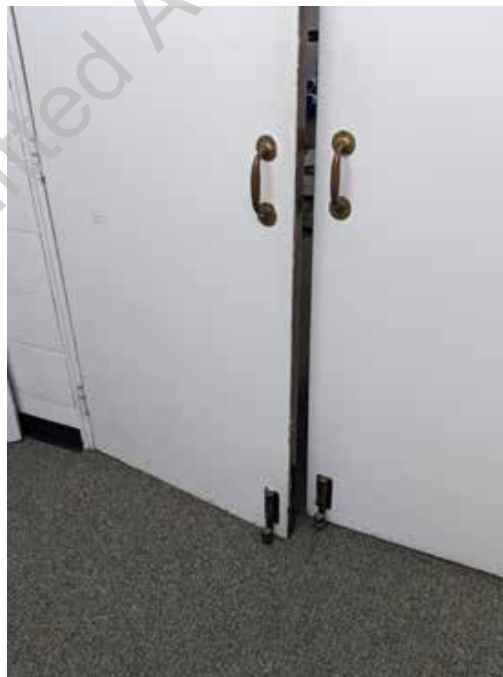
● D1. 40: Door between Lecture Hall and vestibule does not properly seal

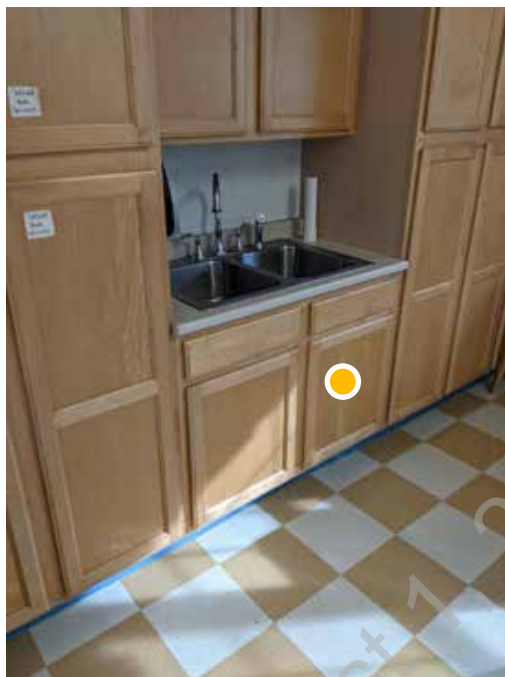
● D1. 41: Kitchenette in Youth Services is not accessible

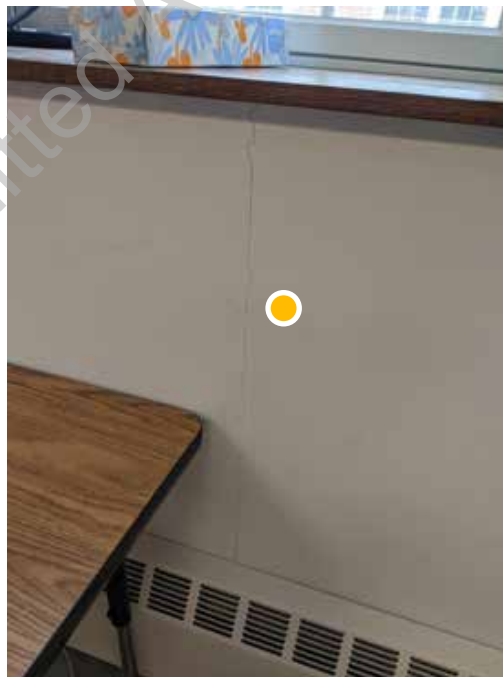
● D1. 44: Gypsum board cracking below windows

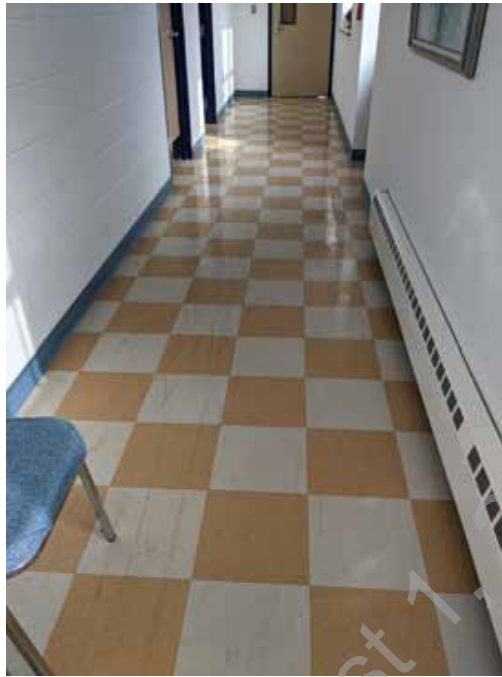
- D1. 45: Scuffed and damaged vinyl tile flooring at corridor adjacent to Parks and Recreation

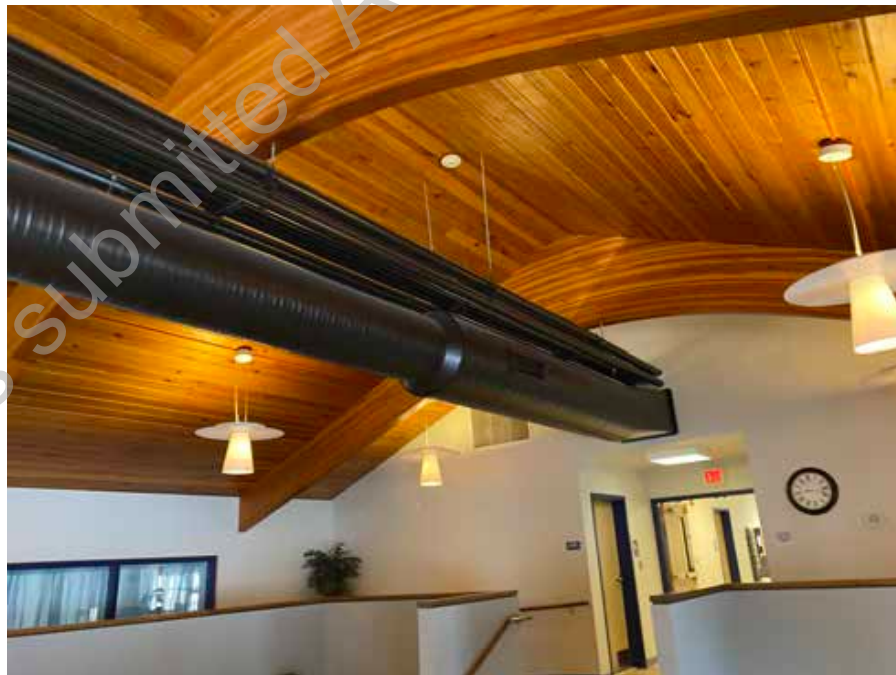
● D2. 6: Ductwork From Fan Coil Unit in Good Condition

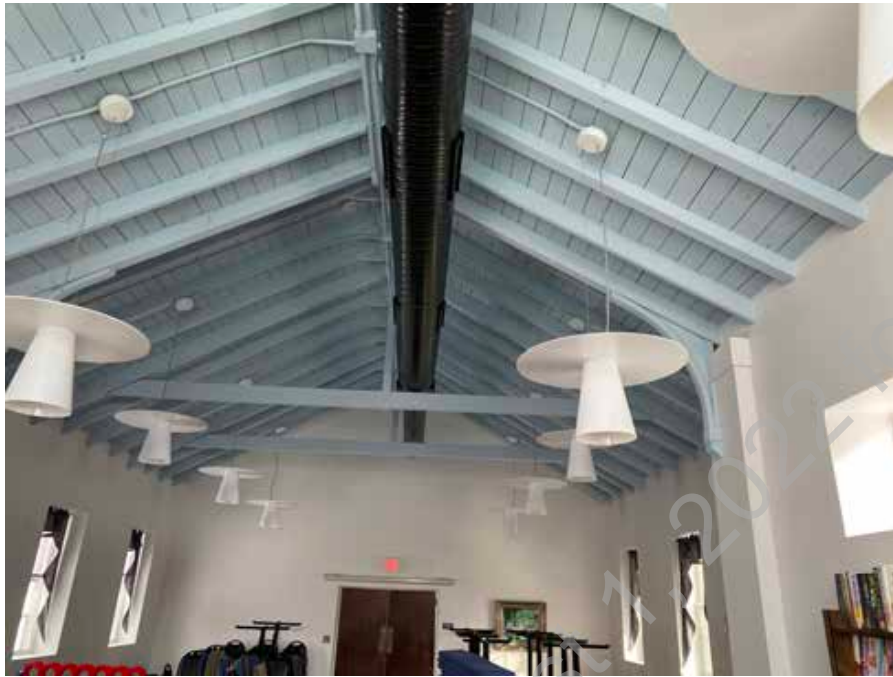
● D2. 7: Ductwork and Lighting in Good Condition

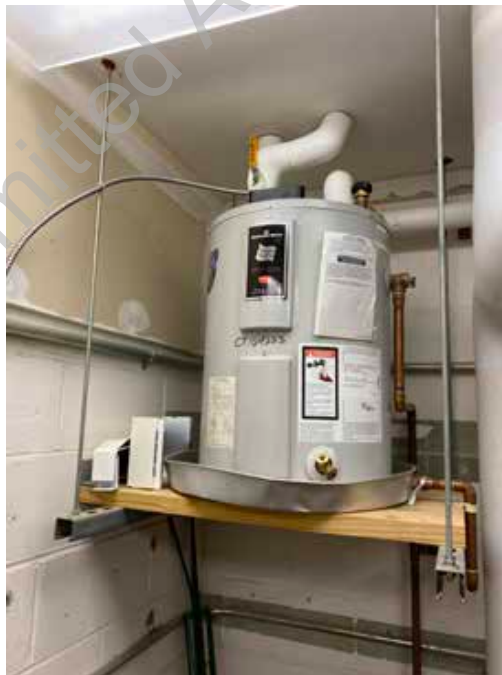
● D2. 8: Electric Domestic Water Heater in Boiler Room

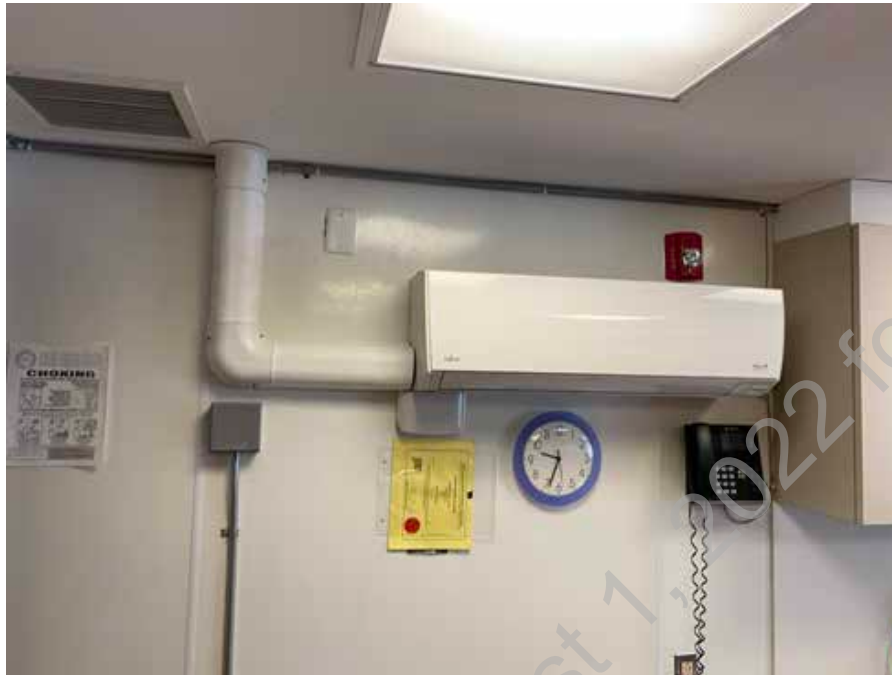
● D2. 23: Fujitsu Wall Mounted Split Unit in Good Condition

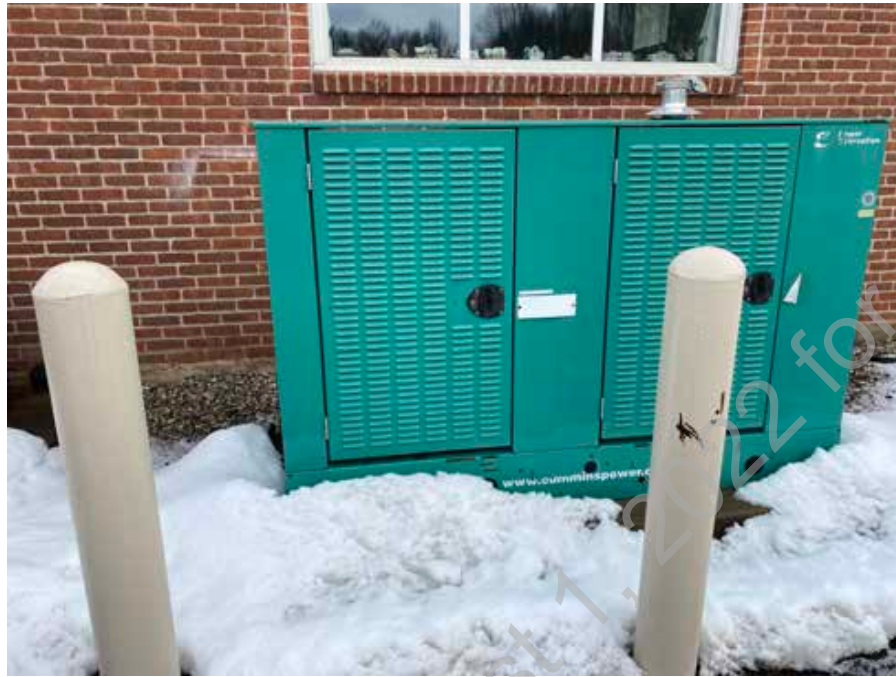
GENERATOR: The building currently has a 60 kW Cummins GGHE natural gas fired standby generator. The generator was installed as part of the 2009 new construction. The generator is in good working condition and has clocked 408 hours which is slightly above average for an 11 year old unit.

● D2. 25: Generator

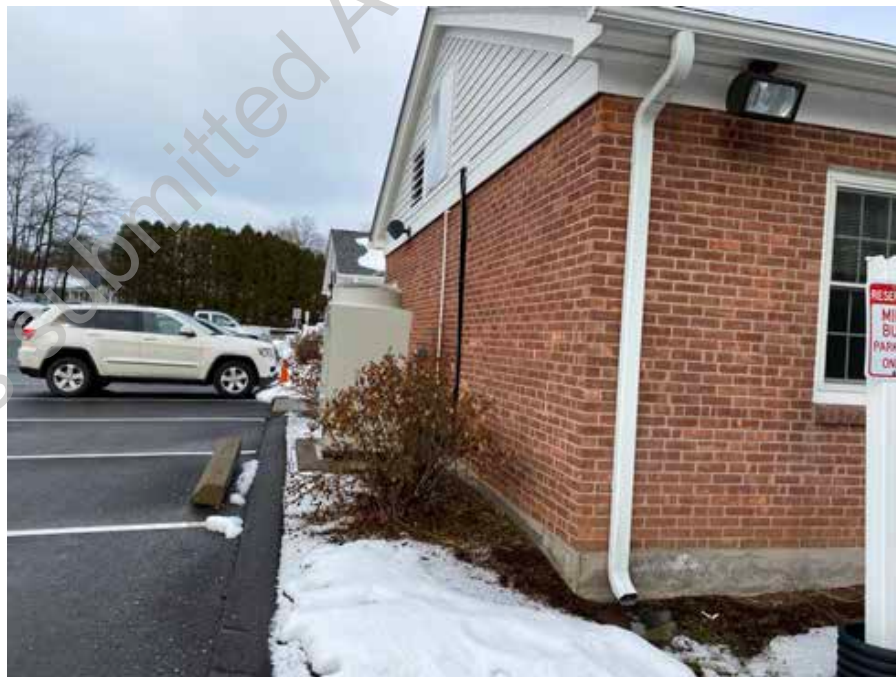
● D2. 26: Gutter Roof Drain System

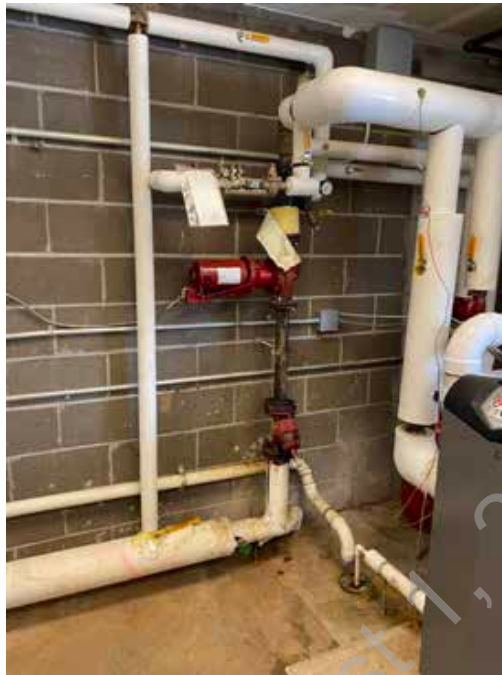
● D2. 27: Hot Water Pumps and Piping in Good Condition

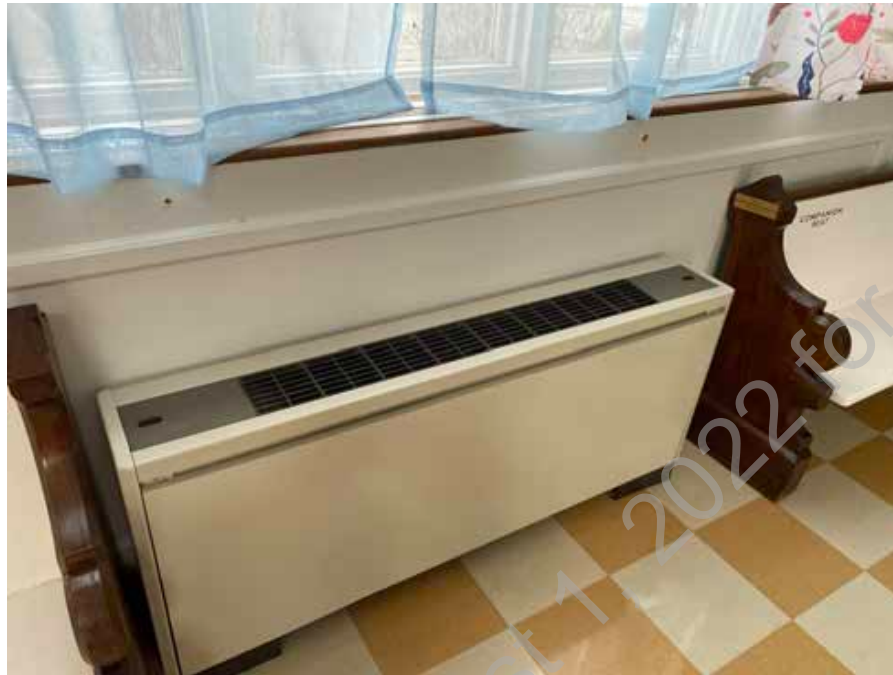
● D2. 29: Indoor Heat Pump Unit in Good Condition

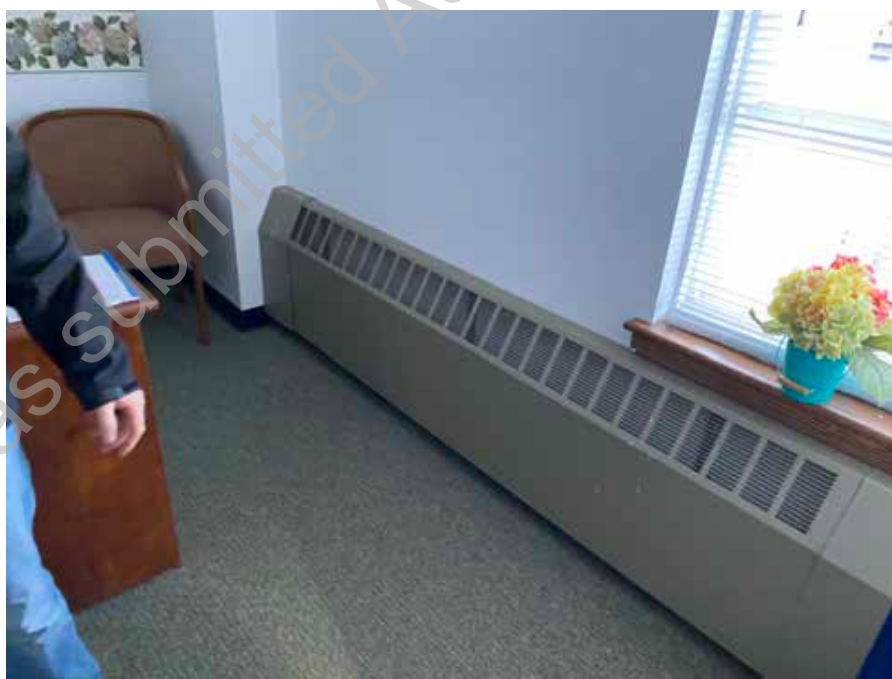
● D2. 36: Old Hot Water Baseboard Radiation

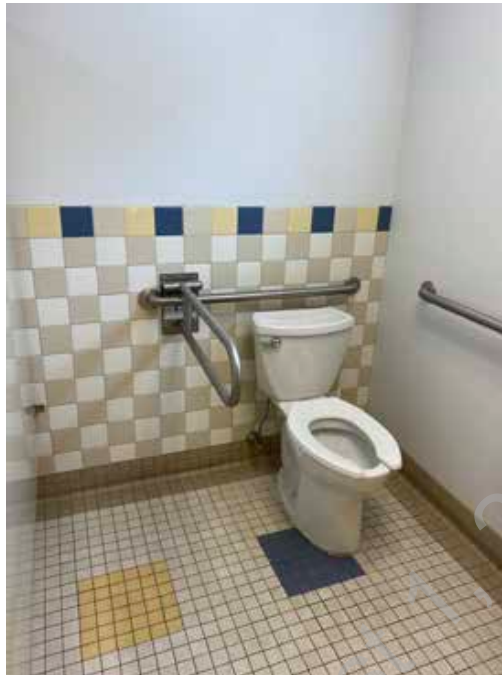
● D2. 39: Plumbing Fixture in Good Condition

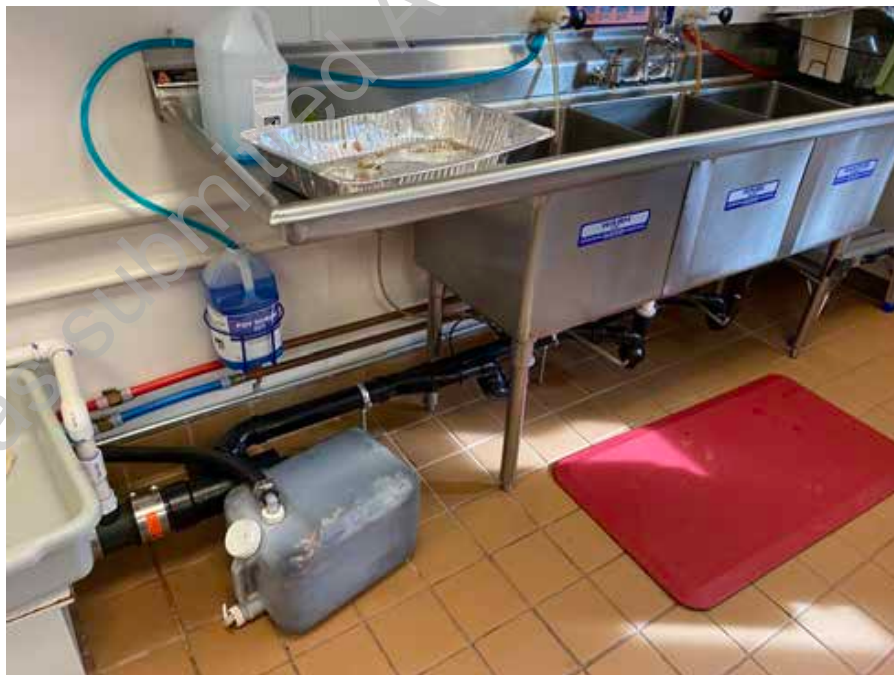
● D2. 40: Plumbing Piping and Equipment in Good Condition

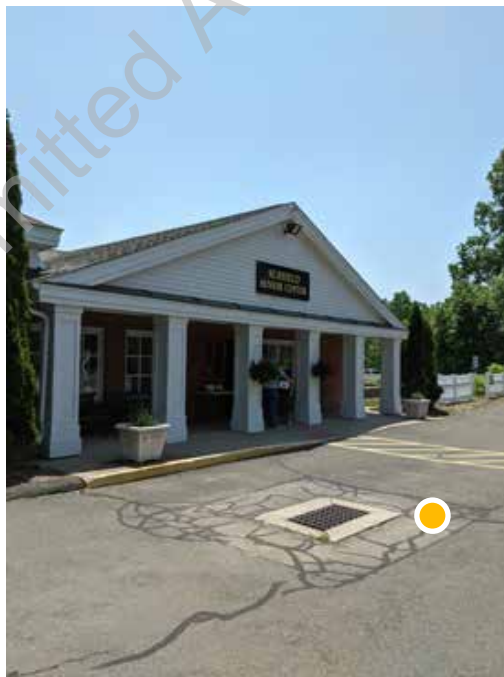
● D3. 2: Cracking throughout parking area and drive aisles has been patched

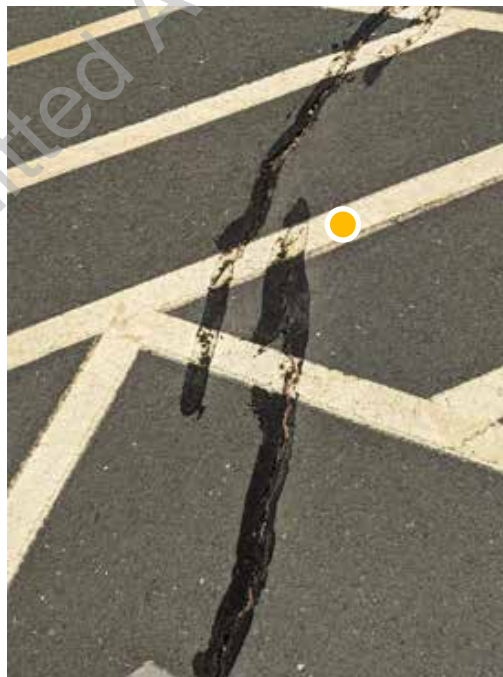
● D3. 4: Cracking throughout parking area and drive aisles has been patched

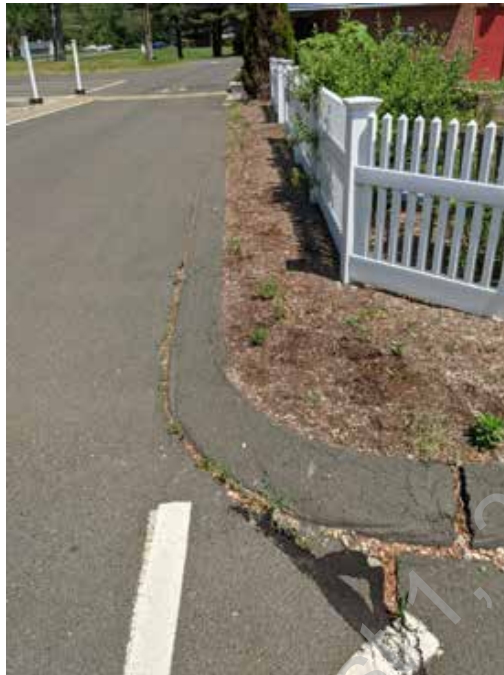
- D3. 5: Bituminous curbing is damaged and sections have begun to separate

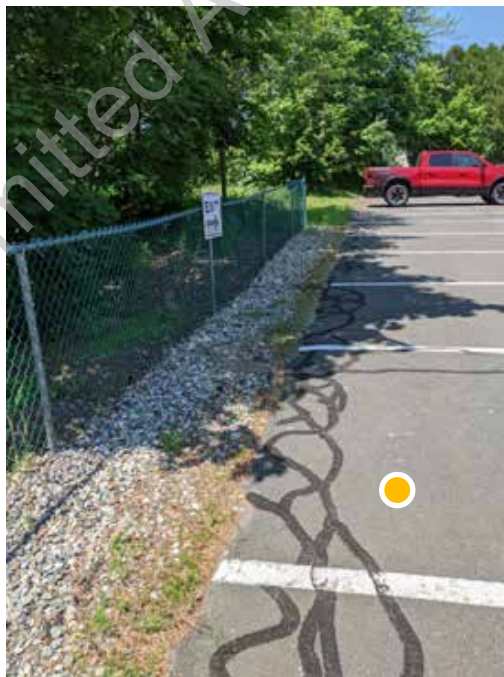
- D3. 6: Cracking along edge of parking area has been patched

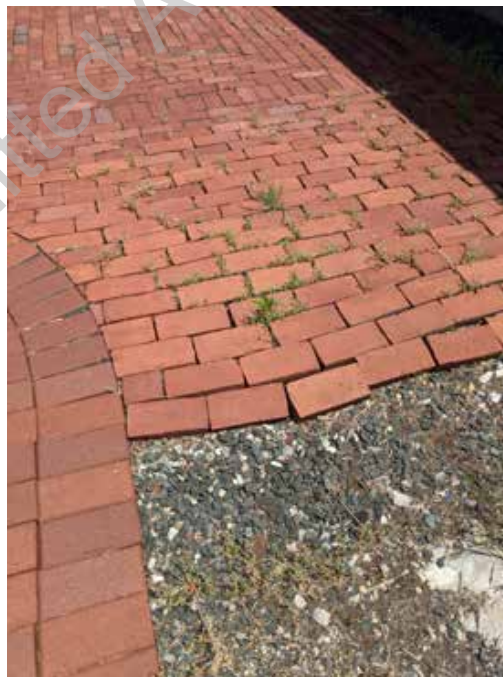
● D3. 8: Bricks at rear courtyard have begun to heave and create unsafe conditions

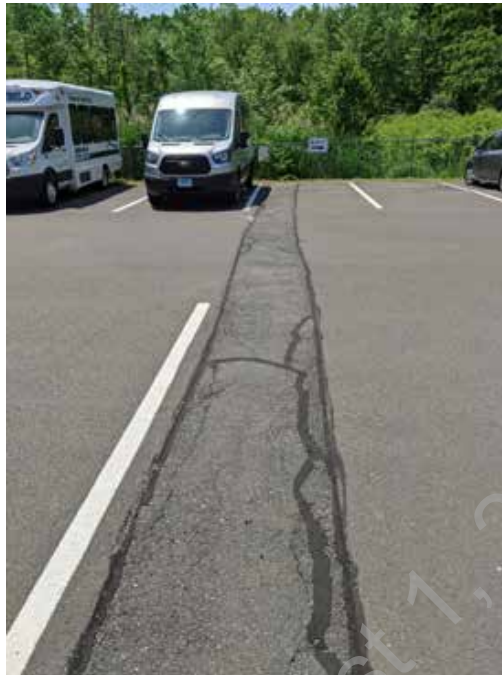
- D3. 9: Bituminous asphalt paving was previously trenched and patched

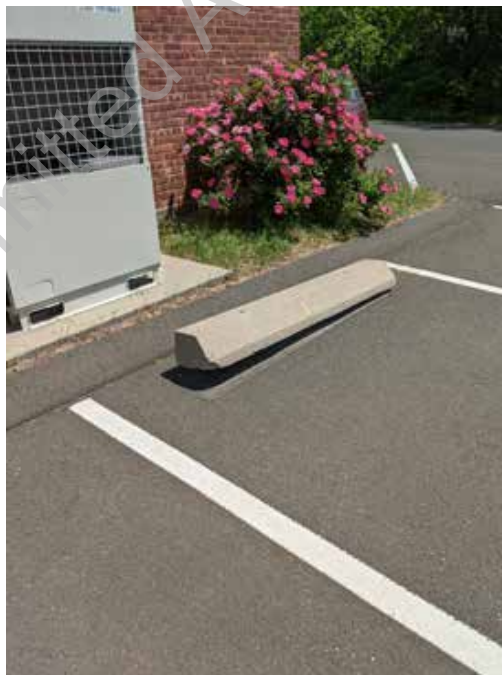
- D3. 10: Parking curb stop has lifted away from parking surface

Repair and level wheel stop	1	EA	\$220	\$ 220	\$ 22	\$ 3	\$ 17	\$ 11	\$ 273	\$ 34	\$ 307	\$ 61	\$ 368									
Provide new concrete ramps to Youth Services and Parks & Rec entrances	100	SF	\$44	\$ 4,400	\$ 440	\$ 66	\$ 330	\$ 220	\$ 5,456	\$ 682	\$ 6,138	\$ 1,228	\$ 7,366									
Level brick patio	1,200	SF	\$17	\$ 19,800	\$ 1,980	\$ 297	\$ 1,485	\$ 990	\$ 24,552	\$ 3,069	\$ 27,621	\$ 5,524	\$ 33,145									
Exterior Improvements				\$ -					\$ -	\$ -	\$ -											
Clean masonry/exposed foundation	11,702	SF	\$2	\$ 25,744	\$ 2,574	\$ 386	\$ 1,931	\$ 1,287	\$ 31,923	\$ 3,990	\$ 35,913	\$ 7,183	\$ 43,096									
Paint existing wood windows	300	SF	\$4	\$ 1,320	\$ 132	\$ 20	\$ 99	\$ 66	\$ 1,637	\$ 205	\$ 1,841	\$ 368	\$ 2,210									
Add gutters at hip roof	164	LF	\$11	\$ 1,804	\$ 180	\$ 27	\$ 135	\$ 90	\$ 2,237	\$ 280	\$ 2,517	\$ 503	\$ 3,020									
Replace gutter/downspout along Main Entrance	10	LF	\$22	\$ 220	\$ 22	\$ 3	\$ 17	\$ 11	\$ 273	\$ 34	\$ 307	\$ 61	\$ 368	Requires further investigation. Resize/recalculate rain water runoff.

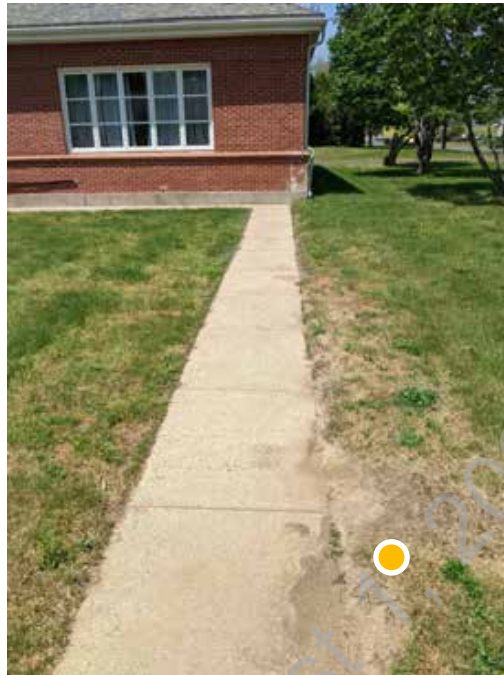
● D3. 11: Soil has eroded onto concrete sidewalks

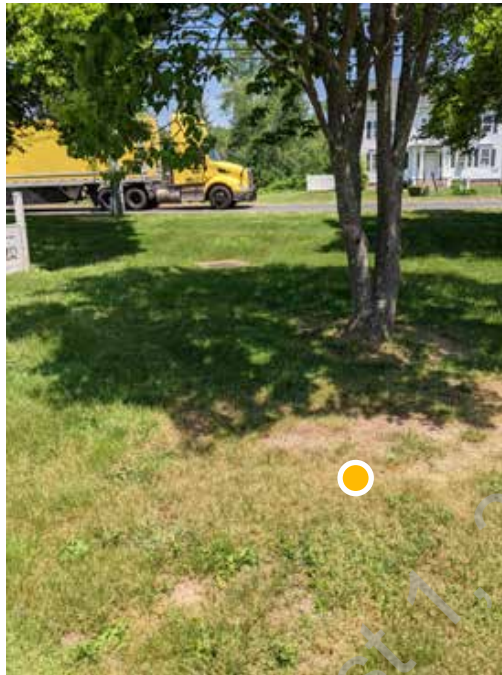
● D3. 13: North lawn area is patchy and requires re-seeding

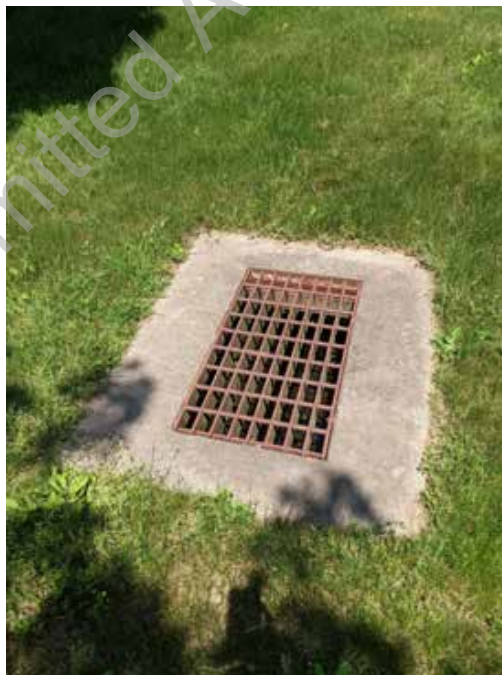
● D3. 14: Concrete basin top located in North lawn area is in good condition

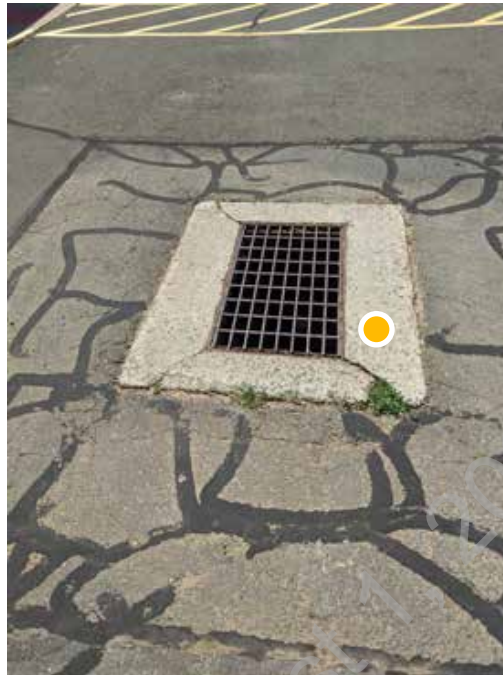
● D3. 15: Cracking and edge chipping at concrete basin top in parking area

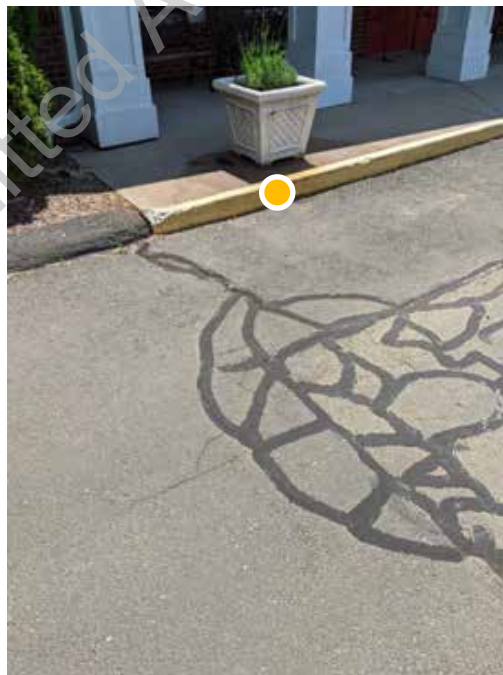
● D3. 16: Spalling concrete curb at main entry sidewalk

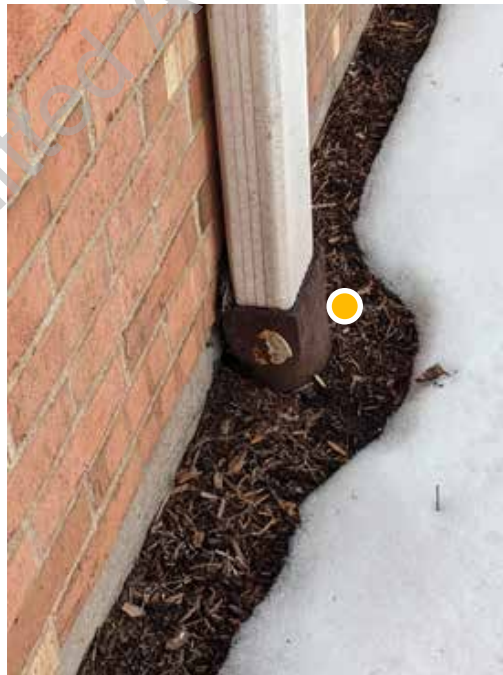
● D1. 4: Rusty boot connecting downspout to sub-surface drainage system

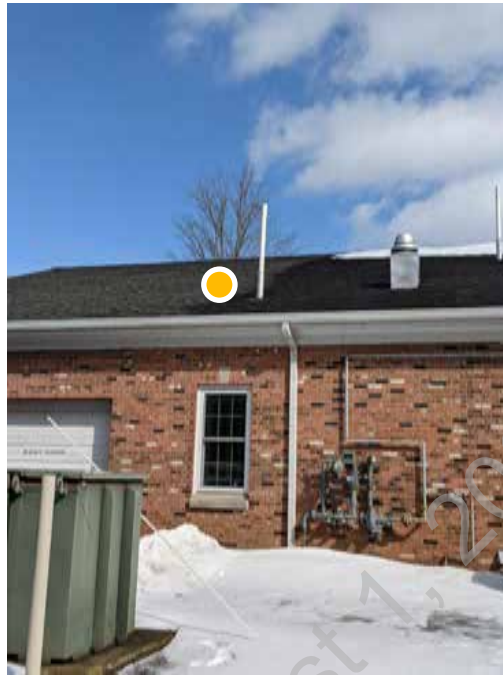
● D1. 7: Uneven drying of asphalt shingle roof surface

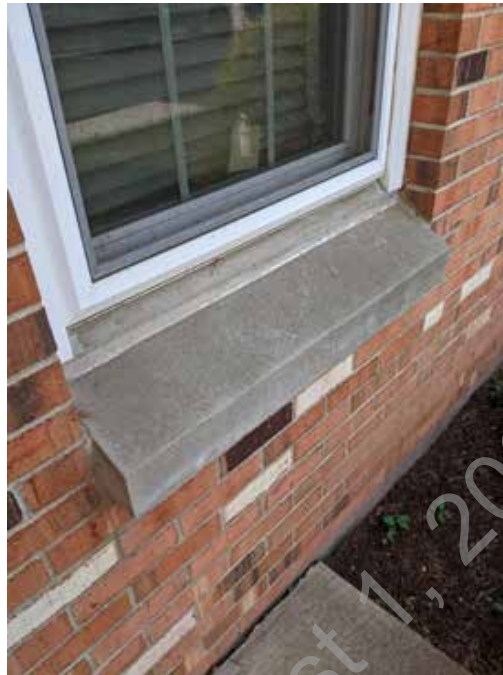
● D1. 11: Concrete window sill

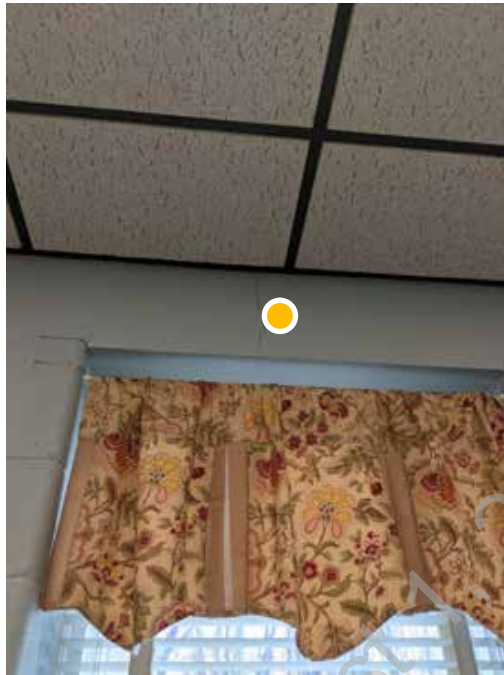
● D1. 13: Gypsum board cracking above windows throughout

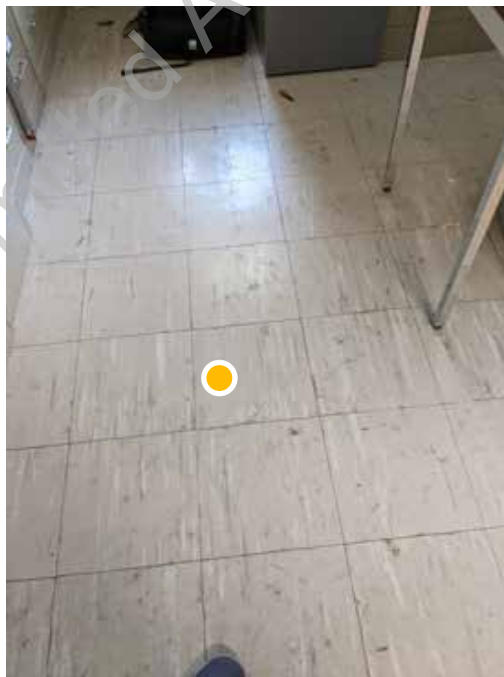
● D1. 14: Cracked and damaged vinyl tile at File Records storage

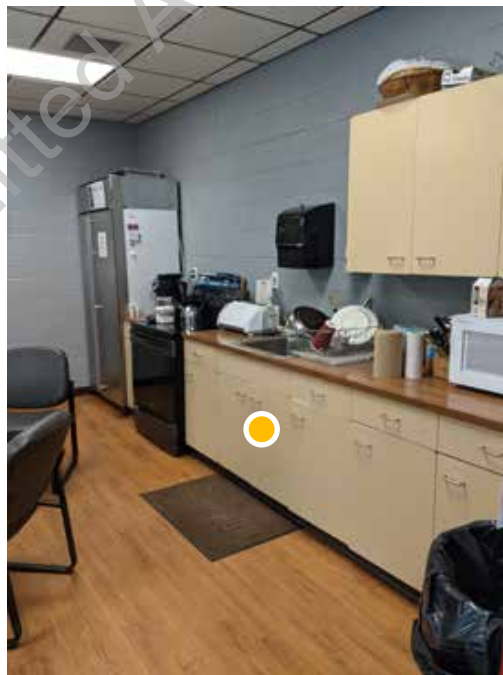
● D1. 16: Kitchenette at staff break area is not accessible

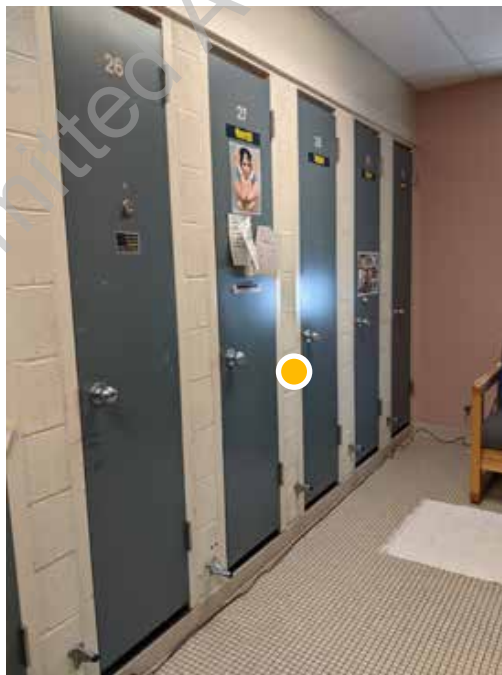
● D1. 18: Male locker room; lockers are built-in and limit future flexibility

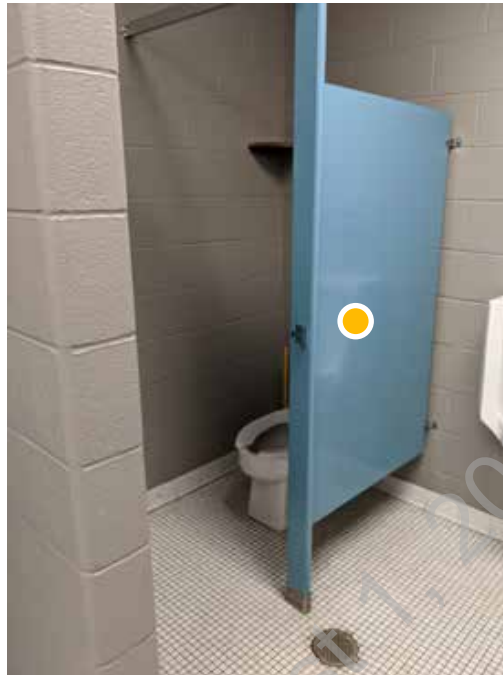
● D1. 19: Toilet stalls do not have required clear space to be considered accessible

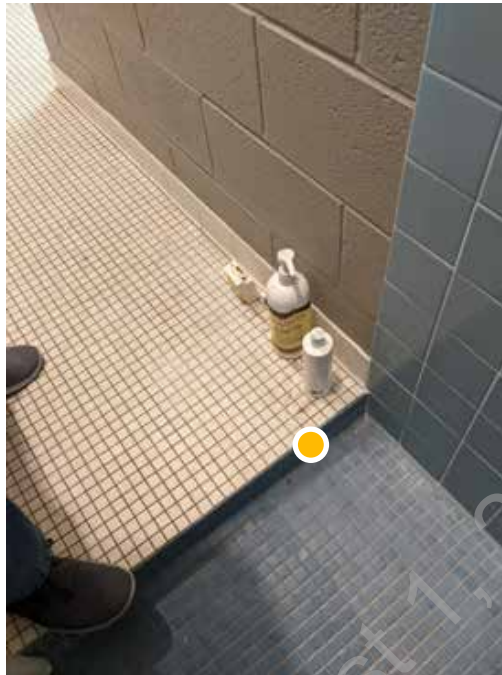
- D1. 21: Step-down into shower space creates a non-accessible condition

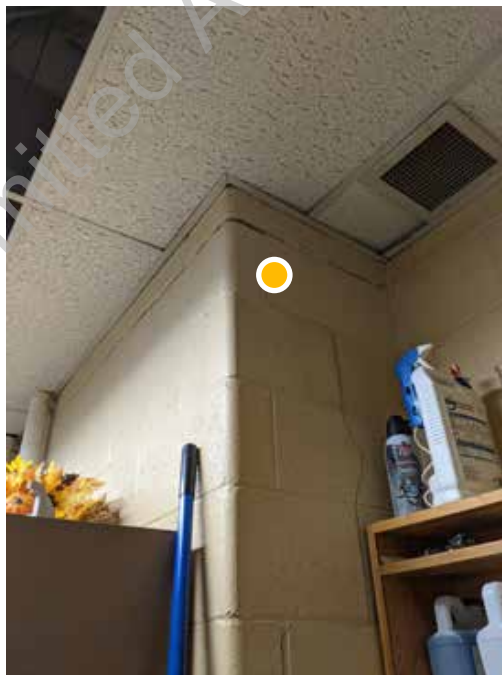
- D1. 22: Cracking of concrete masonry unit walls observed throughout

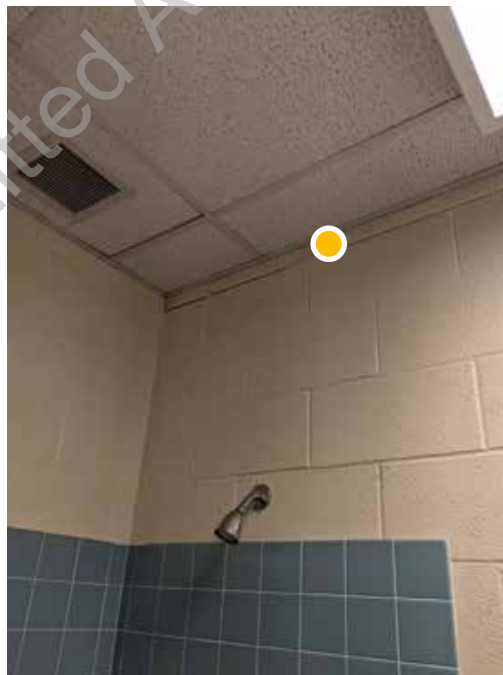
● D1. 24: Cracking of concrete masonry unit walls observed throughout

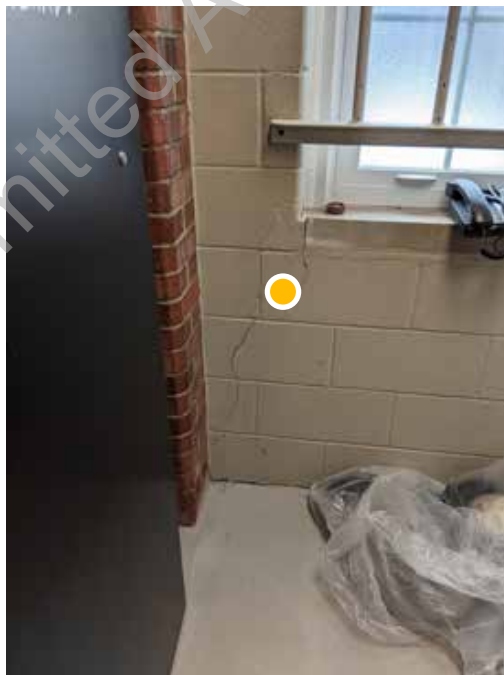
● D1. 26: Cracking of concrete masonry unit walls observed throughout

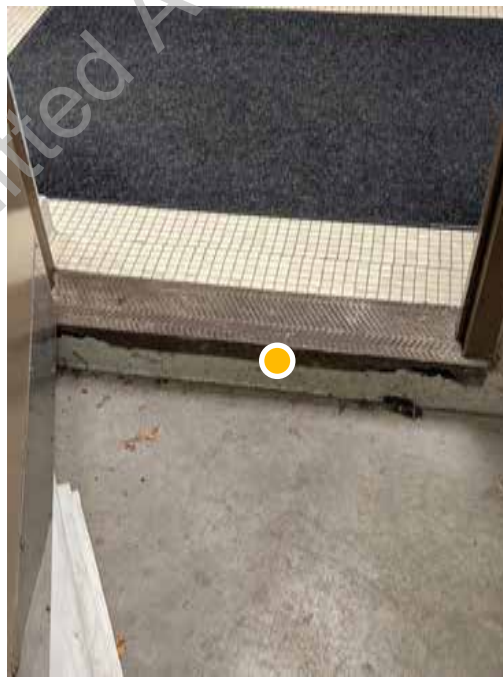
● D1. 28: Step-down into Maintenance Garage and Sally Port creates a non-accessible condition

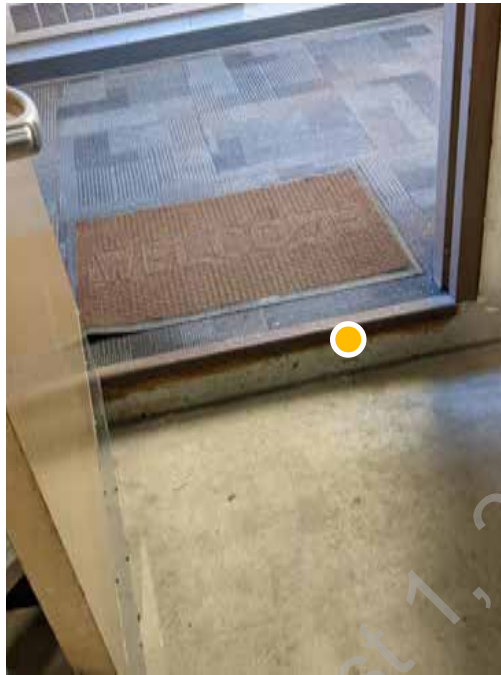
- D1. 29: Step-down into Maintenance Garage and Sally Port creates a non-accessible condition

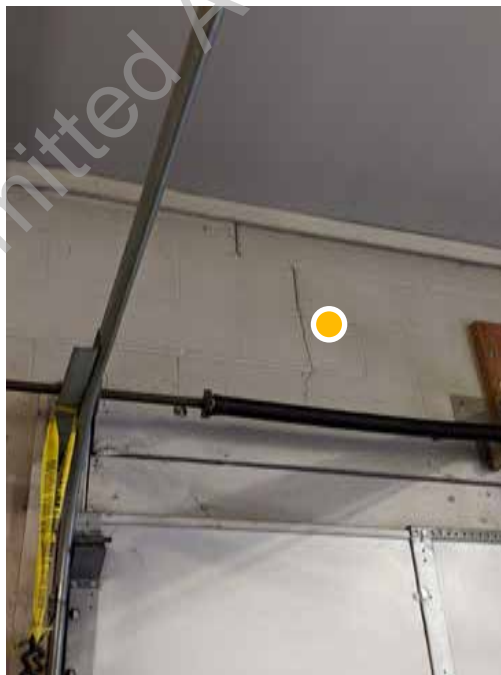
- D1. 30: Cracking of concrete masonry unit walls observed throughout

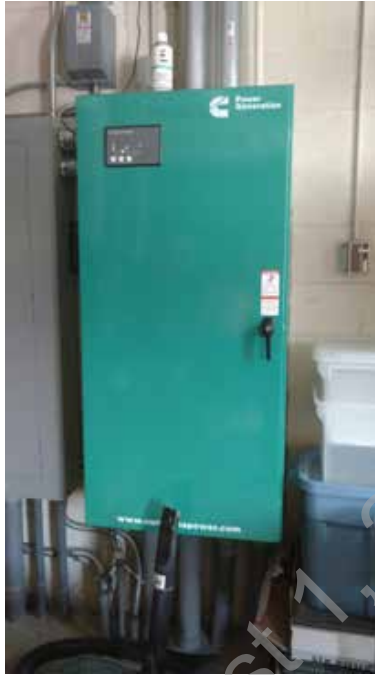
The standby power system has been upgraded since the 1987 construction. The current Cummins unit is believed to have replaced the original Kohler system formerly in the building. The single transfer switch was code compliant to support all loads prior to 1996 but modern codes now require emergency life safety systems to be segregated through a dedicated transfer switch / distribution panels necessitating a minimum of two transfer switches to energize the full building on generator.

● D2. 1: Automatic Transfer Switch

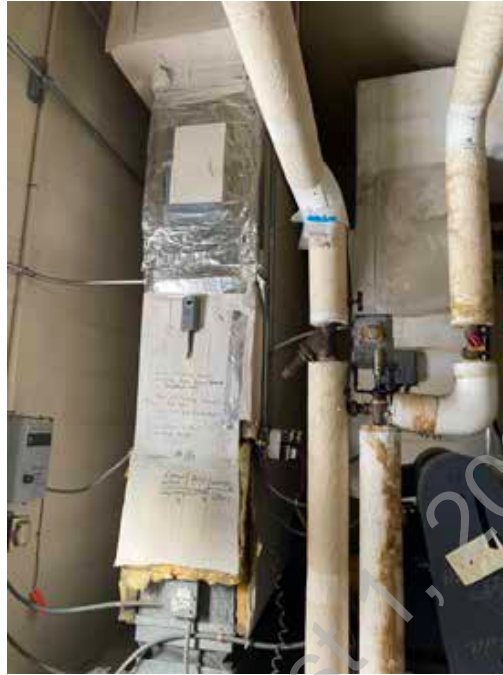
HOT WATER PIPING: The hot water heating systems consists of Copper piping. The majority of the piping was installed during the original construction in 1988. This piping is at the end of its useful life. Some hot water piping was replaced approximately 15 years ago at the same time of the boiler and water heater. This piping appears to be in fair working condition.

● D2. 5: Ductwork and Hot Water Piping in Poor Condition

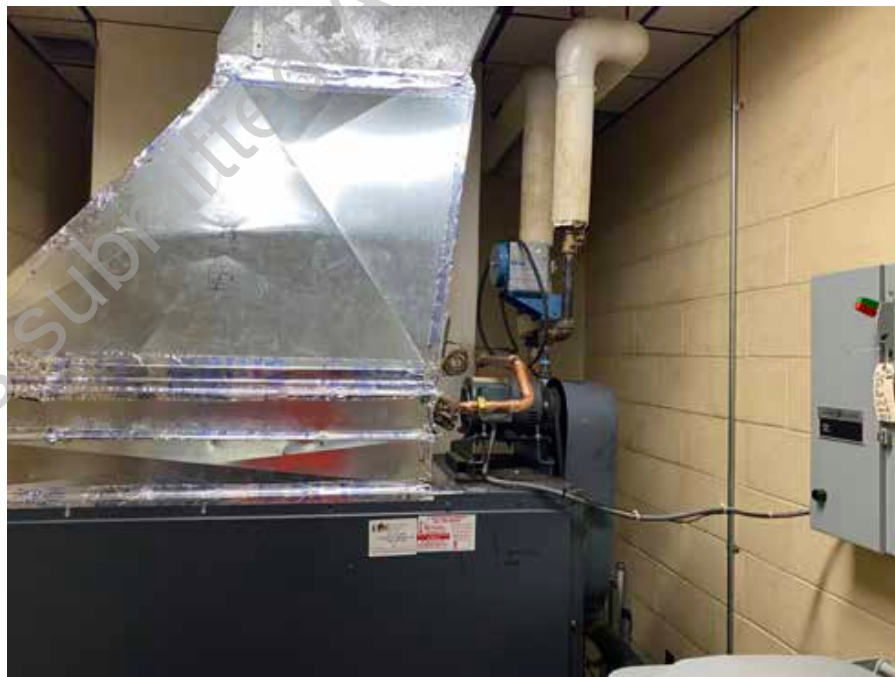
● D2. 10: Hot Water Piping and Dcutwork from HAC 2 in Poor Condition

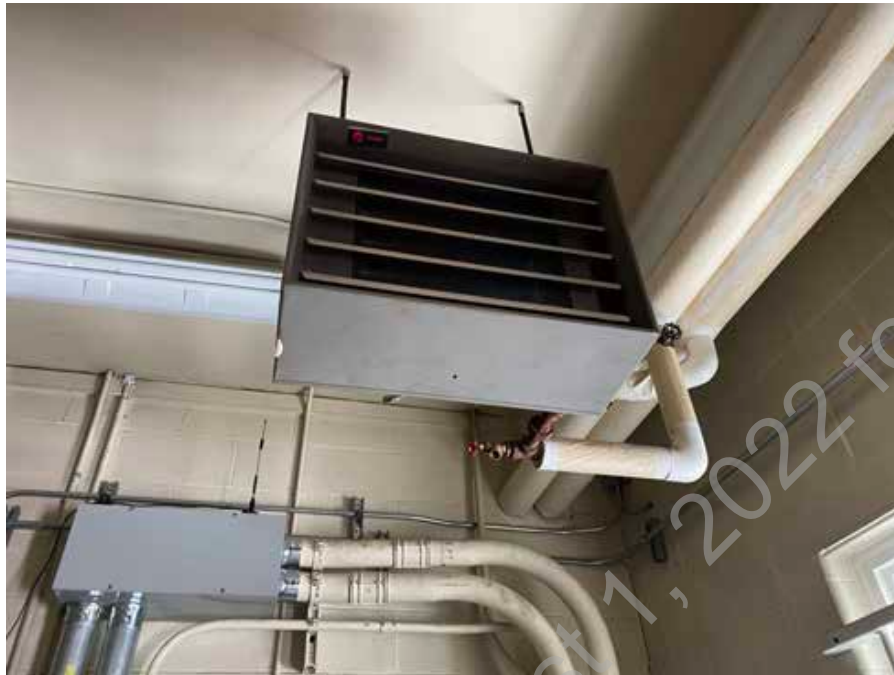
● D2. 11: Hot Water Unit Heater

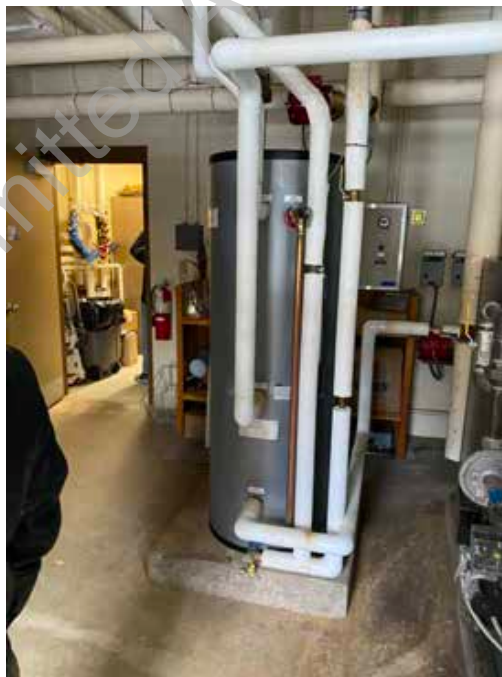
● D2. 12: Indirect Domestic Hot Water Tank and Piping

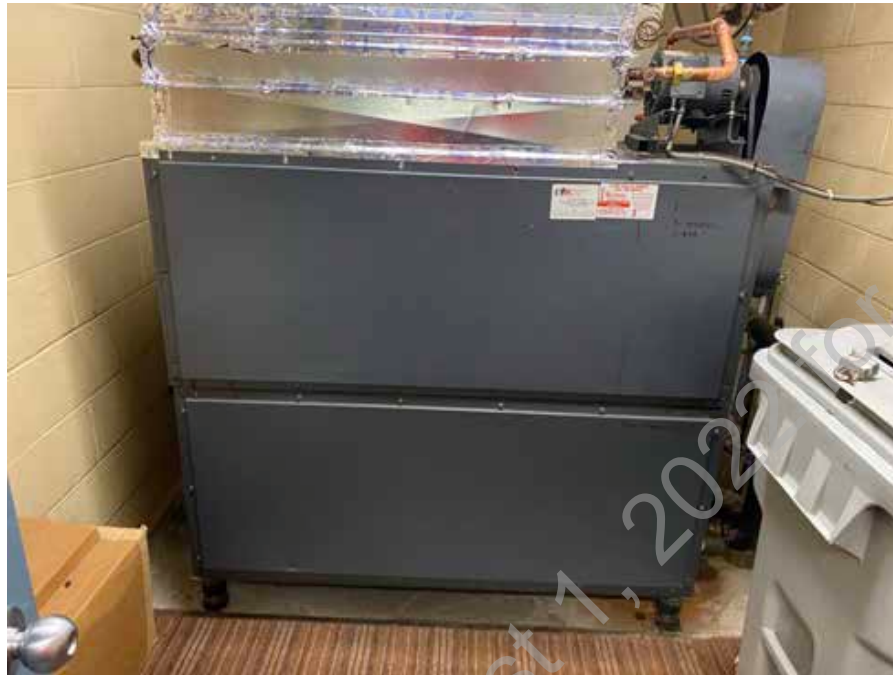
● D2. 13: Indoor Air Handler (HAC 2) in Poor Condition

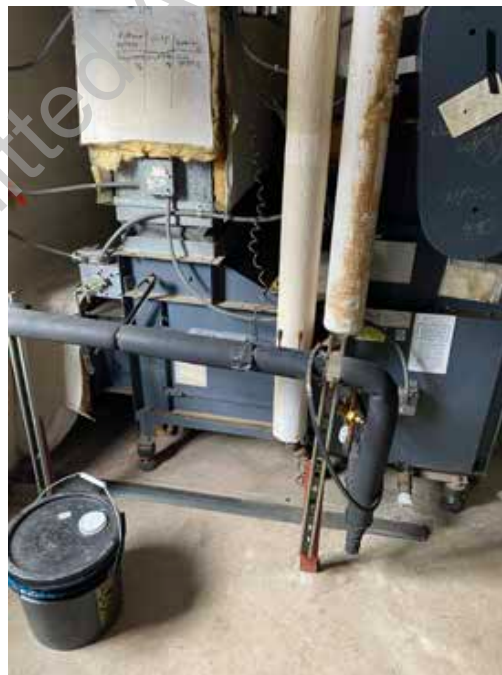
● D2. 14: Indoor Air Handler in Mechanical Room Needs Replacement
