TOWN OF SUFFIELD

CONDITIONS ASSESSMENT & MASTER PLAN

Draft as submitted August 1, 2022 for review

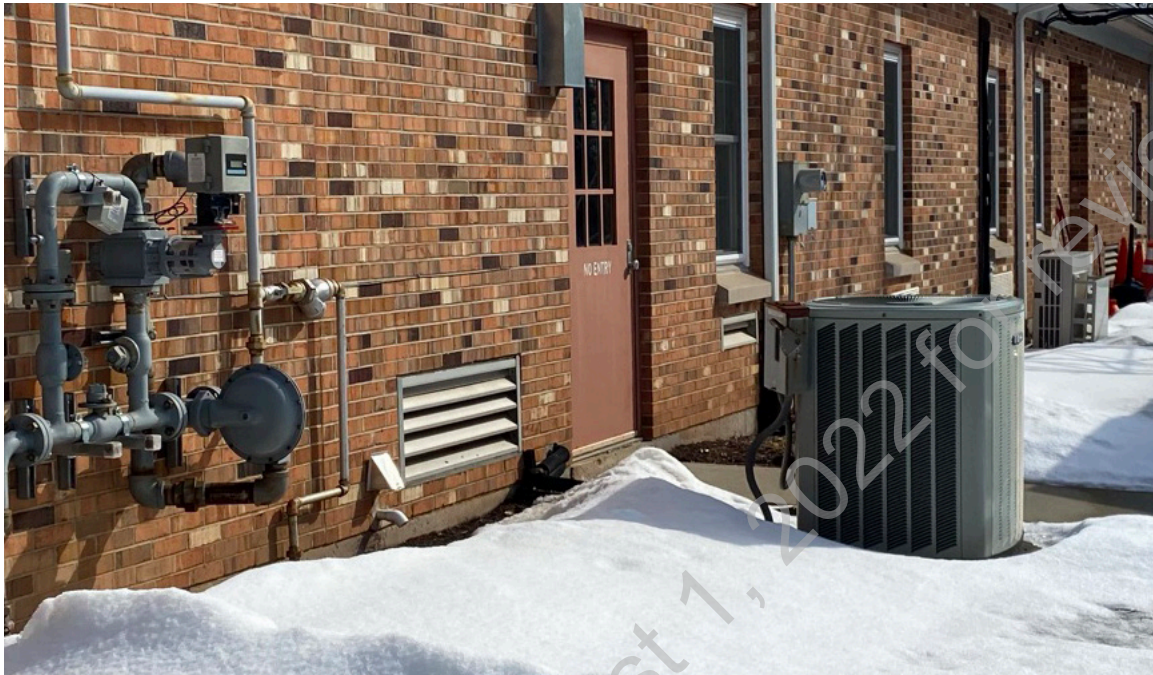
● D2. 21: Natural Gas Service in Fair Condition

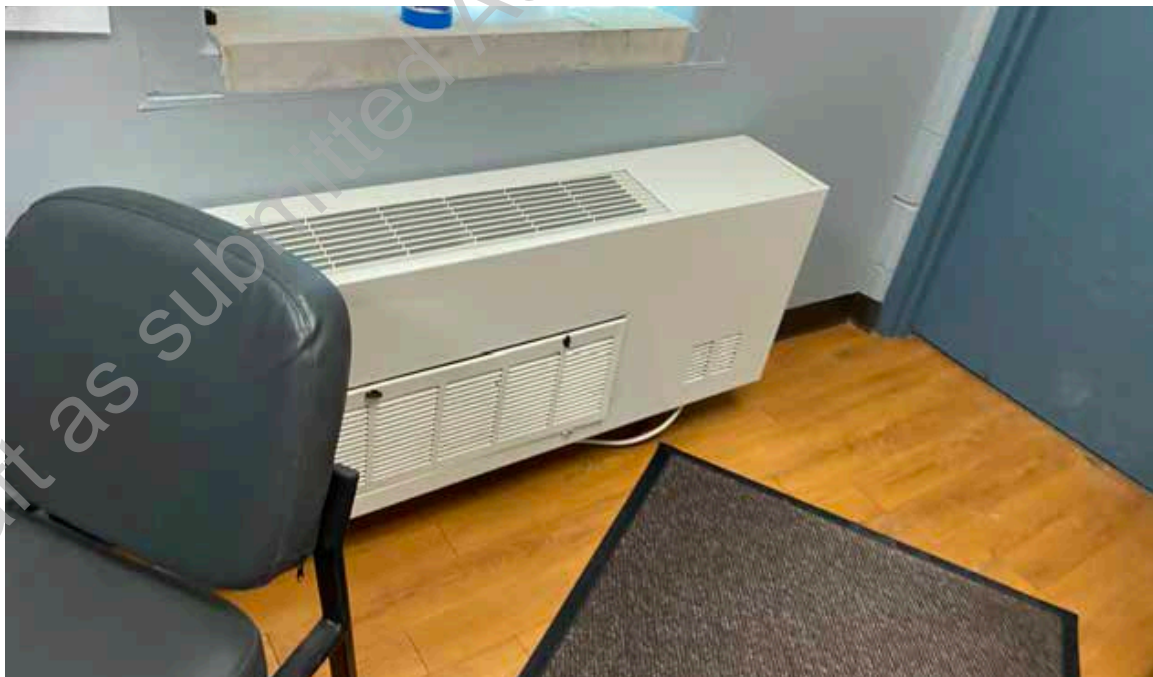
● D2. 22: Newer PTAC Unit in Fair Condition

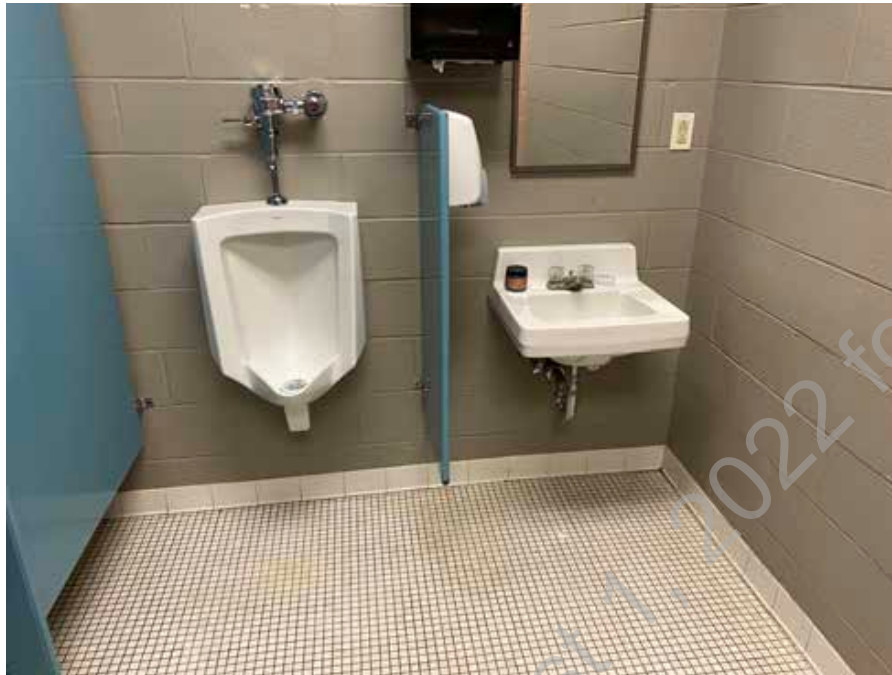
● D2. 23: Plumbing Fixtures in Fair Condition

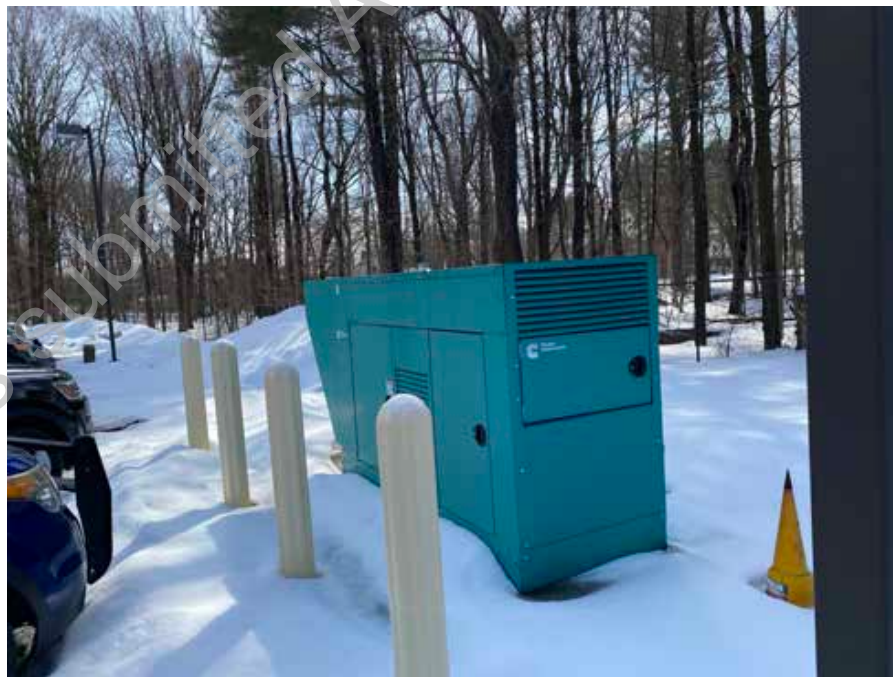
● D2. 30: Standby Generator

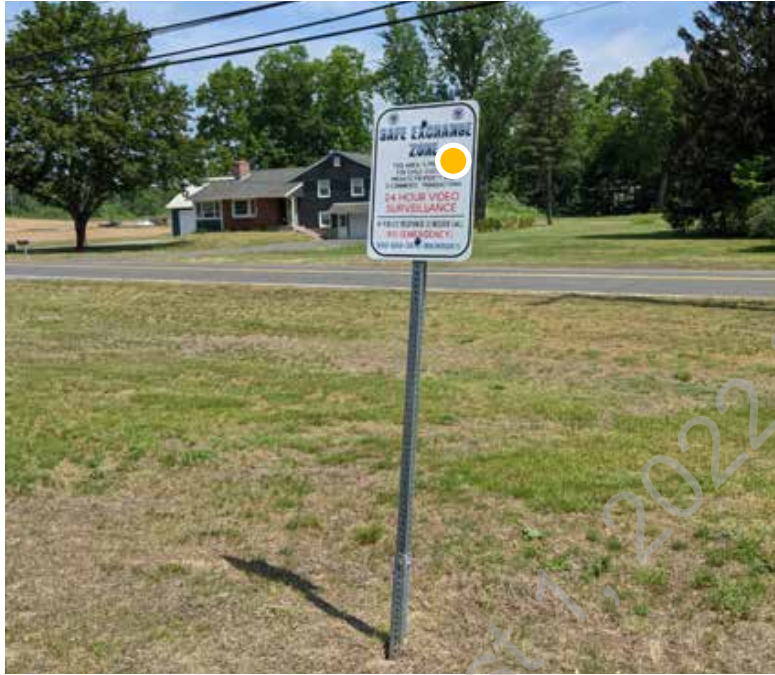
● D3. 5: Parking signage requires reseating

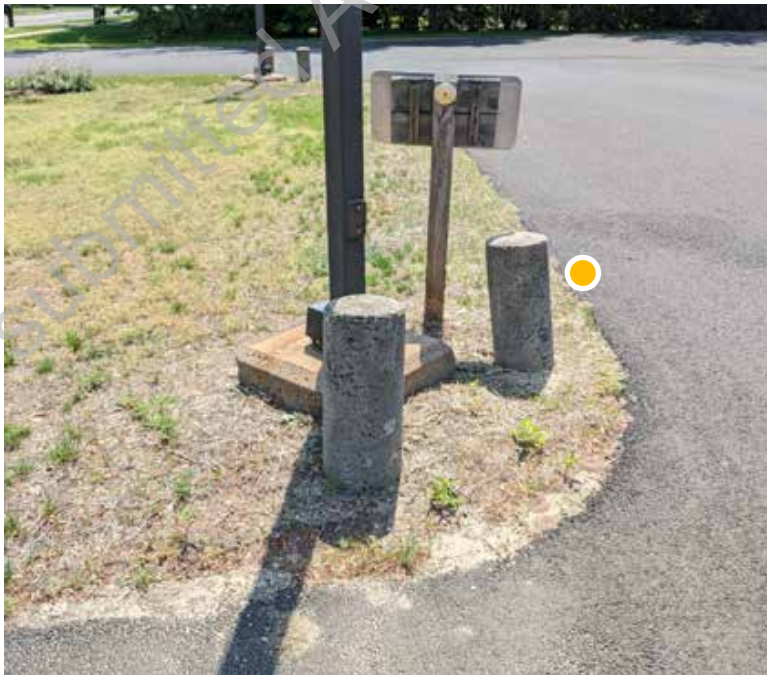
● D3. 6: Concrete bollards require reseating

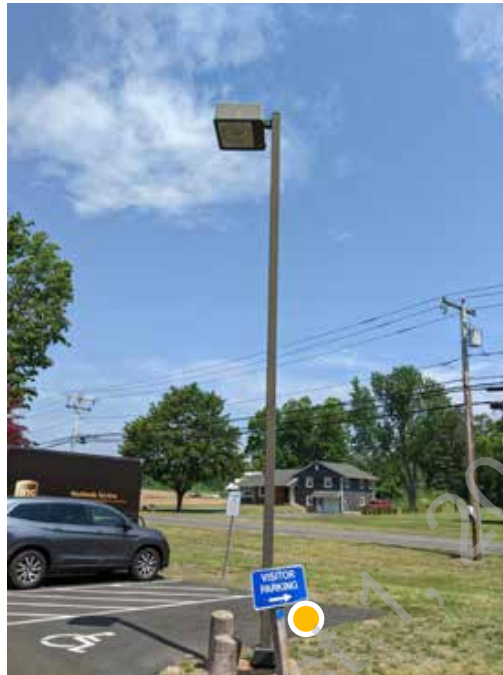
● D3. 7: Parking signage requires reseating

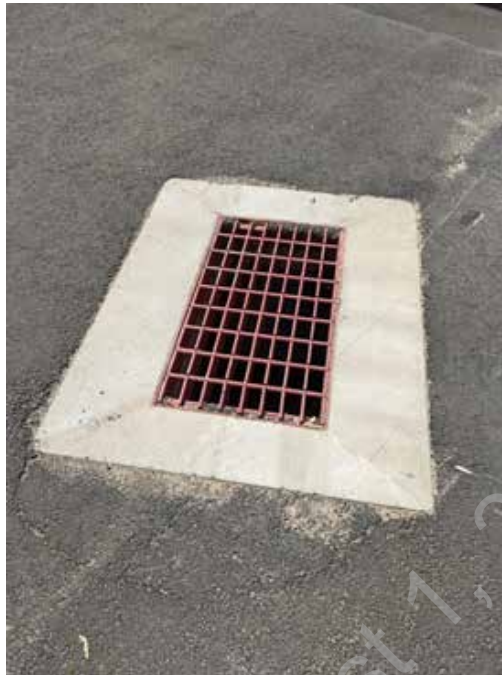
- D3. 9: Concrete basin tops are in good condition and appear to have been replaced along with recent parking lot work

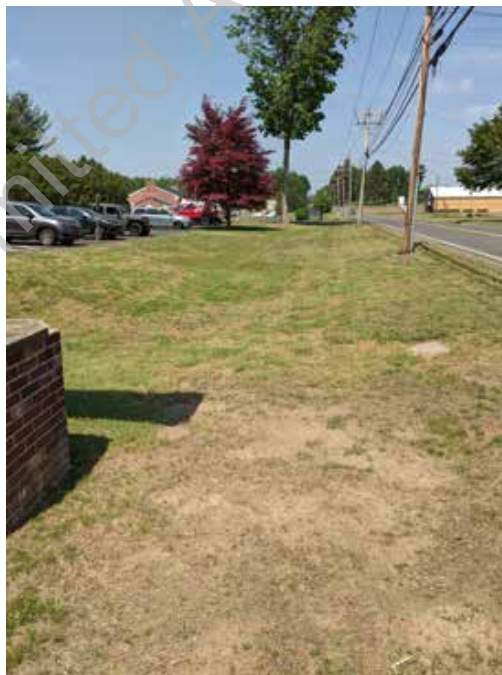
● D3. 14: Lawn area at North side of the site along Mountain Road is patchy and requires reseeding

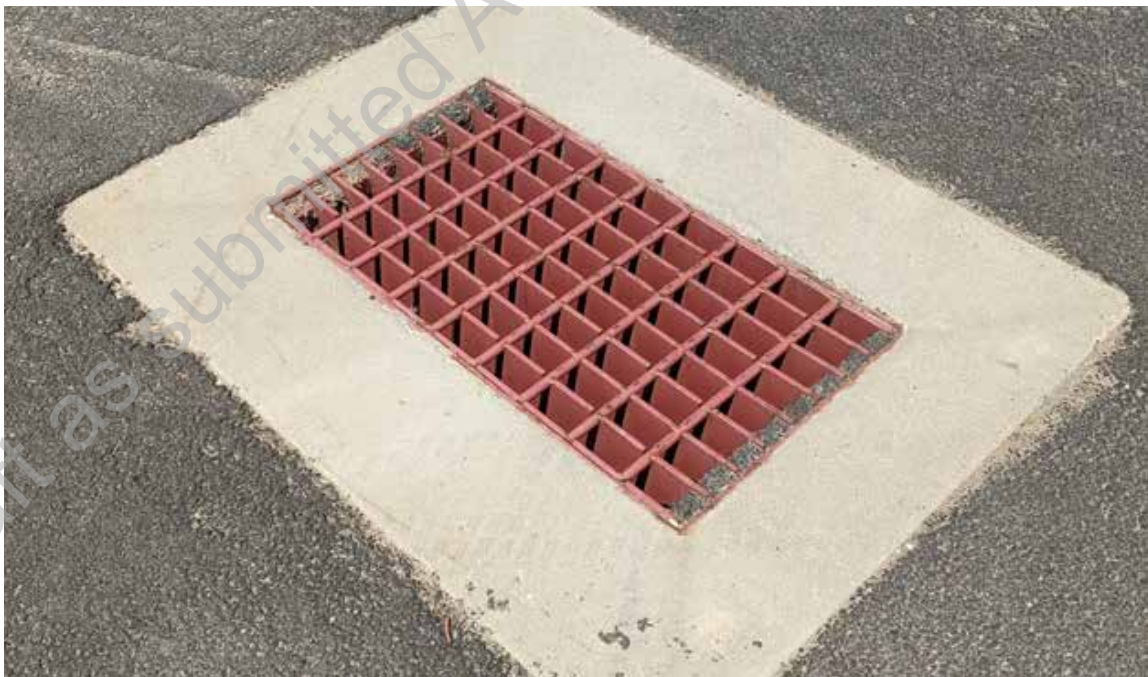
● D3. 16: Concrete basin tops are in good condition and appear to have been replaced along with recent parking lot work

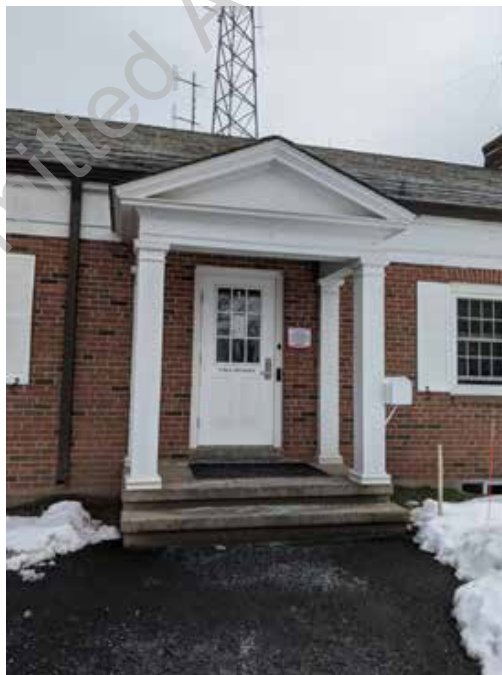
● D1. 2: Main entry is not wheel chair accessible

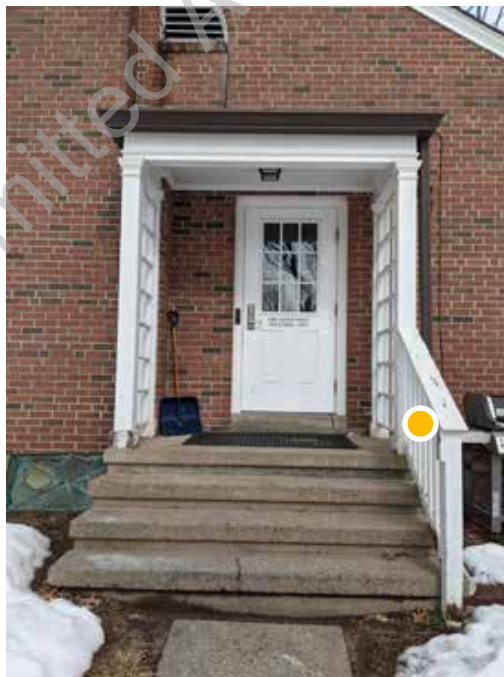
WINDOWS/DOORS/ENTRANCES: Doors, trim, and aluminum windows around the building are in good condition. Some minor rot repair and repainting is required at a few windows, entrance canopies, and the wood railing at the South steps.

● D1. 6: Rear Staff entry is not wheel chair accessible; wood trim and railing is decaying

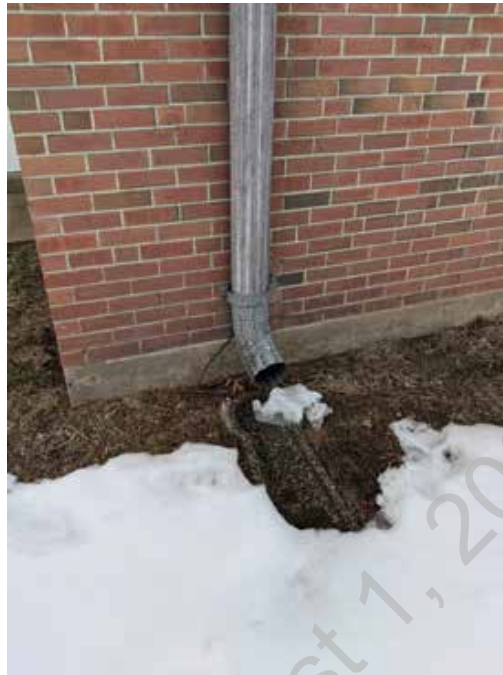
- D1. 7: Downspout splash block is under-sized, some soil erosion observed

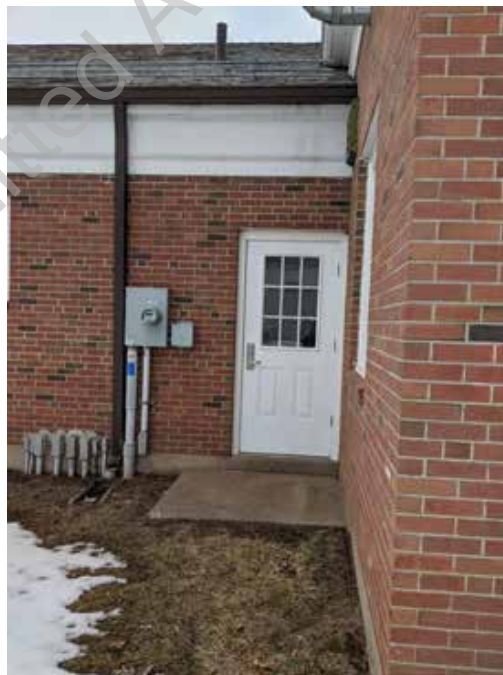
- D1. 8: Rear entry along East façade is not wheel chair accessible

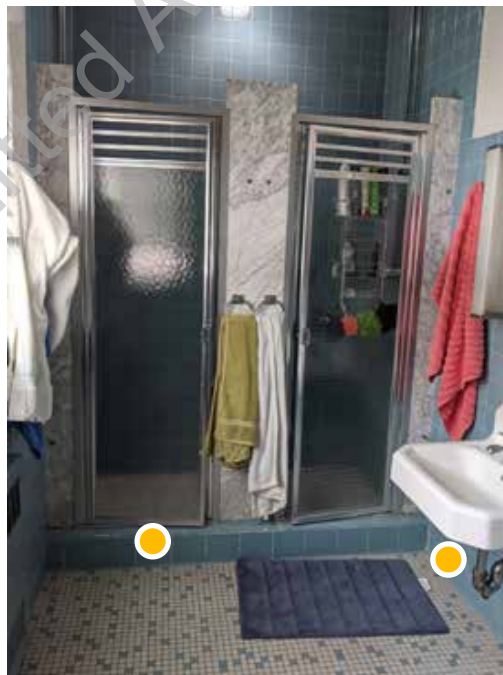
- D1. 12: Shower facilities are not wheel-chair accessible and sink does not have required pipe insulation to be considered ADA-compliant

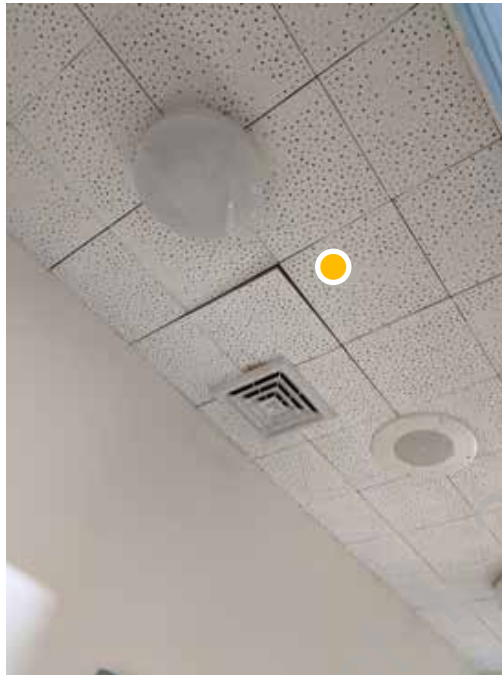
- D1. 13: Wood fiber ceilings throughout are beginning to peel away from substrate

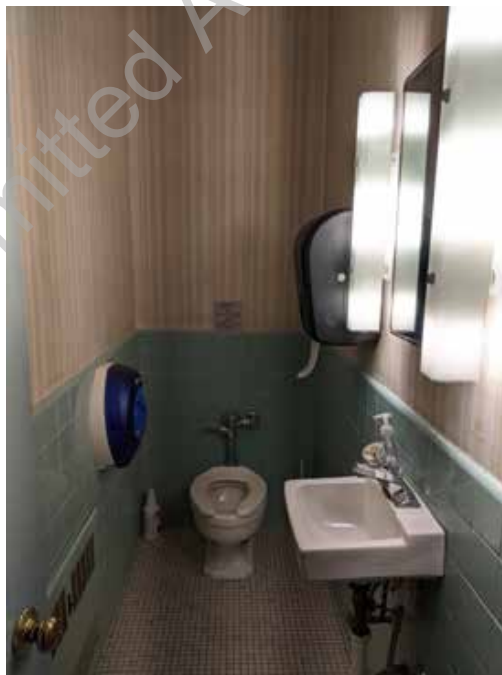
- D1. 14: Toilet room off main corridor is under-sized and sink does not have required pipe insulation to be considered ADA-compliant

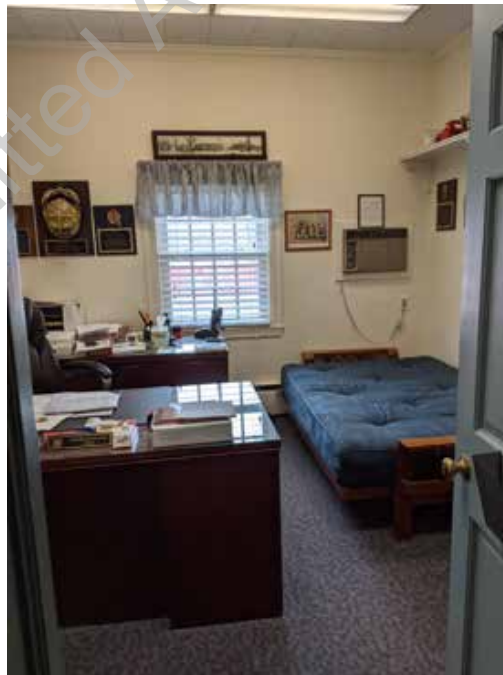
OFFICES: Offices throughout have carpet floors in good condition. Office spaces often double as bunk space.

● D1. 16: Office and bunk space has been combined due to space limitations

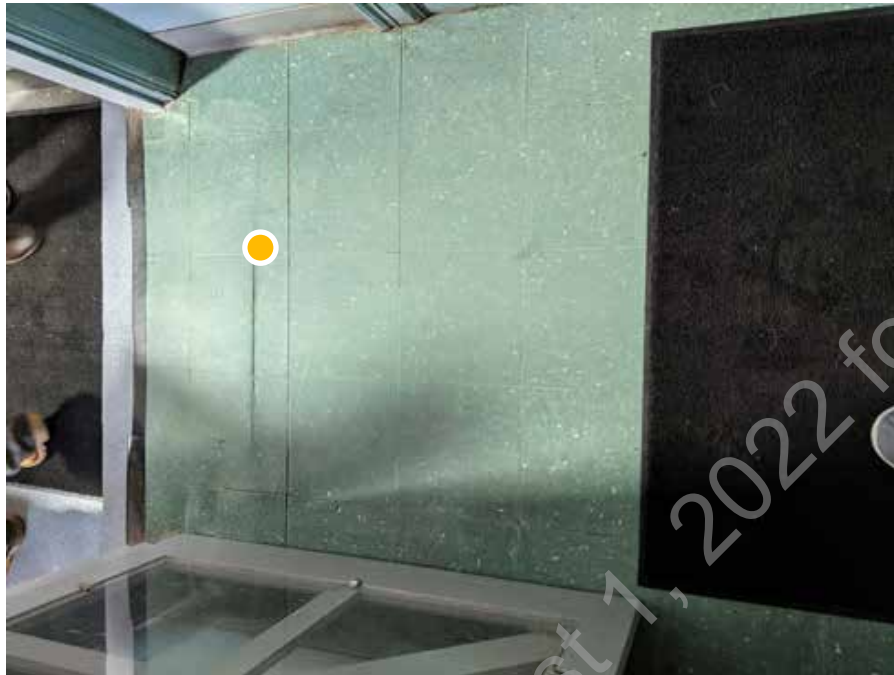
INTERIOR SPACES (GENERAL): While in good condition, vinyl asbestos tile is present throughout the building. Most of this flooring is not in a friable state although some cracking is beginning to show on the green tile near the apparatus bay. Wood fiber ceilings are also present throughout and are in fair condition. Some corners of the ceiling are beginning to peel and deteriorate. It is recommended to abate or encapsulate all vinyl asbestos tile and wood fiber ceilings. General finish material at most interior walls is painted plaster.

● D1. 17: Vinyl asbestos tile is present throughout, some cracking is beginning to show

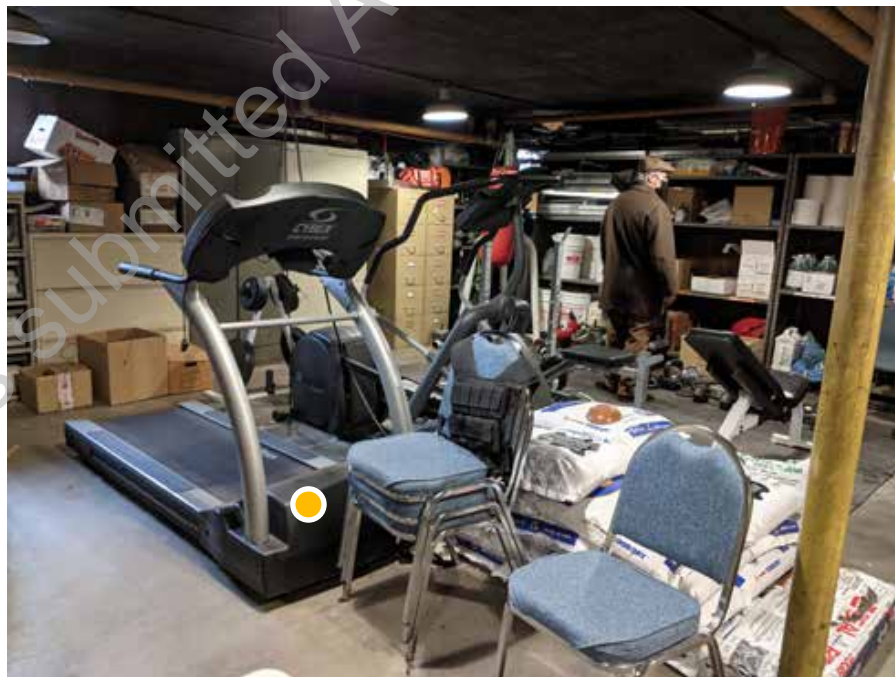
● D1. 20: Fitness equipment is located on the lower level, this space is not wheelchair accessible

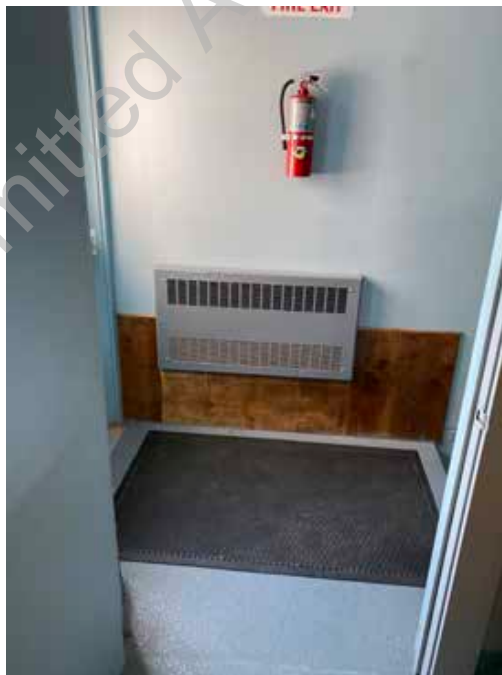
● D2. 18: Hot Water Wall Convector Needs Replacing

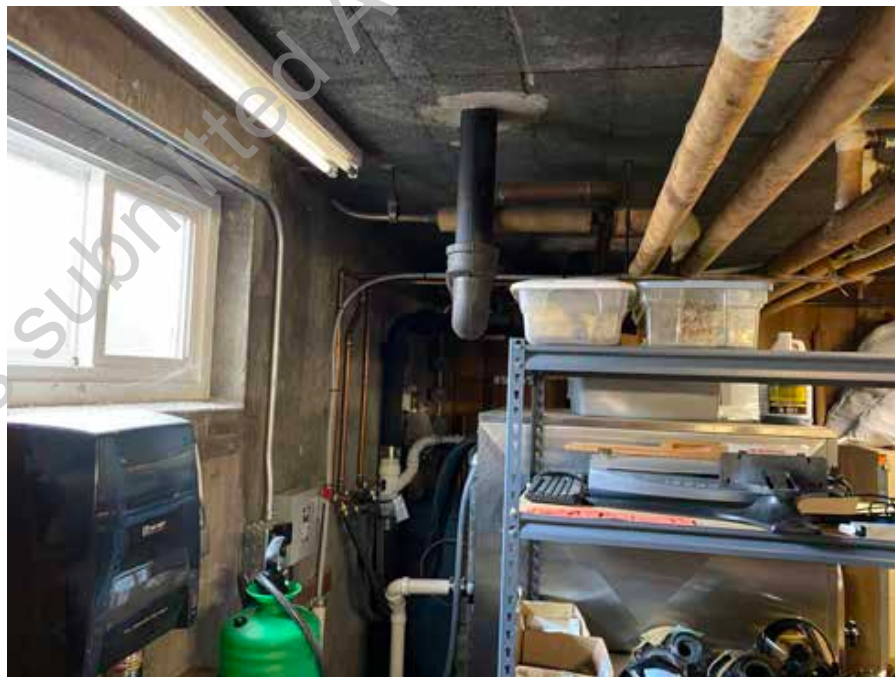
● D2. 20: Hydronic and Domestic Water Piping Needs to be Replaced

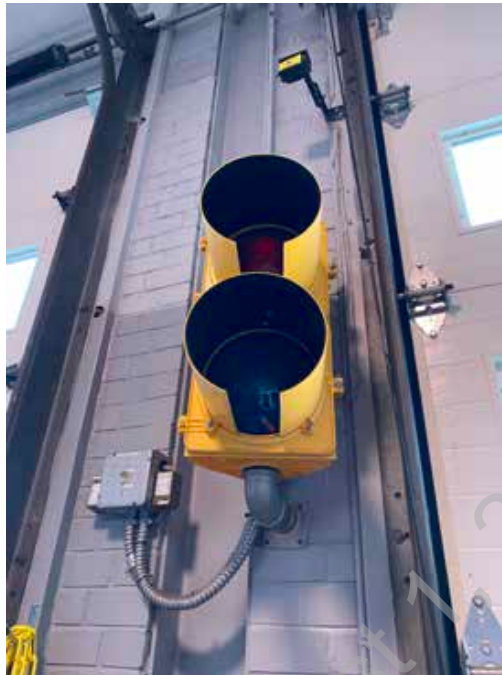
● D2. 25: Internal Traffic Control Light (Non-functional)

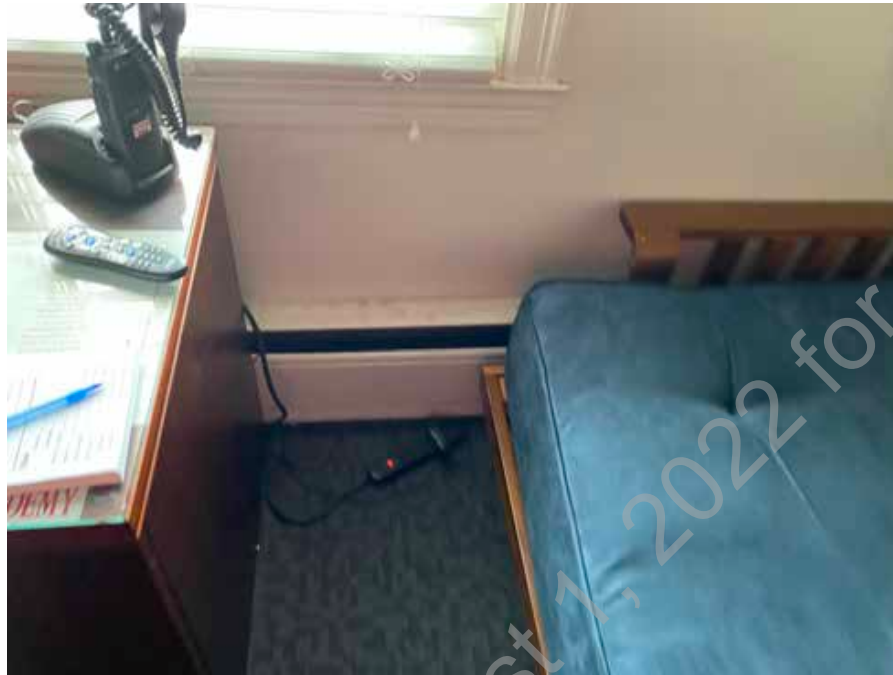
● D2. 31: Old Radiator Needs Replacement

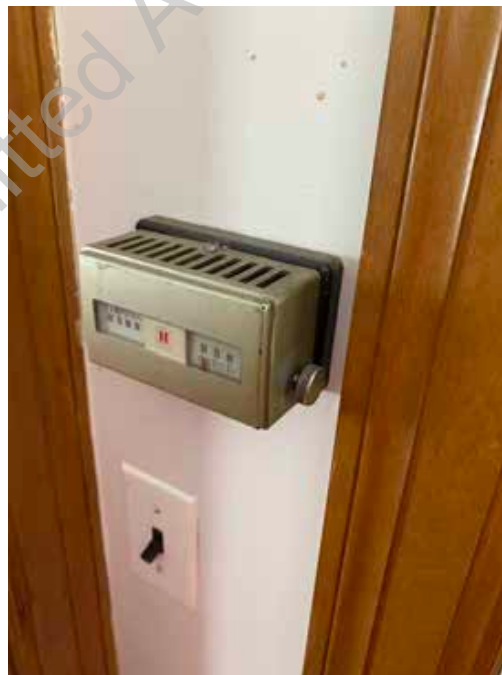
● D2. 32: Old Thermostat

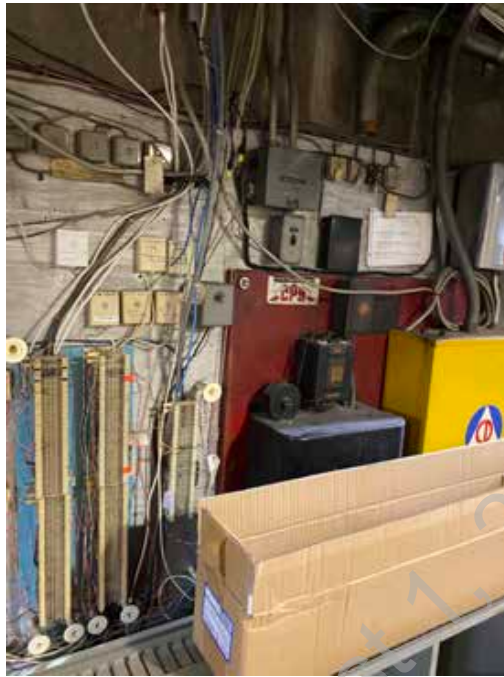
● D2. 33: Outdated Communication Infrastructure

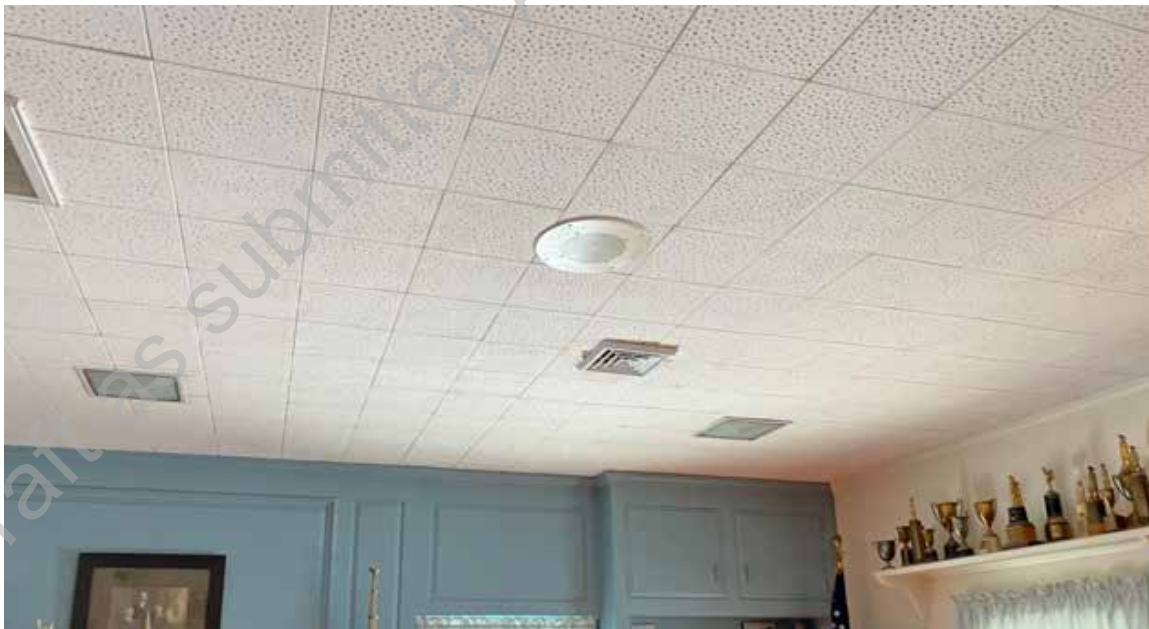
● D2. 34: Outdated Lighting

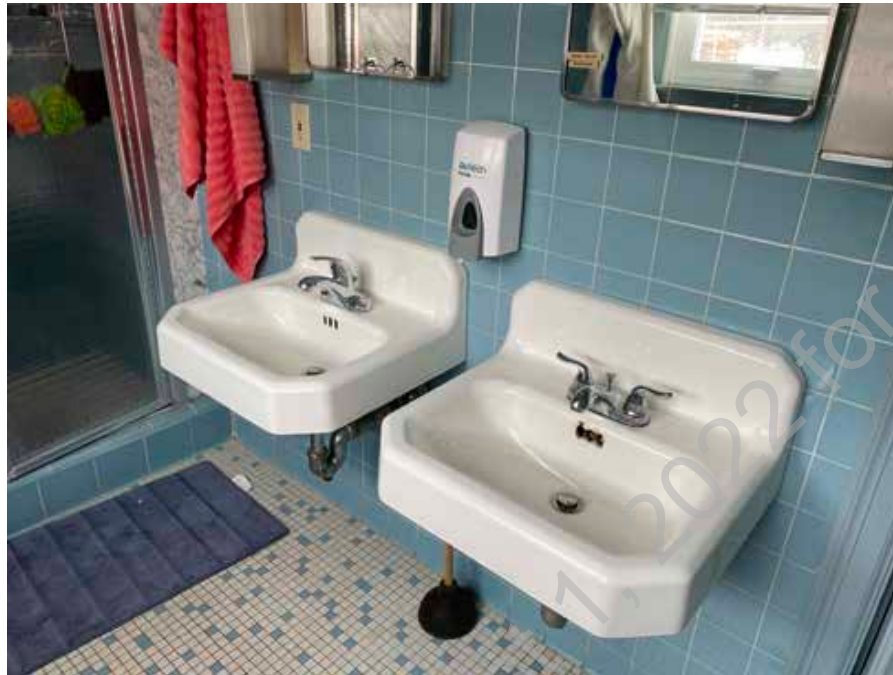
● D2. 35: Outdated Plumbing Fixtures

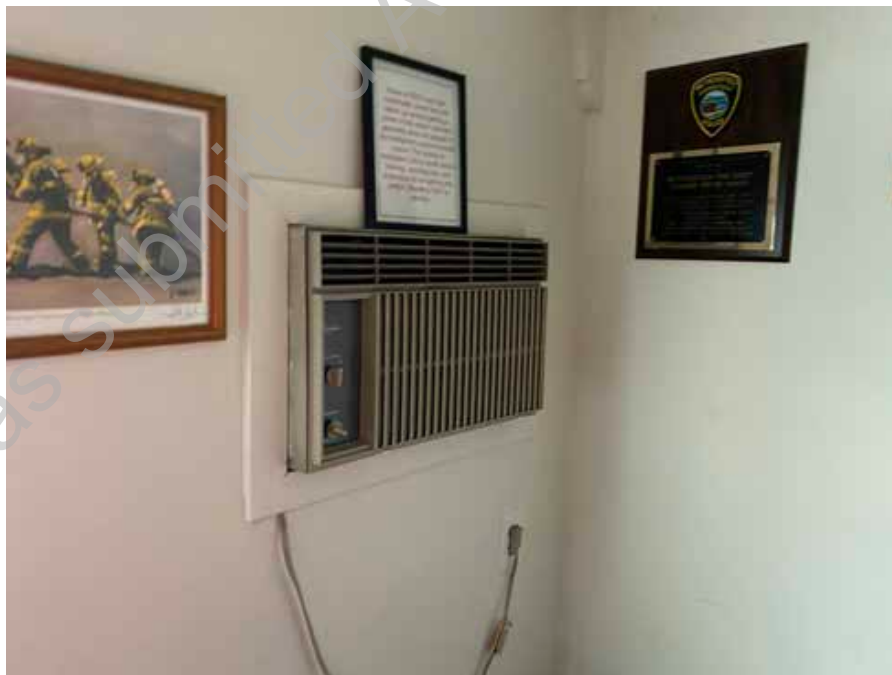
● D2. 42: Thru Wall AC Unit in Poor Condition

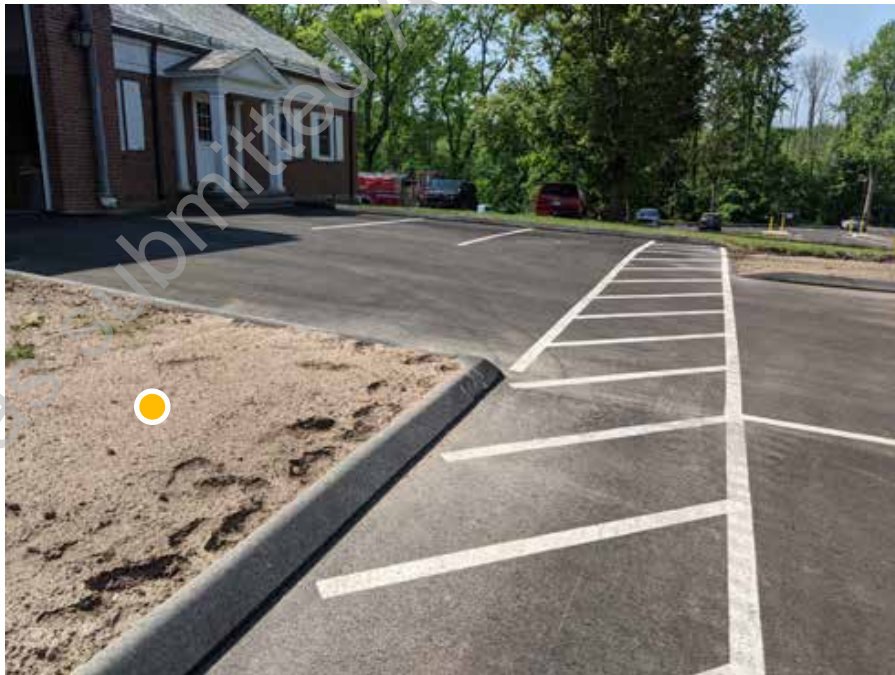
- D3. 2: Grass missing in lawn area due to parking lot work

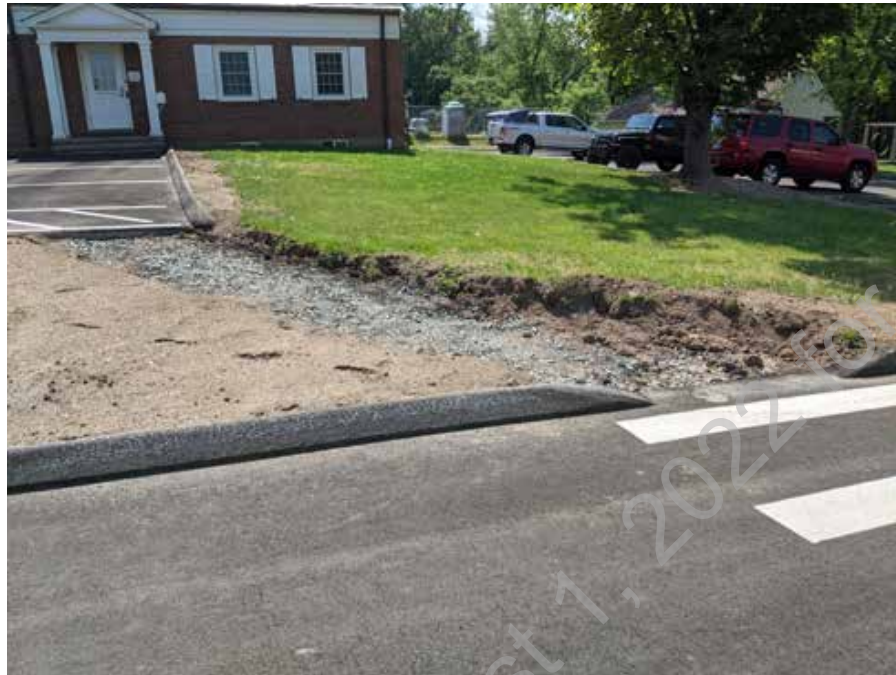
● D3. 3: New sidewalk substrate has been prepared but was not completed at the time of walkthrough

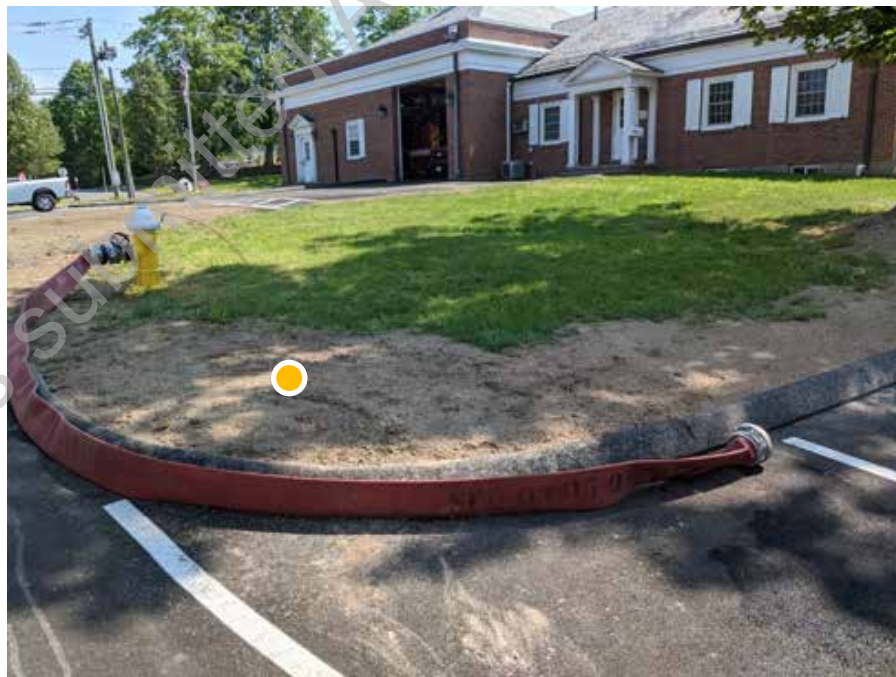
● D3. 4: Grass missing in lawn area due to parking lot work

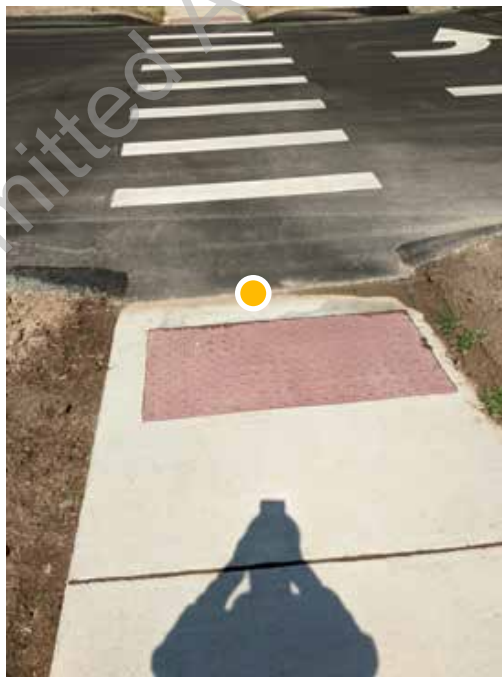
● D3. 6: A low point was observed between concrete sidewalk and parking area and may collect water

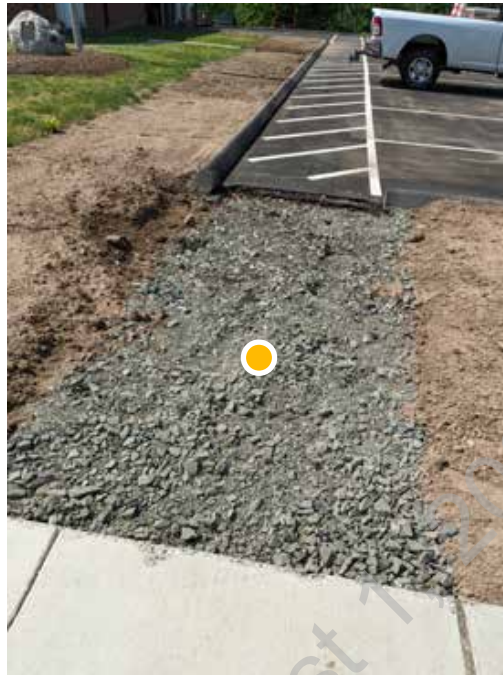
- D3. 7: New sidewalk substrate has been prepared but was not completed at the time of walkthrough

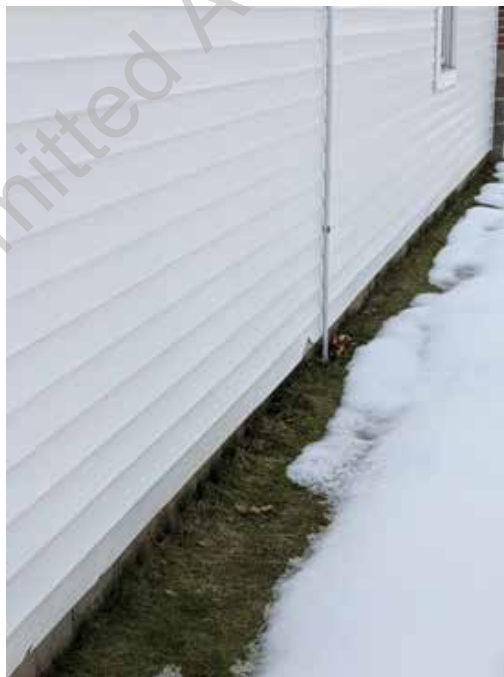
● D1. 6: Damaged vinyl siding at base

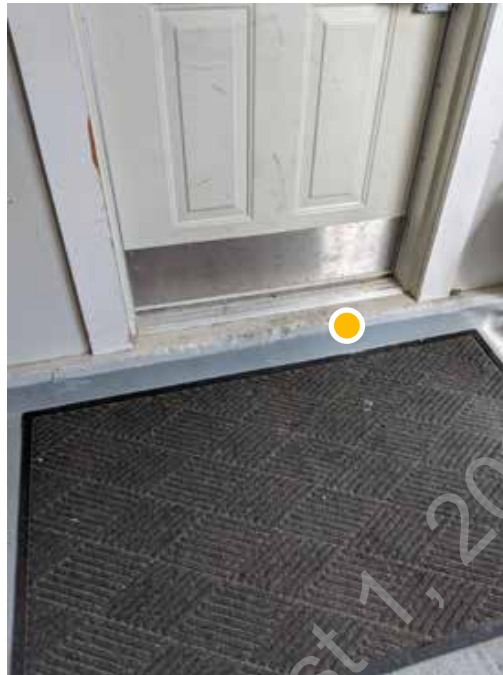
- D1. 7: Step between Apparatus Bay and the rest of the programmed space creates a condition that is not wheelchair accessible

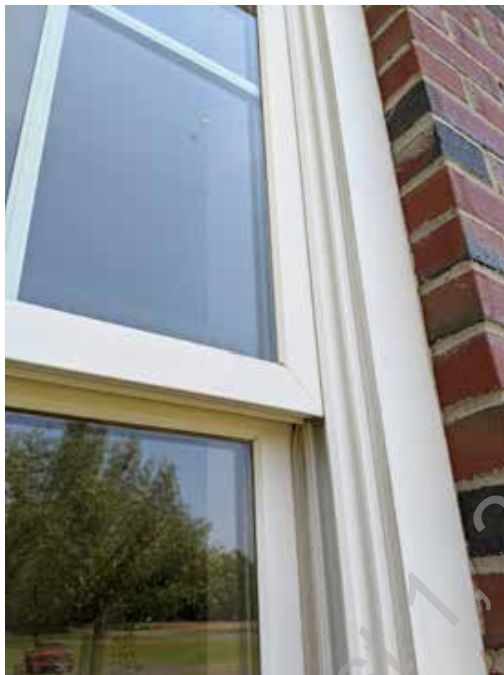
- D1. 9: Vinyl windows throughout are in good condition

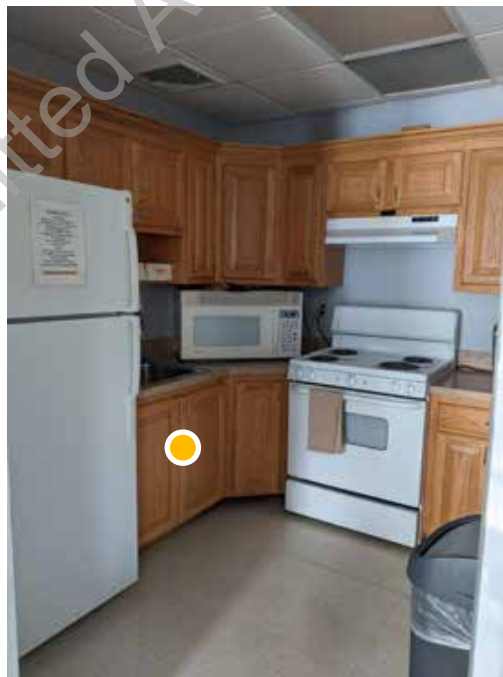
- D1. 12: Kitchen sink does not have the required clear space to be considered wheelchair accessible

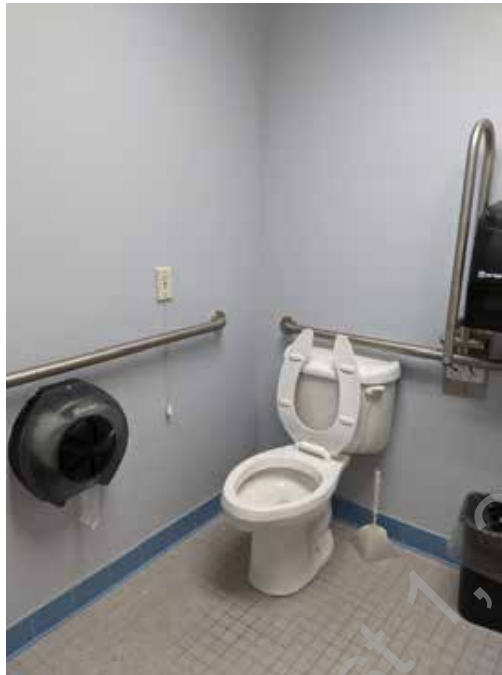
● D1. 13: Toilet Rooms are ADA-compliant

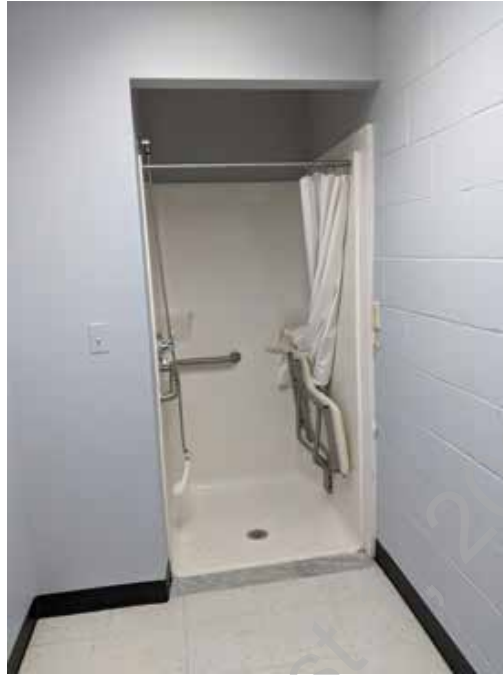
- D1. 15: Shower stall appears to be ADA-compliant as a transfer-type shower

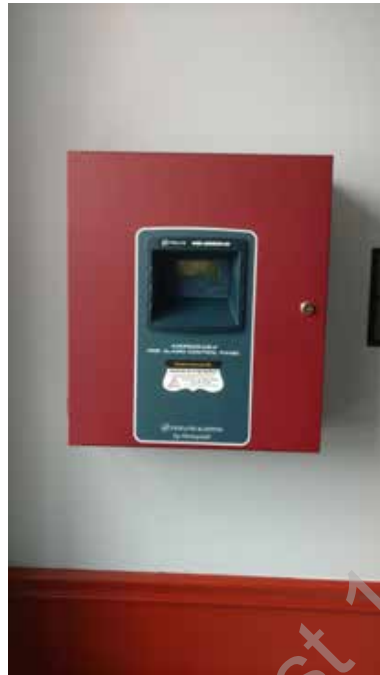
FIRE ALARM SYSTEM: Fire Alarm protective signaling provisions exist in the building and are administered through a Fire Lite Alarms #MS-9050UD control panel. The panel appears to be fully functional and in very good condition. The panel and peripheral equipment dates to approximately 2004. The panel is a 50 point addressable device control panel. The existing occupant notification device layout appears to be in compliance with NFPA requirements with regard to occupant notification standards and initiation device layout. The system communicates to a Central Station via a Notifier #PGSM-4G cellular based communicator complete with an exterior antenna that is installed at the North exterior roof peak. The building is complete with pull stations, smoke detectors and heat detectors and monitors the fire protection service water flow and supervisory conditions.

● D2. 13: Fire Alarm Control Panel

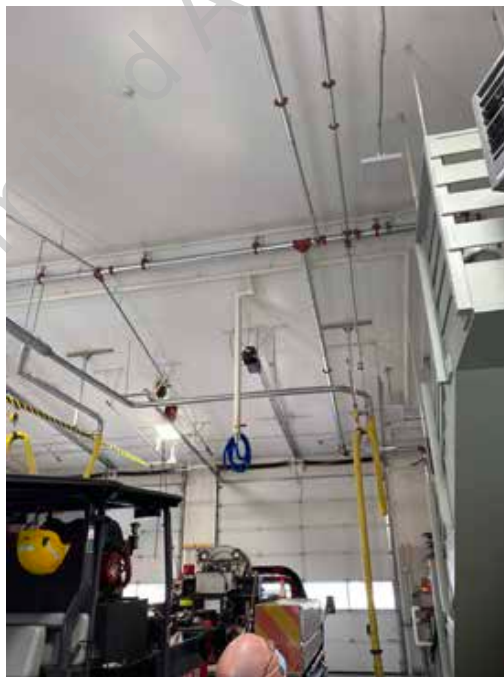
FIRE PROTECTION: The building currently contains a full fire protection sprinkler system. The sprinkler system is a dry system and the fire protection entrance is located in the Apparatus Bay. The sprinkler system appears to be in good working condition.

● D2. 14: Fire protection Sprinkler System in App Bay

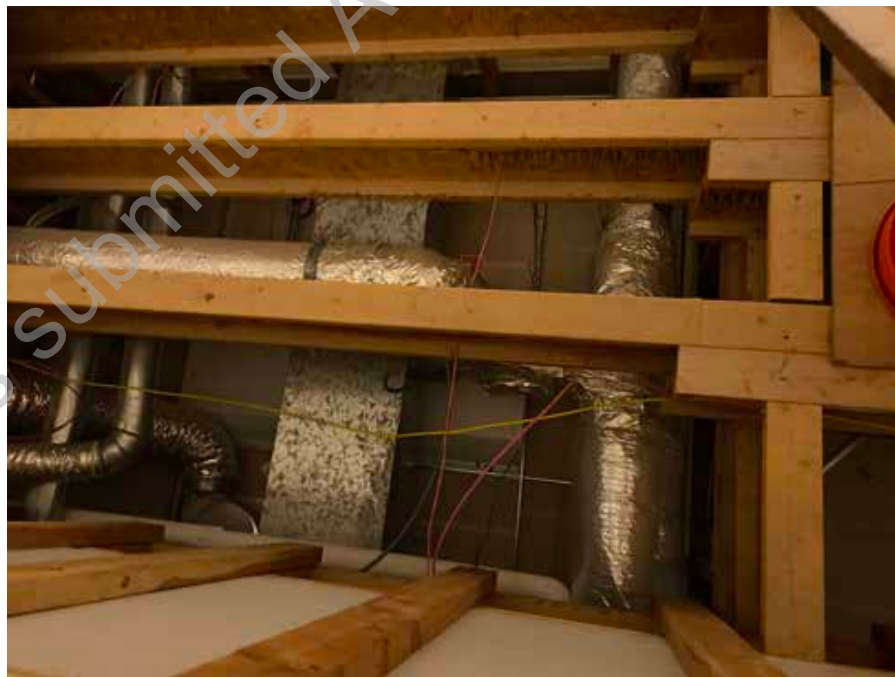
DUCTWORK: The ductwork is original to the building and appears to be in good working condition.

● D2. 16: Furnace Ductwork Routing through Attic Space

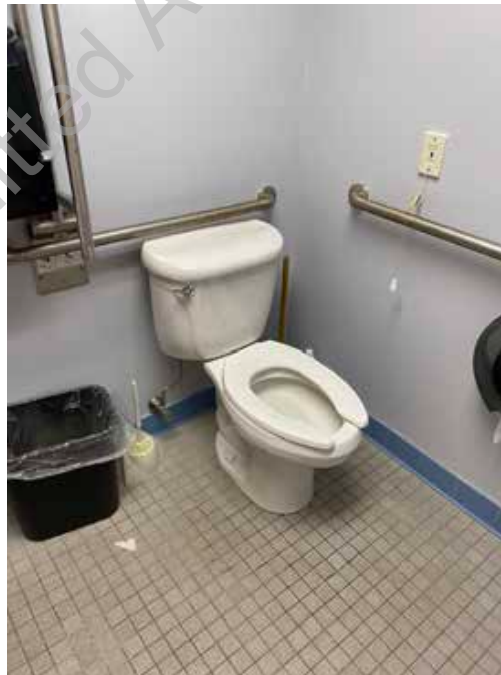
PLUMBING FIXTURES: The plumbing fixtures in the building are from the original 2005 construction and are in good working condition.

● D2. 20: Plumbing Fixture in Good Condition

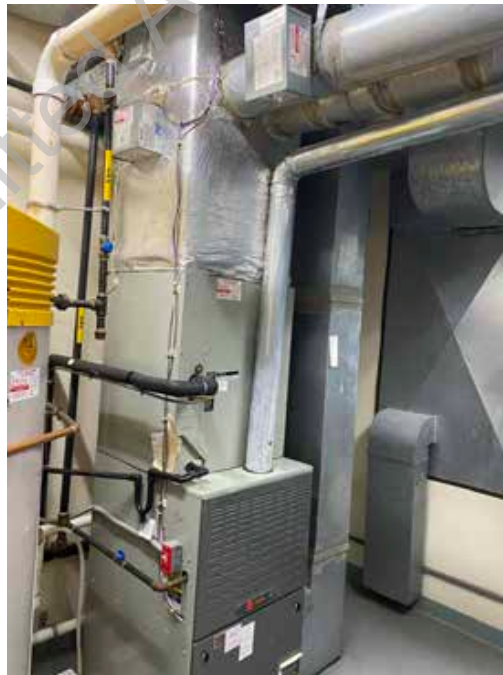
HEATING SYSTEMS: The existing heating plant consists of one propane gas fired furnace manufactured by Trane. This furnace has 60.0 MBH cooling output and a 140 MBH heating output. The furnace was installed original to the 2005 construction and is in good working condition.

● D2. 24: Propane Fired Furnace and Connecting Ductwork

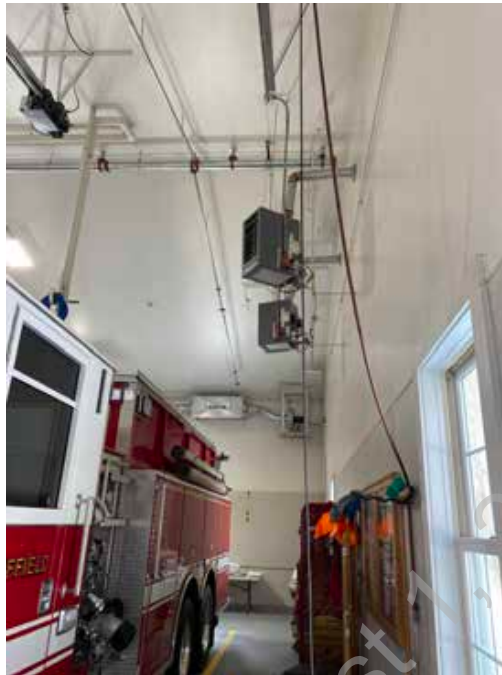
TERMINAL UNITS: The building contains four propane fired unit heaters located in the Apparatus Bay. The unit heaters are original to construction and in good working condition. There are six variable air volume (VAV) boxes located in the ductwork system throughout the building. The VAV boxes control the volume of airflow moving through the ductwork from the furnace. The VAV boxes are in good working condition. The building contains a vehicle exhaust system in the Apparatus Bay manufactured by Plymovent that appears to be in good working condition.

● D2. 25: Propane Fired Unit Heaters in App Bay

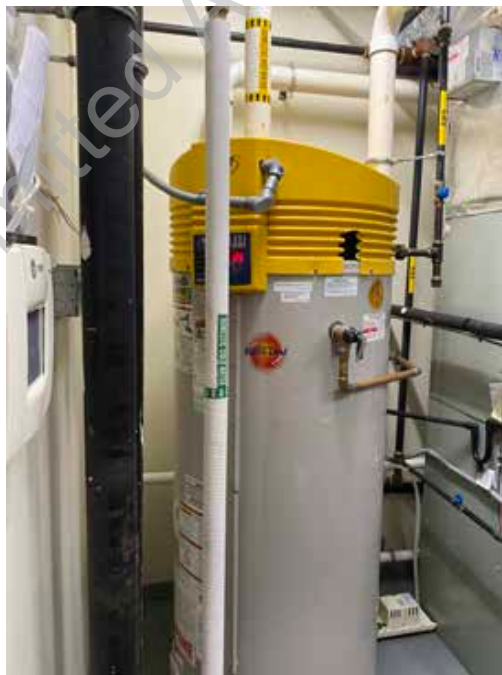
● D2. 26: Propane Fueled Domestic Hot Water Heater
