TOWN OF SUFFIELD

CONDITIONS ASSESSMENT & MASTER PLAN

Draft as submitted August 1, 2022 for review

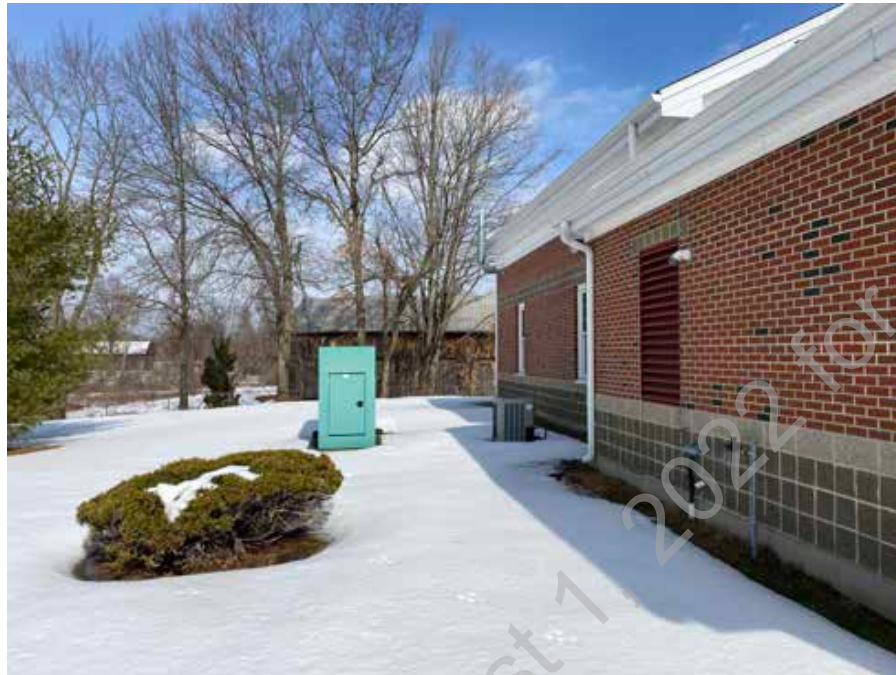
● D2. 27: Propane Gas Service

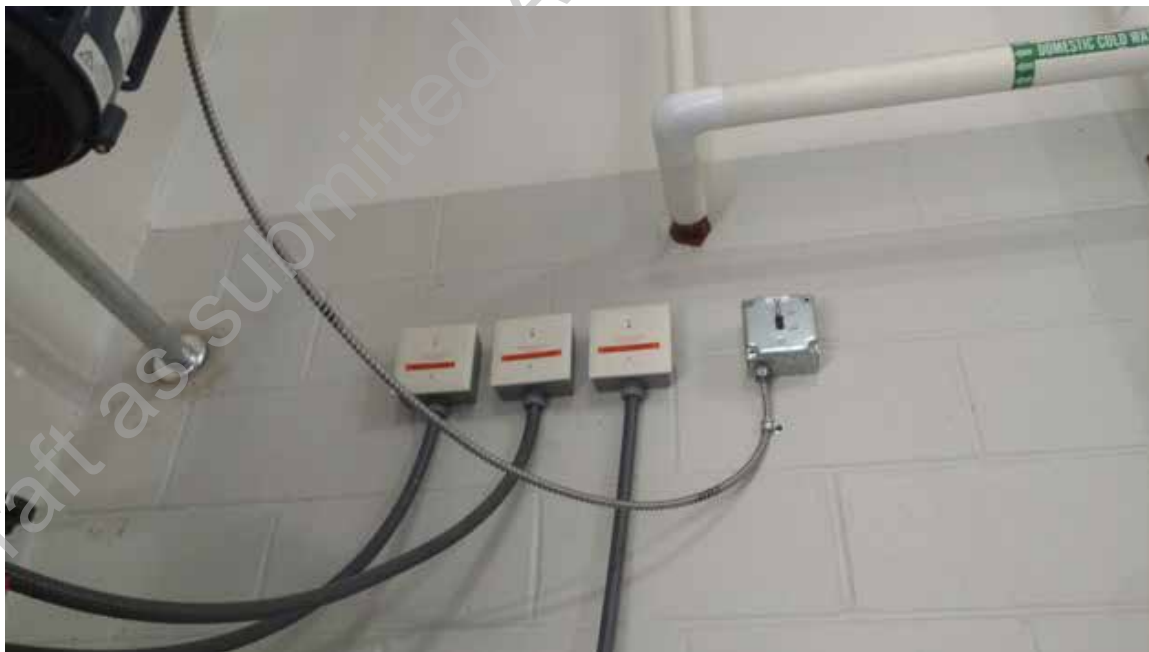
● D2. 30: Sprinkler System Monitoring

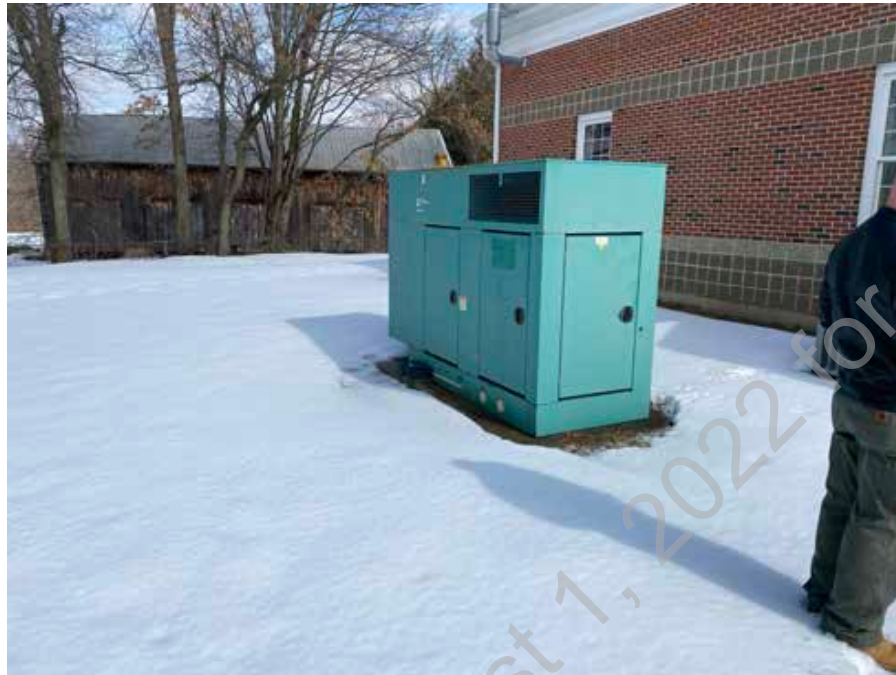
● D2. 31: Standby Generator

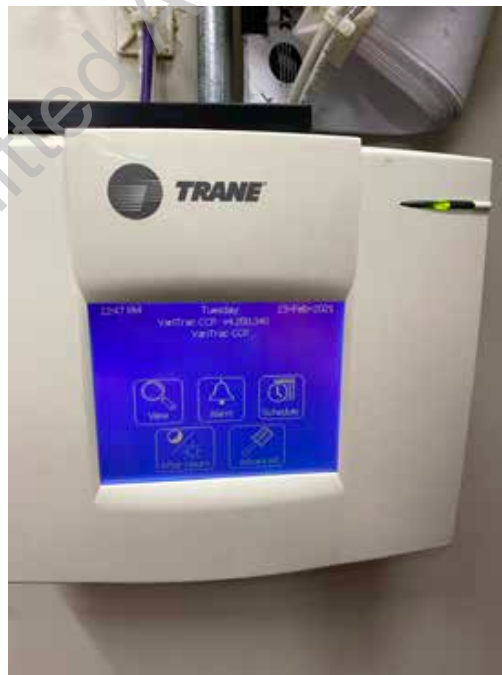
● D2. 32: Trane VariTrac CCP Temperature Control

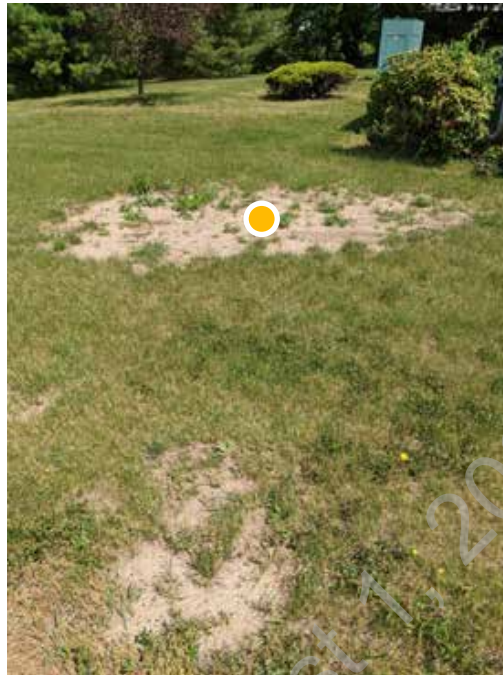
● D3. 3: Lawn areas are patchy throughout and require re-seeding

Replace bituminous curbing	680	LF	\$9	\$ 5,984	\$ 598	\$ 90	\$ 449	\$ 299	\$ 7,420	\$ 928	\$ 8,348	\$ 1,670	\$ 10,017							
Reseed lawns north and south of building	200	SY	\$4	\$ 880	\$ 88	\$ 13	\$ 66	\$ 44	\$ 1,091	\$ 136	\$ 1,228	\$ 246	\$ 1,473							
Reset existing parking signage	2	EA	\$220	\$ 440	\$ 44	\$ 7	\$ 33	\$ 22	\$ 546	\$ 68	\$ 614	\$ 123	\$ 737							
Scrape and repaint existing bollards	4	EA	\$110	\$ 440	\$ 44	\$ 7	\$ 33	\$ 22	\$ 546	\$ 68	\$ 614	\$ 123	\$ 737							
Exterior Improvements				\$ -					\$ -	\$ -	\$ -									
Clean masonry/exposed foundation	3,906	SF	\$2	\$ 8,593	\$ 859	\$ 129	\$ 644	\$ 430	\$ 10,656	\$ 1,332	\$ 11,988	\$ 2,398	\$ 14,385							
Replace vinyl siding/trim	50	SF	\$6	\$ 275	\$ 28	\$ 4	\$ 21	\$ 14	\$ 341	\$ 43	\$ 384	\$ 77	\$ 460							
Paint canopies	130	SF	\$4	\$ 572	\$ 57	\$ 9	\$ 43	\$ 29	\$ 709	\$ 89	\$ 798	\$ 160	\$ 958							
Investigate ice damming issue	1	EA	\$5,500	\$ 5,500	\$ 550	\$ 83	\$ 413	\$ 275	\$ 6,820	\$ 853	\$ 7,673	\$ 1,535	\$ 9,207	Requires further investigation

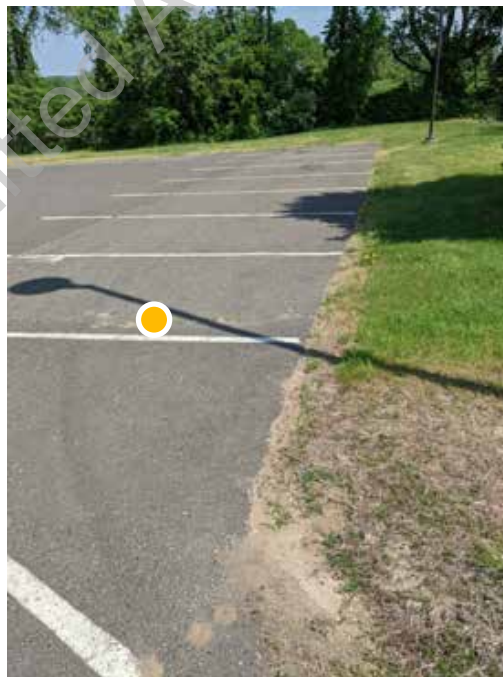
● D3. 4: Bituminous concrete paving is cracking at drive aisles and parking areas throughout the upper and lower parking lots

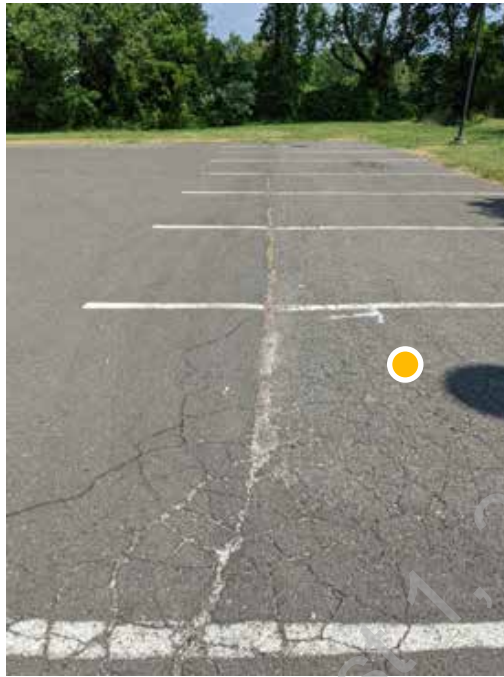
- D3. 5: Bituminous concrete paving is cracking at drive aisles and parking areas throughout the upper and lower parking lots

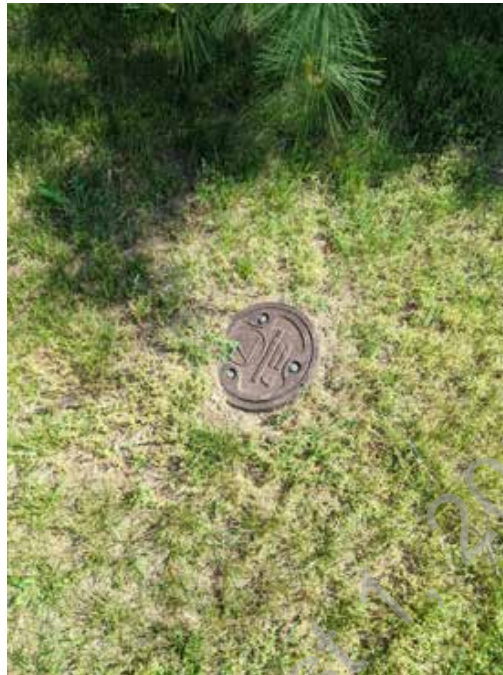
● D3. 7: Cleanout is partially buried

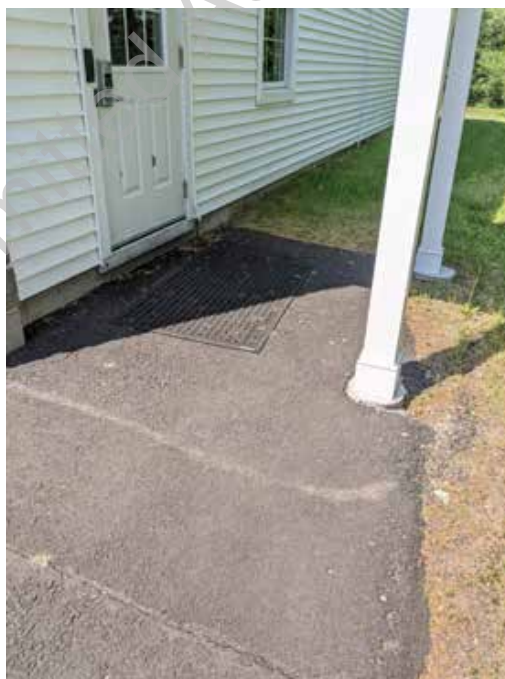
● D3. 10: Bituminous concrete paving at North entrance is beginning to show cracking

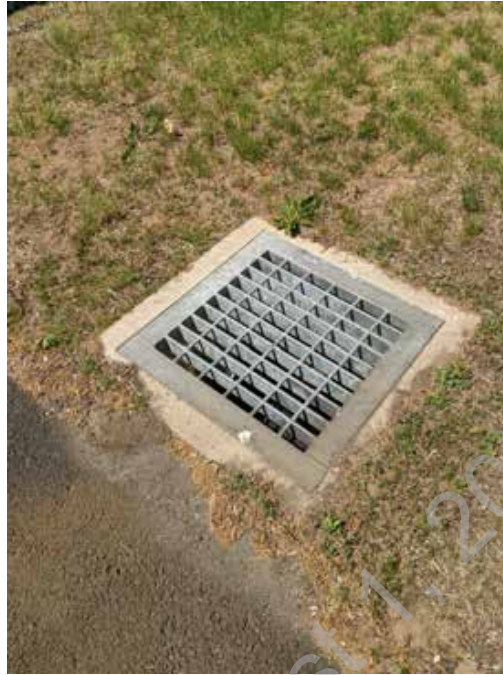
- D3. 11: Concrete catch basin tops are partially buried

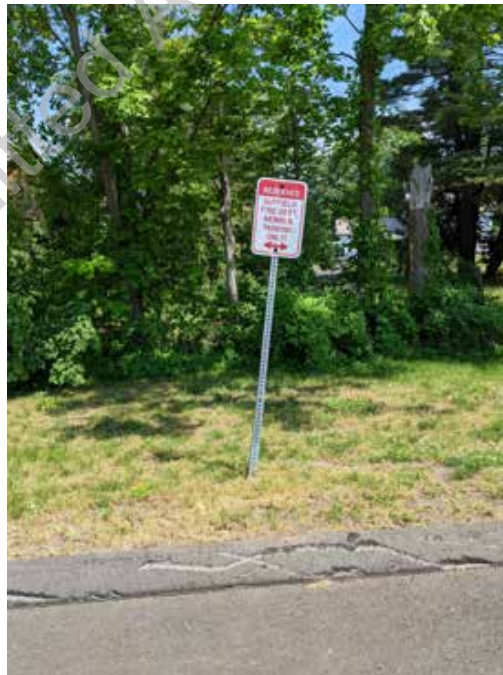
- D3. 12: Parking signage requires resetting

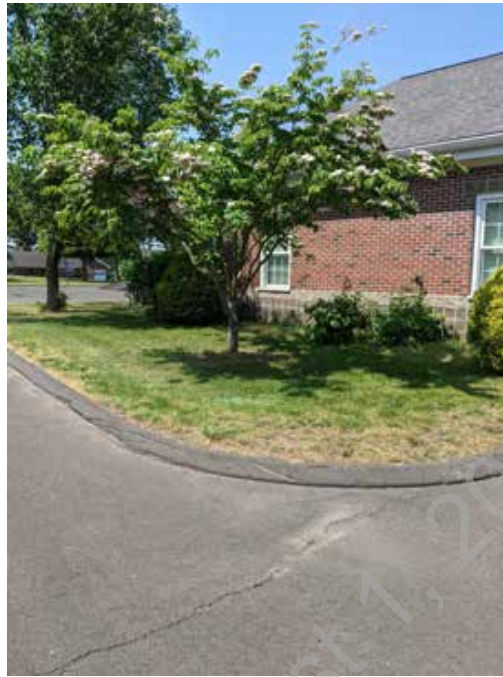
- D3. 15: Bituminous asphalt curbing is damaged at most locations

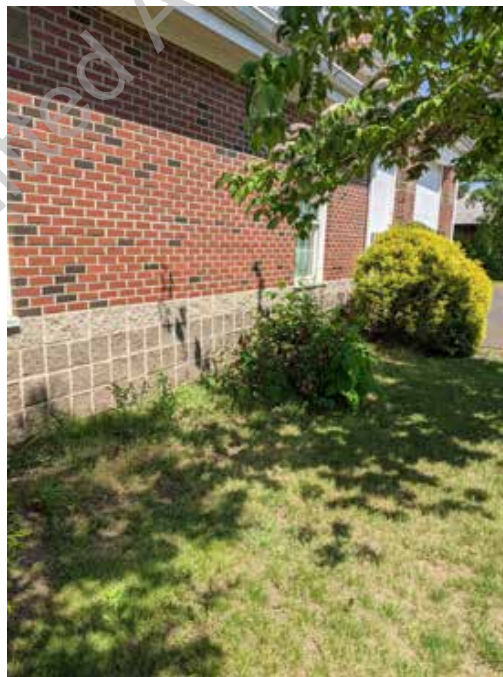
- D3. 16: Planting areas along the East façade contain grass and weeds

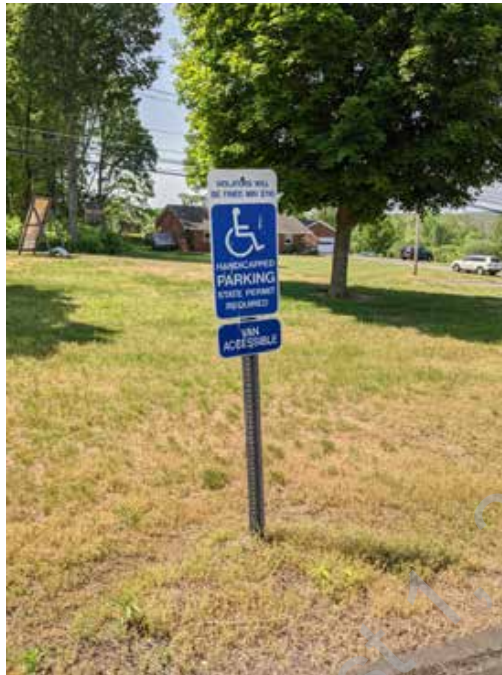
● D3. 17: Parking signage requires resetting

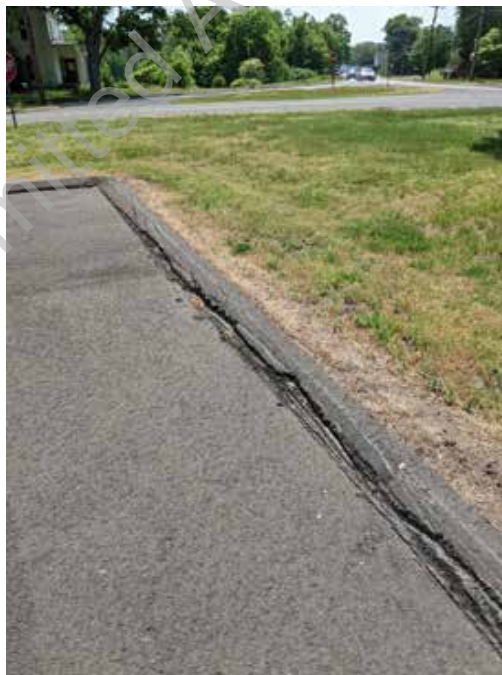
● D3. 18: Bituminous asphalt curbing is damaged at most locations

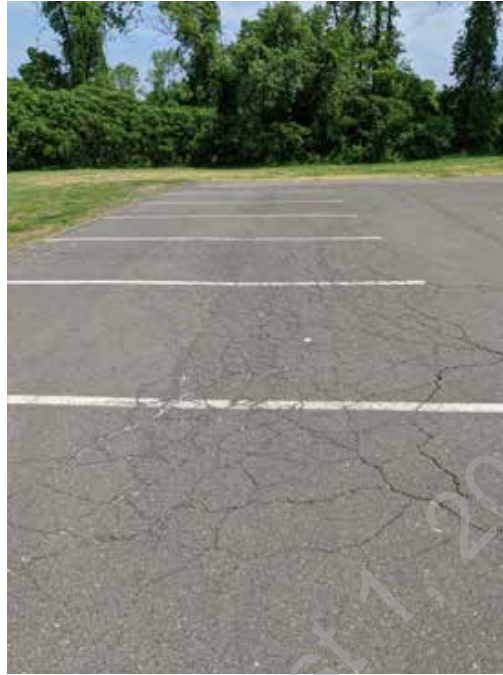
- D3. 19: Bituminous concrete paving is cracking at drive aisles and parking areas throughout the upper and lower parking lots

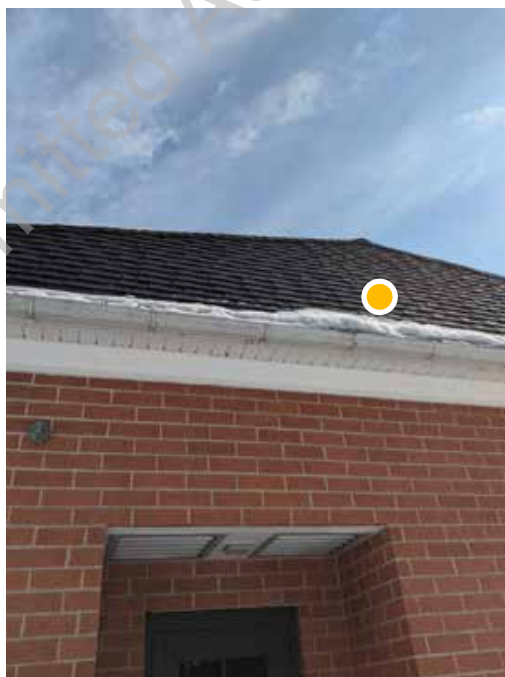
ROOF: Asphalt shingle roof was installed in 2006 and carries a 50-year warranty. Gutters and downspouts can be considered fair condition. Some ice damming was observed at the initial site visit and rerouting of downspout discharge would be recommended. The current configuration discharges water across the main drive aisle potentially causing hazards. A gutter and downspout should be added at the canopy, the current configuration sheds water directly onto the sidewalk.

● D1. 2: Ice and snow build up at gutter system

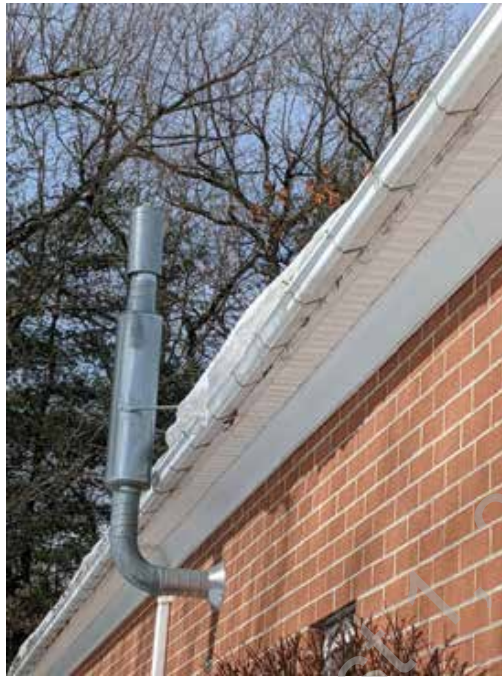
● D1. 5: Ice and snow build up at gutter system

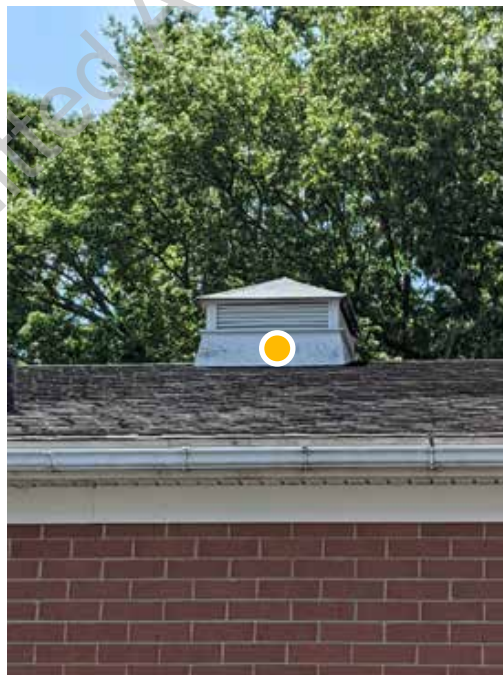
● D1. 8: Vented cupola requires repainting

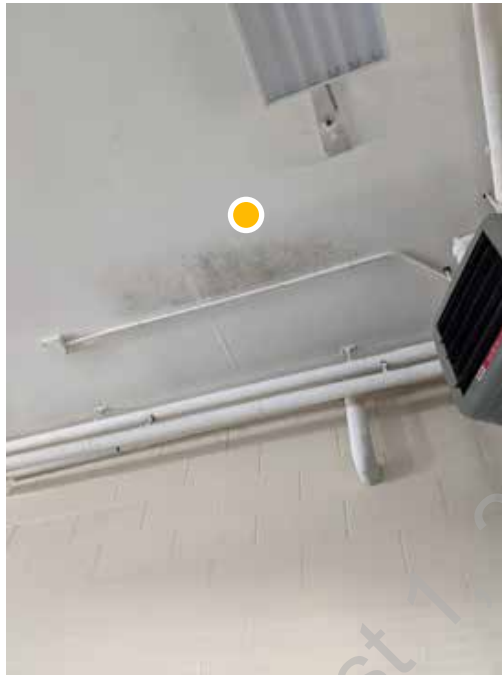
APPARATUS BAY: Concrete masonry unit back-up walls are cracked throughout the apparatus bay. Gypsum board ceiling is in fair condition, however, some suspected mold can be seen above ceiling-mounted heating unit.

- D1. 9: Staining at Apparatus Bay ceiling that is believed to be mold

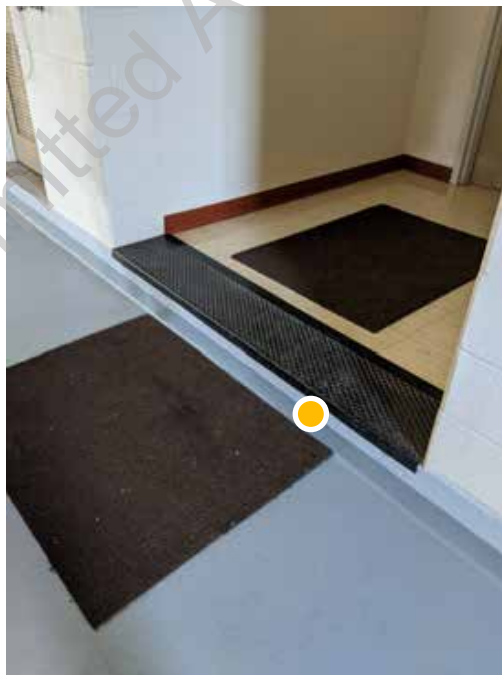
- D1. 10: Step between Apparatus Bay and the rest of the building creates a condition that is not wheelchair accessible

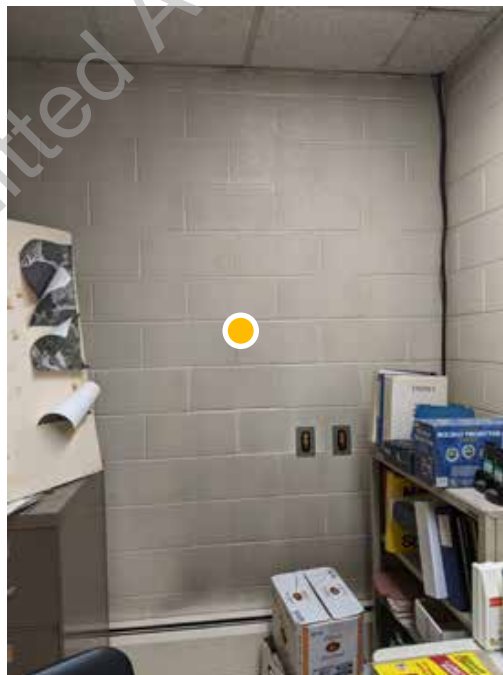
- D1. 12: Staining on Radio room walls; this is likely from particulates, originating in the Apparatus Bay, having settled on the radiant heating system and burning

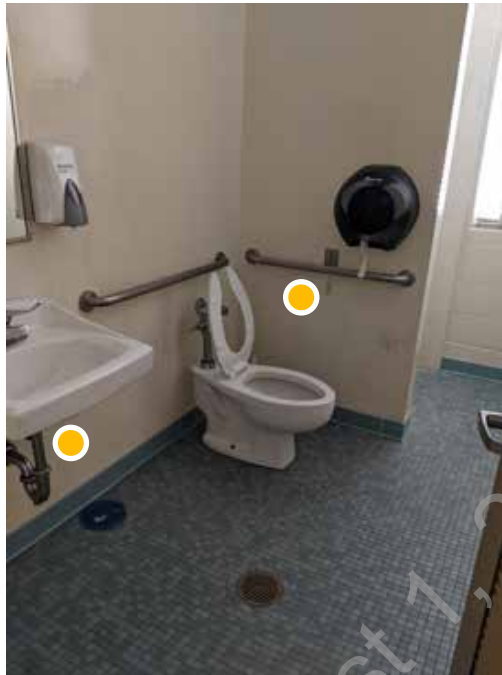
- D1. 13: Grab bars at toilet room do not meet ADA requirements to be considered compliant; pipe insulation is missing below lavatory

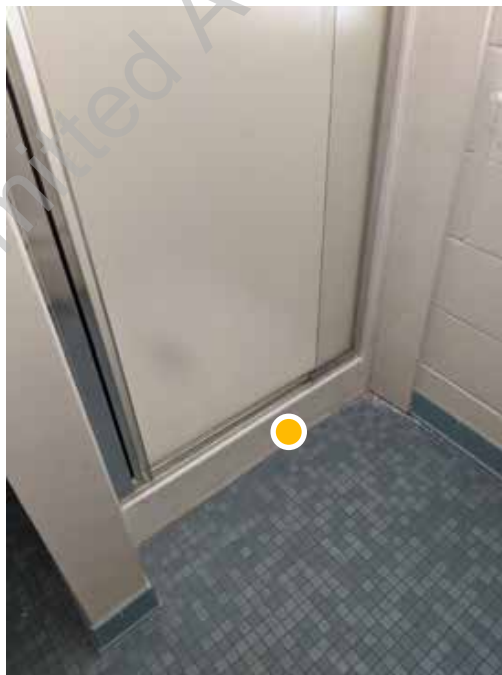
- D1. 14: Showers in Toilet rooms do not meet requirements to be considered ADA-compliant

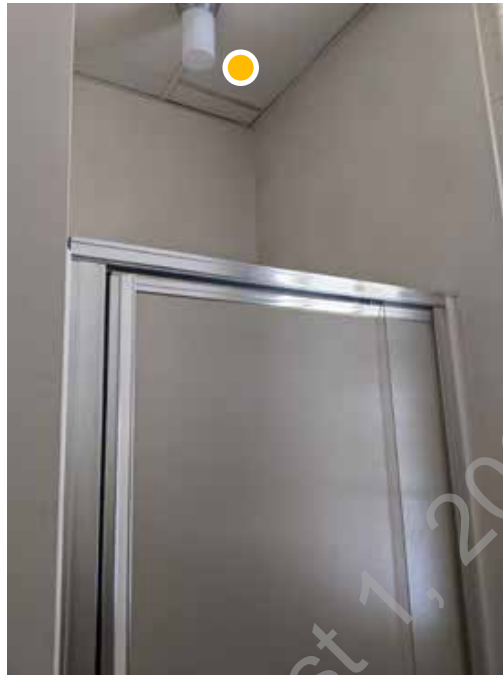
● D1. 15: Acoustic ceiling tile track showing signs of rust above shower stalls

Replace window caulking & sealant	120	SF	\$2	\$ 264	\$ 26	\$ 4	\$ 20	\$ 13	\$ 327	\$ 41	\$ 368	\$ 74	\$ 442								
Interior Improvements				\$ -					\$ -	\$ -	\$ -										
Replace ceiling tiles and grid at shower	70	SF	\$8	\$ 539	\$ 54	\$ 8	\$ 40	\$ 27	\$ 668	\$ 84	\$ 752	\$ 150	\$ 902								
Replace kitchen sink/cabinet with ADA accessible sink and casework	1	EA	\$2,750	\$ 2,750	\$ 275	\$ 41	\$ 206	\$ 138	\$ 3,410	\$ 426	\$ 3,836	\$ 767	\$ 4,604	Technically infeasible without significant renovations							
ADA upgrades at toilet rooms	2	EA	\$6,600	\$ 13,200	\$ 1,320	\$ 198	\$ 990	\$ 660	\$ 16,368	\$ 2,046	\$ 18,414	\$ 3,683	\$ 22,097	Technically infeasible without significant renovations.							
Repair cracks in exterior masonry walls	100	SF	\$22	\$ 2,200	\$ 220	\$ 33	\$ 165	\$ 110	\$ 2,728	\$ 341	\$ 3,069	\$ 614	\$ 3,683								
Clean Radio Office	75	SF	\$1	\$ 83	\$ 8	\$ 1	\$ 6	\$ 4	\$ 102	\$ 13	\$ 115	\$ 23	\$ 138

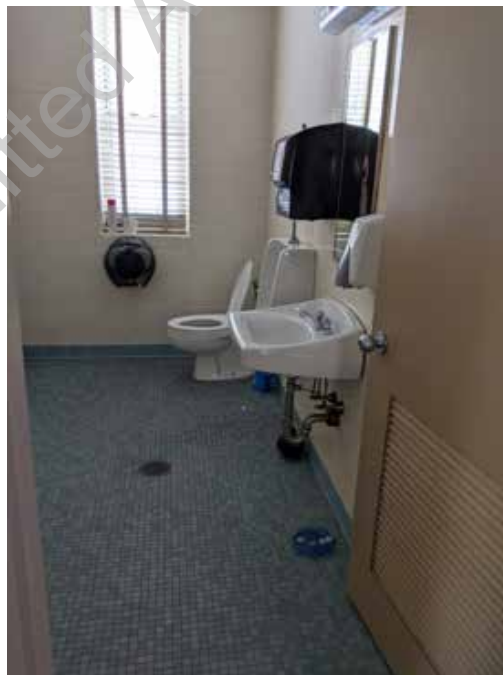
● D1. 16: Grab bars at toilet room do not meet ADA requirements to be considered compliant; pipe insulation is missing below lavatory

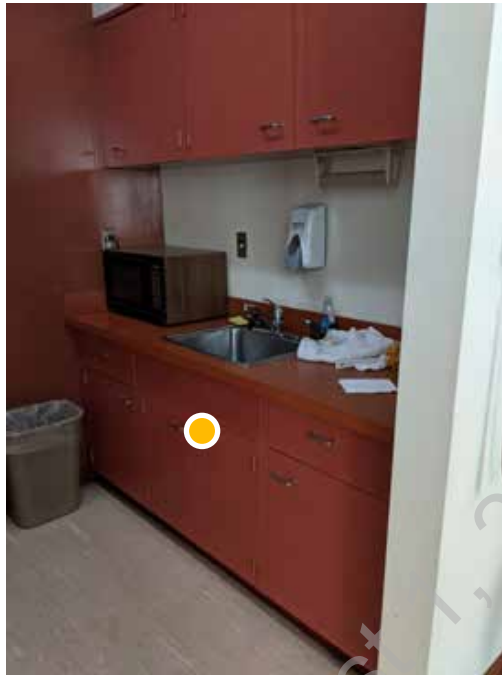
- D1. 17: Kitchen sink does not have the required clear space below to be considered ADA-compliant

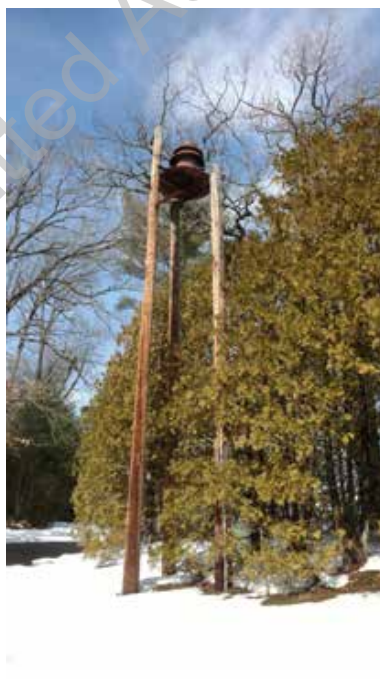
OTHER STRUCTURES: Radio tower and a large propane tank are located behind the building. An antique siren tower is located on the north end of the site and is in poor condition.

● D2. 4: Community Alert Siren

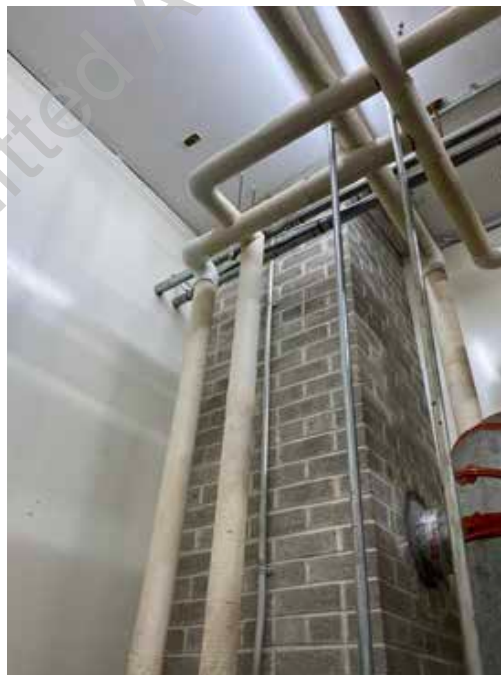
● D2. 6: Domestic Water Piping in Poor Condition

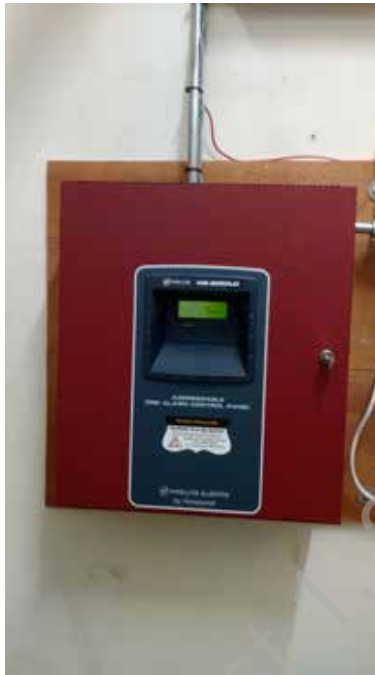
FIRE ALARM SYSTEM: Fire Alarm protective signaling provisions exist in the building and are administered through a Fire Lite Alarms #MS-9050UD control panel. The panel appears to be fully functional and in very good condition. The panel and peripheral equipment date to approximately 2004. The panel is a 50 point addressable device control panel. The existing occupant notification device layout appears to be in compliance with NFPA requirements with regard to occupant notification standards and initiating device layout. The system communicates to a Central Station via a Notifier #PGSM-4G cellular based communicator complete with an exterior antenna that is installed at the North exterior roof peak. The building is complete with pull stations, smoke detectors and heat detectors and monitors the fire protection service water flow and supervisory conditions.

● D2. 13: Fire Alarm Control Panel

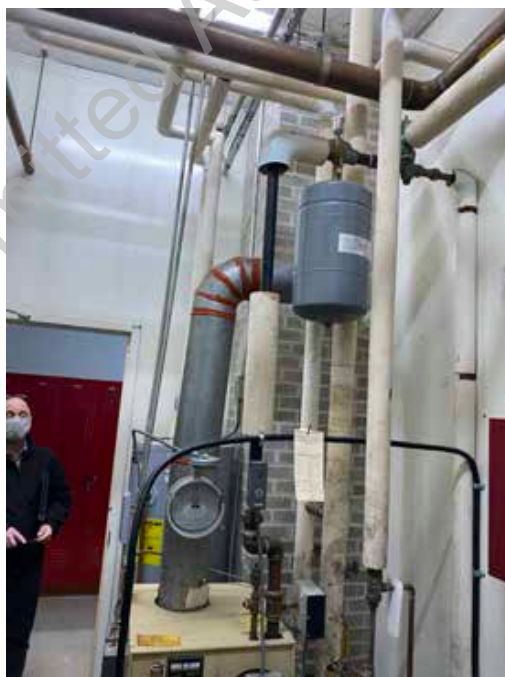
● D2. 16: Hot Water Piping in Poor Condition

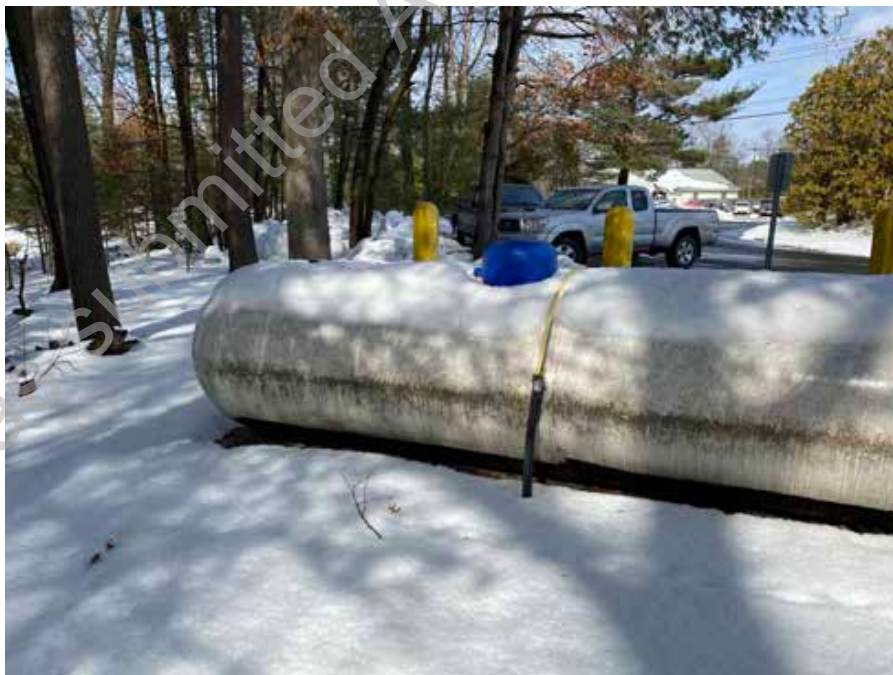
PROPANE SERVICE: The building currently has a propane tank that feeds the boiler. The tank is buried outside of the building and the propane gas is piped into the mechanical room to the boiler. The tank and piping are in fair working condition.

● D2. 24: Propane Tank Located Outside

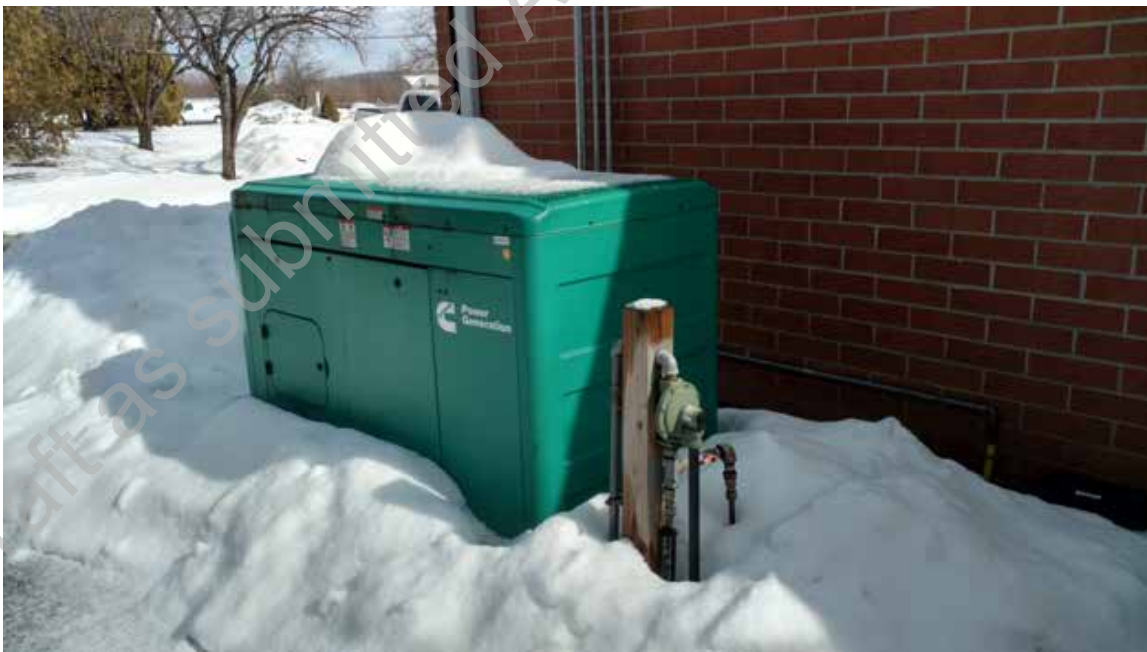
● D2. 28: Standby Generator

Generator	1	EA	\$55,000	\$ 55,000	\$ 5,500	\$ 825	\$ 4,125	\$ 2,750	\$ 68,200	\$ 8,525	\$ 76,725	\$ 15,345	\$ 92,070	5+yrs useful life. Generator is well beyond useful life.							
Lighting - General	3,256	SF	\$9	\$ 28,653	\$ 2,865	\$ 430	\$ 2,149	\$ 1,433	\$ 35,529	\$ 4,441	\$ 39,971	\$ 7,994	\$ 47,965	5+yrs useful life. Light fixtures are older incandescent types with retrofit lamps.							
Fire Alarm System	3,256	SF	\$11	\$ 35,816	\$ 3,582	\$ 537	\$ 2,686	\$ 1,791	\$ 44,412	\$ 5,551	\$ 49,963	\$ 9,993	\$ 59,956	10+yrs useful life. Fire alarm system is in good condition and is addressable technology.							
Subtotal for CIP Items				\$ 424,907					\$ 526,885		\$ 592,745	\$ 118,549	\$ 711,294								
Cost Per Square Foot				\$ 130.50	\$ -	\$ -	\$ -	\$ -	\$ 161.82	\$ -	\$ 182.05	\$ 36.41	\$ 218.46								
Building Vintage Summary																					
Building Vintage		Area		% to TH

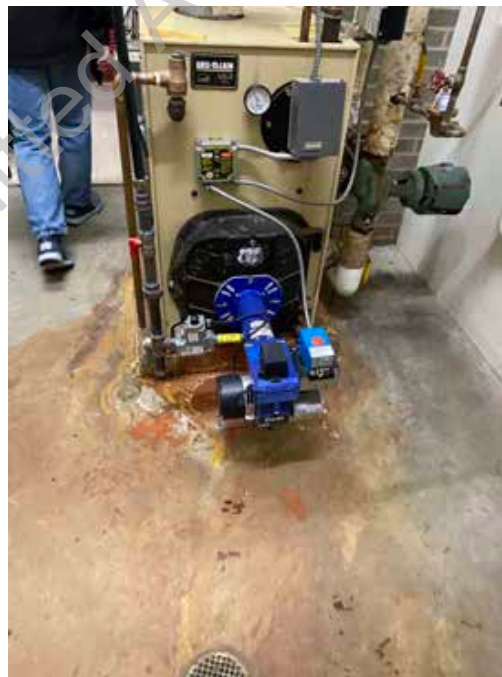
● D2. 30: Weil McLain Propane Fired Hot Water Boiler

Division 23 - Mechanical				\$ -					\$ -	\$ -	\$ -										
Heating Plant (Boilers, Pumps, etc.)	1	SF	\$9	\$ 9	\$ 1	\$ 0	\$ 1	\$ 0	\$ 11	\$ 1	\$ 12	\$ 2	\$ 15	3-5yrs useful life. Boiler plant appears to be original to the 1985 construction and is past its useful life. will need to be replaced.							
Terminal Units	3,256	SF	\$7	\$ 21,490	\$ 2,149	\$ 322	\$ 1,612	\$ 1,074	\$ 26,647	\$ 3,331	\$ 29,978	\$ 5,996	\$ 35,974	3-5yrs useful life. Unit heaters and perimeter fin tube radiation are original to the building and at the end of their useful lives.							
Control Systems	3,256	SF	\$8	\$ 25,071	\$ 2,507	\$ 376	\$ 1,880	\$ 1,254	\$ 31,088	\$ 3,886	\$ 34,974	\$ 6,995	\$ 41,969	3-5yrs useful life. There is no BMS within this building. all other devices controlled by standalone controls original to construction.							
Division 26 - Electrical				\$ -					\$ -	\$ -	\$ -										
Electrical Service / Distribution	3,256	SF	\$22	\$ 71,632	\$ 7,163	\$ 1,074	\$ 5,372	\$ 3,582	\$ 88,824	\$ 11,103	\$ 99,927	\$ 19,985	\$ 119,912	10+yrs useful life. Original service appears to be in good working condition.

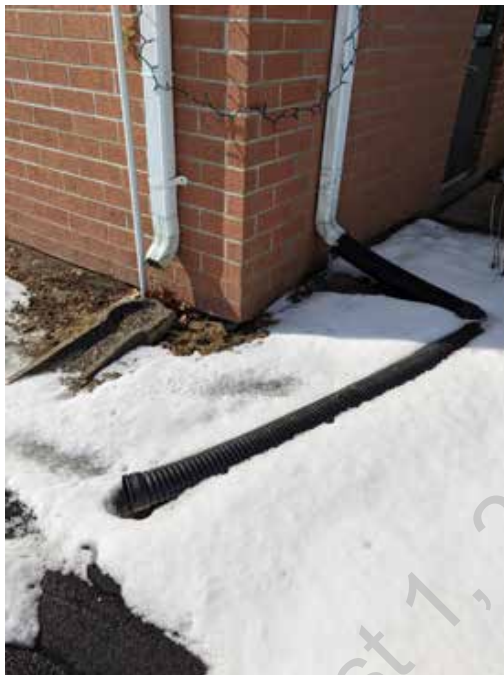
- D3. 1: Downspout requires permanent solution to assist in directional shedding of roof drainage

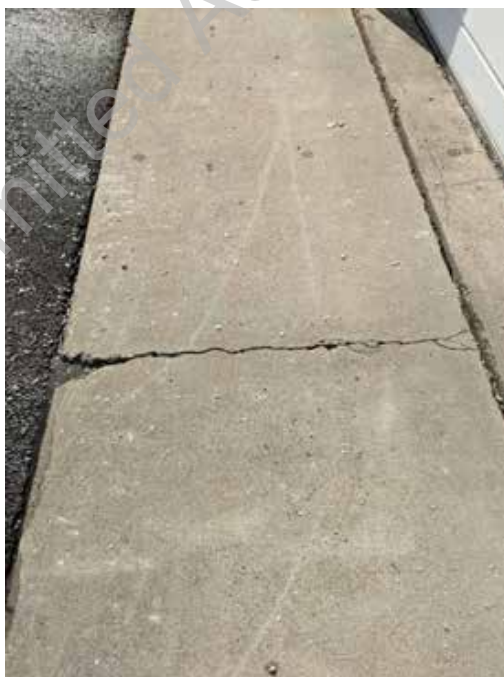
- D3. 2: Cracking observed at Apparatus Bay apron

Regrade/replace concrete sidewalks	280	SF	\$15	\$ 4,312	\$ 431	\$ 65	\$ 323	\$ 216	\$ 5,347	\$ 668	\$ 6,015	\$ 1,203	\$ 7,218								
Repair/replace concrete apron at OH doors	60	SF	\$17	\$ 990	\$ 99	\$ 15	\$ 74	\$ 50	\$ 1,228	\$ 153	\$ 1,381	\$ 276	\$ 1,657								
Regrade drive aisle, trench/connect storm drainage, add gutter/downspout to Entrance canopy	150	SY	\$61	\$ 9,075	\$ 908	\$ 136	\$ 681	\$ 454	\$ 11,253	\$ 1,407	\$ 12,660	\$ 2,532	\$ 15,192								
Add mulch to planting areas along building	10	CY	\$55	\$ 550	\$ 55	\$ 8	\$ 41	\$ 28	\$ 682	\$ 85	\$ 767	\$ 153	\$ 921								
Investigate storm water infiltration at tank	1	EA	\$2,750	\$ 2,750	\$ 275	\$ 41	\$ 206	\$ 138	\$ 3,410	\$ 426	\$ 3,836	\$ 767	\$ 4,604	Requires further investigation							
Exterior Improvements				\$ -					\$ -	\$ -	\$ -										
Clean masonry/exposed foundation	3,256	SF	\$2	\$ 7,163	\$ 716	\$ 107	\$ 537	\$ 358	\$ 8,882	\$ 1,110	\$ 9,993	\$ 1,999	\$ 11,991

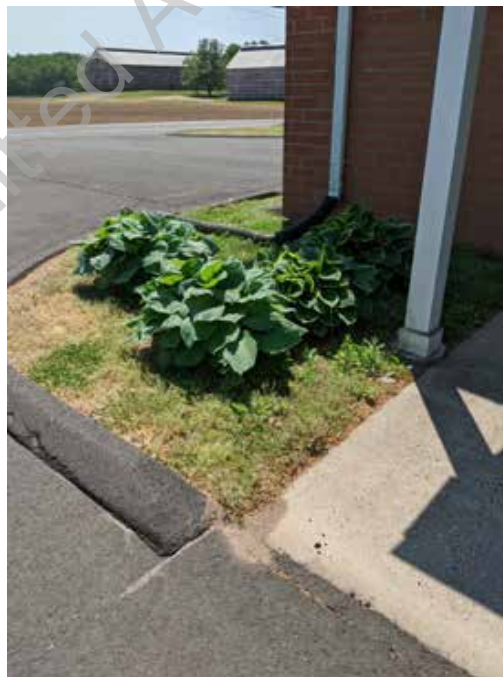
● D3. 4: Downspout requires permanent solution to assist in directional shedding of roof drainage

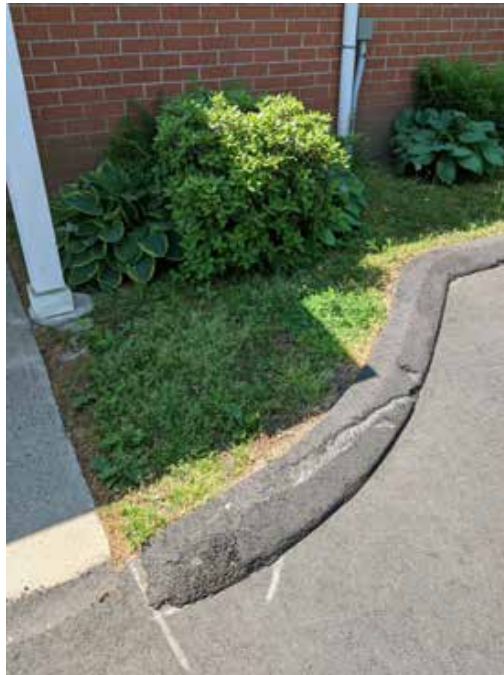
- D3. 5: Bituminous concrete curbing is damaged along all drive aisles

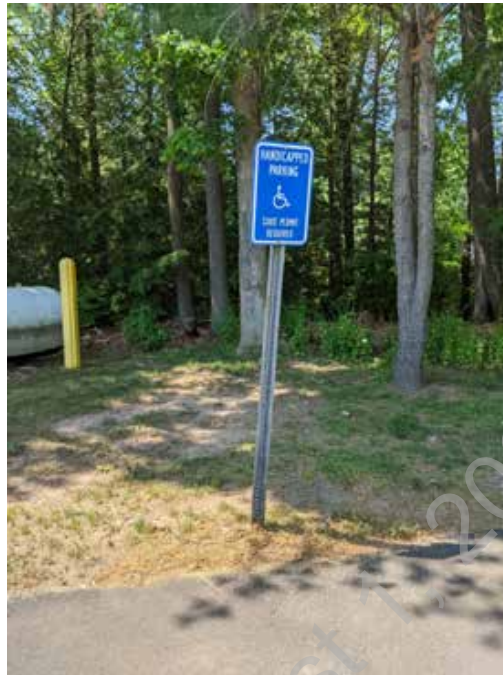
● D3. 7: Parking signage requires reseating

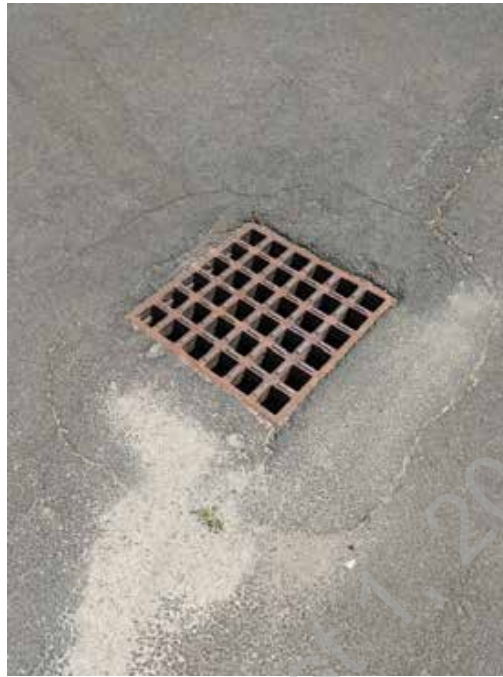
- D3. 11: Storm grate is in poor condition with cracks forming on all sides

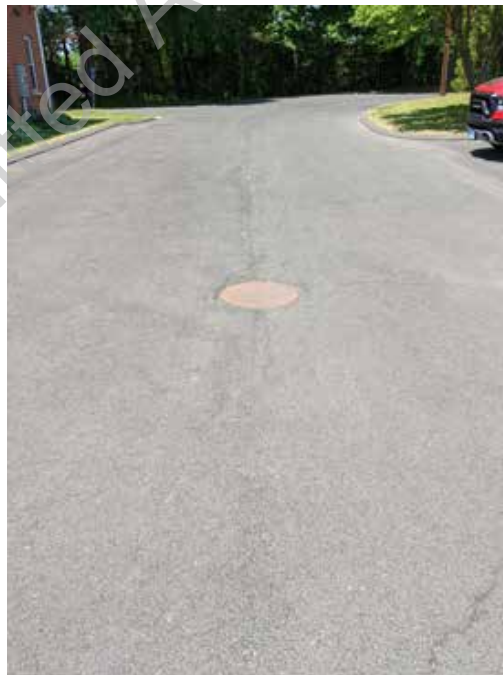
- D3. 12: Bituminous concrete paving is cracked at storm manhole cover

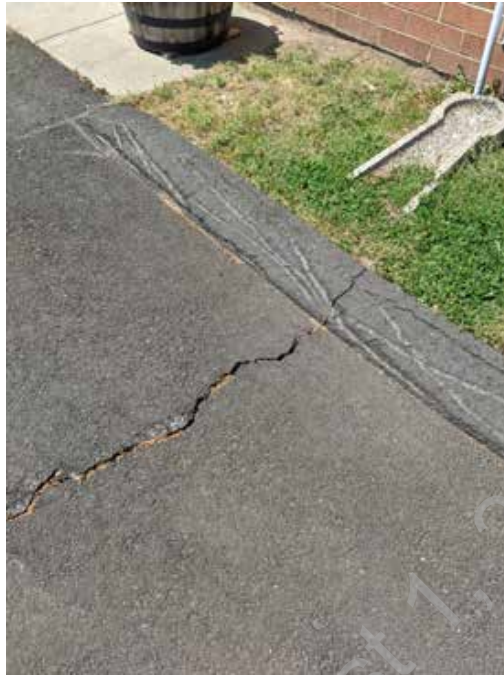
- D3. 13: Bituminous concrete paving and curbing is crack adjacent to Apparatus Bay doors

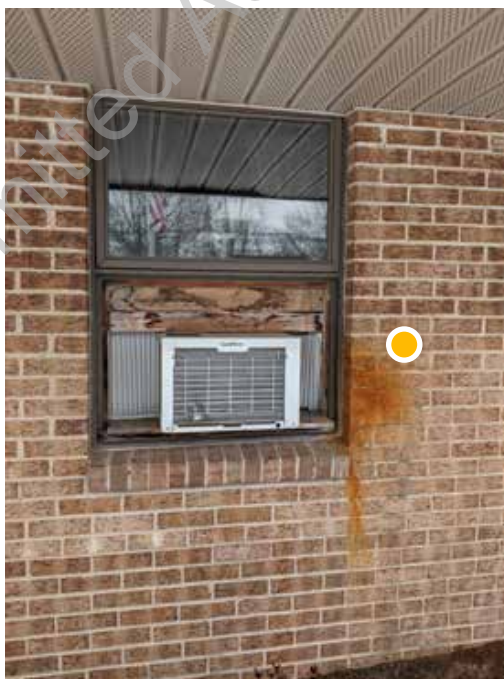
WALLS: Exterior brick veneer is in good condition with a few spots requiring cleaning. Heavy staining was observed adjacent to window air conditioning unit. This unit is improperly fit in the window and should receive a more permanent solution. Exposed concrete foundation is beginning to show wear at Southeast corner of the building, likely due to salt build up during the winter months.

● D1. 6: Window air conditioning unit requires permanent installation solution; has caused staining on adjacent brickwork

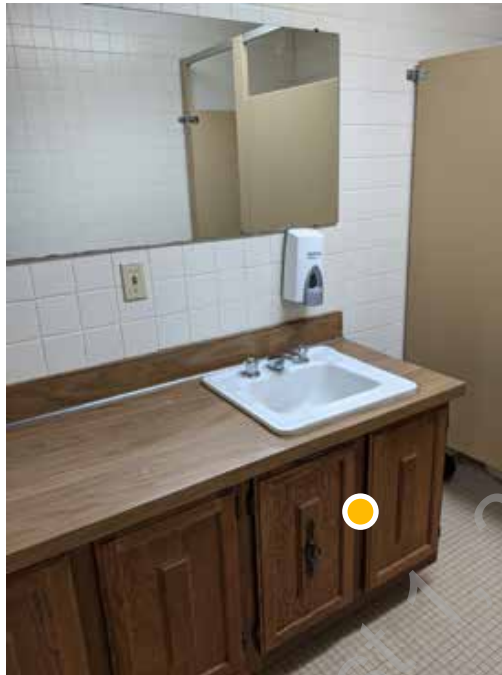
- D1. 9: Lavatory does not have required clear space below and does not meet accessible reach range requirements to be considered ADA-compliant

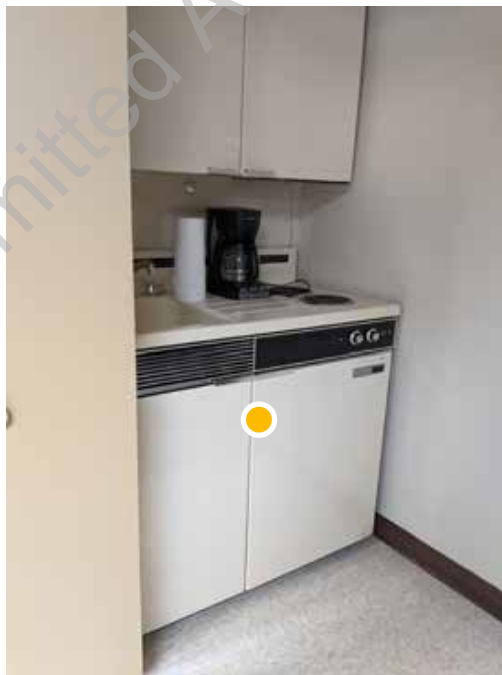
KITCHEN: This building has a small all-in-one kitchenette unit which is very dated and should be replaced with a modern kitchenette that meets current ADA codes.

- D1. 10: Kitchenette sink does not have required clear space below and does not meet accessible reach range requirements to be considered ADA-compliant

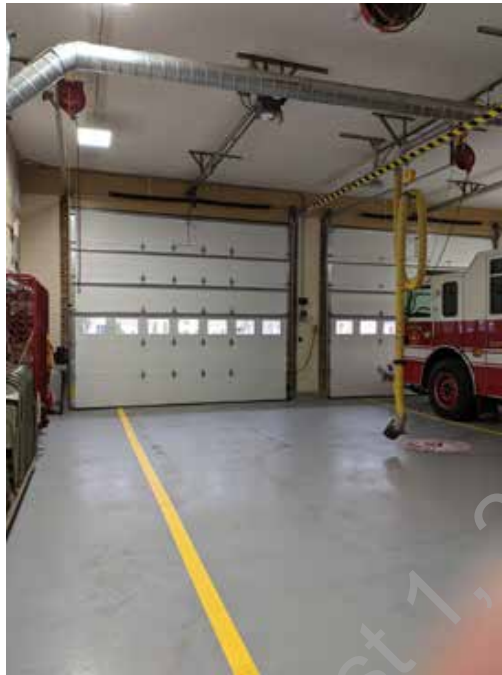
- D1. 13: Apparatus Bay; ceiling has not been repainted since installation of newer light fixtures

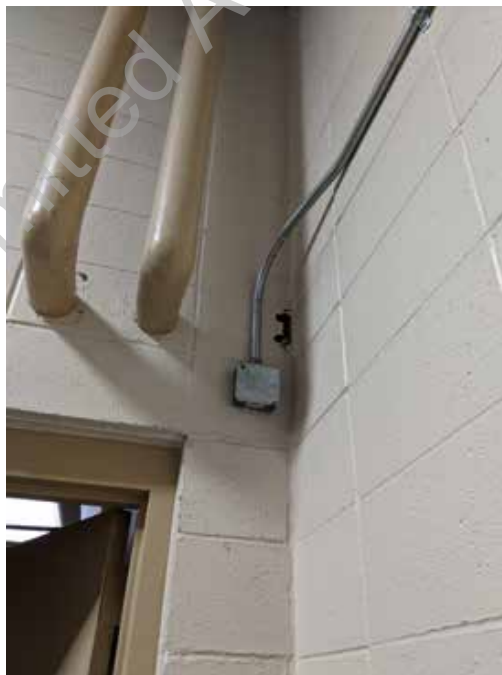
- D1. 14: Concrete masonry units have holes from former electrical conduit locations that have not been repaired

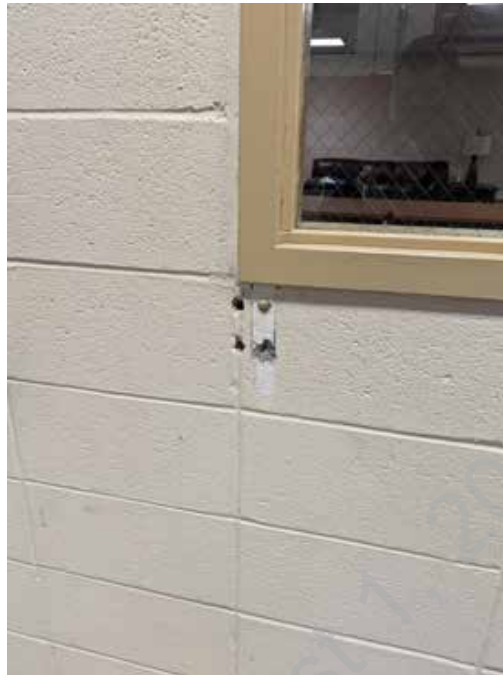
- D1. 15: Concrete masonry units have holes from former electrical conduit locations that have not been repaired

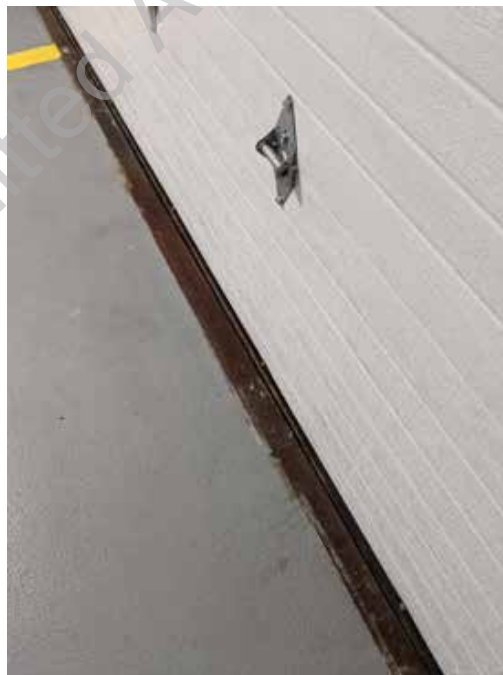
WINDOWS/DOORS/ENTRANCES: Overhead apparatus bay doors, main entrance door, and side doors are all in good condition. The main entrance door frame is beginning to corrode at the base, also likely due to salt buildup. The embedded steel angle at apparatus door sills are beginning to rust.

- D1. 16: Rusting was observed on steel angles at Apparatus Bay doors

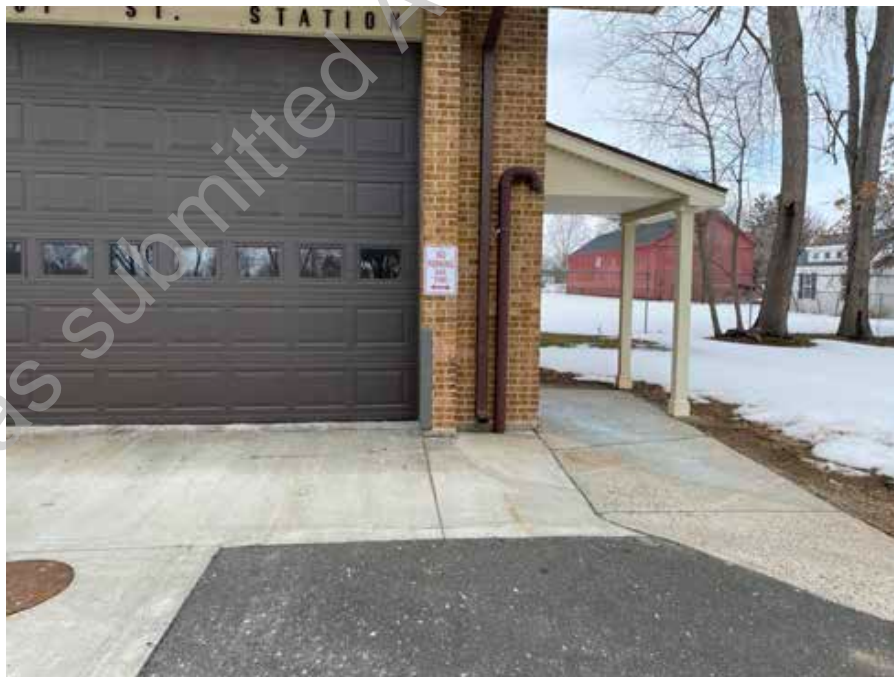
● D2. 10: Gutter Roof Drain System

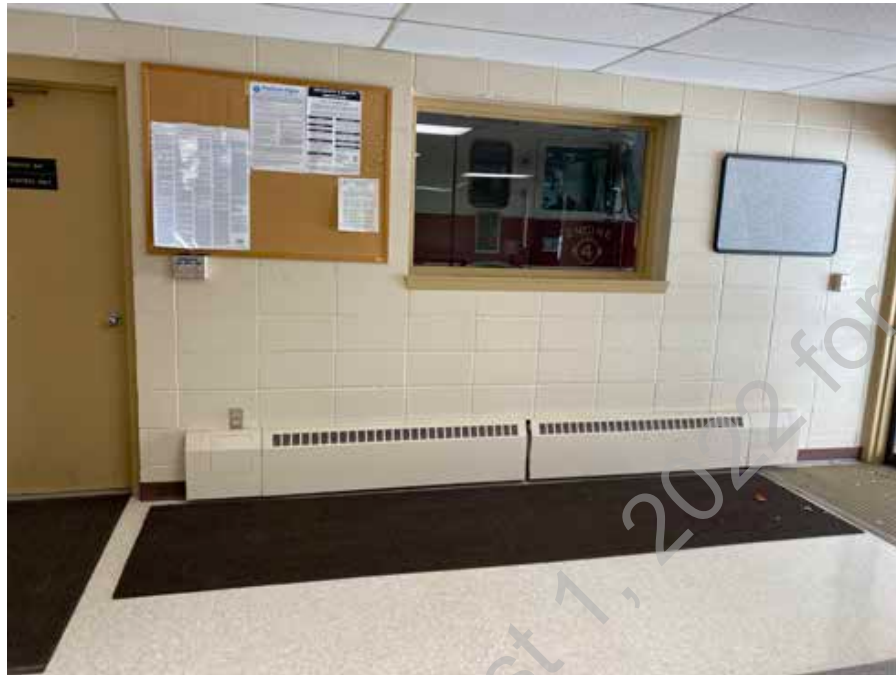
● D2. 11: Hot Water Fin Tube Radiation Needs Replacement
