TOWN OF SUFFIELD

CONDITIONS ASSESSMENT & MASTER PLAN

Draft as submitted August 1, 2022 for review

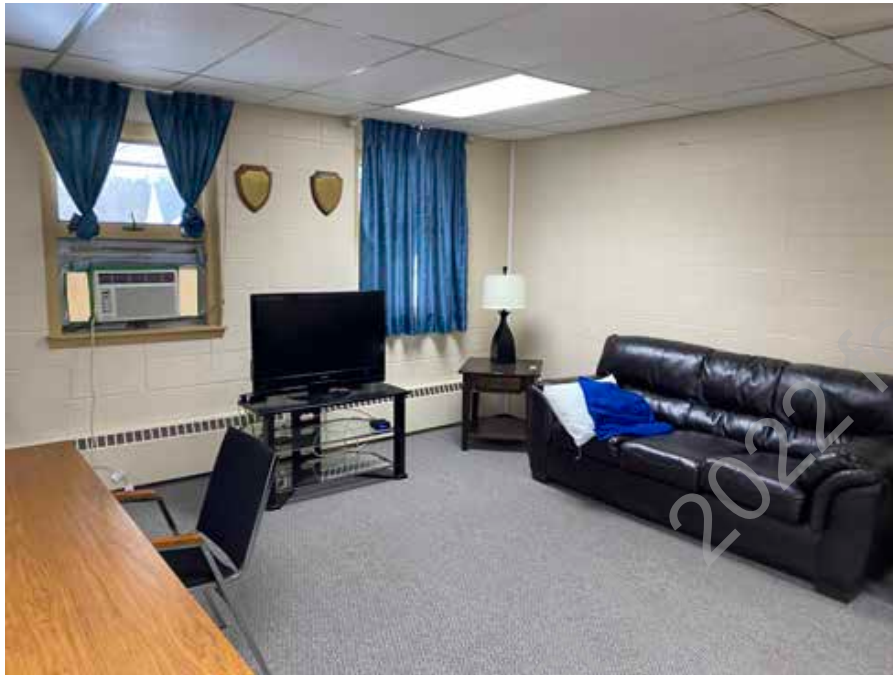
● D2. 13: Interior Lighting 2x4

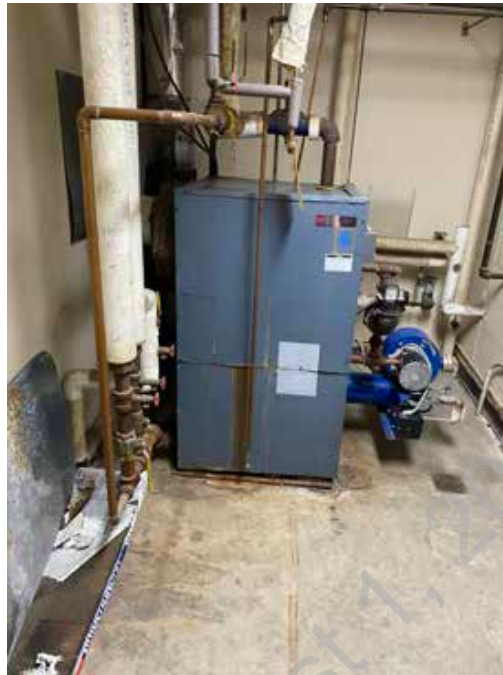
● D2. 15: Natural Gas Boiler

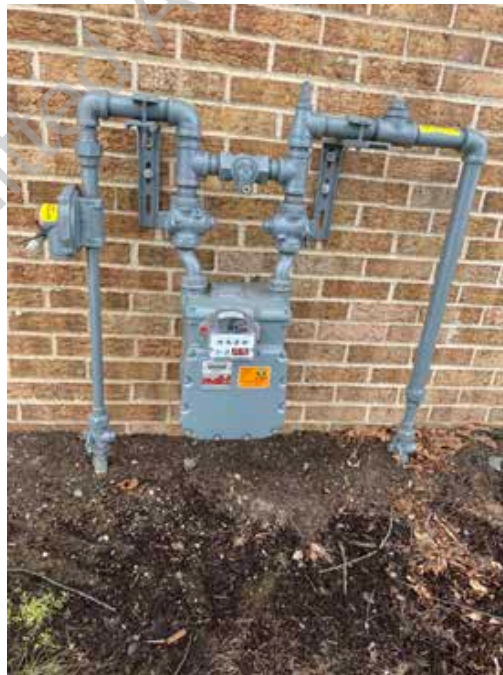
● D2. 16: Natural Gas Service

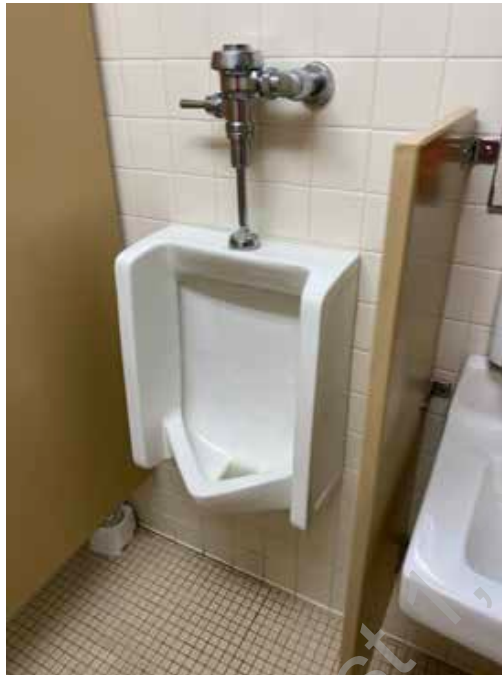
● D2. 17: Plumbing Fixtures Nearing End of Useful Lives

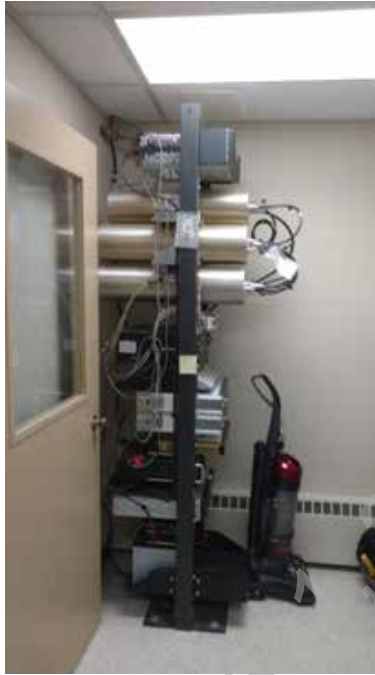
● D2. 19: Radio Equipment

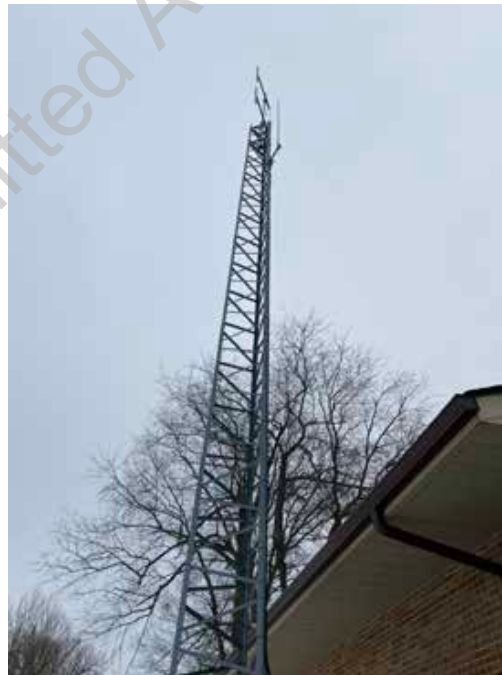
● D2. 20: Radio Tower

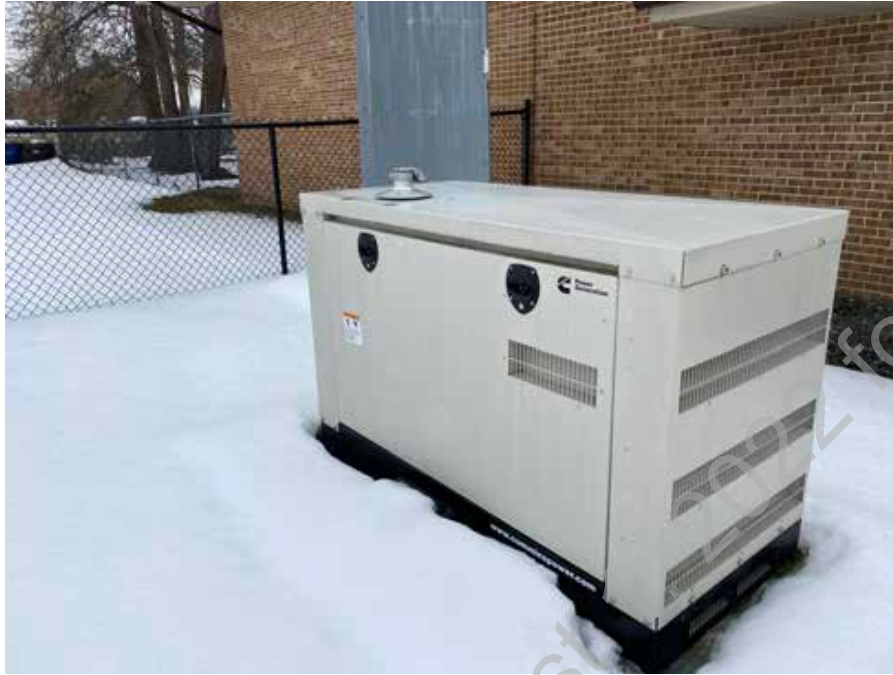
GENERATOR: Standby power is provided from a Cummins GGMA natural gas fired pad mounted generator. This unit appears to be in like-new condition with 57 running hours per the maintenance records.

● D2. 21: Standby Generator

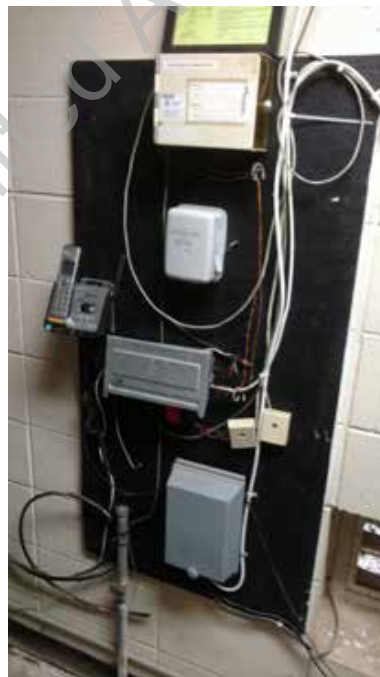
● D2. 22: Telecommunications Service Backboard

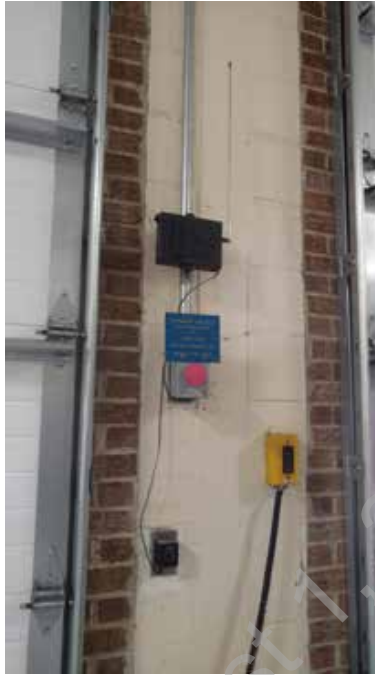
● D2. 23: Traffic Signal Interface

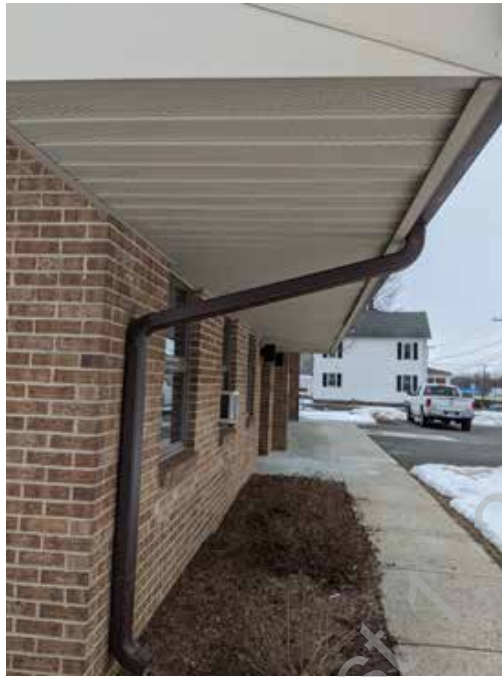
● D3. 1: Exterior soffit along South façade

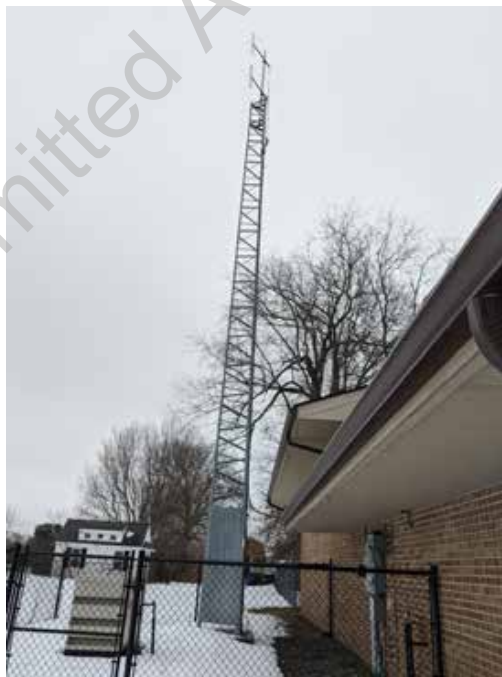
● D3. 2: Radio Tower

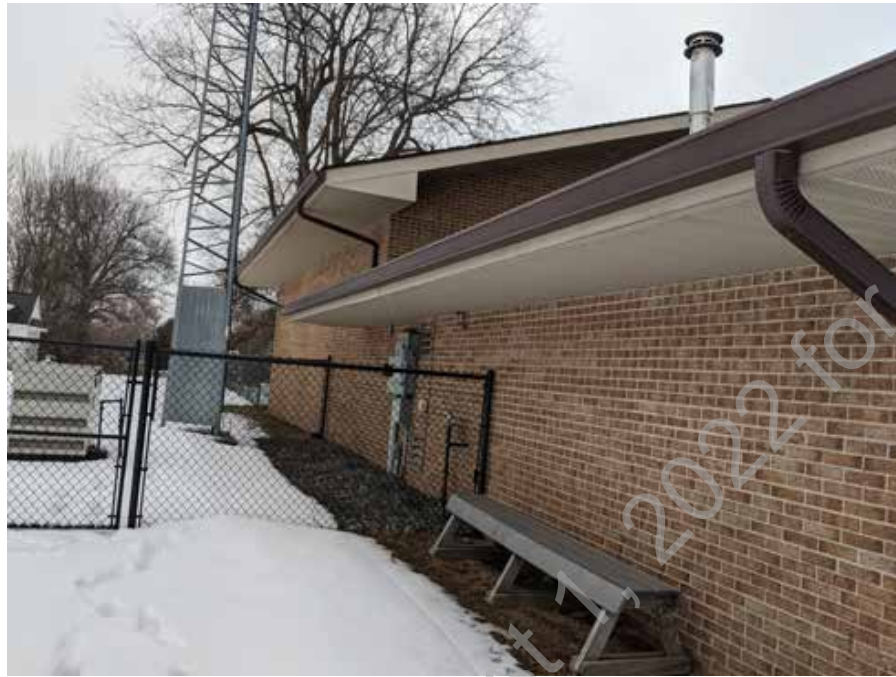
● D3. 3: Exterior soffit along North façade

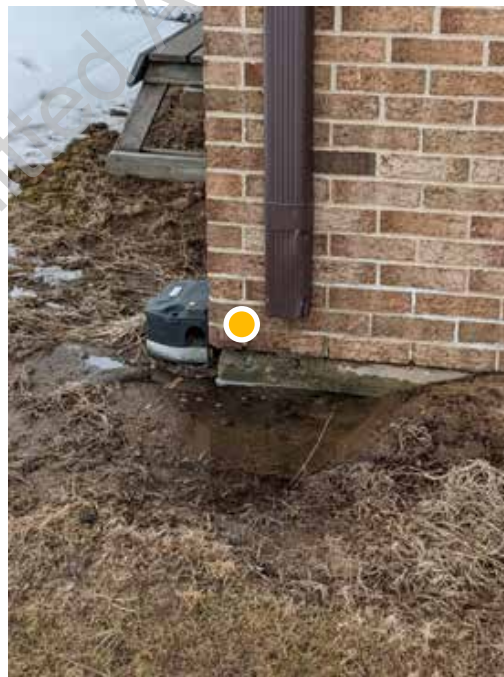
● D3. 4: Missing splash block at downspout locations causing soil erosion; Concrete foundation has begun spalling

Clean masonry/exposed foundation	2,702	SF	\$2	\$ 5,944	\$ 594	\$ 89	\$ 446	\$ 297	\$ 7,371	\$ 921	\$ 8,292	\$ 1,658	\$ 9,951						
Regrade NW corner of building and repair exposed foundation, add splash block at downspout	30	SF	\$17	\$ 495	\$ 50	\$ 7	\$ 37	\$ 25	\$ 614	\$ 77	\$ 691	\$ 138	\$ 829						
Paint storefront entrance	50	SF	\$4	\$ 220	\$ 22	\$ 3	\$ 17	\$ 11	\$ 273	\$ 34	\$ 307	\$ 61	\$ 368						
Interior Improvements				\$ -					\$ -	\$ -	\$ -								
Replace ceiling tiles	1,200	SF	\$8	\$ 9,240	\$ 924	\$ 139	\$ 693	\$ 462	\$ 11,458	\$ 1,432	\$ 12,890	\$ 2,578	\$ 15,468						
Replace kitchen sink/cabinet with ADA accessible sink and casework	1	EA	\$2,750	\$ 2,750	\$ 275	\$ 41	\$ 206	\$ 138	\$ 3,410	\$ 426	\$ 3,836	\$ 767	\$ 4,604	Technically infeasible without significant renovations					
ADA upgrades at toilet rooms	2	EA	\$6,600	\$ 13,200	\$ 1,320	\$ 198	\$ 990	\$ 660	\$ 16,368	\$ 2,046	\$ 18,414	\$ 3,683	\$ 22,097	Technically infeasible without significant renovations
