FACILITY CONDITION ASSESSMENT

Ann Arbor Public Schools
2555 South State Street
Ann Arbor, Michigan 48104

June 29, 2018

EBERWHITE ELEMENTARY
800 SOULE BOULEVARD
ANN ARBOR, MICHIGAN 48103

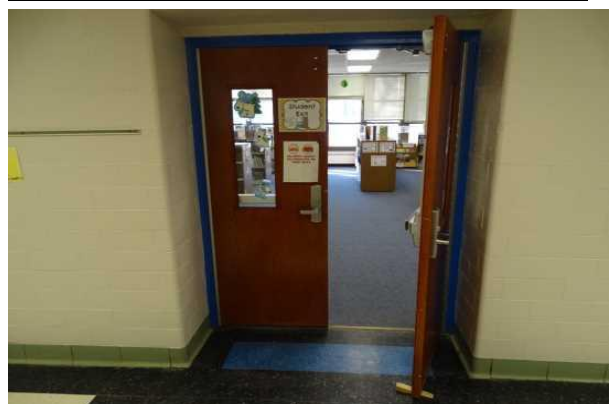
#24:	INTERIOR DOOR
------	---------------

Architectural: The doors for the classroom restrooms need replaced. Some of the doors are antiquated, hard to open and are damaged. The ceiling tiles are stained and damaged. A cost allowance to repair and/or replace these deficient attributes is included in the cost tables.
