FACILITY CONDITION ASSESSMENT

129010.18R000-032.354

March 6, 2018

PRESCHOOL AND FAMILY CENTER (BALAS II AND III)
2725 BOARDWALK STREET
ANN ARBOR, MICHIGAN 48104

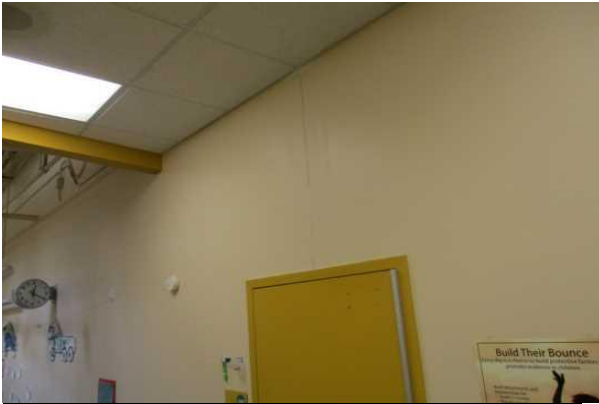
#25:	GYPSUM BOARD WALLS
------	--------------------

Architectural: The ceiling tiles need to be replaced in the computer areas. These are required to hold the heat in the room to activate the fire sprinkler if there should ever be a fire in the room. The gypsum should be repaired in the entries, wet walls and expansion joints added in the areas the wall is cracking on the vertical.

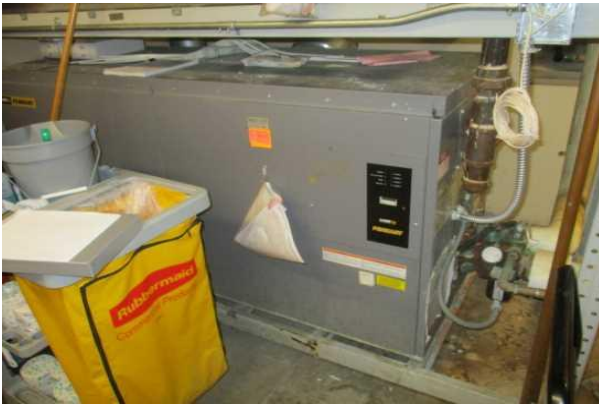
#39:	BOILER
------	--------
