The Garland Company, Inc.

## Aberdeen School District Roof Reports

Prepared For  
Michael Pauley

October 19, 2022

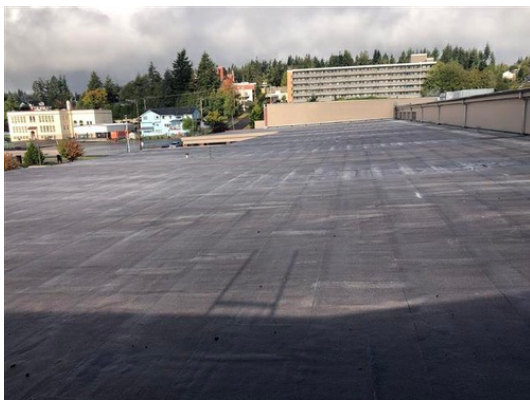
*Photo 5*

Looking out over one of the upper roof sections

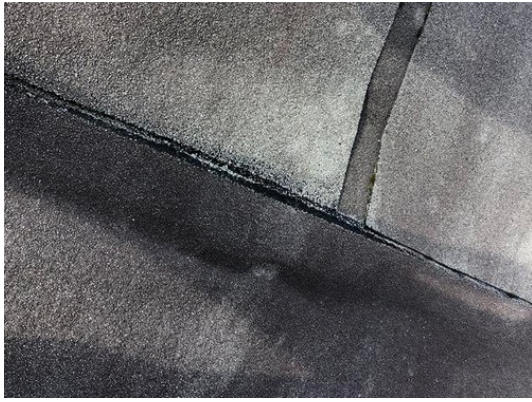
*Photo 6*

Large blister at a seam

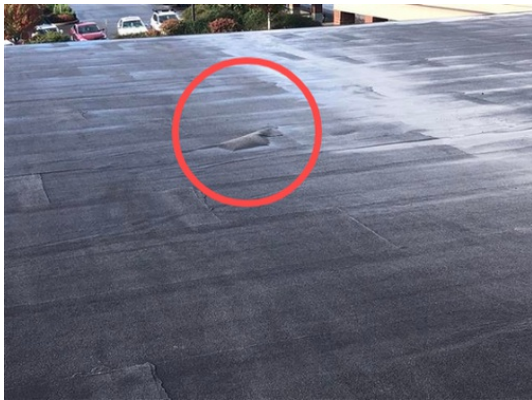
*Photo 7*

Another abnormally large blister

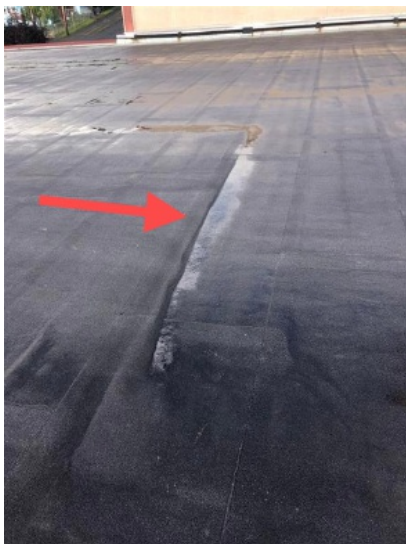
*Photo 8*

A large blister/ripple that has developed and is not blocking the flow of water off this roof

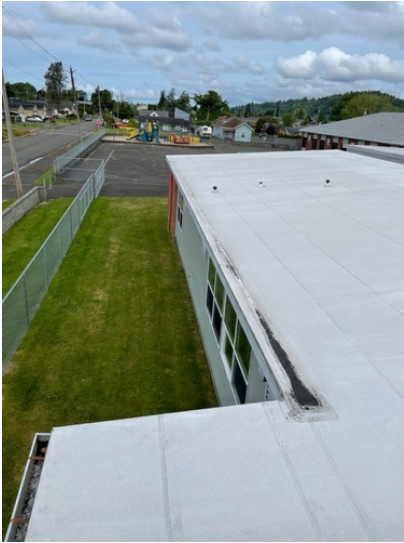
*Photo 3*

The majority of the drainage is from external gutters. Some minor ponding was identified during the inspection.

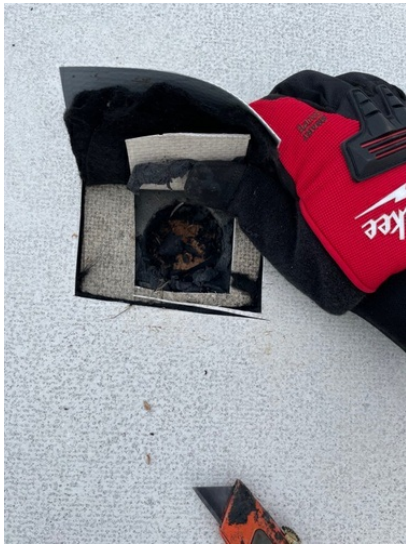
*Photo 9*

The roofing system was cored and two roofs and three inches of insulation were identified above a wood deck.

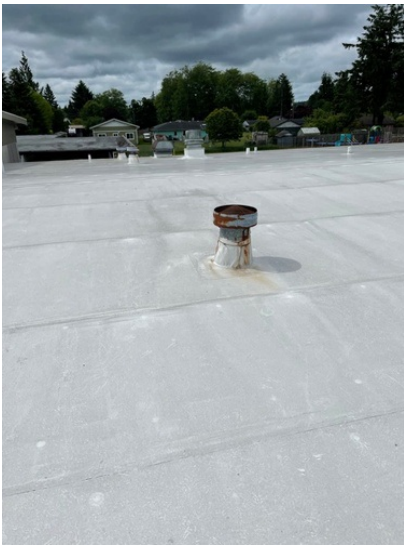
*Photo 3*

Various roof top penetrations have been poorly flashed during the last roof overlay.

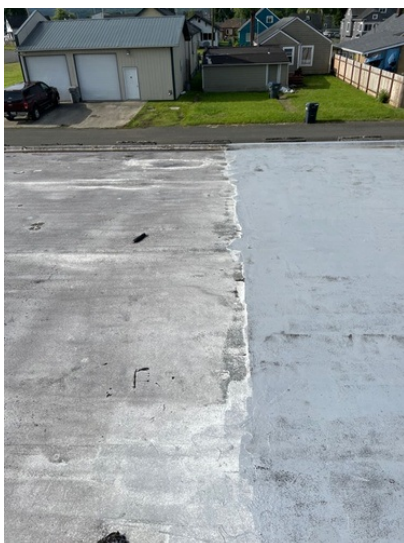
*Photo 2*

An aluminized coating has been applied over a single ply.

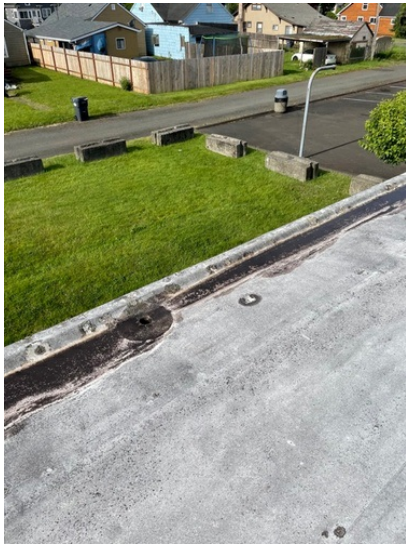
*Photo 3*

The drainage on the roof is poor and used internal drains that run through the building soffit.

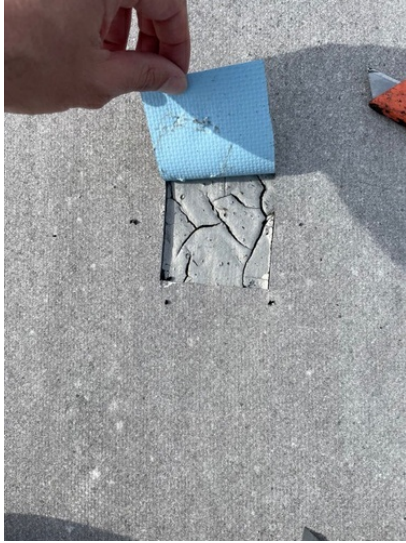
*Photo 16*

The existing roof assembly is comprised of three roofs over a tectum deck.

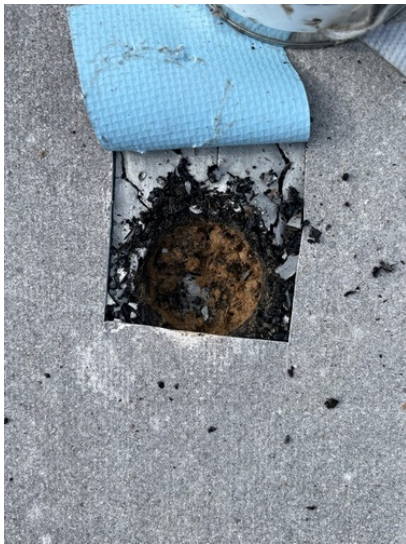
*Photo 17*

A core showing the three roofs.

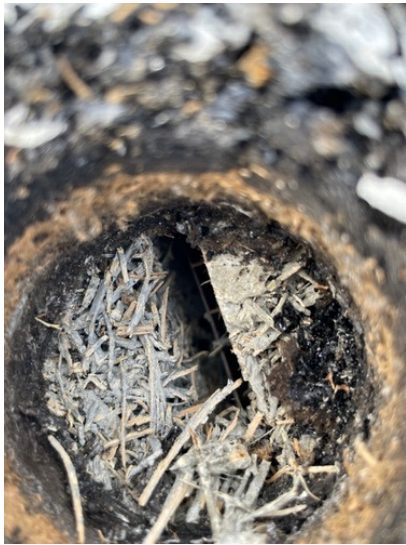
*Photo 18*

A close up of the Tectum deck.

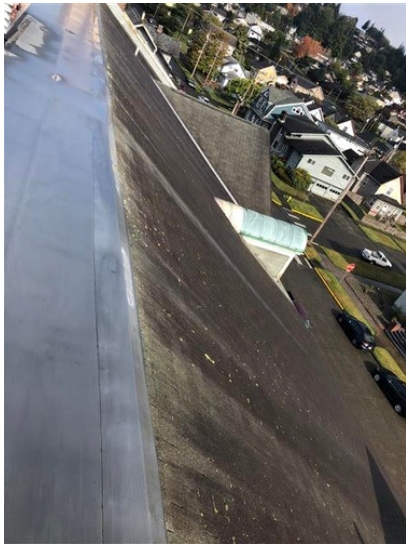
*Photo 4*

Looking down roof edge from catwalk onto steep slope shingle roof section

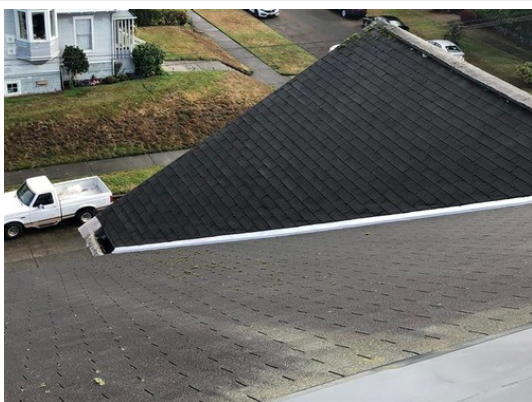
*Photo 9*

Looking down at a steep slope valley and gutter - very difficult to clean these roof sections and gutters

Perform simple roof cleaning and repairs as needed. A lift will be required to access all drains and safely access certain portions of the roof. Cleaning should be done yearly on the single ply flat roof sections and every 5-7 years on the steep slope shingle roof sections.

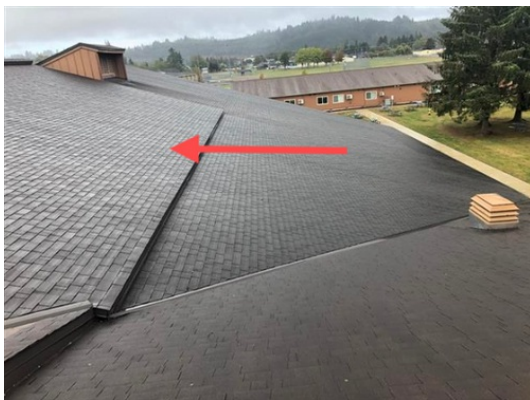
*Photo 5*

Insulated area - all valleys are done with a metal valley detail

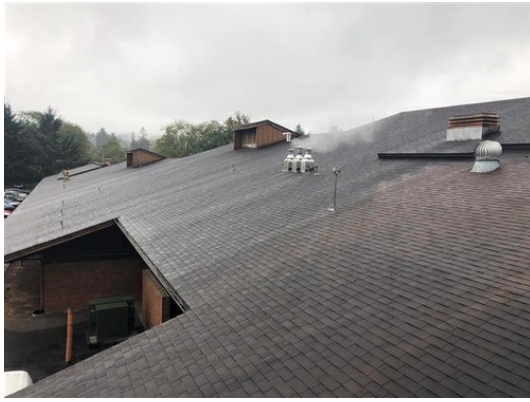
*Photo 7*

Shingles in good condition

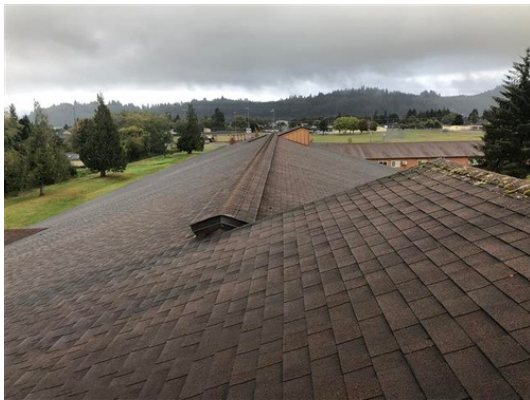
*Photo 8*

Shingles near vents have less dirt and grime on them resulting in the color difference

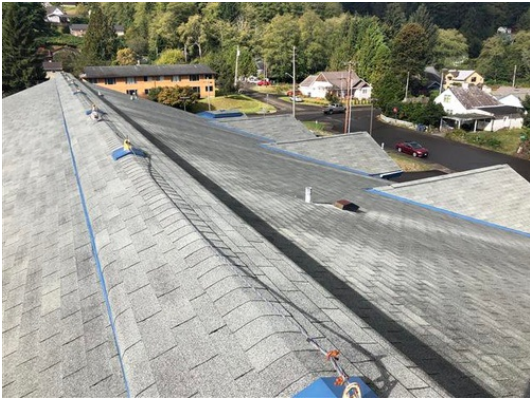
*Photo 2*

Small metal detail in roof section transistion

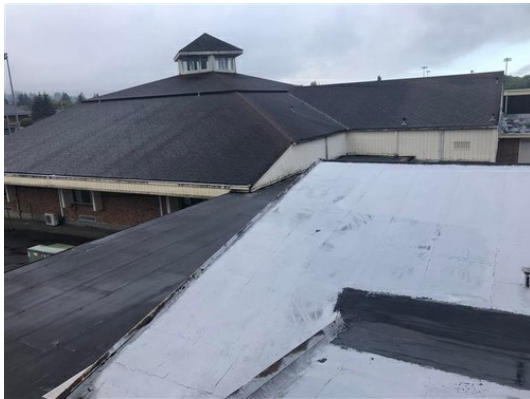
*Photo 1*

Looking out over shingle and smooth BUR sections

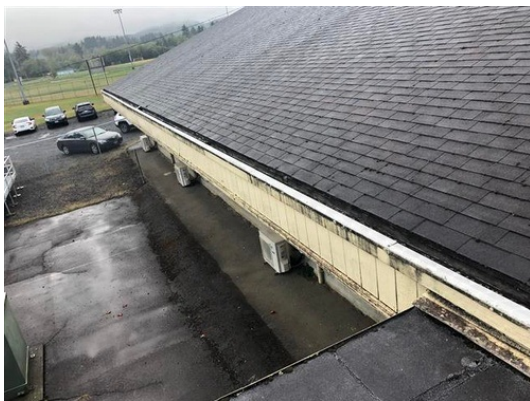
*Photo 2*

Looking down shingle section with gutter

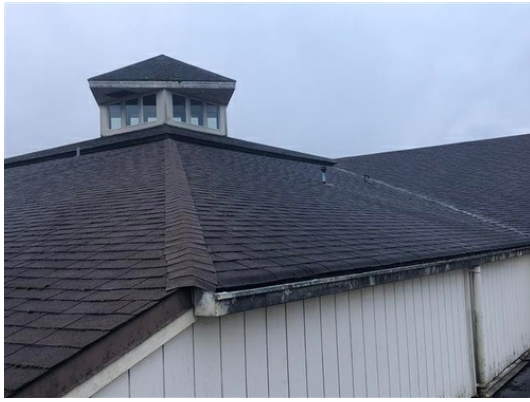
*Photo 3*

Shingle bell tower section

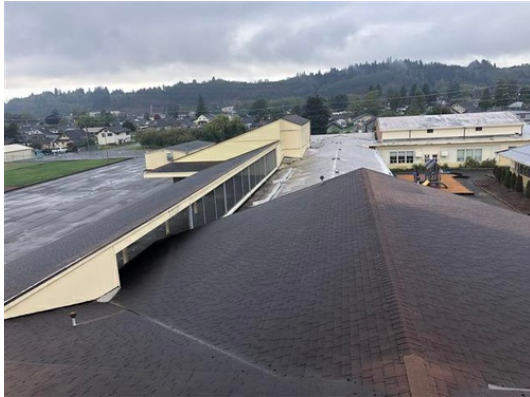
*Photo 4*

Looking down roof sections

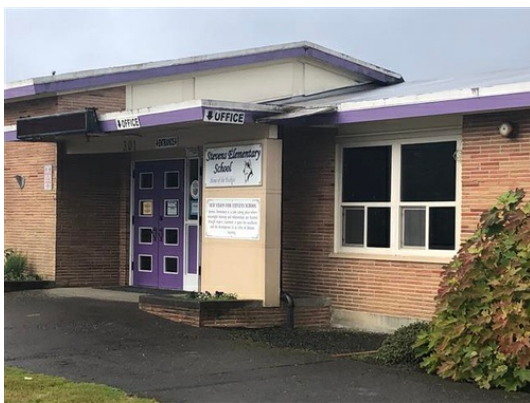
*Photo 7*

Front of the school

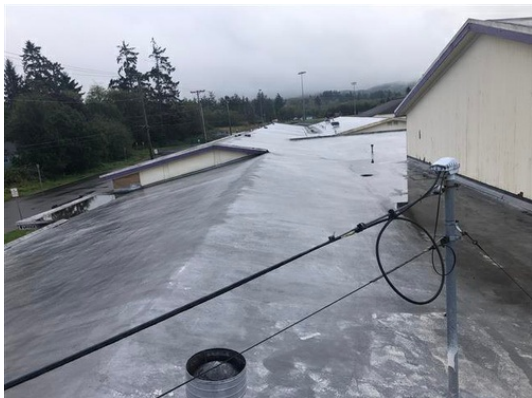
*Photo 15*

Silver coating over smooth BUR roof

- Pressure wash entire roof
- Test all drains and ensure they work properly
- Make repairs as per Garland recommendations
- Thermal scan roof - make repairs to wet decking and insulation at a per sf cost
- Install a fully reinforced liquid applied roof restoration system over entire roof
- Provide on-site project management and weekly reports to the District

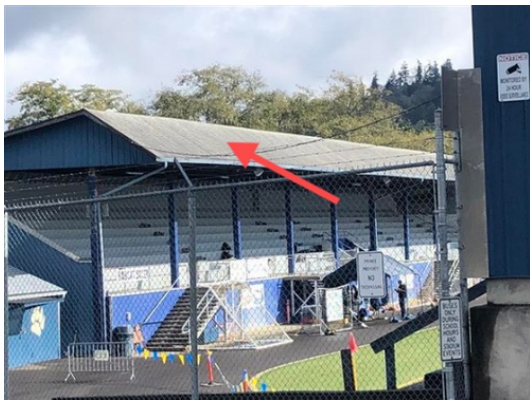
*Photo 1*

Shingle front façade on both roof sections

- Tear off existing shingle roof down to deck
- Replace wet or damaged decking at a per sf cost
- Install full ice and water shield over entire roof surface
- Install new metal details and vents at all locations
- Install new shingles over roof per District's choices
- Install new gutters and downspouts

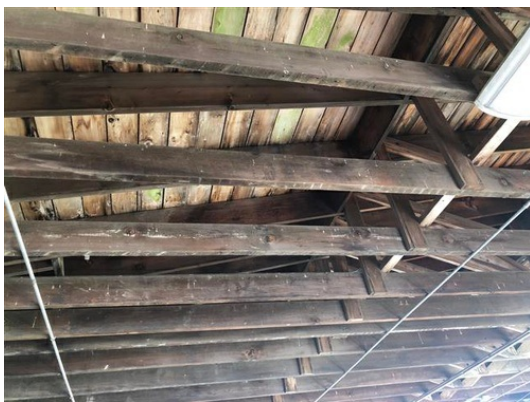
*Photo 2*

Wood slat decking

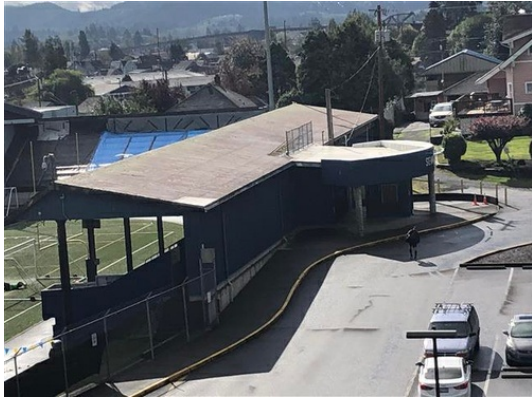
*Photo 4*

West roof section overview
