MARCELLUS
CENTRAL SCHOOL DISTRICT

2015 BUILDING CONDITION SURVEY

VOLUME 01

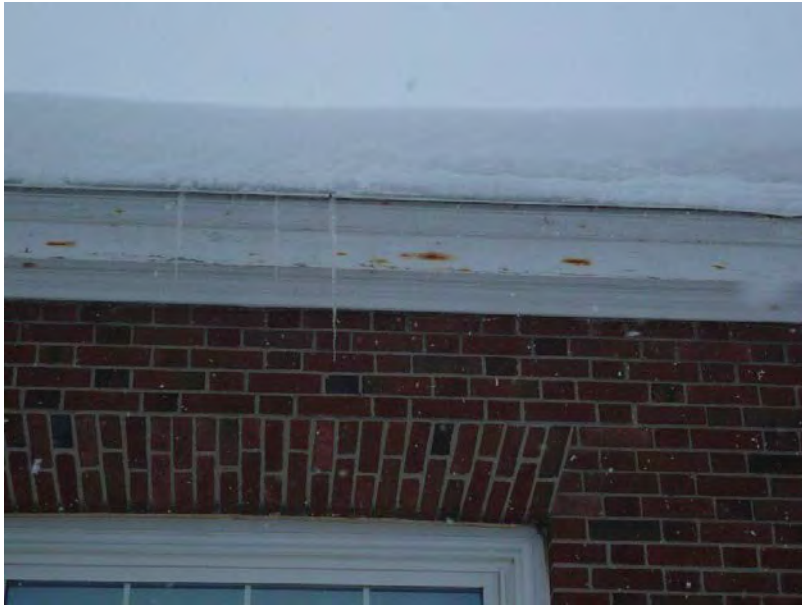
KCH – Paint Wood Fascia

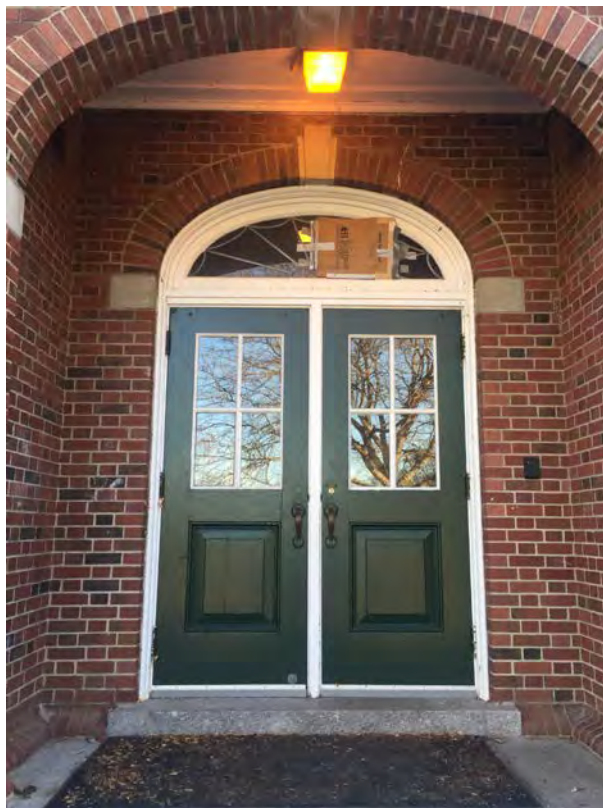
KCH – Older Exterior doors

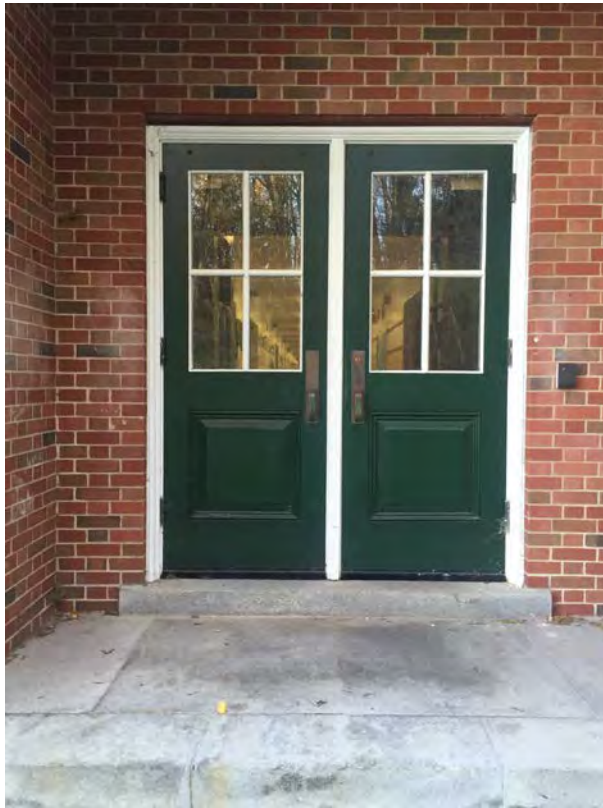
KCH – Older exterior doors

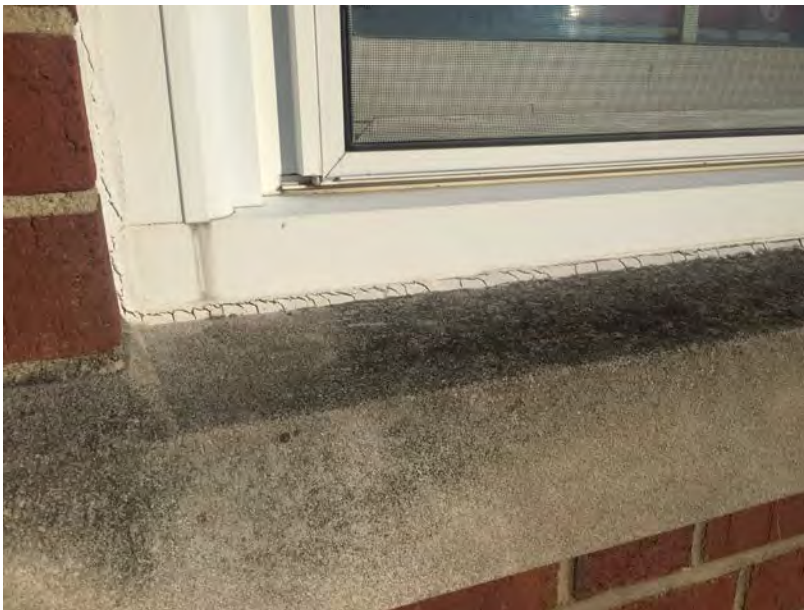
KCH - Caulking

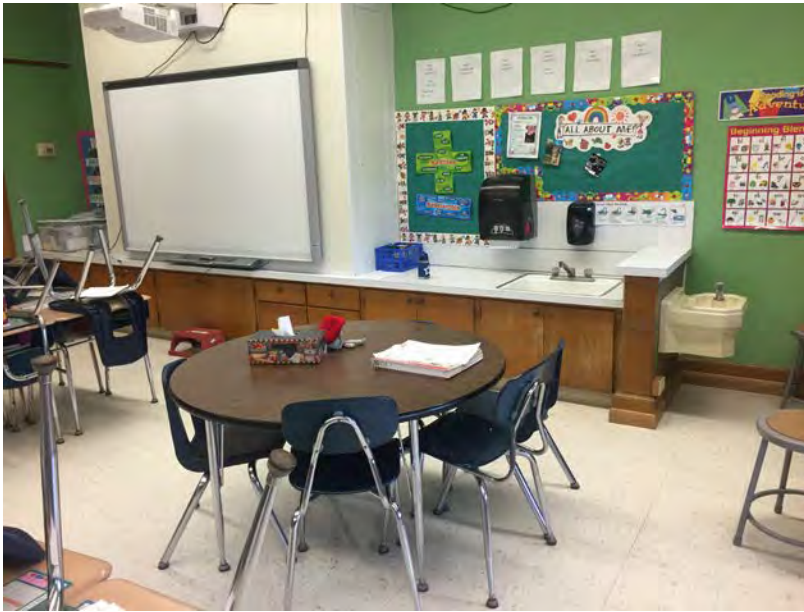
KCH – Classroom cabinetry

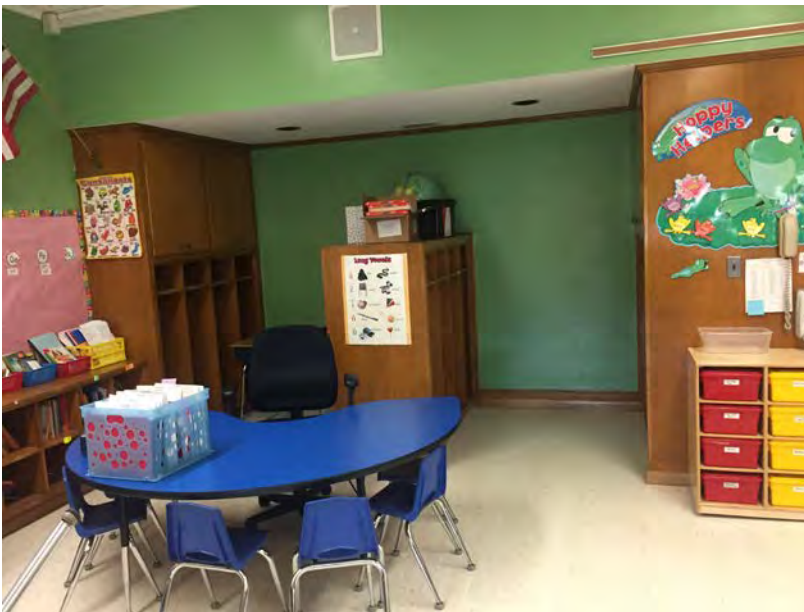
KCH – Classroom cabinetry

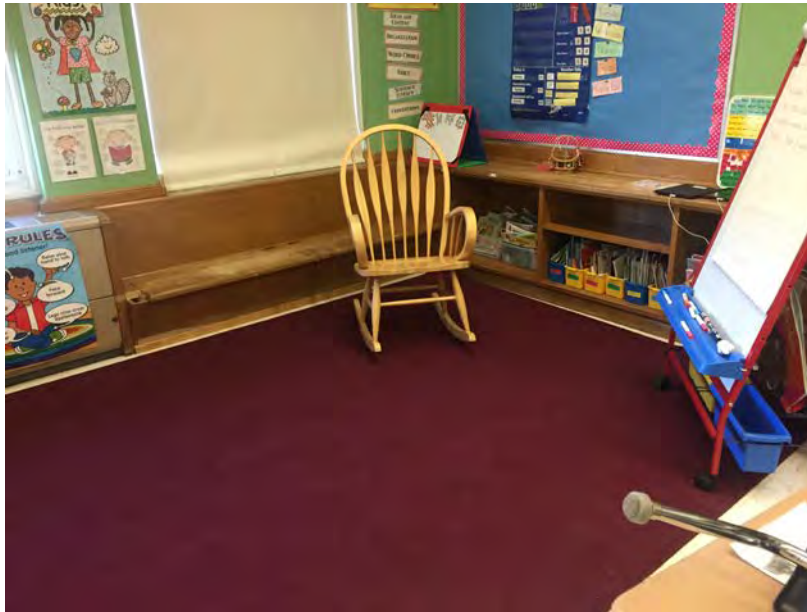
KCH – Classroom benches and bookshelves

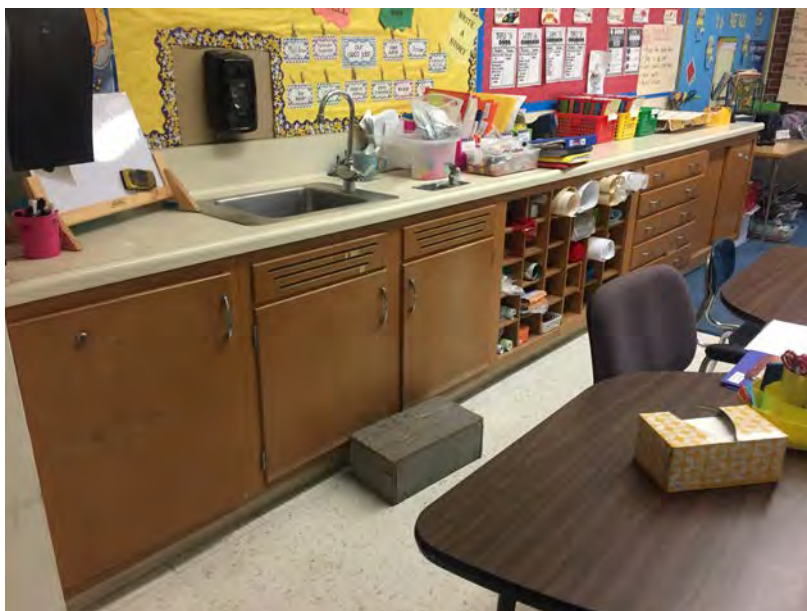
KCH – Classroom cabinetry

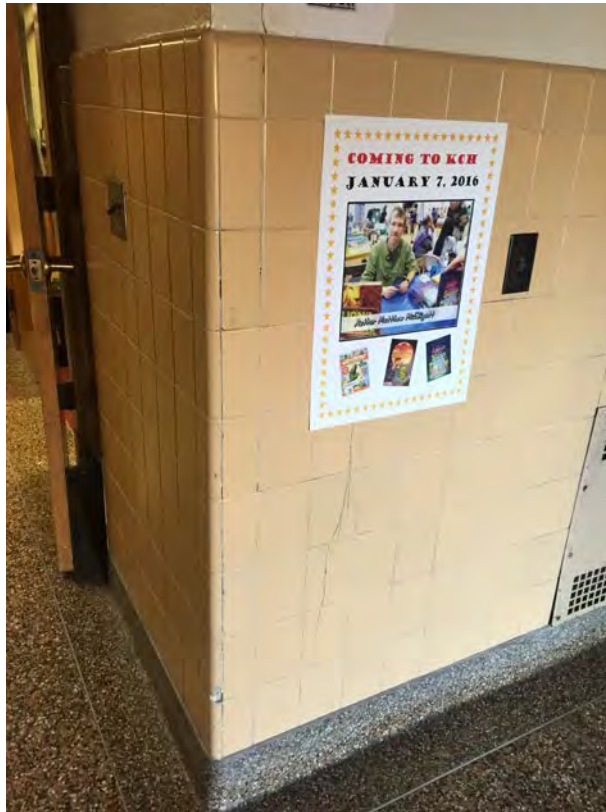
KCH – Corridor walls

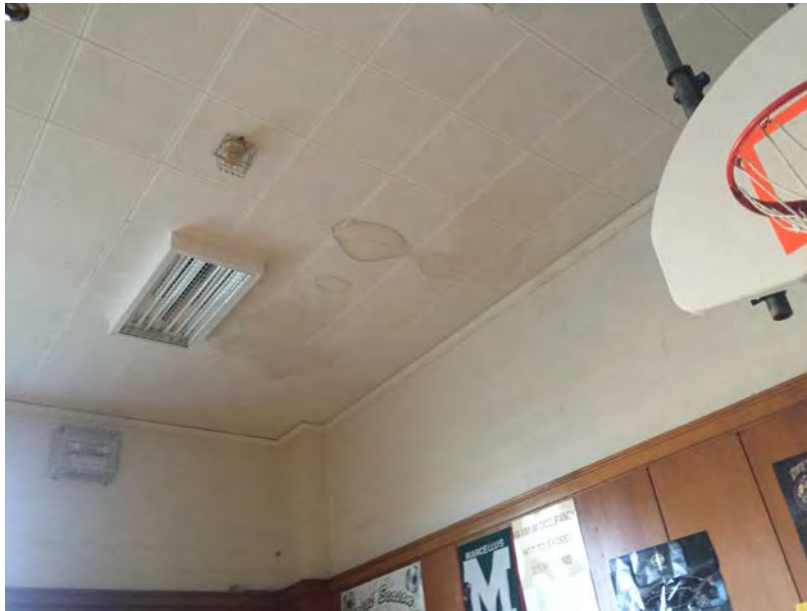
KCH – Gym ceiling

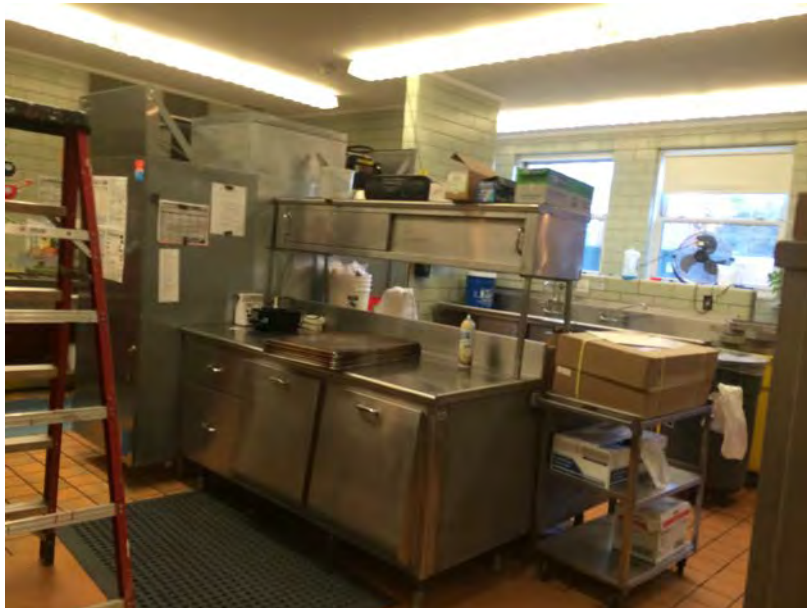
KCH – Kitchen

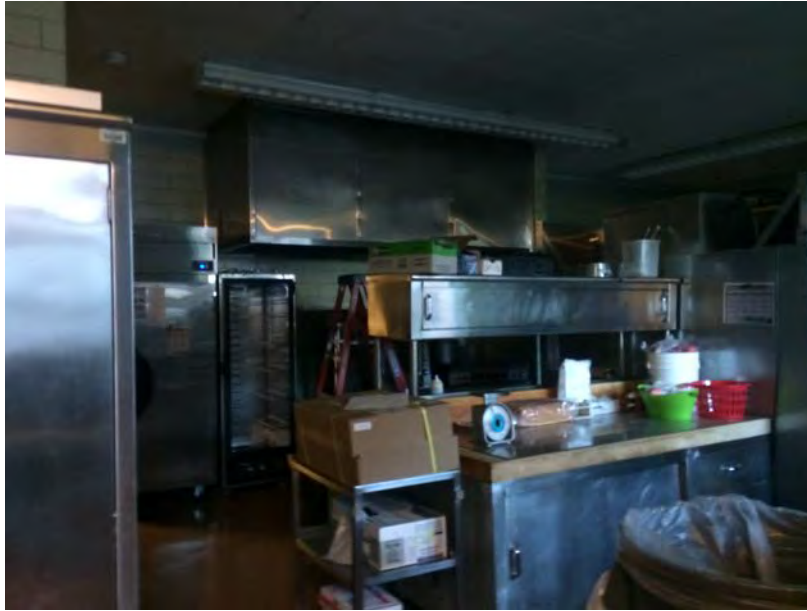
KCH – Kitchen

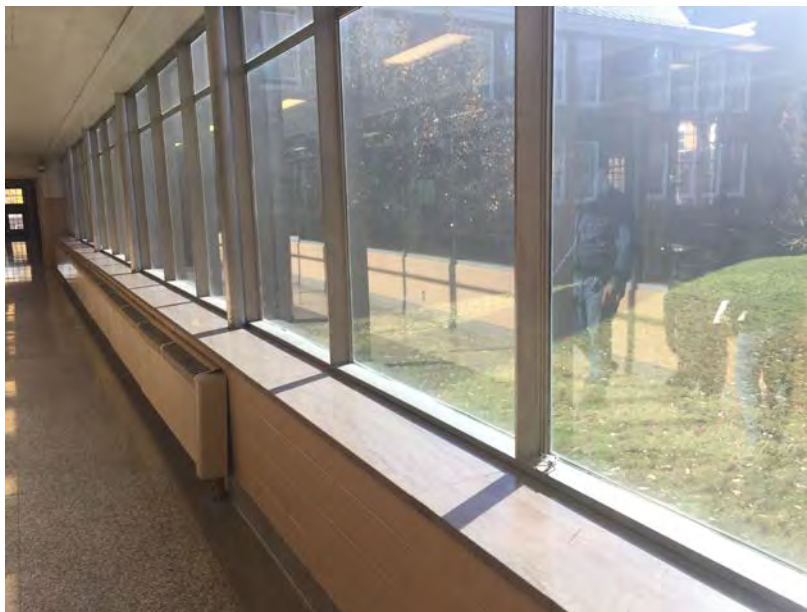
DMS – Provide accessible courtyard access/exit

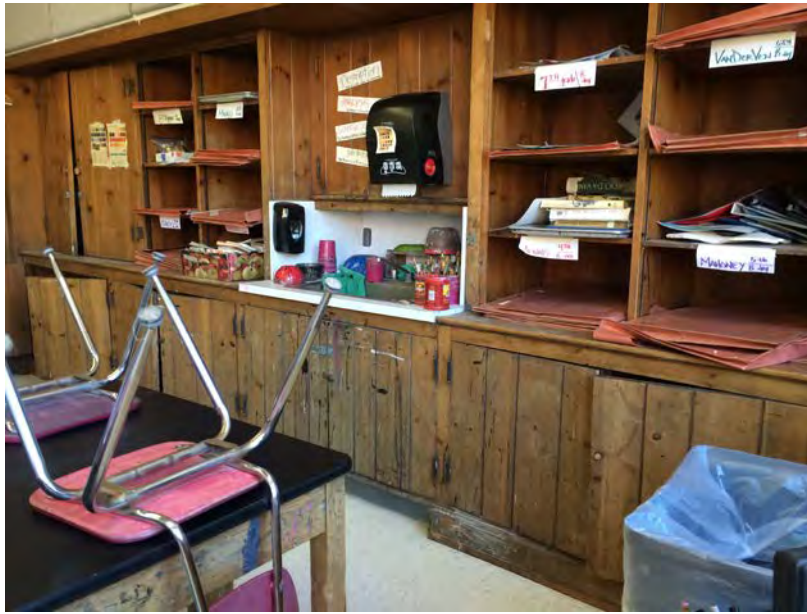
DMS – Renovate Art Classroom

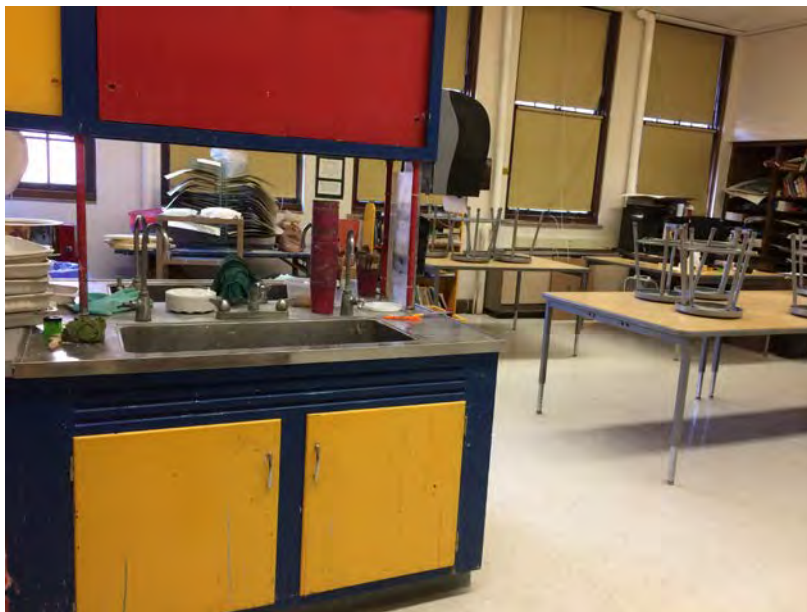
DMS – Renovate Art Classroom

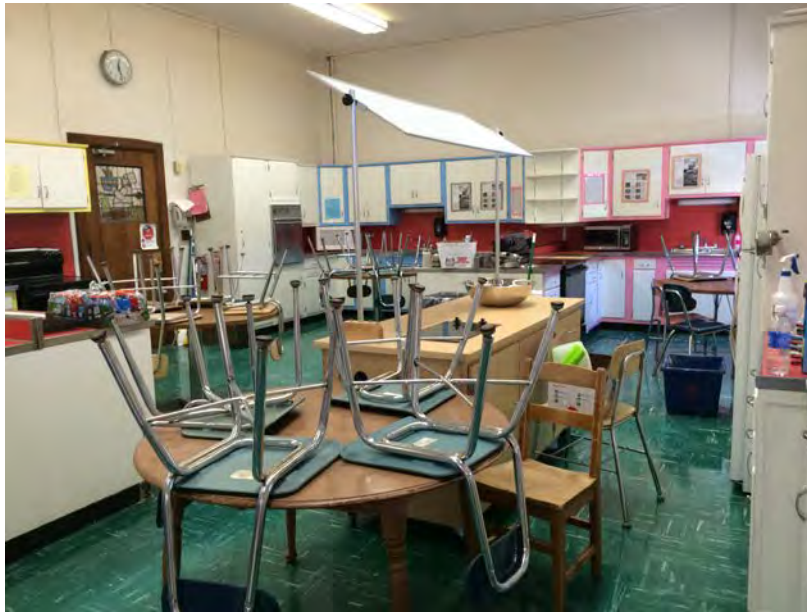
DMS – Renovate classroom

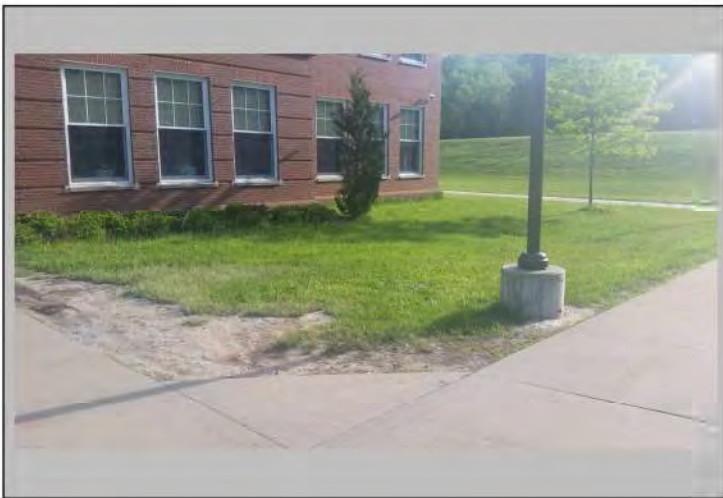
Photograph Number: 14
Budget Line Item Number: \$5,000 (44)

Replace failed storm structure on northwest corner of building, foundation drainage issues

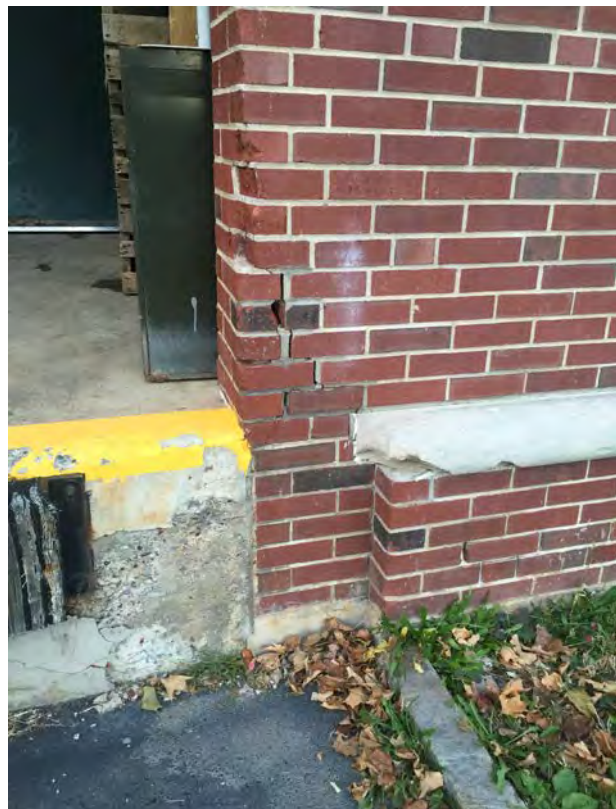
SHS – Masonry Restoration

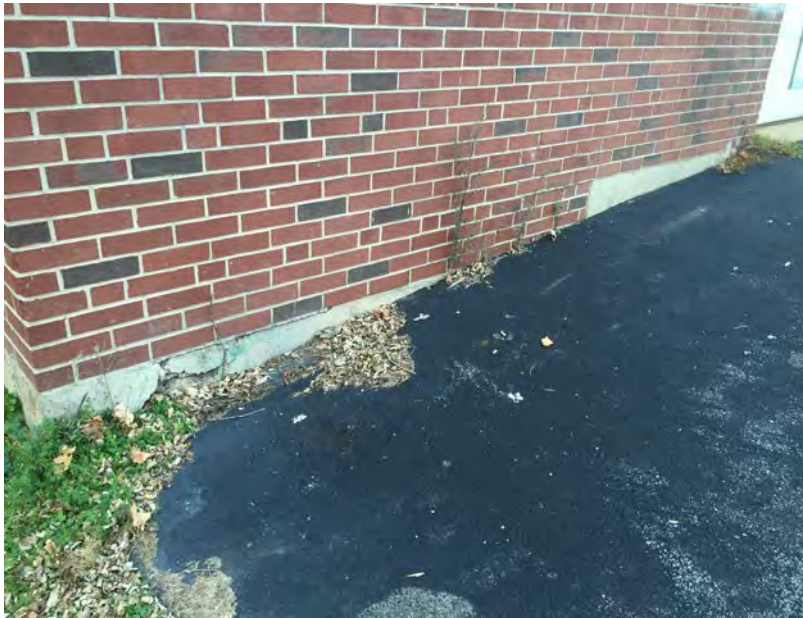
SHS – Masonry restoration

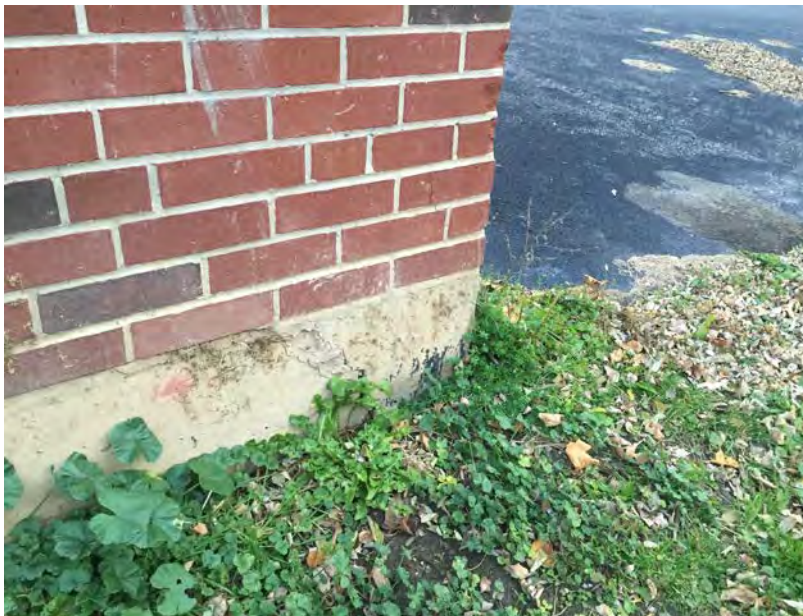
SHS – Masonry restoration

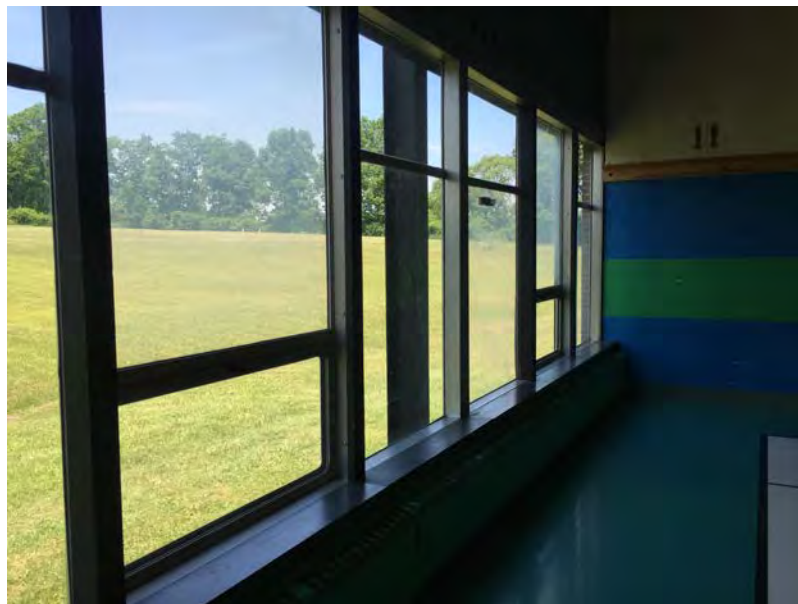
KES – Gym windows

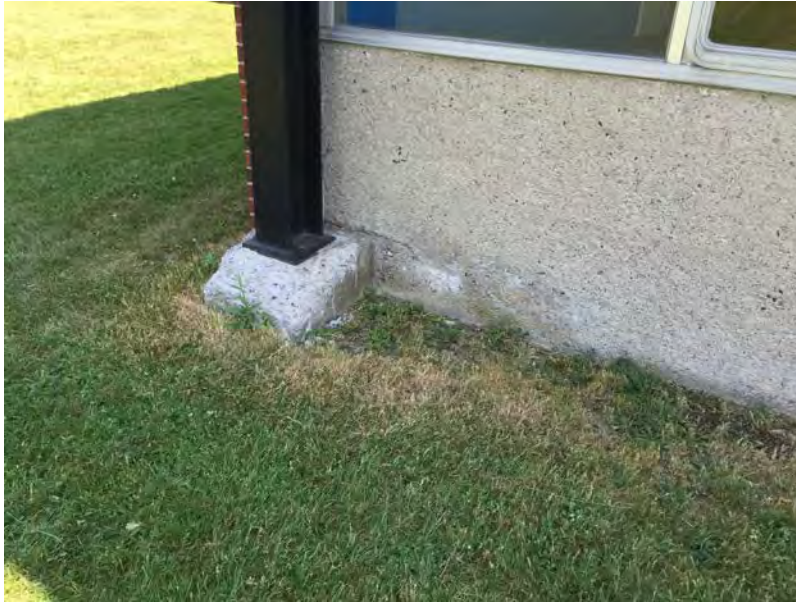
KES – Masonry/concrete restoration – structural piers

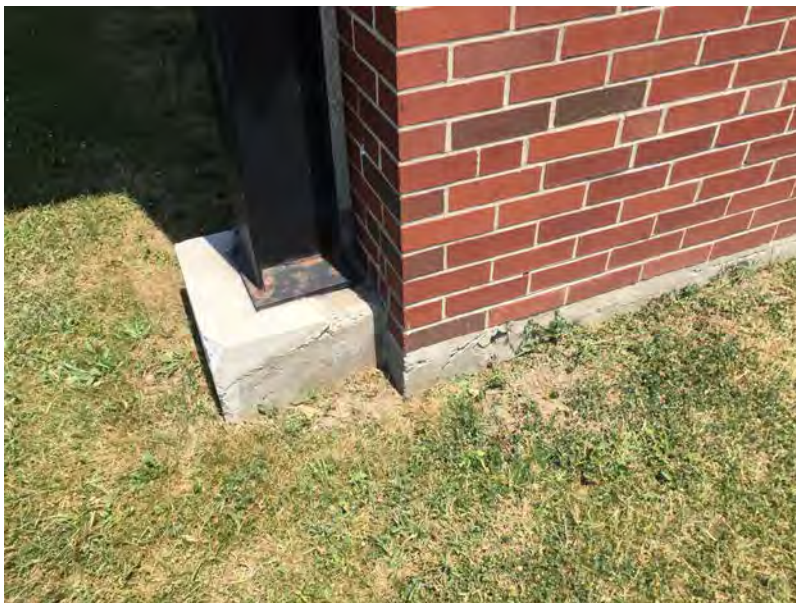
KES – Masonry/concrete restoration – structural piers
