Facility Study and Master Plan

Vernon Public School Central Administration

30 Park Street, Vernon CT 06066

SUMMER 2023

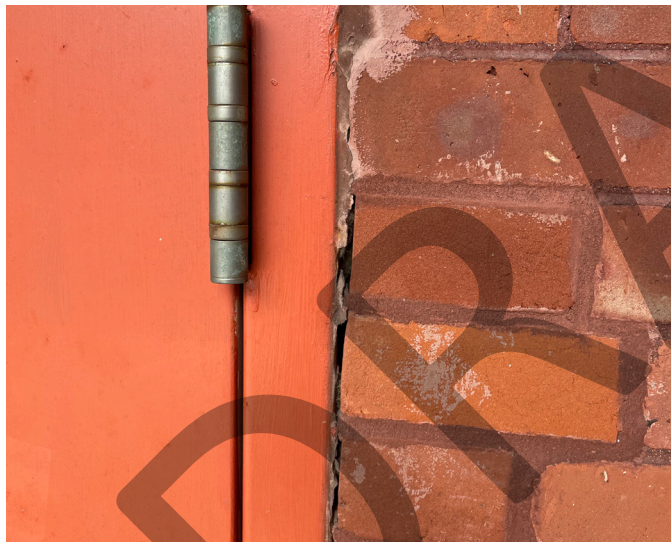
2. Location:

Entrance on Park Street - efflorescence visible on brick as well as discoloration likely from water.

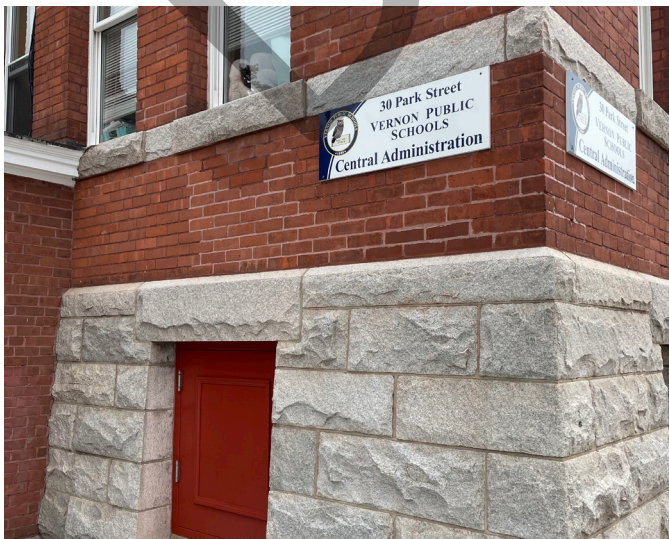
6. Location:

Efflorescence visible inside overhang.

- Further investigation into the source of efflorescence in the exterior brick is recommended.

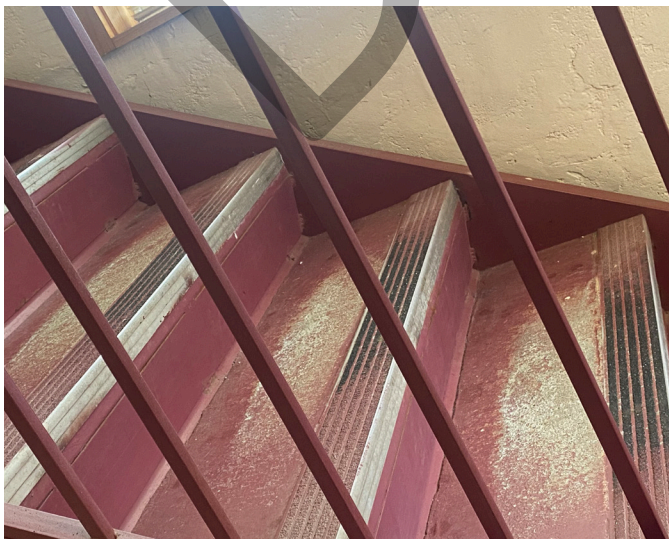
21. Location:

Painted landing is chipped and faded.

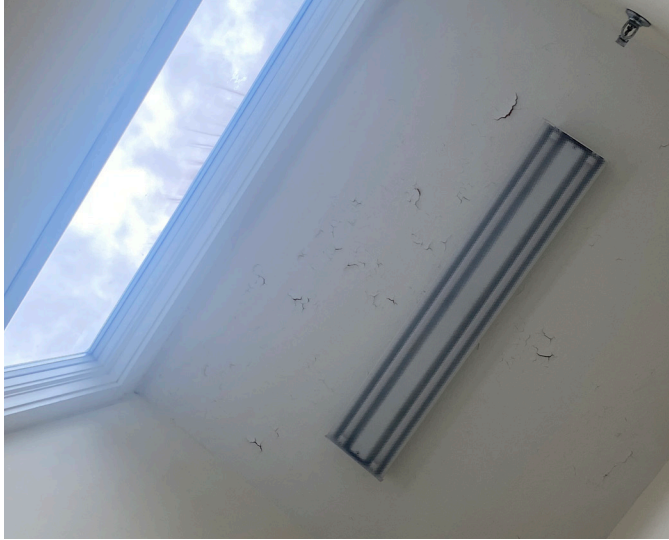
34. Location:

Damage to ceiling is causing paint to peel.

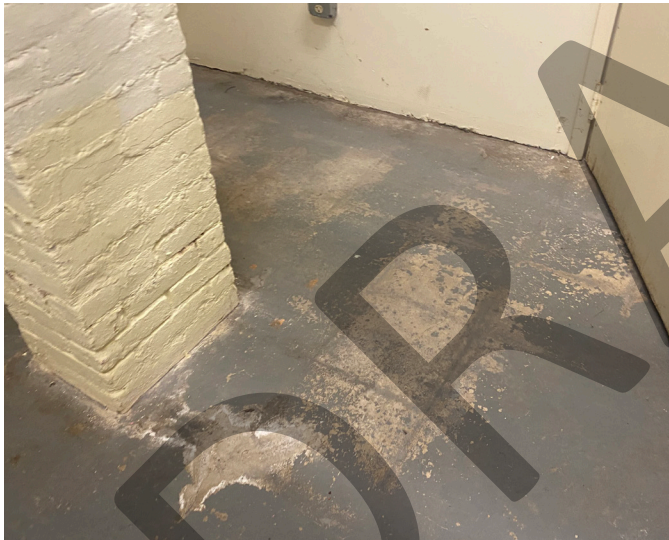
35. Location:

Painted concrete is faded and needs to be refinished.

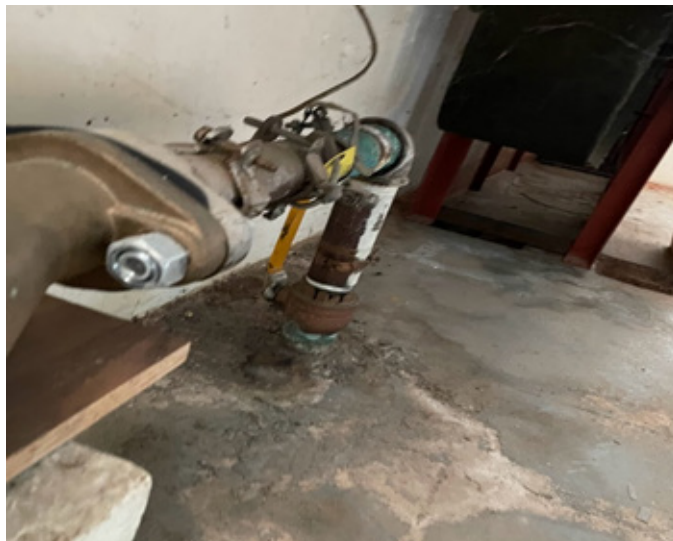
1. Location:

Domestic Water Service

- Domestic water service and piping is nearing the end of its useful life and we recommend it be replaced in its entirety.
- Domestic Water heater is nearing the end of its useful life and we recommend it be replaced with an electric water heater.
- Sanitary system (above and below grade) is nearing the end of its useful life and we recommend it be replaced in its entirety.
- Natural Gas service and system is nearing the end of its useful life and we recommend it be replaced in its entirety.
- Sanitary system (above and below grade) is nearing the end of its useful life and we recommend it be replaced in its entirety.
- Storm water system (above and below grade) is nearing the end of its useful life and we recommend it be replaced in its entirety.

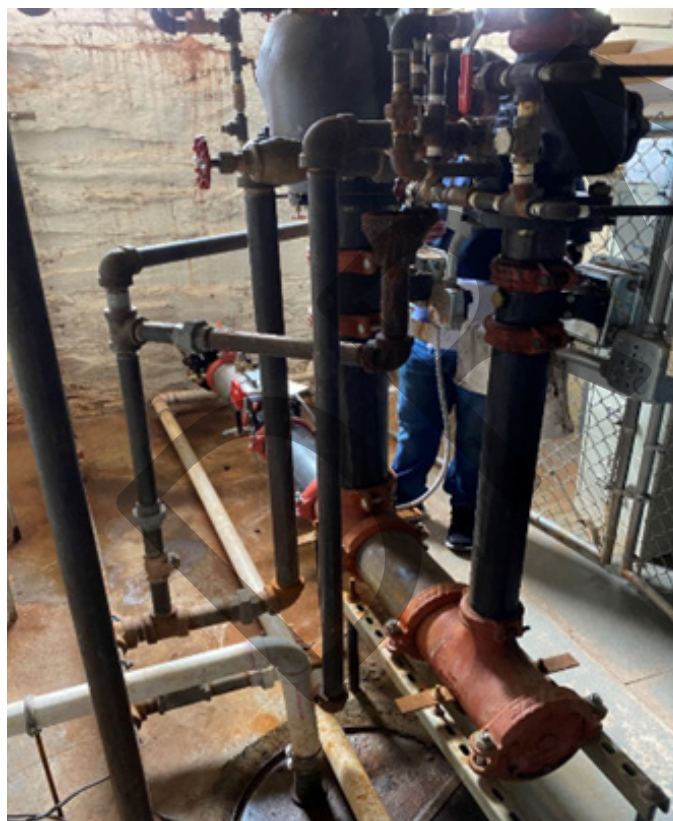
2. Location:

Fire Service and Riser

- Fire service and associated piping is nearing the end of its useful life and we recommend it be replaced in its entirety.

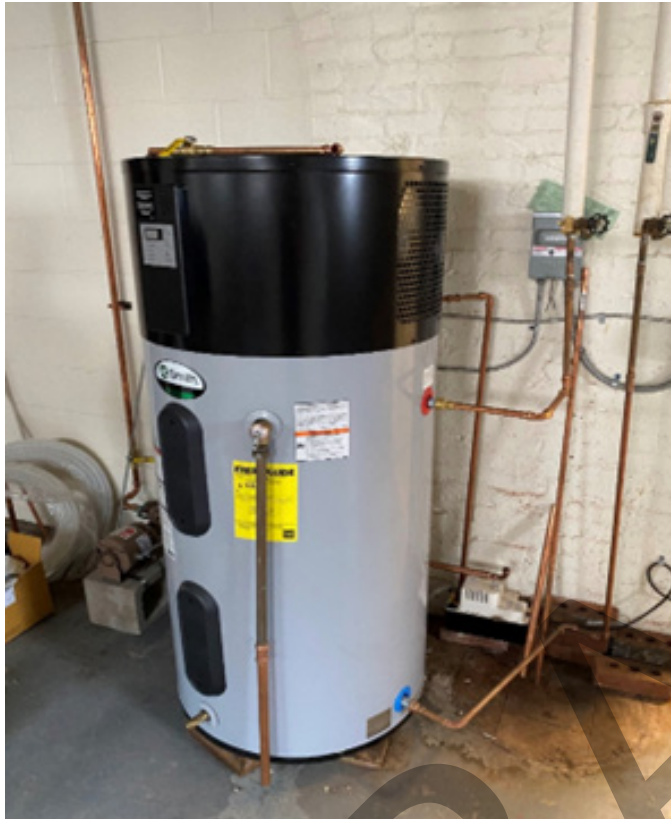
3. Location:

Water Heater

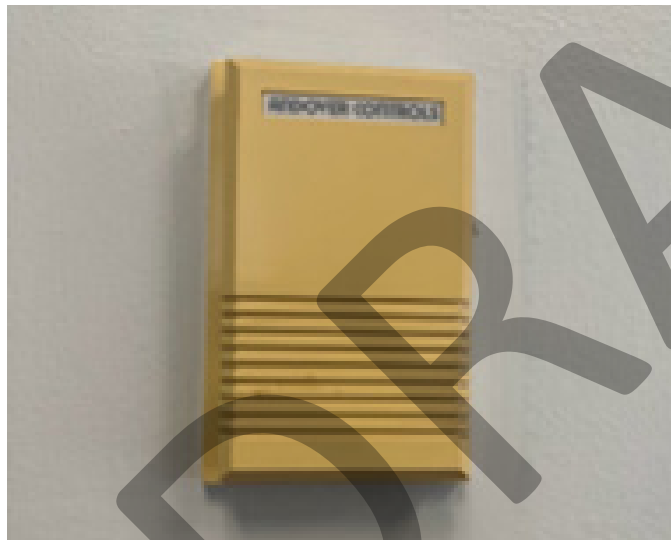
8. Location:

Andover Thermostat

- Controls: The air handling units are controlled by a centralized BAS system. Spaces are controlled by two types of thermostats. Replace all thermostats to have occupancy override and set point adjustment.

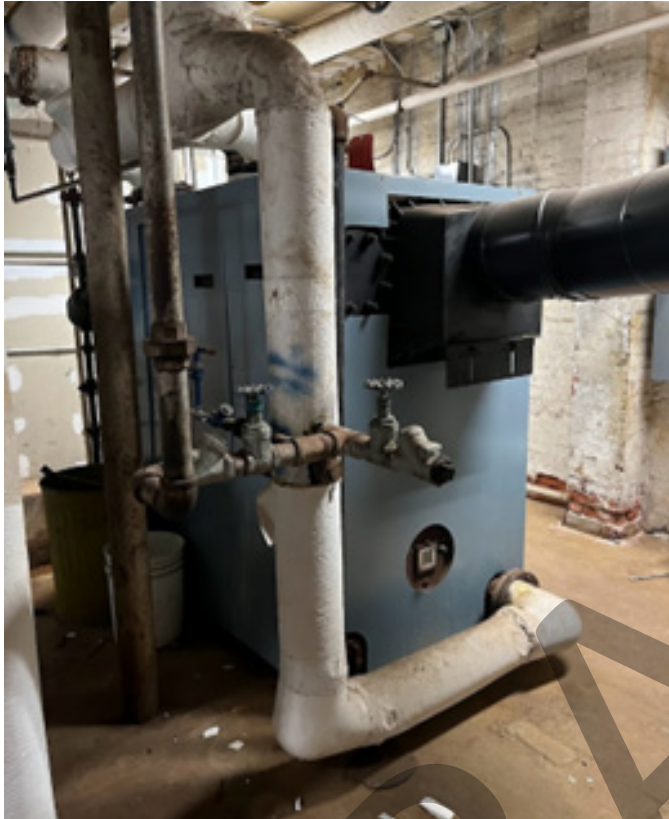
12. Location:

The building is heated by two cast iron boilers in the basement that are in poor condition. The building is cooled by ten air handling units that appear to be in good condition.

Smith Cast Iron Steam Boiler

- Heating Plant: The existing building is served by mid-efficiency steam boilers with condensate return system and duplex boiler feed pumps. Boilers are not near the end of their life however recommend replacing with high efficiency condensing hot water boilers for increased energy savings. Further we recommend replacing all steam and condensate piping throughout building due to corrosion from steam condensate.

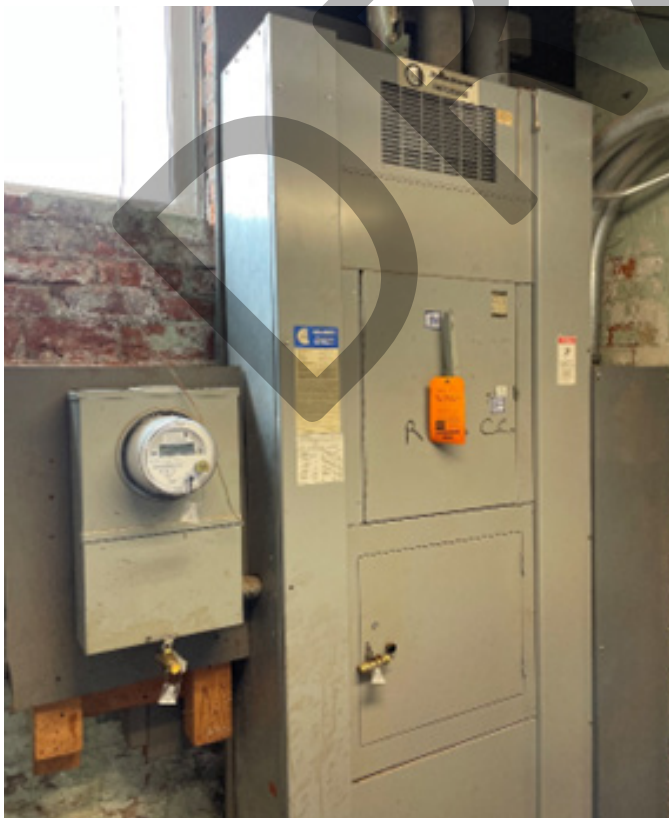
13. Location:

Main Service Disconnect, CT Cabinet and Meter

- Main switch, CT and distribution equipment is well maintained and serviceable, but nearing the end of its lifespan. Recommend replacement in 3-5 years.
- Older branch panelboards are original to the building and in need of immediate replacement. Branch panelboards that were installed as part of more recent renovations and / or upgrades, should provide service for another 15-20 years before replacement is necessary.
- No evidence of a lightning protection system for the building was observed. If none exists, Recommend installing a lightning protection system in the immediate future, to safeguard people and property from fire risk and related hazards associated with lightning exposure .

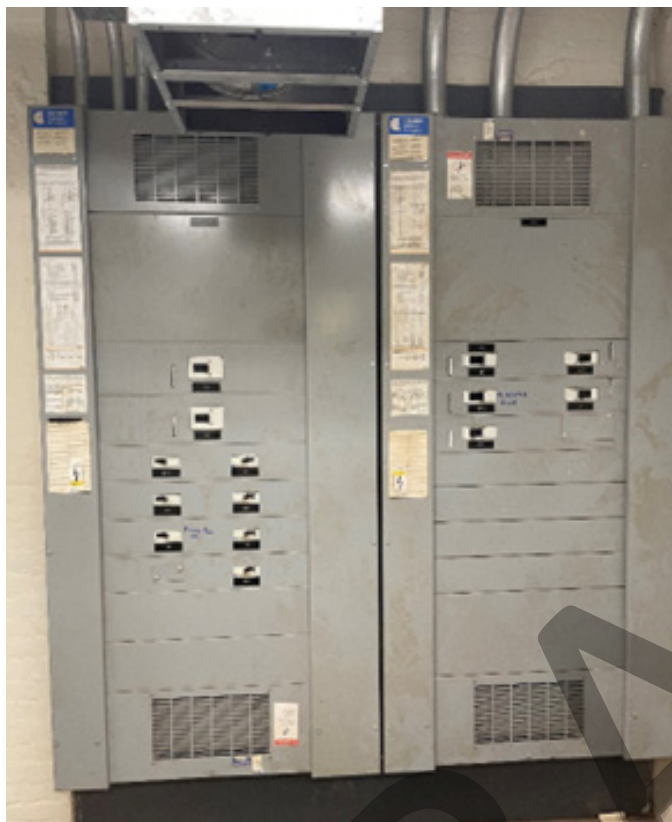
14. Location:

Main Distribution Panels

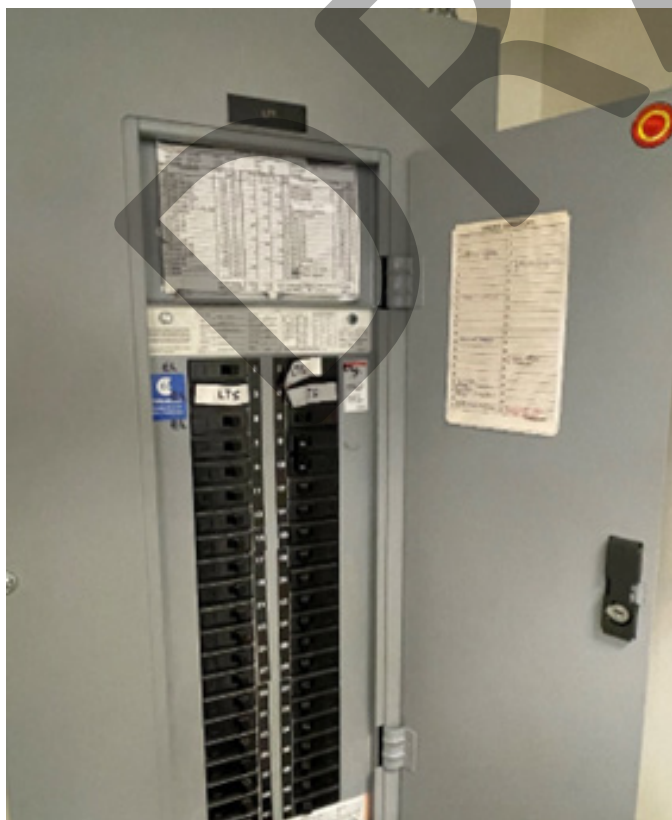
15. Location:

Typical Branch Panelboard Interior

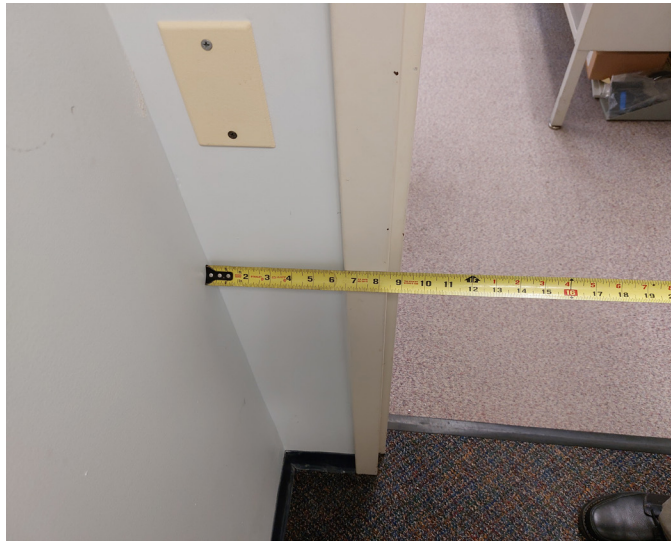
1. Location:

Main Office

Front approach door does not have 18" clearance on latch side of door when approaching from the pull side.

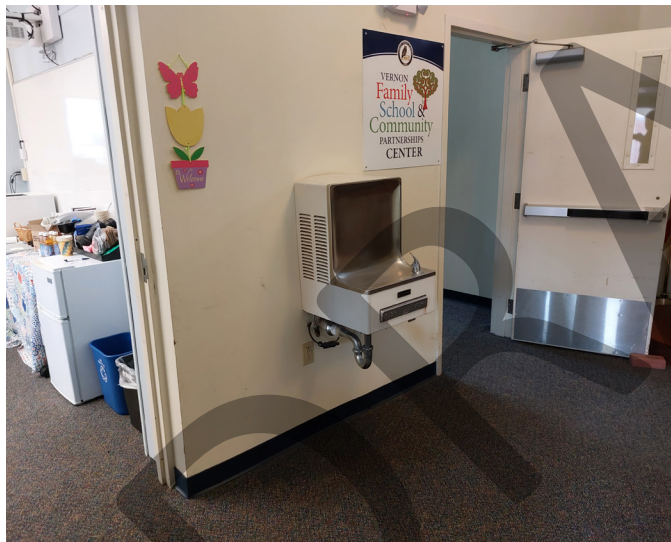
2. Location:

Corridor

Water fountain does not have insulated pipes. Water fountain is considered a protruding object.

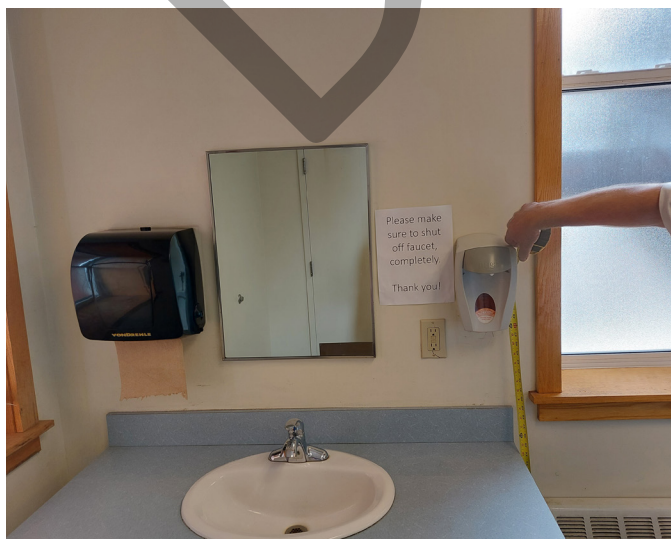
3. Location:

Toilet Room

Mirror is mounted above the required maximum of 40". Operable components of toilet room accessories are located above the required maximum of 48".

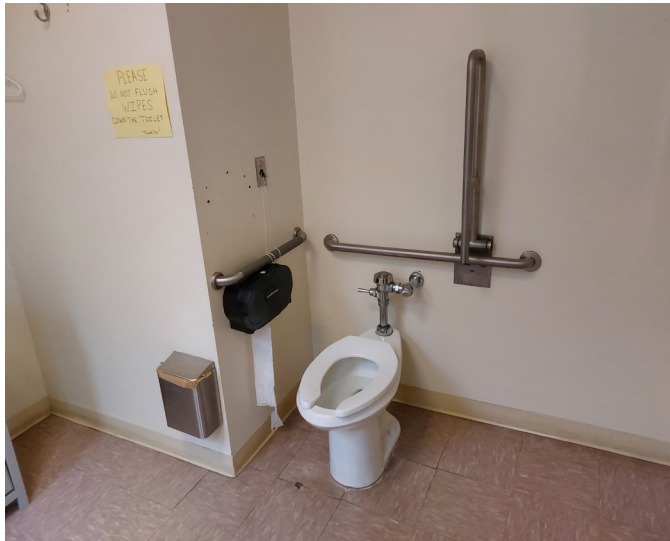
4. Location:

Toilet Room

A vertical grab bar is not present, swing down grab bar is no longer required, controls are located incorrectly, and the sidewall grab bar is not long enough for compliance.

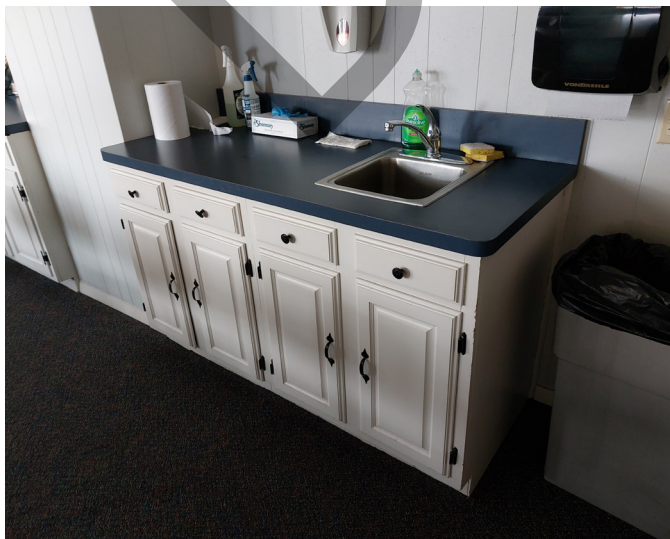
6. Location:

Employee Lounge

Only sink available in this room is not accessible, does not provide proper pull under distance and exceeds height requirements. Accessories are mounted above required maximum height of 48".

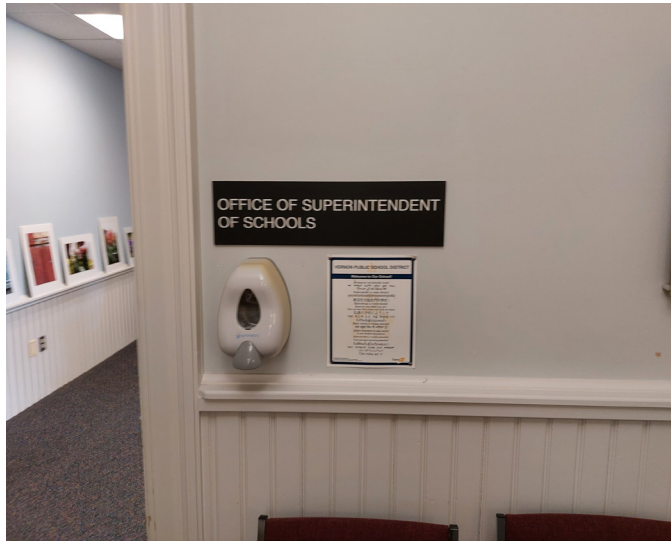
7. Location:

Office of Superintendent

Signage for this area does not meet accessible requirements. Does not have braille characters.

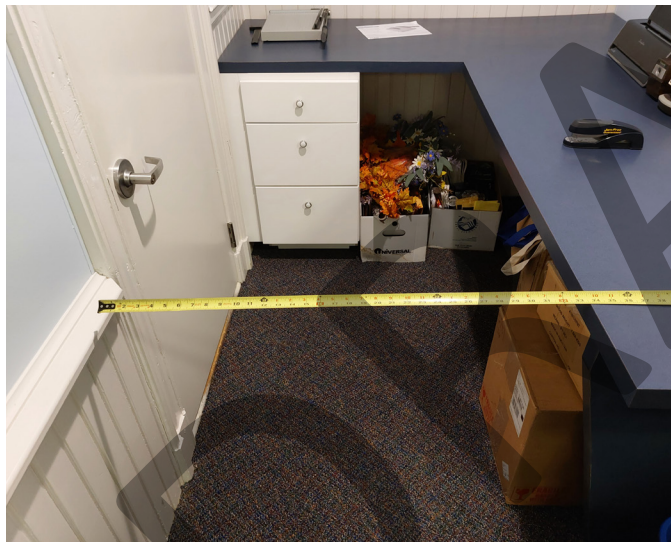
8. Location:

Office of Superintendent

Door does not meet clear space requirement of 48" for latch side approach without closer.

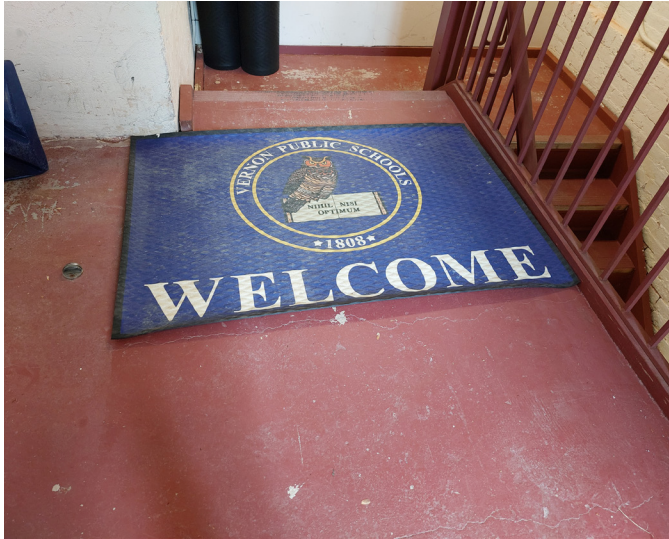
10. Location:

Entry

Welcome mat has edges that are raised greater than a 1/2", presenting a tripping hazard.

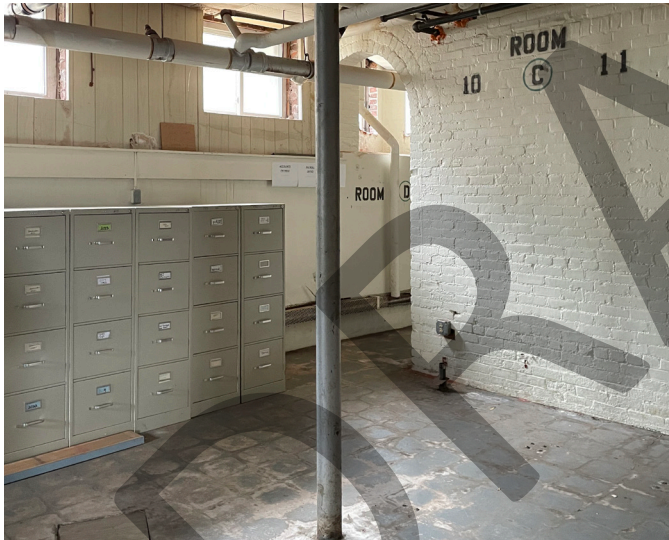
11. Location:

Basement

The basement is currently "locked out" for public access. The floor is mainly used as storage, utility, boiler, electrical, mechanical and workshop spaces. The elevator and stairs go to this level, upgrades will be required for accessibility.

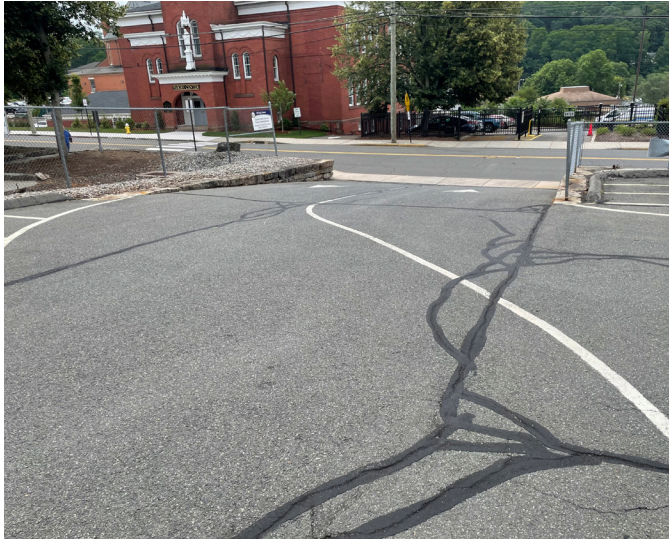
13. Location:

Parking

Side Accessible entrance does not have a circulation path from outside of the site. Side entrance is only accessible from parking lot.

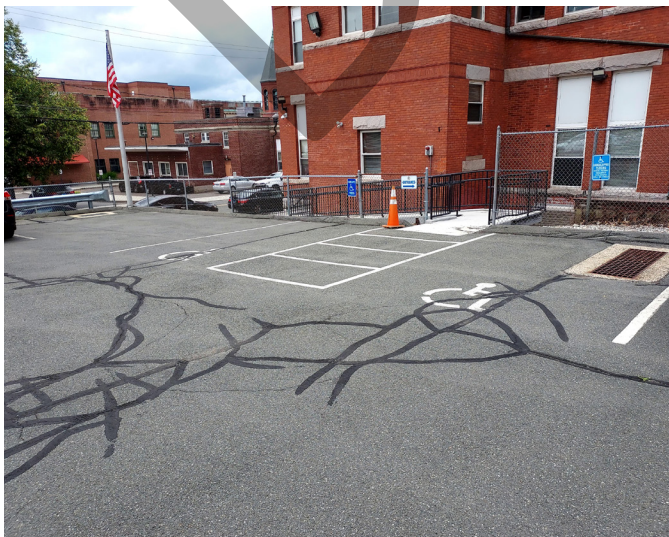
15. Location:

Site

Of the two accessible spaces 1 is sized to be van accessible, but the signage does not indicate this. Signage for both accessible spaces are not located above the required minimum 60" above grade. Parking spaces exceed a slope of 1:48.

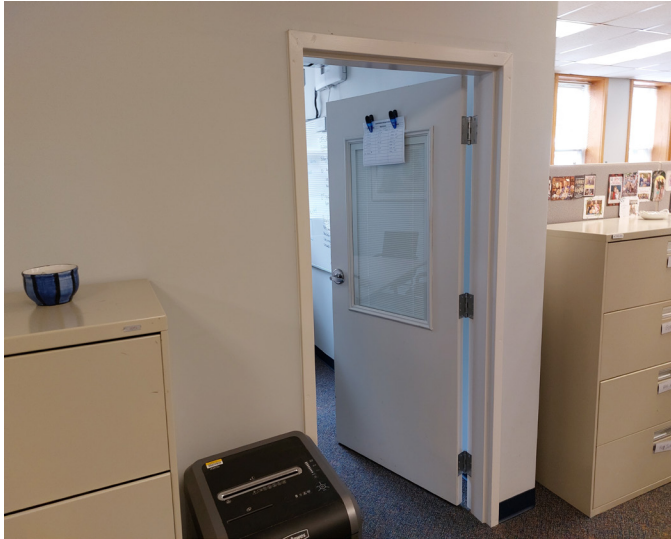
16. Location:

Main Office

No signage designating room or space.

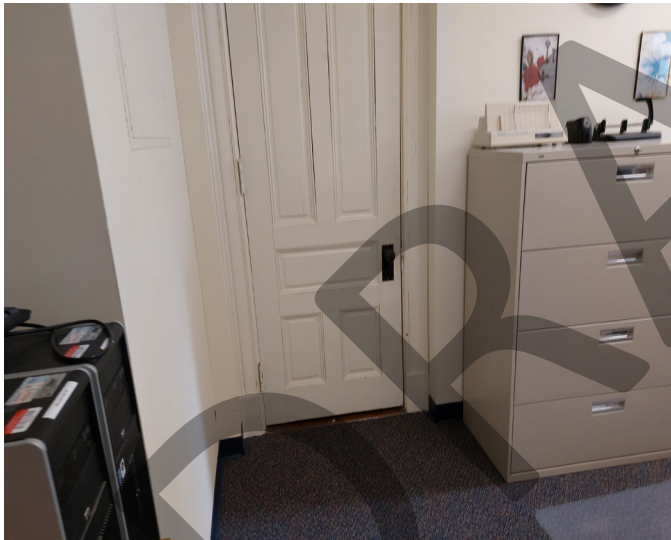
17. Location:

Second Floor Office Area

The existing door is not wide enough and the door hardware is not compliant. This is the exception for this building.

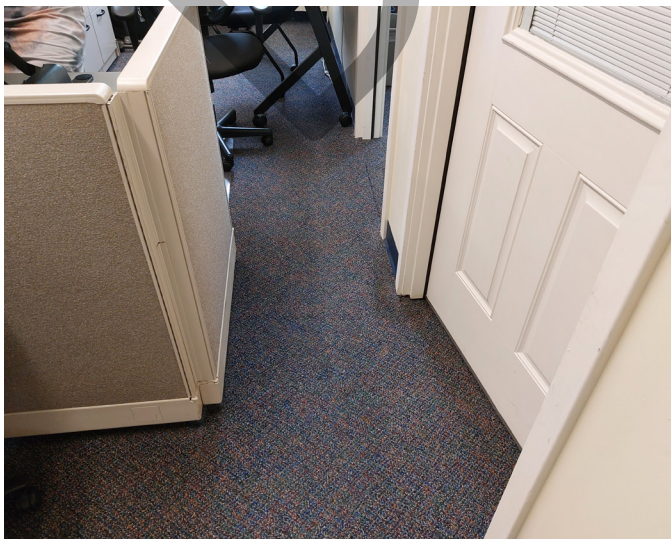
18. Location:

Second Floor Office Area

The office furniture is restricting the clear width and the access to the two office spaces.

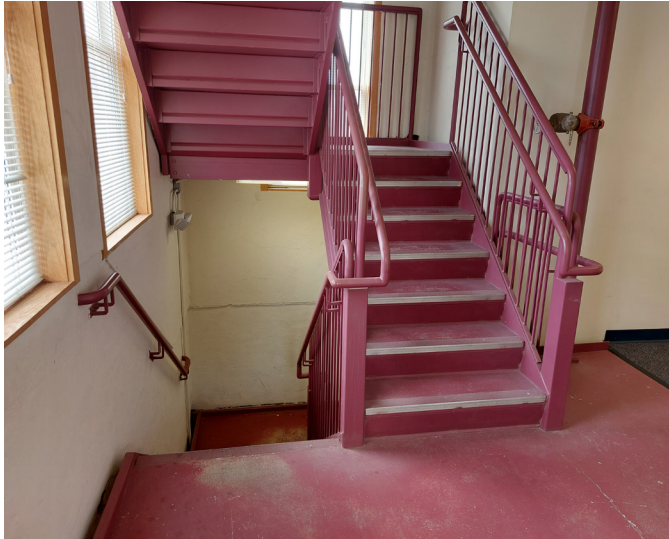
19. Location:

Exit Stair - Second Floor

The handrail extensions at the bottom of the stair are not typical, do not extend for 1' in the direction of the stair.

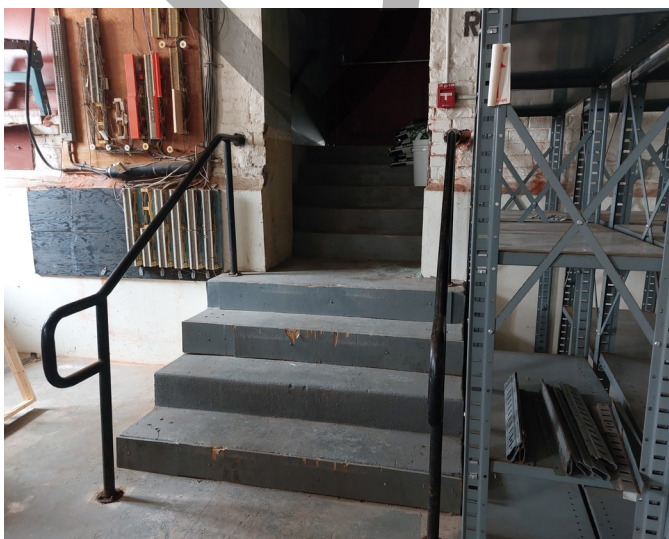
21. Location:

Basement

The exit is not provided with continuous handrails.

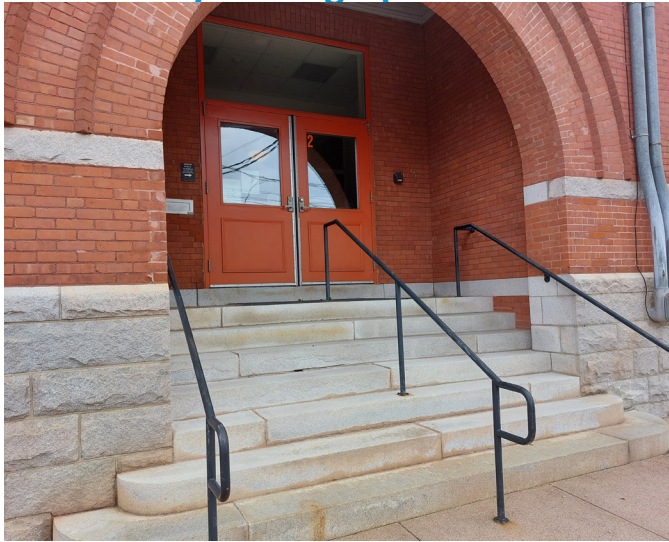
22. Location:

Main Entrance

Signage exists to direct people to the accessible side entrance, but it does not exist in an accessible location. The stair riser and treads are not compliant.

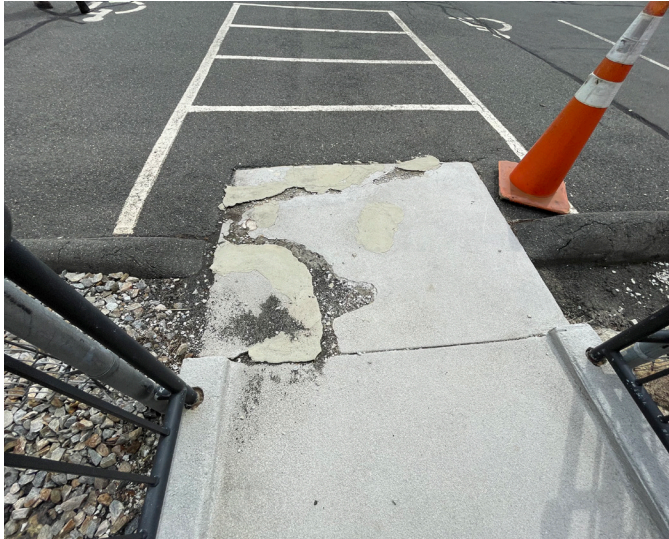
25. Location:

Exterior Ramp

The condition of the ramp is contingent on access. Deterioration will create depressions and loose surfaces, which the wheel chair can not navigate.

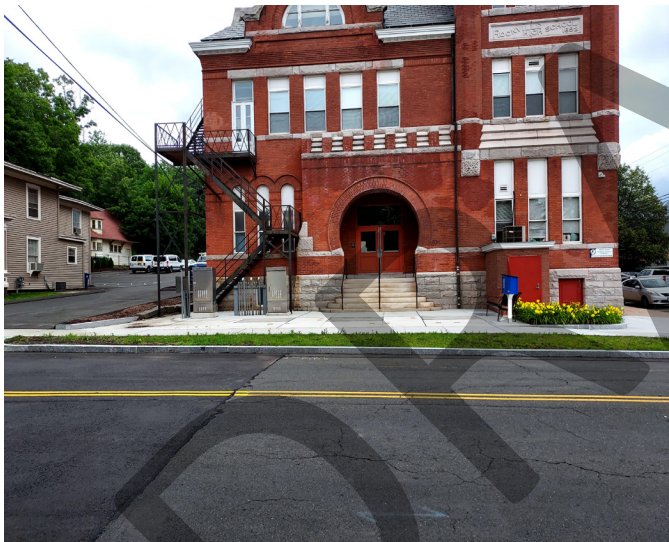
26. Location:

Park Street Side (West)

Originally the high school circa 1892, the building was not designed as an accessible building. Access from the public way is currently not possible.

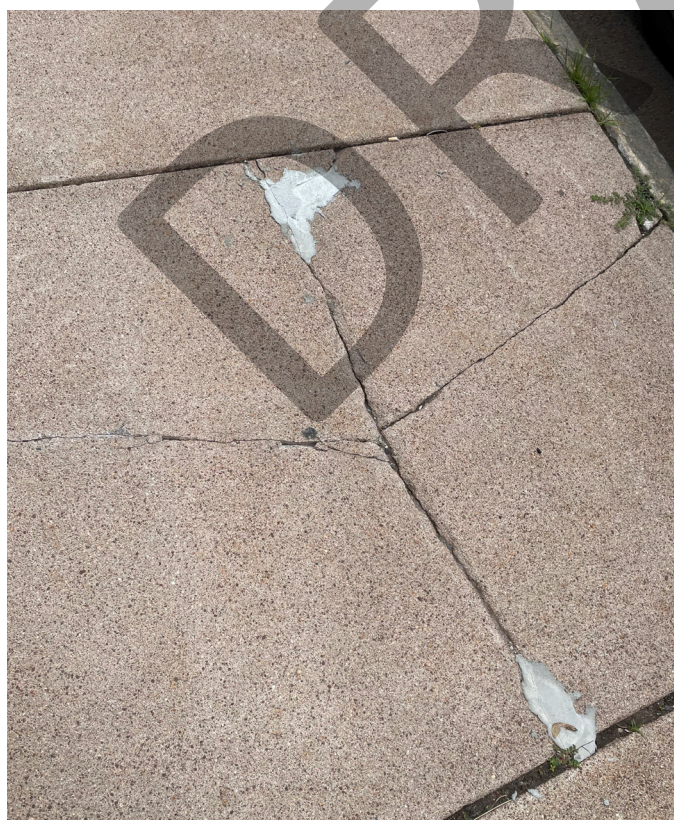
Concrete has been patched in several locations.

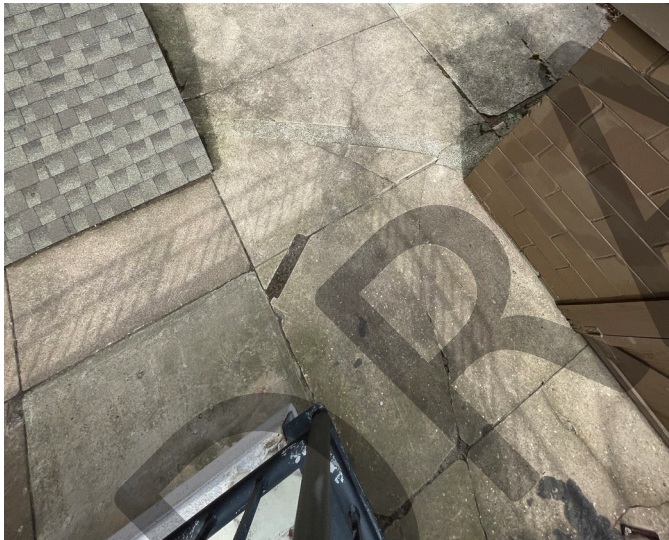
View of concrete stairs, concrete ramp and stone retaining wall.

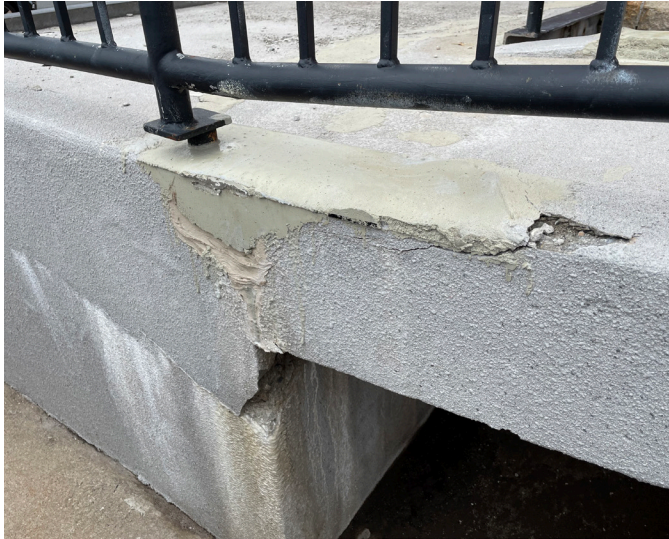
6. Location:

Patchwork at concrete ramp.

- Replace exterior concrete ramp and landing leading from the parking area to the building.
- Repair cracks in walkways and replace missing drain covers.

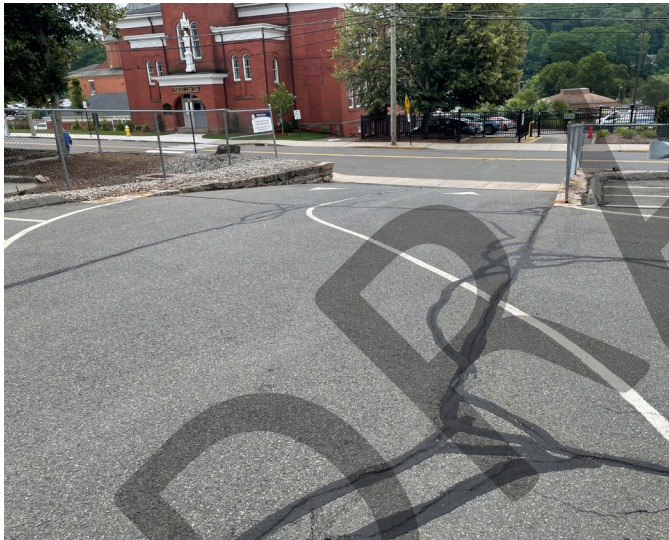
7. Location:

Entry drive from School Street. Parking and drive haven been patched in various locations.

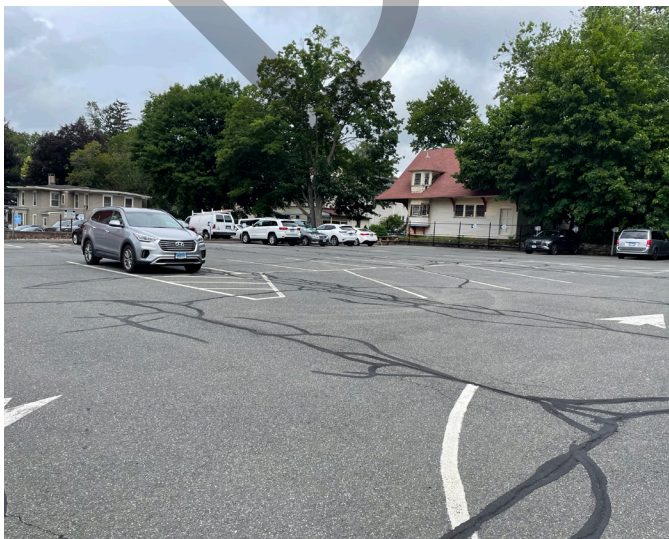
8. Location:

Bituminous parking area with painted directional indicators.

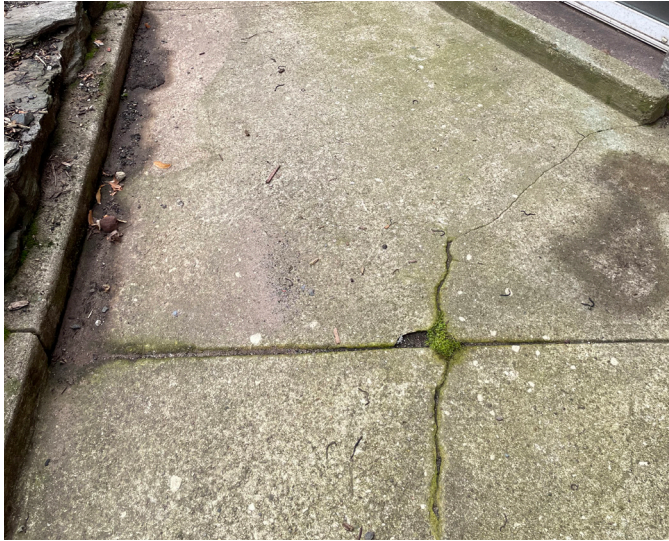
9. Location:

Cracked concrete with mildew build up.

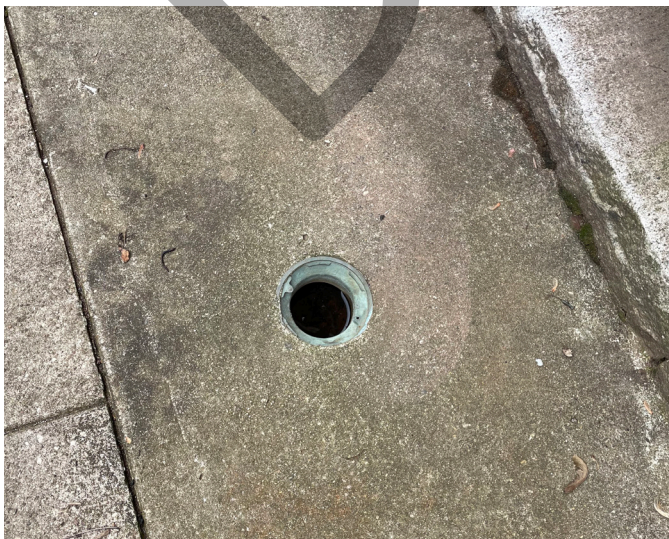
11. Location:

Missing drain cap in concrete walkway

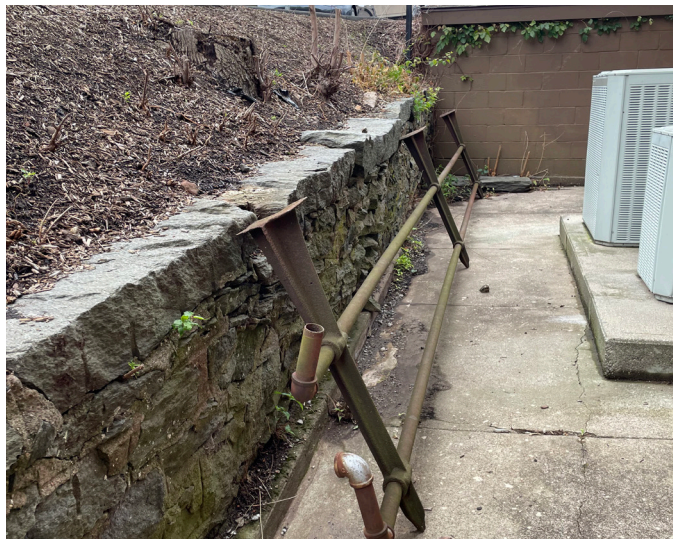
12. Location:

Discarded metal railing

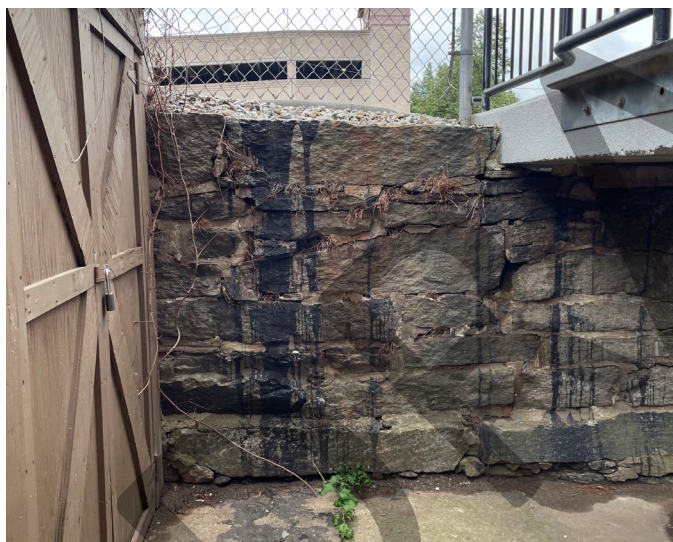
13. Location:

Some areas of decay in the stone retaining wall and staining visible.

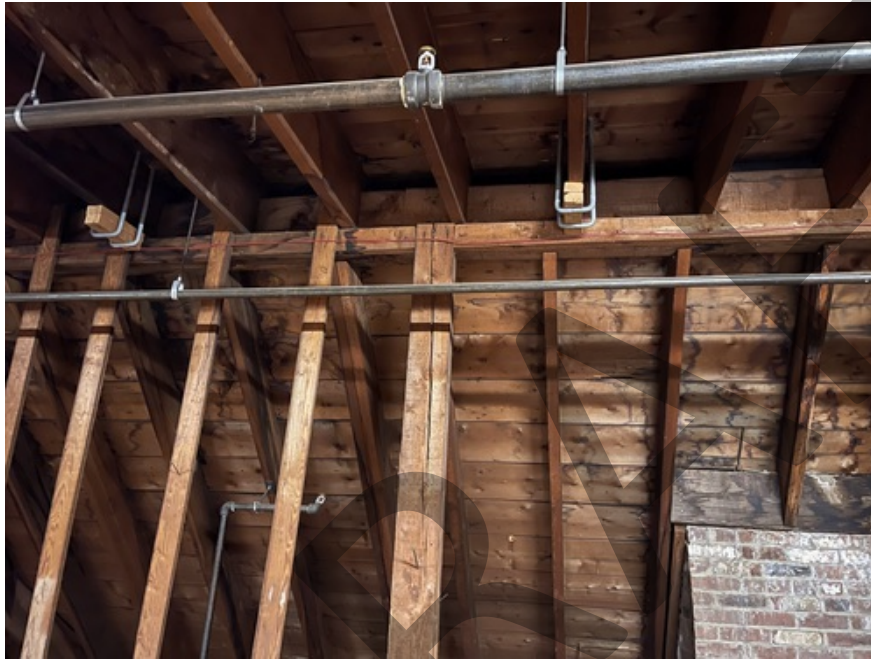
Photo 1

**View of the underside of
the wood plank deck- 16"
OC**

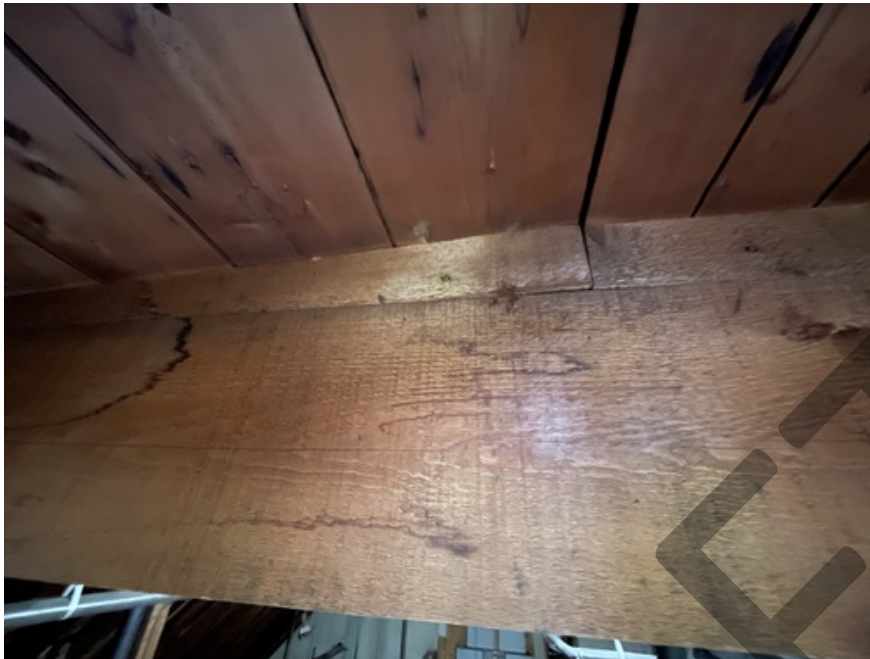
Photo 2

**Wood Decking- Added
shims for slope**

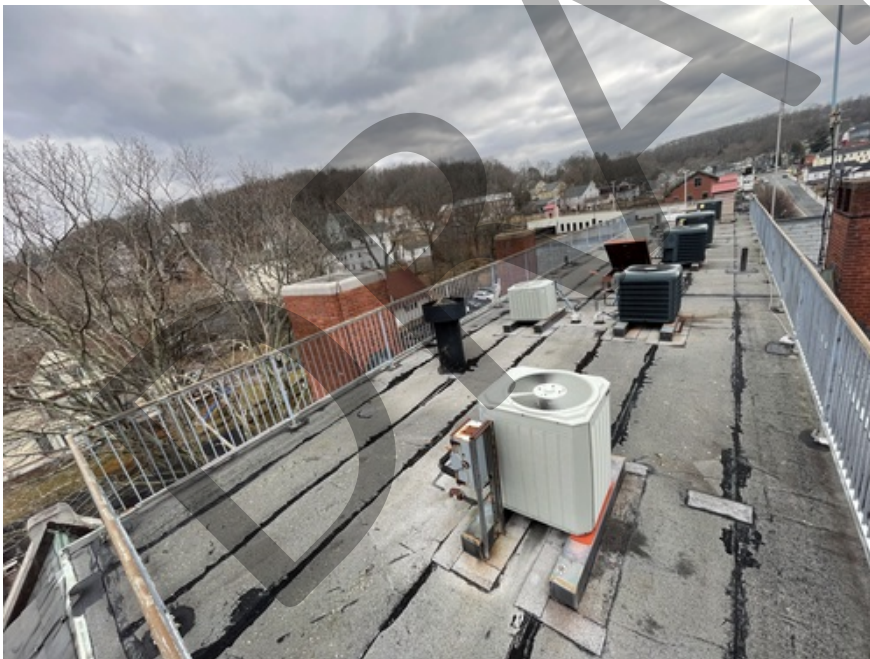
Photo 3

**Overview of the low slope
roof section**

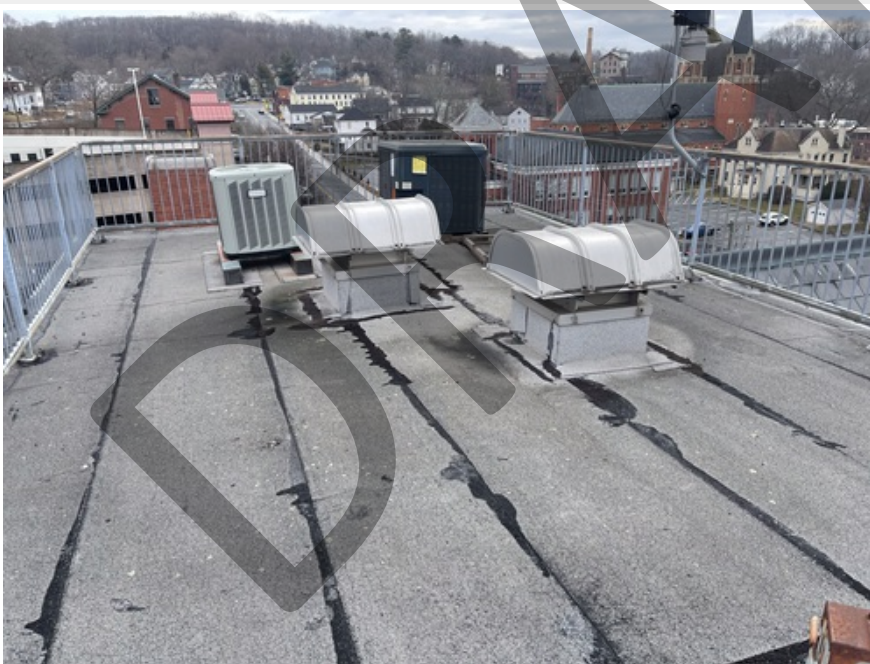
Photo 7

**No ponding or standing
water observed**

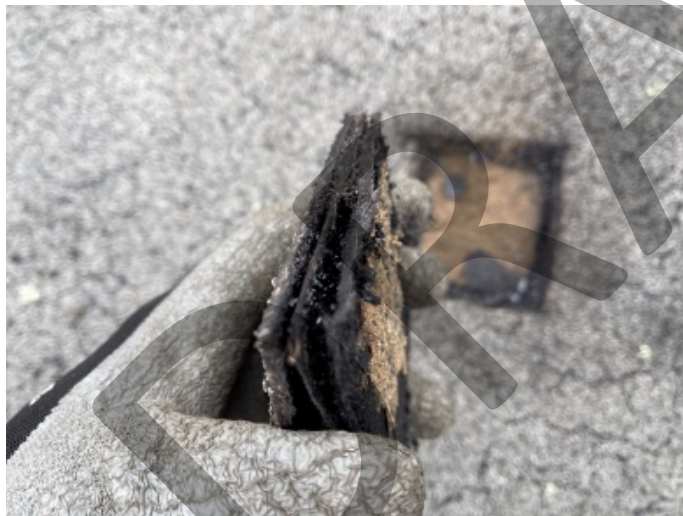
Photo 11

Core Cut: 3 or 4 Ply BUR with mineral surface

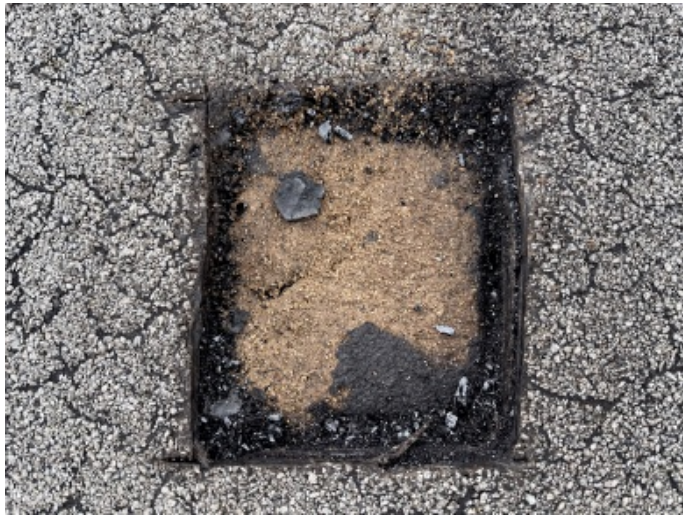
Photo 12

Core Cut: 1/2" saturated perlite insulation over sloped deck

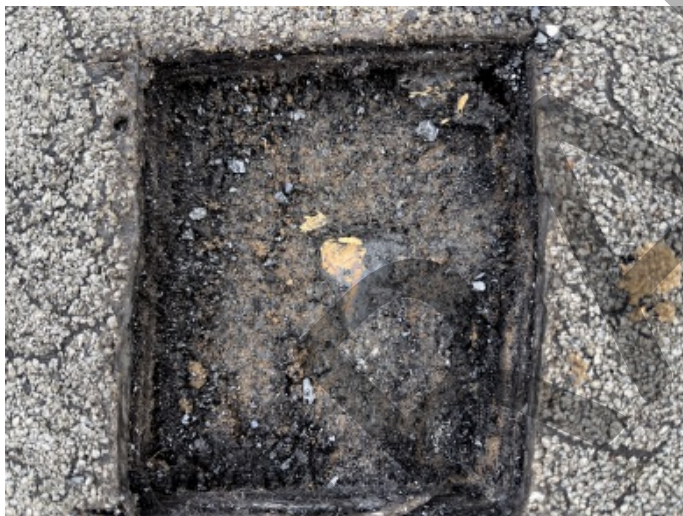
Photo 13

Core Cut: View of the wood deck- a VB layer is the only thing stopping this decking from rotting out

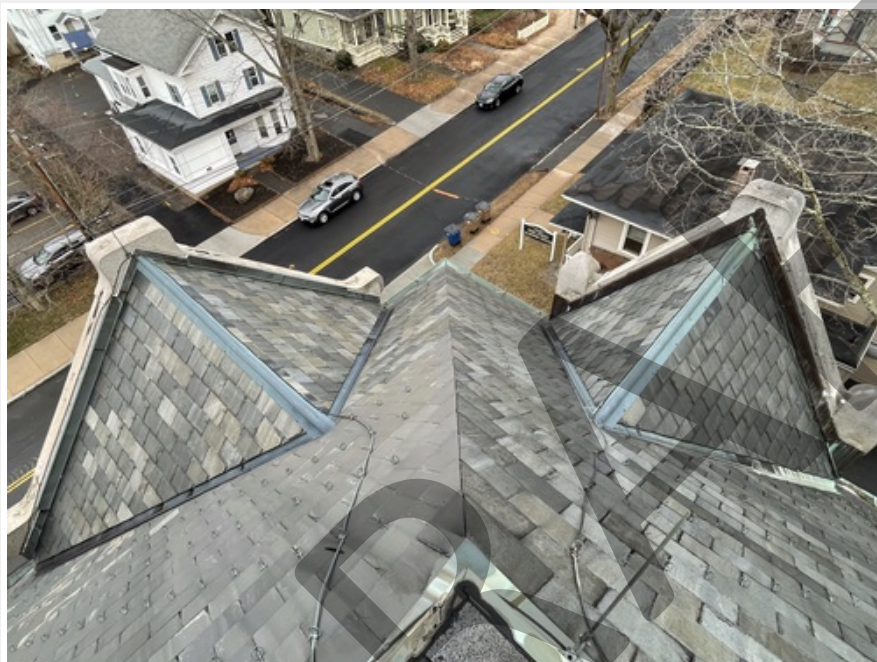
Photo 1

Overview- Gothic dormers

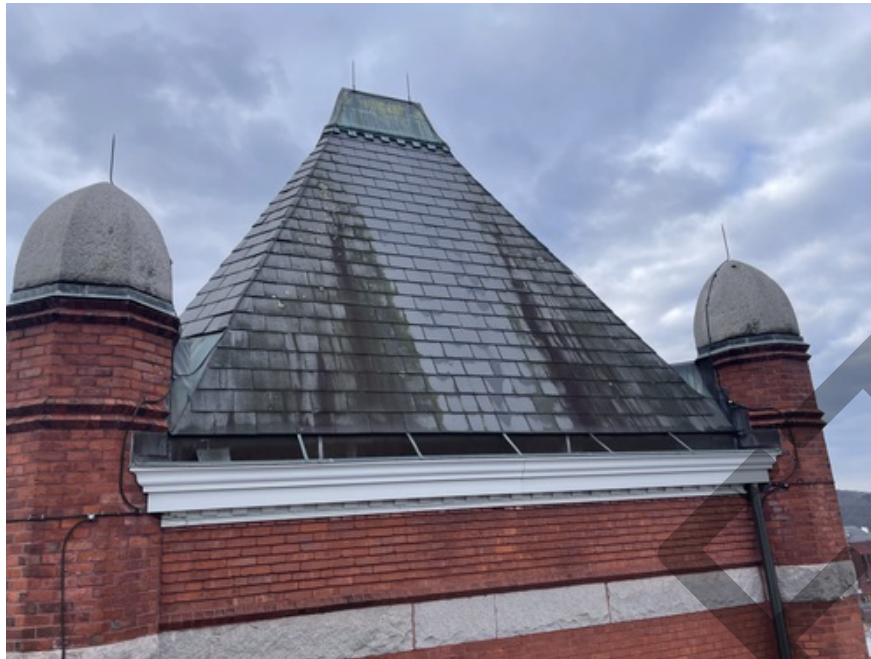
Photo 2

**Bell tower slate and
exposed porous concrete**
