Facility Study and Master Plan

Vernon Public School Central Administration

30 Park Street, Vernon CT 06066

SUMMER 2023

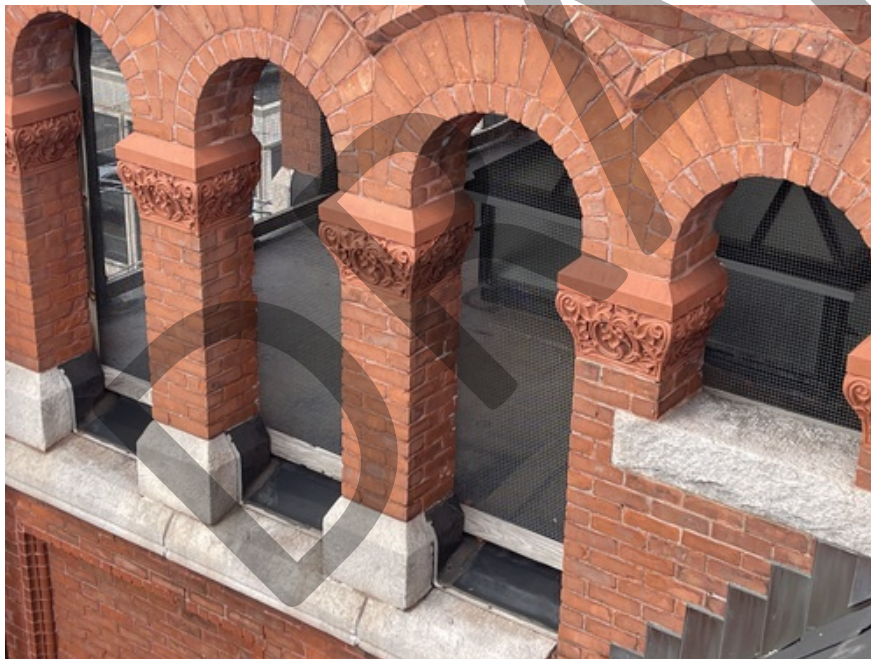
Photo 3

**Inside the bell tower-
Unable to gain access to
inspect EPDM roof**
