Facility Study and Master Plan

Vernon Center Middle School

777 Hartford Turnpike, Vernon CT 06066

SUMMER 2023

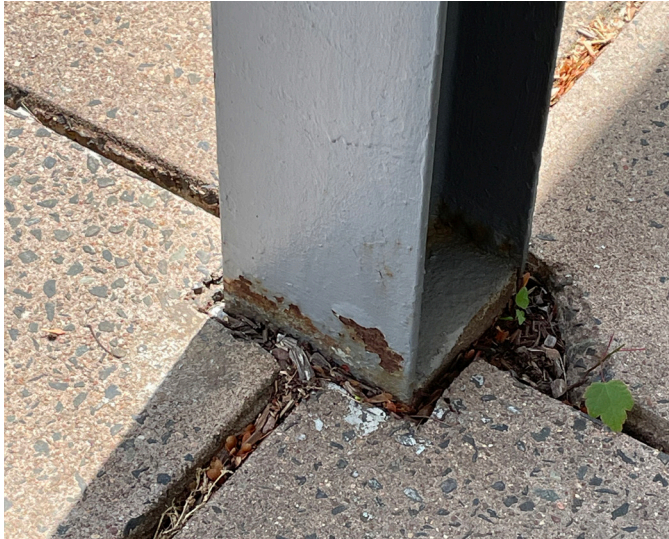
4. Location:

Typical bottom of column

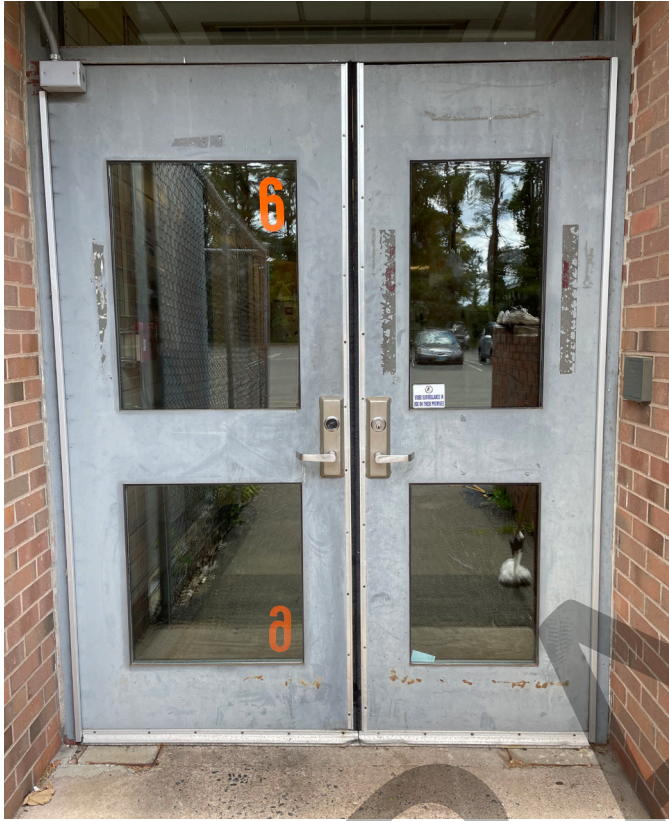
7. Location:

Example of missing weatherstripping. Hardware varies on exterior doors. Lock on this door is broken

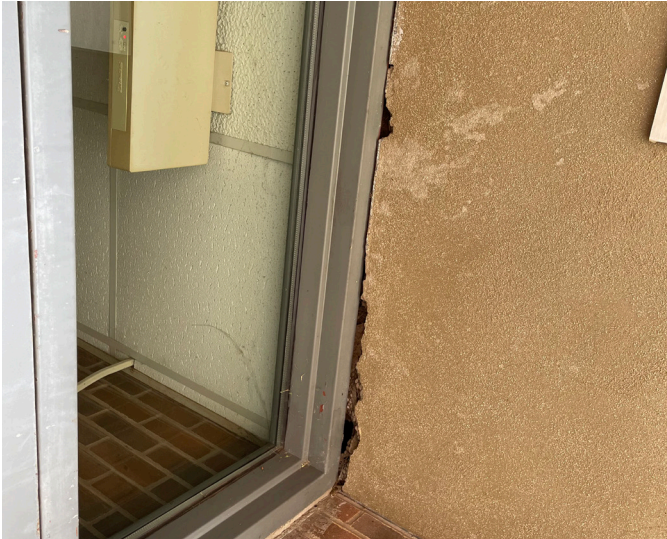
9. Location:

Finish breaking away from facade. No sealant between frame and adjacent surface.

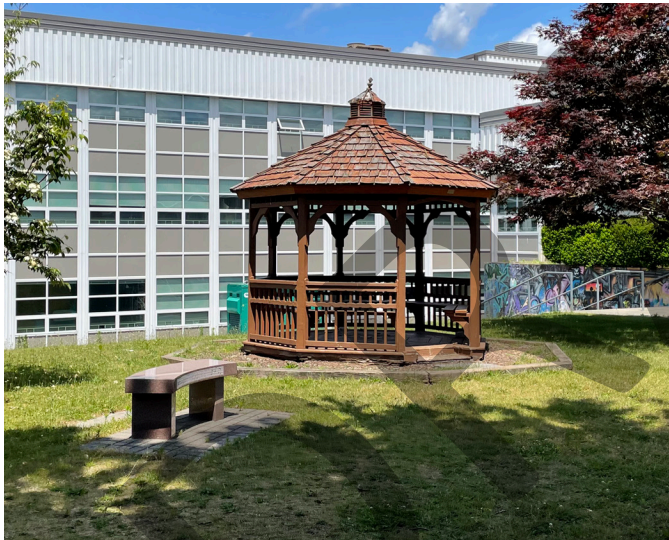
21. Location:

Paint finish on Gazebo is fading.

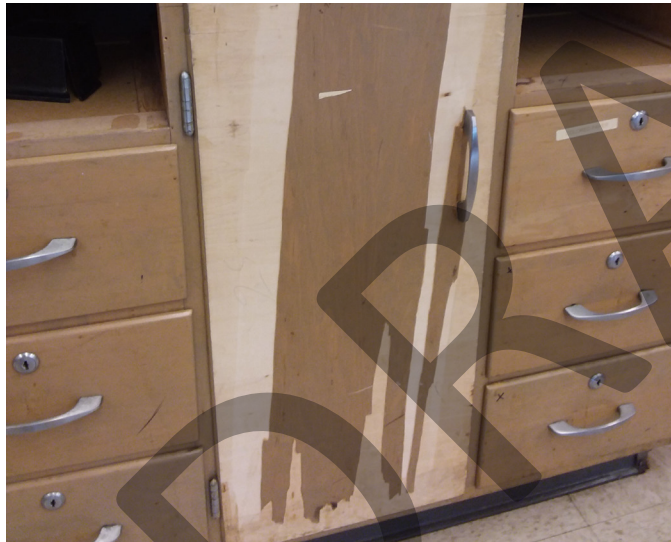
29. Location:

Delaminating casework - typical in a few classrooms.

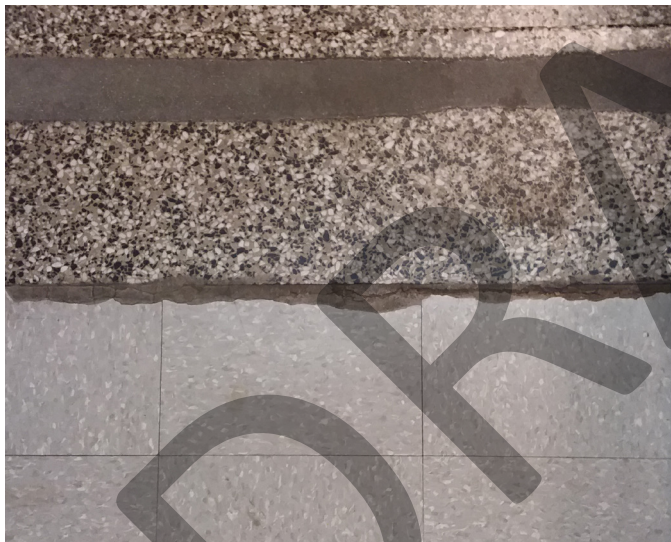
32. Location:

VCT is demolished at transition to terrazzo stair tread.

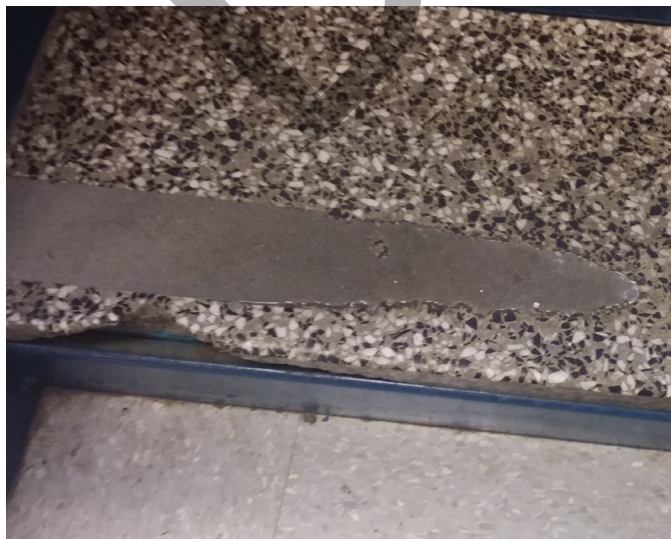
33. Location:

Stair risers do not all connect to the treads properly resulting in loud banging whenever the tread is hit.

- Repair missing or damaged wall base
- Refinish damaged and worn wood doors
- Provide new durable finish to stair risers to address noise concerns
- Repair chipped Terrazzo on stair treads

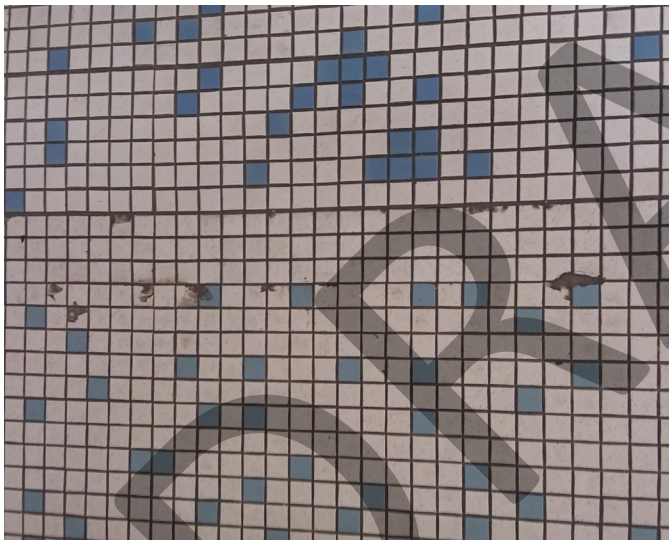
35. Location:

Floor tile is damaged and should be repaired.

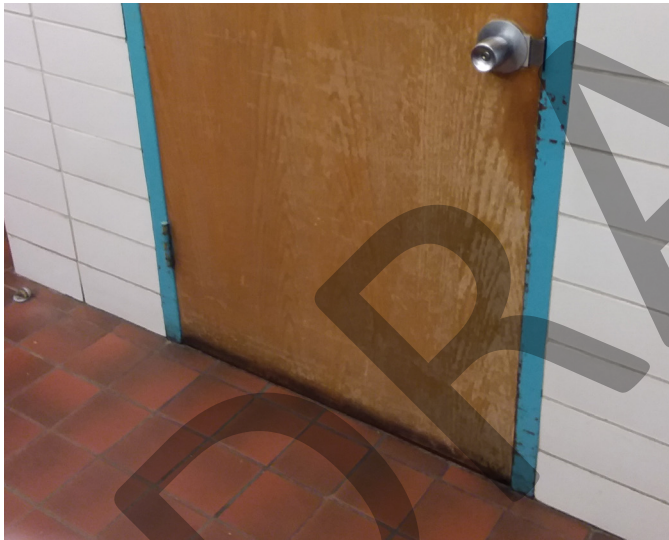
38. Location:

Chipped paint on door frame and faded finish on door.

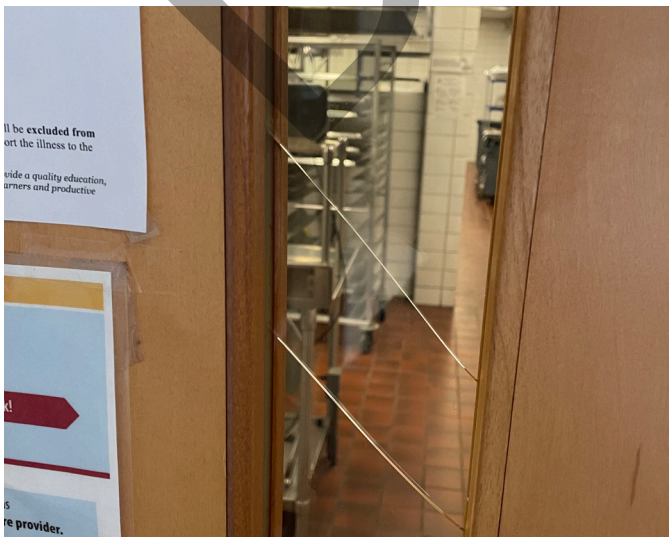
39. Location:

Chipped door frame and damaged VCT at transition.

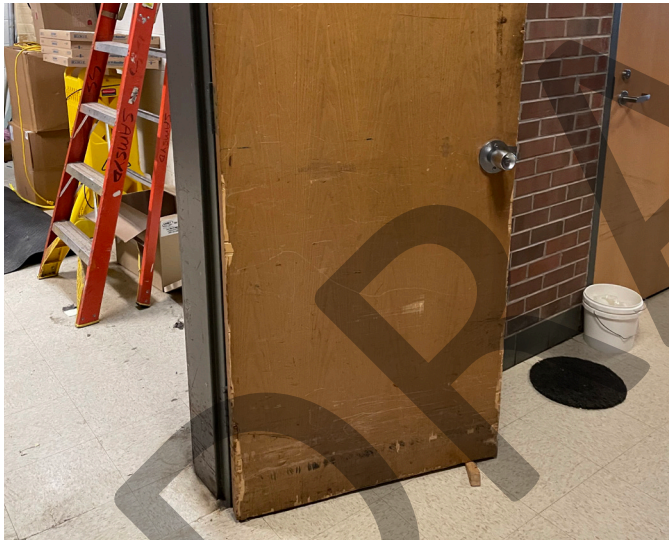
43. Location:

Door is dented and scratched in several areas.

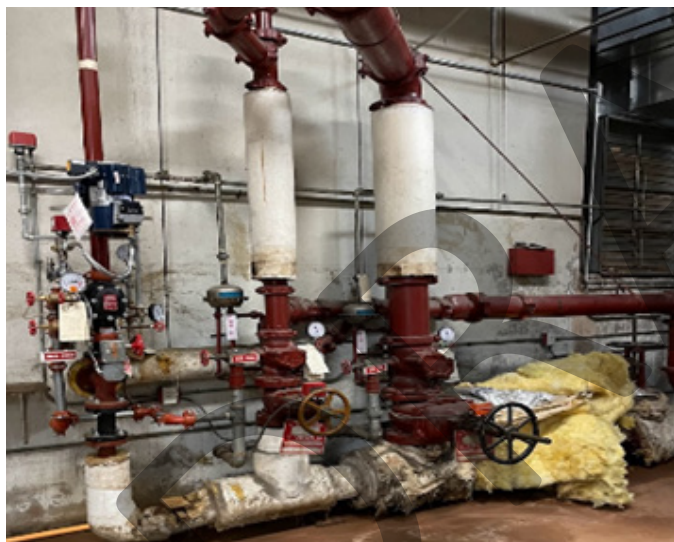
Water Service

- Domestic water service and piping is nearing the end of its useful life and we recommend it be replaced in its entirety.

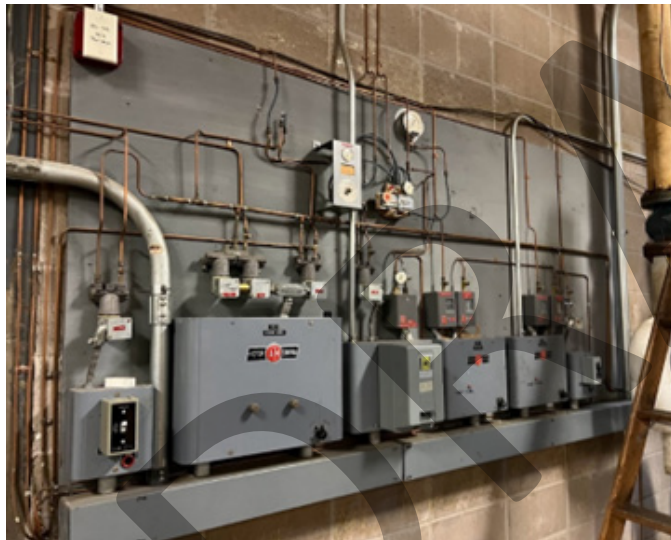
9. Location:

Building Pneumatic Control Systems

- Controls: Recommend replacement of all pneumatic controls with updated digital controls integrated to centralized building management system.
- Provide air handling unit including heating, cooling, energy recovery wheel, and mechanical ventilation for classrooms if window free area does not meet code requirements for natural ventilation.

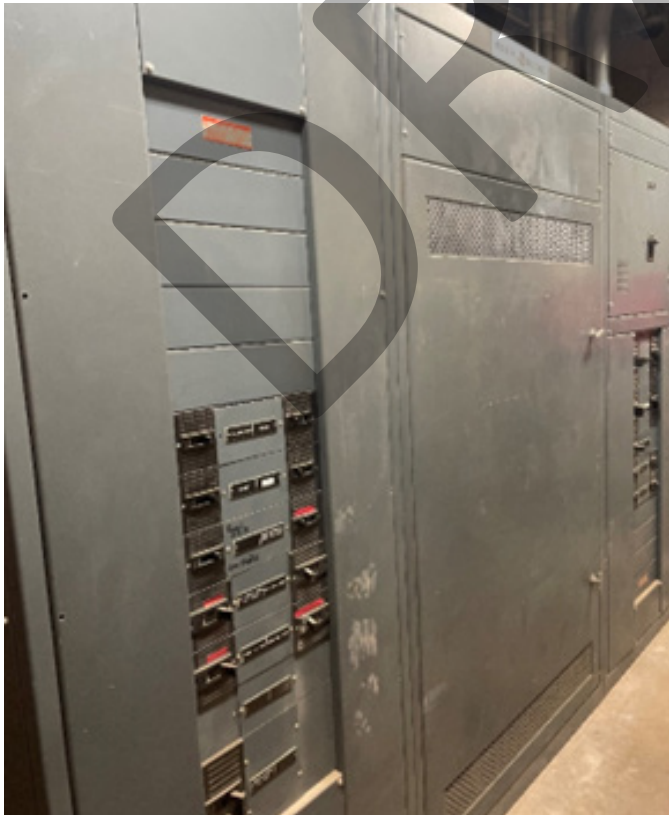
14. Location:

Main Switchboard

- Switchboard and distribution equipment is original to the building and nearing the end of its serviceable lifespan. Recommend replacement in 5-7 years. Branch panelboards that were installed as part of more recent renovations and / or upgrades, should provide service for another 15-20 years before replacement is necessary
- The generator and emergency distribution systems were installed as part of recent renovations. All equipment is in excellent condition. If maintained properly, it should provide reliable service for 20-30 years.
- There is no evidence of a lightning protection system for the building. Recommend installing a lightning protection system in the immediate future, to safeguard people and property from fire risk and related hazards associated with lightning exposure.

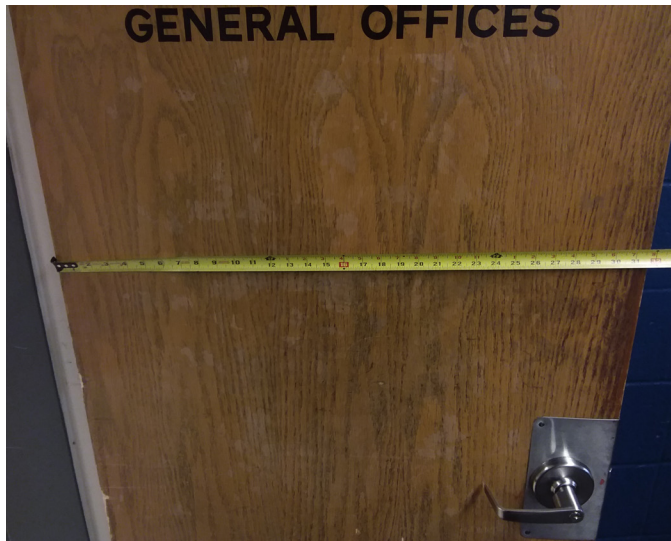
1. Location:

Door does not meet required clear width of 34" in order to provide a 32" clear space when fully opened.

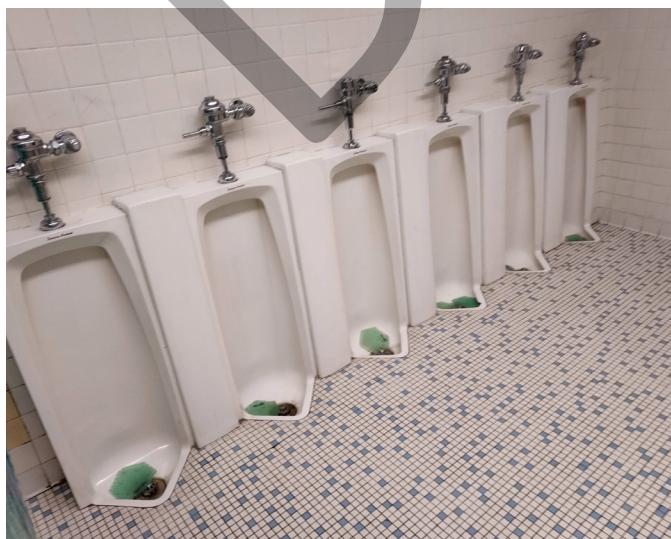
3. Location:

The urinals are original, they do not provide the required clear width for a front approach with the required screens, and control height.

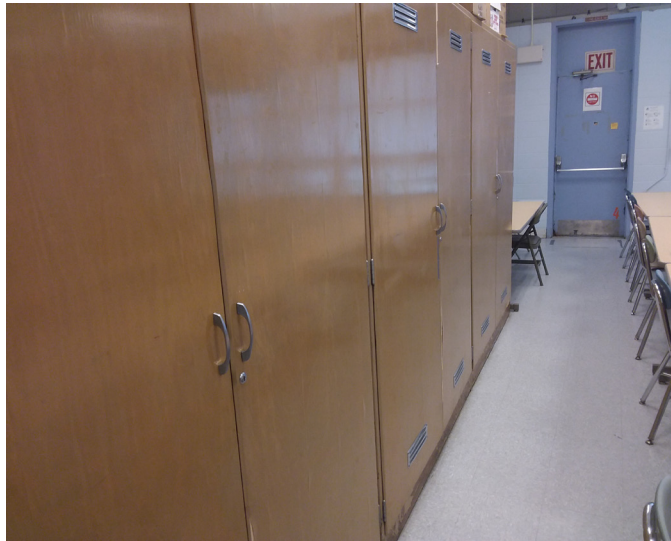
4. Location:

Storage cabinet hardware requires tight gripping to operate.

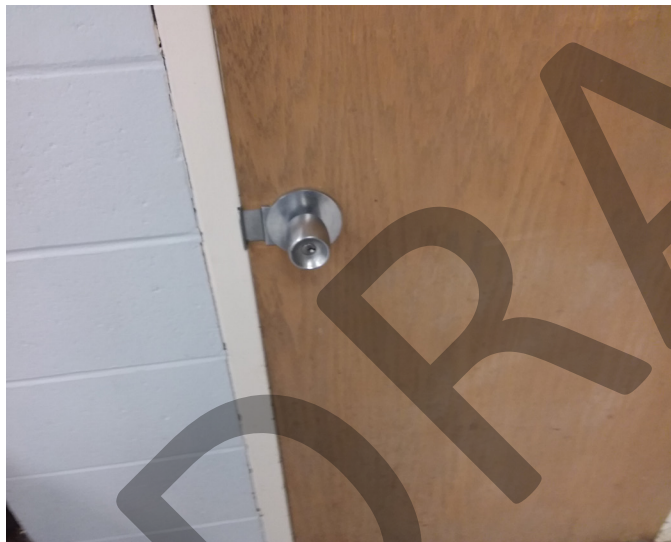
5. Location:

Practice room doors require tight gripping and wrist movement to operate.

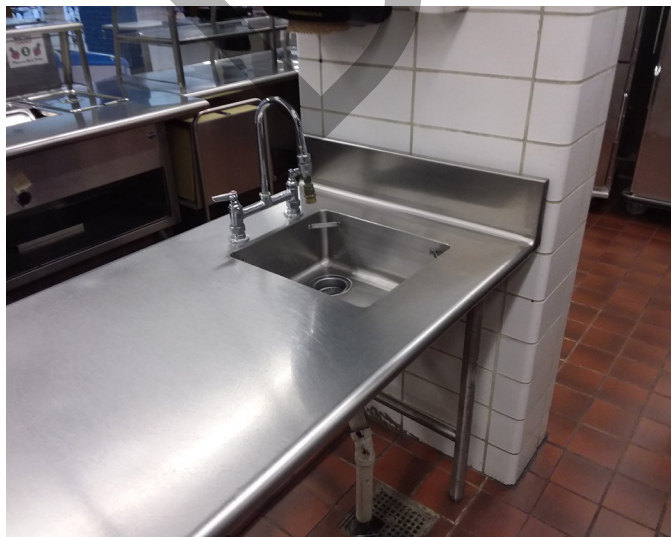
6. Location:

There is not an accessible hand sink located in the kitchen prep area. Drain piping interferes with required pull under distances.

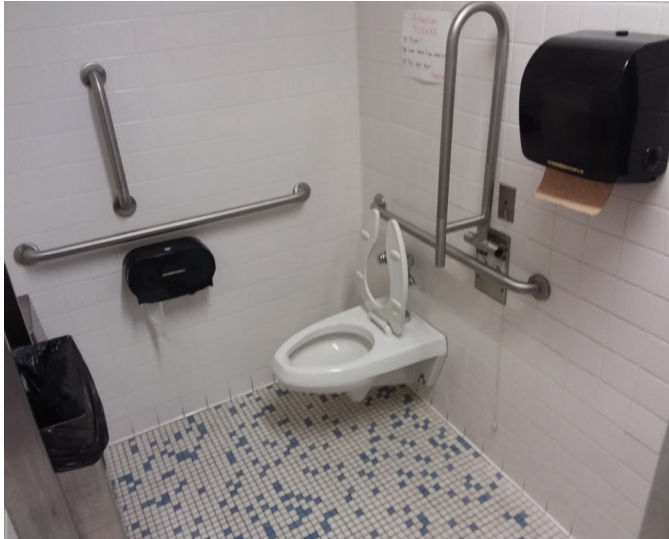
7. Location:

Marked Accessible Toilet Room is does not meet clear space requirements of 56" x 60".

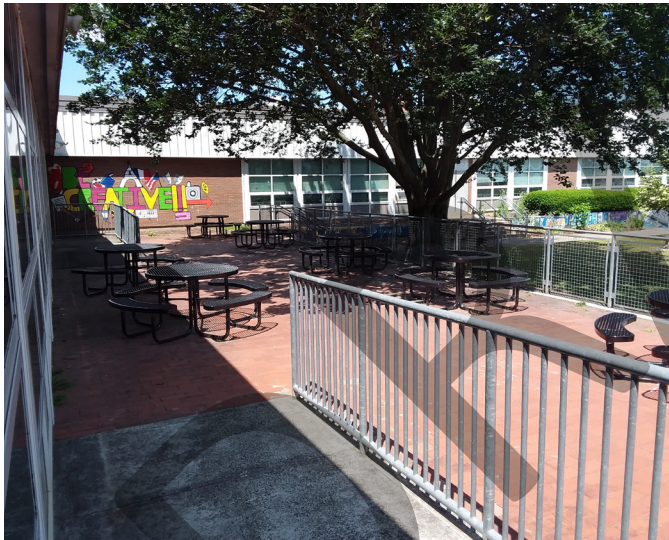
8. Location:

Accessible entrance to courtyard, handrails are not present on both sides of the ramp. Handrail does not extend required 12" beyond end of ramp.

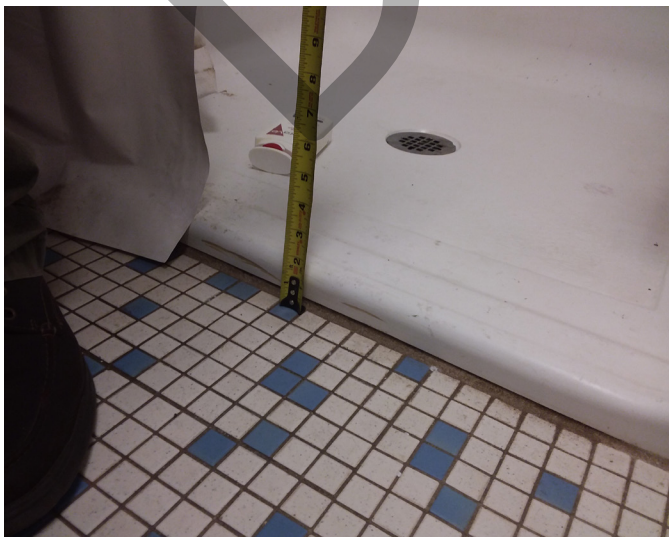
9. Location:

Shower transition is greater than 3/4".

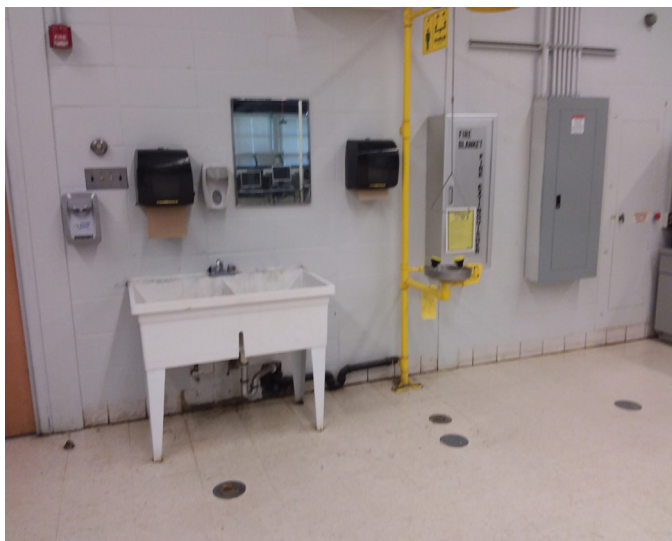
10. Location:

This is the only sink available in this room. Sink does not meet height requirements for pull under distance. Accessories are mounted above maximum required 48". Mirror is mounted above maximum required 40".

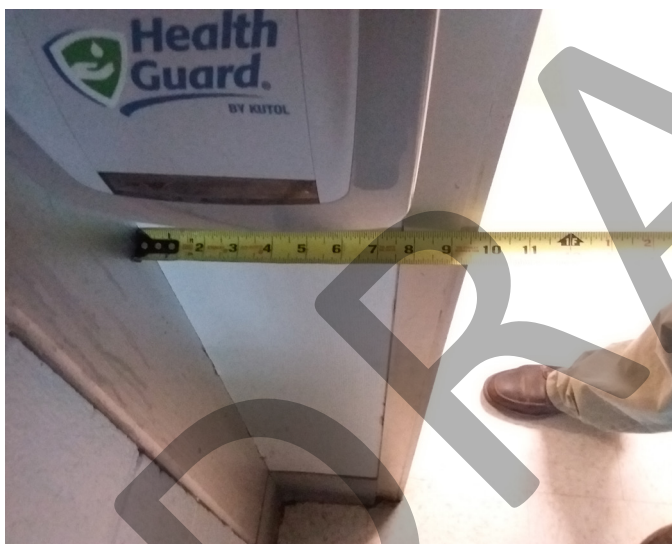
11. Location:

Minimum required clear width of 18" is not achieved on latch side of front approach pull door. Typical at many classrooms throughout the facility.

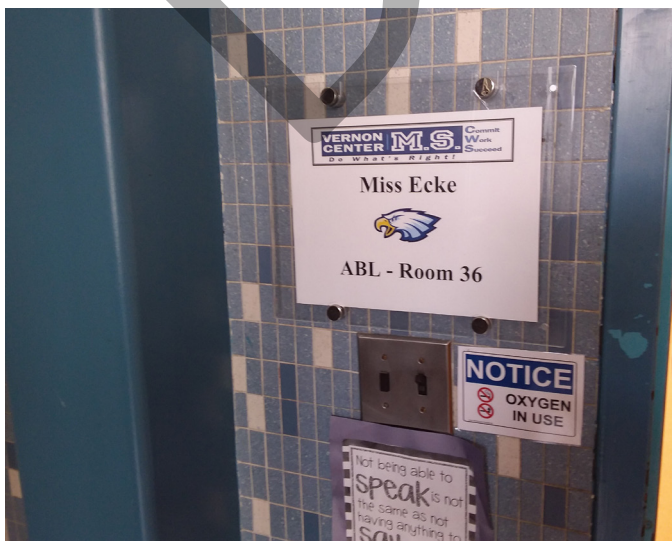
12. Location:

Signage does not meet accessibility requirements of having raised lettering and braille characters. Typical at most classrooms in newer addition wing.

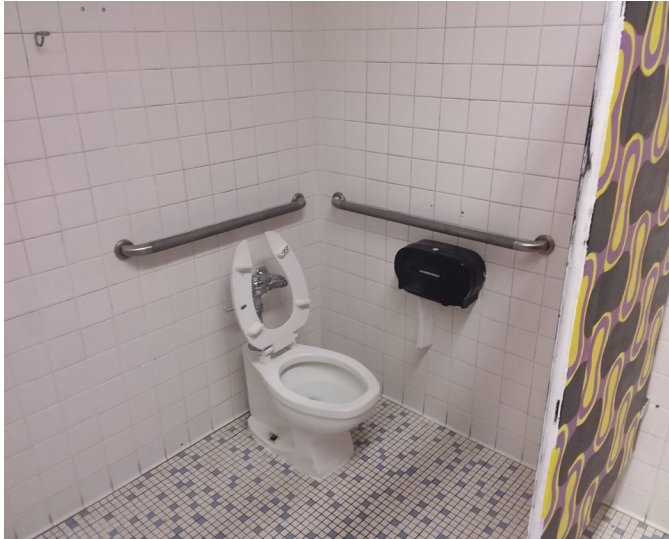
13. Location:

No vertical grab bar provided in accessible stall.

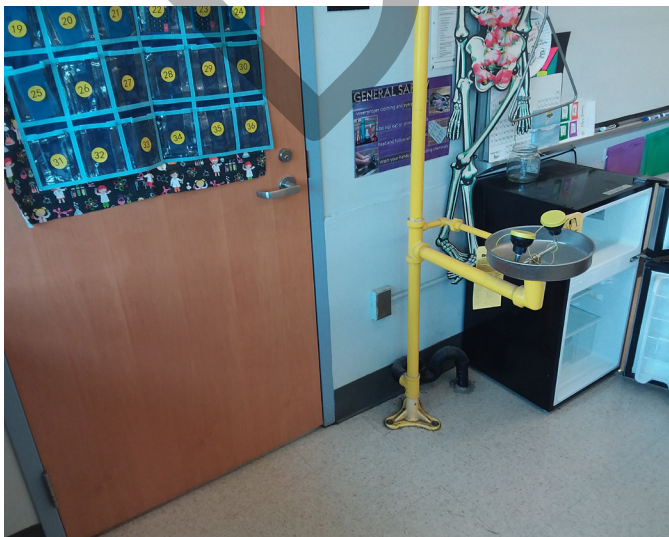
15. Location:

Classroom

Eyewash station impedes on the required 18" clear width on the latch side of a front approach pull door.

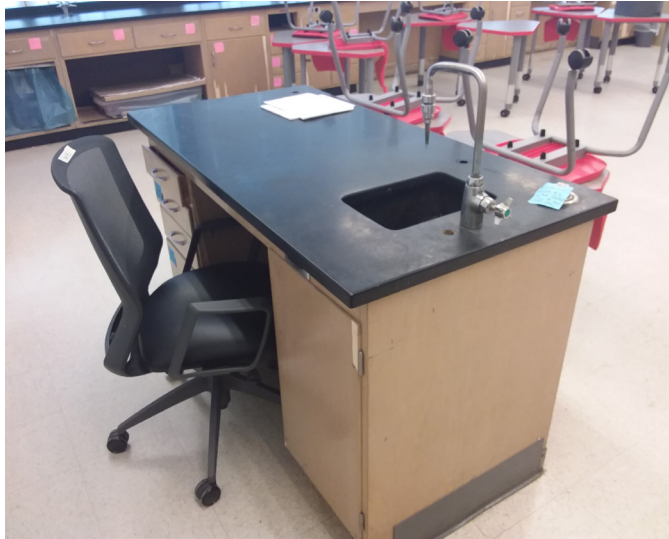
16. Location:

Science Classroom

This sink is the only available in this room. Does not meet accessibility requirements for counter height or pull under distance. Typical at science classrooms.

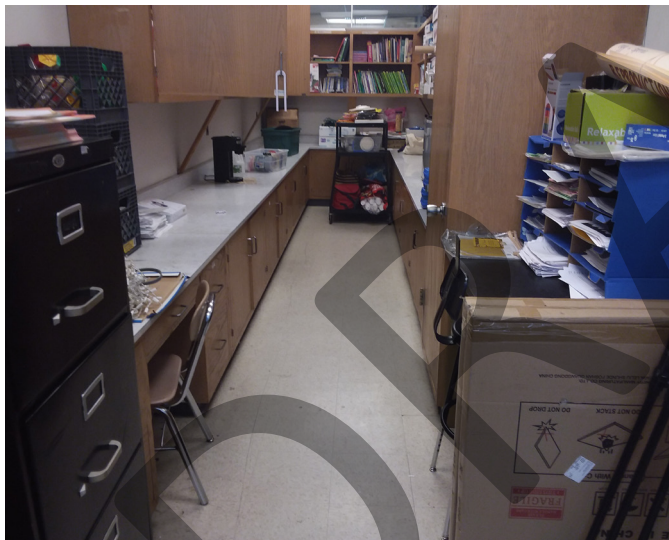
17. Location:

Science Classroom Storage

Storage room does not meet clear width requirement of 36", and a turning space is not provided.

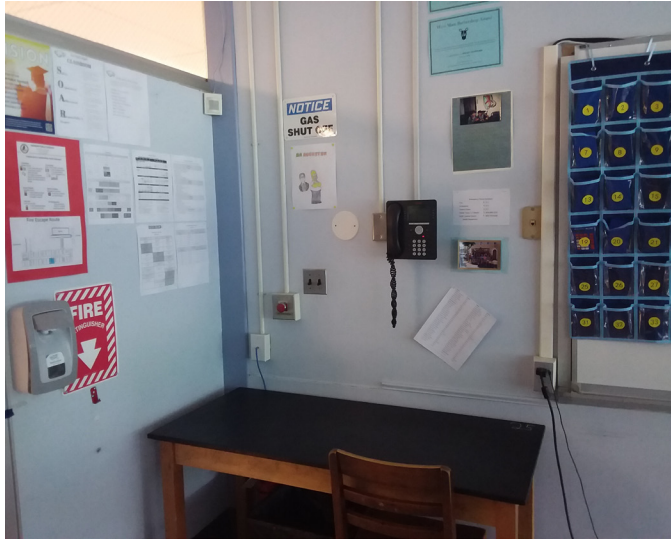
19. Location:

Science Classroom

Telephone is located above the maximum required height of 48".

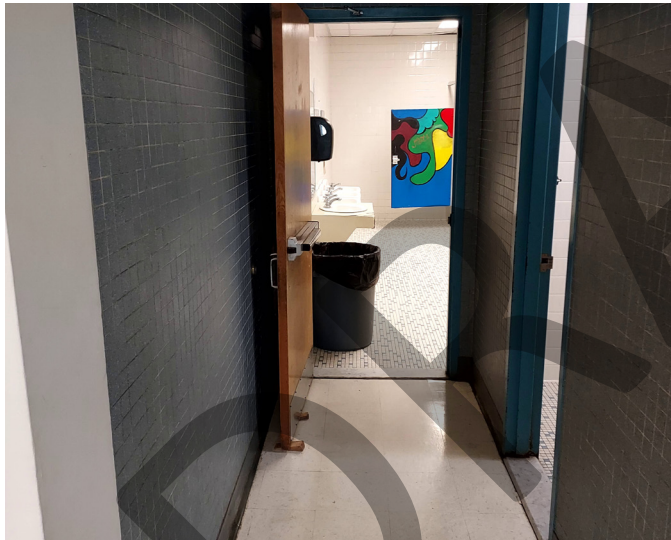
20. Location:

Boys Toilet Room

Does not meet required clear distance of 12" on latch side of door for a front approach pull door.

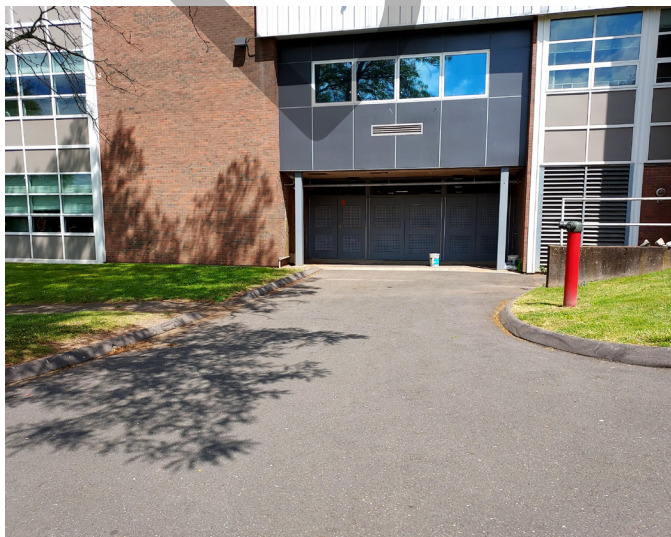
21. Location:

Site

Accessible route from gymnasium to field is not continuous. The accessible route from the gym to the fields involves an overly complex path.

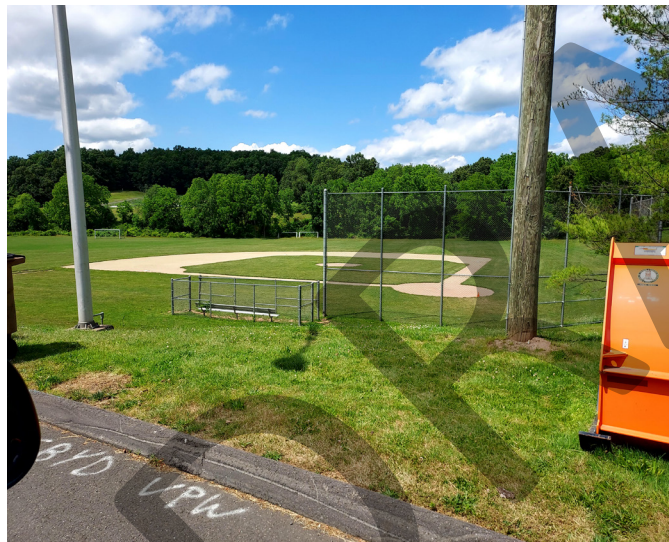
23. Location:

Athletic Fields - North of the Building

Accessible parking and an accessible route to the fields has not been provided.

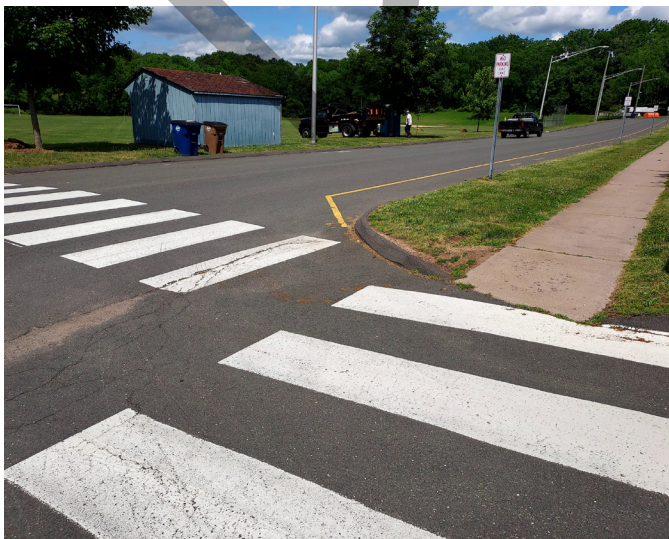
24. Location:

Northwest Corner of the Building

The curb ramp is not in compliance at the intersection, and tactile warning needs to be provided.

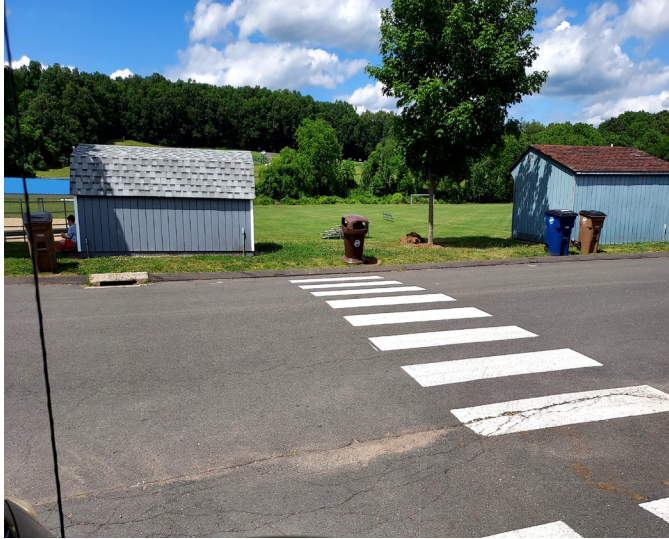
25. Location:

Northwest Corner of the Building

The crosswalk to the fields from the building is not connected to an accessible route.

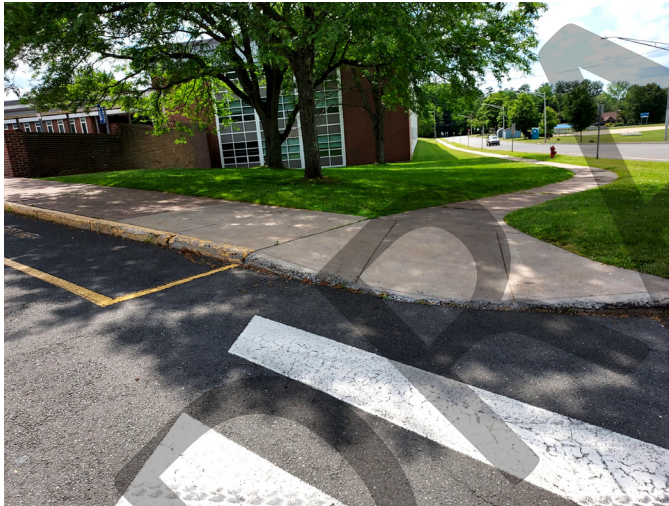
26. Location:

Northeast Corner of the Building

Tactile warning is not provided at the curb ramp.

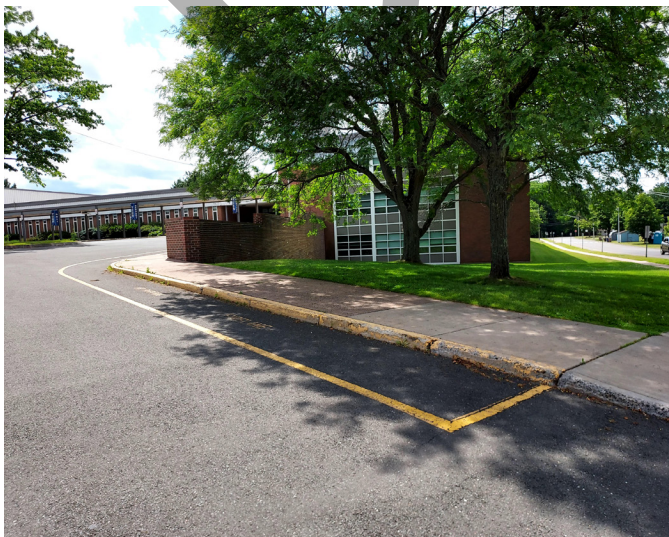
27. Location:

Northeast Corner of the Building

The sloped walkway from the entrance to the accessible route is greater than 1 in 20

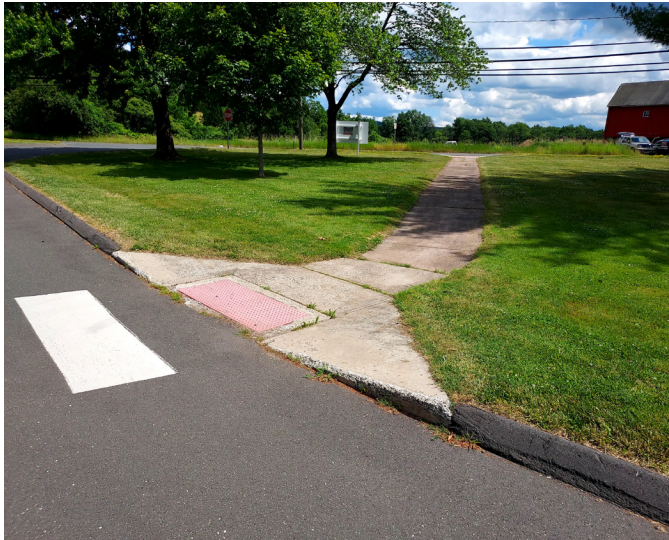
28. Location:

Access to the Public Way

Access is provided but the slope of the walkway exceeds 1 in 20.

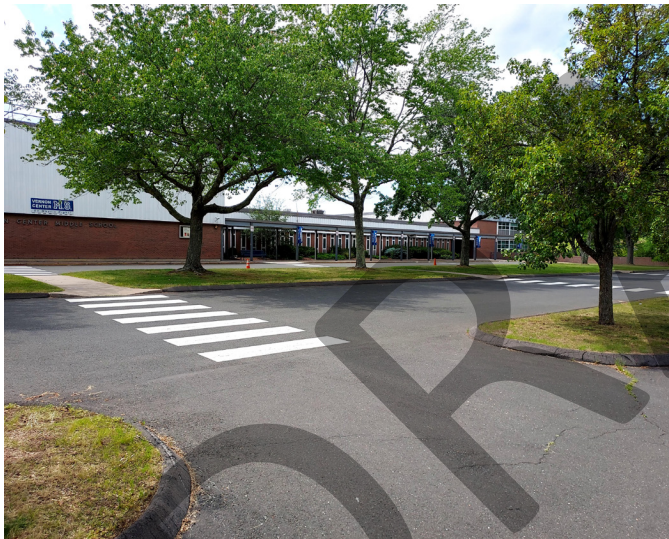
29. Location:

Access to Parking Area

The accessible crosswalk leads into vehicular traffic.

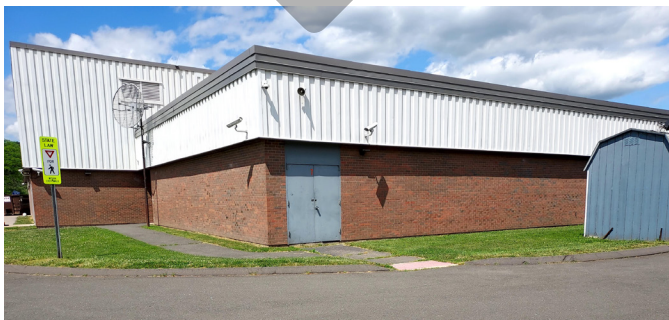
30. Location:

Southwest Corner of the Building

The double doors are not on grade and require a ramped exit / entrance

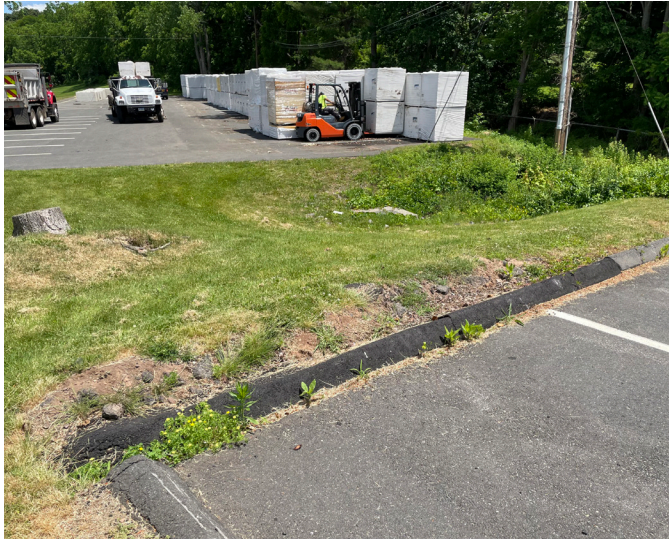
1. Location:

East Parking lot

Parking lot was used as a staging area for ongoing construction. Areas of vegetation overgrowth visible at curbs. Reseed grass in patchy areas throughout site.

- Repair damaged bituminous curbs in parking area
- Repair damaged concrete and bituminous walkways
- Provide signage at service areas
- Reseed grass in patchy areas

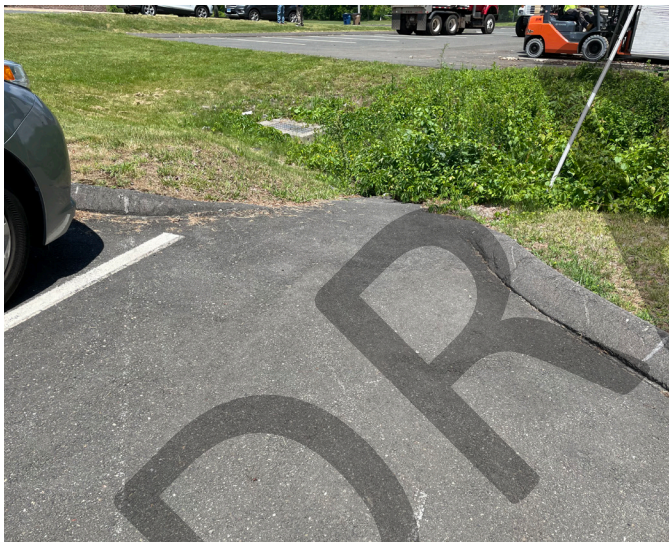
2. Location:

East Parking lot

Pavement sloped and no curbing for drainage

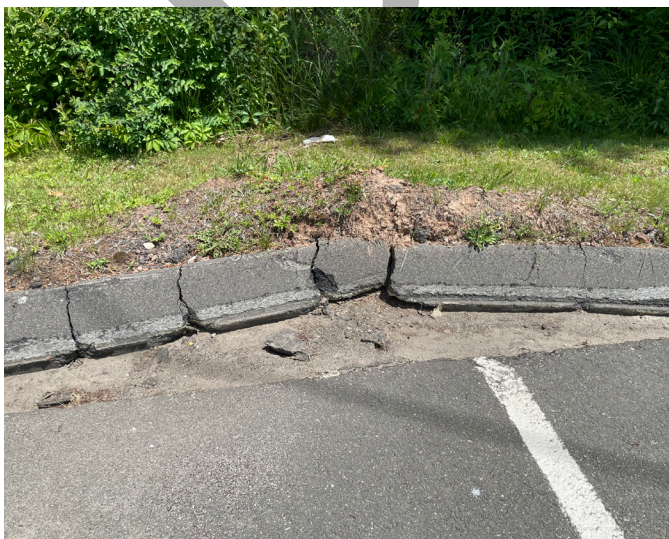
3. Location:

East Parking lot

Damaged bituminous curb.

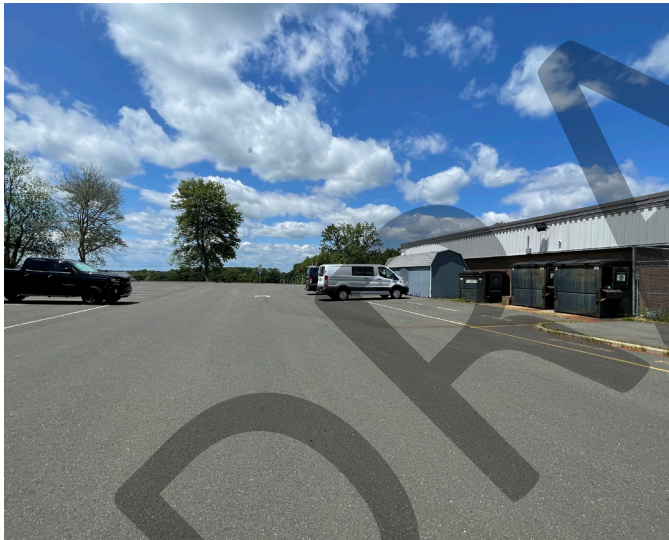
5. Location:

South Parking Lot

Service area to the right. Additional signage for loading and unloading would be beneficial.

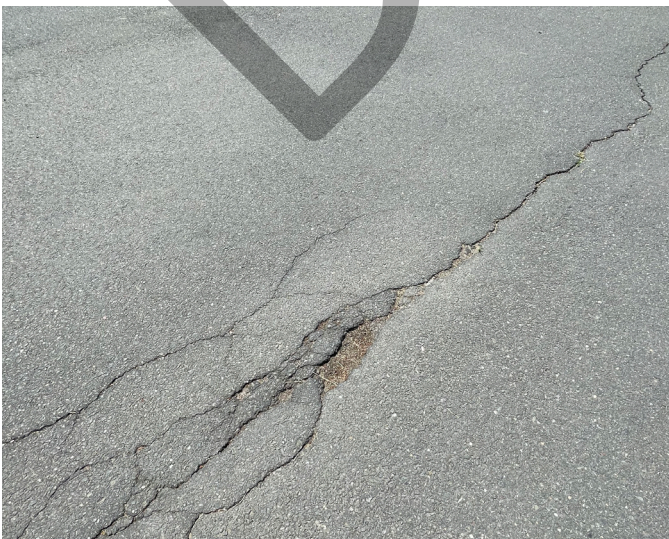
6. Location:

West Driveway

Crack in bituminous pavement

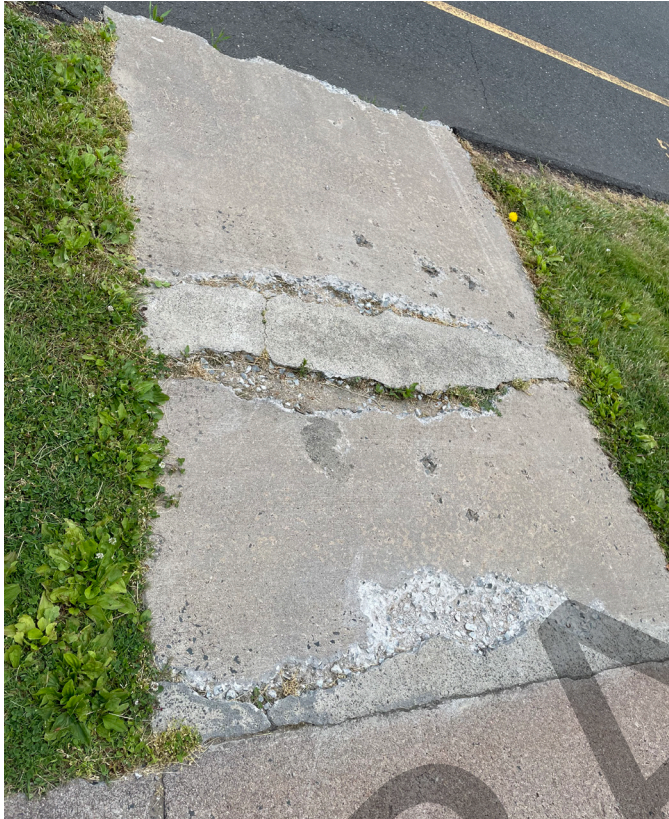
9. Location:

North Drive

Concrete walkway very cracked - needs to be replaced.

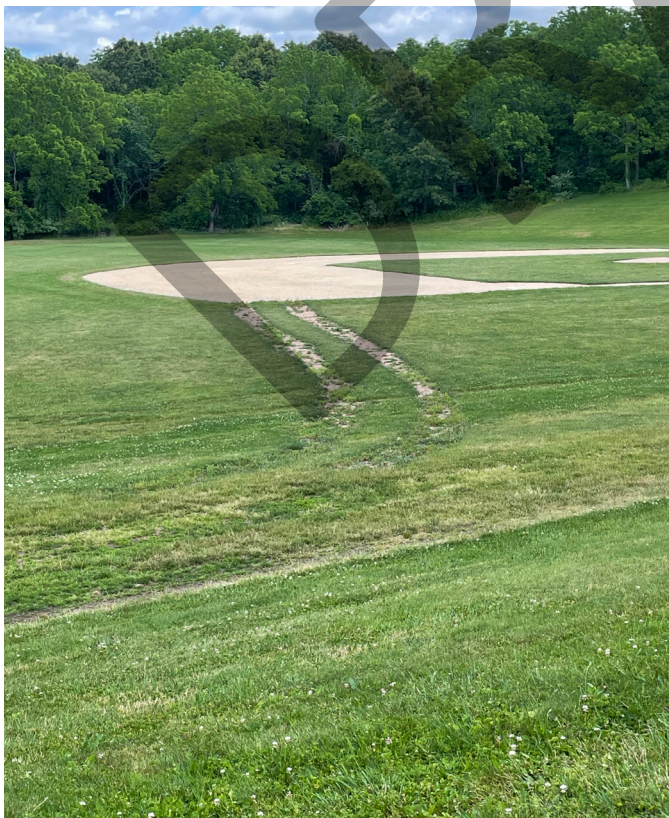
10. Location:

North Play Fields

Tire tracks leading to baseball field

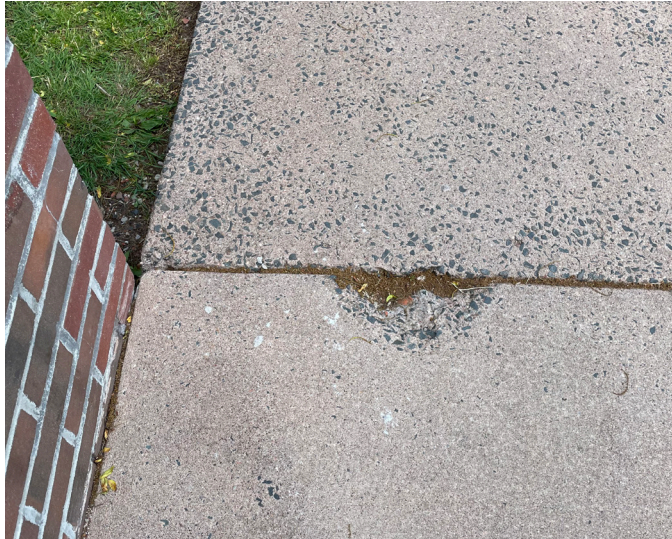
11. Location:

East Walkway Adjacent to Retaining Wall

Missing concrete in walkway

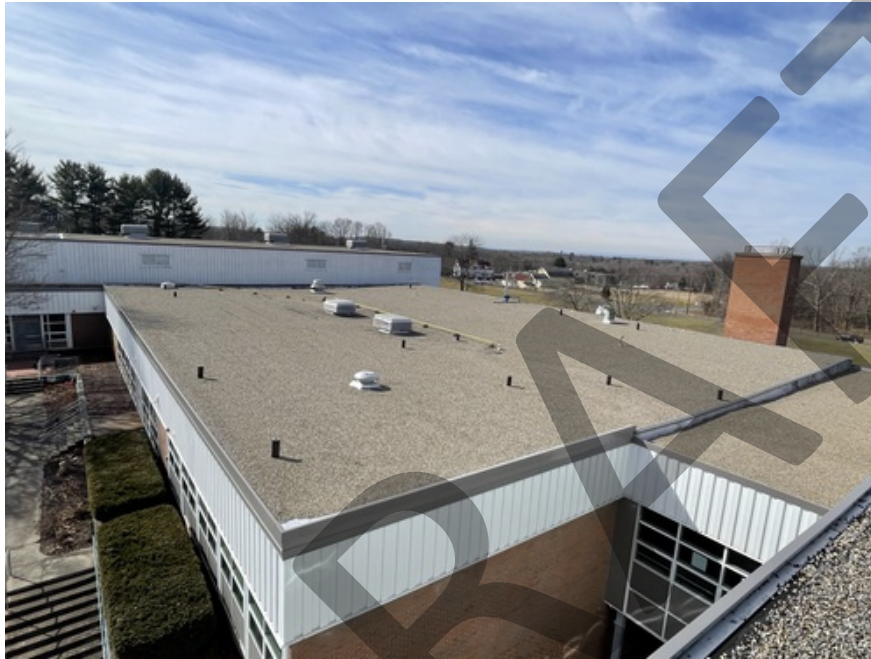
Photo 1

**Overview of the west
facing mid section**

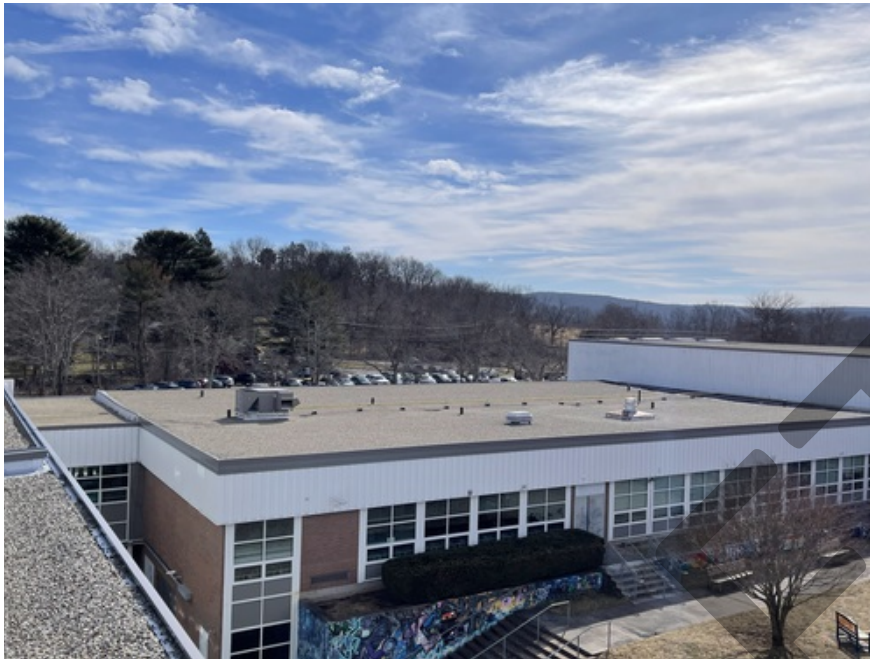
Photo 2

**Overview of the east facing
mid section**

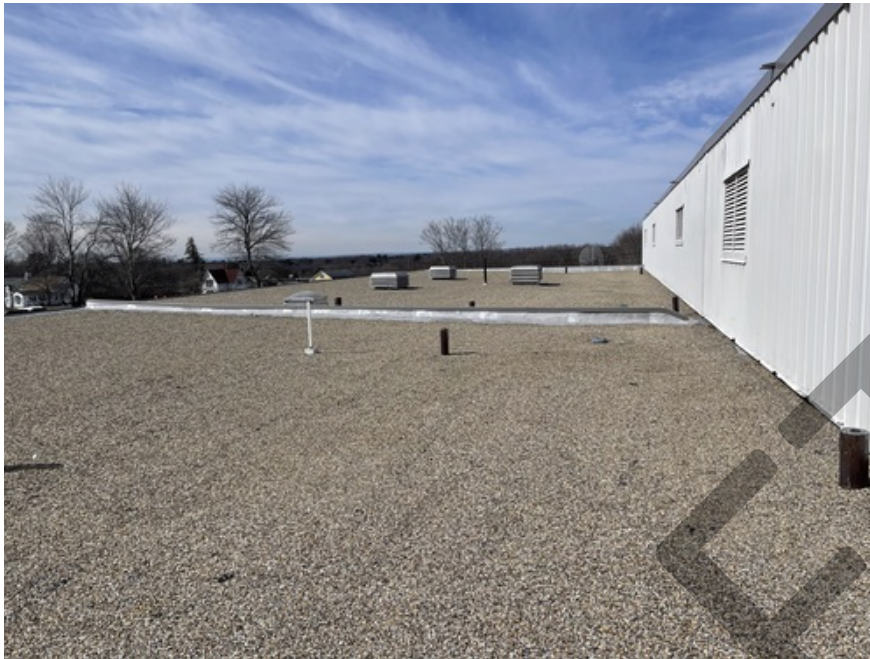
Photo 6

**Overview of the southern
low slope above kitchen-
New pitch boxes added for
cold storage**

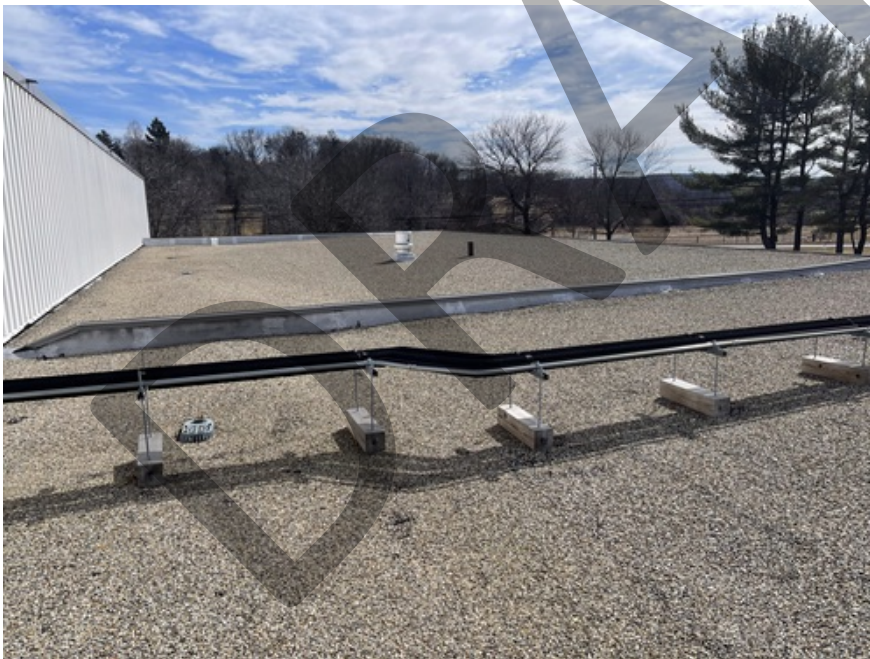
Photo 7

**Overview of the south
facing section**
