Facility Study and Master Plan

Skinner Road School

90 Skinner Rd, Vernon, CT 06066

SUMMER 2023

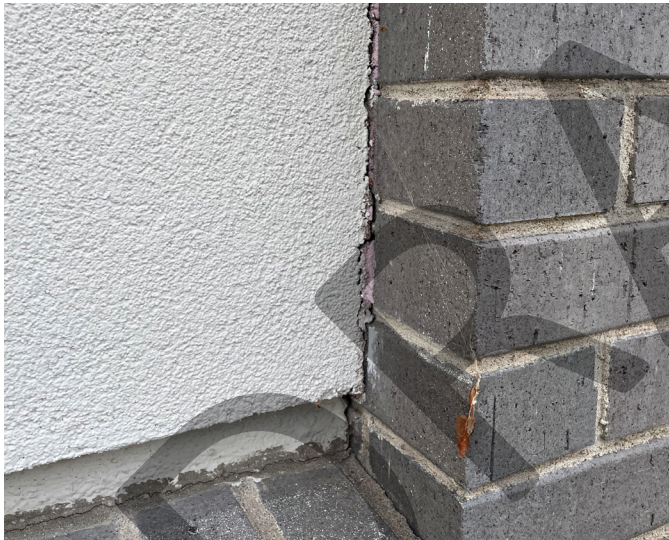
11. Location:

Sealant between cementitious facade and brick facade is almost completely gone.

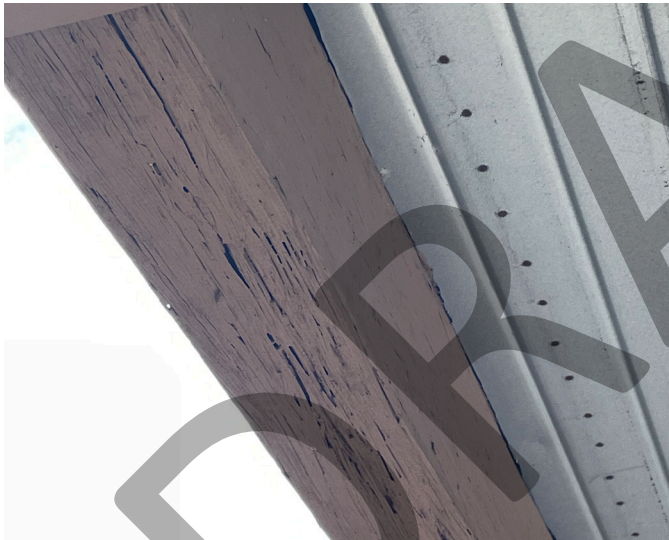
20. Location:

Canopy over entrance is composed of wood. The finish needs to be scraped and repainted.

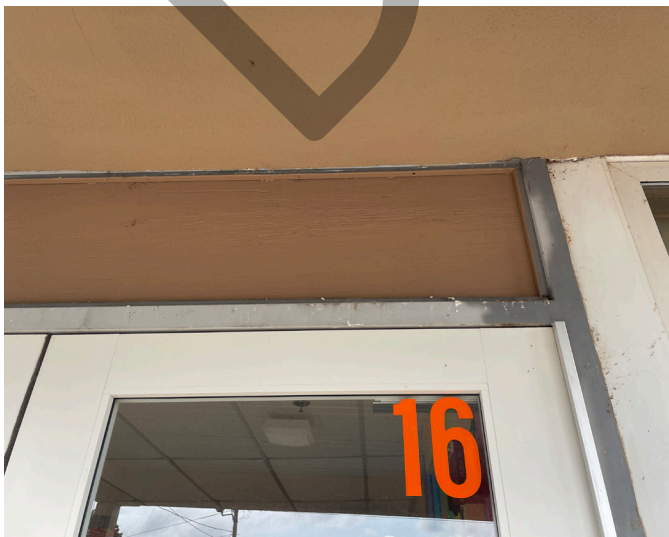
21. Location:

The door frame needs to be refinished. The joint between the frame and soffit needs sealant.

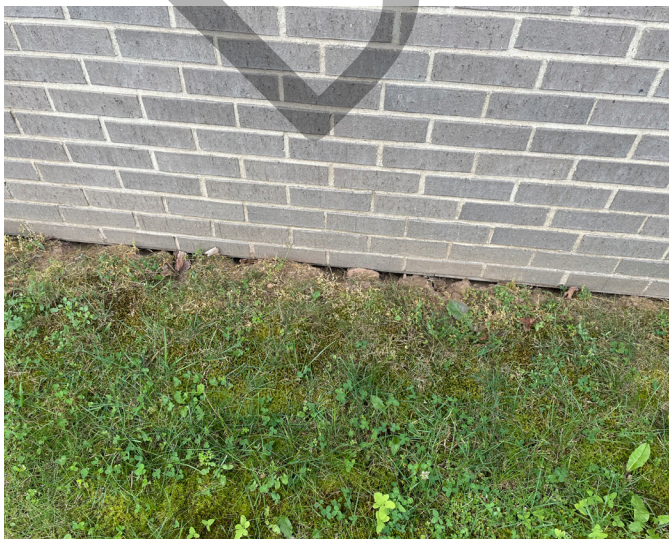
24. Location:

Brick goes almost completely to grade.

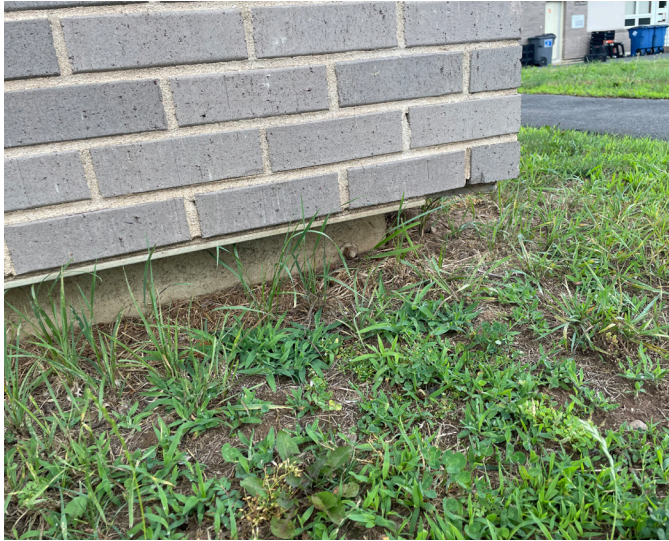
25. Location:

Damage to the edge of concrete foundation and brick.

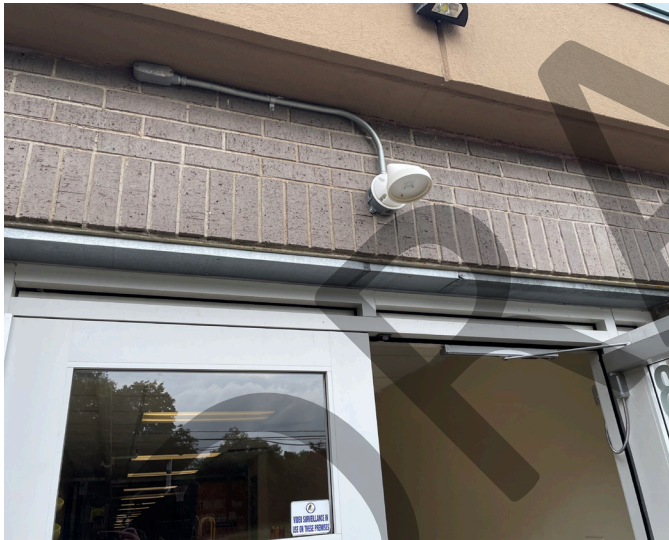
26. Location:

Steel lintel visible with steel covering, possibly wood, below.

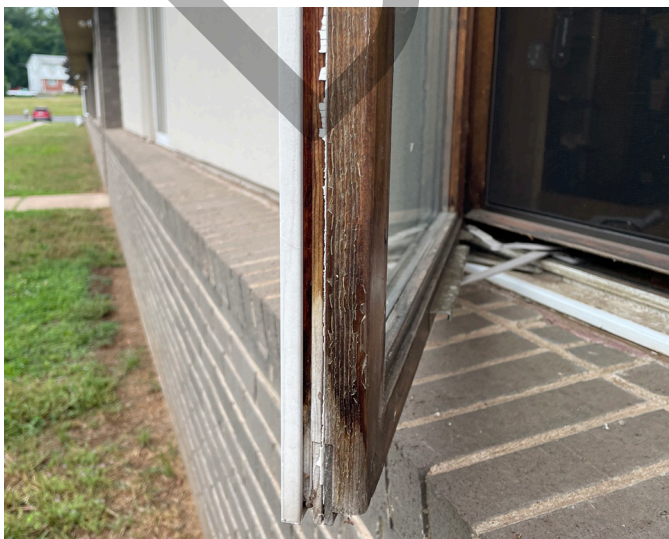
27. Location:

Exterior of window frames are vinyl while interior are wood. This window shows water damage at the edge.

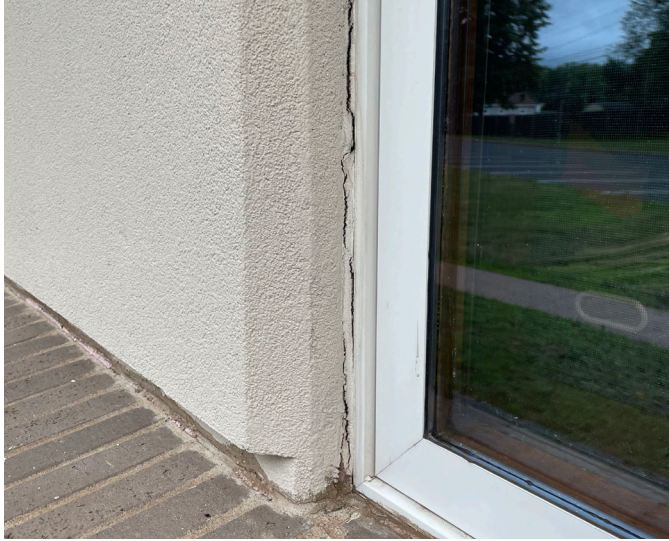
28. Location:

Another example where sealant is needed between the cementitious facade and window frame.

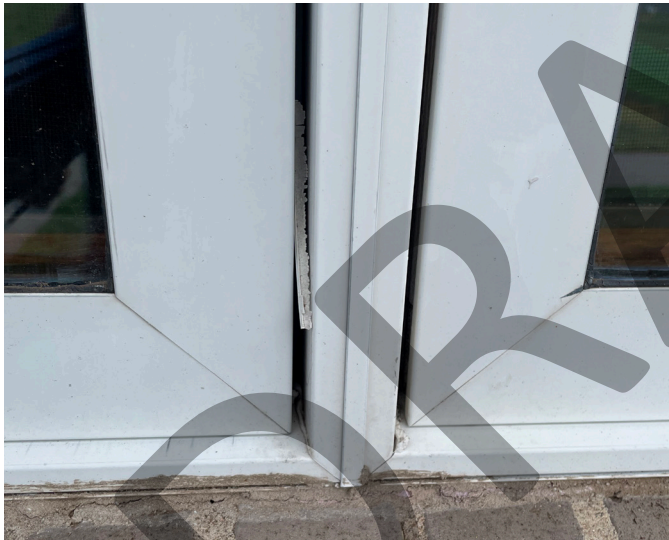
29. Location:

Another example of gasketing broken at window seal

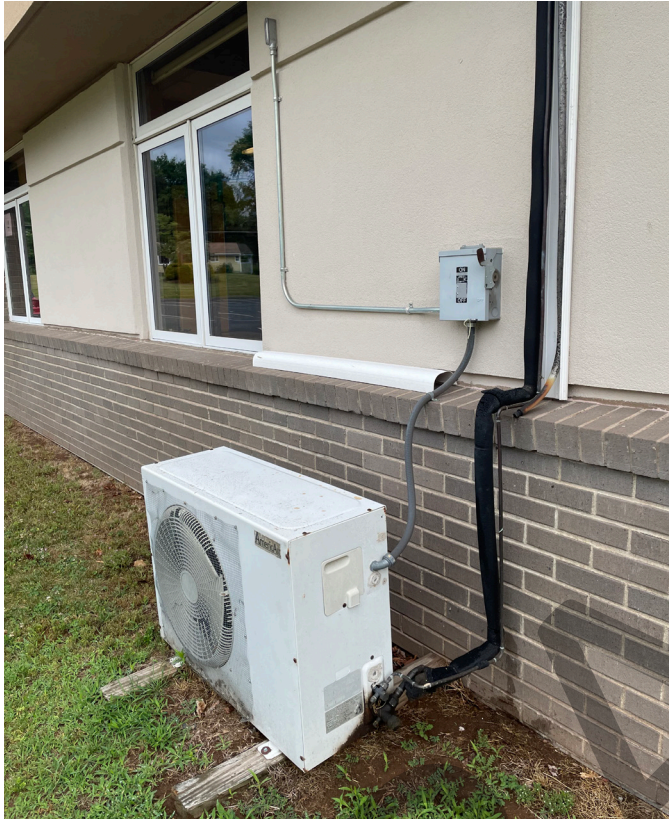
31. Location:

Unit easily accessible by students. Water dripping from pipe onto brick facade

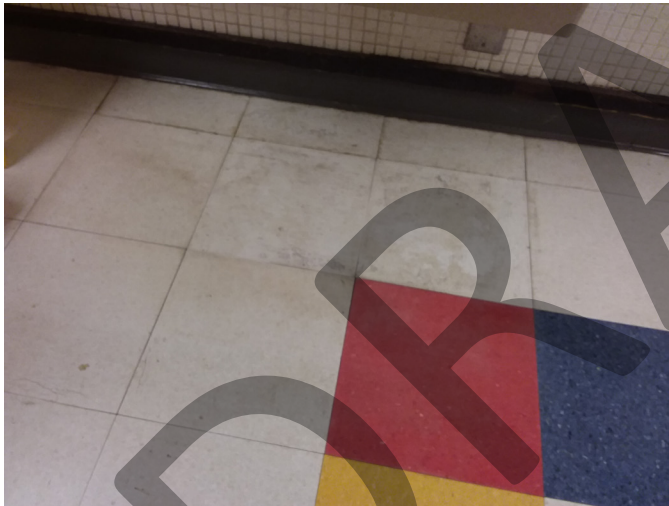
34. Location:

VCT is stained and finish is worn away.
Tile should be replaced.

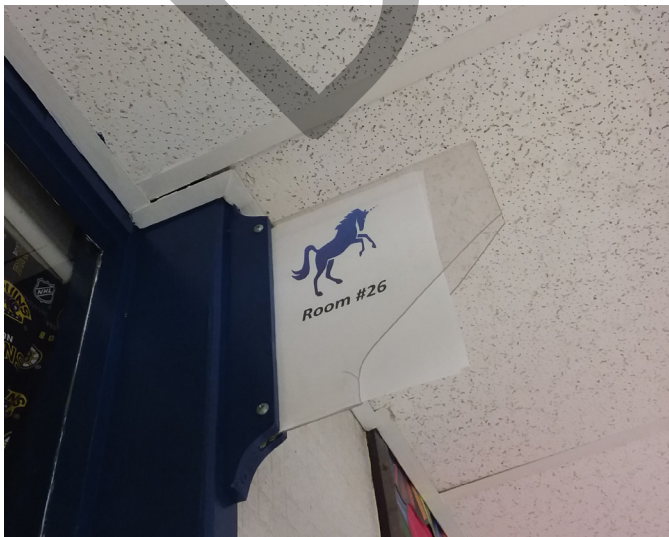
35. Location:

Broken acrylic sign holder. Needs to be replaced.

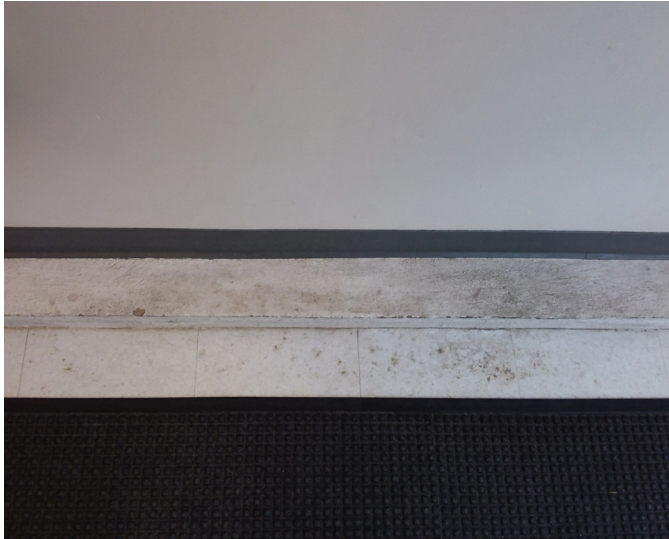
36. Location:

Wood sill/trim needs to be touched up with paint and cleaned.

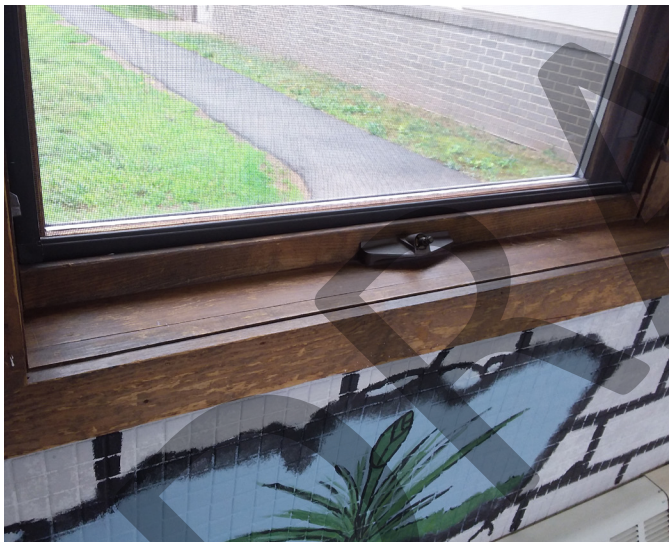
37. Location:

Wood window frames are faded and gouged in areas. They could be refinished.

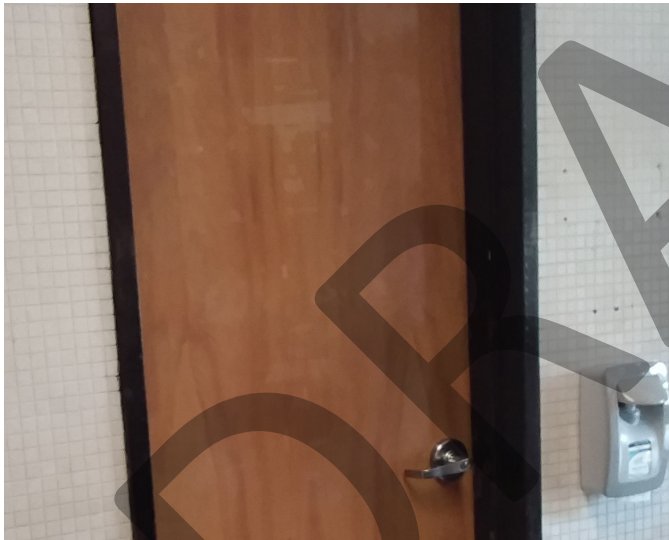
40. Location:

Finish on door is fading

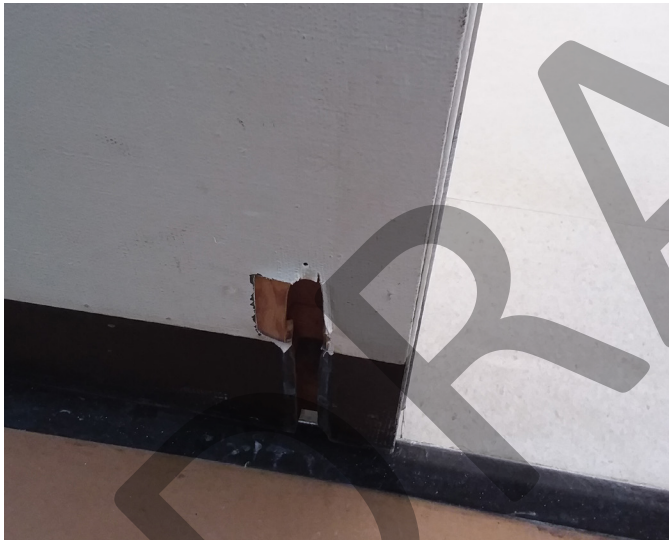
43. Location:

Hole in folding partition needs repair.

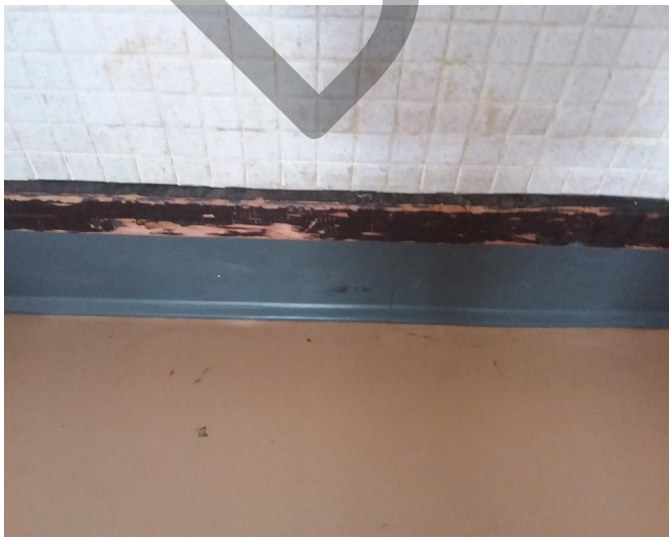
44. Location:

Wood trim is chipped and needs to be repainted/refinished.

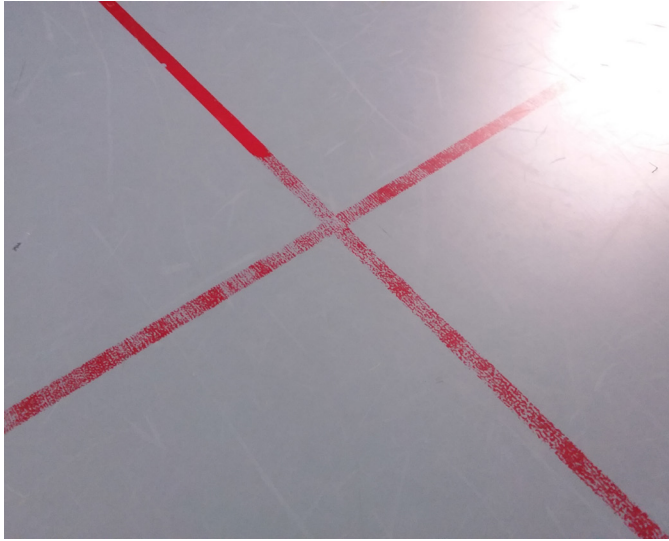
45. Location:

Stripping is fading and needs to be touched up.

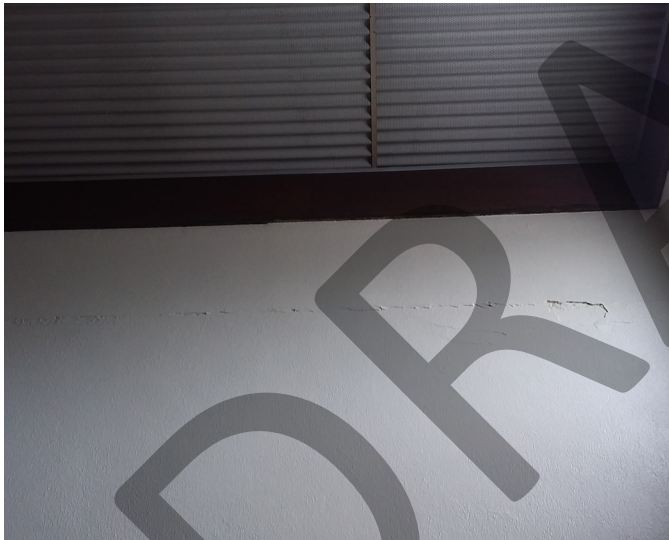
46. Location:

CMU cracking and needs repair.

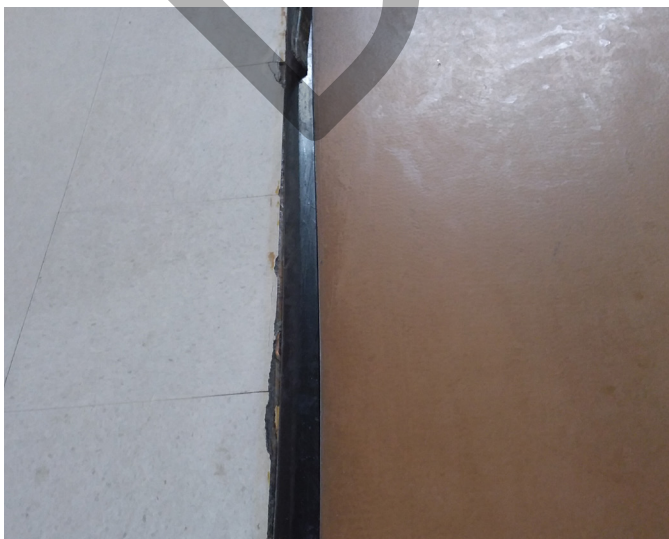
47. Location:

Transition is ripped up and VCT is crumbling.

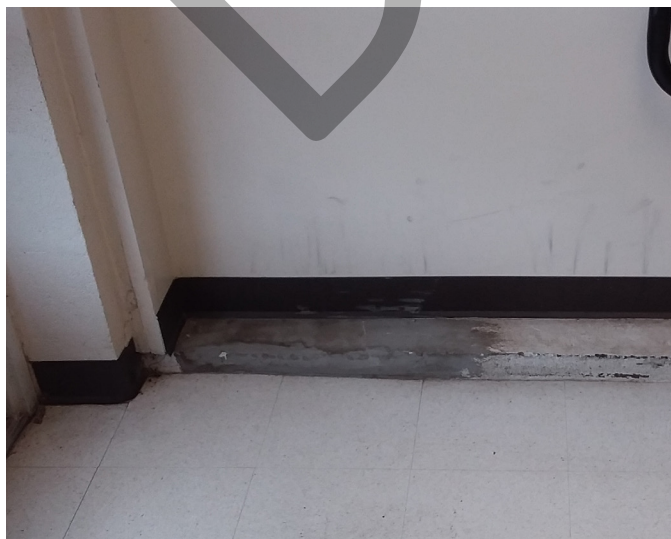
Description:

Missing wall base and base of gypsum wall damaged.

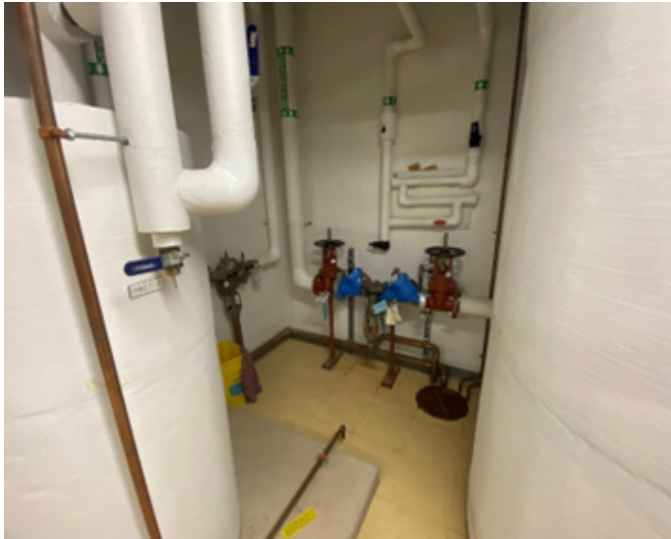
1. Location:

Mechanical Room

Domestic Water Service

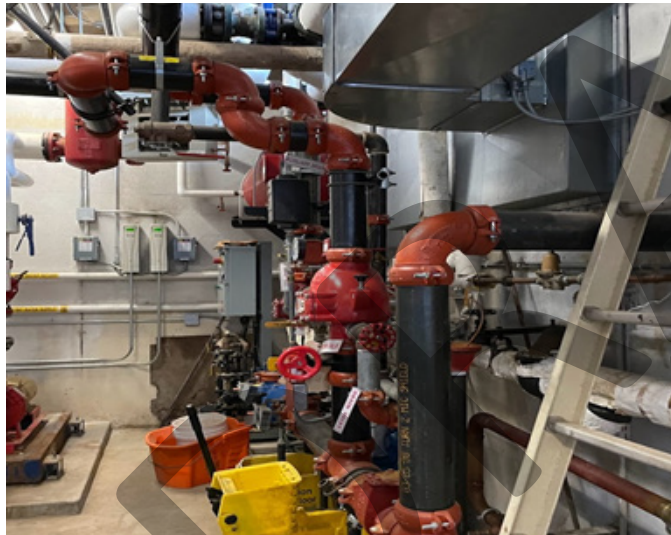
2. Location:

Mechanical Room

Fire Service and Riser

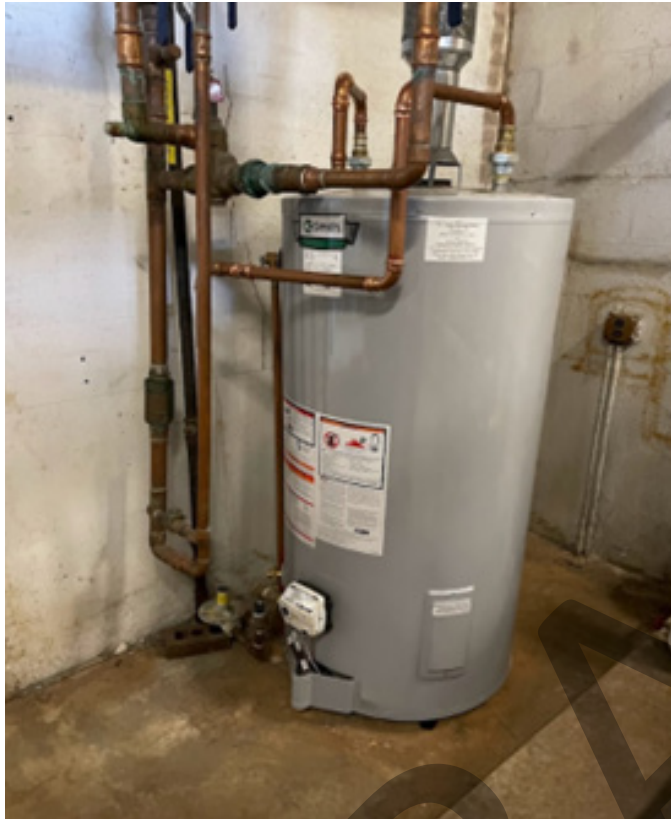
4. Location:

Mechanical Room

Water Heater

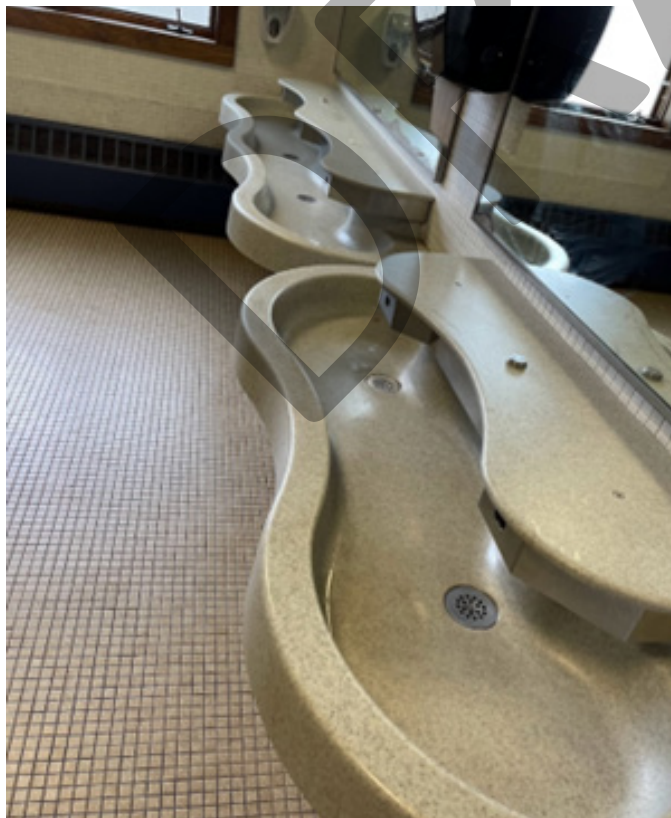
5. Location:

Group Toilet Room

Toilet Room Fixtures

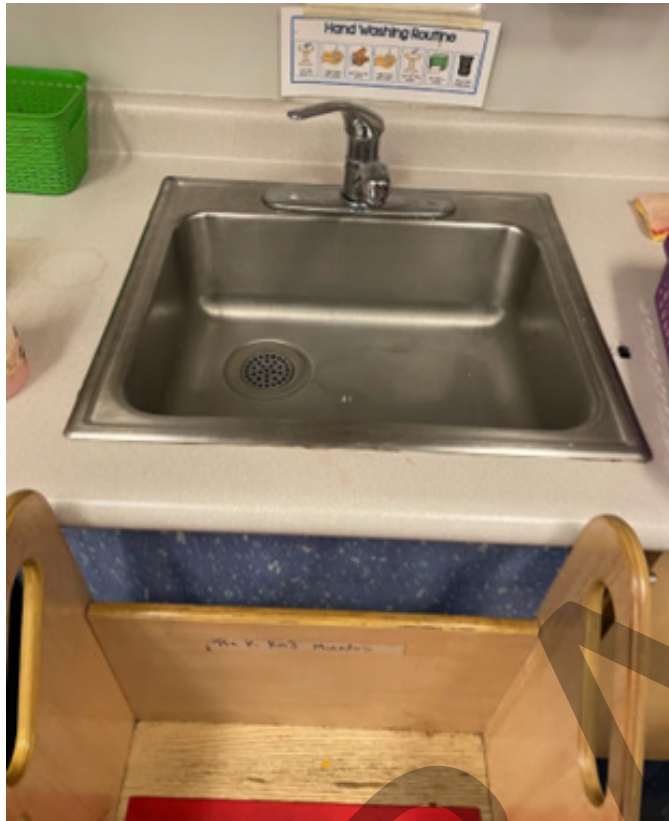
6. Location:

Classroom

Classroom Sink

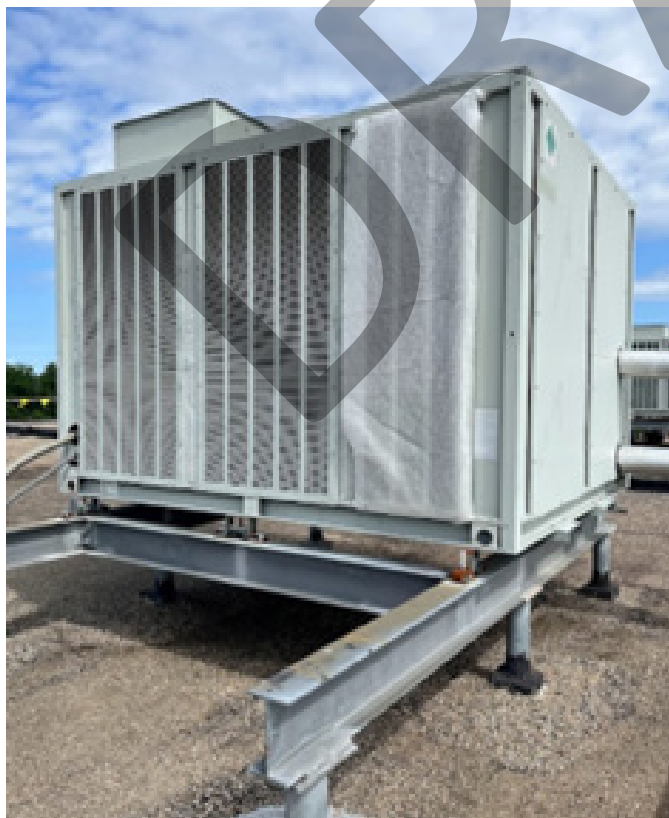
8. Location:

Roof

Roof Top Unit

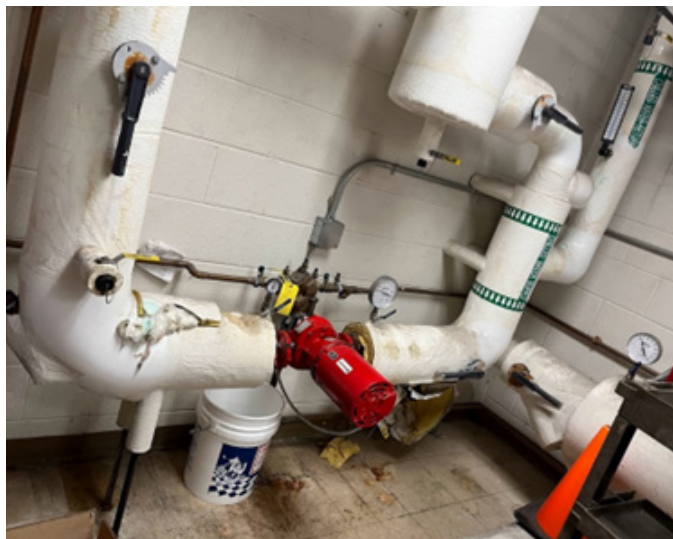
9. Location:

Storage Room

Leaking Chilled Water Pump

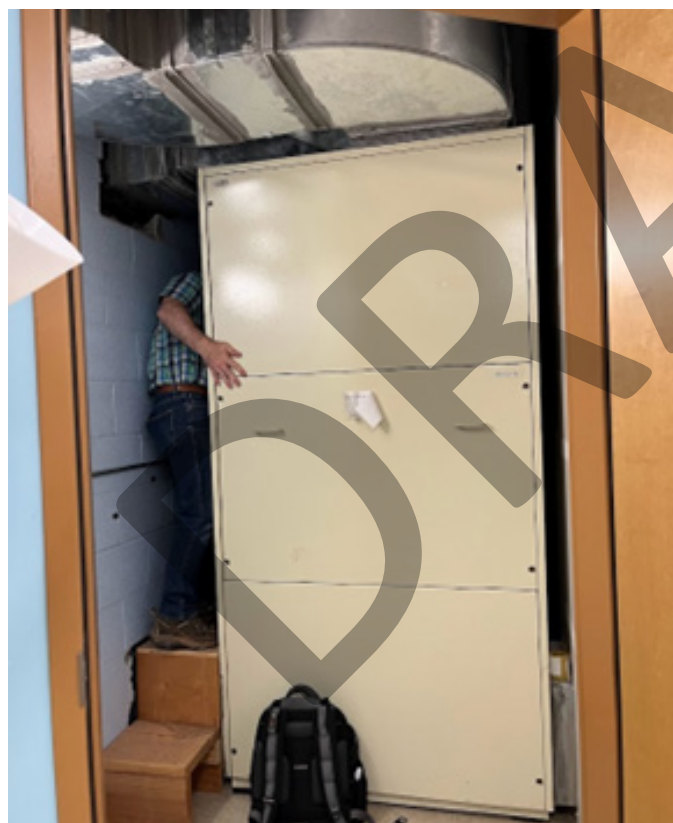
10. Location:

Classroom Closet

Classroom Air Handling Unit Providing Heating, Cooling, and Ventilation

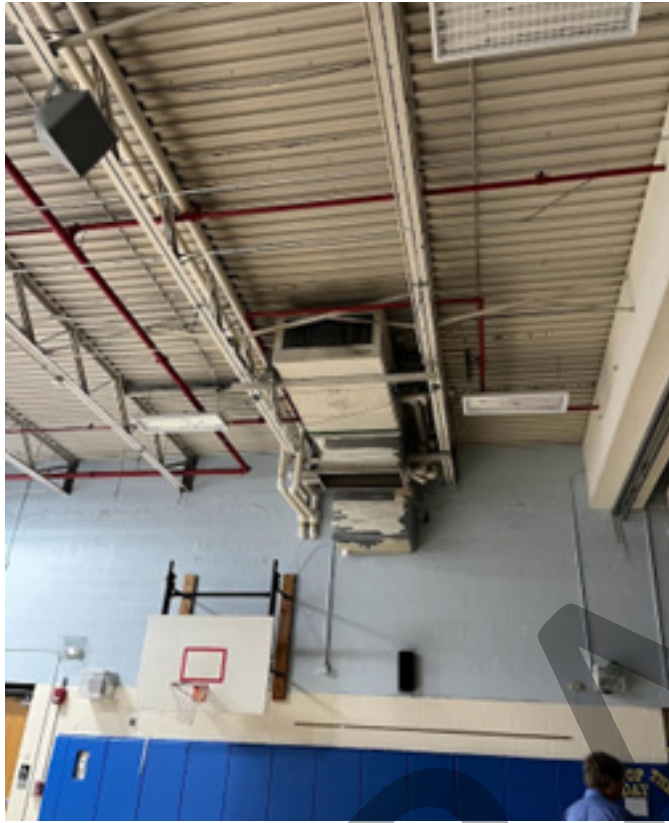
11. Location:

Gymnasium

Ceiling Hung Heating and Ventilation Units

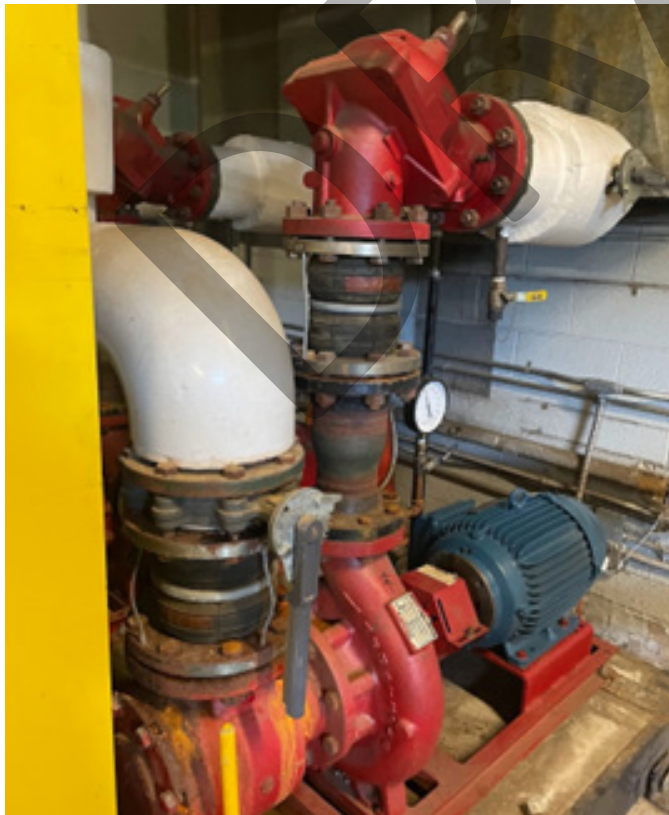
12. Location:

Mechanical Room

Hydronic Pumps

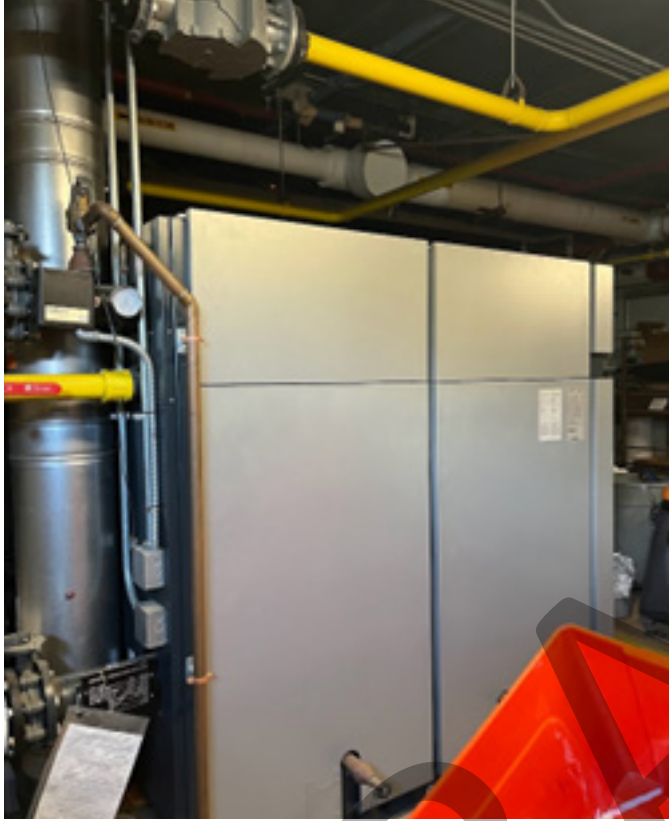
13. Location:

Heating system is served by cast iron mid-efficiency hot water boilers. The system is in fair condition and appears to be from 2009 (14 years old). Cast iron boiler system have an approximately 25 year life expectancy and while not near end of life we would recommend replacing with high efficiency condensing boilers for increased energy savings.

Mechanical Room

Gas Fired Boilers

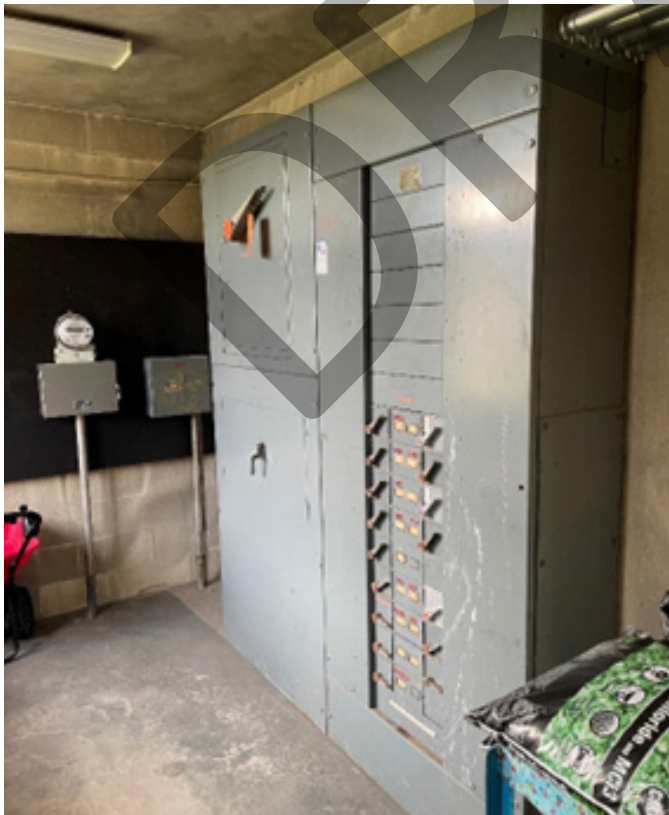
14. Location:

Main Electrical Room

Main Switch, CT and Distribution Section

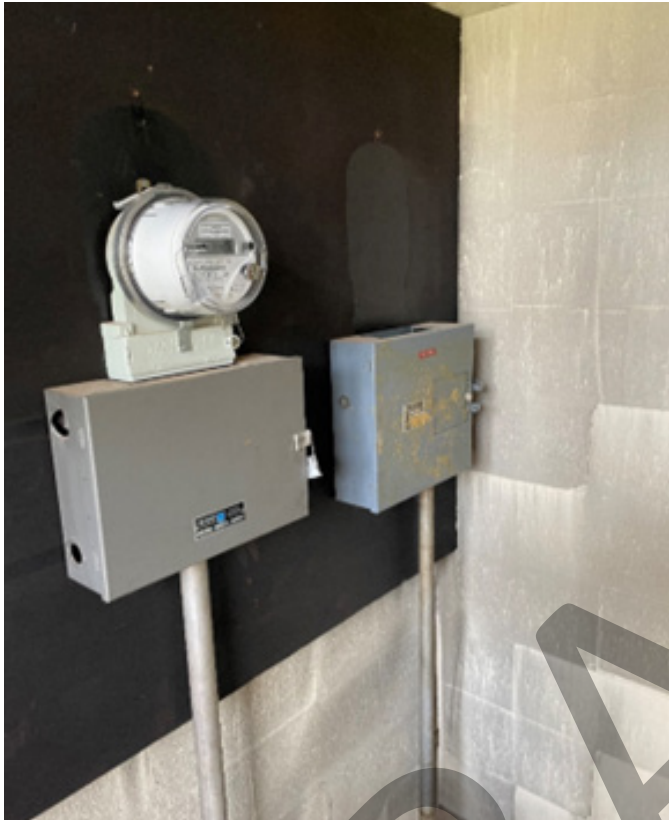
15. Location:

Main Electrical Room

Utility Meter Socket

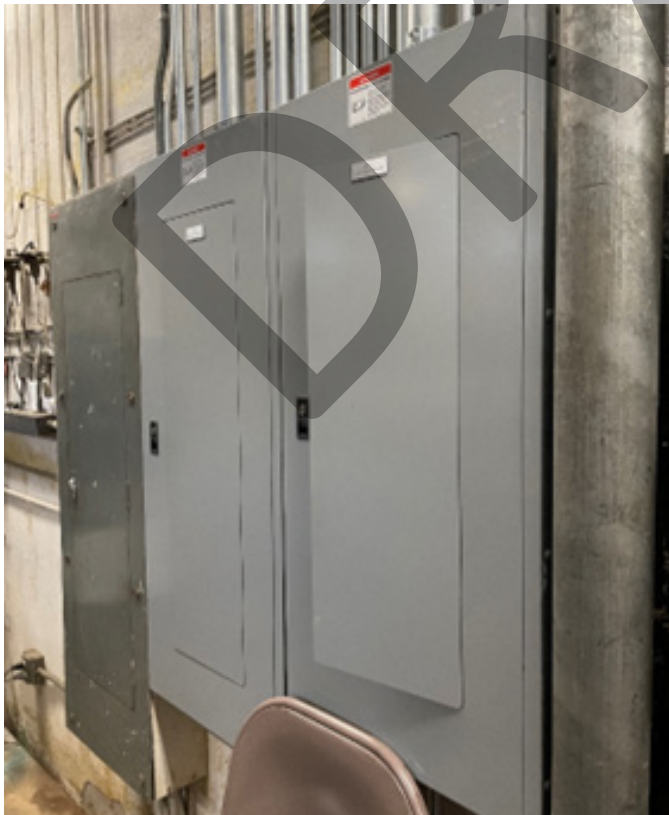
16. Location:

Branch circuit panelboards vary in age between those original to the building, which date from the late 1960's, to those installed as part of later renovations. Branch circuit wiring is in EMT/armored cable, where observed.

Main Level

Typical Branch Panelboards

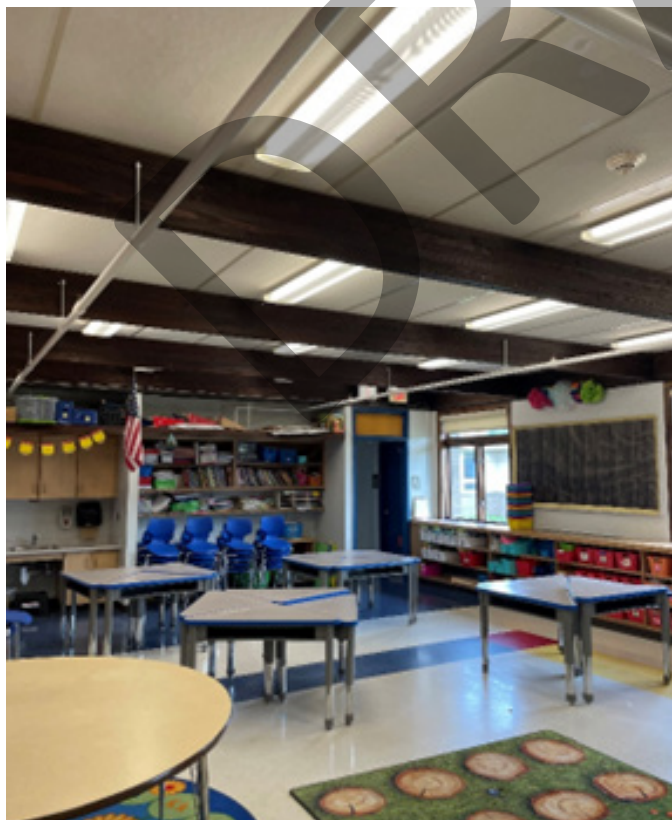
18. Location:

Main Level

Typical Classroom Lighting

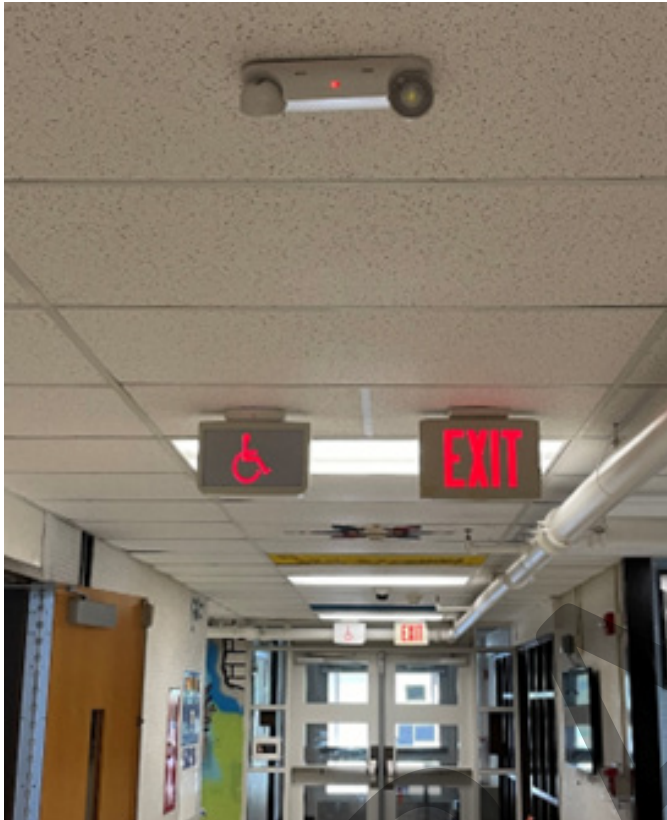
19. Location:

Main Level

Exit Signage and Emergency Fixture

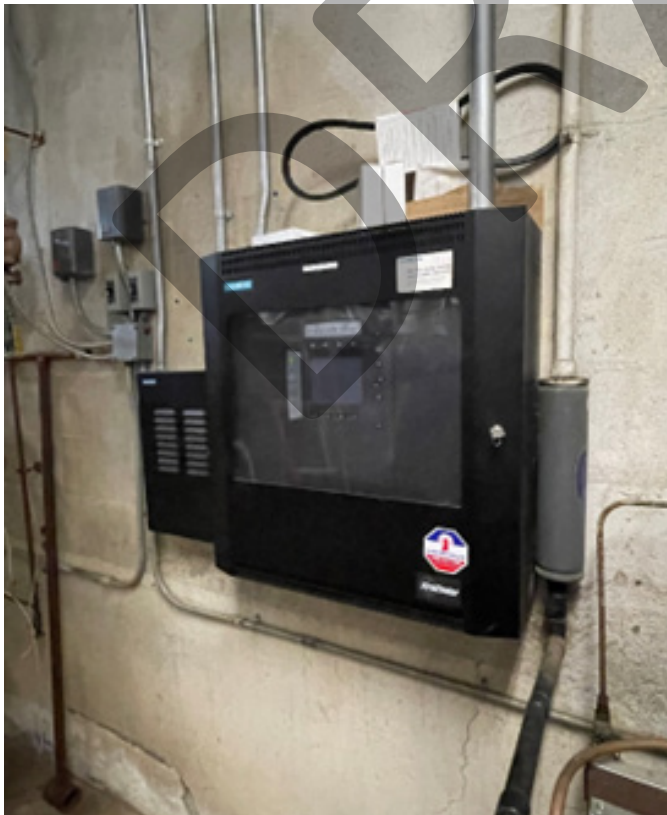
20. Location:

Boiler Room

Fire Alarm Control Panel

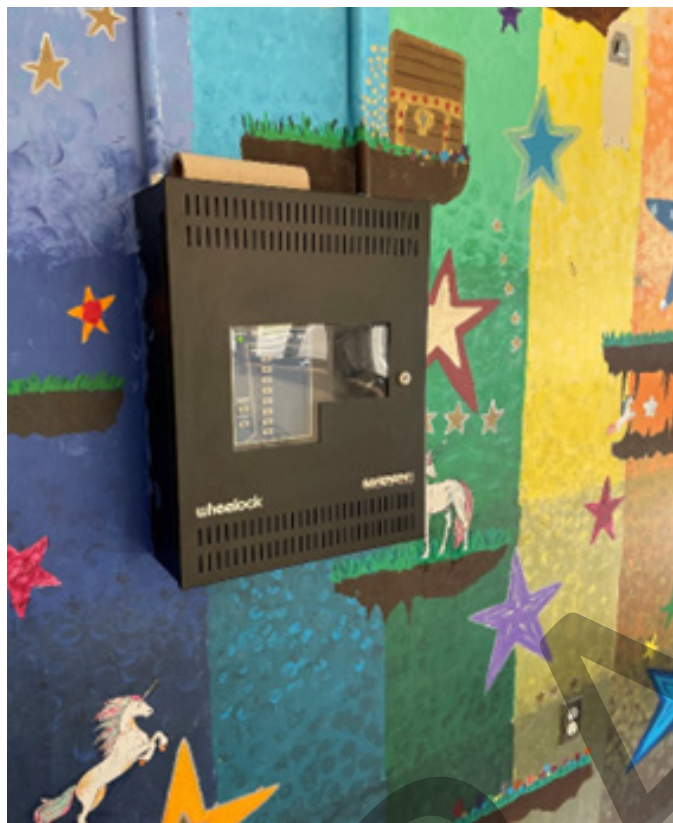
21. Location:

Main Level

Fire Alarm Voice Control Panel

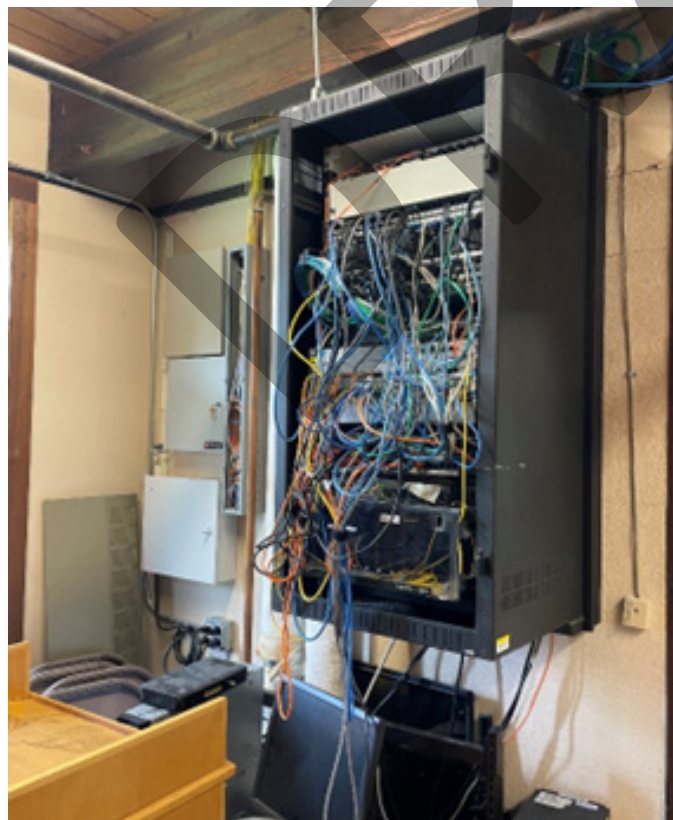
22. Location:

Main Level

Data Systems Rack

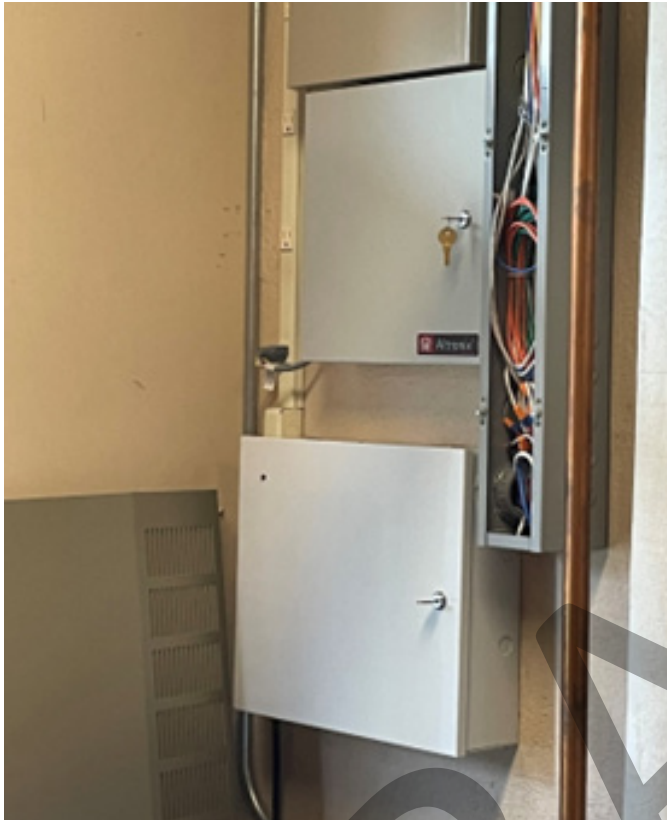
23. Location:

Main Level

Access Control Equipment

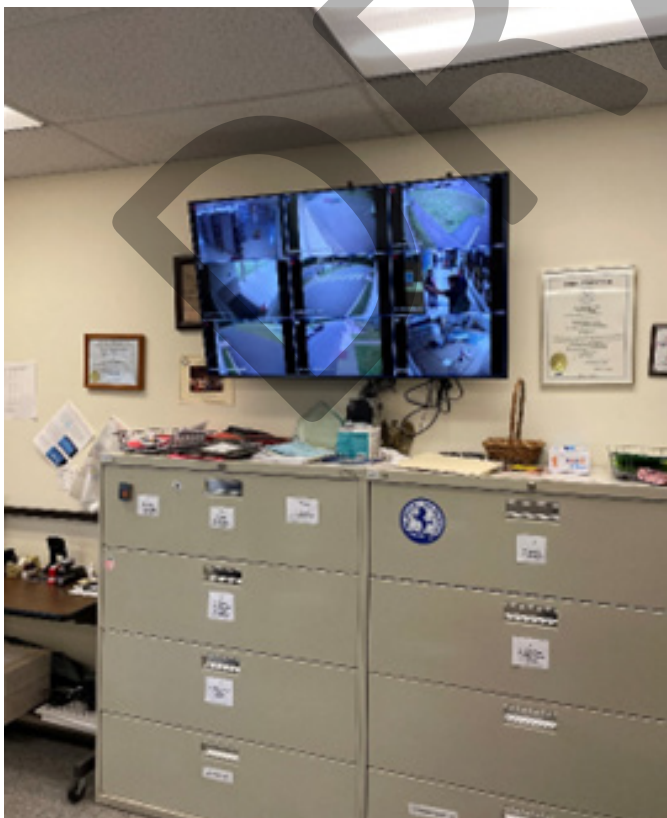
24. Location:

Administration

Networked HD Displays

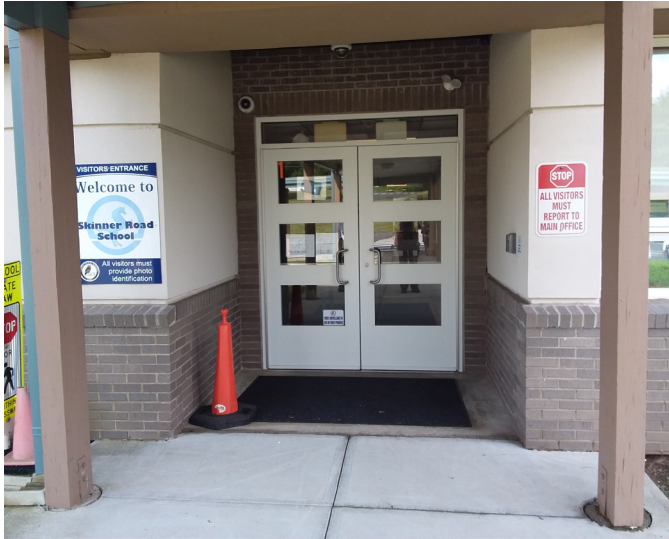
1. Location:

Main Entrance

Main entrance should have signage indicating that entrance is accessible. Signage exists within the vestibule.

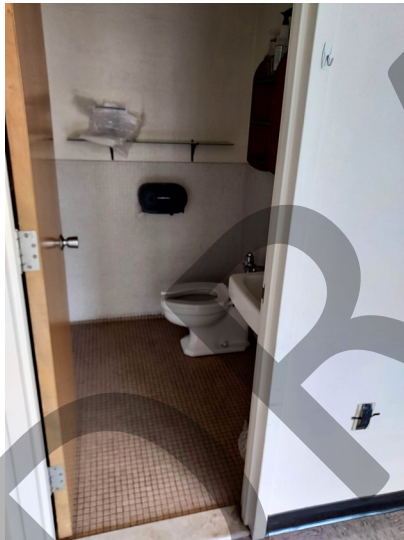
2. Location:

Nurse's Office Restroom

Marked accessible restroom does not satisfy clear width requirement of 32" when fully opened.

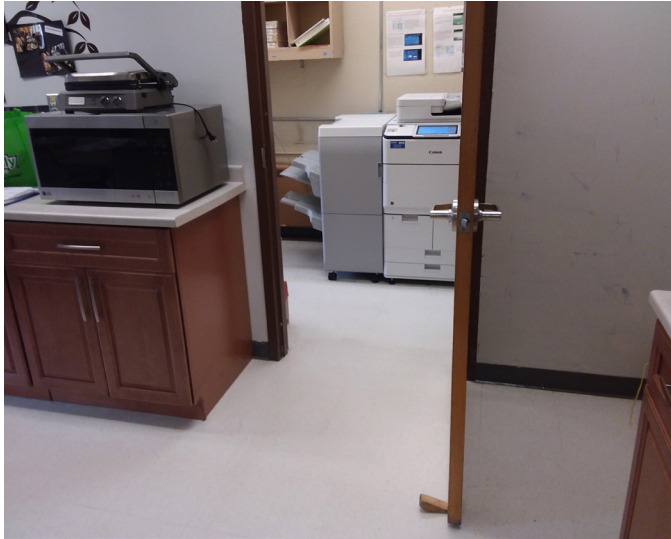
4. Location:

Teachers Lounge

Does not meet requirements for 18" of clearance on pull side of door with automatic closer.

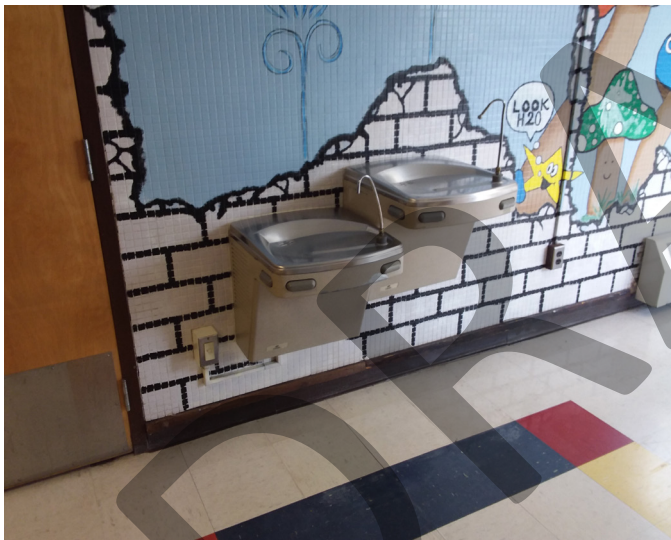
5. Location:

Corridor

Water fountains have leading edge that is greater than 27" off the floor and protrudes greater than 4".

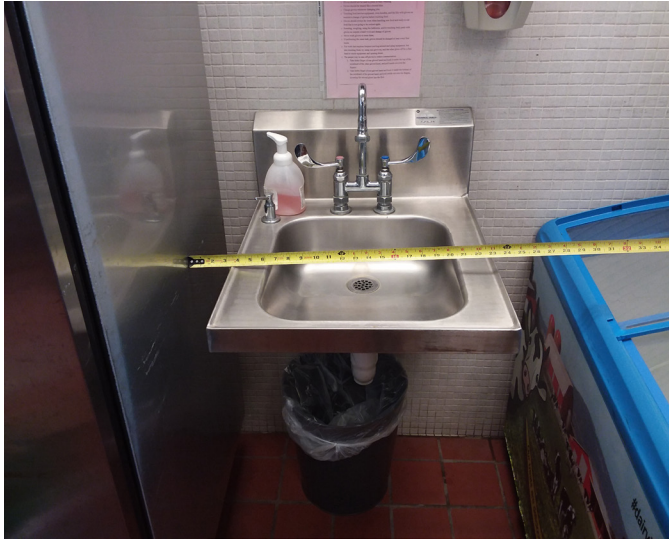
7. Location:

Kitchen

Sink designed to be accessible option within kitchen does not meet required clear width to access.

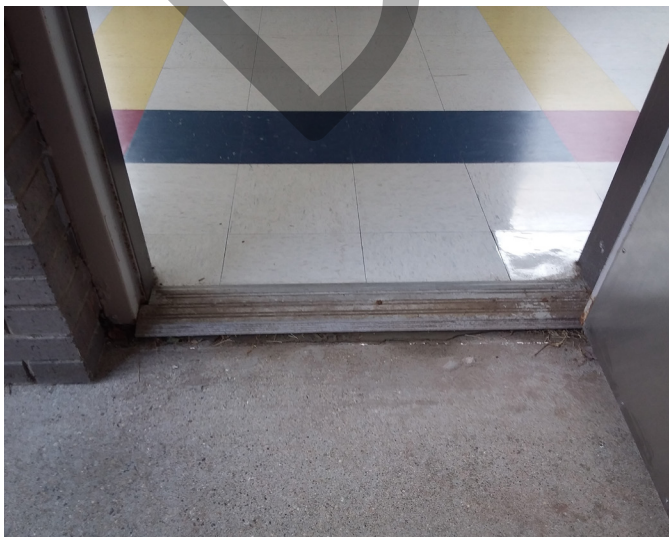
9. Location:

Corridor Exit Route

Threshold is greater than 1/2" above grade on the exterior. Threshold is sloped greater than 1:2 pitch in order to minimize this distance. Typical at emergency exits from connecting corridors.

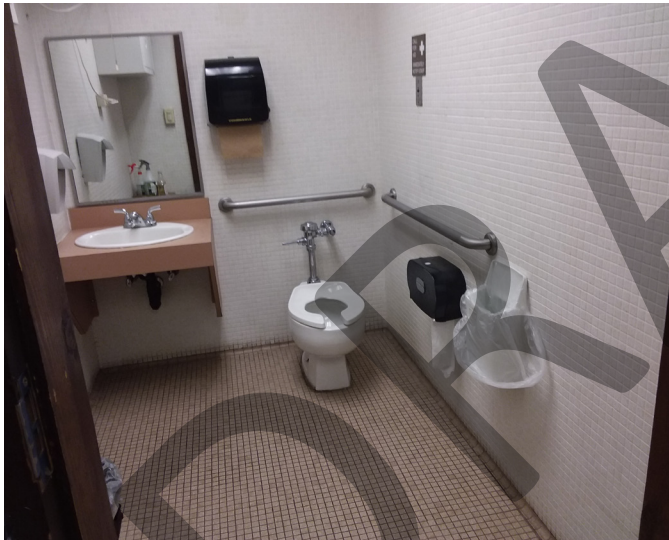
11. Location:

Entry #	Priority	Code Reference	Element	Item	Compliance Requirement	Readily Achievable	Pass/Fail	Photo Ref #	Plan Ref #	Notes	Cost to Fix
154		606.6	Lavatories / Sinks	Exposed Pipes and Surfaces	Water supply and drain pipes under lavatories and sinks shall be insulated or otherwise configured to protect against contact. There shall be no sharp or abrasive surfaces under lavatories and sinks	Y	F	8			
172		609.4	Grab Bars	Position of Grab Bars	Grab bars shall be installed in a horizontal position, 33 inches minimum and 36 inches maximum above the floor measured to the top of the gripping surface or shall be installed as required by Items 1 through 3. 1. The lower grab bar on the back wall of a bathtub shall comply with Section 607.4.1.1 or 607.4.2.1. 2. Vertical grab bars shall comply with Sections 604.5.1, 607.4.1.2.2, 607.4.2.2 and 608.3.1.2. 3. Grab bars at water closets primarily for children's use shall comply with Section 609.4.2.	Y	F	11

Entry #	Priority	Code Reference	Element	Item	Compliance Requirement	Readily Achievable	Pass/Fail	Photo Ref #	Plan Ref #	Notes	Cost to Fix
192		703.1.1	Signage	Designations	Interior and exterior signs identifying permanent rooms and spaces shall comply with sections 703.1, 703.2, and 703.3. EXCEPTION: Exterior signs that are not located at the door to the space they serve shall not be required to comply with 703.3.	Y	F	1, 2, 4, 12, 20, 21, 25, 31			
200		308	Storage	Reach Ranges	Reach ranges shall comply with Section 308.	Y	F	25		Classroom	
201		309	Storage	Operable Parts	Operable parts required to be accessible shall comply with Section 309.	Y	F	21		Coolers	
202		702.1	Alarms	General	Accessible audible and visible alarms and notification appliances shall be installed in accordance with NFPA 72 listed in Section 105.2.2, be powered by a commercial light and power source, be permanently connected to the wiring of the premises electric system, and be permanently installed.	Y	F	11

Toilet Room

No vertical grab bar present. Typical in most toilet rooms throughout the facility.

- Replace telephones to locations where operable components are located below 48” high.
- Replace exit doors that block egress path with their swing.
- Provide vertical grab bars in all accessible bathrooms and accessible stalls.
