Facility Study and Master Plan

Skinner Road School

90 Skinner Rd, Vernon, CT 06066

SUMMER 2023

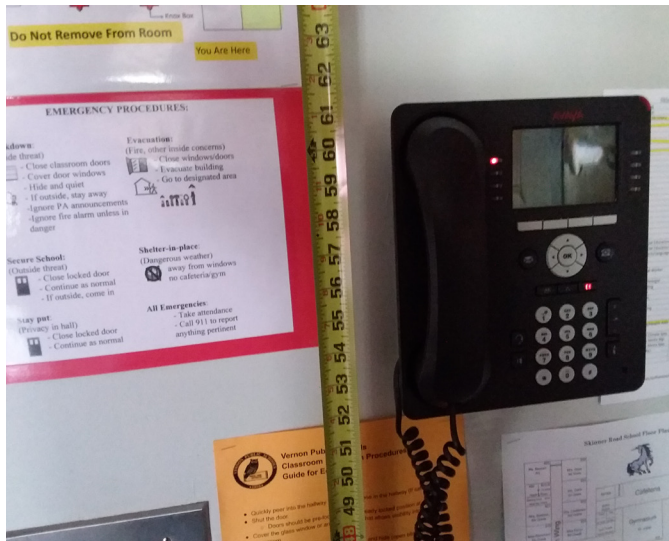
13. Location:

Classroom

Operable components of phone are located above the maximum 48". Typical in most locations with a wall mounted phone.

- Replace telephones to locations where operable components are located below 48” high.
- Replace exit doors that block egress path with their swing.
- Provide vertical grab bars in all accessible bathrooms and accessible stalls.

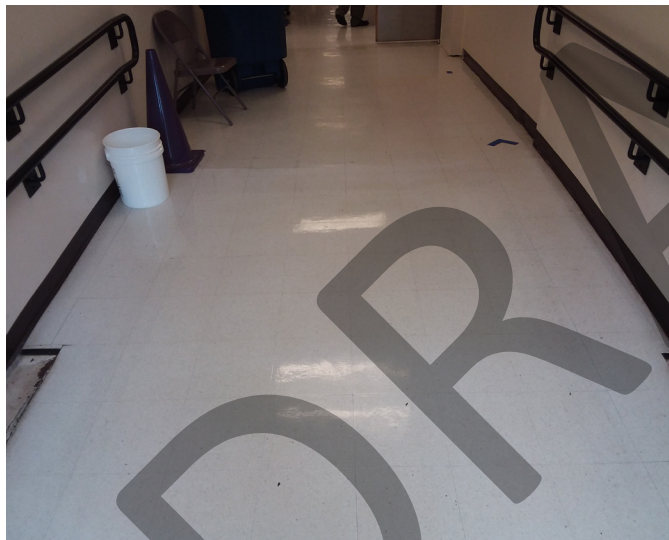
14. Location:

Corridor Exit

Ramp should have slip resistant material. Typical at corridor exits in classroom wings.

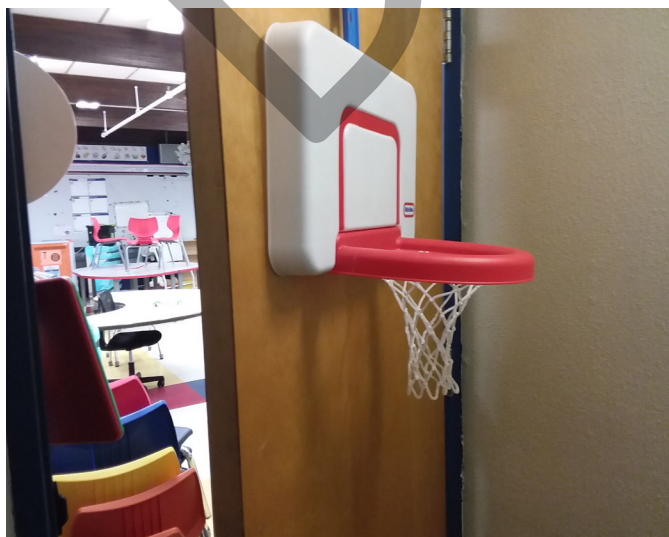
15. Location:

Classroom Exit

Basketball hoop mounted on exit door limits opening angle.

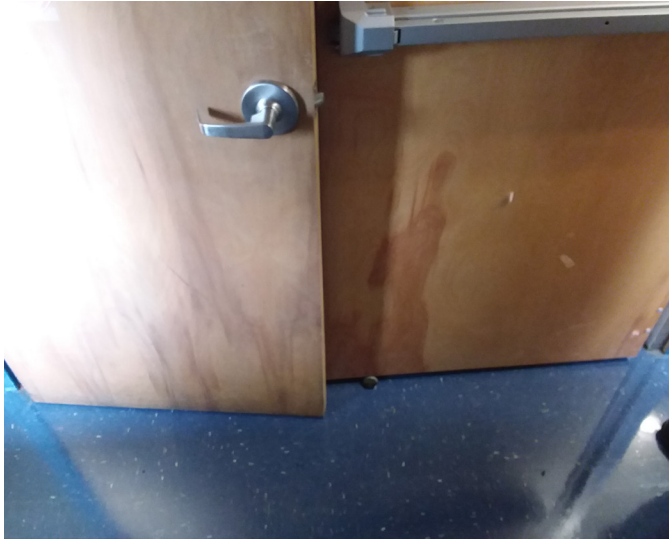
16. Location:

Classroom Exit

Door swings from adjacent classrooms interfere with each other. Typical at most classroom egress doors. A critical piece of the emergency egress plan of the facility.

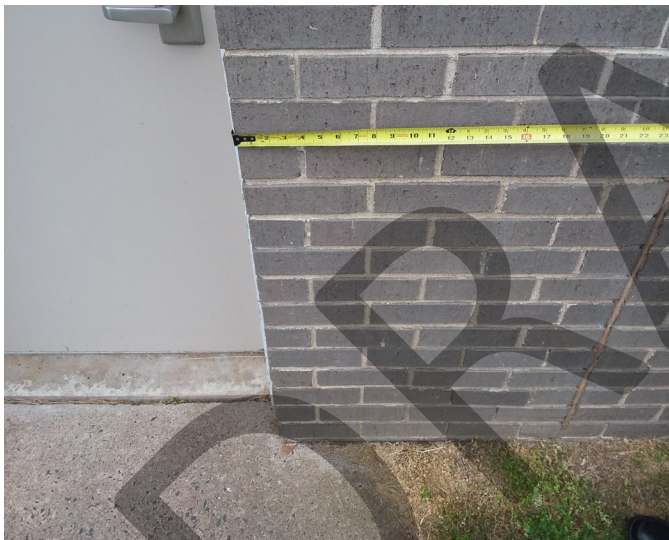
17. Location:

Classroom Exit

Sidewalk does not extend the required 18" for the latch side pull of a door with automatic closer.

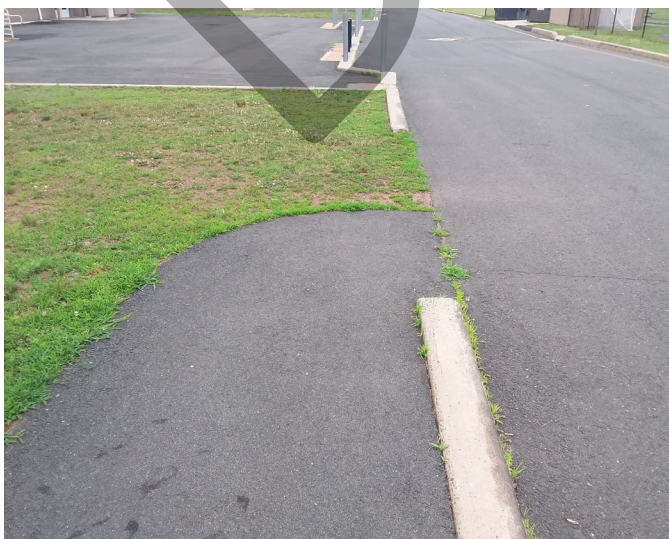
18. Location:

Entry #	Priority	Code Reference	Element	Item	Compliance Requirement	Readily Achievable	Pass/Fail	Photo Ref #	Plan Ref #	Notes	Cost to Fix
22	0	402.2	Curb Ramps	Components	Accessible routes shall consist of one or more of the following components: walking surfaces with a running slope not steeper than 1:20, doorways, ramps, curb ramps excluding the flared sides, elevators, and platform lifts. All components of an accessible route shall comply with the applicable portion of the standard.	Y	F	29, 33			
24		405.4	Ramps	Floor Surfaces	Floor surfaces of ramp runs shall comply with 302.	Y	F	14, 27			
27		406.7	Curb Ramps	Landings	Landings shall be provided at the tops of curb ramps. The clear length of the landing shall be 36 inches (915mm) minimum. The clear width of the landing shall be at least as wide as the curb ramp, excluding flared sides, leading to the landing. EXCEPTION: In alterations, where there is no landing at the top of curb ramps, curb ramp flares shall be provided and shall not be steeper than 1:12.	Y	F	18

Sidewalk Egress Path

Curb ramp does not have required 60"x60" landing at change in direction.

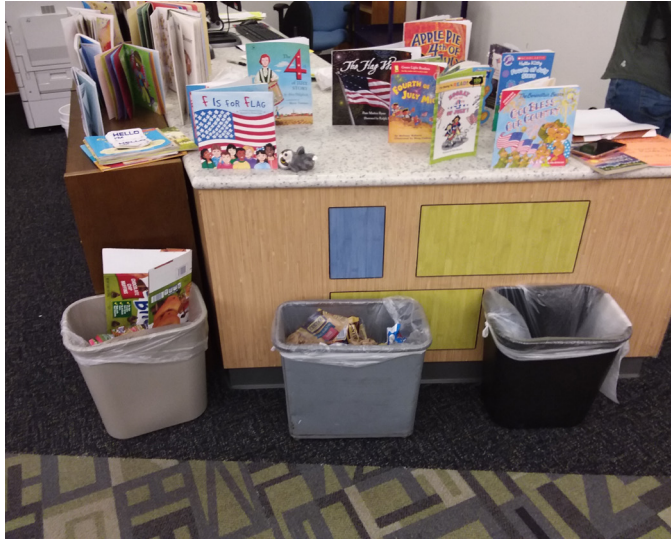
19. Location:

Library

A 36" wide counter space should be allocated for an accessible checkout. A 30"x40" clear space must be available along this counter to approach.

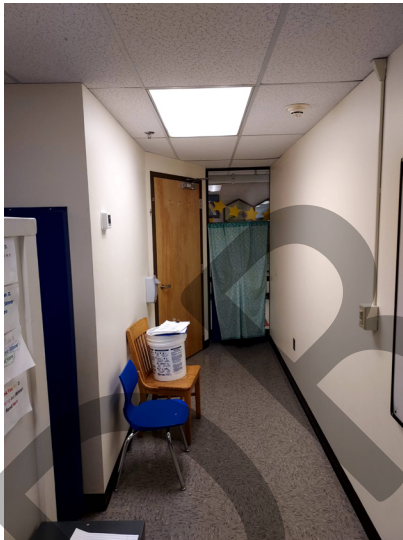
20. Location:

Addition of Time Out Room

The entrance to the door does not allow the proper clear width due to the angled wall installation.

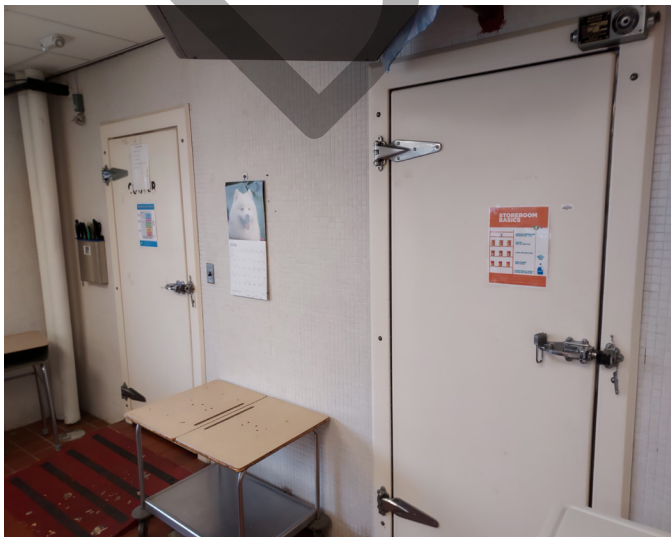
21. Location:

Cooler / Freezer Doors.

Compliant door hardware and access is required.

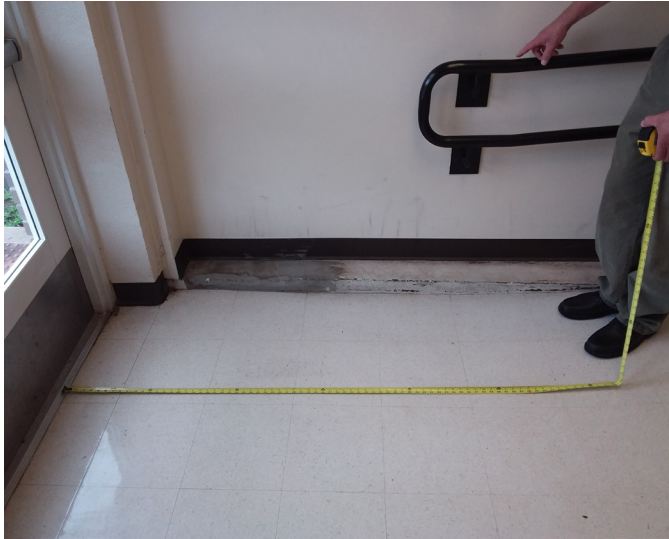
22. Location:

Interior Exit Ramp Landing

The Landing at the door is not long enough.

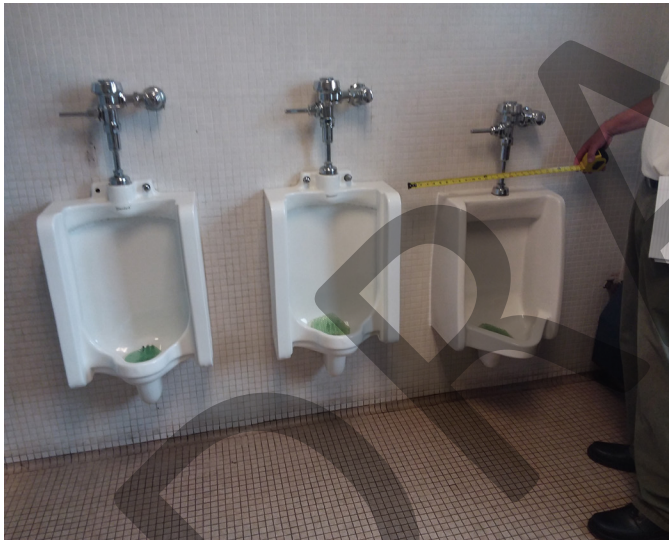
23. Location:

Boys Toilet Room

Urinal screens need to be installed to allow 30 inches clear at the accessible urinal

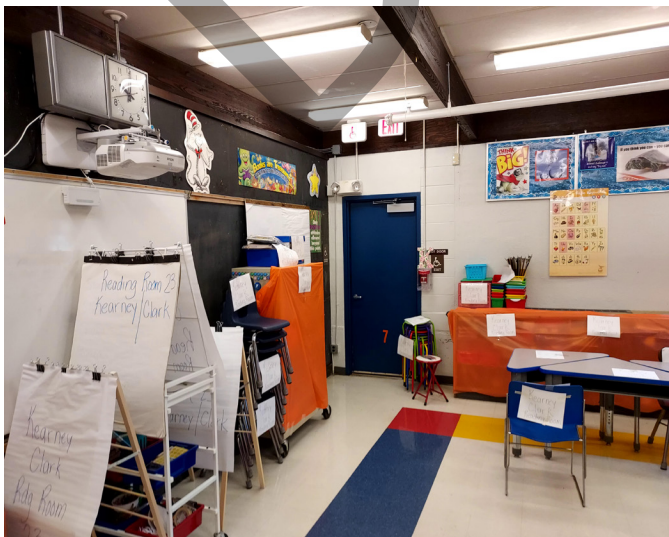
24. Location:

Reading Room

The exit door does not provide the proper push clearance at the door.

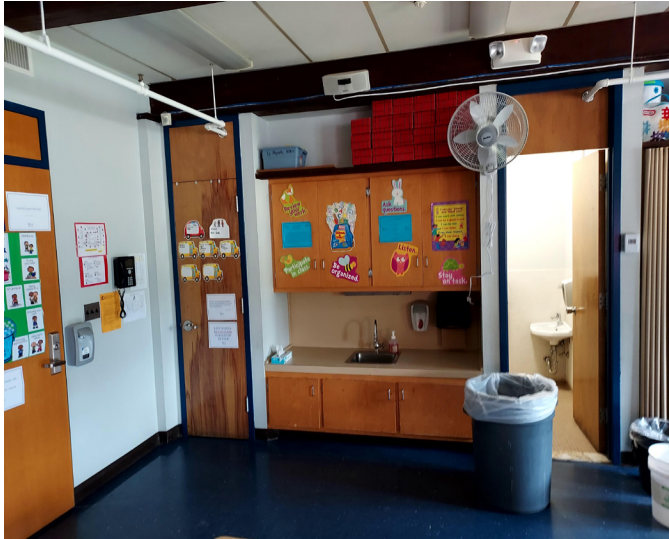
25. Location:

Entry #	Priority	Code Reference	Element	Item	Compliance Requirement	Readily Achievable	Pass/Fail	Photo Ref #	Plan Ref #	Notes	Cost to Fix
151		606.2, 305, 306	Lavatories / Sinks	Clear Floor Space	A clear floor space complying with 305.3, positioned for a forward approach, shall be provided. Knee and toe clearance complying with 306 shall be provided. The dip of the overflow shall not be considered in determining knee and toe clearances. EXCEPTIONS: 1. A parallel approach complying with 305 and centered on the sink, shall be permitted to a kitchen sink in a space where a cook top or conventional range is not provided. 2. The requirement for knee and toe clearance shall not apply to a lavatory in a toilet or bathing facility for a single occupant, accessed only through a private office and not for common use or public use. 3. A knee clearance of 24 inches minimum above the floor shall be permitted at lavatories and sinks used primarily by children 6 through 12 years where the rim or counter surface is 31 inches maximum above the floor. 4. A parallel approach complying with 305 and centered on the sink, shall be permitted at lavatories and sinks used primarily by children 5 years and younger. 5. The requirement for the knee and toe clearance shall not apply to more than one bowl of a multibowl sink. 6. A parallel approach complying with Section 305 and centered on the sink, shall be permitted at wet bars.	Y	F	7, 25

Entry #	Priority	Code Reference	Element	Item	Compliance Requirement	Readily Achievable	Pass/Fail	Photo Ref #	Plan Ref #	Notes	Cost to Fix
206		902.5	Dining Surfaces and Work Surfaces	Dining Surfaces and Work Surfaces for Children's Use	Accessible dining surfaces and work surfaces primarily for children's use shall comply with 902.5. EXCEPTION: Dining surfaces and work surfaces that are used primarily by children ages 5 and younger shall not be required to comply with Section 902.5 where a clear floor space complying with Section 305 is provided for a parallel approach. 902.5.1 Clear Floor Space: A clear floor space complying with Section 305, positioned for forward approach, shall be provided. Knee and toe clearance complying with Section 306 shall be provided. EXCEPTION: A knee clearance 24 inches minimum above the floor shall be permitted. 902.4.2 Height: The tops of tables and counters shall be 26 inches minimum and 30 inches maximum above the floor.	Y	F	25		Classroom

Bathroom off of Classroom

The storage door is too narrow, The bathroom located off the classroom is non-compliant.

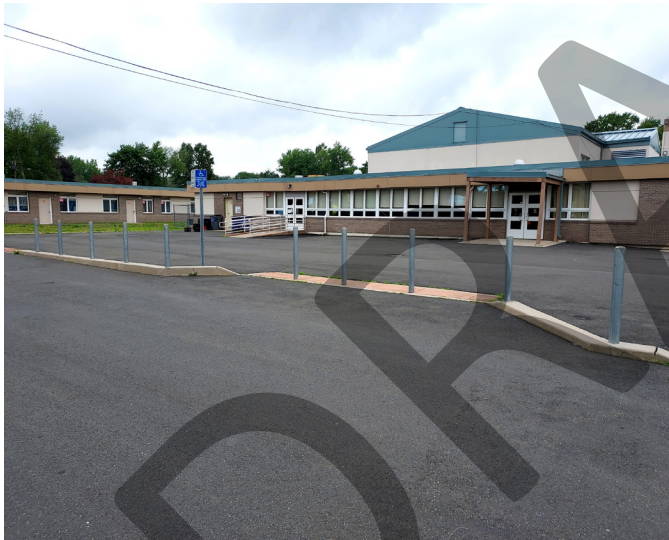
26. Location:

Passenger Loading Zone

The parking lot striping needs to be added to designate the area.

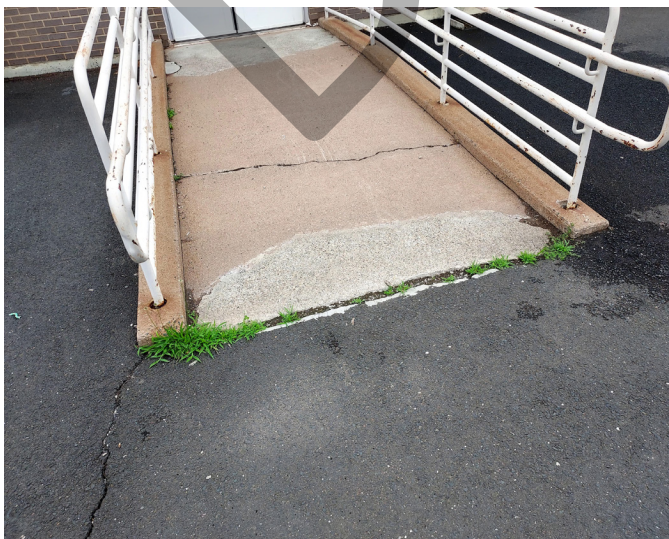
27. Location:

Exit Ramp from the Cafeteria

The transition from the concrete to pavement will create an issue.

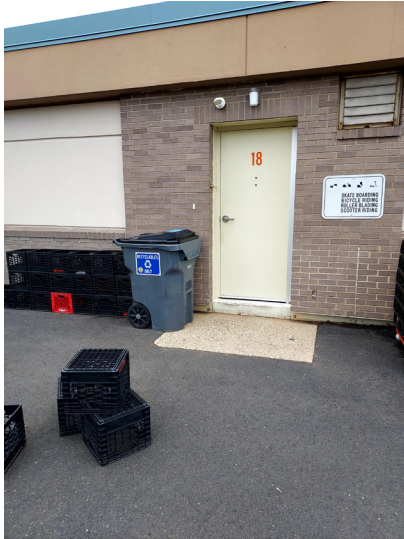
28. Location:

Exit from Kitchen Area

This exit is not at grade.

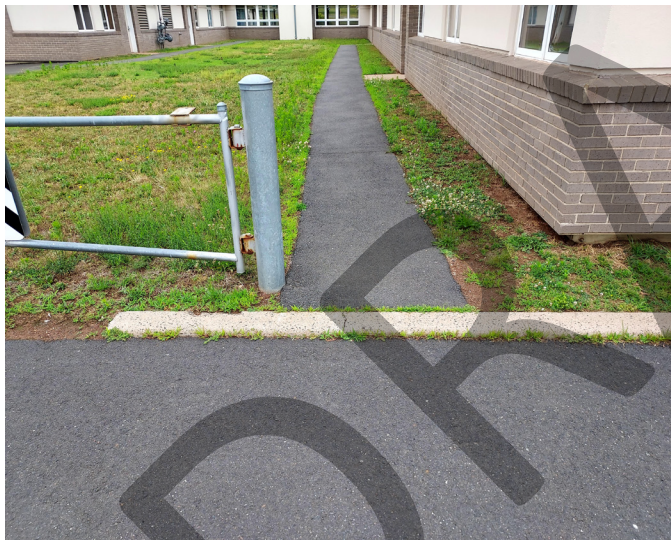
29. Location:

The curb creates an impediment, A curb ramp or cut should be provided.

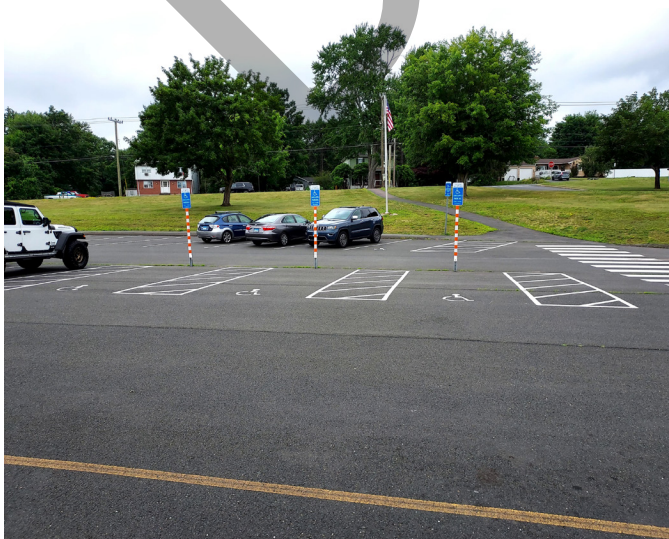
30. Location:

Handicap Accessible Parking Area

The spaces need to be provided with wheel stops, the aisles should connect to the crosswalk, and tactile warning should be added at the walk way from the public way. Access to the public way should be accessible.

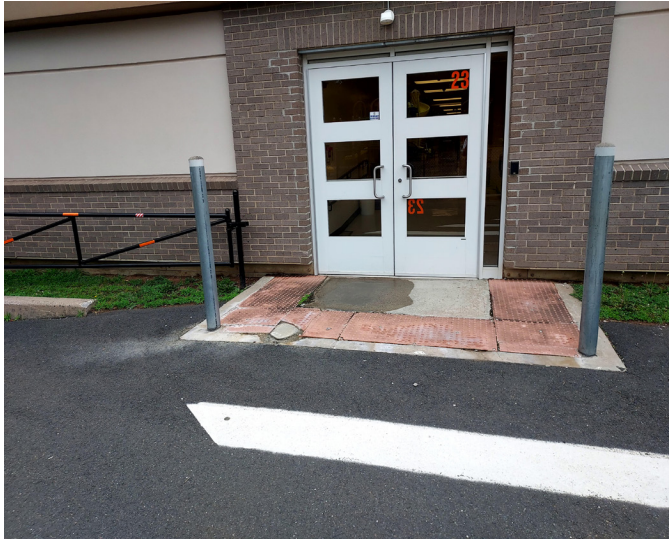
31. Location:

Corridor Exit Doors

The landing needs to be maintained to make sure it is accessible.

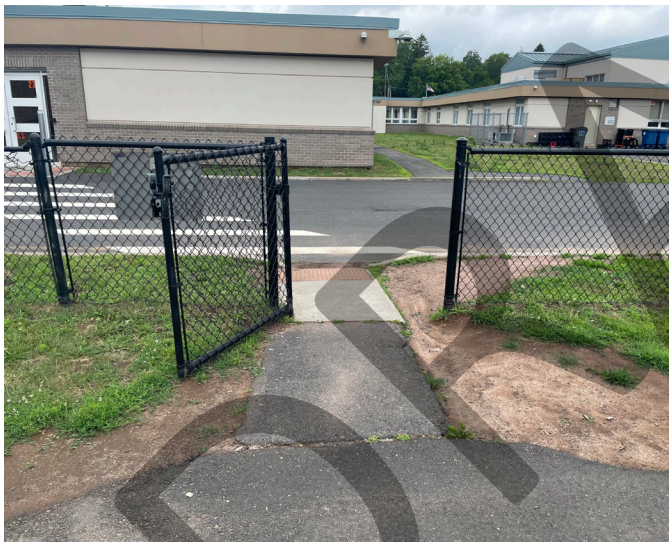
32. Location:

Entrance to Playground Fields

The gate is off set from the sidewalk reducing the required clear width at the entrance gate

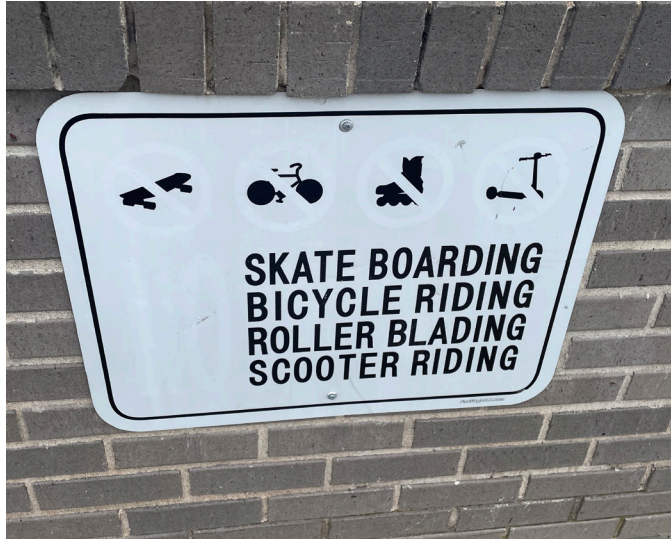
1. Location:

West Elevation

Signage faded

- Remove and replace all damaged tactile warning pads. Remove and replace concrete around these pads to create a smooth surface.
- Provide signage at service entrance for clarity.
- Replace faded signage.
- Replace deteriorating and cracked walkways to create smooth surface.

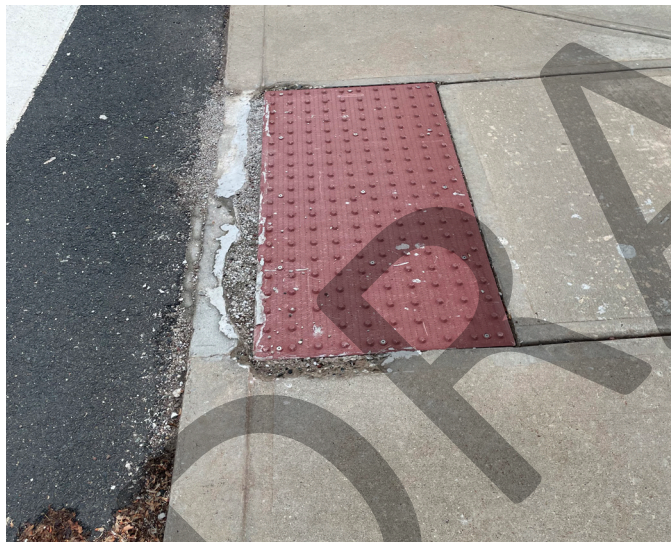
2. Location:

West Elevation

Crosswalk near main entrance from parking - the concrete is deteriorating in front of and around the tactile warning pad creating a hazardous condition.

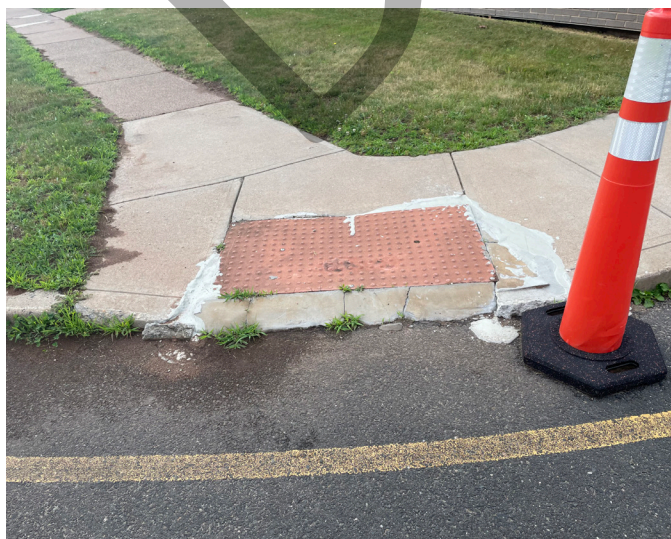
3. Location:

Northwest Corner

The concrete has been patched and vegetation is growing in front of and around the tactile warning pad creating a hazardous condition. No crosswalk indication leading to tactile warning pad. See ADA report for additional information.

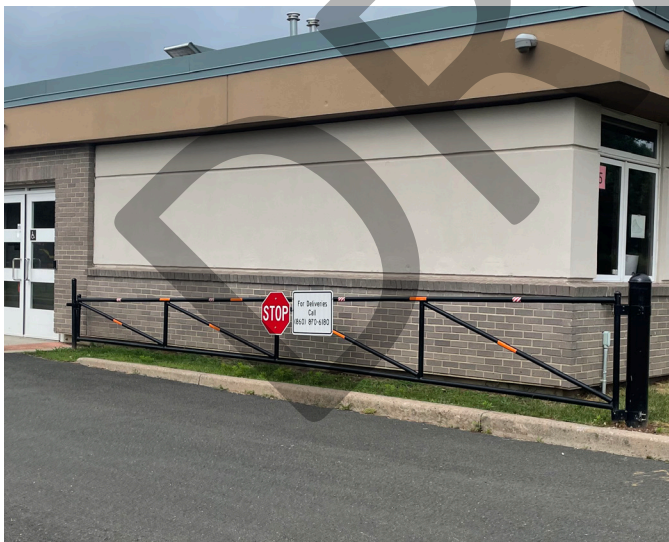
5. Location:

Northeast Elevation

Signage for deliveries and barrier for service areas.

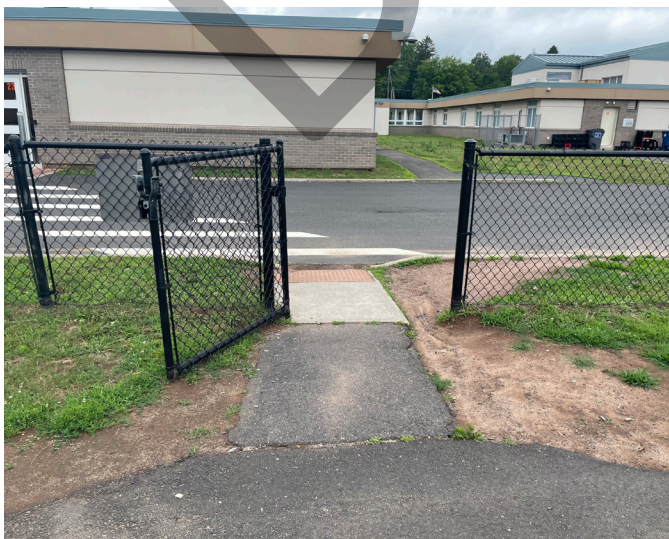
8. Location:

East Site

View of existing metal fence and gate from walkway to playscape area. Grass area needs to be reseeding and gaps between walkways where vegetation is growing infilled.

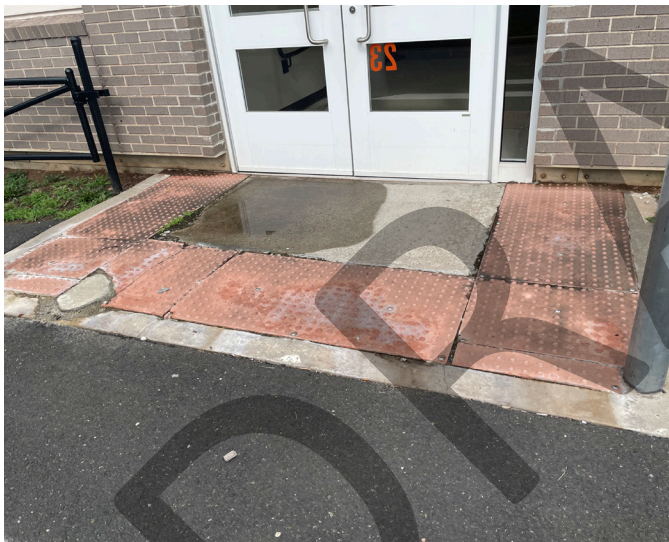
10. Location:

Southeast Elevation

Water pooling at entrance. Tactile warning pads in poor condition. Concrete and warning pads need to be removed and reinstalled with slope away from entrance to avoid water infiltration.

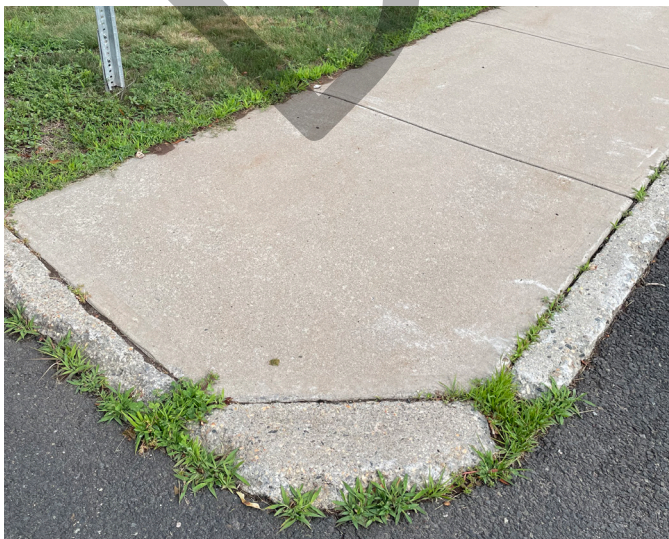
11. Location:

South Parking Area

Overgrowth at concrete sidewalk. No ADA access to this walkway from parking but curb appears to be sloped.

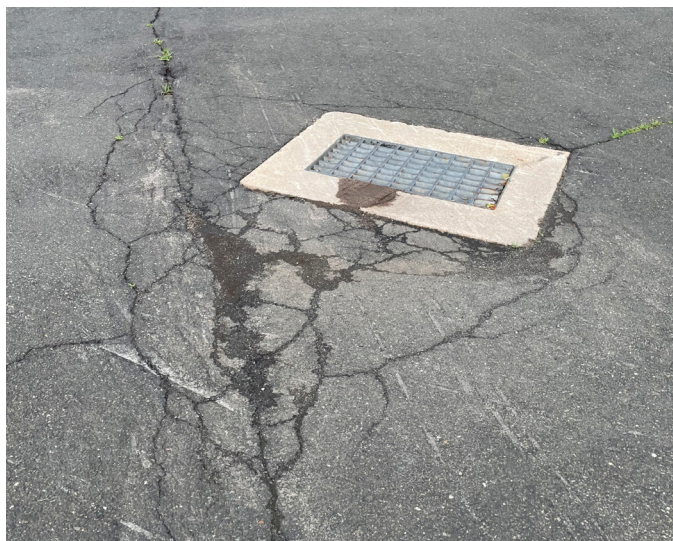
12. Location:

Southeast Parking / Driveway

Cracking in pavement at drainage.

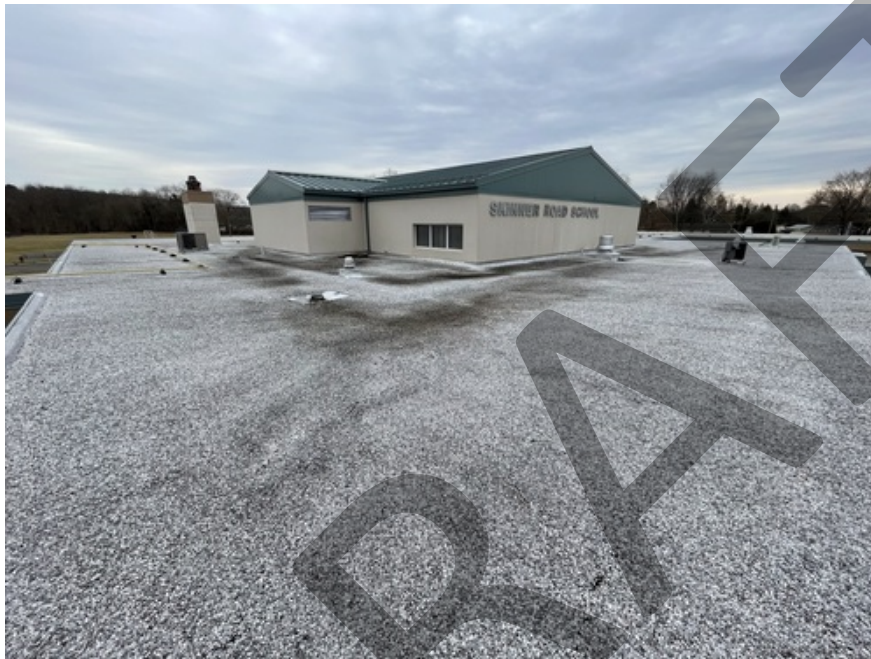
Photo 1

Overview of the center section- Good slope, no ponding and overall great shape

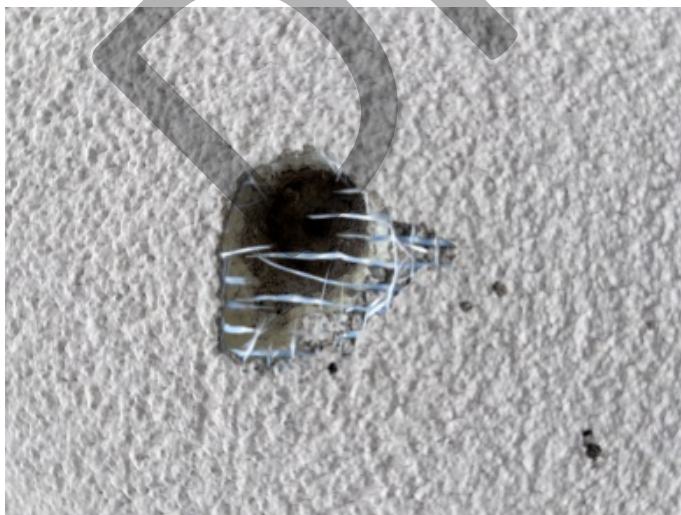
Photo 2

Open condition- Bird damage on eifs facade- Consistent throughout

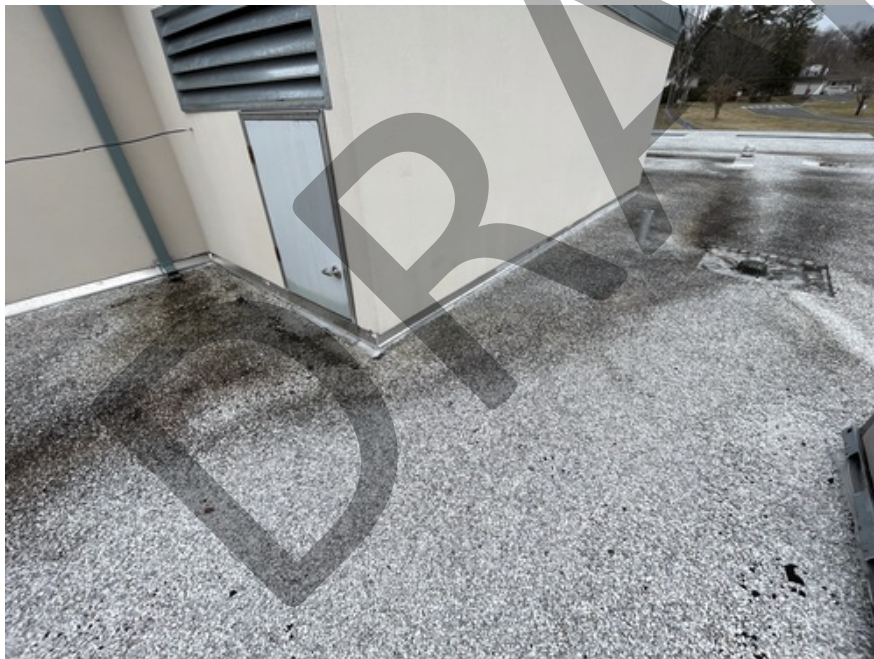
Photo 4

**Area of poor drainage-
Leader
extension suggested**

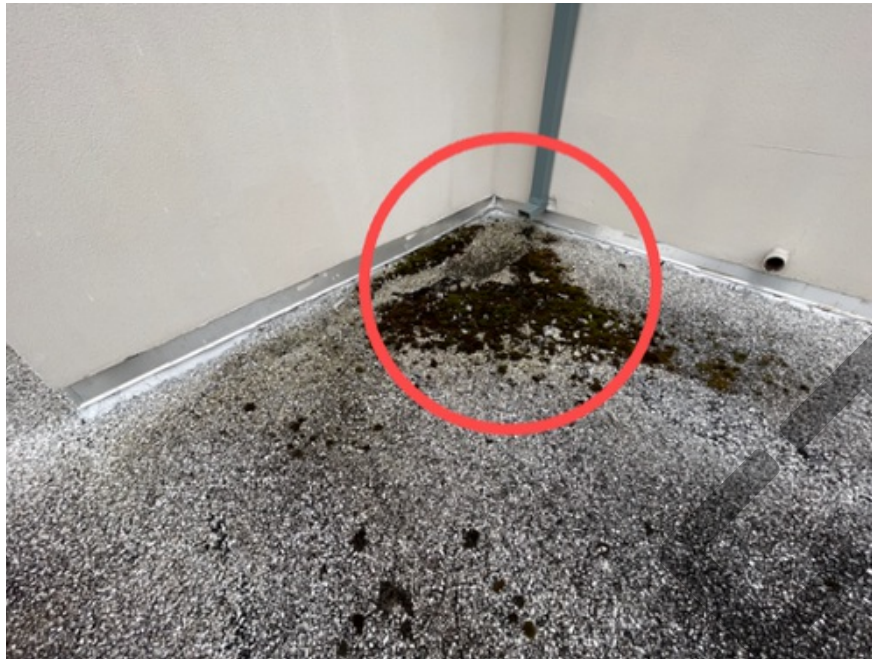
Photo 5

No splash block- Lack of sun- Organic growth

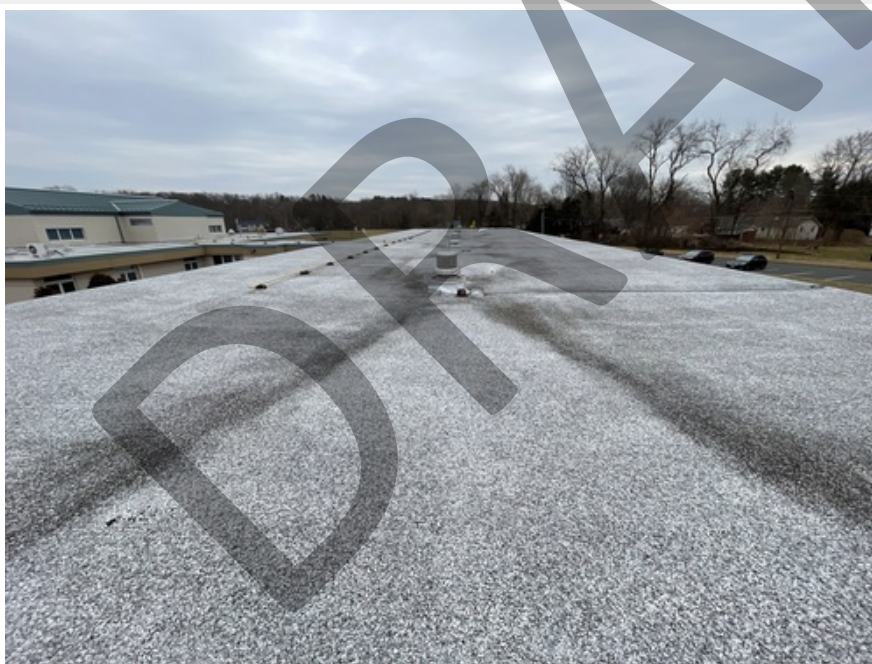
Photo 8

**Overview of the right side
section**

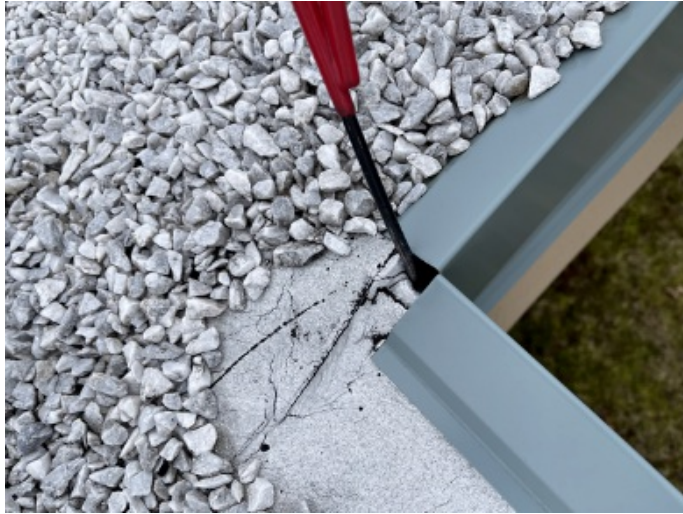
Photo 11

Open condition- Inside corner sealant

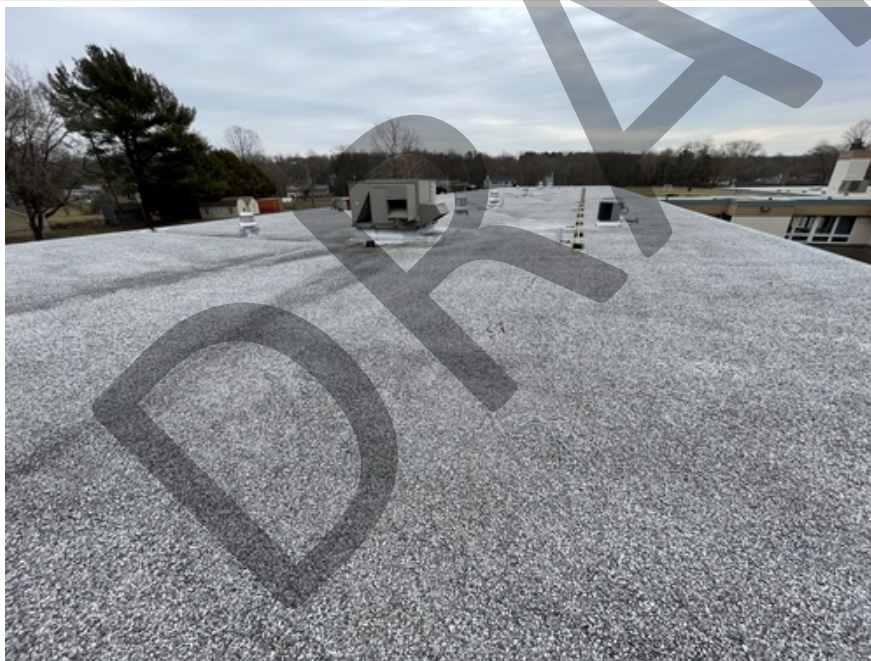
Photo 14

**Overview of the left side
section**

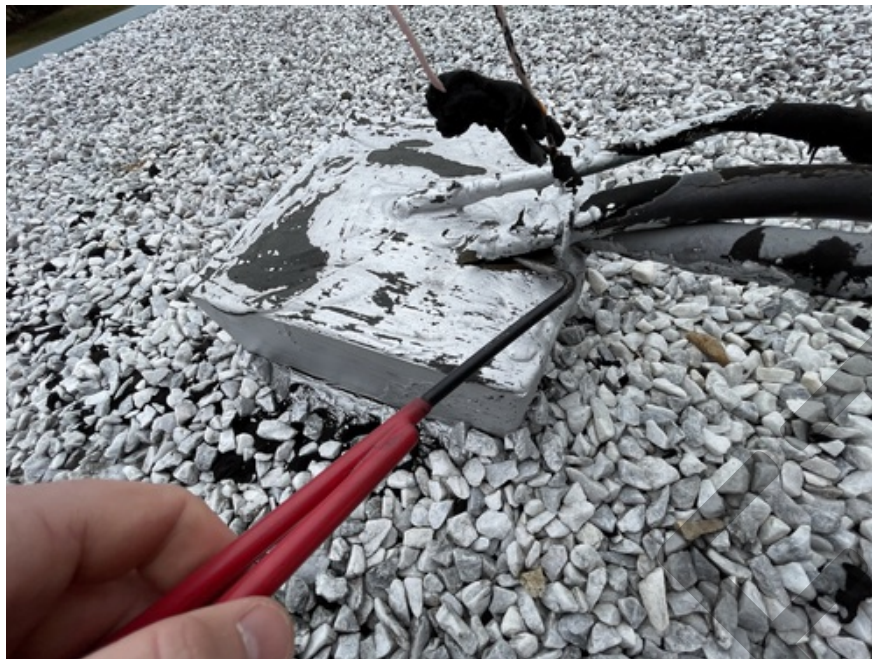
Photo 15

Pitch boxes- Maintenance items

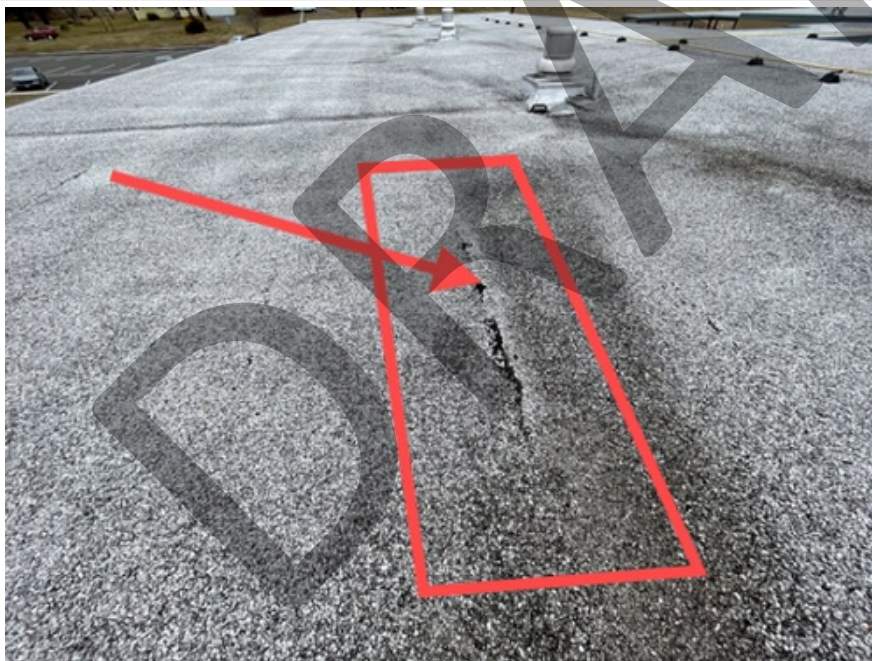
Photo 16

Field seam exposed to UV- High wind area- Sealing and reinforcement suggested

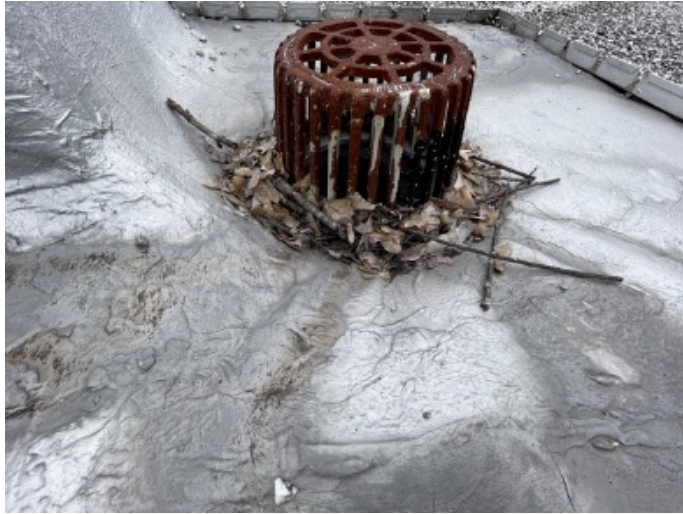
Photo 17

Clogged drain- Maintenance item

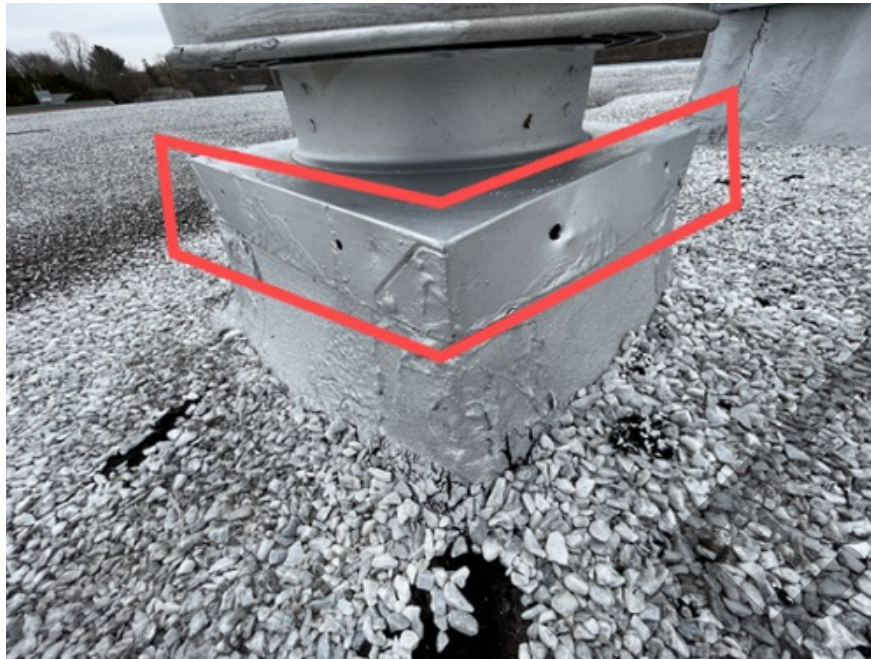
Photo 19

**Fan unit- No securement
evident**
