Facility Study and Master Plan

Rockville High School

SUMMER 2023

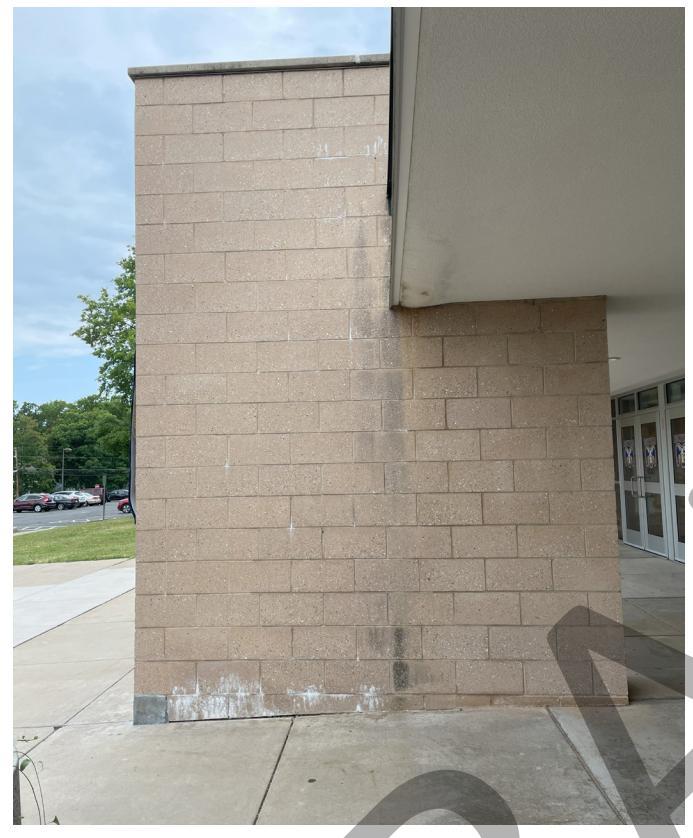
1. Location:

Efflorescence and mildew growth present at base of CMU wall.

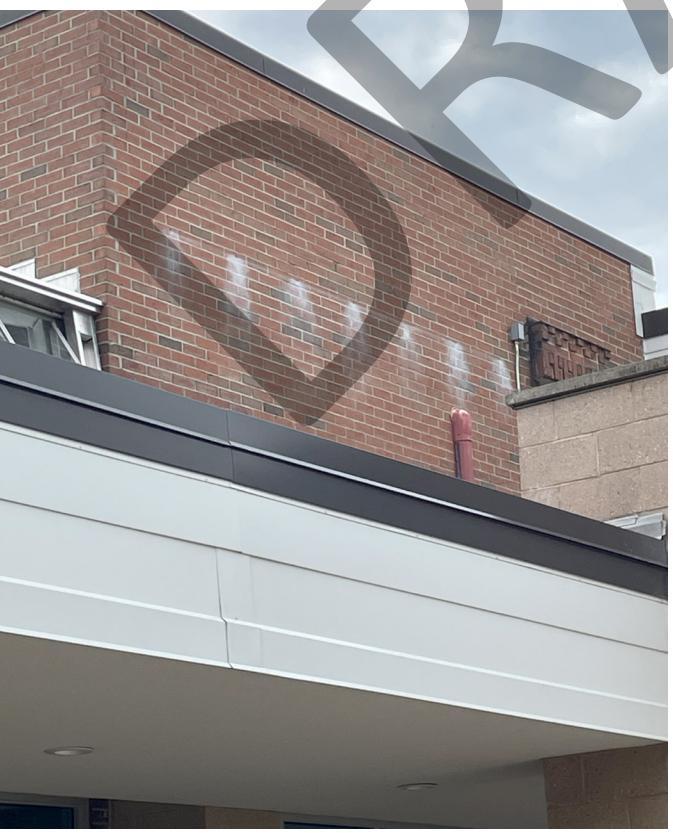
2. Location:

Efflorescence present at brick above main entrance.

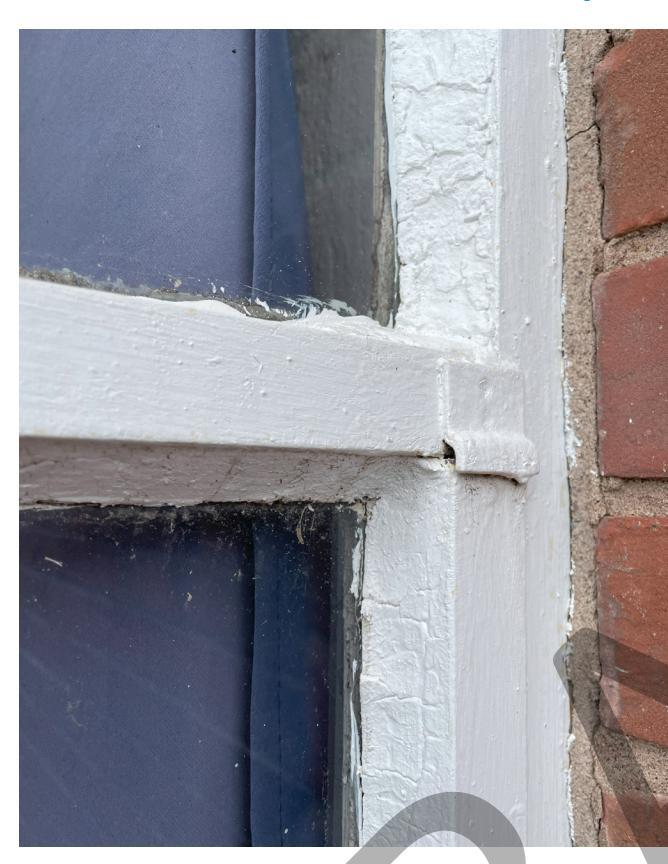
8. Location:

Existing windows appear to be made of wood and have been repainted several times.

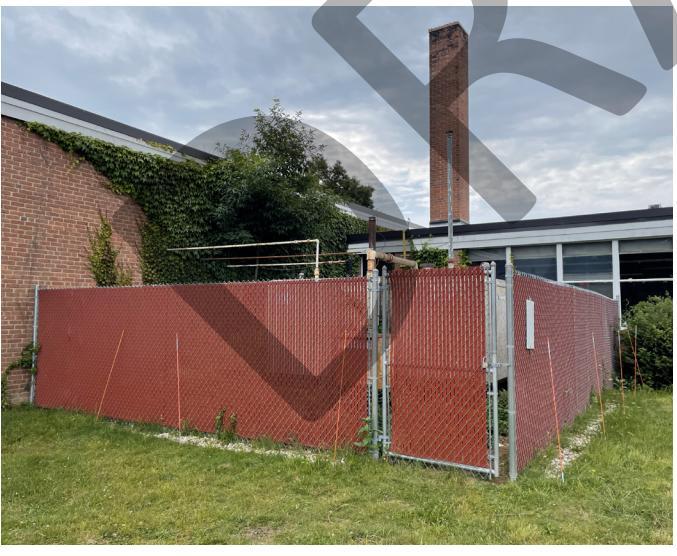
9. Location:

Vegetation overgrowth on exterior of building

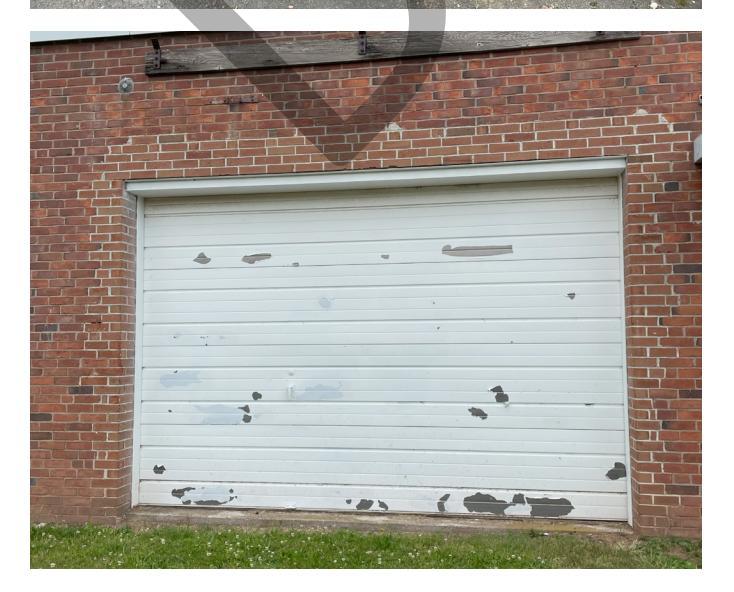
20. Location:

Finish of garage door is peeling away.

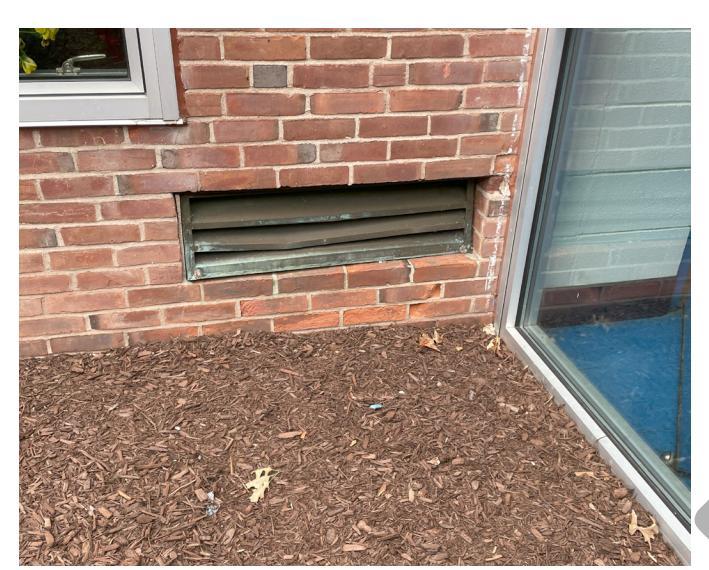
24. Location:

Another example of vent needing to be replaced or removed if not in use.

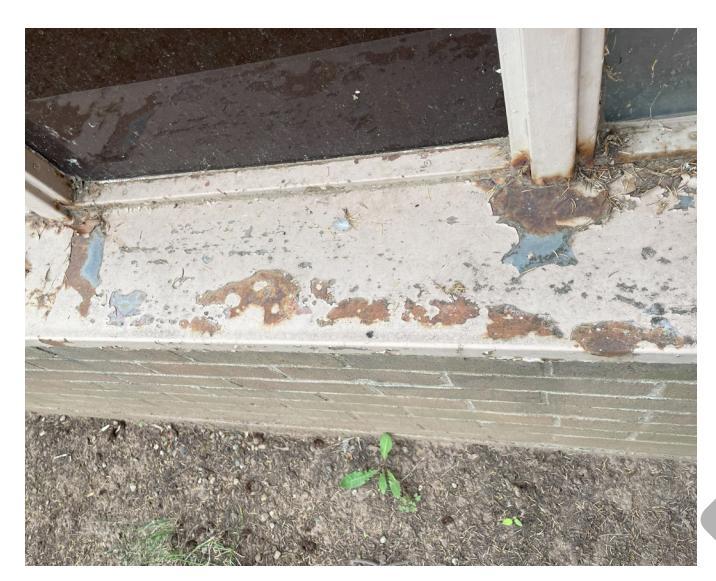
27. Location:

Window sill and frame finish is peeling away and rust is beginning to form.

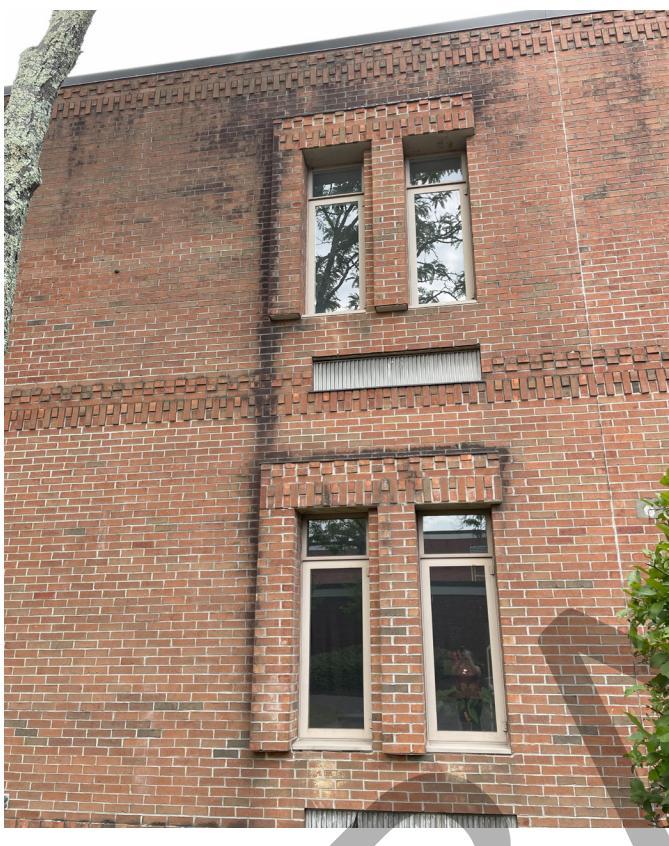
30. Location:

Mold and mildew build up on brick facade

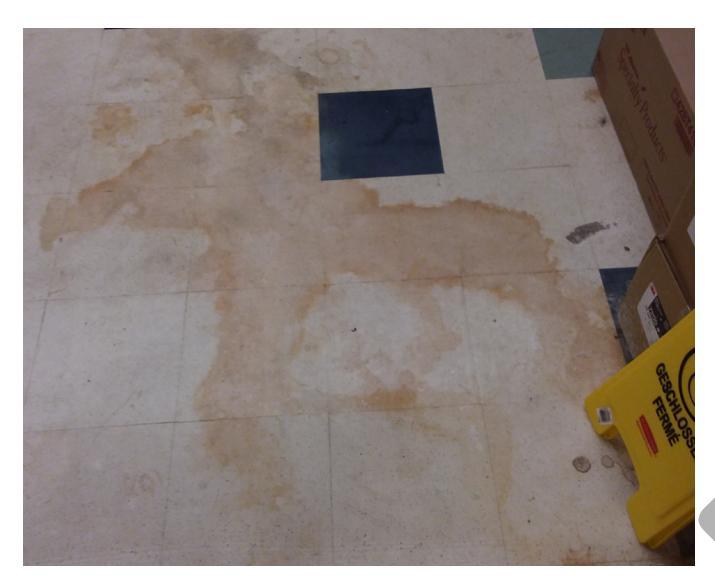
39. Location:

VCT is stained and needs to be refinished or replaced.

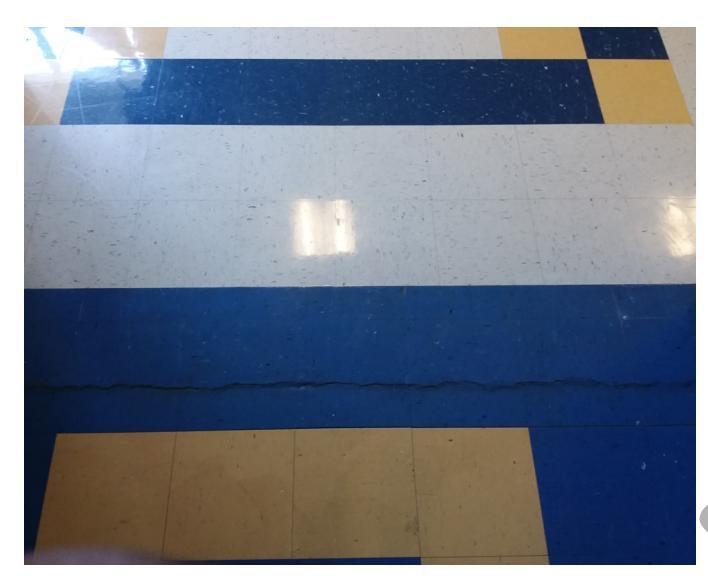
48. Location:

VCT is cracked and not level with the surrounding VCT creating a trip hazard.

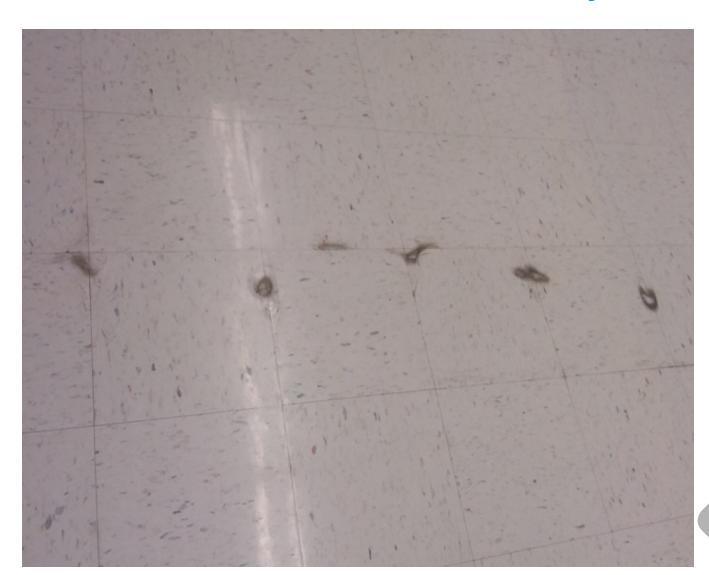
53. Location:

The VCT is bubbling and damaged.

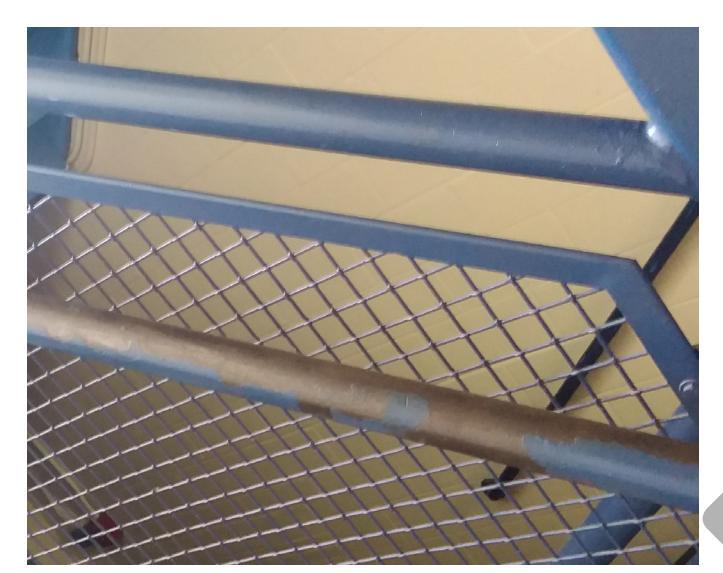
56. Location:

Handrails have chipped and faded paint and need to be refinished.

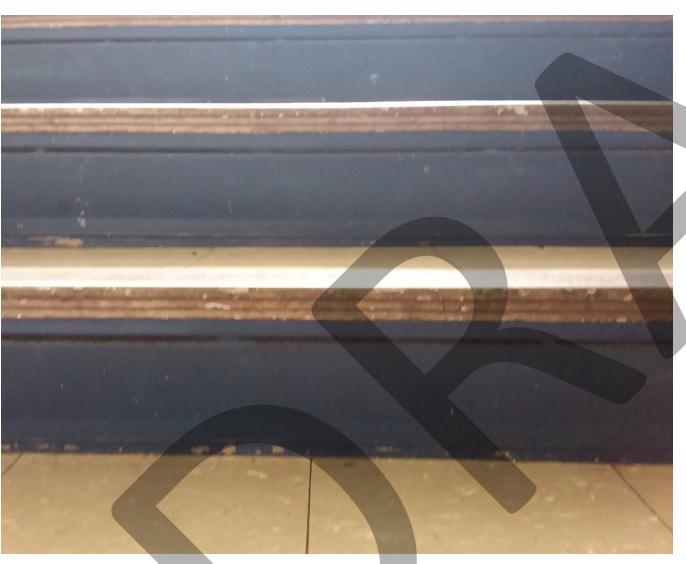
57. Location:

Stair risers and nosing's are chipped and damaged in some areas.

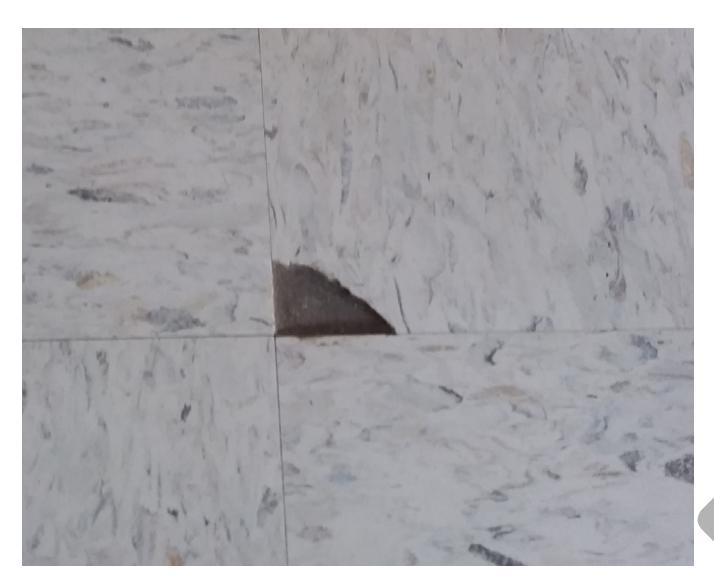
59. Location:

VCT is damaged and chipped.

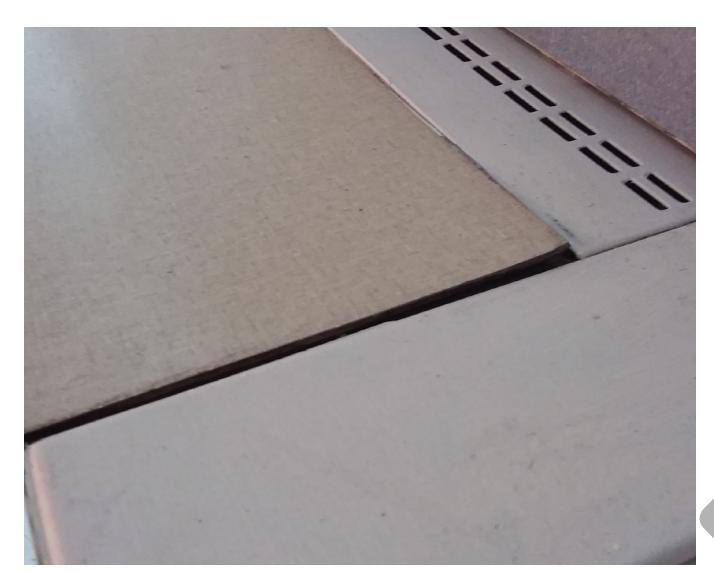
62. Location:

Laminate surface lifting and delaminating by radiators.

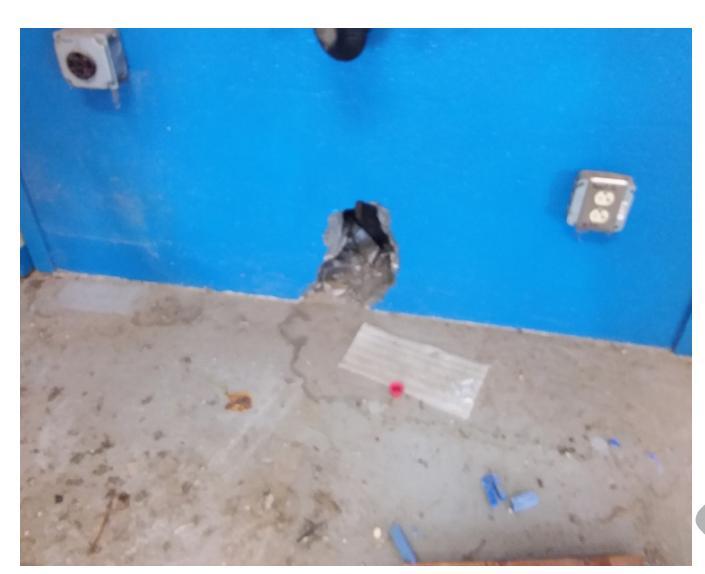
68. Location:

Hole in gypsum needs to be patched.

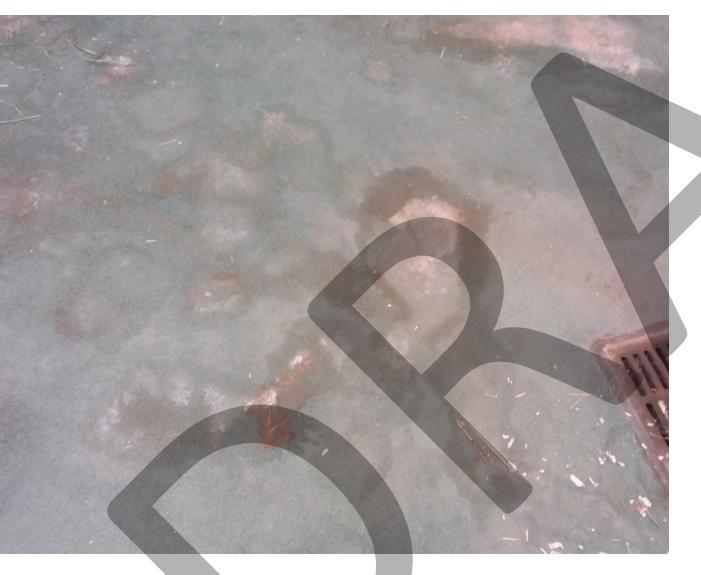
69. Location:

Stained and damaged epoxy floor.

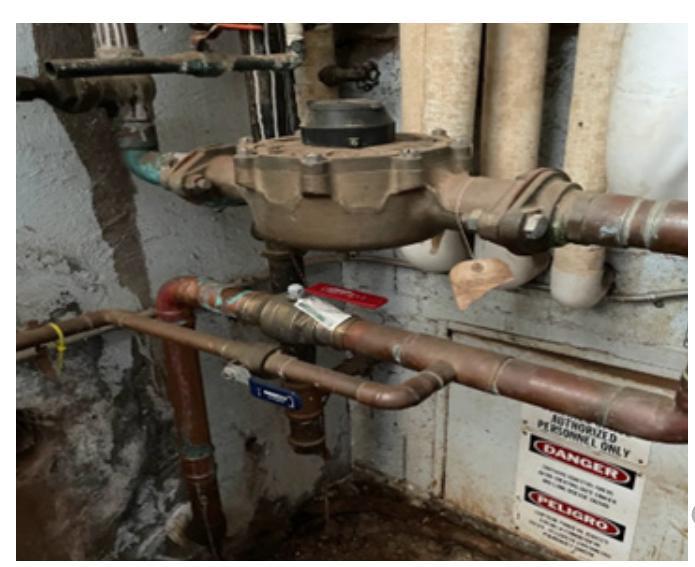
1. Location:

The water service to the building originates in the boiler room of the building and the service entrance appears to be in fair condition with corrosion beginning to form on the piping.

Description: Domestic water service

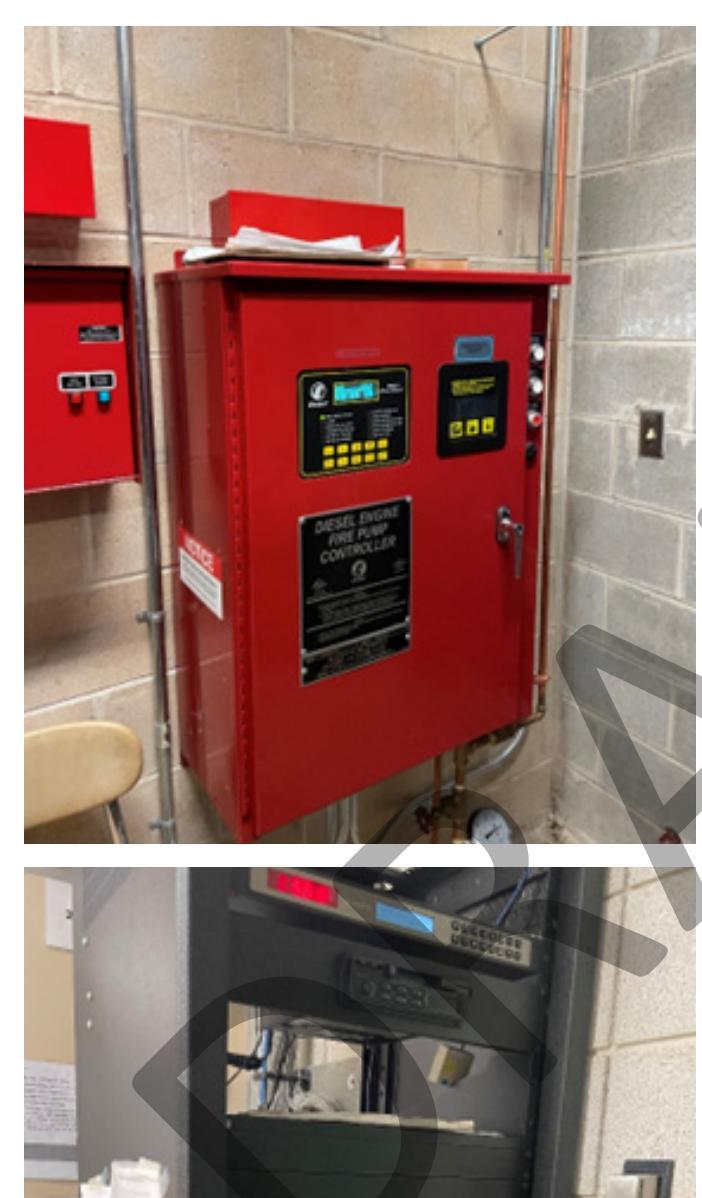
Description:

Fire alarm control panel

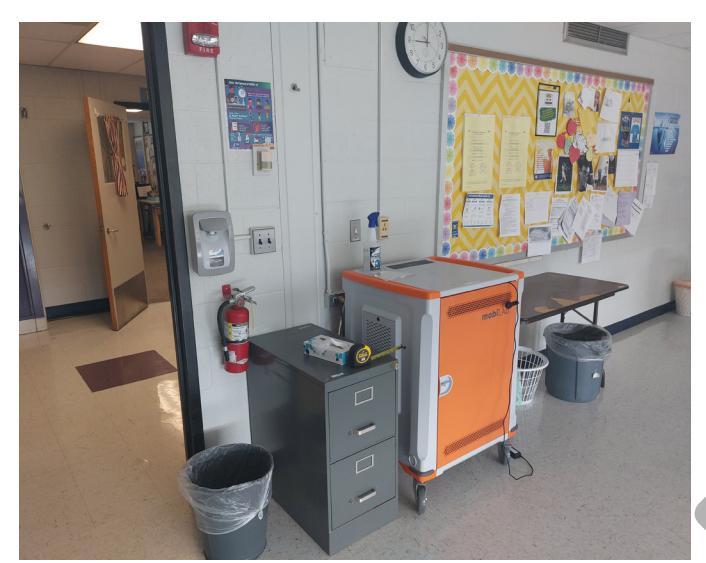
1. Location:

Classroom/Offices

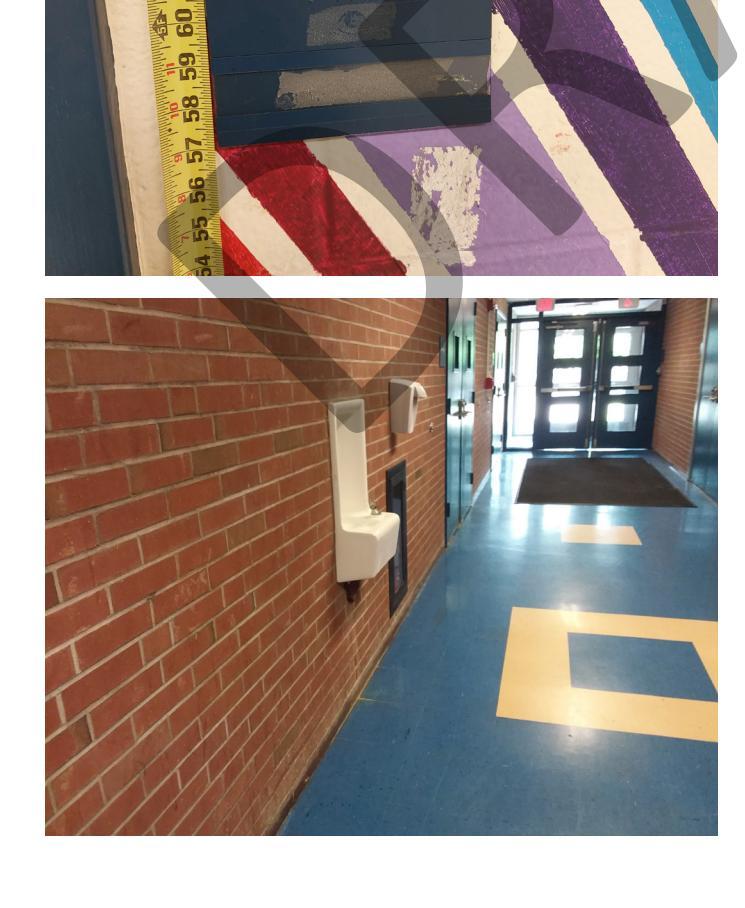
Description:

Drinking fountain does not provide knee and toe clearance for a front approach.

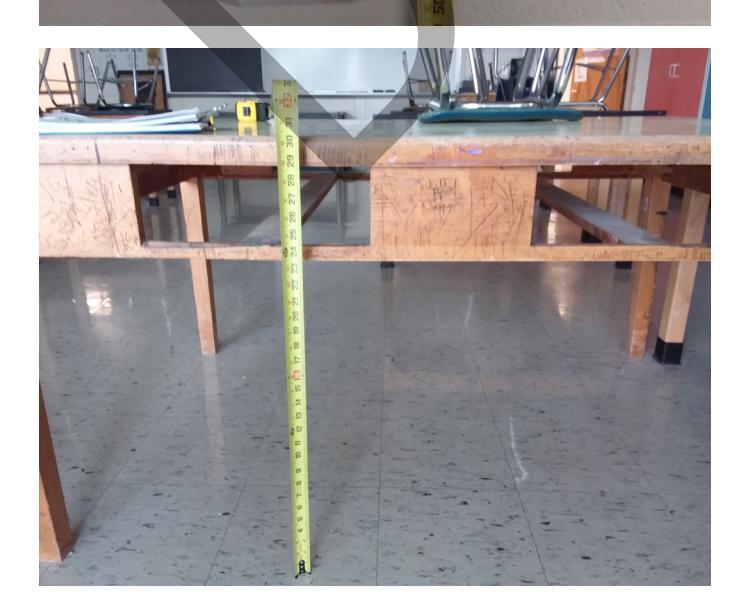
Description:

Typical furniture systems lowest edge is 24", below the required 27" for accessible pull under requirements. No alternate work tables provided.

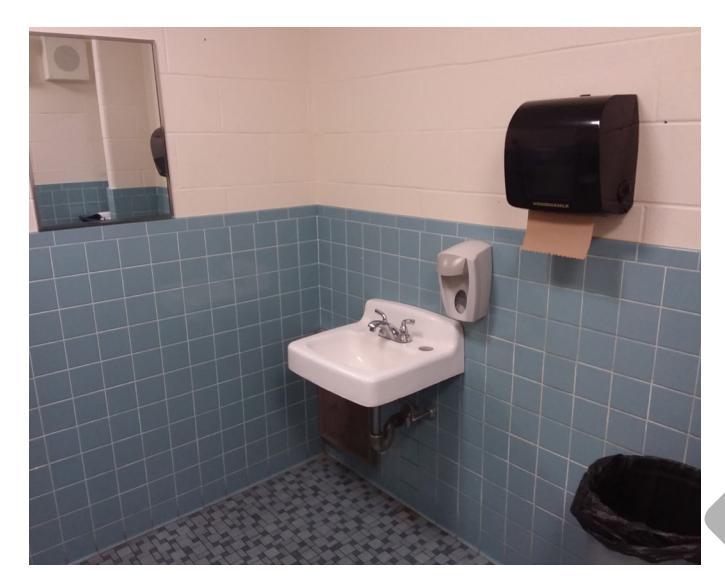
10. Location:

Toilet Room

Description:

Marked accessible restroom has mirror located above minimum 40" base height.

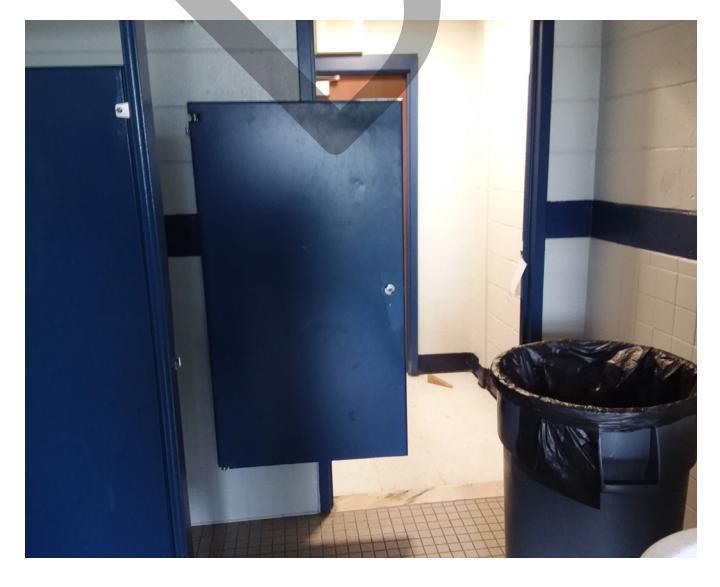
Description:

Modified toilet stall interferes with clearance of access route when opened.

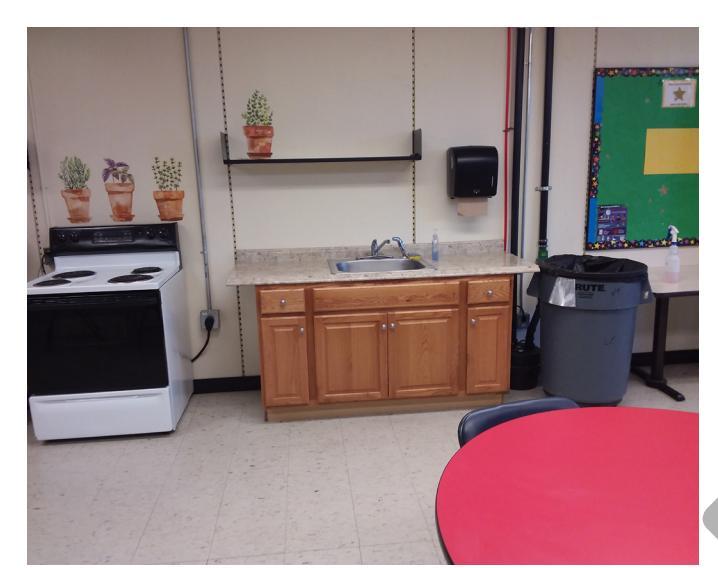
13. Location:

Classroom

Description:

Sink used for curriculum purposes does not meet accessibility requirements.

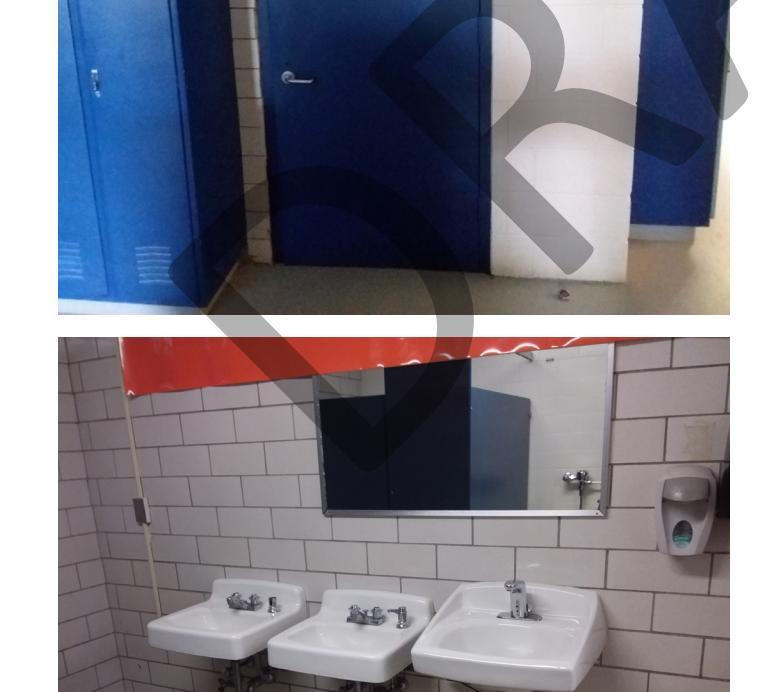
Description:

Mirror is mounted above the minimum 40" height, sinks do not provide proper 17" of pull under distance without hitting plumbing.

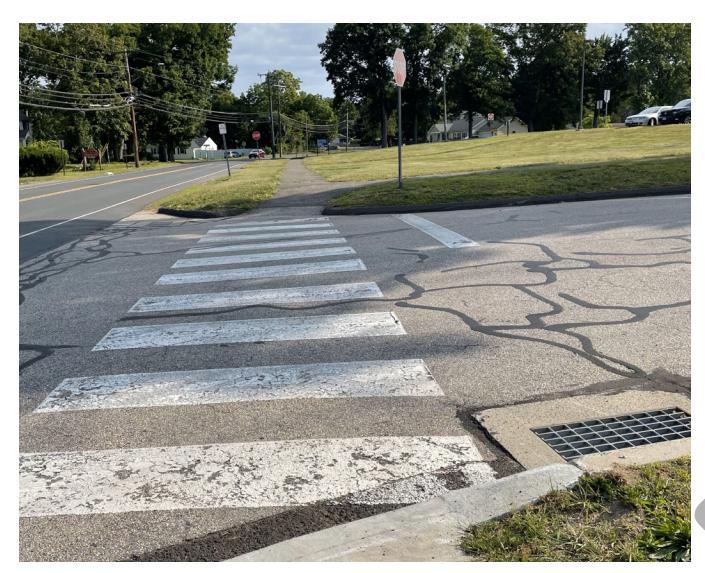
1. Location:

Entry Drive

Description:

Crosswalk painting is fading. No additional directional signage beyond crosswalk, stop sign and stop line.

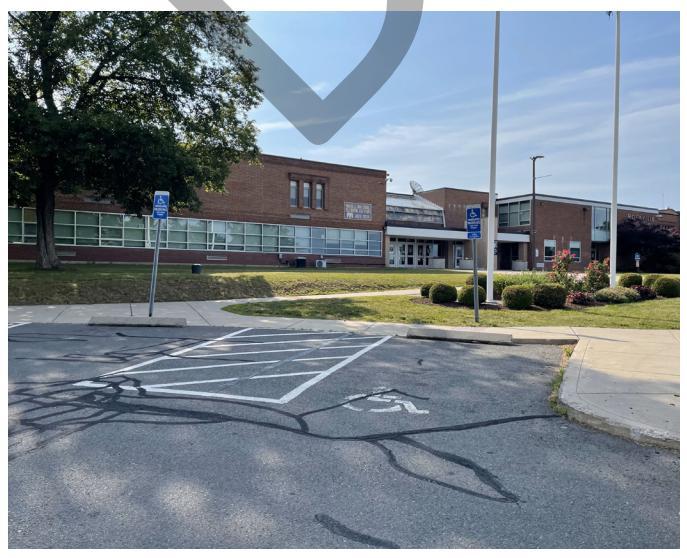
Description:

Parking lot has been patched over time. Handicap parking spaces are designated with signage and stripping.

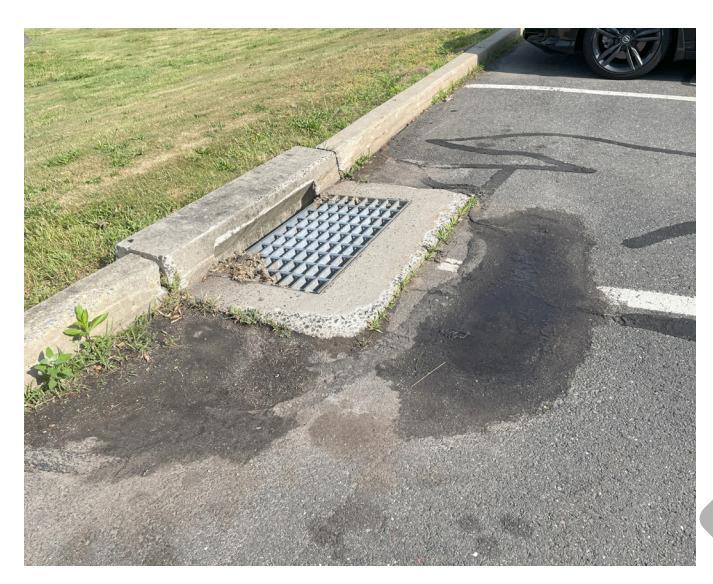
4. Location:

Parking Near Main Entry

Description:

Signs of pooling visible around drainage.

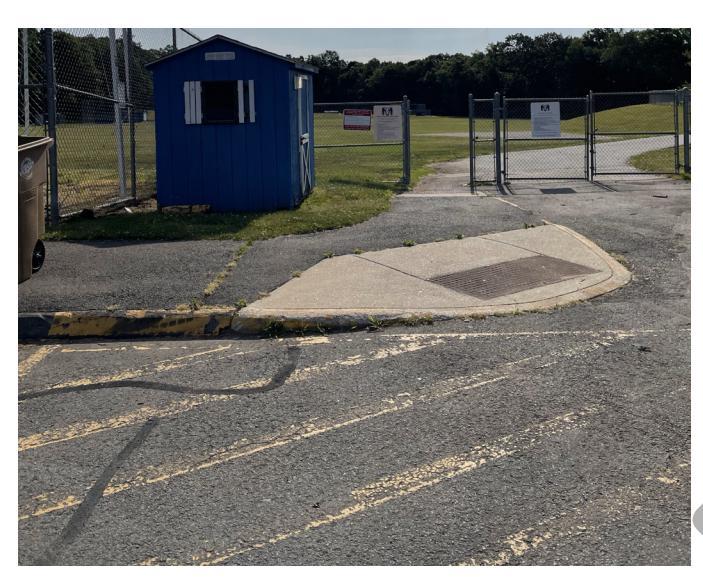
7. Location: North Parking Lot Description: Faded markings

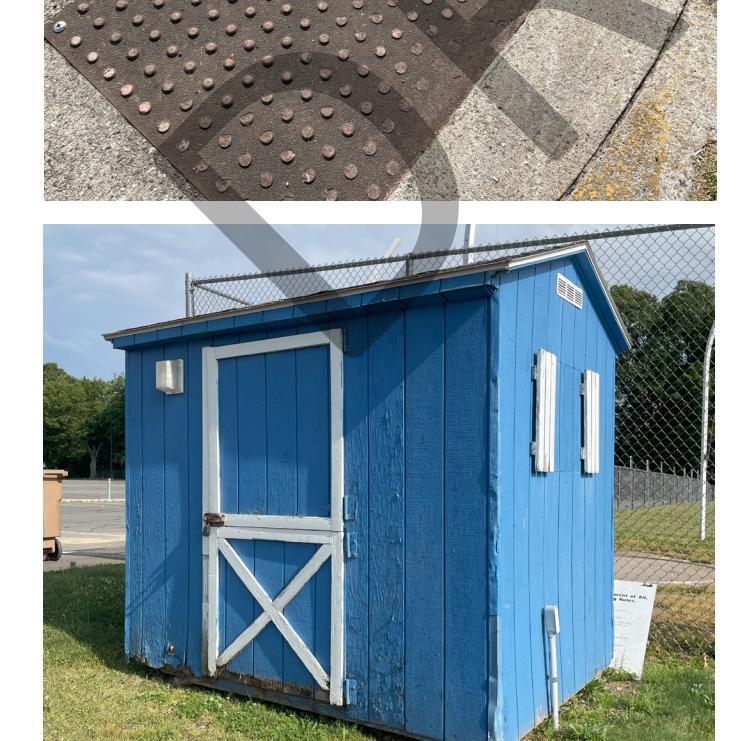
Description:

Deterioration of wood siding and frame clearly visible at storage shed.

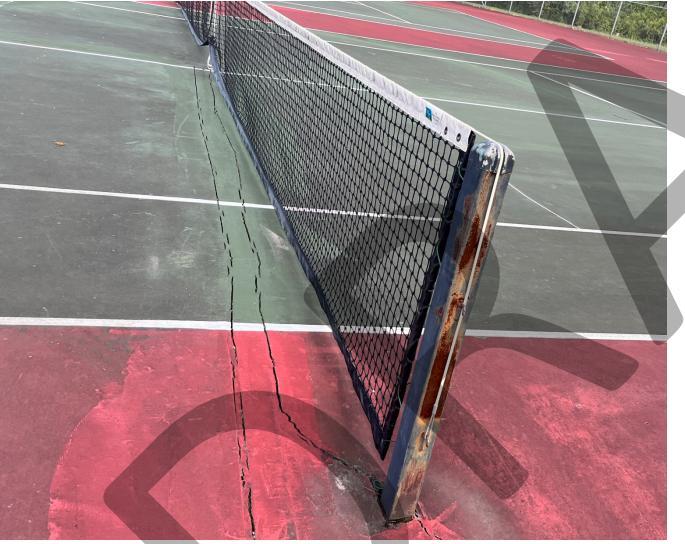
Description:

Cracked concrete around pole of fence

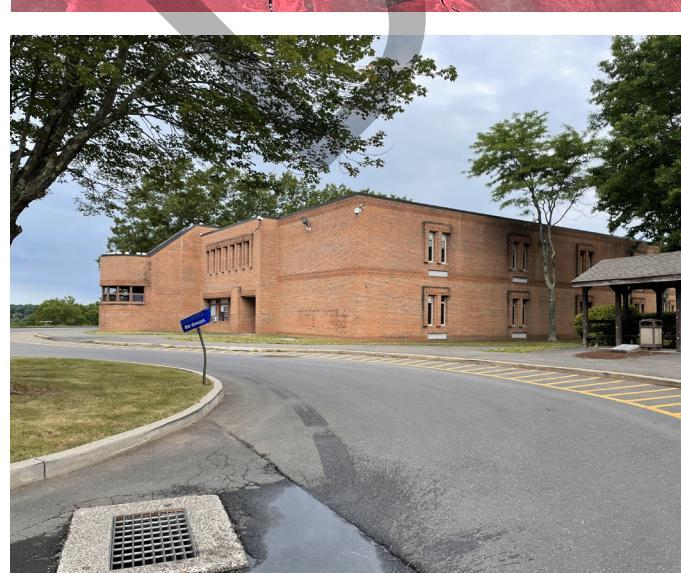
Water pooling around the drainage. Bent pole of newspaper box.

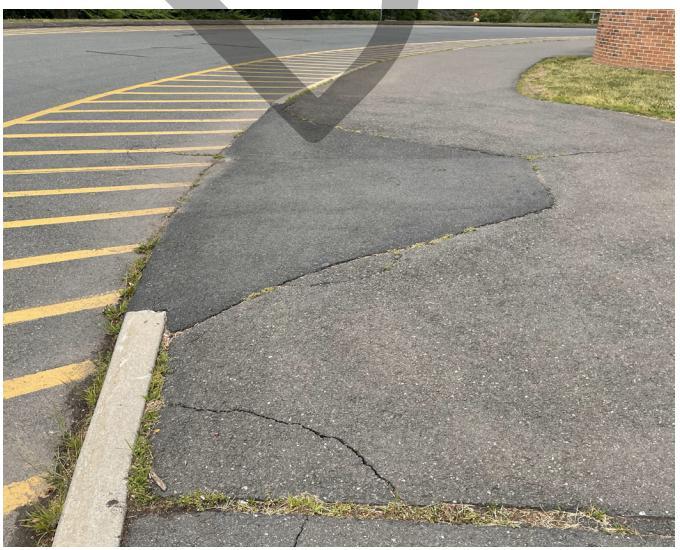
Description:

Cracks visible and weeds growing in cracks. Sloped area but no indication of accessibility.
