Facility Study and Master Plan

Northeast School

69 East St, Vernon, CT 06066

SUMMER 2023

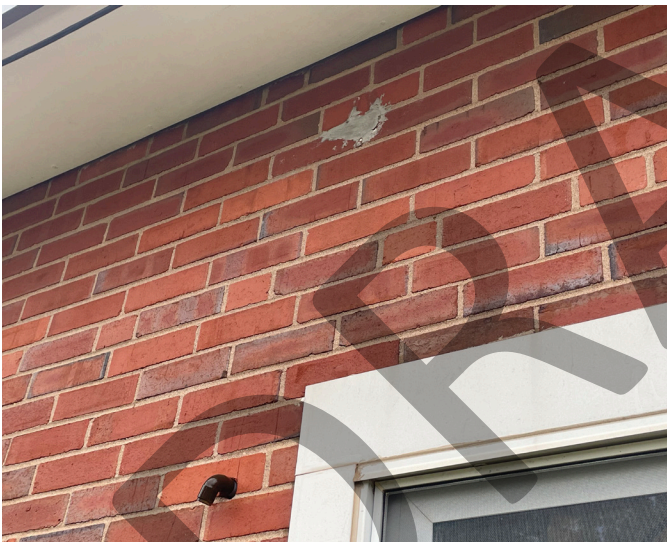
2. Location:

South Elevation

Area of infill at brick facade

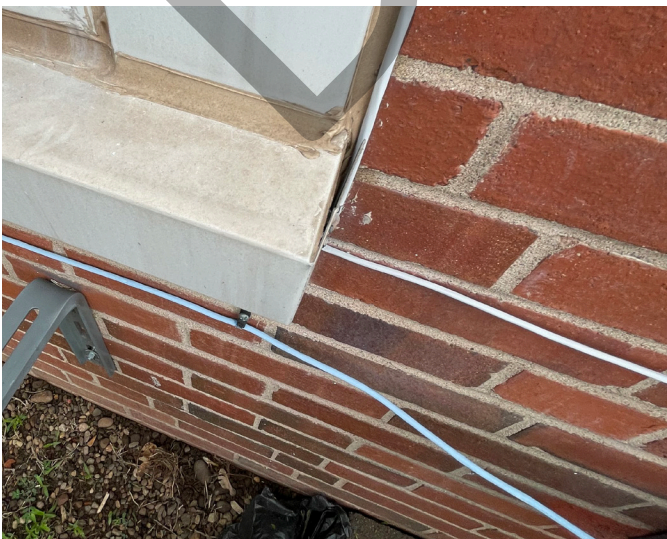
3. Location:

South Elevation

Vinyl sill pulling away from frame - various locations throughout building

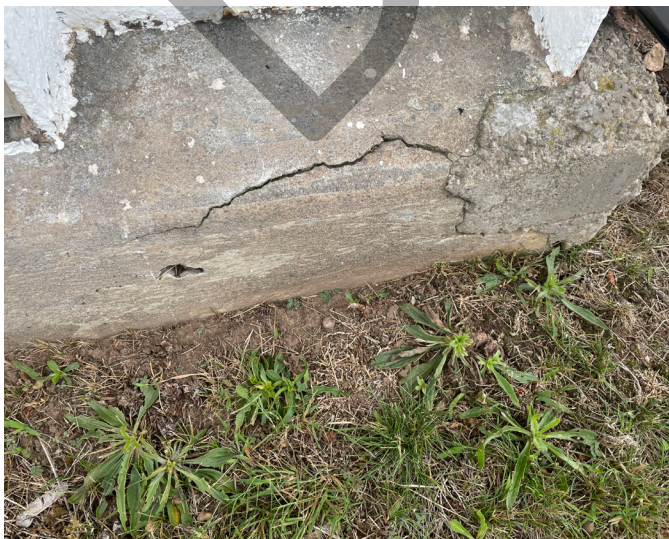
6. Location:

South Elevation

Minor cracking and repair at foundation

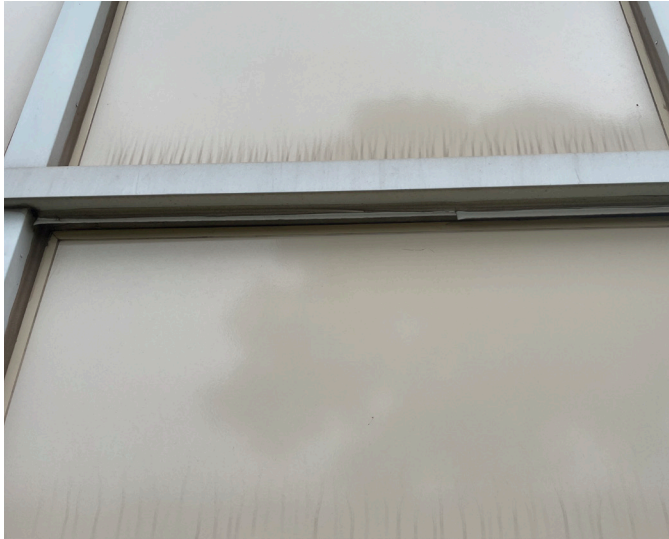
7. Location:

South Elevation

Discoloration of metal panels likely due to age and weather

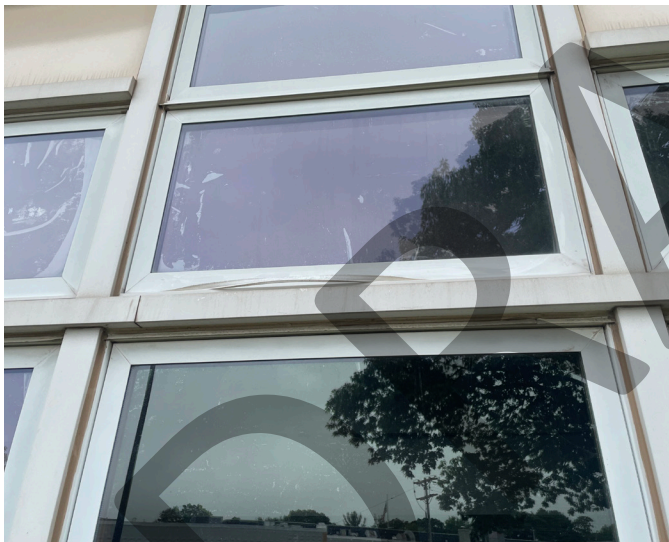
8. Location:

South Elevation

Windows appear to have a film which is bubbling in several locations.

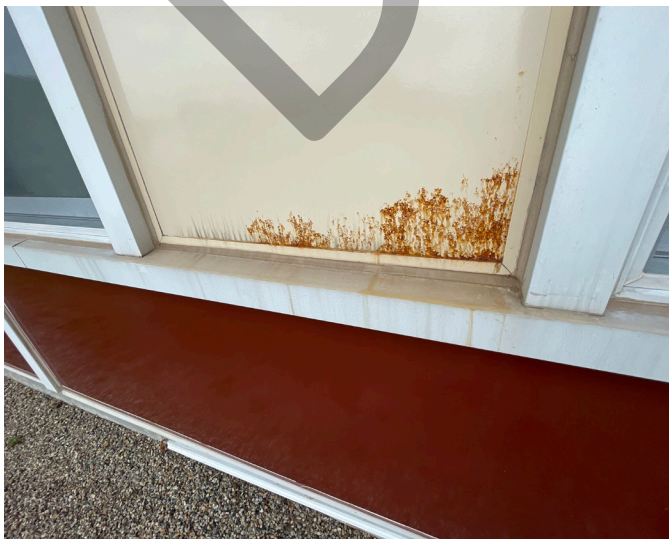
18. Location:

South Elevation

Many panels are rusted and need to be replaced to prevent further deterioration.

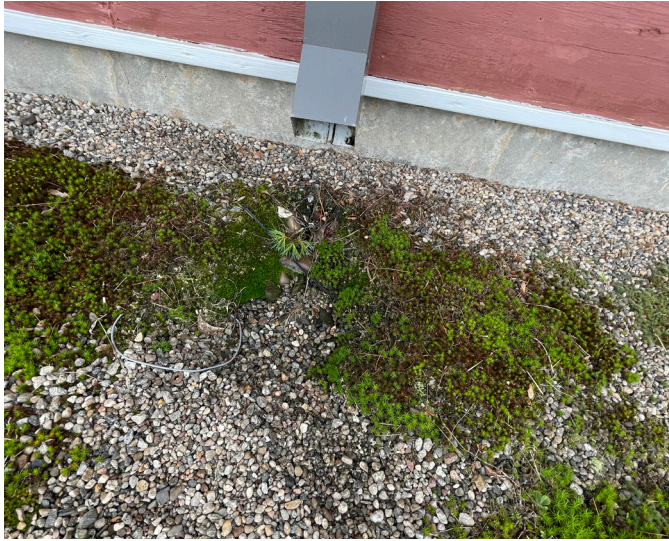
19. Location:

South Elevation

Typical downspout dispensing water directly to the ground in front of the building.

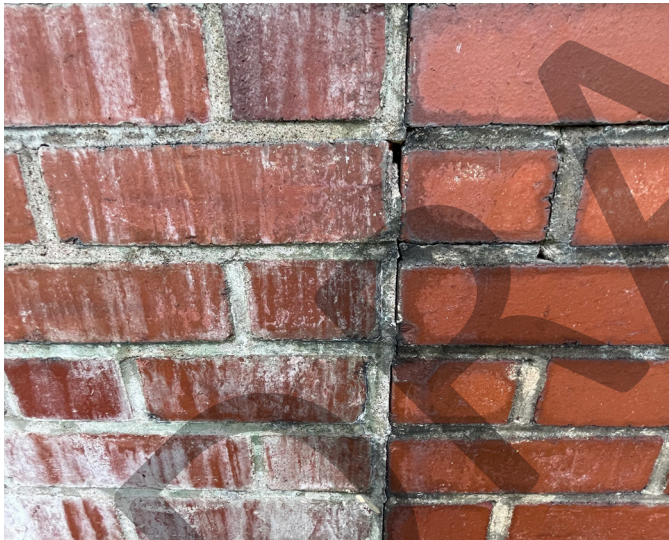
20. Location:

South Elevation

Efflorescence present on the brick. Repointing is needed in this location.

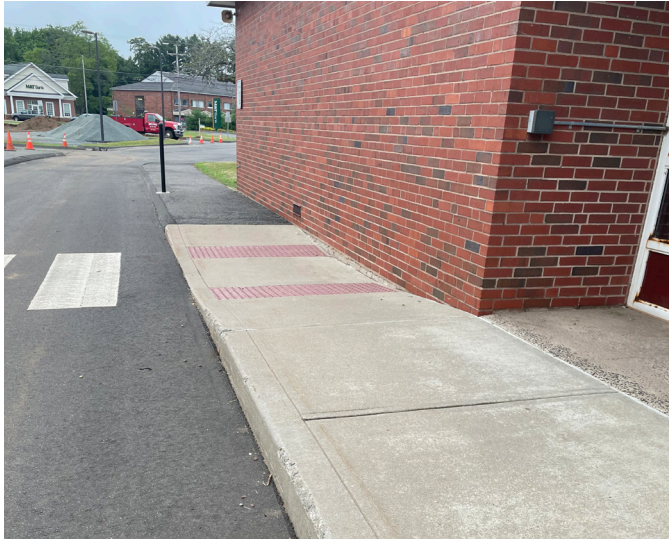
28. Location:

East Elevation

No signage or handrails at ramped area

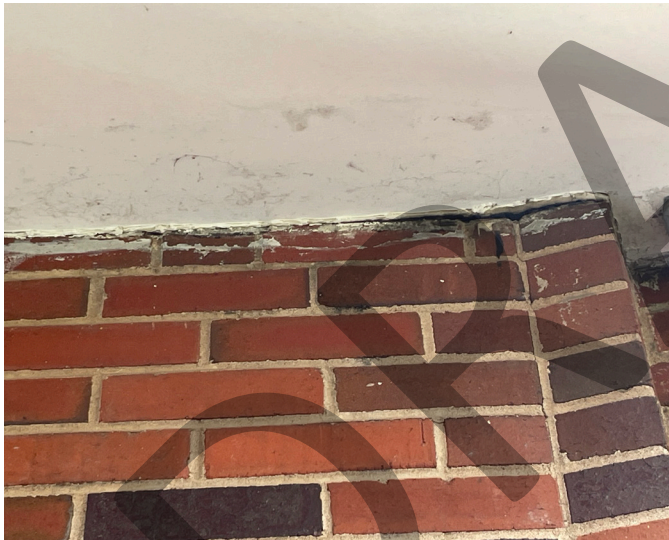
29. Location:

South Elevation - Vestibule

Gap between brick and soffit. Soffit needs to be refinished.

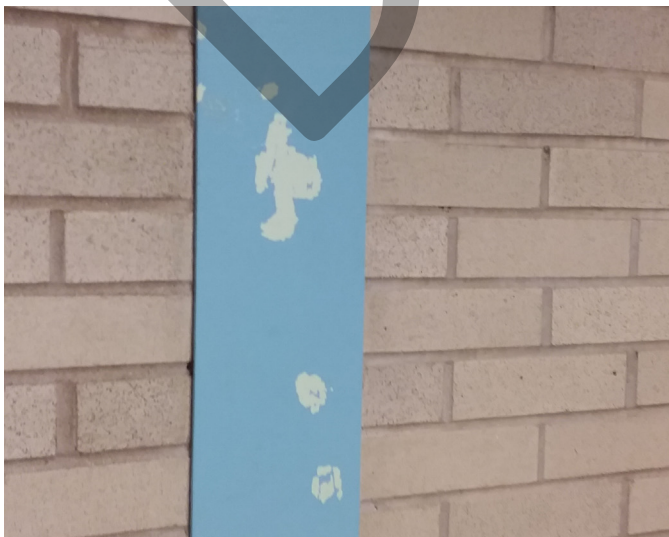
30. Location:

Corridor - East

Paint peeling and chipping off. Needs to be repainted.

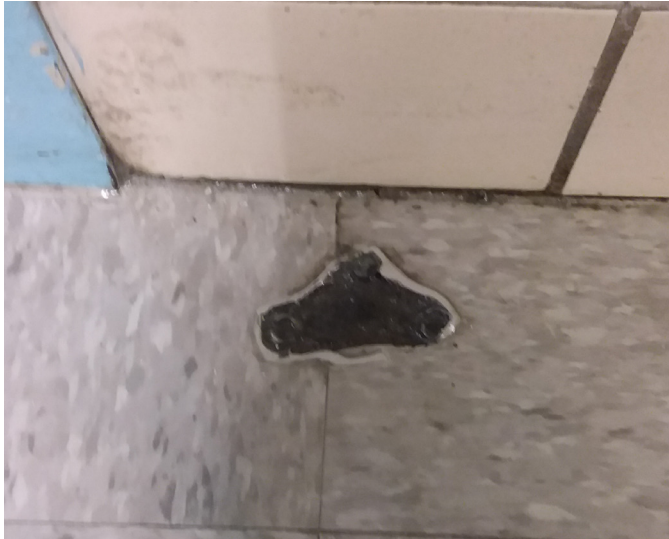
31. Location:

Corridor - East

Gouge in VCT exploding seafloor underneath.

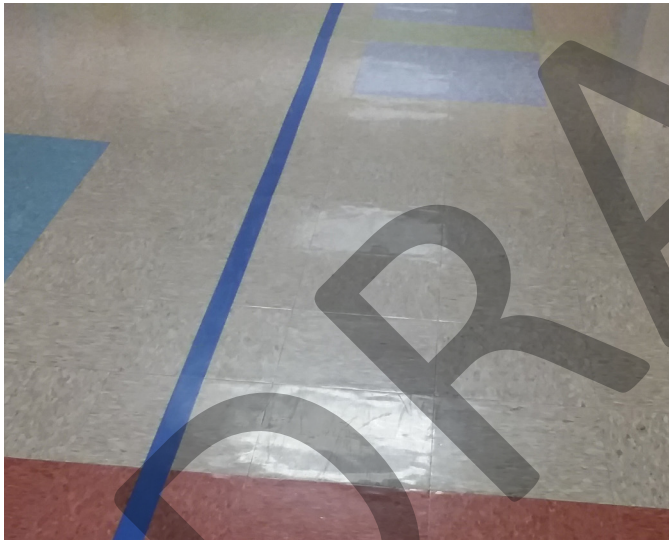
32. Location:

Corridor - East

VCT is bubbling and cracking in areas.

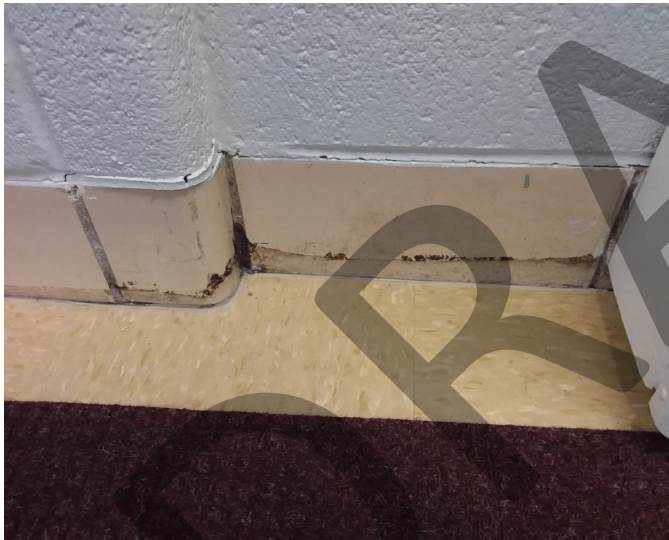
41. Location:

Main Office Suite

Wall base appears damaged and stained.

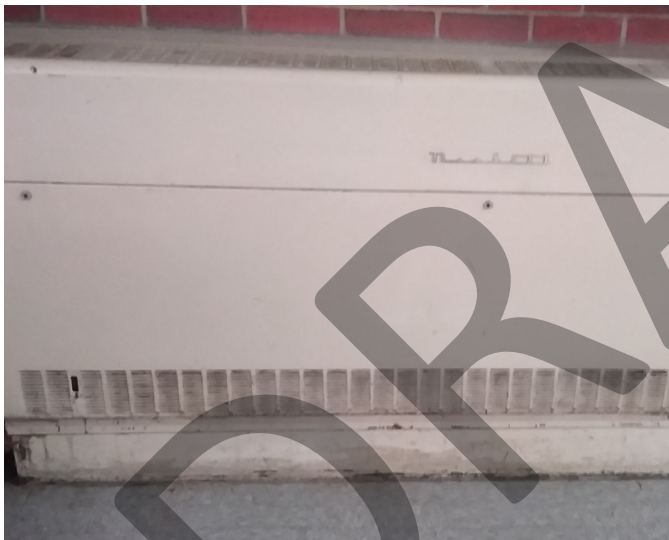
44. Location:

Cafeteria

Radiator has chipped paint and scuff marks. Needs to be repainted.

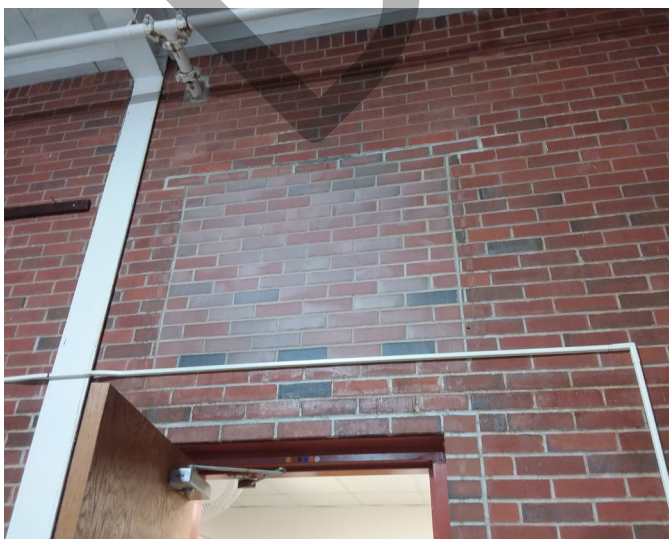
45. Location:

Cafeteria

Brick is faded and needs some cosmetic cleaning.

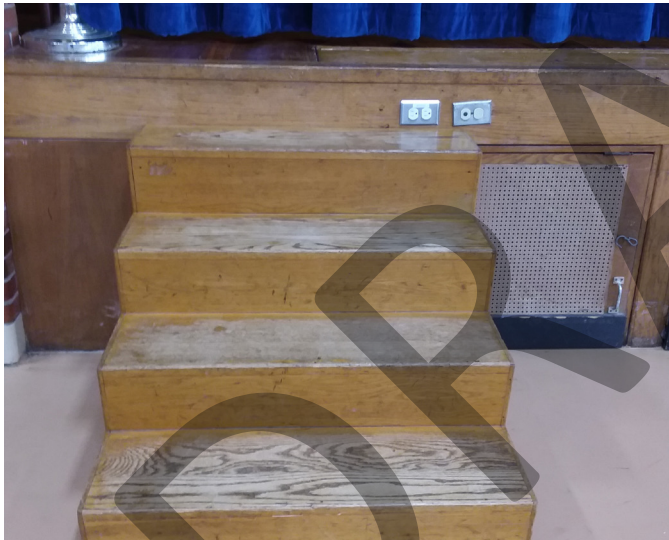
50. Location:

Gymnasium

Wood stairs up to stage are faded and scratched. Stairs need to be refinished and repaired.

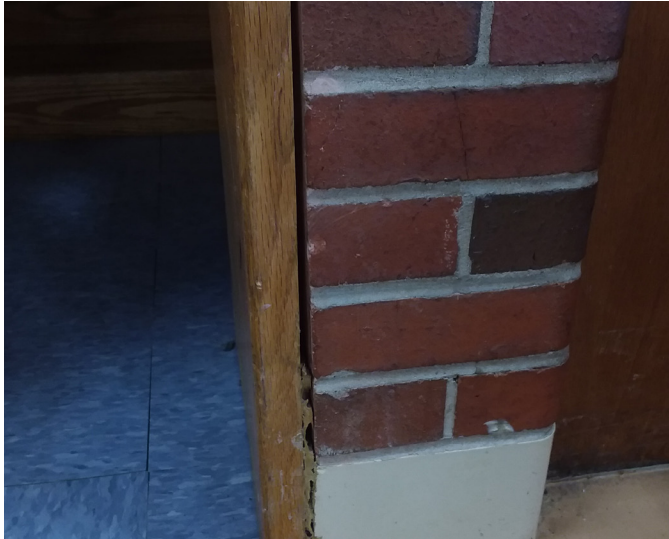
52. Location:

Gap between wood door frame and brick.

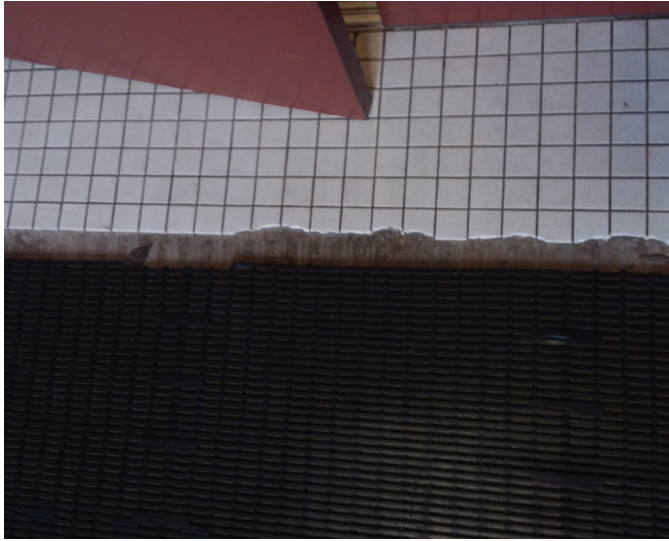
55. Location:

Floor tile is very damaged and some tile has been completely torn up.

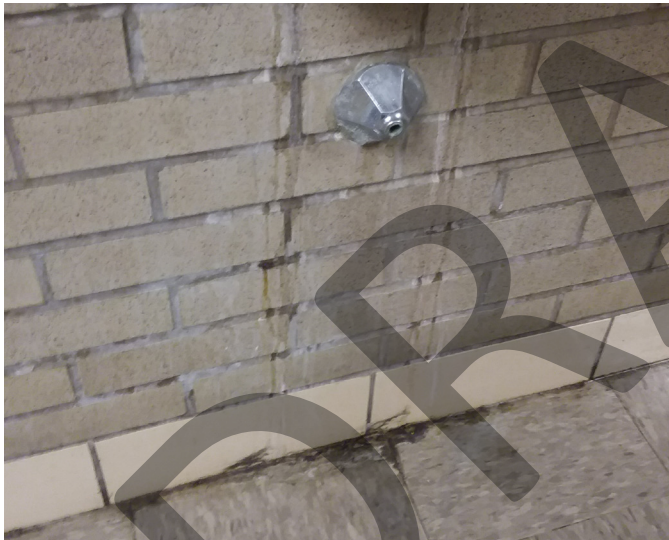
56. Location:

Water staining on brick and deterioration of some of VCT.

- Access areas with water damage on walls, floors and ceilings
- Repaint handrails as needed
- Repaint walls in areas where they are scuffed up.

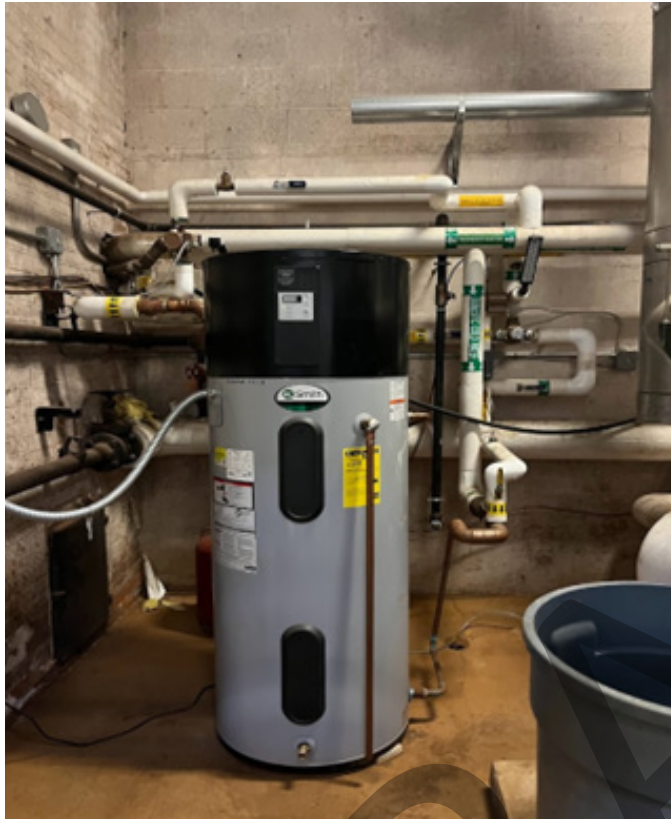
3. Location:

The domestic water in this building is heated using an electric heat pump water heater. This water heater is relatively newer as it was installed on 08/27/2018 and appears to be in fair condition with no signs of any damage.

Water Heater

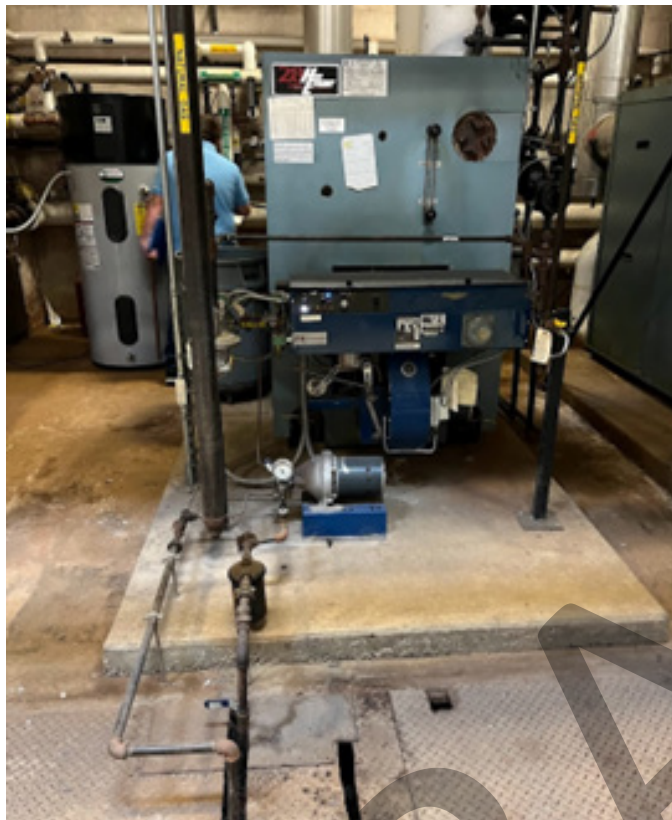
10. Location:

Heating system is served by cast iron mid-efficiency steam boilers with condensate system and duplex boiler feed pumps. The system is in fair condition and appears to be from 2008 (15 years old). Cast iron boiler system have an approximately 25 year life expectancy and while not near end of life we would recommend replacing with high efficiency condensing boilers for increased energy savings.

Gas Fired Cast Iron Boiler

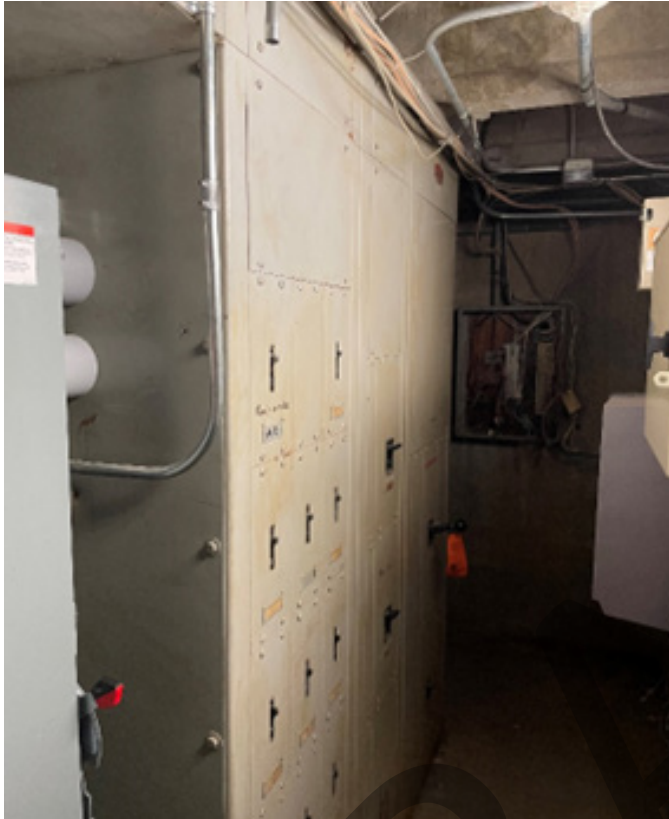
12. Location:

System	Condition	Comments
Main Service	Poor	Switchboard is Original to the Building and Past its Serviceable Lifespan.
Power Distribution	Poor	Older Equipment that is Original to the Building is Past its Serviceable Lifespan.
Life Safety Power	N/A	There is No Life Safety Power to the Building.
Emergency Power	N/A	There is No Emergency Power to the Building.
Transformers	N/A	There are No Distribution Transformers in the Building.
Grounding	Fair	Service Equipment Grounding, Where Observed, Appeared Undamaged and In Fair Condition.
Lightning Protection	N/A	There is No Lighting Protection System for the Building.

Main Switchboard

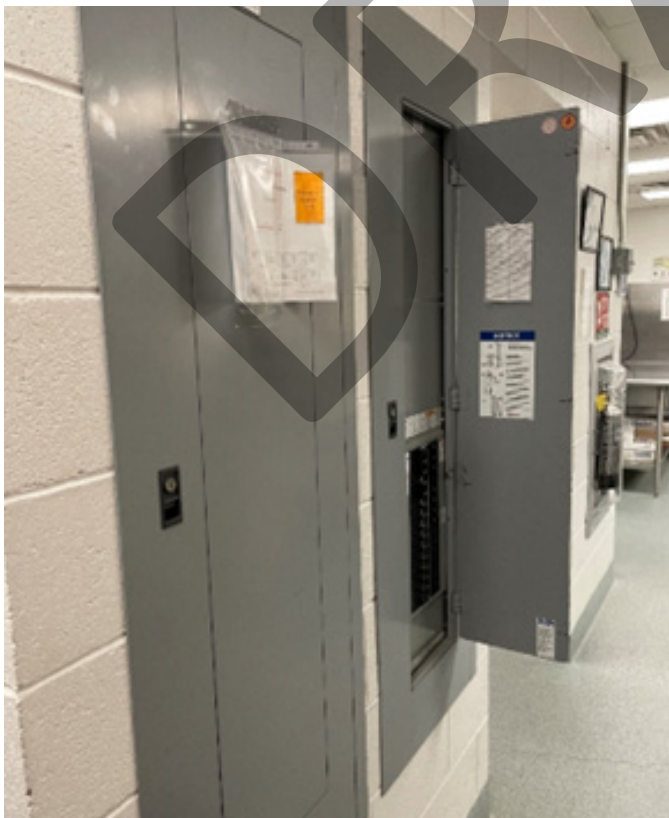
13. Location:

Branch circuit panelboards vary in age between those original to the building, which date from the early 1960's, to those installed as part of the 2008 renovations. Branch circuit wiring is in EMT/armored cable, where observed. Panels and equipment that are original to the building are in poor condition and in need of replacement.

New Replacement Branch Panel boards

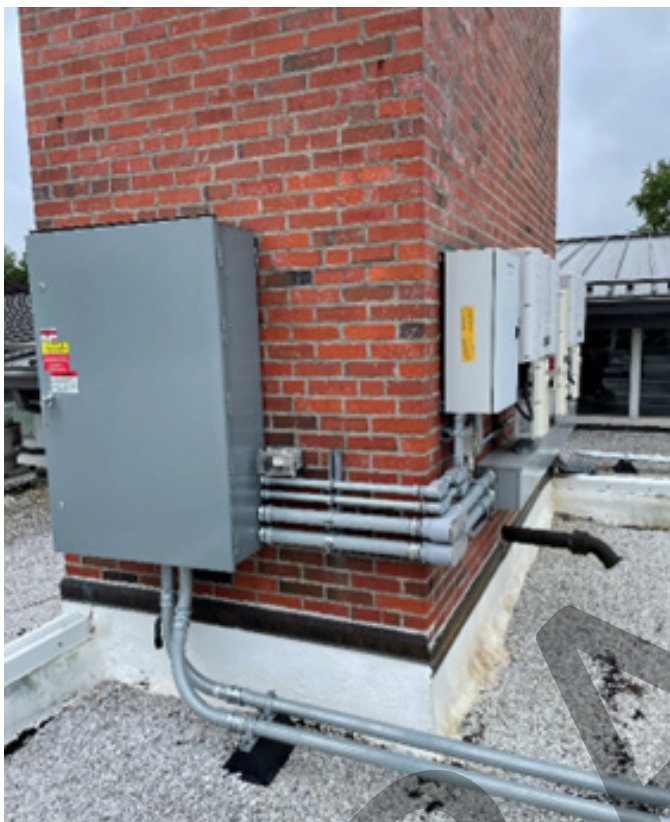
14. Location:

The PV system is of the grid connected type and does not include battery back-up storage or secondary electrical generation devices. The system utilizes roof mounted solar arrays and produces AC power at 208V into local services via inverters. Disconnects for the PV system are installed on the roof and in the main electrical room. The PV system meter is located outside the maintenance entrance, above the utility transformer vault. All PV system equipment is well maintained and in good condition.

PV System Disconnect and Inverters

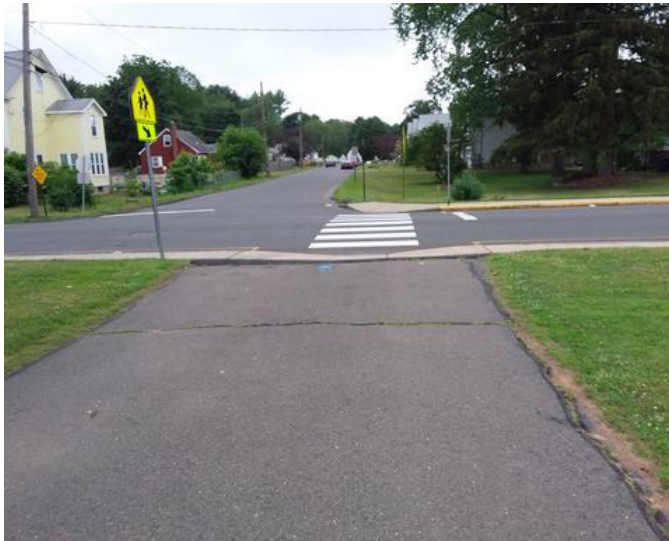
1. Location:

No tactile warning at designated school crosswalk to provide indications to the visually impaired.

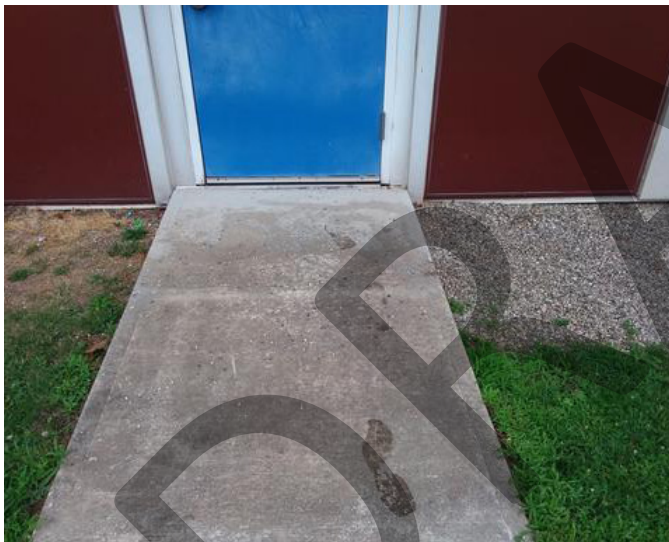
2. Location:

The landing provided does not have the proper width for an accessible door.

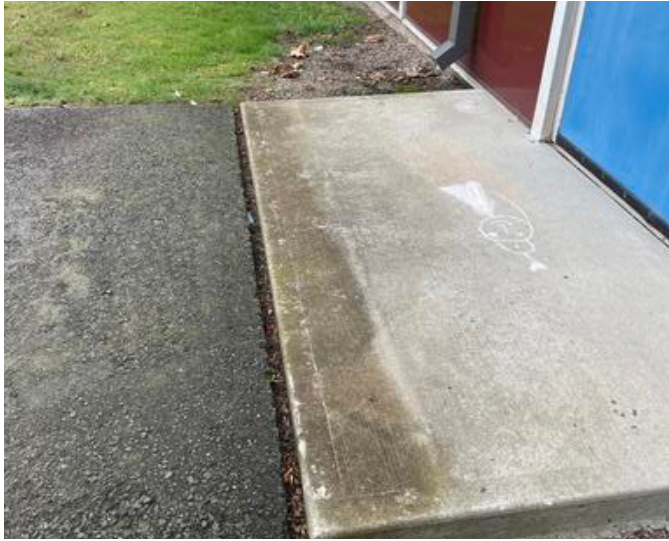
4. Location:

The gap between concrete landing and asphalt walkway is greater than 1/2" at door to classroom.

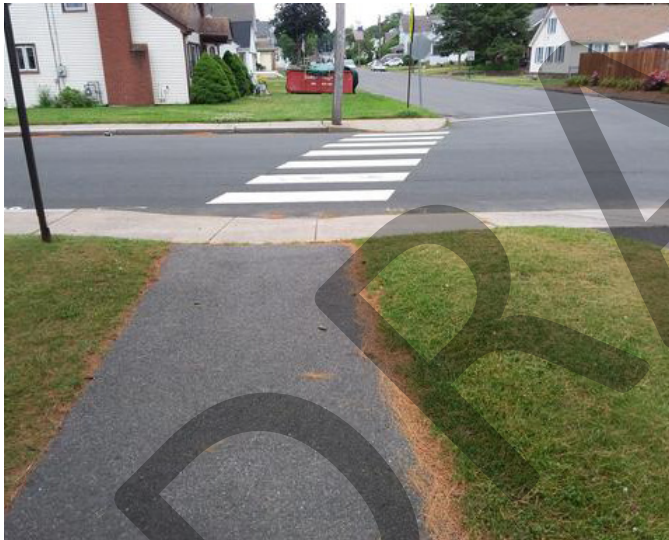
5. Location:

No tactile warning strip at crosswalk to provide indications to the visually impaired

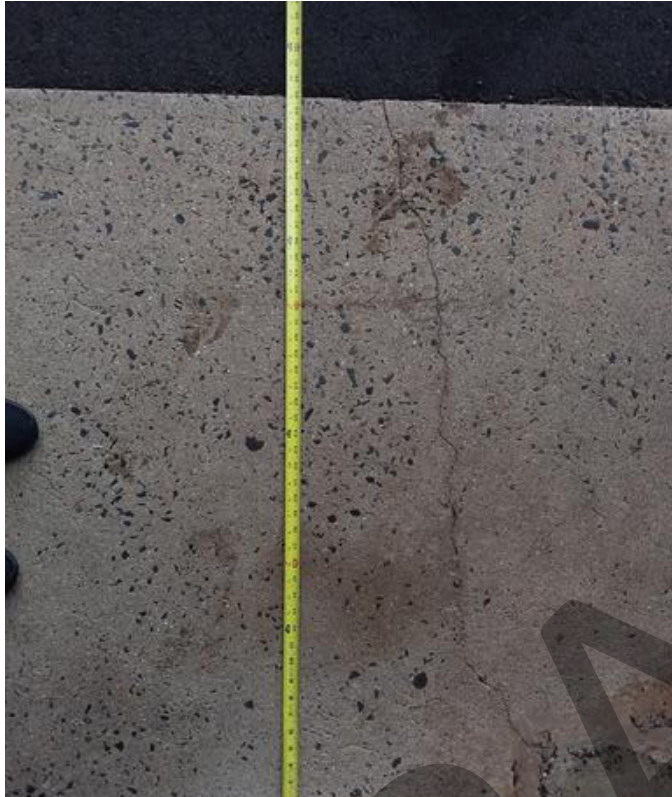
7. Location:

Exterior Door - South

The exterior landing is not the proper depth from the exit door.

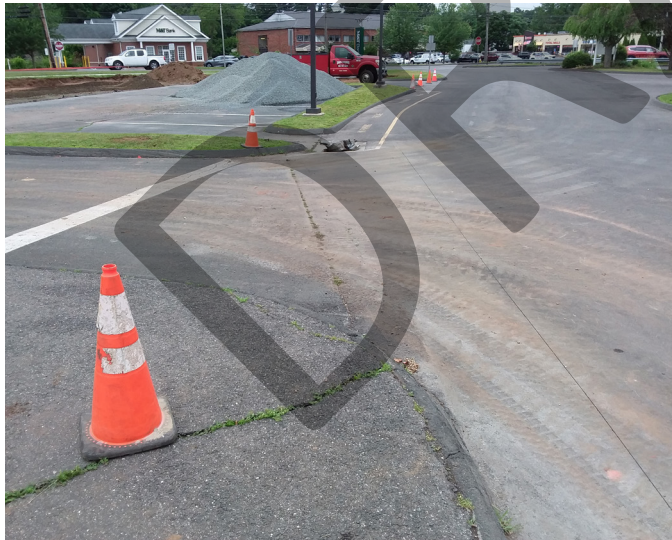
8. Location:

Exterior

The site access sidewalk does not have a curb ramp with a tactile warning strip.

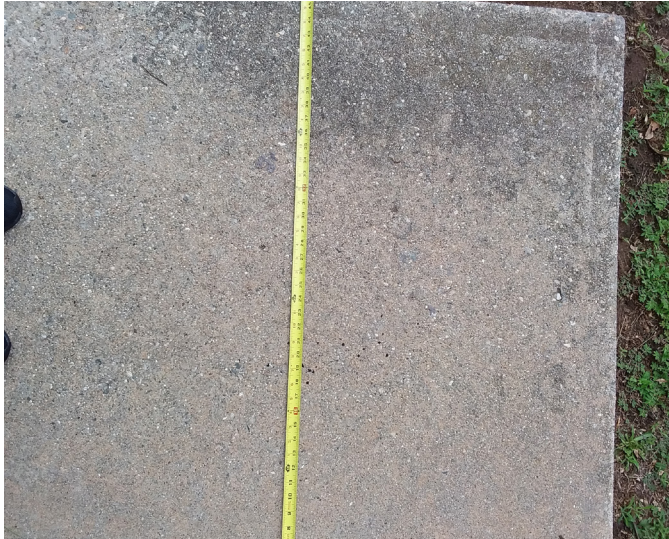
9. Location:

Exterior -South

The exterior landing is not the proper depth from the exit door.

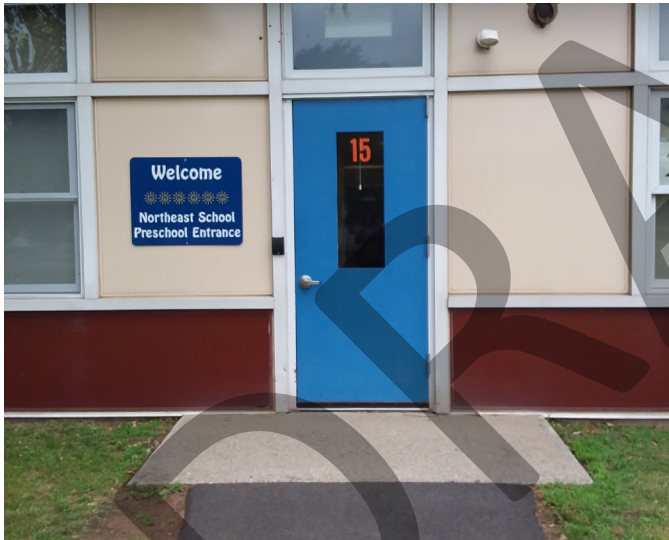
10. Location:

The signage does not indicate the entrance is accessible or direct visitors to the front entrance to the building.

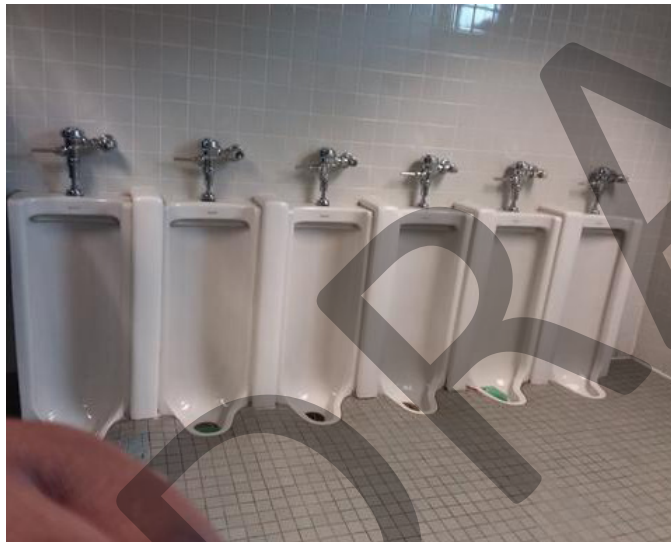
13. Location:

Entry #	Priority	Code Reference	Element	Item	Compliance Requirement	Readily Achievable	Pass/Fail	Photo Ref #	Plan Ref #	Notes	Cost to Fix
142		604.10.3	Toilet Compartments	Ambulatory Accessible Compartments: Doors	Toilet compartment doors, including door hardware, shall comply with 404, except that if the approach is to the latch side of the compartment door, the clearance between the door side of the compartment and any obstruction shall be 42 inches minimum. The door shall be self-closing. A door pull complying with 404.2.6 shall be placed on both sides of the door near the latch. Compartment doors shall not swing into the required minimum area of the compartment.	Y	F	43			
144		605.2	Urinals	Height and Depth	Urinals shall be the stall-type or shall be of the wall hung type with the rim 17 inches maximum above the floor. Wall hung urinals shall be 13½ inches minimum in depth measured from the outer face of the urinal rim to the wall.	Y	F	13

Boys Restroom

The urinals are very old and do not provide the proper height, screens, and accessible width.

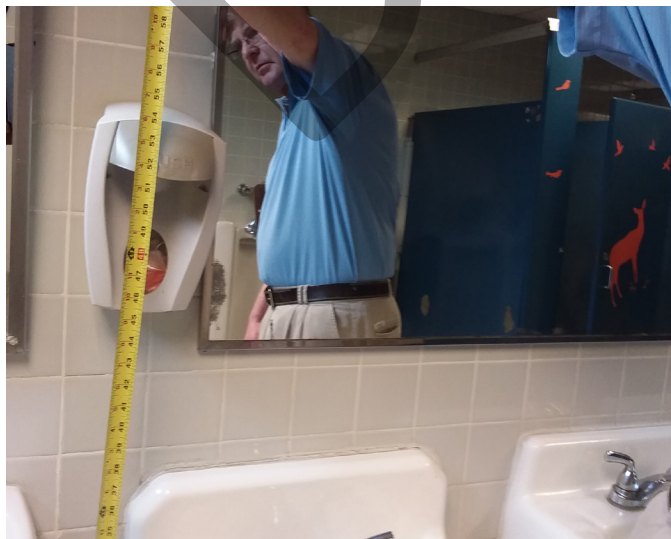
14. Location:

Entry #	Priority	Code Reference	Element	Item	Compliance Requirement	Readily Achievable	Pass/Fail	Photo Ref #	Plan Ref #	Notes	Cost to Fix
134		604.4	Water Closets	Seat Height	The seat height of a water closet shall be 17 inches minimum and 19 inches maximum above the floor, measured to the top of the seat. Seats shall not be sprung to return to a lifted position. EXCEPTION: A water closet in a toilet room for a single occupant, accessed only through a private office and not for common use or public use, shall not be required to comply with Section 604.4.	Y	F	42			
136		604.7	Water Closets	Dispensers	Toilet paper dispensers shall comply with 309.4. Where the dispenser is located above the grab bar, the outlet of the dispenser shall be located within an area 24 inches minimum and 36 inches maximum from the rear wall. Where the dispenser is located below the grab bar, the outlet of the dispenser shall be located within an area 24 inches minimum and 42 inches maximum from the rear wall. The outlet of the dispenser shall be located 18 inches minimum and 48 inches maximum above the floor. Dispensers shall comply with Section 609.3. Dispensers shall not be of a type that control delivery, or do not allow continuous paper flow.	Y	F	14

Boy Restroom

The height of the operable part of the soap dispenser is greater than 48 inches.

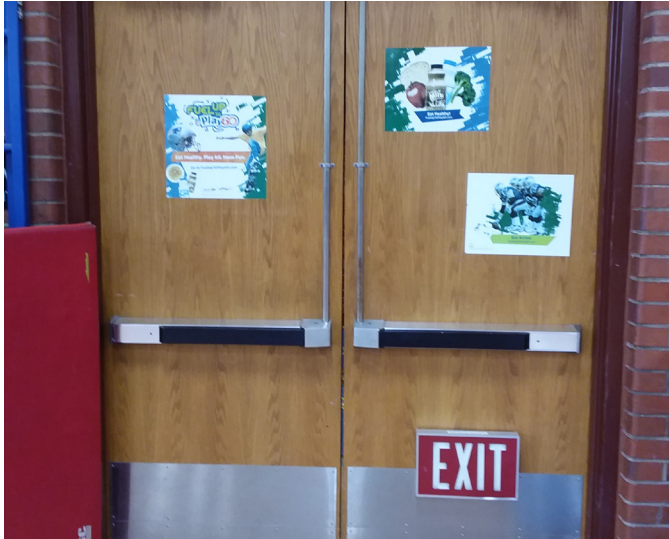
15. Location:

Gymnasium

One of the door leaves is required to be a 36" wide leaf.

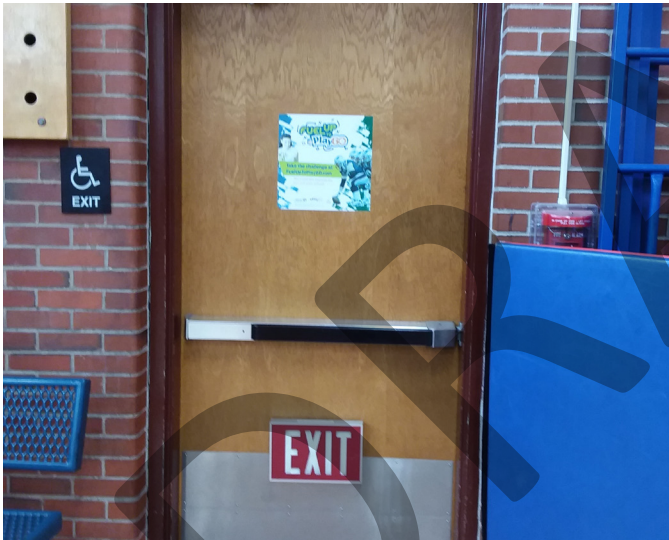
16. Location:

Gymnasium

Exit signs for exiting should not be mounted to the door

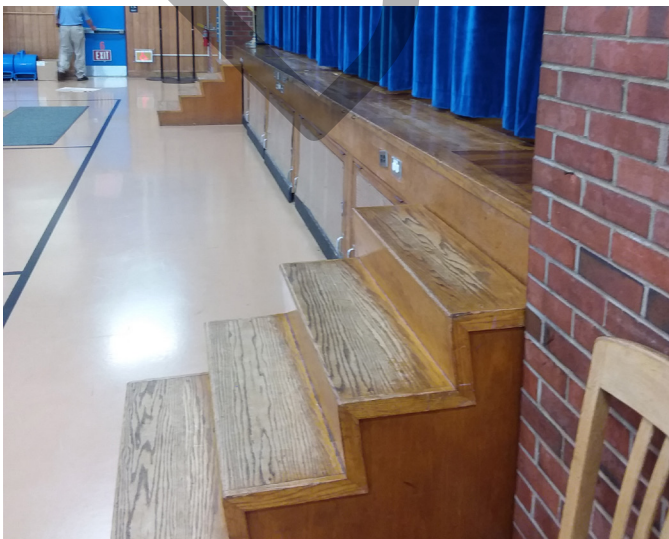
17. Location:

Entry #	Priority	Code Reference	Element	Item	Compliance Requirement	Readily Achievable	Pass/Fail	Photo Ref #	Plan Ref #	Notes	Cost to Fix
49		402.2	Ramps	Components	Accessible routes shall consist of one or more of the following components: walking surfaces with a slope not steeper than 1:20, doors and doorways, ramps, curb ramps excluding the flared sides, elevators, and platform lifts. All components of an accessible route shall comply with the applicable portions of this standard.	Y	F	2			
73		504.2	Stairways	Treads and Risers	All steps on a flight of stairs shall have uniform riser height and uniform tread depth. Risers shall be 4 inches (100mm) minimum and 7 inches (180mm) maximum in height. Treads shall be 11 inches (280mm) minimum in depth.	Y	F	17		Stage	
75		504.5	Stairways	Nosings	The radius of curvature at the leading edge of the tread shall be ½ inch (13mm) maximum. Nosings that project beyond risers shall have the underside of the leading edge curved or beveled. Risers shall be permitted to slope under the tread at an angle of 30 degrees maximum from vertical. The permitted projection of the nosing shall extend 1½ inches (38mm) maximum over the tread or floor below.	Y	F	17

Gymnasium -stage

Stairs leading to stage do not have railings on either side of the stair, consistent stair tread widths and riser heights.

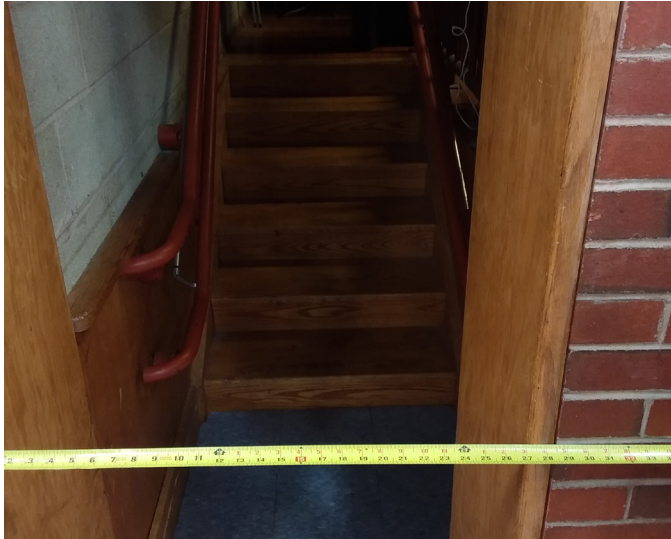
18. Location:

Gymnasium - stage

The clear opening width leading to stairs is 28". The opening should be as wide as the stair, a 36" wide door opening or a 34" clear cased opening.

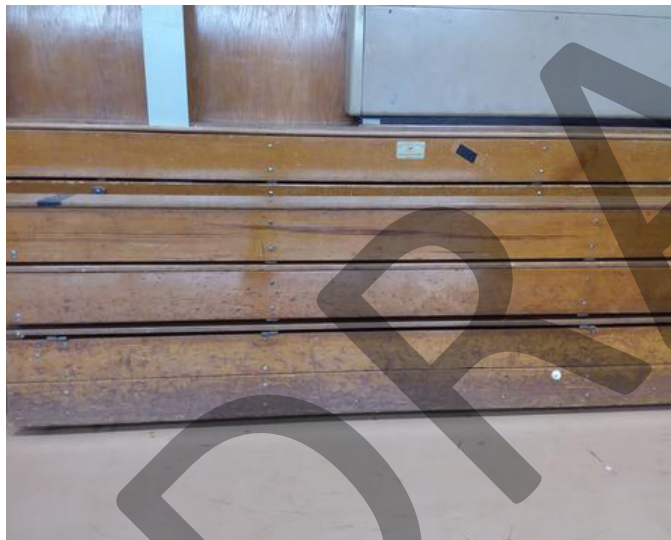
19. Location:

Entry #	Priority	Code Reference	Element	Item	Compliance Requirement	Readily Achievable	Pass/Fail	Photo Ref #	Plan Ref #	Notes	Cost to Fix
215		802.3	Assembly Areas	Wheelchair Spaces: Width	A single wheelchair space shall be 36 inches minimum in width. Where two adjacent wheelchair spaces are provided, each wheelchair space shall be 33 inches minimum in width.	Y	F	19			
219		802.7	Assembly Areas	Companion Seats	A companion seat, complying with Section 802.7, shall be provided beside each wheelchair space.	Y	F	19

Bleachers need to be upgraded or replaced to provide accessible seating areas.

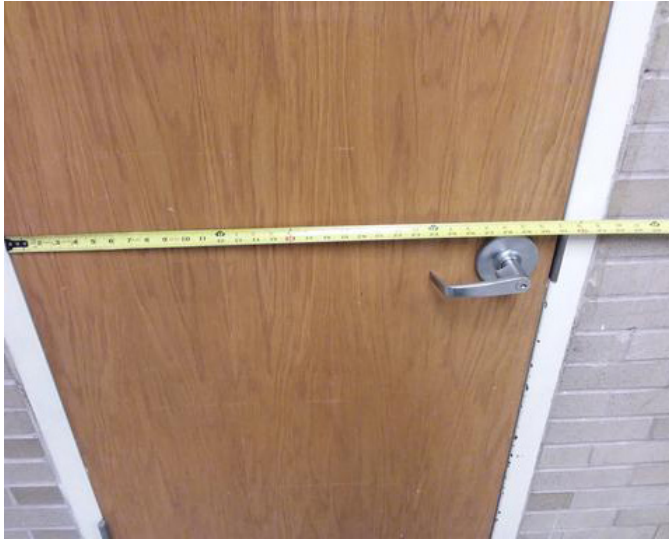
21. Location:

Door from stage to Corridor

The clear width of the door does not meet r to stage stairs measuring 31"

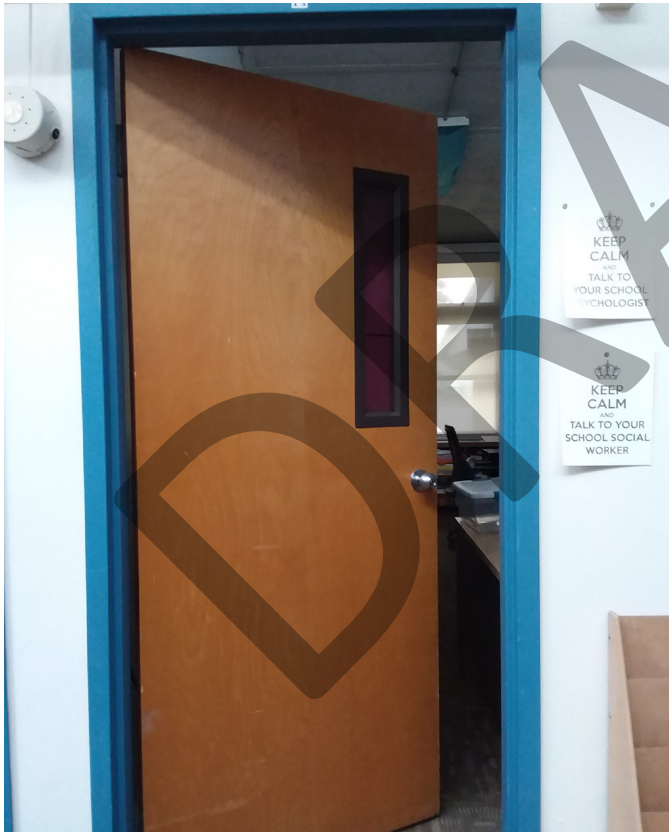
22. Location:

Entry #	Priority	Code Reference	Element	Item	Compliance Requirement	Readily Achievable	Pass/Fail	Photo Ref #	Plan Ref #	Notes	Cost to Fix
186		704.2.4	Telephones	Wheelchair Accessible Telephones: Cord Length	The telephone handset cord shall be 29 inches minimum in length.	Y	F	24			
191		703.1	Signage	General	Accessible signs shall comply with Section 703. Tactile signs shall contain both raised characters and braille. Where signs with both visual and raised characters are required, either one sign with both visual and raised characters, or two separate signs, one with visual, and one with raised characters, shall be provided.	Y	F	22			
192		703.1.1	Signage	Designations	Interior and exterior signs identifying permanent rooms and spaces shall comply with sections 703.1, 703.2, and 703.3. EXCEPTION: Exterior signs that are not located at the door to the space they serve shall not be required to comply with 703.3.	Y	F	6, 10, 22

Entry #	Priority	Code Reference	Element	Item	Compliance Requirement	Readily Achievable	Pass/Fail	Photo Ref #	Plan Ref #	Notes	Cost to Fix
193		703.3	Signage	Raised Characters	<p>Raised characters shall comply with 703.3 and shall be duplicated in braille complying with 703.4.</p> <p>703.3.2 Depth: Raised characters shall be 1/32 inch minimum above their background. 703.3.3 Case: Characters shall be uppercase. 703.3.4 Style: Characters shall be sans serif. Characters shall not be italic, oblique, script, highly decorative, or of other unusual forms. 703.3.6 Character Proportions: The uppercase letter "O" shall be used to determine the allowable width of all characters of a font. The width of the uppercase letter "O" of the font shall be 55 percent minimum and 110 percent maximum of the height of the uppercase letter "I" of the font. 703.3.5 Character Height: The uppercase letter "I" shall be used to determine the allowable height of all characters of a font. The height of the uppercase letter "I" of the font, measured vertically from the baseline of the character, shall be 5/8 inch minimum and 2 inches maximum. <u>EXCEPTION:</u> Where separate raised and visual characters with the same information are provided, the height of the raised uppercase letter "I" shall be permitted to be 1/2 inch minimum.</p>	Y	F	6, 10, 22

Entry #	Priority	Code Reference	Element	Item	Compliance Requirement	Readily Achievable	Pass/Fail	Photo Ref #	Plan Ref #	Notes	Cost to Fix
194		703.3	Signage	Raised Characters	703.2.6 Stroke Thickness: The stroke width shall be 15 percent maximum of the height of the uppercase letter "i" measured at the top surface of the character and 30 percent maximum of the height of the uppercase letter "I" measured at the base of the character. 703.3.8 Character Spacing: Character spacing shall be measured between the two closest points of adjacent raised characters within a message, excluding word spaces. Spacing between individual raised characters shall be 1/8 inch minimum measured at the top surface of the characters, 1/16 inch minimum measured at the base of the characters, and 4 times the raised character stroke width maximum. Characters shall be separated from raised borders and decorative elements 3/8 inch minimum. 703.3.9 Line Spacing: Spacing between the baselines of separate lines of raised characters within a message shall be 135 percent minimum and 170 percent maximum of the raised character height.	Y	F	6, 10, 22

Entry #	Priority	Code Reference	Element	Item	Compliance Requirement	Readily Achievable	Pass/Fail	Photo Ref #	Plan Ref #	Notes	Cost to Fix
195		703.4	Signage	Braille	703.4.3 Dimensions: Braille dots shall have a domed or rounded shape and shall comply with Table 703.4.3. 703.4.2 Uppercase Letters: The indication of an uppercase letter or letters shall only be used before the first word of sentences, proper nouns and names, individual letters of the alphabet, initials, and acronyms. 703.4.4 Position: Braille shall be below the corresponding text. If text is multi-lined, braille shall be placed below the entire text. Braille shall be separated 3/8 inch minimum from any other raised characters and 3/8 inch minimum from raised borders and decorative elements. Braille provided on elevator car controls shall be separated 3/16 inch minimum and shall be located either directly below or adjacent to the corresponding raised characters or symbols.	Y	F	6, 10, 22

Office Suite

The entrance door is not provided with room signage.

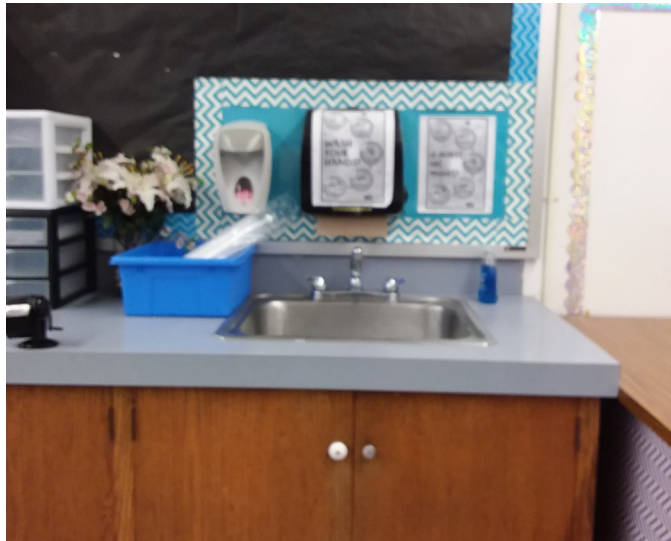
23. Location:

Entry #	Priority	Code Reference	Element	Item	Compliance Requirement	Readily Achievable	Pass/Fail	Photo Ref #	Plan Ref #	Notes	Cost to Fix
42		308.2.2	Access Route Interior	Forward Reach: Obstructed High Reach	Where a high forward reach is over an obstruction, the clear floor space complying with Section 305 shall extend beneath the element for a distance not less than the required reach depth over the obstruction. The high forward reach shall be 48 inches (1220 mm) maximum above the floor where the reach depth is 20 inches (510 mm) maximum. Where the reach depth exceeds 20 inches (510 mm), the high forward reach shall be 44 inches (1120 mm) maximum above the floor and the reach depth shall be 25 inches (635 mm) maximum.	Y	F	14			
43		309.4	Access Route Interior	Operable Parts: Operation	Operable parts shall be operable with one hand and shall not require tight grasping, pinching, or twisting of the wrist. The force required to activate operable parts shall be 5 pounds (22.2 N) maximum. EXCEPTION: Gas pump nozzles shall not be required to provide operable parts that have an activating force of 5 pounds (22.2 N) maximum.	Y	F	23		Sink Controls

Entry #	Priority	Code Reference	Element	Item	Compliance Requirement	Readily Achievable	Pass/Fail	Photo Ref #	Plan Ref #	Notes	Cost to Fix
151		606.2, 305, 306	Lavatories / Sinks	Clear Floor Space	A clear floor space complying with 305.3, positioned for a forward approach, shall be provided. Knee and toe clearance complying with 306 shall be provided. The dip of the overflow shall not be considered in determining knee and toe clearances. EXCEPTIONS: 1. A parallel approach complying with 305 and centered on the sink, shall be permitted to a kitchen sink in a space where a cook top or conventional range is not provided. 2. The requirement for knee and toe clearance shall not apply to a lavatory in a toilet or bathing facility for a single occupant, accessed only through a private office and not for common use or public use. 3. A knee clearance of 24 inches minimum above the floor shall be permitted at lavatories and sinks used primarily by children 6 through 12 years where the rim or counter surface is 31 inches maximum above the floor. 4. A parallel approach complying with 305 and centered on the sink, shall be permitted at lavatories and sinks used primarily by children 5 years and younger. 5. The requirement for the knee and toe clearance shall not apply to more than one bowl of a multibowl sink. 6. A parallel approach complying with Section 305 and centered on the sink, shall be permitted at wet bars.	Y	F	23

Entry #	Priority	Code Reference	Element	Item	Compliance Requirement	Readily Achievable	Pass/Fail	Photo Ref #	Plan Ref #	Notes	Cost to Fix
204		902.2	Dining Surfaces and Work Surfaces	Clear Floor Space	A clear floor space complying with Section 305, positioned for a forward approach, shall be provided. Knee and toe clearance complying with Section 306 shall be provided. EXCEPTIONS: 1. At drink surfaces 12 inches or less in depth, knee and toe space shall not be required to extend beneath the surface beyond the depth of the drink surface provided. 2. Dining surfaces that are 15 inches minimum and 24 maximum in height are permitted to have a clear floor space complying with Section 305 positioned for a parallel approach.	Y	F	23			
206		902.5	Dining Surfaces and Work Surfaces	Dining Surfaces and Work Surfaces for Children's Use	Accessible dining surfaces and work surfaces primarily for children's use shall comply with 902.5. EXCEPTION: Dining surfaces and work surfaces that are used primarily by children ages 5 and younger shall not be required to comply with Section 902.5 where a clear floor space complying with Section 305 is provided for a parallel approach. 902.5.1 Clear Floor Space: A clear floor space complying with Section 305, positioned for forward approach, shall be provided. Knee and toe clearance complying with Section 306 shall be provided, EXCEPTION: A knee clearance 24 inches minimum above the floor shall be permitted. 902.4.2 Height: The tops of tables and counters shall be 26 inches minimum and 30 inches maximum above the floor.	Y	F	23

Typical Classroom

Sink is not provided with knee clearance for accessibility and the controls are non compliant.

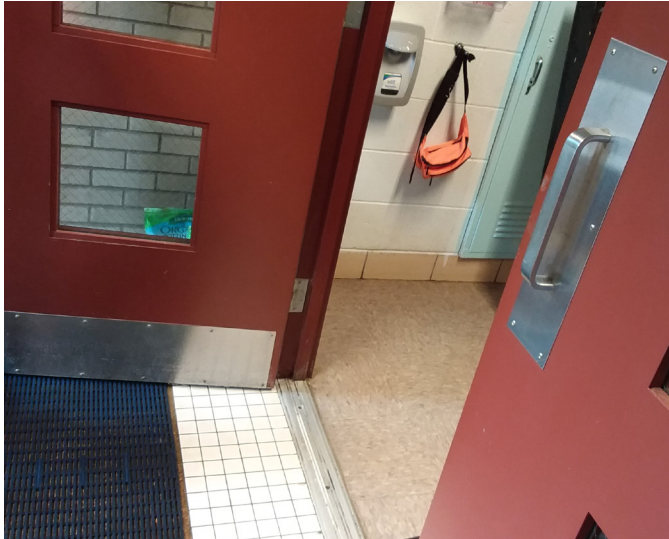
25. Location:

Vestibule

The vestibule mat is not secured to the floor creating a trip hazard.

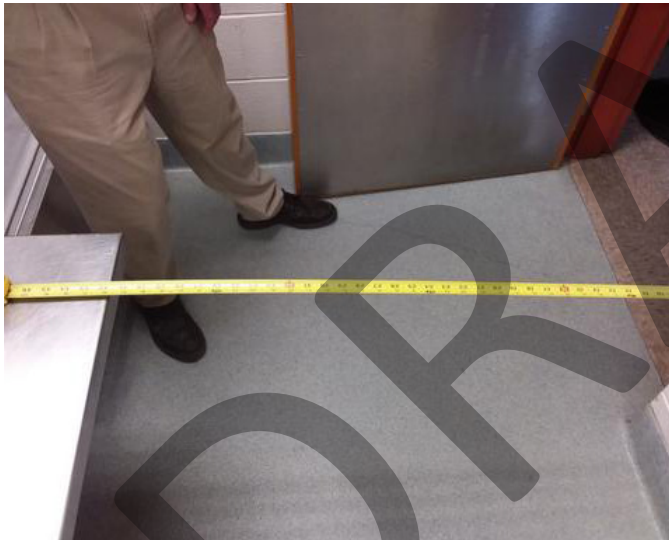
26. Location:

Kitchen

The maneuvering clearance at the entrance door to the servery is not compliant due to the location of the serving counter.
