Facility Study and Master Plan

Northeast School

69 East St, Vernon, CT 06066

SUMMER 2023

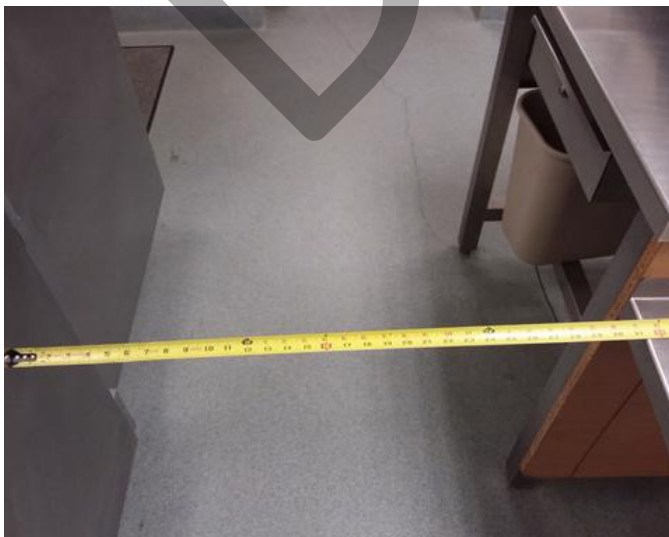
27. Location:

Kitchen

The clear width of the passage is less than the required. The current clearance restricts access to an exit.

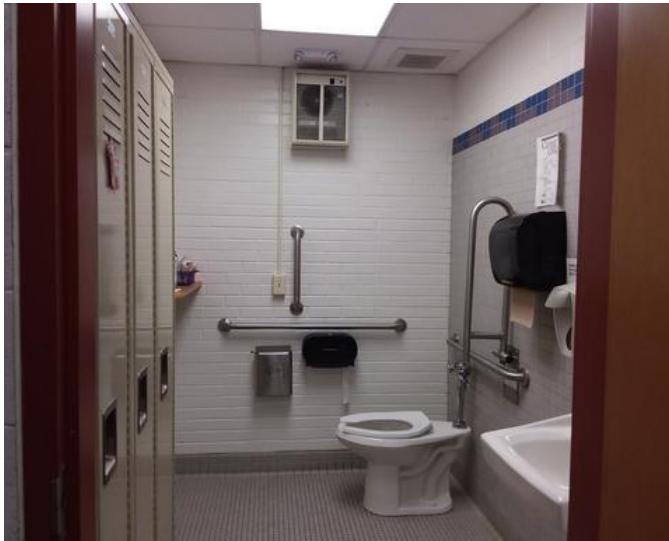
28. Location:

The installation of lockers within the toilet room inhibit the maneuvering clearances within the toilet room.

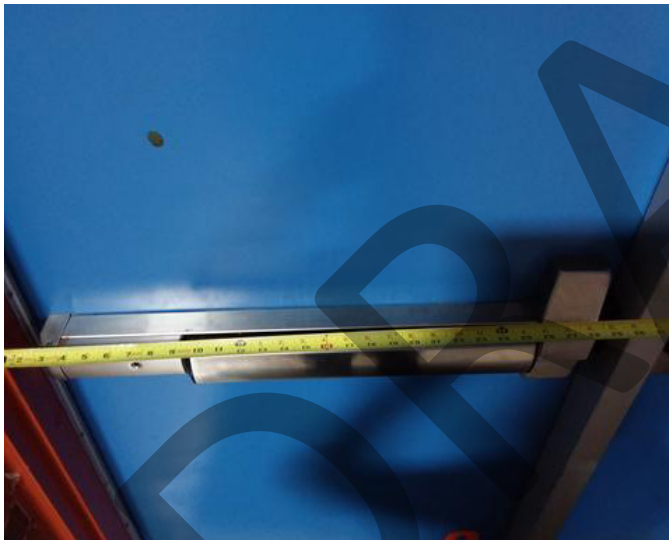
29. Location:

Cafeteria

One of the door leaves is required to be a 36" wide leaf.

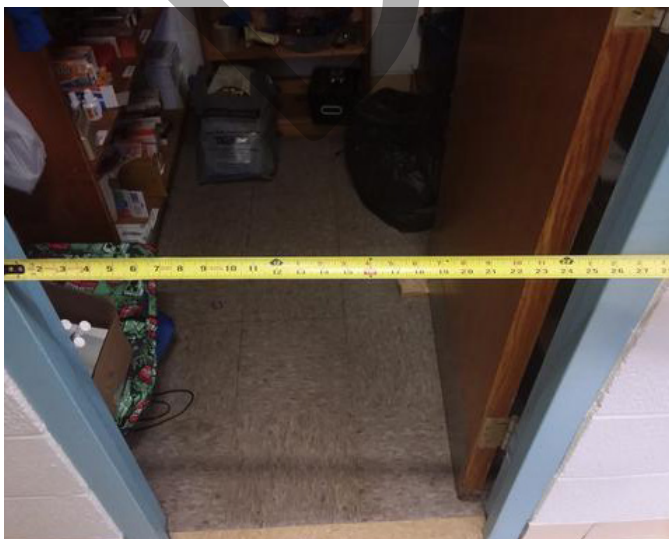
30. Location:

Storage

Typical of many of the accessory doors throughout the building, the minimum door opening width is non compliant.

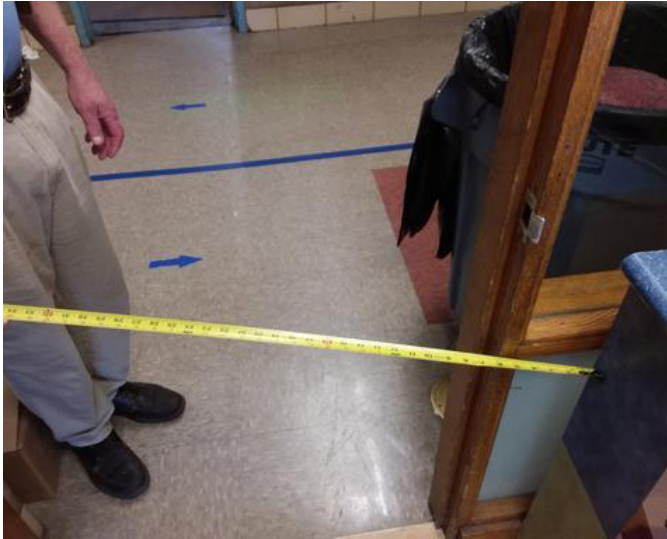
31. Location:

Reception Area

The pull clearance at the door is restricted by the reception area casework.

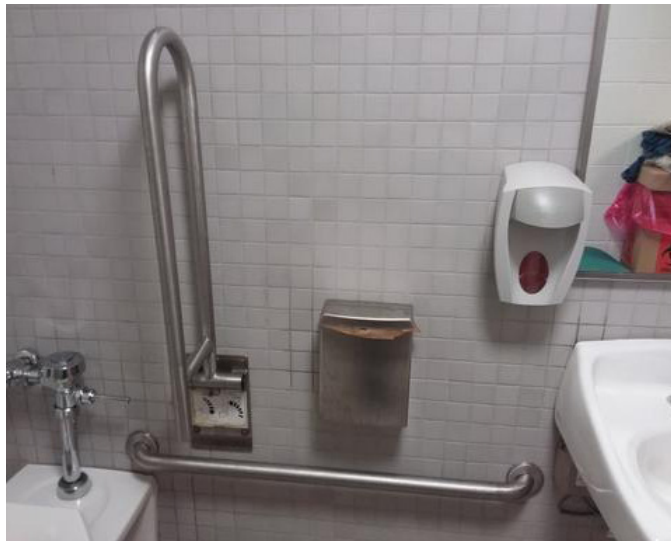
34. Location:

The location of grab bar at rear wall is non compliant.

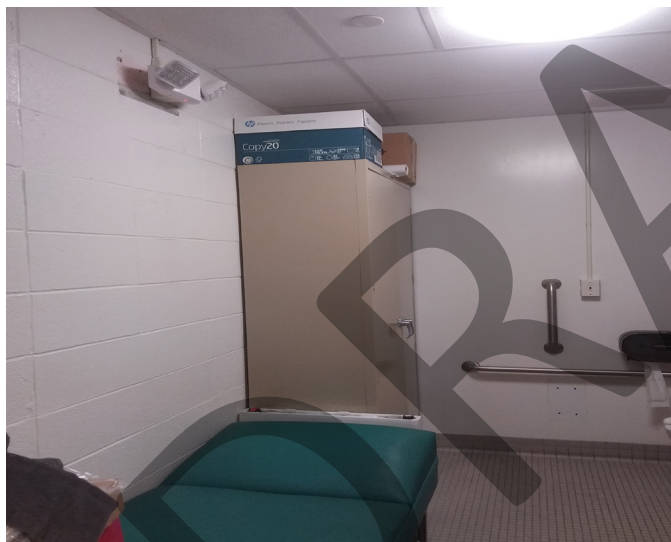
35. Location:

Nurse's Room

The installation of a storage cabinet and a cot restrict accessibility to the toilet.

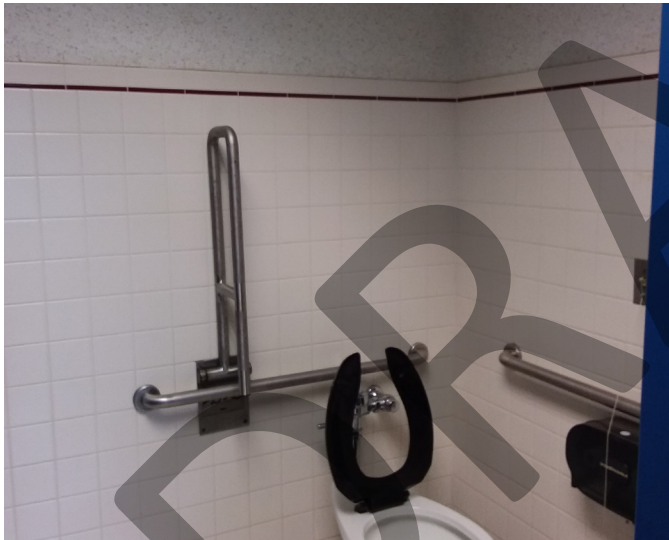
38. Location:

The movable grab bar at the rear wall is no longer required per the latest code.

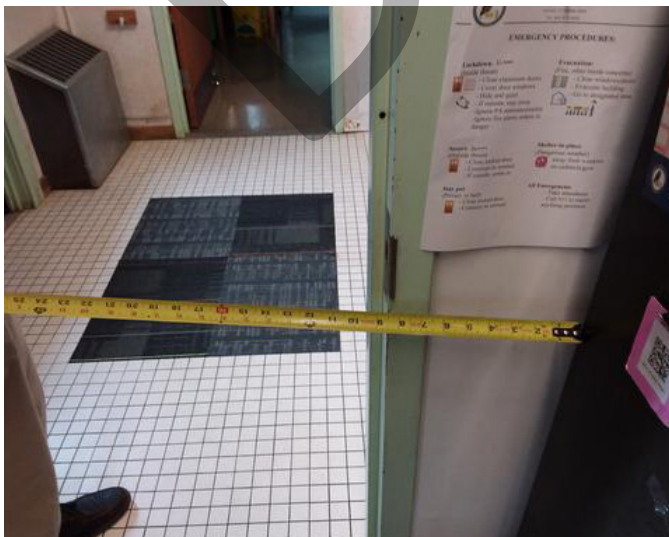
39. Location:

Classroom / Exit Vestibule

The required pull clearances have not been provided.

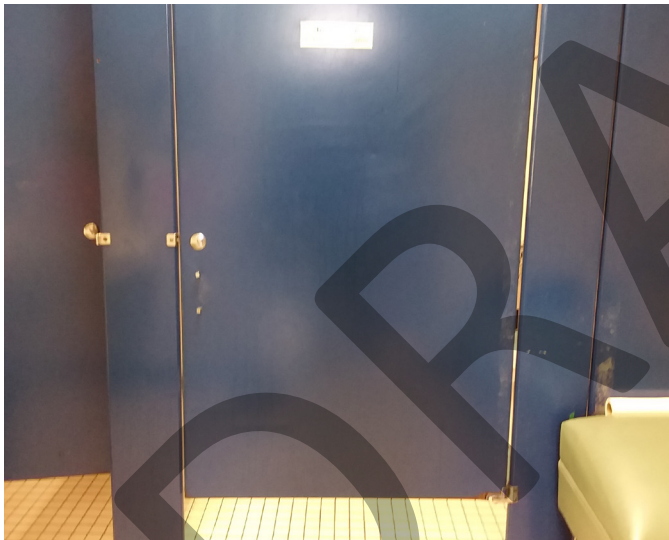
41. Location:

Restroom

The handle for the accessible stall door needs to be replaced.

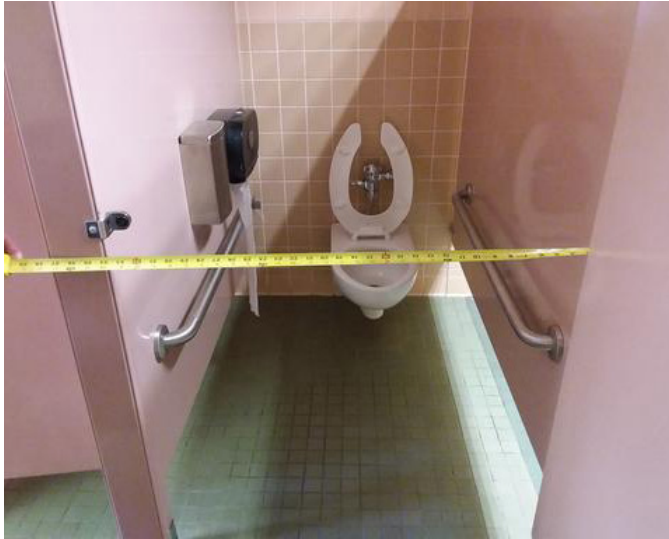
43. Location:

Restroom

The toilet within the ambulatory accessible stall is not properly located within the stall.

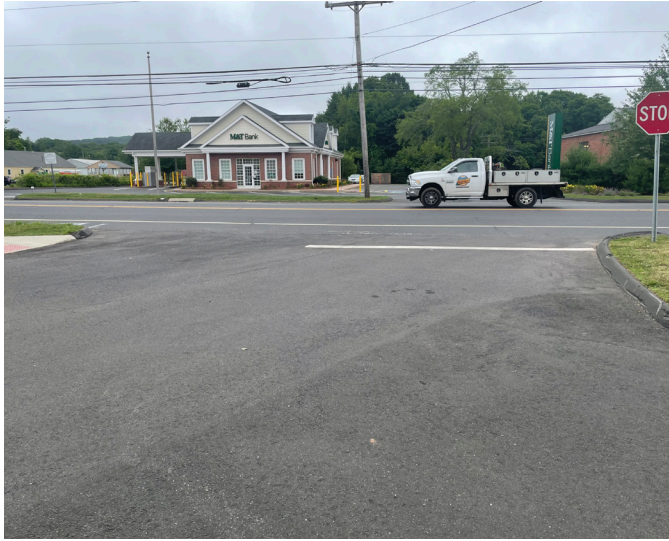
1. Location:

Entry from Route 30

No lane striping or directional signage.

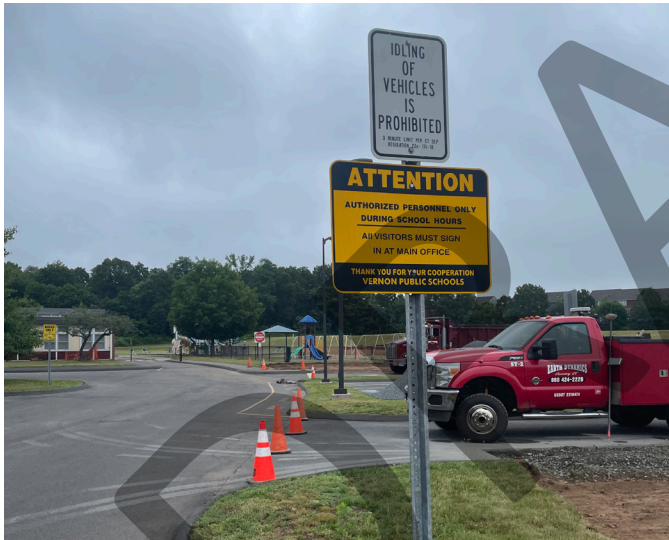
2. Location:

Entry from Route 30

Minimal signage at entry. Ongoing construction at time of survey.

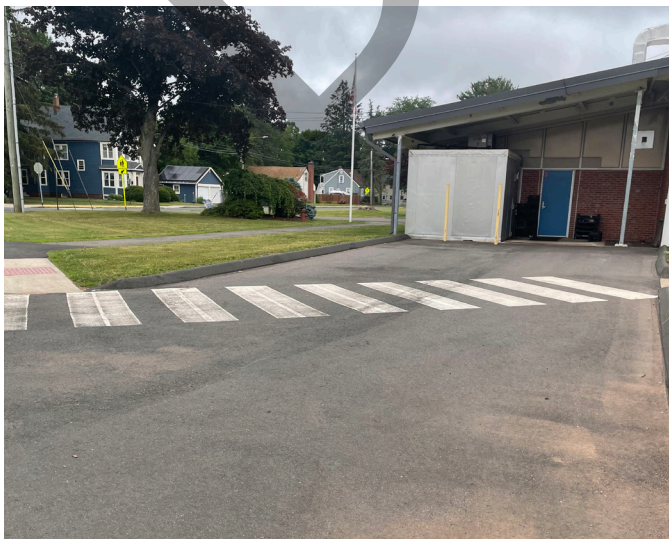
3. Location:

South Elevation

Area appears to be used for deliveries but there is no clear designation with signage or ground markings.

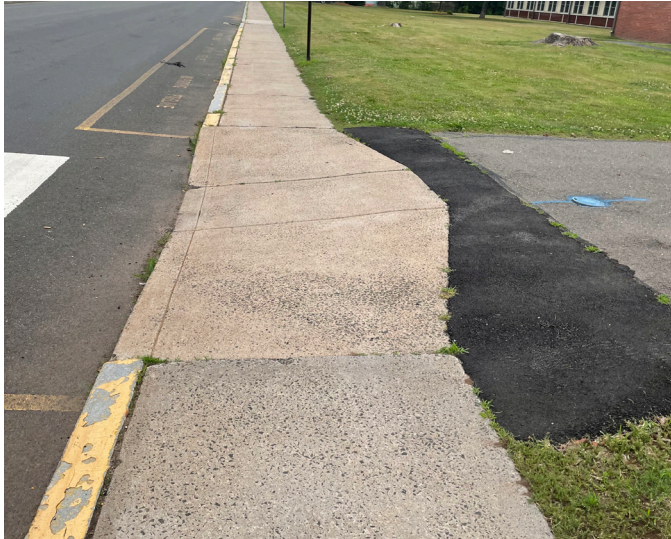
4. Location:

West Elevation Entrance

Walkway entry has been repaired and sloped

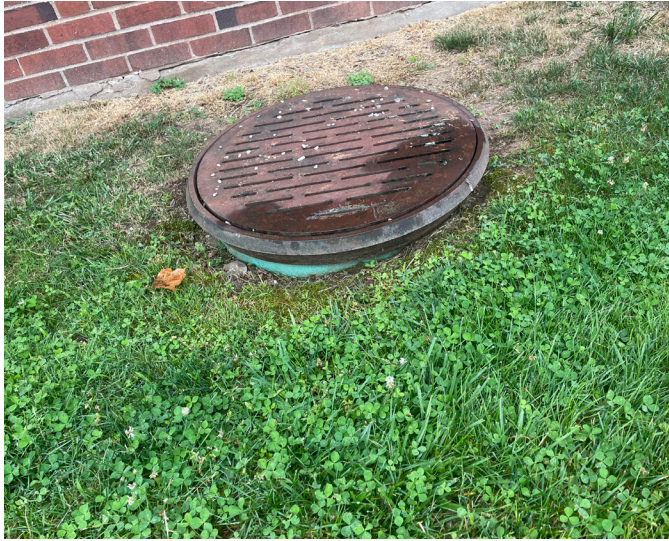
7. Location:

West Elevation

Drain sits higher than grade level

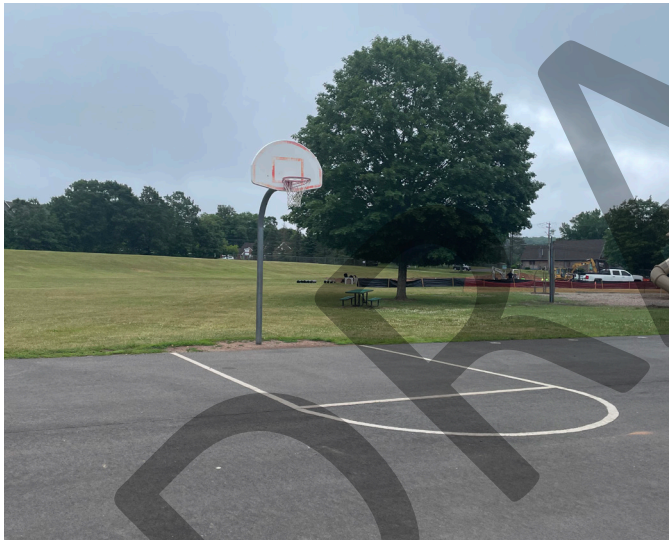
8. Location:

North Paved Area

Single basketball hoop in bituminous paved area - assumed to be play area for kids as there are no designated parking spaces.

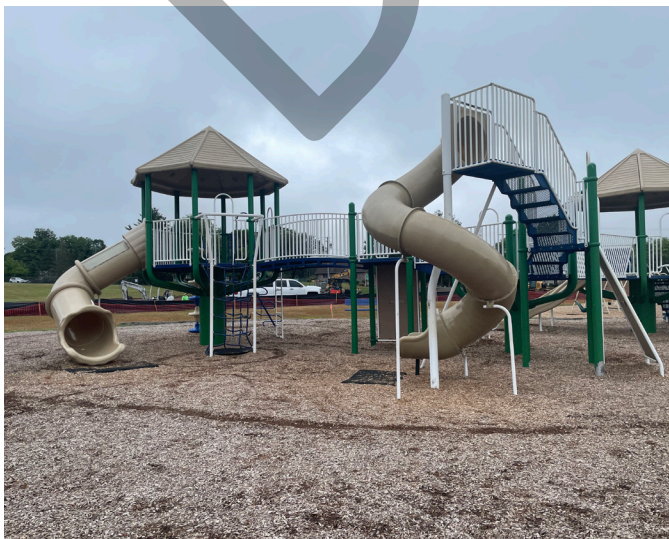
9. Location:

Playscape

Appears to be in good condition.
Mulched area around the playscape with wood barriers.

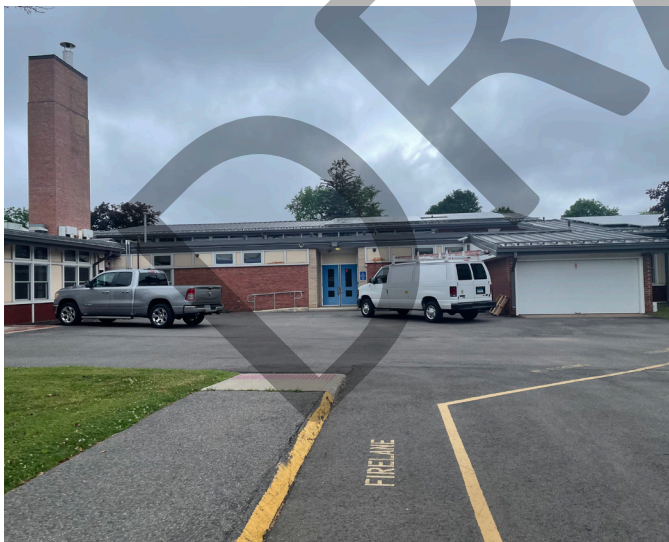
11. Location:

North Paved Area

Possible area for deliveries and/or loading - no signage present

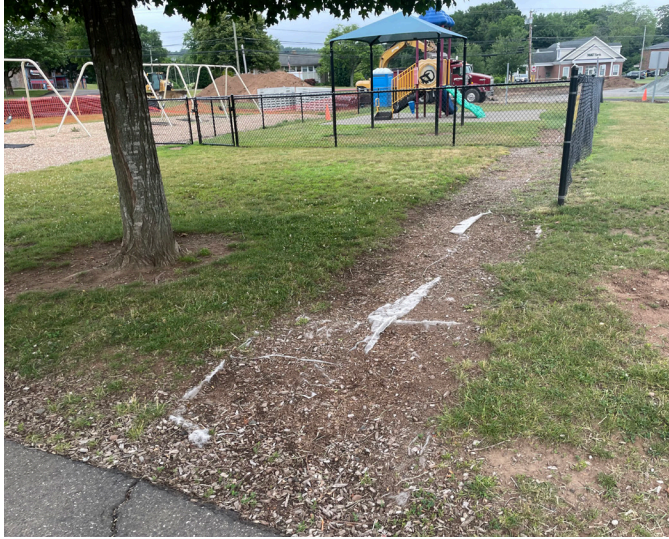
12. Location:

Play area

Mulched walkway is in need of clean up
- no accessible entrance to play area

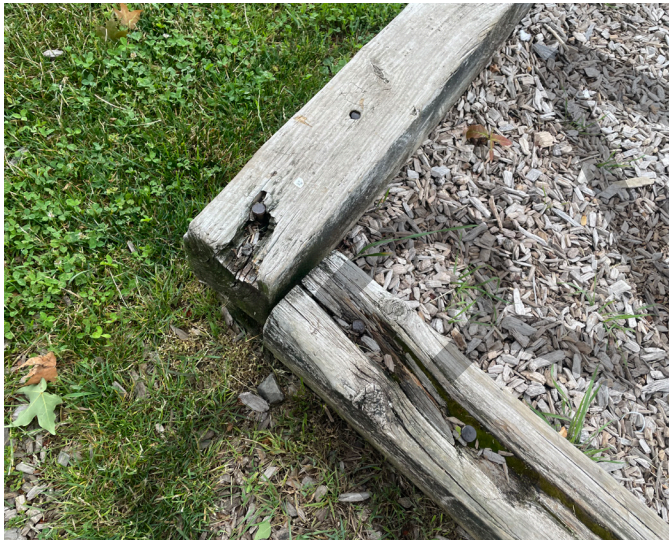
13. Location:

Playscape

Wood barriers in fair condition.

- Provide directional signage and pavement markings for bus and parent drop off.
- Provide signage for delivery areas
- Replace wood barriers at playscapes as they have begun to deteriorate.
- Repair / replace cracked bituminous walkways.
- Review drainage in grassy areas. See Architectural Survey for additional information on building drainage.

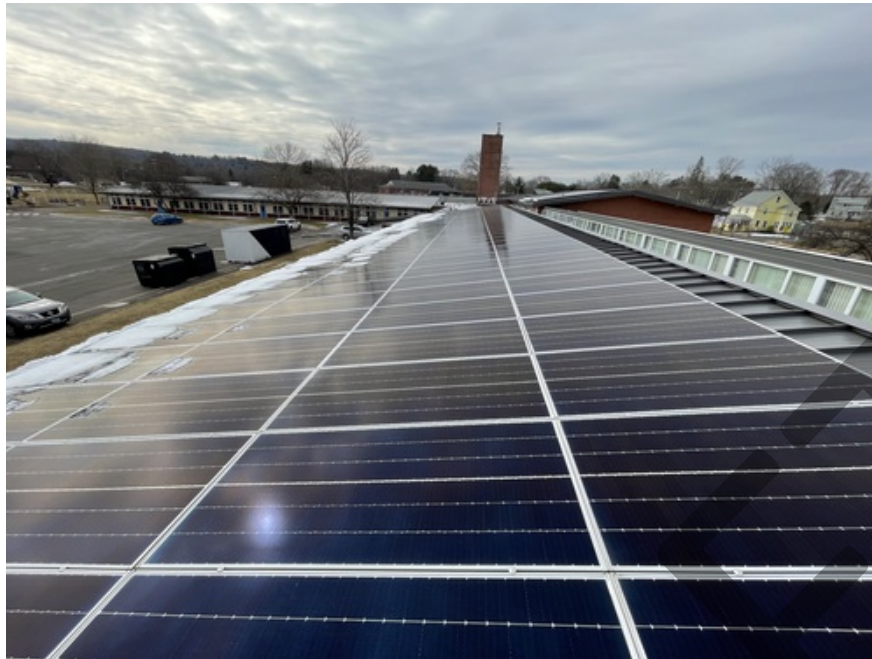
Photo 2

Solar section overview

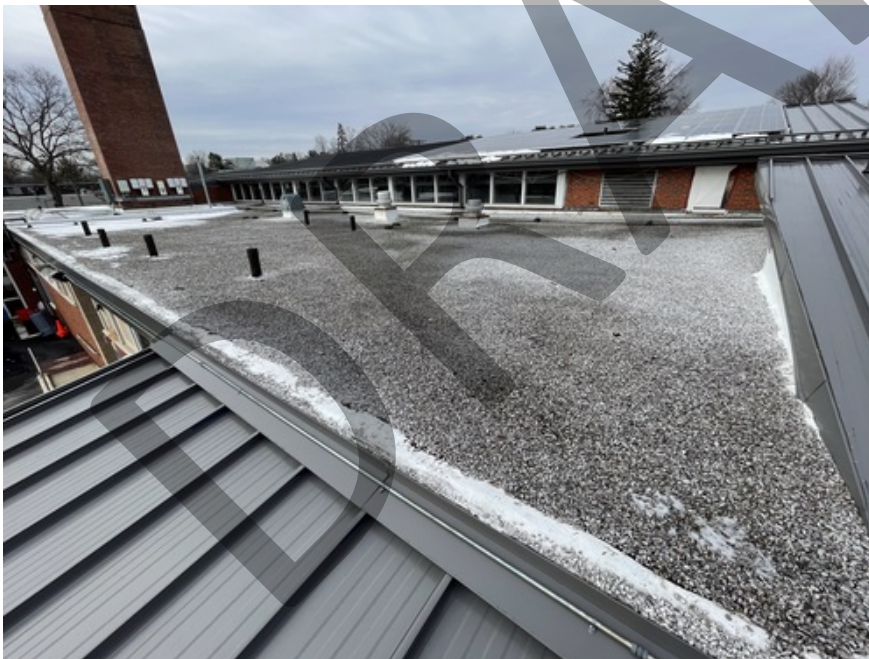
Photo 11

Overview of the Low Slope roof sections

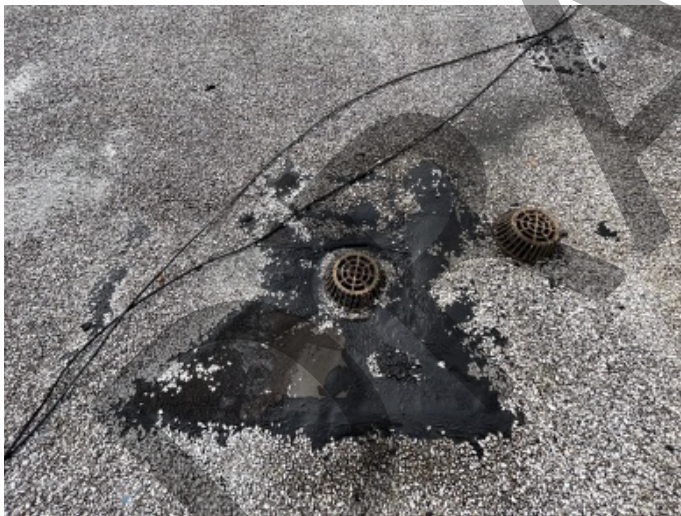
Photo 15

Exposed felts- UV protectant recommended

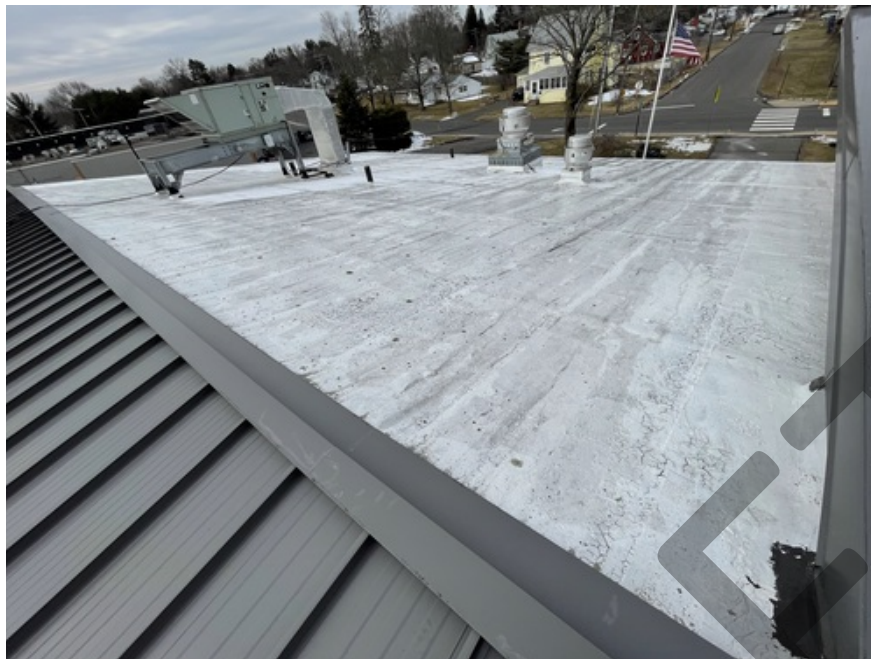
Photo 16

**Overview of the rear
membrane sloped section**

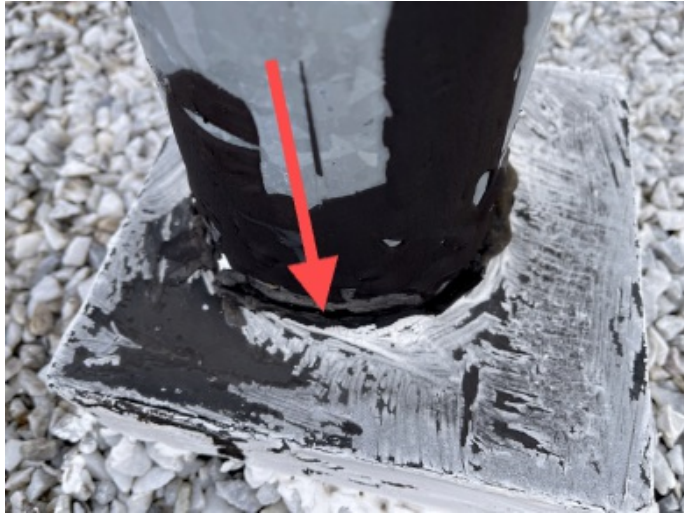
Photo 18

**Open condition- Pitch boxes are open-
Consistent throughout**
