Facility Study and Master Plan

# Next Step Building

38 Park Street, Vernon CT 06066

SUMMER 2023

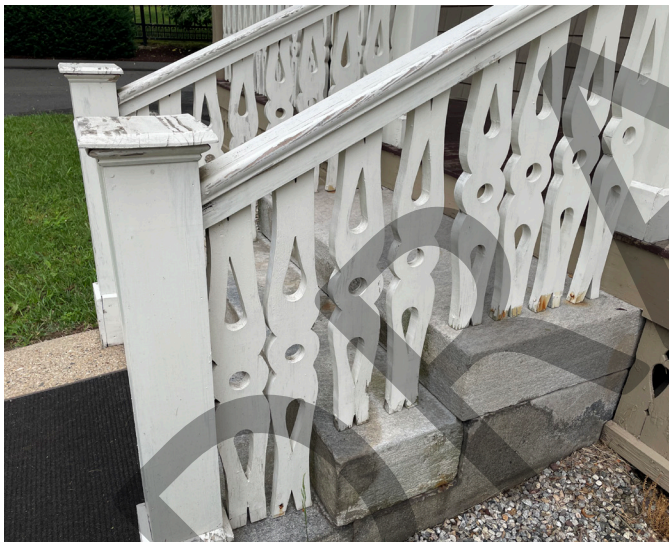
Finish on wood decorative barrier below porch is peeling.

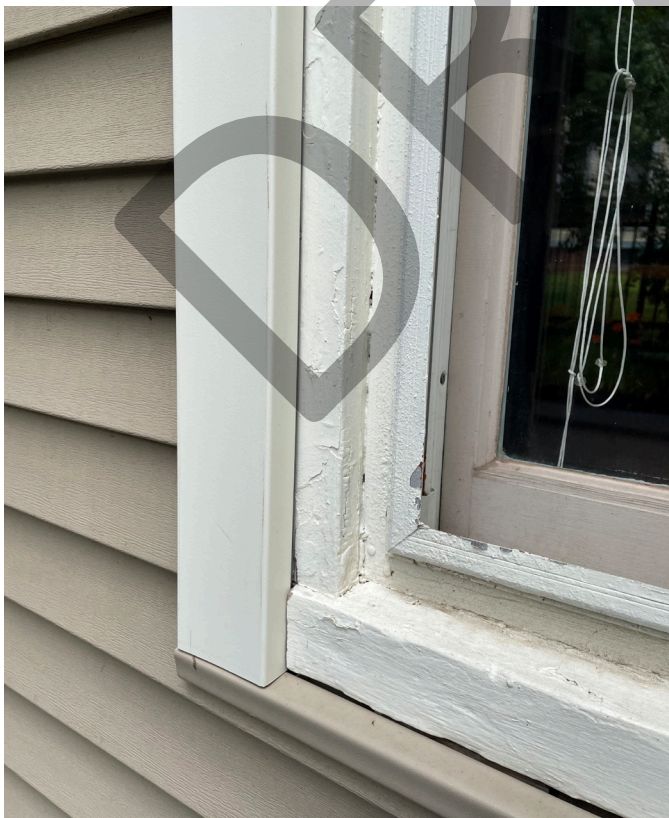
Various parts of the window frame appears to be made of wood and metal. The frame needs to be refinished.

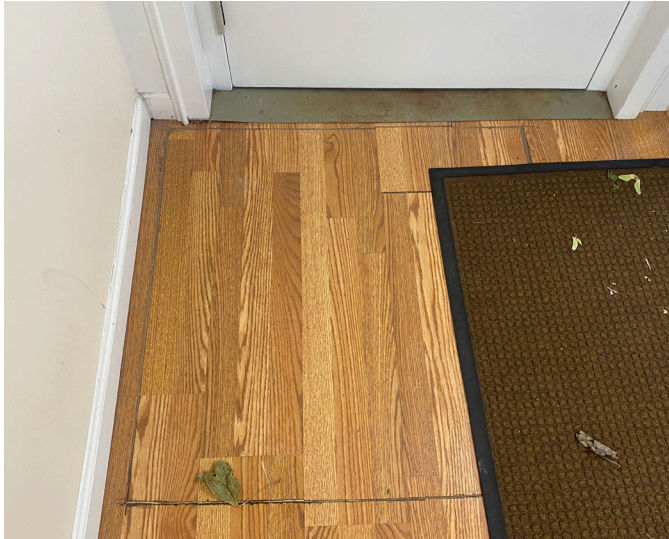
First Floor back vestibule

Patch in laminate floor near lift.

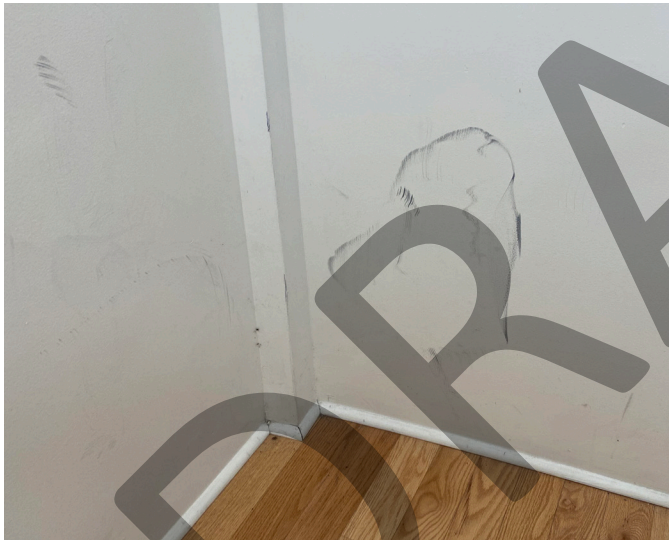
First Floor back vestibule

Scuffs and scraped the need touch up.

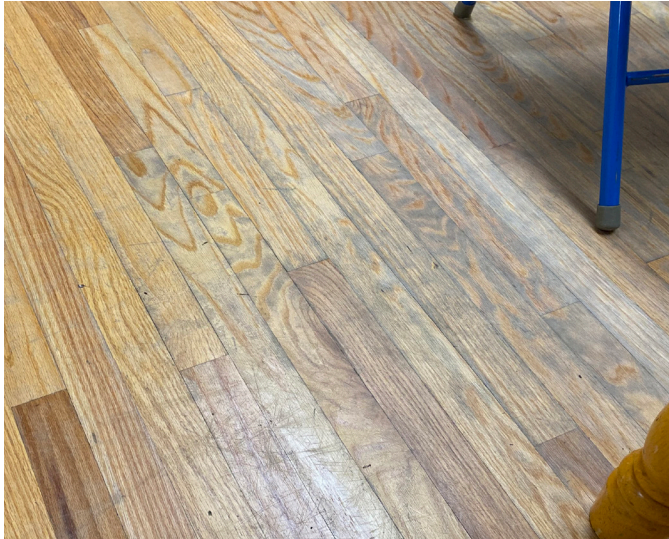
First Floor

Fading and scratching of hard wood floor.

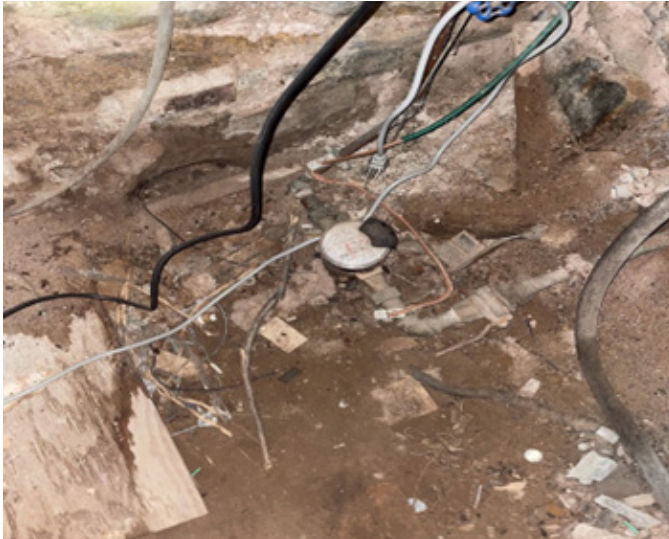
Basement

Domestic Water Service

- Domestic water service and piping is nearing the end of its useful life and we recommend it be replaced in its entirety.
- Domestic Water heater is nearing the end of its useful life and we recommend it be replaced with an electric water heater.
- Sanitary system (above and below grade) is nearing the end of its useful life and we recommend it be replaced in its entirety.

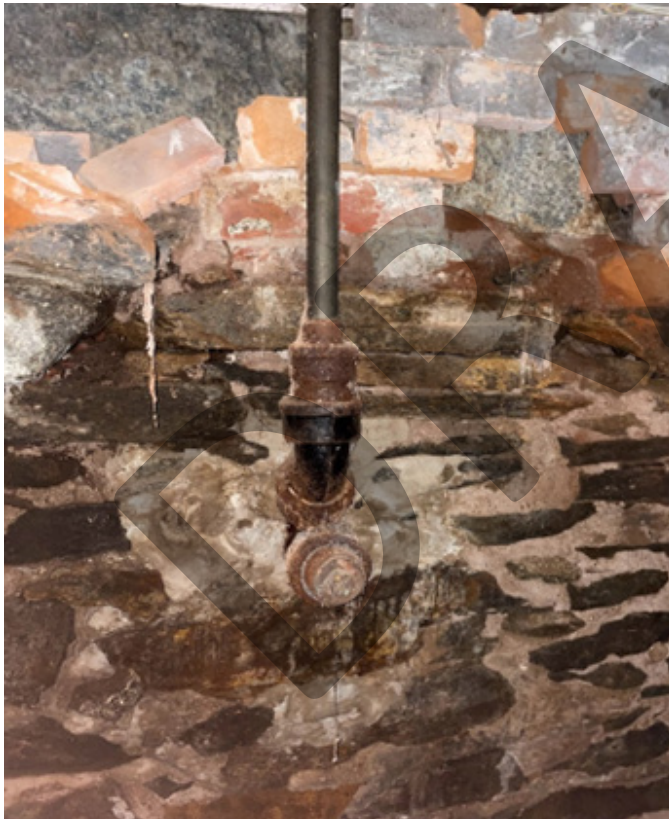
Basement

Water Heater

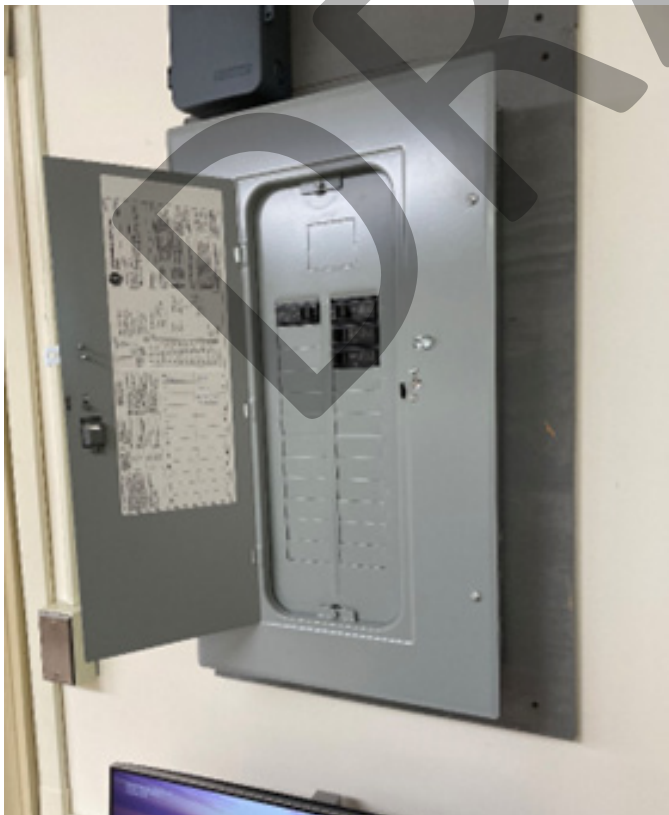
Second Floor

Old Load Center Style Panel

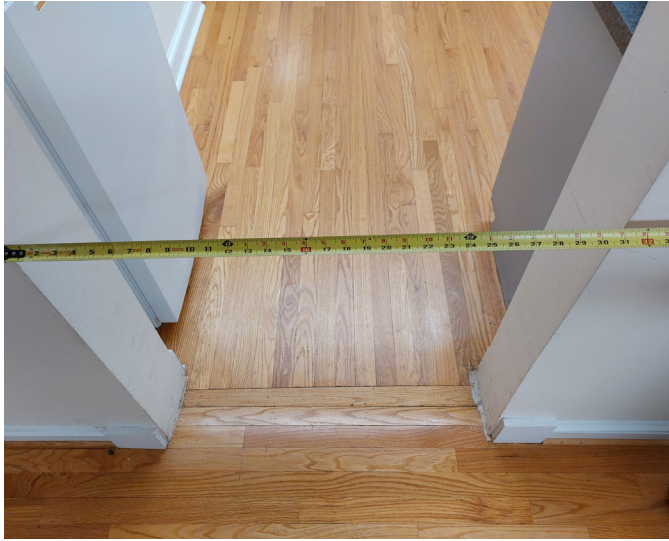
Main Entry

Typical openings do not meet the required 32" clear width.

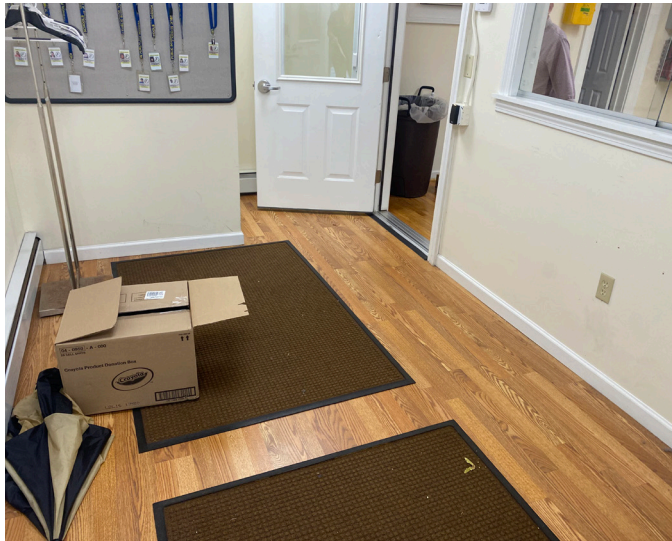
### 4. Location:

Door shown does not have required clear space for a latch approach pull door.

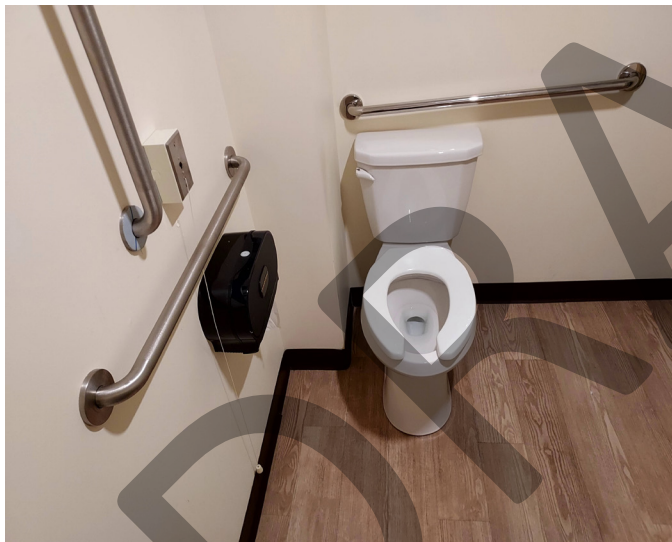
### 5. Location:

Toilet is located less than the required 16" off of side wall. Wall chase interferes with clear distance of 56" x 60" required surrounding toilet. Control is not on the open side of the toilet.

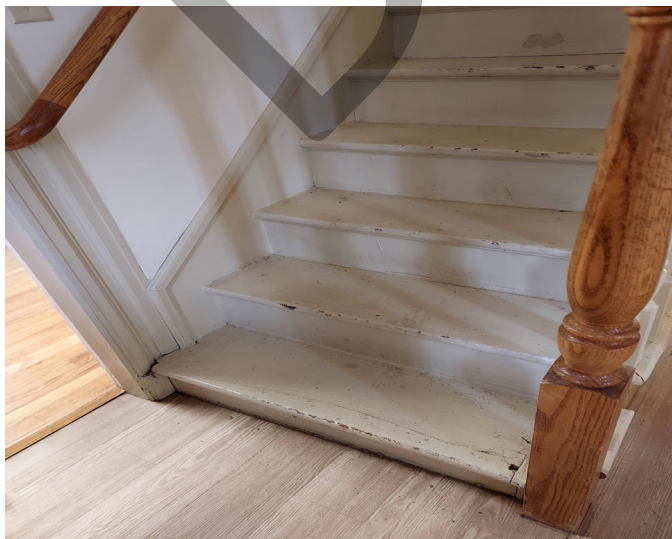
### 6. Location:

Primary staircase does not have equal riser heights.

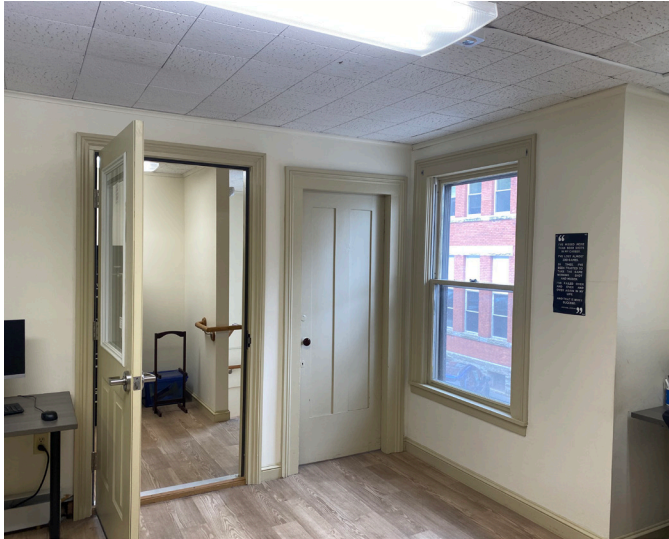
### 7. Location:

Threshold leading from accessible lift creates an elevation change greater than 3/4" between floors.

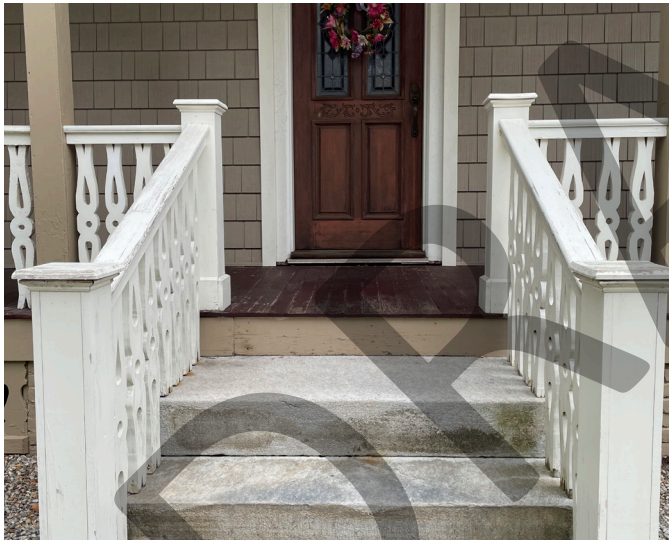
### 8. Location:

Front entry is not an accessible entrance. Signage is not provided indicating direction of closest accessible entrance.

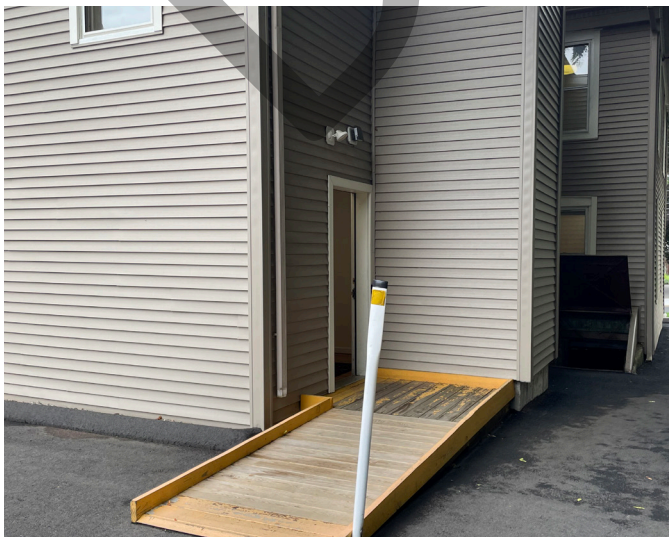
### 9. Location:

Ramp at highest point is greater than 6" above grade. Handrails are not provided. Landing at top of ramp is less than required 60"x60".

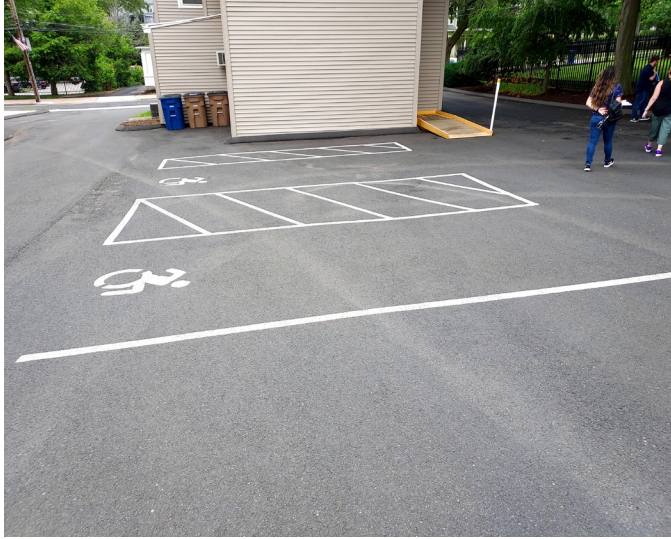
### 10. Location:

The proper signage, wheel stops and slope from the access aisles to the ramp entrance is needed. Signage at the accessible entrance is required.

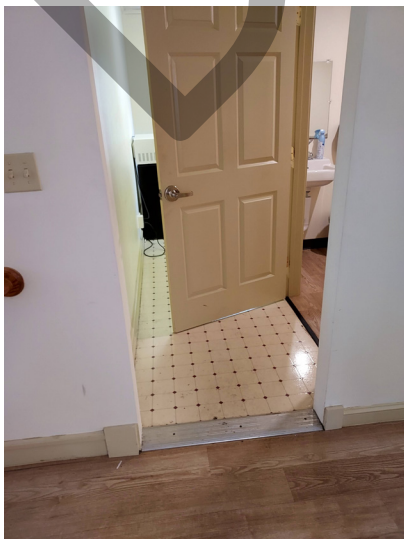
### 12. Location:

Door shown does not have required clear space for a latch approach. The cased opening does not provide the required clear width.

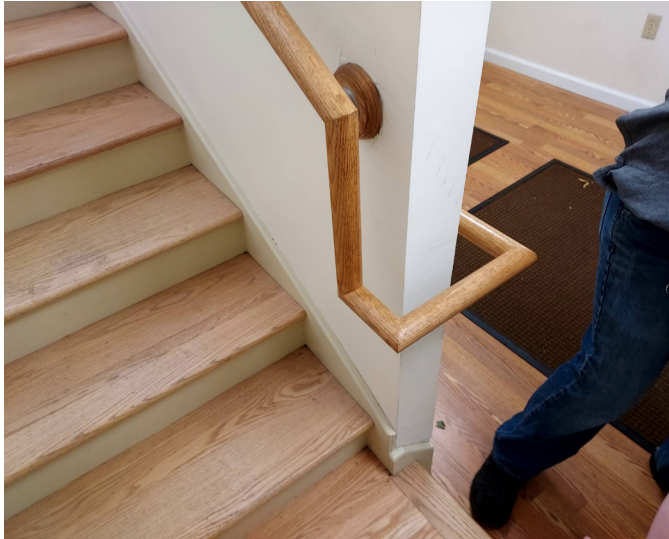
### 13. Location:

The handrail extension does not comply. The stair landing blocks the door shown in photo 15.

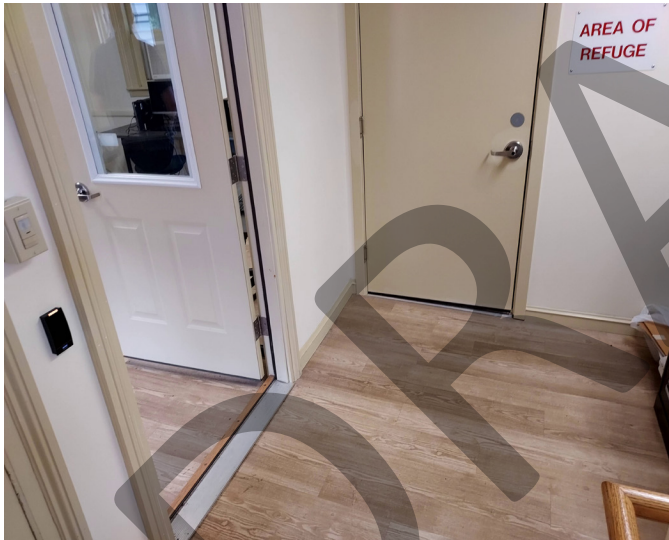
### 14. Location:

The access to the lift is impeded by the door threshold. The accessible signage throughout the facility is not installed.

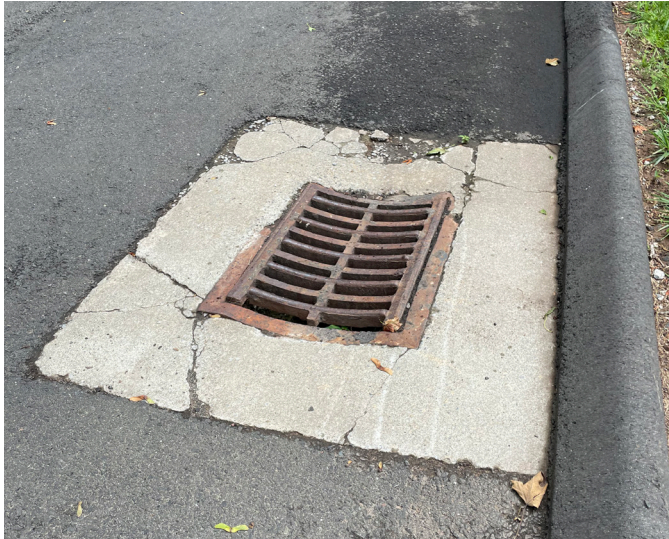
### 1. Location:

Drainage at driveway - grate needs to be replaced.

- Replace sewer drainage grate at north driveway
- Provide one way signage if restricting entrance and exit sides of the driveways.

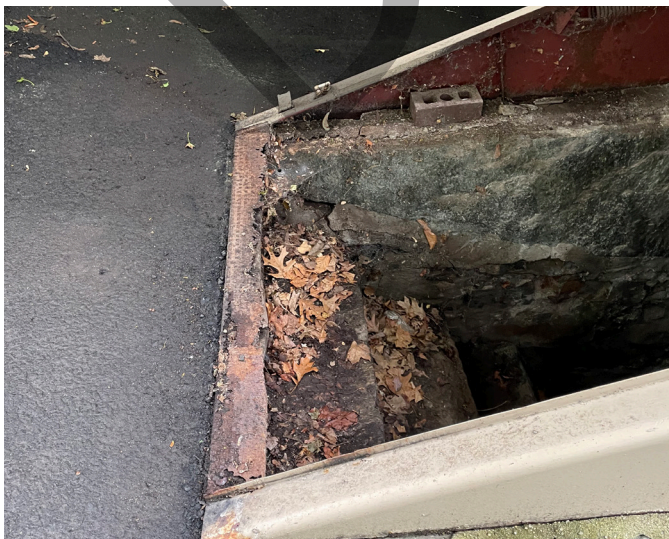
### 3. Location:

Debris collecting at basement hatch

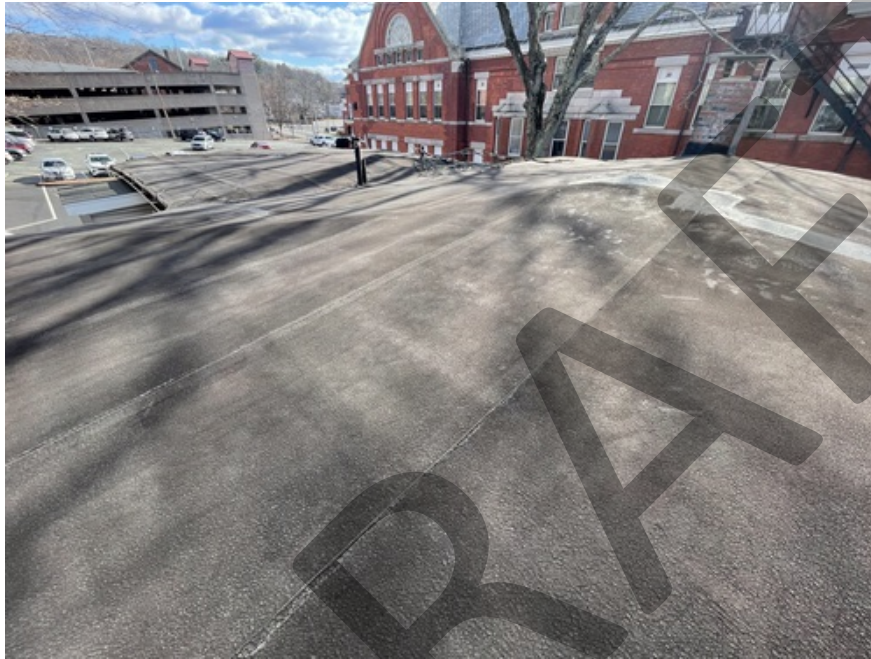
*Photo 1*

**Overview of the roof-  
Smooth app**

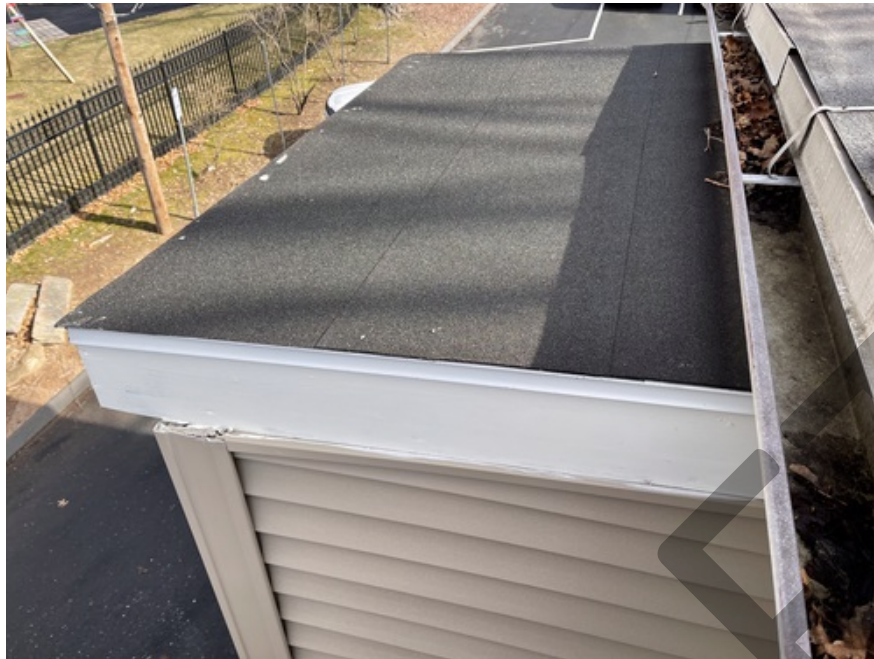
*Photo 13*

**Overview- Side elevator  
roof**

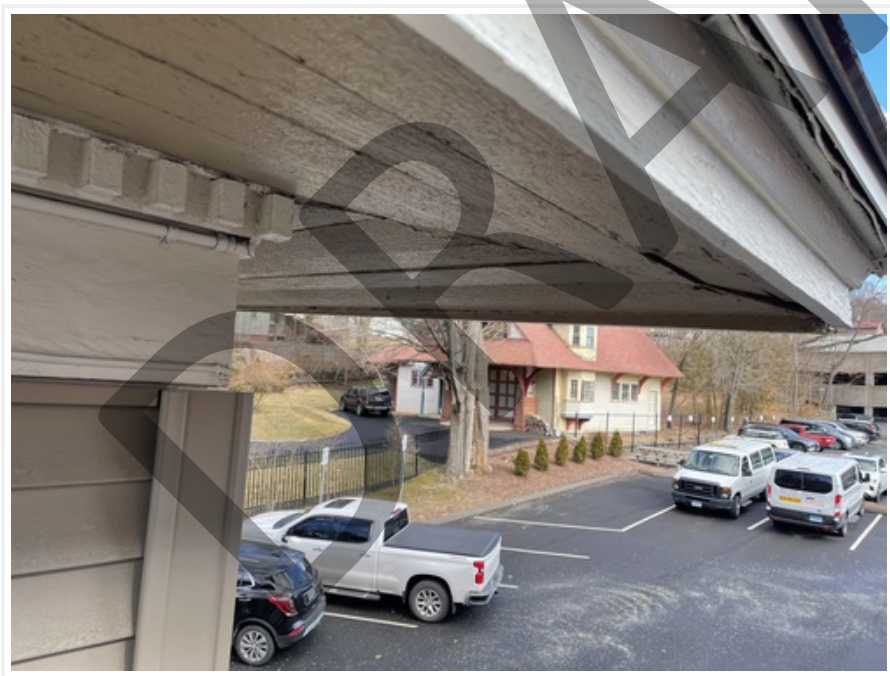
*Photo 16*  
**View of the wood soffit and  
dental crown**

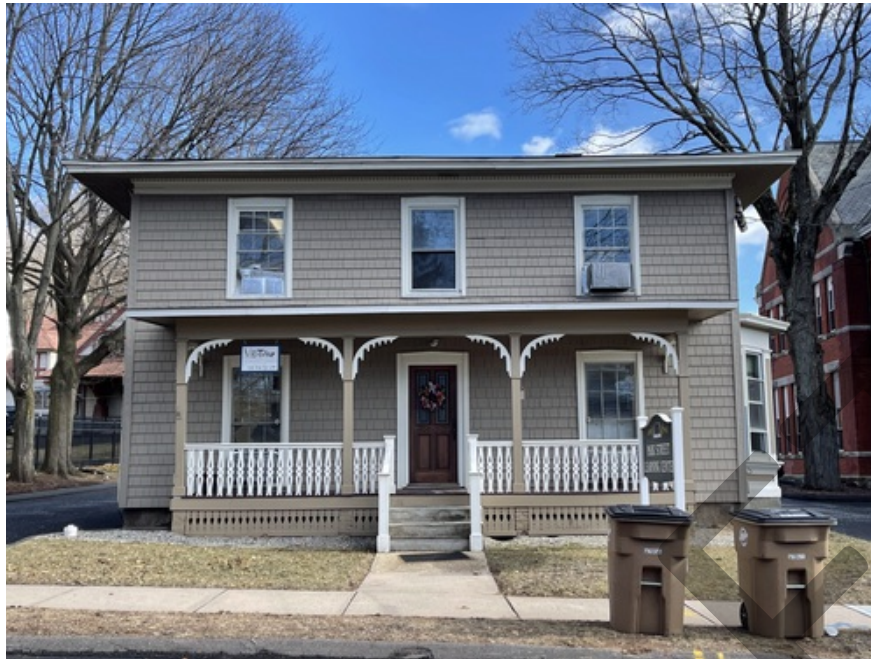
*Photo 17*

**View of the front of the building**

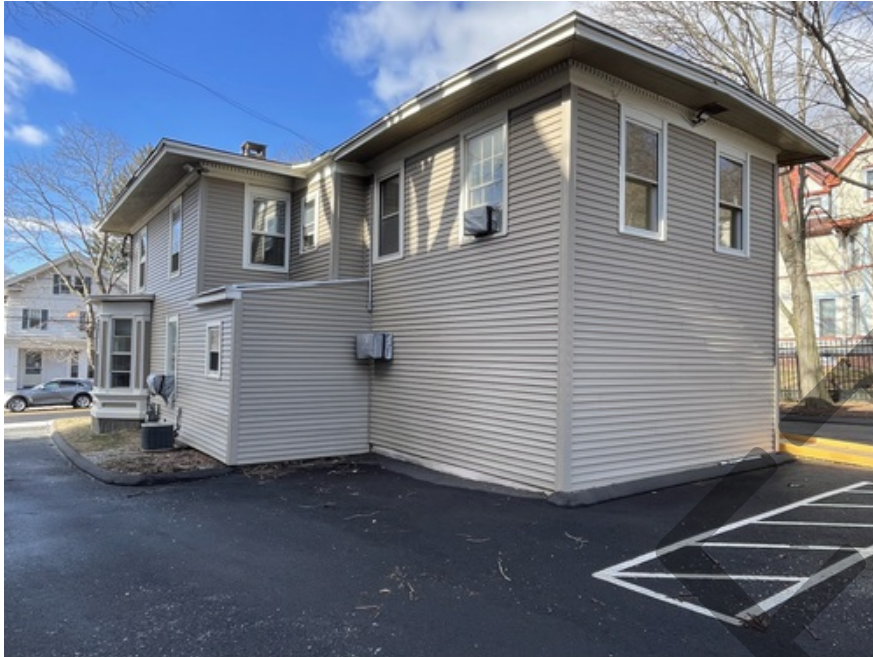
*Photo 18*

**View of the north side of the building**

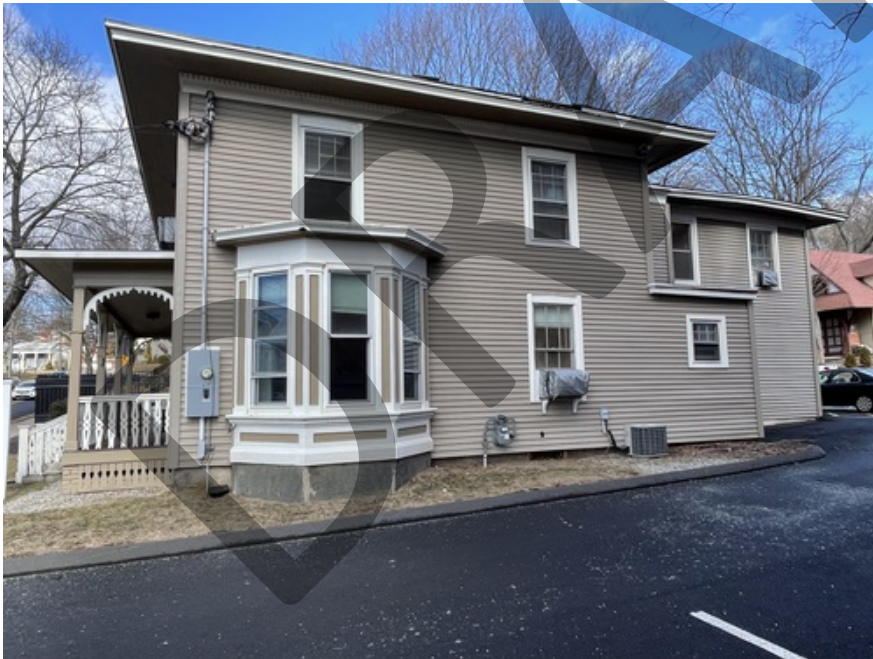
*Photo 19*

**View of the back of the building**
