Facility Study and Master Plan

# Maple Street School

20 Maple St, Vernon, CT 06066

SUMMER 2023

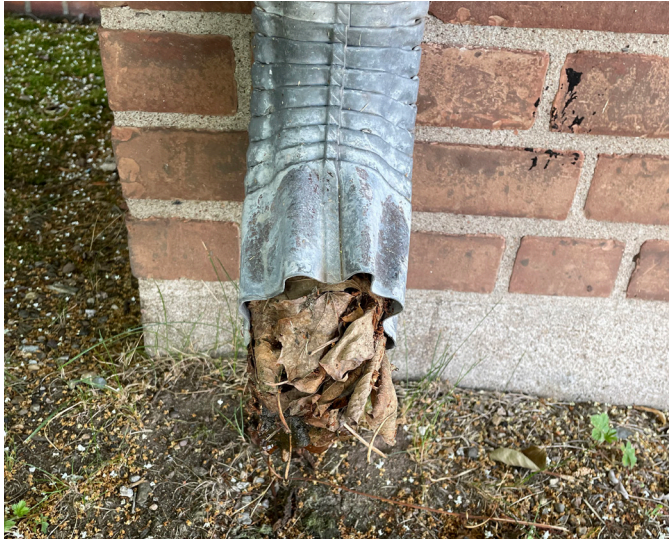
### 4. Location:

Downspout clogged with leaves and debris

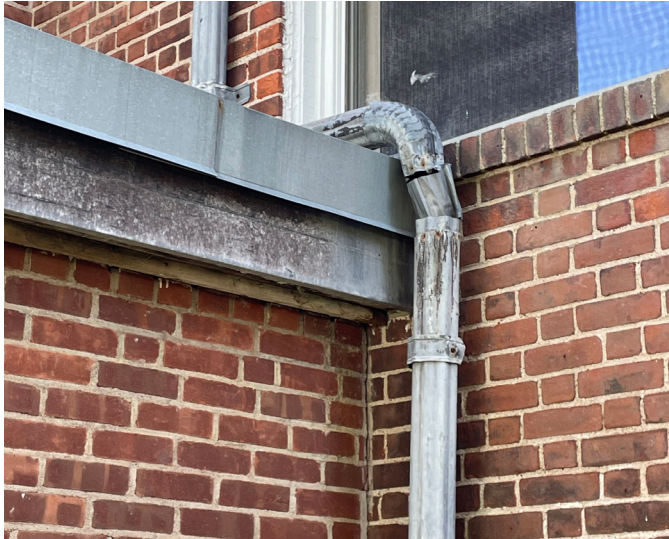
### 7. Location:

Downspout coming part. Roof fascia finish faded and discolored

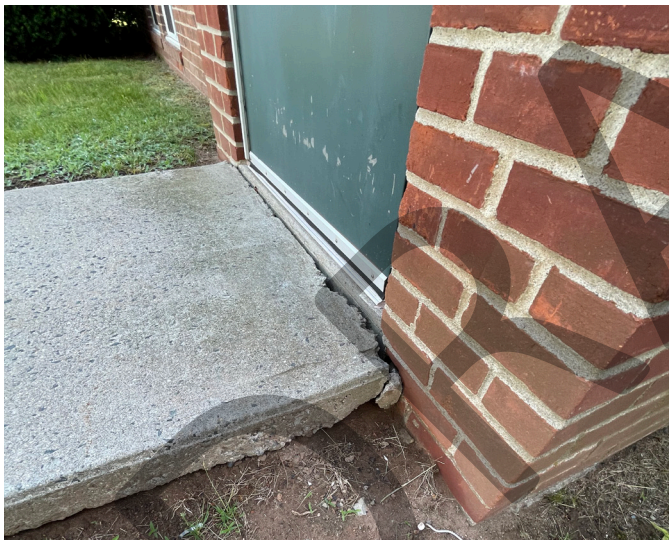
### 8. Location:

Lower portion of door damaged. Concrete pad deteriorating around edges.

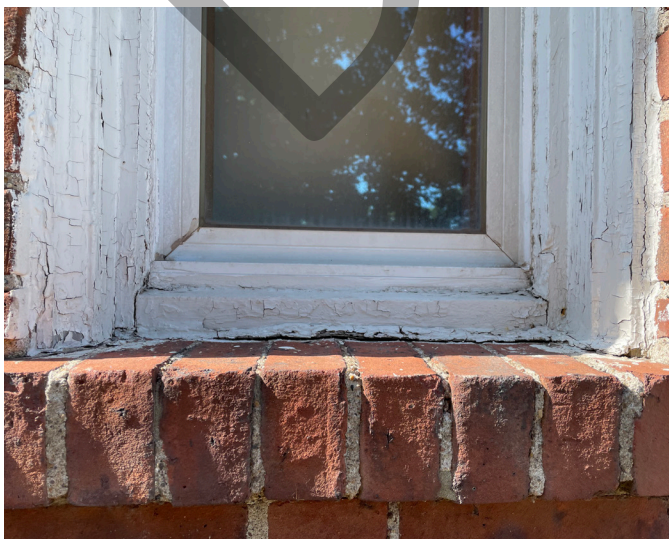
### 9. Location:

Existing window frame has been repainted many times - paint is peeling away and sealant is next to non-existent.

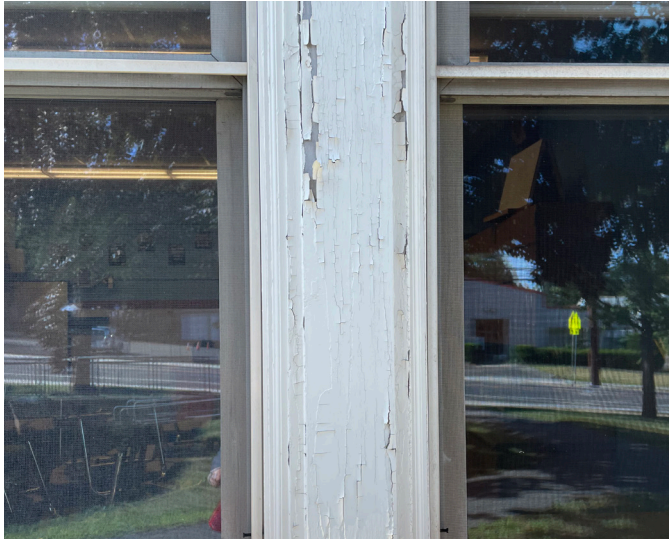
### 10. Location:

Paint peeling from wood frames - Typical condition

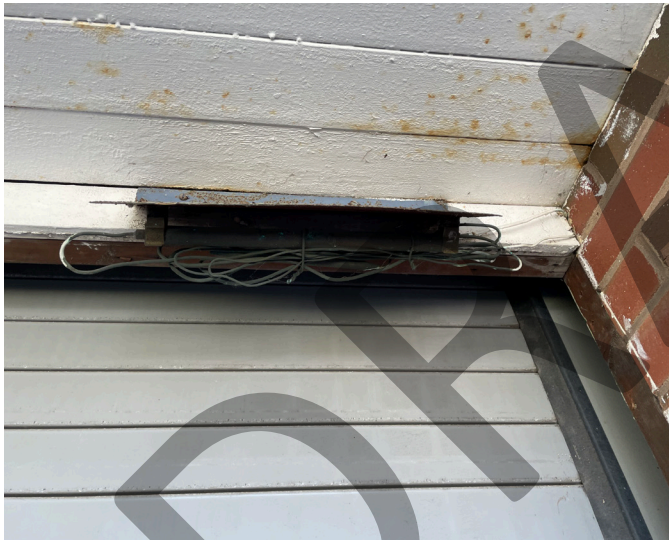
### 11. Location:

Exposed wires at overhead service door

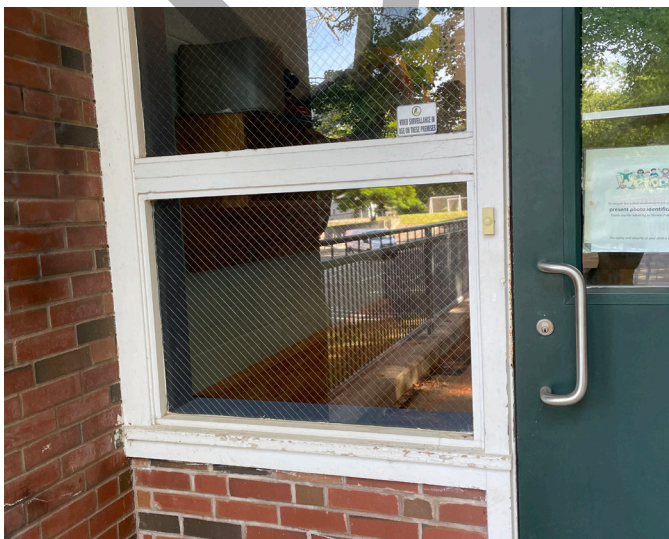
### 15. Location:

Peeling paint from wood window frames  
- typical throughout wood frames

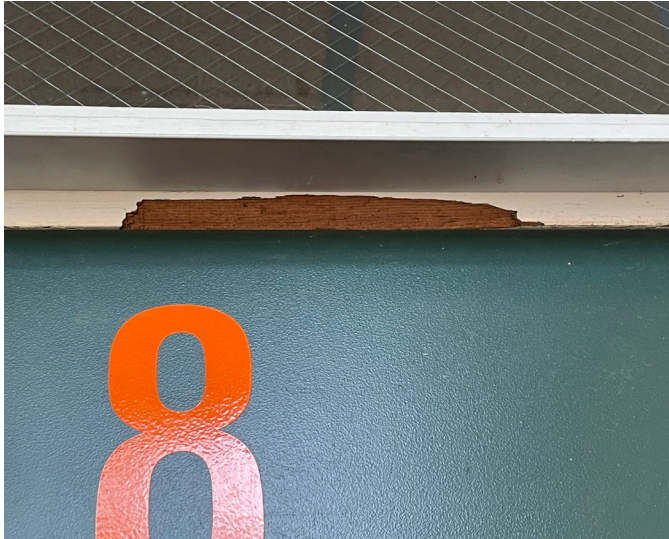
### 16. Location:

Damage to wood door frame visible

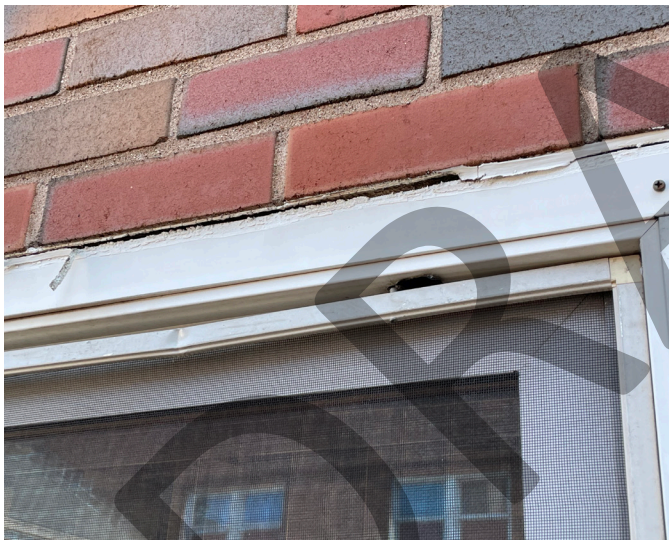
### 17. Location:

Sealant falling away from window frame

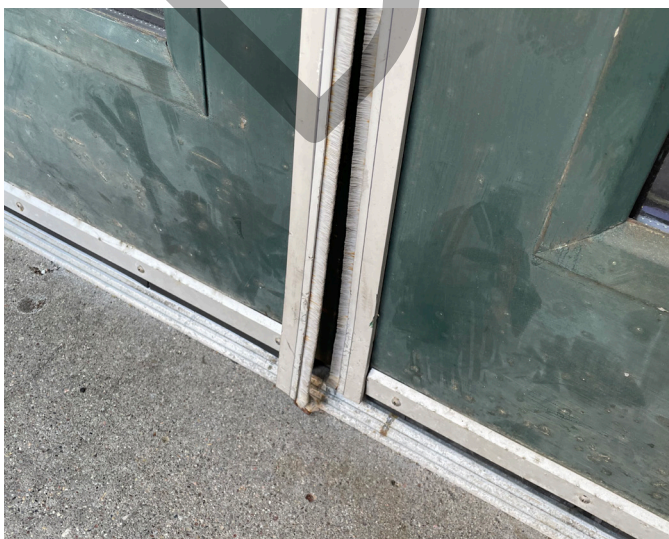
### 18. Location:

Weatherstripping falling away from exterior door

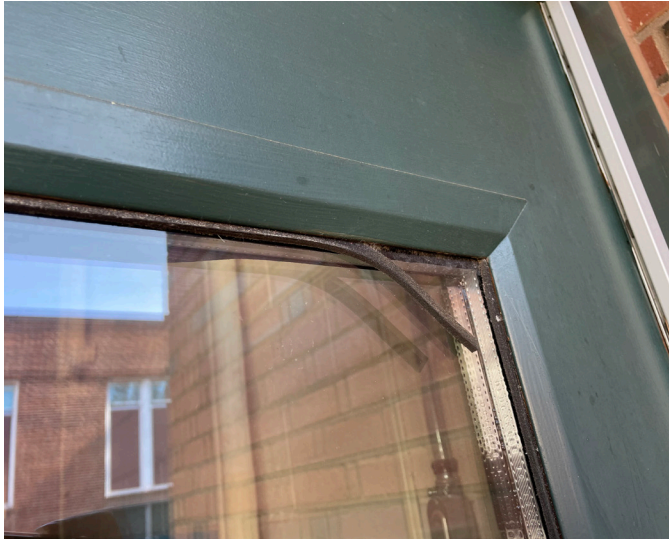
### 19. Location:

Seal falling away from existing aluminum door.

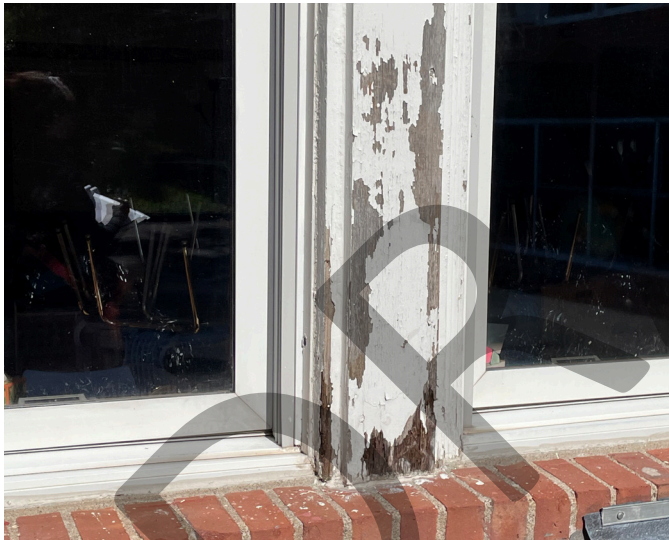
### 20. Location:

Wood frame's paint has peeled away and wood is beginning to rot.

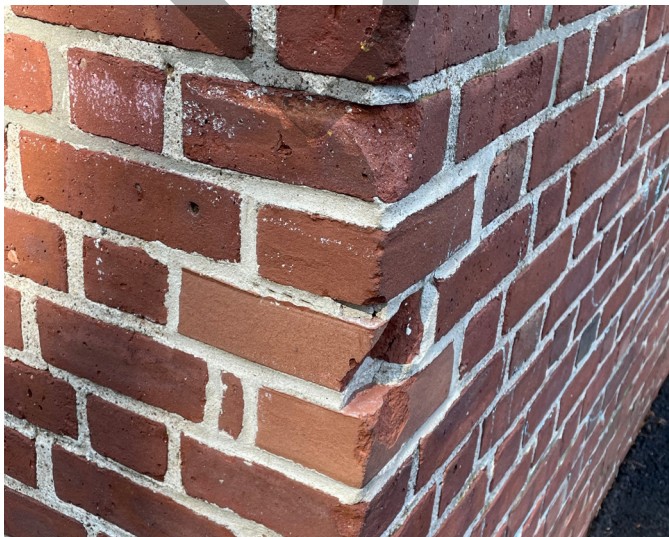
### 21. Location:

Damaged brick

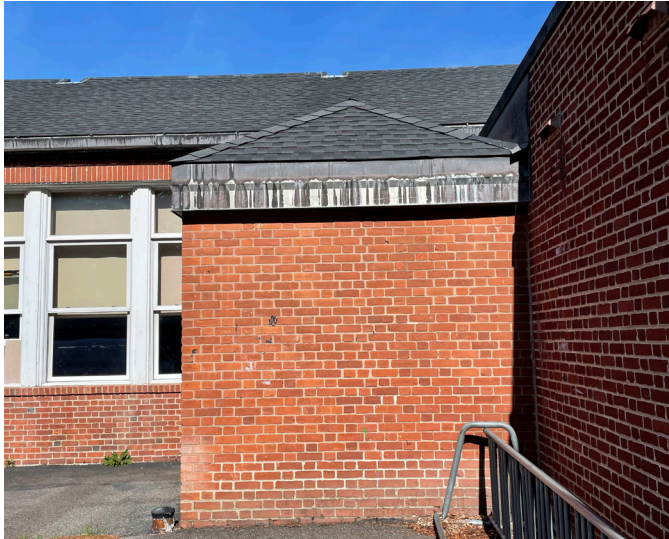
### 22. Location:

Roof fascia discolored due to age and water.

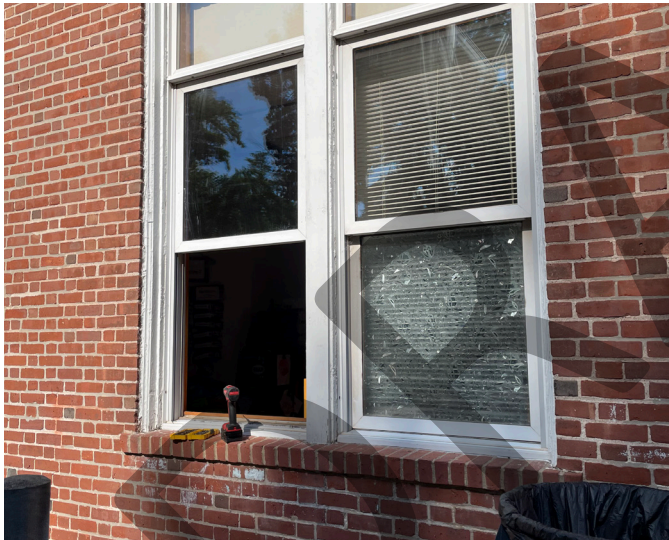
### 23. Location:

Window vandalized night prior. Team on site fixing and replacing the damaged window.

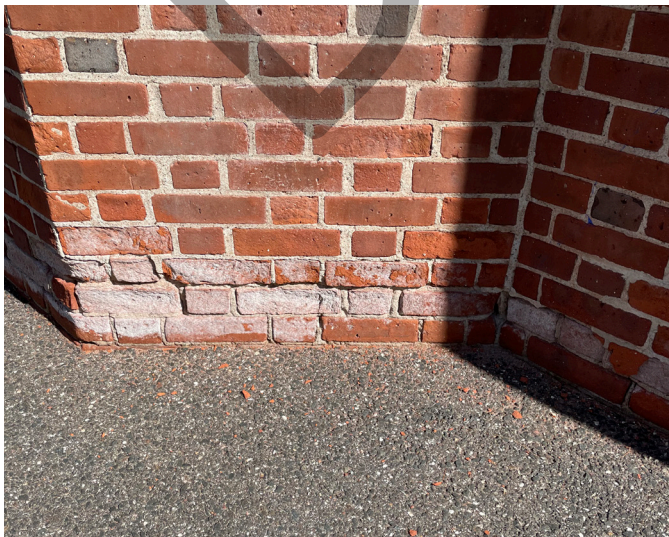
### 24. Location:

Efflorescence visible at the bottom of brick facade

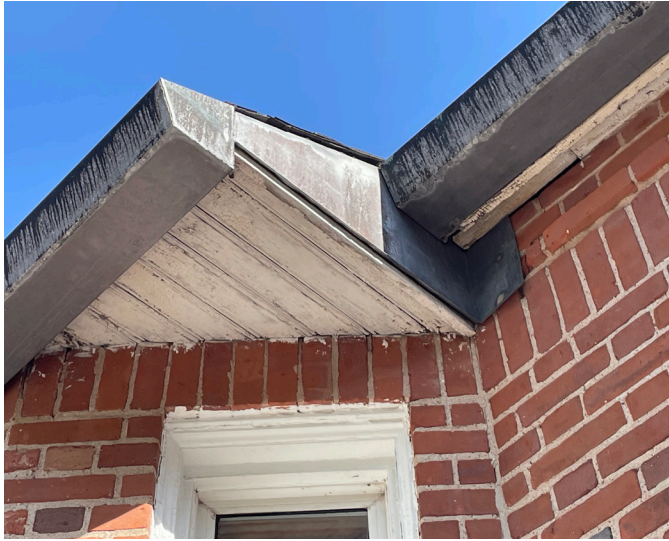
### 25. Location:

Soffit and fascia finish faded due to age.

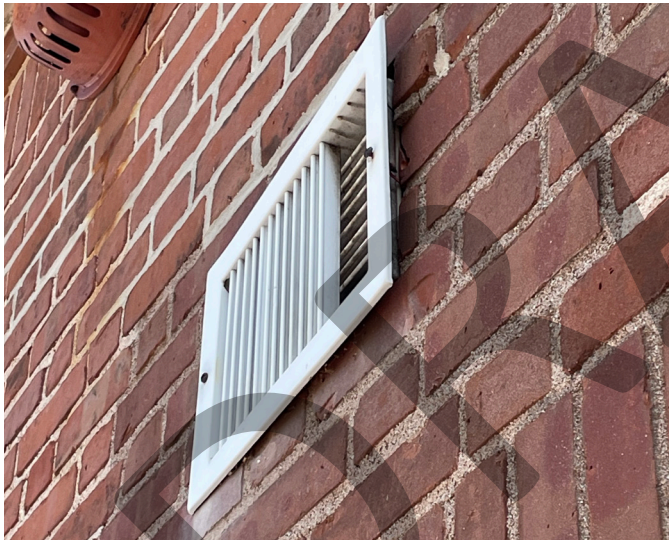
### 26. Location:

Vent pulling away from facade

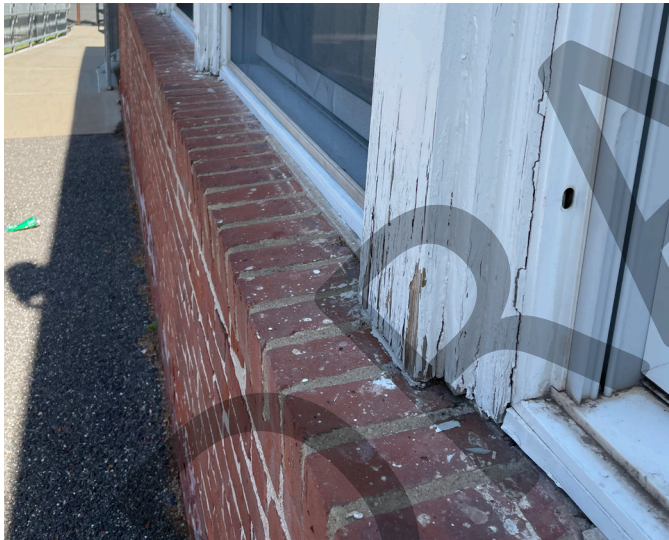
### 29. Location:

Deteriorated wood frame

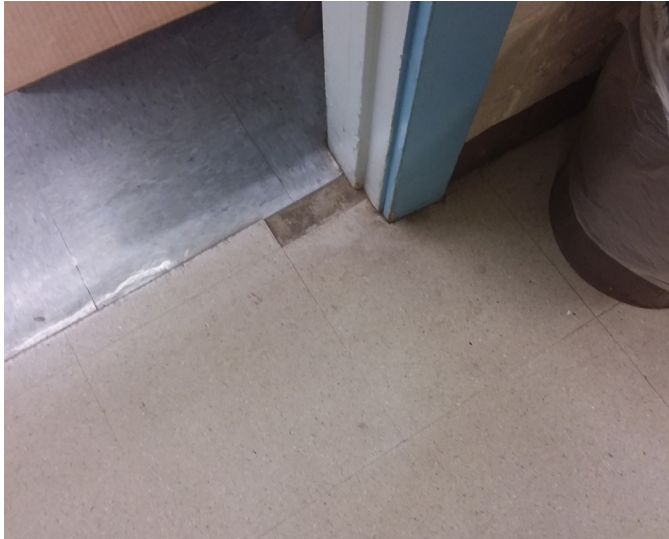
### 40. Location:

VCT is ripped up and exposed sub floor.

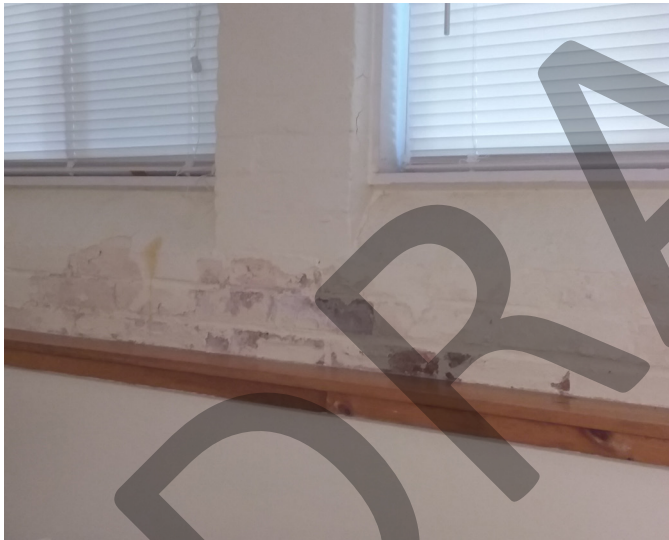
### 44. Location:

Paint on bricks is fading.

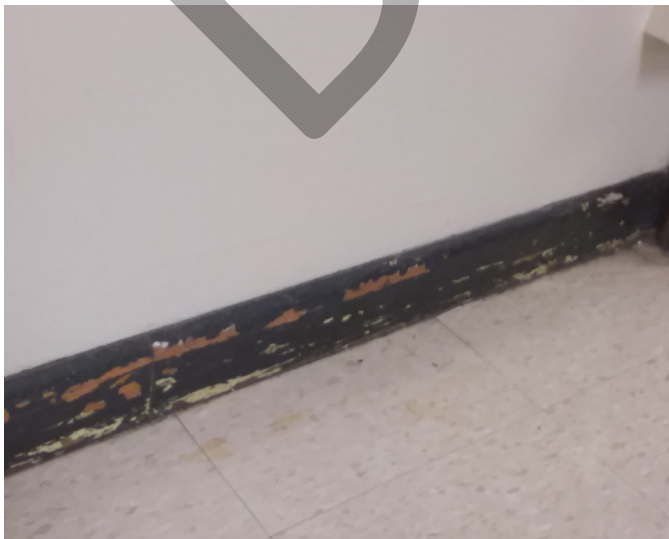
### 45. Location:

Wall base is chipped and scratched.

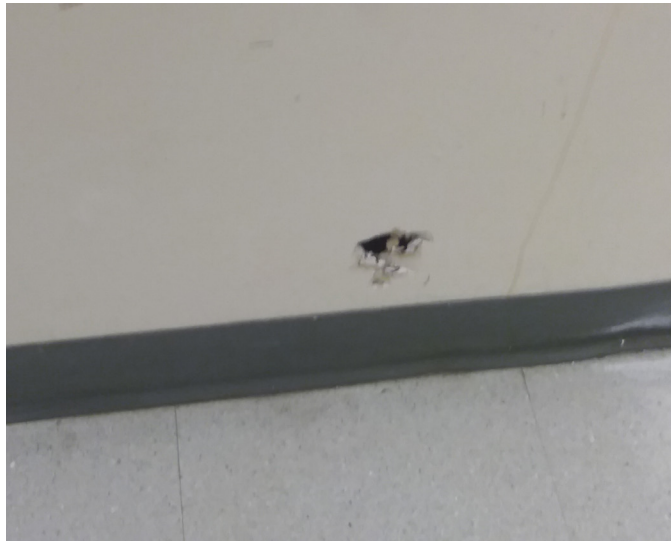
### 46. Location:

Hole in wall needs repair.

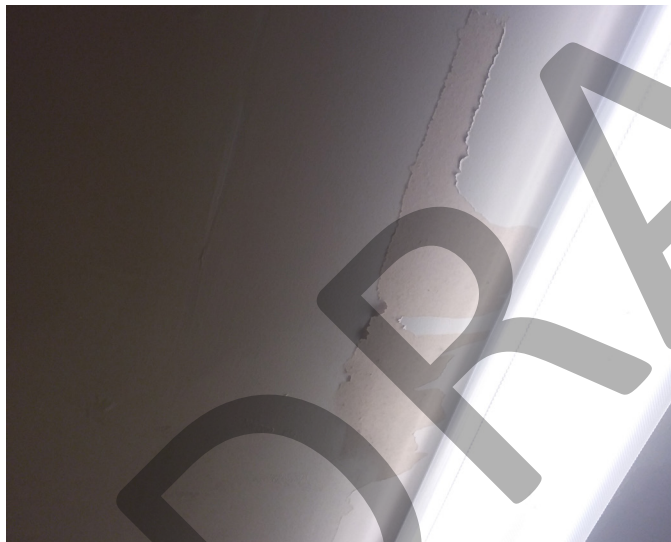
### 47. Location:

Ceiling paint peeling and needs to be touched up.

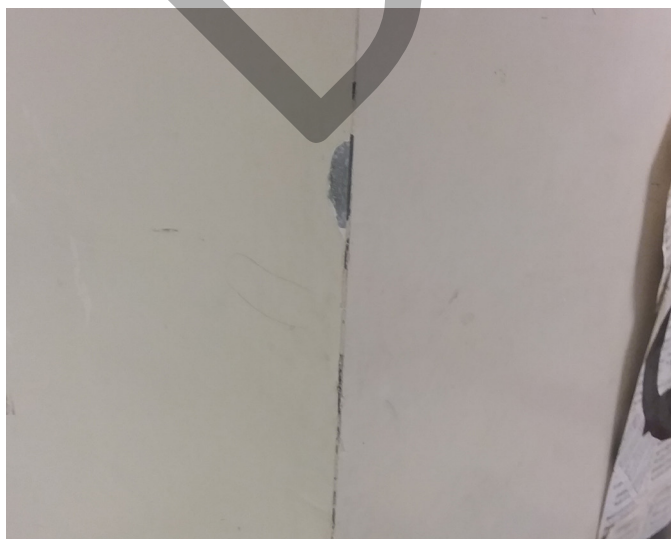
### 48. Location:

Paint and gypsum chipping on corner.

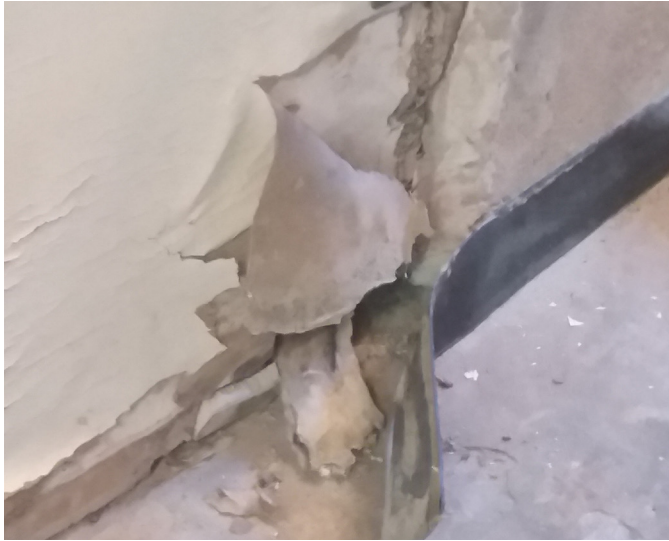
### 49. Location:

Bottom of wall damaged and wall base peeling off.

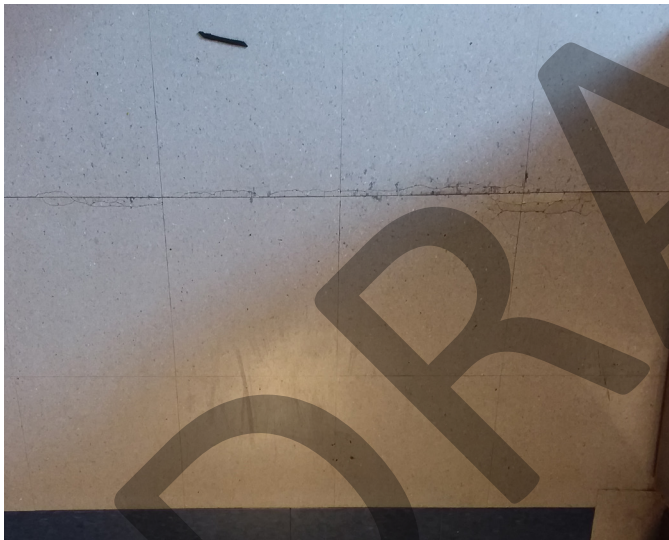
### 53. Location:

VCT is bubbling and showing cracking.

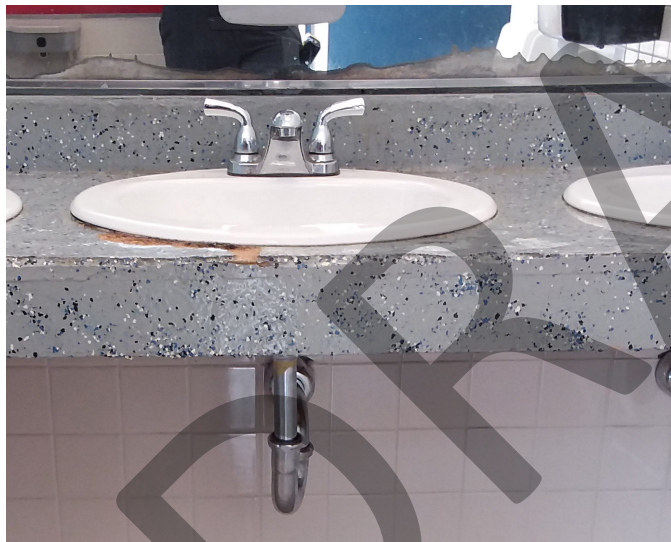
### 56. Location:

Counter top chipped and bubbling.

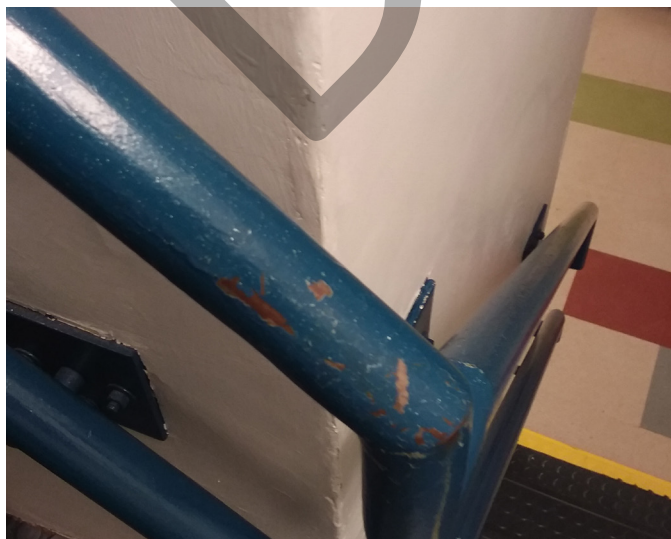
### 57. Location:

Paint chipping at railing

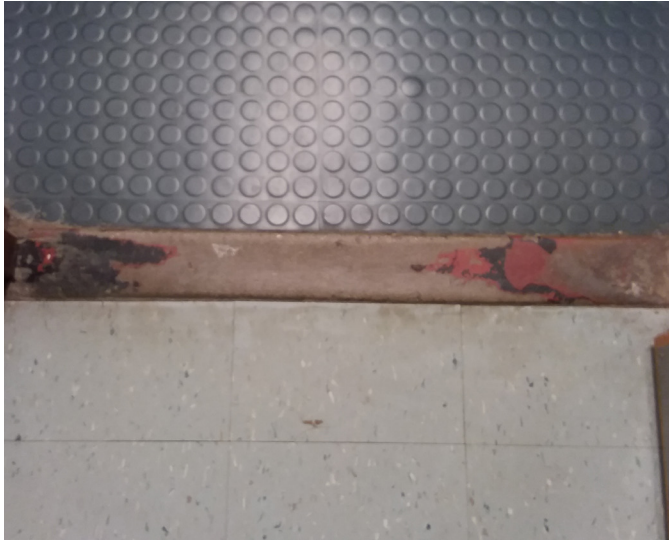
### 58. Location:

Transition faded and worn.

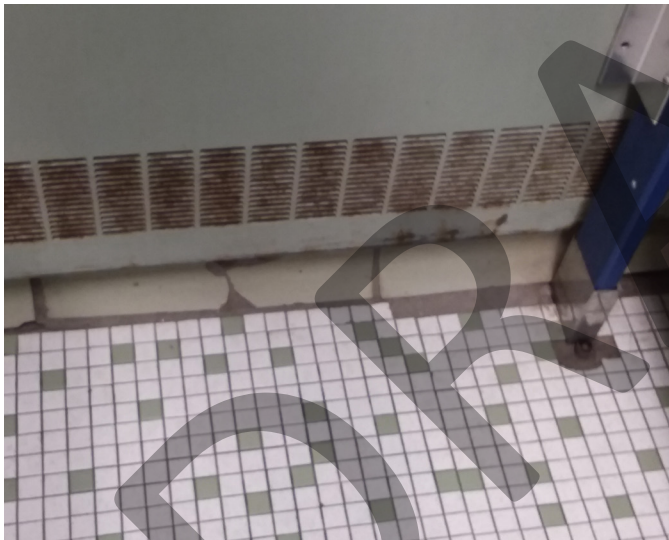
### 65. Location:

Chipped floor and wall tile. The radiator also seems rusted and the paint is chipped.

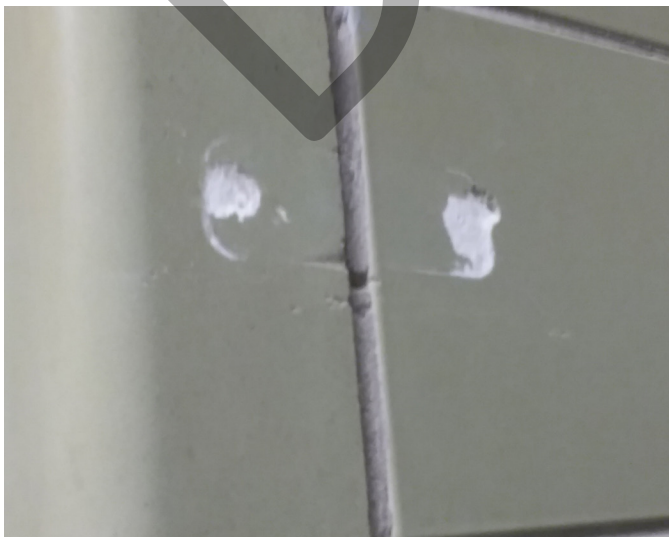
### 66. Location:

Chips in wall tile.

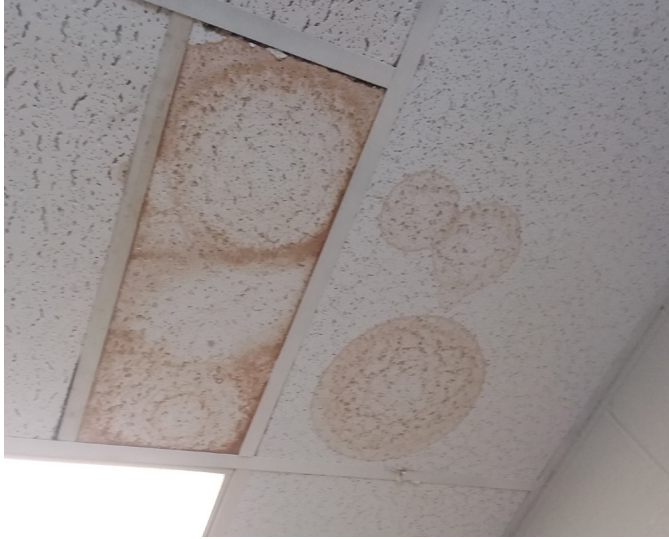
**67. Location:**

Water damage seen on ceiling tile

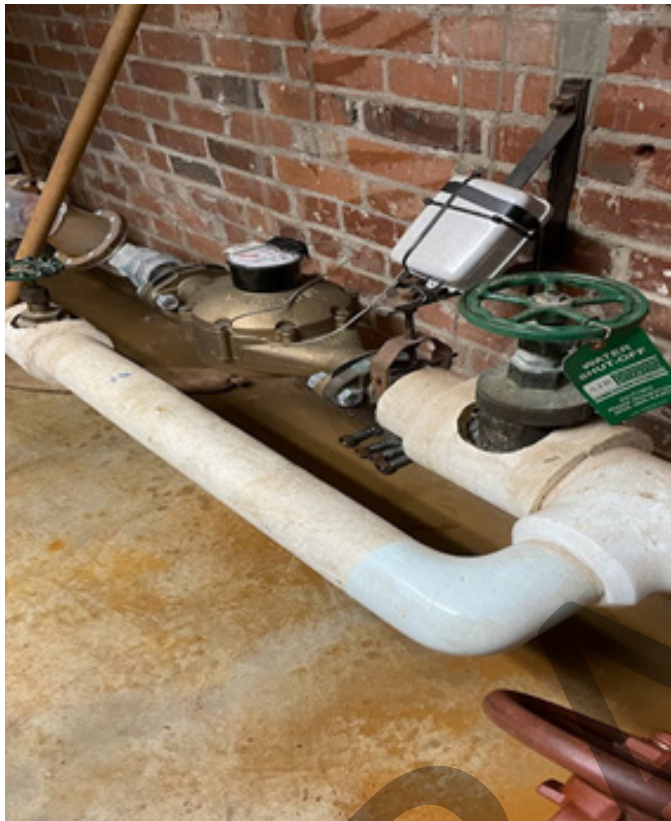
### 1. Location:

Domestic Water Service

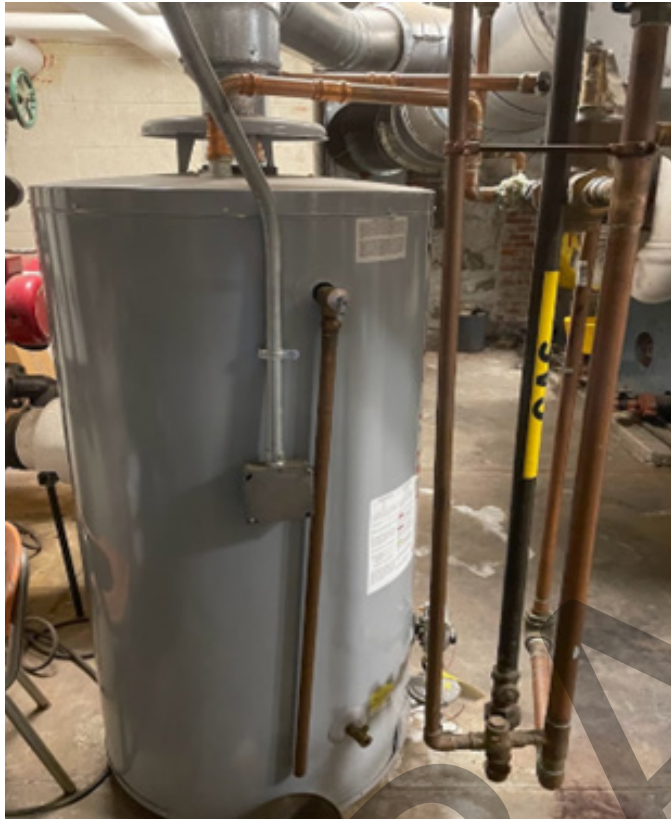
### 3. Location:

room. This water heater is newer as it was built in 2016 and appears to be in fair condition with little signs of any major damage to the unit.

Water Heater

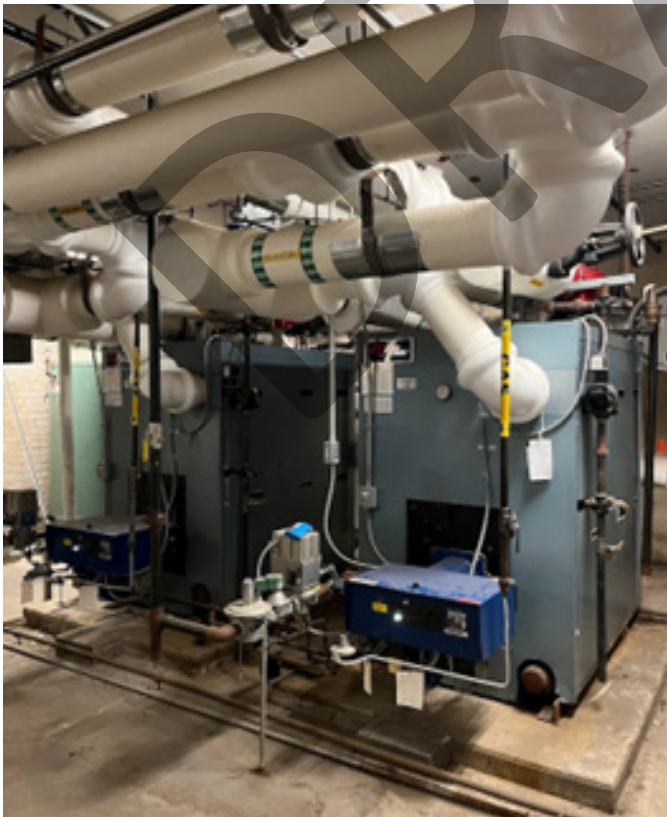
### 8. Location:

Heating system is served by cast iron mid-efficiency hot water boilers and pumps. The system is in fair condition and appears to be from 2009 (14 years old). Cast iron boiler system have an approximately 25 year life expectancy and while not near end of life we would recommend replacing with high efficiency condensing boilers for increased energy savings.

Cast Iron Gas Fired Boilers

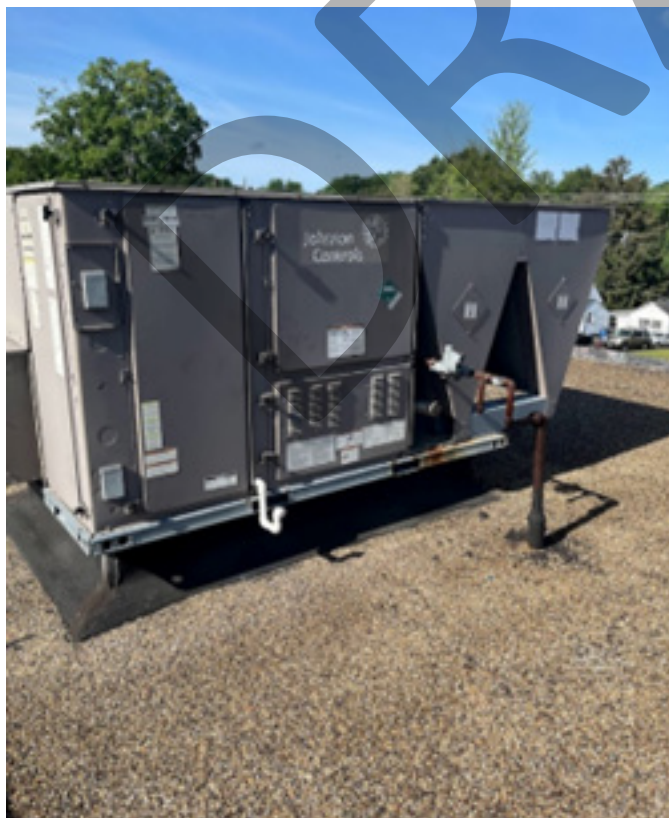
### 12. Location:

Gymnasium ventilation is provided by 12.5 Ton roof top unit located on Admin area roof. Unit is comprised of 240 MBH gas fired 2 stage indirect heating unit, DX cooling, supply fan, outside air hood, and MERV-7 filters. Unit provides mixed outside air with supply air under all conditions.

Gymnasium Ventilation Roof Top Unit

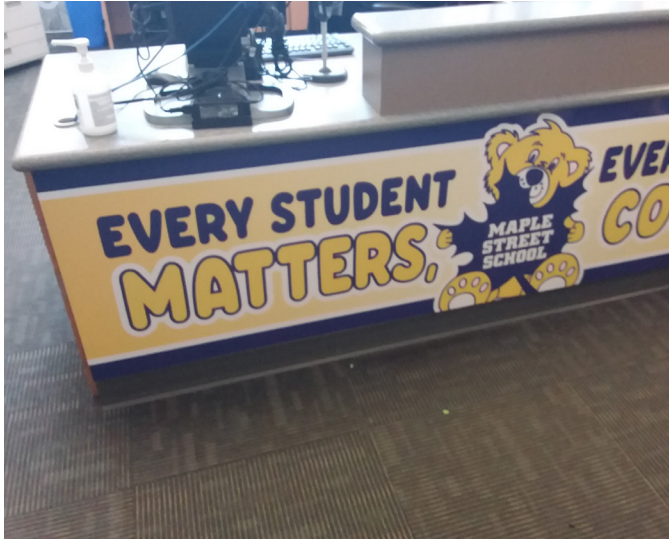
### 1. Location:

Lower, accessible portion of countertop is not clear.

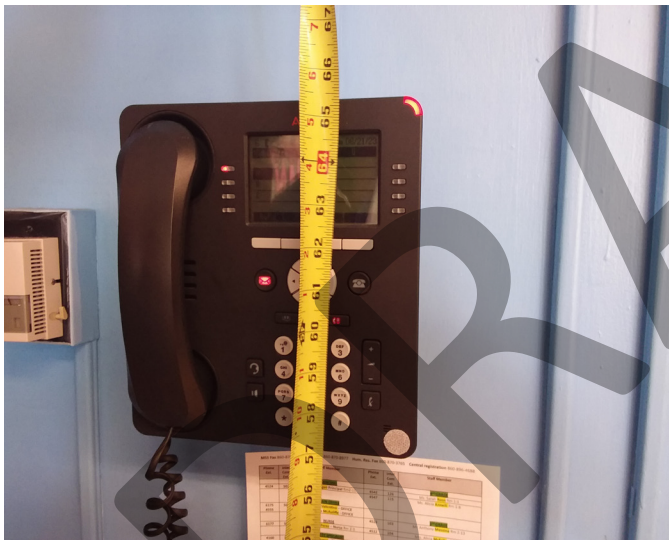
### 2. Location:

Operable components of telephone are located above the minimum 48".

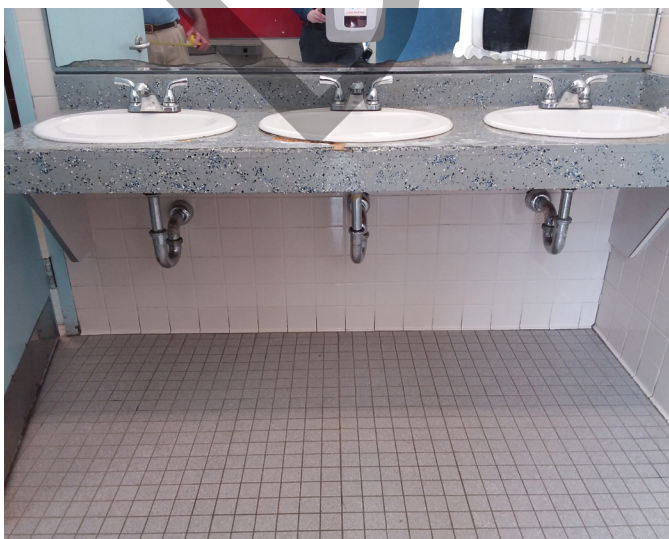
### 3. Location:

Plumbing beneath sinks is uninsulated.  
Typical at most toilet room locations.

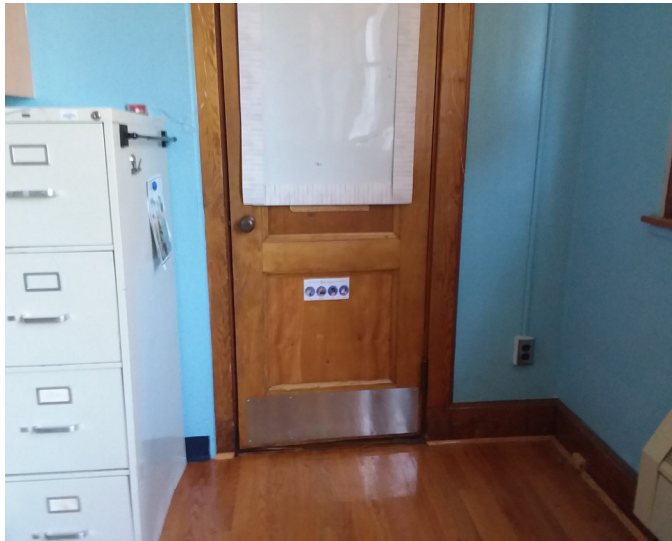
### 4. Location:

Door hardware for door leading to coat storage requires tight gripping to operate.

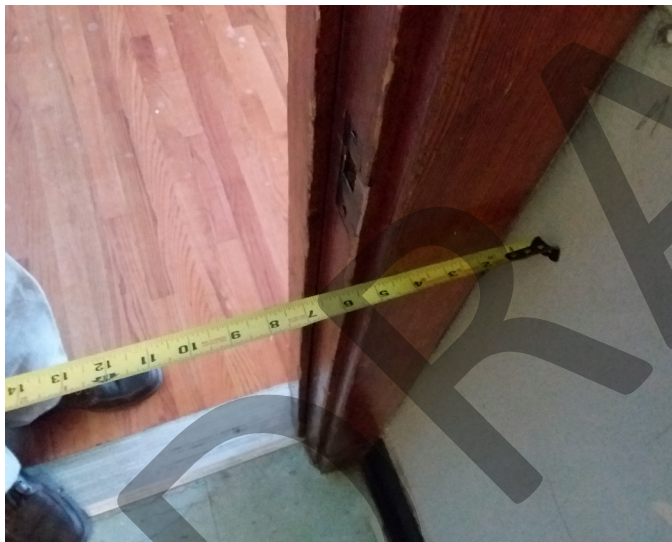
### 5. Location:

Latch side clearance on Pull side of door does not meet minimum requirement of 18"

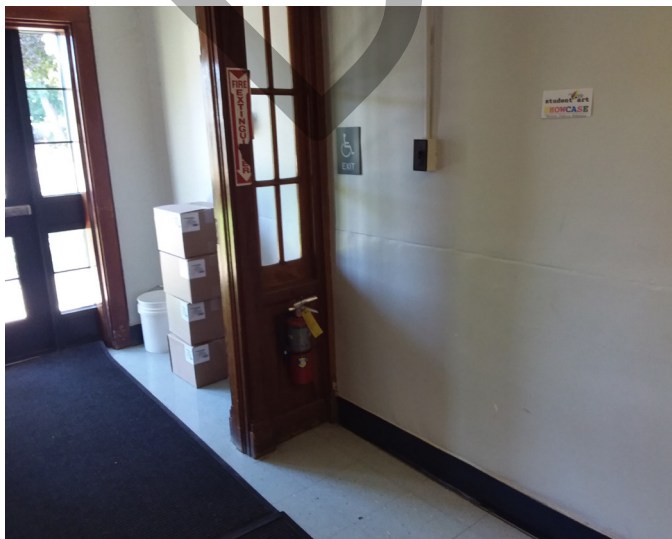
### 6. Location:

Signage is located in an inaccessible area, does not have 18" of clear width centered on the signage.

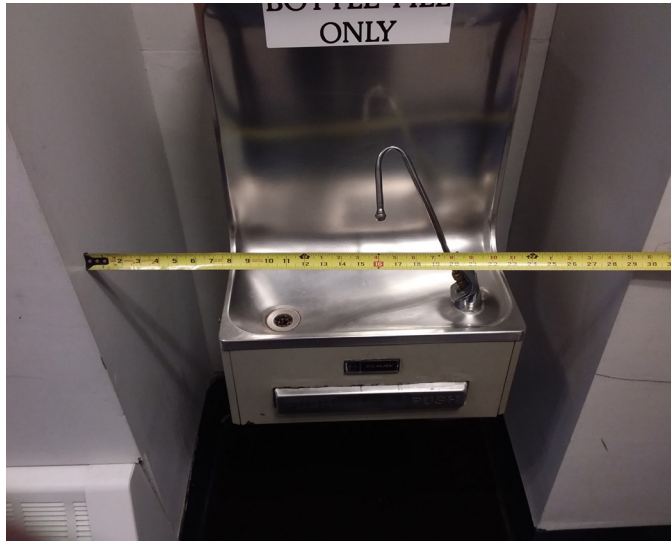
### 7. Location:

Drinking fountain does not have clear width or height required to pull under.

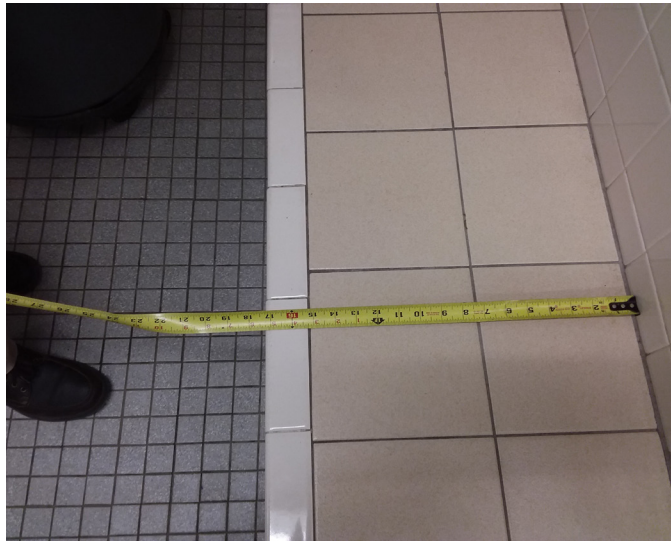
### 10. Location:

Accessible bench does not meet depth requirement of 24".

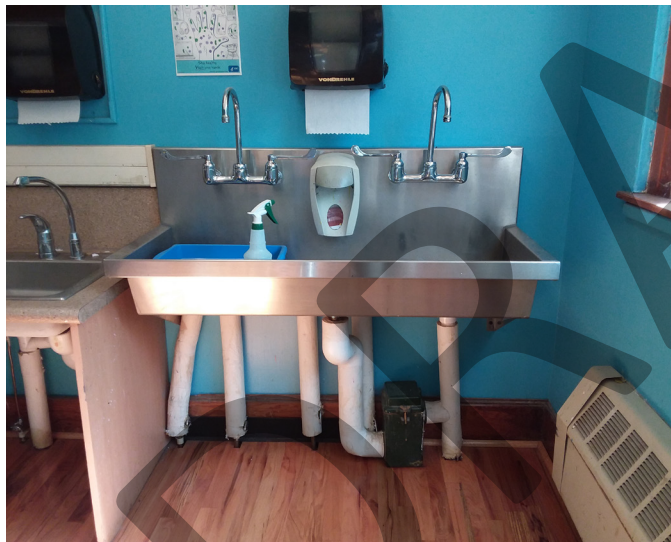
### 11. Location:

Proper toe clearance is not achieved by this accessible sink.

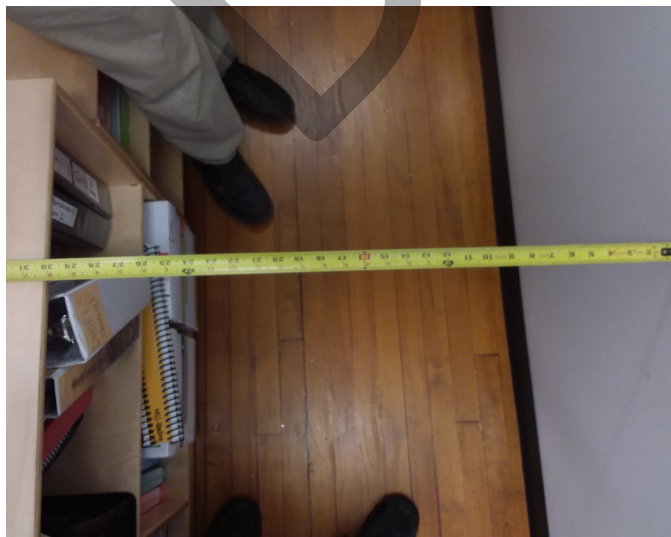
### 12. Location:

Corridors within this smaller classroom wing do not meet required clear distance. Doors and Openings do not meet standards either.

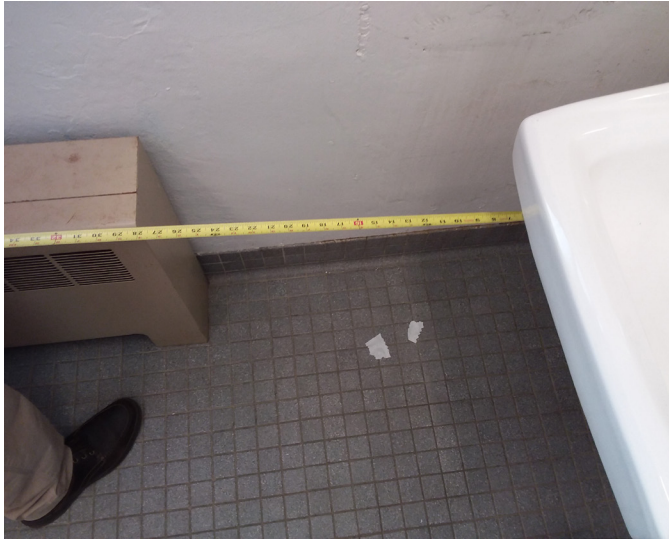
### 13. Location:

The floor mounted cabinet unit heater impedes the front approach to the sink.

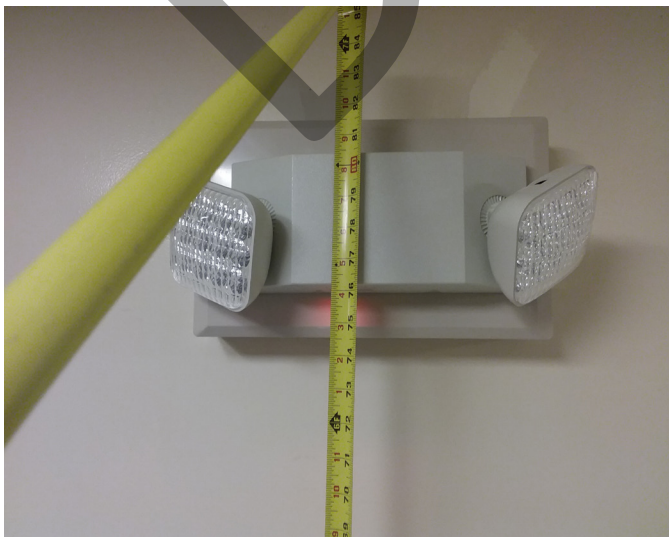
### 15. Location:

Emergency lighting protrudes greater than 4" into travel path and sits lower than the required 80" above the floor level.

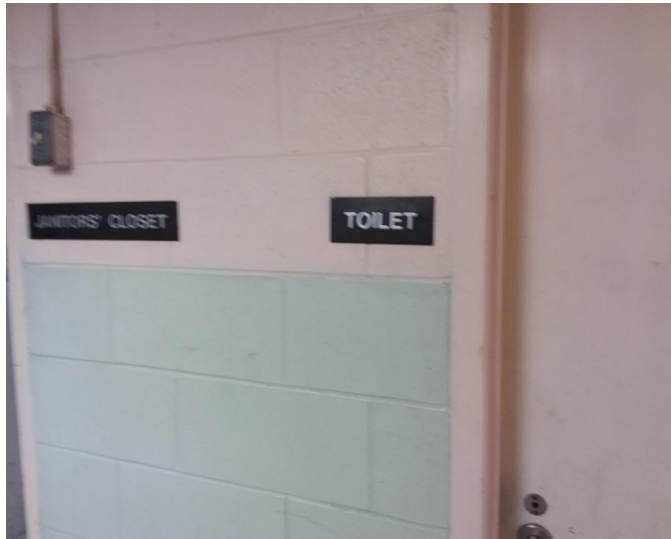
### 16. Location:

Signage does not have braille characters.

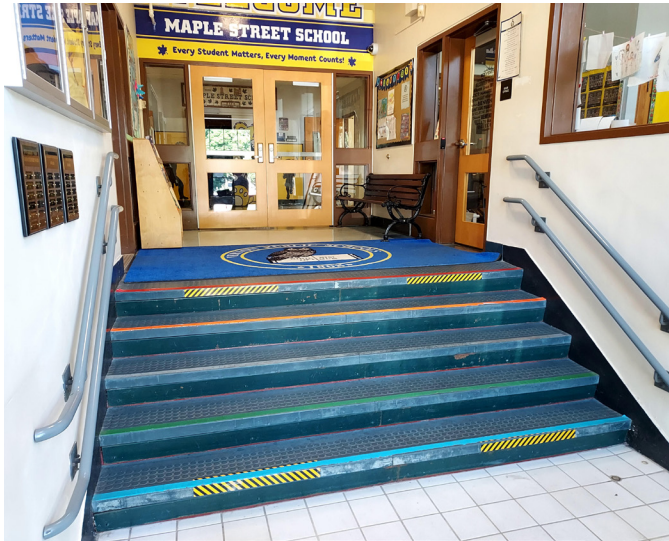
### 19. Location:

Stairs to the Main Office, Principal's Office, Main Corridor. The mat in the lobby is not fixed.

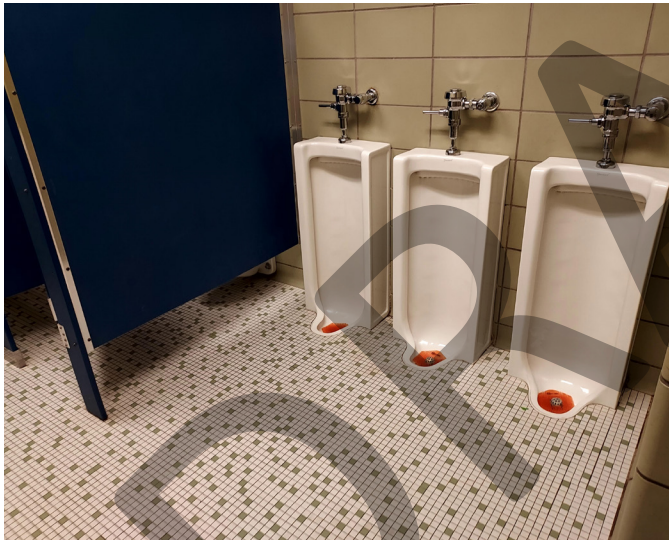
### 20. Location:

Urinals are non compliant.

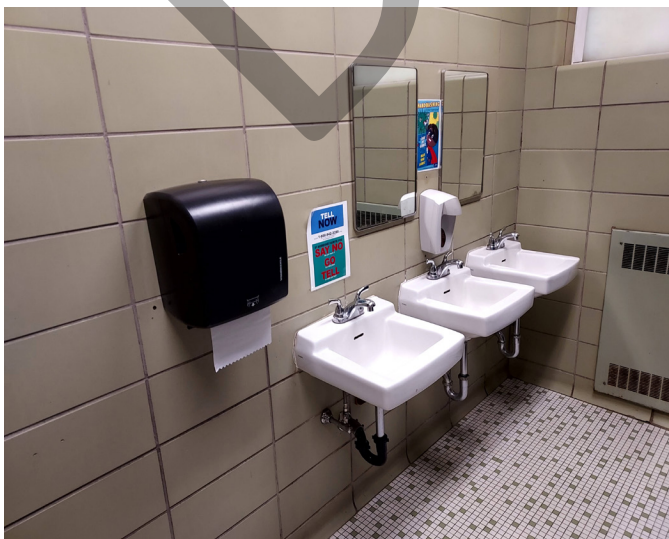
### 21. Location:

The sinks are non compliant.

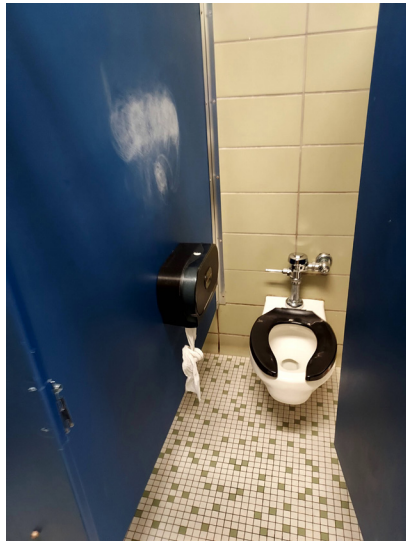
### 22. Location:

The toilet stalls are non compliant.

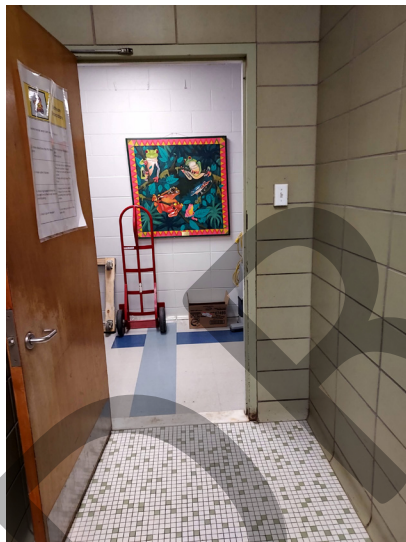
### 23. Location:

The clearance at the pull side of the door is non compliant

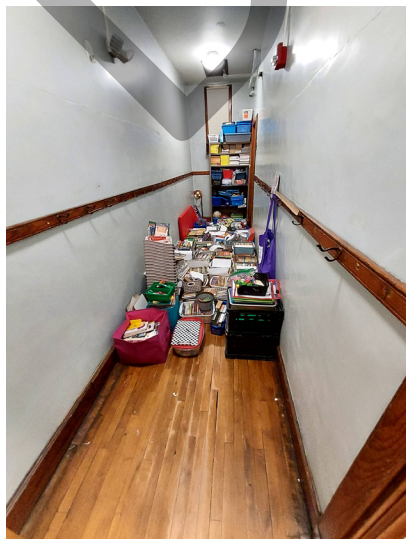
### 24. Location:

The coat room is not accessible due to the doors to the rooms.

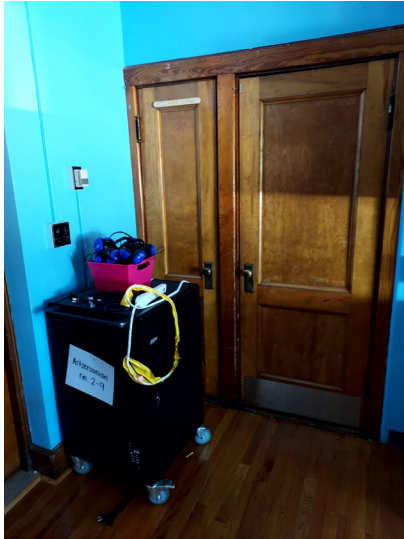
### 25. Location:

The door width and door hardware are non compliant

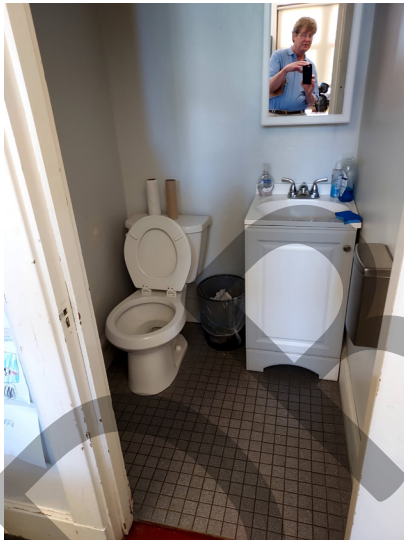
### 26. Location:

The bathroom is not accessible.

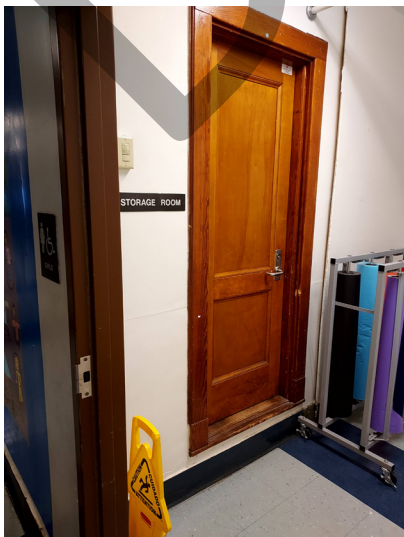
### 27. Location:

The door threshold, width and hardware are non compliant

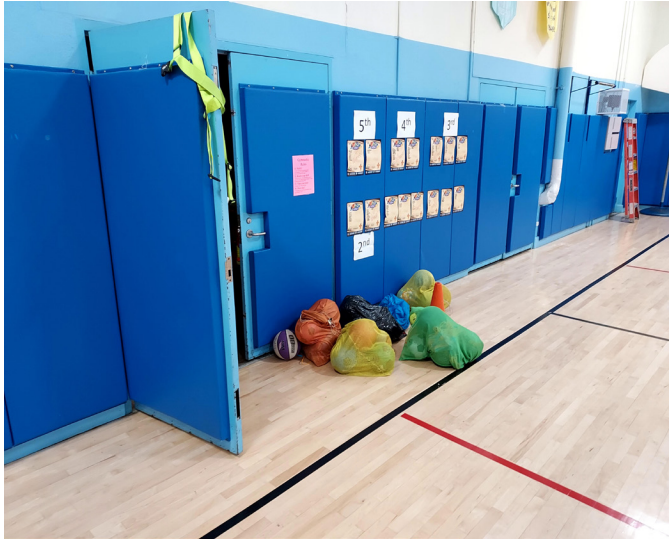
### 28. Location:

The doors located off the Gymnasium are not labeled. One is possibly the Physical Ed Office.
