Facility Study and Master Plan

# Maple Street School

20 Maple St, Vernon, CT 06066

SUMMER 2023

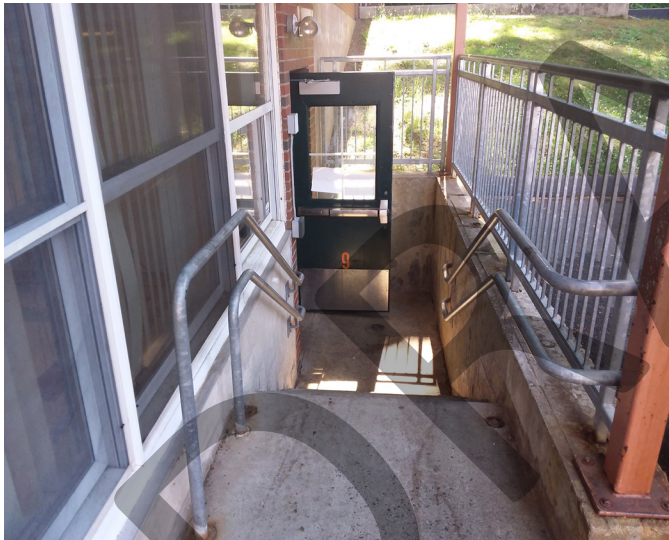
### 29. Location:

The updated exit stairway does not provide the Cafeteria with an accessible exit.

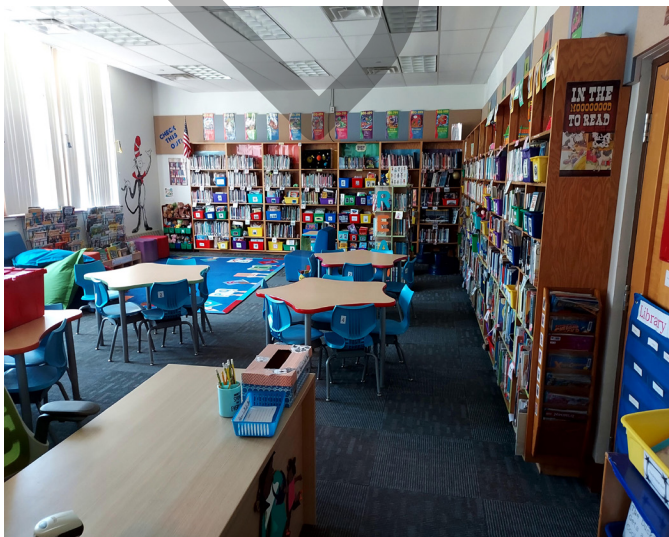
### 30. Location:

The check out desk needs to be dedicated for that purpose. The storage shelves are not all accessible. A dedicated seating and work space area is not included.

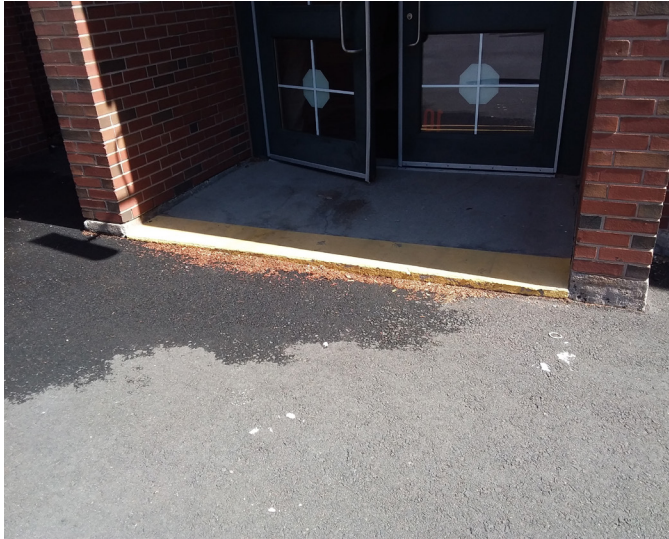
### 31. Location:

Height of transition from landing to grade is greater than 3/4".

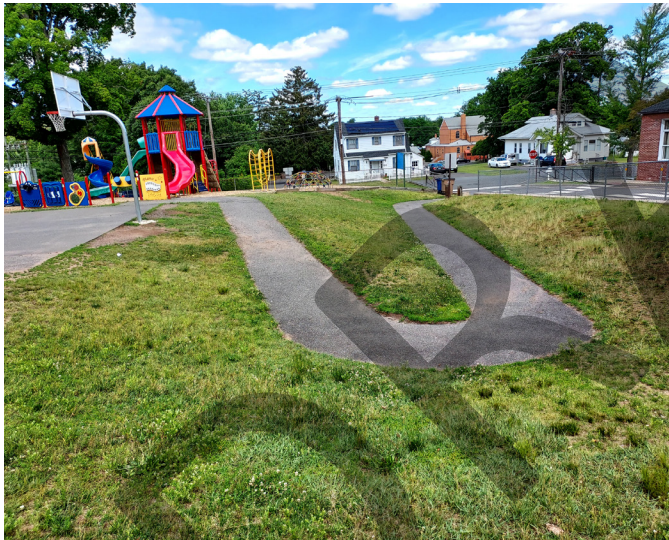
### 32. Location:

Ramp leading to playground exceeds maximum length. Does not satisfy landing requirements at change in direction.

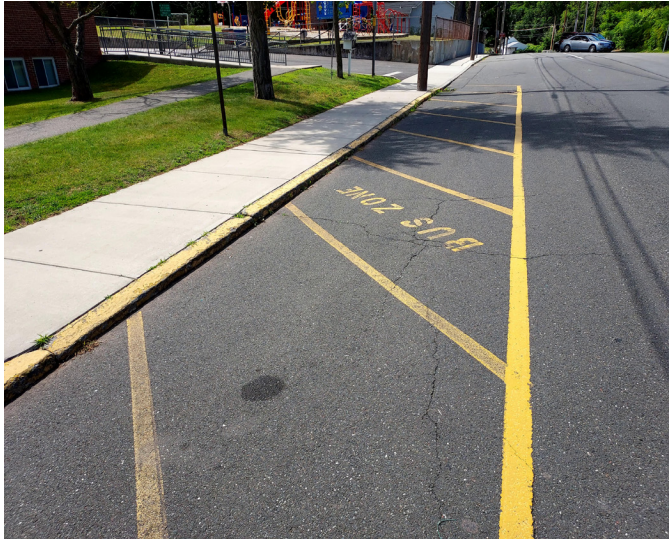
### 34. Location:

Access from the bus drop to the accessible entrance is non compliant. Accessible parking, loading zone or drop off area is not close to the main entrance.

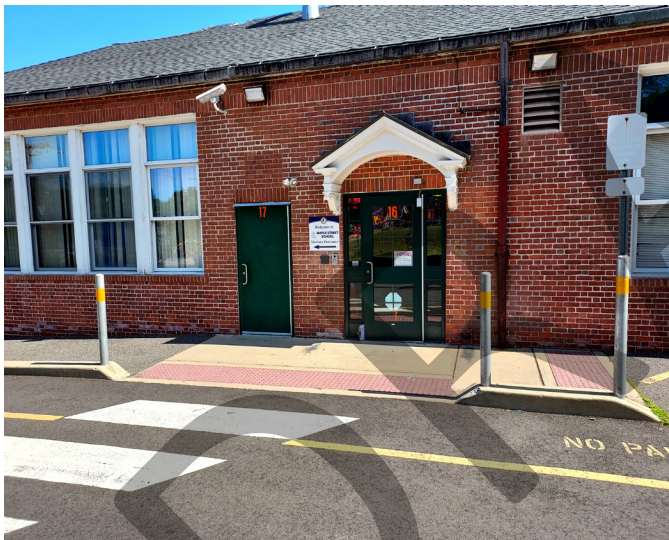
### 35. Location:

The signage directs visitors to the Main / Visitors Entrance which is not accessible.

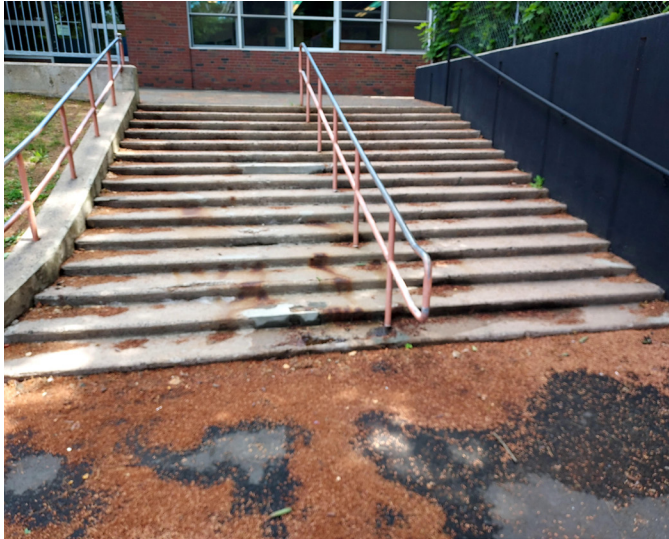
### 37. Location:

Stair provides access up and around building perimeter. The lack of handrails and distance between handrails do not comply.

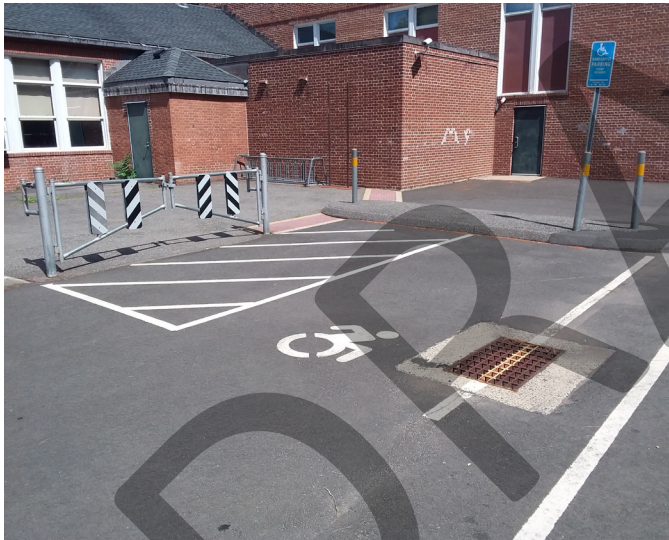
### 38. Location:

The only accessible parking space for the building. The space is located at the back of the building, signage to find this space is lacking. A van accessible, loading zone or drop off area are not available.

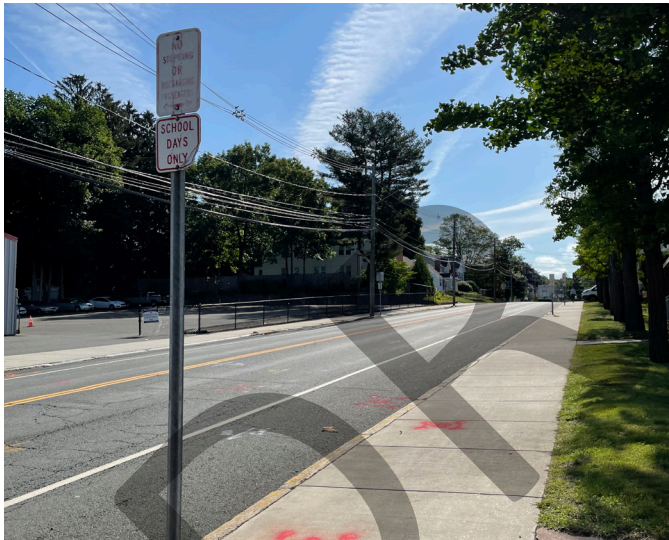
### 2. Location:

Signage along Union Street is faded

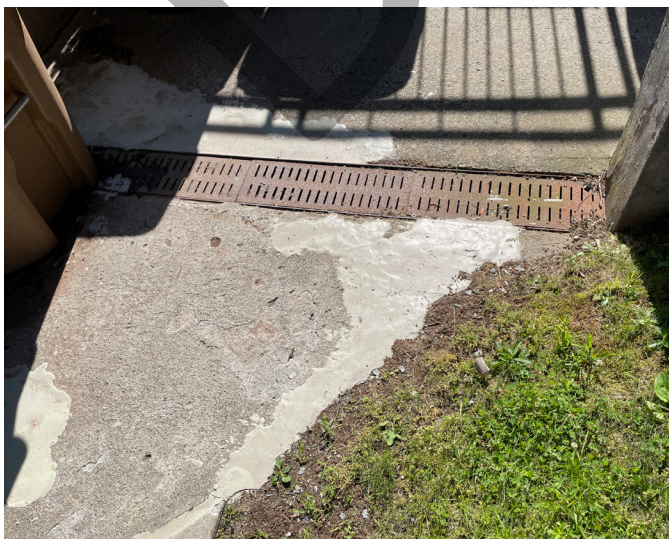
### 3. Location:

Exterior Ramp leading to Kitchen. The concrete finish is worn and the grass area has overtaken the path. Grate for drainage needs to be cleaned out.

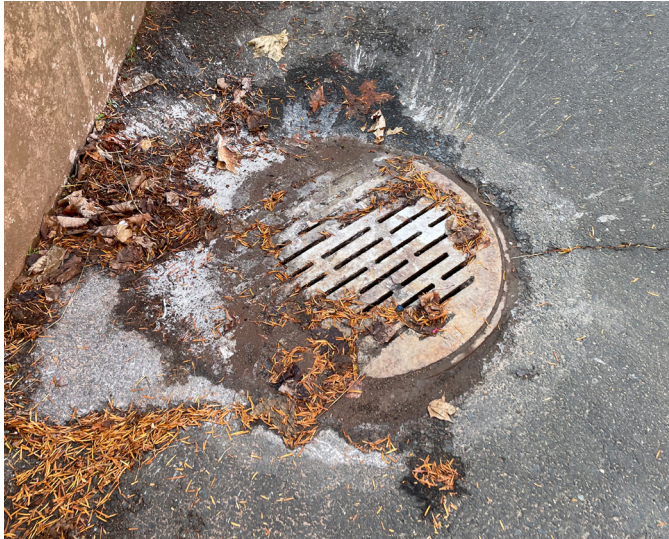
### 4. Location:

Drain clogged with leave and debris.

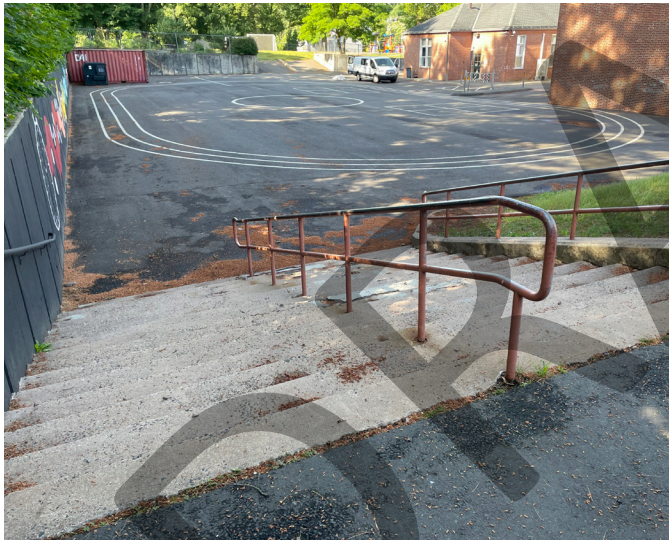
### 5. Location:

Exterior concrete stair with metal handrail. Handrail finish is faded. See ADA report for additional information.

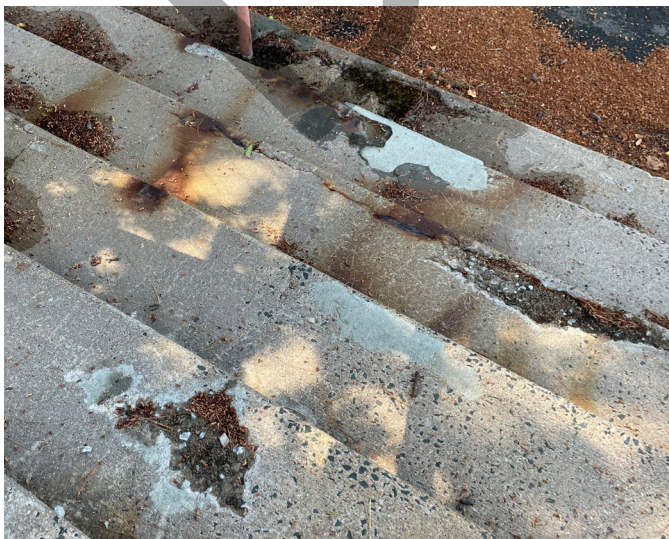
### 6. Location:

Concrete tread severely damaged.

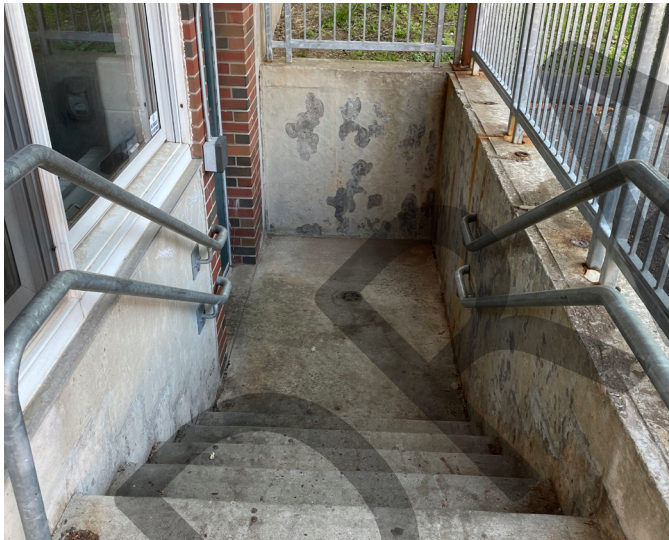
### 8. Location:

Stair leading to the Cafeteria. Areas where old posts were need to be infilled. The finish on the concrete face is falling away.

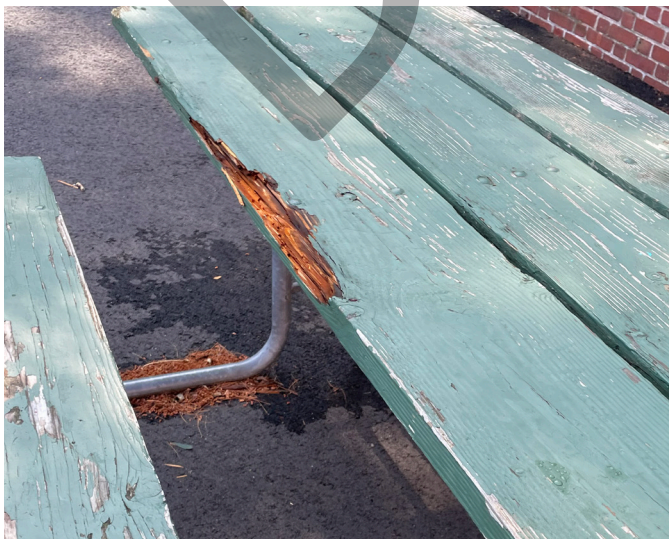
### 9. Location:

Wooden picnic table is damage and needs to be repaired or replaced.

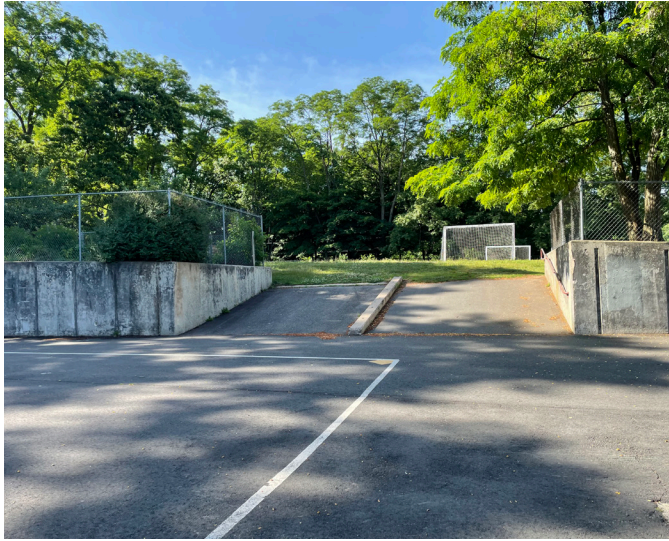
### 10. Location:

Bituminous sloped area leading to fields.  
No signage or barriers to stop vehicles from entering the area

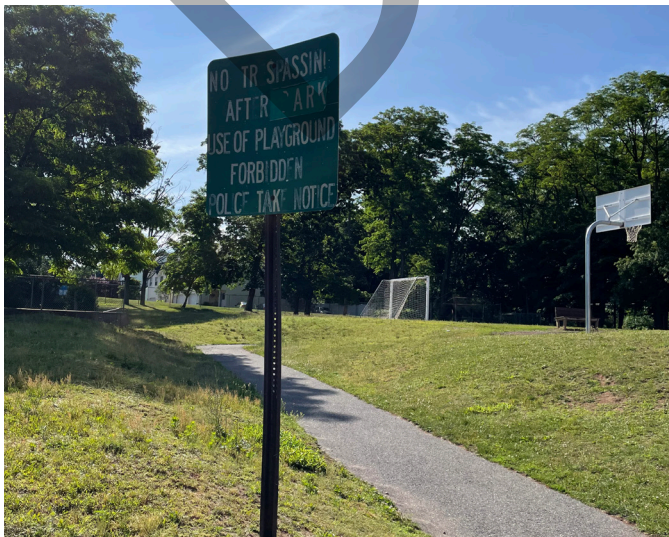
### 12. Location:

Signage letter is faded.

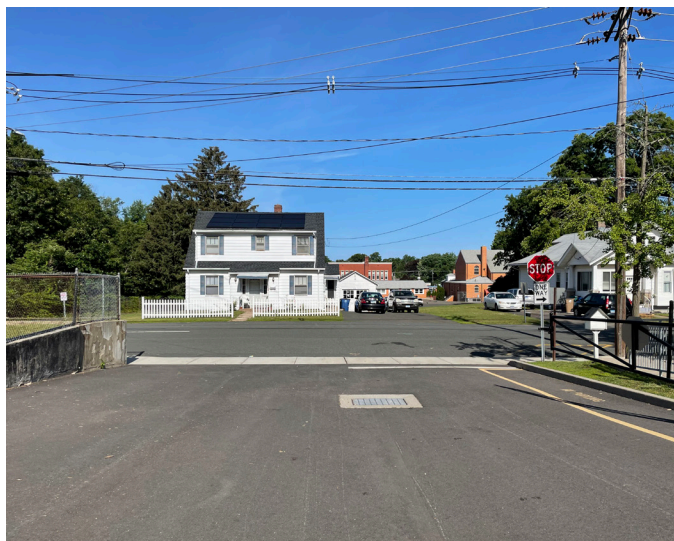
### 13. Location:

Limited signage and no directional markings on the ground.

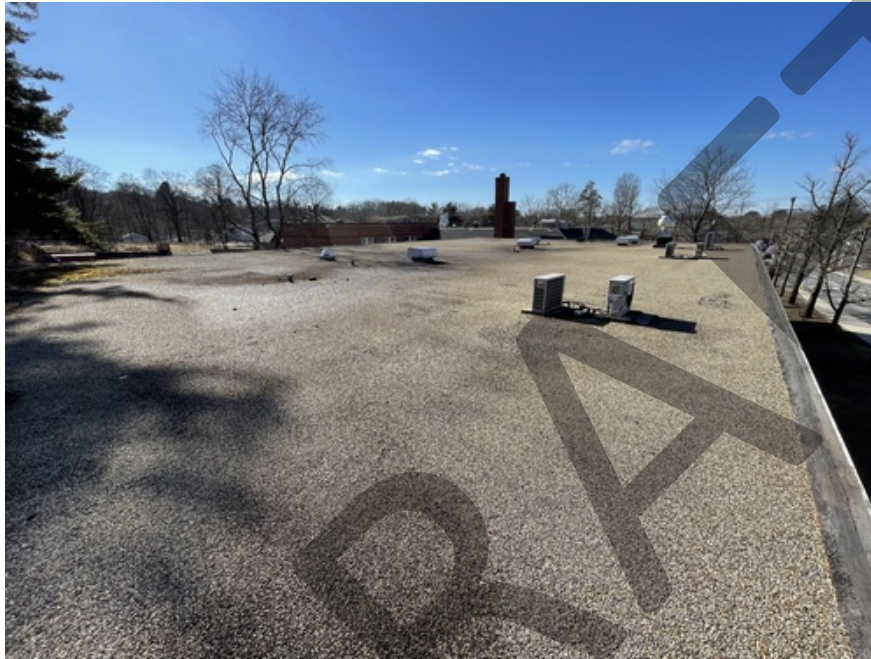
*Photo 1*

**Overview of the northeast  
most low slope section**

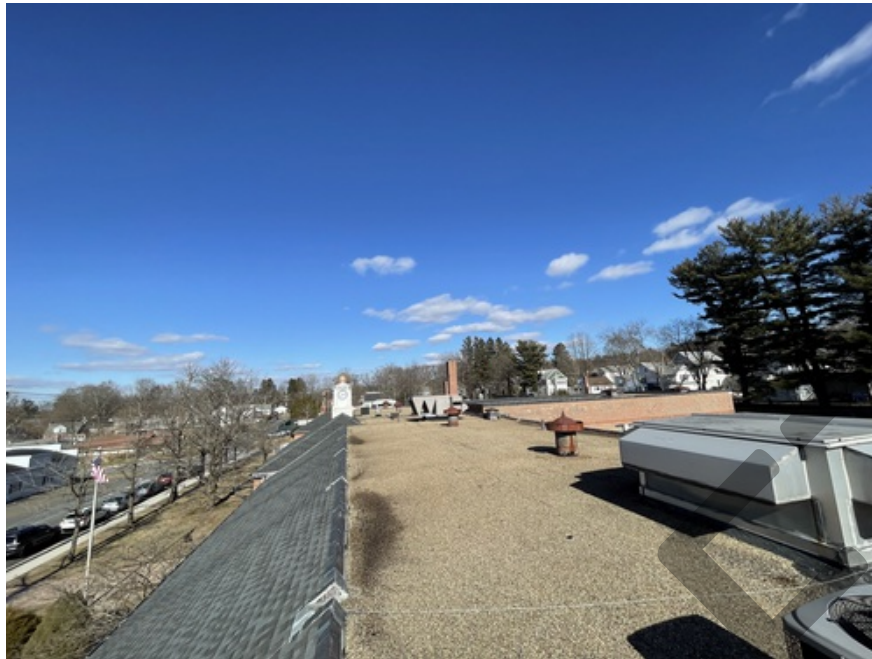
*Photo 2*

**Overview of the front west facing low slope section**

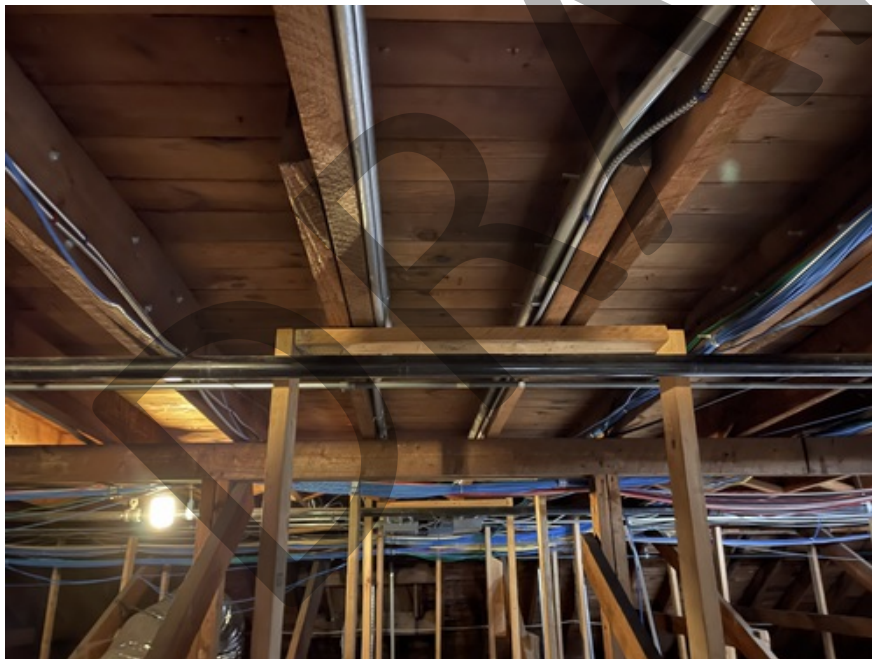
*Photo 3*

**Overview of the wooden plank decking below the original school section**

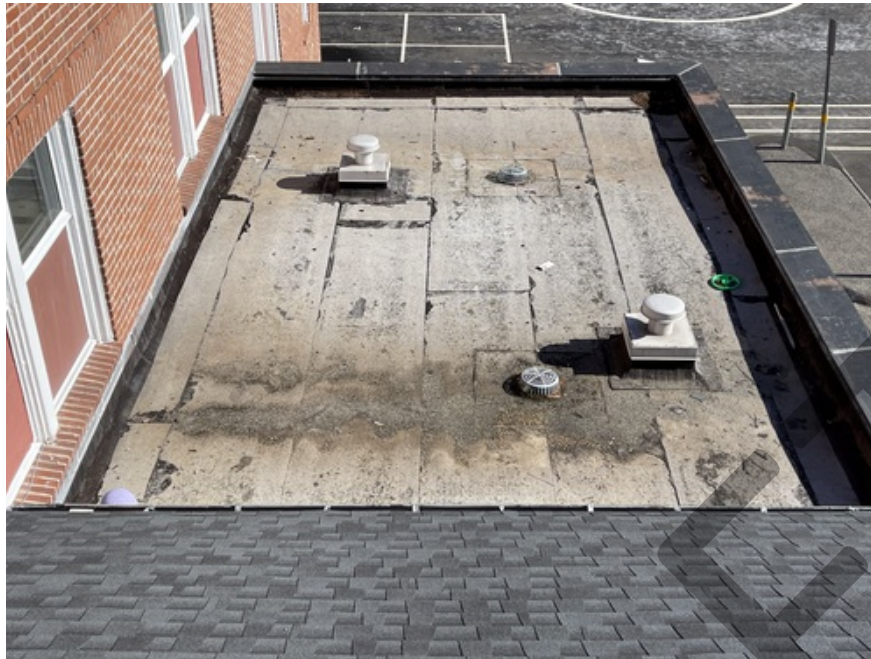
*Photo 4*

**View of the mineral modified section- mid-level- Clogged drain and minor ponding**

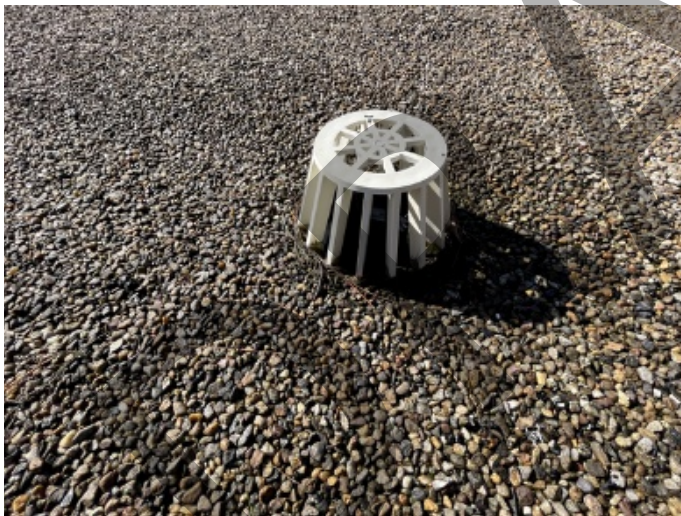
*Photo 7*

**Drain grate openings larger than the pea gravel- Will cause a clogged drain- Screen recommended**

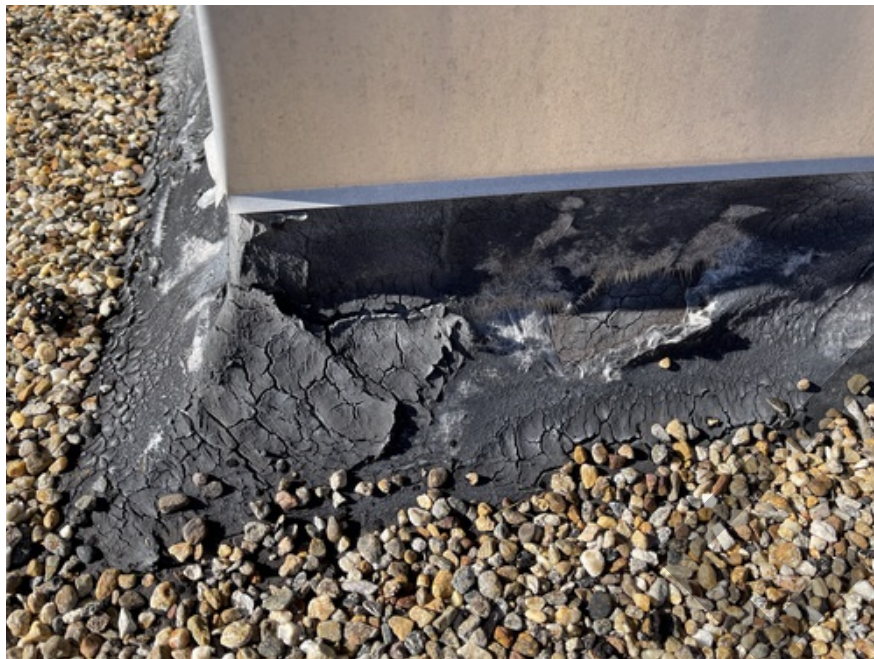
*Photo 12*

**Failed previous repairs-  
Consistent throughout**

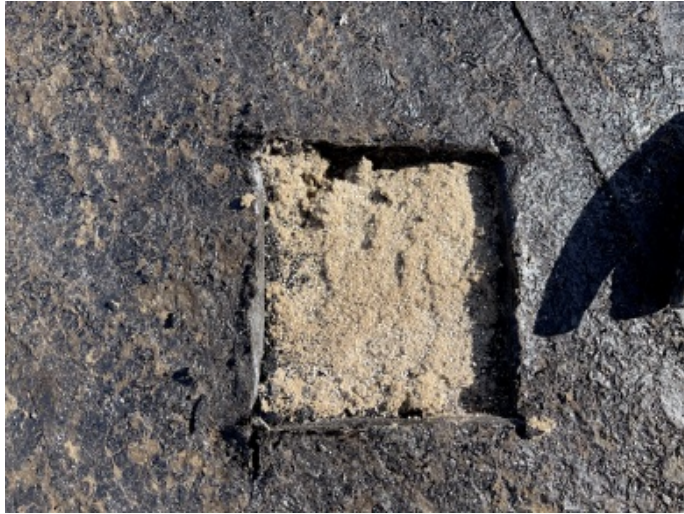
*Photo 24*

**Core Cut:** Perlite used as coverboard- Results were dry

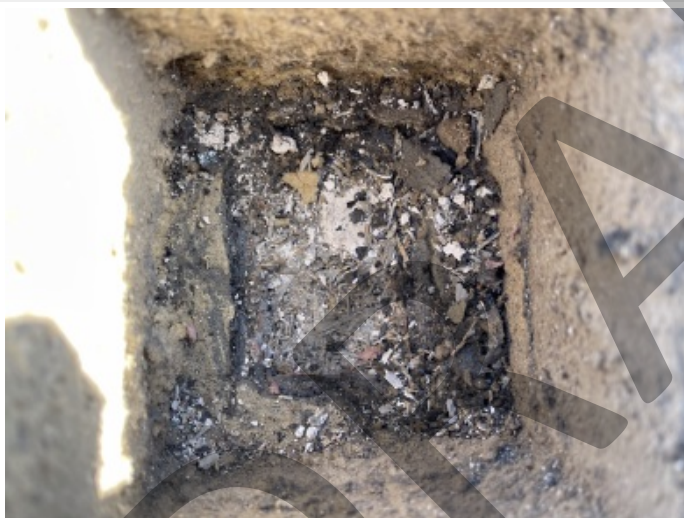
*Photo 25*

**Core Cut:** View of the tectum deck below

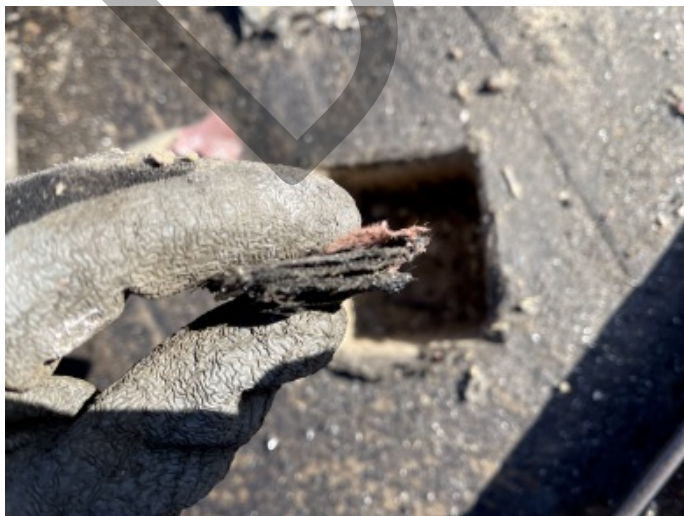
*Photo 26*

**Core Cut:** Two ply hot mopped VB layer

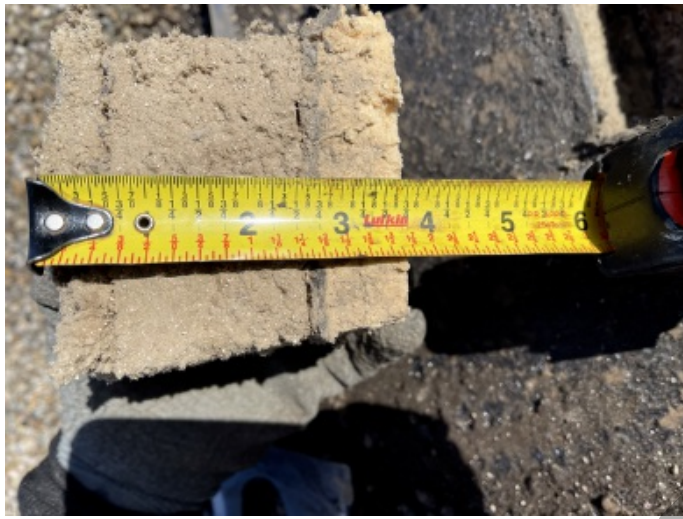
*Photo 27*

**Core Cut: System layers - 1" Iso, 2" Iso, 1/2" Perlite coverboard**
