Facility Study and Master Plan

Lake Street School

201 Lake Street, Vernon, CT 06066

SUMMER 2023

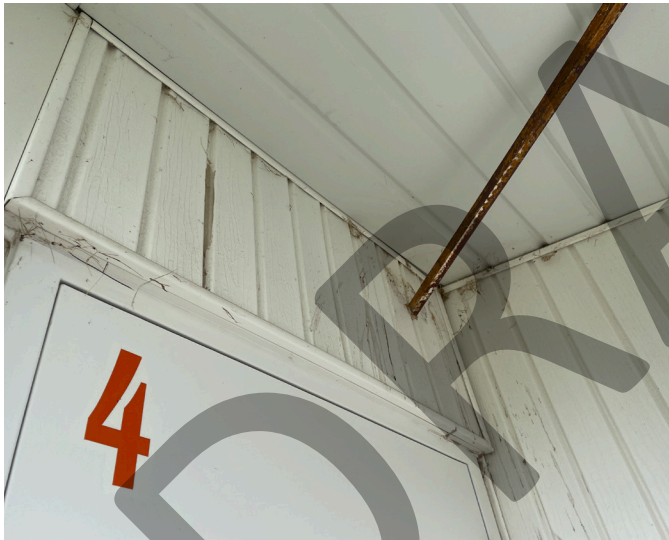
2. Location:

Typical vinyl siding. Support like for the roof is rusted - this is a typical condition.

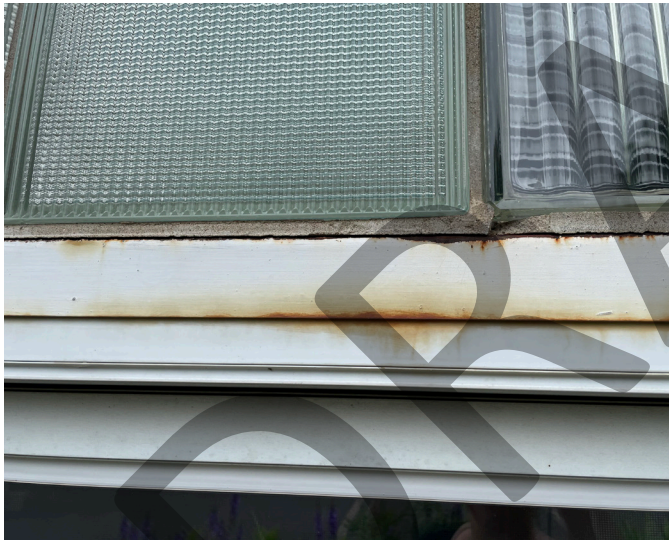
5. Location:

Rusting window lintel - typical condition.

- Window lintels need to be refinished due to rusting.
- Replace any damaged or broken glazing or glass blocks
- Provide sealant at all window and glass block locations
- Review weatherproofing of existing foundation and repair where deterioration has occurred.
- Direct roof drainage away from facade of building to reduce deterioration of finishes
- Replace damaged vinyl siding at Gymnasium/Cafeteria
- Further investigation into the water content of the slab is needed - many areas of bubbling under the VCT was visible at time of the survey.
- Replace damaged and broken blinds
- Replace any damaged ceiling tiles
- Replace damaged wood floor in Gymnasium
- Repaint walls and door frames where wear and tear is seen
- Repair delaminating casework in classrooms

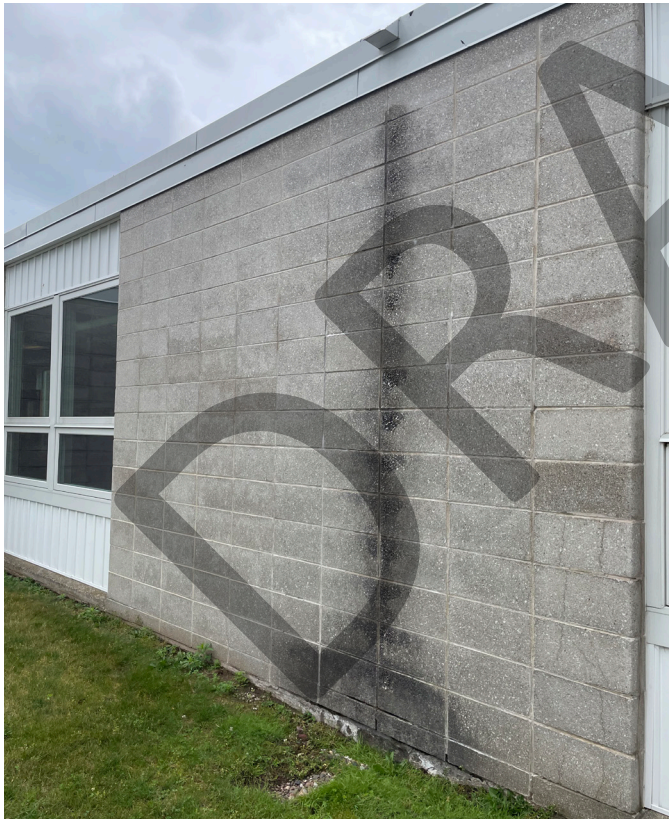
15. Location:

Water from roof drain has caused discoloration on the block wall and created deterioration of the grouting between the block. Deterioration of the foundation is also visible at this location.

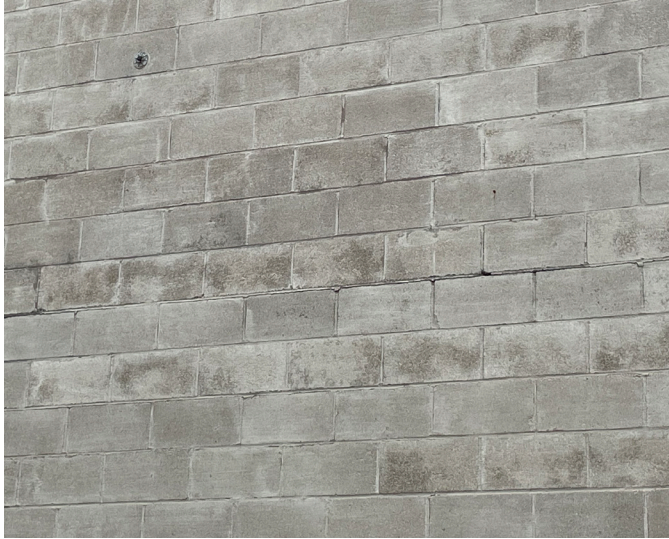
16. Location:

Repointing required at the CMU.

- The rusting support rods at each exterior exit door require further review.
- Repoint CMU exterior facades

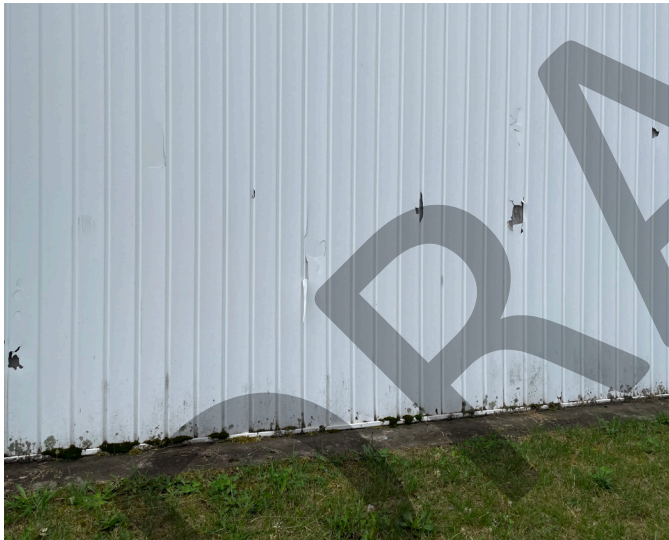
17. Location:

Vinyl siding is damaged throughout this facade. Large amounts of mold and mildew build up is visible along the bottom of the siding.

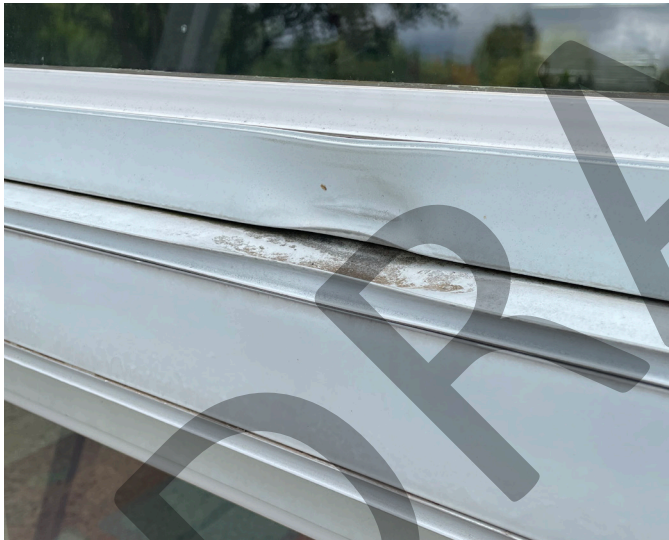
20. Location:

Damaged storefront system

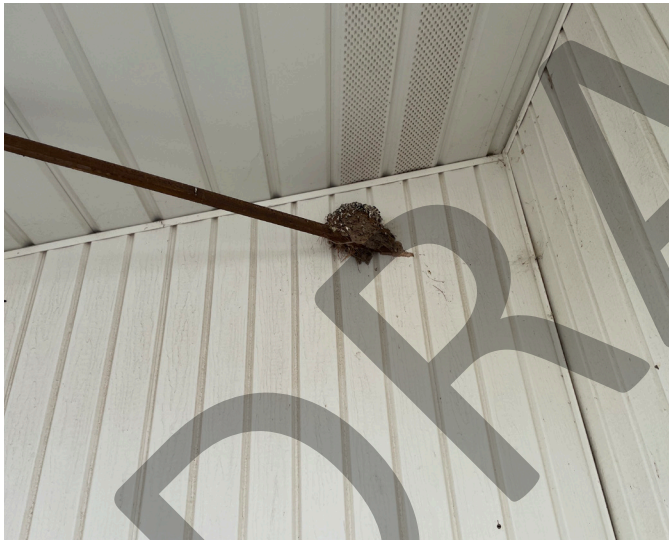
23. Location:

Many areas where birds and other animals have build nests at exposed structure

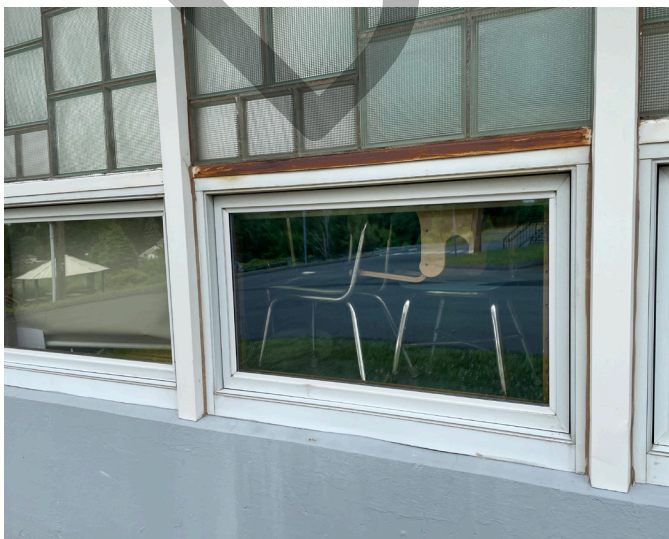
24. Location:

Lintel severely rusted.

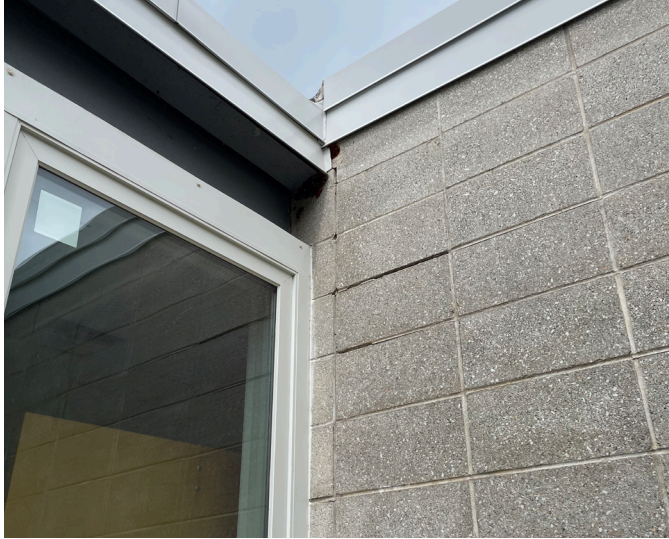
25. Location:

CMU needs repainting

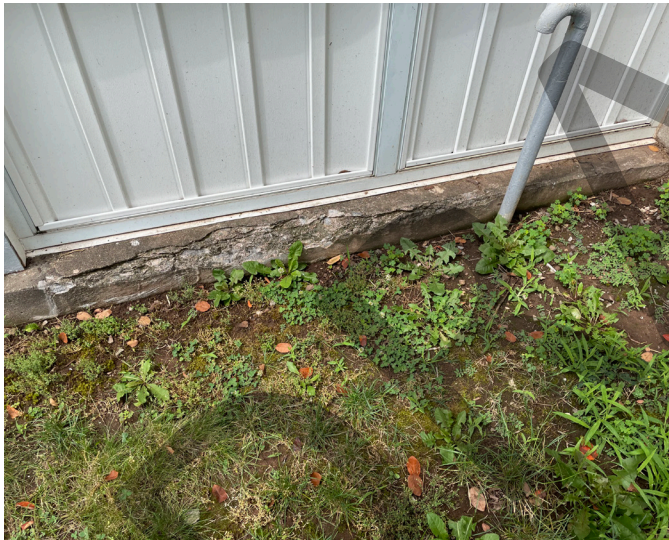
26. Location:

Deterioration of foundation visible

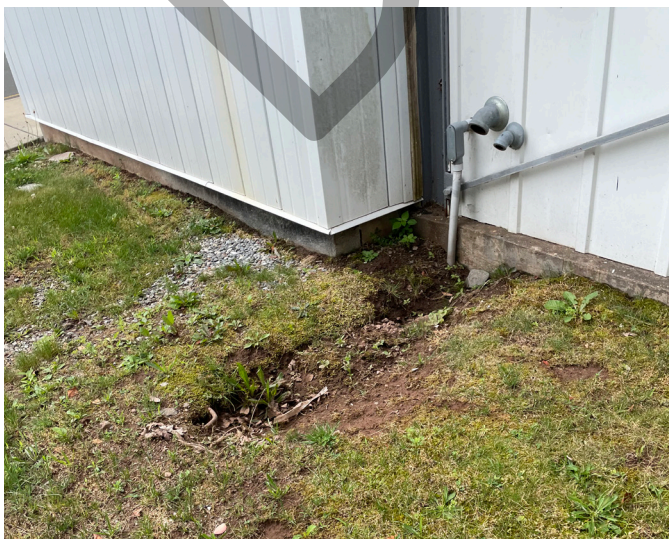
27. Location:

Discoloration of siding. Trench dug at some point needs to be infilled or covered.

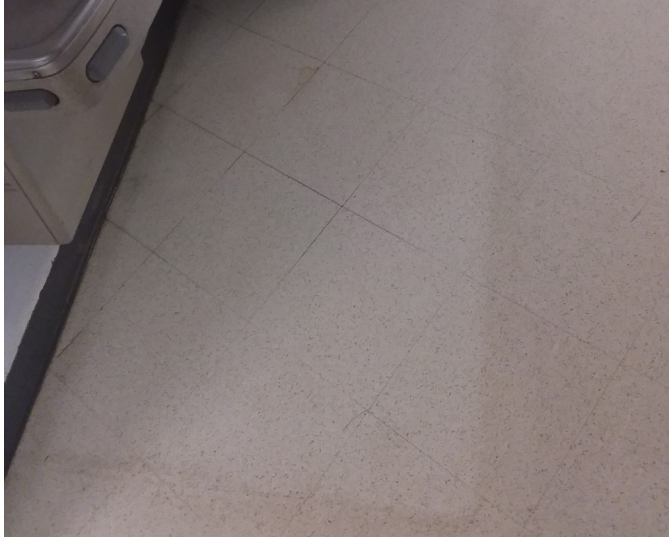
28. Location:

Vinyl composite tile (VCT) is stained and discolored.

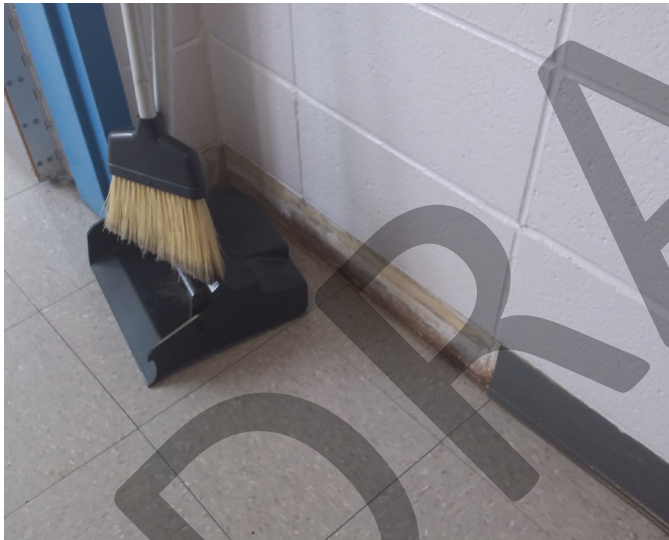
29. Location:

Wall base missing.

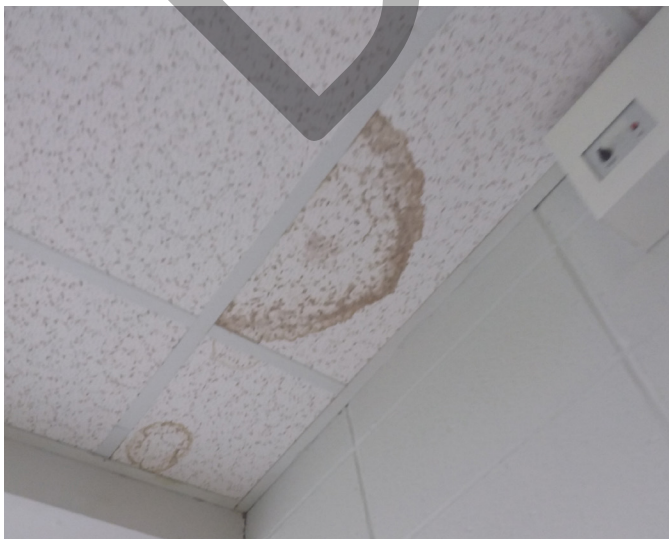
30. Location:

Stain on ceiling tile indicating water damage.

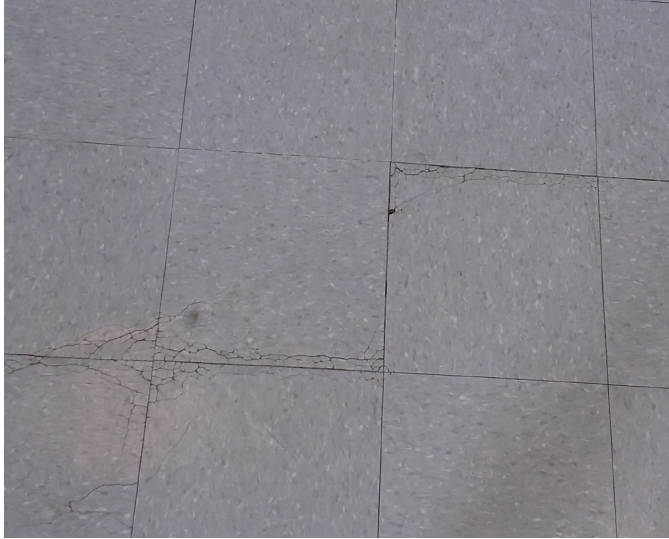
31. Location:

VCT is cracking and damaged.

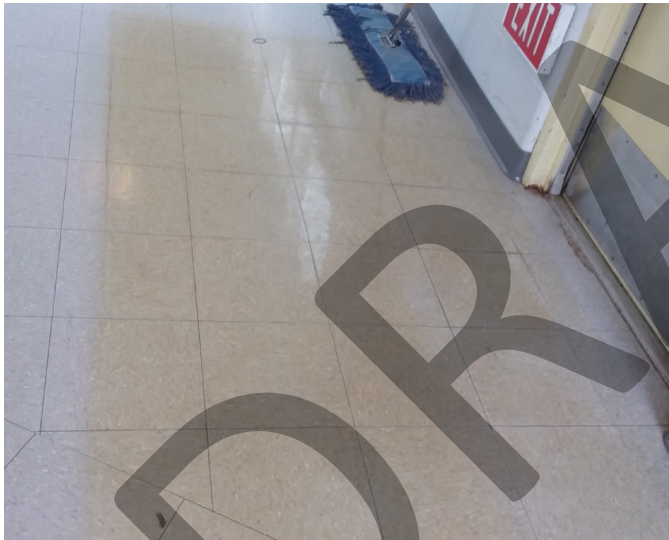
32. Location:

VCT has yellowed over time.

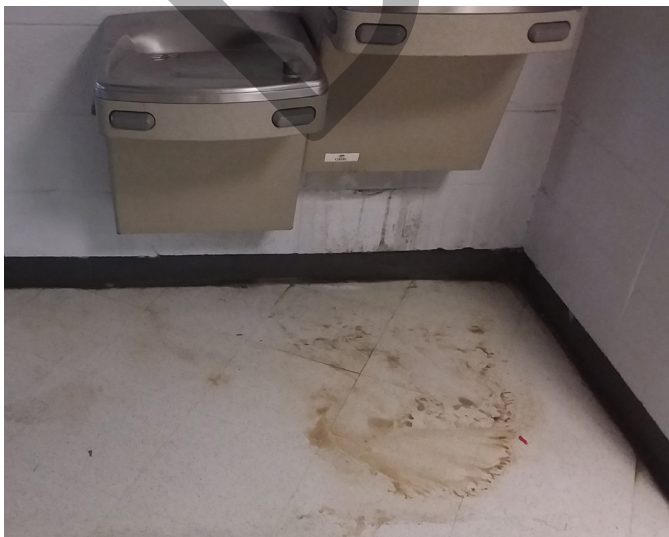
33. Location:

VCT is stained and there appears to be water damage.

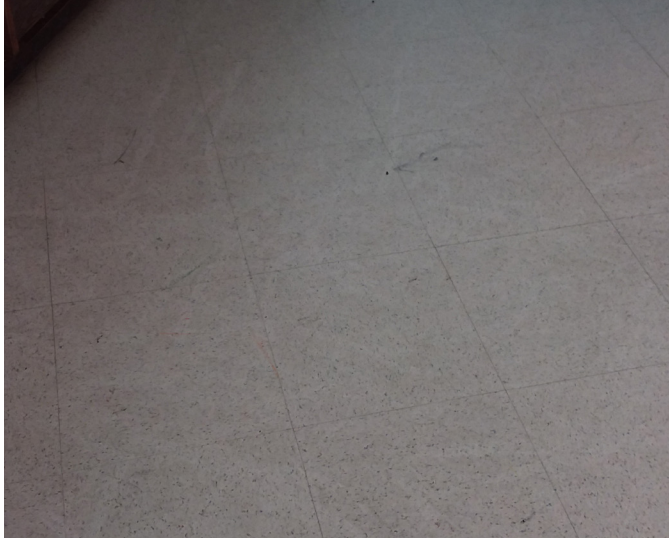
34. Location:

VCT is stained and scratched.

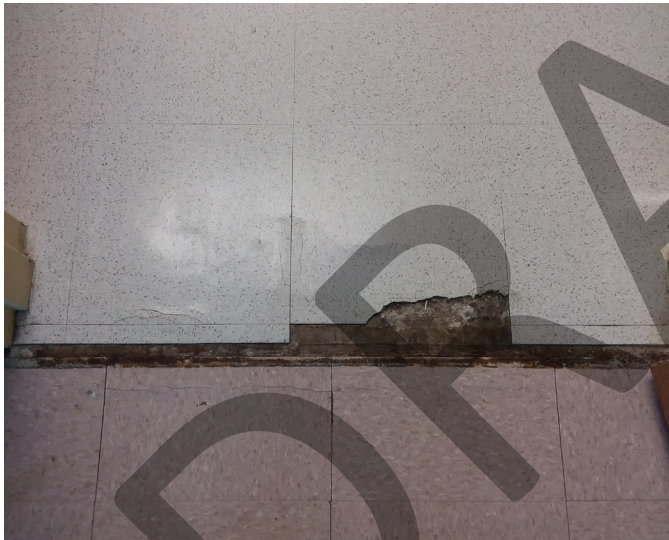
35. Location:

VCT is cracking and peeling up leaving sub flooring exposed.

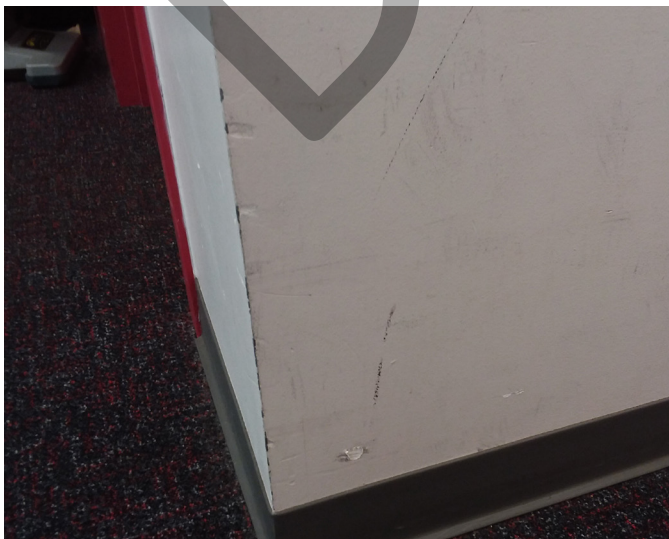
36. Location:

Chipped gypsum corner needs to be fixed and repainted.

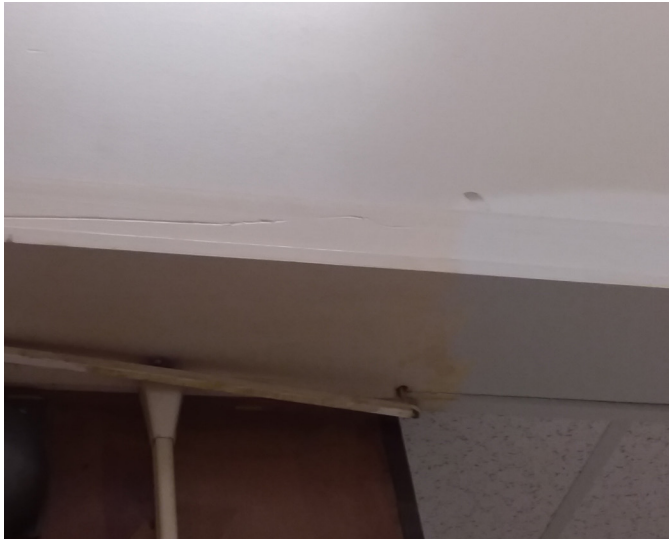
37. Location:

Discoloration of gypsum soffit near entrance of Cafeteria.

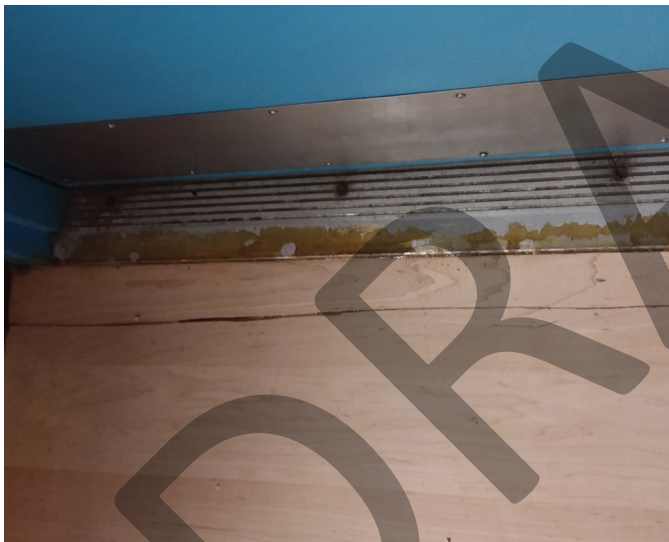
38. Location:

Rusted metal transition interior of gym.

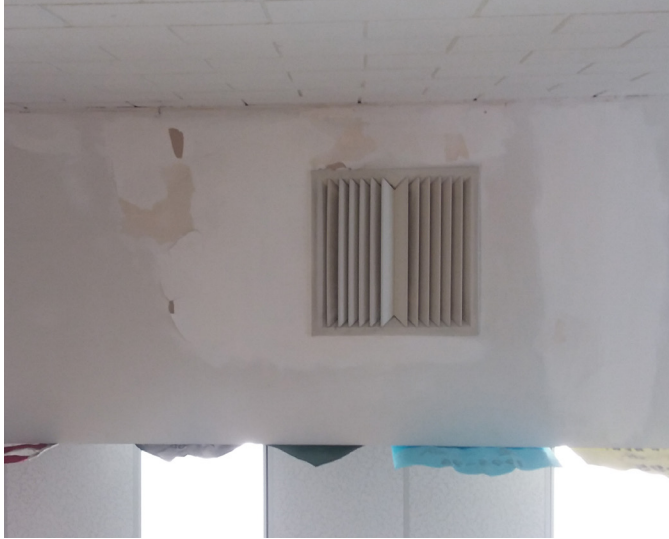
40. Location:

Patching and peeling of gypsum around many diffusers.

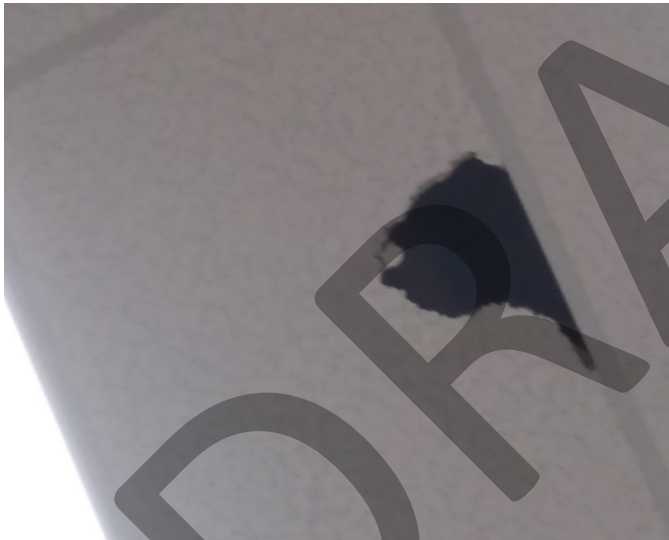
41. Location:

Hole in ceiling tile that needs to be replaced.

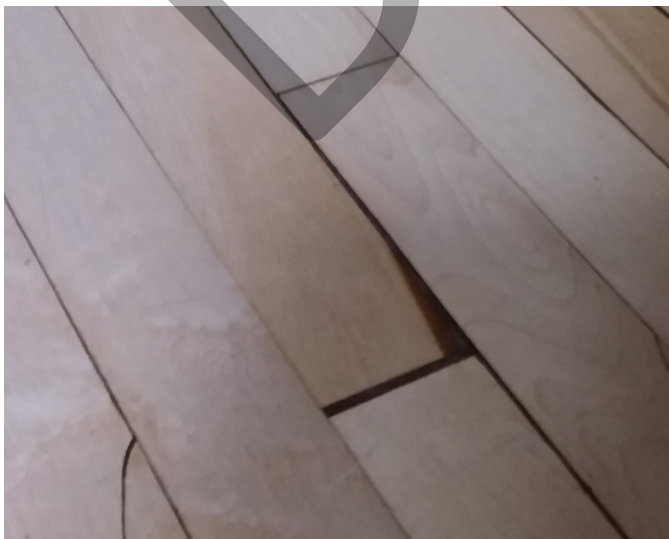
42. Location:

Wood floor is dented and cracked. Poses a tripping hazard.

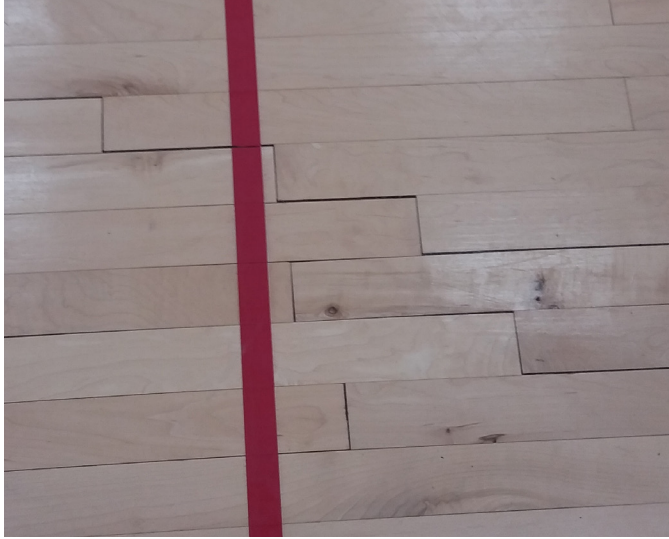
43. Location:

Wood floor is separating and cracking along the sides of the wood planks.

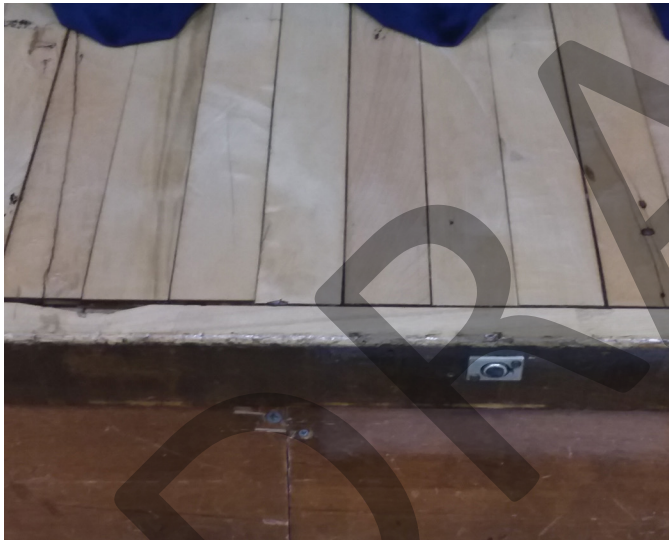
44. Location:

Edge of stage is very chipped and some wood planks are also cracking.

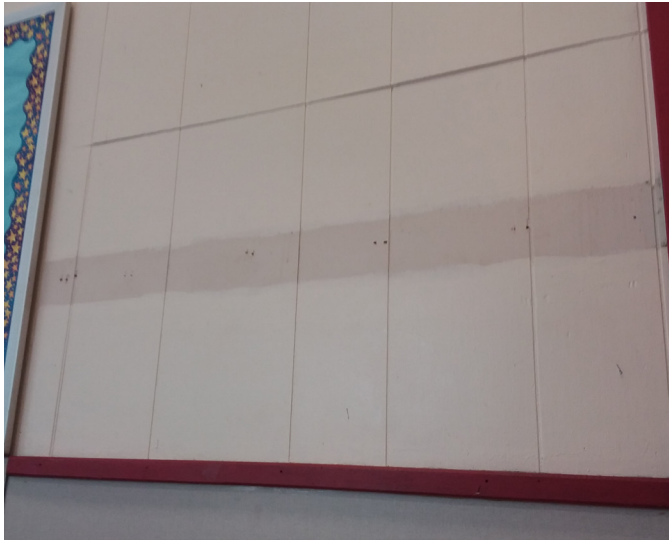
46. Location:

Paint on wall needs to be touched up.

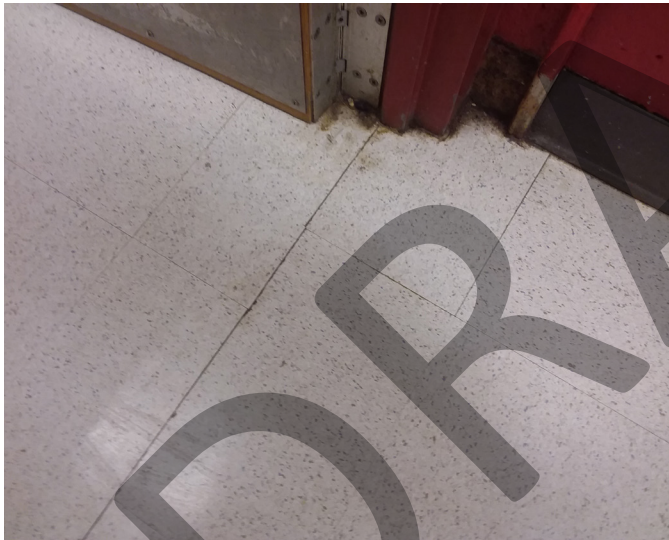
47. Location:

VCT at the Cafe entrance is separating creating an increased risk for cracking and dirt build up.

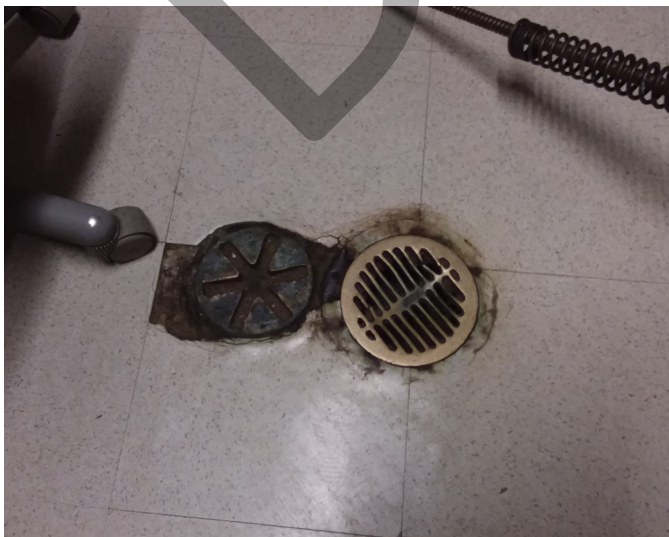
48. Location:

Significant damage to VCT that surrounds floor drain.

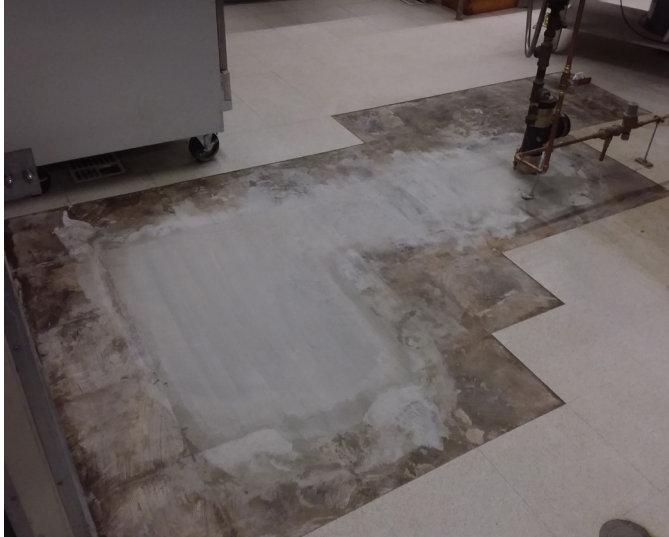
49. Location:

An entire patch of VCT is missing and sub floor is exposed.

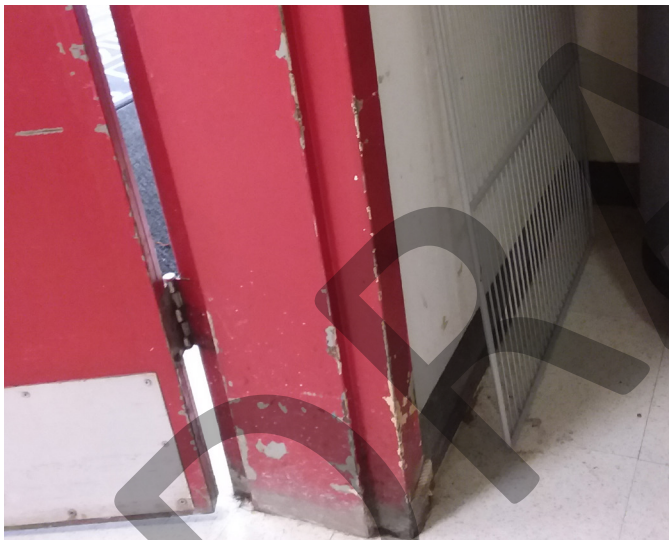
50. Location:

Door frame needs to be refinised

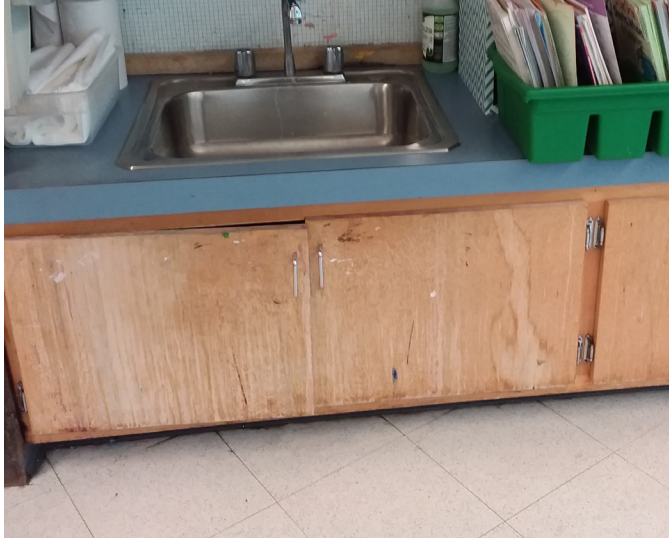
52. Location:

Casework is delaminating

- Window lintels need to be refinished due to rusting.
- Replace any damaged or broken glazing or glass blocks
- Provide sealant at all window and glass block locations
- Review weatherproofing of existing foundation and repair where deterioration has occurred.
- Direct roof drainage away from facade of building to reduce deterioration of finishes
- Replace damaged vinyl siding at Gymnasium/Cafeteria
- Further investigation into the water content of the slab is needed - many areas of bubbling under the VCT was visible at time of the survey.
- Replace damaged and broken blinds
- Replace any damaged ceiling tiles
- Replace damaged wood floor in Gymnasium
- Repaint walls and door frames where wear and tear is seen
- Repair delaminating casework in classrooms

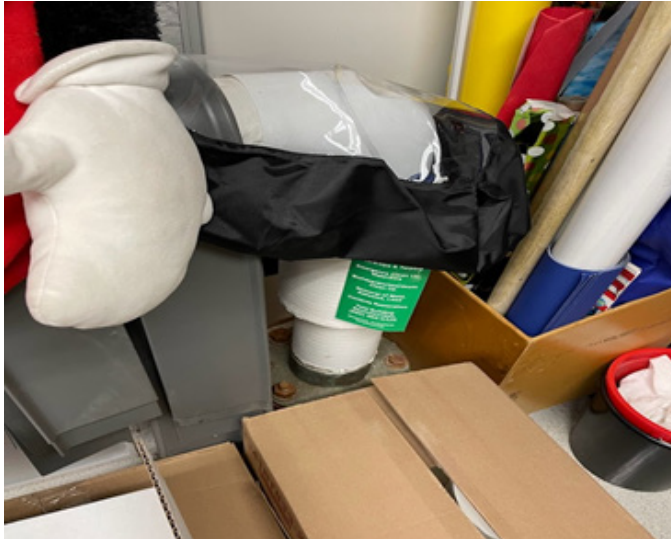
1. Location:

Domestic Water Service

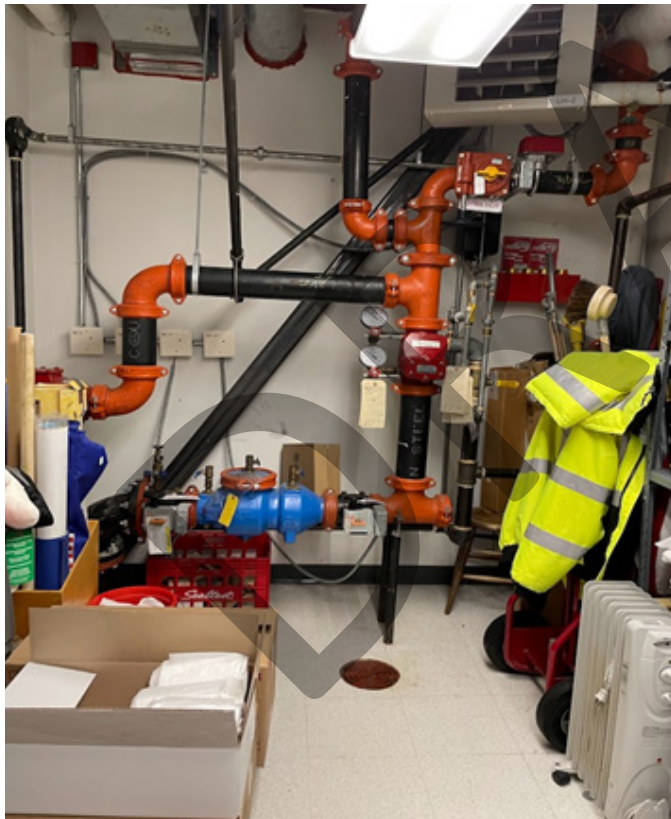
2. Location:

Fire Service and Riser

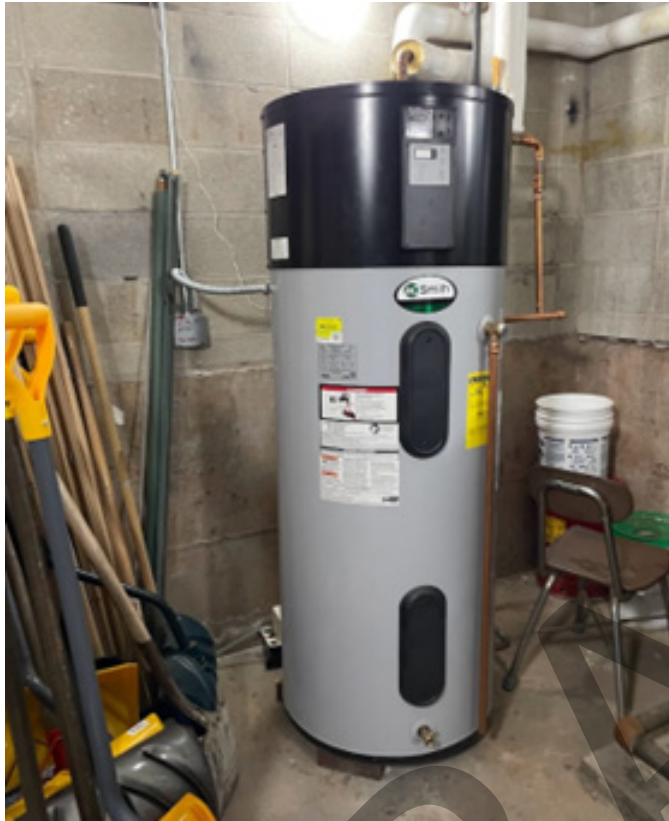
3. Location:

Water Heater

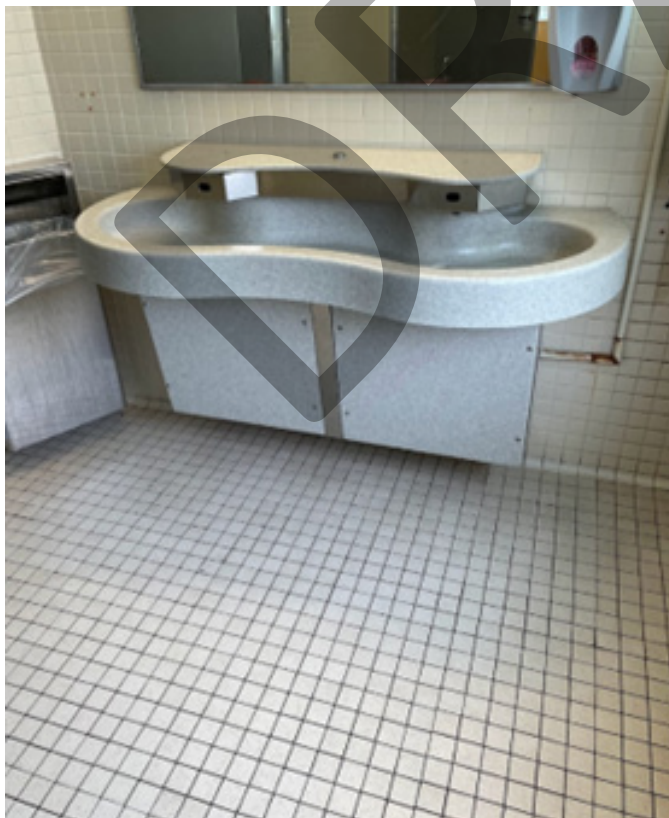
4. Location:

Toilet Room Fixtures

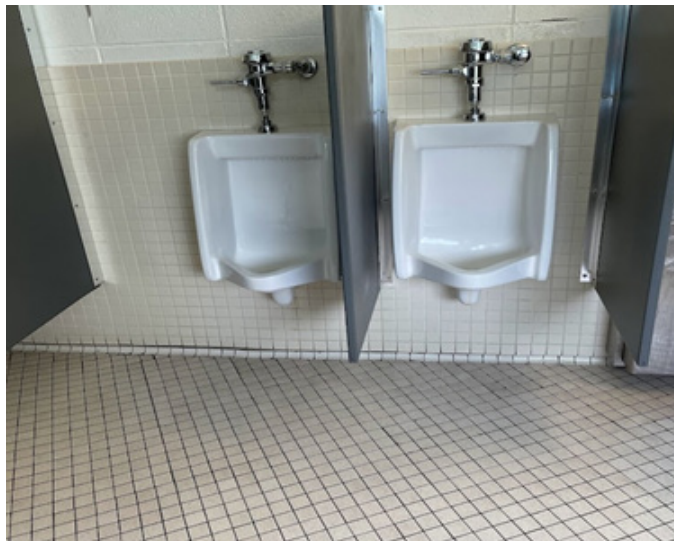
5. Location:

Toilet Room Fixtures

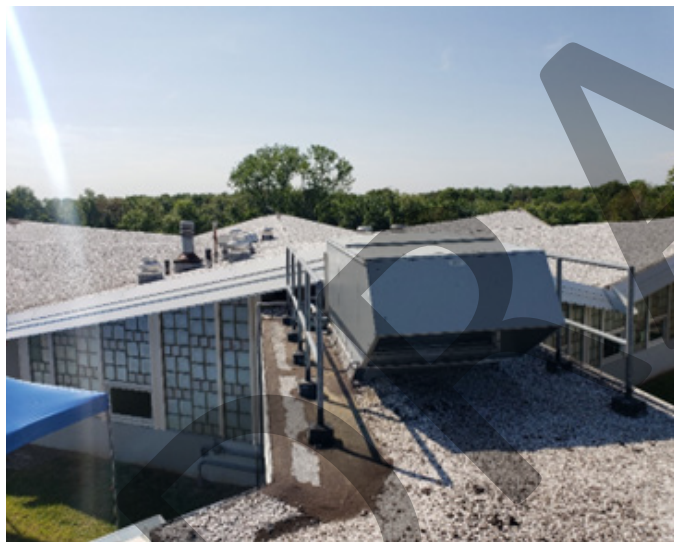
6. Location:

Classroom Ventilation Make up Air Unit

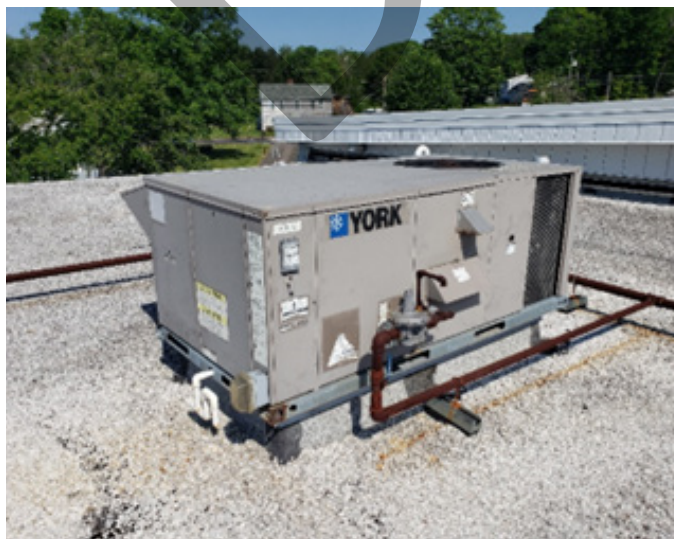
7. Location:

Administration area is served by RTU-3 located on roof. Unit provides heating, cooling and ventilation air. Unit is gas fired heating, DX cooling, with mixed supply air and outside air. Unit has MERV-7 filters. RTU-3 is nearing the end of its useful life and utilizes R-22 refrigerant which is no longer available except on secondary market. Unit should be replaced.

Roof Top Unit 3 Serving Admin. Area

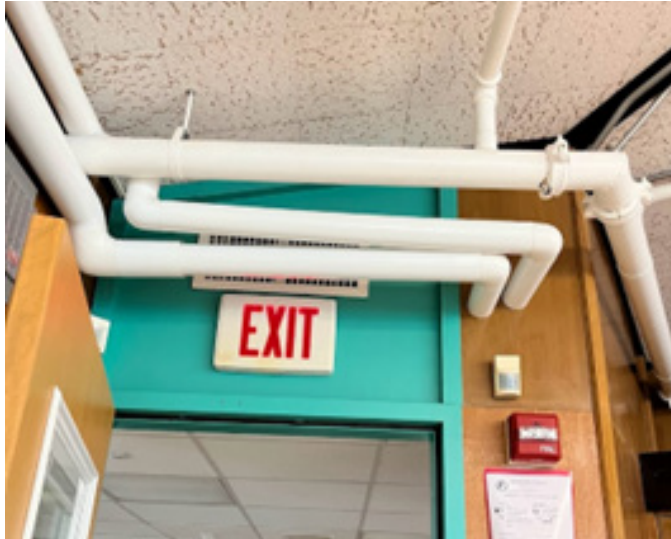
8. Location:

Hydronic Piping in Classroom

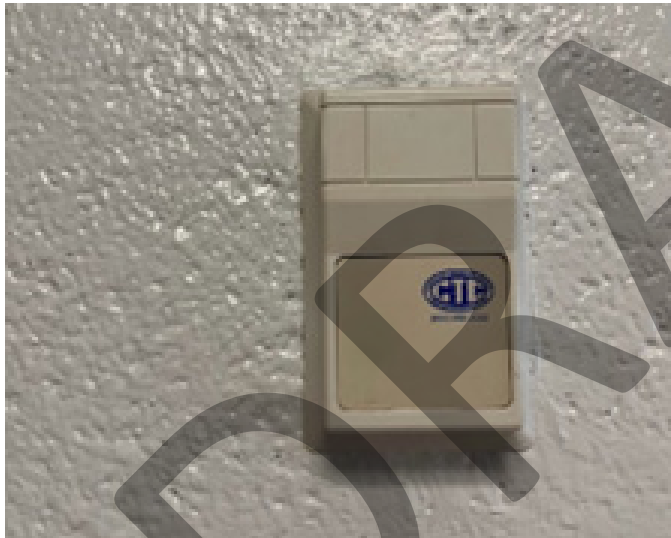
9. Location:

Space Thermostat

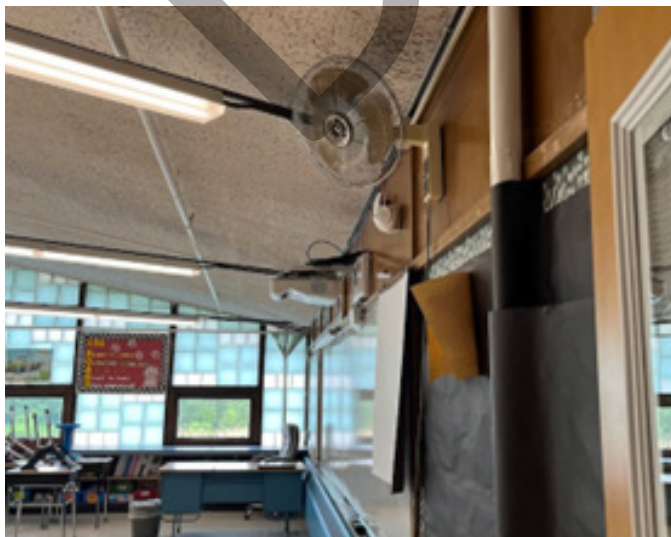
10. Location:

Classroom Oscillating Fan

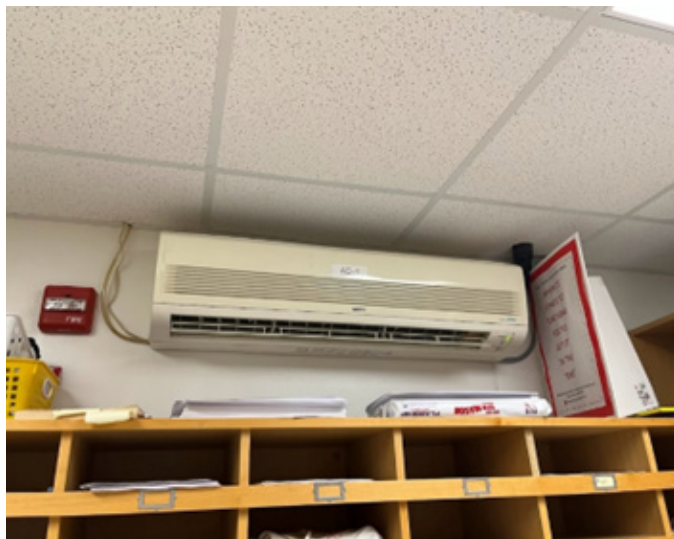
11. Location:

System AC Units

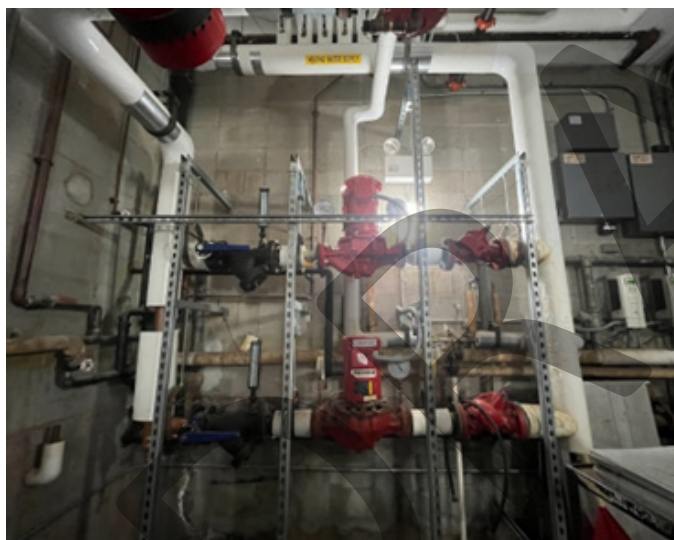
12. Location:

Hydronic Pump System

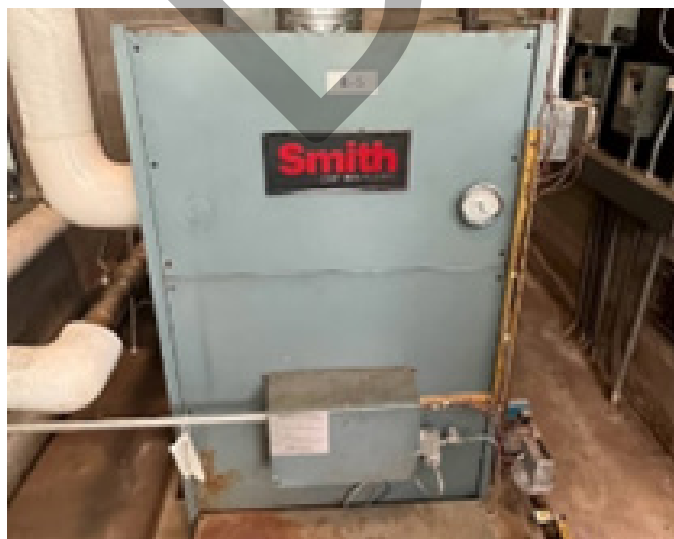
13. Location:

Heating system is served by cast iron mid-efficiency hot water boilers and pumps. The system is in fair condition and appears to be from 2008 (15 years old). Cast iron boiler system have an approximately 25 year life expectancy and while not near end of life we would recommend replacing with high efficiency condensing boilers for increased energy savings.

Smith Cast Iron Boiler

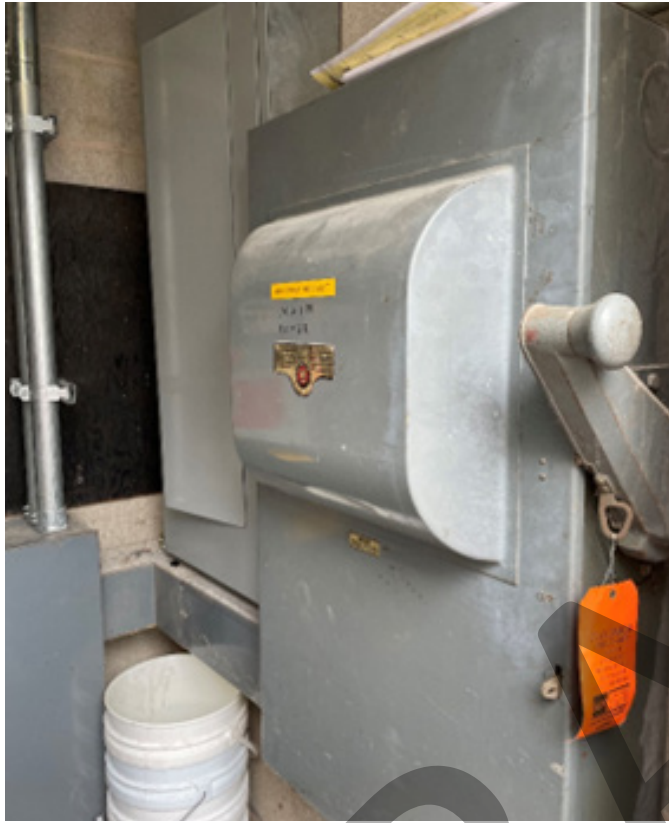
14. Location:

Original Main Service Equipment

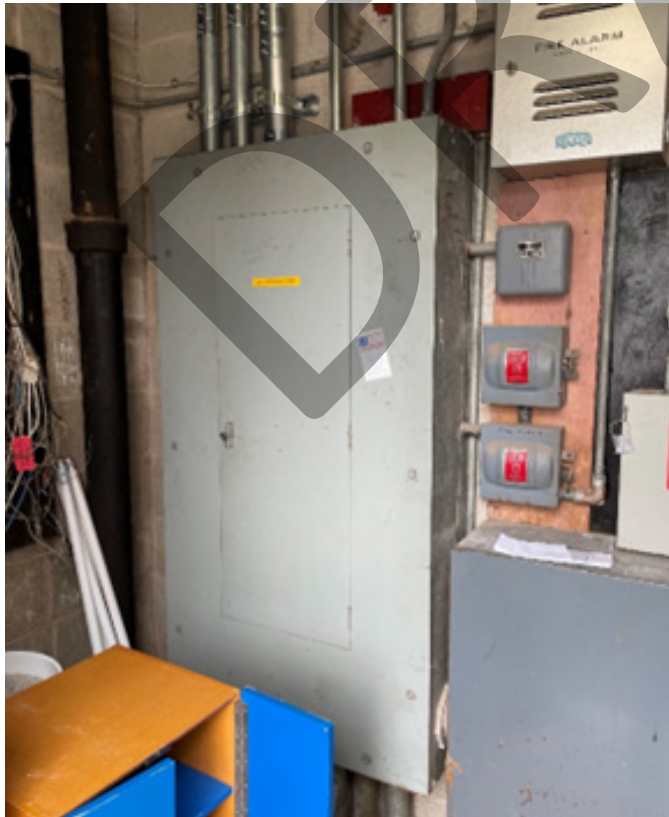
15. Location:

Main Service Distribution Panel

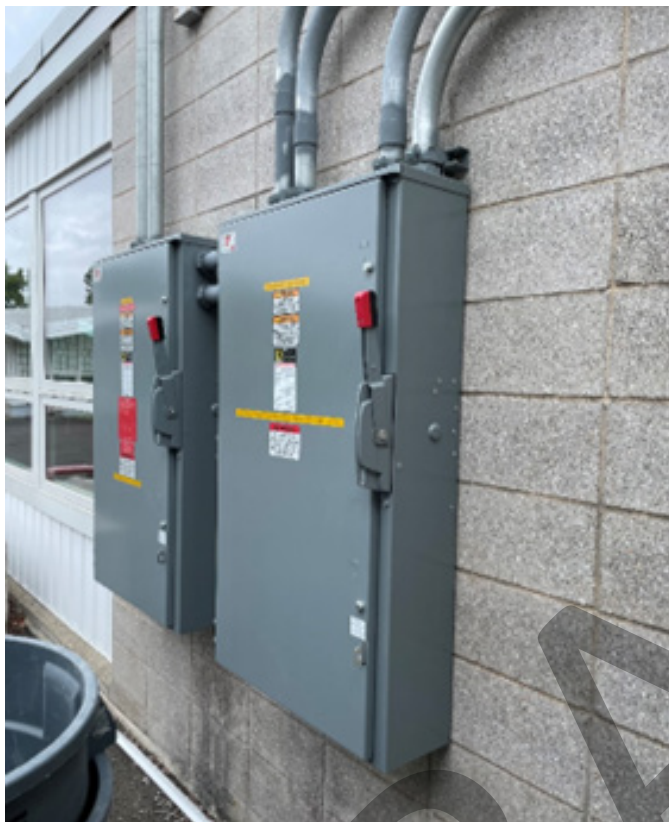
16. Location:

New Main Service Disconnect and PV System Shut-Down Switch

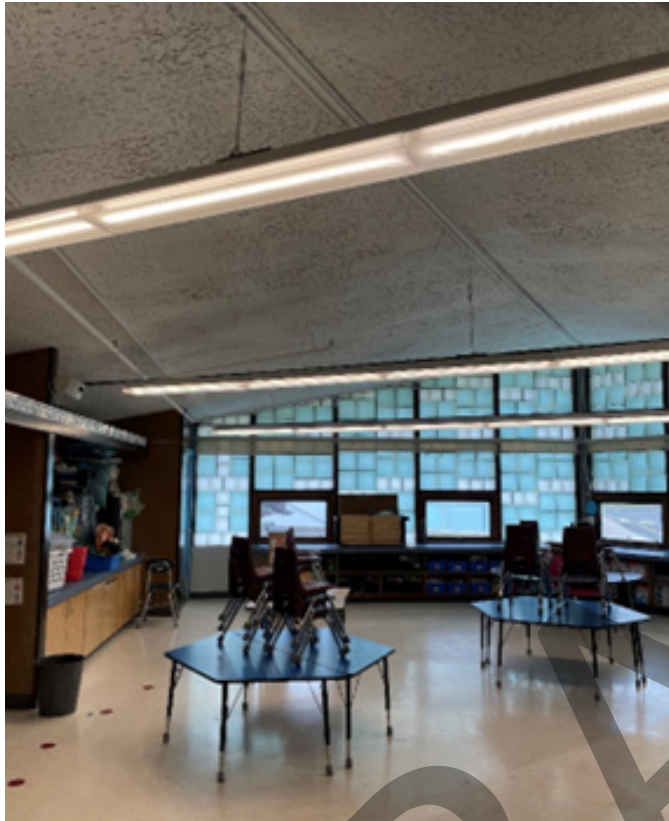
18. Location:

Typical Classroom Lighting

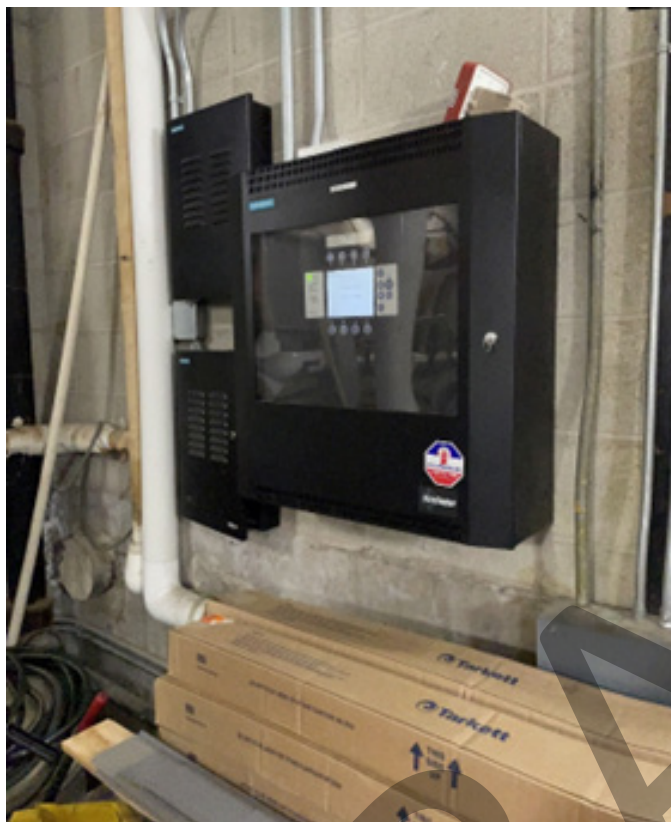
20. Location:

Fire Alarm Control Panel

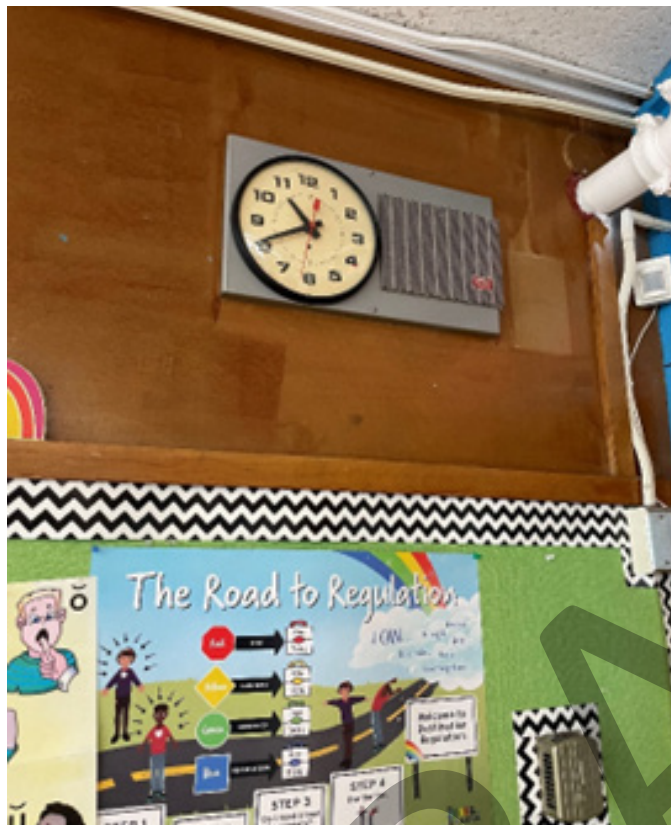
24. Location:

Typical Combination Clock/Speaker

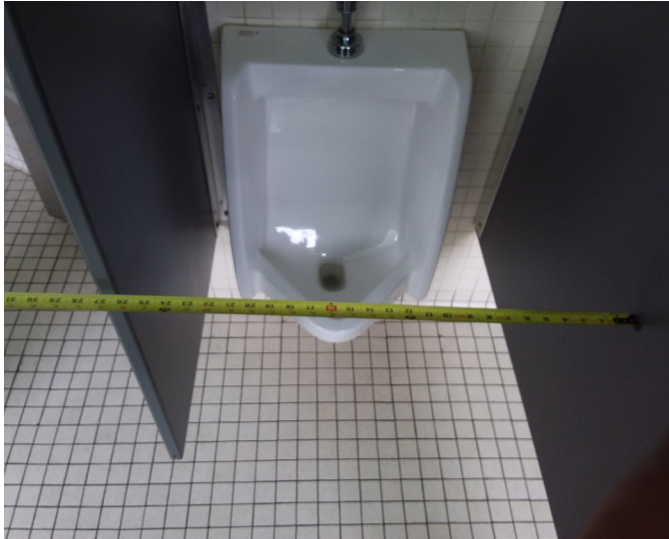
1. Location:

The clear width at the accessible urinal needs to be at minimum 30 inches.

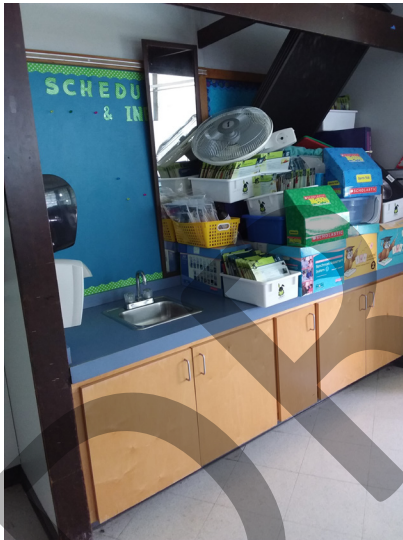
2. Location:

The sink, associated controls, counter height & knee clearance are not ADA compliant.

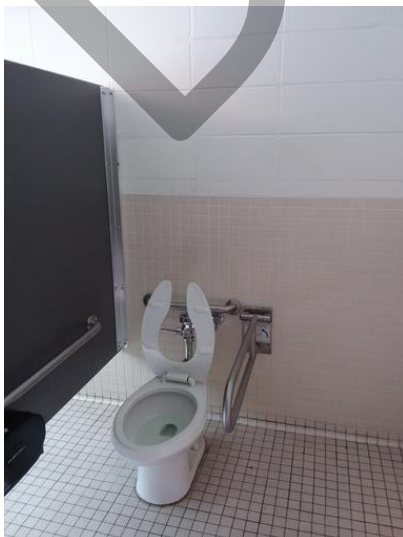
3. Location:

There is not a vertical grab bar and the rear grab bar is under sized. The swing down grab bar is no longer required.
