Facility Study and Master Plan

Lake Street School

201 Lake Street, Vernon, CT 06066

SUMMER 2023

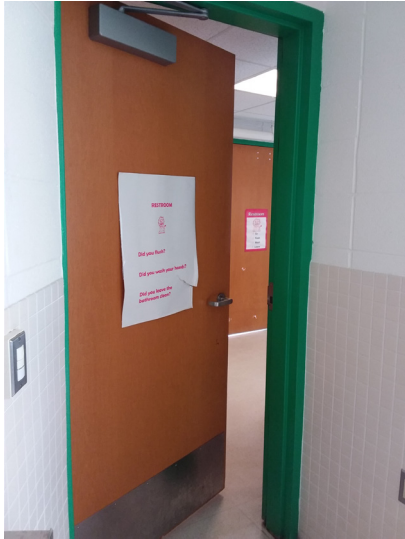
4. Location:

The push side door clearance is not compliant.

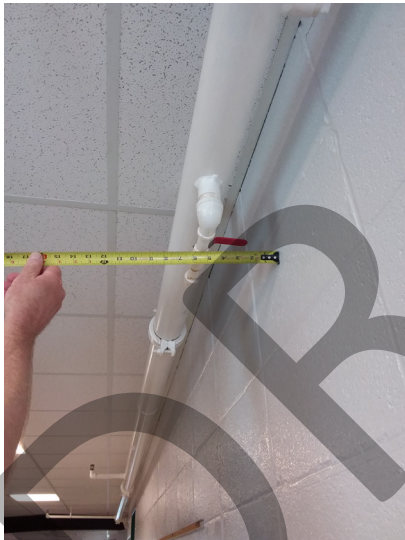
5. Location:

The sprinkler pipe extension is considered a protruding object.

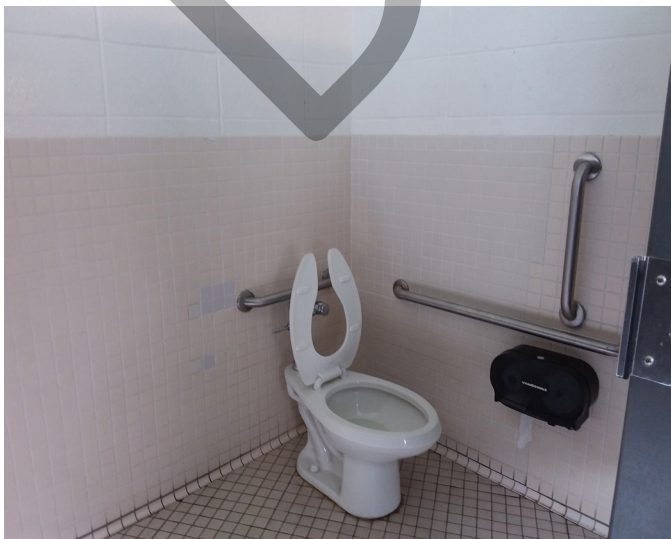
6. Location:

The grab bar at the rear of the toilet is not at the required length.

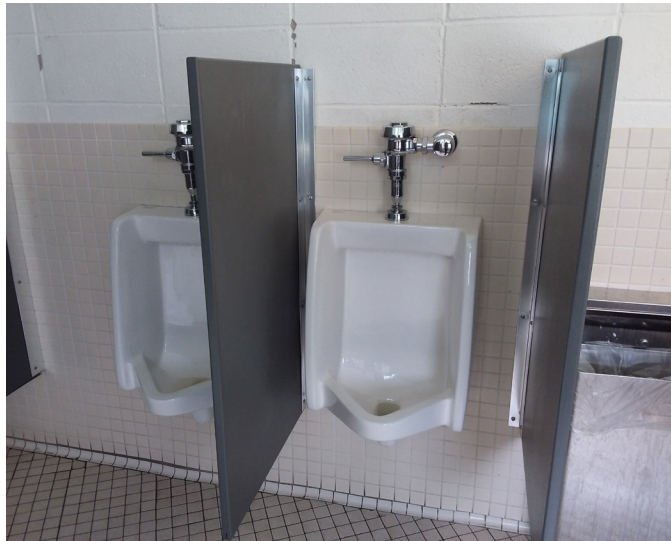
7. Location:

The front approach clear width is not compliant due to the location of the urinal between the screens.

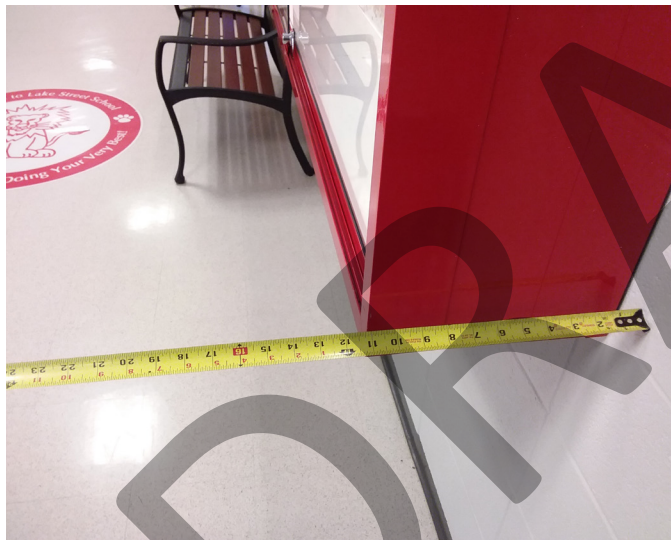
8. Location:

The wall mounted display case creates a protruding object.

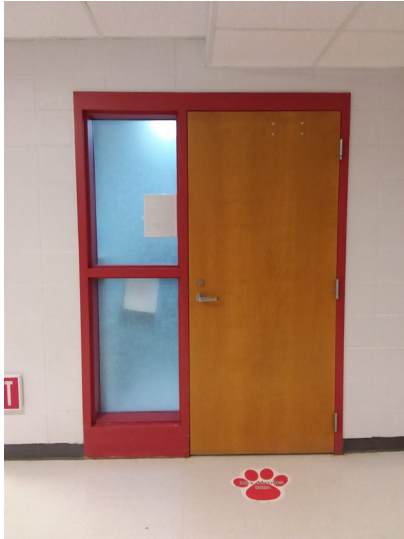
10. Location:

No signage at door to designate the purpose of the space

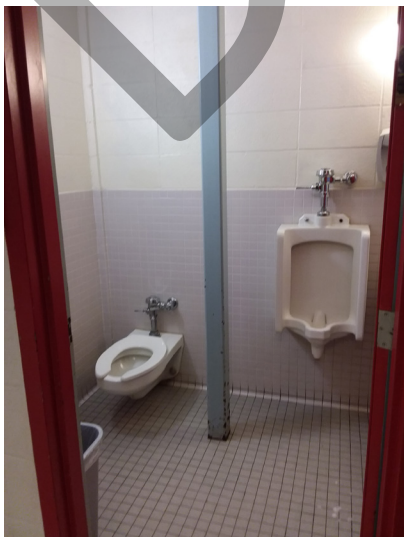
12. Location:

Currently, the toilet room is not an accessible toilet room

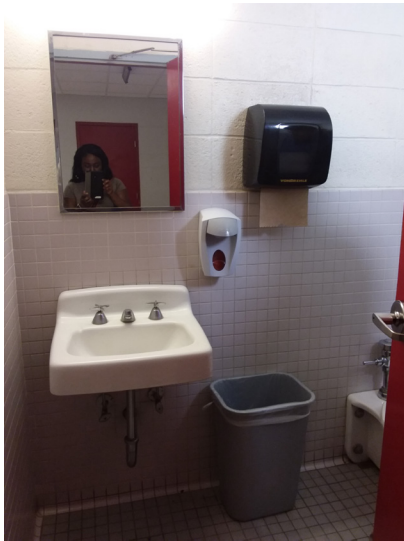
13. Location:

Currently, the toilet room is not an accessible toilet room

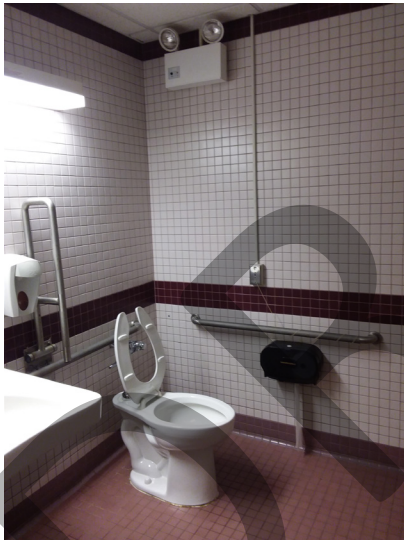
14. Location:

No vertical grab bar

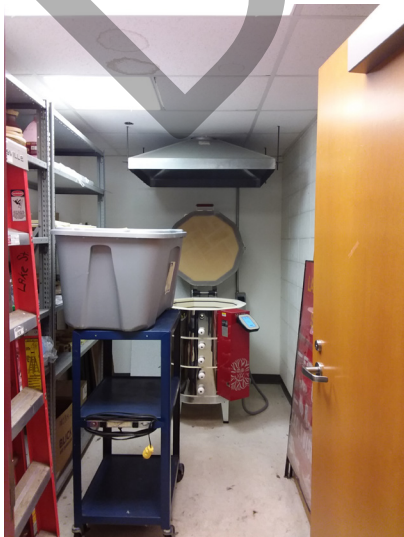
15. Location:

If this space / room is a teaching area it needs to be accessible with all the proper clearances.

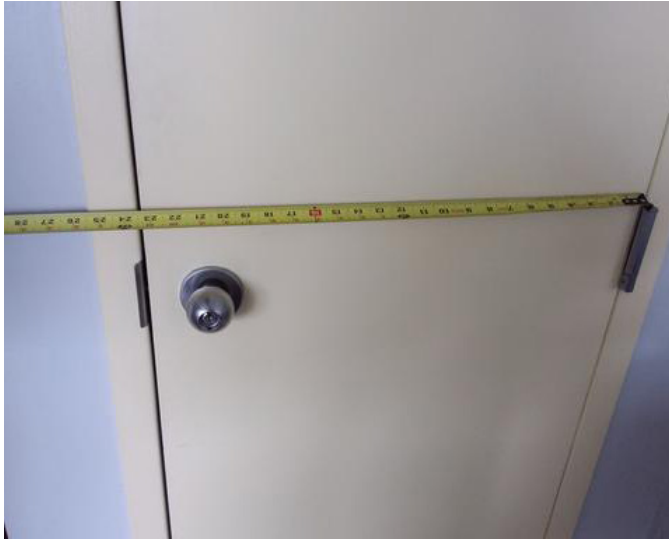
16. Location:

The building's occupants are storing items within this closet, alternative accessible storage needs to be provided.

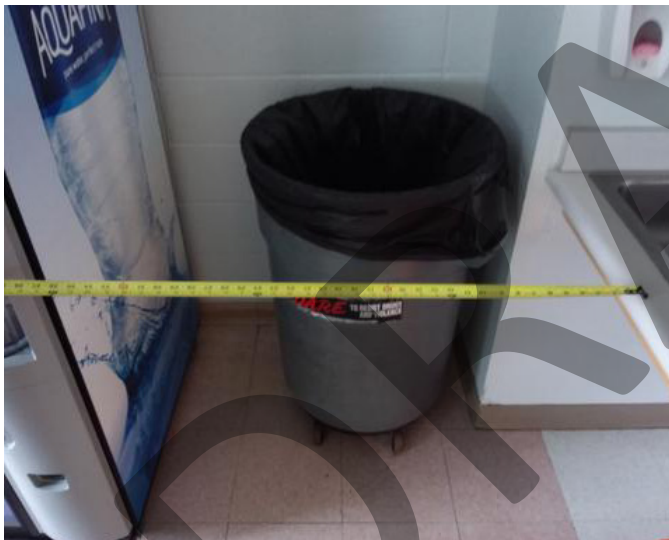
17. Location:

Space between counter and vending machine does not allow proper clearance at the room's sink.

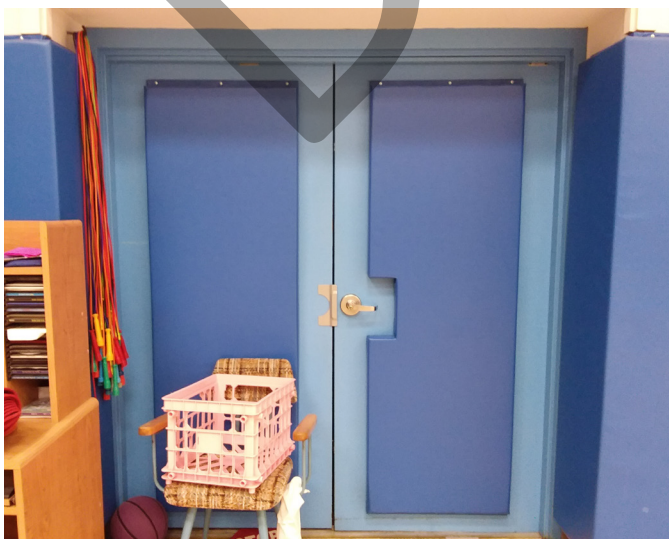
18. Location:

The room does not have any signage so you would not know it is the Physical Education Office.

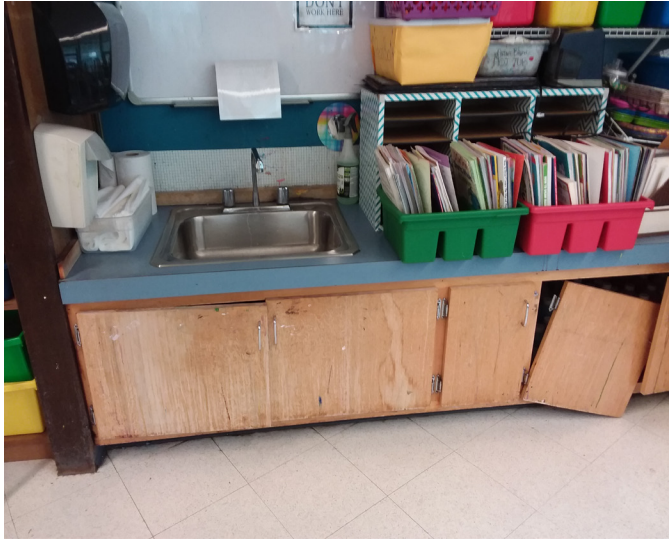
19. Location:

The sink, associated controls, counter height & knee clearance are not ADA compliant.

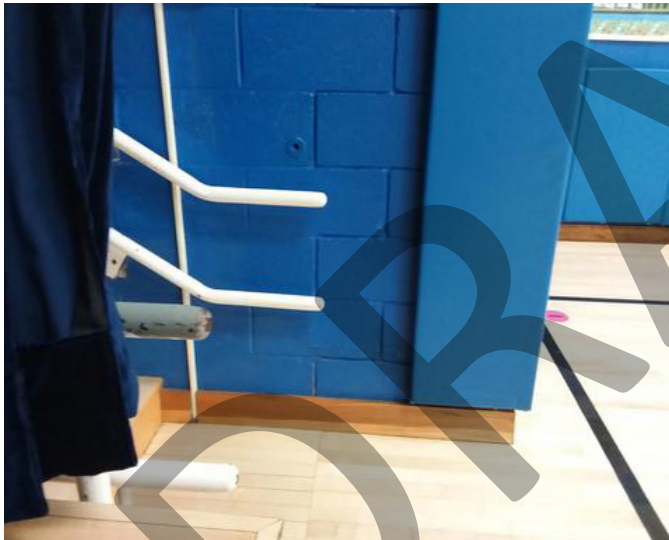
20. Location:

The existing stair railing does not return to a wall or post.

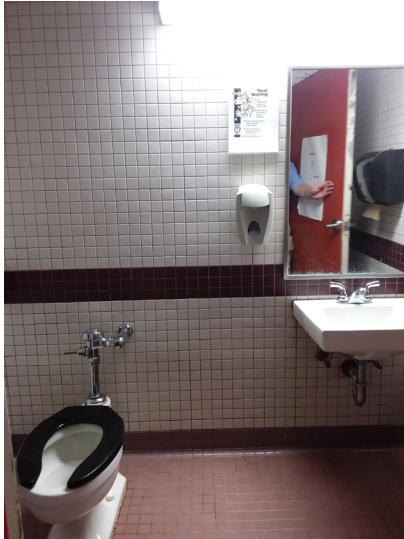
22. Location:

The toilet is not provided with compliant grab bars or insulated plumbing piping.

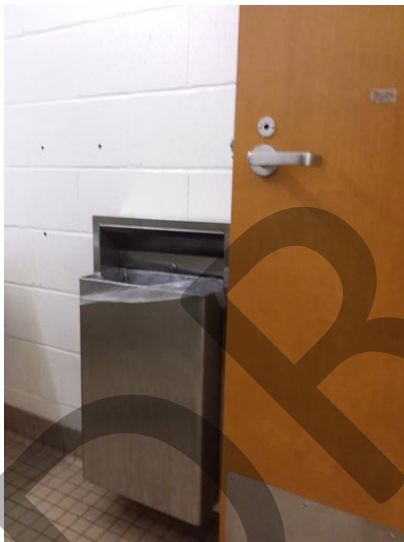
23. Location:

The trash receptacle encroaches on the clear floor space required at the door.

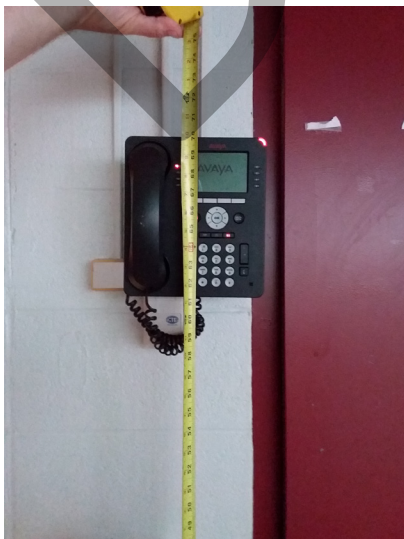
24. Location:

Bottom of telephone 61" from floor

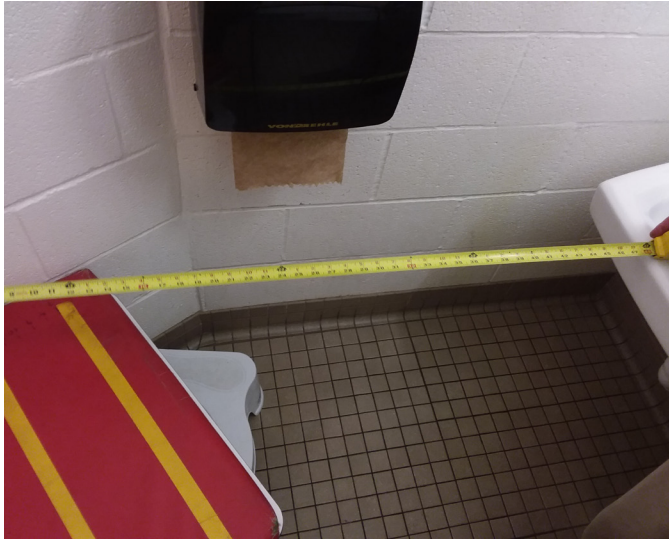
25. Location:

Distance between edge sink and wall is 47"

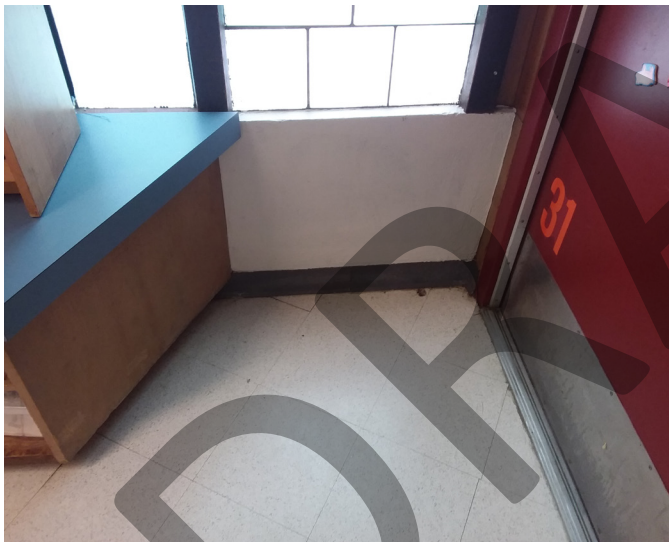
26. Location:

Space between door to the exterior and casework does not provide sufficient maneuvering clearance.

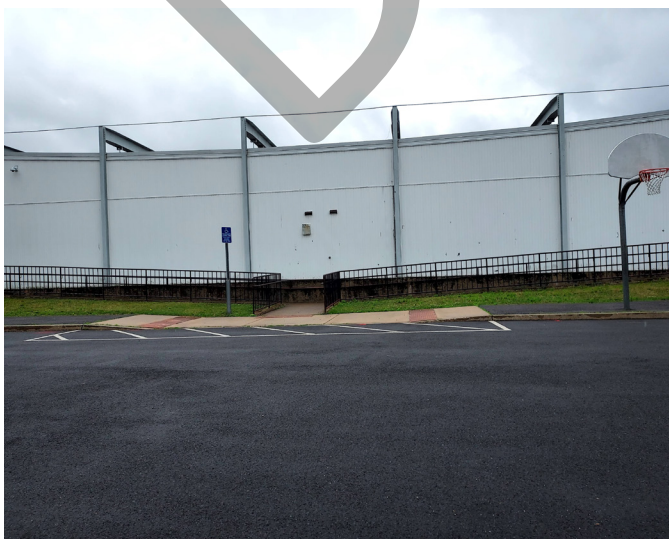
27. Location:

The ramp from the gym to the loading zone is non compliant

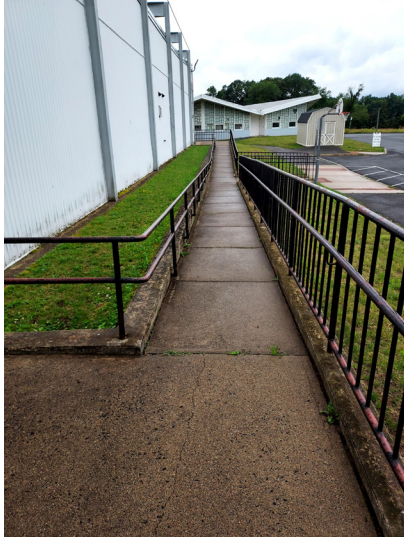
28. Location:

The ramps from either side of the gym require landing a rise of 30 inches from the passenger loading zone.

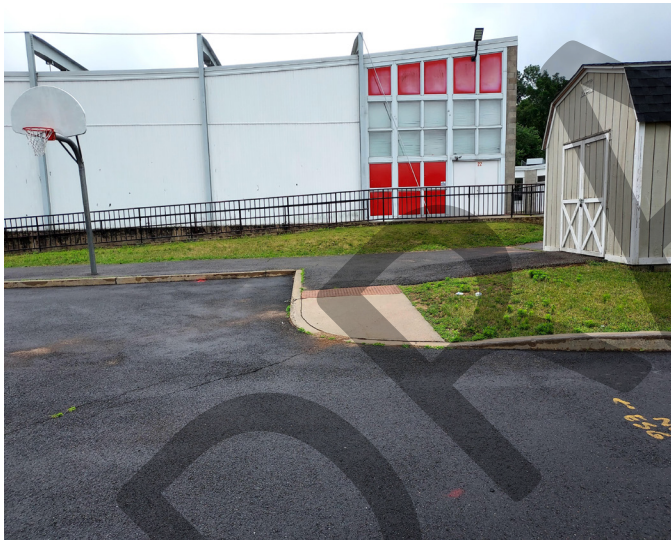
29. Location:

The curb ramp does not lead to a crosswalk, accessible parking or an accessible route.

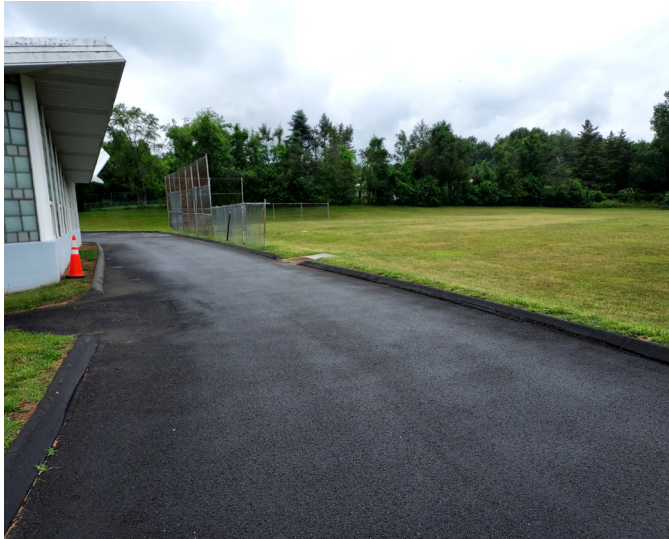
31. Location:

Baseball / Softball Field

The access to the field should be provided from a designated parking spot and from the building. A curb ramp has been provided, but the accessible route has not been provided.

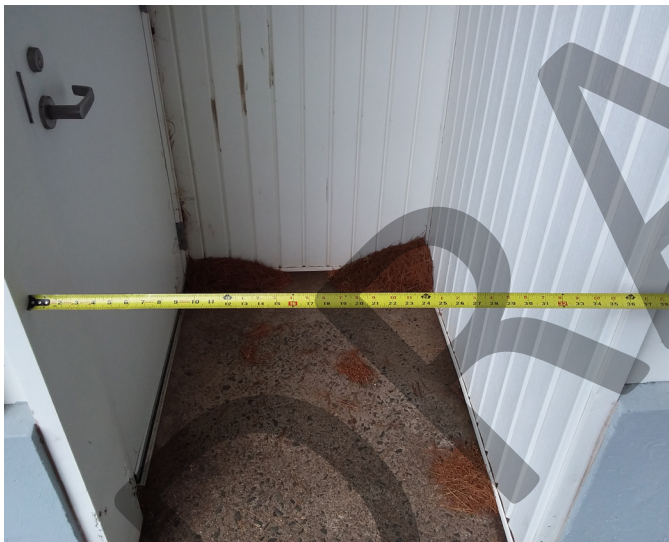
32. Location:

Exterior

The landing at the door is not wide enough to provide access / exiting.

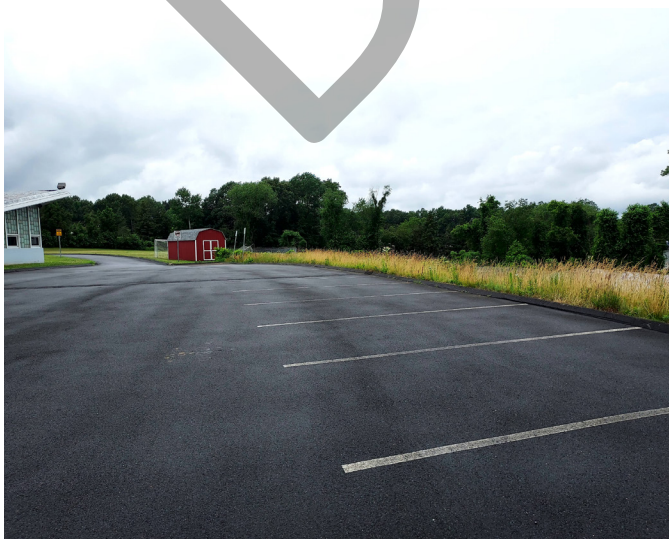
33. Location:

Exterior - North Side Parking Lot

A passenger loading zone has been provided in this area, but there is not any accessible parking spots in this lot.

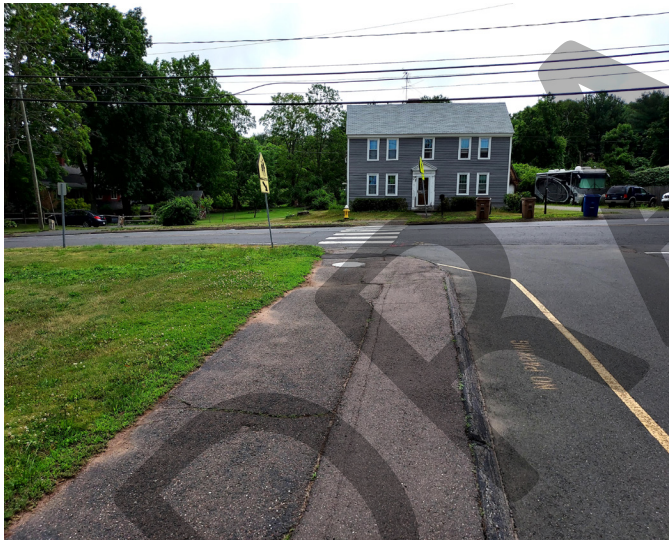
35. Location:

Crosswalk at Lake Street

A compliant curb ramp and tactile warning strip need to be present at the crosswalk.

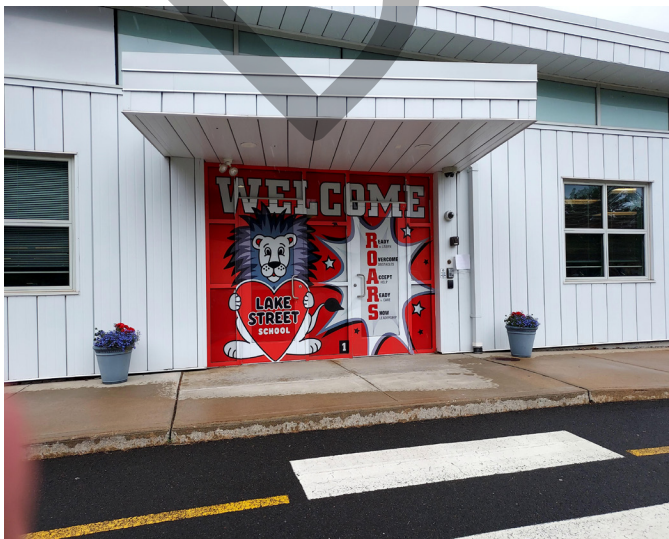
36. Location:

Front Entrance

The accessible entrance should be denoted with the proper signage. The crosswalk does not connect to the main entrance with a curb ramp.

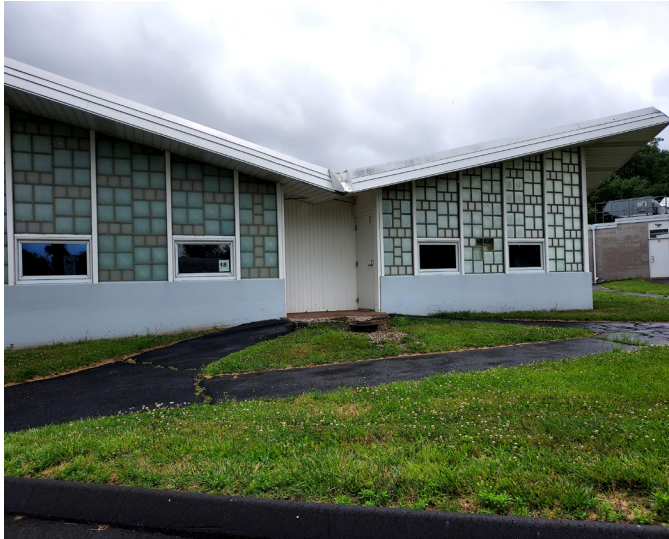
37. Location:

Typical Exterior Classroom Exits

Exits / entrances from the classrooms need to have compliant access via ramps, walkways and door ways to the site accessible route

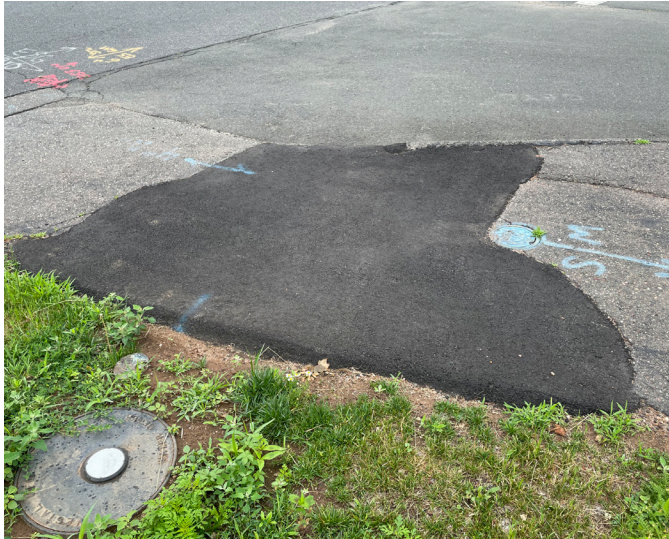
1. Location:

Entry Drive

Patched area of sidewalk

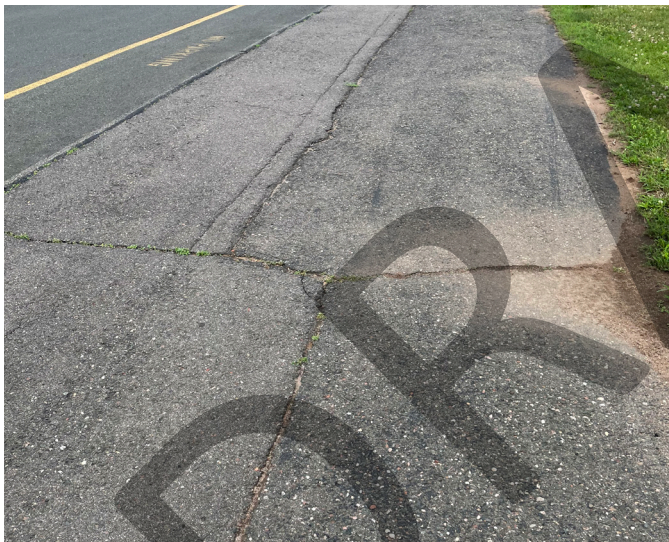
2. Location:

Sidewalk at Entry Drive

Cracks and erosion visible at sidewalk leading from the main entrance.

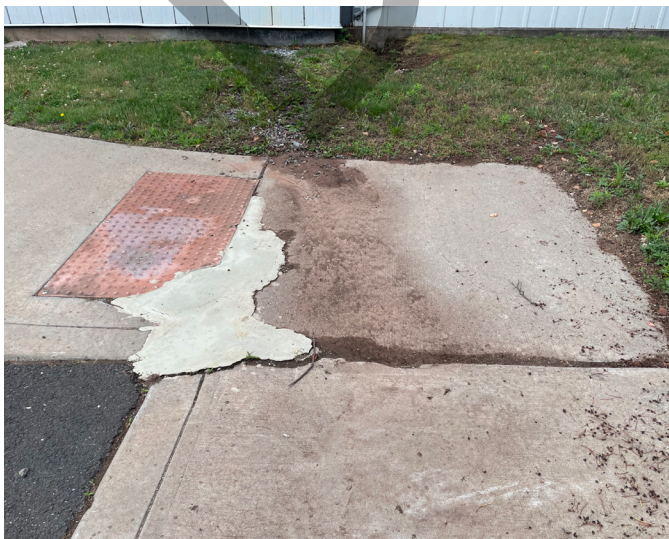
3. Location:

Front Handicap Parking

Damaged and cracking sidewalk adjacent to handicap parking see ADA report for additional information.

- Demolish and provide all new walkways to exterior exits of classroom wings
- Provide handrails / guardrails at any sloped walkways
- Repair damaged concrete walkways adjacent to handicap parking spaces

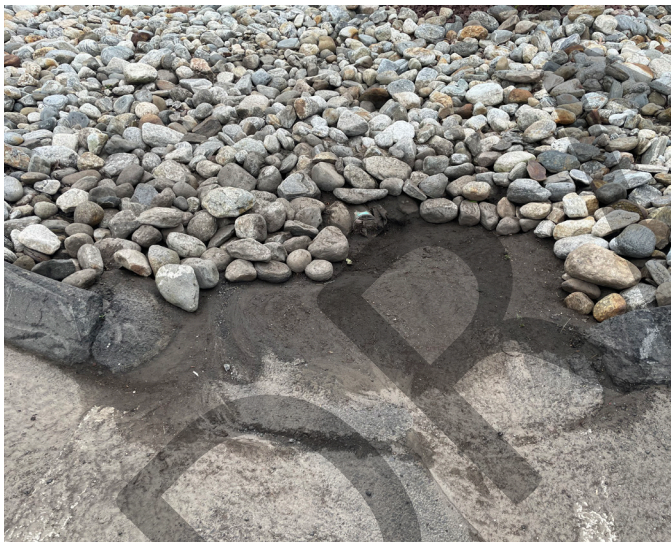
5. Location:

Rain Garden

No curbing in this area likely due to drainage concerns.

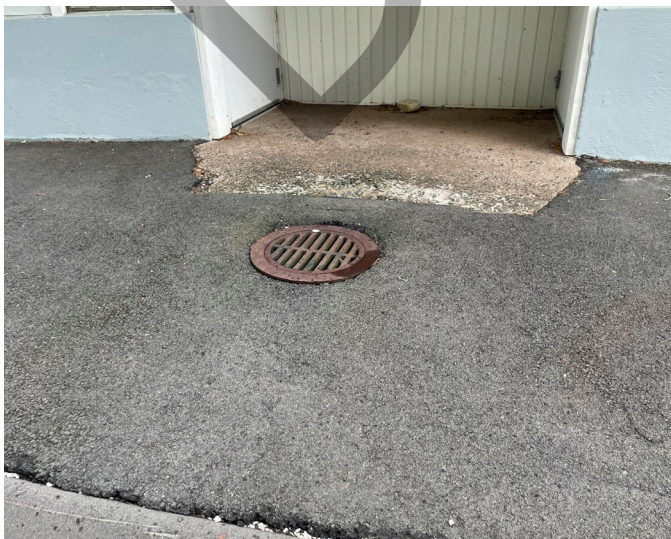
6. Location:

South Classroom Entrance

View of sloped pavement - uneven connection of bituminous sloped area with concrete pad and bituminous driveway.

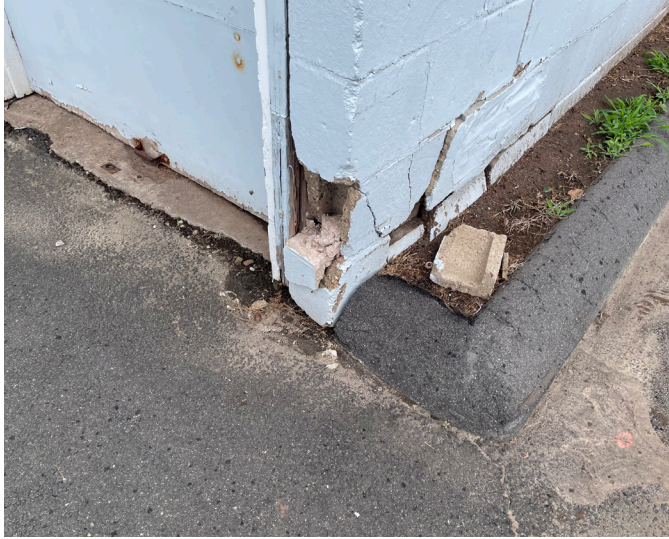
7. Location:

Shed at South Area of Site

Shed is in poor condition - damage likely due to a plow or vehicle hitting the corner.

- Existing shed at South area of site should be removed is not needed. If still needed repair damaged CMU, replace garage door and replace roof. Provide signage to avoid cars parking and blocking off door.

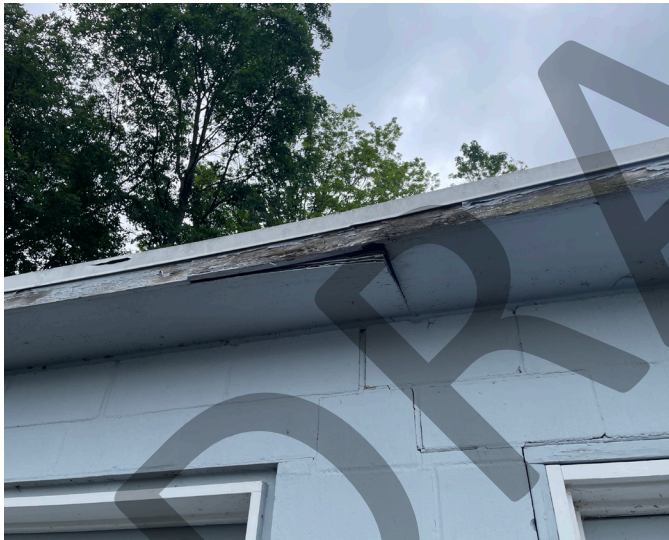
8. Location:

Shed at South Area of Site

Cracking in CMU and deterioration of roof is visible.

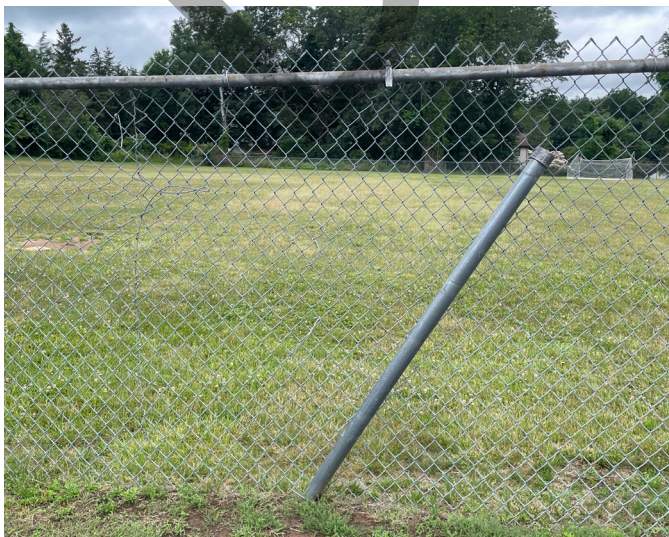
9. Location:

Play Fields at West Area of Site

Metal fence post damage

- Repair areas of damaged metal fencing.
- Provide site drainage and separate rock drainage areas from grassy areas with curbing
- Exterior ramp: Repair damaged areas of concrete, refinish handrails and clean concrete of mildew.

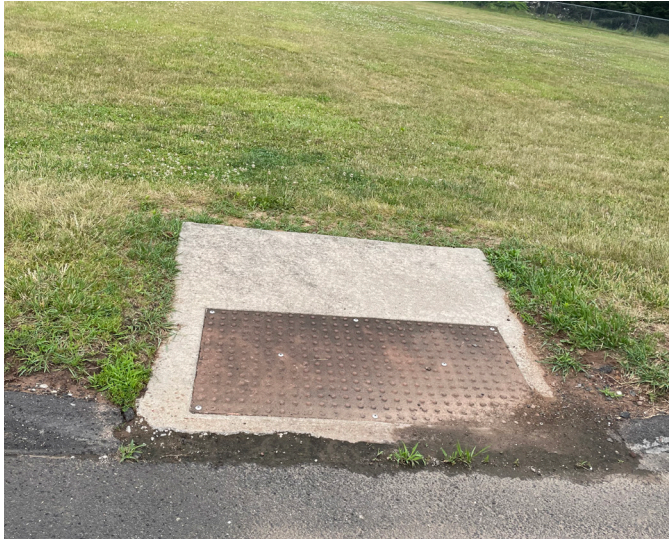
10. Location:

North of Building

Concrete pad and warning pad does not lead to a walkway.

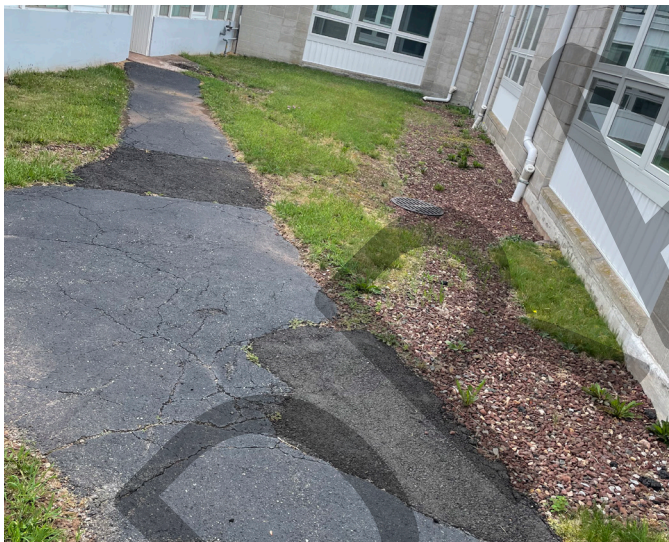
11. Location:

North - Area between Classroom Wings

Bituminous walkways in poor condition. Pebble/stone areas mixed in with grassy areas.

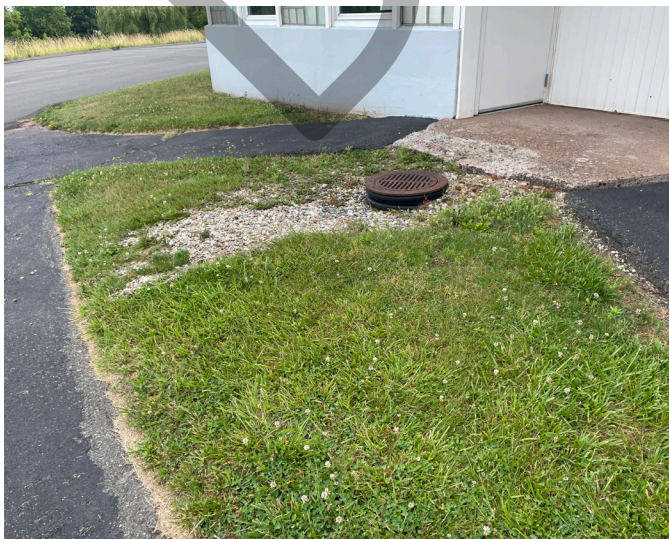
12. Location:

North - Area between Classroom Wings

Drain set above grade. Concrete door exit pad in poor condition.

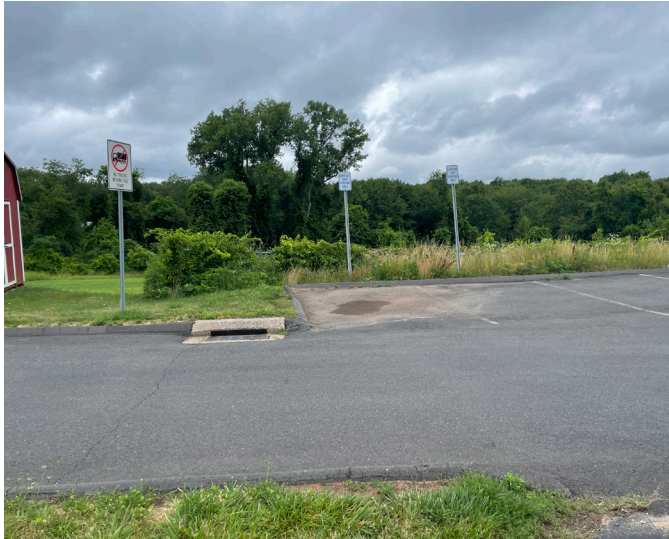
13. Location:

North Parking

Visible pooling and run off at parking is a drainage is a concern

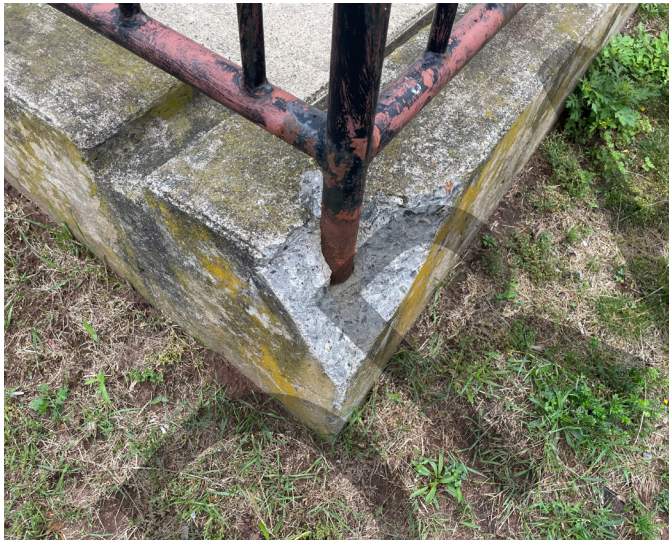
14. Location:

Exterior Ramp at North of Building

Damaged concrete corner. Mold and mildew growth on concrete

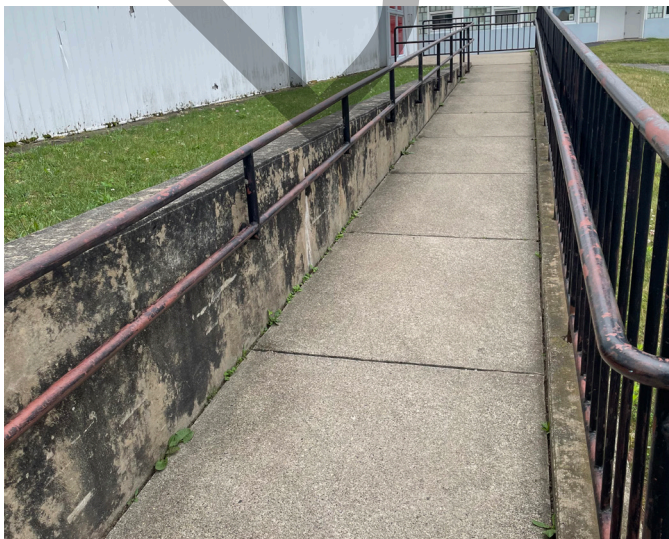
15. Location:

Exterior Ramp at North of Building

Mold and mildew growth on concrete. Paint on handrails is significantly degraded.

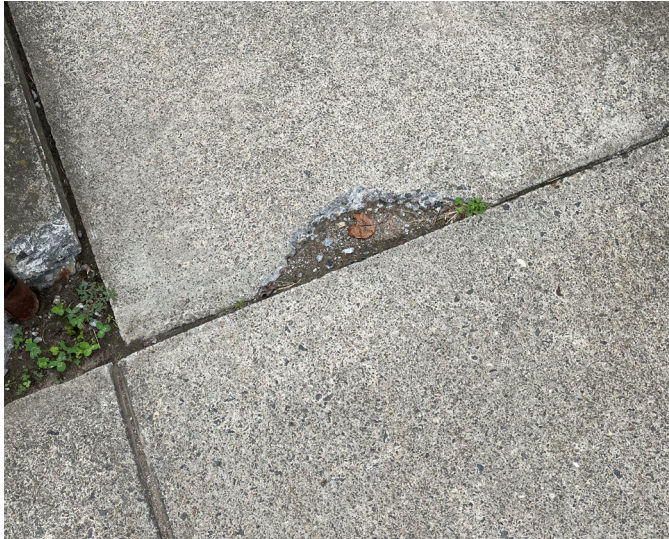
16. Location:

Exterior Ramp at North of Building

Damage at concrete ramp

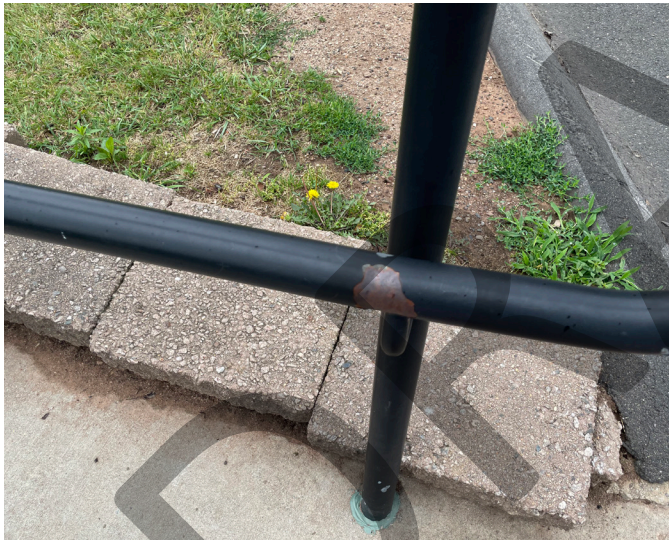
17. Location:

North Playscape

Paint peeling away at handrail.

- Playscape: Replace areas of missing bricks, fill in areas of missing mulch and refinish handrails where paint has deteriorated.
- Provide signage indicated loading area(s) as well as directional signage for clarity.

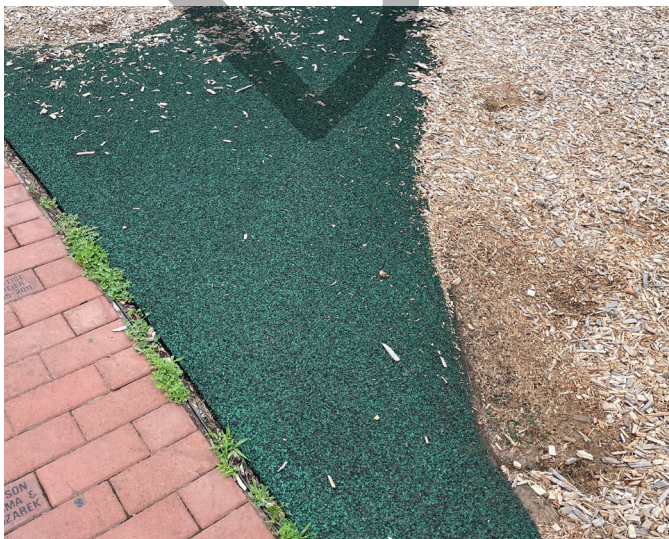
18. Location:

Playscape

Weeds growing between rubberized flooring and brick pathway. Mulch missing in some areas.

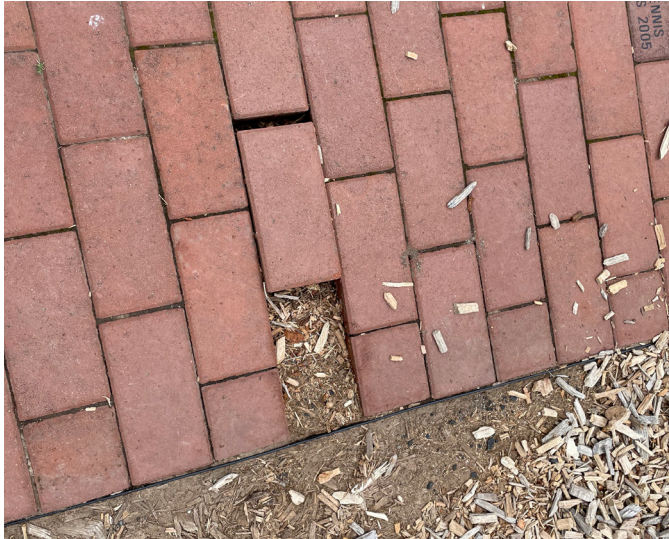
19. Location:

Playscape

Bricks missing in brick pathway.

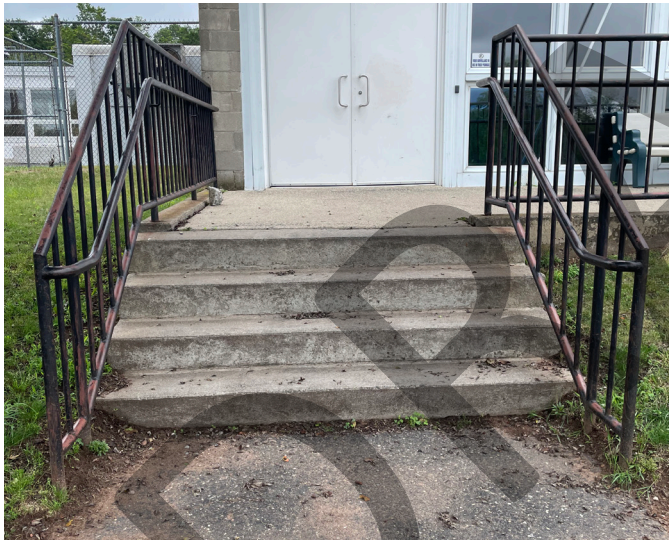
20. Location:

North Exterior Stair

Debris build up at stairs and loose piece of concrete on landing.

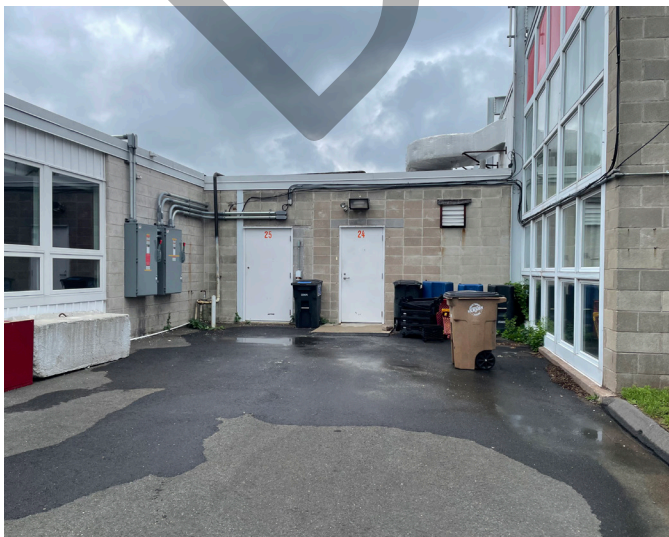
21. Location:

Assumed Service Area

Drainage is lacking in this area and causing water build up near doors. No signage for deliveries / loading / unloading.

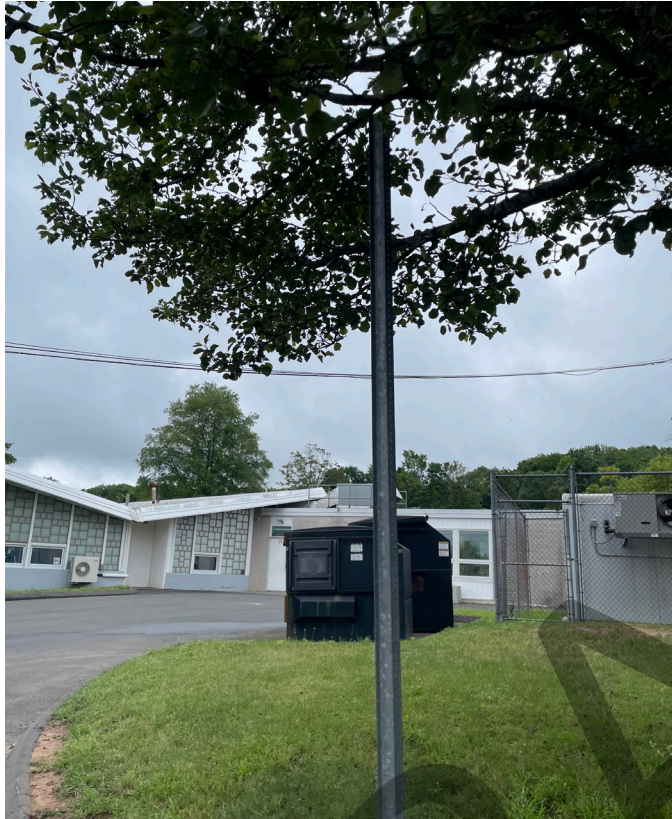
22. Location:

North Area of Site

Post missing signage.

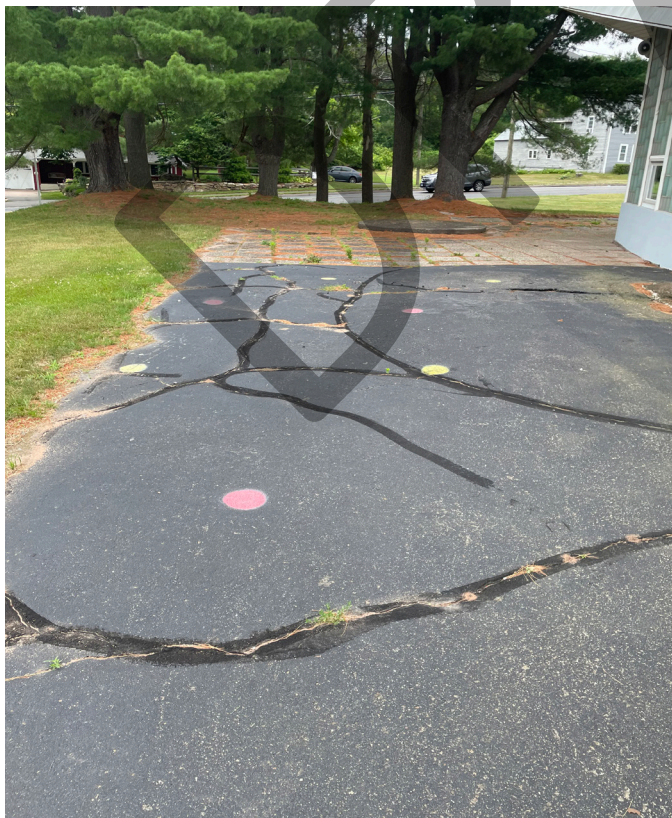
23. Location:

Northeast

Bituminous paved area has been repaired in the past but cracking is visible again.

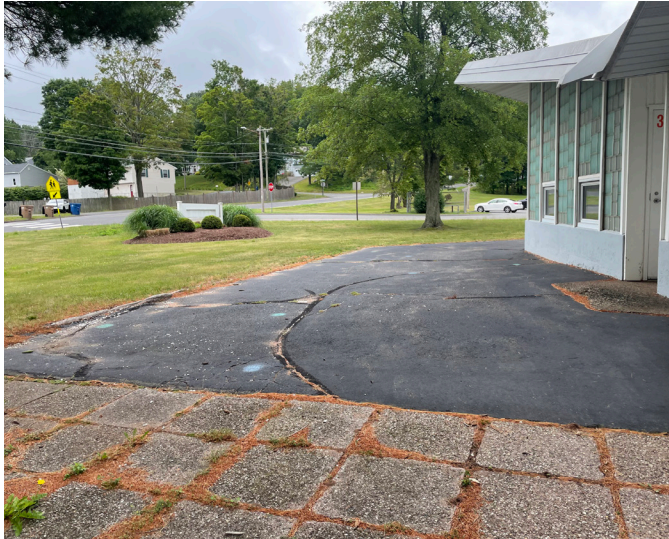
24. Location:

East - Near Lake Street

View of bituminous and concrete paver walkway. Debris and grass have built up all over the concrete pavers.

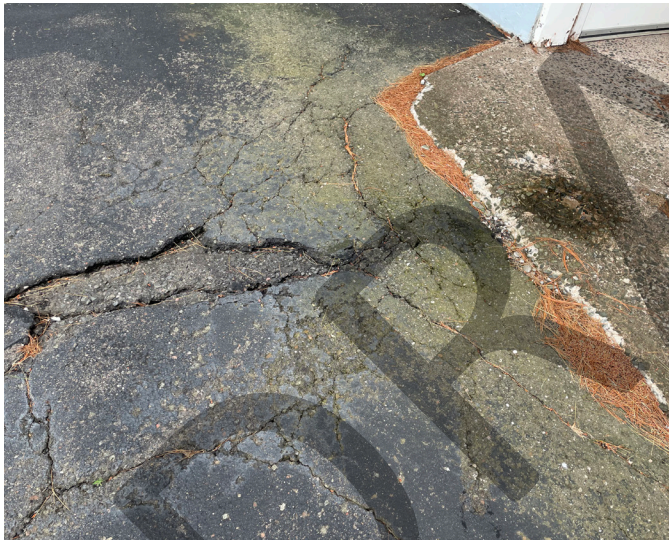
25. Location:

East - Near Lake Street

View of significant damaged areas of bituminous walkway and concrete pad.

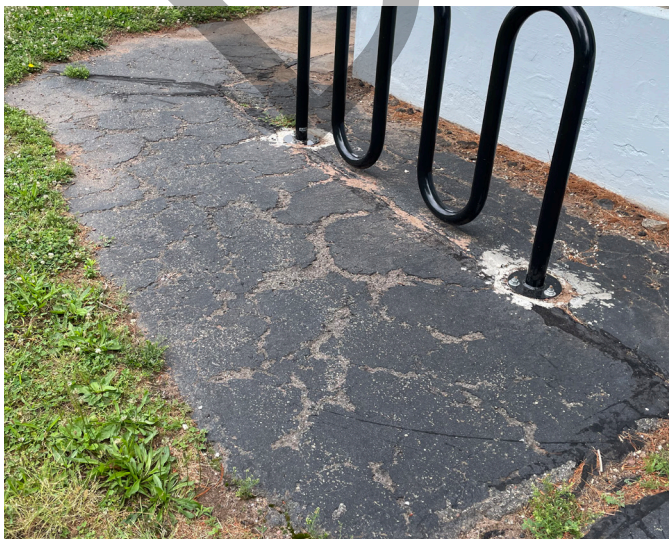
26. Location:

East - Near Lake Street

Paving around bike rack is in poor condition.

- Provide drainage at entrances to Kitchen
- Clean and repair concrete pavers at West side of building.
- Replace walkways at bike rack.

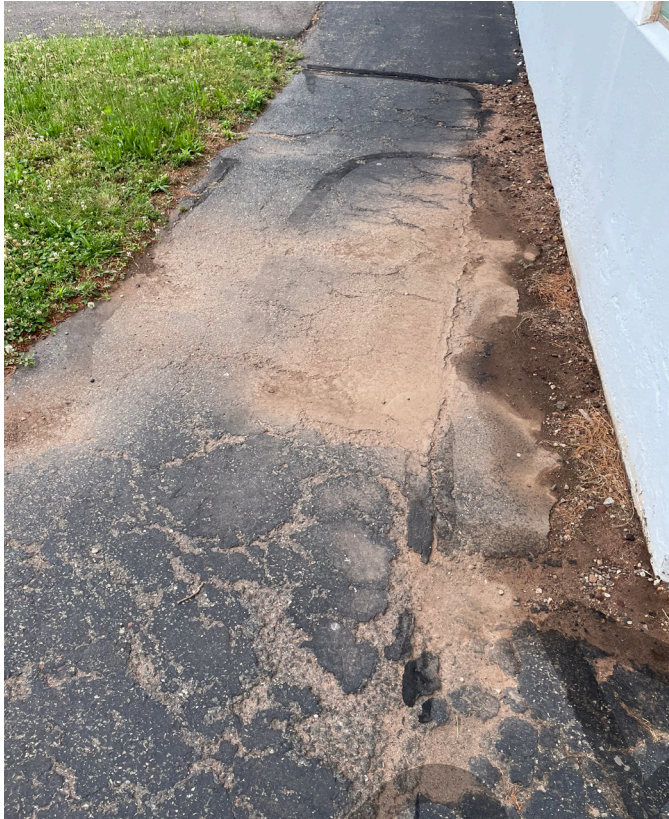
27. Location:

Southeast Walkway

Walkway adjacent to classroom wing is cracked and has significant run off from lack of drainage.

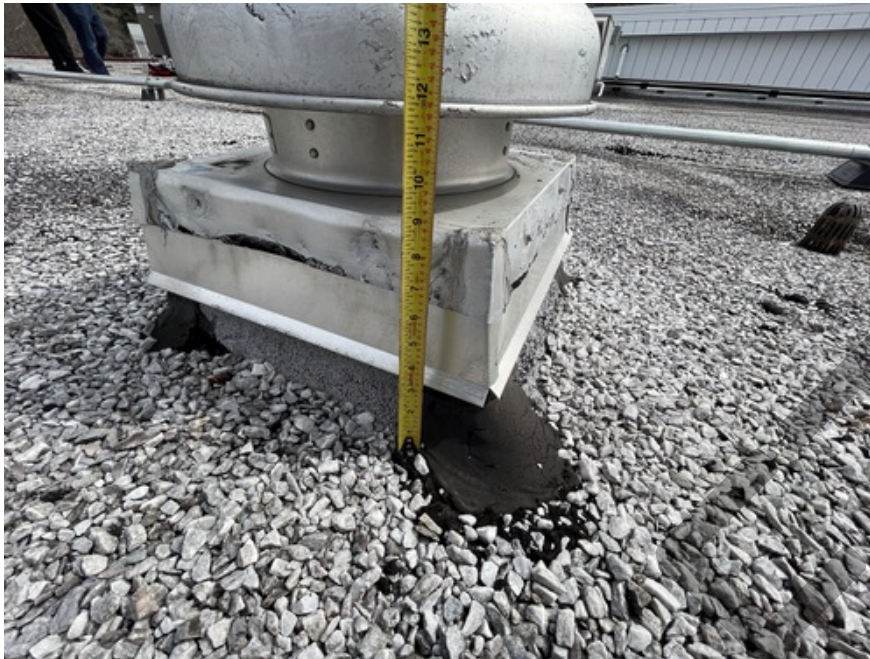
Photo 14

Flashing heights- Low

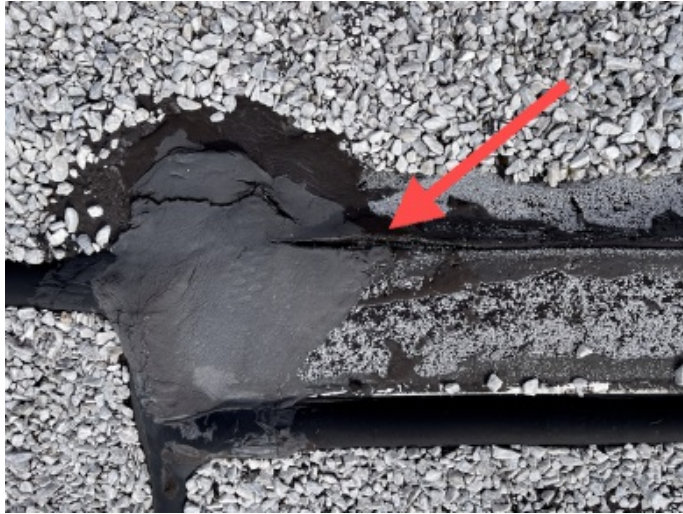
Photo 16

Failed previous repairs

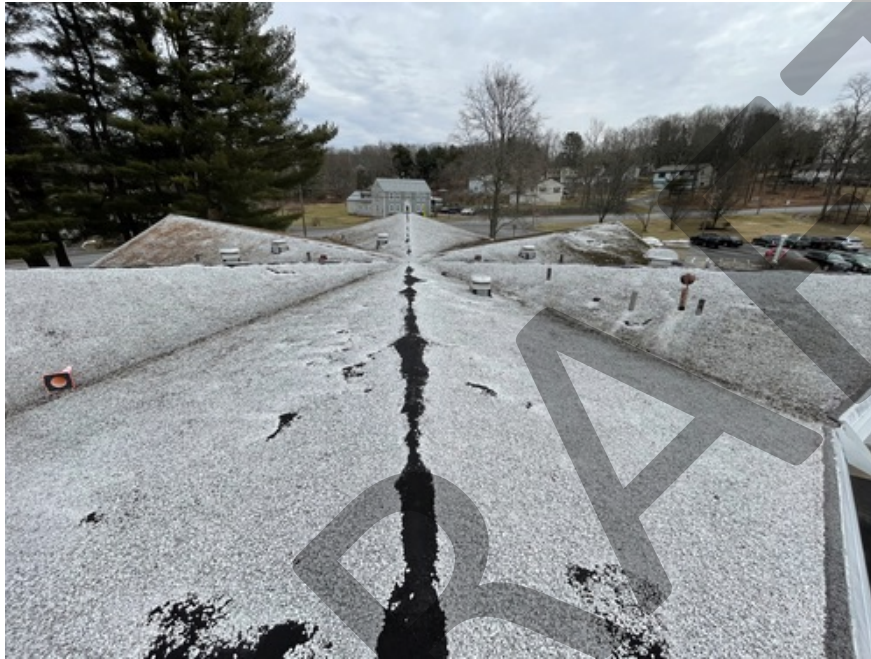
Photo 1

**Overview of the POD roofs-
Flood and gravel is not
recommended in the
northeast on any slopes
greater than 2:12"**

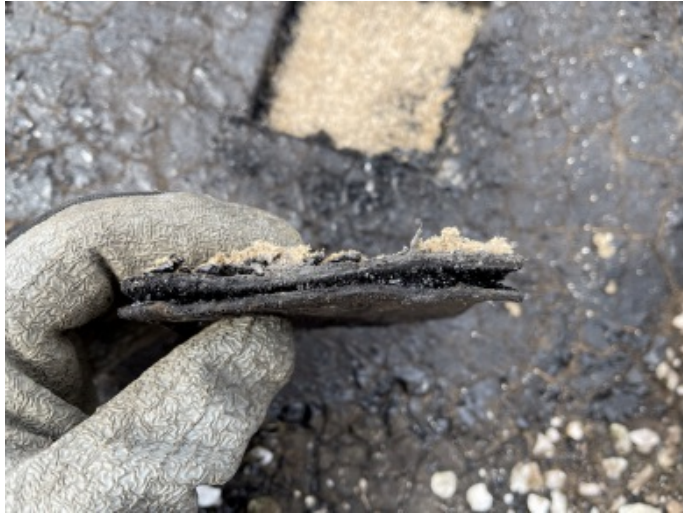
Photo 10

Core Cut: Two Ply flood and gravel

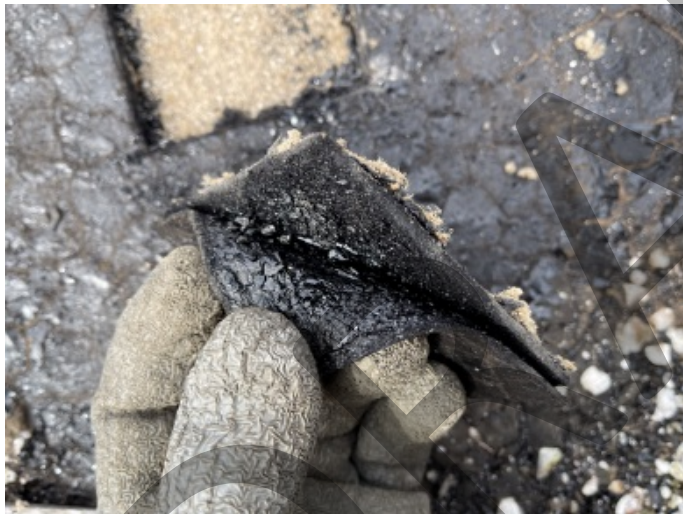
Photo 11

Core Cut: Failing interply adhesion - Not restorable
