Facility Study and Master Plan

Lake Street School

201 Lake Street, Vernon, CT 06066

SUMMER 2023

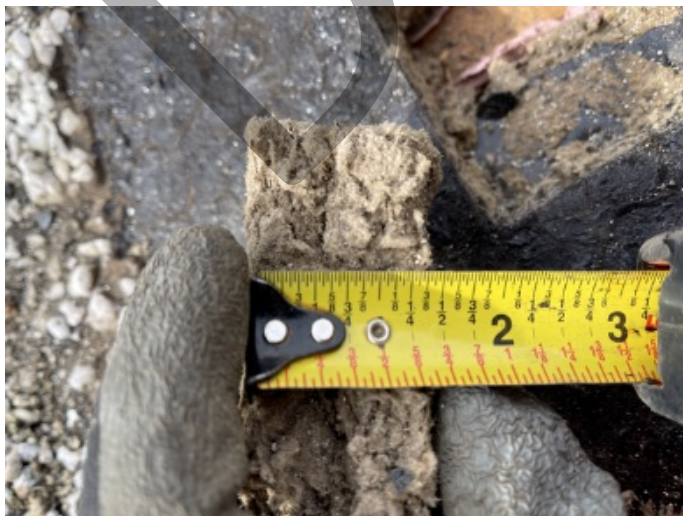
Photo 12

Core Cut: 1-1/2" of wood fiber- Under deck insulation assumed

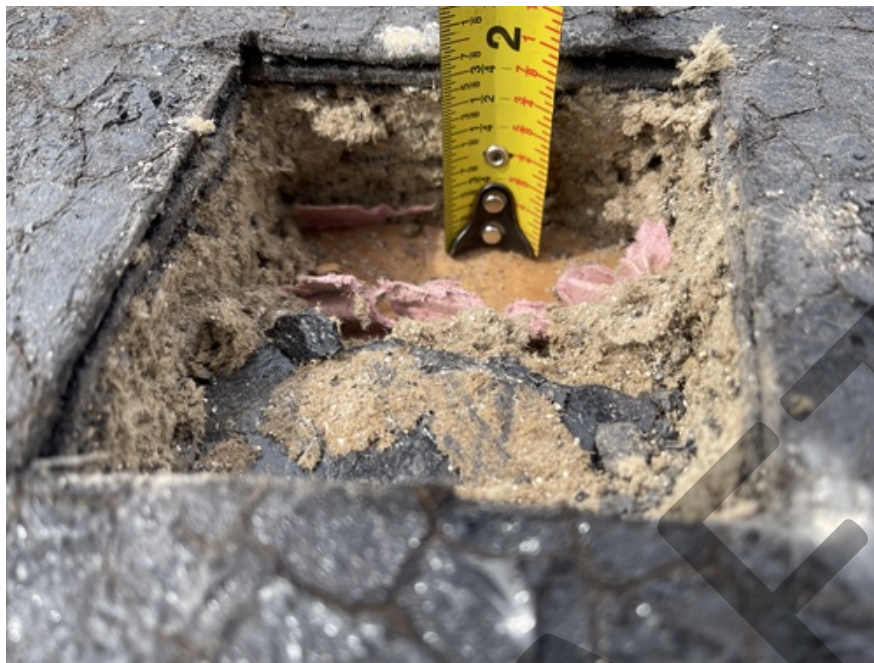
Photo 13

Core Cut: Overview of system over wood deck

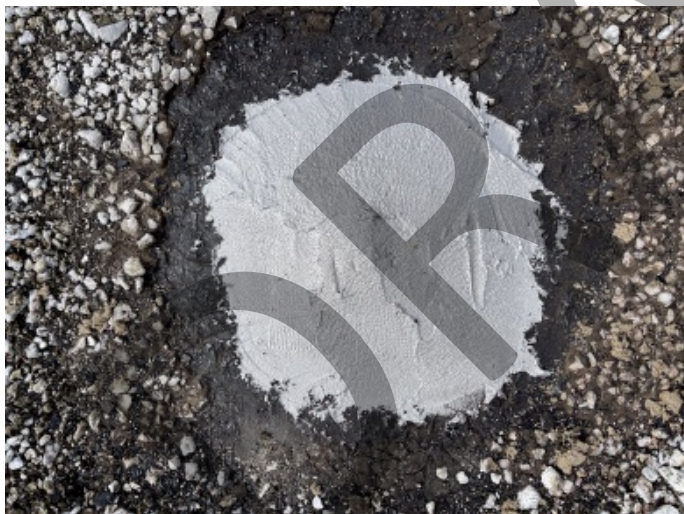
Photo 14

Properly repaired core sample

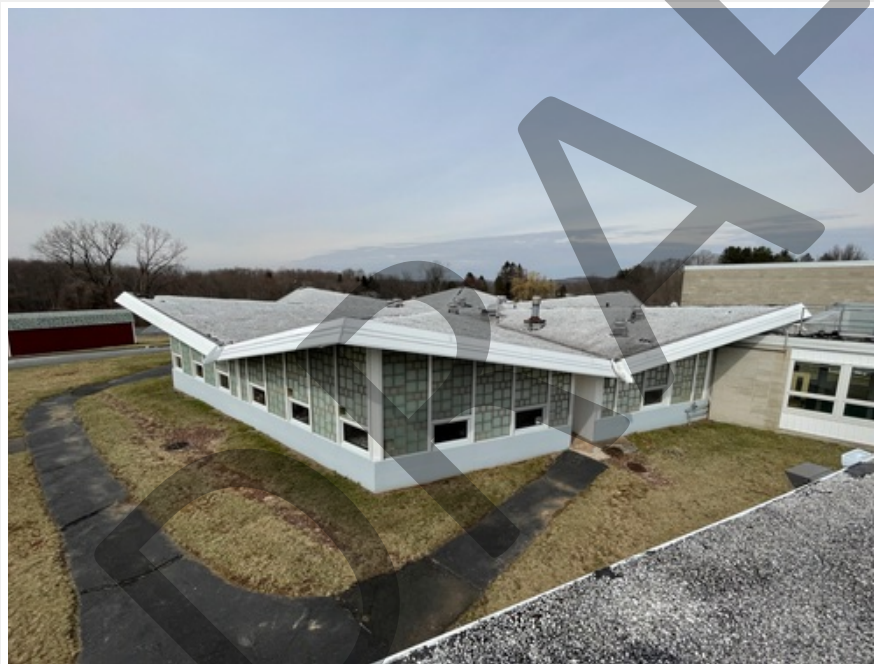
Photo 16

Visual overview
