Facility Study and Master Plan

Center Road School

20 Center Rd, Vernon, CT 06066

SUMMER 2023

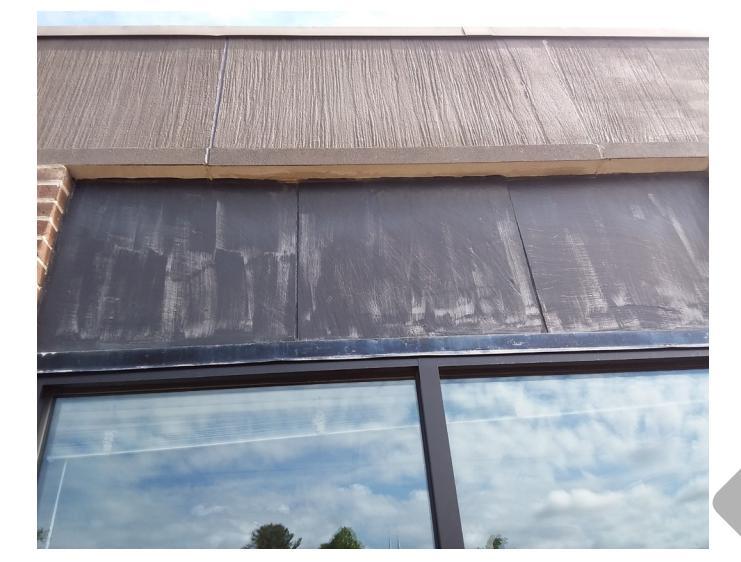
1. Location:

Panels above windows need to be replaced or refinished.

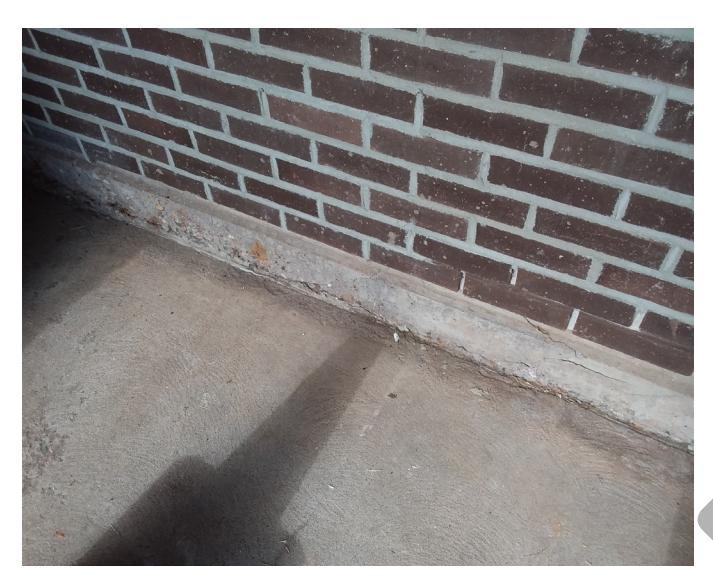
6. Location:

Efflorescence visible at the bottom of the brick. Brick is in direct contact with the pavement.

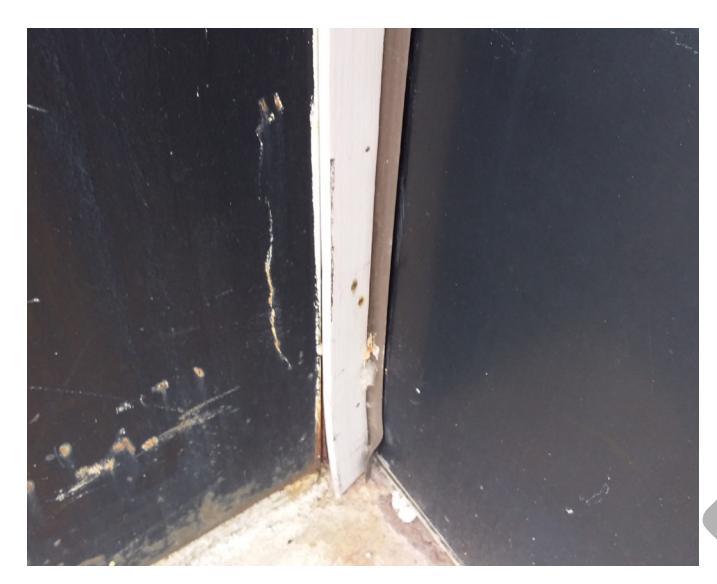
14. Location:

Trim at garage door is damage and should be replaced.

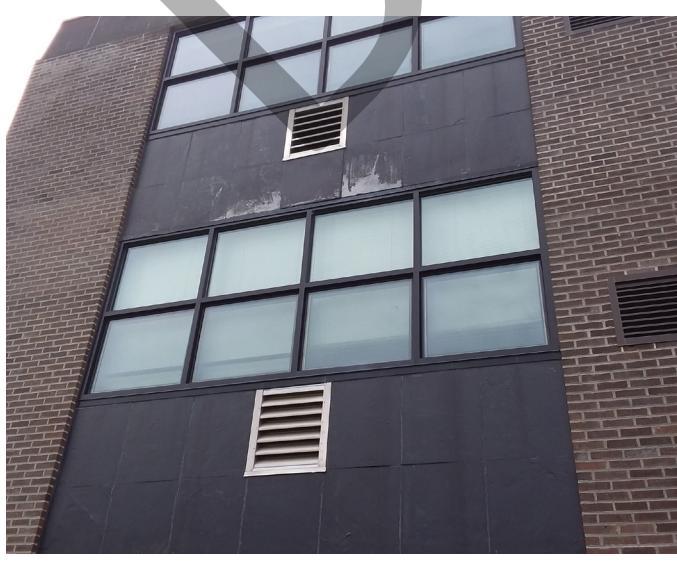
15. Location:

Sealants at vents should be refinished. Remove any insect infiltrations.

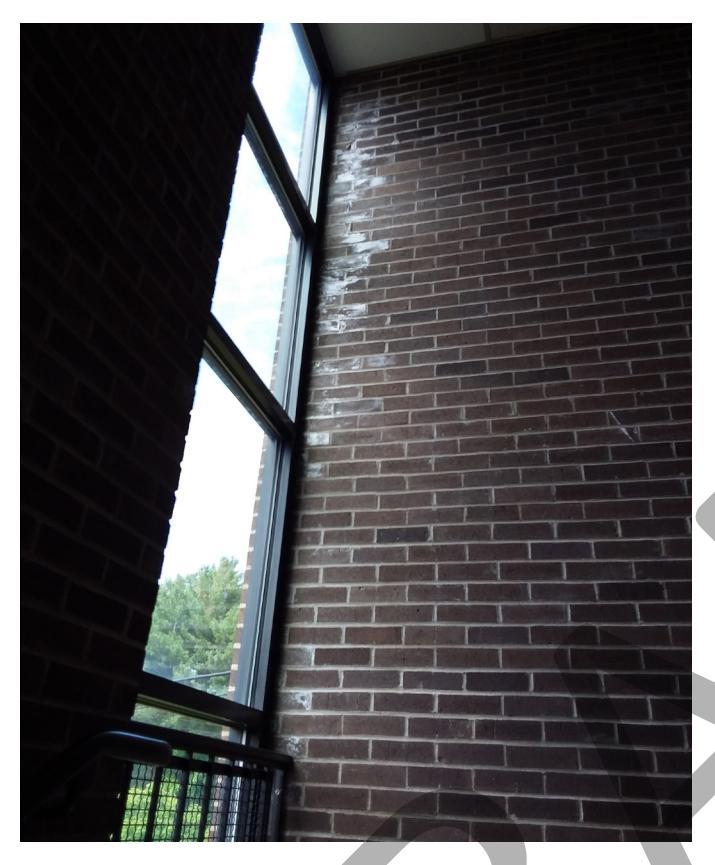
26. Location:

Efflorescence visible in interior of stairways.

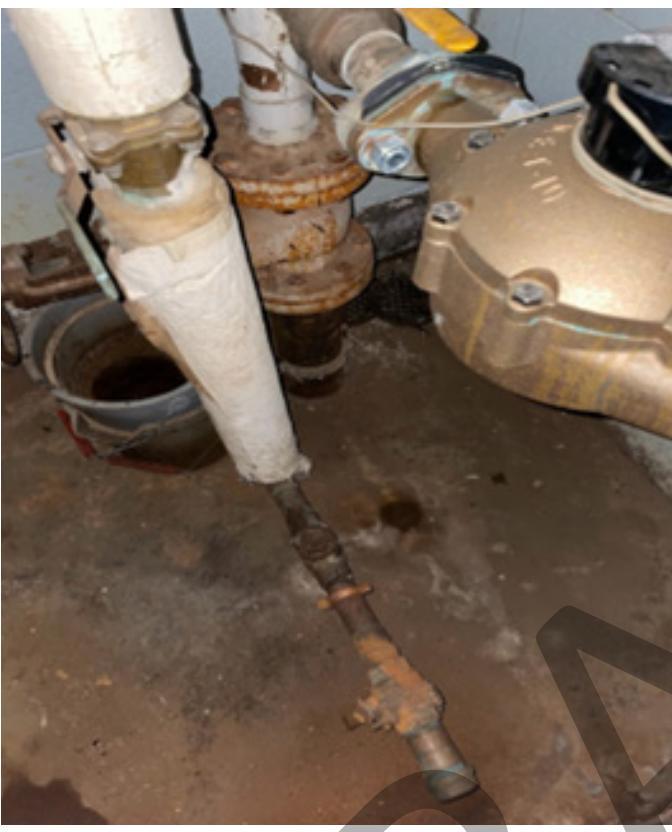
1. Location: Boiler Room Description: Domestic Water Service

- Domestic water service and piping is nearing the end of its useful life and we recommend it be replaced in its entirety.
- Domestic Water heater is nearing the end of its useful life and we recommend it be replaced with a highefficiency gas-fired water heater.
- Sanitary system (above and below grade) is nearing the end of its useful life and we recommend it be replaced in its entirety.
- Storm water system (above and below grade) is nearing the end of its useful life and we recommend it be replaced in its entirety.

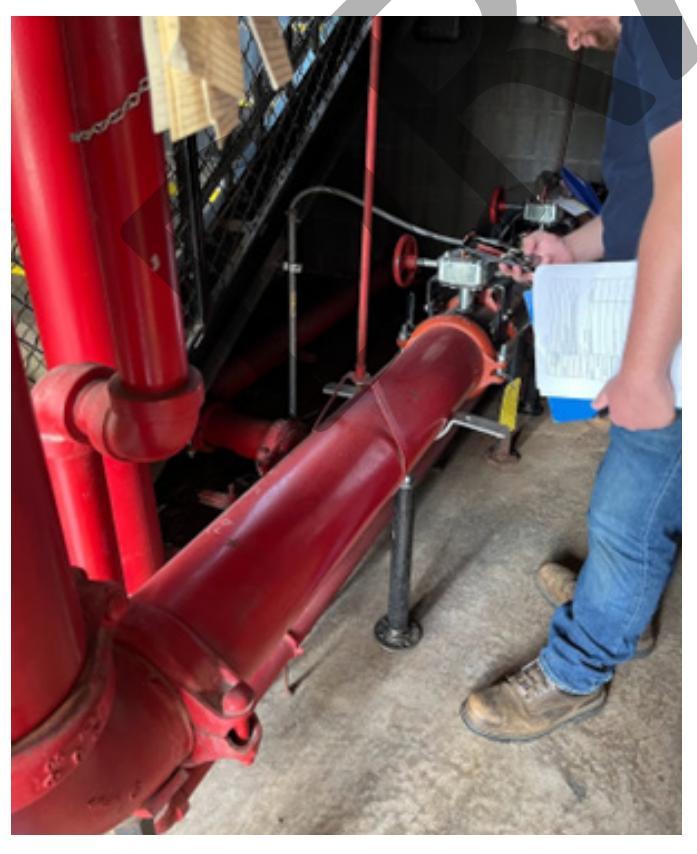
2. Location: Stairwell

> Description: Fire Service and Riser

- Replace guards missing from upright sprinkler heads in the gymnasium
- Replace sprinkler covers missing from concealed pendant sprinkler heads
- Fire service and associated piping is nearing the end of its useful life and we recommend it be replaced in its entirety.

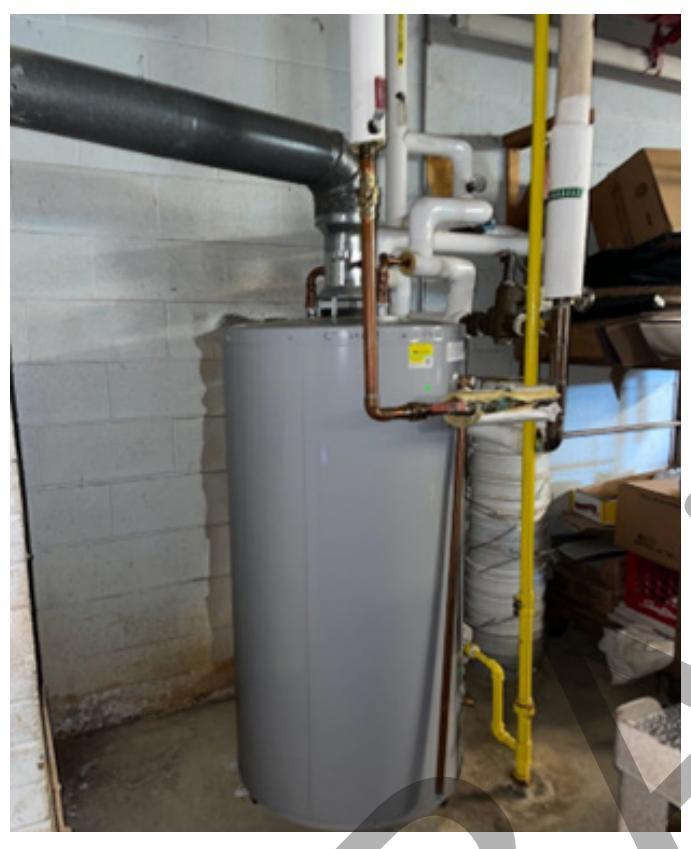
3. Location: Boiler Room Description: Water Heater

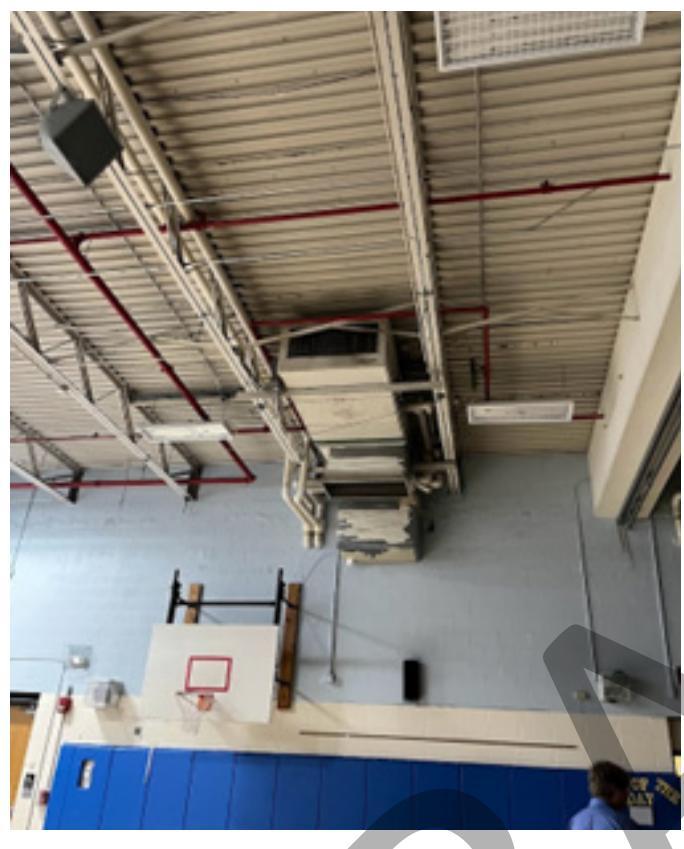
9. Location:

Celing Hung Heating and Ventilation Units

- (2) Gymnasium air handling units are in good working condition and (2) air handing units are past their useful life and we recommend replacing. Provide single zone variable air volume heating, cooling and ventilation roof top unit with outside air for Gym.

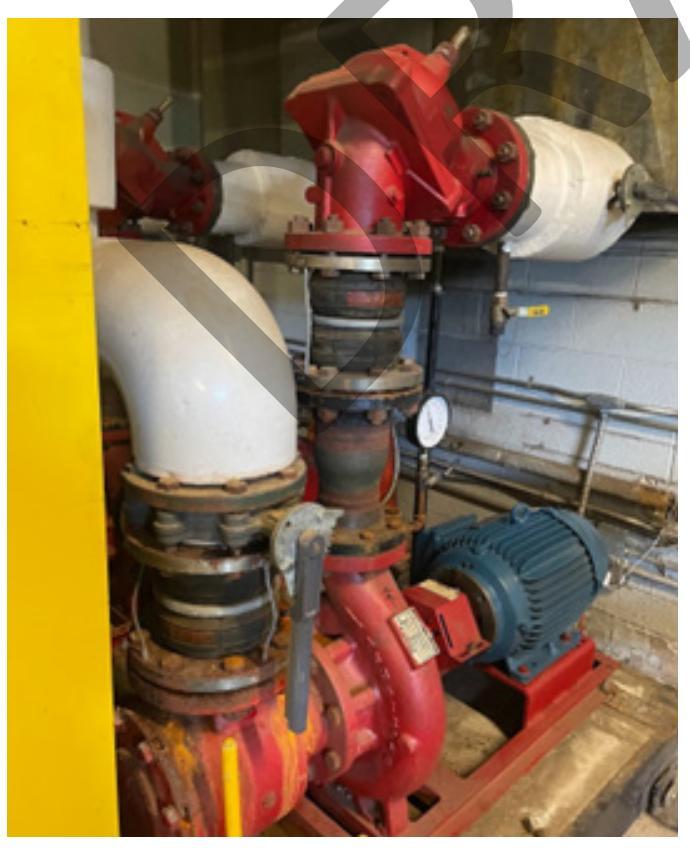
10. Location: Mechanical Room

> Description: Hydronic Pumps

- Hot water pumps are nearing the end of their useful life and we recommend they be replaced in kind.
- Convectors in classrooms and offices are nearing the end of their useful life and we recommend they be replaced in kind.

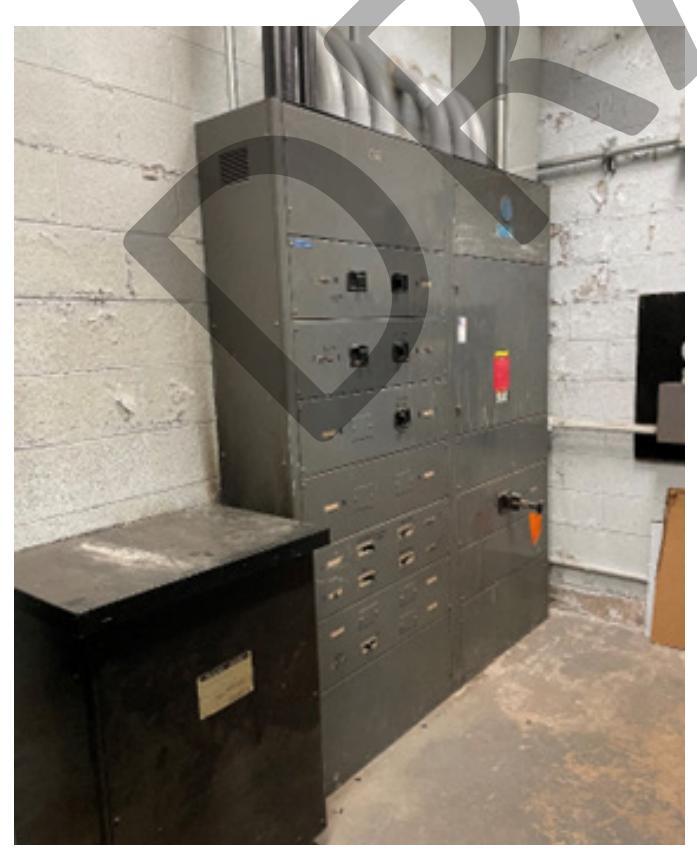
12. Location:

Main Switchboard and Distribution Transformer

- Switchboard is more than 50 years old and in need of immediate replacement.
- The Distribution transformer and distribution equipment that is original to the building are in poor condition and in need of immediate replacement. Branch panelboards that were installed as part of more recent renovations and / or upgrades, should provide service for another 15-20 years before replacement is recommended.
- PV system equipment is in good condition and should provide reliable service for another 10-15 years before improvements and / or repairs are required.
- There is no evidence of a lightning protection system for the building. Recommend installing a lightning protection system in the immediate future, to safeguard people and property from fire risk and related hazards associated with lightning exposure.

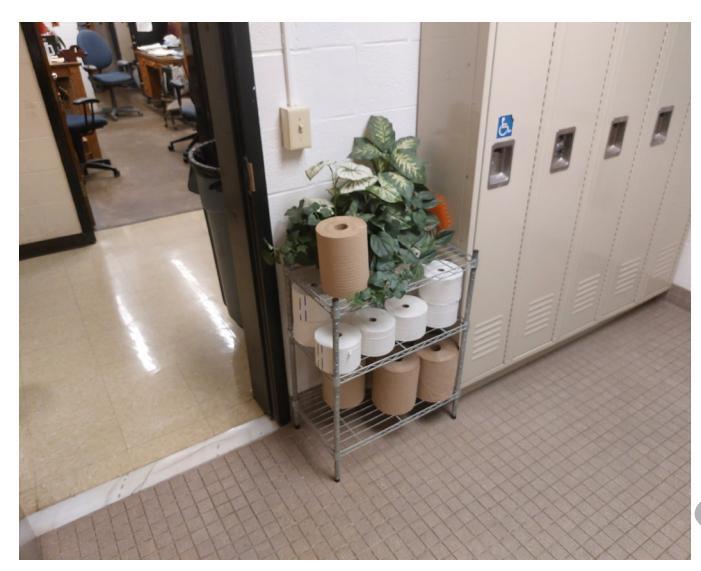
1. Location:

Movable furniture interferes with required 18" pull distance on latch side of front approach door.

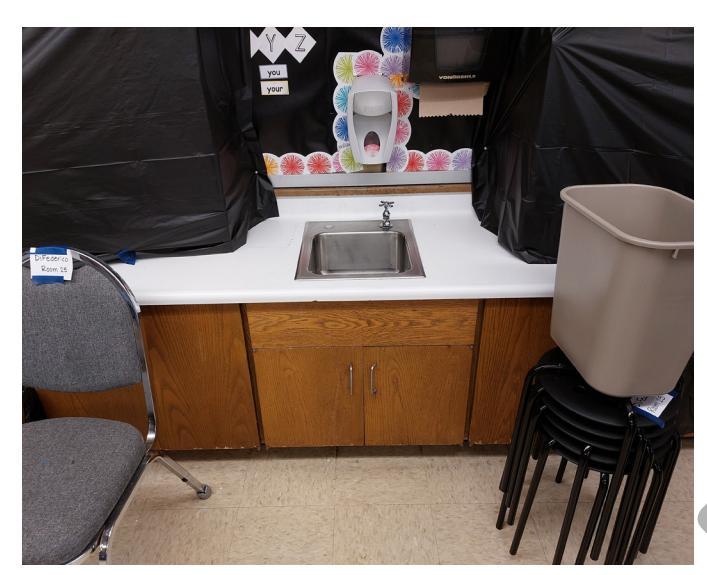
13. Location:

Only sink provided in classroom does not meet accessibility requirements for pull under distance.

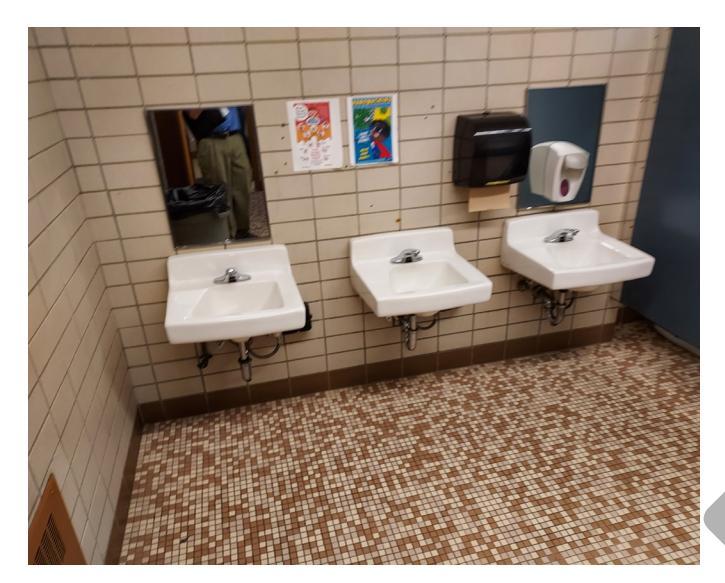
19. Location:

Drain piping is uninsulated.

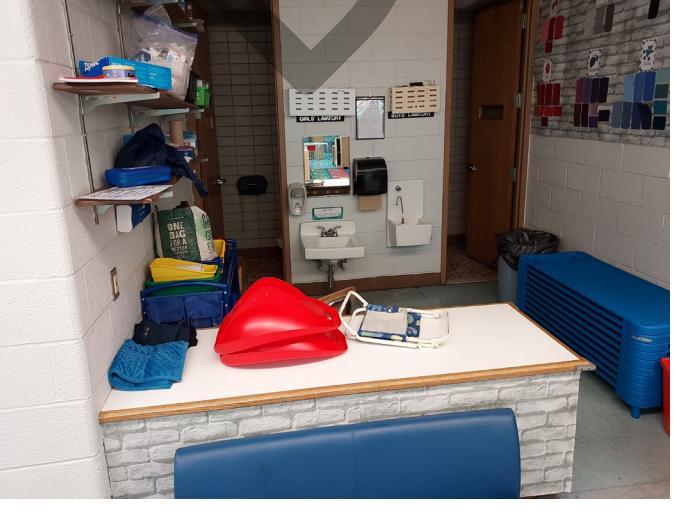
Description:

The bathrooms located within the classroom are not accessible

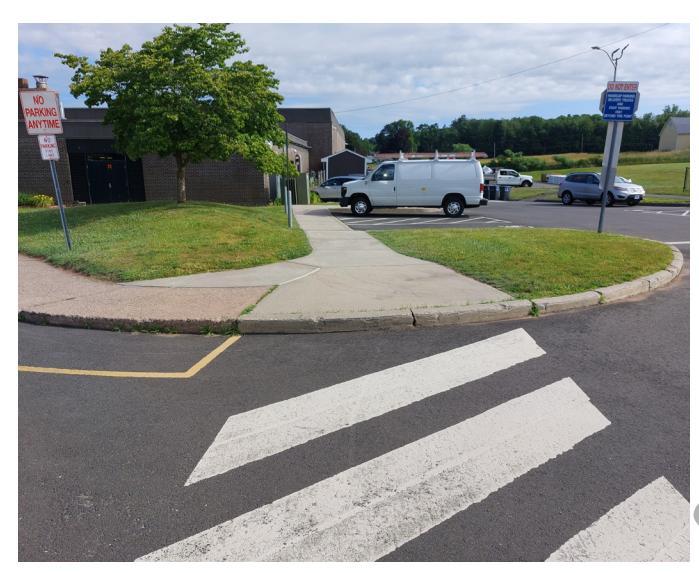
22. Location:

Site

Description:

Site access route does not provide curb ramps.

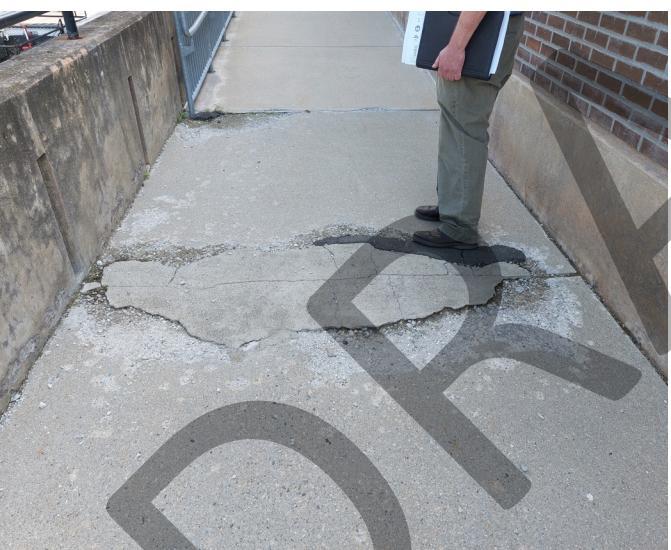
23. Location:

Site

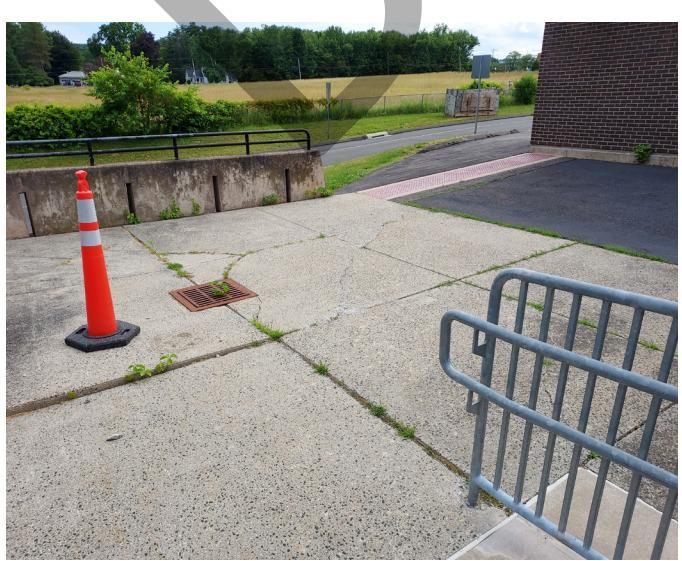
Description:

Fire Egress path has uneven surface, variance of up to 1/2". Surface slopes greater than required maximum along egress path.

- Insulate all exposed drain pipes of sinks intended to be accessible.
- Repair cast in place concrete along multiple egress routes that has degraded and caused unlevel conditions.

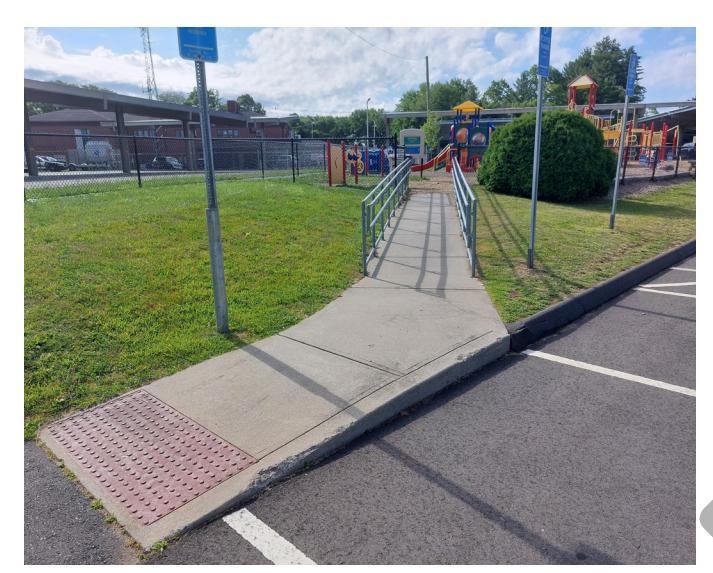
25. Location:

Site

Description:

Handrail does not extend to the end of the ramp, slope continues down to grade.

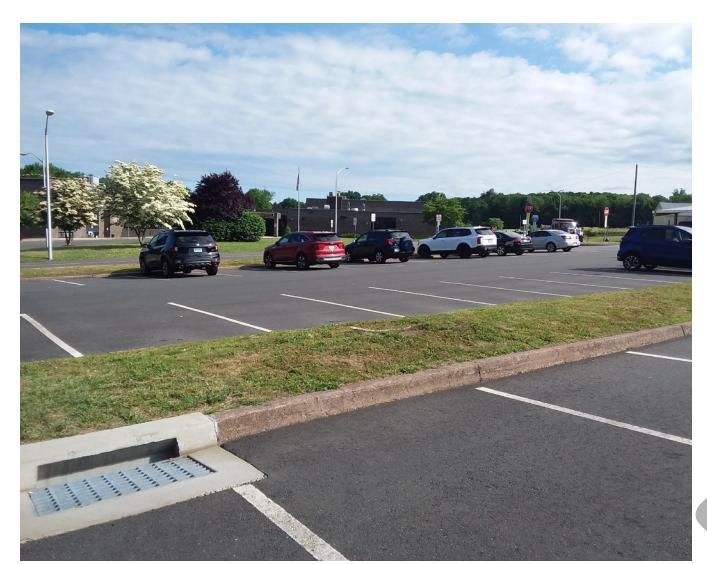
1. Location:

Parking Lot

Description:

Appears to be new and is in excellent condition.

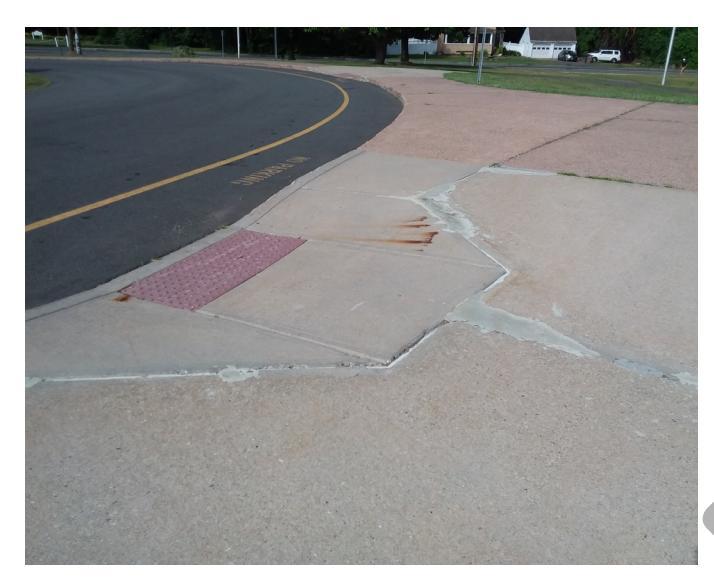
4. Location:

Main Entry

Description:

Some patching at the ADA area has occurred - no walkway designation - see ADA report.

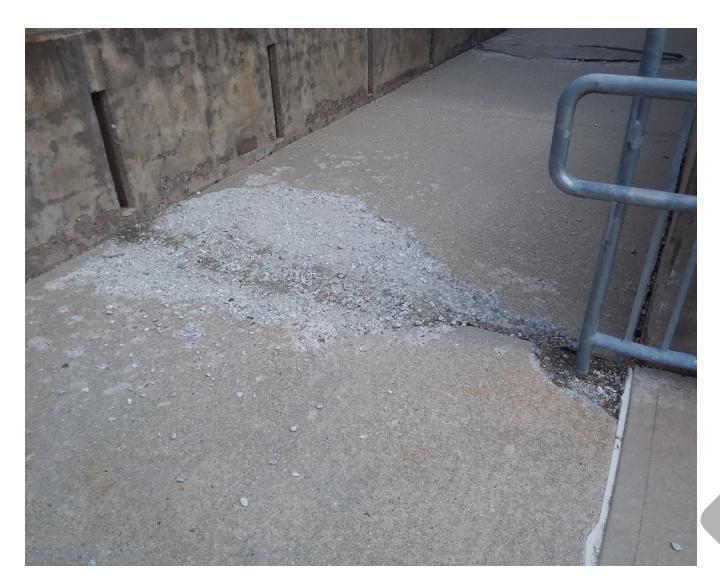
7. Location:

Front of Building

Concrete ramp in poor condition

- Provide signage for Service Area and designate with striping any areas reserved for loading/unloading.
- Repair damaged concrete ramp
