Facility Study and Master Plan

# 166 Union Street

166 Union Street, Vernon, CT 06066

**SUMMER 2023**

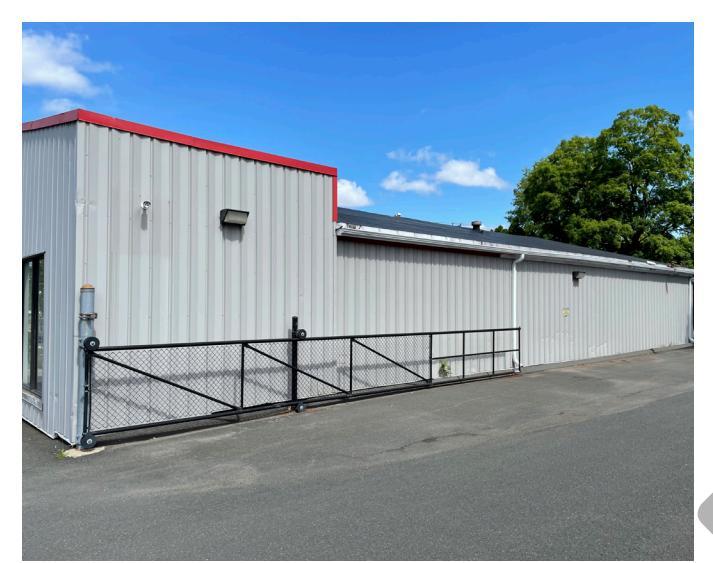
1. Location:

Dents throughout facade

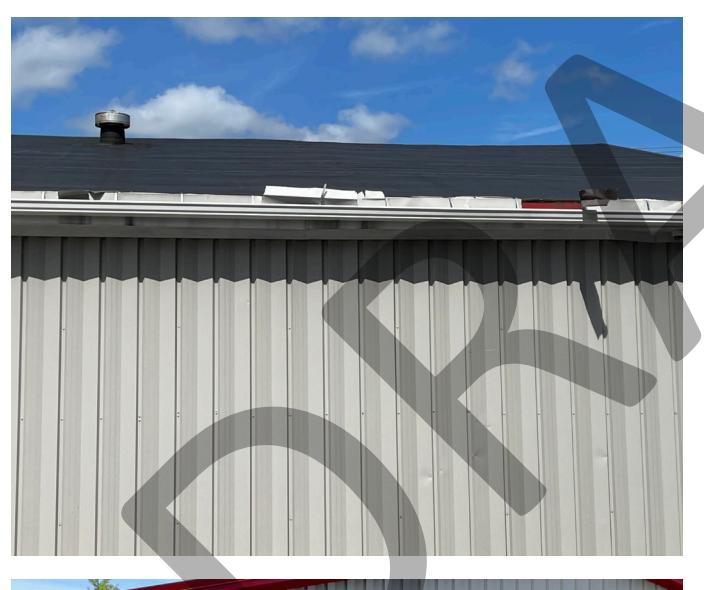
# 2. Location:

Dents throughout metal siding facade

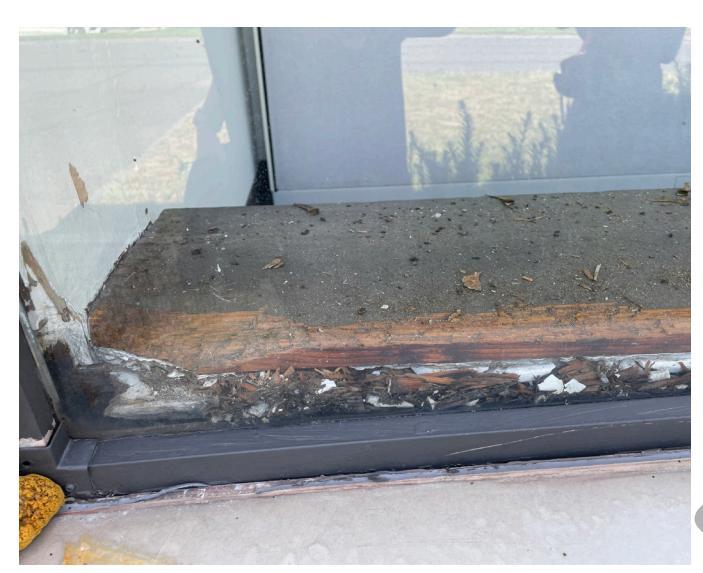
**10.** Location:

Rotting interior wood sill. Sealant deteriorating on the outside.

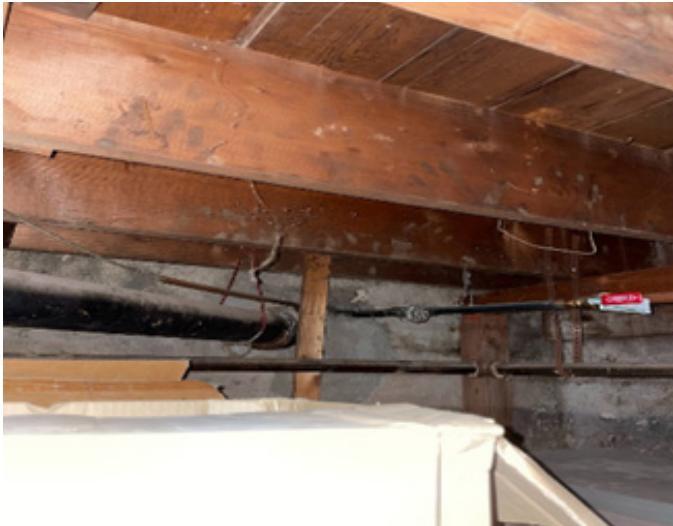
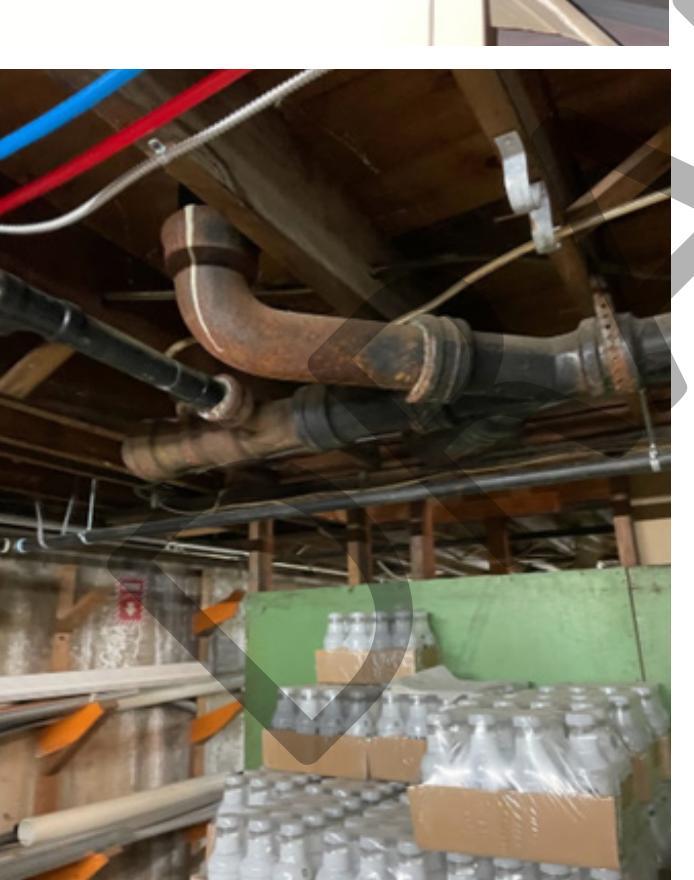
**1. Location:**Basement **Description:**Water Service **2. Location:**Basement **Description:**Hot, Cold, Sanitary Piping

- Domestic water service and piping is nearing the end of its useful life and we recommend it be replaced in its entirety.
- Domestic Water heater is nearing the end of its useful life and we recommend it be replaced with an electric water heater.
- Natural Gas service and system is nearing the end of its useful life and we recommend it be replaced in its entirety.
- Sanitary system (above and below grade) is nearing the end of its useful life and we recommend it be replaced in its entirety.

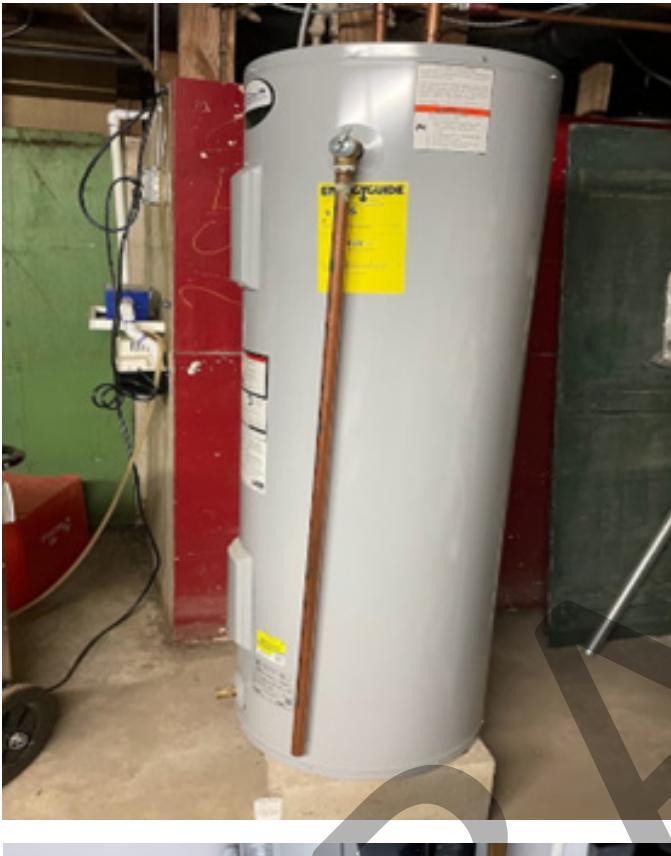
3. Location: Basement Description: Water Heater

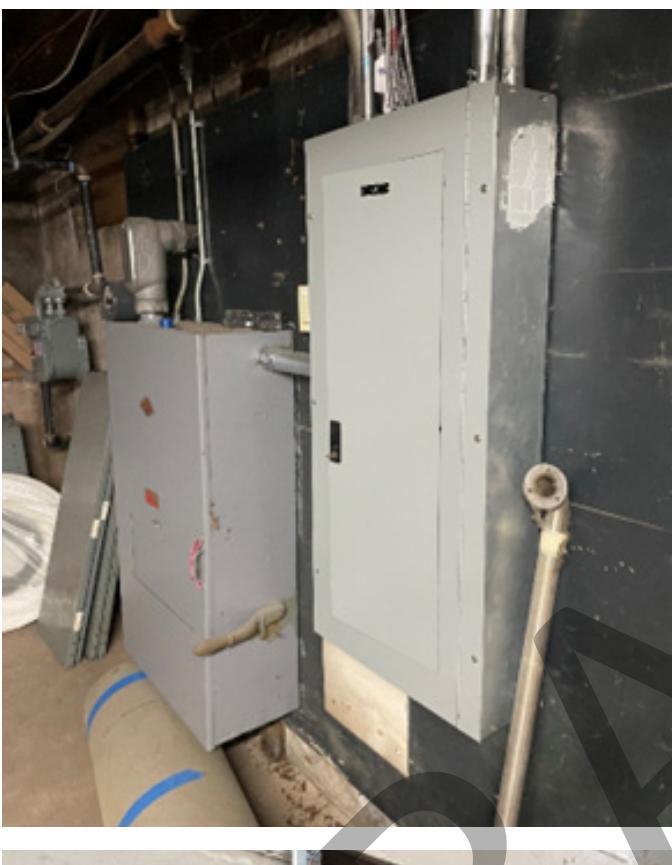
**13.** Location:

> Description: Old Load Center Panels

- Main Switch and CT Cabinet is past its serviceable lifespan and in need of immediate replacement.
- Older style load center panels are poorly maintained and in need of immediate replacement.
- There is no evidence of a lightning protection system for the building. Recommend installing a lightning protection system in the immediate future, to safeguard people and property from fire risk and related hazards associated with lightning exposure.

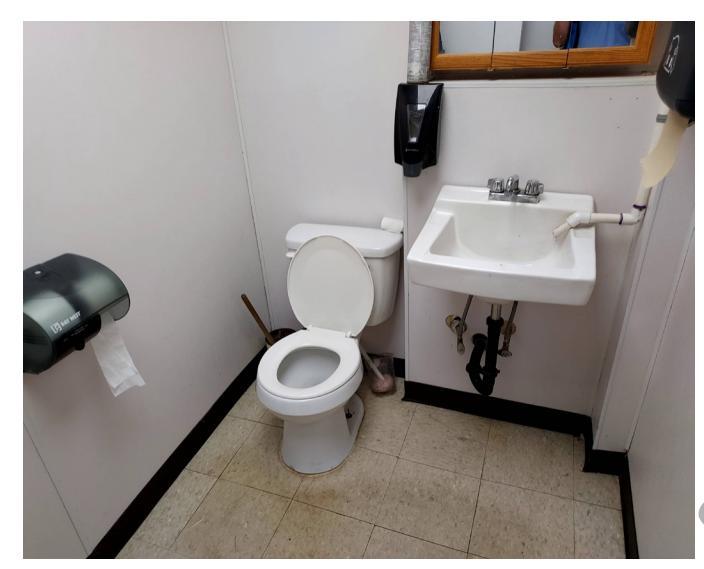
Toilet Room

Required clear space for sink not provided due to furniture. Counter height not compliant. Casework under sink does not allow for required pull under distance. Casework has operable elements below minimum required 15"

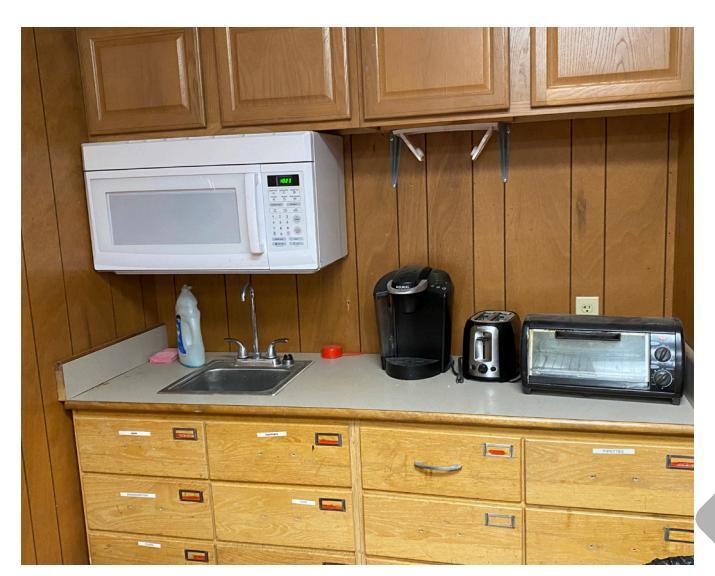
Break Room

Hardware is missing from several cabinets. Require tight pinching in order to open.

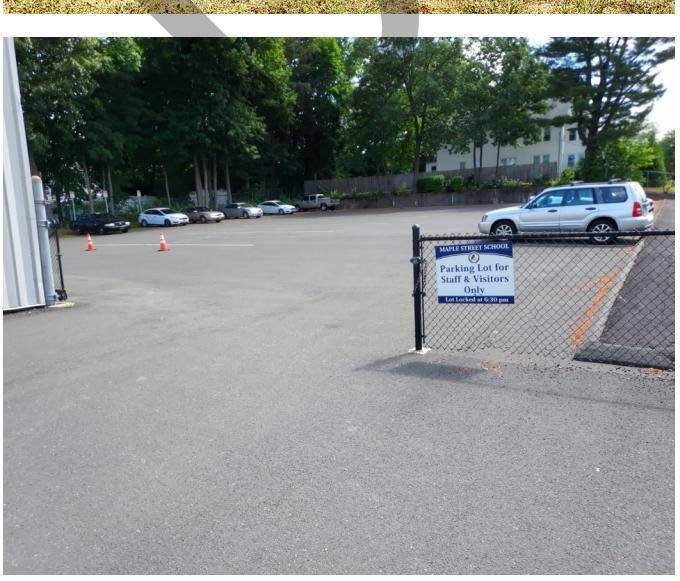
No accessible spaces provided for this facility. Accessible spaces not feasible in this lot due to cross slope of parking spaces far exceeding maximum slope of 1:48.

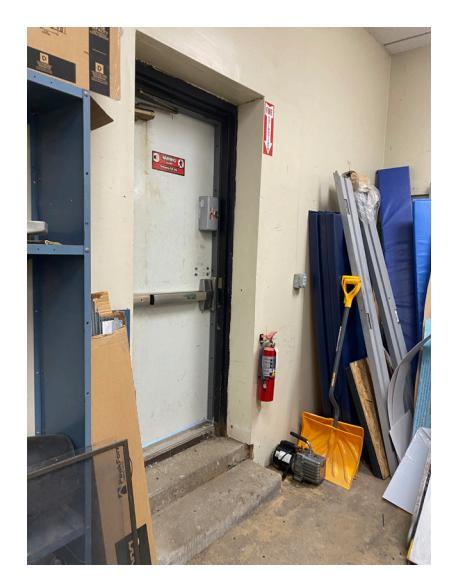
## **10.** Location:

Exit Door

The exit door has steps to exit. The exit is not accessible. Modifications would need to be made inside and outside for a second exit.

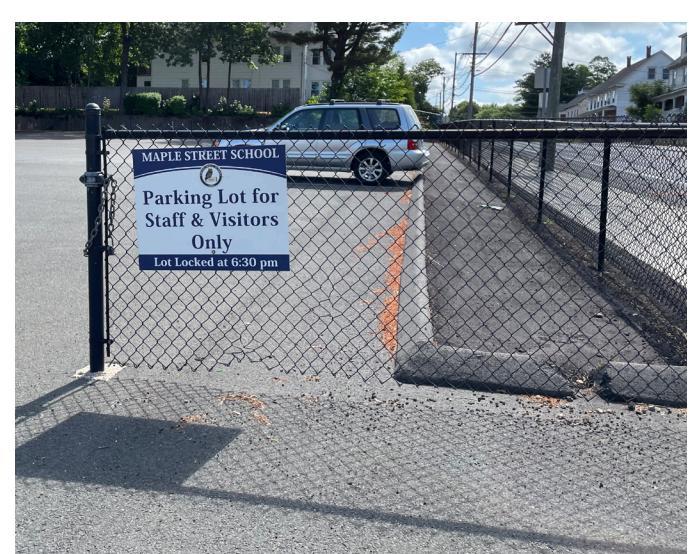
## **1. Location**:

East Parking Lot

Designated parking for Municipal vehicles. No curbs along this side of the parking.

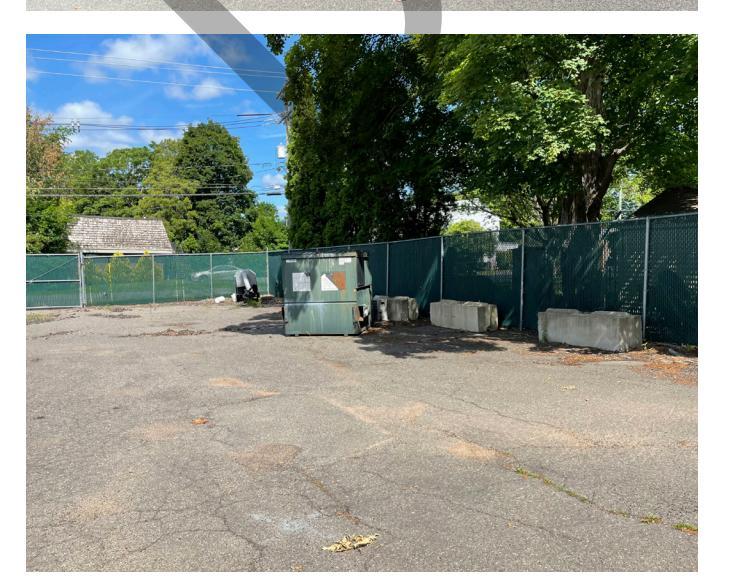
## **3.** Location:

North Paved Area

Cracked bituminous pavement

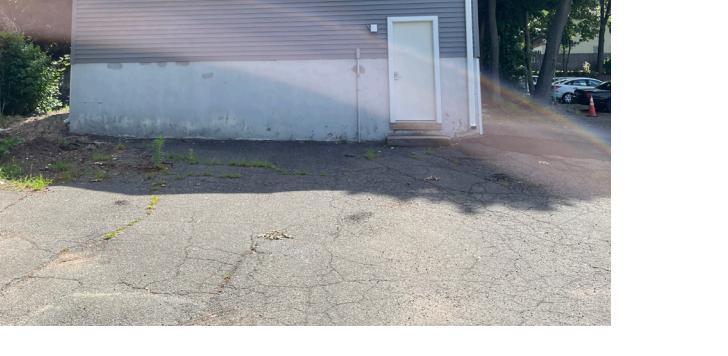
Garage has vinyl siding and a concrete foundation that is damaged in some areas.

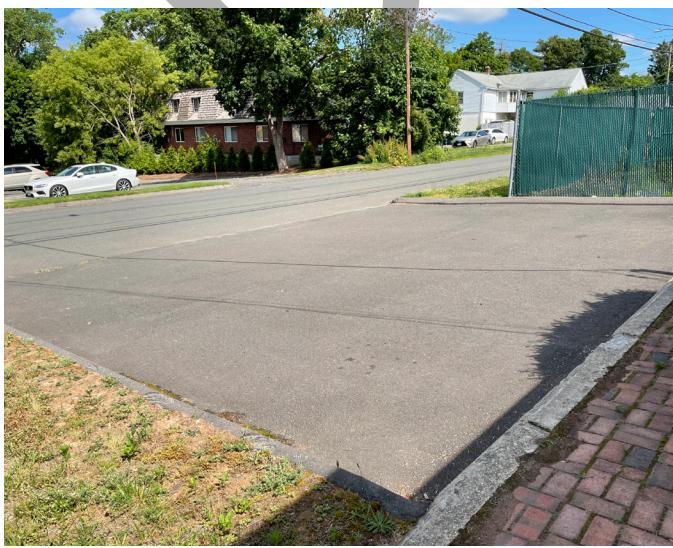
No signage or striping indicating parking spaces.
