BEDFORD CITY SCHOOL DISTRICT

***Ohio Facilities Construction Commission
Classroom Facilities Assistance Program
Facilities Assessment Report***

***Submitted by
Harrison Planning Group
June 2018***

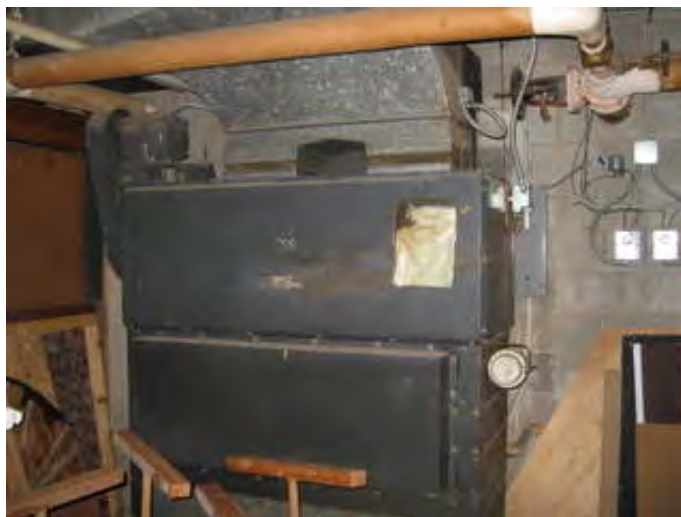
Lower level mechanical room air handling unit

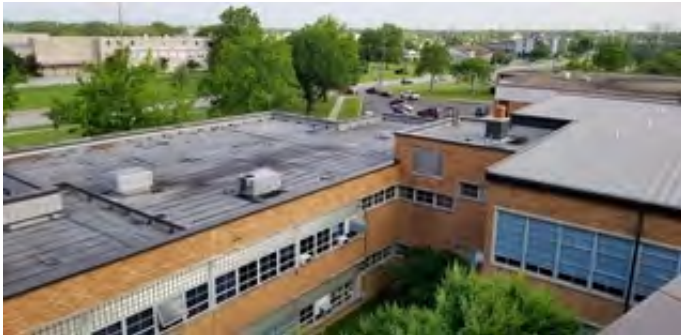
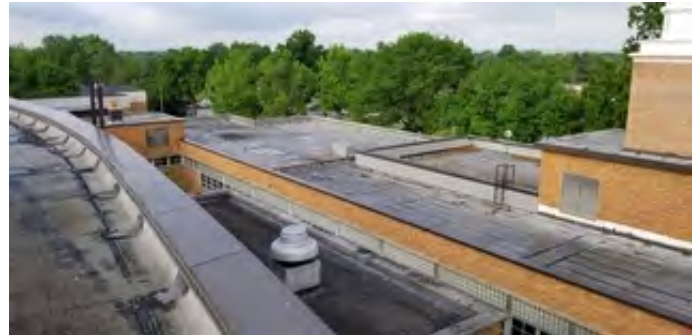
Typical roofing at overall facility

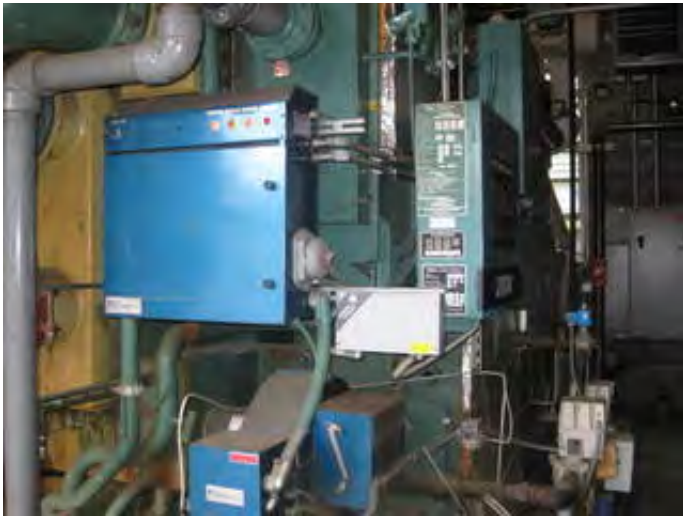
1958 mechanical building absorption chiller

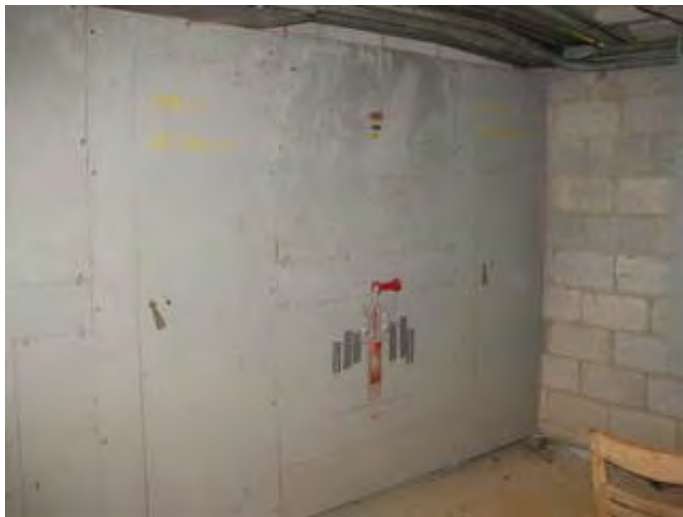
Main distribution equipment

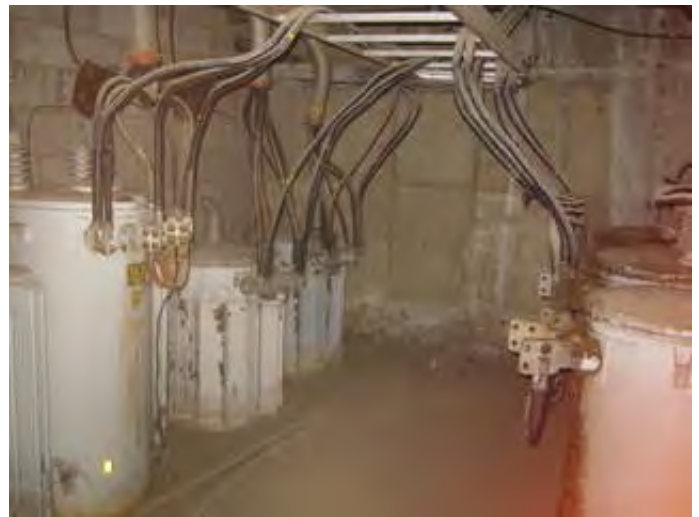
Pad mounted transformers in electrical vault

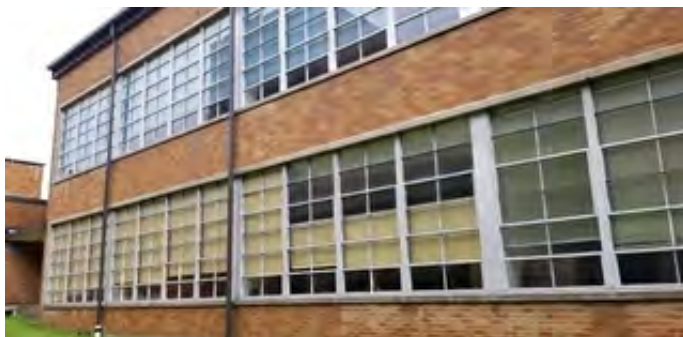
Typical windows at 1954 original construction

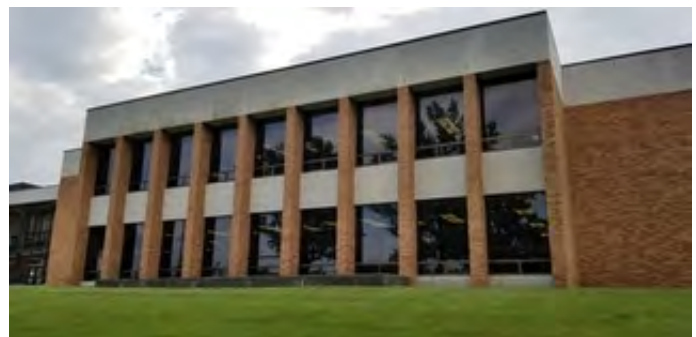
Typical windows at 1971 addition

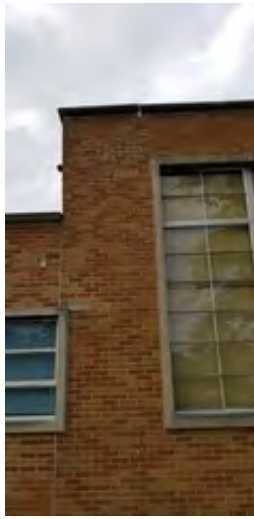
Cracking brick at 1958 addition

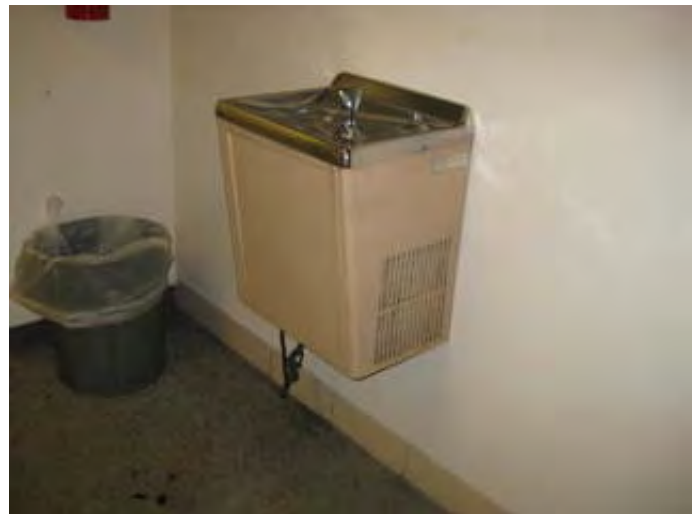
Non-compliant electric water cooler

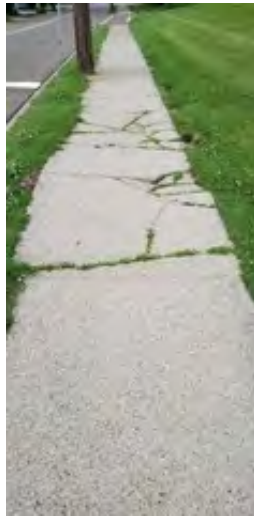
Damaged concrete sidewalks

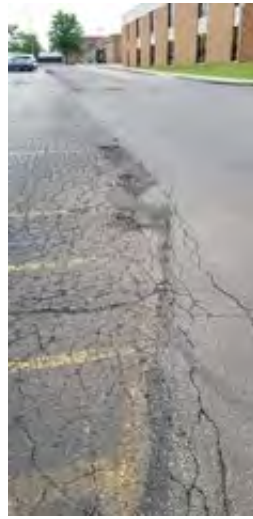
Asphalt pavement in poor condition

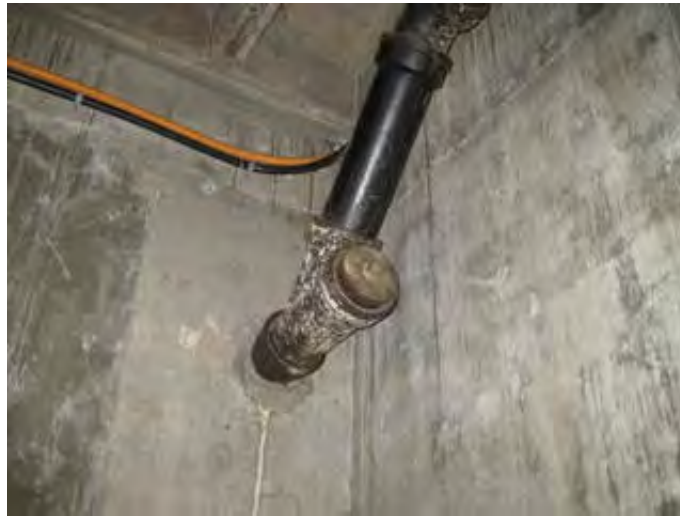
Cast-iron sanitary piping

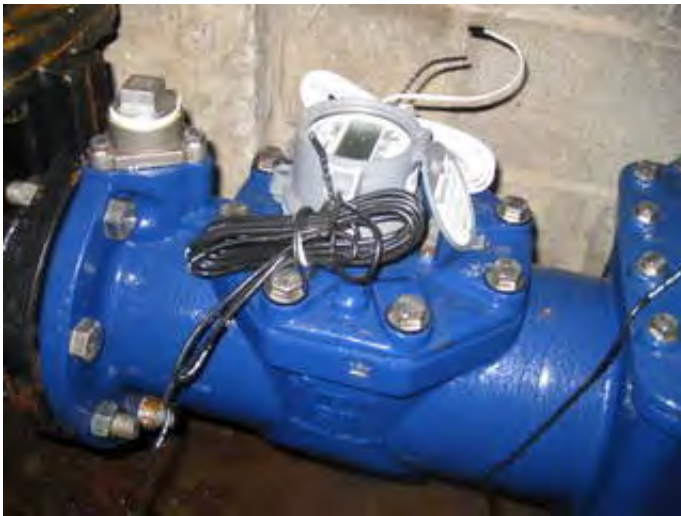
Water service meter

Recommendations: Provide funding for water quality testing.

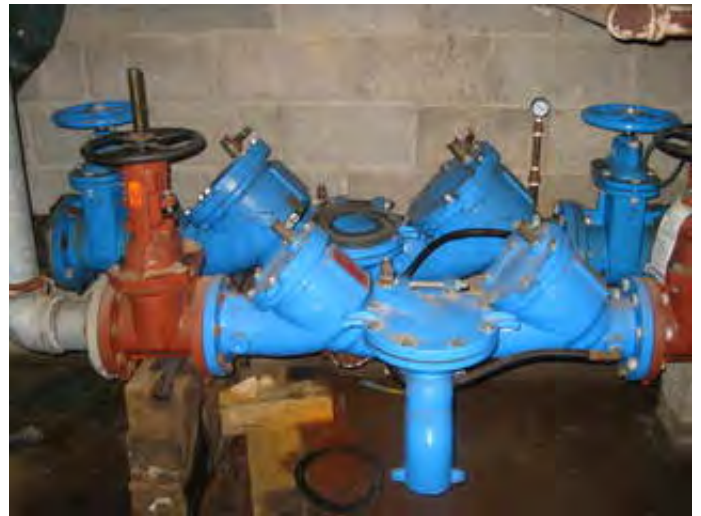
Water service back-flow preventor

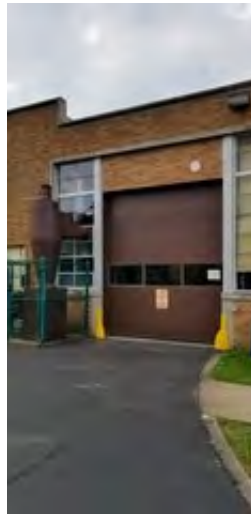
Rating: 3 Needs Replacement

Overhead door at shop

Recommendations: Replace all exterior doors to comply with Ohio Building Code, ADA, and Ohio School Design Manual guidelines. Replacement of single glazed door vision panels, transoms, and sidelights is addressed in Item F. Provide for replacement of overhead doors in poor condition.

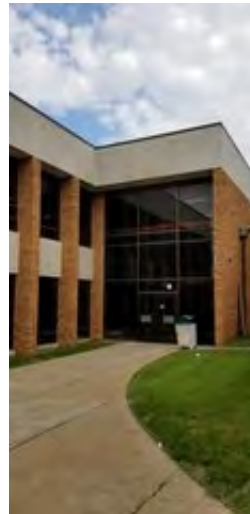
Entrance doors at 1971 addition

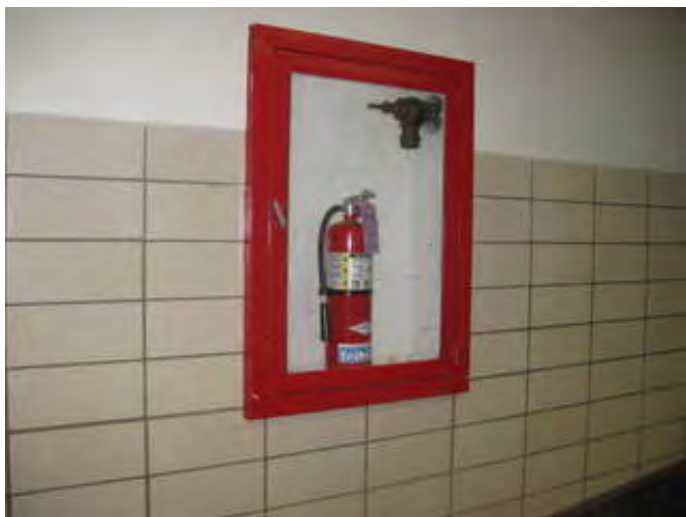
Corridor fire extinguisher cabinet

Emergency Safety		Points Allocated	Points
4.17 Adequate fire safety equipment is properly located		15	4
<i>The facility is not sprinkled. Fire alarm devices are not adequately provided. Fire extinguishers are inadequately provided.</i>

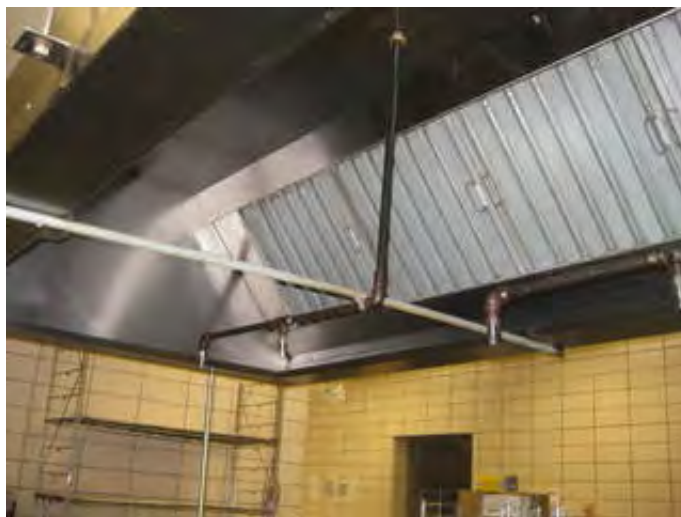
Kitchen hood fire suppression

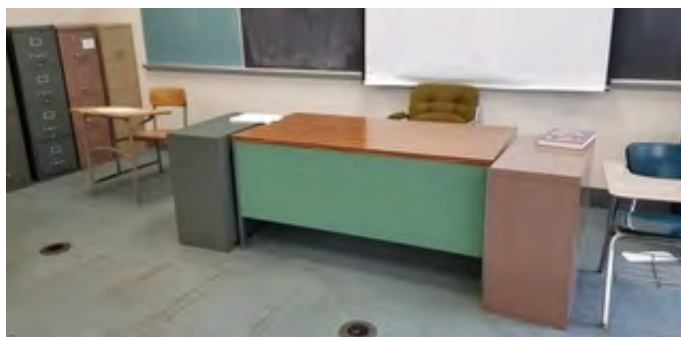
Description: The typical classroom furniture is mismatched, and in generally poor and aged condition, consisting of miscellaneous student desks & chairs, miscellaneous teacher desks & chairs, miscellaneous file cabinet, reading table, computer workstation, miscellaneous bookcases, and wastebaskets. The facility's furniture and loose equipment were evaluated in item 6.17 in the CEFPI section of this report, and on a scale of 1 to 10 the overall facility received a rating of 3 due to observed conditions, and due to the fact that it lacks some of the Ohio School Design Manual required elements.

Typical teacher desk and workstation

Recommendations: Provide for replacement of outdated or inadequate furniture.

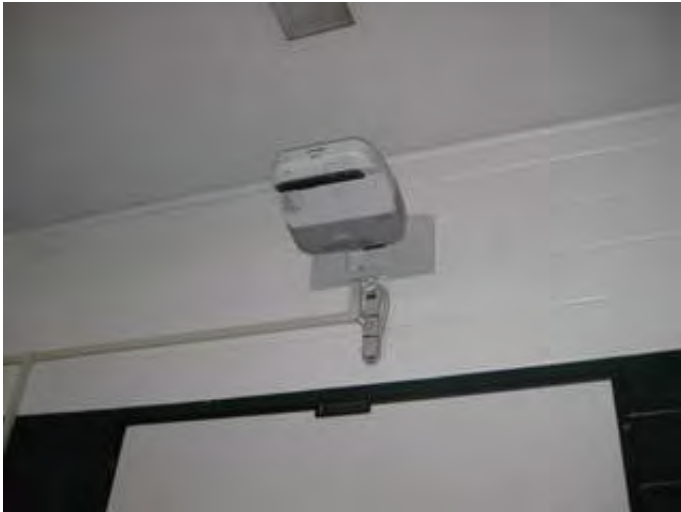
Rating: 2 Needs Repair

Overhead projector

Recommendations: Provide partial technology upgrades, wiring and systems per Ohio School Design Manual guidelines.

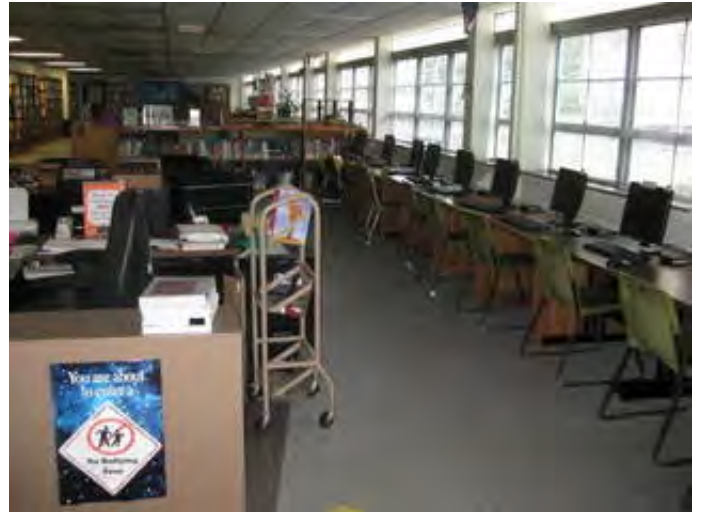
Computers in media center

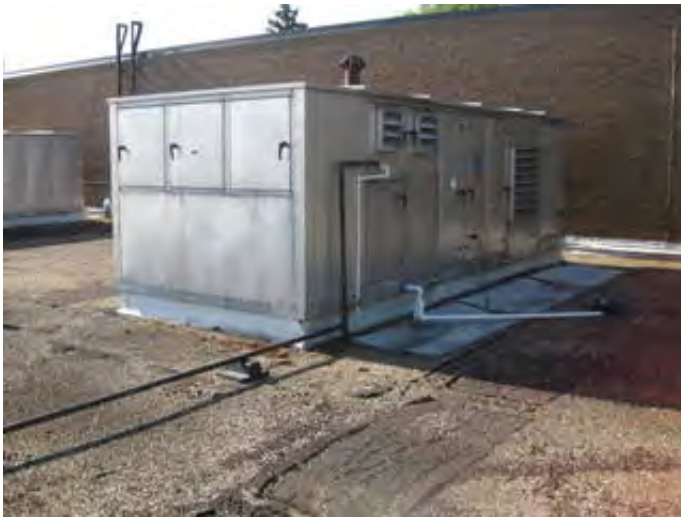
Rooftop HVAC equipment

Recommendations: Provide replacement of all rooftop equipment due to age, to meet Ohio School Design Manual guidelines. OFCC requires rooftop equipment 10-years old to be replaced.

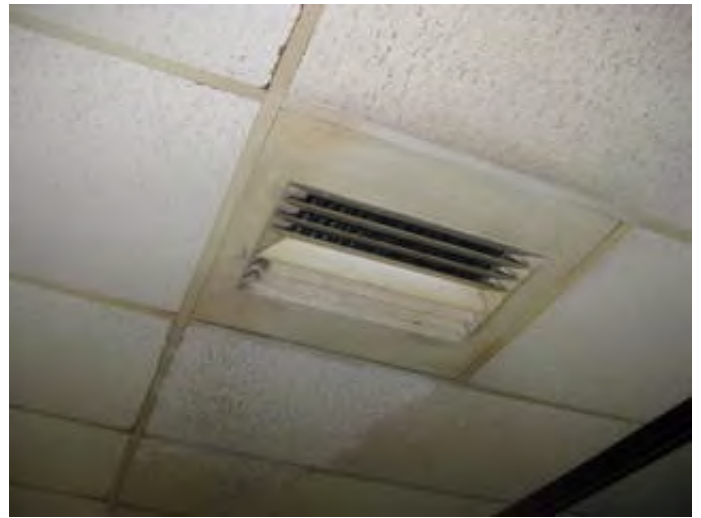
Ceiling air diffuser

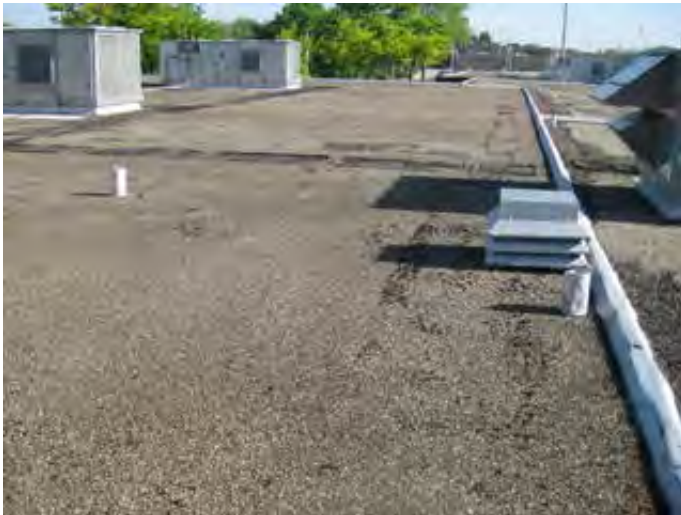
Built-up asphalt roofing

Recommendations: The roof over the overall facility requires replacement to meet Ohio School Design Manual guidelines for age of system and due to condition. The flashing throughout the overall facility requires replacement due to condition. Overflow roof drains are required throughout the overall facility. Provide safety protection cages at ladder access to the various roof levels.

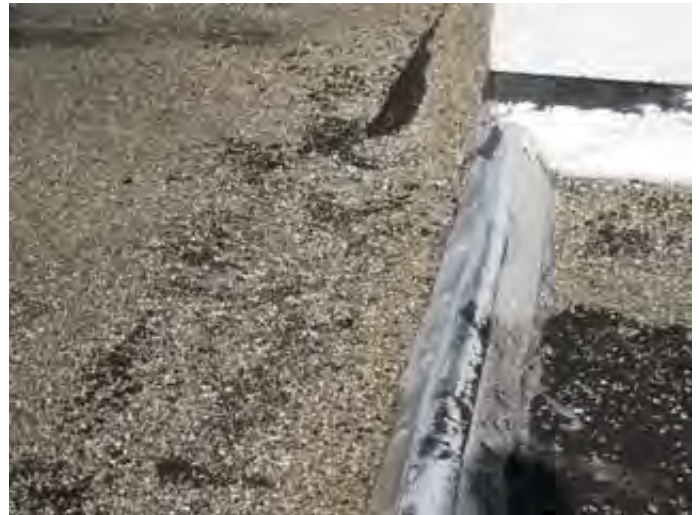
Roofing expansion joint

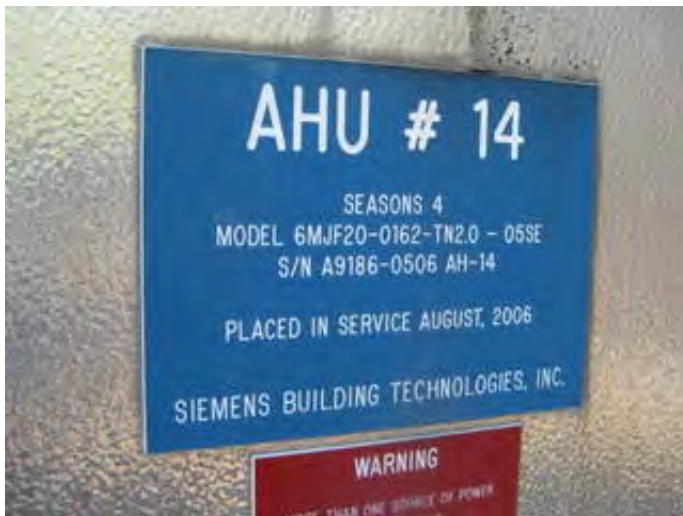
Rooftop air-handling unit tag

Recommendations: Replace the existing rooftop HVAC units due to OFCC requirements of being over 10-years of age. Funding included in Item A - Heating System.

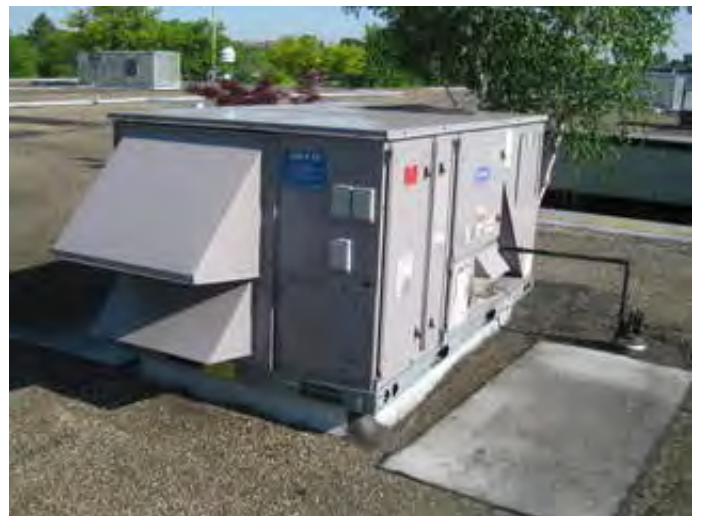
Rooftop air-handling equipment

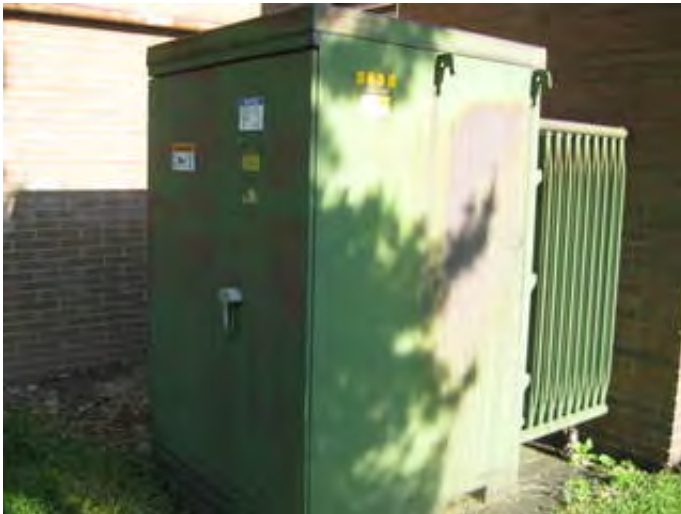
Pad mounted transformer

Recommendations: The entire electrical system requires replacement to meet Ohio School Design Manual guidelines for classroom capacity and due to age. The emergency generator for life safety systems is included in the entire electrical system replacement funded in this Item D - Electrical. Provide building lightning protection and grounding. Lighting protection and grounding is included in the entire electrical system replacement funded in this Item D - Electrical.

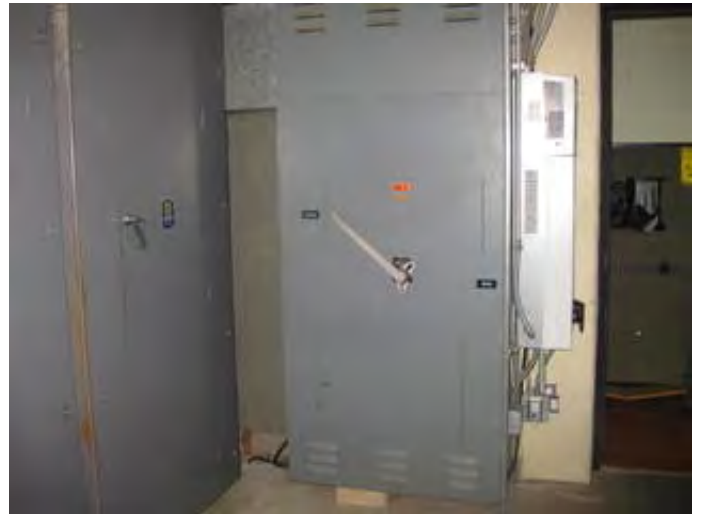
Electrical main distribution equipment

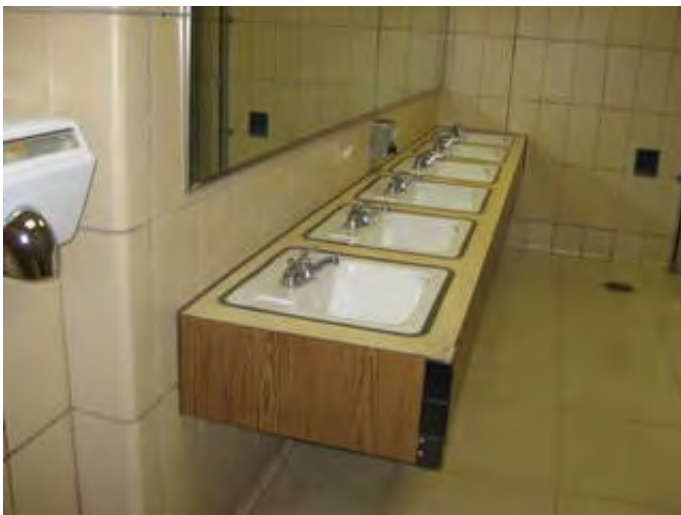
Restroom lavatories

To facilitate compliance with OBC and OFCC fixture requirements, provide new toilets, new lavatory sinks, new urinals, and new electric water coolers. Due to age, condition, LEED, and OFCC requirements, replace urinals with waterless fixtures, faucets and valves, and safety shower / eyewash stations. See Item O for issues related to ADA requirements. Provide the science classrooms with the required compressed air and gas connections. For replacement of electric water coolers refer to Item O. Provide additional exterior hose bibs. No work required in the auditorium fixed seating area.

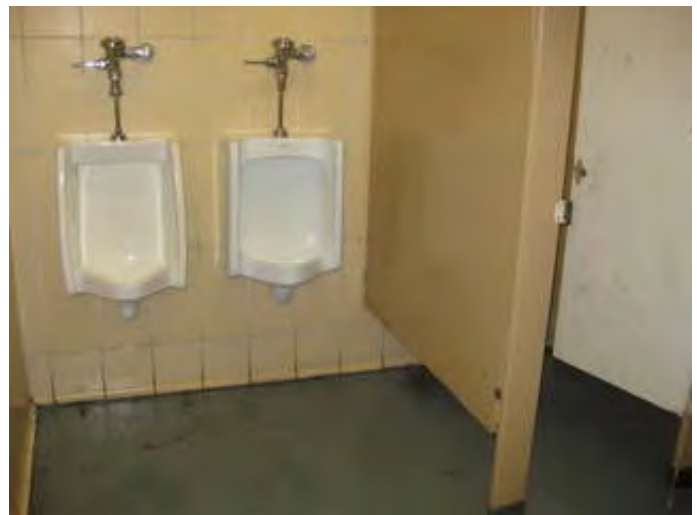
Wall mounted urinals

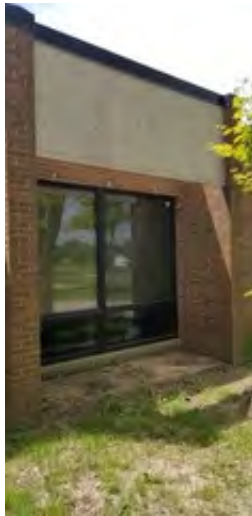
Typical classroom windows

Recommendations: Provide a new insulated window system with integral blinds to meet with Ohio School Design Manual guidelines. Replace single glazed window transoms and sidelights in exterior doors of the overall facility with insulated and approved safety glass. No work is required in the 1968 fixed seating auditorium addition.

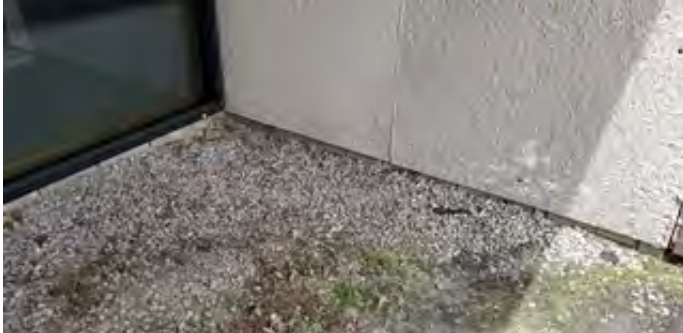
Typical masonry foundation

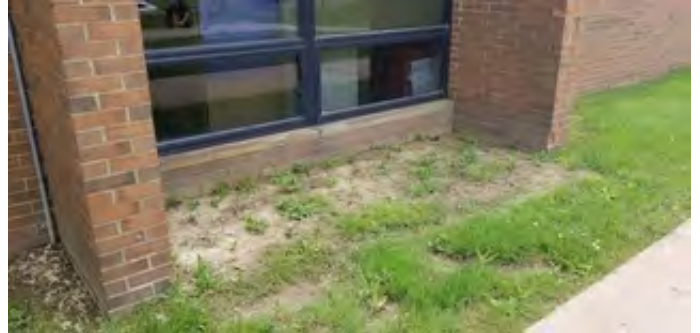
Typical masonry foundation

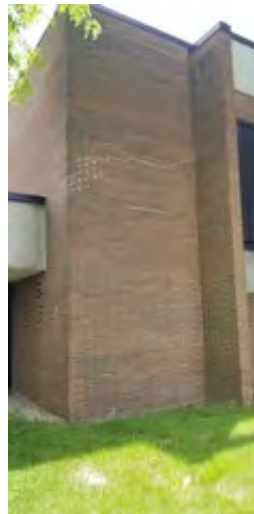
Brick veneer at gymnasium

Recommendations: Provide tuckpointing in all areas of mortar deterioration as required throughout the overall facility. Provide masonry cleaning and sealing as required throughout the overall facility. Repair damaged brick veneer system at areas of separation of brick veneer from the bearing wall. No work is required in the 1968 fixed seating auditorium addition.

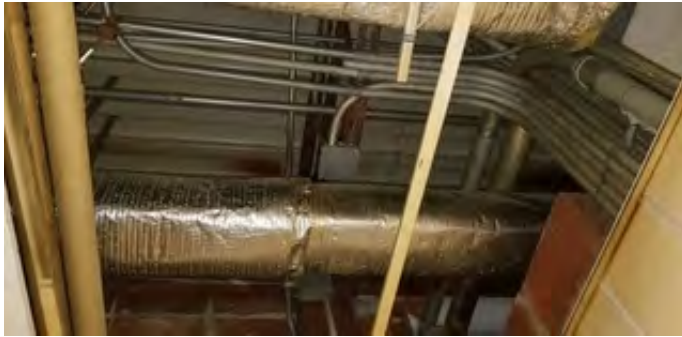
Bar joist and metal deck roof

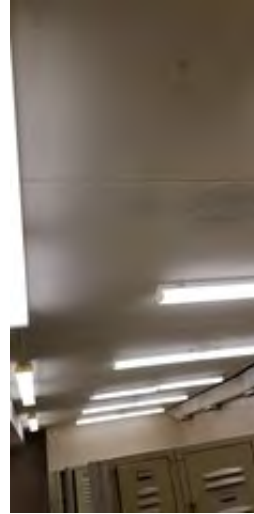
Precast concrete plank at locker rooms

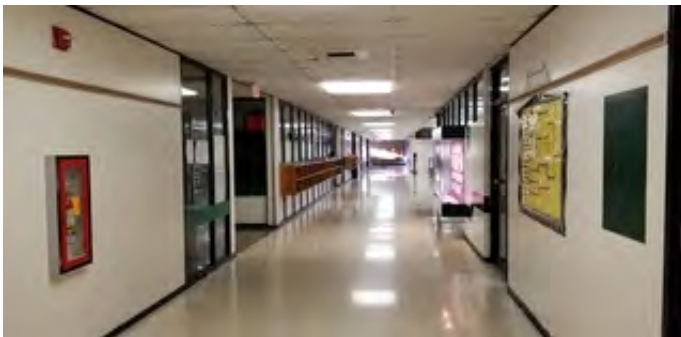
The overall facility features conventionally partitioned classrooms with 12" VCT type flooring, lay-in type ceilings, as well as metal partition wall type wall finishes, and they are in fair to poor condition. The overall facility has corridors with terrazzo type flooring, lay-in type ceilings, as well as drywall and brick type wall finishes, and they are in fair condition. The overall facility has restrooms with terrazzo type flooring, lay-in type ceilings, as well as glazed block type wall finishes, and they are in fair to poor condition. Toilet partitions are wood with plastic laminate, and are in good condition. Classroom casework in the overall facility is metal type construction that is original to the building, is inadequately provided, and in fair to poor condition. Classrooms are not provided adequate chalkboards, markerboards, and tackboards, which are in fair condition. The lockers, located in the corridors, are adequately provided, and in fair to poor condition. The art program is equipped with a kiln, and existing kiln ventilation is adequate. The facility is equipped with wood non-louvered interior doors that are flush mounted without proper ADA hardware and clearances, and in fair to poor condition. The gymnasium space has wood type flooring that is aged beyond its useful lifecycle, exposed bar joist and metal deck type ceilings, as well as painted block type wall finishes, and they are in fair condition. Gymnasium telescoping stands are plastic and metal type construction in good condition. Gymnasium basketball backboards are electrically operated type, and are in good condition. The media center has carpet type flooring, lay-in type ceilings, as well as drywall type wall finishes, and they are in fair condition. Student dining has terrazzo type flooring, lay-in type ceilings, as well as drywall and glazing (windows) type wall finishes, and they are in fair condition. The existing kitchen is full service, and the existing kitchen equipment is more than 20 years old. A walk-in cooler and freezer are located within the kitchen space, and are in fair condition.

Typical corridor finishes

Provide complete replacement of finishes and casework due to installation of systems outlined in Items A, C, D, E, K, L, M, N, T, U, and due to condition. Provide for replacement of ceiling at fixed seating auditorium addition due to installation of systems outlined in Items A, C, D, E, K, L, M, N, T, U, and due to condition. Funding for replacement of interior doors is provided in Item O, including doors here noted as being in poor condition. Provide for repairs to terrazzo flooring due to condition. Provide for removal and replacement of wood flooring in the gymnasium due to age and condition. Provide for replacement of bleachers in the gymnasium due to age and condition. Provide for replacement of toilet partitions due to work outlined in Item O, and due to condition. Provide for replacement of toilet accessories due to age and condition. Provide for replacement of kitchen equipment due to age and condition of equipment.

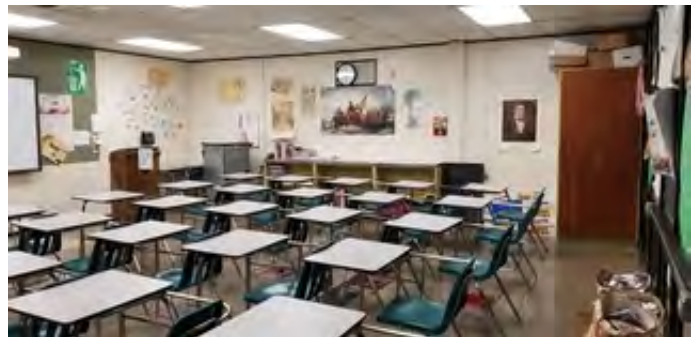
Typical classroom finishes

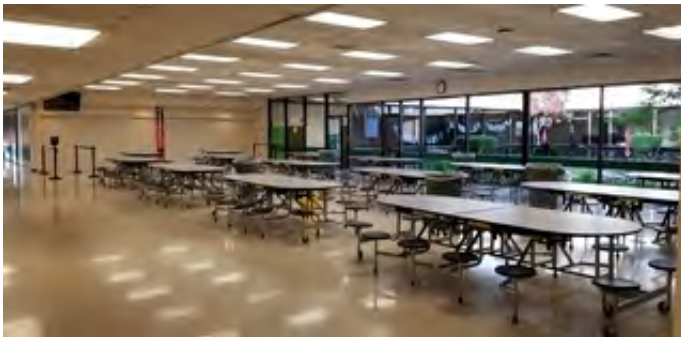
The typical classrooms in the overall facility are equipped with 2x4 lay-in surface mount fluorescent fixtures with a combination of single and dual level switching. Classroom fixtures are in fair condition, providing an average illumination of 53 FC, thus complying with the 50 FC recommended by the OSDM. The typical corridors in the overall facility are equipped with 2x4 and 4x4 lay-in fluorescent fixtures with dual level switching. Corridor fixtures are in fair condition, providing an average illumination of 21 FC, thus complying with the 20 FC recommended by the OSDM. The gymnasium space is equipped with 2x4 suspended mount fluorescent fixture type lighting, in fair condition, providing an average illumination of 22 FC, which is less than the 50 FC recommended by the OSDM. The media center is equipped with 2x4 lay-in fluorescent fixture type lighting in fair condition, providing an average illumination of 66 FC, thus complying with the 50 FC recommended by the OSDM. The student dining space is equipped with 2x4 lay-in fluorescent fixture type lighting with multi-level switching. Student dining fixtures are in fair condition, providing an average illumination of 45 FC, which is less than the 50 FC recommended by the OSDM. The kitchen spaces are equipped with 2x4 lay-in and 1x4 surface mount fluorescent fixture type lighting with multi-level switching. Kitchen fixtures are in fair condition, providing an average illumination of 44 FC, which is less than the 75-80 FC recommended by the OSDM. The service areas in the overall facility are equipped with 1x4 surface mount fluorescent fixture type lighting in fair condition. The typical administrative spaces in the overall facility are equipped with 2x4 lay-in fluorescent fixture type lighting in good condition, providing adequate illumination based on OSDM requirements. The overall lighting systems of the facility are not fully compliant with Ohio School Design Manual guidelines due to age and condition, inadequate lighting levels, and lack of multi-level switching.

Lighting in student dining area

Provide complete replacement of lighting system due to condition, lighting levels, lack of multilevel switching, and installation of systems outlined in Items A, C, D, J, L, M, N, and U.

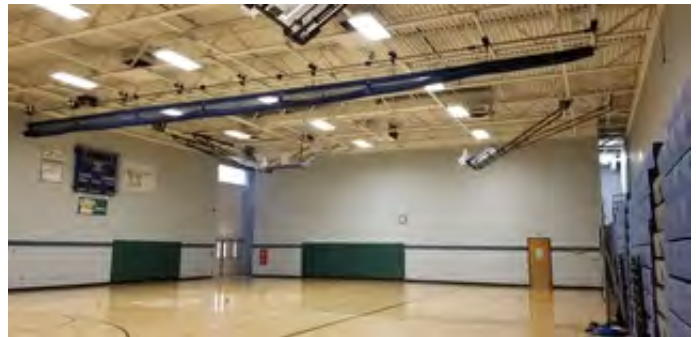
Lighting in gymnasium

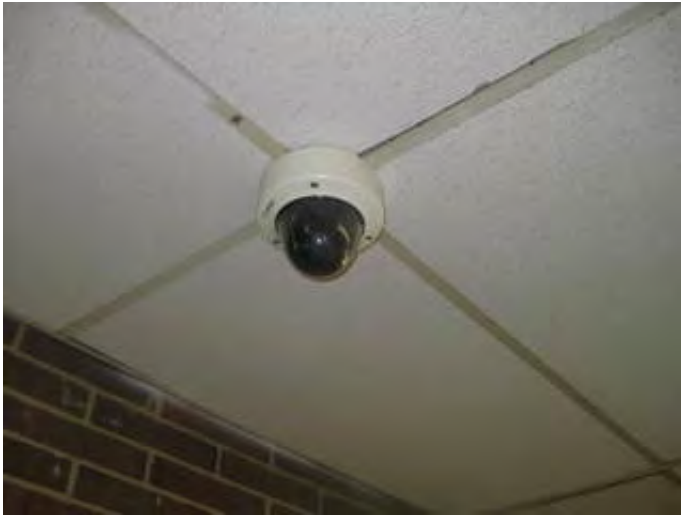
- Description:** The overall facility contains a security system consisting of security cameras, door contacts, electric door strikes activated from a remote area and monitored by intercom and door buzzer, and motion sensors. The existing security system is in adequate condition. The exterior security lighting consists of wall and pole mounted fixtures. Exterior security lighting is in fair condition and provides adequate coverage.
- Rating:** 3 Needs Replacement
- Recommendations:** Provide additional building security systems as desired from the district to more thoroughly protect the building during school hours and after school hours. Provide security fencing, as desired by the district, to more thoroughly protect the building during school hours and after school hours, by allocating a portion of the comprehensive security systems funding provided in this Item L- Security Systems.

Ceiling mounted security camera

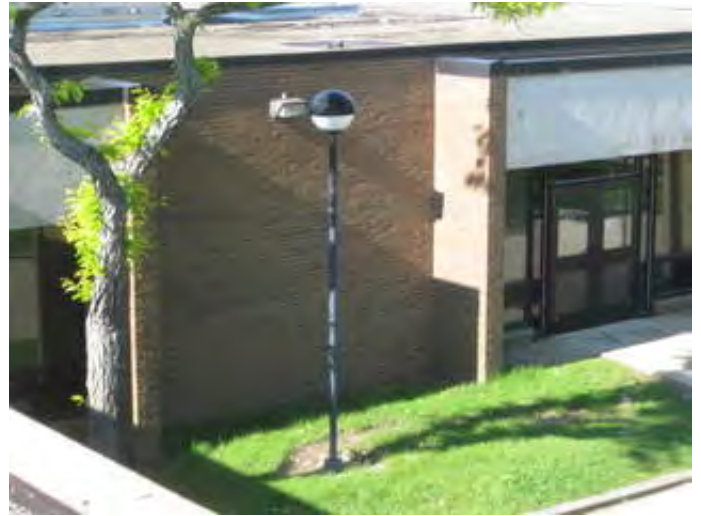
Wall and pole mounted exterior lighting

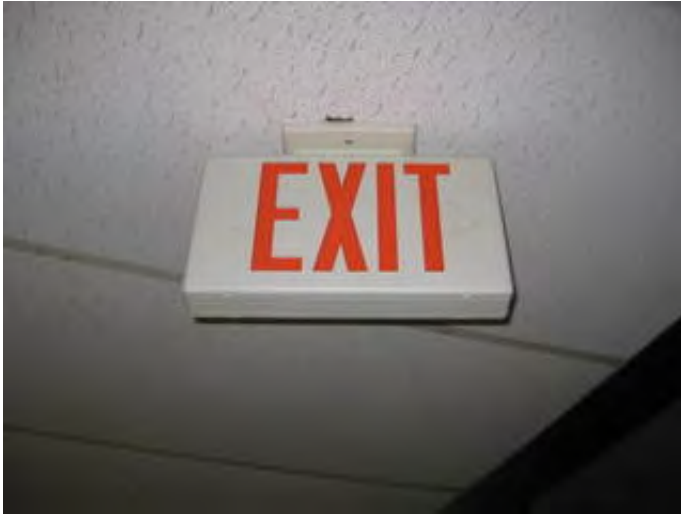
Description: The overall facility does contain an emergency/egress lighting system with battery back-up within each fixture. The system is in fair condition but does not provide adequate coverage with exit signage or adequate illumination with emergency light fixtures in some areas.

Ceiling mounted exit signage

Recommendations: Emergency power generator is funded under Item D - Electrical. Provide complete replacement of emergency and egress lighting as required to satisfy local fire and building officials as well as Ohio Building Code. Provide exit signage on separate electrical circuits.

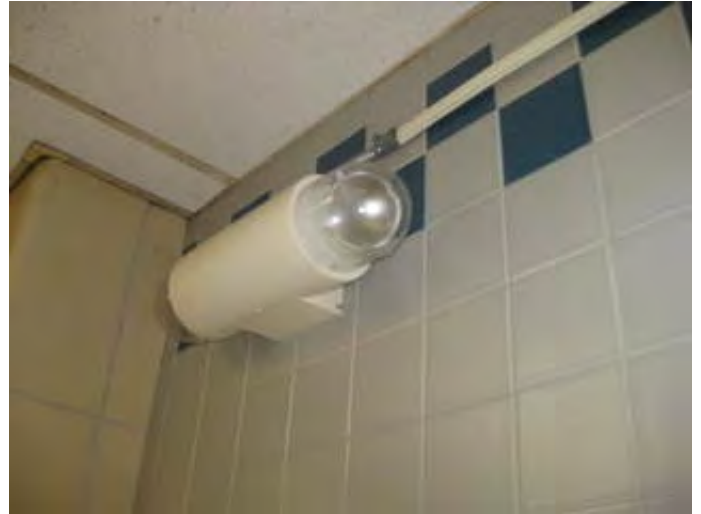
Wall mounted emergency lighting

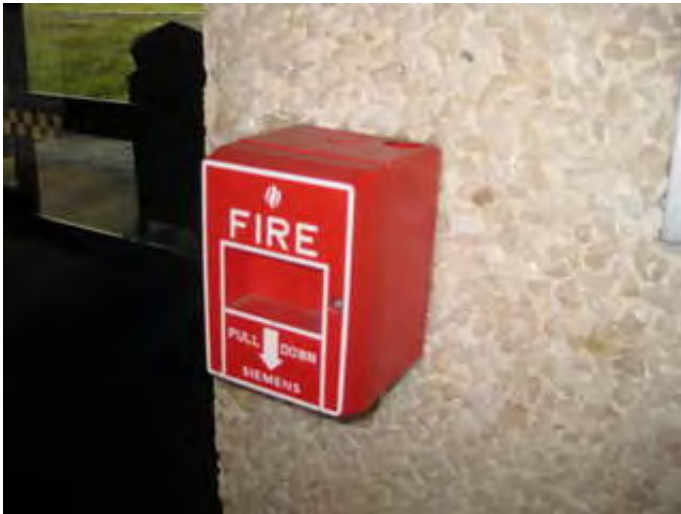
Description: The overall facility contains a fire alarm system in fair condition. Manual pull stations are mounted in corridors and assembly areas. Manual pull stations are not mounted at required exits. Horns and strobes are not mounted in all classrooms as required. Mechanical equipment does contain automatic fire alarm devices. The system does not have additional zone capabilities. The system is not adequately provided throughout the facility. The fire alarm system does not meet NFPA requirements and Ohio School Design Manual guidelines.

Fire alarm pull station

Recommendations: Provide complete replacement of fire alarm system consisting of manual fire alarm pull stations mounted at required heights, remote annunciator panels, automatic fire detection devices in all air devices and mechanical equipment, and horn/strobe devices located in all occupied spaces to meet Ohio School Design Manual guidelines.

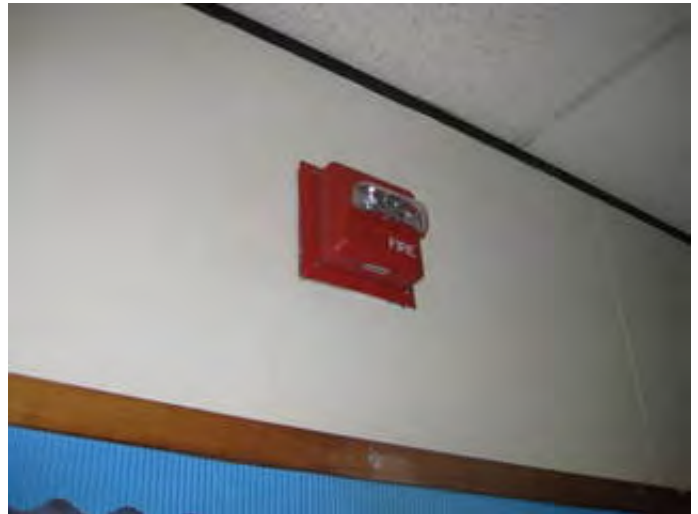
Fire alarm strobe device

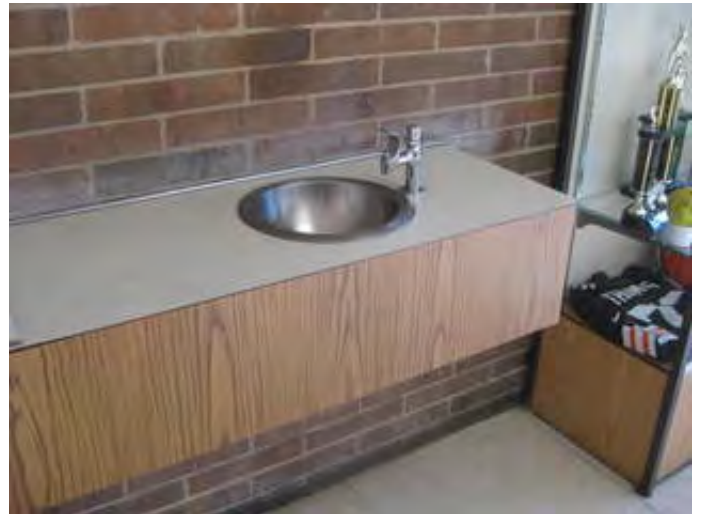
Non-compliant water fountain

Recommendations: Provide signage, ramp, lift at stage, water coolers, toilets, sinks and toilet partitions to meet ADA requirements. Replace existing interior doors, door frames and door hardware. Replace existing interior door hardware. Rework narrow interior door openings to provide 3' x 7' door and hollow metal frame, door lite and hardware. Provide ADA door assist on exterior doors along accessible routes.

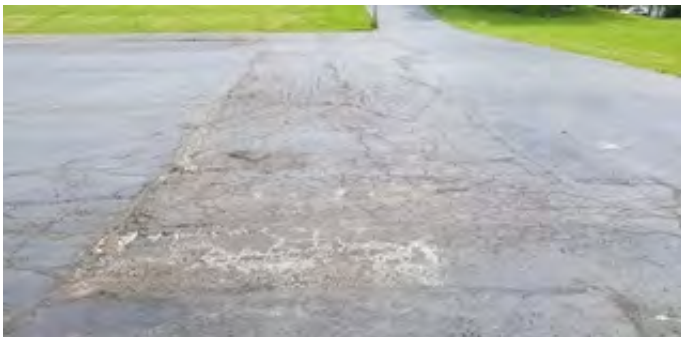
Asphalt pavement in poor condition

Provide for replacement of asphalt pavement in poor condition. Provide for replacement of heavy duty asphalt pavement in poor condition. Provide for replacement of concrete sidewalks in poor condition. Provide concrete curbs to delineate vehicular traffic patterns, and to meet OSDM guidelines. Provide heavy duty concrete pavement at the dumpster pad. Provide a dedicated and separated bus loading and unloading zone on the site. Provide site contingency allowances for unforeseen conditions.

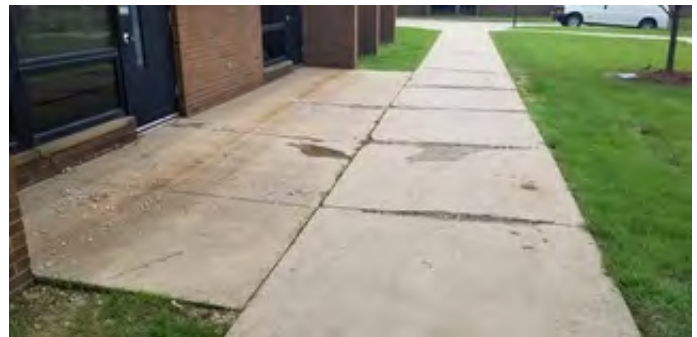
Concrete sidewalk in poor condition

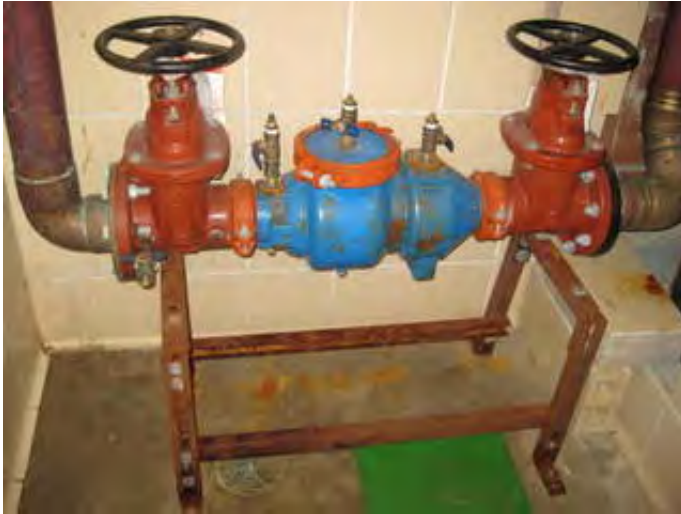
Water service back-flow preventer

Recommendations: Increase water service size for fire protection which is included in the cost of the fire suppression system installation funded under Item U - Life Safety. Provide funding for water quality testing.

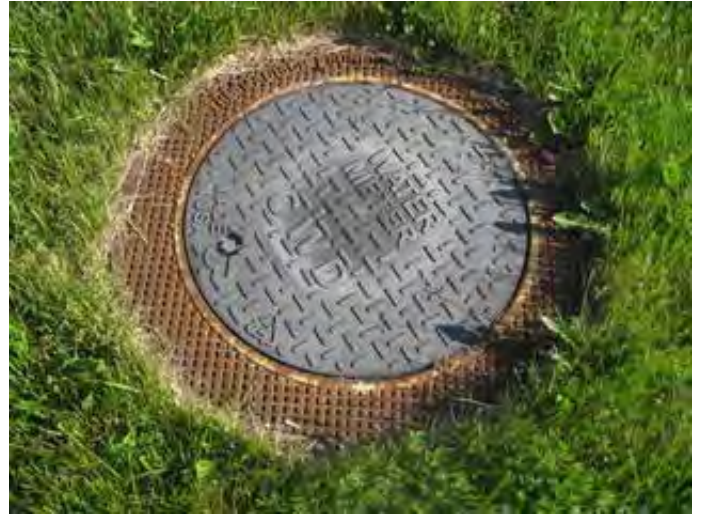
Water service meter

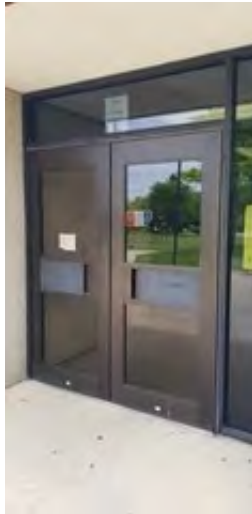
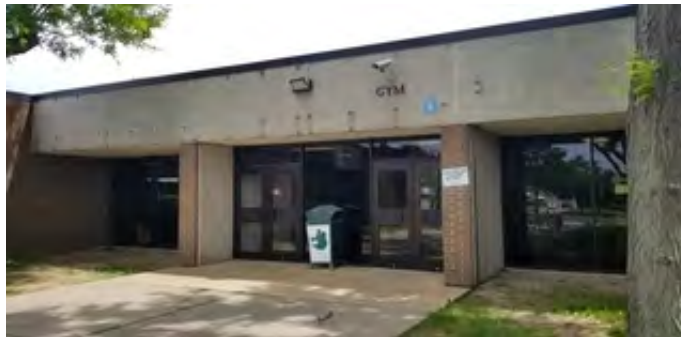
Description: Typical exterior doors in the overall facility are aluminum and composite type construction, installed on steel frames, and in fair to poor condition. Typical exterior doors feature single glazed tempered glass vision panels. Entrance doors in the overall facility are aluminum type construction, installed on steel frames, and in fair to poor condition. Entrance doors feature single glazed tempered glass vision panels. There are no overhead doors in the facility.

Typical entrance doors

Recommendations: Replace all exterior doors to comply with Ohio Building Code, ADA, and Ohio School Design Manual guidelines. Replacement of single glazed transoms and sidelights is addressed in Item F.

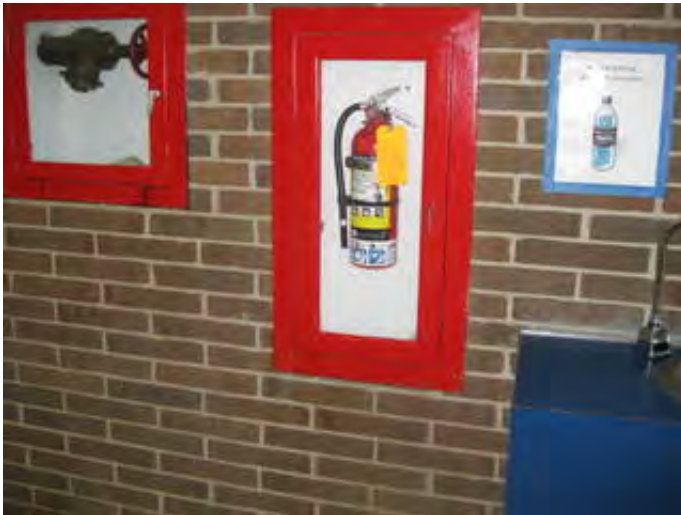
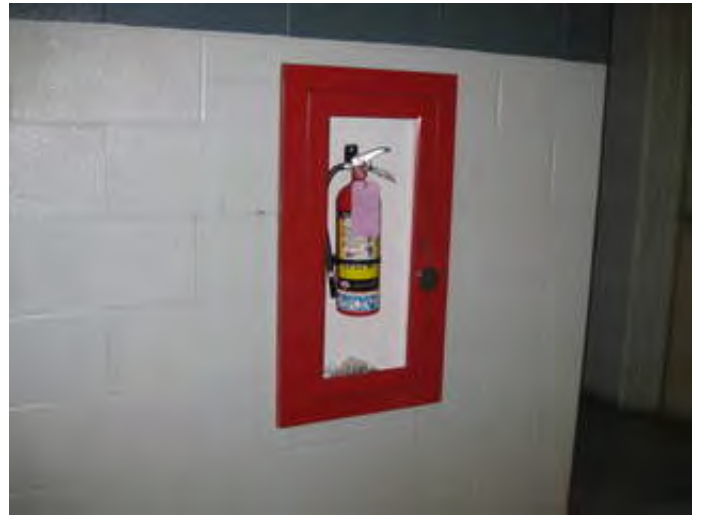
Fire extinguisher cabinet

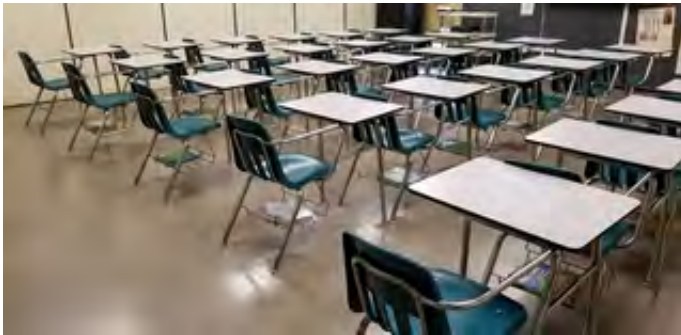
Typical student desks and chairs

Recommendations: Provide for replacement of outdated or inadequate furniture. No work is required in the 1968 fixed seating auditorium addition.

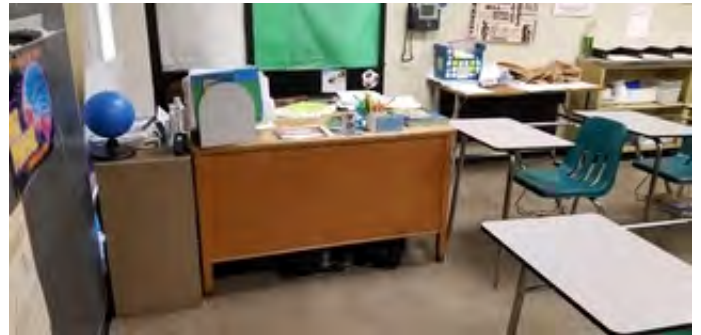
Typical teacher desk and workstation

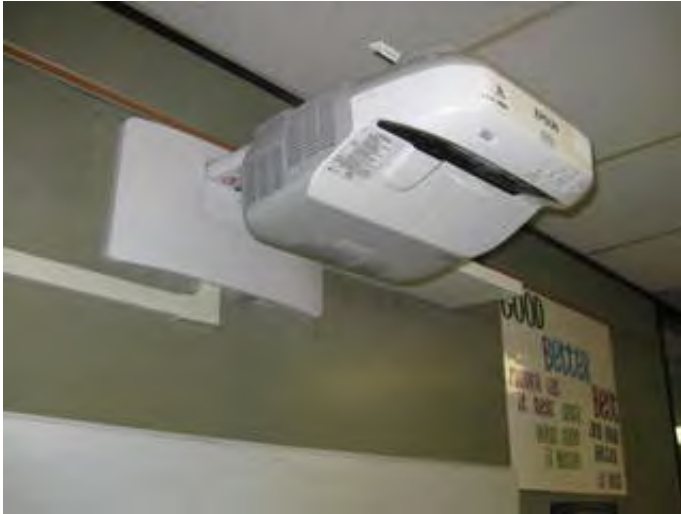
Classroom projector

Recommendations: Provide technology upgrades, wiring and systems per Ohio School Design Manual guidelines.

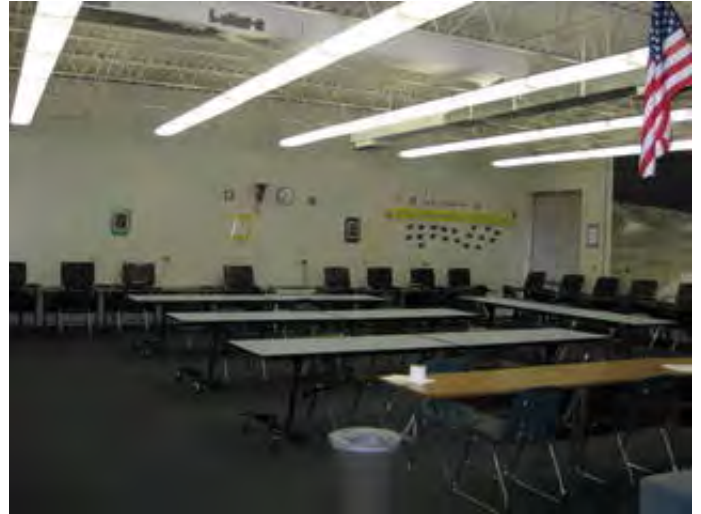
Computer lab

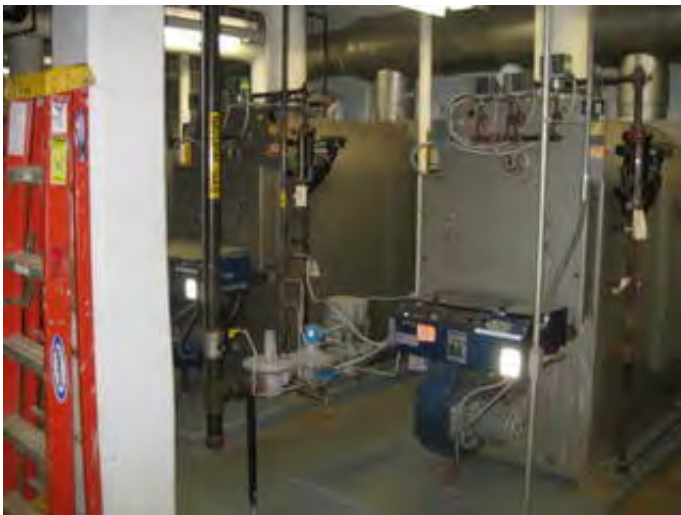
Gas fire boilers

Recommendations: Provide new overall heating system, including air conditioning, to meet Ohio School Design Manual guidelines. Although one of the boilers is only 15 years old the cost to replace entire system dictates replacement of complete system including newer boiler. Provide funding to convert existing non-ducted system to ducted air system in the overall facility. The clear area above finished ceilings will allow for the installation of ductwork.

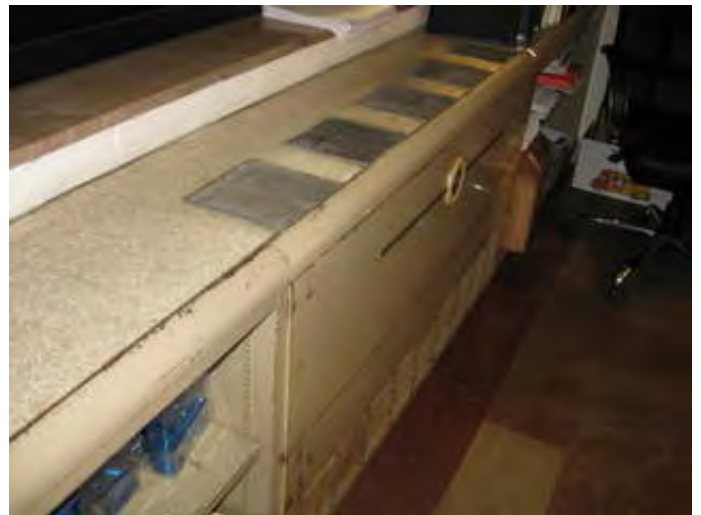
Classroom unit ventilators
