BEDFORD CITY SCHOOL DISTRICT

***Ohio Facilities Construction Commission
Classroom Facilities Assistance Program
Facilities Assessment Report***

***Submitted by
Harrison Planning Group
June 2018***

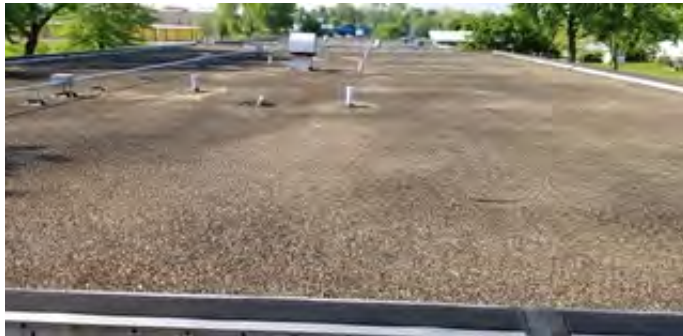
Roof at 1955 original construction

Recommendations: The roof over the 1955 original construction and the 1965 addition requires replacement to meet Ohio School Design Manual guidelines for age of system and due to condition. The flashing at the 1955 original construction and the 1965 addition requires replacement due to condition. Overflow roof drains are required throughout the overall facility. Provide for replacement of access hatch, including safety protection cage at the 1955 original construction. Provide for safety protection cage at the access ladder to the 1965 addition.

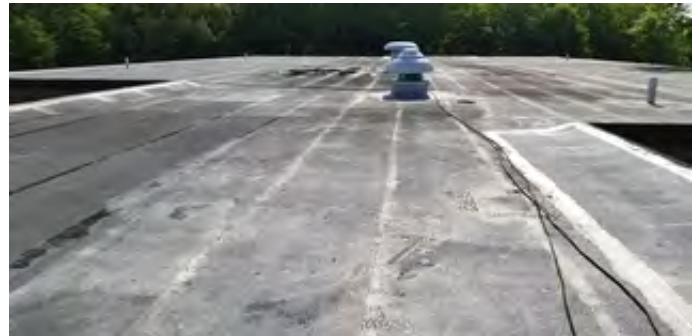
Roof at 1965 addition

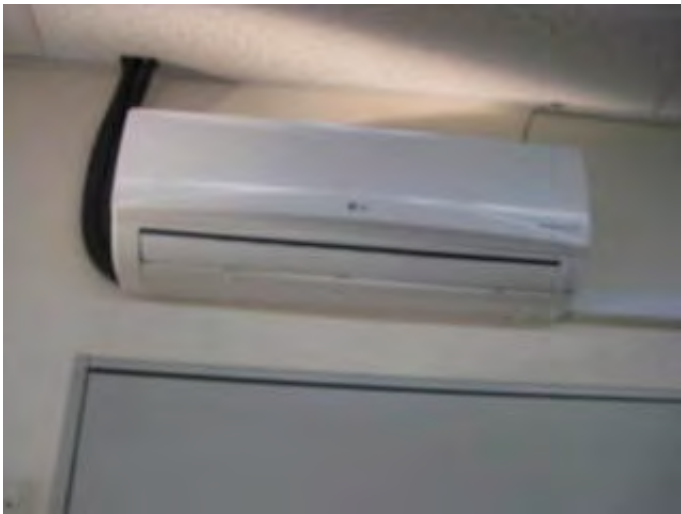
Self contained air-conditioning unit with remote condensing unit

Recommendations: Provide an air conditioning system throughout the overall facility to meet Ohio School Design Manual guidelines. Funding included in Item A - Heating System. Provide new restroom exhaust system. Restroom exhaust system provided with complete HVAC system replacement. Provide new kiln exhaust system.

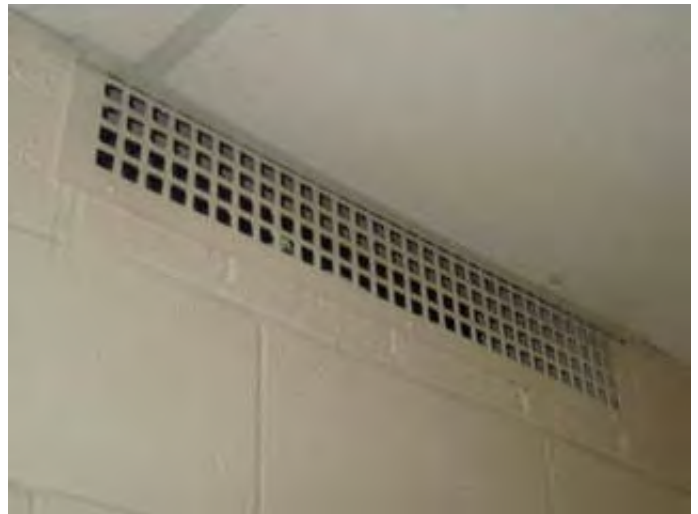
Corridor transfer grille

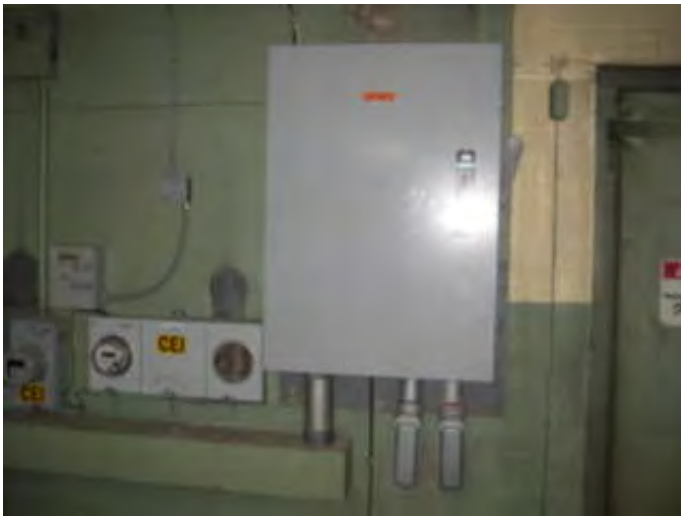
Description: The electrical system for the overall facility is an 800-amp, 240-volt, 3-phase, 4-wire system in fair condition. The main distribution equipment is Siemens installed in 2000. The panel system is in fair condition. The panel system was installed in 1955, 1965, and 2000 and cannot be expanded for additional capacity. The transformer is owned by the utility company and is in a vault within the building. Classrooms are not equipped with adequate electrical outlets. Corridors and the exterior of the building are not equipped with adequate electrical outlets for building maintenance. The facility does not contain lightning protection with grounding.

Main distribution panel

Recommendations: The entire electrical system requires replacement to meet Ohio School Design Manual guidelines for classroom capacity, the addition of an air conditioning system, and due to condition and age. The emergency generator for life safety systems is included in the entire electrical system replacement funded in this Item D - Electrical. Provide building lightning protection and grounding. Lighting protection and grounding is included in the entire electrical system replacement funded in this Item D - Electrical.

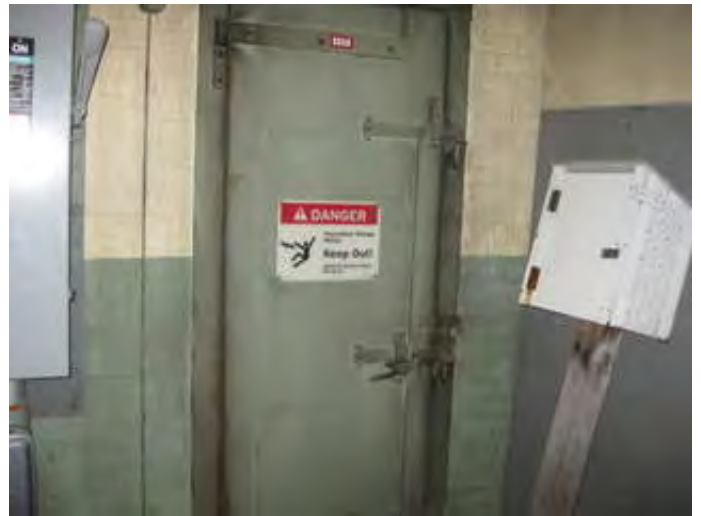
Electric transformer room

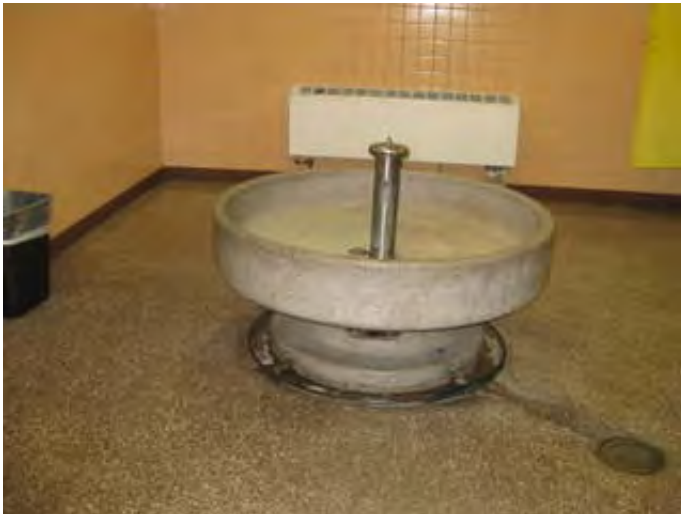
Student restroom wash fountain

Provide new wall mounted toilet room fixtures to replace existing fixtures due to condition and required ADA renovations. Remove and replace existing drinking fountains and water coolers due to age, condition, and ADA compliance. Replace domestic water heater only, not remote storage tank, due to age and condition. Provide wall hung urinals in locations of current floor mounted urinals. Provide wall patch at each wall to wall hung urinal replacement. Due to age, condition, LEED, and OFCC requirements, replace urinals with waterless fixtures, faucets and valves. See Item O for issues related to ADA requirements. Provide additional exterior hose bibs.

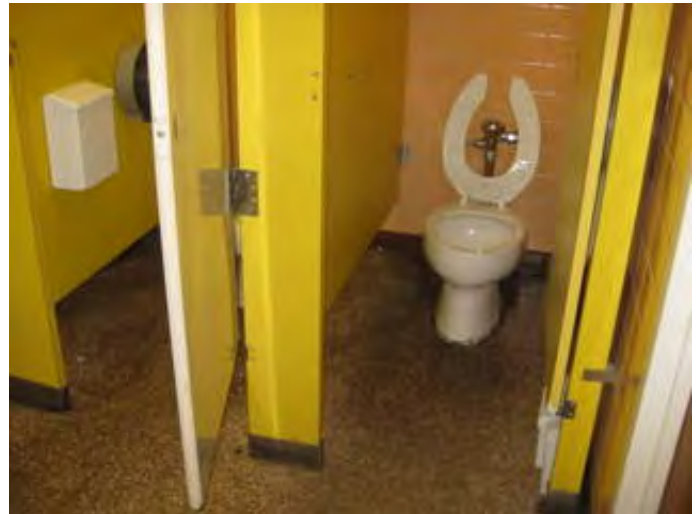
Floor mounted water closet

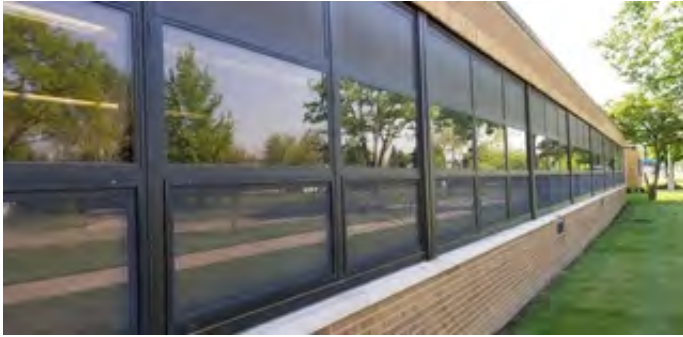
Typical windows at the 1955 original construction

Recommendations: Replace single glazed window vision panels in exterior doors of the overall facility with insulated and approved safety glass. No work is required in the 1965 addition.

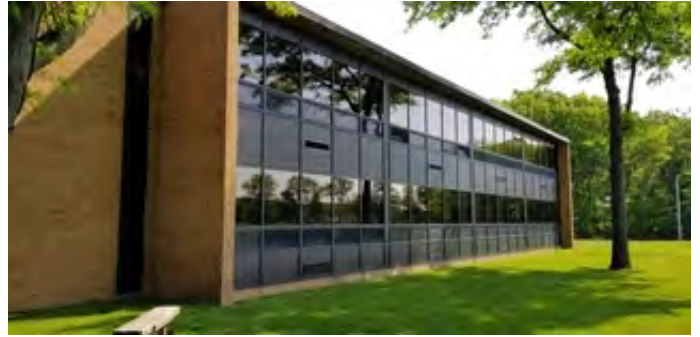
Typical windows at the 1965 addition

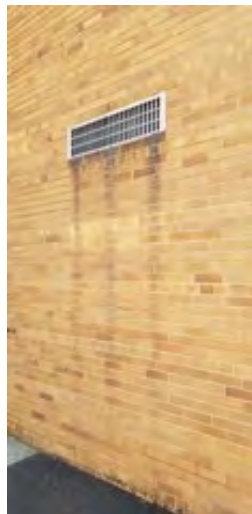
Brick wall with louvered grill

Recommendations: Provide masonry cleaning and sealing as required throughout the overall facility. Provide for brick infill at exterior grilles following unit ventilator removal, including CMU back-up, rigid insulation, vapor barrier and exterior face brick.

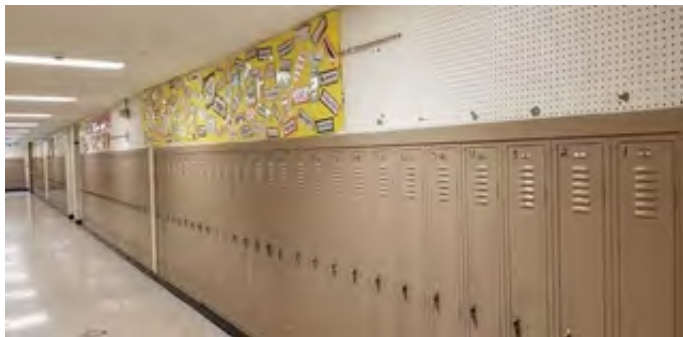
Typical corridor finishes

Provide complete replacement of finishes and casework throughout the overall facility due to installation of systems outlined in Items A, C, D, E, K, L, M, N, T, U, and due to condition. Provide plaster refinishing due to work outlined in Items A, C, D, E, K, L, M, N, T, and U. Funding for replacement of interior doors is provided in Item O, including doors here noted as being in poor condition. Provide for repairs to terrazzo flooring due to condition. Provide for replacement of basketball backboards due to age and condition. Provide for replacement of toilet partitions due to work outlined in Item O, and due to condition. Provide for replacement of toilet accessories due to age and condition. Provide for replacement of kitchen equipment due to age and condition of equipment.

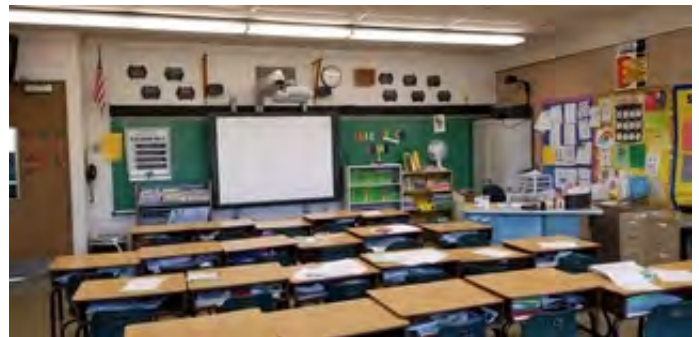
Typical classroom finishes

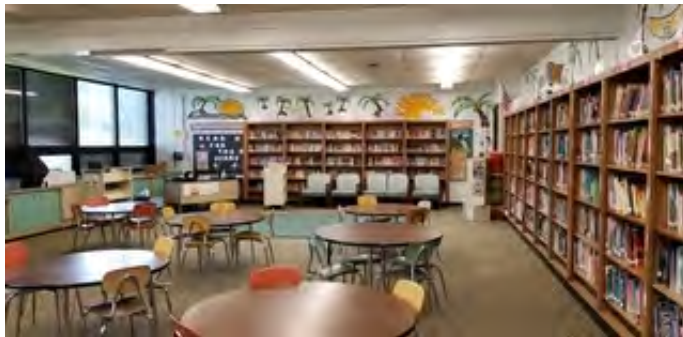
Lighting in media center

Provide complete replacement of lighting system due to condition, lighting levels, lack of multilevel switching and installation of systems outlined in Items A, C, D, J, L, M, N, and U.

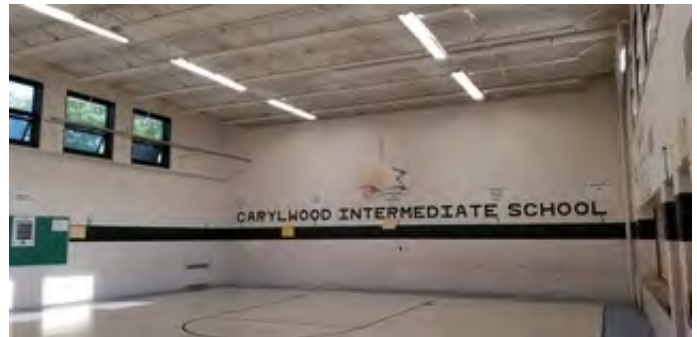
Lighting in gymnasium

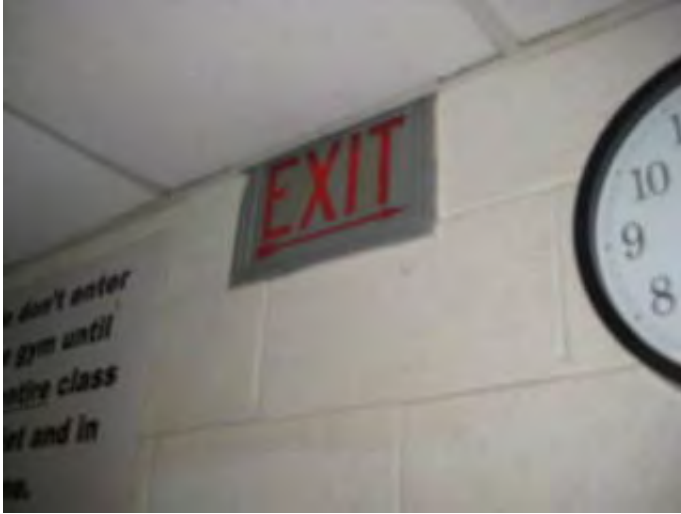
- Description:** The overall facility does contain an emergency/egress lighting system. The system is in fair condition and does not provide adequate coverage with exit signage or adequate illumination with emergency light fixtures.
- Rating:** 3 Needs Replacement
- Recommendations:** Provide complete replacement of emergency/egress lighting system to meet Ohio School Design Manual guidelines and as required to satisfy local fire and building officials as well as Ohio Building Code. Provide exit signage on separate electrical circuits. Supplement battery backup wall mounted emergency lighting fixtures to increase lighting levels in corridors and egress paths to at least 1.5-foot candles in all areas.

Exit signage

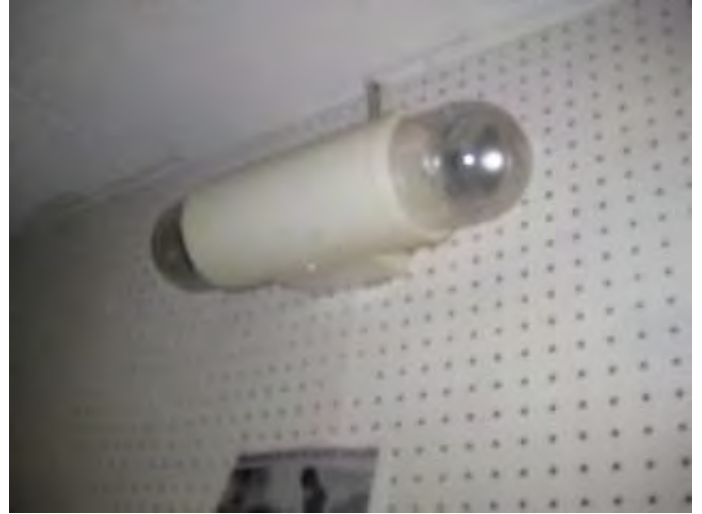
Emergency egress lighting

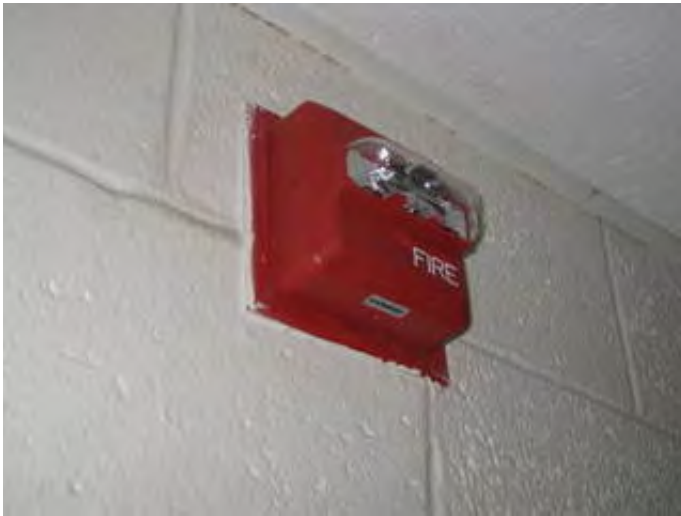
Description: The overall facility contains a fire alarm system in fair condition. Manual pull stations are mounted in corridors and assembly areas. Manual pull stations are mounted at exits. Horns and strobes are not mounted in all required locations. Mechanical equipment does not contain automatic fire alarm devices. The system does not have additional zone capabilities. The system is not adequately provided throughout the facility. The fire alarm system does not meet NFPA requirements and Ohio School Design Manual guidelines.

Horn / strobe device

Recommendations: Provide complete replacement of fire alarm system consisting of manual fire alarm pull stations mounted at required heights, remote annunciator panels, automatic fire detection devices in all air devices and mechanical equipment, and horn/strobe devices located in all occupied spaces to meet Ohio School Design Manual guidelines.

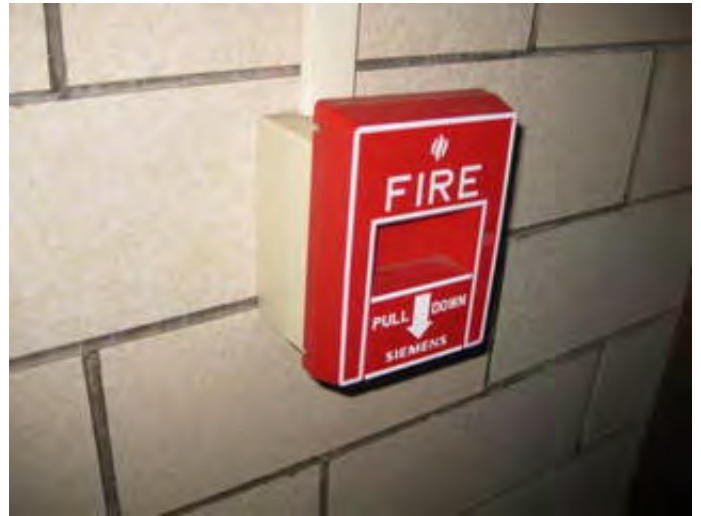
Fire alarm pull station

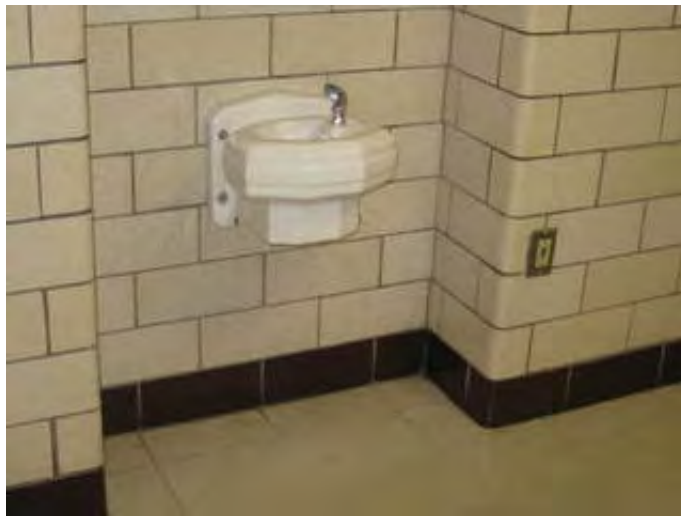
Non-compliant water fountain

Recommendations: Provide signage, ramps, a lift at the stage, an elevator in the 1965 addition, electric water coolers, sinks, restroom accessories, toilets and toilet partitions to meet ADA requirements. Replace existing interior doors, door frames and door hardware. Rework recessed interior doors and openings to allow for required clearances. Funding includes 3' x 7' door, hollow metal frame, door lite and hardware. Provide ADA door assist on exterior doors along accessible routes.

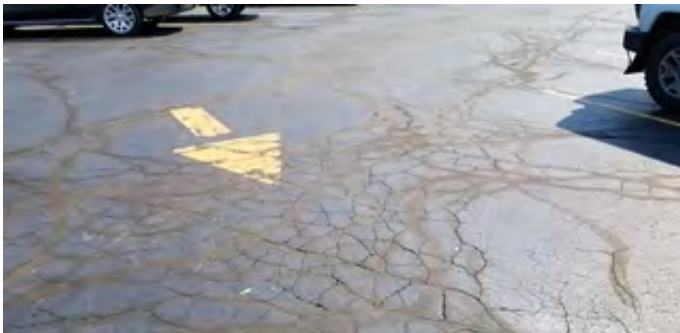
Asphalt pavement in poor condition

Provide for removal of aged playground equipment due to condition. Provide for replacement of playground equipment in poor condition. Provide for replacement of asphalt pavement in poor condition. Provide for replacement of concrete sidewalks in poor condition. Provide concrete curbs to delineate vehicular traffic patterns, and to meet OSDM guidelines. Provide a dedicated and separated bus loading and unloading zone on the site. Provide site contingency allowances for unforeseen conditions.

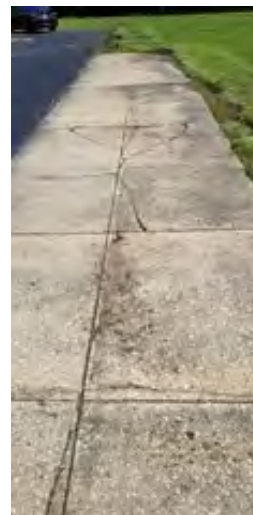
Concrete sidewalk in poor condition

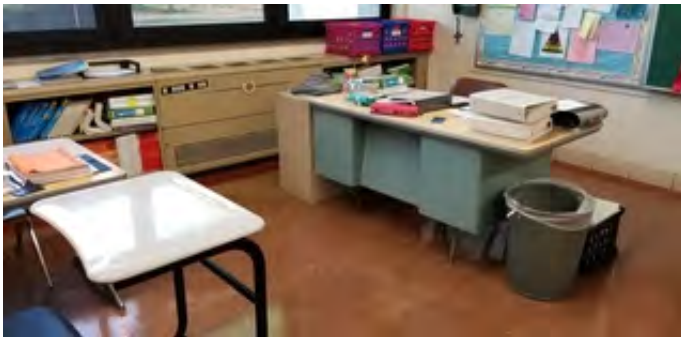
Typical teacher desk

Recommendations: Provide for replacement of outdated or inadequate furniture.

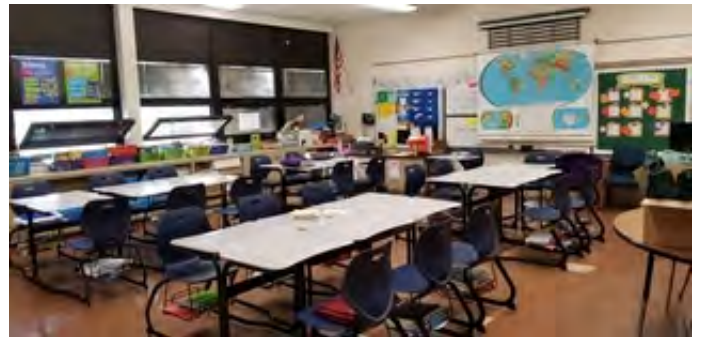
Typical student desks and chairs

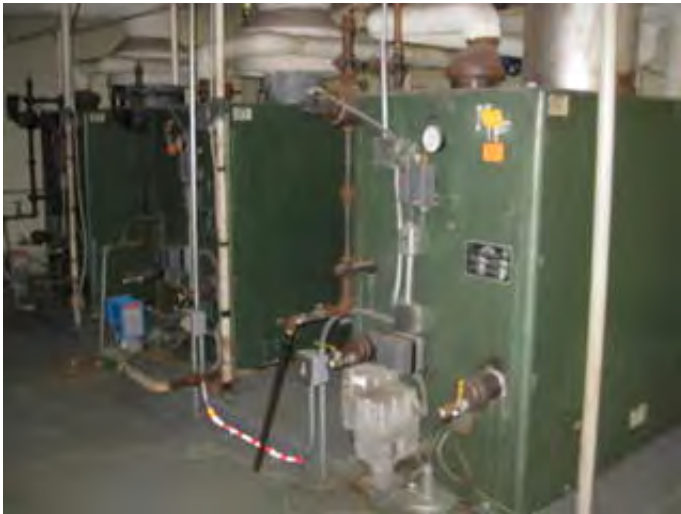
Description: The existing system for the 1962 original building and 1965 addition consists of three Bryan natural gas-fired copper tube boilers serving unit ventilators located in the lower level mechanical room. The boilers are rated at 1,200,000 BTU/hr for a total of 3,600,000 BTU/hr. The system was installed in 1962 and 1965 and is in fair condition. Existing controls are both pneumatic and digital. The system in the 1962 original building and 1965 addition are not capable of providing Ohio Building Code fresh air requirements. The existing system for the 1984 gymnasium addition consists of two York exterior pad mounted gas-fired forced air furnace units with cooling coils. The system was installed in 1984 and is in acceptable condition. Existing controls are digital. The existing system for the 2002 addition consists of individual electric furnaces with condensing units. The system was installed in 2002 and is in acceptable condition. Existing controls are digital. Systems in the 1984 gymnasium and the 2002 addition can provide Ohio Building Code fresh air requirements. According to school officials, the site does not contain underground fuel tanks.

Rating: 3 Needs Replacement

Gas fired boilers

Recommendations: Provide new overall heating system, including air conditioning, in the 1962 original building and 1965 addition to meet Ohio School Design Manual guidelines. Provide funding to convert existing non-ducted system to ducted air system in the 1962 original building and the 1965 addition. The clear area above finished ceilings will allow for the installation of ductwork. Provide for replacement of the two exterior pad mounted gas-fired forced air furnace units with cooling coils in the 1984 addition due to age and condition. No work required in 2002 addition.

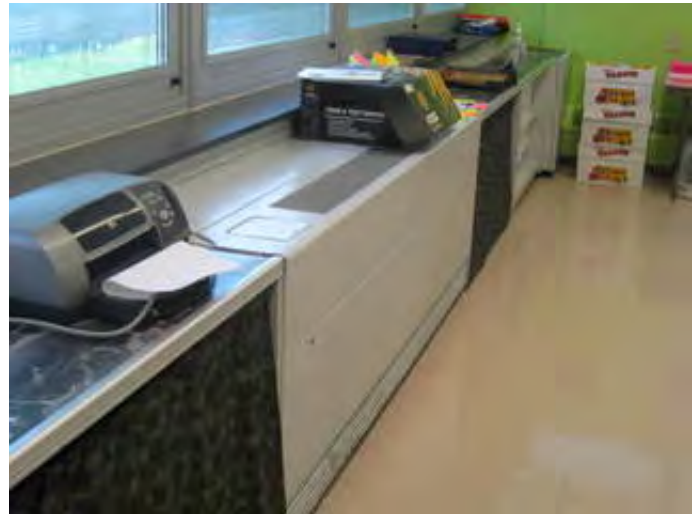
Classroom unit ventilators

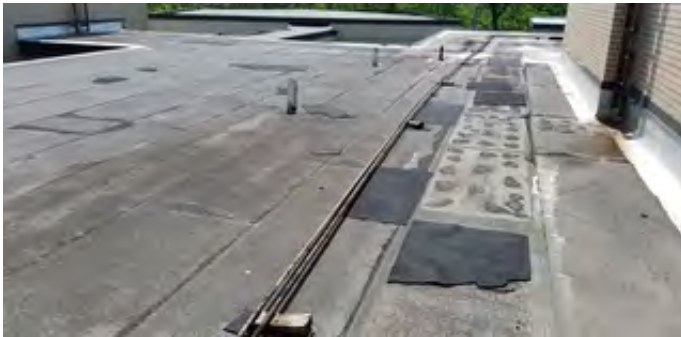
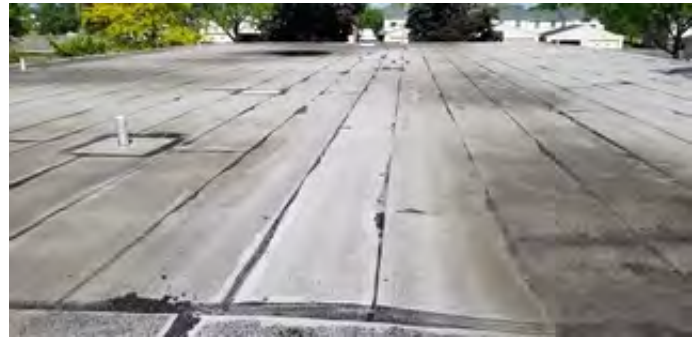
The roof over the 1962 original construction and 1965 addition is a built up asphalt system that is over 7 years old, and is in fair to poor condition. The area over the student dining at the 1965 addition is a ballasted membrane roof that is over 15 years old, and is in fair to poor condition. There are areas of leaking reported by the district. Access to the roof was gained by an access door and ladder that is in fair condition. Fall safety protection cages are not provided. There were observations of standing water on the roof. Metal cap flashings are in fair condition, with stone coping in good condition. Roof storm drainage is addressed through a system of roof drains, which are properly located, and in fair condition. The roof is not equipped with overflow roof drains though they are needed on this building. No problems requiring attention were encountered with any roof penetrations. The roof over the 1984 addition is a standing seam metal type roof in good condition. There are no areas of leaking reported by the district. The roof over the 2002 addition is a ballasted membrane roof system that is over 15 years old, and is in good condition. There are no areas of leaking reported by the district. Access to this roof is gained by the roof of the 1962 original construction. There were no areas of standing water on the roof. Metal cap flashings are in good condition. Roof storm drainage is addressed through a system of roof drains, which are properly located, and in fair condition. The roof is not equipped with overflow roof drains though they are needed on this building. No problems requiring attention were encountered with any roof penetrations. There is a covered walkway at the main entrance area, which is steel type construction with an insulated translucent panel system which is in good condition.

3 Needs Replacement

Roof at 1962 original construction

The roof over the 1962 original construction, 1965 and 2002 additions requires replacement to meet Ohio School Design Manual guidelines for age of system and due to condition. The flashing at the 1962 original construction and 1965 addition requires replacement due to condition. Overflow roof drains are required throughout the overall facility. Provide for replacement of access hatch, including safety protection cage at the 1962 original construction, as well as the 1965 addition. Provide for safety protection cage at the access ladder to the 1965 addition. No work is required at the 1984 addition at this time.

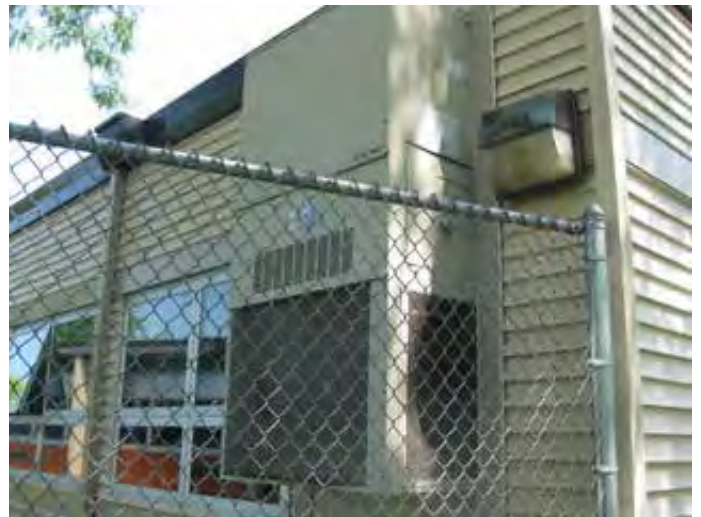
2002 addition packaged HVAC unit

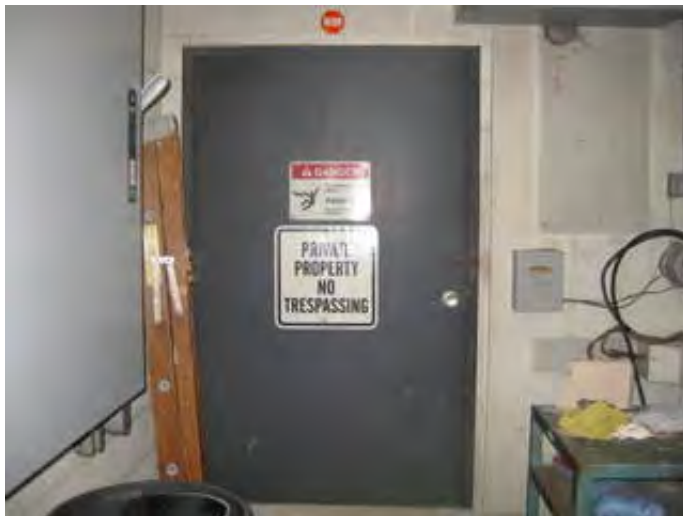
Description: The electrical system for the entire facility, except for the 1984 gymnasium addition, is an 800-amp, 240-volt, 3-phase, 4-wire service which back feeds the original sub-panel installed with the respective addition. The main distribution equipment is Siemens installed in 2000 and is in fair condition. The electrical system for the 1984 gymnasium addition is a 600-amp, 120/208-volt, 3-phase, 4 wire, system in adequate condition. The system was installed in 1984. The transformers are owned by the utility company and are located southwest of the gymnasium (pad mounted) and west of the 2002 addition (pole mounted). The panel system is in fair condition in the 1962 original building and 1965 addition but is in good condition in the 1984 gymnasium addition and 2002 addition. The panel system was installed in 1962 and 1965 and cannot be expanded for additional capacity. Classrooms are not equipped with adequate electrical outlets, except for the 2002 addition. Corridors of the building are equipped with adequate electrical outlets for building maintenance. The exterior of the building is not equipped with adequate electrical outlets for building maintenance. The facility does not contain lightning protection with grounding.

Rating: 3 Needs Replacement

Transformer room

Recommendations: The electrical system in the 1962 original building, 1965 addition, and 1984 gymnasium addition requires replacement to meet Ohio School Design Manual guidelines for classroom capacity, the addition of an air conditioning system, and due to age and condition. Provide building lightning protection and grounding in the 2002 addition. Lighting protection and grounding for the 1962 original building, 1965 addition, and 1984 gymnasium addition is included in the entire electrical system replacement funded in this Item D - Electrical.

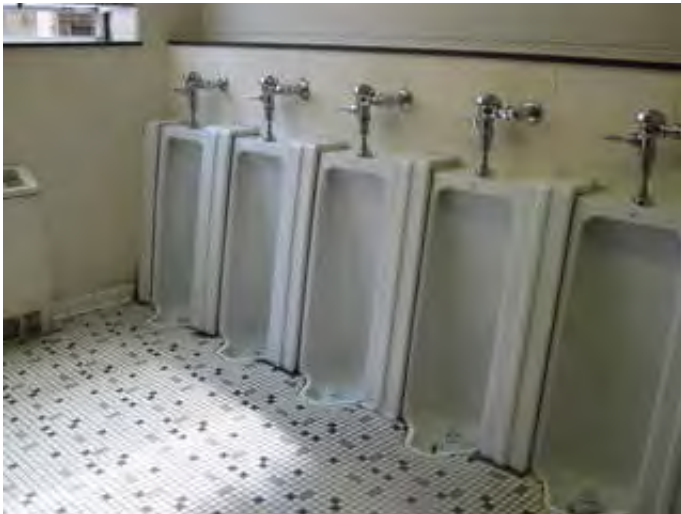
Description: A back-flow preventer is provided. Domestic supply piping is copper in adequate condition. Sanitary waste piping is cast-iron in adequate condition. The domestic water heater is a gas fire O.A. Smith, installed in 1989, with a remote storage tank unit located in the lower level mechanical room in fair condition. The school contains 2 large group restrooms for boys, 2 large group restrooms for girls, 1 kitchen restroom, 1 health clinic restrooms, and 3 restrooms for staff. Due to existing grade configuration, kindergarten / pre-k classroom restrooms are not required. Kitchen fixtures consist of 1 single compartment sink, 1 triple compartment sink, 1 lavatory sink, 1 garbage disposal unit, and 4 reach-in coolers, which are in fair condition. The school does meet the OBC requirements for fixtures. Relative to LEED requirements, the school is not equipped with low flow type fixtures. For female students, per OBC and OSDM requirements, this facility should be equipped with 4 toilets, and 2 lavatory sinks. Observations revealed that the school is equipped with 11 toilets, and 8 lavatory sinks. For male students, per OBC and OSDM requirements, this facility should be equipped with 2 toilets, 2 urinals, and 2 lavatory sinks. Observations revealed that the school is equipped with 5 toilets, 13 urinals, and 8 lavatory sinks. The exterior of the 1984 addition and the 2002 addition does not contain an adequate quantity of hose bibs. The existing exterior hose bibs are in fair condition.

Rating: 2 Needs Repair

Floor mounted urinals

Recommendations: To facilitate compliance with OBC and OFCC fixture requirements, provide new toilets, new lavatory sinks, new urinals, and new electric water coolers. Replace domestic water heater only, not remote storage tank, due to age and condition. Provide wall hung urinals in locations of current floor mounted urinals. Provide wall patch at each wall to wall hung urinal replacement. Due to age, condition, LEED, and OFCC requirements, replace urinals with waterless fixtures, faucets and valves. See Item O: Handicap Access for issues related to ADA requirements. Provide additional exterior hose bibs at the 1984 addition and the 2002 addition.

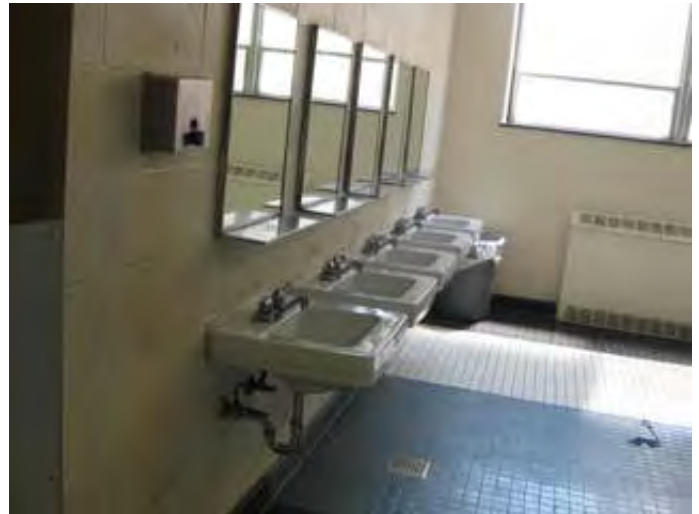
Restroom lavatories

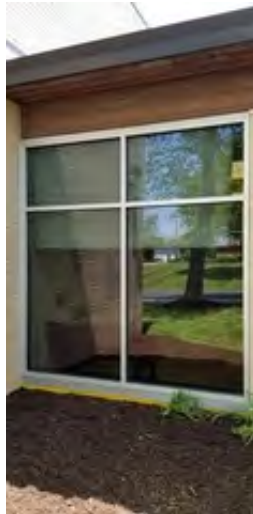
Description: The overall facility is equipped with thermally broken aluminum frame windows with a double glazed insulated type window system in good condition, which were replaced in 2013, except for the 2002 addition, which was installed in 2002, and the 1984 addition, which was installed in 1984, and shows signs of broken seals. Window system seals are in good condition, with no air and water infiltration being experienced. Window system hardware is in good condition. The window system features integral blinds, in good condition. The window system is equipped with insect screens on operable windows, in good condition. This facility is not equipped with any curtain wall systems. This facility does not feature any glass block windows. The exterior doors in the overall facility are equipped with aluminum frame vision panels, sidelights and transoms with a combination of double glazed and single glazed window system, in good condition. The school does not contain skylights. Window security grilles are not provided for ground floor windows. There is not a greenhouse associated with this school.

Rating: 2 Needs Repair

Window at 1962 original construction

Recommendations: Replace single glazed window vision panels in exterior doors of the overall facility with insulated and approved safety glass. Replace a couple of single glazed window units at the 1962 original construction due to condition. Replace windows at the 1984 addition due to condition. No work is required in the 2002 addition at the present time.

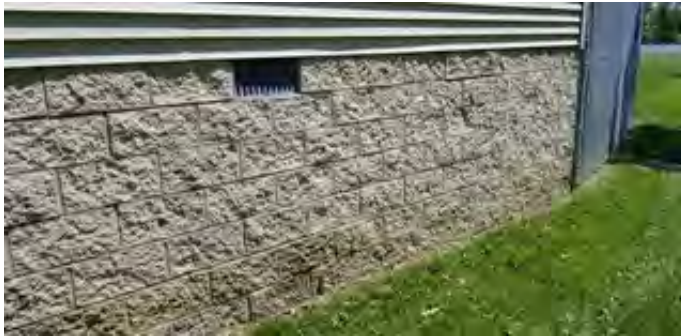
Masonry foundation wall at 2002 addition

Recommendations: Existing conditions require no renovation or replacement at the present time.

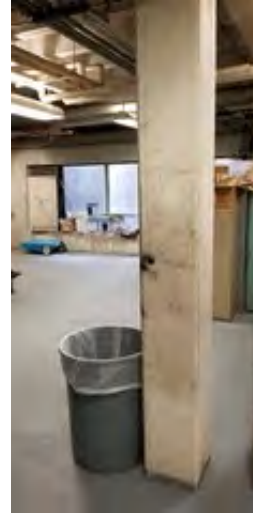
Concrete foundation walls at original construction

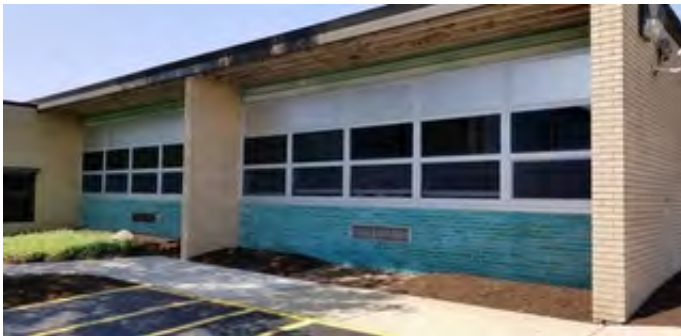
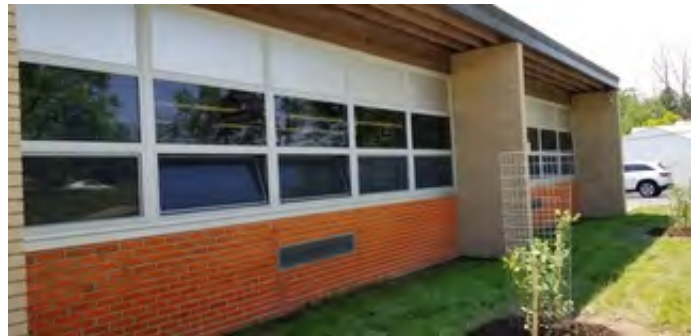
Brick veneer at classroom

Recommendations: Provide masonry cleaning and sealing as required throughout the overall facility. Provide tuckpoint in areas that showed minor deterioration or cracks. No work is required in the 1984 and 2002 additions at the present time. Provide for brick infill at exterior grilles following unit ventilator removal, including CMU back-up, rigid insulation, vapor barrier and exterior face brick.

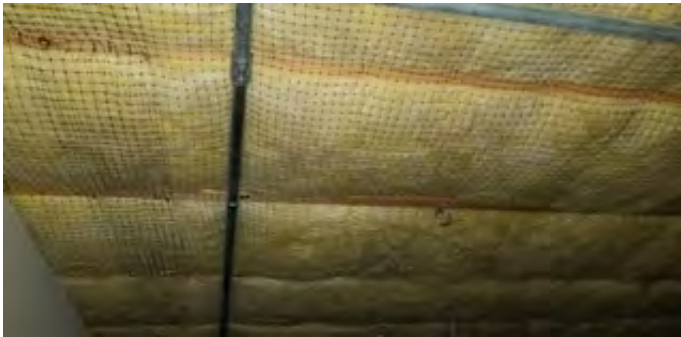
Wood roof structure at 2002 addition

Recommendations: Provide a fire separation assembly in the 2002 addition to address wood roof structure. Provide for replacement of wood flooring system in the 2002 addition. No work is required in the 1962 original construction, 1965 or 1984 additions at the present time.

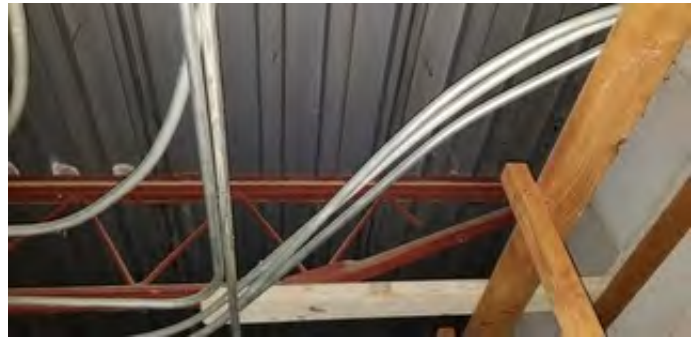
Metal deck on steel bar joist at 1965 addition

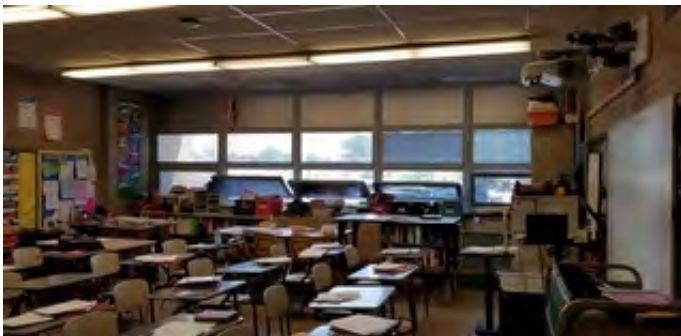
Typical classroom finishes

Provide complete replacement of finishes and casework throughout the overall facility due to installation of systems outlined in Items A, C, D, E, K, L, M, N, T, U, and due to condition. Funding for replacement of interior doors is provided in Item O, including doors here noted as being in poor condition. Provide for replacement of toilet partitions due to work outlined in Item O, and due to condition. Provide for replacement of toilet accessories due to age and condition. Provide for replacement of kitchen equipment due to age and condition of equipment.

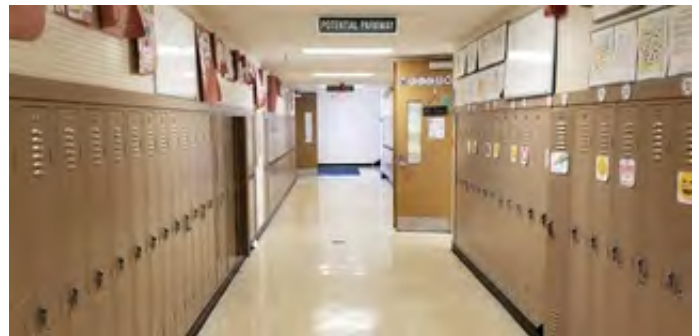
Typical corridor finishes

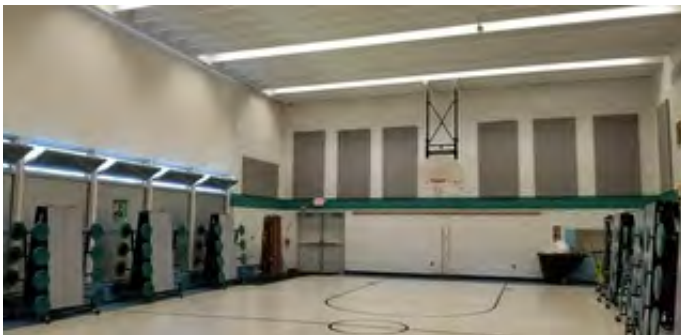
Lighting in student dining area

Provide complete replacement of lighting system due to condition, lighting levels, lack of multilevel switching, and installation of systems outlined in Items A, C, D, I, J, L, M, N, and U.

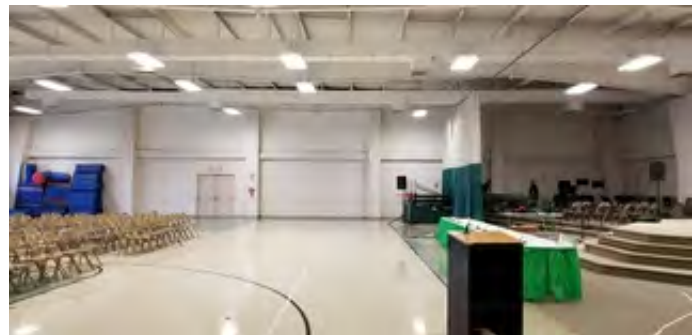
Lighting in gymnasium

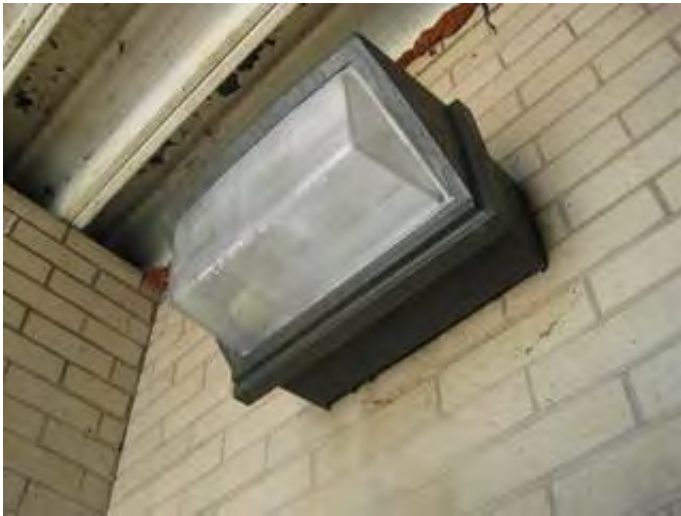
Wall mounted exterior lighting fixture

Recommendations: Provide additional building security systems including additional desired from the district to more thoroughly protect the building during school hours and after school hours. Provide security fencing, as desired by the district, to more thoroughly protect the building during school hours and after school hours, by allocating a portion of the comprehensive security systems funding provided in this Item L- Security Systems. Provide upgrade to exterior security lighting system to meet Ohio School Design Manual guidelines.

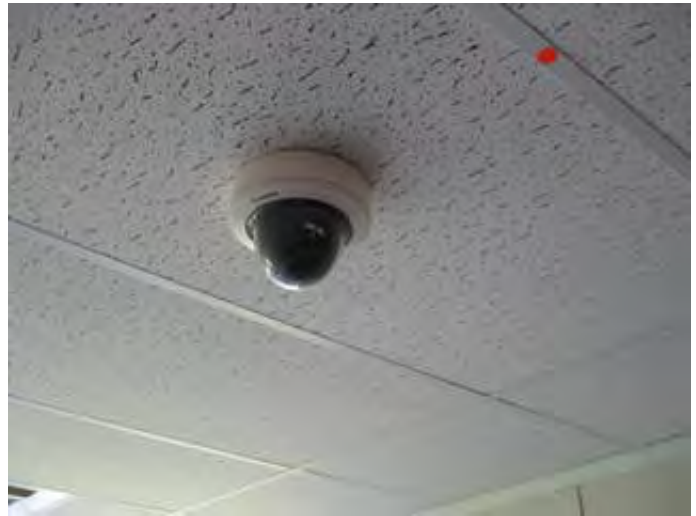
Ceiling mounted security camera

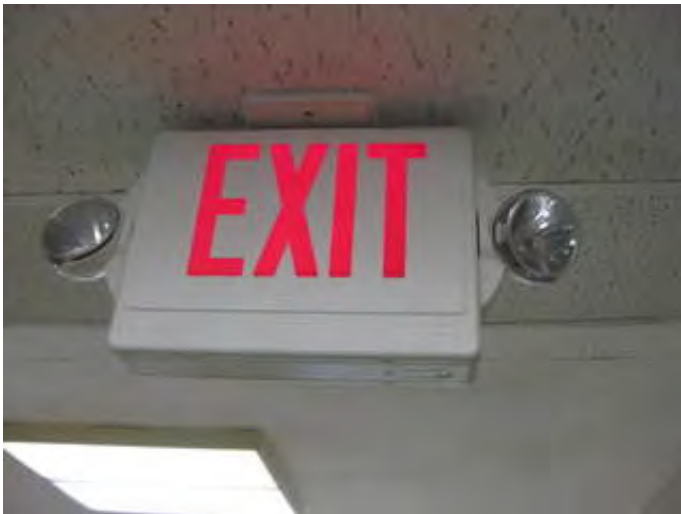
Combination exit and emergency lighting fixture in 1962 original building

- Rating:** 2 Needs Repair
- Recommendations:** Provide a new emergency/egress lighting system in the 1962 original building and 1965 addition to meet Ohio School Design Manual guidelines and as required to satisfy local fire and building officials as well as Ohio Building Code. Provide exit signage on separate electrical circuits. Supplement battery backup wall mounted emergency lighting fixtures to increase lighting levels in corridors and egress paths to at least 1.5-foot candles in all areas. Provide a new emergency/egress lighting system in the 1984 gymnasium addition and 2002 modular addition, due to the scope of above ceiling work required in other plates, to meet Ohio School Design Manual guidelines and as required to satisfy local fire and building officials as well as Ohio Building Code.

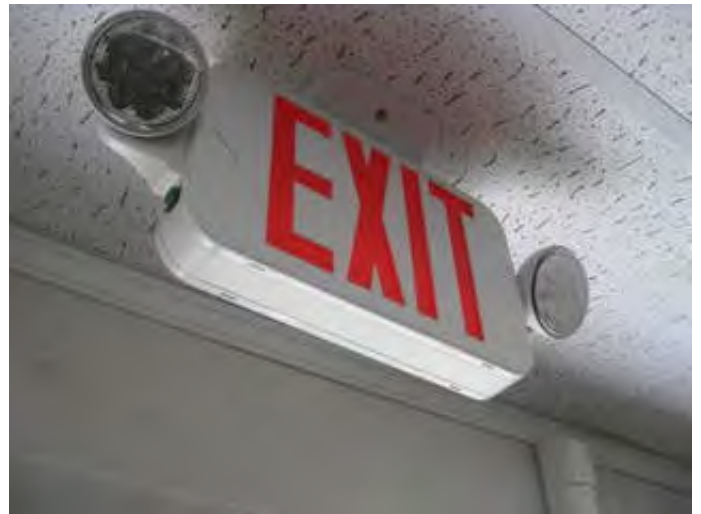
Combination exit and emergency lighting fixture in 2002 addition

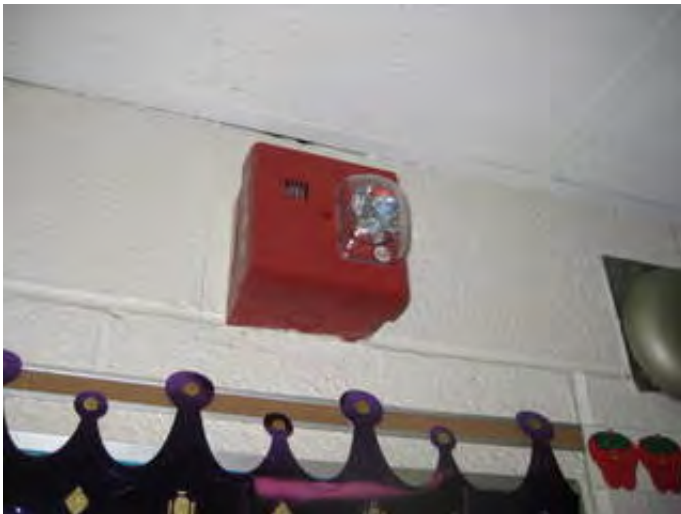
Wall mounted horn strobe device

Recommendations: Provide new fire alarm system in the 1962 original building and 1965 addition consisting of manual fire alarm pull stations mounted at required heights, remote annunciator panels, automatic fire detection devices in all air devices and mechanical equipment, and horn/strobe devices located in all occupied spaces to meet Ohio School Design Manual guidelines. Provide capacity to incorporate the 1984 and 2002 devices into new system.

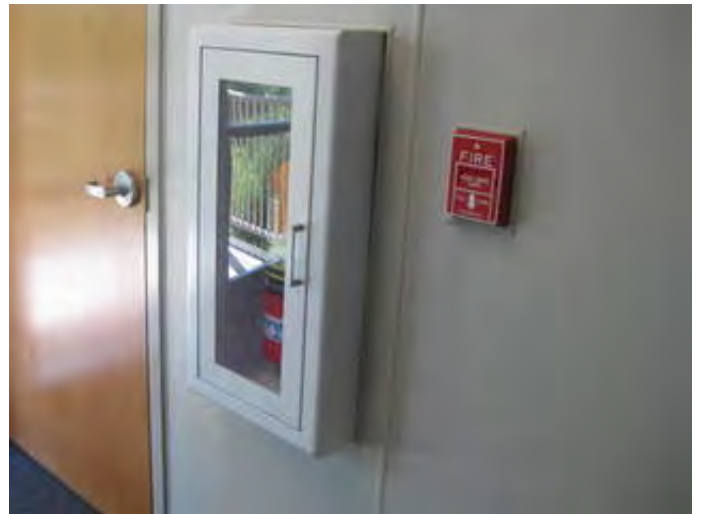
Fire alarm pull station

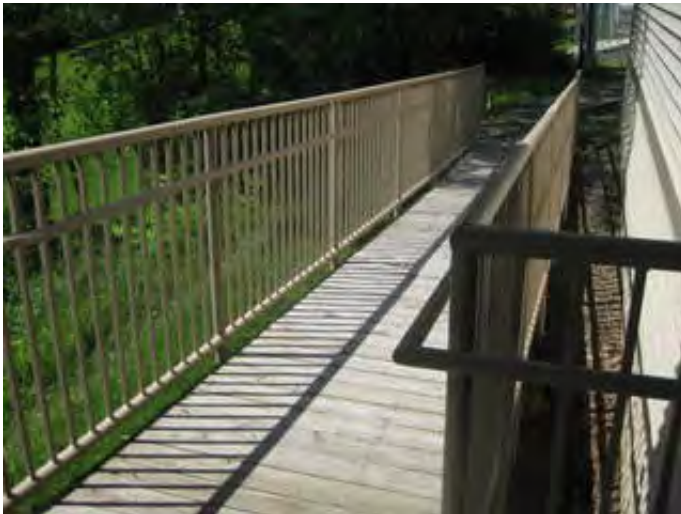
Exterior ramp at 2002 addition

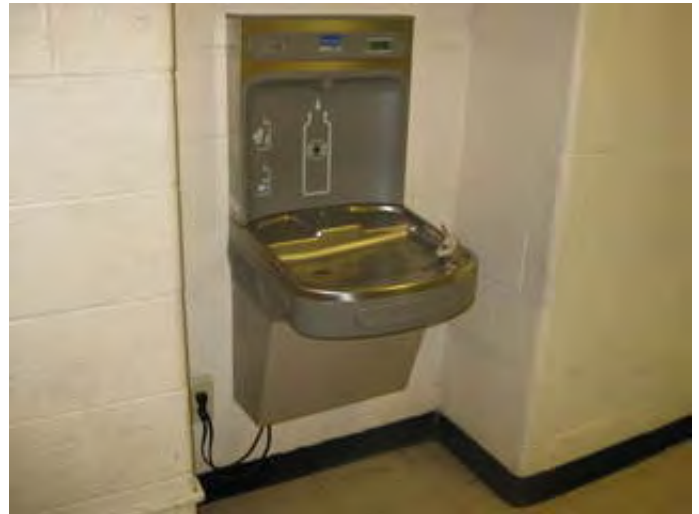
ADA compliant electric water cooler

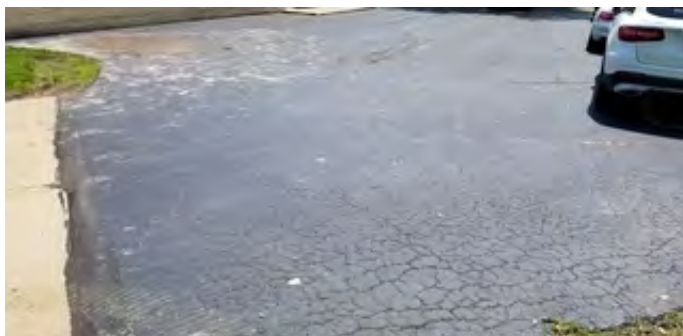
Asphalt pavement in poor condition

Provide for removal of older playground equipment due to condition. Provide for replacement of playground equipment in poor condition. Provide for replacement of asphalt pavement in poor condition. Provide for replacement of heavy duty asphalt pavement in poor condition. Provide for replacement of concrete sidewalks in poor condition. Provide heavy duty concrete pavement at the dumpster pad. Provide site contingency allowances for unforeseen conditions.

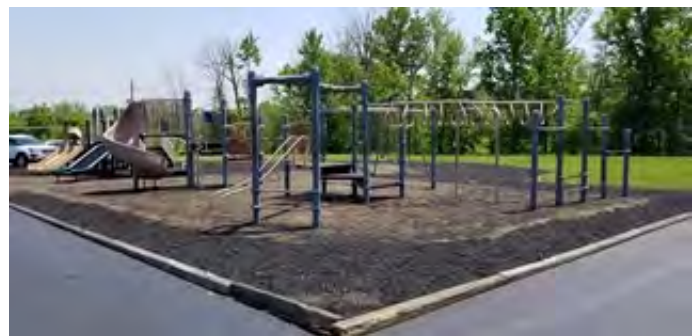
Playground equipment

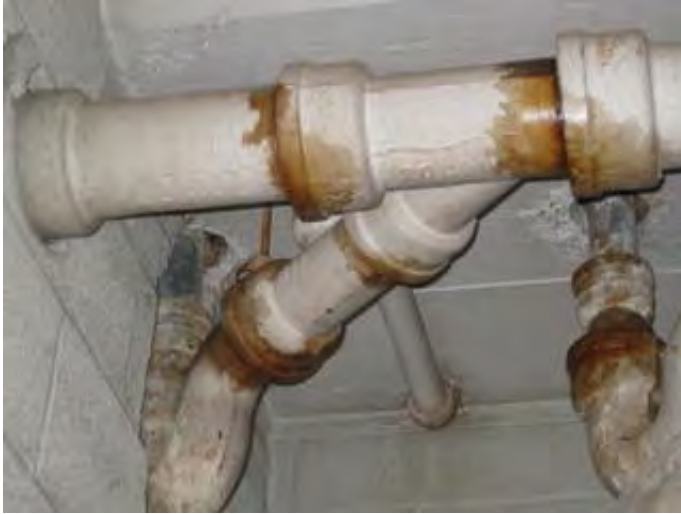
Cast-iron sanitary sewer piping

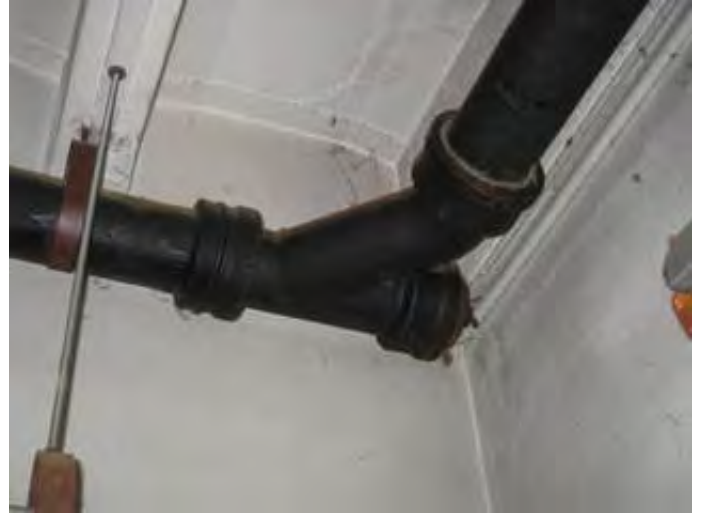
Cast-iron sanitary sewer piping

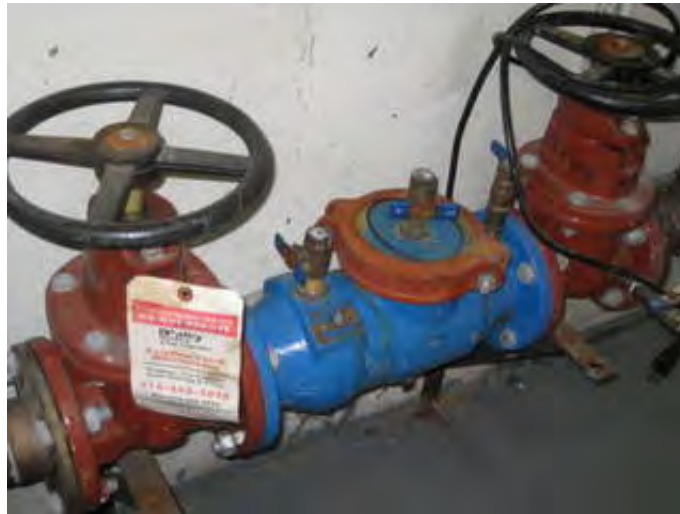
Water service back-flow preventor

Recommendations: Increase water service size for fire protection which is included in the cost of the fire suppression system installation funded under Item U - Life Safety. Provide funding for water quality testing.

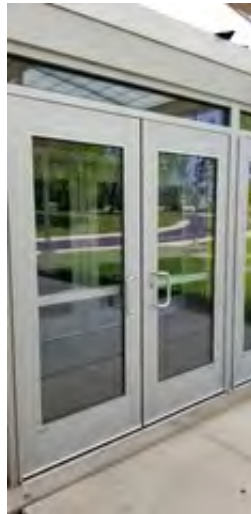
Typical entrance doors

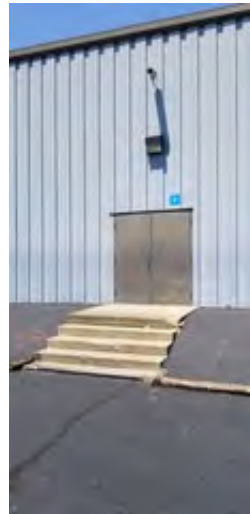
Exterior doors at 1984 addition

Recommendations: Provide for replacement of doors in poor condition. Replacement of single glazed door vision panels, transoms, and sidelights is addressed in Item F. No work is required in the 1962 original construction or 2002 addition at the present time.
