BEDFORD CITY SCHOOL DISTRICT

***Ohio Facilities Construction Commission
Classroom Facilities Assistance Program
Facilities Assessment Report***

***Submitted by
Harrison Planning Group
June 2018***

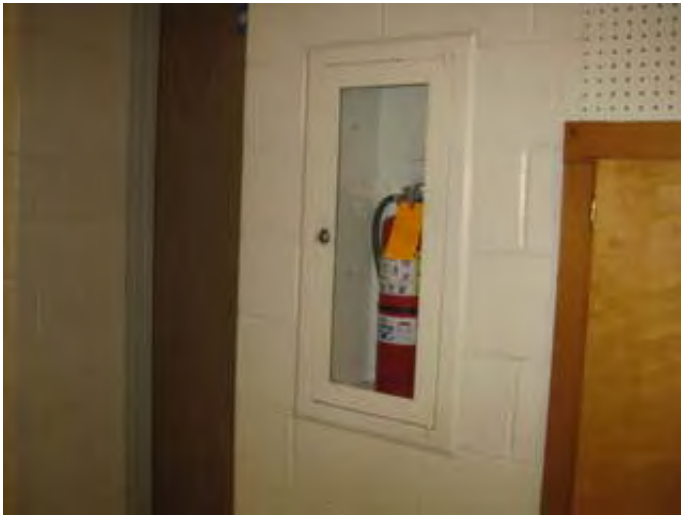
Fire extinguisher cabinet in 1962 original construction

Emergency Safety		Points Allocated	Points
4.17 Adequate fire safety equipment is properly located		15	4
<i>The facility is not sprinkled. Fire alarm devices are not adequately provided, except in the 2002 addition. Fire extinguishers are inadequately provided, except in the 2002 addition.</i>

Other: Fire extinguishers and cabinets	\$0.12	sq.ft. (of entire building addition)		Required	Required	Required		\$5,516.52	Provide fire extinguishers and cabinets adequately spaced and mounted at required ADA mounting heights.
Other: Remove existing overhead and corridor security grilles	\$1,500.00	lump sum		Required				\$1,500.00	Remove the overhead security grille in the 1962 original construction.
Sum:			\$246,235.72	\$141,814.84	\$64,368.48	\$23,140.40	\$16,912.00

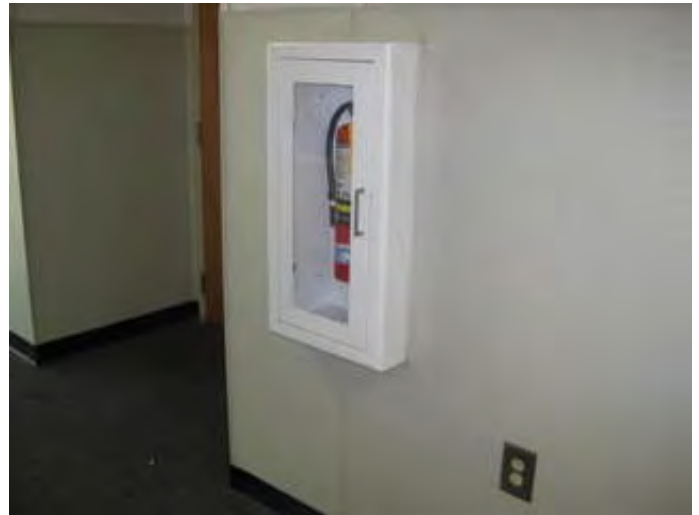
Fire extinguisher cabinet in 2002 addition

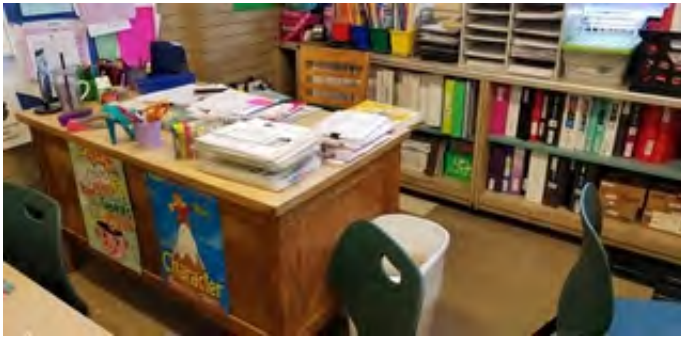
Typical teacher desk

Recommendations: Provide for replacement of outdated or inadequate furniture.

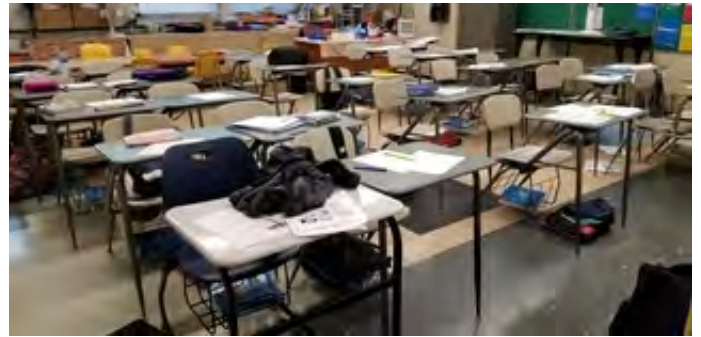
Typical student desks and chairs

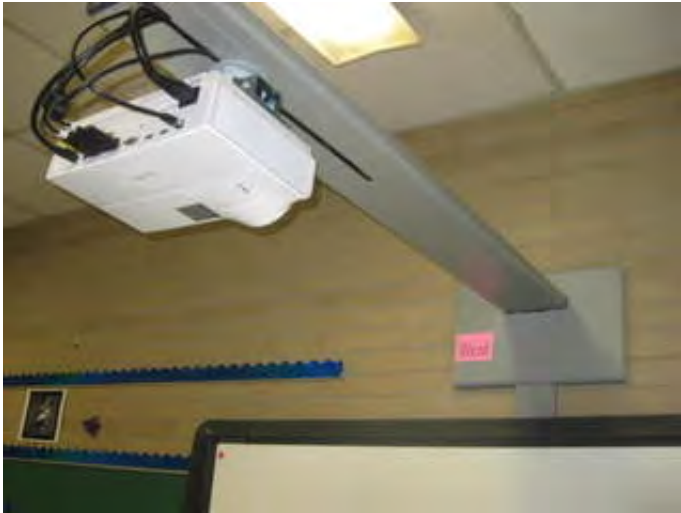
Classroom projector

Recommendations: Provide technology upgrades, wiring and systems per Ohio School Design Manual guidelines.

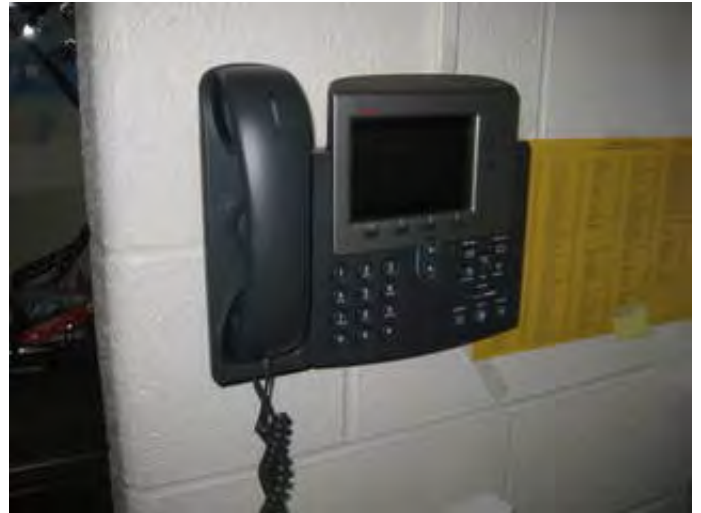
Classroom telephone set

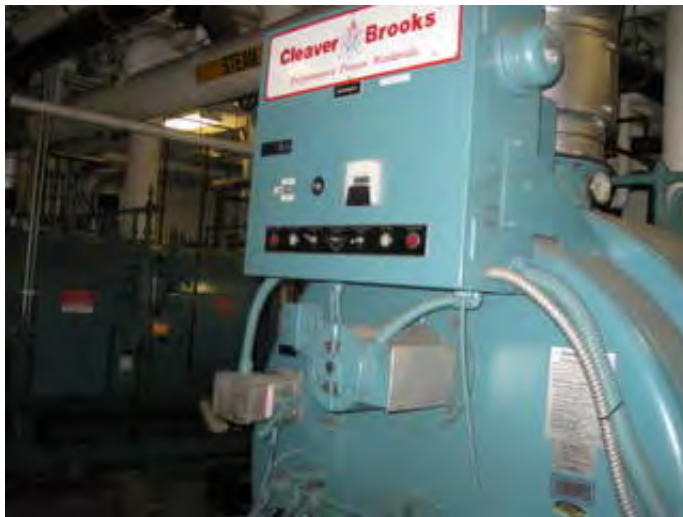
Gas fired boiler

Recommendations: Provide new overall heating system, including air conditioning, to meet Ohio School Design Manual guidelines. Provide funding to convert existing non-ducted system to ducted air system in the overall facility. The clear area above finished ceilings will allow for the installation of ductwork.

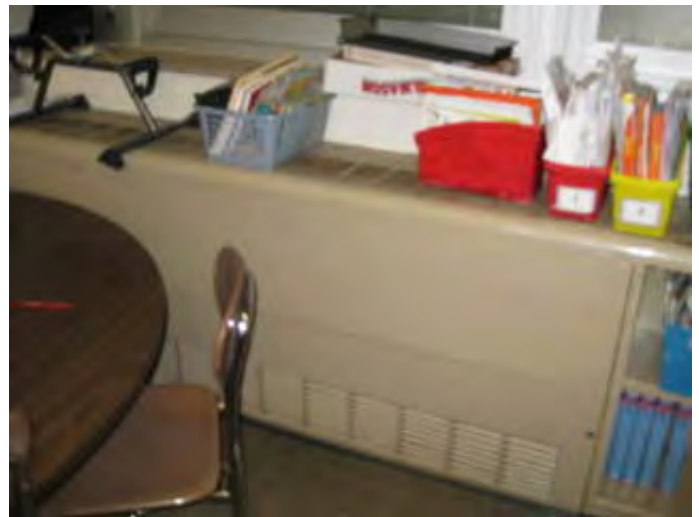
Classroom unit ventilator

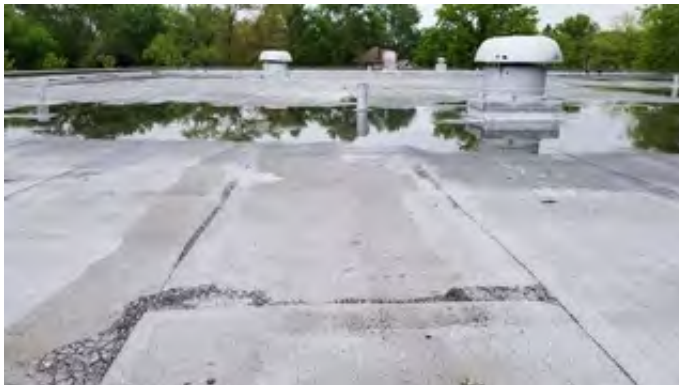
Roof at 1959 addition

The roof over the 1953 original construction and the 1959 addition requires replacement to meet Ohio School Design Manual guidelines for age of system and due to condition. The flashing at the 1953 original construction and the 1959 addition requires replacement due to condition. Overflow roof drains are required throughout the overall facility. Provide for replacement of access hatch, including safety protection cage at the 1953 original construction. Provide for safety protection cage at the access ladder to the 1959 addition.

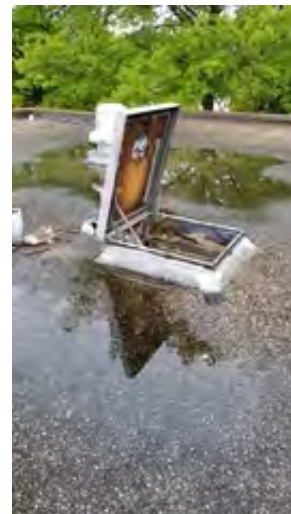
Roof at 1953 original construction

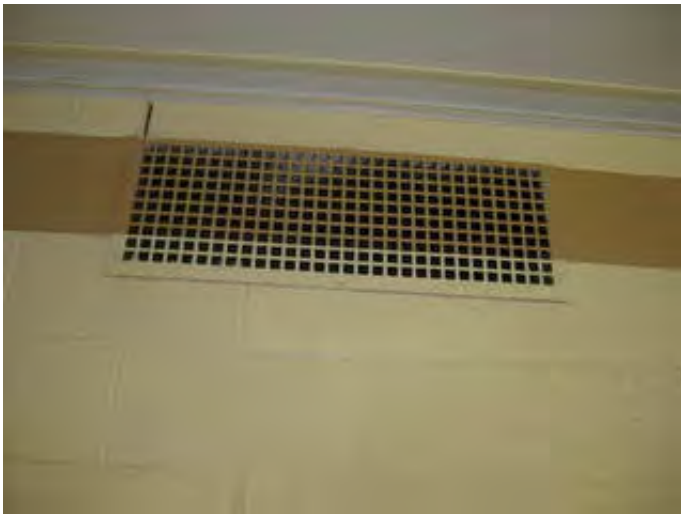
Transfer grille

Recommendations: Provide an air conditioning system throughout the overall facility to meet Ohio School Design Manual guidelines. Funding included in Item A - Heating System. Provide new restroom exhaust systems. Restroom exhaust system provided with complete HVAC system replacement. Provide exhaust for existing art room kiln.

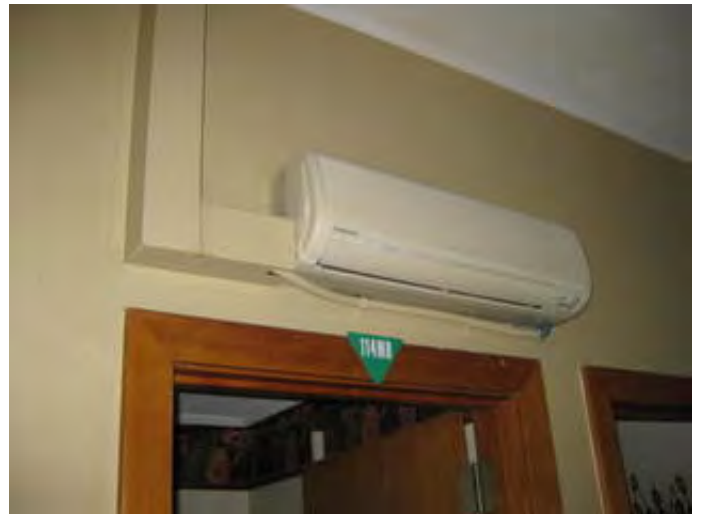
Self contained air conditioning unit

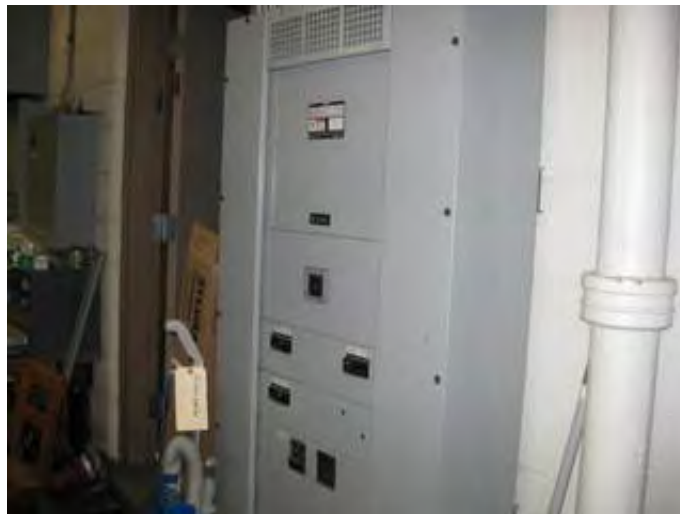
Main distribution panel

Recommendations: The entire electrical system requires replacement to meet Ohio School Design Manual guidelines for classroom capacity, the addition of an air conditioning system, and due to condition and age. The emergency generator for life safety systems is included in the entire electrical system replacement funded in this Item D - Electrical. Provide building lightning protection and grounding. Lighting protection and grounding is included in the entire electrical system replacement funded in this Item D - Electrical.

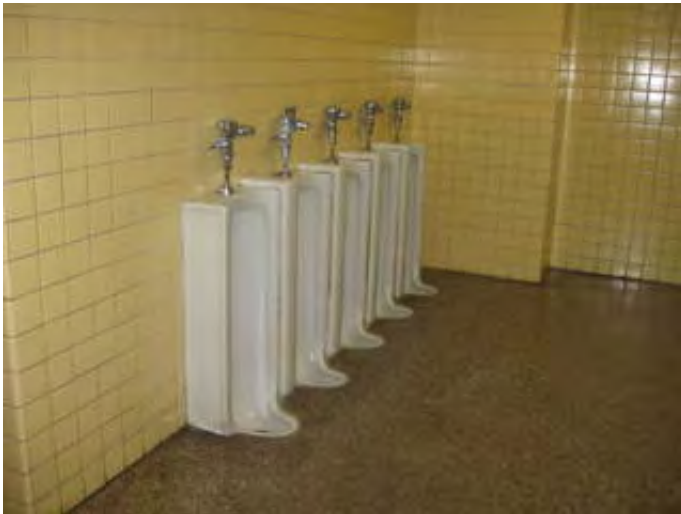
Floor mounted urinals

Item	Cost	Unit	Whole Building	1953 Original Construction (1953)	1959 Addition (1959)	1966 Addition (1966)	Sum	Comments
Domestic Supply Piping:	\$3.50	sq.ft. (of entire building addition)		25,019 ft ²	13,798 ft ²	10,876 ft ²	\$173,925.50	(remove / replace)
Toilet:	\$3,800.00	unit		7 Required	0 Required	2 Required	\$34,200.00	(new)
Urinal:	\$3,800.00	unit		5 Required	7 Required	0 Required	\$45,600.00	(new)
Urinal:	\$1,500.00	unit				5 Required	\$7,500.00	(remove / replace)
Sink:	\$1,500.00	unit		7 Required	4 Required	4 Required	\$22,500.00	(remove / replace)
Other: Exterior hose bibs	\$1,200.00	each			1 Required	1 Required	\$2,400.00	Provide additional exterior hose bibs.
Other: Wall patching at floor urinal removal	\$2,000.00	each		5 Required	7 Required		\$24,000.00	Provide wall hung urinals in locations of current floor mounted urinals. Provide wall patch at each wall to wall hung urinal replacement.

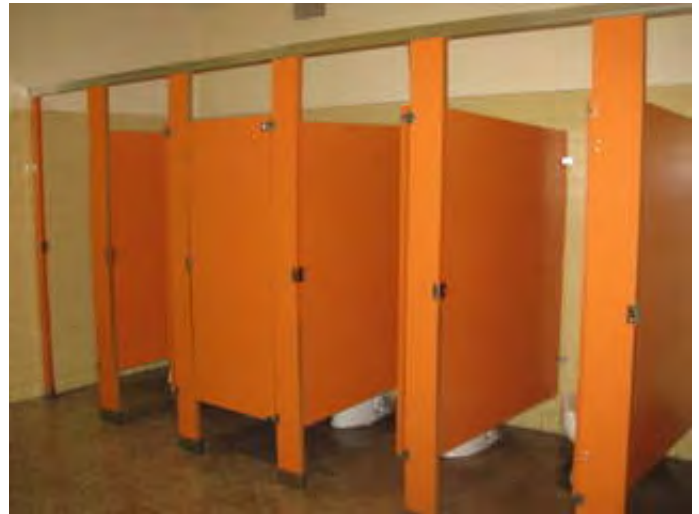
Water closet partitions

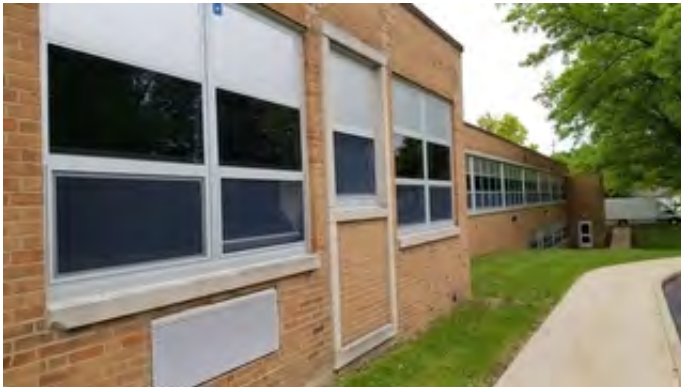
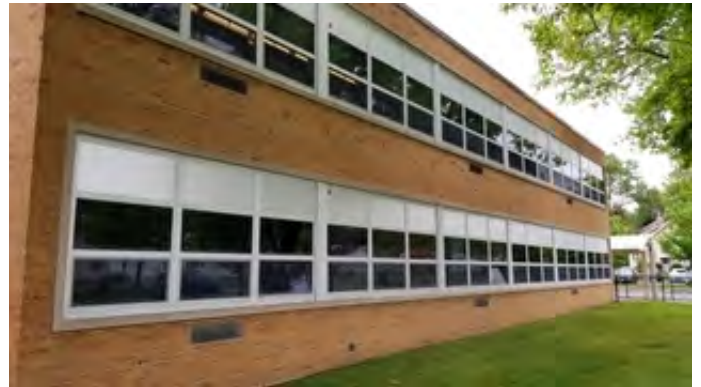
Typical windows in classroom

Recommendations: Replace single glazed window vision panels, transoms and sidelights in exterior doors of the overall facility with insulated and approved safety glass.

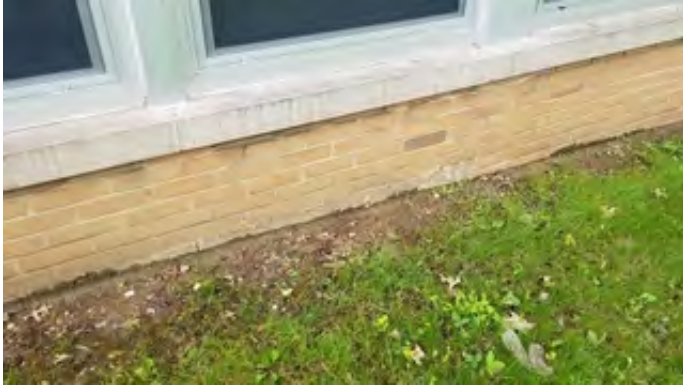
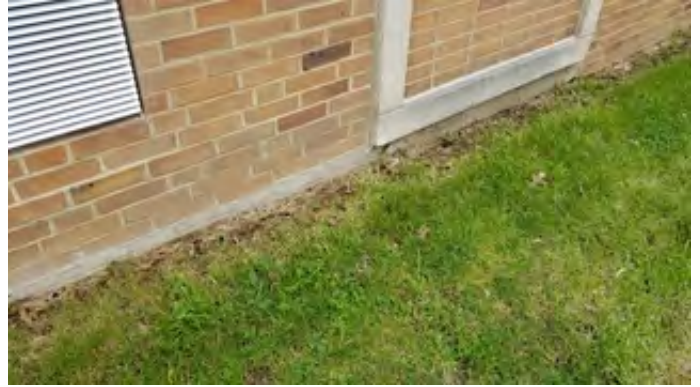
Masonry block foundation

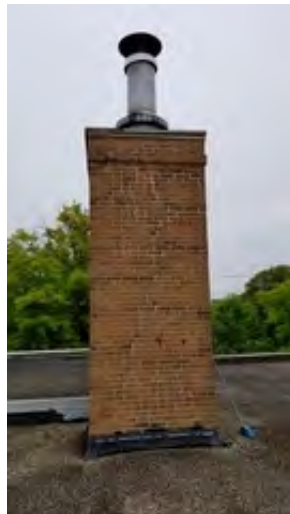
Chimney at 1953 original construction

Recommendations: Provide masonry cleaning and sealing as required throughout the overall facility. Provide for brick infill at exterior grilles following unit ventilator removal, including CMU back-up, rigid insulation, vapor barrier and exterior face brick.

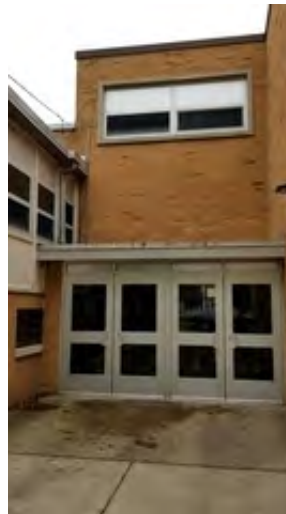
Typical exterior brick veneer

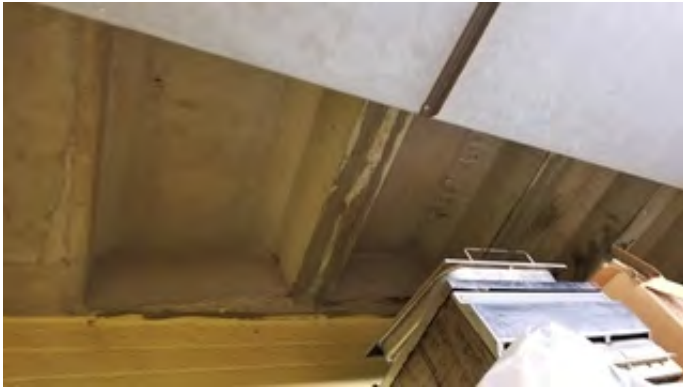
Cast in place concrete at mechanical room

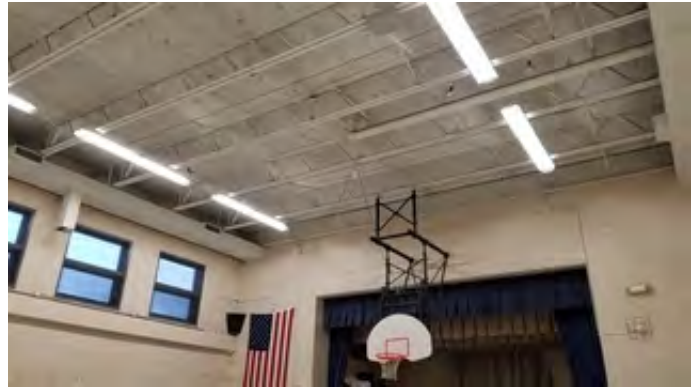
Exposed bar joist and insulated panel

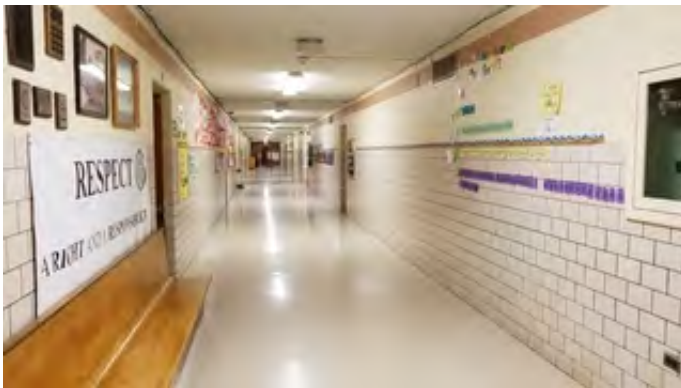
The overall facility features conventionally partitioned classrooms, with the 1966 addition featuring a shared octagon shaped common space with flexible partition walls that open to the common space. The overall facility features 9" vinyl tile type flooring, plaster and lay-in type ceilings, as well as plaster and block type wall finishes, and they are in fair condition. The overall facility has corridors with 9" and 12" vinyl tile type flooring, plaster and lay-in type ceilings, as well as glazed block and block type wall finishes, and they are in fair condition. The overall facility has restrooms with terrazzo and quarry tile type flooring, plaster, acoustical plaster and lay-in type ceilings, as well as glazed block, block, concrete and ceramic tile type wall finishes, and they are in fair to poor condition. Toilet partitions are a combination of metal, plastic, and wood, and are in poor condition. Classroom casework in the overall facility is a combination of built-in wood and metal units with plastic laminate and metal tops, is inadequately provided, and in fair to poor condition. Classrooms are provided adequate chalkboards, markerboards, and tackboards, which are in fair condition. Student storage consists of classroom storage cubbies and coat hooks located in the classrooms, are adequately provided, and in fair to poor condition. A kiln is provided in the mechanical room for use by the art program, which is not provided with an adequate ventilation system. The facility is equipped with wood non-louvered interior doors that are recessed without proper ADA hardware and clearances, and in fair condition. The gymnasium space has 12" vinyl tile type flooring, exposed bar joist and acoustical panel type ceilings, as well as painted and glazed block type wall finishes, and they are in fair condition. No seating is provided in the Gymnasium. Gymnasium basketball backboards are fixed type, and are in fair to poor condition. The media center, located in a former classroom of the 1966 addition, has 9" vinyl tile type flooring, lay-in type ceilings, as well as painted block type wall finishes, and they are in fair condition. Student dining, located in the 1953 original construction, has 9" vinyl tile type flooring, acoustical plaster type ceilings, as well as glazed block and plaster type wall finishes, and they are in poor condition. The art classroom utilizes the back portion of the student dining space as shared space for dining and instruction. The existing kitchen is full service, and the existing kitchen equipment, is over 20 years old, and is in fair to poor condition. Reach-in coolers and freezers are located within the kitchen space, and are in fair to poor condition.

Typical corridor finishes

Typical classroom finishes

Provide complete replacement of finishes and casework throughout the overall facility due to installation of systems outlined in Items A, C, D, E, K, L, M, N, T, U, and due to condition. Provide plaster refinishing due to work outlined in Items A, C, D, E, K, L, M, N, T, and U. Funding for replacement of interior doors is provided in Item O, including doors here noted as being in poor condition. Provide for repairs to terrazzo flooring due to condition. Provide for replacement of basketball backboards due to age and condition. Provide for replacement of toilet partitions due to work outlined in Item O, and due to condition. Provide for replacement of toilet accessories due to age and condition. Provide for replacement of kitchen equipment due to age and condition of equipment. See Item C for kiln ventilation system.

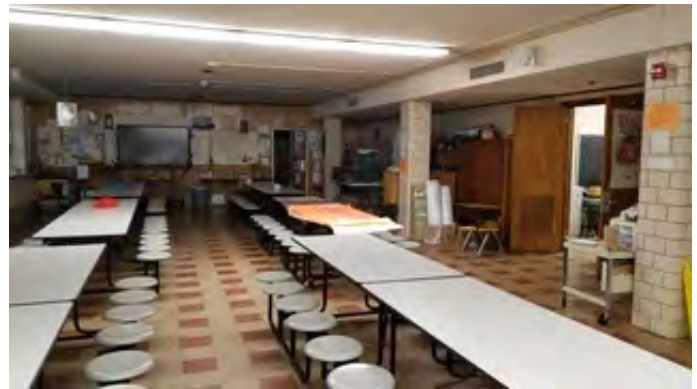
Typical classrooms in the overall facility are equipped with 1x4 surface mount fluorescent fixtures with a combination of single and dual level switching. Classroom fixtures are in fair condition, providing an average illumination of 56 FC, thus complying with the 50 FC recommended by the OSDM. Typical corridors in the overall facility are equipped with 1x4 surface mount fluorescent fixtures with dual level switching. Corridor fixtures are in fair condition, providing an average illumination of 27 FC, thus complying with the 20 FC recommended by the OSDM. The primary gymnasium space is equipped with 1x4 surface mount fluorescent fixture type lighting, in fair condition, providing an average illumination of 16 FC, which is less than the 50 FC recommended by the OSDM. The media center is equipped with 1x4 surface mount fluorescent fixture type lighting in fair condition, providing an average illumination of 77 FC, thus complying with the 50 FC recommended by the OSDM. The student dining space is equipped with 1x4 surface mount fluorescent fixture type lighting with multi-level switching. Student dining fixtures are in fair condition, providing an average illumination of 30 FC, which is less than the 50 FC recommended by the OSDM. The kitchen spaces are equipped with 1x4 surface mount fluorescent fixture type lighting with multi-level switching. Kitchen fixtures are in fair condition, providing an average illumination of 65 FC, which is less than the 75-80 FC recommended by the OSDM. The service areas in the overall facility are equipped with 1x4 surface mount fluorescent fixture type lighting in fair condition. The typical administrative spaces in the overall facility are equipped with 2x4 lay-in and 1x4 surface mount fluorescent fixture type lighting in fair condition, providing adequate illumination based on OSDM requirements. The overall lighting systems of the facility are not fully compliant with Ohio School Design Manual guidelines due to age and condition, inadequate lighting levels, and lack of multi-level switching.

Lighting in the gymnasium

Lighting in student dining area

Provide complete replacement of lighting system due to condition, lighting levels, lack of multilevel switching and installation of systems outlined in Items A, C, D, J, L, M, N, and U.

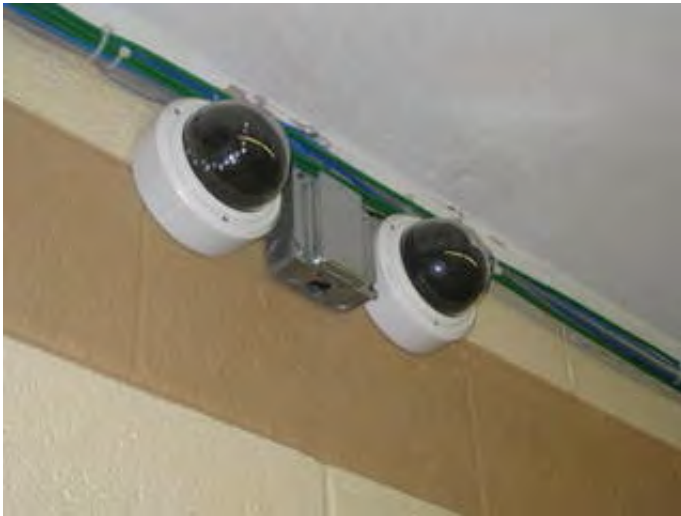
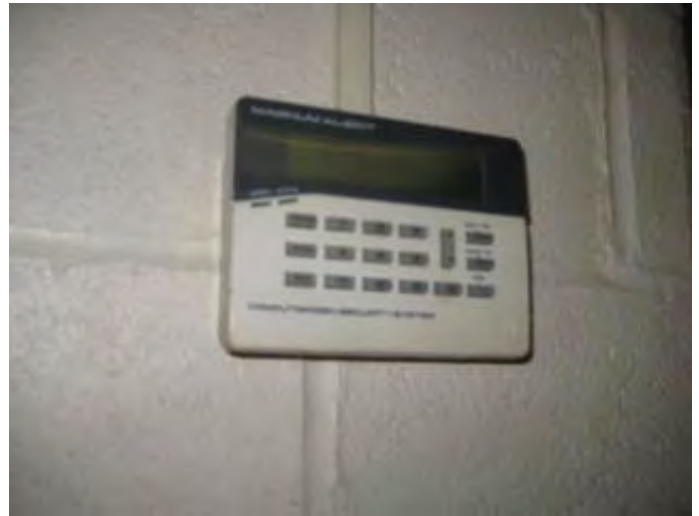
Description: The overall facility contains a security system consisting of security cameras, door contacts, electric door strikes activated from a remote area and monitored by a security camera and door buzzer, and motion sensors. The existing security system is in adequate condition. The exterior security lighting consists of wall mounted fixtures. Exterior security lighting is in adequate condition and provides inadequate coverage.

Corridor mounted security cameras

Security keypad

Recommendations: Provide complete replacement of security systems including additional security cameras, glass break sensors, door contacts, and motion sensors as desired from the district to more thoroughly protect the building during school hours and after school hours and to meet Ohio School Design Manual guidelines. Provide upgrade to exterior security lighting system to meet Ohio School Design Manual guidelines. Provide security fencing, as desired by the district, to more thoroughly protect the building during school hours and after school hours, by allocating a portion of the comprehensive security systems funding provided in this Item L- Security Systems.

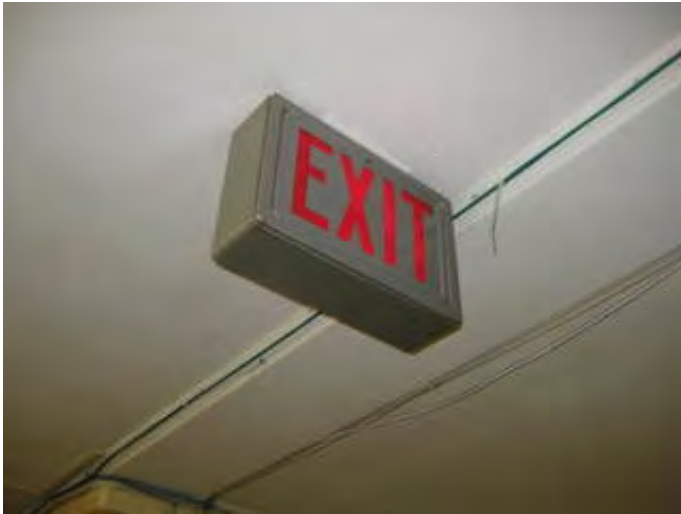
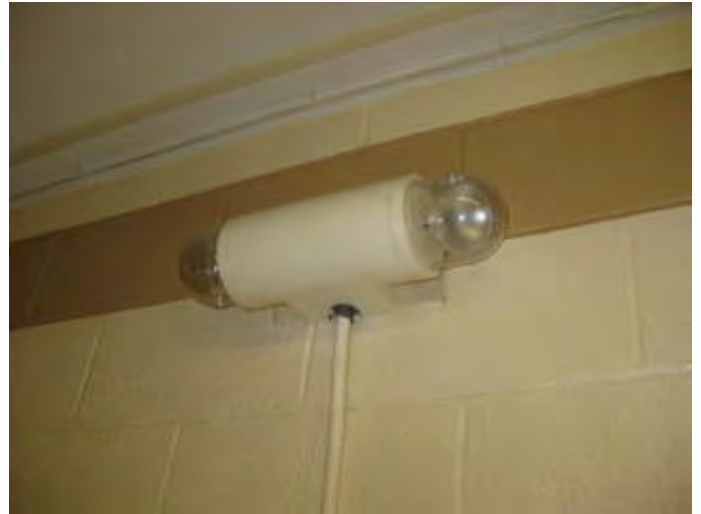
- Description:** The overall facility does contain an emergency/egress lighting system. The system is in fair condition and does not provide adequate coverage with exit signage or adequate illumination with emergency light fixtures.
- Rating:** 3 Needs Replacement
- Recommendations:** Provide complete replacement of emergency/egress lighting system to meet Ohio School Design Manual guidelines and as required to satisfy local fire and building officials as well as Ohio Building Code. Provide exit signage on separate electrical circuits. Supplement battery backup wall mounted emergency lighting fixtures to increase lighting levels in corridors and egress paths to at least 1.5-foot candles in all areas. Emergency power generator is funded under Item D - Electrical.

Ceiling mounted exit signage

Corridor mounted emergency lighting

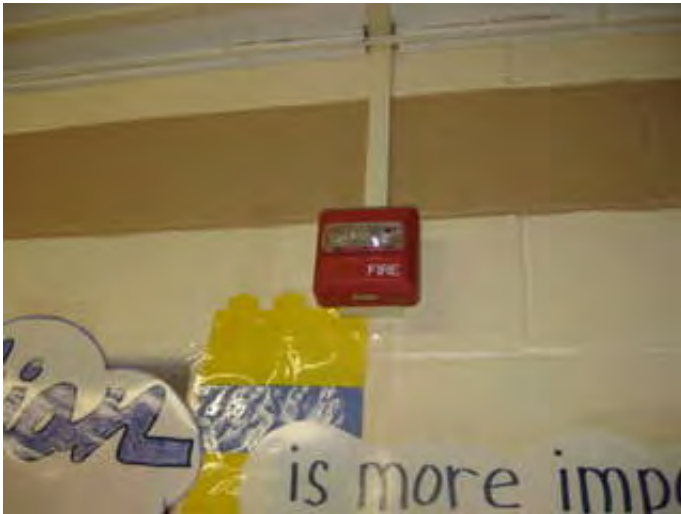
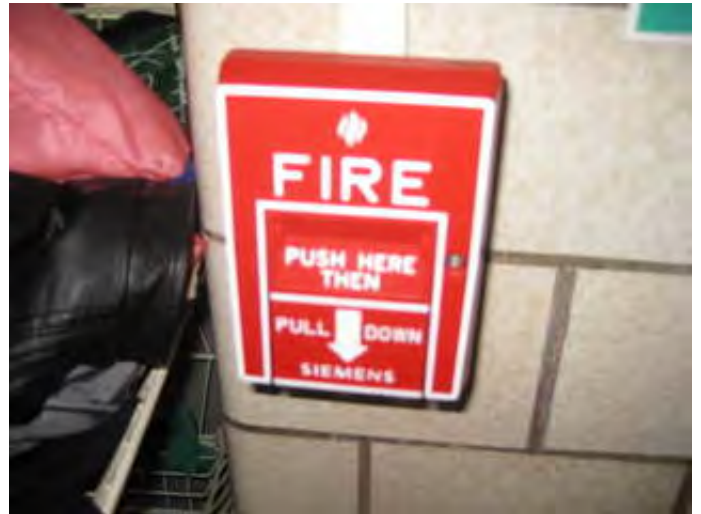
Description: The overall facility contains a fire alarm system in fair condition. Manual pull stations are mounted in corridors and assembly areas. Manual pull stations are mounted at exits. Horns and strobes are not mounted in all required areas. Mechanical equipment does not contain automatic fire alarm devices. The system does not have additional zone capabilities. The system is not adequately provided throughout the facility. The fire alarm system does not meet NFPA requirements and Ohio School Design Manual guidelines.

Wall mounted horn/strobe device

Fire alarm pull station

Recommendations: Provide complete replacement of fire alarm system consisting of manual fire alarm pull stations mounted at required heights, remote annunciator panels, automatic fire detection devices in all air devices and mechanical equipment, and horn/strobe devices located in all occupied spaces to meet Ohio School Design Manual guidelines.

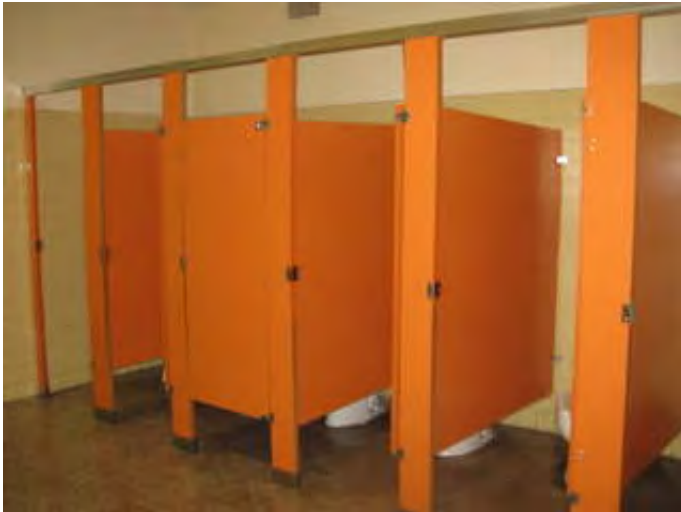
Non-compliant water closet stalls

Recommendations: Provide signage, lift, elevator, drinking fountains, toilets, sinks, restroom accessories, and toilet partitions to meet ADA requirements. Replace existing interior doors and door hardware. Rework narrow and recessed interior doors and openings to allow for required clearances. Funding includes 3' x 7' door, hollow metal frame, door lite and hardware. Provide ADA door assist on exterior doors along accessible routes.

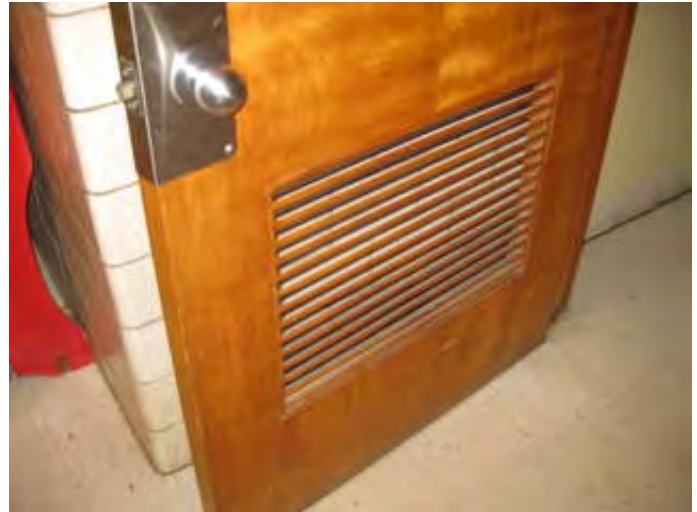
Non-compliant door hardware

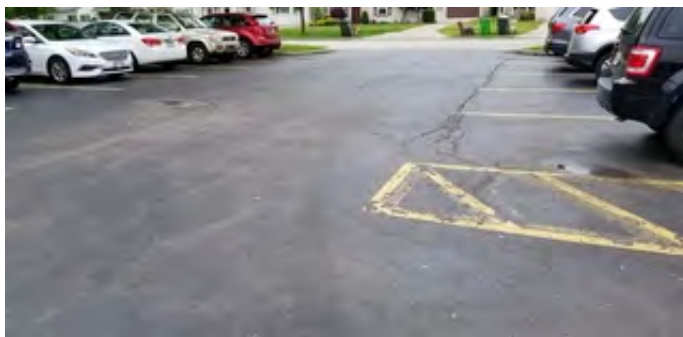
Asphalt pavement at parking lot

Provide for removal of aged and damaged playground equipment due to condition. Provide for replacement of older and damaged playground equipment in poor condition. Provide for replacement of asphalt pavement in poor condition. Provide for replacement of concrete sidewalks in poor condition. Provide concrete curbs to delineate vehicular traffic patterns, and to meet OSDM guidelines. Provide site contingency allowances for unforeseen conditions.

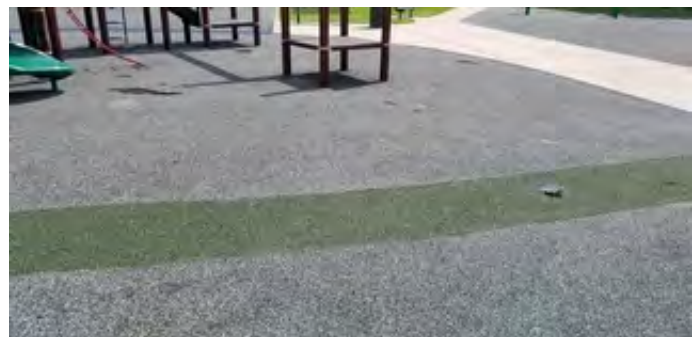
Damaged rubberized soft surfacing at playground

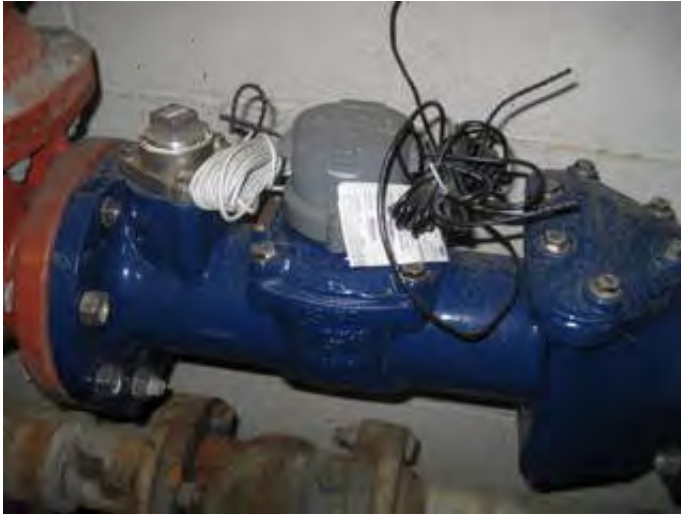
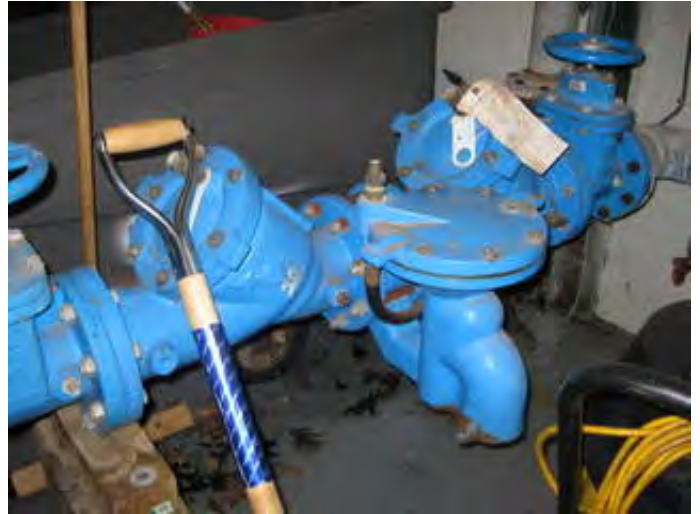
Water service meter

Water service back-flow preventer

Recommendations: Increase water service size for fire protection which is included in the cost of the fire suppression system installation funded under Item U - Life Safety. Replace galvanized water service main piping. Provide funding for water quality testing.

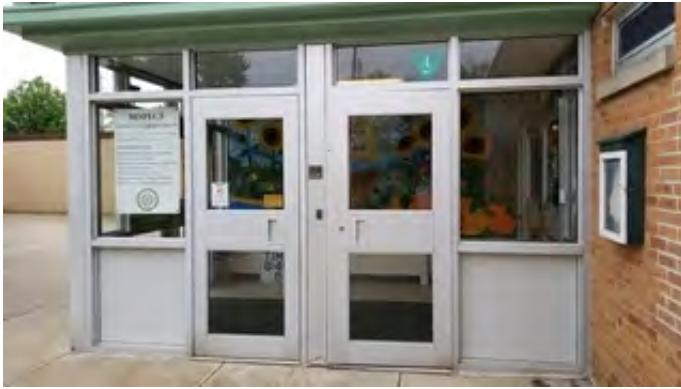
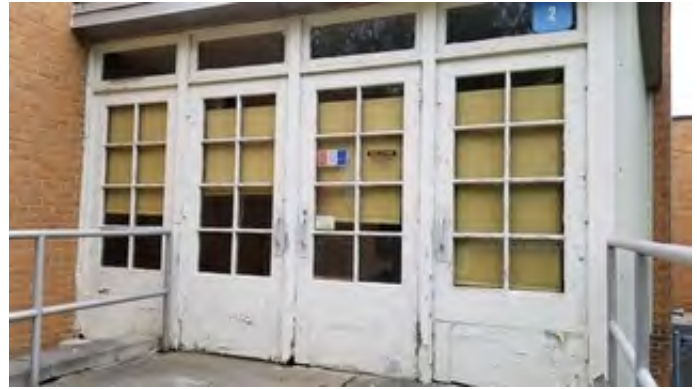
Description: Typical entrance and exterior doors in the overall facility are aluminum type construction, installed on aluminum frames, and in good condition. Typical exterior doors feature single glazed tempered glass vision panels. A couple exterior doors showed signs of corrosion from salt, and are in poor condition. One entrance has wood type doors, installed on wood frames, and in poor condition. One exterior service door is a hollow metal door on a steel frame, which is in poor condition. Overhead doors are aluminum type in good condition.

Typical entrance doors

Wood entrance doors

Recommendations: Replace damaged exterior doors at the main entrance due to poor condition. Replace exterior service door at mechanical room due to poor condition. Replacement of single glazed door vision panels, transoms, and sidelights is addressed in Item F.

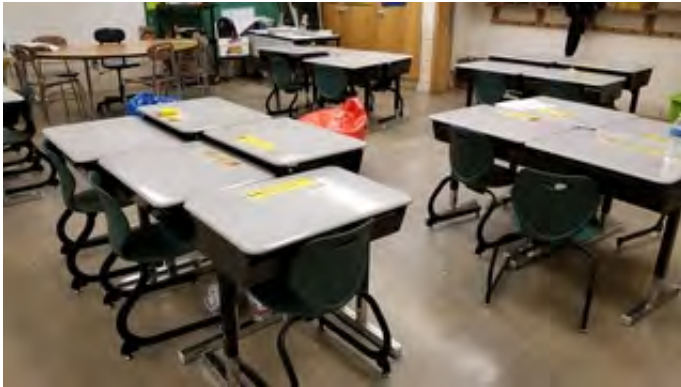
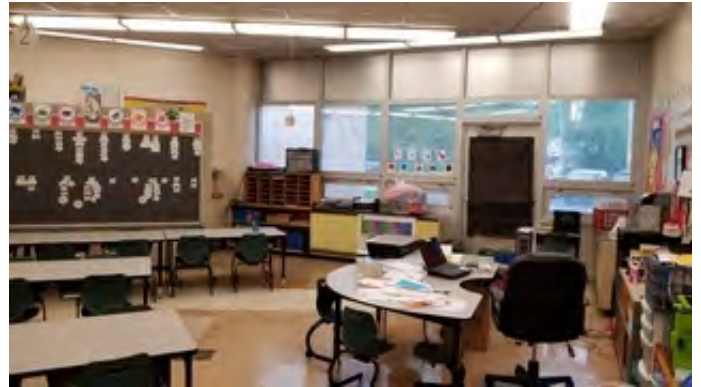
Description: The typical classroom furniture throughout the overall facility is of relatively consistent design, and in generally good condition, consisting of consistent student desks & chairs, miscellaneous teacher desks & chairs, file cabinets, reading table, computer workstation, bookcases, and wastebaskets. The facility's furniture and loose equipment were evaluated in item 6.17 in the CEFPI section of this report, and on a scale of 1 to 10 the overall facility received a rating of 6 due to observed conditions, and due to the fact that it lacks some of the Ohio School Design Manual required elements.

Typical student desks and chairs

Teacher workstation

Recommendations: Provide for replacement of outdated or inadequate furniture.

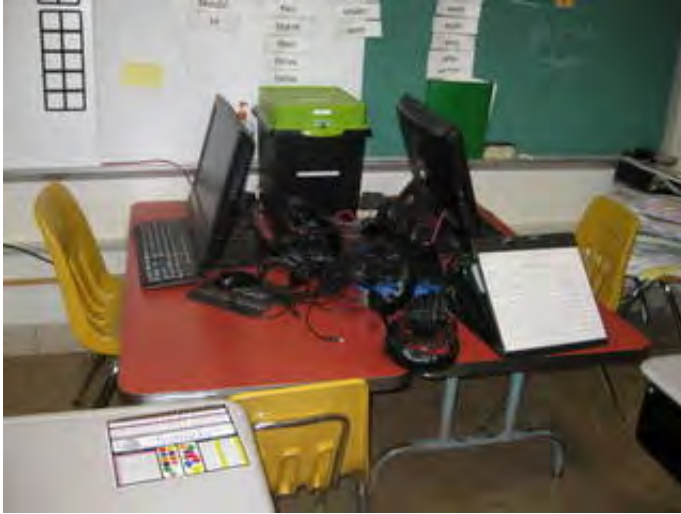
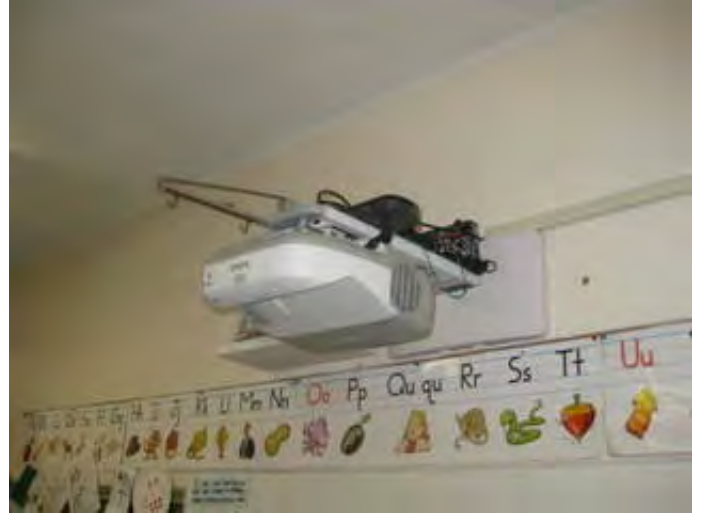
Student classroom computers

Short throw classroom projectors

Recommendations: Provide technology upgrades, wiring and systems per Ohio School Design Manual guidelines.

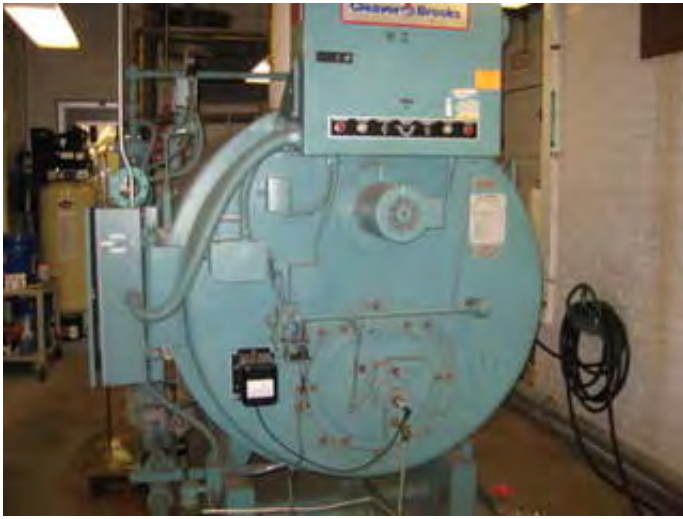
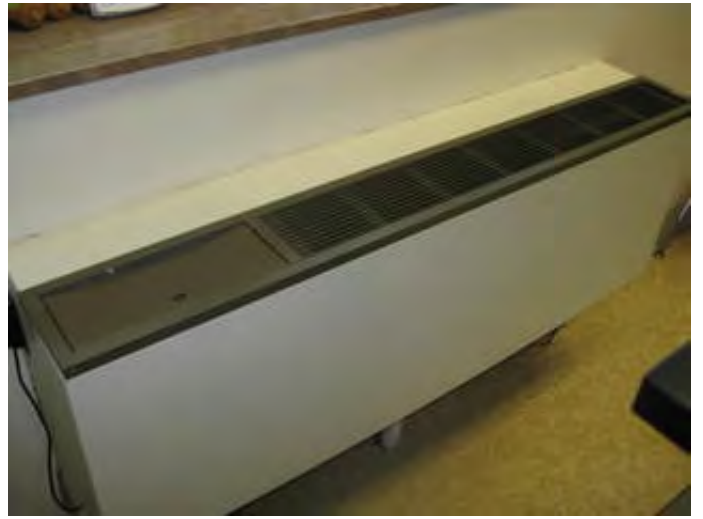
Gas fired boiler

Classroom unit ventilator

Provide new overall heating system, including air conditioning, to meet Ohio School Design Manual guidelines. Provide funding to convert existing non-ducted system to ducted air system in the overall facility. The clear area above finished ceilings will allow for the installation of ductwork.

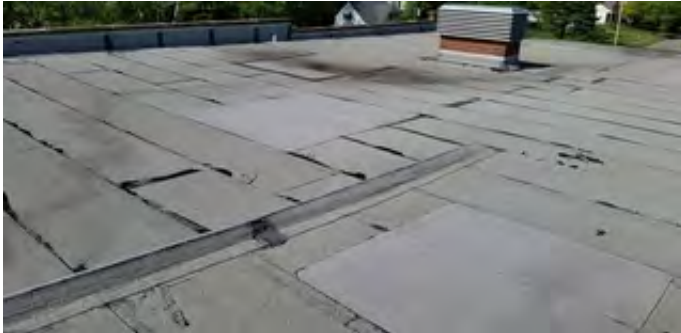
Asphalt roofing

The roof over the overall facility requires replacement to meet Ohio School Design Manual guidelines for age of system and due to condition. Stone coping at the 1905 original construction requires replacement due to condition. The flashing at the 1959 and 1965 additions requires replacement due to condition. Overflow roof drains are required throughout the overall facility. Provide for safety protection cage at the access ladder to the 1905 original construction and 1959 addition.

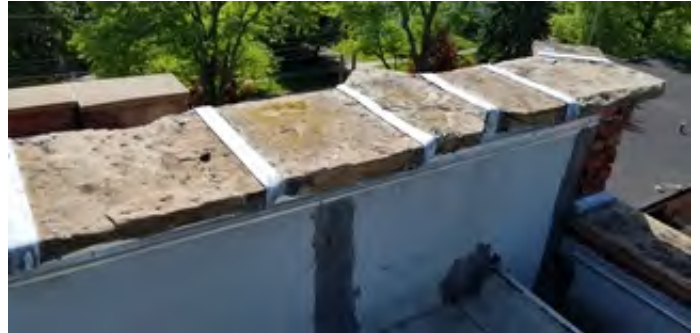
Stone coping with straps

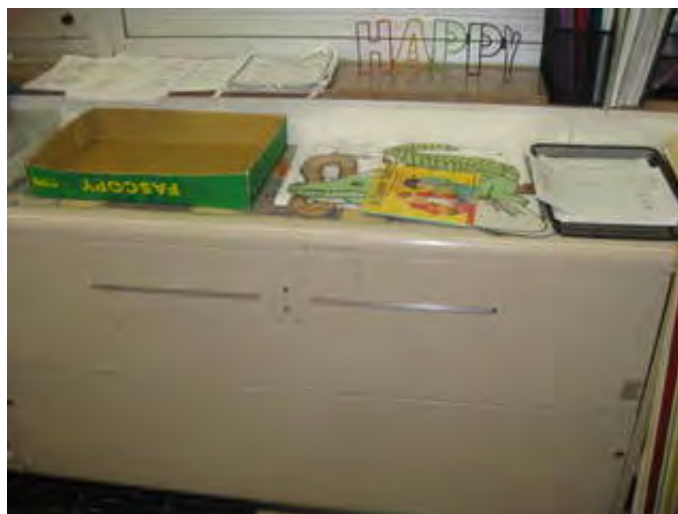
Classroom unit ventilator

Provide an air conditioning system throughout the overall facility to meet Ohio School Design Manual guidelines. Funding included in Item A - Heating System. Provide new restroom exhaust systems. Restroom exhaust systems provided with complete HVAC system replacement. Provide exhaust for existing art room kiln.

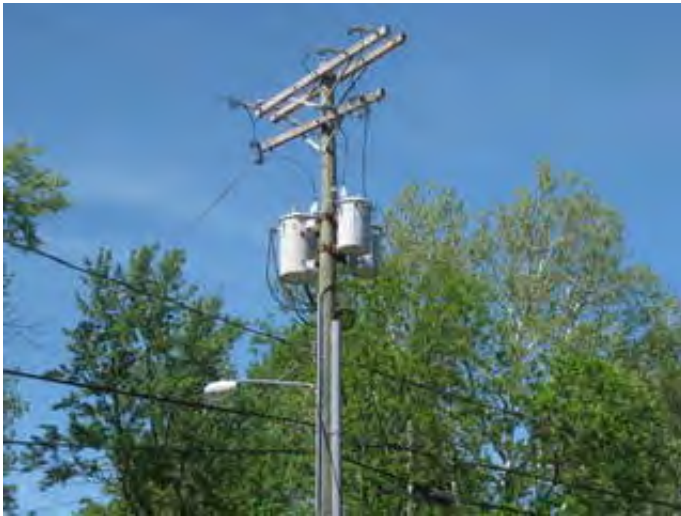
Pole mounted transformers

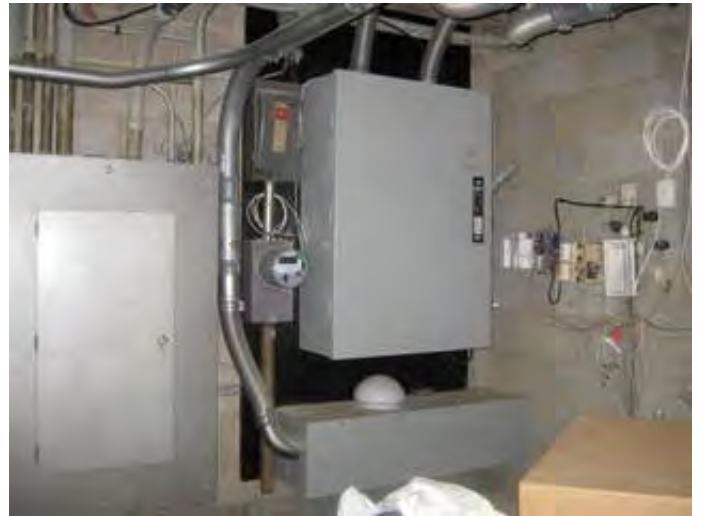
Main distribution equipment

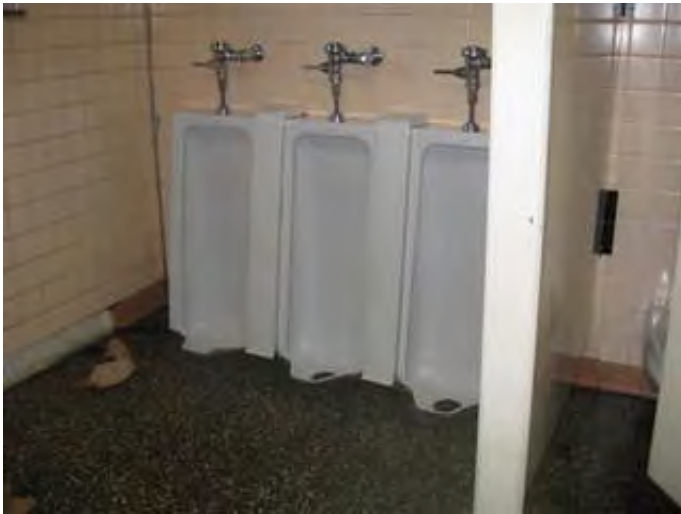
Floor mounted urinals

To facilitate compliance with OBC and OFCC fixture requirements, provide new toilets, new lavatory sinks, new urinals, and new electric water coolers. Provide wall hung urinals in locations of current floor mounted urinals. Provide wall patch at each wall to wall hung urinal replacement. See Item O for issues related to ADA requirements. Provide exterior hose bibs in 1905 original building.

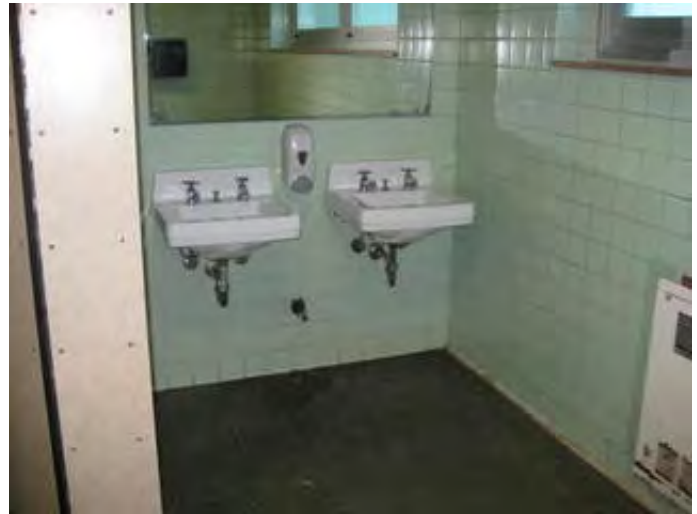
Wall mounted lavatories

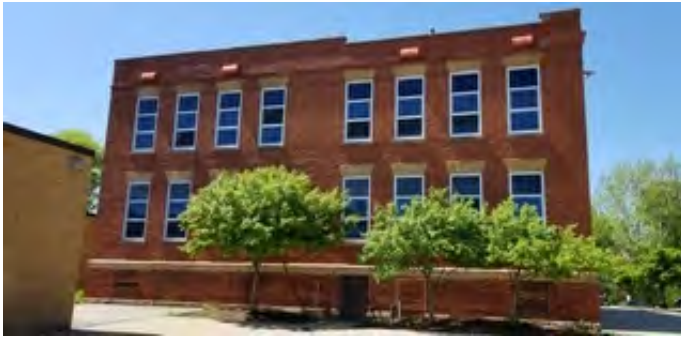
Windows at 1905 original construction

Recommendations: Replace single glazed window vision panels, transoms and sidelights in exterior doors of the overall facility with insulated and approved safety glass. No work is required in the 1992 atrium addition.

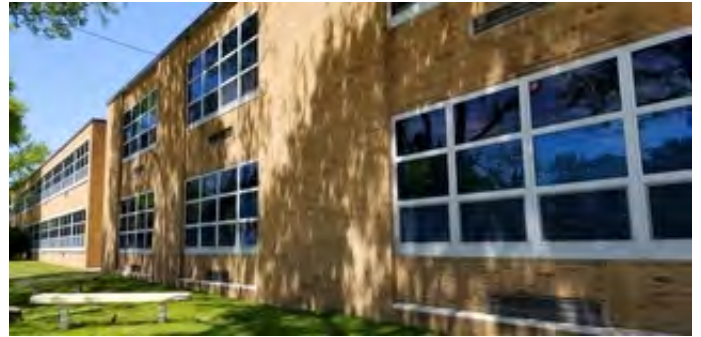
Typical classroom windows

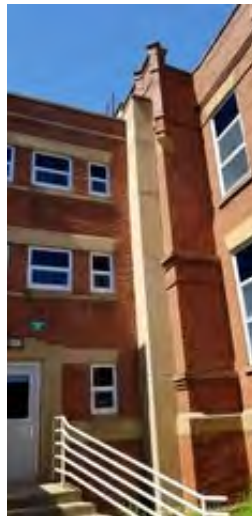
Description: The 1905 original construction has a brick and stone veneer on a masonry bearing wall system, which displayed several areas of deterioration, and is in generally fair condition, with some areas in poor condition. The exterior masonry appears to have sufficient control joints, as there is no cracking. The 1959 and 1965 additions have a brick veneer on a masonry bearing wall system, which displayed no locations of deterioration, and is in good condition. The exterior masonry appears to have appropriately spaced and adequately caulked control joints in fair condition. The 1992 atrium addition has a masonry unit type wall system, which displayed no locations of deterioration, and is in good condition. The exterior masonry appears to have sufficient control joints, as there is no cracking. The exterior masonry has not been cleaned and sealed in recent years. Architectural exterior accent materials consist of stone, which is in good condition. Interior walls are concrete masonry units, glazed block, and wood framed partitions with plaster and are in good condition. Interior masonry appears to have adequately spaced and caulked control joints in fair condition. The window sills are stone, and are in good condition. The exterior lintels are steel, and are in good condition. A chimney at the 1959 addition is in good condition, and is still required for the boiler system. The 1905 original construction, 1959 and 1965 additions utilize grilles for outside air intake at unit ventilators.

Brick veneer at 1905 original construction

Recommendations: Provide masonry cleaning and sealing as required throughout the overall facility. Provide masonry tuckpointing at the 1905 original construction due to condition. Provide for brick infill at exterior grilles following unit ventilator removal, including CMU back-up, rigid insulation, vapor barrier and exterior face brick.

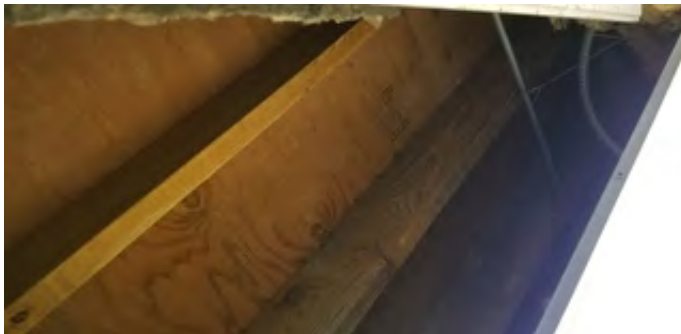
Wood flooring system in 1905 original construction

Recommendations: Provide for replacement of wood flooring system at the 1905 addition. Provide fire separation assembly for wood roof structure in the 1905 original construction. Refer to Item U for pricing of fire suppression system for wood structures. No work is required in the 1959, 1965 and 1992 additions at the present time.
