BEDFORD CITY SCHOOL DISTRICT

***Ohio Facilities Construction Commission
Classroom Facilities Assistance Program
Facilities Assessment Report***

***Submitted by
Harrison Planning Group
June 2018***

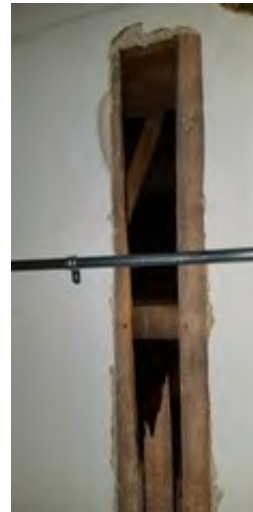
Wood roof structure at 1905 original construction

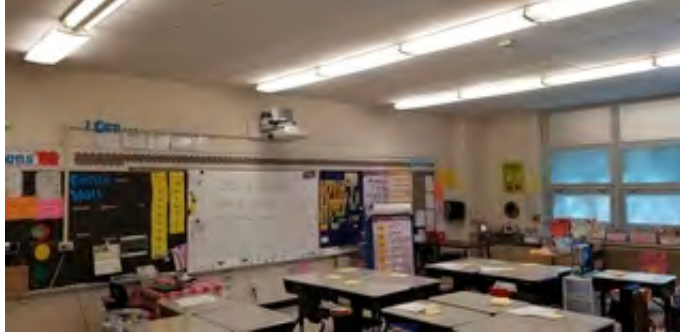
Typical classroom finishes

Provide complete replacement of finishes and casework throughout the overall facility due to installation of systems outlined in Items A, C, D, E, I, K, L, M, N, T, U, and due to condition. Provide for painting and acoustical ceiling at 1992 addition due to work outlined in Items A, C, D, E, K, L, M, N, T, and U. Provide plaster refinishing due to condition and work outlined in Items A, C, D, E, I, K, L, M, N, T, and U. Funding for replacement of interior doors is provided in Item O, including doors here noted as being in poor condition. Provide for repairs to terrazzo flooring due to condition. Provide for removal and replacement of wood flooring in classrooms at the 1905 original construction. Provide for replacement of basketball backboards due to age and condition. Provide for replacement of toilet partitions due to work outlined in Item O, and due to condition. Provide for replacement of toilet accessories due to age and condition. Provide for replacement of kitchen equipment due to age and condition of equipment.

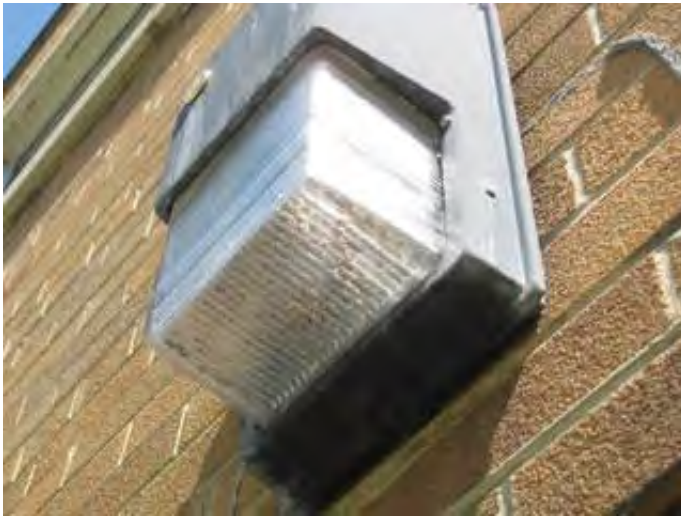
Wall mounted exterior lighting fixture

Recommendations: Provide upgrade to building security systems including additional security cameras, glass break sensors, door contacts, and motion sensors as desired from the district to more thoroughly protect the building during school hours and after school hours and to meet Ohio School Design Manual guidelines. Provide upgrade to exterior security lighting system to meet Ohio School Design Manual guidelines. Provide security fencing, as desired by the district, to more thoroughly protect the building during school hours and after school hours, by allocating a portion of the comprehensive security systems funding provided in this Item L- Security Systems.

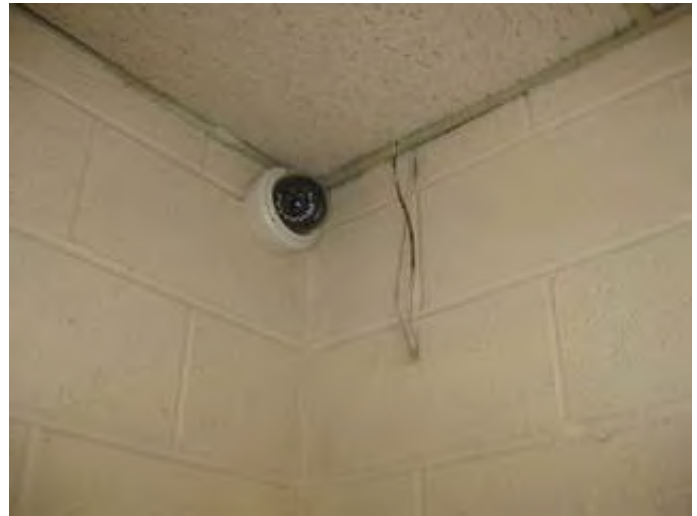
Corridor mounted security camera

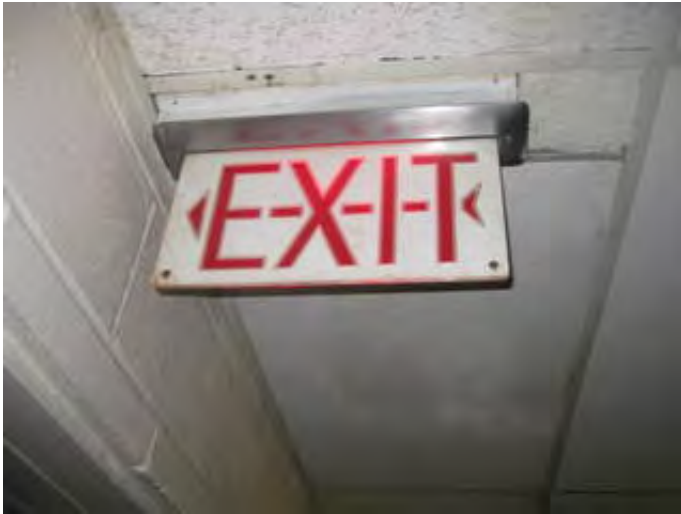
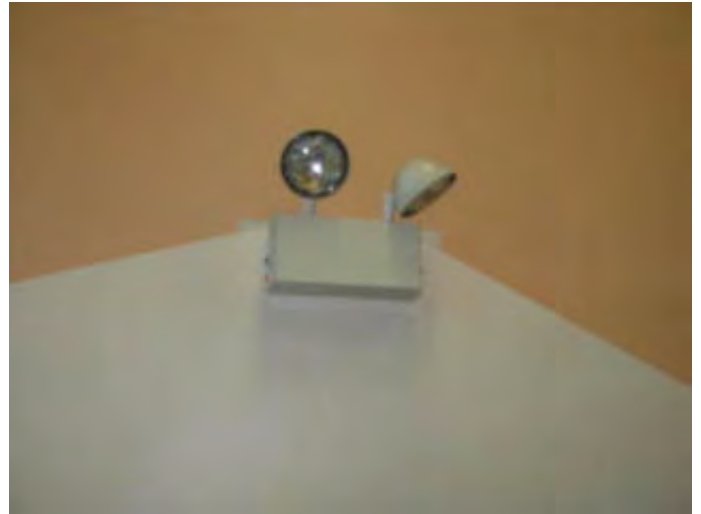
- Description:** The overall facility does contain an emergency/egress lighting system. The system is in poor condition and does not provide adequate coverage with exit signage or adequate illumination with emergency light fixtures.
- Rating:** 3 Needs Replacement
- Recommendations:** Provide complete replacement of emergency/egress lighting system to meet Ohio School Design Manual guidelines and as required to satisfy local fire and building officials as well as Ohio Building Code. Provide exit signage on separate electrical circuits. Supplement battery backup wall mounted emergency lighting fixtures to increase lighting levels in corridors and egress paths to at least 1.5-foot candles in all areas. Emergency power generator is funded under Item D - Electrical.

Exit signage

Emergency lighting

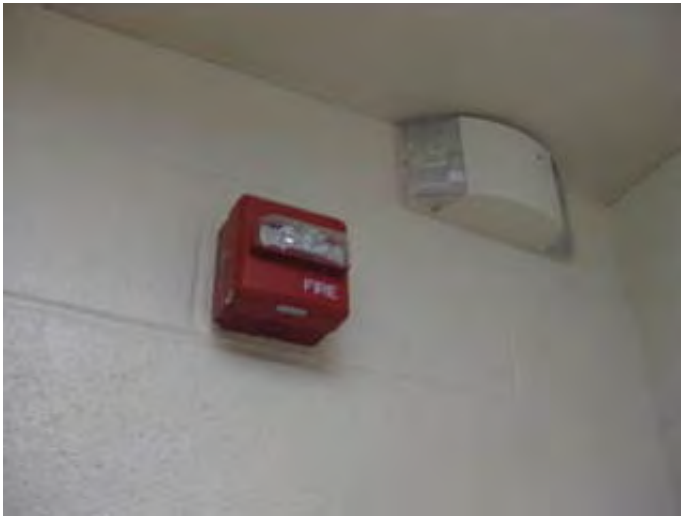
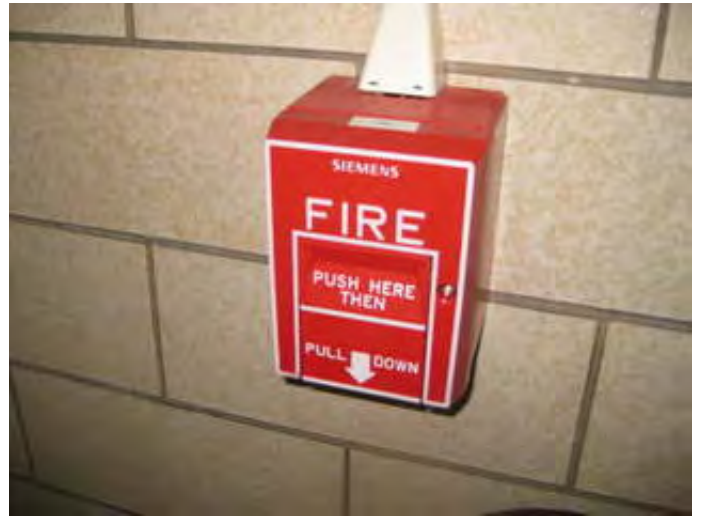
Description: The entire facility contains a fire alarm system in fair condition. Manual pull stations are mounted in corridors and at exits. Horns and strobes are mounted in corridors, the gym, and assembly areas. Mechanical equipment does not contain automatic fire alarm devices. There are no horns and strobes in the classrooms. The system is not adequately provided throughout and does not have additional zone capabilities. The fire alarm system does not meet NFPA requirements and Ohio School Design Manual guidelines.

Fire alarm horn strobe device

Fire alarm pull station

Recommendations: Provide complete replacement of fire alarm system consisting of manual fire alarm pull stations mounted at required heights, remote annunciator panels, automatic fire detection devices in all air devices and mechanical equipment, and horn/strobe devices located in all occupied spaces to meet Ohio School Design Manual guidelines.

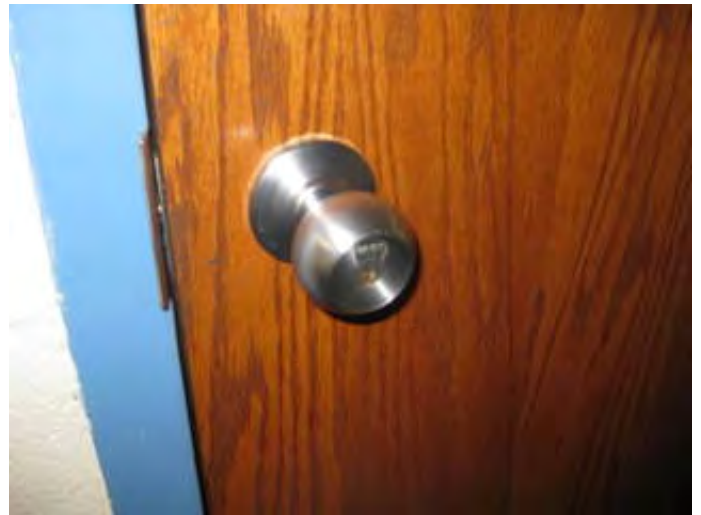
Non-compliant door hardware

Recommendations: Provide signage, elevators, drinking fountains, toilets, restroom accessories, sinks and toilet partitions to meet ADA requirements. Replace existing interior doors, door frames and door hardware. Rework narrow interior door openings to provide 3' x 7' door and hollow metal frame, door lite and hardware. Rework recessed interior doors and openings to allow for required clearances. Funding includes 3' x 7' door, hollow metal frame, door lite and hardware. Provide ADA door assist on exterior doors along accessible routes. Provide one elevator in the 1905 addition and one elevator in the 1959 addition.

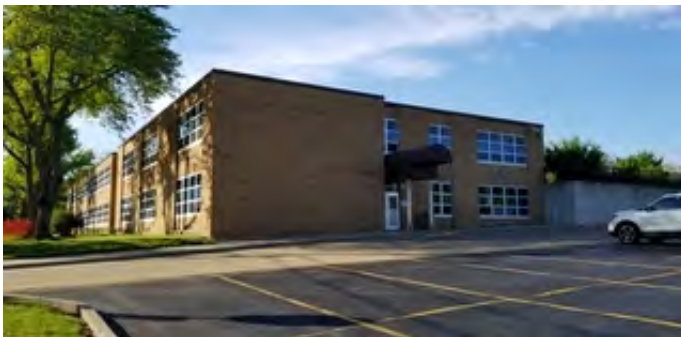
Asphalt pavement in parking lot

Provide for removal of playground equipment due to condition. Provide for replacement of playground equipment in poor condition. Provide for replacement of asphalt pavement in poor condition. Provide for replacement of heavy duty asphalt pavement in poor condition. Provide for replacement of concrete sidewalks in poor condition. Provide exterior steps and handrail at the kitchen area of the 1959 addition to meet safety requirements. Provide site contingency allowances for unforeseen conditions.

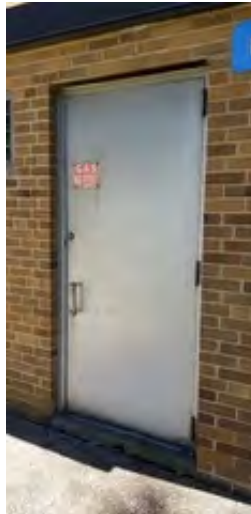
Exterior door at service area

Recommendations: Provide for replacement of doors in poor condition. See Item F for replacement of single glazed vision panels, transoms and sidelights. No work is required in the 1905 original construction, 1965 and 1992 additions at the present time.

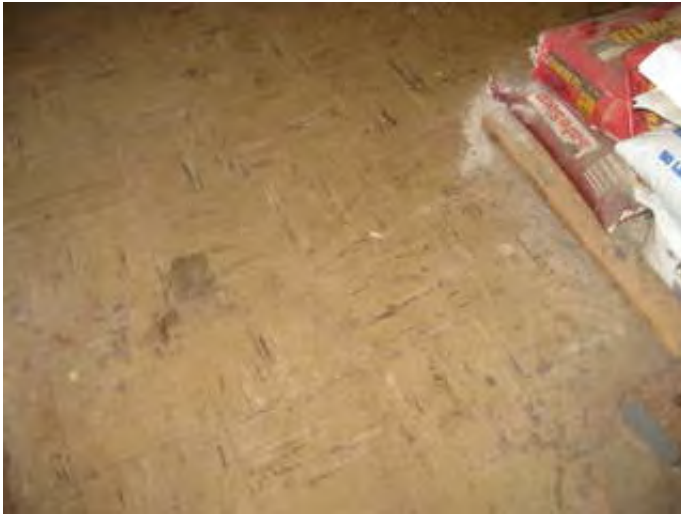
Assumed hazardous flooring material

Recommendations: The Ohio Facilities Construction Commission requires removal of all hazardous material within school facilities. The district performed a previous project funded by a bond issue that removed hazardous materials. OFCC will engage the services of an independent Enhanced Environmental Assessment (EEA) Consultant to perform an EEA to confirm scope and budget.

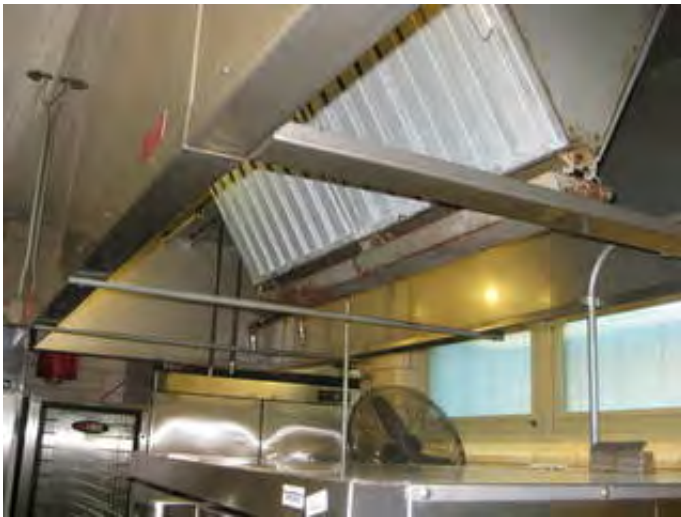
Kitchen hood fire suppression

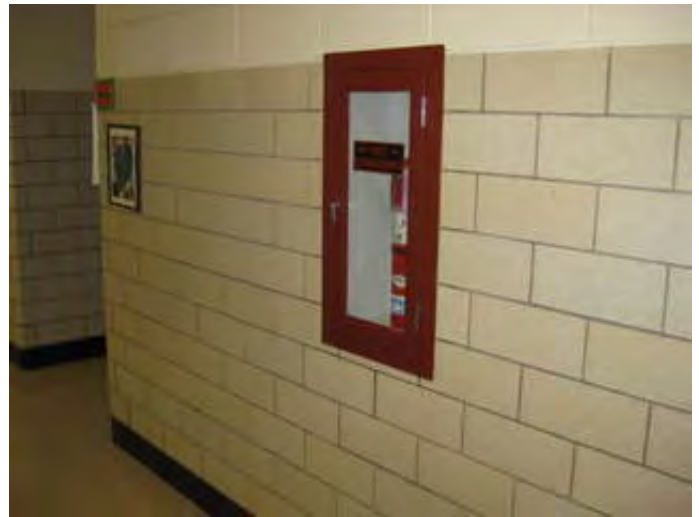
Fire extinguisher cabinet

Item	Cost	Unit	Whole Building	1905 Original Construction (1905) 16,466 ft²	1959 Addition (1959) 25,650 ft²	1965 Addition (1965) 12,720 ft²	1992 Atrium Addition (1992) 2,351 ft²	Sum	Comments
Sprinkler / Fire Suppression System:	\$3.20	sq.ft. (Qty)		16,466 Required	25,650 Required	12,720 Required	2,351 Required	\$182,998.40	(includes increase of service piping, if required)
New Exterior Stair Enclosure	\$42,500.00	per level		1 Required	1 Required			\$85,000.00	(all inclusive)
Water Main	\$40.00	in.ft.			250 Required			\$10,000.00	(new)
Handrails:	\$5,000.00	level			3 Required			\$15,000.00	
Other: Back-flow preventer at fire main	\$6,000.00	each		1 Required				\$6,000.00	Provide back-flow preventer at water fire service.
Other: Fire extinguishers and cabinets	\$0.12	sq.ft. (of entire building addition)		Required	Required	Required	Required	\$6,862.44	Provide fire extinguishers and cabinets adequately spaced and mounted at required ADA mounting heights.

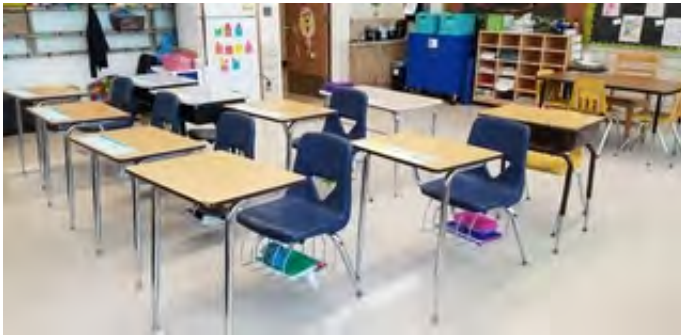
Rating: 3 Needs Replacement

Typical student desks and chairs

Recommendations: Provide for replacement of outdated or inadequate furniture.

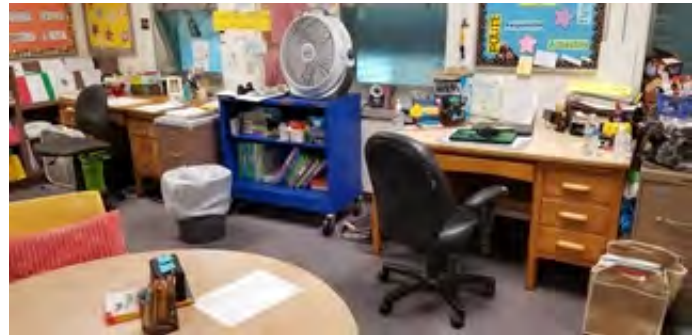
Typical teacher desk and workstation

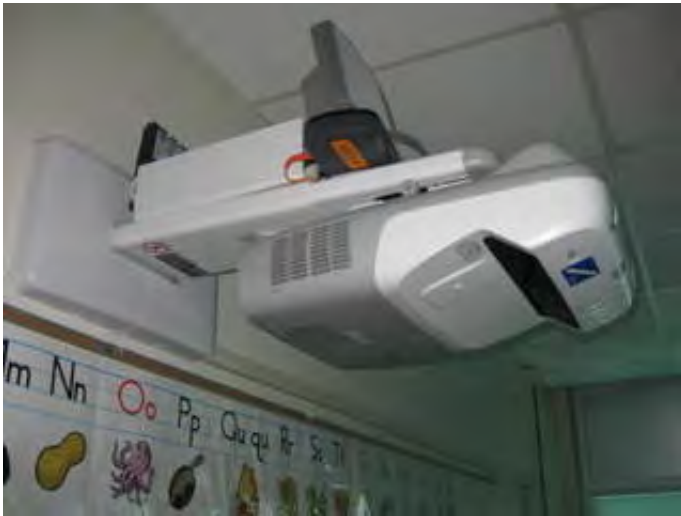
Rating: 3 Needs Replacement

Classroom projector

Recommendations: Provide partial technology upgrades, wiring and systems per Ohio School Design Manual guidelines.

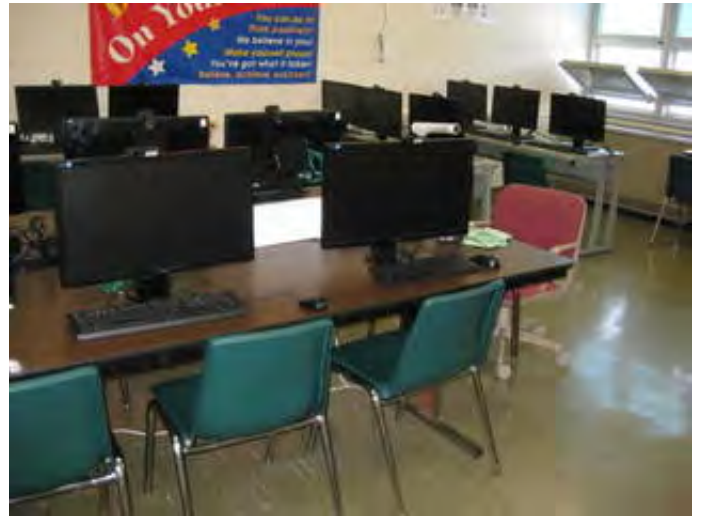
Computer lab
