ATHLETIC FACILITIES CONDITION ASSESSMENT

Roanoke County Public Schools
Roanoke, Virginia

July 30, 2018

Draper Aden Associates
Engineering • Surveying • Environmental Services

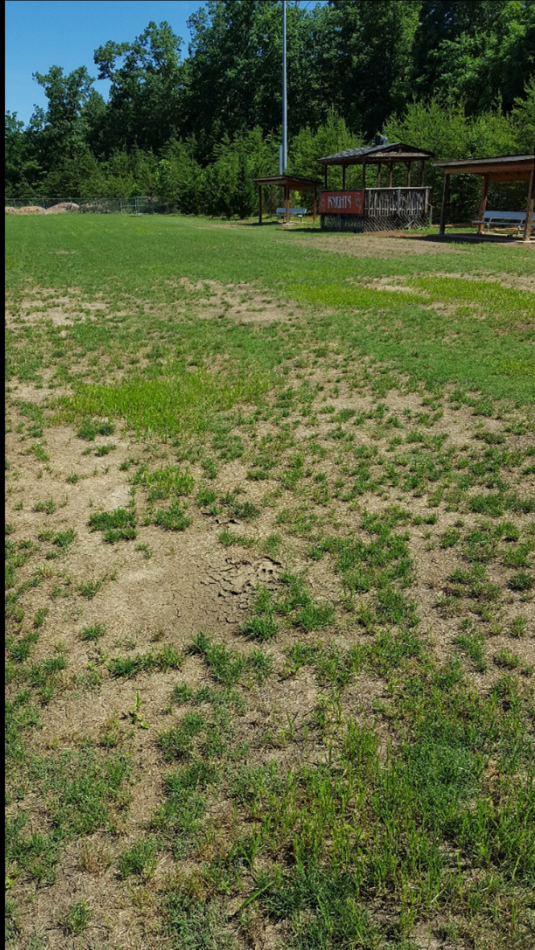
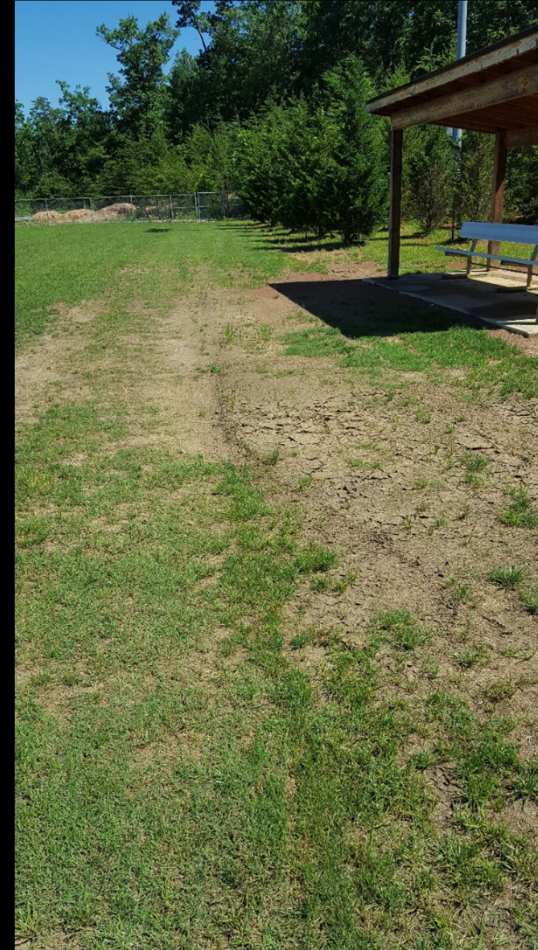
- ◆ Existing Condition
 - Natural grass field that is mostly covered, however there are some areas where the grass is sparse or barren. These barren areas are located in high wear areas such as, front of goals, penalty kick, center field, and sidelines.
 - The field is crowned in the center but there are some subtle planarity changes across the field. There is evidence that water ponds in these areas.
 - Bleachers seem to be in good condition. DAA recommends an evaluation by a structural engineer
 - End netting behind each goal is sagging.
 - The field average G-MAX tests result was 123 which falls within ASTM maximum allowed of 200.

01. Barren Area and Signs of Ponding Water

02. Barren Area and Signs of Ponding Water

- ◆ Recommendations
 - Short Term:
 - Sand dress the low areas causing planarity issues to create a smooth surface. This will also temporarily help drainage.

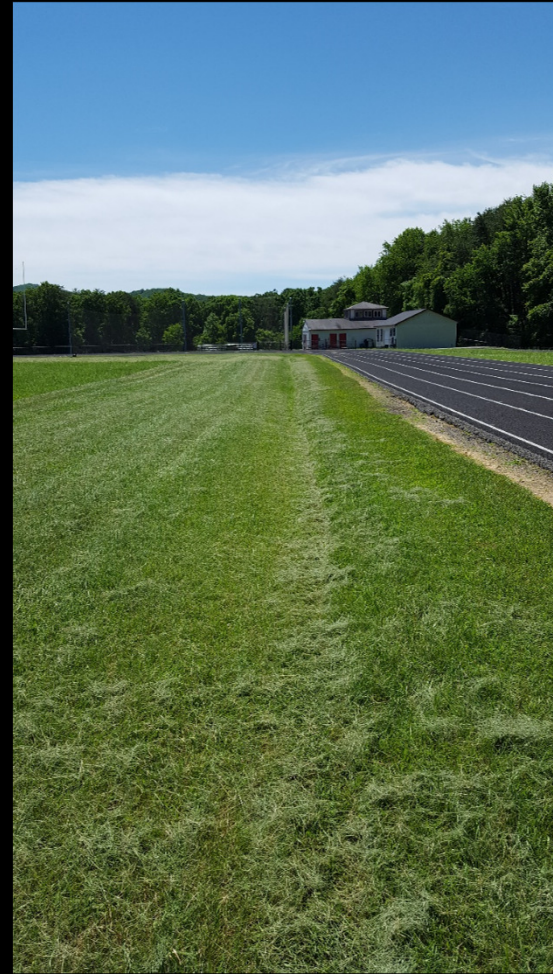
01. Large Drainage Ditch

02. Large Drainage Ditch

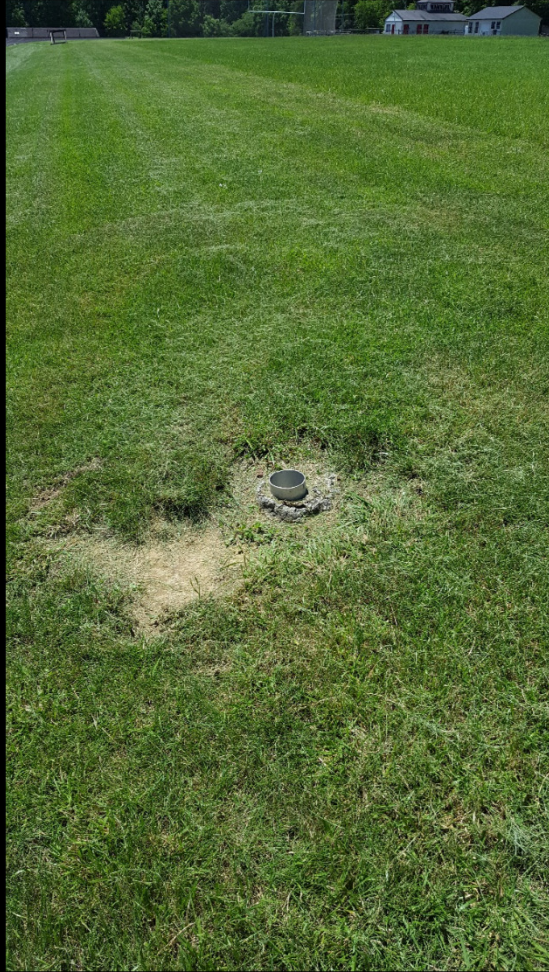
- Net sleeve location could be a safety hazard if a player fell on it.
 - Although the G-MAX value of the field was satisfactory, the soil was wet due to significant amount of rain in the area recently. As the field becomes hard and dry during the summer, care should be taken to keep the field subsoil moist in order to maintain a safe G-MAX value.

03. Net Sleeve

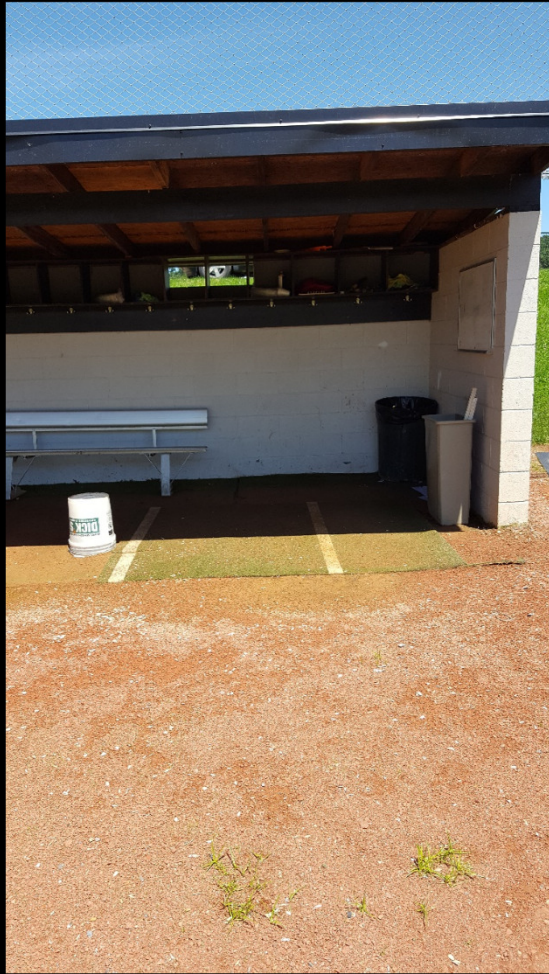
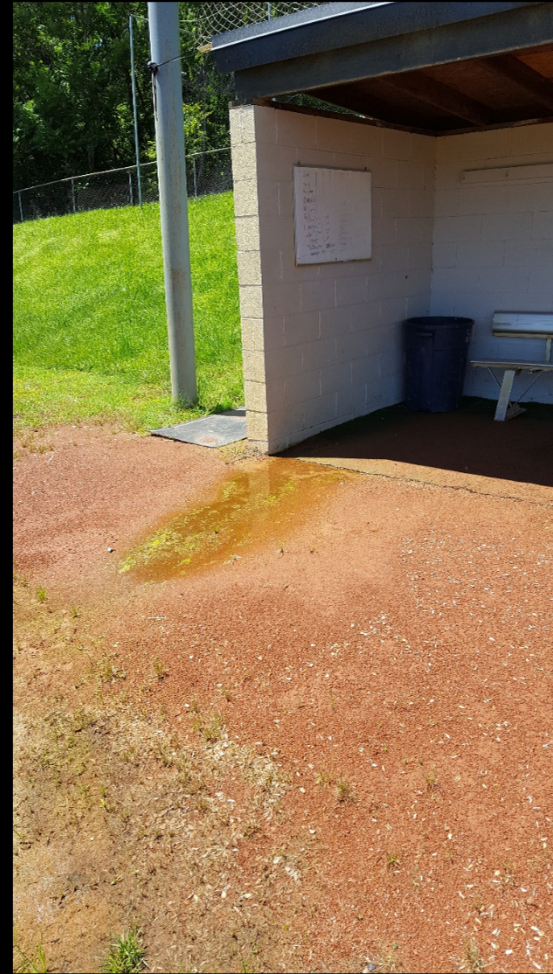
- Natural grass field in good condition.
- Standing water in each dugout
- Set of bleachers on left field side of home plate require repair.

01. Standing Water in Dugout

02. Standing Water in Dugout

- Address the drainage issues at each dugout utilizing a French drain system.
- Repair backstop netting at corner of right field dugout.

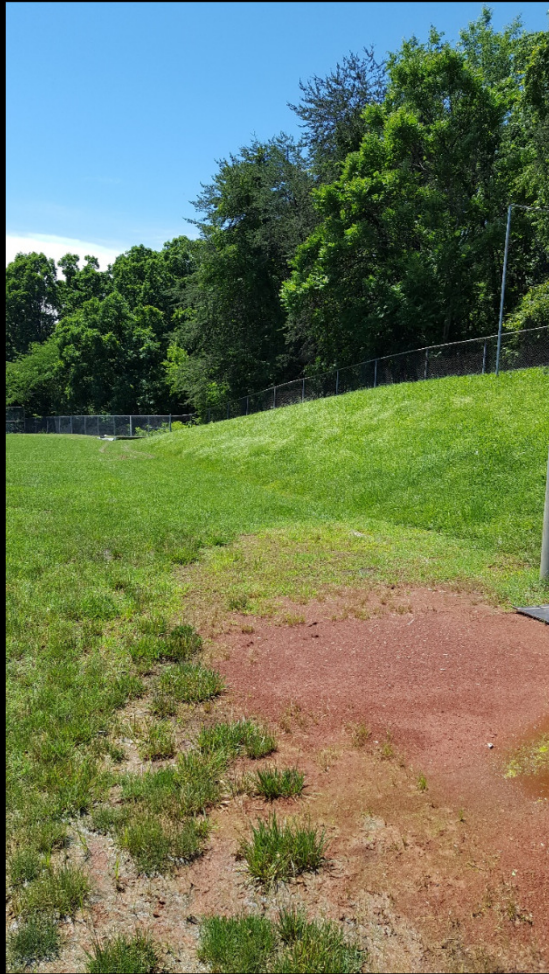
03. Slope Down Right Field Line

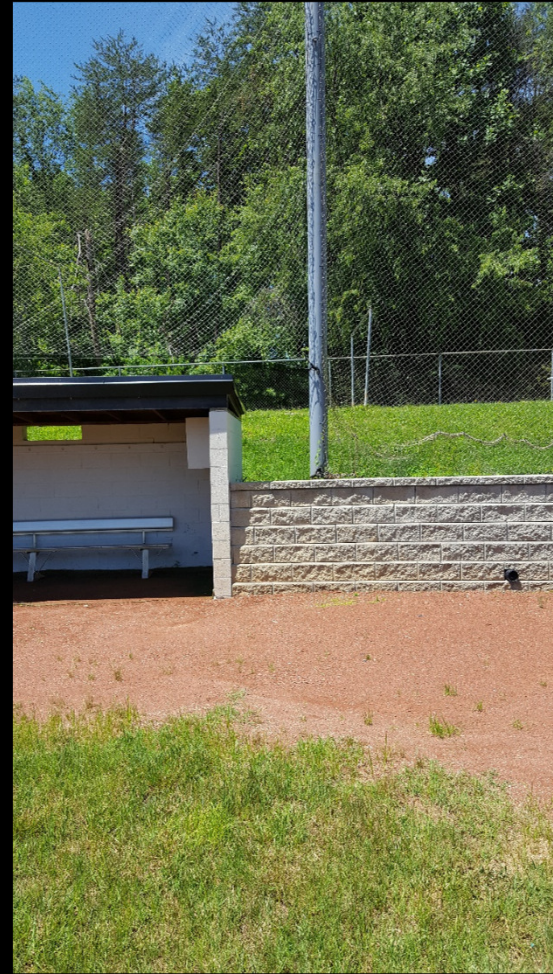
04. Hole in Safety Netting

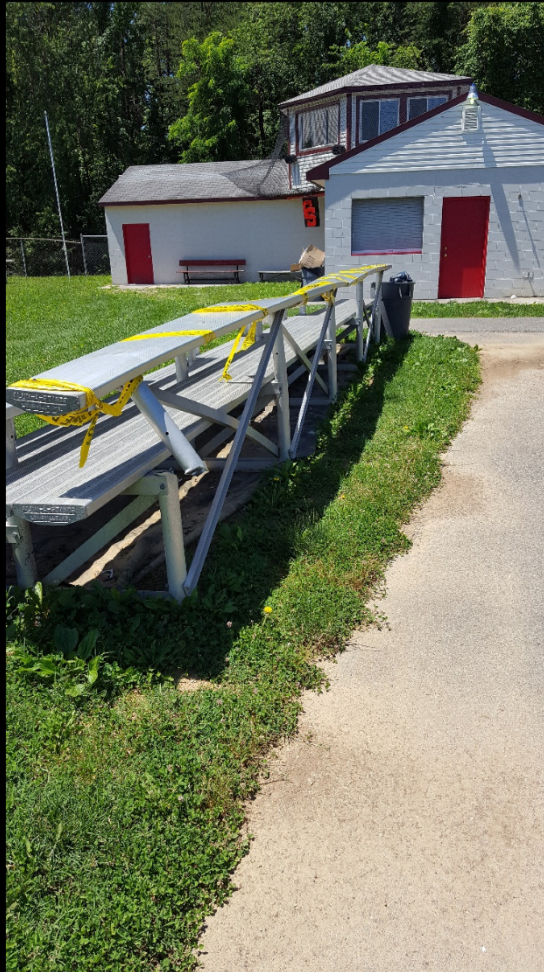
05. Bleachers

- Repair set of bleachers on left field side of home plate.
- Aerate, seed, and fertilize the field regularly to provide a good stand of grass and even playing surface.

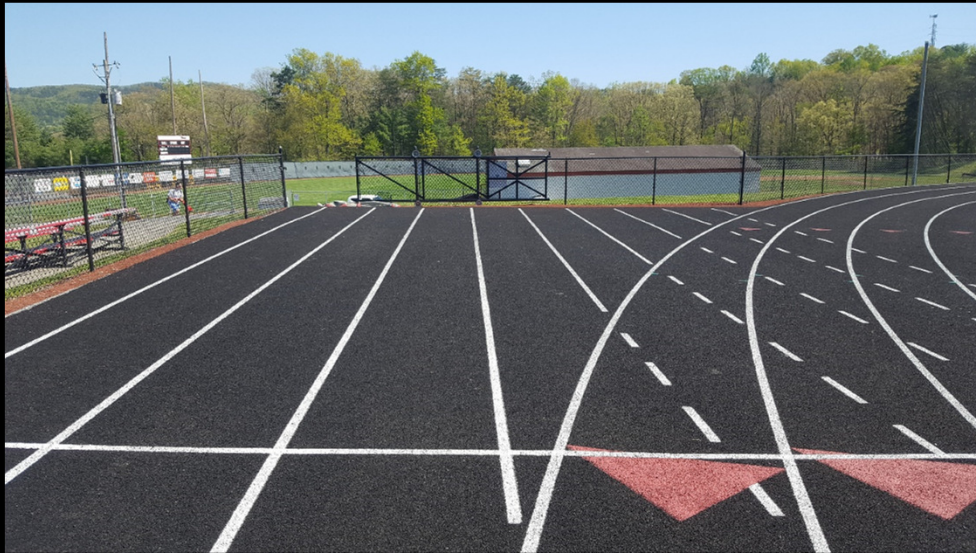
01. Striping

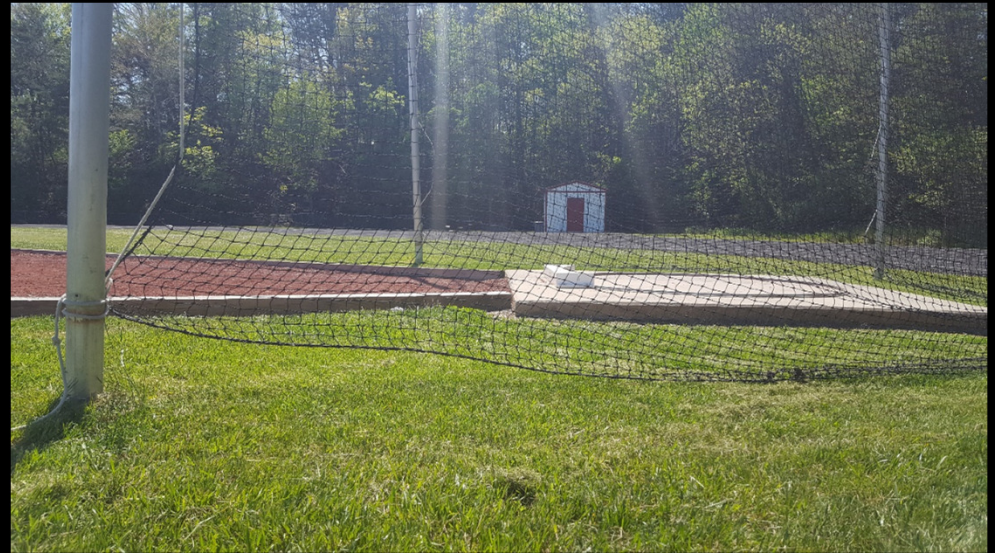
02. Shot Put Circle

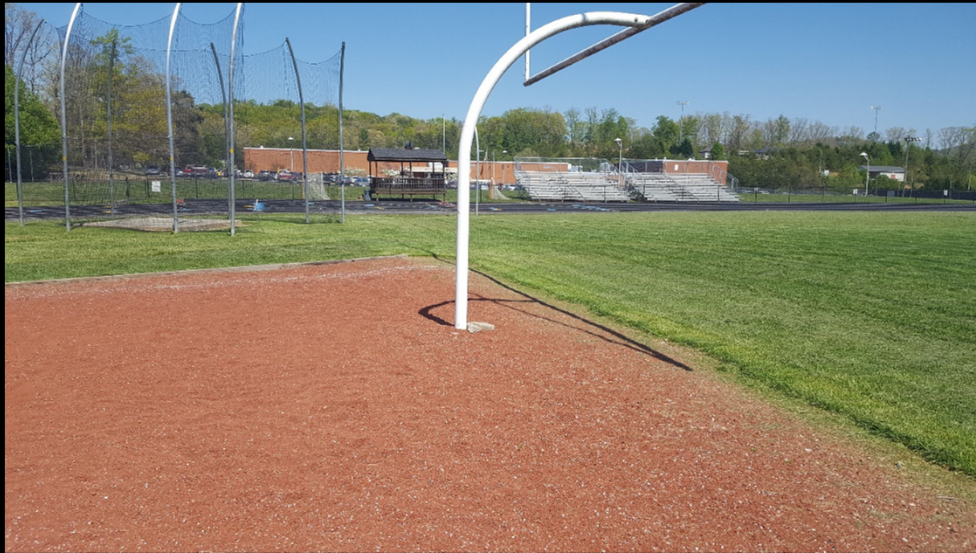
03. Goal Post in Shot Put Landing Area

- Install trench drain along sides of field at inside edge of track
- Remove and replace synthetic surfacing within approximately 3-5 years
- Relocate or reorient shot put landing area to avoid football goal post.
- Regrade the field with laser grading equipment to ensure acceptable planarity.

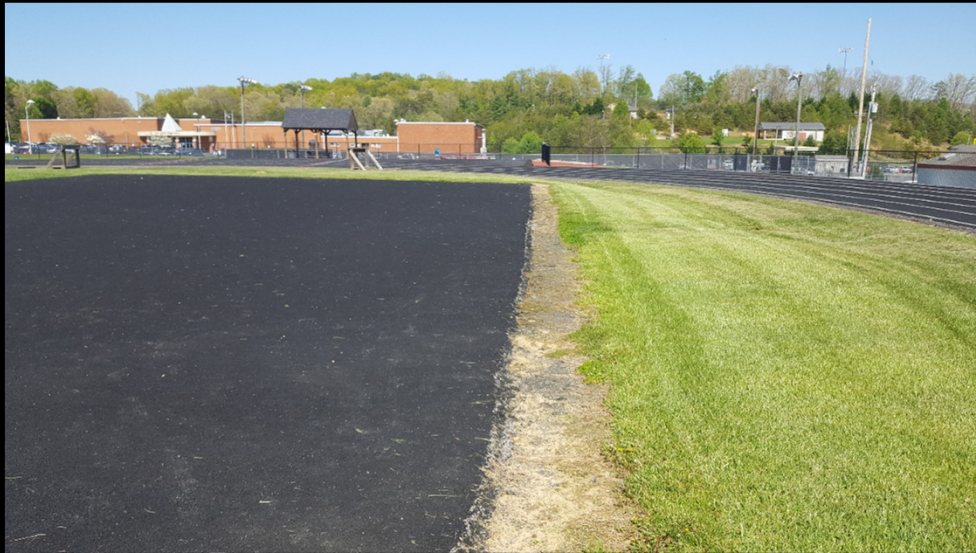
05. Swale in Grass Field

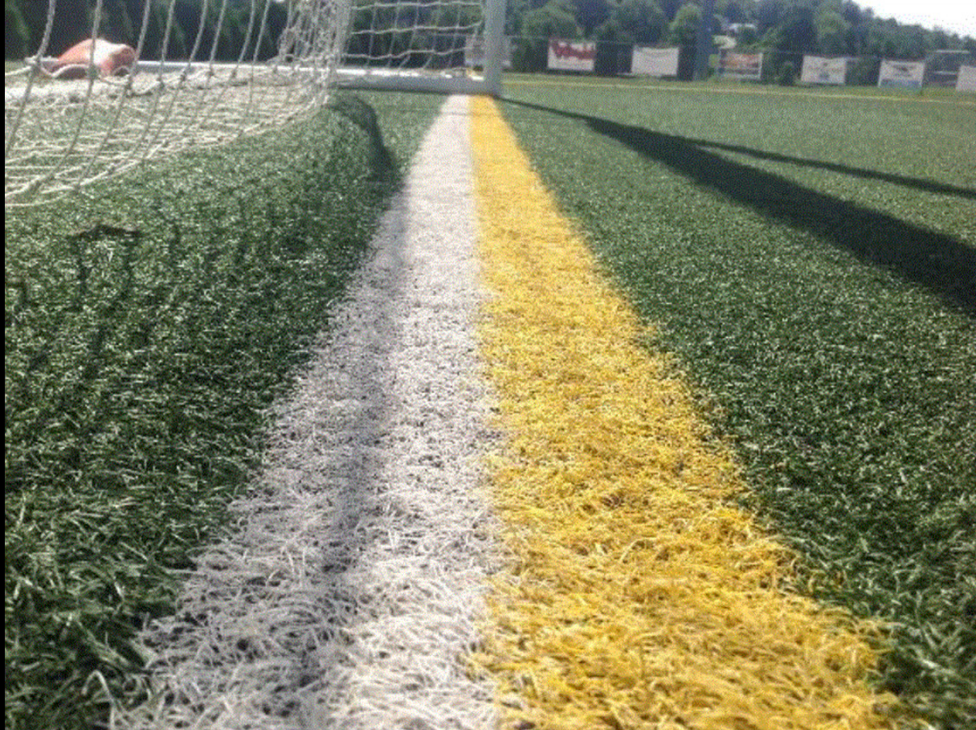
- ◆ Existing Condition
 - Synthetic turf surface (Field Turf Duraspine). The field was installed in 2007 making its age 11 years.
 - The infill material is a mixture sand and rubber. The depth of infill ranged from approximately 1.25" – 1.5" with pile height approximately 2.0".
 - Fibers are laying over and are starting to coil.
 - The penalty kick line on the south end of the field been replaced but is coming loose. This area needs to be repaired.
 - A repair was previously made on the north end of the field at approximately the 2 ½ yard line.
 - There were slight planarity changes near midfield.
 - Signs of weeds/grasses growing along the edge of the synthetic turf field.
 - The average G-MAX test result for the entire field was 140 which falls within the ASTM maximum allowed of 200.
 - Bleachers seem to be in good condition. DAA recommends an evaluation by a structural engineer.

01. Fibers Laying Over and Coiling

- Plan to replace the synthetic turf field within the next 2 years. Contact Draper Aden Associates prior to replacing the existing turf to discuss school needs and product options.

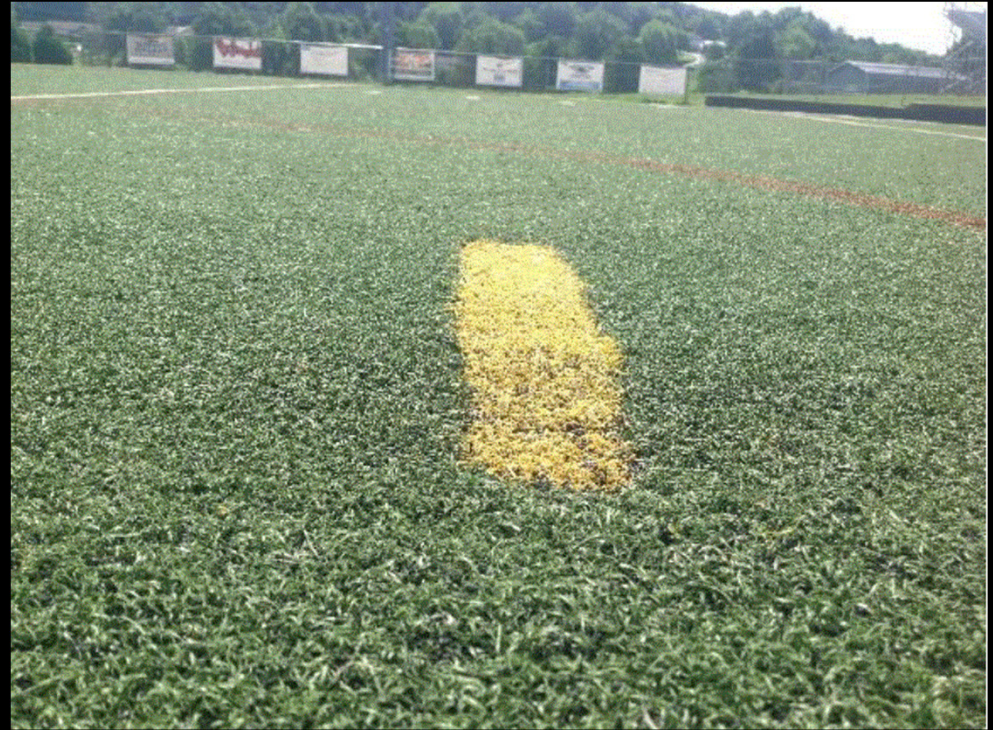
02. Planarity Issue

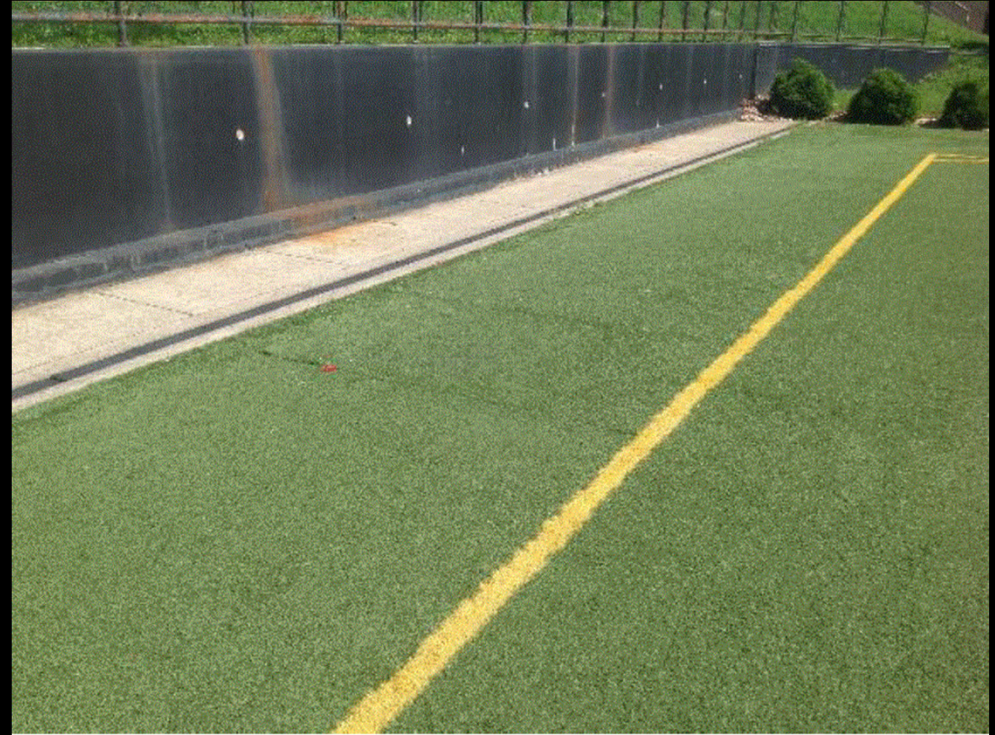
06. Seam and Planarity Issue

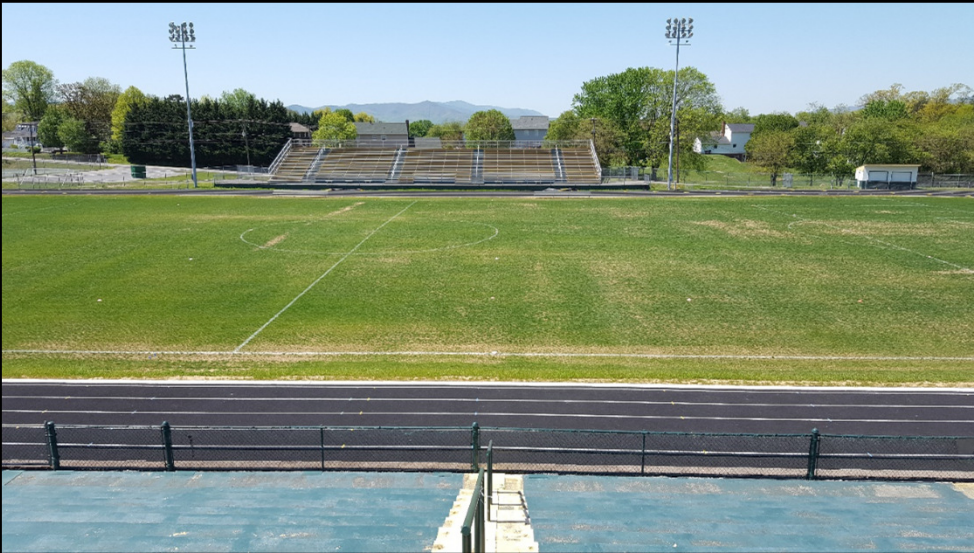
- ◆ Existing Condition
 - Natural grass field that is mostly covered, however there are a few areas where the grass is sparse or barren. These barren areas are located in high wear areas such as, front of goals, penalty kick, center field, and sidelines.
 - Perimeter fence requires repair in some locations.
 - The field average G-MAX tests result was 63 which falls within ASTM maximum allowed of 200.
 - The fence in front of the home side bleachers requires repair in some locations.
 - Asphalt in front on visitor side bleachers requires repair in one location.
 - Parking lot adjacent to tennis courts and the asphalt walk entering the stadium from this parking needs asphalt and subgrade repair.

01. Barren Areas

- ◆ Recommendations
 - **Short Term:**
 - Sand dress the low areas that are causing planarity issues to create a smooth surface. This will also temporarily help drainage.

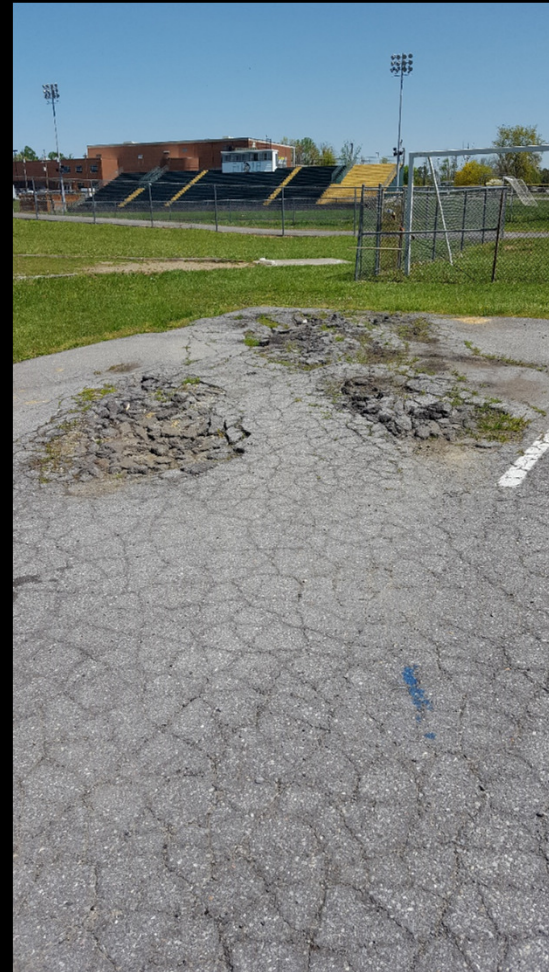
08. Tennis Court Parking Lot

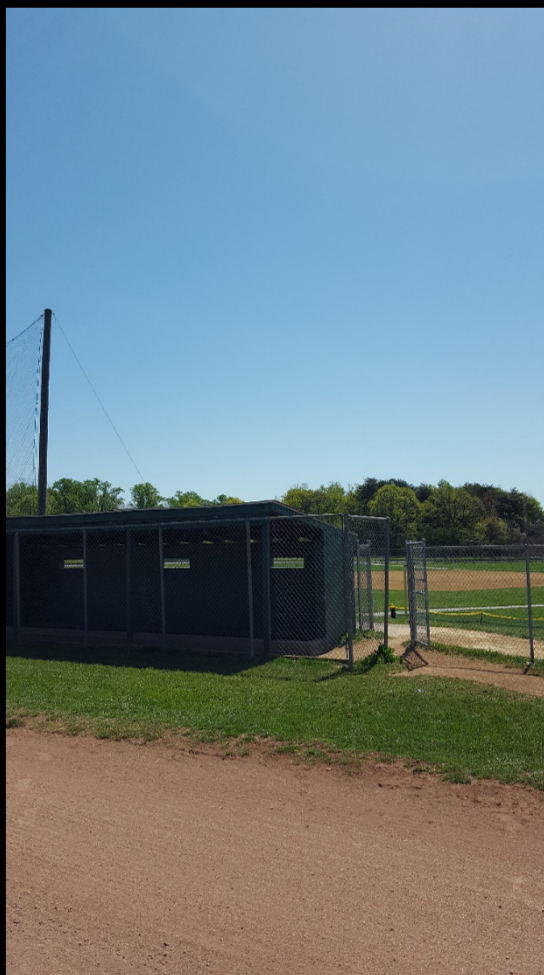
03. Extend Safety Netting Along Right Field

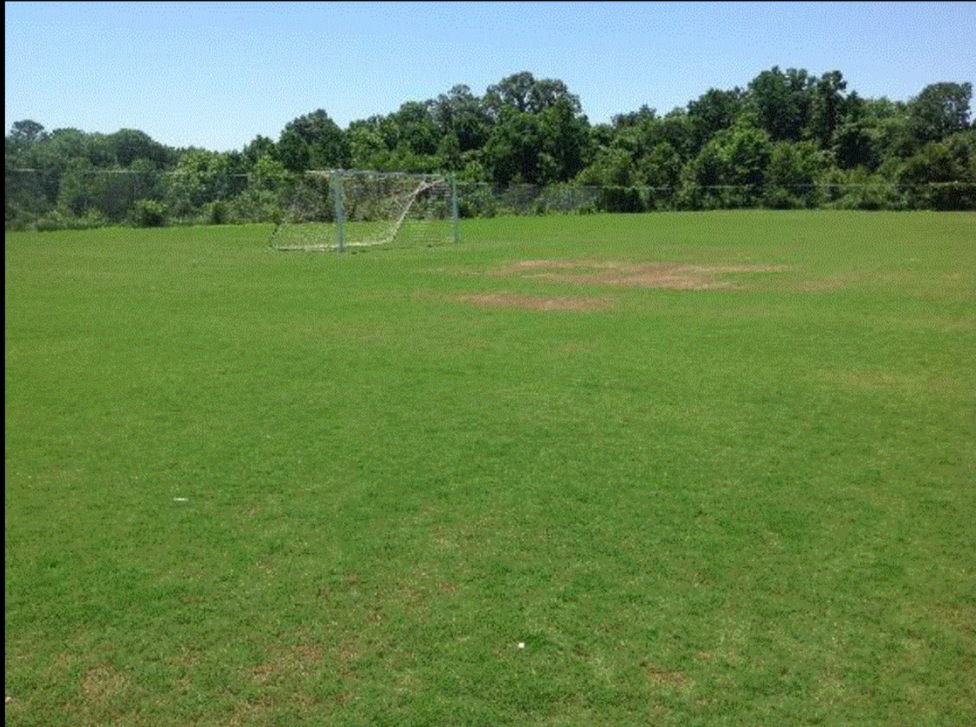
01. Barren Spots and No End Netting

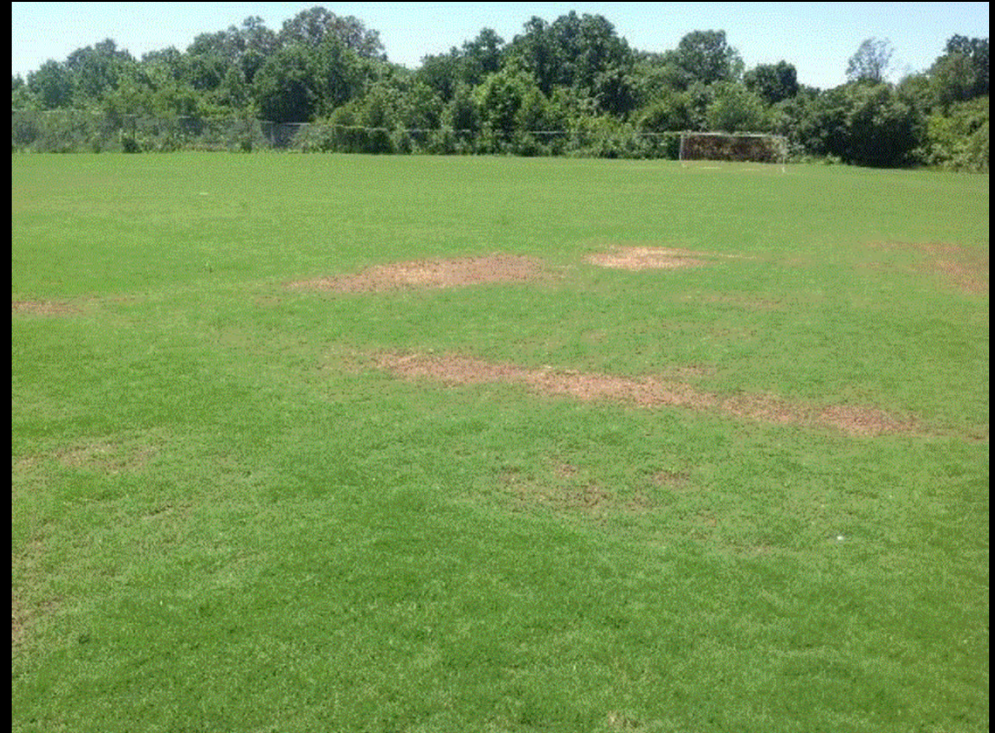
02. Barren Spots in Turf

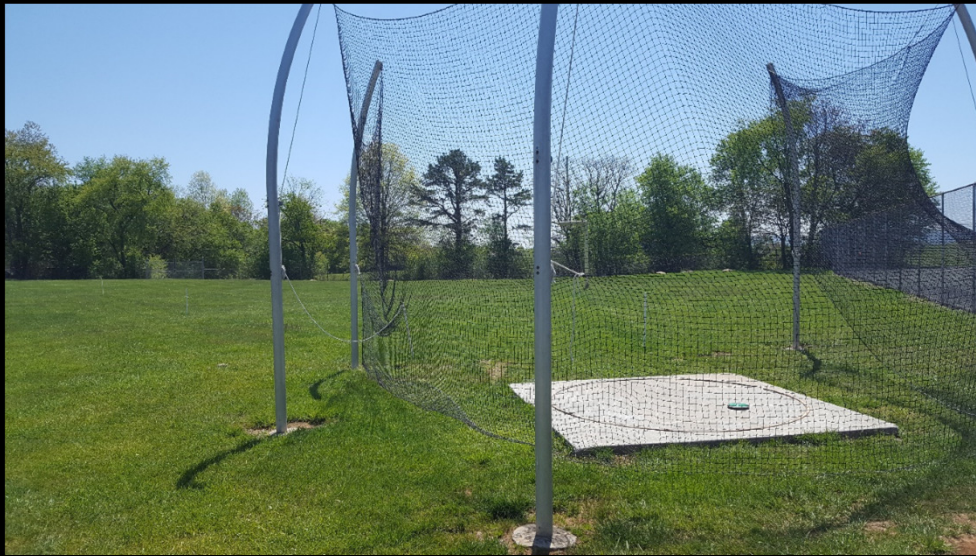
03. Discus Cage Netting Sag

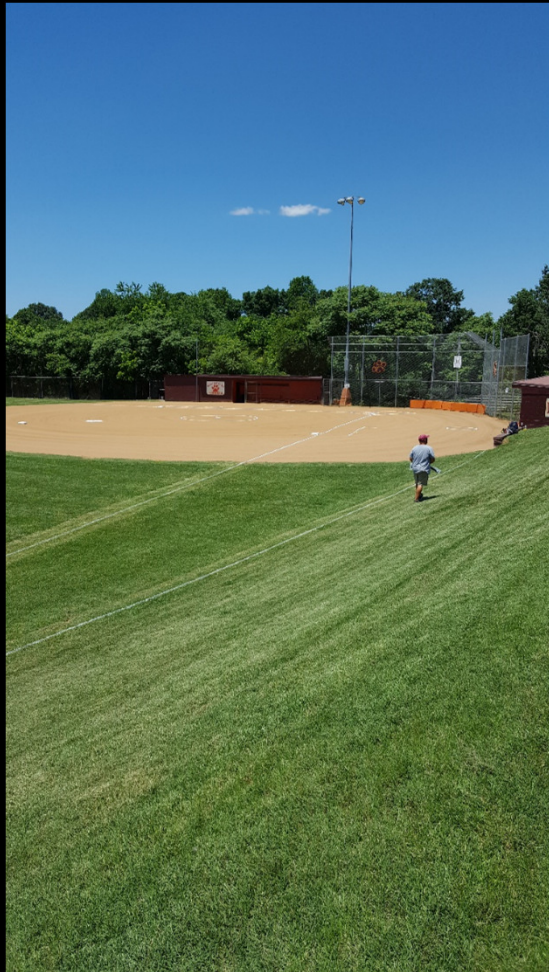
01. No Fencing Along Left Field Line

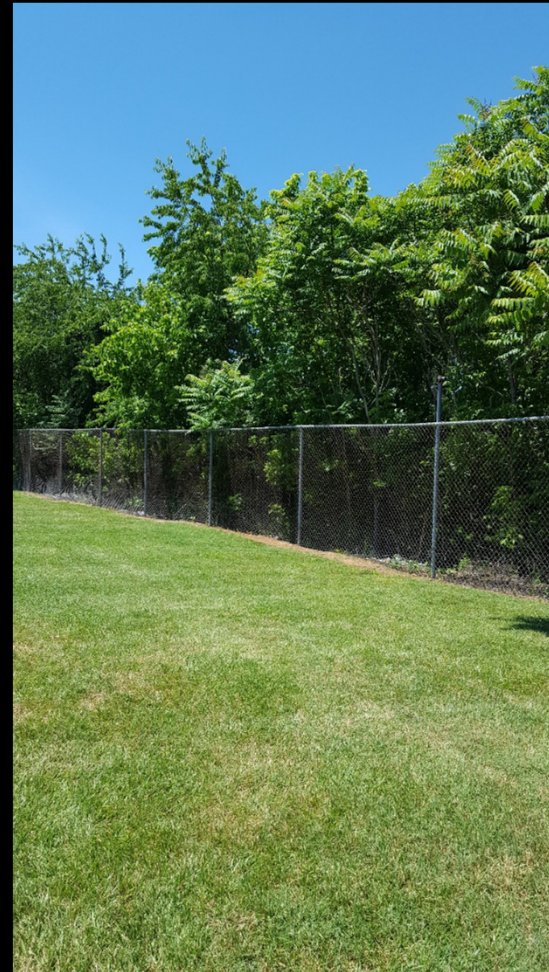
02. Trees Needing Trim Along Right Field Line

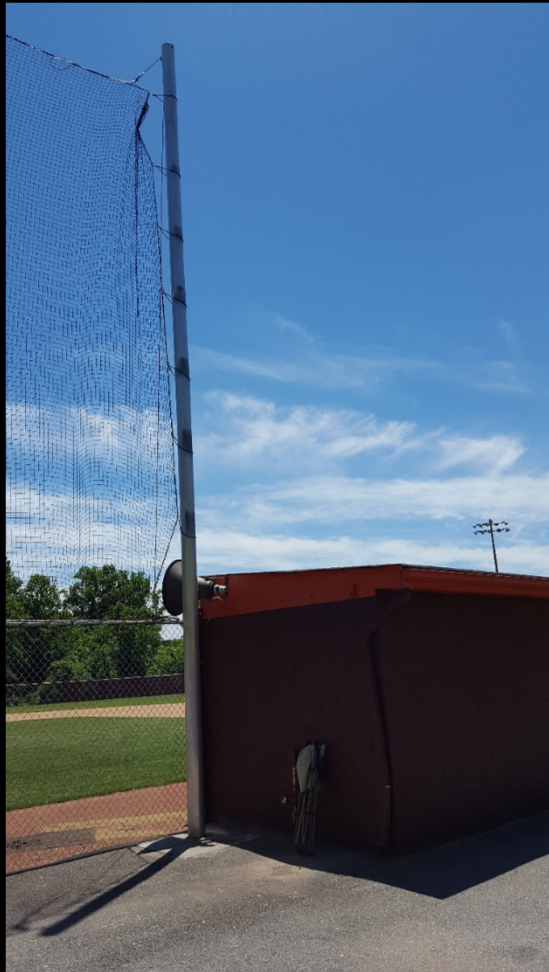
01. Extend Safety Netting Down Right Field Line

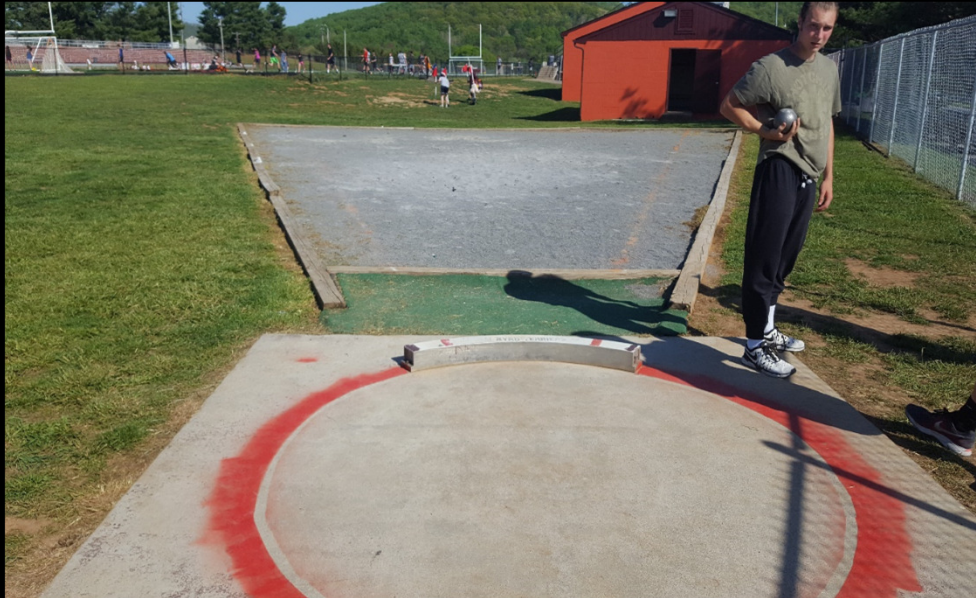
03. No Shot Put Circle Ring

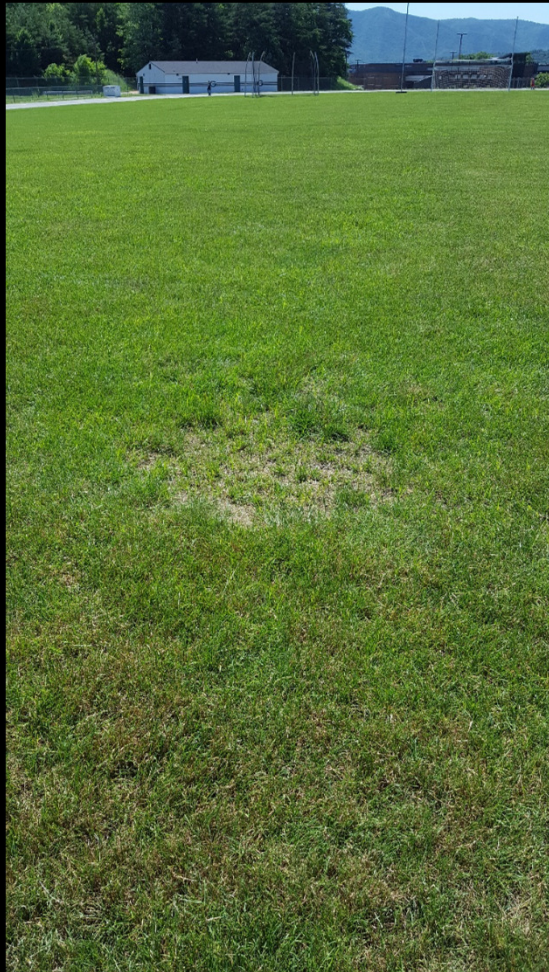
01. Barren Areas and Planarity Changes

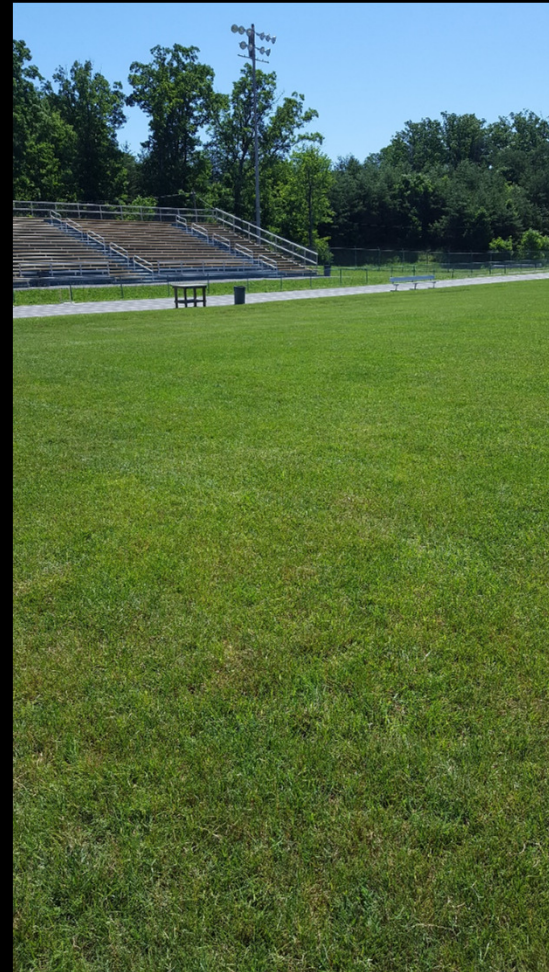
02. Planarity Changes

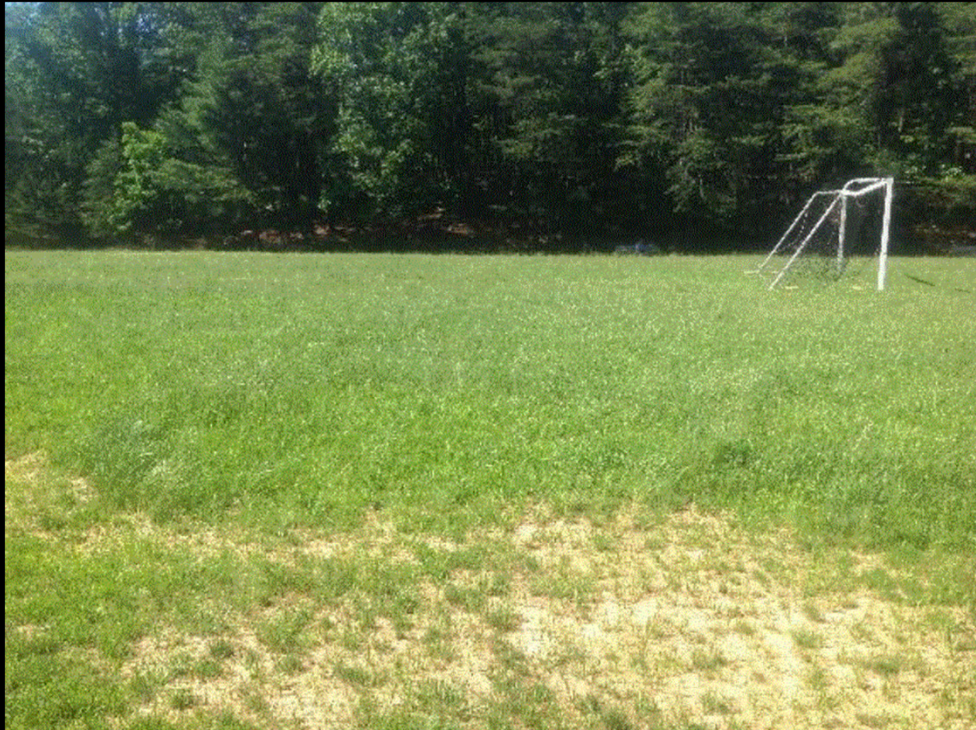
01. Barren Areas and Planarity Changes

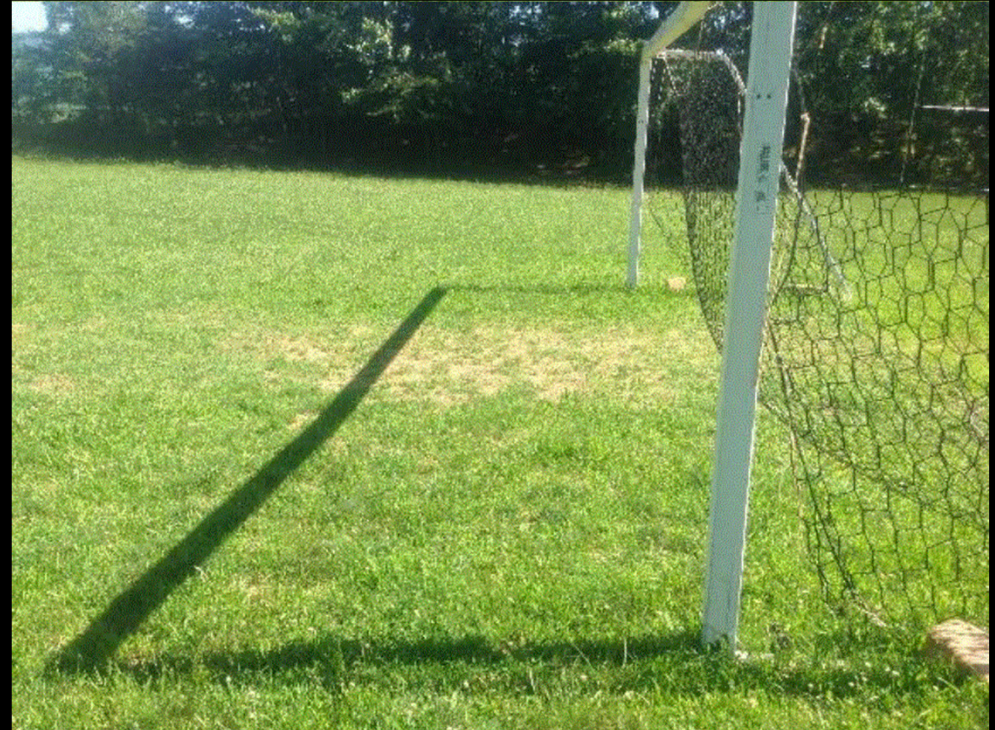
02. Barren Areas and Planarity Changes

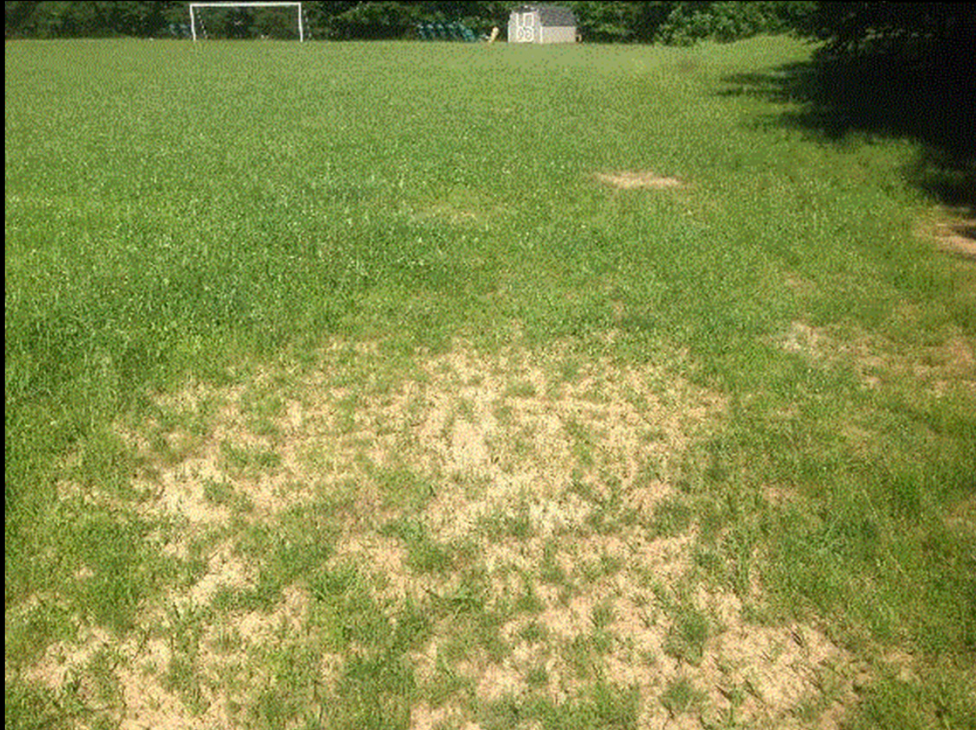
03. Barren Areas and Planarity Changes

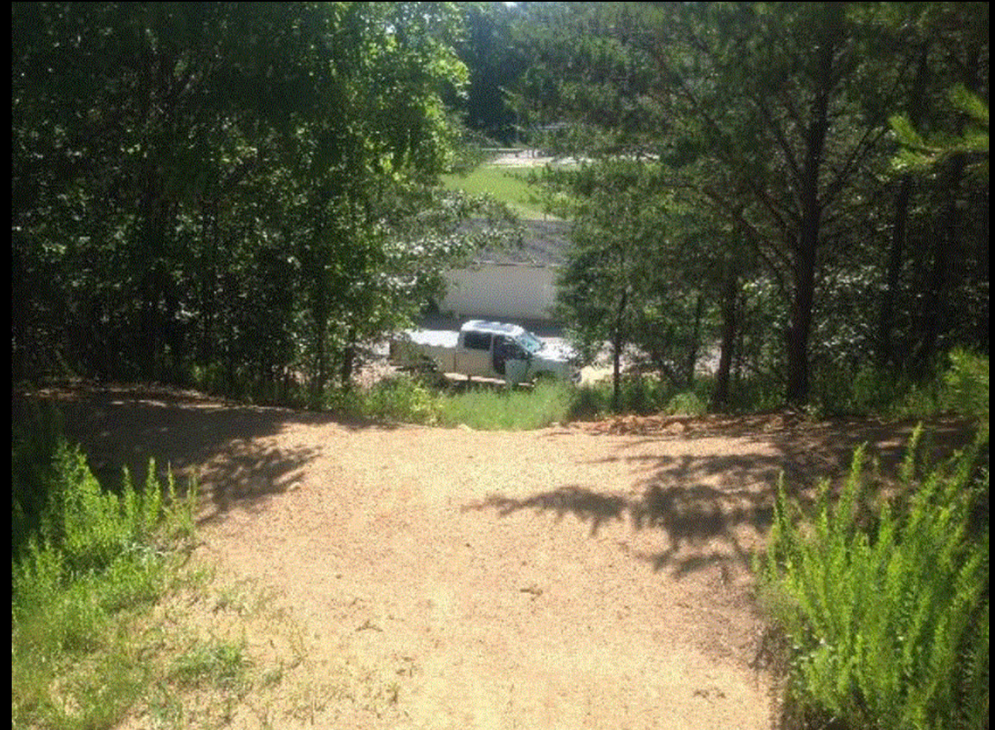
04. Difficult Field Access

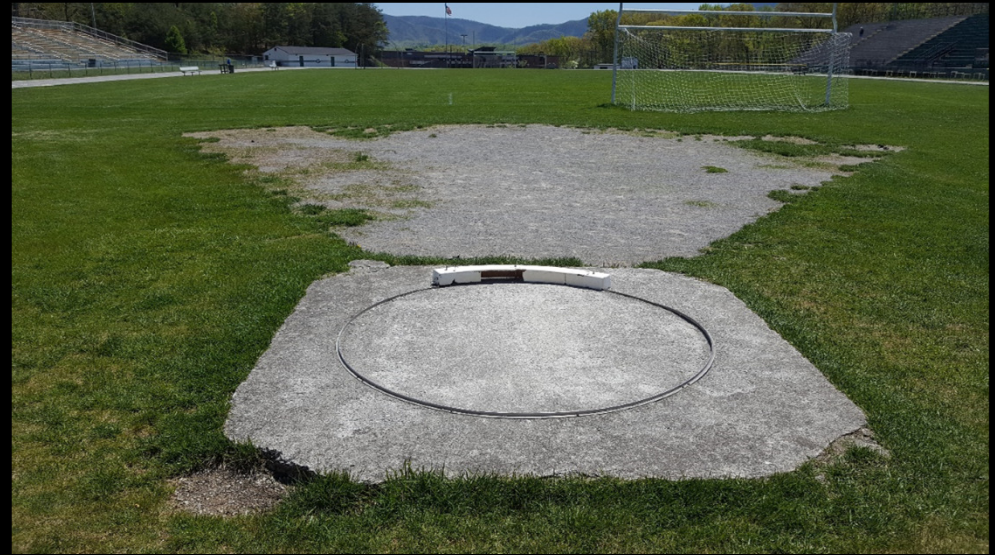
04. Shot Put Not in Conformance

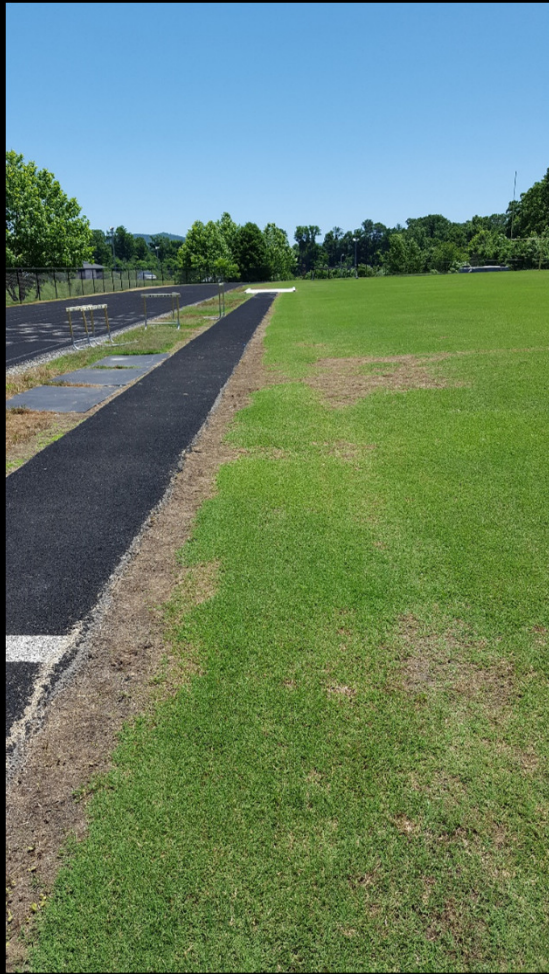
01. Barren Areas Signs of Ponding

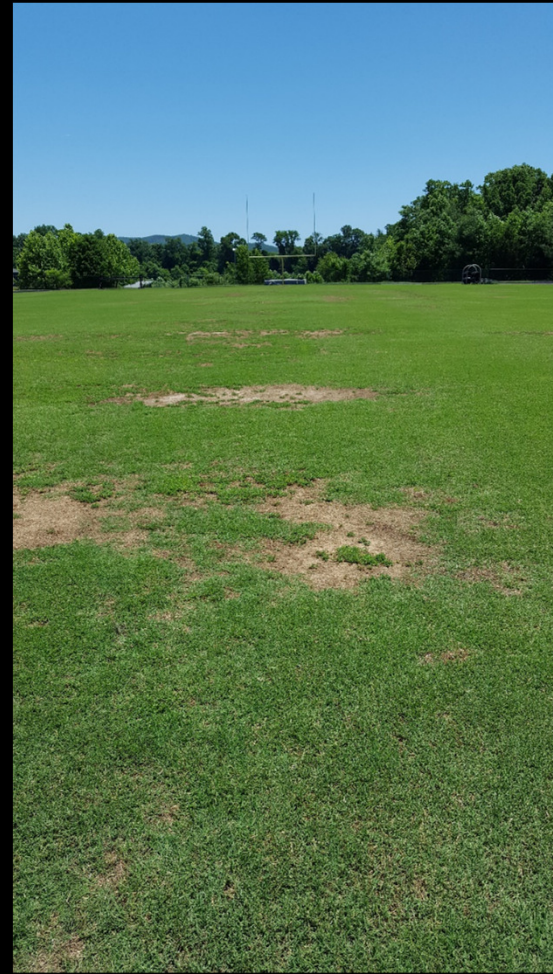
02. Barren Areas and Planarity Changes

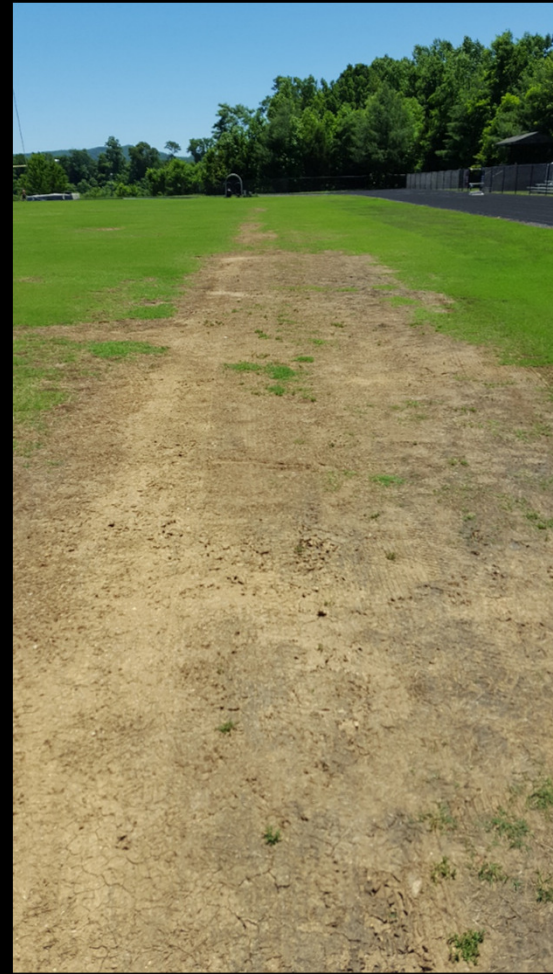
04. Barren Areas

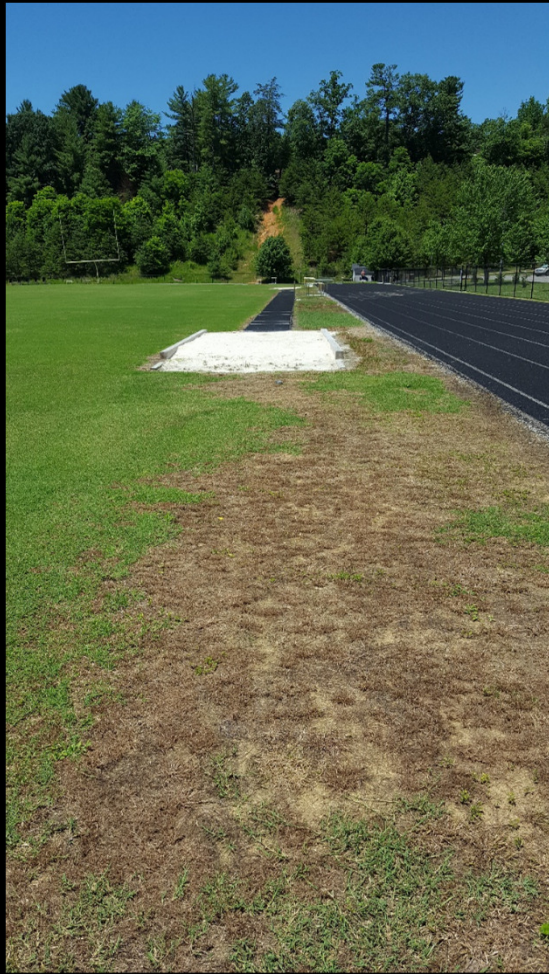
05. Barren Areas
