ATHLETIC FACILITIES CONDITION ASSESSMENT

Roanoke County Public Schools
Roanoke, Virginia

July 30, 2018

Draper Aden Associates
Engineering • Surveying • Environmental Services

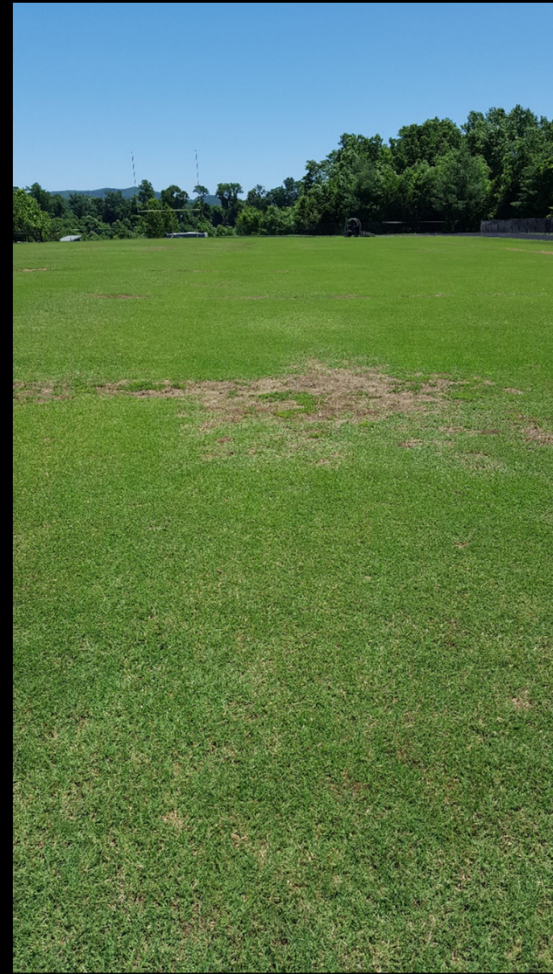
06. Barren Areas and Planarity Changes

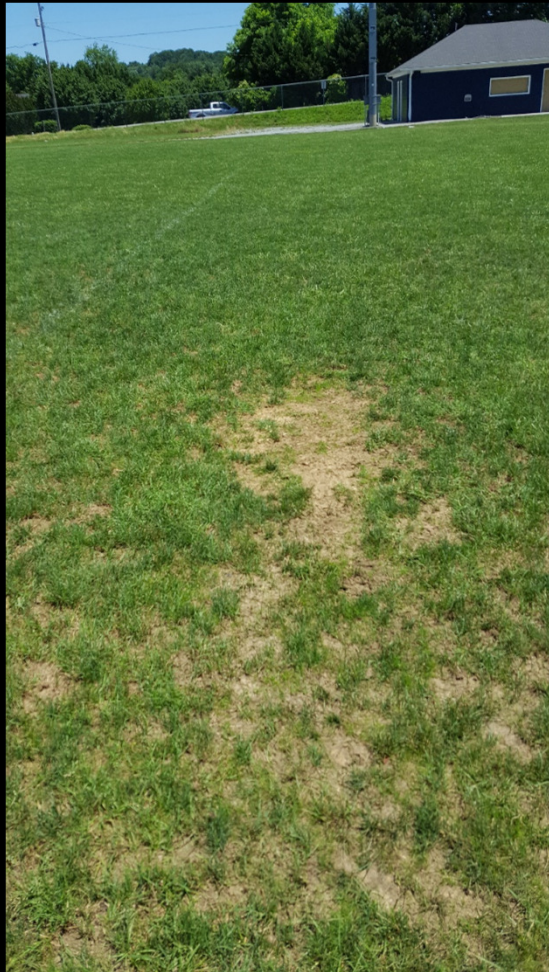
01. Barren Areas and Planarity Changes

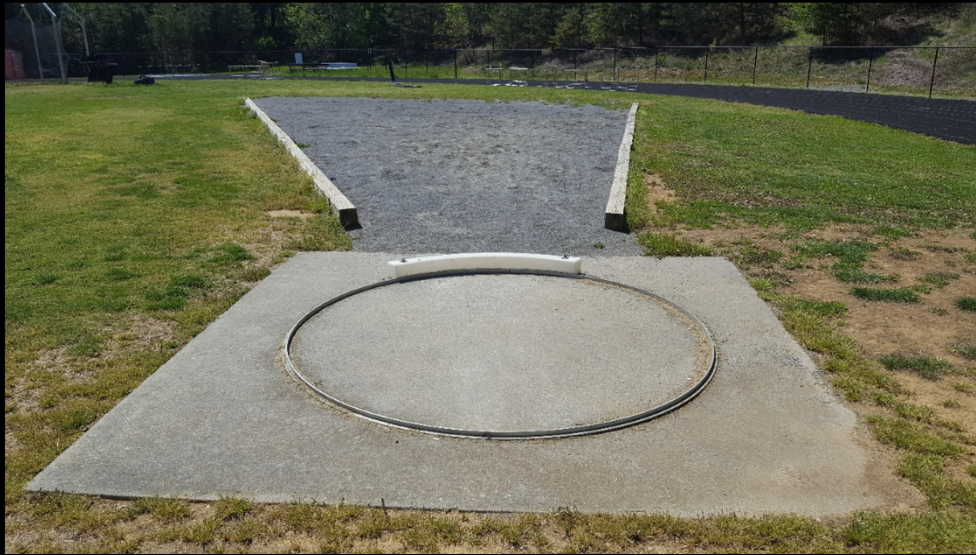
03. Shot Put

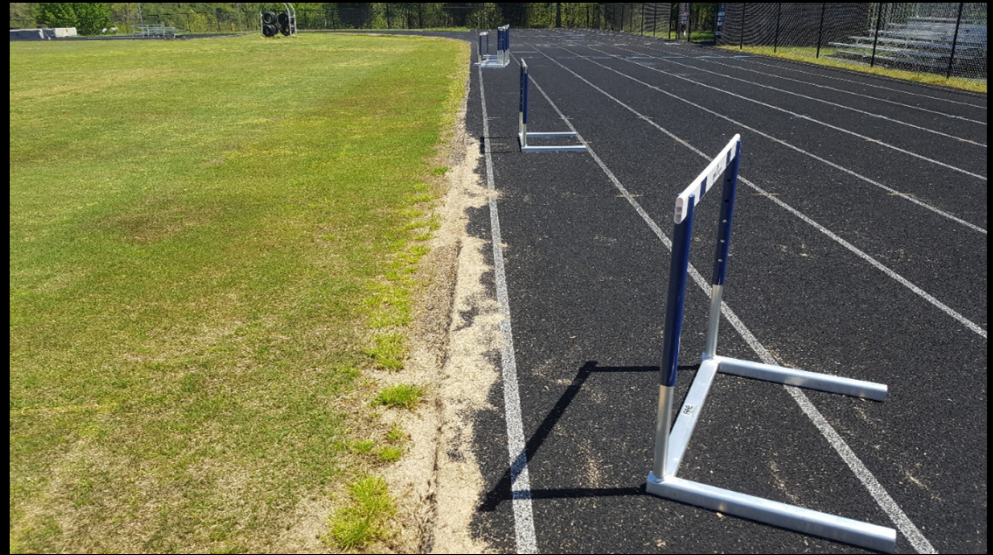
04. Inside Edge No Curb or Trench Drain

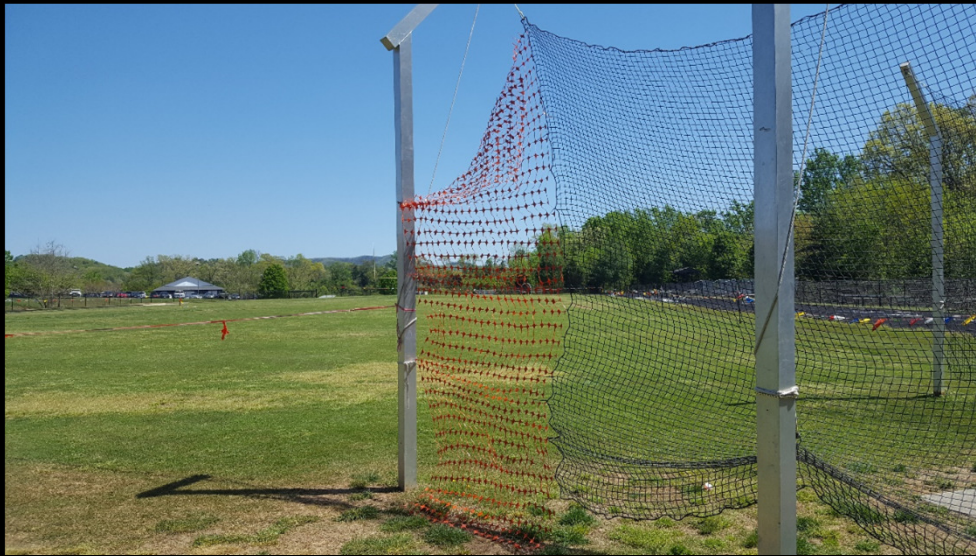
05. Incorrect Netting

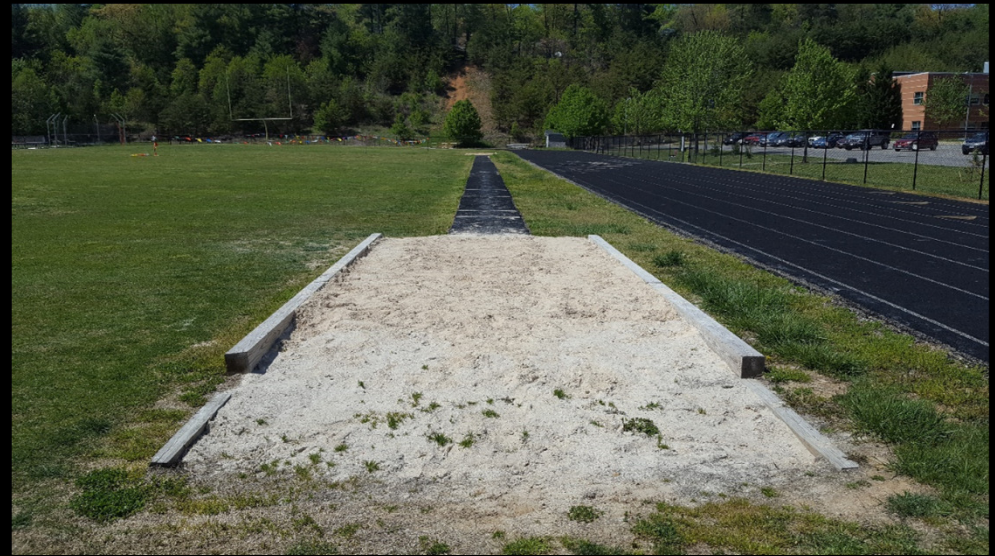
06. Sand Pits
