## Canutillo ISD - Facility Condition Assessment

### Facility Condition by Campus

# **Facility Condition Assessment** Canutillo H. School Condition Assessment

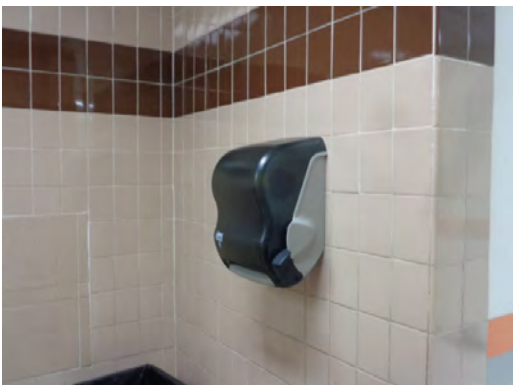
Alderete\_MS Replace paper towel holders with hand dryers

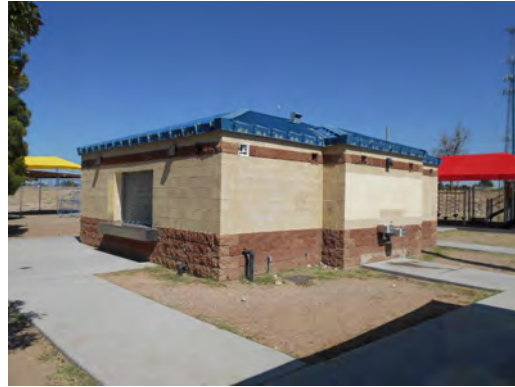
Canutillo ES\_Clean CMU before painting

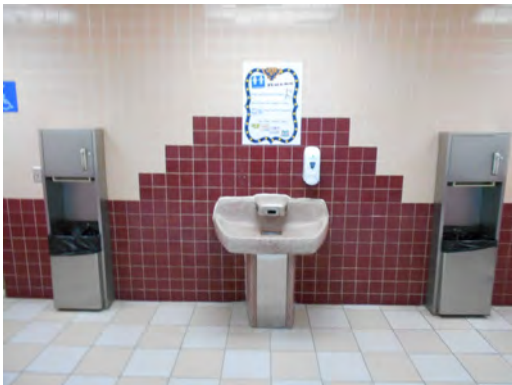
Davenport\_ES Replace paper towel holders with hand dryers

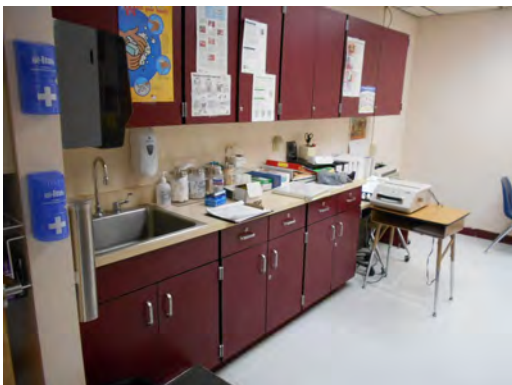
Davenport\_ES Replace built-in base cabinets

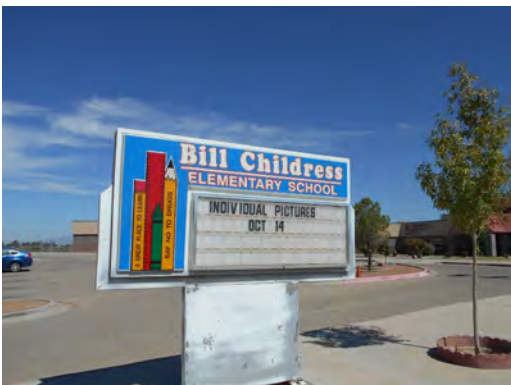
| Deficiency | Category | Qty | UoM | Priority | Repair Cost | ID |
|---|---|---|---|---|---|---|
| Site Marquee Is Damaged And Requires Replacement | Repair | 1 | Ea. | 4 | \$7,351 | 131 |

Childress ES\_Marquee

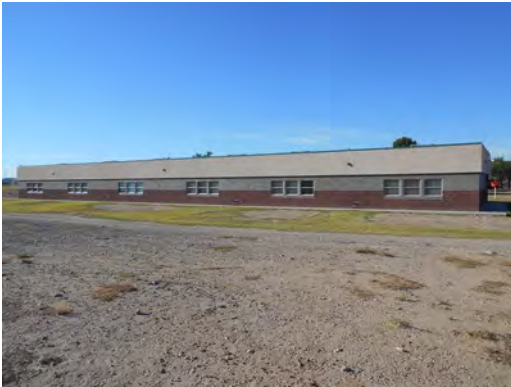
| Deficiency | Category | Qty | UoM | Priority | Repair Cost | ID |
|---|---|---|---|---|---|---|
| Site Drainage Requires Regrading | Repair | 2,800 | SF | 4 | \$1,740 | 132 |

Childress ES\_Regarding required

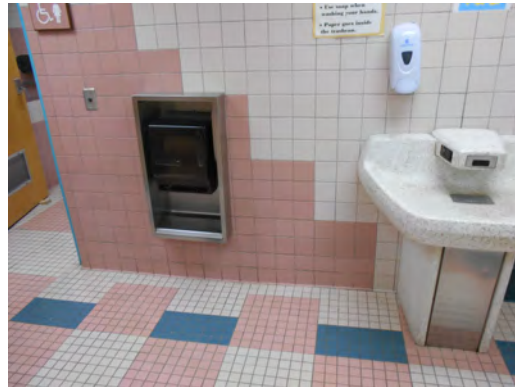
Childress ES\_Replace paper towel holders with electric dryers

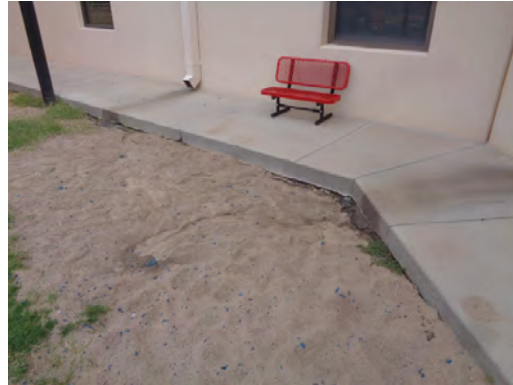
Garcia\_ES SiteDrainage, add storm drain in this area,

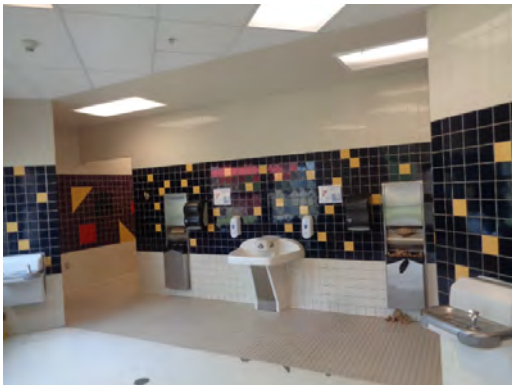
Garcia\_ES Replace paper towel holders with hand dryers

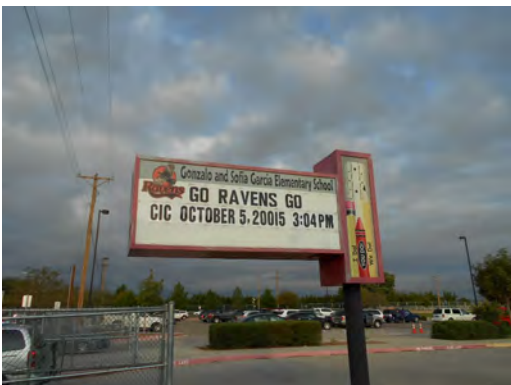
Garcia\_ES Old Marquee sign
