RE: Jones Park Playground Safety Inspection

Jones Park Playground Inspection Asheville, NC

Jones Park Playground
544 Kimberly Ave
Asheville, NC 28804

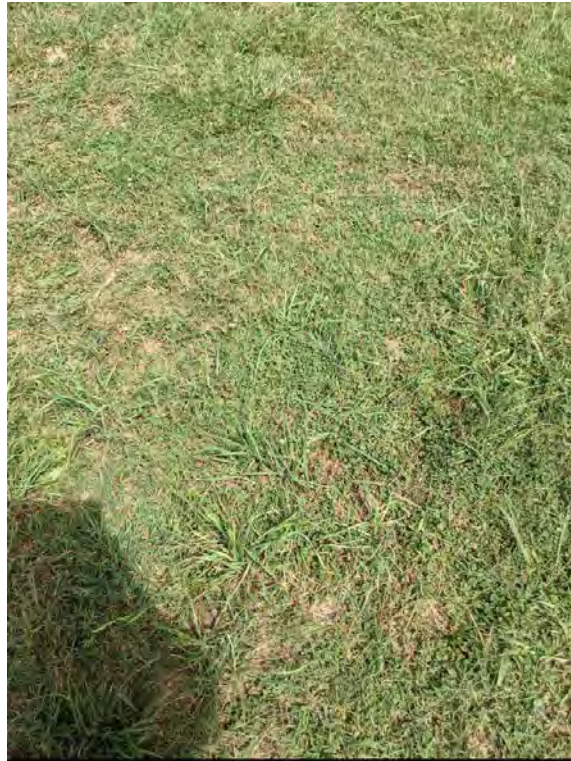
723.jpeg

NO ADA Path to Play Area

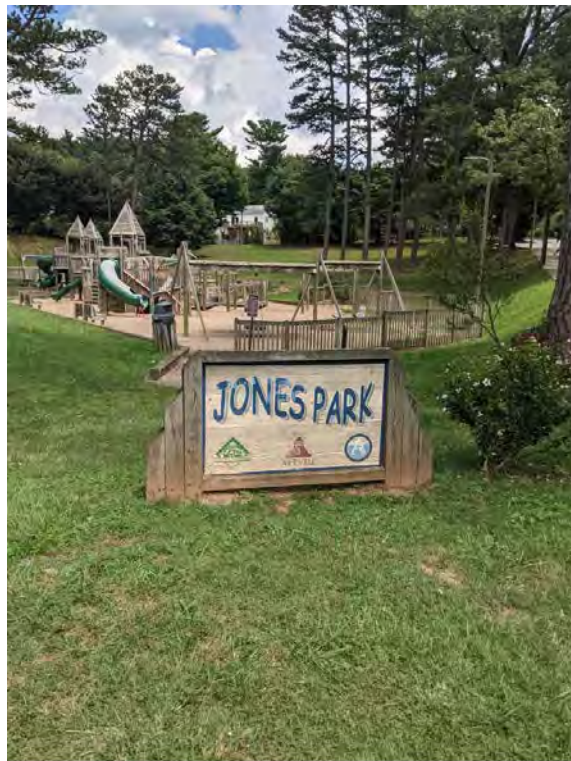
724.jpeg

No Age Appropriate, Manufacturer's ID or Safety Rules Sign Present

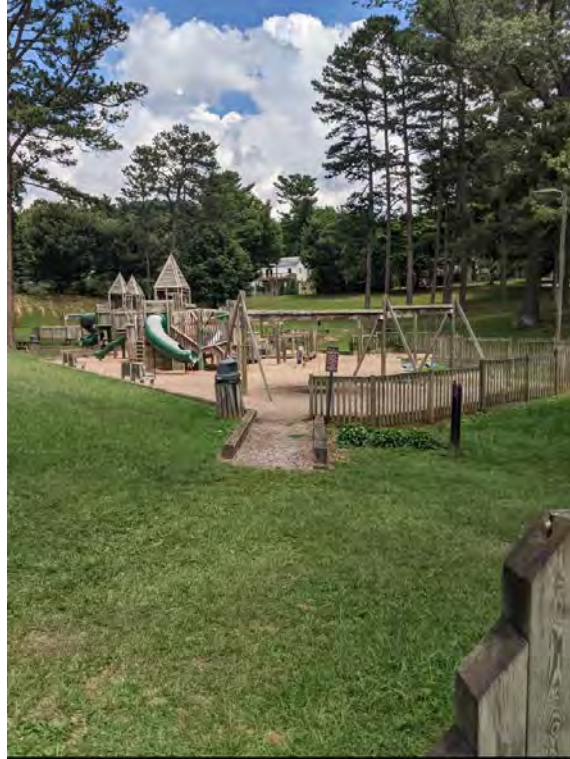
725.jpeg

No Clearly Identified ADA Entrance

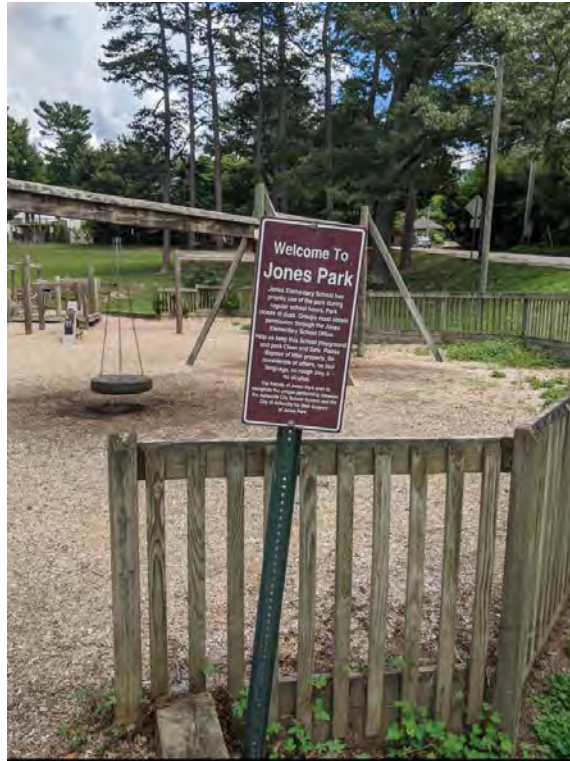
727.jpeg

**Entrance Sign Does Not Include
Intended Ages of Users
Manufacturer's Identification
Safety and Rule Information
ASTM Hard Surface and Other Labels**

Issue Identified **Playground does not have age-appropriate signage and/or labeling**
Recommendation *Review issues of non-compliance relating to Signage Failure to Warn items (see comments, notes and/or photo(s) for detail) and take appropriate steps to correct deficiencies.*

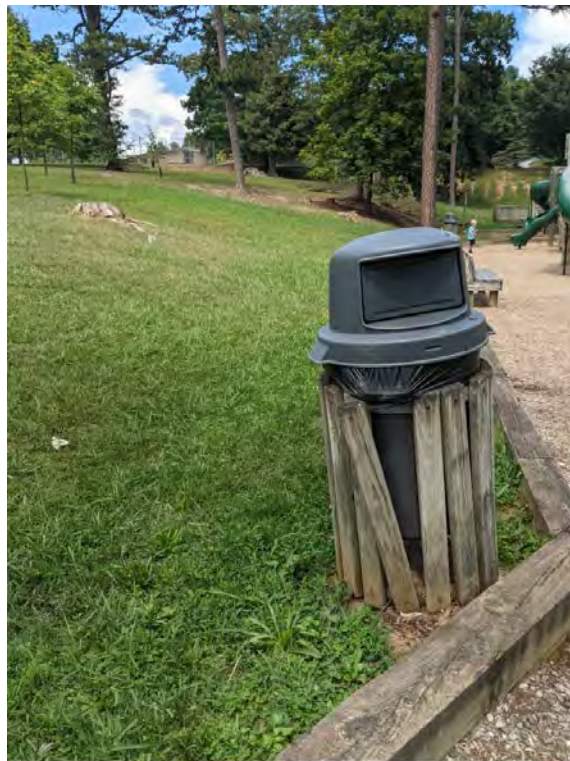
728.jpeg

Trash Receptacle Needs Repair

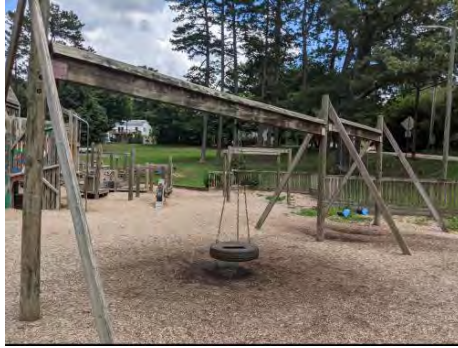
729.jpeg

Ponding Water Under Swing

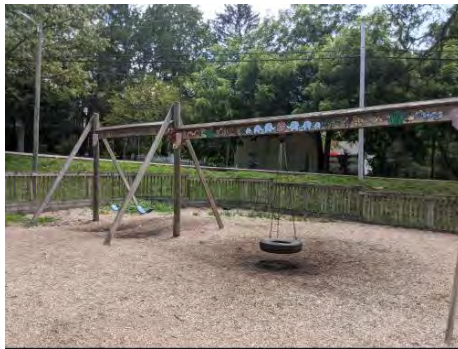
730.jpeg

Tire Swing Surfacing Less than 9"

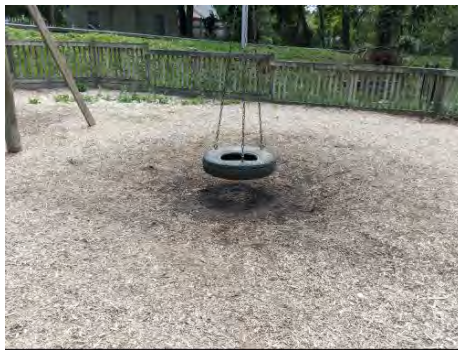
731.jpeg

Ponding Water Under Swing

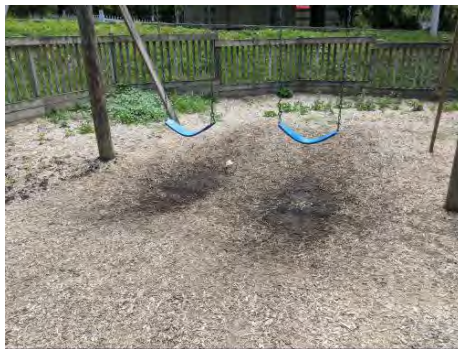
732.jpeg

Ponding Water Under Belt Swings

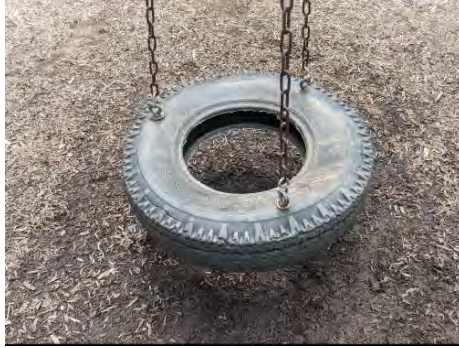
733.jpeg

Tire Swing Has Rusted Chains
Open S-Hooks

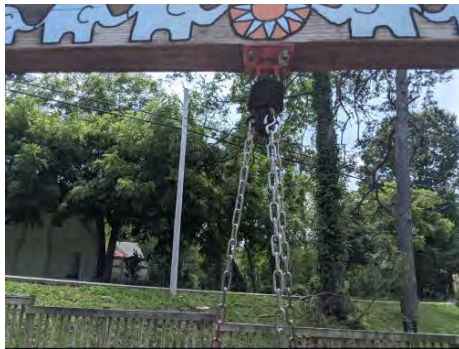
734.jpeg

Open S-Hooks

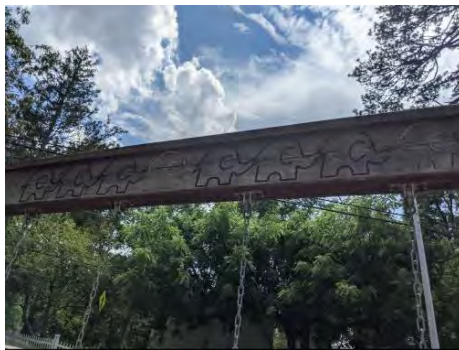
735.jpeg

Rusting Hardware

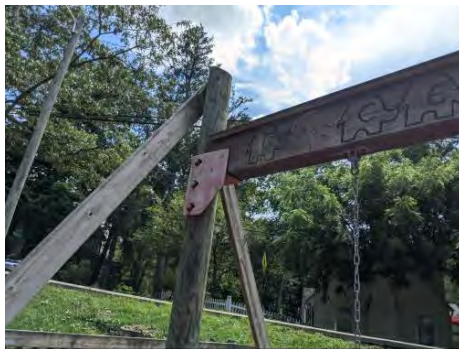
736.jpeg

Rusting Brackets

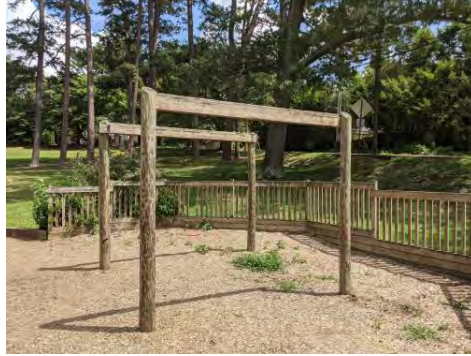
743.jpeg

No Longer In Use

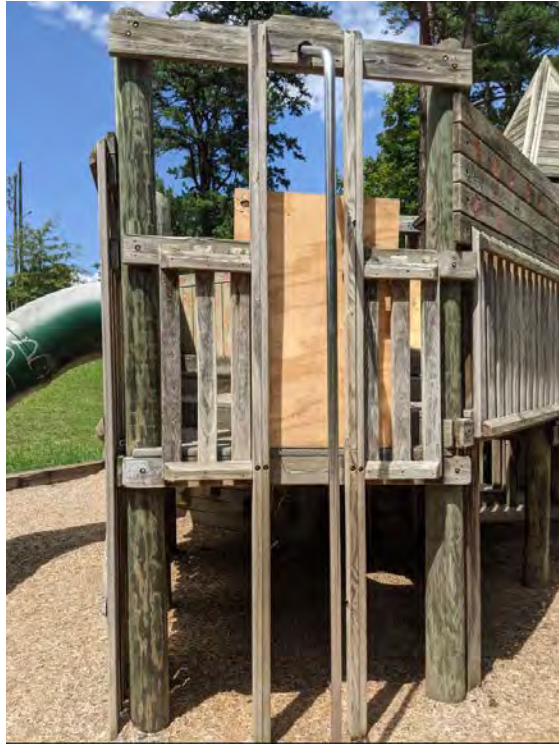
744.jpeg

Center Tire Deck - Blocked Off

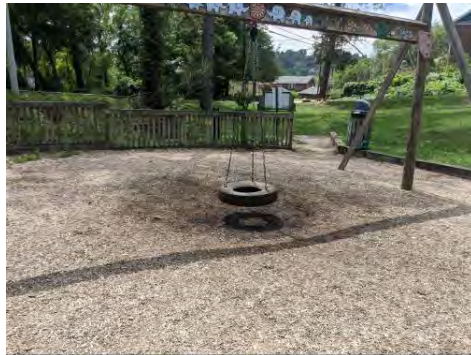
745.jpeg

Tire Swing Needs More Surfacing

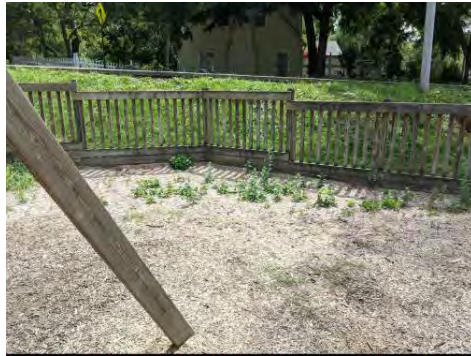
746.jpeg

Maintenance Neglect

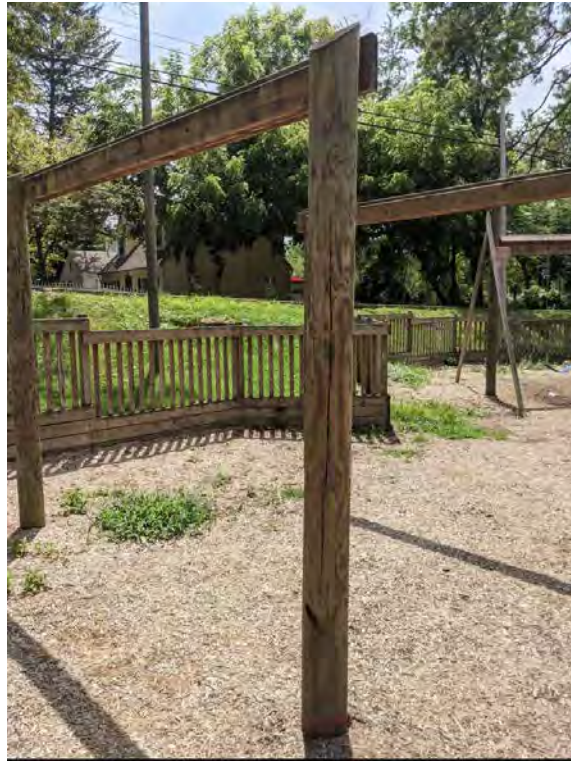
749.jpeg

Possible Track Ride

No Longer In Use

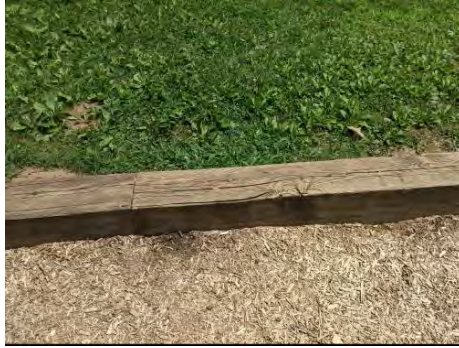
751.jpeg

Borders Are Cracking

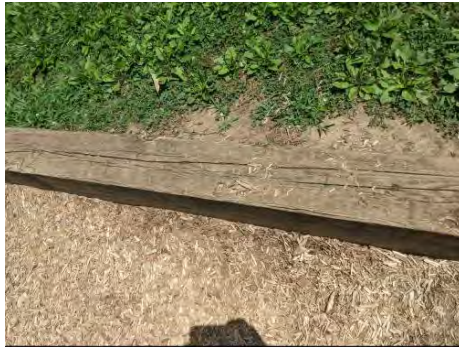
752.jpeg

Borders Are Cracking

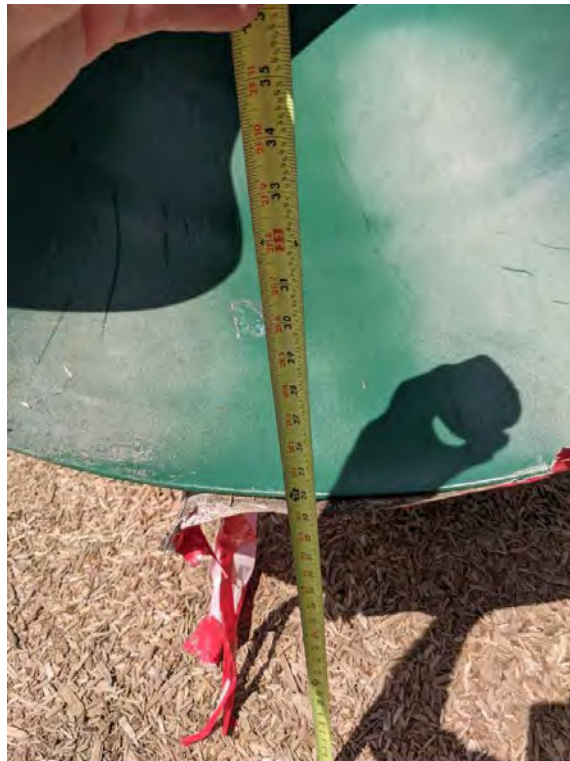
756.jpeg

Exceeds Maximum Height of 15"

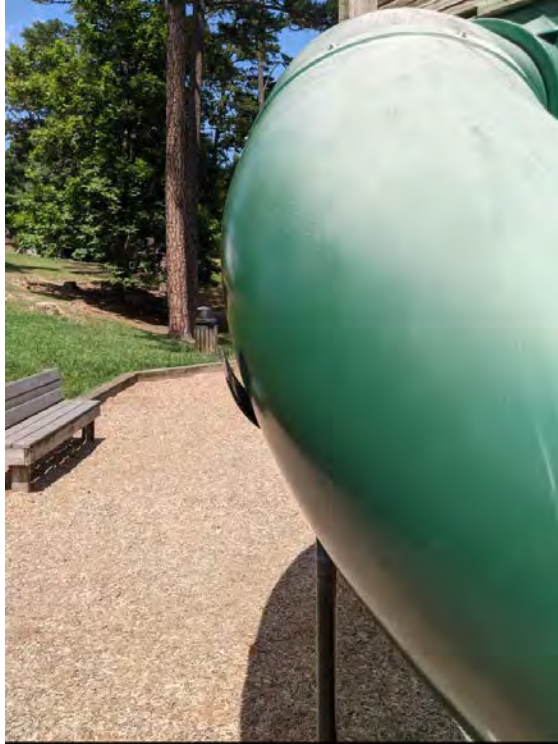
759.jpeg

**Slide Support Bracket Is Loose
Missing Bolt**

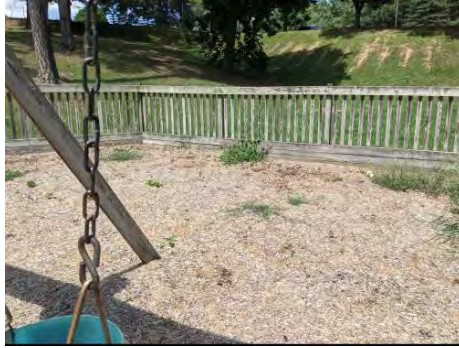
762.jpeg

Comments Open S-Hook on Tot Swing

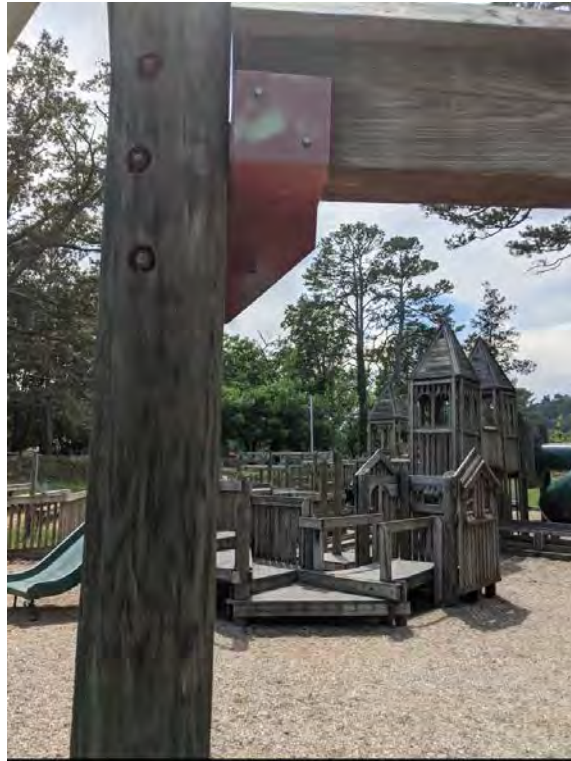
766.jpeg

Rusting Bracket

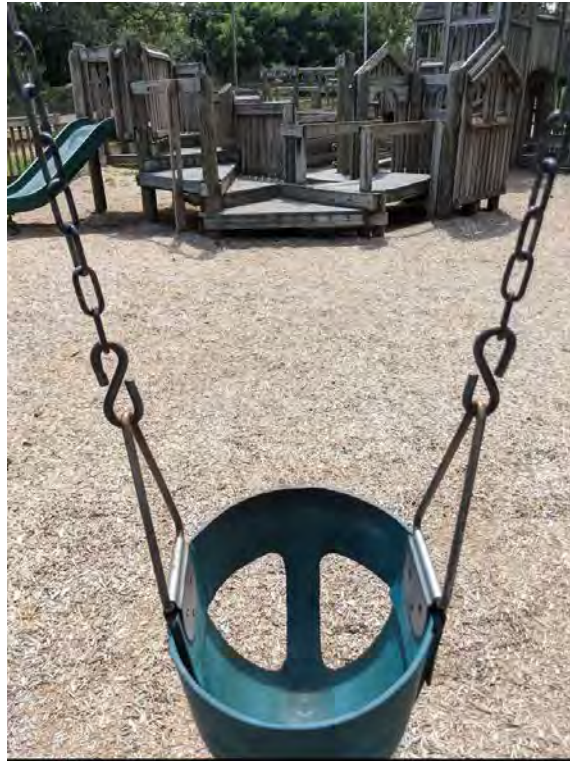
768.jpeg

Tot Swing Chains Are Rusting

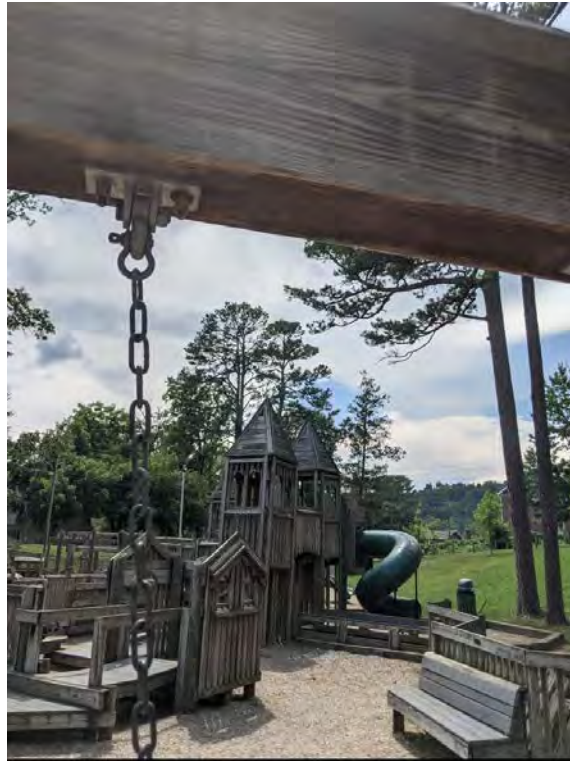
770.jpeg

**Incorrect Hardware on Tot Swing
Has Protruding Bolt**

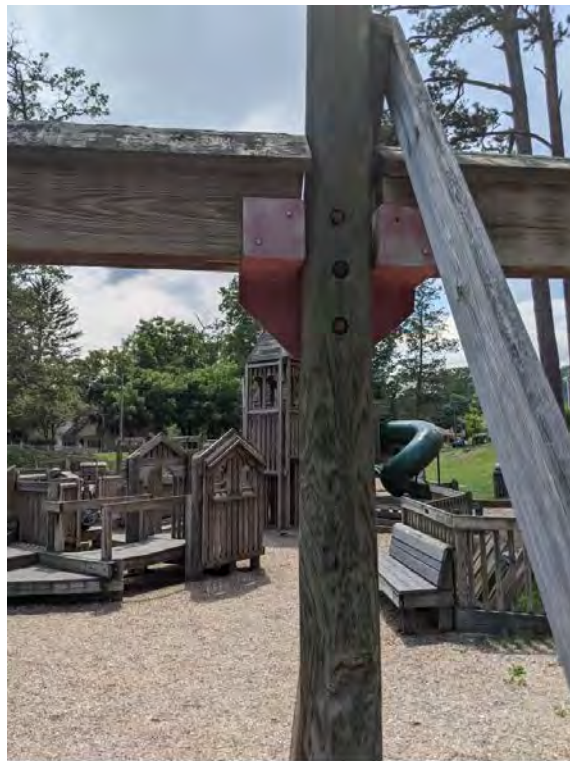
771.jpeg

Rusting Hardware

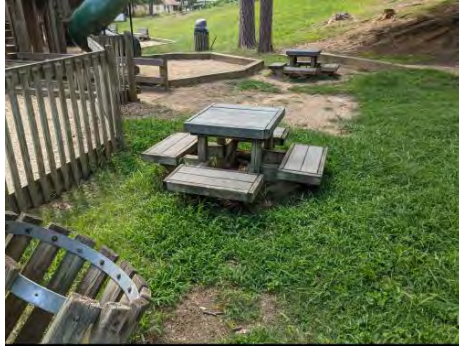
(60)

Picnic Table Has Cracks

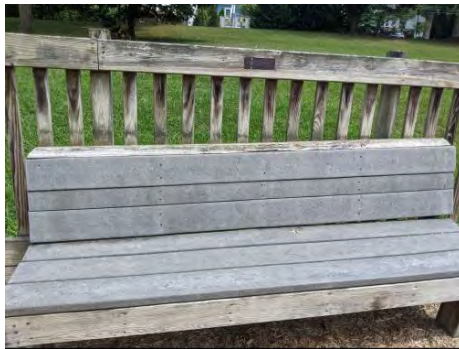
(61)

Bench Has Cracks

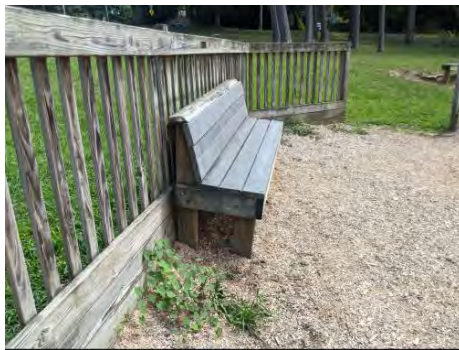
(62)

Bench Has Cracks

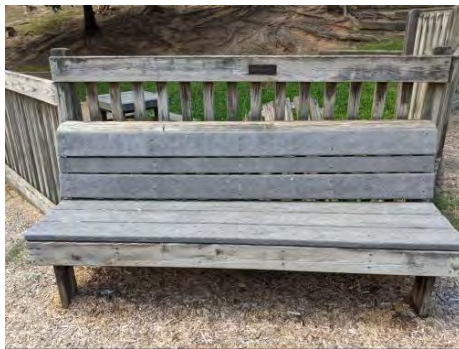
(63)

Bench Has Cracks

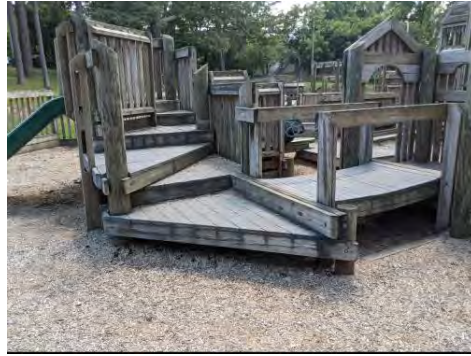
(65)

Possible Intended ADA Platform

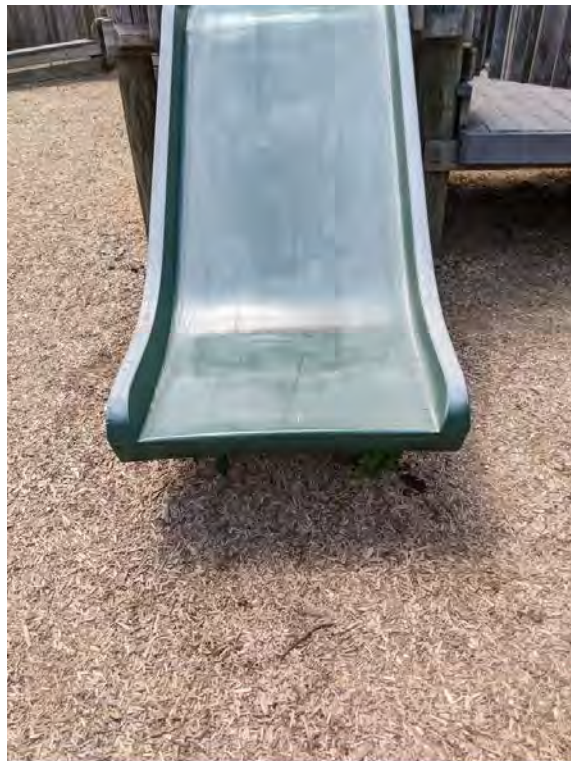
(68)

Comments _____
Slide Exit Too High

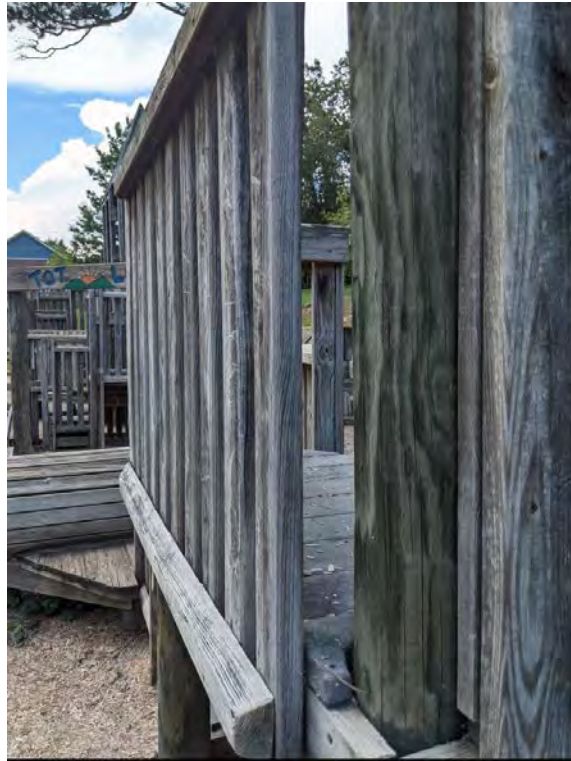
(69)

Comments Multiple Cracks in Wood

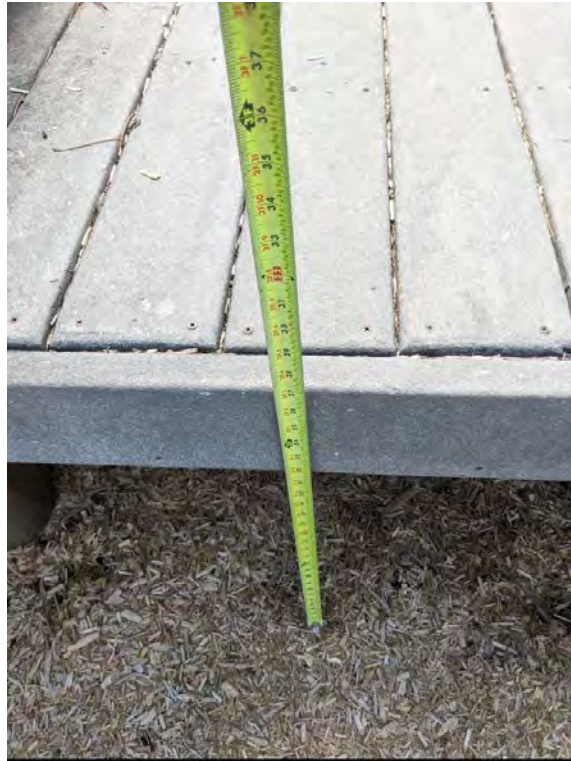
(71)

Platform Exceeds ADA 18" Maximum Height

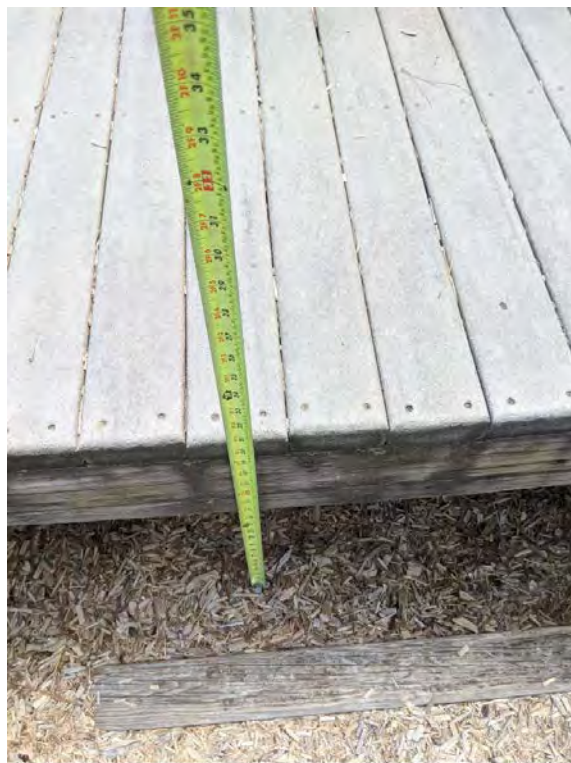
(72)

Platform Exceeds ADA 18" Maximum Height

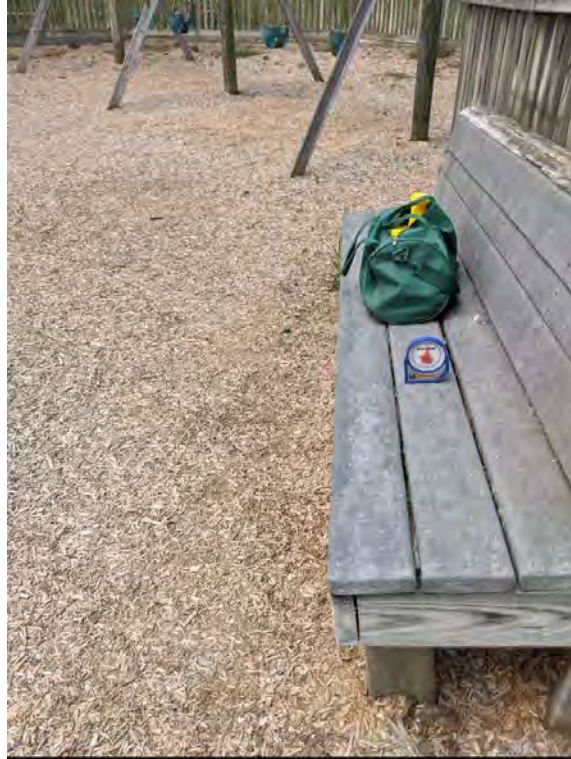
(75)

Bench Is Not Level

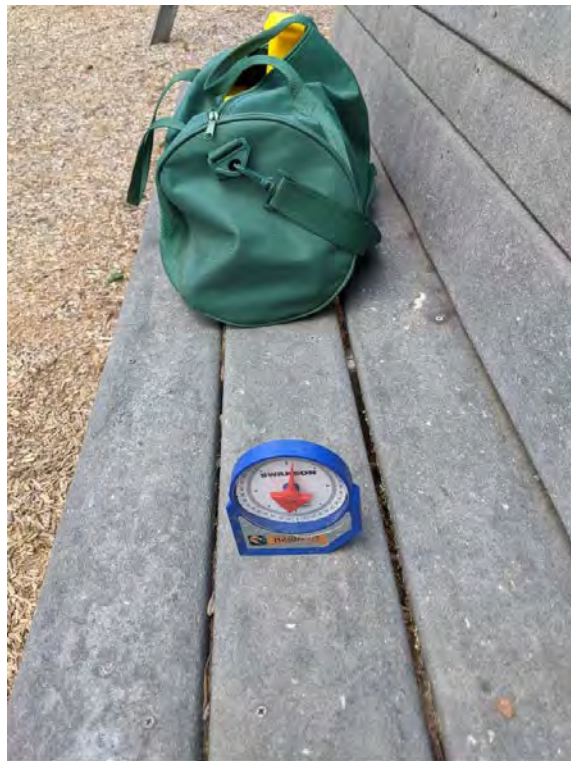
(76)

Bench Slope is Over 2%

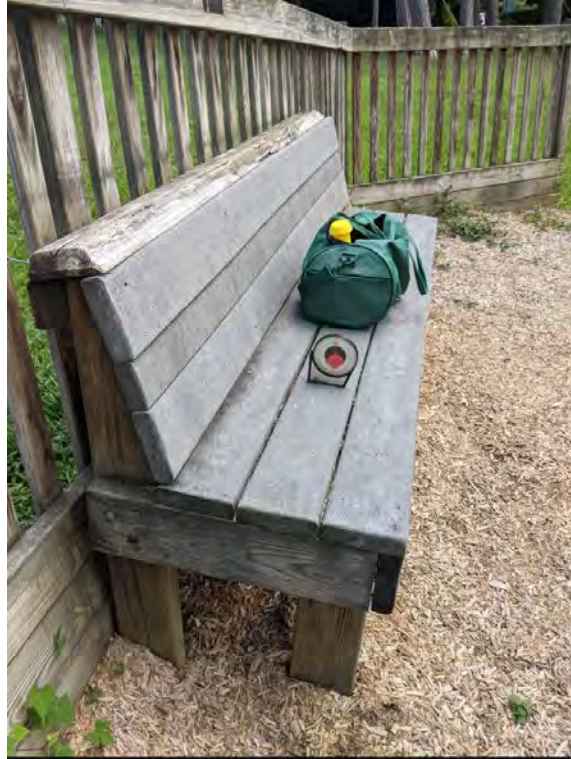
(77)

Bench Not Level

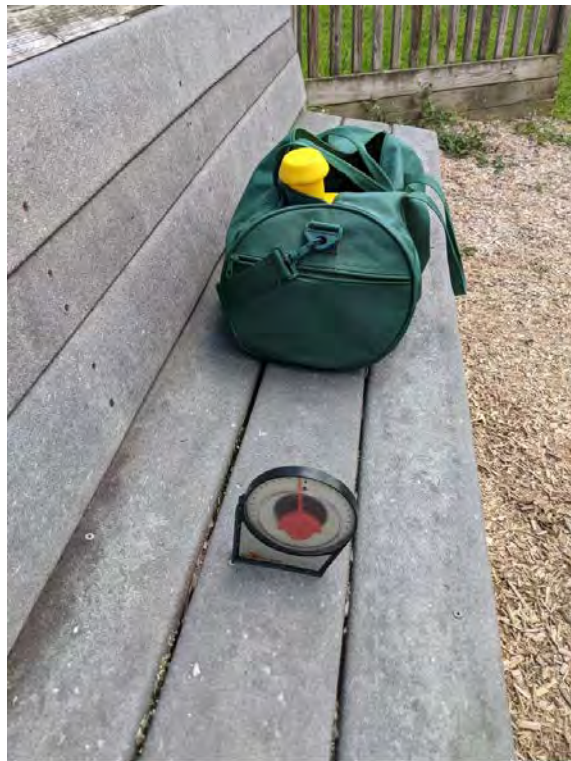
(78)

Bench Not Level

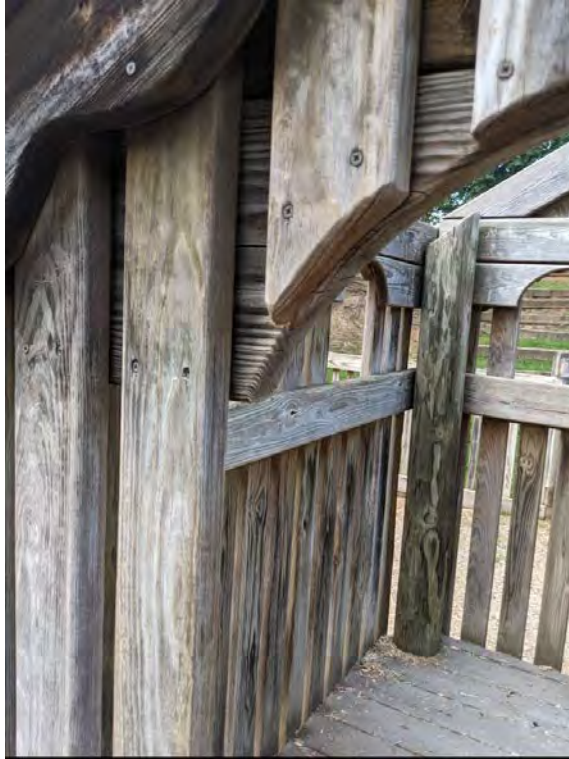
(109)

Sharp Edge at Bottom of Board

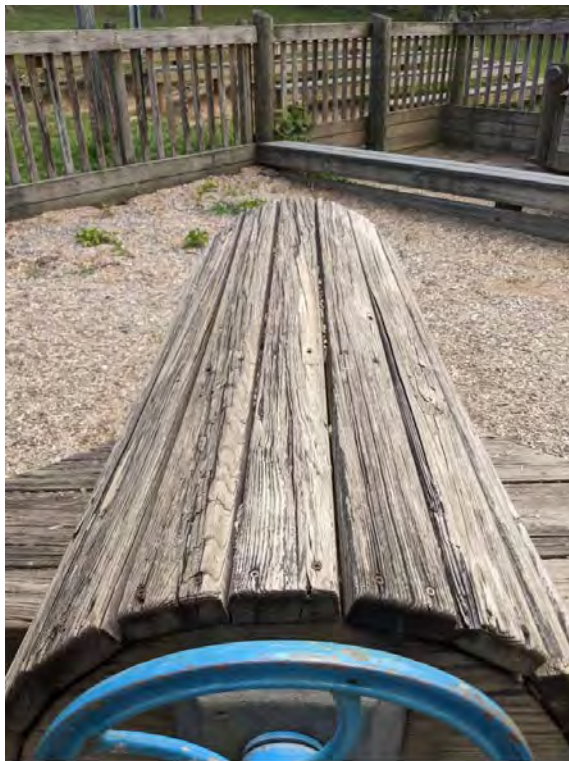
(110)

Multiple Cracks in Wood

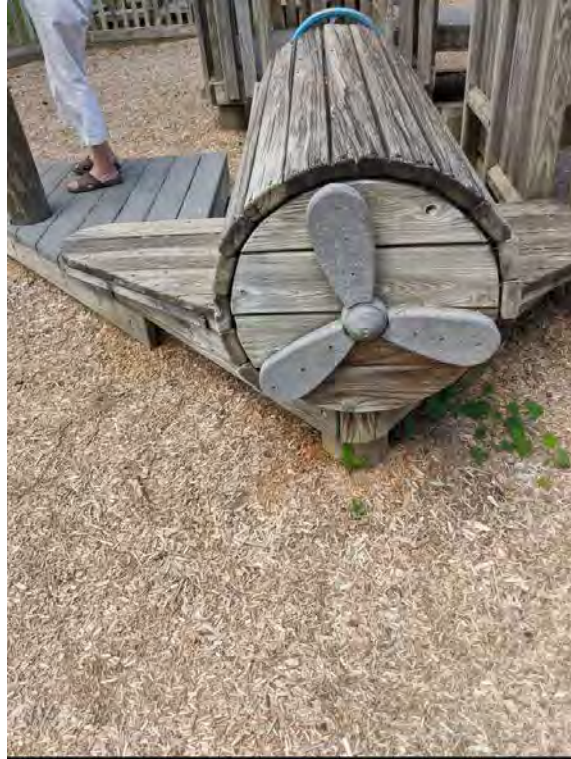
(115)

Cracks in Wood

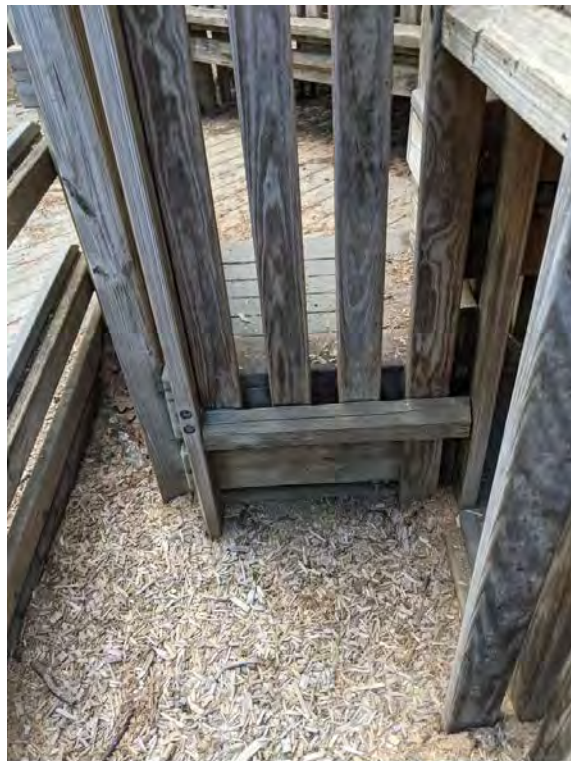
(116)

Cracks in Wood

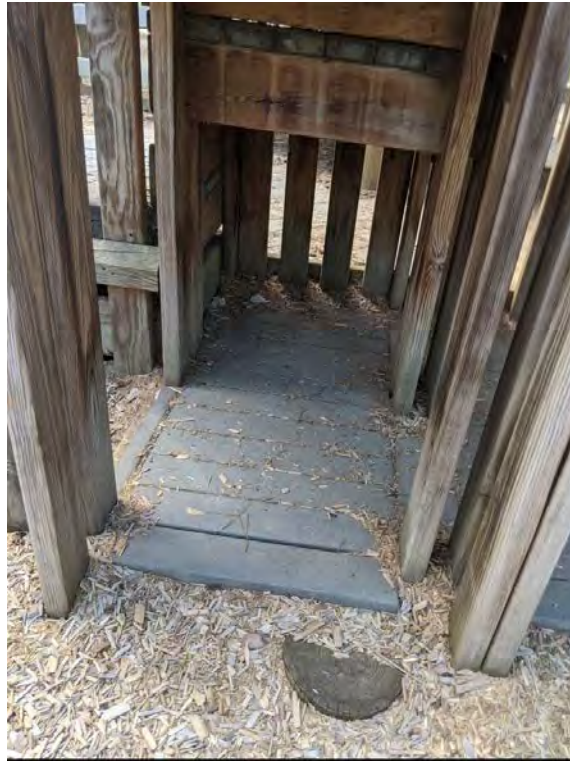
(117)

Cracks in Wood

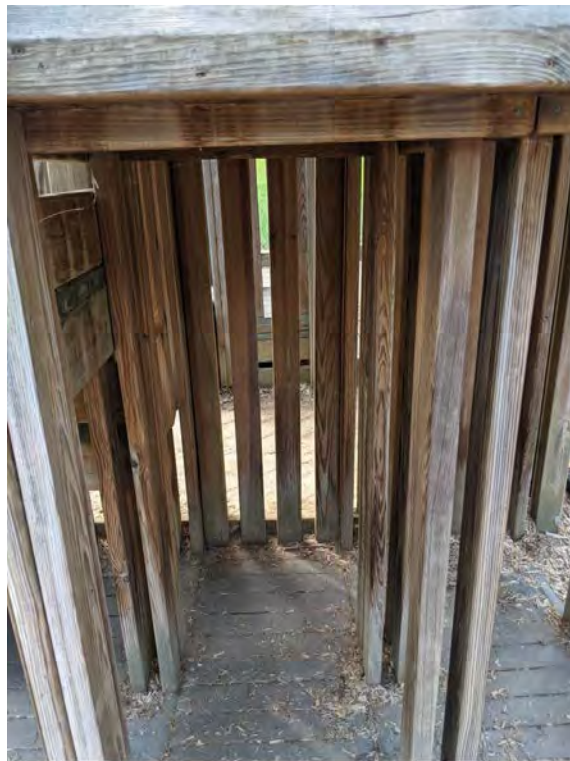
(118)

Cracks in Wood

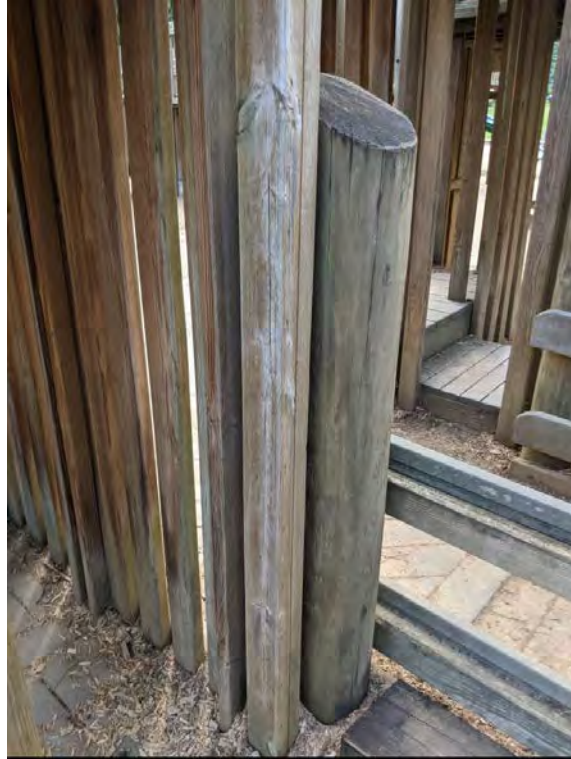
(121)

Cracks in Wood

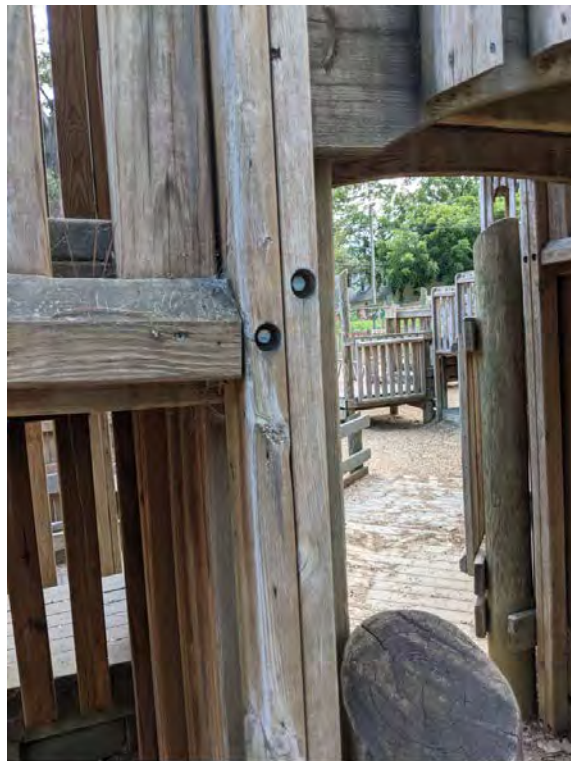
(122)

Cracks in Wood

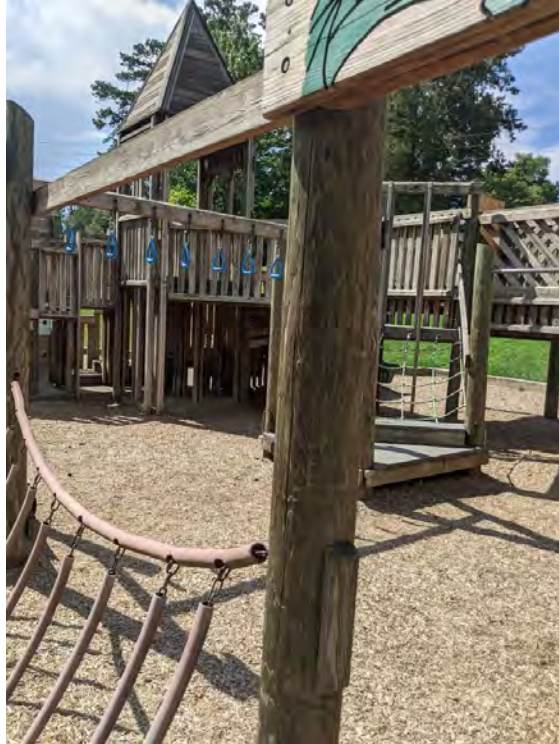
(1)

Comments [Splinters](#)

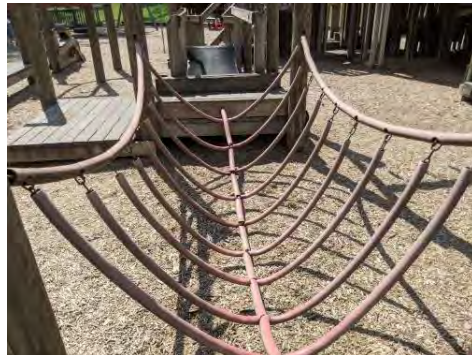
(2)

Comments [Flexible Bridge](#)
[Plastic Cracking](#)

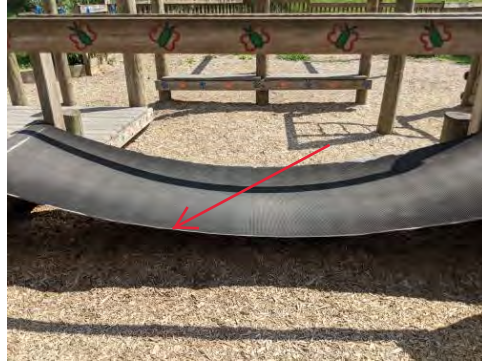
(8)

Rubber Bride Edges Are Worn

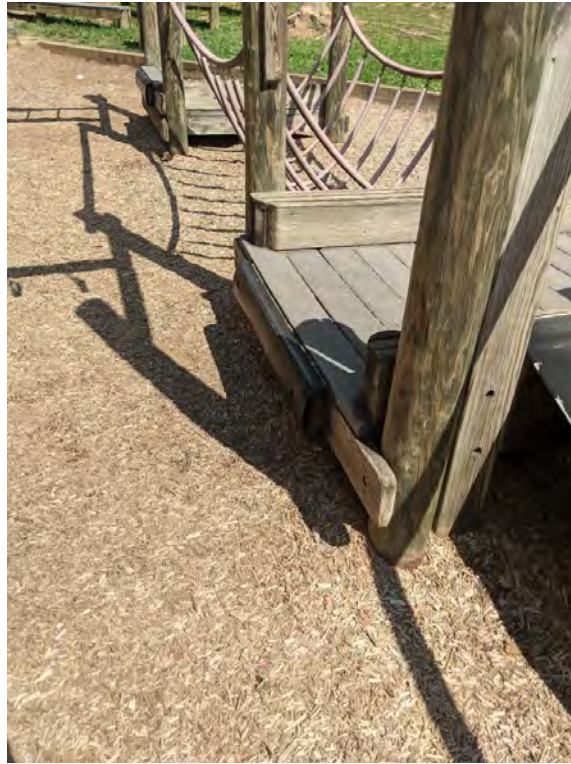
(9)

Open Hole on Rubber Pad

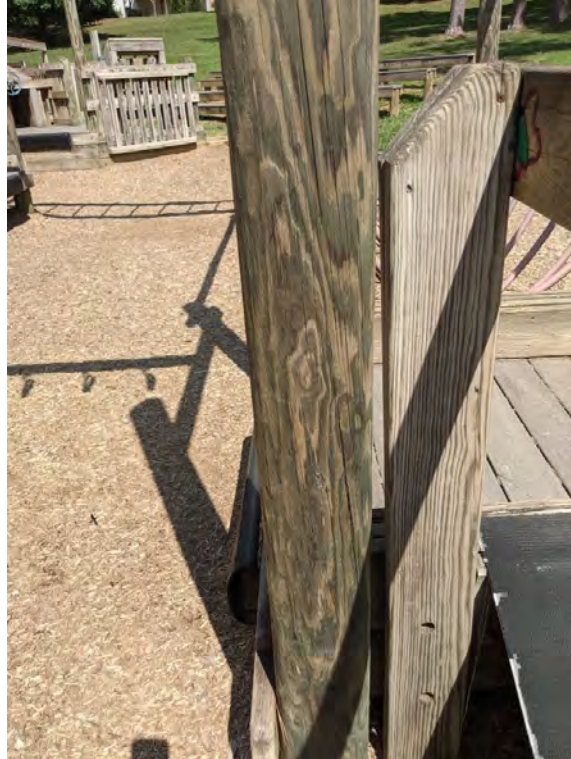
(10)

Post Cracking

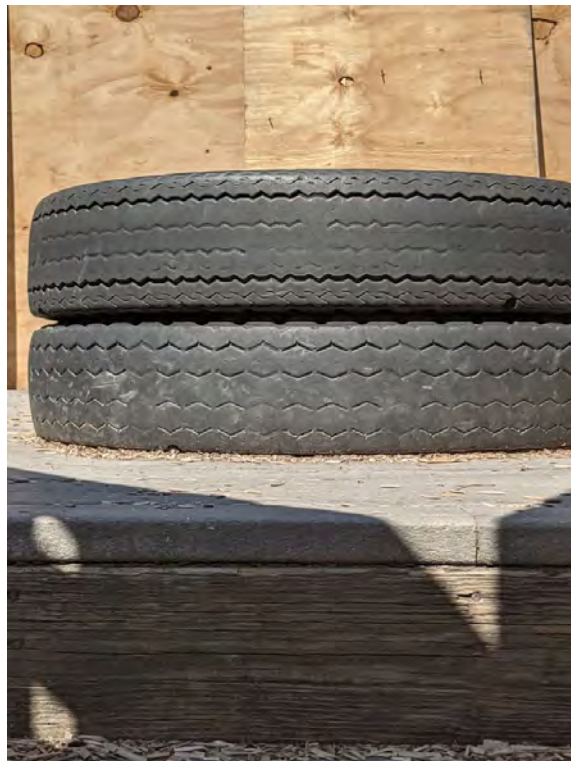
(15)

Deck View of Open Hole on Tire Component

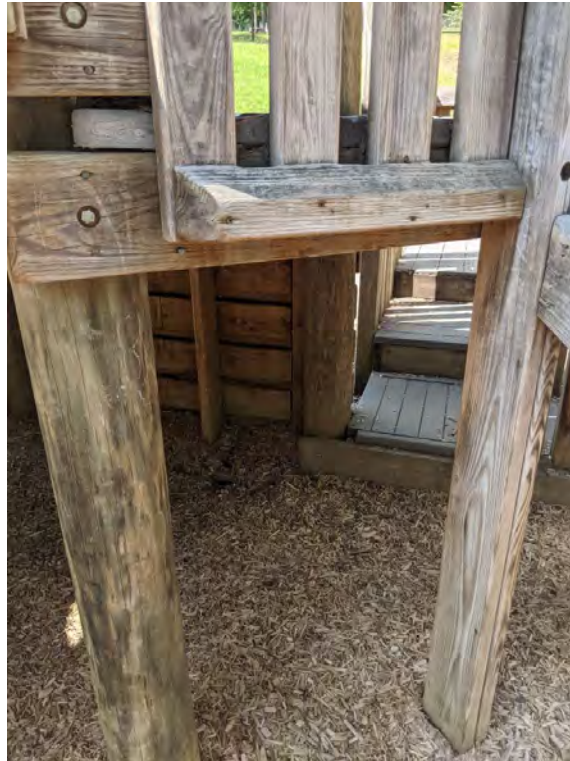
(16)

Cracks and Splinters

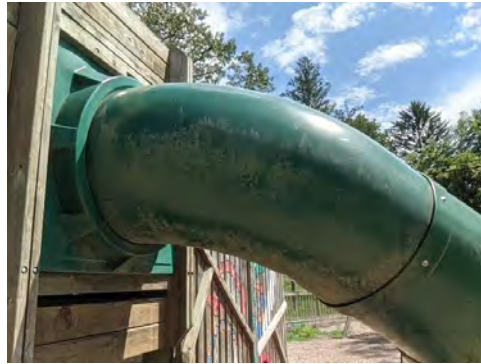
(34)

Comments _____
Spiral Tube Slide Needs Cleaning

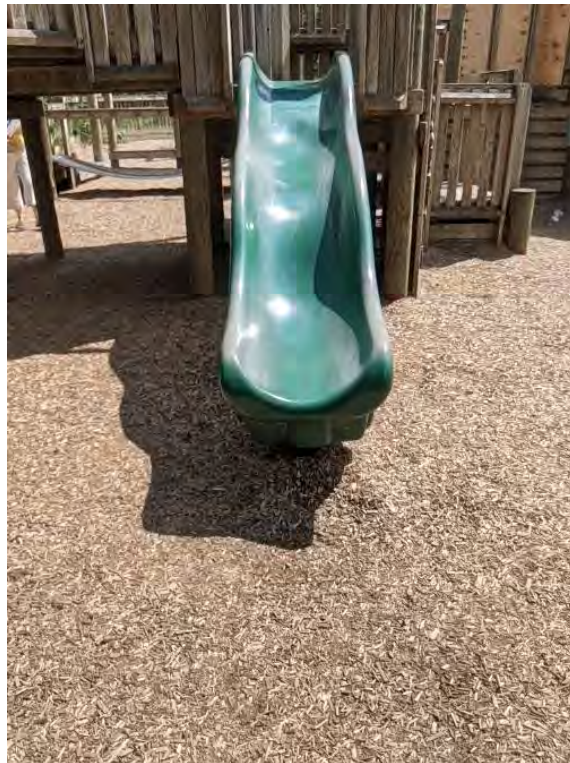
(35)

Comments _____
Wave Slide Exit

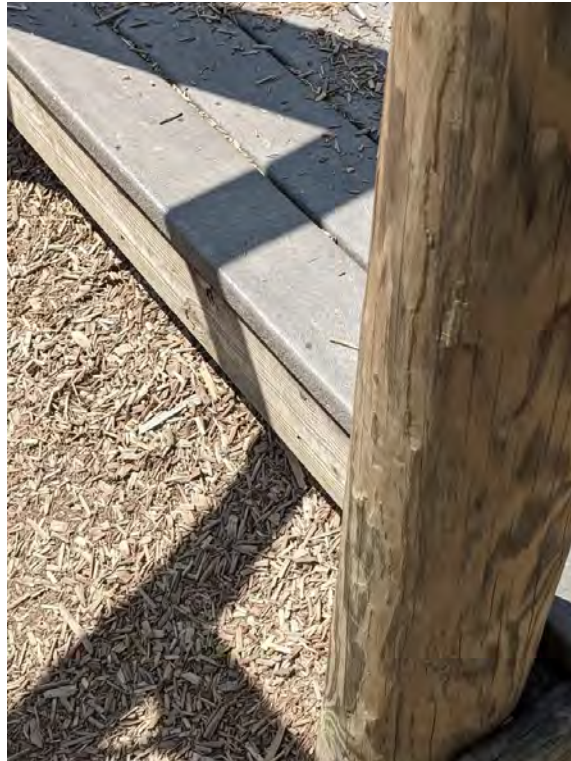
(36)

Small Cracks in Post

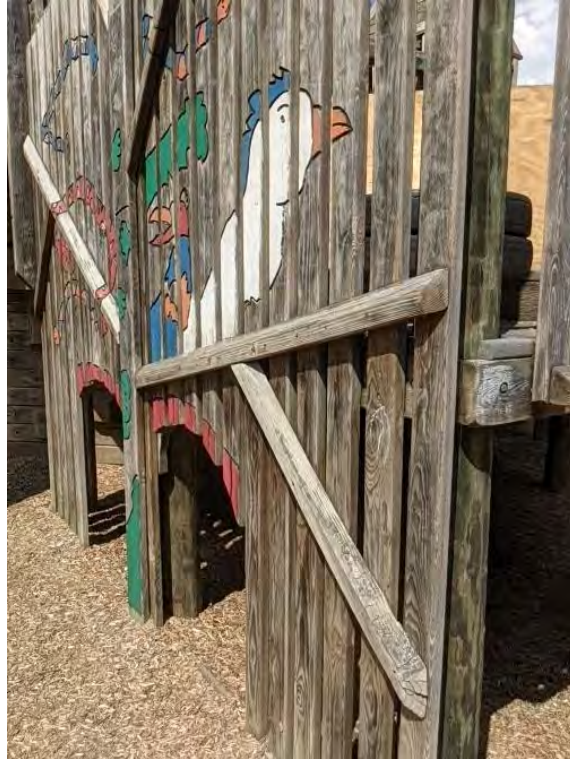
(38)

Cracks

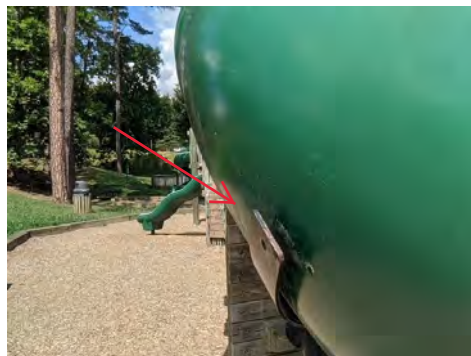
(44)

Spiral Tube Slide Exit Has Sharp Edge

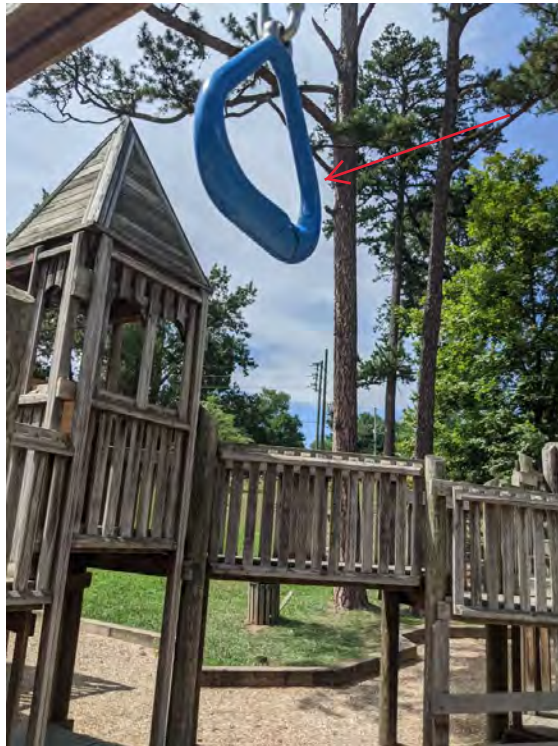
(62)

Comments _____
Rings Treks
